KIRK STREET AGENTS' HOUSE

Lowell National Historical Park

KIRK STREET AGENTS' HOUSE
HISTORIC STRUCTURE REPORT

Lowell National Historical Park
Lowell, Massachusetts

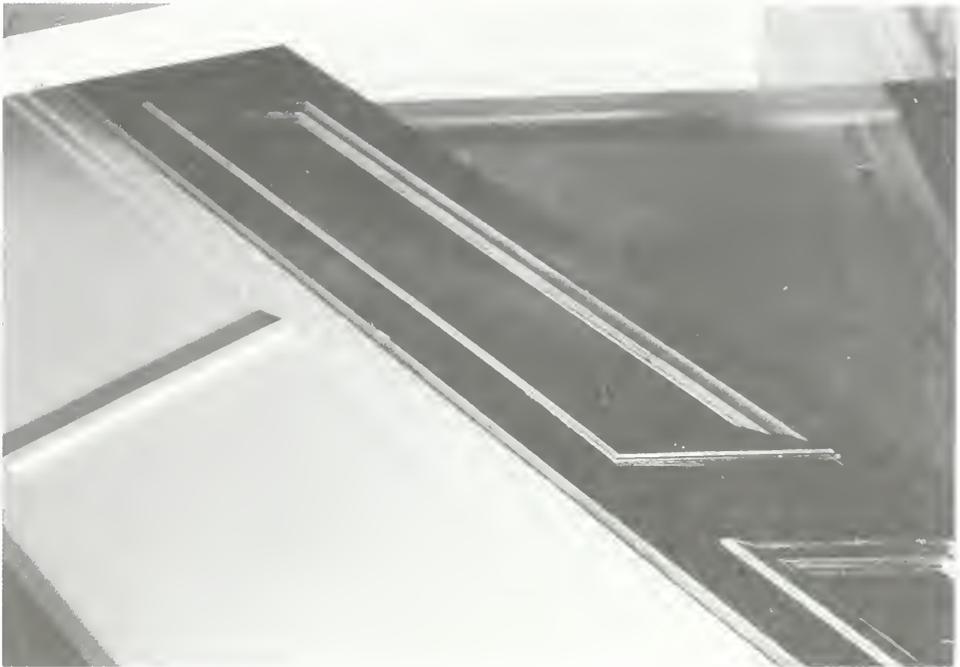
**Figure 49. Room N102 (North-Unit Stair
Hall), 1870's Paneling on Stair Stringer.**

Staircase. The staircase is original, and it has retained its original Type-1 baseboard. It is thought that the original newel and balustrade here were replaced with more elaborate ones, and that the stair stringer and stairwell fascia board were decorated with recessed paneling, in the 1870's. The 1870's paneling remains, but the 1870's newel and balustrade have been replaced with a modern newel and a solid balustrade of boards and plywood (fig. 49). The paneling is in good condition, but it needs to be refinished.

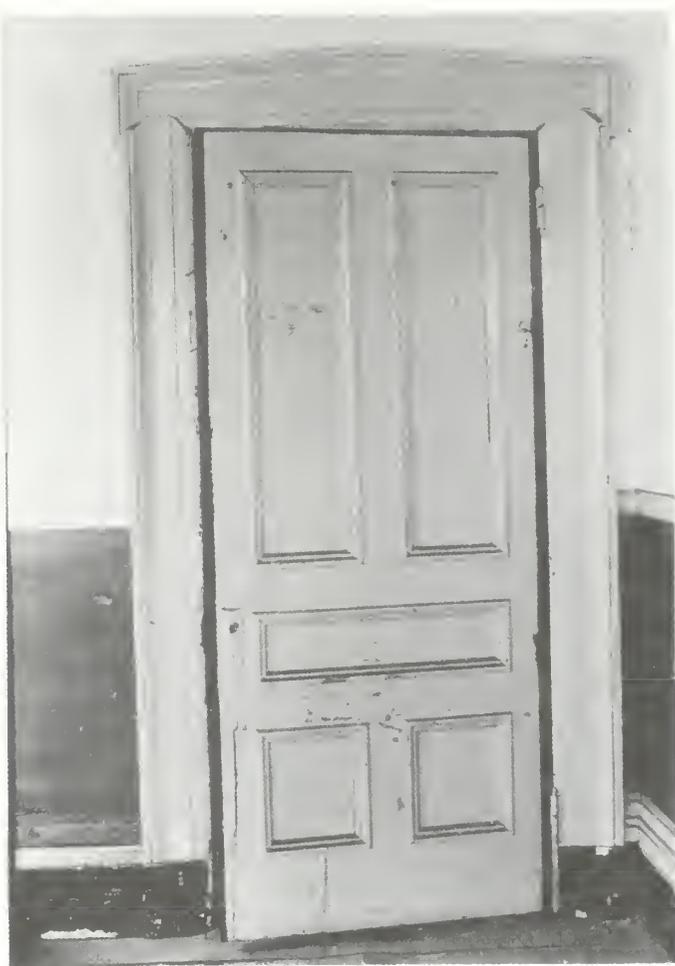
Figure 54. Room N101, East (Dining Room) Portion: 1890's Five-Panel Door.

All three of the doorways now hold five-panel doors dating to the 1890's (fig. 54). The door in doorway D107 has been covered with a sheet of metal, presumably for fire-protection purposes.

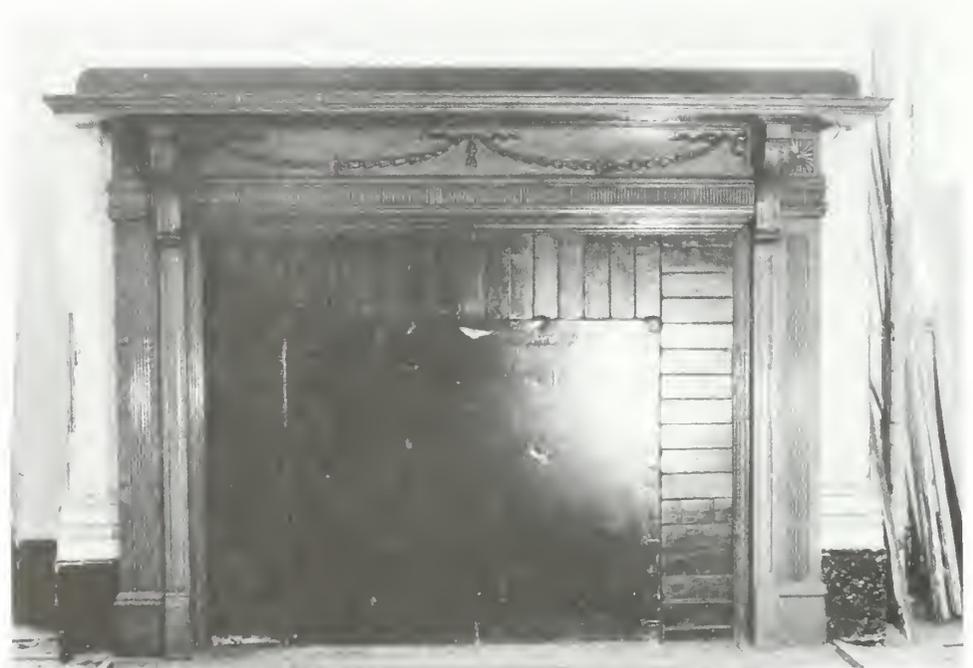
Figure 55. Room N101, East (Dining Room) Portion: 1890's Mantel.

Fireplaces. Of the two fireplaces on the north wall of Room N101, only the east one retains a mantel. This is an oak mantel in the Colonial Revival style (fig. 55); it was installed to replace the original marble mantel during the 1890's updating of the north unit. It is thought that the west fireplace received a similar mantel at this time; the outline of the back of the mantel shelf is visible in the paint on the wall. Wallpaper fragments and paint lines on the wall around the west fireplace wall also show the outline of the original marble mantel here.

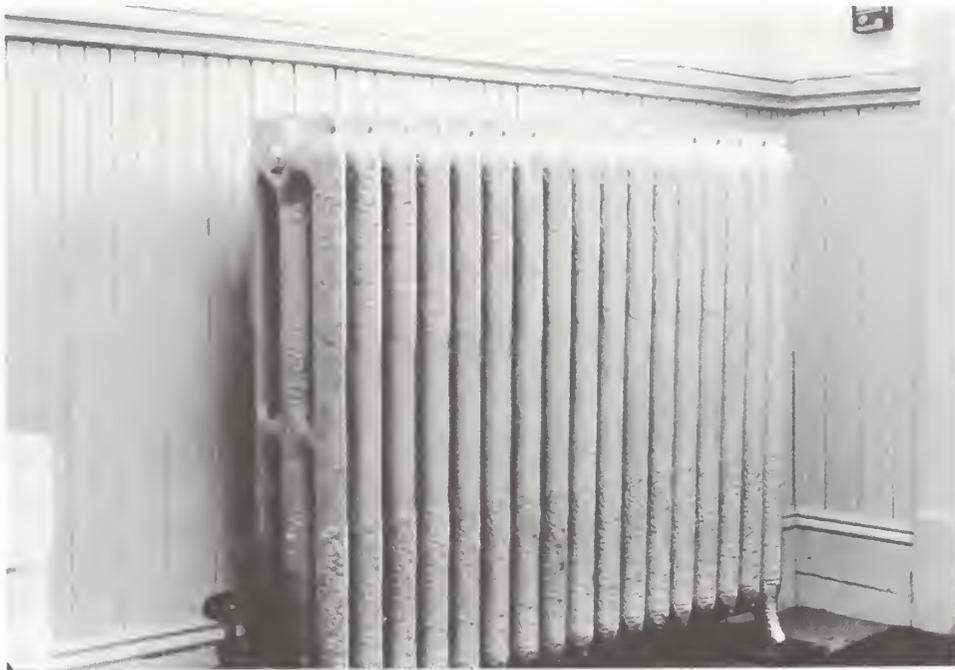
Figure 56. Room E103 (Ell Stair Hall), East Wall: Ca.-1900 "Rococo" Radiator.

Heating and Plumbing Equipment. A large silver-painted radiator is located along the east wall (fig. 56). It is a Type-2 “Rococo” radiator dating to circa 1900.

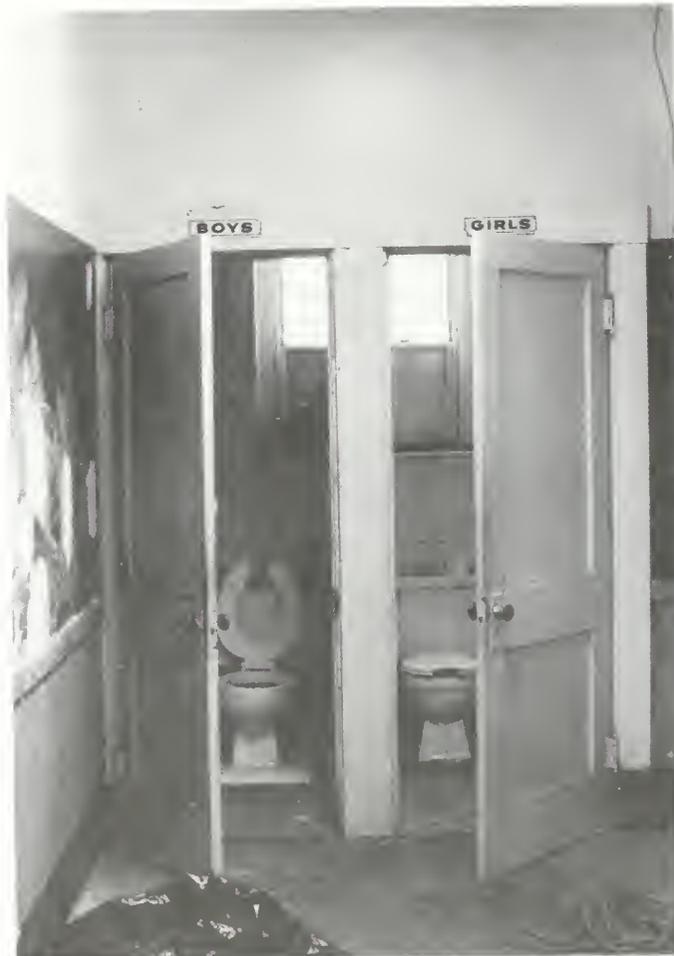
Plan. This space no longer acts as a vertical link between stories, since it no longer retains its original service stairway. However, the room continues to serve as a horizontal link between the first stories of the main block and the ell. Two toilet stalls have been built at the extreme south end of the space (fig. 91).

Figure 91. Room S105 (South-Unit Stair Tower): Toilet Area.

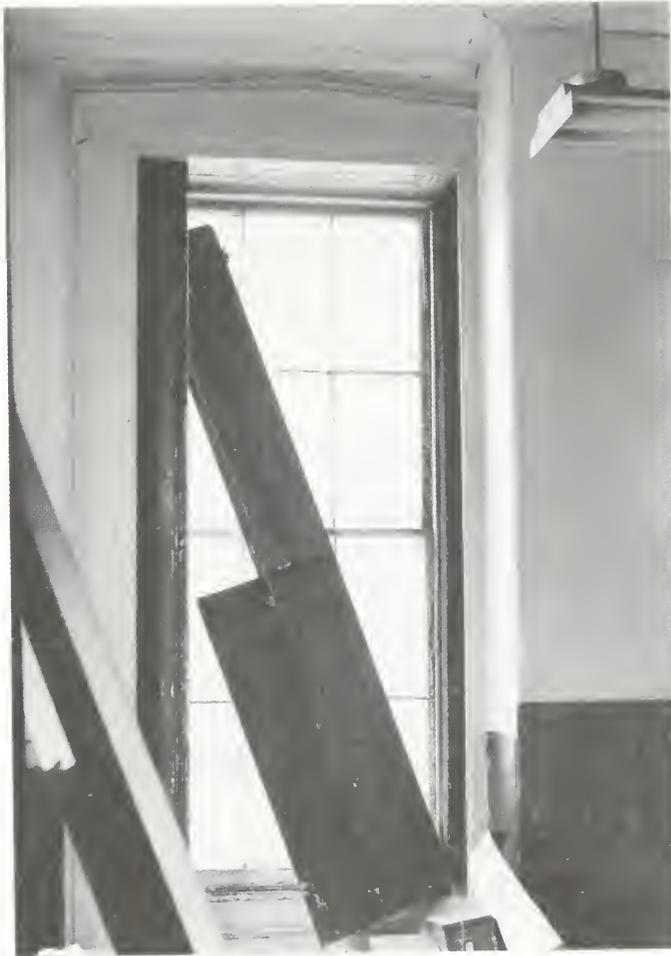
Window W129, at the west end of the north wall, is in poor condition (fig. 92). The surround, interior blinds, and sashes are original, but the blinds are hanging from a single hinge, some of the lower reveal panels are missing, and the sash stops are gouged and split.

Figure 92. Room N101, West (Drawing Room) Portion,
North Wall: Window W129.

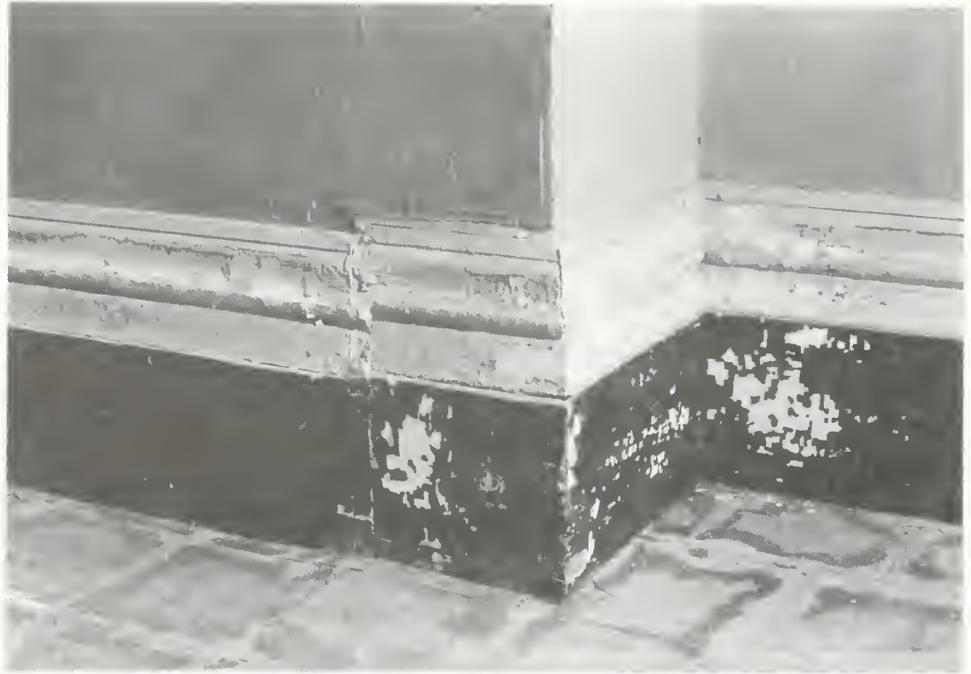
Original Type-1 baseboard runs along the north and west walls, and along the back of the cupboard in the southeast corner of the room. Most of this baseboard is attached with wire nails, which indicates that it has been reworked. The baseboard on the portion of plaster wall that covers over the former fireplace at the east end of the north wall is patched (fig. 93). The baseboard on the east wall, and on the east end of the south wall, appears to be the lower portion of the original baseboard minus the top molding. The rest of the south wall has Type-B

Figure 93. Room S201 (East Bedroom Portion): Baseboard Patch at Former Fireplace Opening.

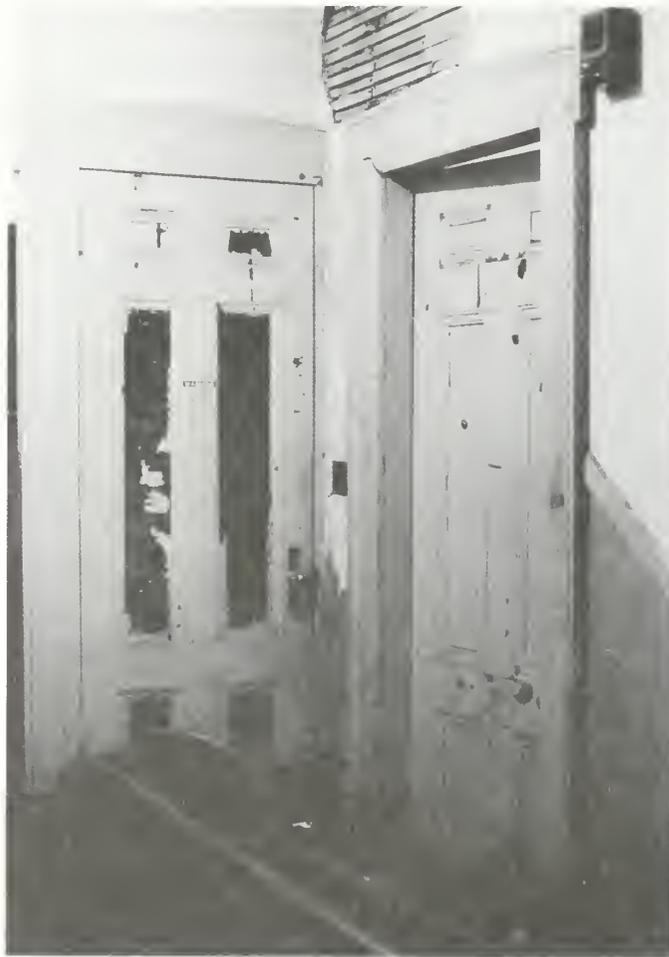
Walls. Original lath and plaster appear to be extant on the east wall and on the south stair wall. Some of this is failing, exposing the 1847 lath (fig. 94). Ca.-1922 plaster is found on most of the north wall. The west ends of the north and south walls (west of D209 and D210) consist of ca.-1945 plasterboard. A section of 1/8-inch plywood covers a 4- by 4 1/2-foot section of the south wall just west of D210.

Doorways. The two doorways in the east half of the stair hall (D211 and D212) are original. They have retained their original Type-J surrounds and six-panel doors. The paint on both doorways is failing (fig. 94).

Figure 94. Room S202 (South-Unit Stair Hall), East End.

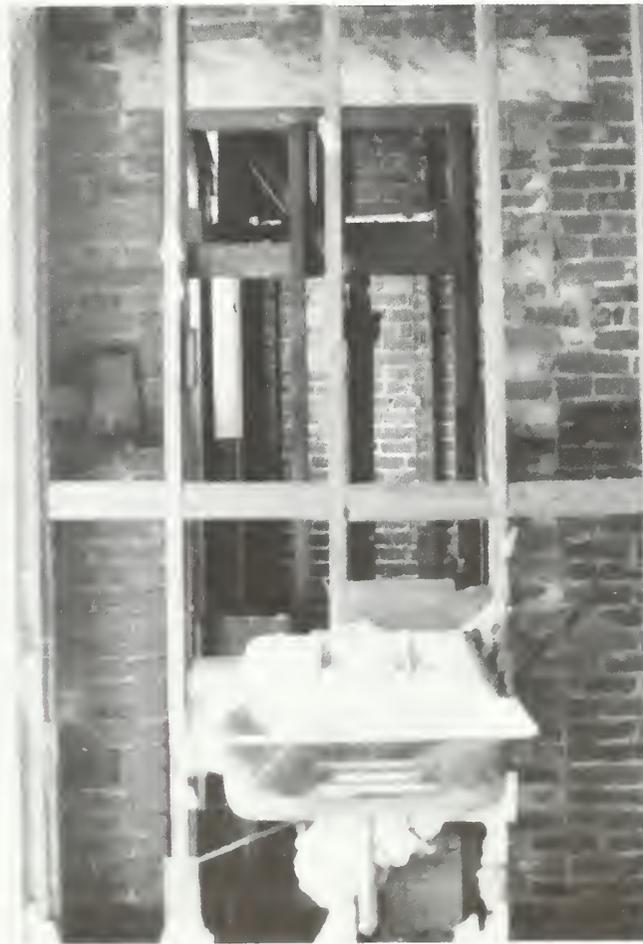
There is also a ca.-1922 doorway at the south end of the east wall (D203), which leads into N204, now fitted up as a bathroom. It had a plain 4-inch-wide surround and two-panel door, which were removed when the east wall was stripped of its plaster. The stripping revealed the original doorway from N201 into the stair tower, which was located at the north end of the east wall (fig. 96).

Doorways. The only doorway in N204 sits in the south end of the west brick wall (203). It is a ca.-1922 doorway that leads into Room N201. Before the room was gutted, this doorway had a plain, narrow surround and a plain door with two large recessed panels. The two toilet stalls had doorways with plain surrounds; their doors had disappeared, so their appearance is not known. The demolition work revealed the rough edges in the west brick wall where D203 had been punched through it. It also exposed the original doorway to N201, located at the north end of the west wall (fig. 96).

Figure 96. Room N201, East (Bedroom) Portion, East Wall:
Exposed 1847 Doorway.

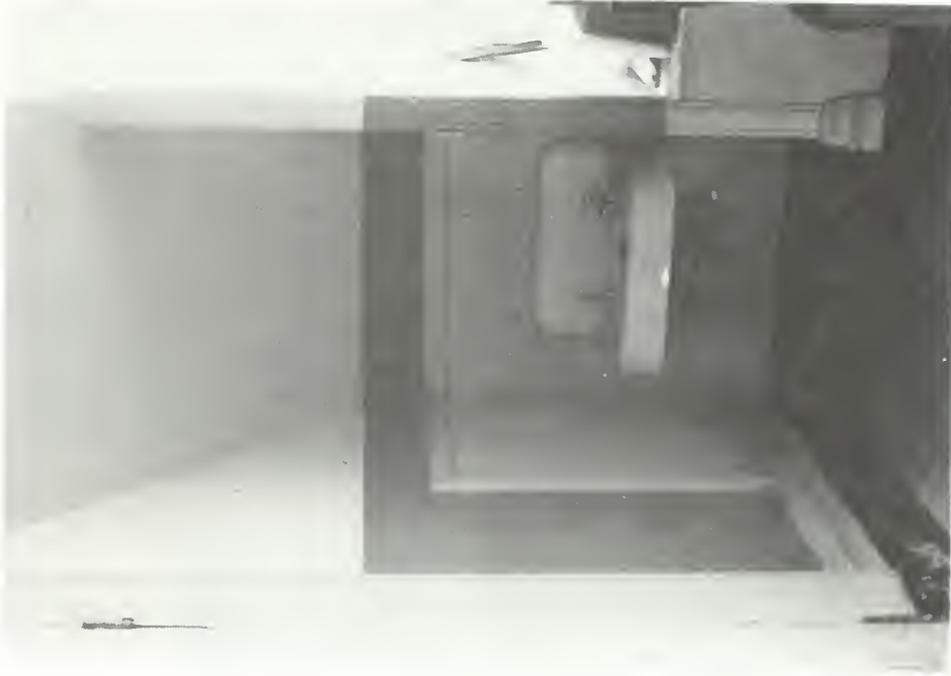
Type-1 wainscot lines the rear portion of the closet in the northeast corner of the room, below the stairway to the attic (fig. 98). This is the same ca.-1922 wainscot as used in the ell's stair halls (E103 and E202) and the south unit's stair tower (S105).

Wall-mounted sinks from the 1930's are located in the closet under the attic stairway (fig. 98) and at the extreme east end of the north wall. The large cast-iron pipe below window W227 appears to be a sewer pipe, perhaps related to these two sinks.

Figure 98. Room N203, East-Bedroom
Portion: 20th-Century Sink in
Closet under Attic Stairway.

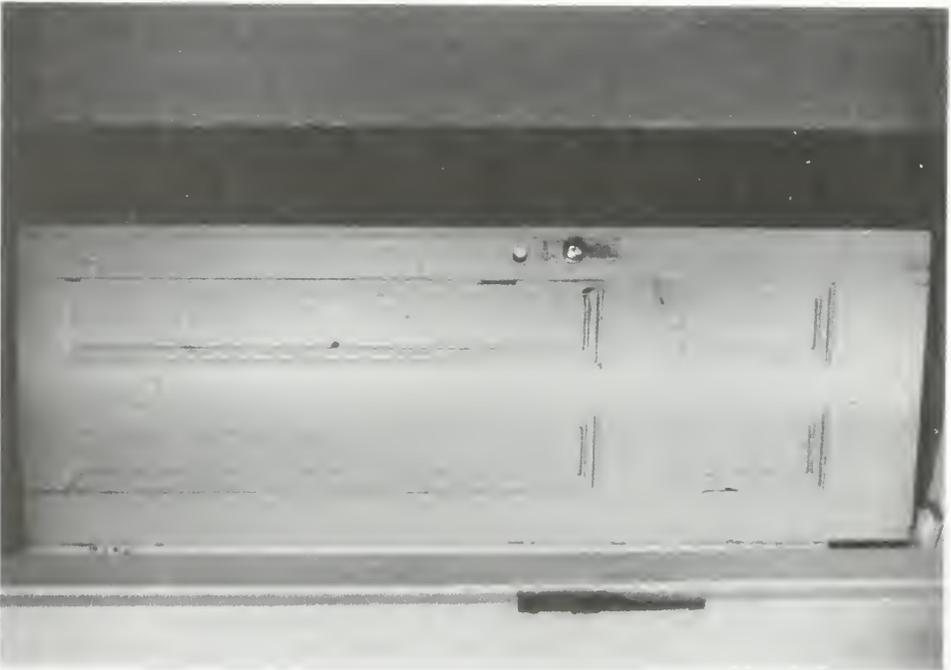
All five doorways have retained their 1847 Type-J surrounds. Four of them hold their original six-panel doors. Doorway D204 does not retain its original six-panel door. Instead, it holds an original four-panel door (fig. 97) that paint analysis indicates was originally located elsewhere in the north unit's stair tower. It is thought that the door came from the partition that originally divided the stair tower in half.

Figure 97. Room N202 (North-Unit Stair
Hall), East Wall: 1847 Four-Panel Door.

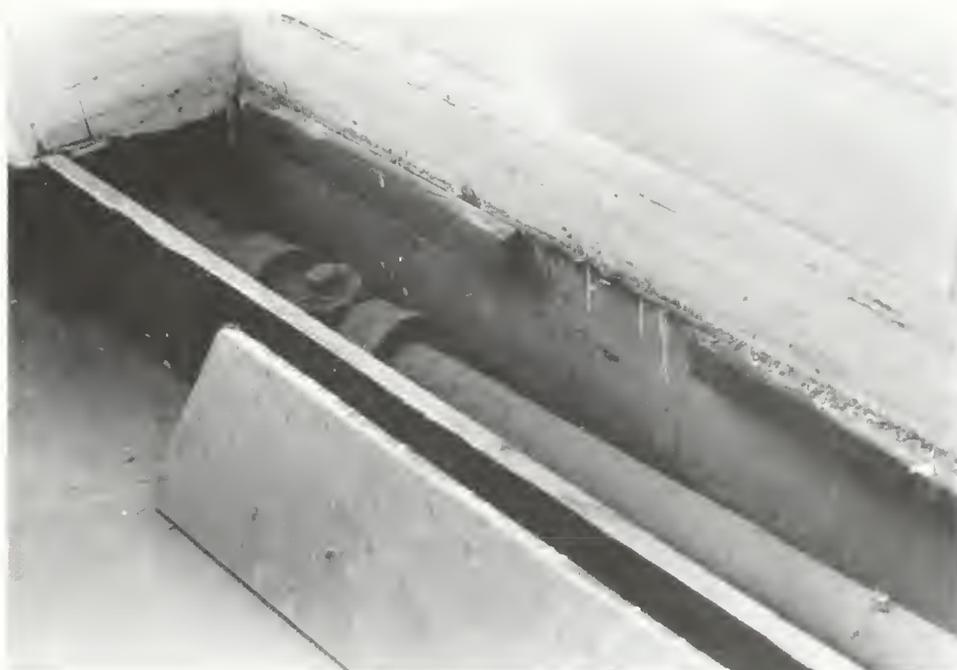
The two original window openings in the east wall (W226 and W227) have retained most of their 1847 elements in fair condition. The right bottom panel is missing from both windows' reveals. A box has been built into the recess under W227, through which a large cast-iron pipe runs (fig. 99).

Figure 99. Room N203 (East and West Bedrooms in North Unit), East Wall:
Box under W227 Concealing Waste Pipe.

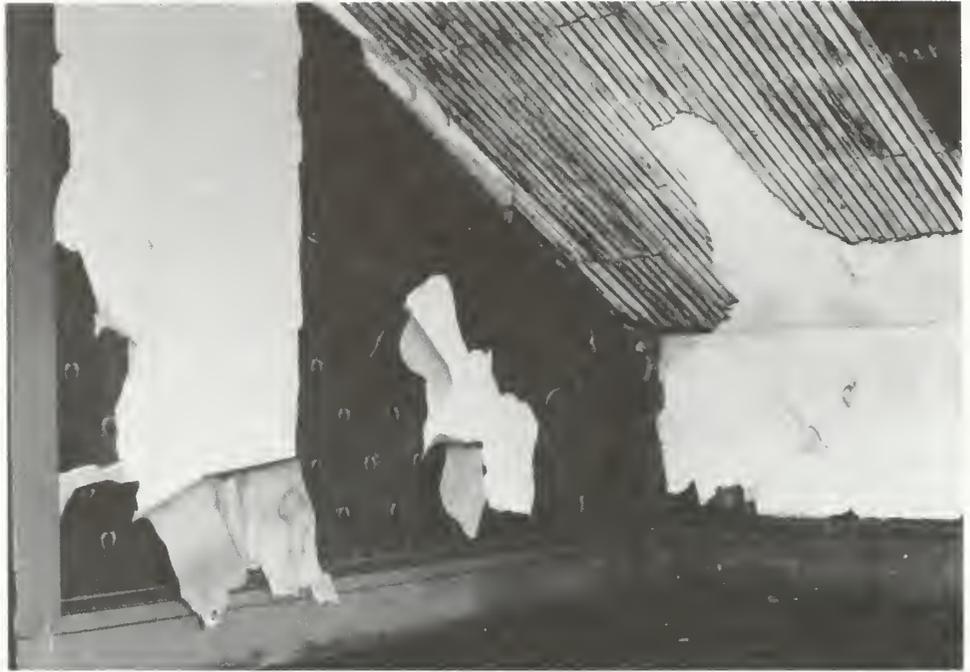
Finishes. The woodwork in most of the rooms is finished with graining. The woodwork in S304 and S306 is painted blue-green. Large pieces and fragments of wallpaper (fig. 100) can be found in all of the rooms except Room S302, the storage room (see Appendix F).

Figure 100. Room S304 (South-Unit Attic Bedroom), East Wall.
