ATWOOD-HIGGINS HISTORIC DISTRICT CULTURAL LANDSCAPE REPORT AND OUTBUILDINGS HISTORIC STRUCTURES REPORT

CAPE COD NATIONAL SEASHORE

CULTURAL LANDSCAPE REPORT AND OUTBUILDINGS HISTORIC STRUCTURES REPORT

WELLFLEET, MASSACHUSETTS

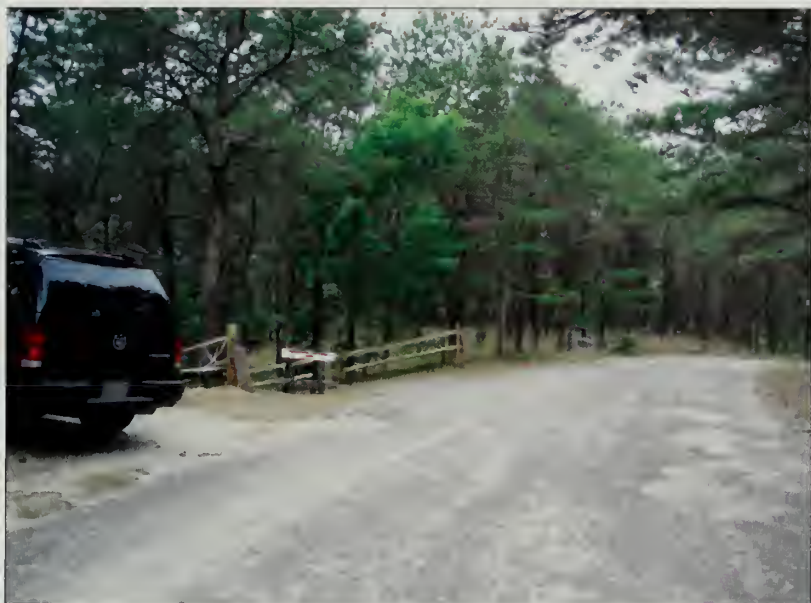
Figure 51. Entrance to Old Town Road, looking west toward the building complex from Bound Brook Island Road. (OCLP, June 2010.)

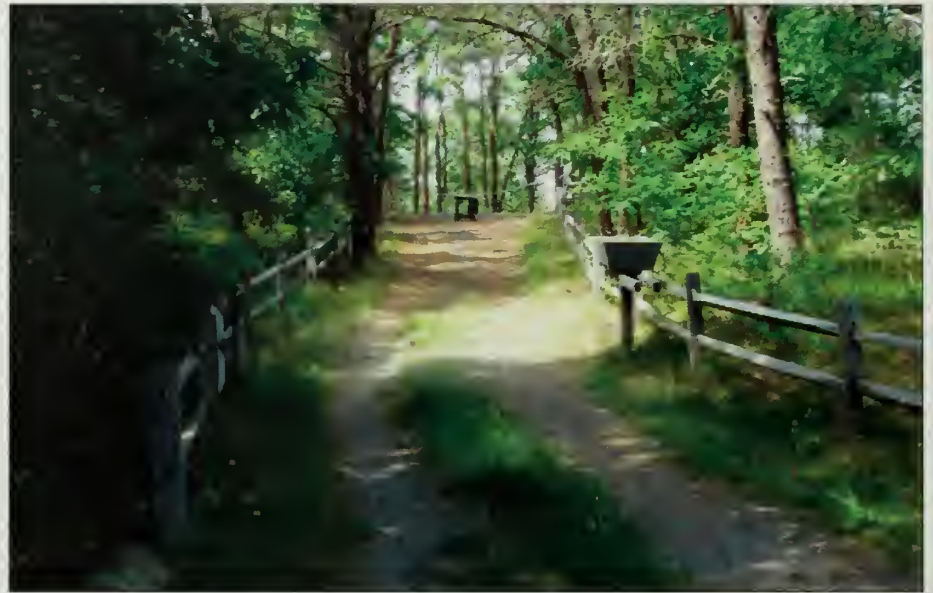
The Atwood-Higgins driveway branches off from Bound Brook Island Road and descends south to a rolling meadow containing the Country Store, Barn, and Guest House. The driveway is lined with split rail fences that historically contained three rails, but after replacement in 2007, now contain two rails. The posts are set 10 ½ feet apart. Beyond the fences, the driveway is lined with mature pine, oak, and black locust. The driveway is nine to ten feet wide and surfaced with a mix of sand and gravel. A small remnant of asphalt indicates that at one time this portion of the driveway was paved. The grade is steep, as evidenced by the erosion and gullies down the steepest part of the driveway. The slope diminishes at the edge of a meadow, where an old wooden crank gate that is no longer functional serves as gateway into the property (Figure 54).

Figure 53. Bound Brook Island Road west of entrance to the building complex, where it transitions to sand. Note the fencing obscured by pine trees at left. (OCLP, July 2007.)

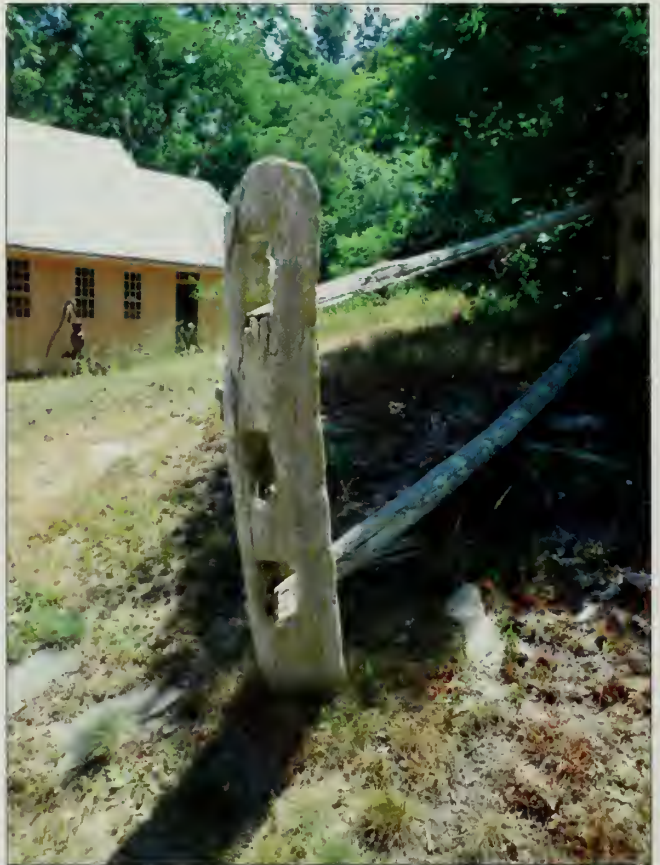
Placed in front of both north and south facing doors to the house are two halves of an old granite mill stone (Figure 72). Nineteen feet north of the eastern section of the house stands an old rusted pump set in a square wooden platform about three feet by three feet. Roughly seven feet north of this feature is a little green water spigot that sits about three feet south of the section of split-rail fence mentioned above (see Figure 64). In moderate condition, the fence has three rails and is only one rail long, ending at the white oak tree. It was missing a rail in May, but repairs made to the property in June resulted in its replacement. The post on the east side of this fence, closest to the road, is made out of a whale bone given to George Higgins as a gift.⁶ It is worn and sponge-like, almost attaining the appearance of old wood in color but not texture. Several rusted iron nails are buried along its sides, probably inserted there to reinforce the rail holes (see Figure 65; Figure 73).

Figure 73. Whale bone fence post, looking southwest. (OCLP, June 2010.)

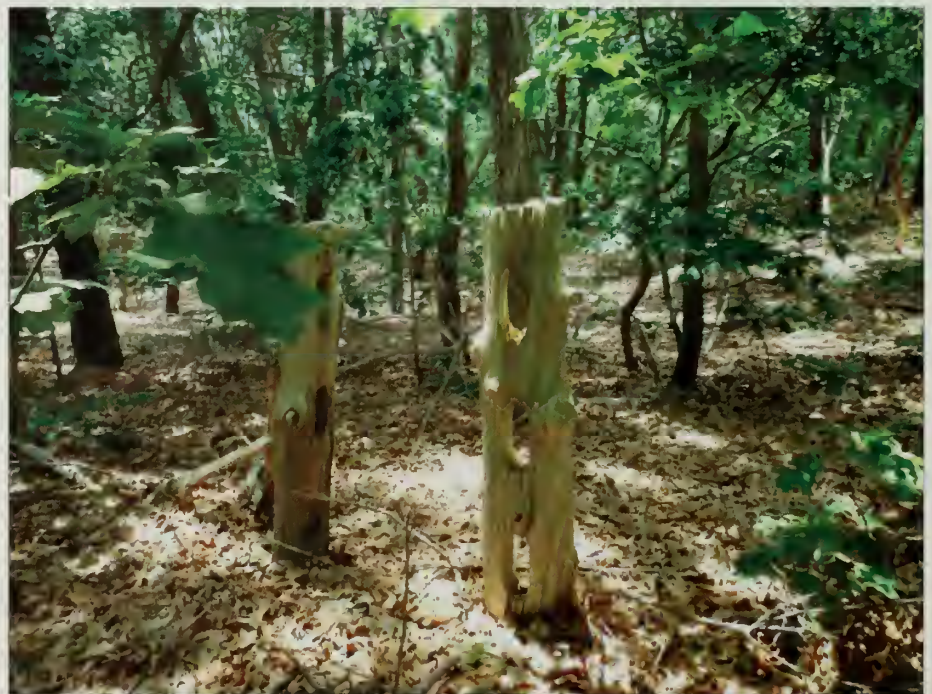
Figure 74. Posts that once supported three-rail fences. These fence remnants are in the woods on the ridge west of the house and near the Garage (OCLP, June 2010.)

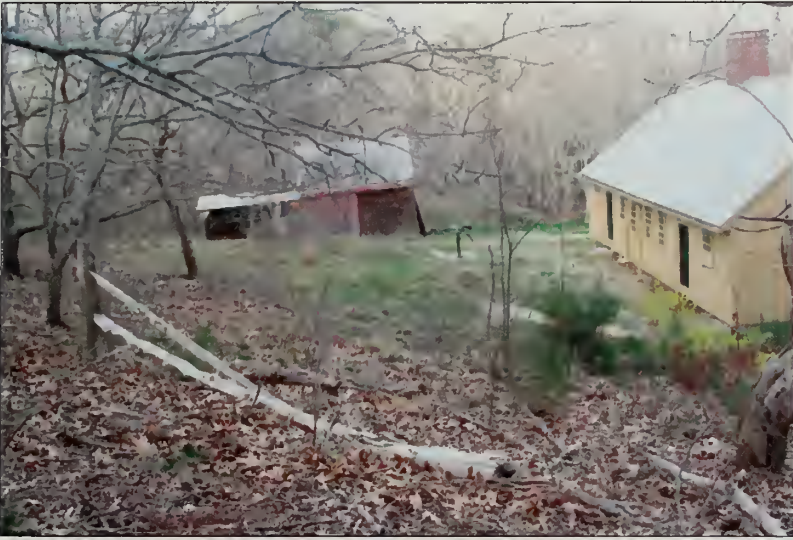
Figure 75. Fence along the slope above the house, looking east to the woodshed. Note the sandy spot left of the building by the small pine trees which marks a possible fox or coyote den. (OCLP, April 2007.)

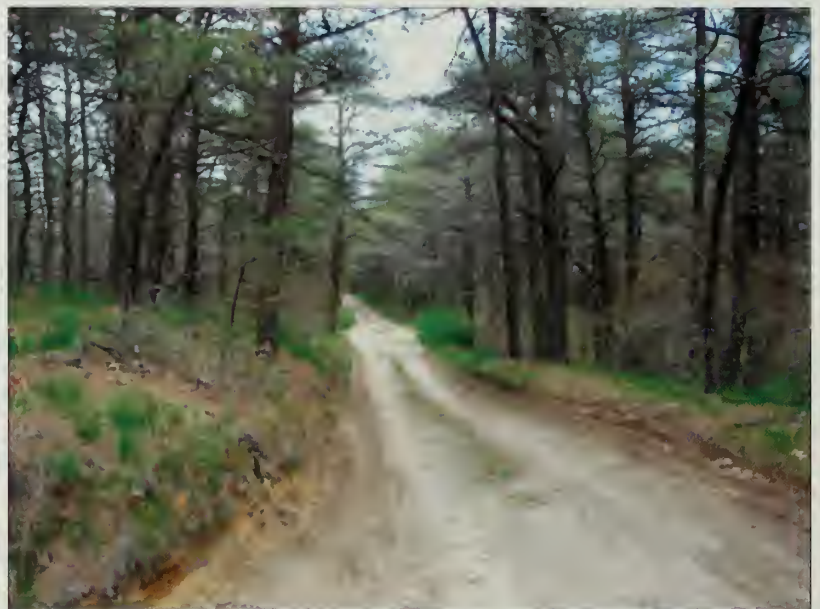
stands about eight inches tall, roughly two feet east of the north corner of the Garage (Figure 108).

Figure 108. Wooden post northeast of the Garage, visible in right foreground. (OCLP, July 2010.)

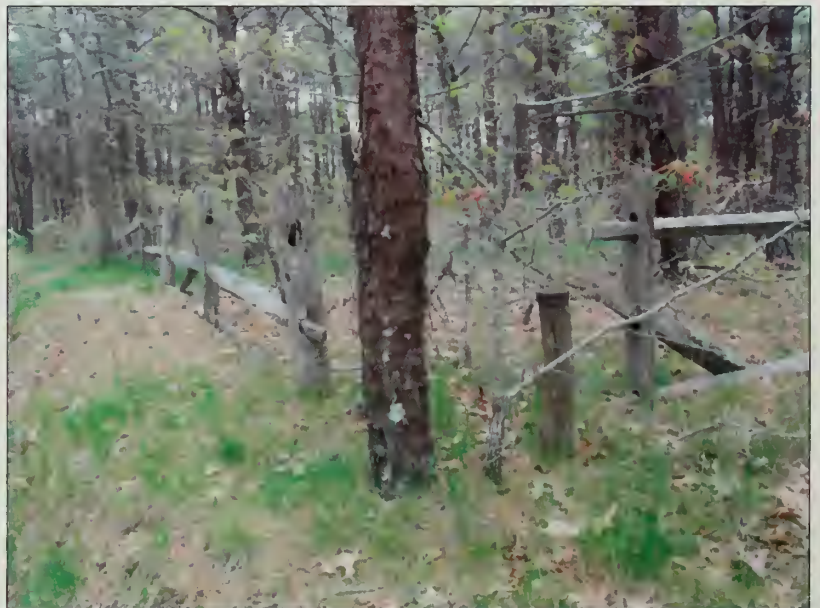
Most roads along the perimeter of the Atwood-Higgins property and drives within the property are lined with split-rail fences, though sections are missing (Figure 109). Two sections of fence line the southwesterly side of Bound Brook Road: a short section at the terminus of the Old Town Road trace and a long section to the west of the Atwood-Higgins driveway. The long section of mostly intact, split-rail fence with three rails leads west along the south side of Bound Brook Island Road, before turning a corner south about 300 feet from the entrance to the Atwood-Higgins complex (Figure 110). In the northwest corner of this fence, about three feet south of the road, is the wooden base of an old turnstile with a rusted metal ring circling its top. What is likely the turning portion of this turnstile is now stored in the main section of the Barn. Only two rail sections of the fence are standing to the south of the turnstile base.

Figure 109. Bound Brook Island Road, west of the Atwood-Higgins building complex. (OCLP, May 2007.)

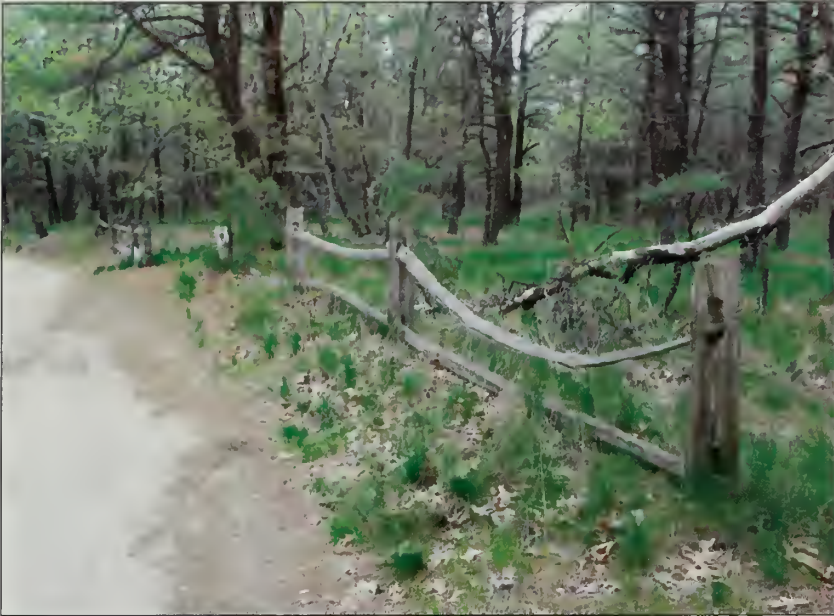
Figure 110. Fence corner on the south side of Bound Brook Island Road, west of the Atwood-Higgins building complex, looking east. Note the old turnstile base at the corner. (OCLP, May 2007.)

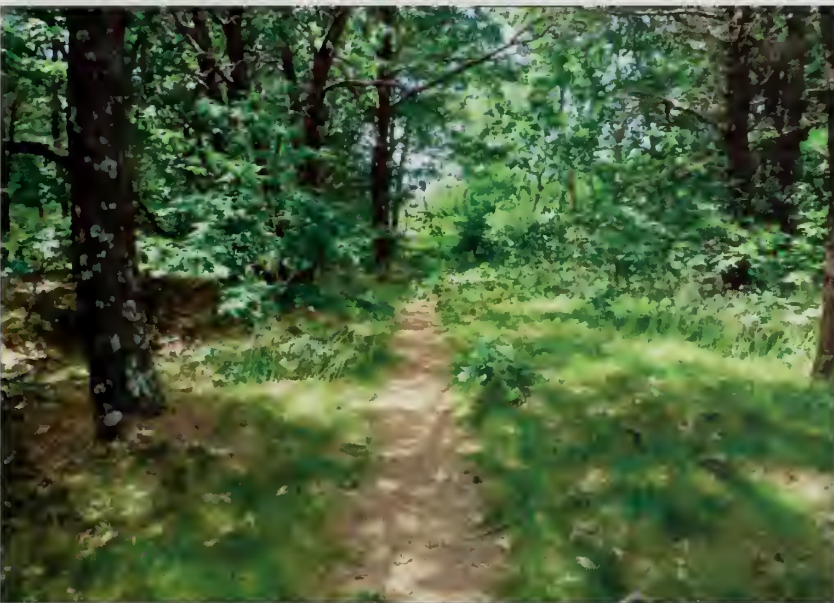
begins on the north side of the road, just opposite the turnstile corner, and extends for about 75 feet along the roadside (Figure 111). The second section comprises a few pieces of fallen fence, lying on the south side of the road roughly 450 feet further west of this point.

Figure 111. Section of fence with two rails, northwest of the site on the north side of Bound Brook Island Road. (OCLP, May 2007.)

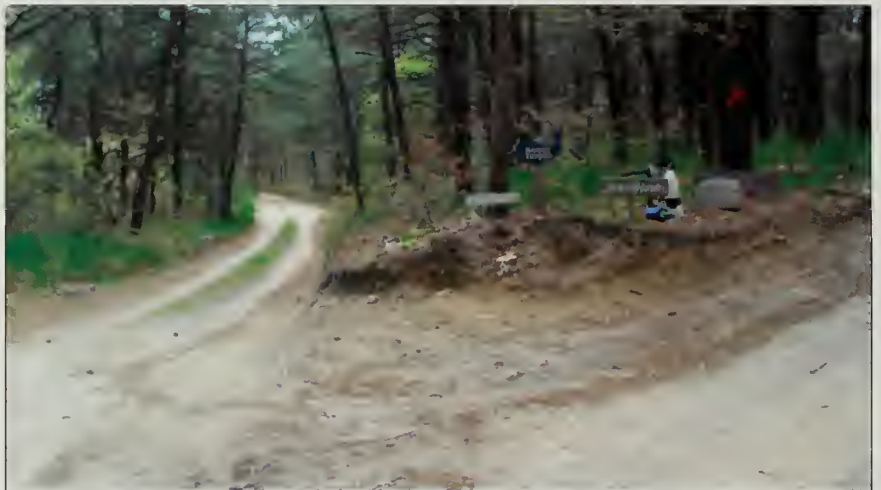
Another split-rail fence with two rails runs along the right side of sandy Bound Brook Way, which splits off from Bound Brook Island Road about a quarter mile west of the Atwood-Higgins building complex. This fence is partially collapsed and begins about 150 feet north of the fork with Bound Brook Island Road (Figures 114 and 115). After branching north, Bound Brook Way continues a short distance before curving west toward the shore and a group of summer homes. The name markers for these residences are posted at the fork from Bound Brook Island Road.

Figure 114. Fence running along the east side of Bound Brook Island Road. (OCLP, May 2010.)

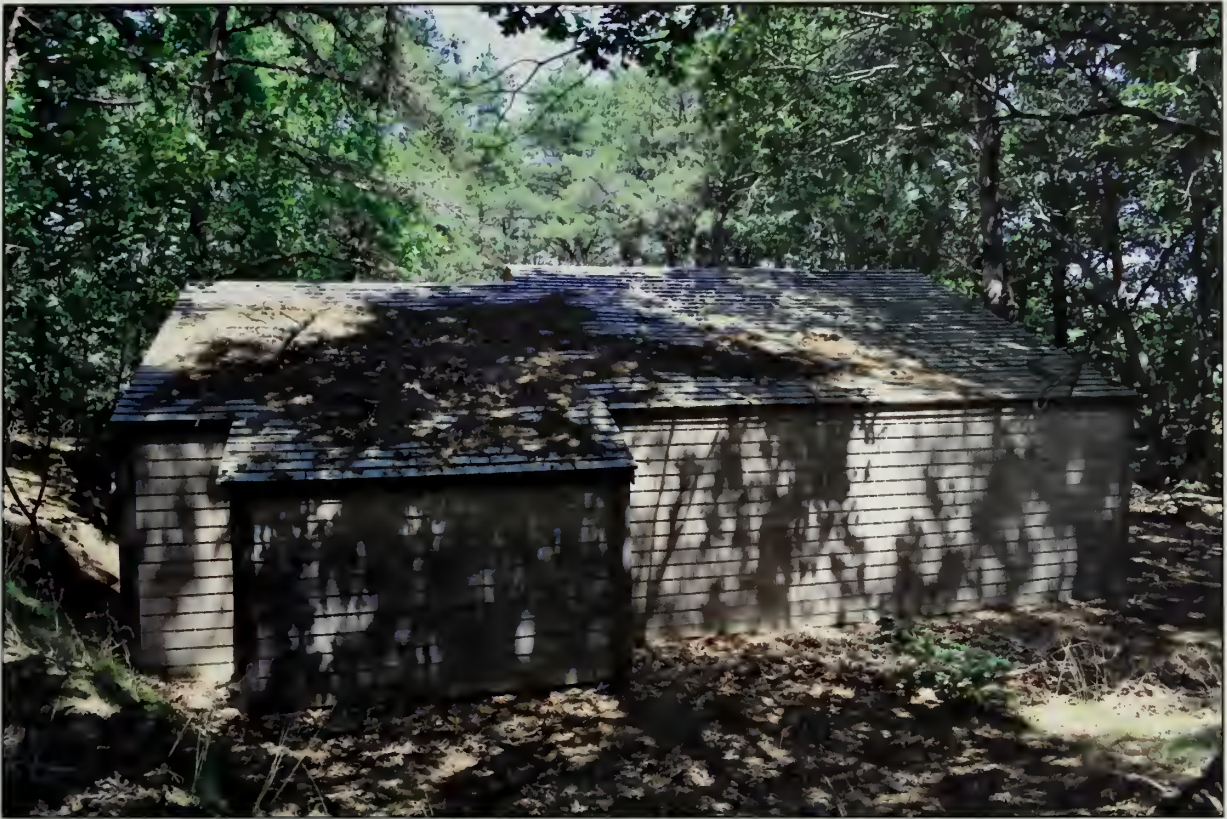
three bay door openings on this elevation constituting the majority of the elevation (Figure 254). The siding on the northwest elevation is also flush, vertical, wooden boards. The southwest and southeast elevation is sided with wooden shingles, some appearing newer than others (Figures 256 and 257). The wooden shingles on the southwest elevation projection of Room 102 were replaced in 2007 and are in excellent condition; the shingles on the southeast elevation of Room 101 also appear to have been recently replaced as well.

Figure 256. Southwest elevation, Garage (OCLP, 2010).

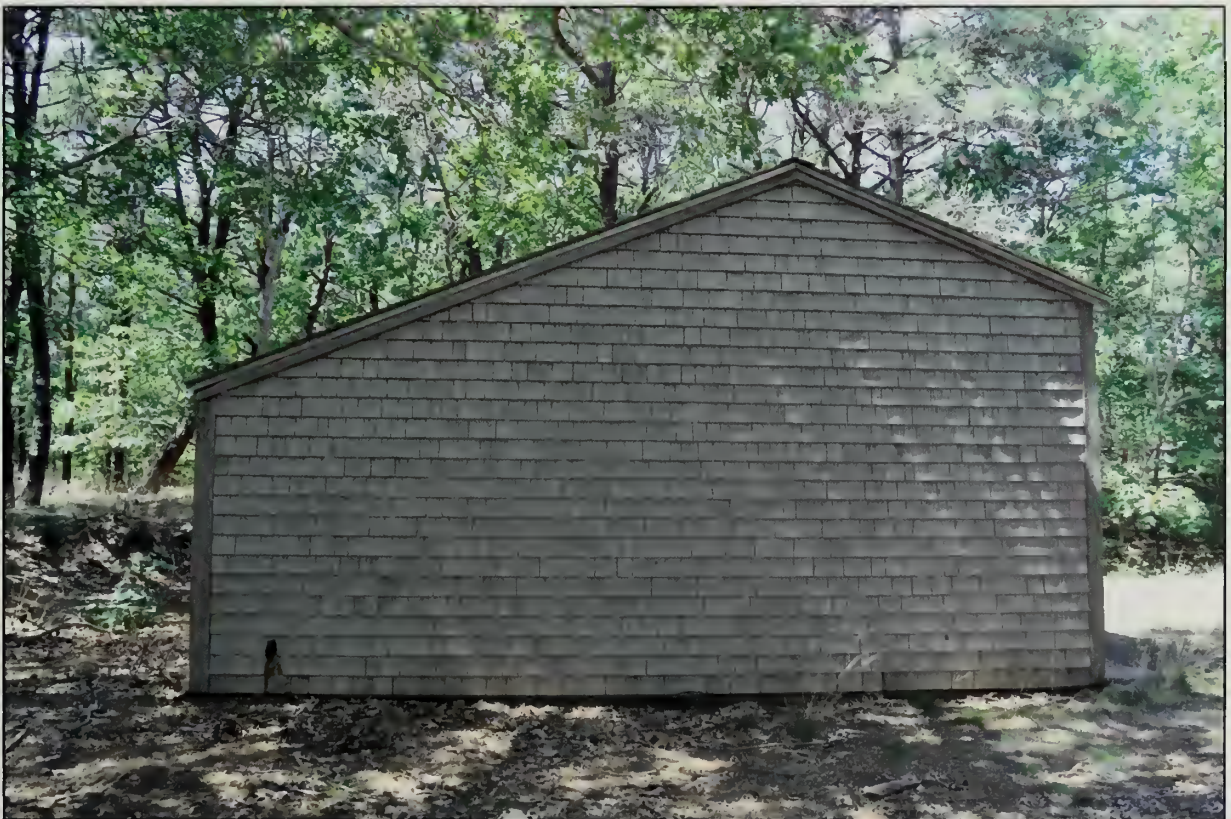
Figure 257. Southeast elevation, Garage (OCLP, 2010).

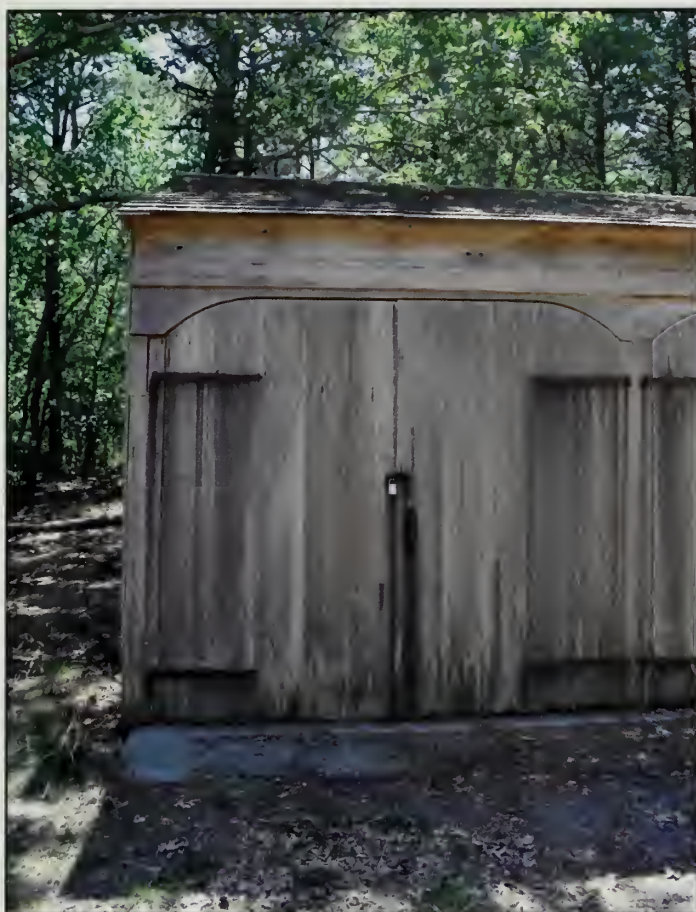
Doorway Number	Width	Height	Description
D101	97 inches	87 ½ inches	D101 is located in the northeast elevation and provides access to Room 101 (Figure 259). D101 is constructed with curved top corners and is hung with a set of unfinished double wooden batten doors. Each door has a width of 48 ½ inches. There are two iron strap hinges located on the upper and lower halves of each door (Figure 260). The hardware on the doors within D101 consists of two iron hook and eye fasteners (one large and one small), a modern imbedded deadbolt, a modern padlock, and an iron thumb latch door pull (Figure 261). There is also a metal cane bolt on the interior of Room 101 that provides a locking mechanism for the door of D101.
D102	97 inches	86 ½ inches ¹	D102 is also located in the northeast elevation and provides access to Room 101 (Figure 262). D102 is constructed with curved top corners and is hung with a set of unfinished wooden batten doors. Each door has a width of 48 ½ inches. There are two iron strap hinges located on the upper and lower halves of each door. There is no external door hardware on the doors of D102; however, there is a metal cane bolt located on the interior of Room 101 that provides the locking mechanism for the door of D102. Note: The difference in height between D101 and D102 is due to the rotting wood at the bottom of D102

Figure 259. D101 in northeast elevation, Garage (OCLP, 2010).

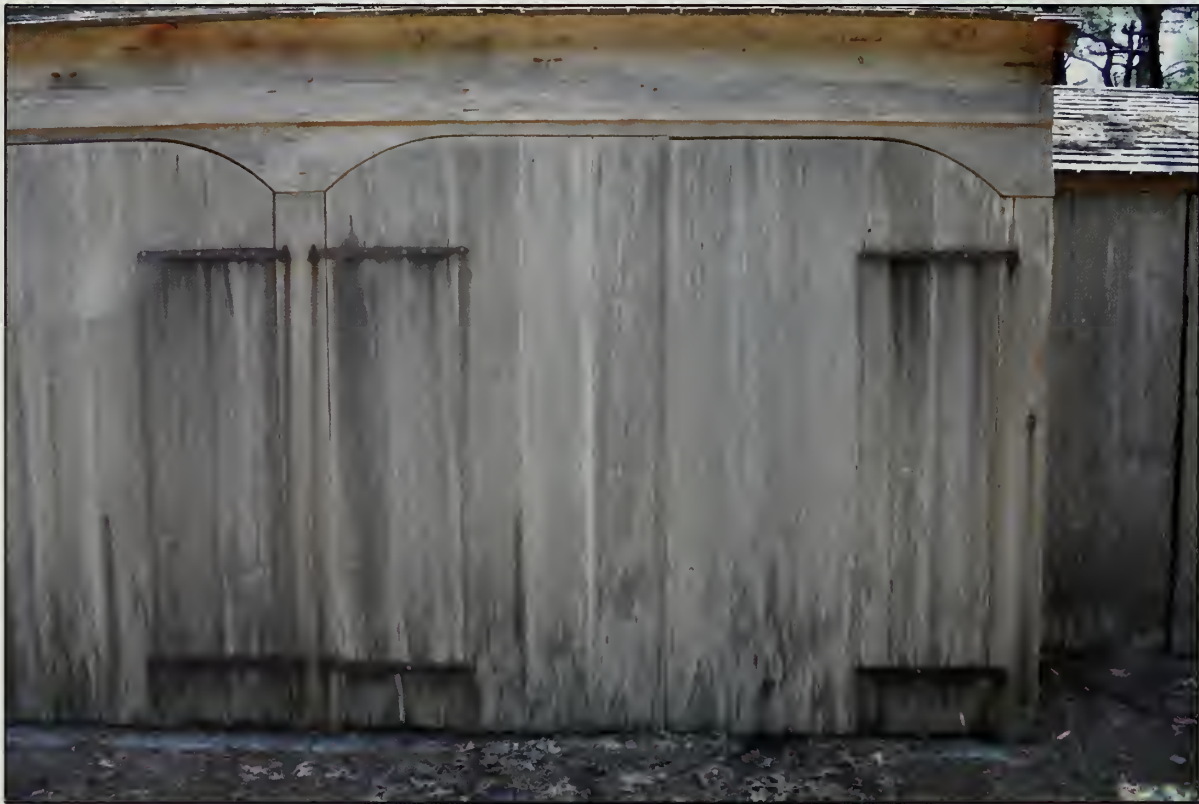
Figure 262. D102 in northeast elevation, Garage (OCLP, 2010).

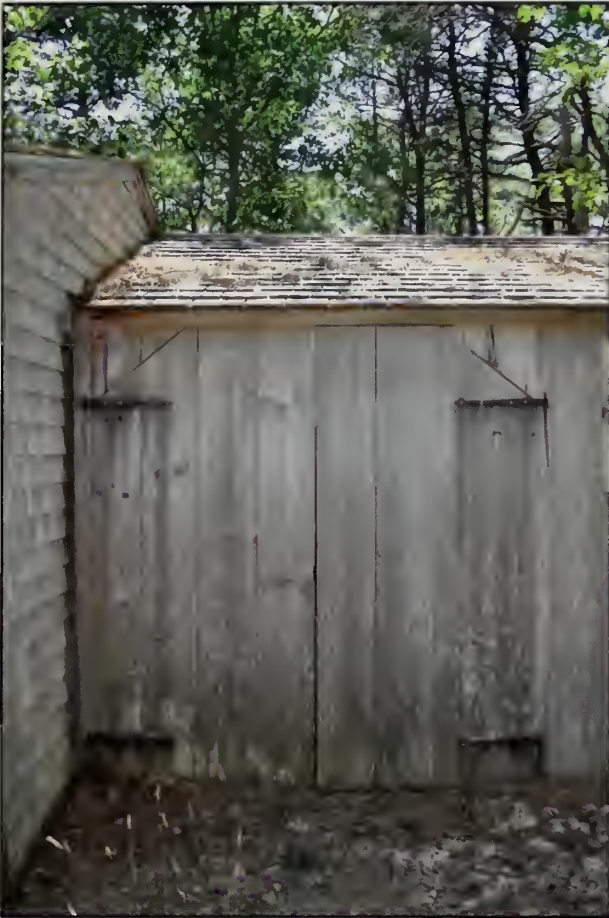
D103	86 inches	89 inches	D103 is located in the northeast elevation and provides access to Room 102 (Figure 263). D103 and is thinner and taller than D101 and D102 and is constructed with cut top corners unlike the curved top corners of D101 and D102 (Figure 264). D103 is hung with a set of unfinished wooden batten doors, each door measuring 43 inches wide. There are two iron strap hinges located on the upper and lower halves of both doors. There is no external hardware located on the door of D103; however, there is a metal cane bolt located on the interior of Room 102 that provides the locking mechanism for the door of D103.

Figure 263. D103 in northeast elevation, Garage (OCLP, 2010).

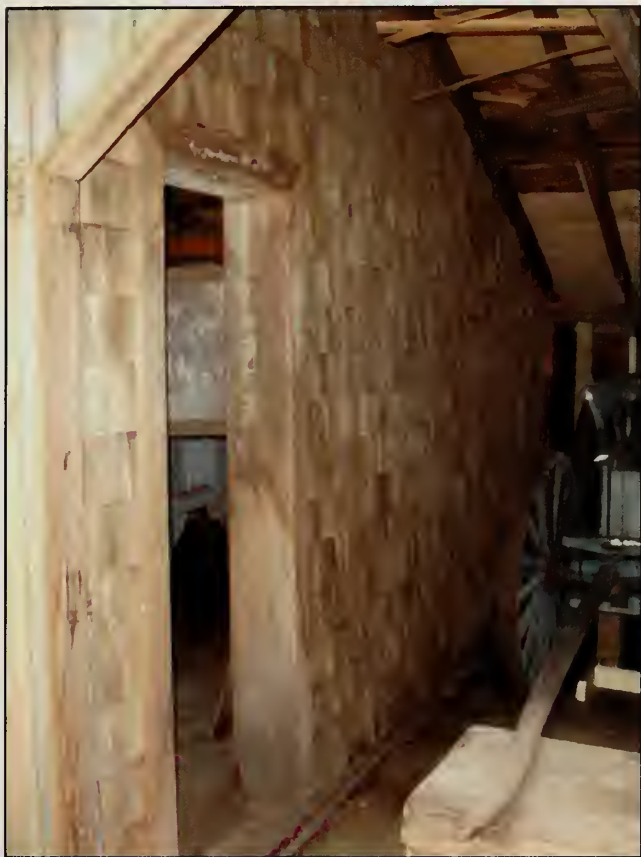
Figure 274. Southeast wall of Room 102, Garage. Note siding is exterior wooden shingles (2007).

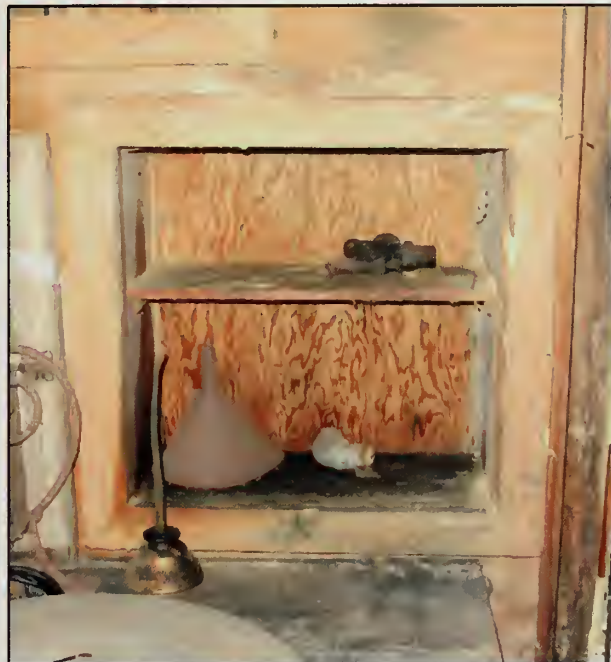
Several built-in cabinets are located within Room 102. The first is located on the northeast wall below window W101 and has two interior shelves (Figure 275). This built-in measures 16 ½ inches wide by 16 inches tall and surrounded by 2 inch flat board casing.

Figure 275. Built-in cabinet, northeast wall of Room 102, Garage (2007).

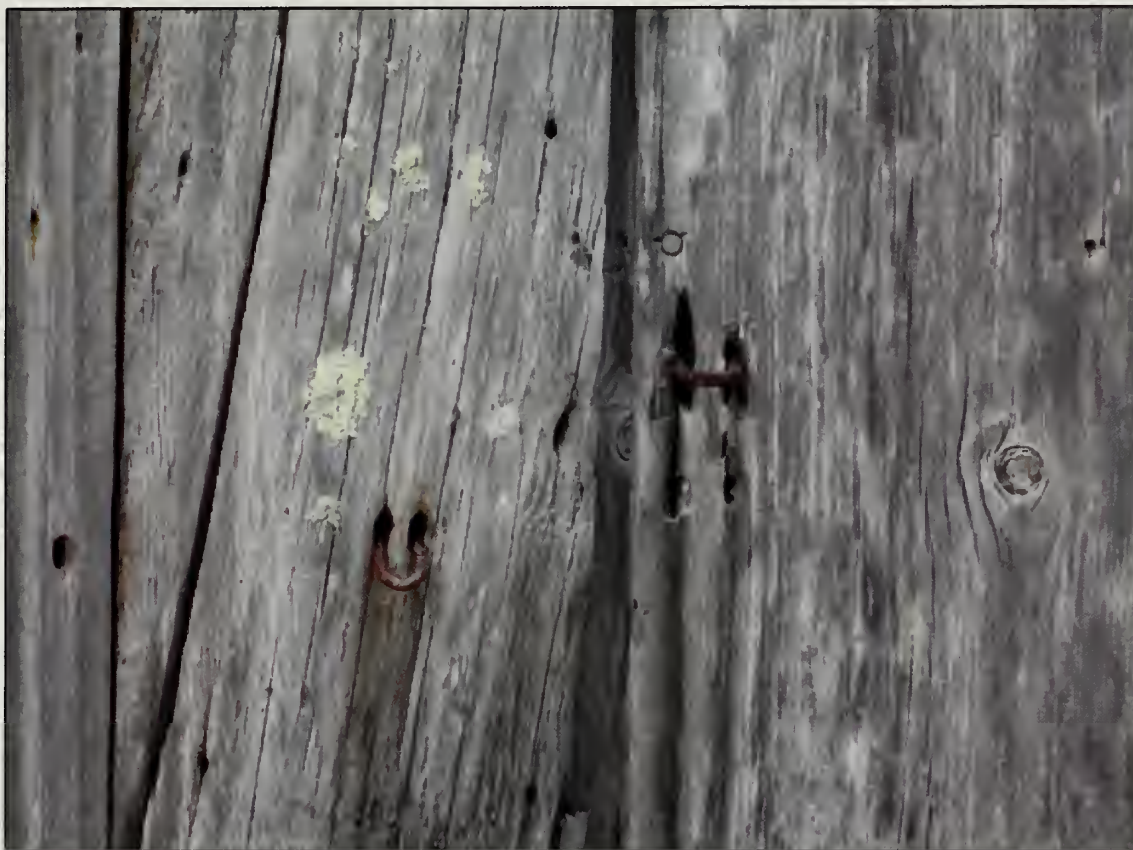
Doorway Number	Width	Height	Description
D101	35 inches	78 ½ inches	D101 is located in the south elevation provides access to the entry area within the Barn (Figure 287). A single, unfinished, wooden batten door is hung within D101. The hardware on this door consists of two iron strap hinges, an iron thumb latch, an iron hook and eye fastener, and a modern padlock that is hung from a piece of iron (Figure 288). There are two large stone steps currently located under D101 (Figure 289).
D102	108 ½ inches	109 inches	D102 is located in the south elevation of the Barn, has a set of large, unfinished, wooden batten doors, and provides access to the Carriage Room (Figure 290). There are three metal strap hinges on each door hung within D102. A long board has been placed across both doors as the locking mechanism.
D103	38 inches	81 inches	D103 is located in the east elevation of the east side annex of the Barn and provides access to the Shed (Figure 291). The hardware on the door of D103 consists on iron strap hinge and two iron eyes of what appeared to have been parts of iron hook and eye fasteners (Figure 292).

Figure 292. Hardware (two iron eyes) on door within D103, east elevation, Barn (2007).

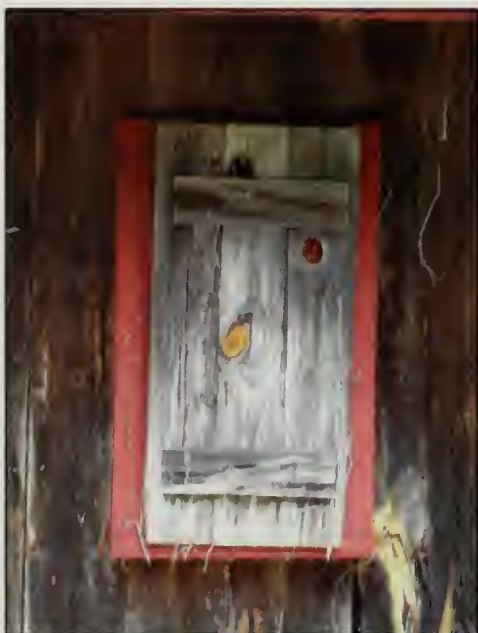
W103	n/a	n/a	W103 is located in the south elevation of the Barn and opens into the interior of the Shed of the east side annex (Figure 297). W103 does not contain a window sash and is covered by an unfinished, wooden batten fixed shutter. Measurements of W103 were not taken due to severe insect infestation in the immediate area making the window inaccessible. The flat board casing surrounding W103 is painted red.
W104	n/a	n/a	W104 is located in the east elevation of the Barn and opens into the interior of the Carriage Room (Figure 298). W104 consists of an opening and casing only, with no actual window or sill in place. Measurements were not taken of W104 because of its inaccessibility due to its height from both the exterior and interior of the Barn. The flat board casing of W104 is painted red.
W105	15 inches	10 $\frac{1}{2}$ inches	W105 is located in the east elevation of the east side annex of the Barn and punctuates the interior east wall of the Shed (Figure 299). W105 is a single fixed transom window with two lights. Each pane of glass within W105 measures 6 inches wide by 8 inches tall. The muntins located within W105 have flat, angular profiles and measures $\frac{3}{4}$ inch wide by $\frac{1}{4}$ inch deep. The flat board casing that flanks W105 on the left and right sides measures $2\frac{1}{2}$ inches and is missing from the top of the window. The casing and muntins are painted red.

Figure 297. W103 in south elevation, Barn (2007).

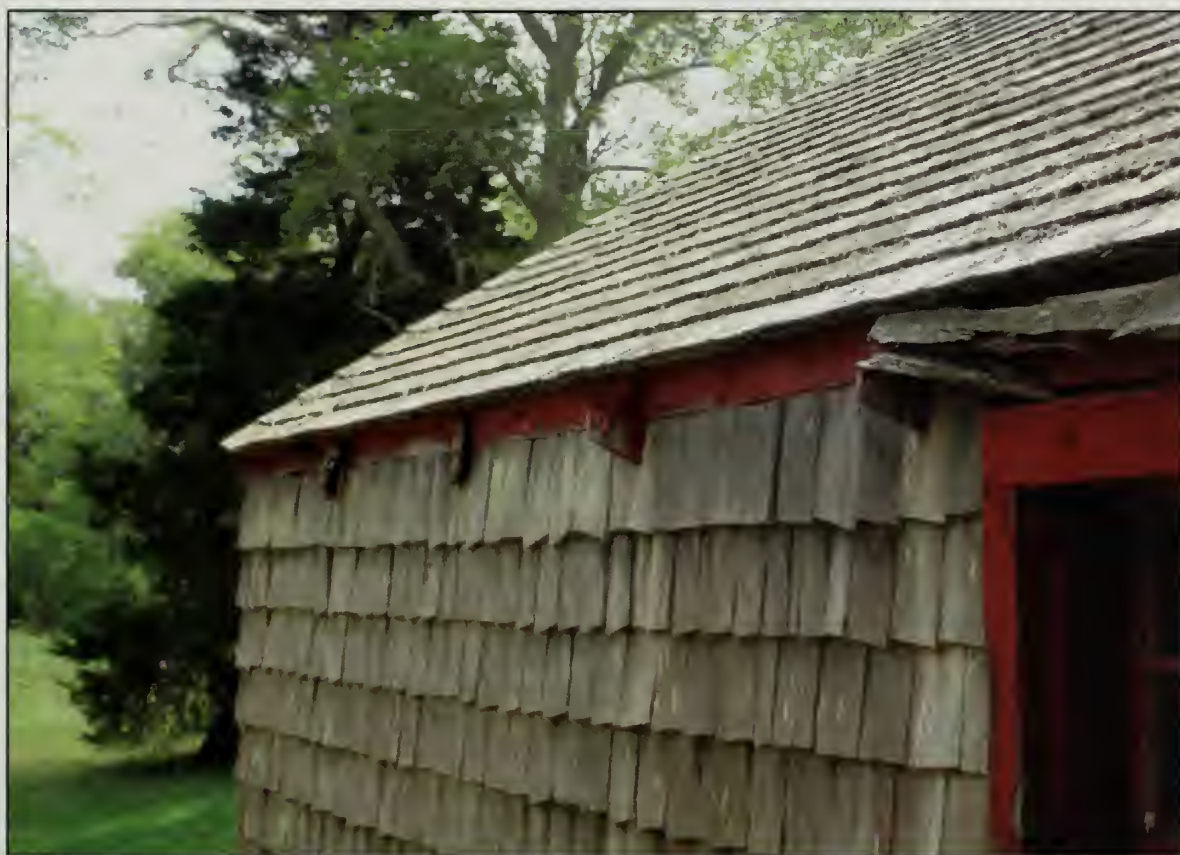
Two miscellaneous exterior features that relate to the roof system are visible on the Barn. The first is a set of two posts that are affixed to the west elevation of the Barn. Historic photographic documentation shows these posts were constructed to support a former open porch roof that was once on this elevation (Figure 306). The second feature in place as part of the roofing system of the Barn is a lightning rod on the east end of the gable roof of the principal mass (Figure 307).

Figure 306. Wooden posts that once supported a former open porch roof, west elevation, Barn (2007).

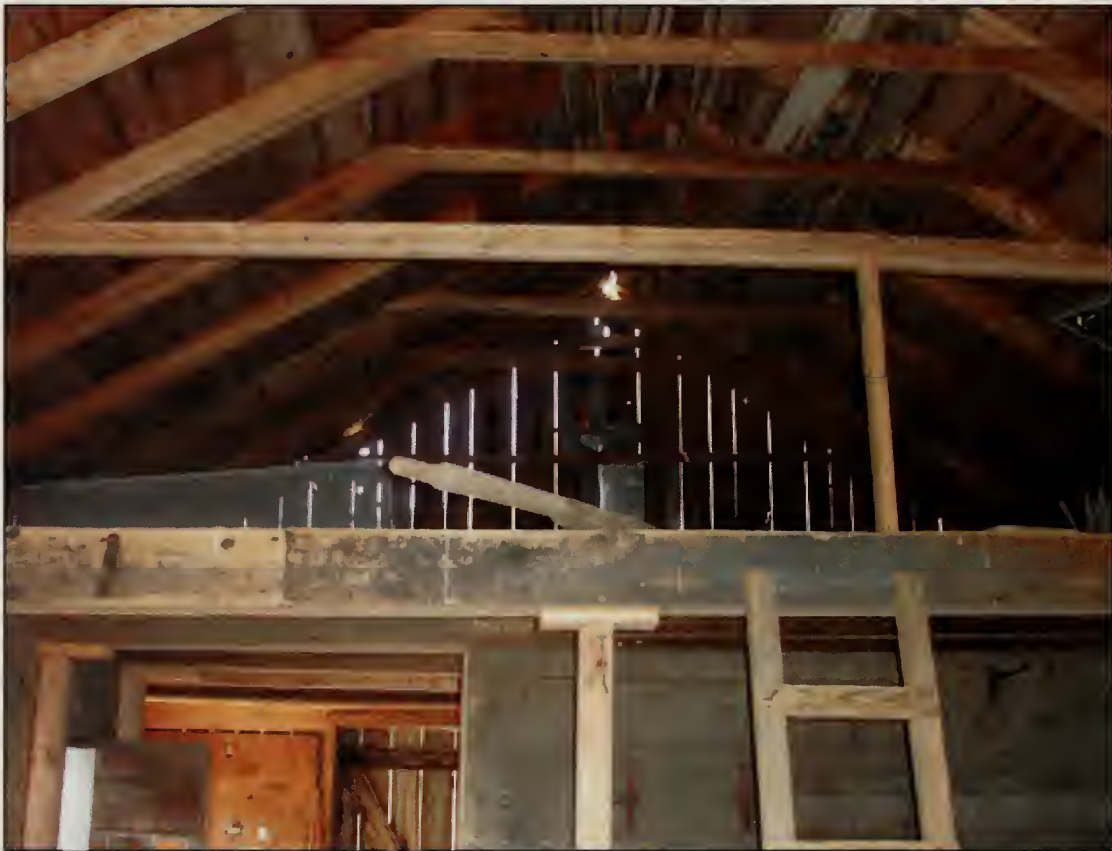
The Loft Area of the Barn was inaccessible at the time of the site visit and a detailed description of the interior will not be included in this report (Figure.353).

Figure 353. Loft of Barn (2007).

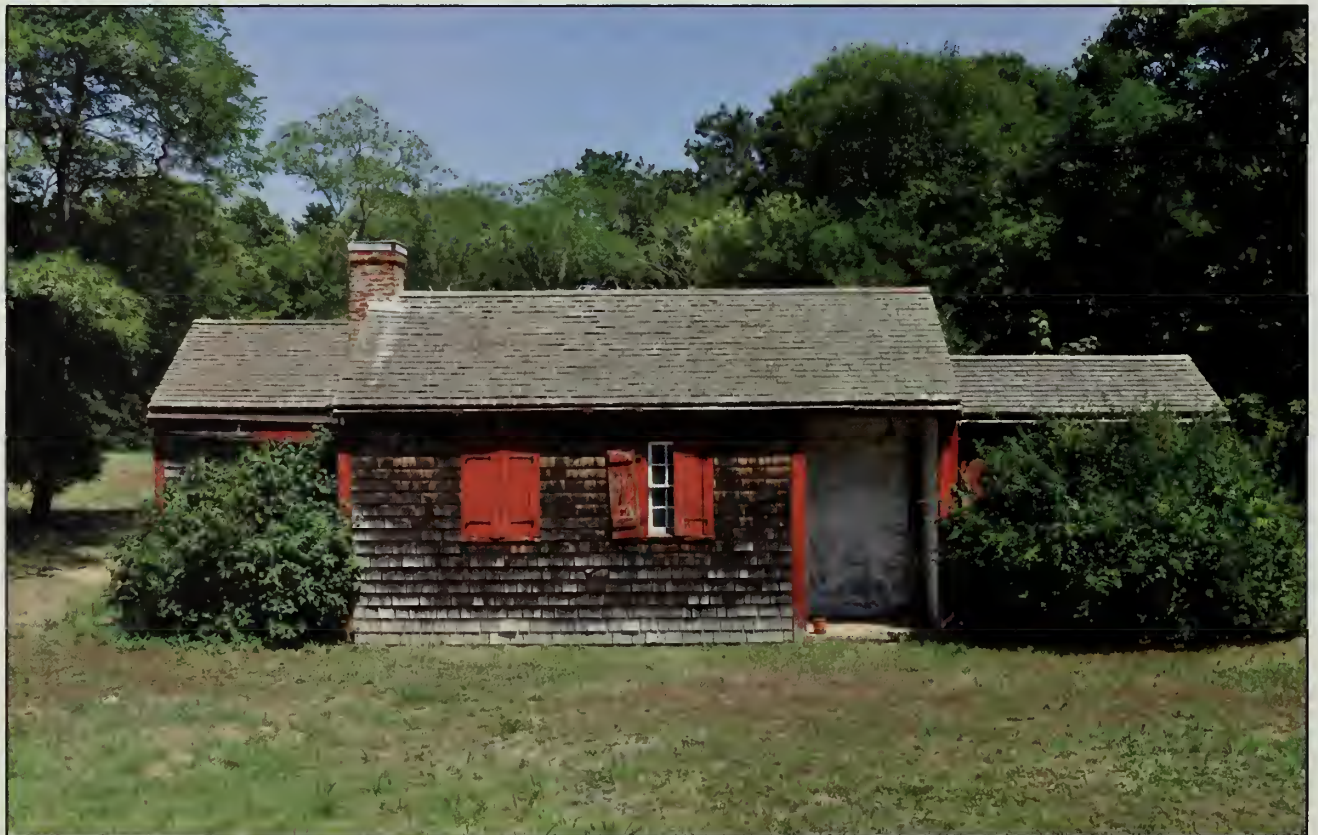
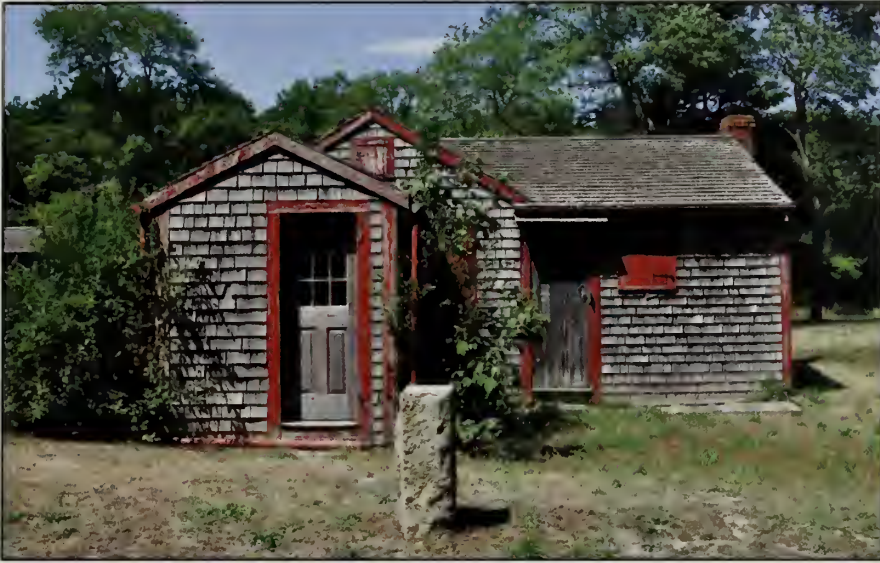
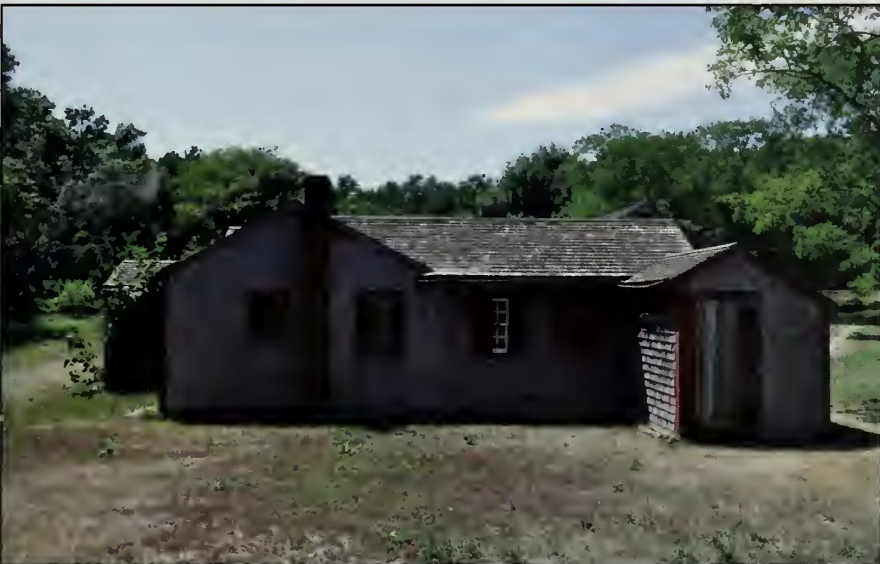
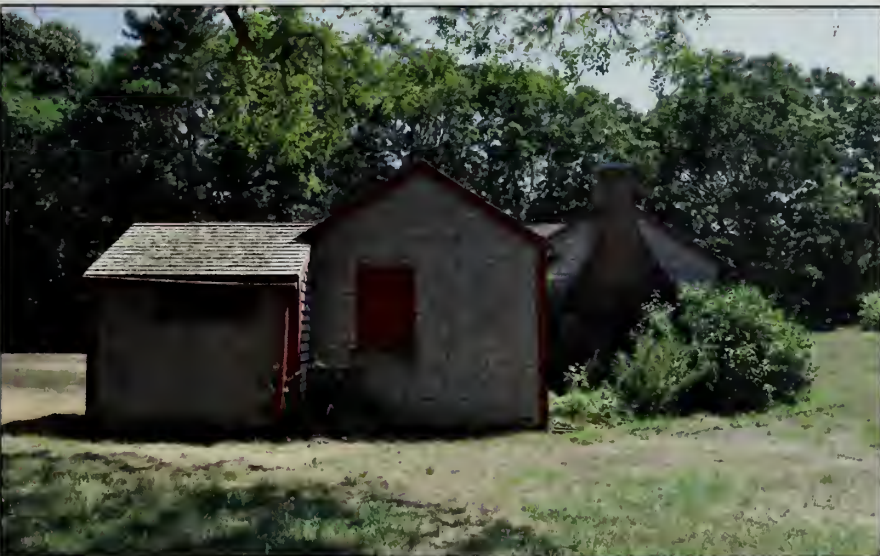
The Guest House is sided with unpainted, wooden shingles laid in a coursed pattern on all four elevations (Figures 354, 355, 356, 357). George K. Higgins notes on page 132 of his journal that the “addition [1951 Bathroom/North Bedroom/Closet Addition] was shingled using the white cedar shingles in place of split Cypress Virginia shingles originally used when the

Guest House was built in 1929.” It is unknown if the shingles noted are those presently on the Guest House.

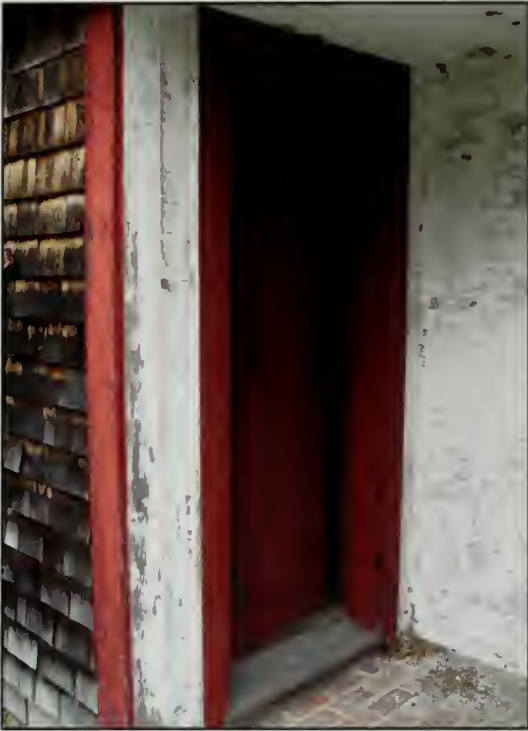
Doorway Number	Width	Height	Description
D101	29 ½ inches	77 inches	D101 is located in the west elevation of the Guest House and provides access to the Living Room (Figure 359). D101 is hung with a wooden batten door constructed of beaded board and is painted red. This door has an iron thumb latch for hardware with no apparent locking mechanism (Figure 360). D101 is cased with flat 5 ¼ inch wooden boards on the top, right, and left sides that are also painted red. There is a threshold at the bottom of D101 that measures 3 ¾ inches wide (Figure 361).
D102	27 inches	75 inches	D102 is located in the south elevation of the Guest House and provides access to the Kitchen (Figure 362). D102 is hung with a Dutch door. The upper half of the Dutch door consists of 9 fixed lights; the lower half consists of 2 raised wooden panels. This door is painted red with much of the finish worn off due to environmental conditions. The door hardware is located on the upper half of the door and consists of an iron pull and two embedded deadbolt locking mechanisms (Figure 363). D102 is cased on the top, right and left sides with flat, wooden boards that measure 4 ½ inches wide and are painted red. Located on the ground next to D102 is a shutter door that appears to fit this doorway. The measurements of this shutter door are 27 inches wide by 75 inches tall. The threshold of D102 measures ¾ inch tall.

Figure 359. D101 in east elevation, Guest House (2007).

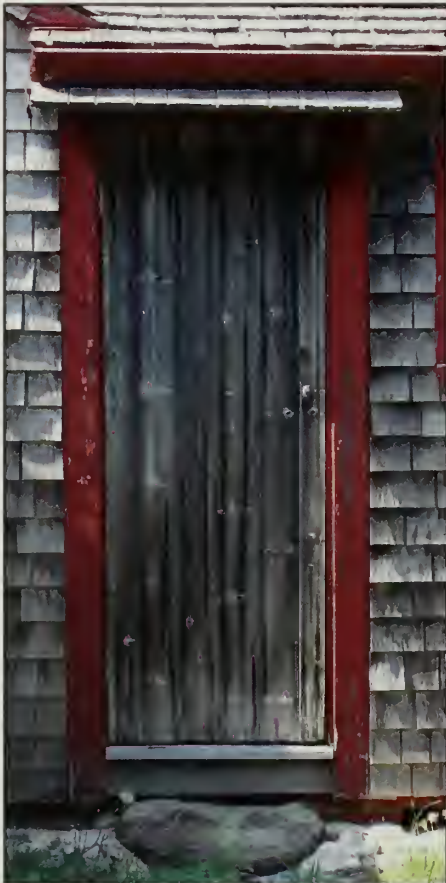
D103	28 inches	78 ½ inches	D103 is located in the south elevation of the Guest House and provides access to the South Bedroom (Figure 364). D103 is hung with two doors, one exterior door and one interior door. The exterior door is a wooden batten door constructed of 6 unpainted, flush vertical flat boards. The hardware on this door is a wooden doorknob pull and a modern metal imbedded deadbolt locking mechanism (Figure 365). The interior door is also a batten door and is constructed of wooden beaded boards that are finished with red paint. The interior door does not have any hardware facing the exterior door. Located on the top, right, and left sides of D103 is a casing comprised of 4 ½ inch , flat, wooden boards finished in red paint. Also located on top of D103 is a small and shallow shed roof. There is a white wooden screen door with two screen panels (one on the top and one on the bottom) located on the floor of the South Bedroom that appears to be fitted for D103. The threshold of D103 measures 1 ¼ inch tall.

Figure 364. D103 in south elevation, Guest House (2007).

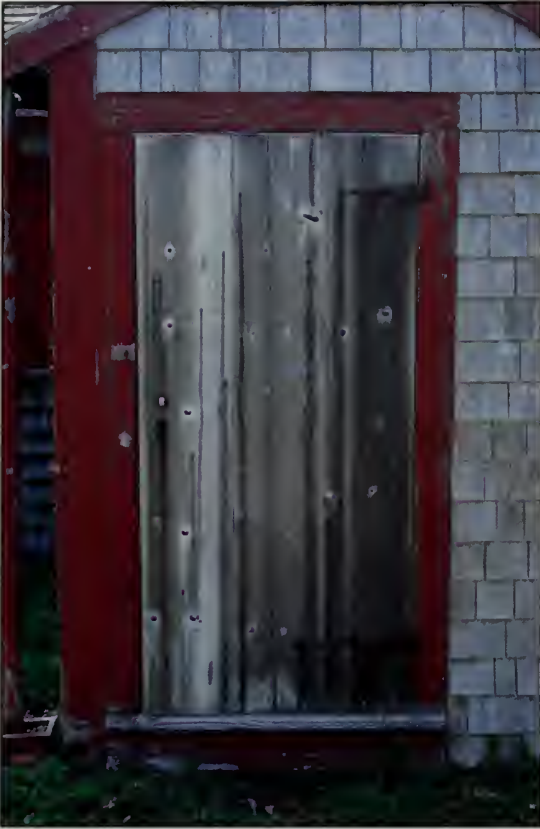
D104	33 ½ inches	72 inches	D104 is located in the east elevation of the Guest House and provides access to the Closet (Figure 366). D104 is hung with a wooden batten door constructed of 3 unpainted, flush vertical flat boards. The exterior hardware on this door consists of an iron circle door pull, a modern metal embedded deadbolt, and 2 metal strap hinges on the northern end of the door (Figure 367). D104 is cased on the top, bottom, right and left sides with flat, wooden boards that measure 4 ½ inches wide and are painted red. The threshold of D104 measures 1 ¼ inches tall.

Figure 366. D104 in east elevation, Guest House (2007).

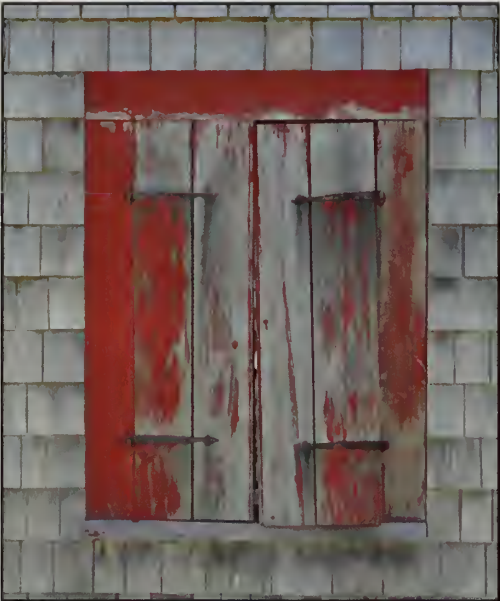
W111	21 ¼ inches	38 inches	W111 is located in the east elevation of the Guest House and opens into the interior of the Bathroom (Figure 376). W111 contains a three-over-three double hung sash window. Each pane of glass measures 5 ½ inches wide by 7 ½ inches tall. The muntins have flat, angular profiles that measure ½ inch wide by ¼ inch deep. The casing that surrounds W111 consists of 4 ½ inch, flat, wooden boards on the top, right, and left sides. The sill of W111 measures 1 ¾ inches tall. There are two wooden batten shutters on the exterior of W111. Both shutters measure 11 inches wide by 37 ¾ inches tall. There are two iron strap hinges located on the top and bottom of each shutter. The muntins, casing, sills and shutters are finished with red paint.
W112	21 ¼ inches	38 inches	W112 is located in the east elevation of the Guest House and opens into the interior of the North Bedroom (Figure 377). W112 contains a three-over-three double hung sash window. Each pane of glass measures 5 ½ inches wide by 7 ½ inches tall. The muntins have a flat, angular profile and measure ½ inch wide by ¼ inch deep. The casing that surrounds the top, right, and left sides of W112 consists of 4 ½ inch, flat, wooden boards. The sill of W112 measures 1 ¾ inches tall. W112 has two wooden batten exterior shutters. The southern shutter measures 11 inches wide by 37 ¾ tall; the northern shutter measures 11 ¼ inches wide by 37 ¾ inches tall. There are two iron strap hinges located on the top and bottom of each shutter. The muntins, casing, sills and shutters are finished with red paint.

Figure 376. W111 in east elevation, Guest House (OCLP, 2010).
