ATWOOD-HIGGINS HISTORIC DISTRICT CULTURAL LANDSCAPE REPORT AND OUTBUILDINGS HISTORIC STRUCTURES REPORT

CAPE COD NATIONAL SEASHORE

CULTURAL LANDSCAPE REPORT AND OUTBUILDINGS HISTORIC STRUCTURES REPORT

WELLFLEET, MASSACHUSETTS

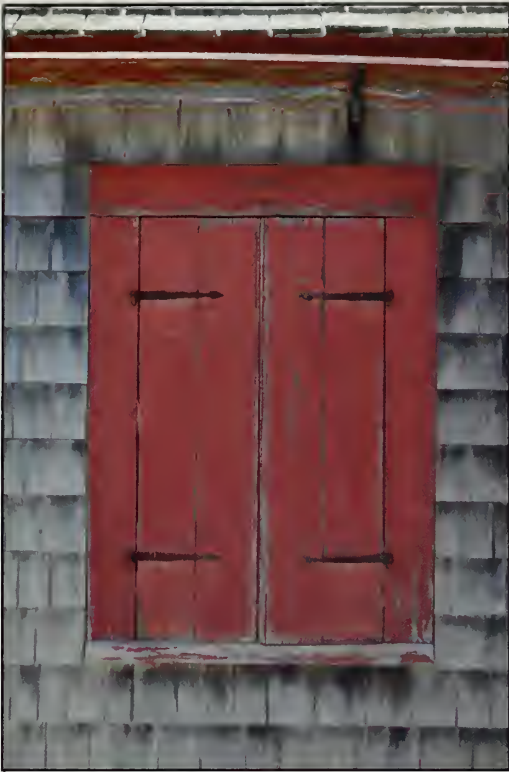
W113	22 ¼ inches	37 ½ inches	W113 is in the east elevation of the Guest House and opens in the interior of the North Bedroom (Figure 378). W113 contains a three-over-three double hung sash window. Each pane of glass measures 5 ½ inches wide by 7 ½ inches tall. The muntins of W113 have flat, angular profiles and measure 1 inch wide by ¼ inch deep. The casing that surrounds the top, right, and left sides of W113 consists of 4 ½ inch, flat, wooden boards. The sill of W113 measures 1 ¾ inches tall. There are two wooden batten shutters located on the exterior of W113. The southern shutter measures 10 ¾ inches wide by 37 ½ inches tall; the northern shutter measures 11 ¼ inches wide by 37 ½ inches tall. There are two iron strap hinges located on the top and bottom of each shutter. The muntins, casing, sills and shutters are finished with red paint.

Figure 378. W113 in east elevation, Guest House (OCLP, 2010).

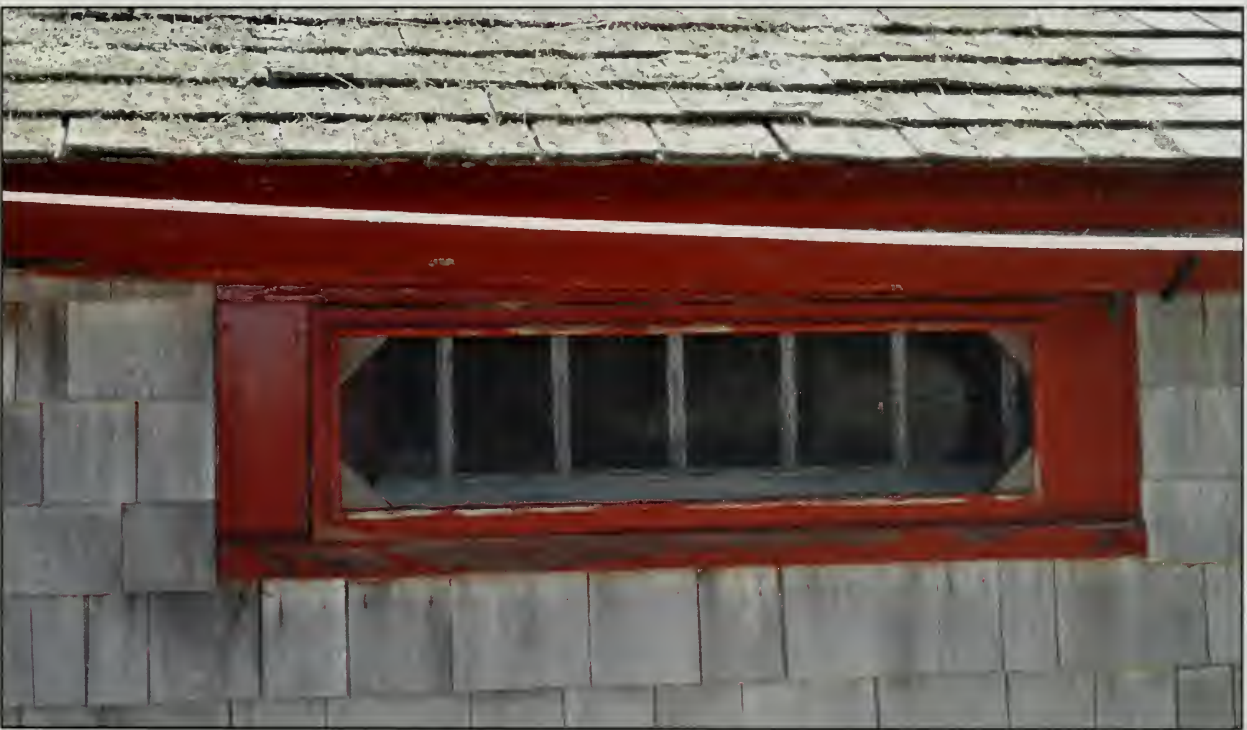
Window Number	Width	Height	Description
W114	11 $\frac{3}{4}$ inches	39 $\frac{3}{4}$ inches	W114 is located in the north elevation of the Guest House and punctuates the interior north wall of the Closet (Figure 379). W114 is a fixed transom window with 6 lights. Each pane of glass measures 5 $\frac{1}{2}$ inches wide by 7 $\frac{1}{2}$ inches tall. The muntins of W114 have flat, angular profiles and measure $\frac{3}{4}$ inch wide by $\frac{1}{4}$ inch deep. The casing that surrounds the right and left sides of W114 consists of flat wooden boards that measure 4 $\frac{1}{2}$ inches wide. The top casing of W114 also consists of a flat, wooden board and measures 4 inches wide. The sill of W114 measures 1 $\frac{3}{4}$ inches tall. There is a screen with a 1 $\frac{1}{2}$ inch wide wooden frame that covers the exterior of W114.
W115	22 $\frac{1}{4}$ inches	38 $\frac{1}{4}$ inches	W115 is located in the north elevation of the Guest House and opens into the interior of the North Bedroom (Figure 380). W115 is a three-over-three double hung sash window. Each pane of glass measures 5 $\frac{1}{2}$ inches wide by 7 $\frac{1}{2}$ inches tall. The muntins of W115 have flat, angular profiles and measure $\frac{3}{4}$ inch wide by $\frac{1}{4}$ inch deep. The casing that surrounds the top, right, and left sides of W115 consists of flat, wooden boards that measure 4 $\frac{1}{2}$ inches wide. The sill measures 1 $\frac{3}{4}$ inches tall. There are two wooden batten shutters located on the exterior of W115. The eastern shutter measures 11 inches wide by 37 $\frac{3}{4}$ inches tall; the western shutter measures 11 $\frac{1}{4}$ inches wide by 37 $\frac{3}{4}$ inches tall. There are two iron strap hinges located on the top and bottom of each shutter. The muntins, casing, sills and shutters are finished with red paint.

Figure 379. W114 in north elevation, Guest House (OCLP, 2010).

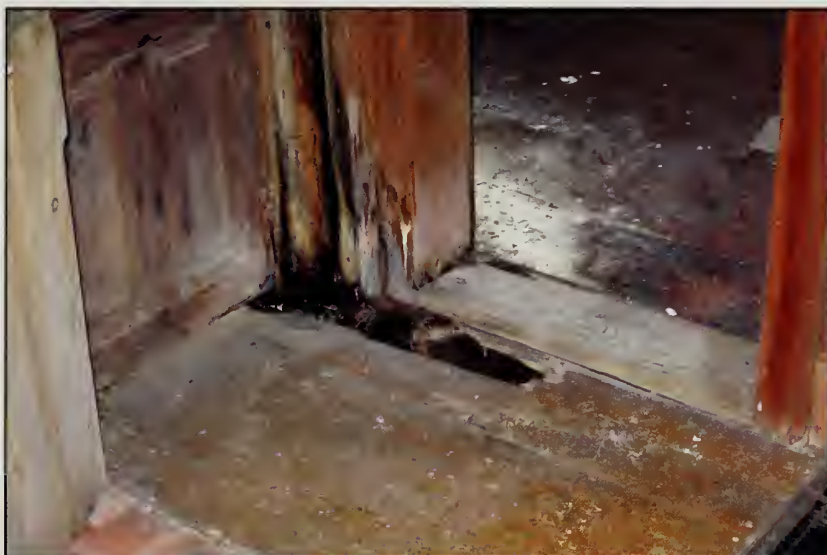
this room are 20 feet 6 inches wide (north-south direction) by 12 feet 6 inches deep (west-east direction). The Living Room is accessed through four separate doorways: D101 and D105 located in the south wall, and D106 and D107 in the east wall. The flooring material of the Living Room consists of wide, wooden boards of varying lengths running in a north-south direction and finished in a mustard yellow paint with splatters of white, green, red, and brown paint (Figure 389). There is a large hole in the northeast corner of the floor next to the threshold of D107 (Figure 390).

Figure 390. Large hole in northeast corner of floor in Living Room, Guest House (2007).

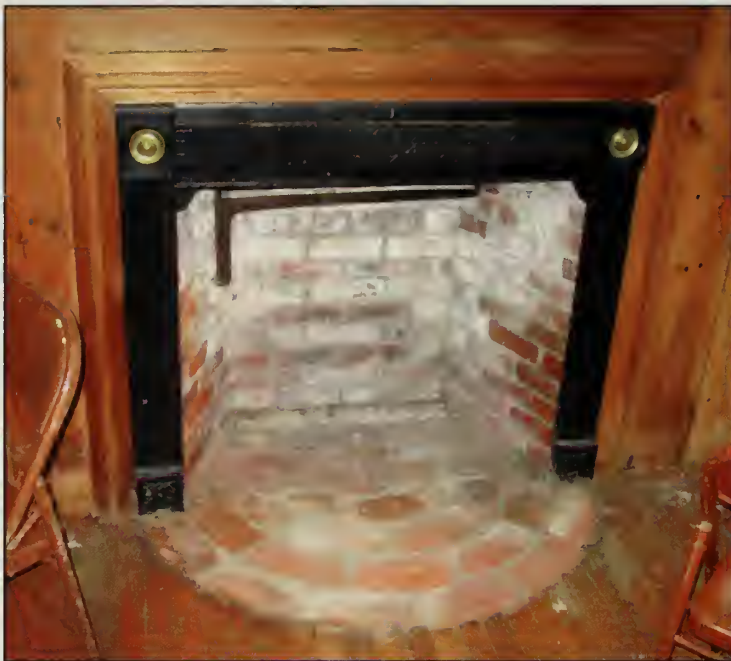
There are two special features located within the Study. The first is a fireplace located in the east end of the north wall (Figure 514) that measures 36 inches wide by 31 ½ inches tall. The fireplace and semi-circular hearth is constructed of brick. The trim surrounding the fireplace is decorative stone painted black that measures 4 ½ inches on the right and left sides and 6 ¾ inches on the top. Located within the fireplace is an iron fireplace crane fastened on the left side. The second special feature located within the Study is the built-in bed placed on the north end of the west wall (Figure 515). The bed frame is painted off-white, extends one-quarter up the west wall and contains 5 built-in drawers.

Figure 514. Fireplace in north wall of Study, Country Store (2007).

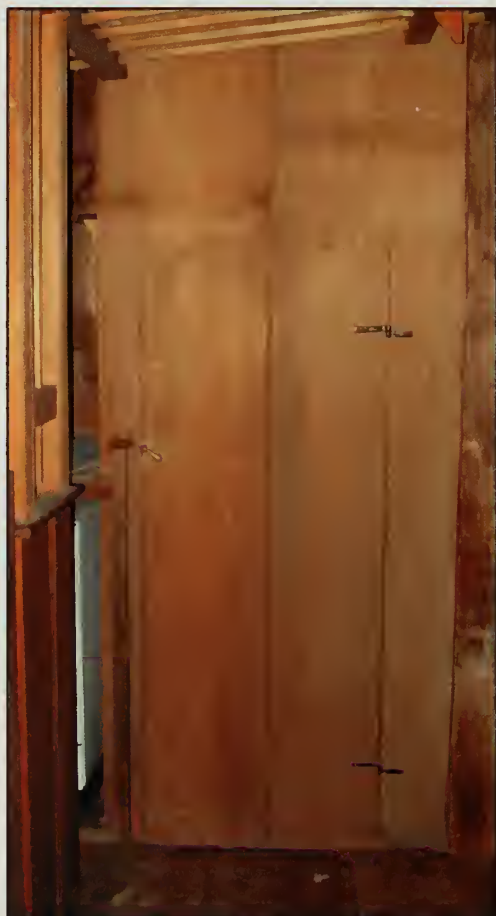
description, refer to the Current Description, Country Store, Exterior Elements – Doorways section of this report. D105 is located in the south wall and is described above. D106 is located in the south end of the west wall and provides access to a closet (Figure 520). D106 is hung with a wooden door constructed of the unpainted, vertical, tongue-and-groove siding seen on the west wall. The hardware on this door consists of a small metal handle. To the right of D106 is D107. D107 provides access to the stairwell leading to the second floor of the Country Store and measures 27 inches wide by 73 ½ inches tall (Figure 521). D107 is hung with an unpainted 4-paneled door with the panels raised facing the Country Store Room and recessed facing the stairwell. The hardware on this door consists of an iron thumb latch. D108 is located in the north wall and provides access to the Store Room (Figure 522). D108 measures 29 ½ inches wide by 74 ¼ inches tall. D108 is hung with a wooden door constructed of the unpainted, vertical, tongue-and-groove siding seen on west end of the north wall. The hardware on the door within D108 consists of a wooden door latch. D109 is located to the immediate right of D108 and provides access to a closet (Figure 523). D109 measures 25 ¾ inches wide by 71 inches tall. D109 is hung with a 2-paneled door with the panels raised facing the Country Store Room and recessed facing the interior of the closet. The hardware located on this door consists of an iron thumb latch.

Figure 520. D106 in west wall of Country Store Room, Country Store (2007).

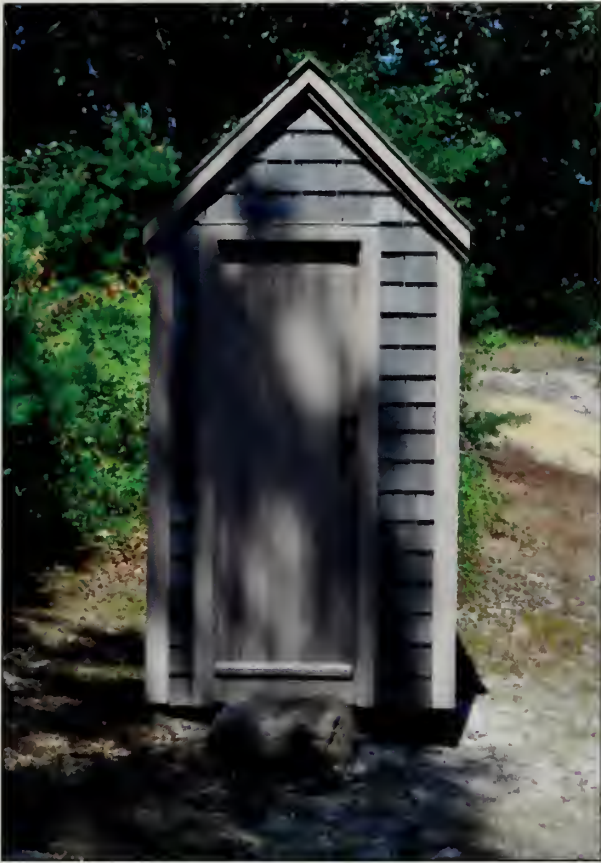
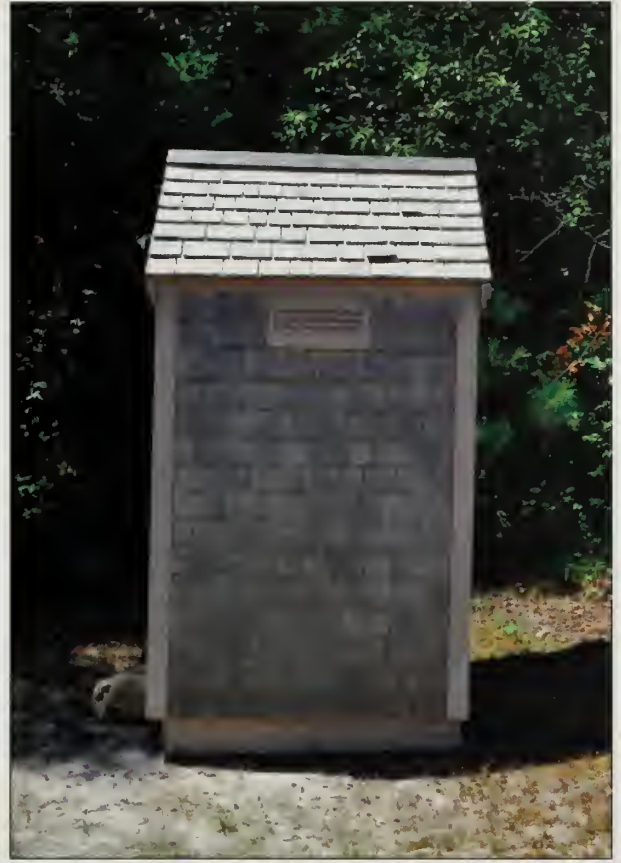
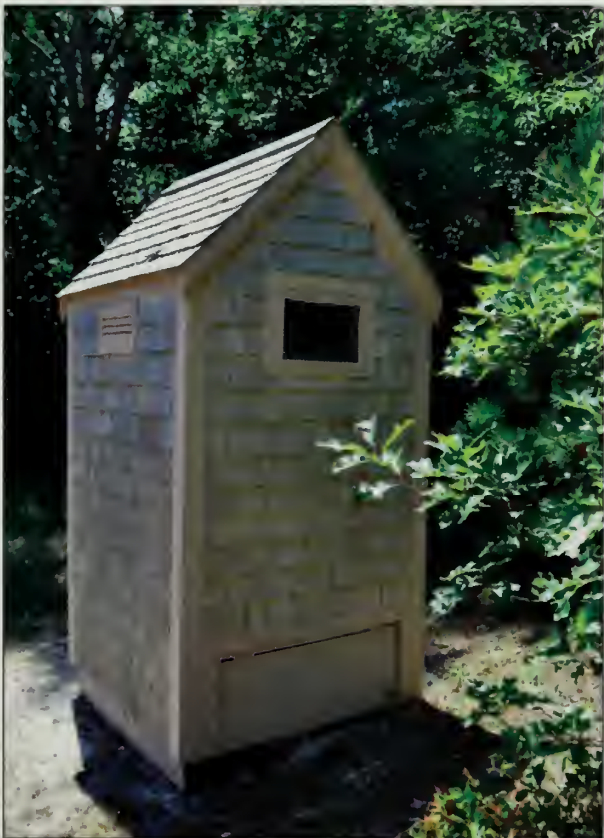
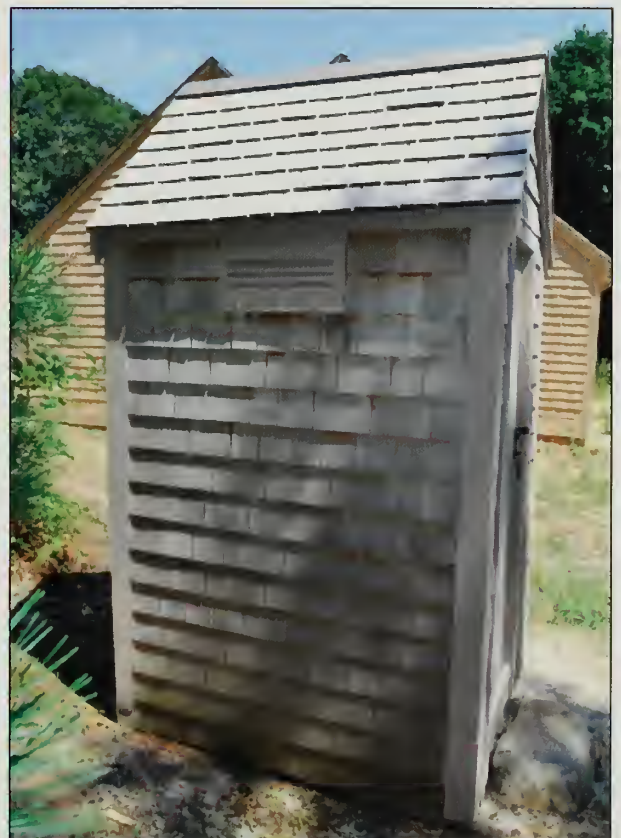
The Atwood-Higgins House Privy is a wood-framed structure located approximately ten feet west of the house, near the edge of the wooded slope (Figures 531 through 534). The National Park Service reconstructed the privy in 2007 utilizing some of the fabric from the original privy, and constructed it to its original dimensions. The original privy was documented by the List of Classified Structures team in the 1990s and likely dated to about 1919, when George K. Higgins acquired the property. One of the privies, perhaps the original house privy, was known as the Vermont privy because it was moved to the property from Vermont.

Figure 531. South elevation, Atwood-Higgins House Privy, rebuilt in 2007 (OCLP, August 2010).

Figure 532. East elevation, Atwood-Higgins House Privy, rebuilt in 2007 (OCLP, August 2010).

Figure 533. East and north elevations, Atwood-Higgins House Privy, rebuilt in 2007 (OCLP, August 2010).

Figure 534. West elevation, Atwood-Higgins House Privy, rebuilt in 2007 (OCLP, August 2010).

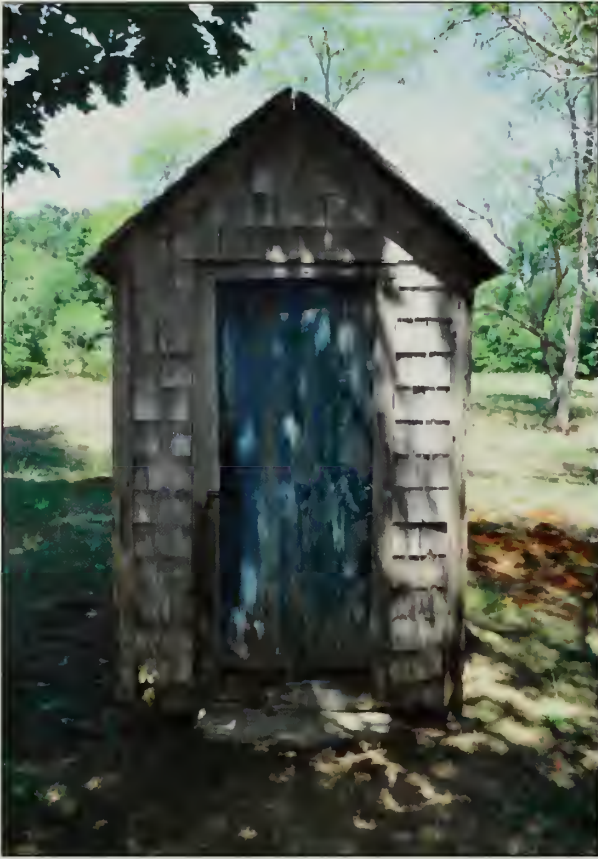
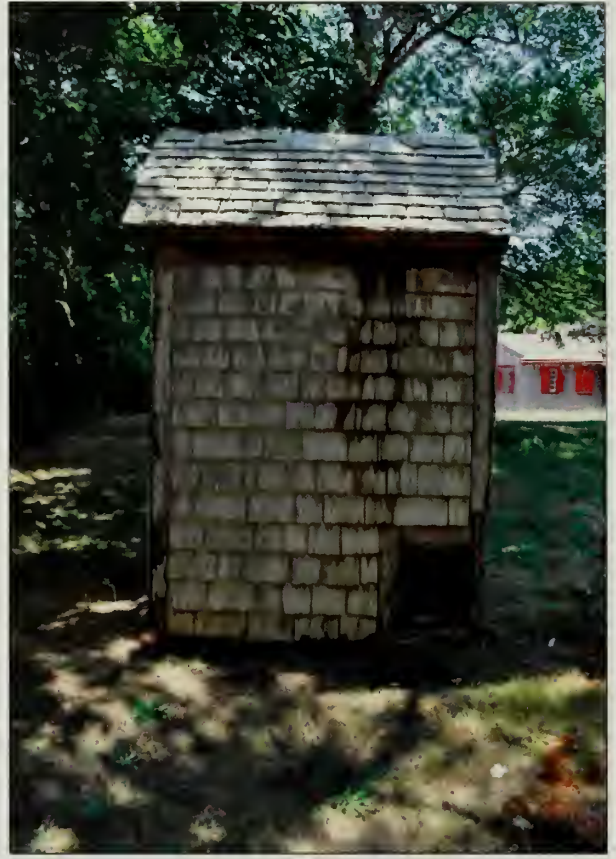
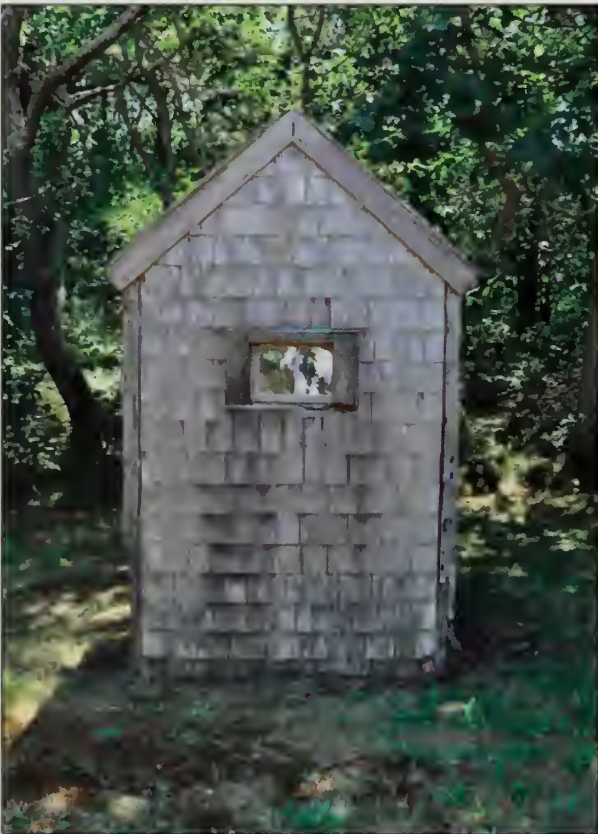
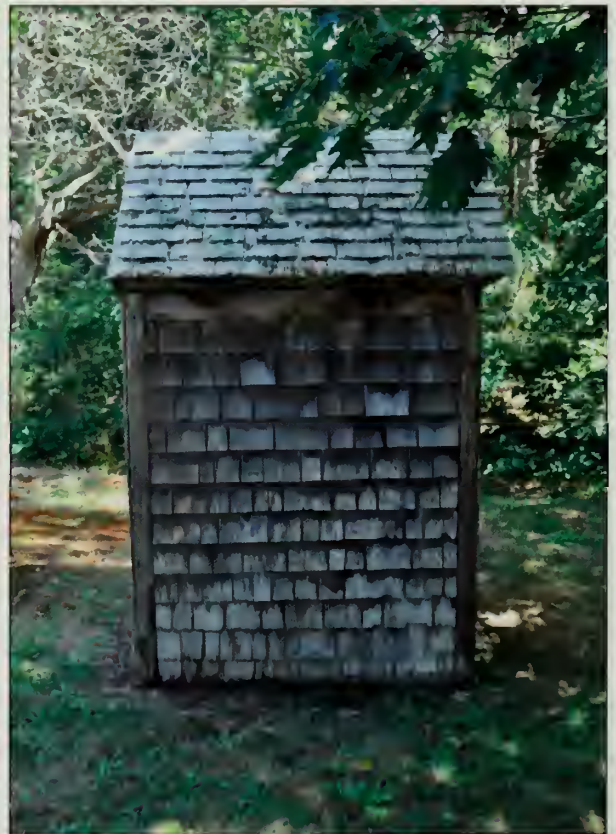
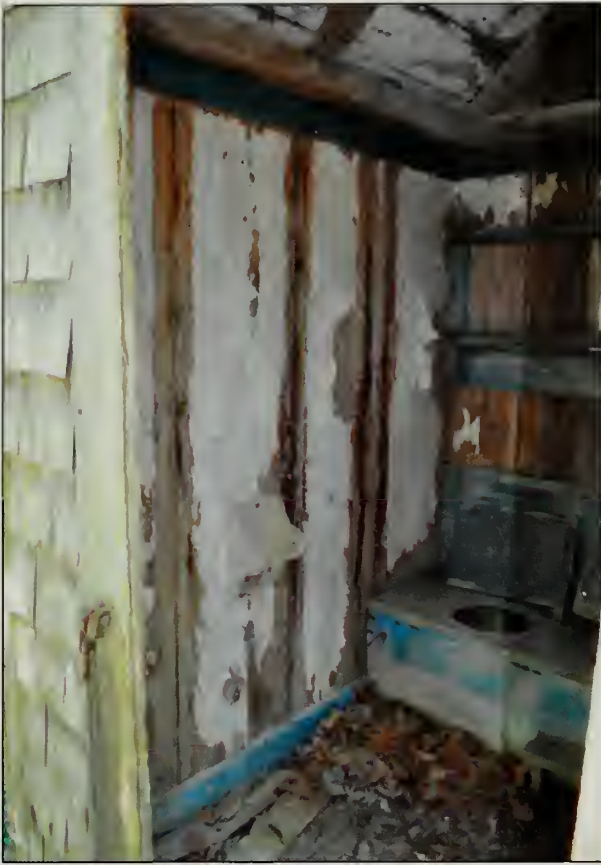
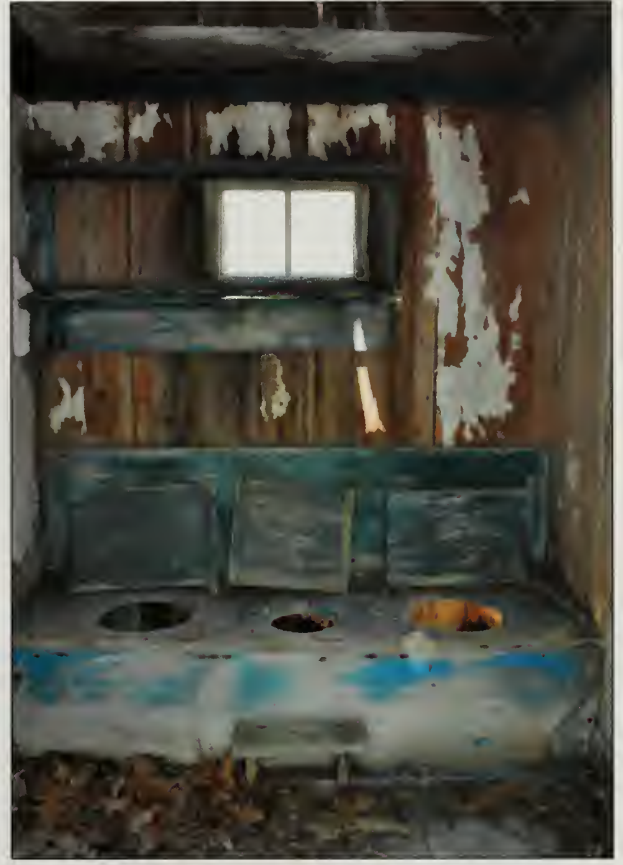
The Guest House Privy is a one-story, one-bay-wide, wood-framed structure located approximately 100 feet east of the Guest House, near the edge of the wooded slope that descends to the Herring River. The structure faces south (Figures 535 through 542).

Figure 535. South elevation, Guest House Privy (OCLP, August 2010).

Figure 536. East elevation, Guest House Privy (OCLP, August 2010).

Figure 537. North elevation, Guest House Privy (OCLP, August 2010).

Figure 538. West elevation, Guest House Privy, rebuilt in 2007 (OCLP, August 2010).

Figure 539. Interior view of west and north walls of Guest House Privy (OCLP, August 2010).

Figure 540. Interior view of north wall and seats in Guest House Privy (OCLP, August 2010).

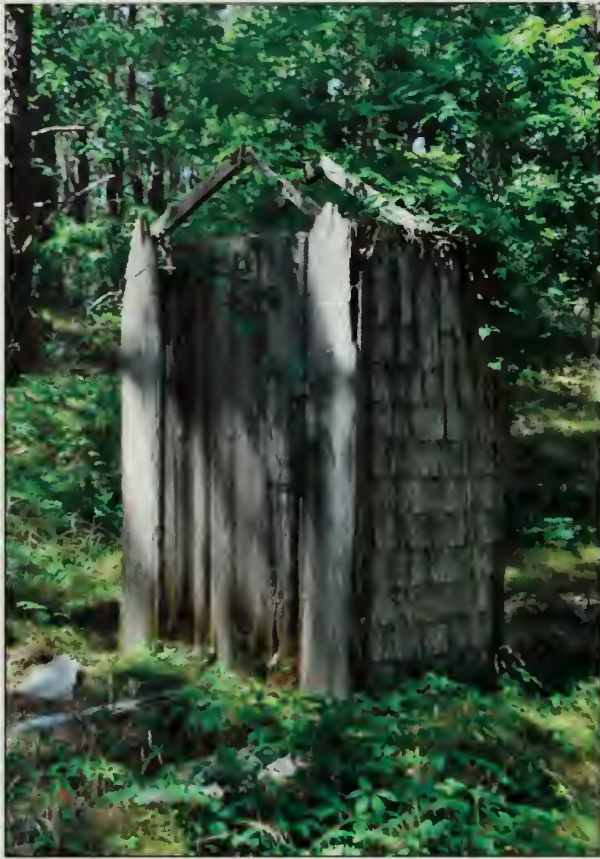
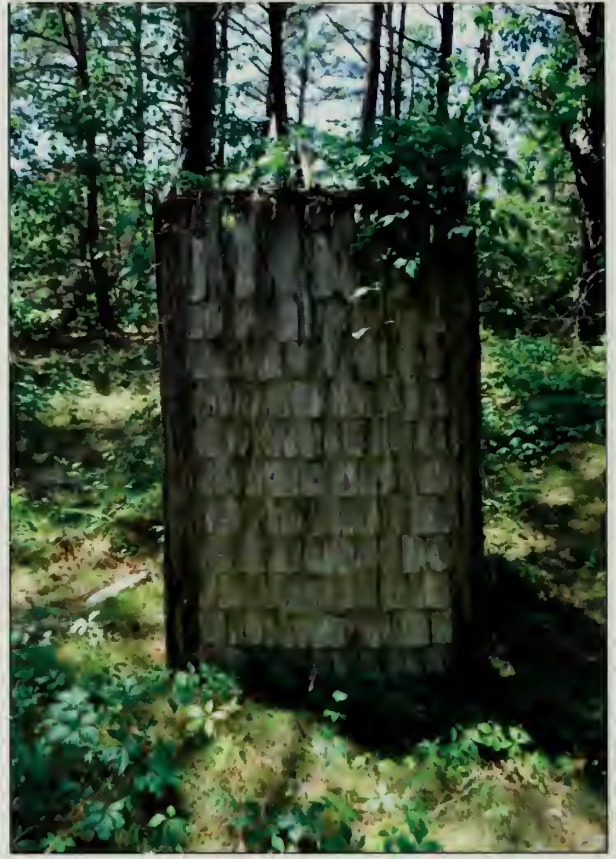
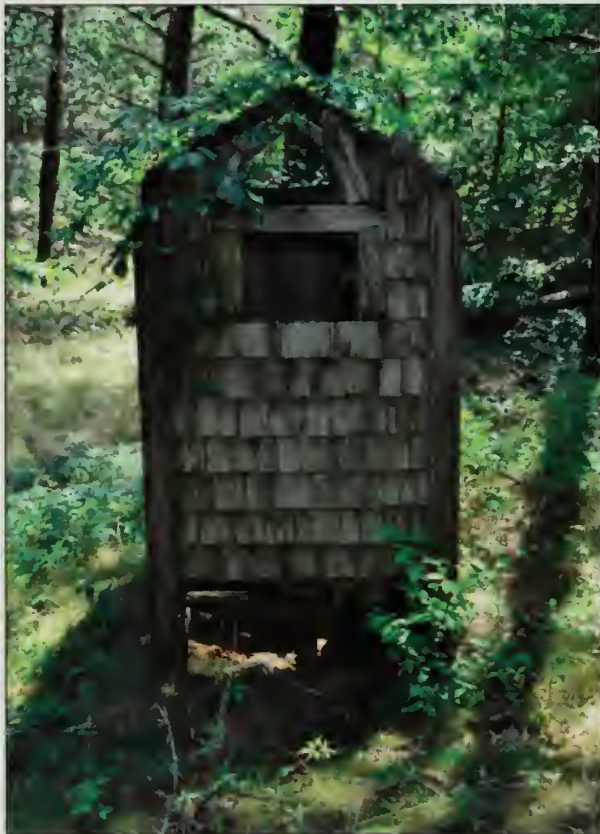
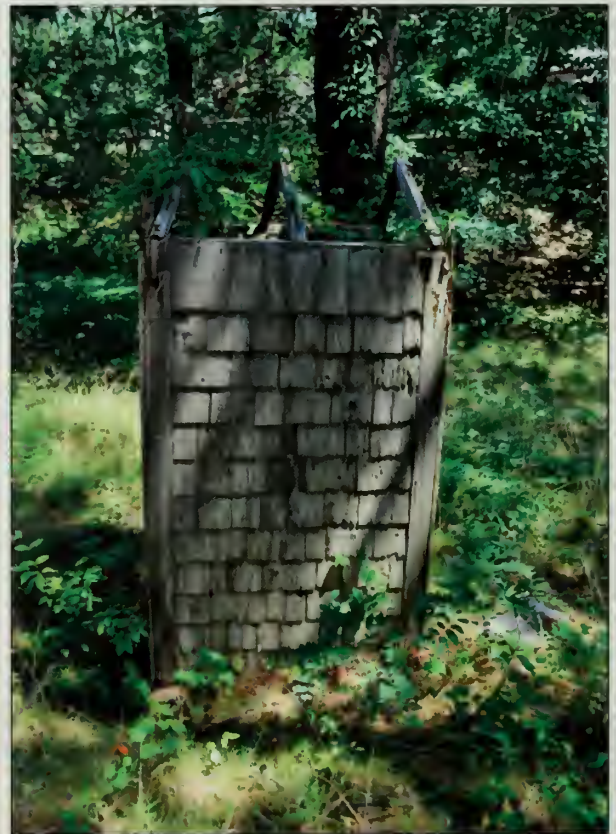
The Northwest Privy is a wood-framed structure located approximately 70 feet west of the Country Store and driveway, in a depression in the woods (Figures 543 through 546). The structure is a one-story, one-bay-wide, wood-frame building similar in design to the Guest House Privy. The front gable faces south and has rotted through. Only the rafters remain. Wood shingles cover the exterior, but are rotting. An unfinished, plank door is centered in the facade (south elevation). The privy is in poor condition and close to collapsing. The roof is gone and vines climb over the northeast half of the structure.

Figure 543. South and east elevations, Northeast Privy (OCLP, August 2010).

Figure 544. East elevation, Northeast Privy (OCLP, August 2010).

Figure 545. North elevation, Northeast Privy (OCLP, August 2010).

Figure 546. West elevation, Northeast Privy (OCLP, August 2010).

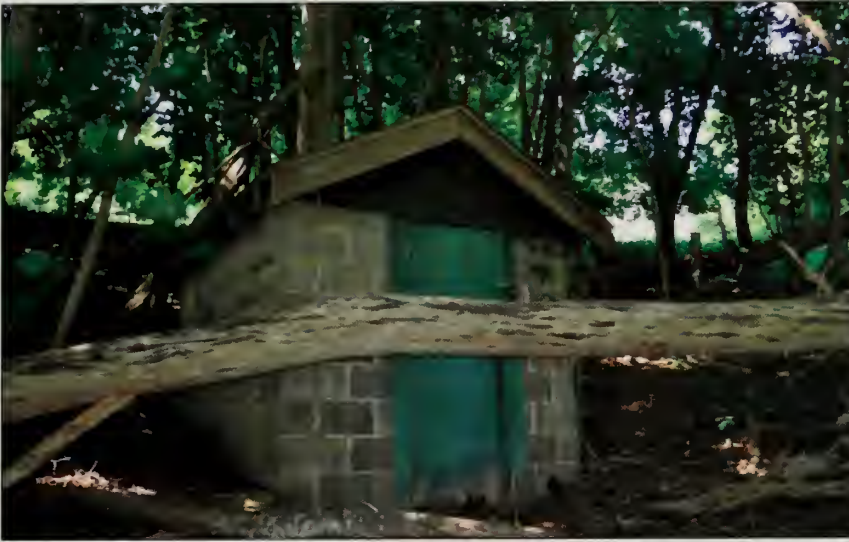
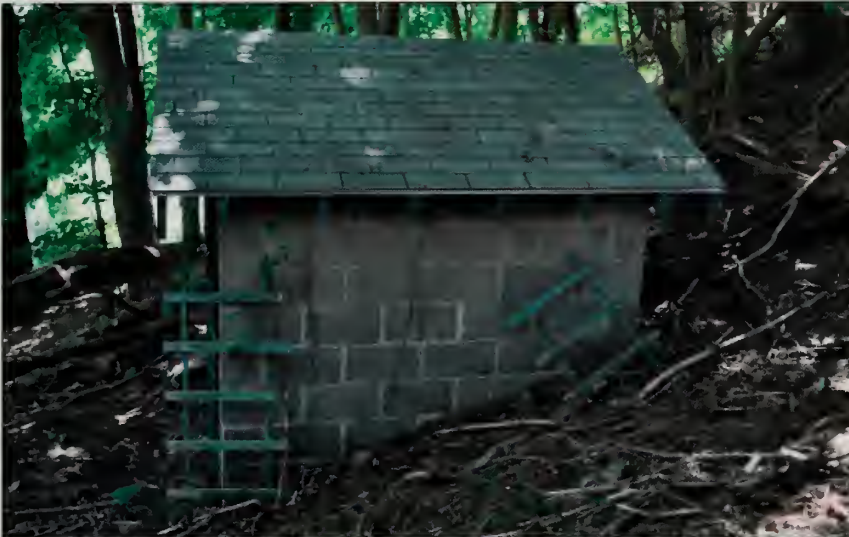
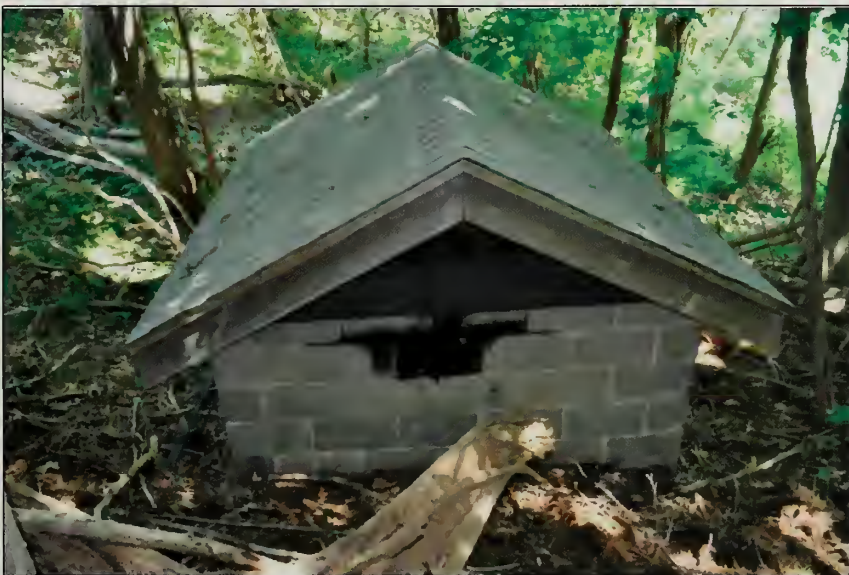
The Wellhouse is a small, concrete-block, utilitarian building set into the hillside at the southeast edge of the property, near a sharp bend in the Herring River (Figures 547 through 549). The Wellhouse faces southeast toward the river and is not visible from the other structures in the Historic District. The Wellhouse has an asphalt-clad, front gable roof with overhanging eaves and exposed rafter tails painted green. A single, wood plank, pedestrian door centered in the east facade provides access to the pump inside. The concrete block Wellhouse was constructed in 1932, during the installation of the water system upgrade that provided water to the house and lawns (see Figure 199). The Wellhouse is in good condition. The structure is surrounded by mature and declining trees, some of which have toppled near the structure. A fragment of a trellis is leaning near, but not attached to the structure.

Figure 547. South and east elevations, Wellhouse (OCLP, August 2010).

Figure 548. North elevation, Wellhouse (OCLP, August 2010).

Figure 549. West elevation, Wellhouse (OCLP, August 2010).
