BALCONY HOUSE: A HISTORY OF A CLIFF DWELLING, MESA VERDE NATIONAL PARK, COLORADO

by
Kathleen Fiero

with
Report of the 1910 Excavation and Repair of Balcony House
by
Jesse L. Nusbaum

Mesa Verde Museum Association, Inc.
Mesa Verde National Park, Colorado
1998

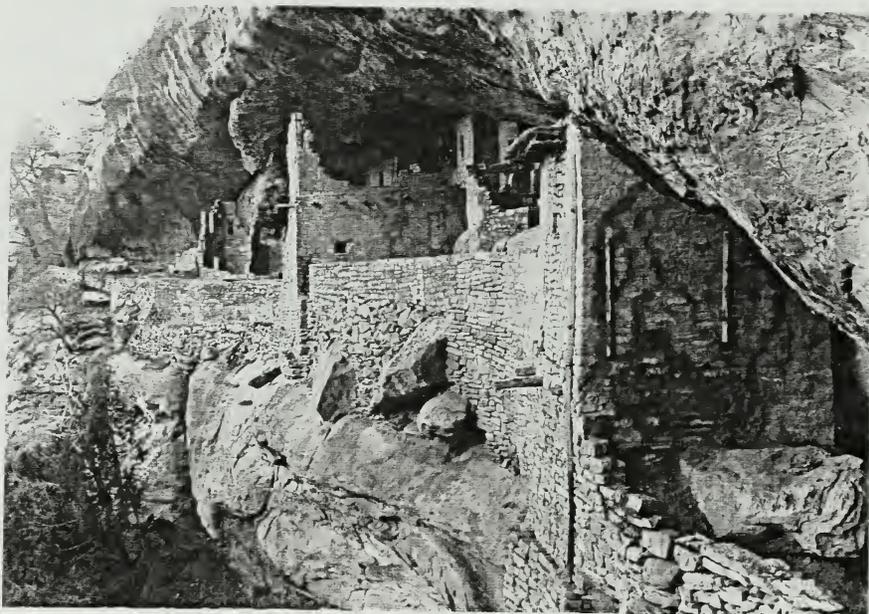
Figure 2.27. West wall of North Plaza, Balcony House 1910 after stabilization. Notice the dark mortar that has not yet dried and the balcony on Room 5 at upper right of photo, Photo by Jesse L. Nusbaum, Courtesy Museum of New Mexico, Neg. No. 2151.39, 60523.

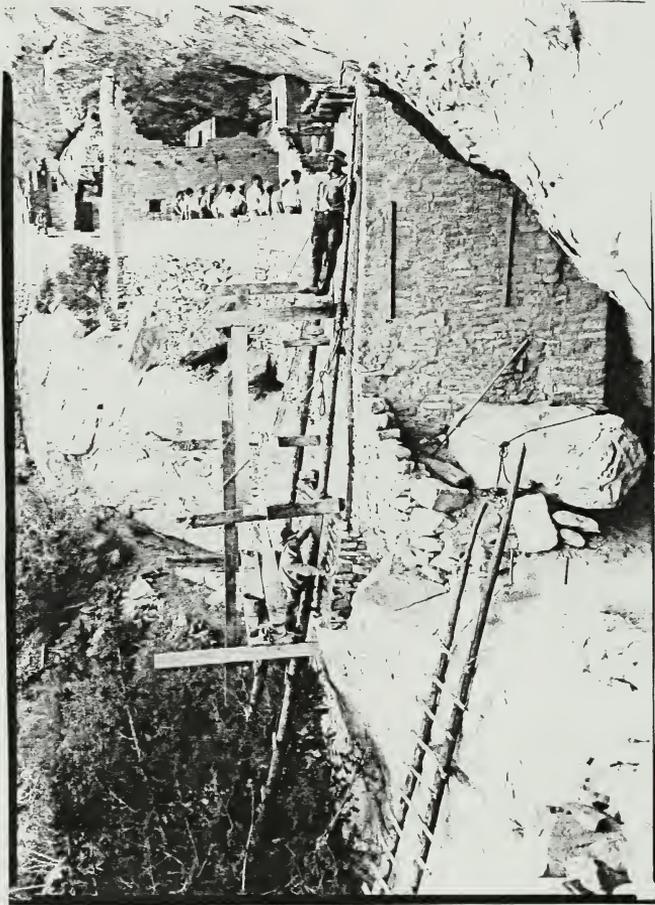
The many repairs made by Nusbaum to the site's front retaining wall have been so successful that no movement has been noted in the upper walls resting on this foundation. In 1934 some work was done on the footing of this wall under and north of the boulder that this wall is built around. From Nusbaum's description of his stabilization--redoing the wall

Figure 4.3. Al Lancaster stands at top of scaffolding looking east over Soda Canyon during 1934 stabilization. Visitors are in the North Plaza with a Park ranger. Photo by C. Markley, Mesa Verde National Park , Neg. No. 0284.

on the boulder, it is probably correct to state that the 1934 work was done on a section of the wall not modified by Nusbaum. Eroded mortar and stones were replaced in 1934--no major structural modifications were needed (Figure 4.3).

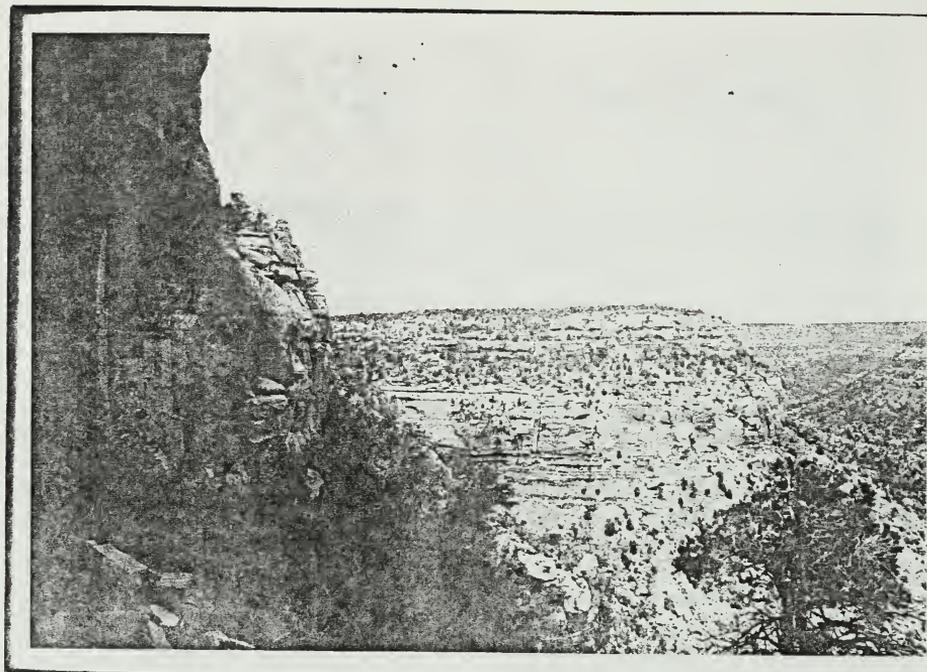
Figure 5.1. Looking northeast down Soda Canyon, 1907, a portion of the north end of Balcony House is visible at left before any repairs or stabilization. Photo by Jesse L. Nusbaum. Courtesy Museum of New Mexico, Neg. No. 2150.1, 60500.

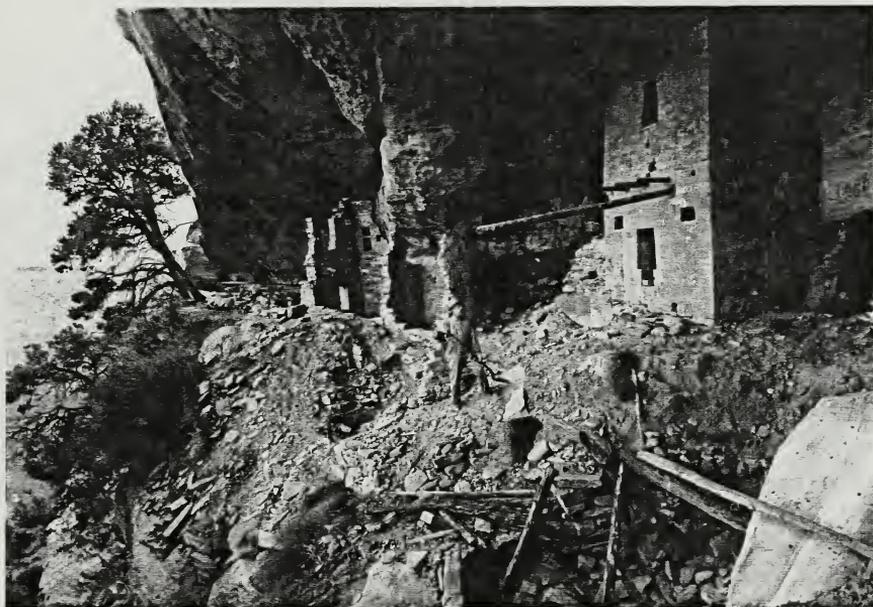
That Balcony House needed attention to save it from early destruction was obvious. The ruin was a discouraging sight, and much labor was necessary to put it in repair. In the south or Kiva Plaza, which consists of two large kivas surrounded by rooms on all but the front side and separated from the North Plaza by a heavy wall without a door opening, the demolition was almost complete. (Figure 5.8) The outside retaining wall, from two to eleven feet high originally, was forced over the cliff, probably as the result of the jar received when the immense slabs of rock from the cave arch high above fell, demolishing and carrying with them the walls of the rooms underneath and the kiva walls below, the combined force of which was sufficient to loosen the massive retaining wall from its inclined footing on the lower rim. In order to remove the large slabs,

Figure 5.8. E.M. Nusbaum in the South Plaza at the start of the repair, 1910. Looking south at the demolition of the kiva area. Photo by Jesse L. Nusbaum, Courtesy Museum of New Mexico Neg. No.2151.42, 6316.

was moved at one end only, the other acting as a pivot or center. This sheared off half of the outside wall and left the remainder in a tottering condition which has gradually become worse. A mason secured by ropes replaced the buttress and retaining wall and built it up so as to underpin the shaky second story that a slight pressure of the hand could easily sway.

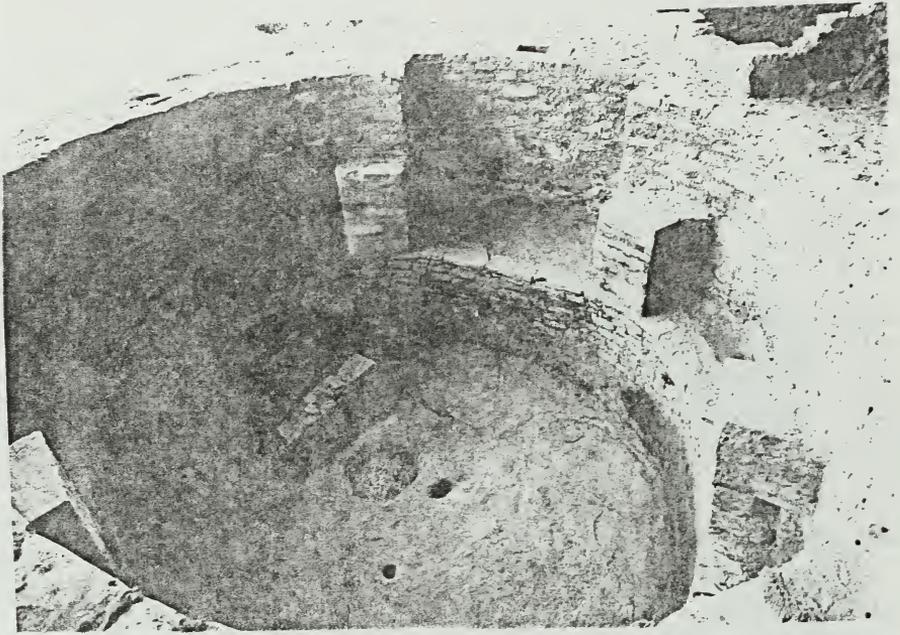
In the south kiva, the demolition was not so pronounced, and the slabs excavated in the kiva, though large enough to do great damage, had luckily fallen near the front so that the rear of the kiva below the base of the pilasters was not disturbed. No doubt these longer and less massive slabs crushed the walls of the rooms adjacent on the south and carried the south part of the retaining wall over the cliff. The demolition of the south kiva is of comparatively recent date, as the fresh fracture on the arch of the cave indicates, whereas the fracture above the north kiva is nearly obliterated. This falling and caving away gradually undermined the dirt fill on which some of the buildings were placed, and in turn either caused large cracks to appear in the more substantial buildings or precipitated the whole building into the kiva depressions below (Figure 5.9, 5.10).

Figure 5.9. South Kiva, Kiva B, in South Plaza 1910 after stabilization. Note niche in pilaster at right, fire pit, deflector, and sipapu on floor at center. Photo by Jesse L. Nusbaum, Courtesy Museum of New Mexico, Neg. No. 2151 26, 69521

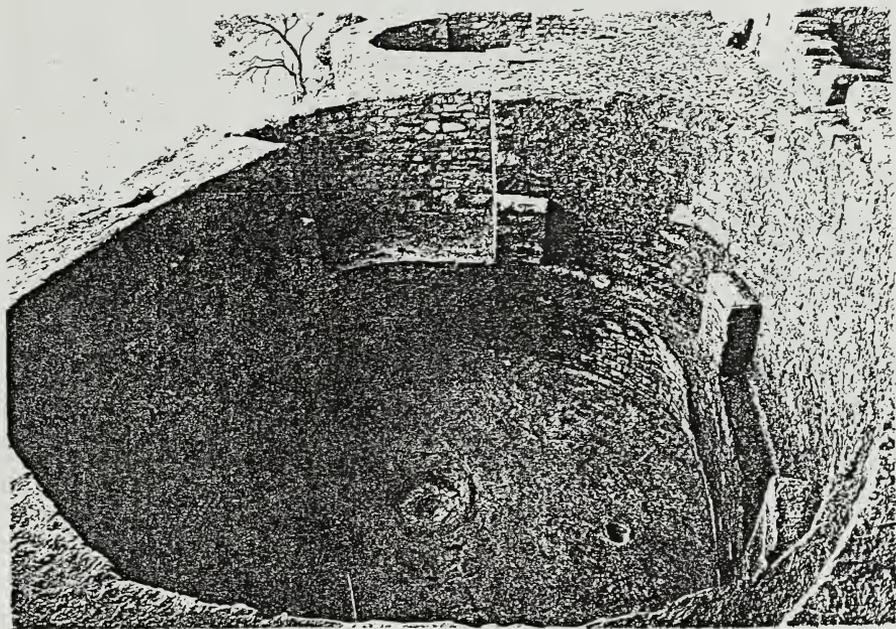
Figure 5.10. North Kiva, Kiva A, in South Plaza 1910 after stabilization. Note fire pit in center of floor and pit in floor at right of photo. Photo by J esse L. Nusbaum, Courtesy Museum of New Mexico, Neg. No 60520.

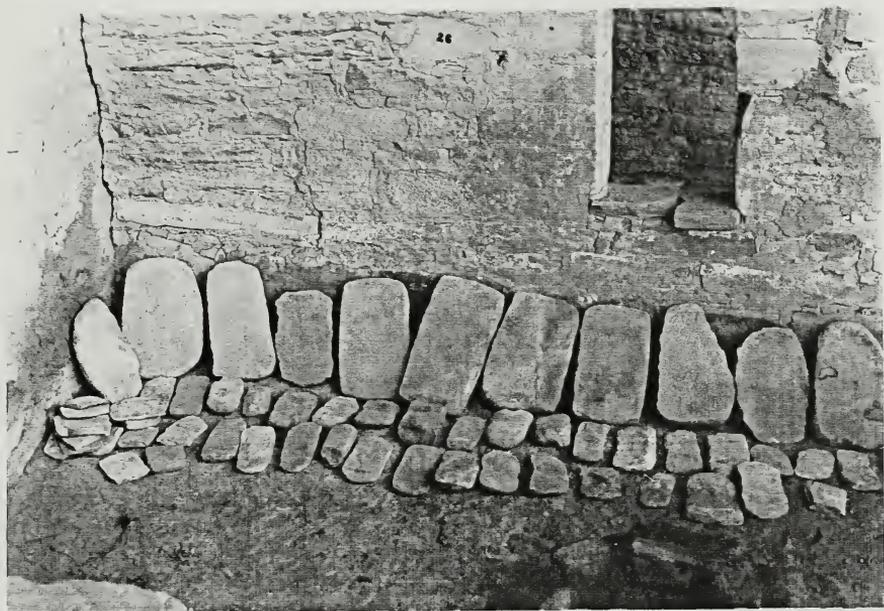
The front room facing on the south side of the South Plaza is here designated as the milling room of the pueblo.³⁸ Lined up against the west wall, nearly destroyed by careless excavation, was found the remains of eight mills or metate bins in a row. Contrary to the usual custom, the bins are placed tight against the west wall, leaving no room for the women to kneel, as is customary, between the bins and the wall. No metates were found in place, but the large number excavated nearby seems to indicate the existence of such a room. No other bins were found (Figure 5.14).

Figure 5.14. Room 26 after stabilization 1910 with manos and metates found in excavation placed where Nusbaum found 8 mealing bins. Photo by Jesse L. Nusbaum, Courtesy Museum of New Mexico, Neg. No. 2151.33, 60522.

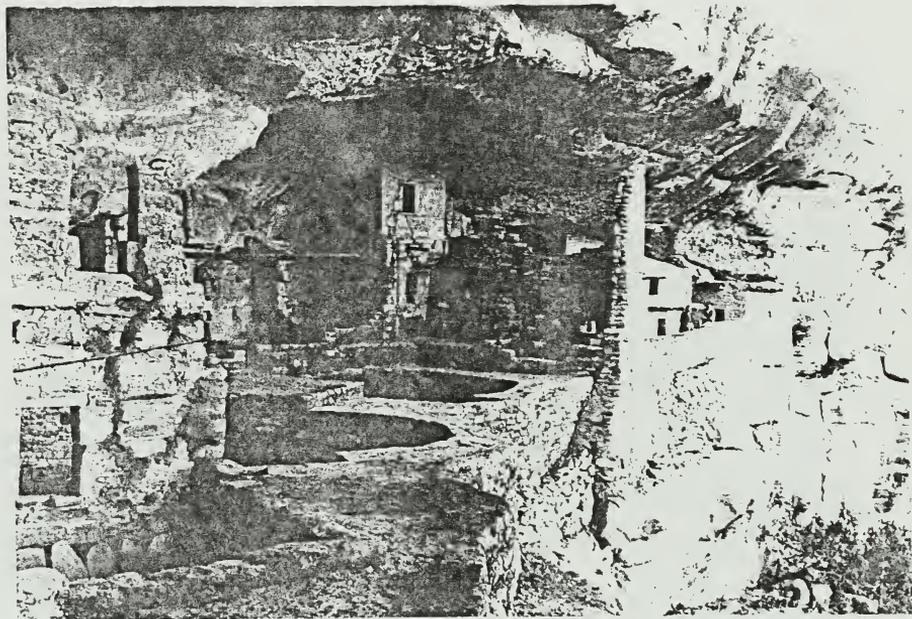
Figure 5.16. Balcony House looking from the south in 1916 after stabilization. Two unidentified people are standing in the North Plaza at the balustrade wall. Photo by Jesse L. Nusbaum, Courtesy Museum of New Mexico, Neg. No. 2151.19, 60515.

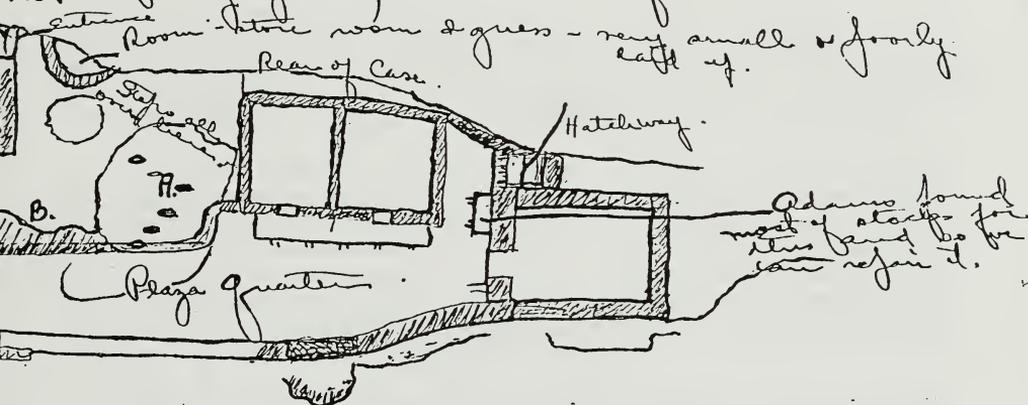
Figure 6.2. First courtyard of Balcony House (now known as North Plaza).

Adams found most of sticks for this and so we can repair it.)

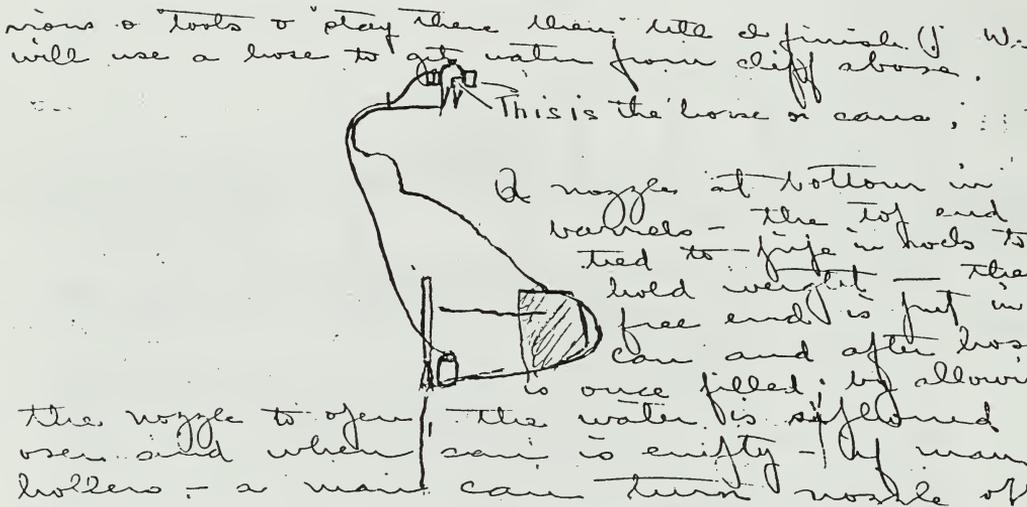
Came off mesa after dark last night—came to Durango this A.M. Back tomorrow with all necessary irons and tools and stay there then till I finish. We will use a hose to get water from cliff above (Figure 6.3)

Figure 6.3. Sketch of water delivery system for stabilization.

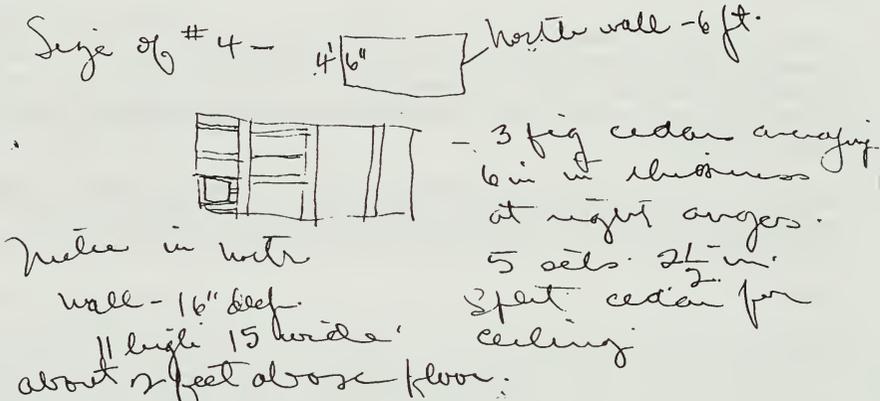
4 (Room 4)

The rear wall of # 4 X # 5 was in very bad repair, probably as bad as any on the ruin. A large hole had either been punched or blasted out near the top of lower # 4 and had caused building to crack and settle in alarming fashion. The main portion leaning to north about 6 to 10 in out of line. An iron brace with three turn buckles solved the difficulty and pulled it back and tight to cliff. Two more in north wall pulled the sag nearly out and then new masonry was put in and cracks filled making a good solid wall once more (Figure D.3).

Figure D.3. Room 4 Plan View.
