# Arlington House, The Robert E. Lee Memorial

## North Dependency Historic Structure Report

2010-0053-P

Report prepared by Charles Fisher, Chad Randl and Kaaren Staveteig

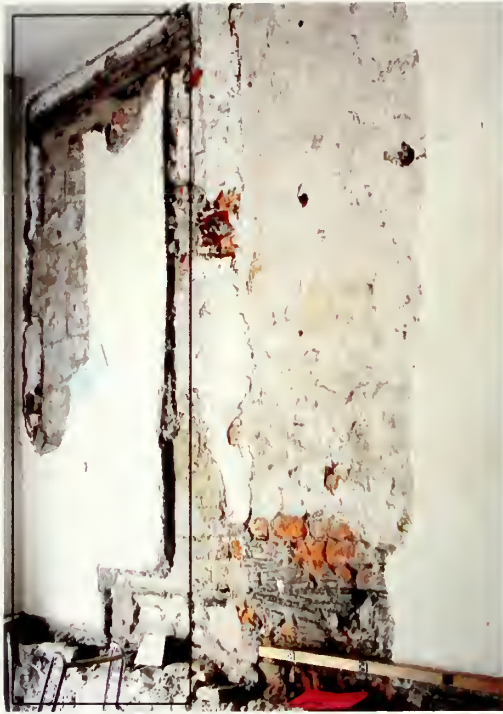
Figure 7. Center room, south corner of west wall, 2003, shows the infilled original door set between a wood lintel above and the masonry shoulder below. This door led to the upper floor of the west room. NPS plaster and concrete block from 1964 conceal much of the historic opening. The partition dividing the forward vestibule and the rear living space ran perpendicular to this wall joining it near the center of the image (to the right of the door).

Located roughly at the current grade, the center room was divided into this forward vestibule containing the entrances to the upper-level east and west rooms, and a rear living space (Figure 7). Due to the tight location and lack of evidence of permanent stairs on the walls, it is likely that the upper-level doorways in the center room were reached by way of wood ships ladders. The crawl space below the center room was unoccupied.

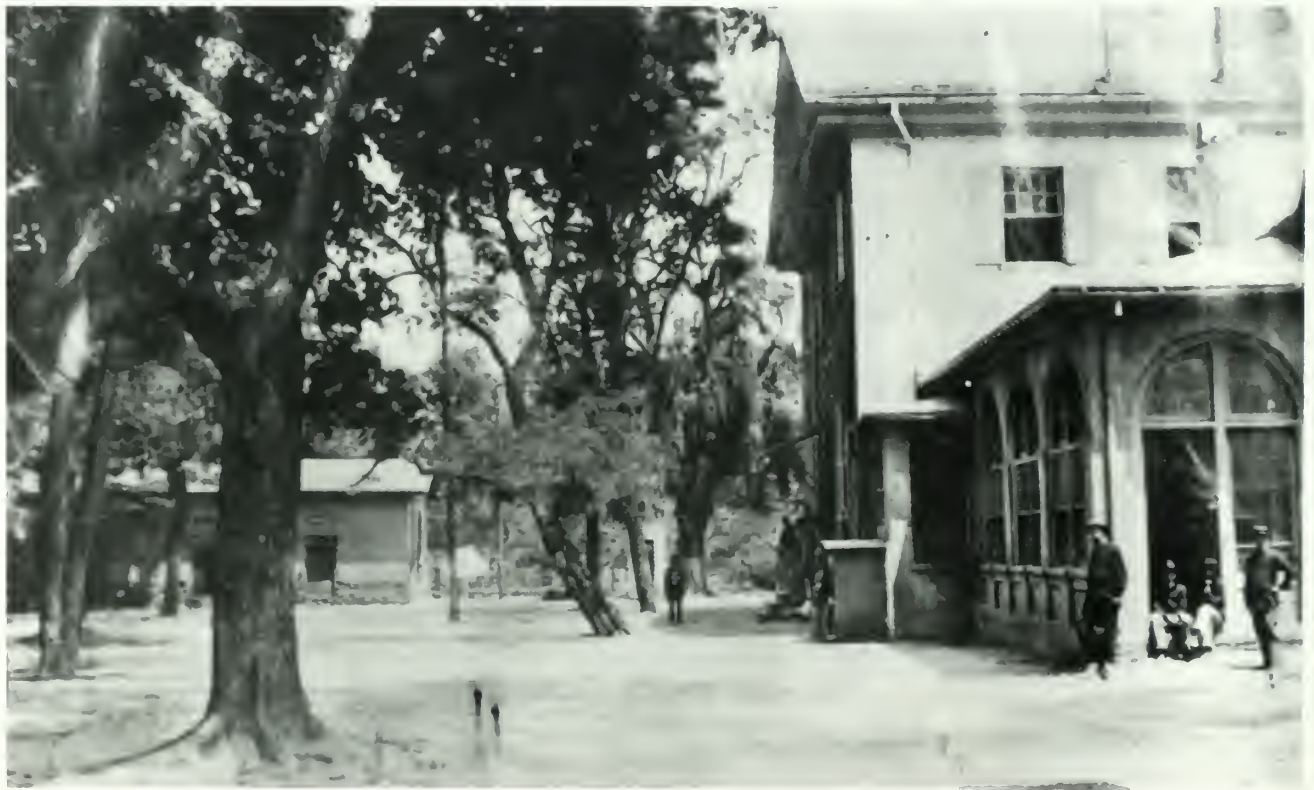
Figure 8. South elevation, 1864 photo by Andrew Russell showing center and east doors of the North Dependency. This image confirms that the door openings were near grade during the Civil War period. Other features seen on this elevation (the rough cast stucco, panel doors, exposed stone foundation, painted panels, and cornices above the door) correspond to the building's current appearance.

Captain Andrew Russell, a colleague of the well-known Civil War photographer Matthew Brady, took a series of photographs at Arlington on June 28-29, 1864. One image showed much of the south and east elevations (Figure 8). While it can not be assumed that the south exterior elevation had remained untouched between the original construction and the time Russell took the photographs, the current physical investigation has confirmed that many of the features, materials, and characteristics seen in the photographs were original to the building's construction.

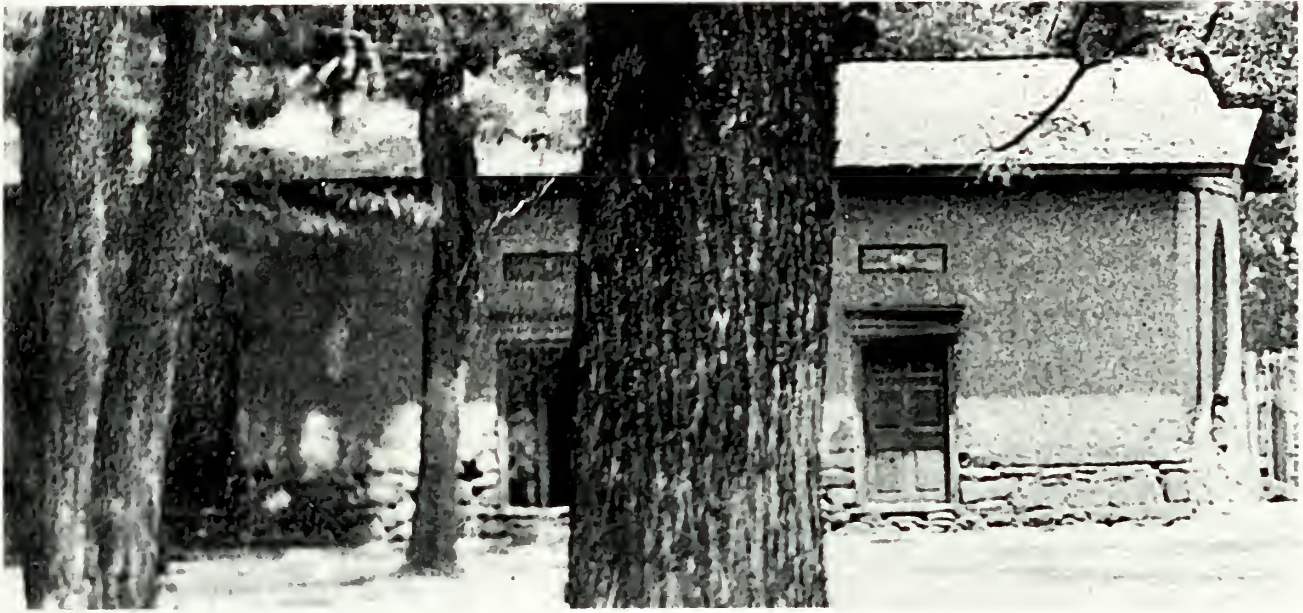
Figure 9. South elevation. Close-up of Andrew Russell photograph, 1864. A light-colored horse or sheep is visible on the painted panel above the east room door. Note that gutters and downspouts were not present on the building at this time. Also note the missing skirt board in the lower portion of the east elevation arch.

The photographs reveal important information about the condition and appearance of the North Dependency. The building appeared in sound, though not well-maintained condition (Figure 9). Masonry foundation stones were in prominent relief; rising moisture in the wall was quite evident; and the mortar joints were in need of repointing. The exterior walls appear to be covered in a rough cast stucco finish. There is, what appears to be, a projecting cornice above each of the doors on the south elevation. The photograph shows that the North Dependency, divided into three sections was entered through panel doors set just above grade. With the exception

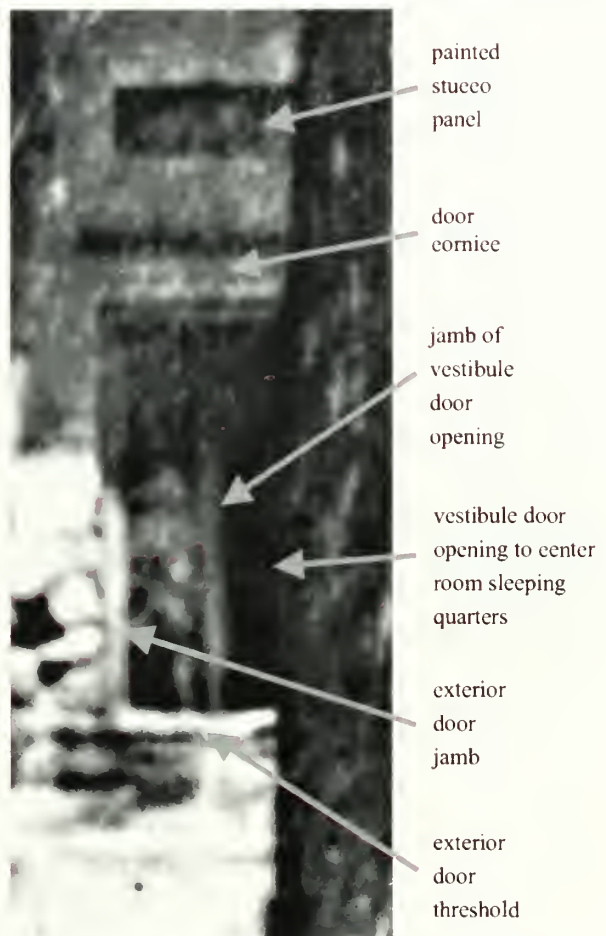
Figure 10. South elevation, center door. This further enlargement of the 1864 Andrew Russell photo shows the west side of the inner vestibule wall visible through the center room exterior doorway.

Because the exterior door to the center room was open at the time the photograph was taken, the image provides additional information about the interior of that space (Figure 10). A recessed horizontal line is visible along the left (west) side of the opening. This line appears to be a doorway jamb on the inner vestibule wall—a feature for which there is physical evidence discussed below. Unfortunately, because of the small size of the feature in the image and the poor quality of the print, it is not possible to determine with certainty the partition's construction.

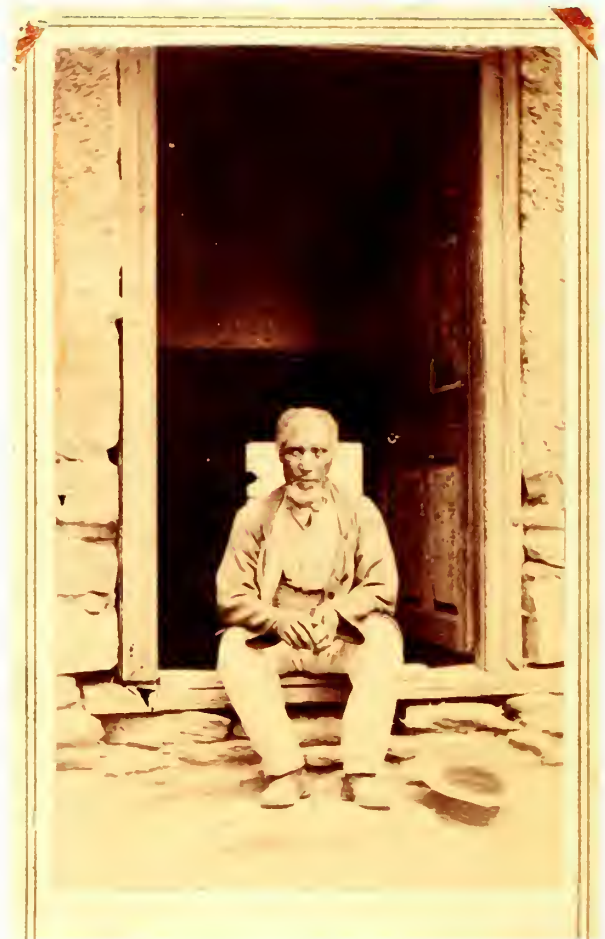
Figure 11. Doorway to east room, photograph of "Uncle Joe", circa 1864. The image shows the east summer kitchen window on the north wall directly behind Uncle Joe. (A muntin is visible just over his right shoulder.) The bulkhead that framed the entrance landing and boxed out the upper-level is also visible directly above and behind him. From Uncle Joe's position on the sill, it is clear that the landing within the doorway was lower than the height of the sill. This photograph also shows the 1860s era door and frame characteristics, and confirms the presence of the rough east stucco and exposed foundation exterior.

The photograph confirms the generally poor condition of the building at the time of the Civil War. Mortar around the stones framing the east doorway was deteriorated and there are sizable gaps between the wood door frame and the masonry finishes. As with the Russell photograph, the door threshold along the south elevation was located a noticeable distance above the then current grade level. While the sepia-tinted photograph is difficult to interpret,

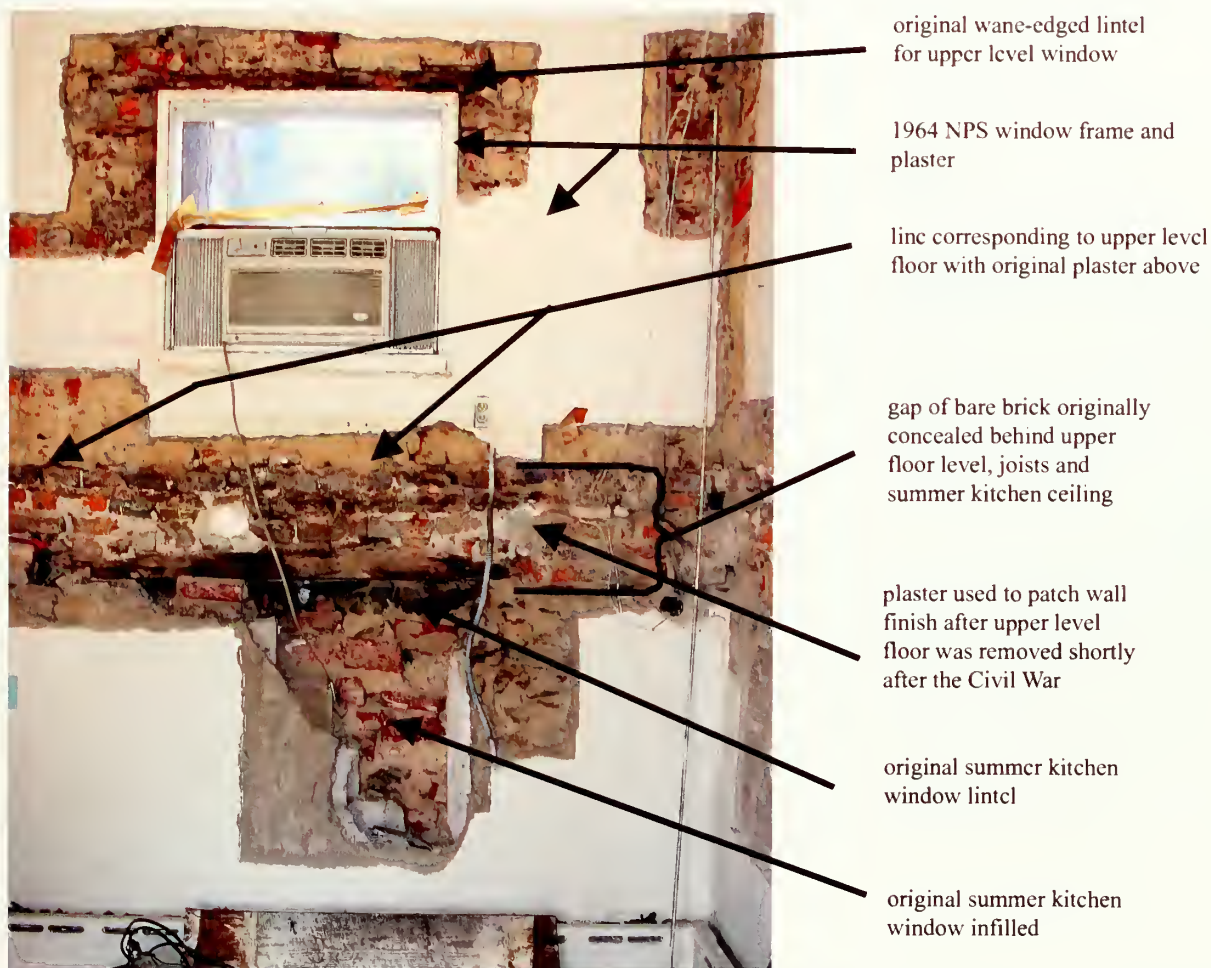
Figure 13. East room, east half of north wall, 2003. Showing evidence of original upper-level floor location and summer kitchen window. Also visible are alterations made when the upper-level floor was removed by the QMC after the Civil War, work done by the QMC in 1929, and changes made in 1964 when the NPS infilled the lower window and converted the room back to a single story space.

Considerable information about the east room's historic configuration as two distinct spaces was revealed beneath the 1964 plaster along the north wall (Figure 13). Here the lower edge of the upper living space is even more clearly defined than on the south wall. Original plaster ends at a relatively smooth line that corresponded with what was probably the upper edge of a baseboard. The position of this line corresponds with the position of the unused baseboard nailing blocks on the south wall. Again, the gap of bare brick below corresponds to an area originally hidden beneath the upper-level floor, joists and summer kitchen ceiling. (This area was patched with plaster shortly after the Civil War when the upper-level was removed from this space.) Further up, original nailing blocks are set within the brick wall further indicating plans for a chair rail molding. As with those found on the east wall, the absence of nail holes indicates that moldings were likely never installed.

Also on the north wall, the position of the wood lintels from the summer kitchen north windows are clearly discernible. Their position has not changed since the building was constructed. The lower edge of these beams corresponds to the original shoulder height (and the original height of the summer kitchen ceiling). The lower edge of the lintels and the shoulder height also match up with a distinct line found on surviving plaster on the west wall. The line is found along the west wall, remnants of original plaster on what was the summer kitchen's upper wall surface survived beneath the 1964 NPS plaster (Figure 14). Below the line, the original plaster has approximately 8-10 whitewash layers with accumulated soot, flyspots, grease, and other staining consistent with a kitchen space. The upper edge of the whitewash marks where the kitchen ceiling once met the wall surface. While the edges of the upper room plaster and paint on the north, east, and south walls shed light on the location of the upper-level floor surface, the paint and plaster edge on the west wall provide a definite position of the summer kitchen ceiling. It also shows that the summer kitchen ceiling was flush with the shoulder line—an indication of how that ceiling/floor assembly was constructed.

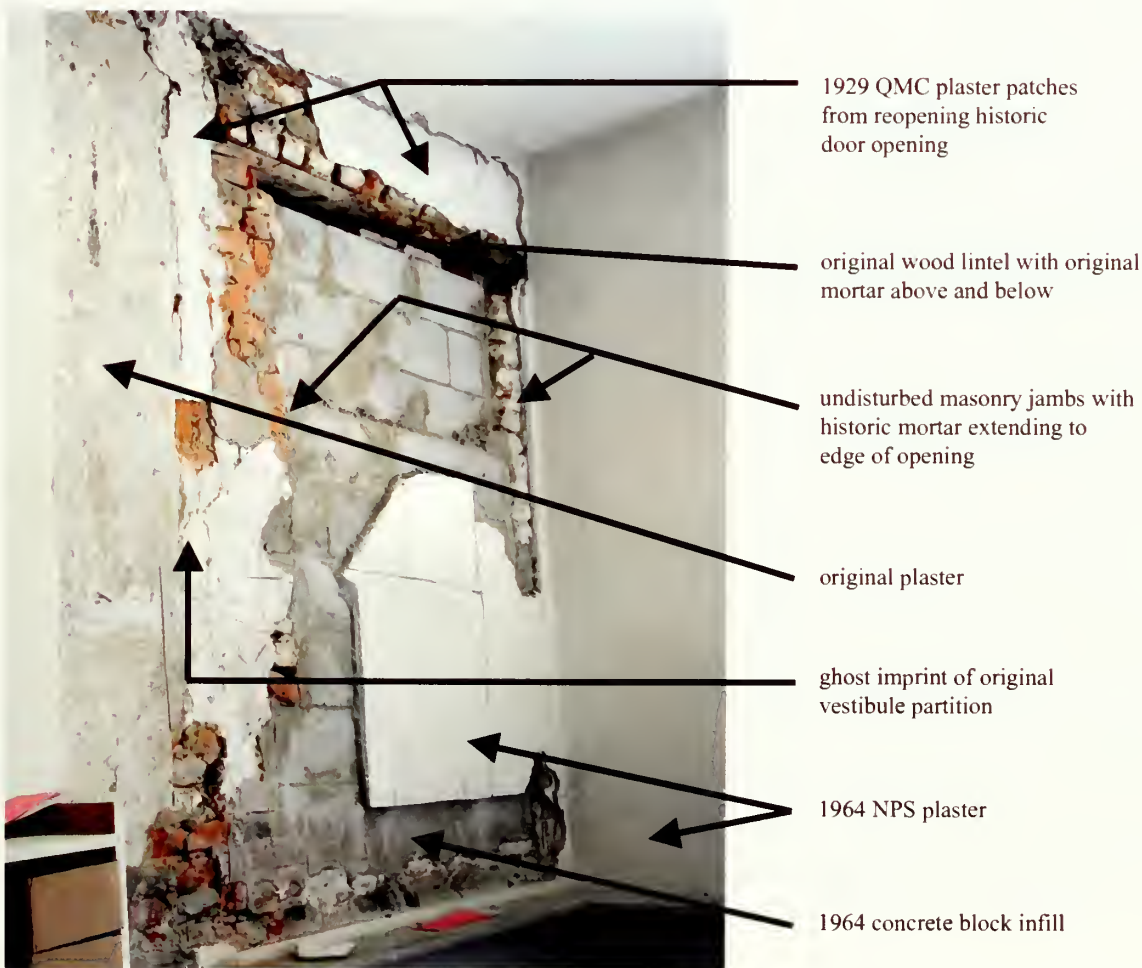
Figure 18. Center room, south corner of east wall, 2003. Showing the original doorway to the east room upper-level. This opening and the corresponding opening on the west wall were filled in by the QMC after the Civil War, when the adjacent rooms were converted to a single story space. The QMC reestablished the openings in 1929 as part of their restoration. The National Park Service closed them up again in 1964 when they reverted to single story spaces in the end rooms.

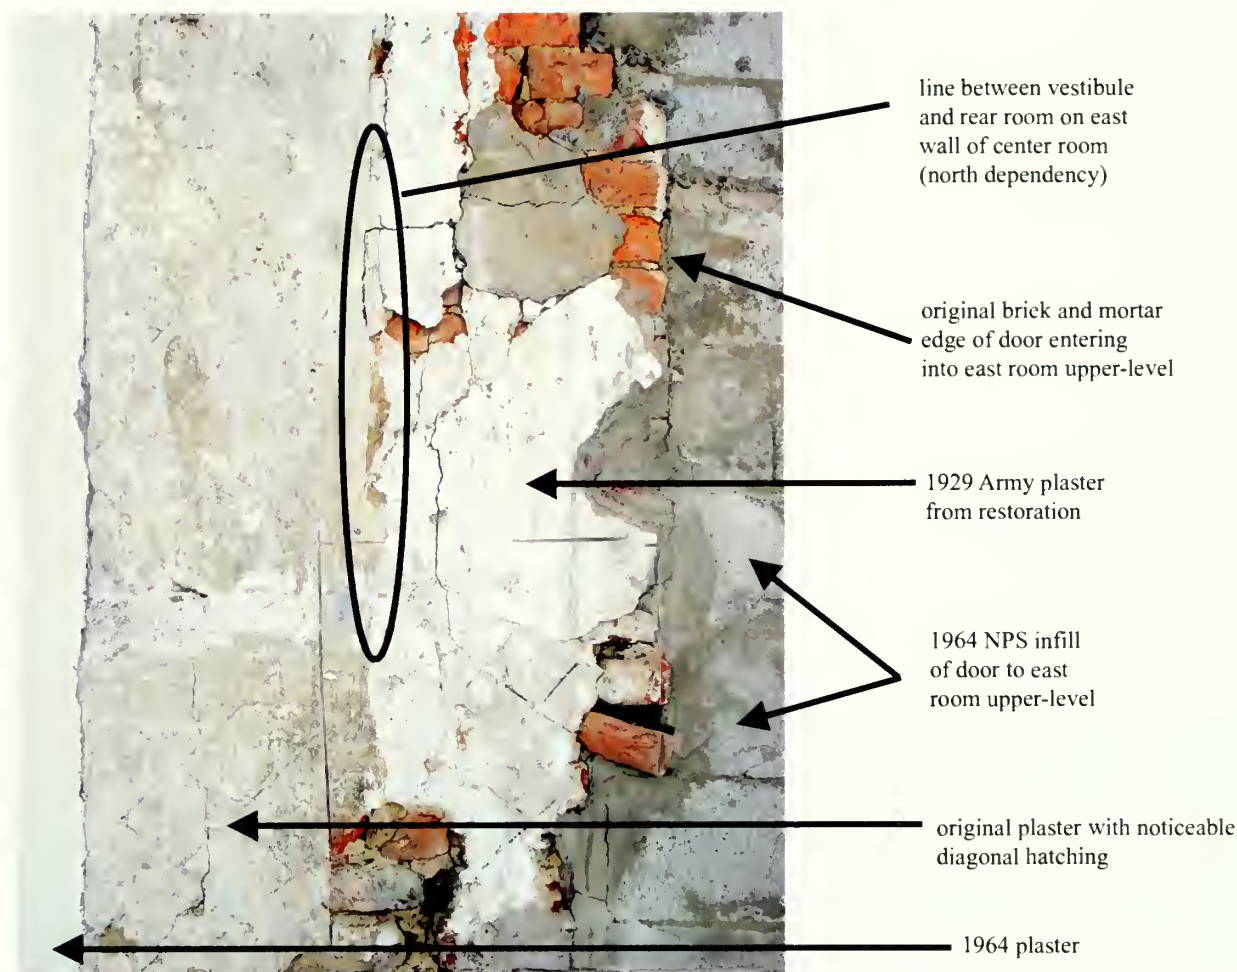
Physical investigation also confirmed that the center room interior was originally divided into a forward vestibule and a rear living space. Ghost imprints in the original plaster show where the finish was applied up against the original vestibule partition approximately 5'-5" into the room from the south wall (Figure 19). The imprint left on the plaster and the lack of any visible points of connection suggest that a simple wood partition existed, probably of vertically-oriented wood planks approximately 1" thick and tied to the floor and ceiling joists rather than the walls. See *Appendix F*:

Figure 19. Center room, close up of east wall, 2003. Showing line where original plaster abutted vestibule partition. In 1929, when the QMC reopened the doorway (seen at right) to the east room upper-level, they patched the brick work with a Portland cement-based plaster to the right of the line.

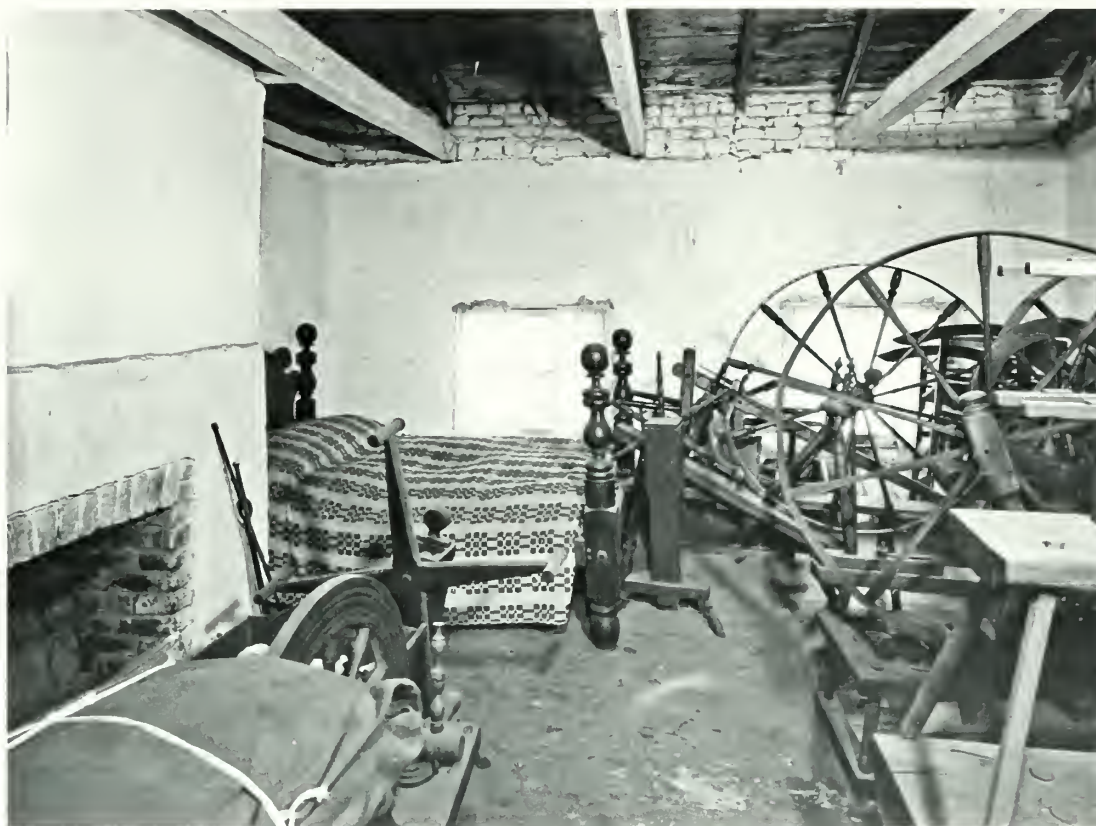
Figure 23. West room, upper-level 1959. This NPS photo shows the roof structure above the west room before the NPS installed additional joists and supports in 1964. The sheathing and rafters date to the 1880s QMC work. Joists are original.

Much of the current roof structure installed in the North Dependency in the 1880s survives today, along with some original joists and 1960s era reinforcement (Figure 23). The mention of “additions as may be necessary” and “carpenter work, and painting, about the roofs, including repairs of eorniees, necessary to put the whole in proper order” in the September 1885 specification ended up involving significant work on the roof. Most of the original outriggers appear to have been retained even though the majority of roof joists above the center and east rooms were replaced. New 2" by 6" roof rafters were installed at approximately 2' o.c. Original joists were replaced with new circular sawn joists above the east and center rooms (excepting one full joist in each space and sleepers and other timbers framing around the fireplace above the east room). The rafters passed through the tops of the east and west walls and, at the peak, were butted together against a 2" by 10" ridge beam. Continuous sheathing was installed on the rafters.

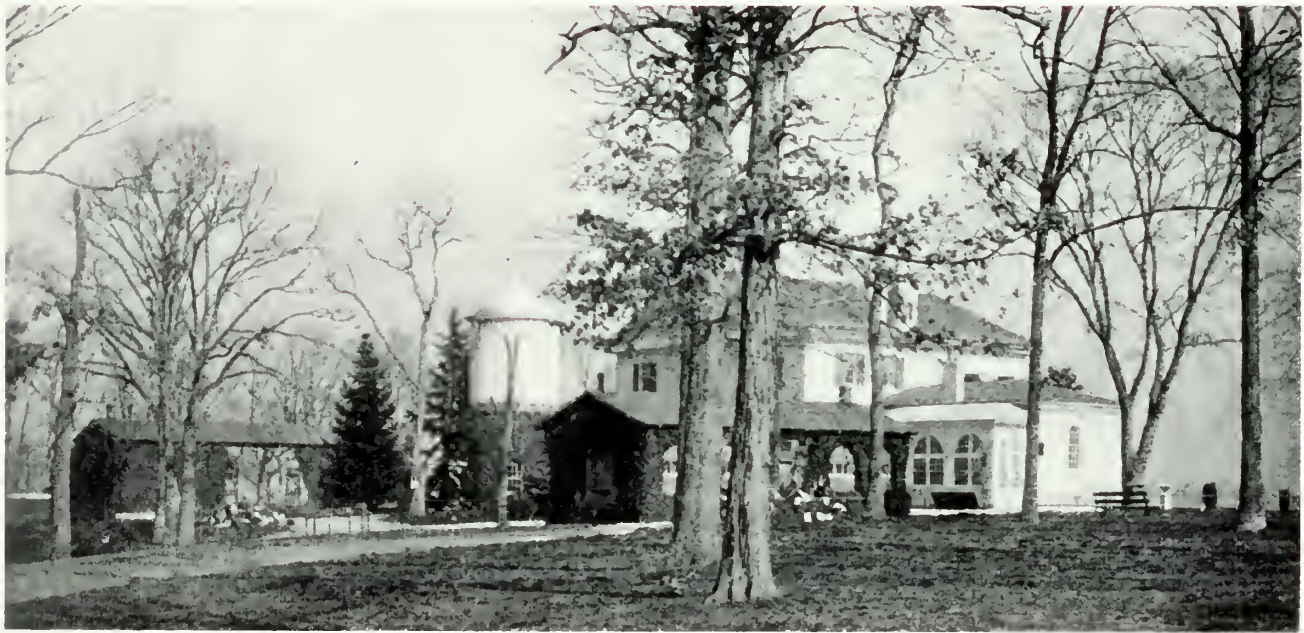
There is little information about the condition and work done on the North Dependency during this period. An 1897 photograph of the south elevation of the building shows much of it covered in vegetation (Figure 24). Doors that are different from those seen in the Uncle Joe and Andrew Russell photographs are visible. These doors appear dark in color and have a four-light window in the upper half.

Figure 24. Arlington in 1897. Note the extensive vine coverage. Replacement doors have glazed four-light panels in the upper half.

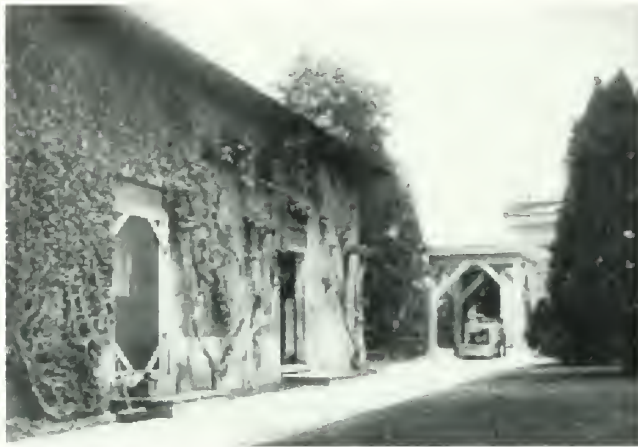
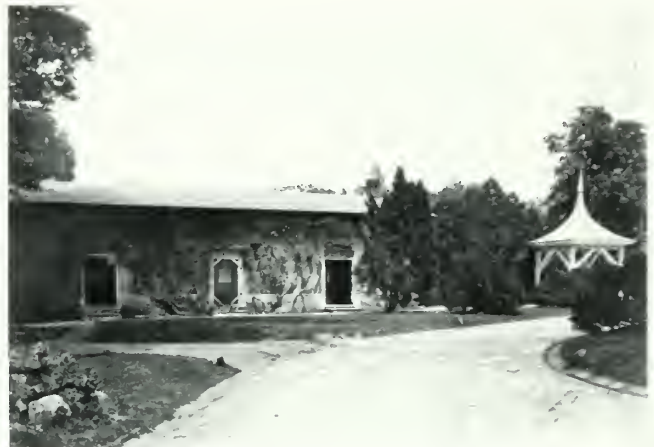
Photographs from around 1900 provide a better view of the doors (Figures 25 and 26). The images also show that the masonry foundation had been parged and that the projecting cornices above the doors had been removed and replaced with flat panels. (The foundation probably received the coat of stucco at the time the interior was converted to a single story space—the finish concealing infilled lower-level windows on the north elevation.) The flat panels, doors, soffit, and outriggers all appear darker than the door jambs are lighter. A screen door is installed on the center room, in keeping with its use as a residence. All three doors on the south elevation were entered after one step (a platform) above the grade level. With hinges on the west side door jamb, their swing was reversed from Civil War-era. From open doors on the east and west rooms, it is clear that the removal of the upper-level and raising of the floor to grade had already occurred by the time these photographs were taken. In one image the shoulder in the east room is clearly visible, in another image one of the north elevation upper windows can be seen in the back of the west room. The corresponding lower windows are not visible since they were filled in.

Figures 25 and 26. Photographs of south elevation, circa 1900. The photos show the replacement doors and the foundation with its stucco finish (in the 1860s the foundation was exposed masonry). More importantly, the open door to the east room reveals an exposed shoulder where the original upper-level floor joists once sat. This is consistent with the space being used after the Civil War as a single-level open room with a floor at-grade.

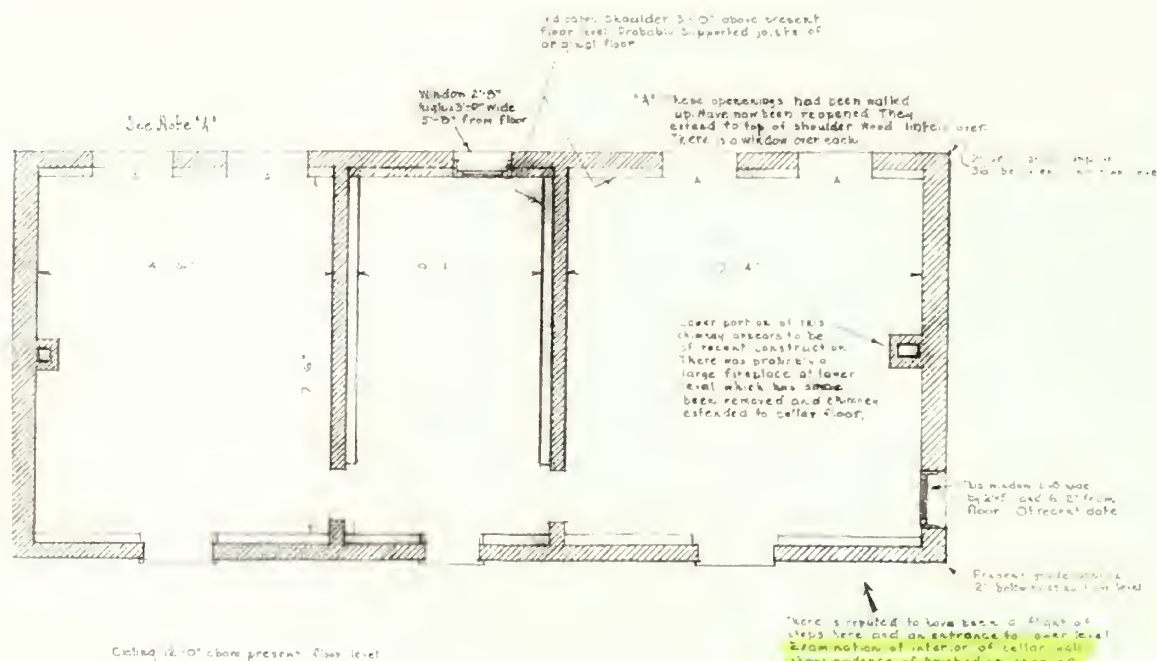
Figure 27. This undated and confusing plan seemingly shows the condition immediately before the QMC restoration, including the interiors as single story spaces, chimneys for stoves instead of fireplaces, and a window on east wall of the east room. Upon closer examination, the drawing appears to have been drawn sometime early in the restoration phase. While showing the interior as a single level, notes indicate that the windows in the kitchen (lower-level) have been reopened. Also the original interior doorways to the upper-level are shown reopened (unlike the South Dependency, interior doorways connecting the three rooms never existed when the building was converted to a single level around the 1870s).

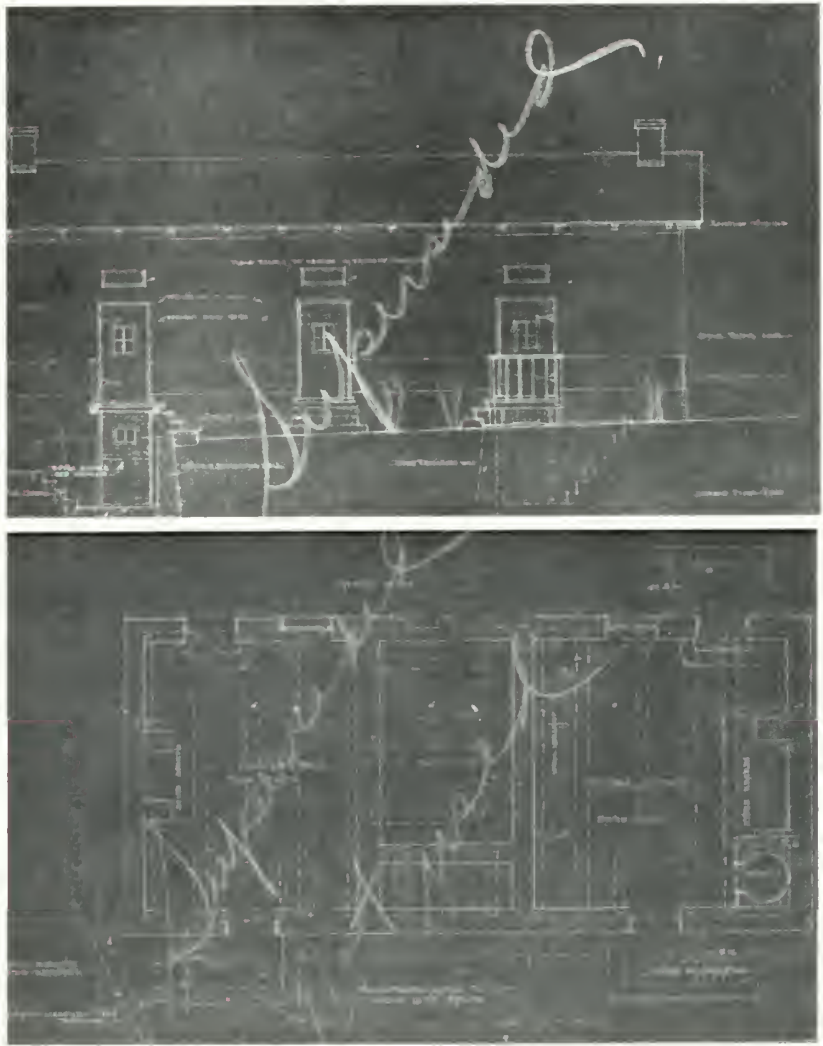
Figures 28 (top) and 29. Preliminary restoration drawings from 1929. Note the creation of below-grade entrances to the east and west lower-level rooms. The original exterior door openings were to be raised (hence the missing cornices) and provide access to the upper-level rooms.

Drawings dated September 9, 1929 show the removal of the connecting building that linked the comfort station and the north dependency. Notes on the drawings state that the walls shall be stuccoed to correspond with the present exterior walls.<sup>50</sup> A series of plan and sectional drawings were done on November 23, 1929. Most “Superseded” and “Not Used” written across. These drawings show plans to divide the end room interiors into upper and lower-levels with two sets of doors on the south elevation corresponding to the upper and lower-level rooms, and a pair of doors on the north elevation (Figures 28 and 29).

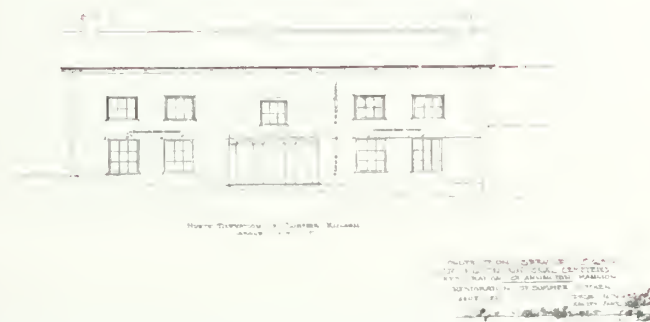
Figure 30. North elevation, final elevation for the QMC restoration, 1930. Note reopened lower-level east and west room windows.

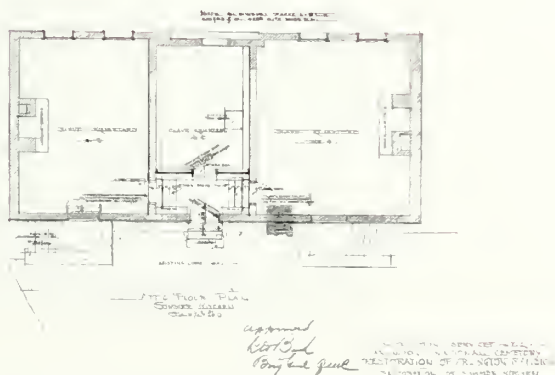
Figure 31. Upper-level, final QMC restoration plan, 1930. Note below-grade entrances to lower-level east and west rooms, reconstructed fireplaces, center room vestibule partition, and reopened historic openings from center room vestibule to east and west upper-level rooms.

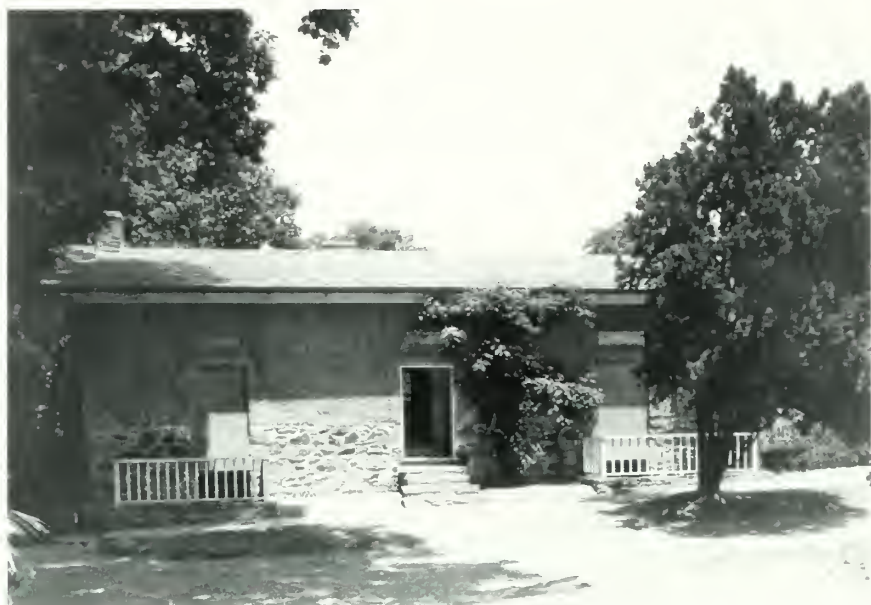
Figure 32. South elevation, 1933 photo. Shows building after QMC restoration. Changes include insertion of a reproduction vestibule partition in the center room; infill of the east and west room historic door openings; the shift upward of all three door openings (obliterating the door cornices) in order to accommodate the two below-grade entrances to the end rooms; and removal of approximately 2' wide band of rough cast finish to align it with the midpoint of the raised door openings.

ing walls, and the three stone steps leading from grade to the center room entrance. The two lower-level openings had wood plank Dutch doors with strap hinges and two light openings in the upper half, while the center room door was a plank door with a four-light sash set in the upper half. To accommodate the doors below-grade, new lintels were installed above the previous door threshold. To retain the proportion of the upper door openings, they were correspondingly shifted upwards on the wall. To provide space above, the cornices over each of the earlier door openings were removed and these spaces, as well as the earlier door openings, were infilled, though recessed several inches in from the wall plane (Figures 32 and 33).

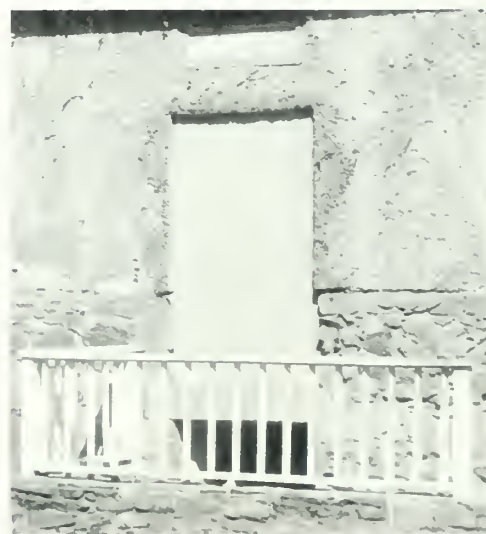
Figure 33. South elevation, closeup of below-grade entrance to summer kitchen and infilled historic door opening following QMC restoration. The upper two feet of the stone foundation wall was exposed and the infilled door area was raised into the area where a cornice had been located historically.

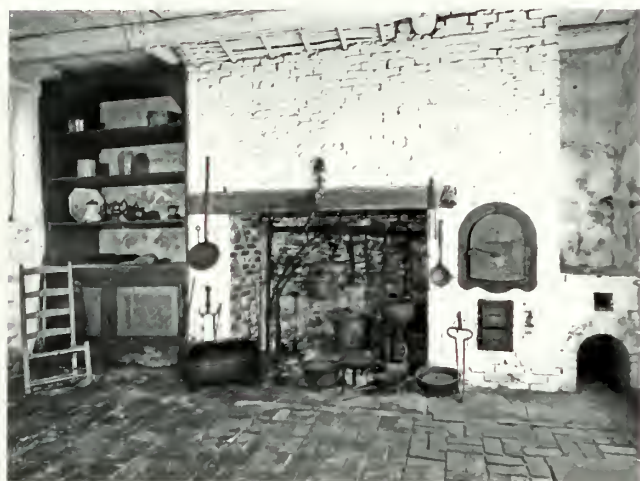
Figure 34 (top left). East room lower-level, 1959 photo showing conditions after 1930 QMC restoration of summer kitchen. Note reconstructed fireplace and exposed joists for upper-level floor

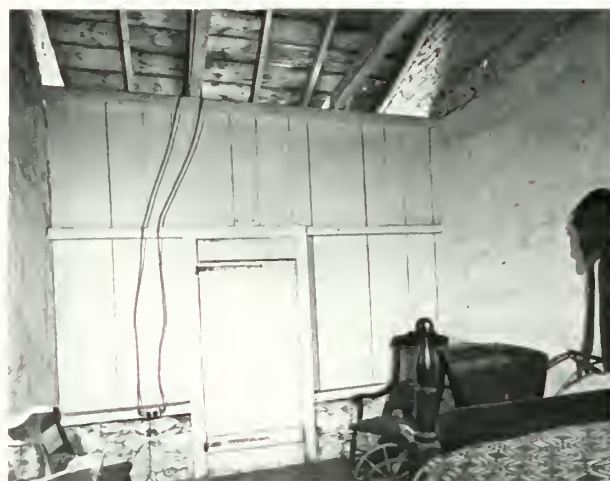
Figure 35 (top right). Center room looking south, 1959 photo showing 1930 QMC restoration of the space as a living area behind an entrance vestibule. Note 1880s roof rafters, sheathing, and replacement joist (on left), original joist on the right.

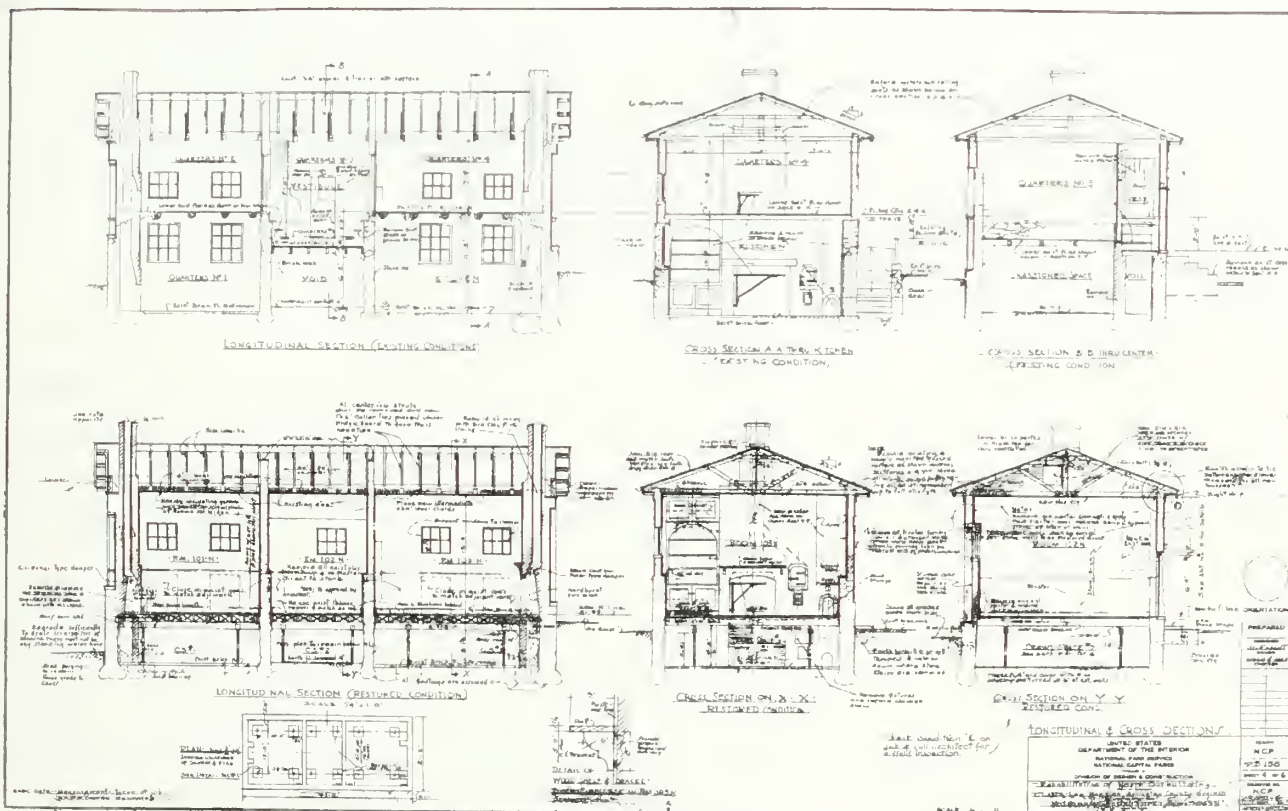
Figure 37. 1960 section drawing depicting the NPS intention to restore the North Dependency interiors to single story spaces with a summer kitchen, living quarters, and entrances on grade. The existing plans are shown above and the proposed restoration plans are below.

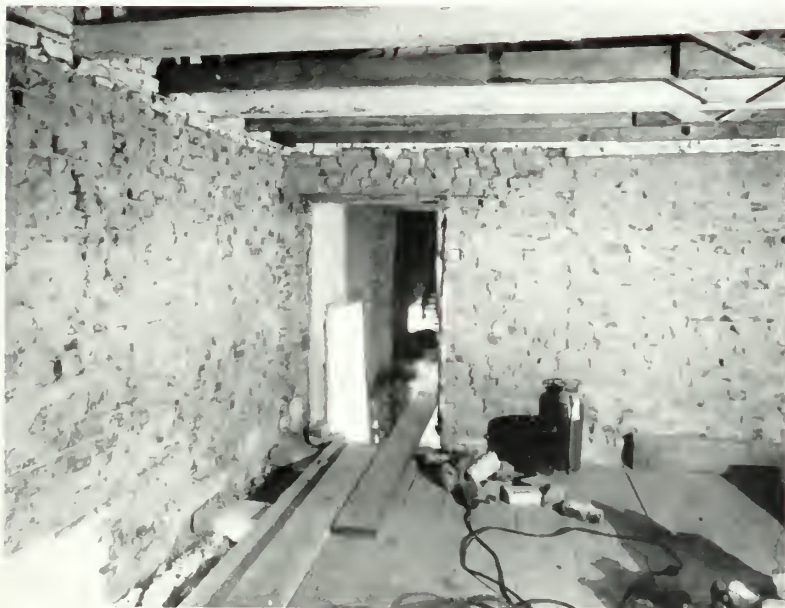
Figure 38. Looking west from east room upper-level into center room through the doorway, 1964 photo showing NPS removal of QMC upper-level floors in progress, and additional joists (those unpainted) inserted between the older joists.

Rowe’s photographs from July 27, 1964, show work underway in the interior of the North Dependency (Figures 38 and 39). Plaster had been removed from the wall surfaces in the upper-level rooms. Strips from 2' - 5' wide, where the plaster had been removed exposing the masonry walls were visible along the lower-level walls. This was clearly a result of the NPS historians search for evidence of an original floor location near grade. Areas near the fireplace and doorways also had significant areas where plaster had been removed in the search for clues to the historic configuration of these spaces. The photographs show that the east and west doorways at-grade on the south elevation had been opened up, but that the center room door had not yet been lowered to its 1860 position (after having been raised and the cornice removed as part of the 1929 QMC restoration). At the time Rowe took his photographs, the upper-level interior doors into the center room were still opened up and the oak sill is visible above the east door. The new, unpainted joists and braces added to the roof structure the previous week are clearly visible next to the older whitewashed joists.

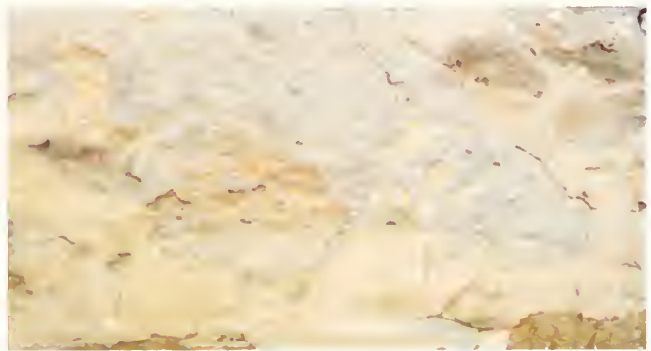
Finish analysis identified early paint coatings on the stone foundation on the north elevation, at the northwest end and on the south elevation (Figure 4). This treatment may have been applied in the years immediately following construction, concurrent with the exterior painted brick on the upper walls. Due to the fragmentary nature of the paint, a detail analysis may not be conclusive as to its date of origin. By the 1850s, the stone foundation was exposed. A drawing by Lee's daughter and early photographs from 1864 through c.1900 show the stone coursing and a distinctive variation of color from stone to stone. However, at some point in the early twentieth century, photographs show a parged coating of lime/cement mixture, giving the lower walls a smooth, more regular appearance. During the QMC restoration, the parging was removed.

Figure 4. Numerous areas of paint on the stone foundation may be evidence of an early coatings treatment.

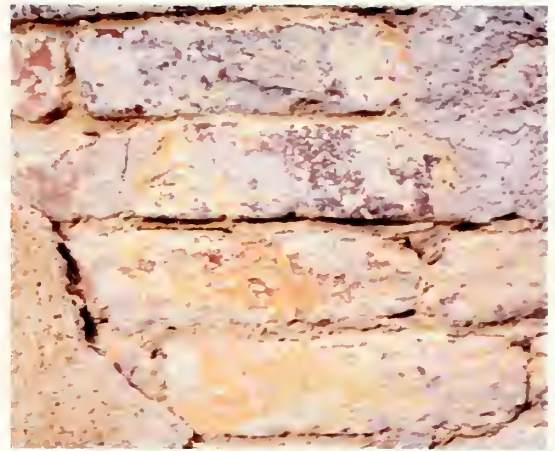
The exterior brick within the recessed niches on the north, west, and east elevations was initially only covered with paint, providing a more formal appearance than bare brick (Figure 5). Several coatings are still evident on the historic brick beneath surviving sections of the first stucco application. These coatings show evidence of being exposed to the weather for some time when viewed under a microscope. The base coat, a glossy white oil paint, is covered by a gold yellow distemper, which is covered with a mottled coat of medium rose.

Figure 5: Paint on brick gave the building a more finished appearance in the early years before stucco had been applied to certain wall sections.

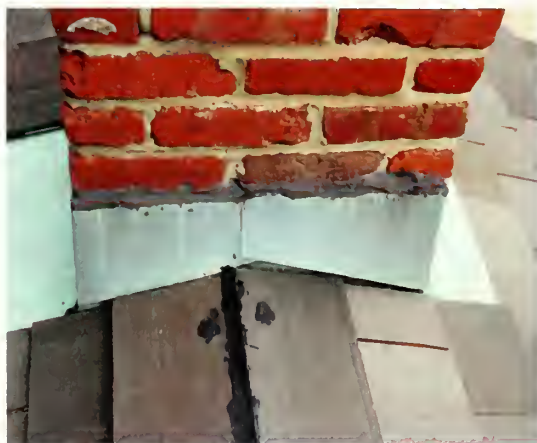
Figure 6: improper installation of flashing.

**Deficiencies:** Tar seals have failed allowing water to infiltrate; flashing has not been properly installed (Figure 6).

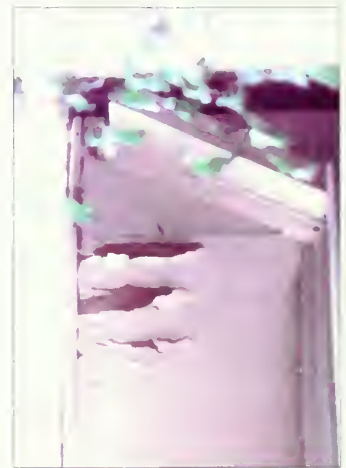
The eaves on the North Dependency are tongue and groove board, painted white. A roof leak on the northwest corner has caused paint failure and wood rot (Figure 8).

Figure 8: Paint failure and wood rot at NW corner of the eave.

**Recommendations:** The existing eave detail where the boards meet in a seam at the edge of the roof is not typical for pre-Civil War construction. Moreover, it is a bad detail that allows water to wick inward causing wood rot. The eave boards should be removed and reinstalled correctly; cleaned and painted. A replacement board should be installed after the roof leak has been addressed.

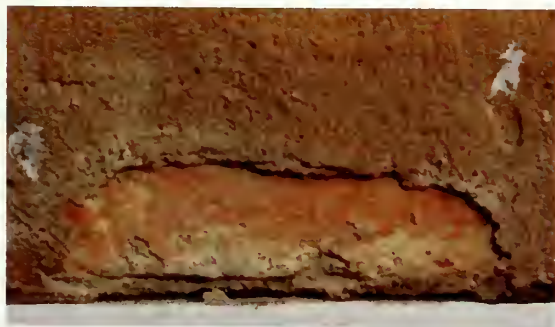
Numerous patches of smooth stucco of varying mixes have been applied over the years to the recessed niches (Figure 9). Three different applications have been identified thus far. The earliest smooth stucco is a two-layer soft render of pure white binder above a yellow base coat and small pieces of lime (shells) and tiny stones. Coatings include a white oil base under a gold yellow distemper topped by a layer of medium rose with a mottle of terra cotta. This mix is primarily found in more protected areas. See *Appendix F: Field Notes, Section I*. The QMC’s 1930 stucco is a Portland cement mix with small aggregate. It is hard and grey and found primarily in areas along the west and north elevations. See *Appendix E: Field Notes, Section I*. In 1964, the National Park Service used a beige restoration stucco similar to the earliest mix but with less aggregate. They topped their applications with a lime paint, similar in color to the older material.

**Deficiencies:** Sections of the smooth stucco have delaminated from the columns and wall surrounds on both the north and west elevations.

Figure 9: Layers of smooth stucco finish.

**Recommendations:** The stucco should be sounded for areas of delamination and dead sections should be removed. Since areas of pre-Civil War stucco remain, repairs should be made only as needed.

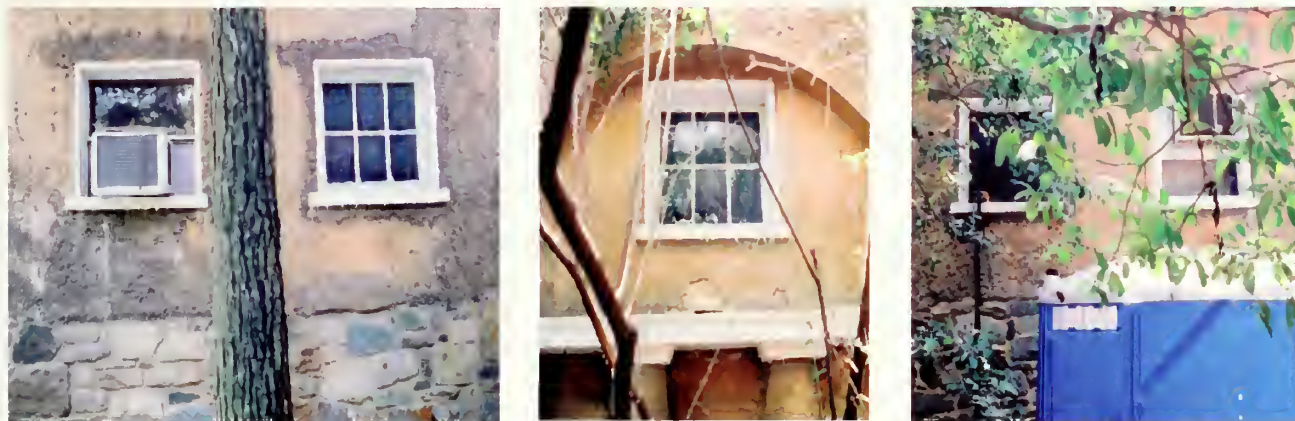
Figure 12. Left-windows opening into the east room (ND5 and ND6); center-window opening into center room (ND9); right-windows opening into the west room (ND10 and ND 11).

**Deficiencies:** The extant window jambs and sash are generally in good condition. The relationship of the window frames to the rough cast on the exterior vary from window to window. A slight overlap of the stucco over the wood frame is appropriate. Most if not all the sills have been altered or replaced. New ones lack a drip edge.

**Recommendations:** All existing window frames should be removed, marked, and stored in the Park's collection. The rough cast should be removed around the opening and reapplied with a slight overlap on the wood frame. All window sills need drip edges. With the possible exception of the center room window, the current sash and frame construction is too light for the 1850s. New six-light sash for the upper-level with top butt hinges to project inward, should be milled. Jambs should be constructed of cypress and sills of walnut. The four lower-level window openings should be re-opened and filled with a six-over-three hung window with a fixed upper sash and an operable lower sash appropriate for the 1860 time period. See *Appendix F: Supplemental Drawings*.
