# Arlington House, The Robert E. Lee Memorial

## North Dependency Historic Structure Report

2010-0053-P

Report prepared by Charles Fisher, Chad Randl and Kaaren Staveteig

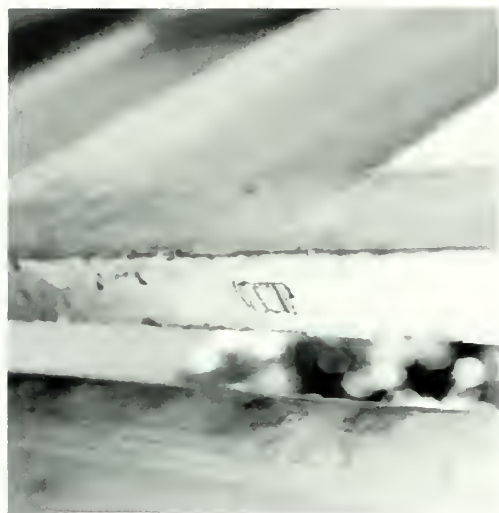
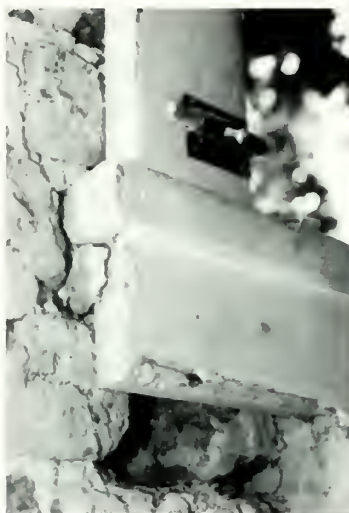
Figure 13. Vertical wood muntins with through tenon mortised into bottom rail of sash.

Figure 14. Profile, stool and apron.

accessible toilet. The window unit on the west of the east room has six divided lights. The L shaped reproduction strap hinges were installed by the QMC in the 1930s. The glazing is inconsistent in texture and color from light to light suggesting repair and replacement at varied times. The sash are ill fitting due to paint buildup but the joints are sound. The fixed sash in the western-most opening in the east room was fabricated in recent years to accommodate the portable window cooling unit. The frame and sash in the center room predates the 1930 restoration. Based upon a preliminary investigation, it may be pre-Civil War in origin (Figure 13 and 14).

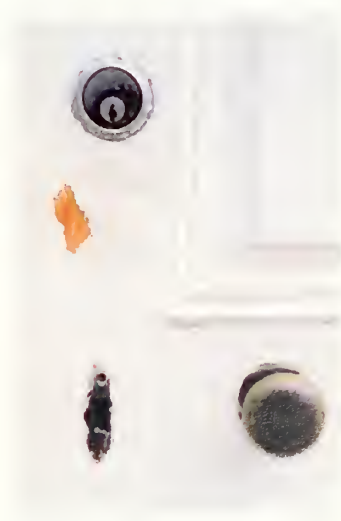
Figure 18. Door hardware needs to be tightened.

**Recommendations:** The hardware on the doors needs to be tightened and resecured as soon as possible (Figure 18). As part of a restoration

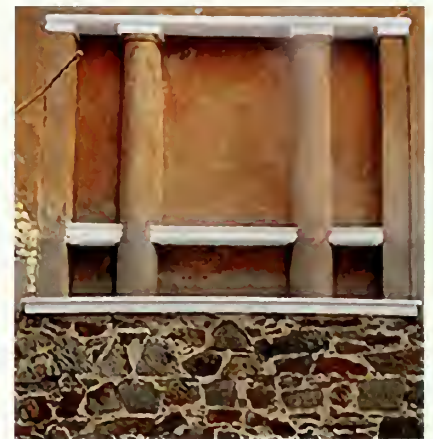
Figure 20. West elevation, ponding water on horizontal trim surface.

**Deficiencies:** The fascia board, replaced by the National Park Service in the 1960s, is deteriorated (Figure 19). Depressions on the flat, horizontal trim surfaces directly below the attic vent within the rectilinear niche allow water to pool precipitating deterioration (Figure 20). All eave modillions on this elevation are replacements from the 1960s when the number was increased from 5 to 8. None are structural in function.

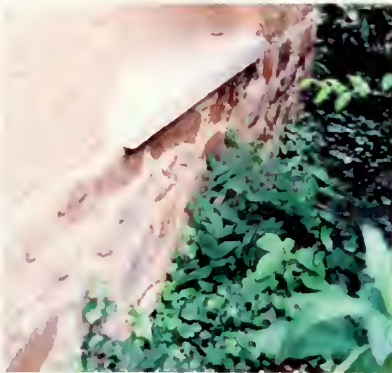
Figure 22. East elevation, vegetation provides a high moisture environment for the wood trim.

All eave modillions on this elevation are replacements from the 1960s when the number was increased from 5 to 8. None are structural in function. Although most surfaces are sealed with paint, the vegetation is thick against the building and provides a high moisture environment (Figure 22). Appropriate landscape measures should be undertaken.

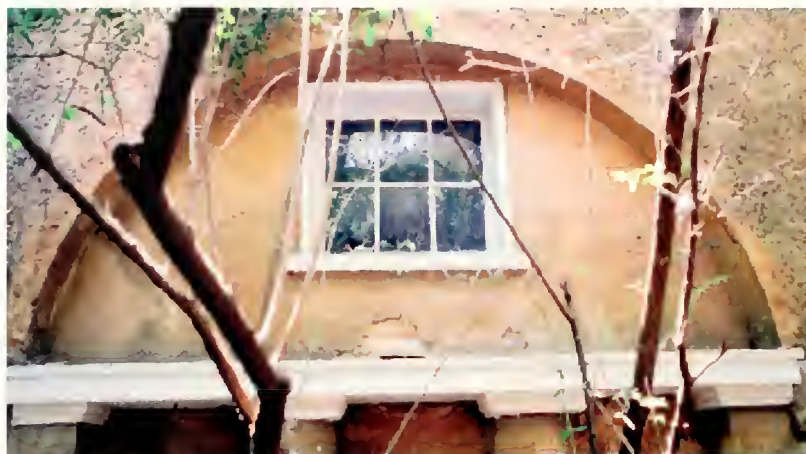
Figure 24. North elevation, many wood elements in the niche (e.g. the column capitals, upper skirt board) were reused from other locations. Early paint layers including a layer of purple were identified in the paint stratification.

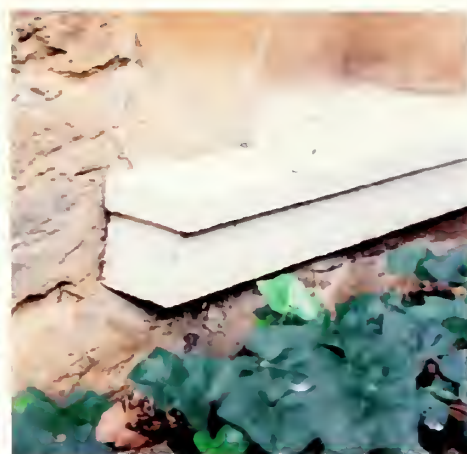
Figure 25. North elevation skirtboard replaced in the 1960s, does not match the original profile as found on the South Dependency.

**Deficiencies:** The fascia board, replaced by the National Park Service in the 1960s, is deteriorated. All pieces are painted white. Evidence of a moisture leak is seen on the eave near the east end. The skirt board within the center niche is a replacement and does not match the profile and construction of the original (Figure 25). The corresponding skirt board on the South Dependency provides an appropriate model for reproduction.

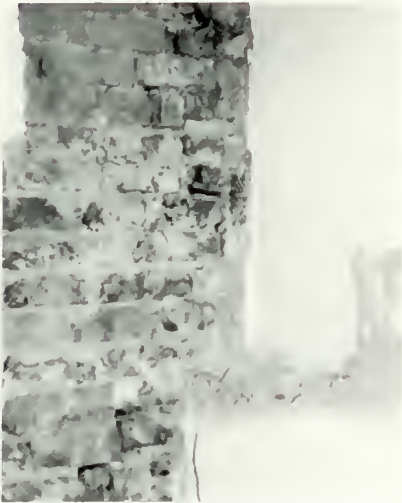
The interior space of the east room measures 17'-6" x 17'-8" with a ceiling height of 12'-5". The ceiling and all walls were plastered and painted white by the National Park Service in 1964. A 4'-3" high masonry shoulder projects 1' into the room along the north and south walls, serving as a structural support for floor joists when an earlier floor was located at that level (Figure 26). Until the investigative work began, it was covered with layers of 1960s plaster, capped with a painted 1" x 8" wood sill (white). Two 3'-4" x 3'-4" window openings are extant on the north wall (Figure 27 shows window on west with exposed lintel). An 18" square chimney chase, finished in white painted plaster, was constructed by the National Park Service in the 1960s along the east wall—it rests on the floating floor and is not connected to the remaining 1929 fireplace structure below (Figure 28).

Figure 26. Shoulder served as structural support for floor.

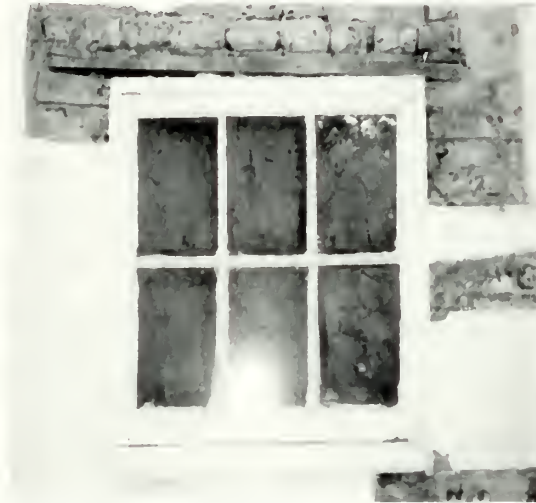
Figure 27. Replacement window.

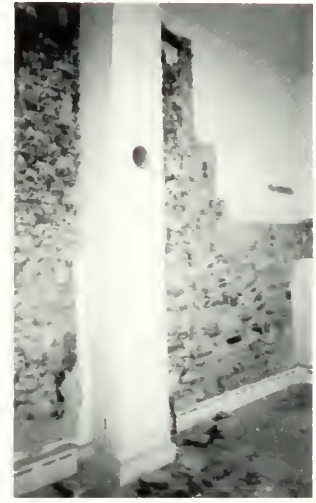
Figure 28. 1960s chimney chase.

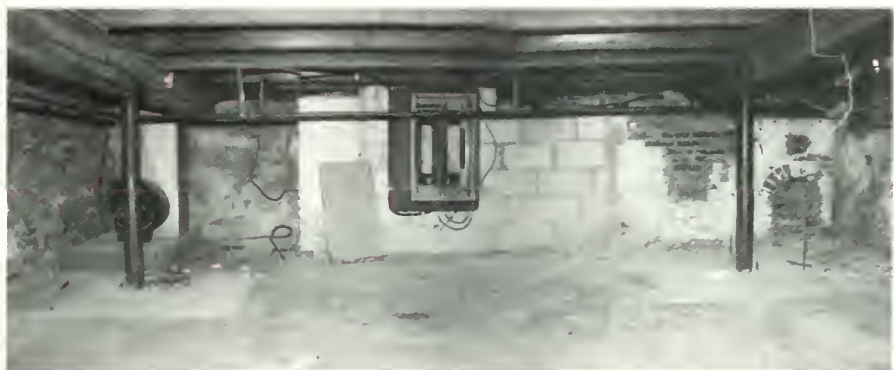
There are various areas of earlier plaster along the west and south walls. Some areas date to the 1929 QMC restoration, but limited areas along the west wall are much older, possibly original. When the QMC undertook their restoration, they stripped the walls of QMC nineteenth century plaster but kept original material and added patches of Portland-based plaster where needed. It is therefore likely that since this earlier plaster is original; its survival owed in part to closure of the lower half of the cellar when the room was converted to a single story space. The early plaster is friable because of its

Figure 29. West wall of crawl space.

below-grade location and lack of ventilation in the space. Portions of the 1929-era plaster are sound, other areas have delaminated. The ceiling for this space is formed by the unfinished, underside of the floating floor.

The reconstruction of the 1929 QMC fireplace projects 30" inward from the east wall and has a 6' opening that was infilled with cement block in 1960 (Figure 29). The fireplace has been cut off just below the ceiling level. Elements of the design used by the QMC for the fireplace, oven, etc. on the east wall of the summer kitchen remain. An electrical junction box is mounted to the cement block infill. There is evidence of a key brick just to the north of the 1929 fireplace. This is probably part of the original fireplace that was removed by the QMC when they raised the floor level and converted the room to a single story space. The keyed brick is approximately 5'-4" to the right (south) of the northeast corner.

Deficiencies: Some areas of the earlier plaster are dead. This is particularly the case along the west wall where much of the earlier finish has deteriorated and delaminated from the masonry wall. Mortar dust is collecting at the base of each wall, an indication of moisture movement, wicking up through the foundation, and breaking down the calcium in the mortar. Efflorescence can be seen on the east wall between the north wall and the fireplace. Small rodents are undermining the sand base of the brick floor. Crickets, mice, and snakes are past or present occupants. Ventilation was deficient but improved when portions of the flooring above were removed.

Recommendations: Water management and ventilation issues should be addressed first by routinely opening windows, preventing splashback and improving drainage on the east and north elevations. Where possible, areas with early plaster should be consolidated by applying a bonding agent such as a *Plasterweld* mixture of 1 part resinous emulsion to 1 part water. The surface should first be carefully cleaned with air from a no-pressure airhose. Then apply *Plasterweld* with a soft brush. If NPS decides to conserve areas of the early plaster, a perforated frame can be mounted to the masonry wall around the plaster and an acrylic glass sheet attached to the frame. The installation should allow for air flow between the plaster face and the glass.

Deteriorated mortar joints should be raked back to where they are sound (1/2" - 1") and repointed with a new appropriate mix.

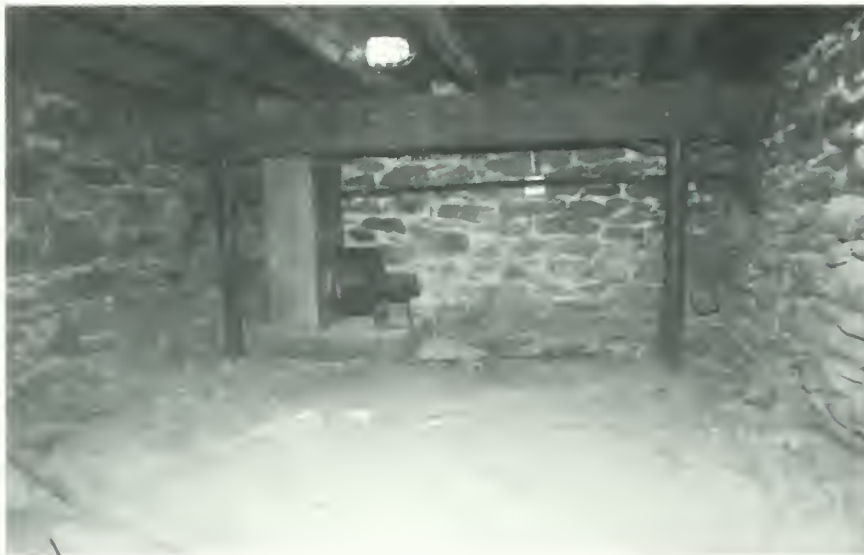
The north wall shows signs of considerable past disturbance (Figure 32). The right (east) two thirds of the wall has been rebuilt mostly in brick, even below grade (inner wythe), and pointed with a soft white mortar distinct from the original lime flecked clay sediment mortar. The mortar also does not

match the mortar known to have been used by the QMC during its 1929 restoration. It is possible that it constitutes an area that was repaired independent of the restoration work. This repointed area covers the eastern 6' of the wall from approximately 1' above the current floor level to an area about 4' above the current floor level, where it joins a second disturbed area. Composed of three brick courses, this second area, 3'-8" west of the east wall and between 4' above the floor, appears to have been rebuilt using older bricks and a newer

Figure 32. The north wall of crawl space in center room.

mortar. Visual inspection suggests that this area dates to the 1964 NPS restoration. These disturbed areas correspond to the niche on the exterior north elevation. Because it is recessed, this area has a thinner wall than the rest of the structure. The brick upper portion of the north wall appears undisturbed with original mortar in the joints. Most areas are covered with whitewash.

**Recommendations:** All three cellar spaces, including that of the center room require better air circulation. A 4-6 mil polyethylene vapor retarder should cover the floor.

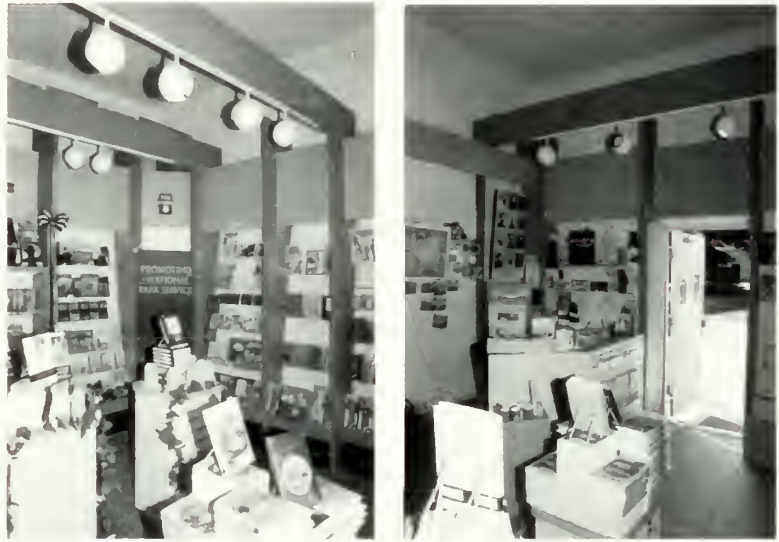
The interior space of the west room measures 18'-6" x 14'-6" with a ceiling height of 12'-3". The ceiling and four walls are whitewashed gypsum board (Figure 33). NPS drawings show the same

Figure 33. West room with book store concessionaire.

Recommendations: The thorough physical investigation should be undertaken to determine the condition of the walls, ceiling and floor before a work program is undertaken.

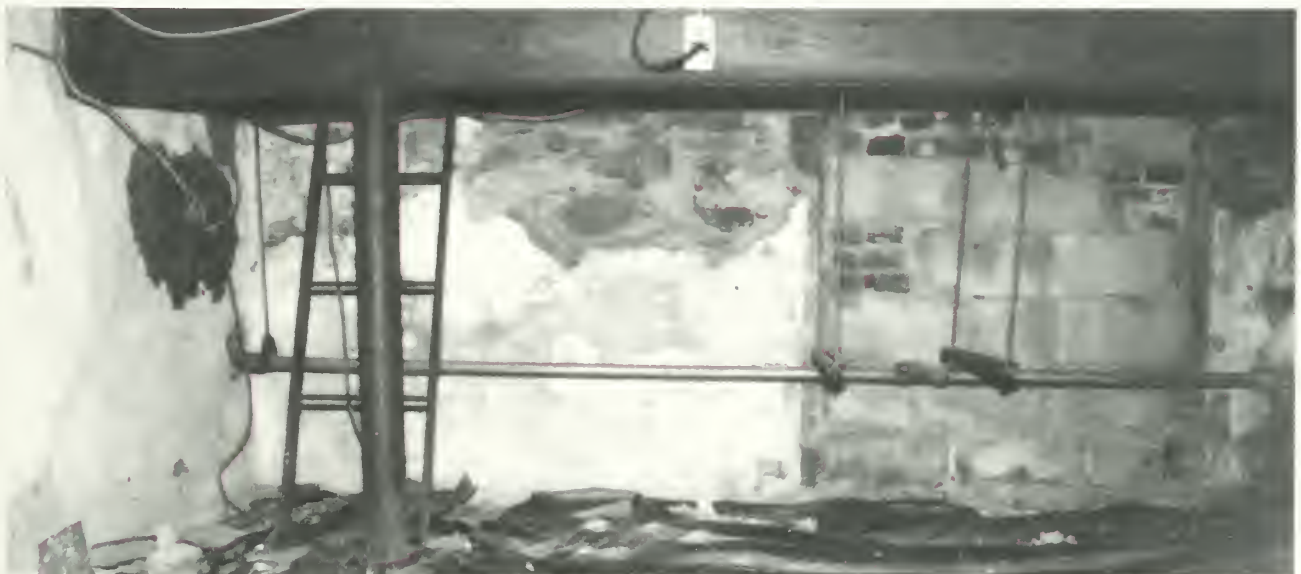
Figure 34. South wall, crawl space below west room.

sonry walls in the cellar have a noticeably horizontal stone coursing. The original finish was probably plaster with whitewash. Small bits of plaster or whitewash finish remain on isolated stones along both the east and west walls (Figure 34).

Deficiencies: Mortar joints on the west wall are deteriorated due to splash and ponding along roadway adjacent to the building.

Recommendations: A thorough physical investigation should be completed to determine the condition of the walls, ceiling, and floor before a work program is undertaken. The west wall should be carefully monitored until repointed.

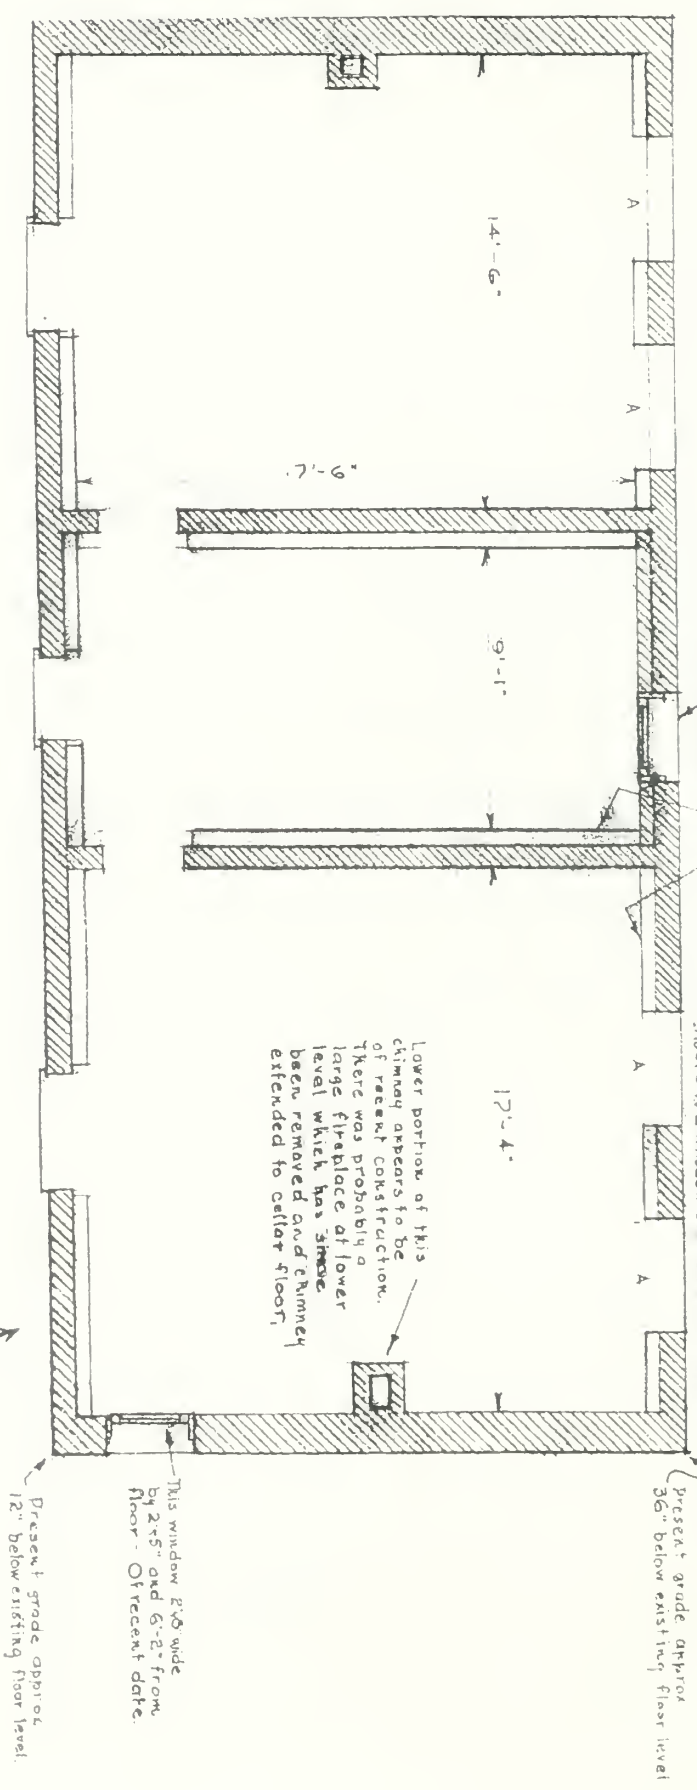
There is reputed to have been a flight of steps here and an entrance to lower level. Examination of interior of cellar wall shows evidence of bricked up opening.

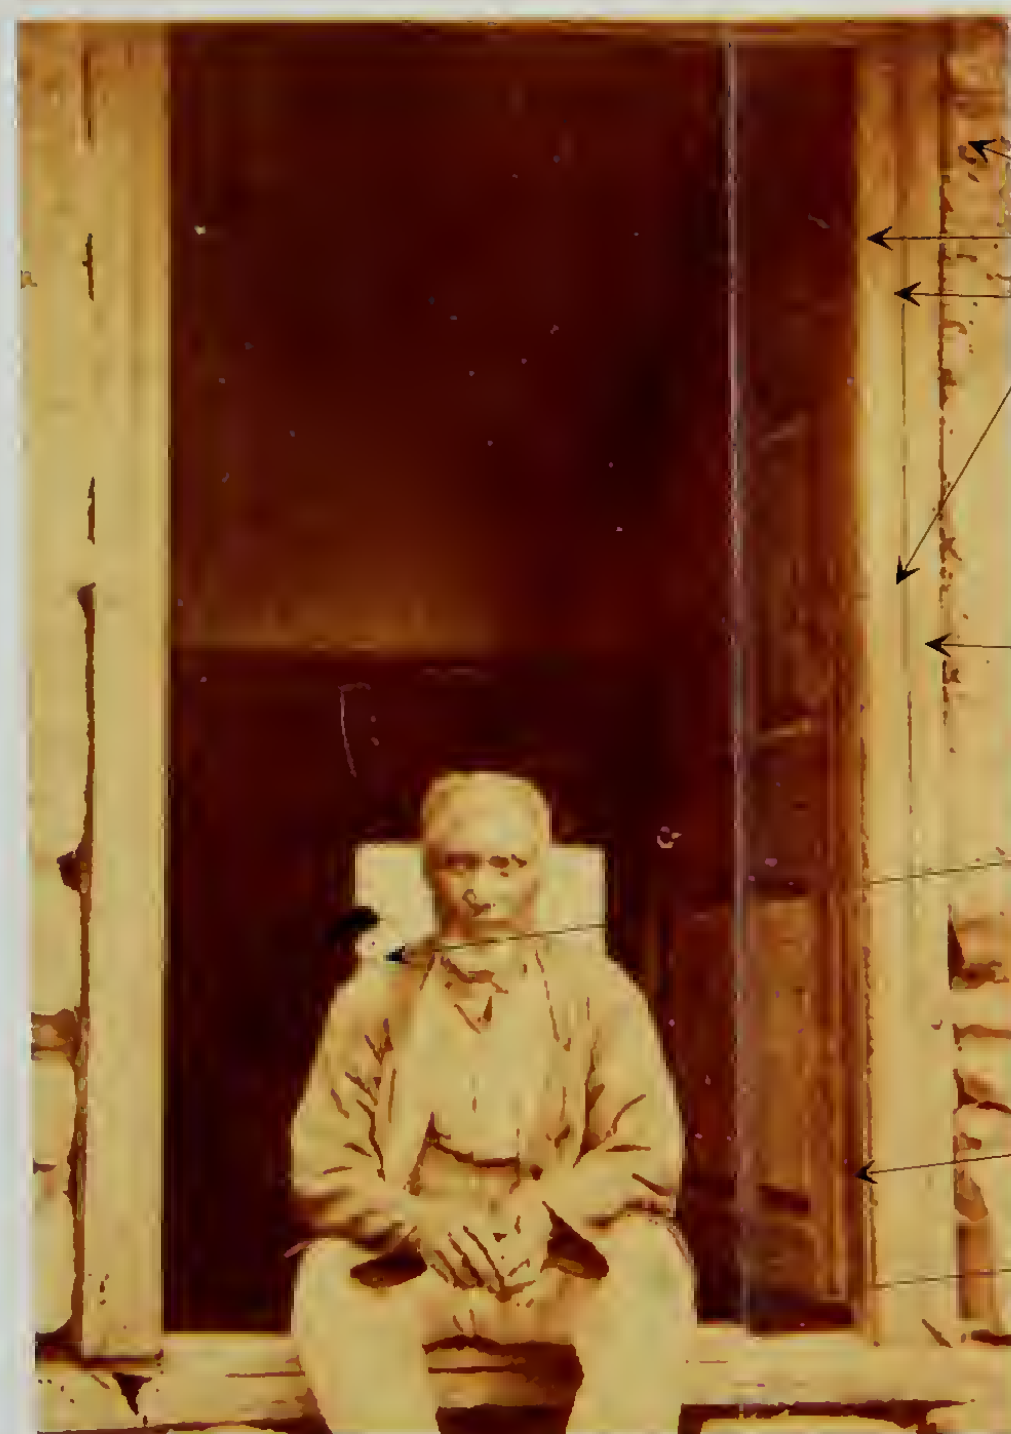
- ← Pebble dash finish
- ← Beaded architrave
- ← Nails attaching beaded-edge architrave
- ← Muntin bar on north window
- ← Mullion bar in north window
- ← Cast iron hinge
- ← Step-down or steps beyond threshold

North Dependency, 1865 Historic Photograph of South Elevation Kitchen Entry.

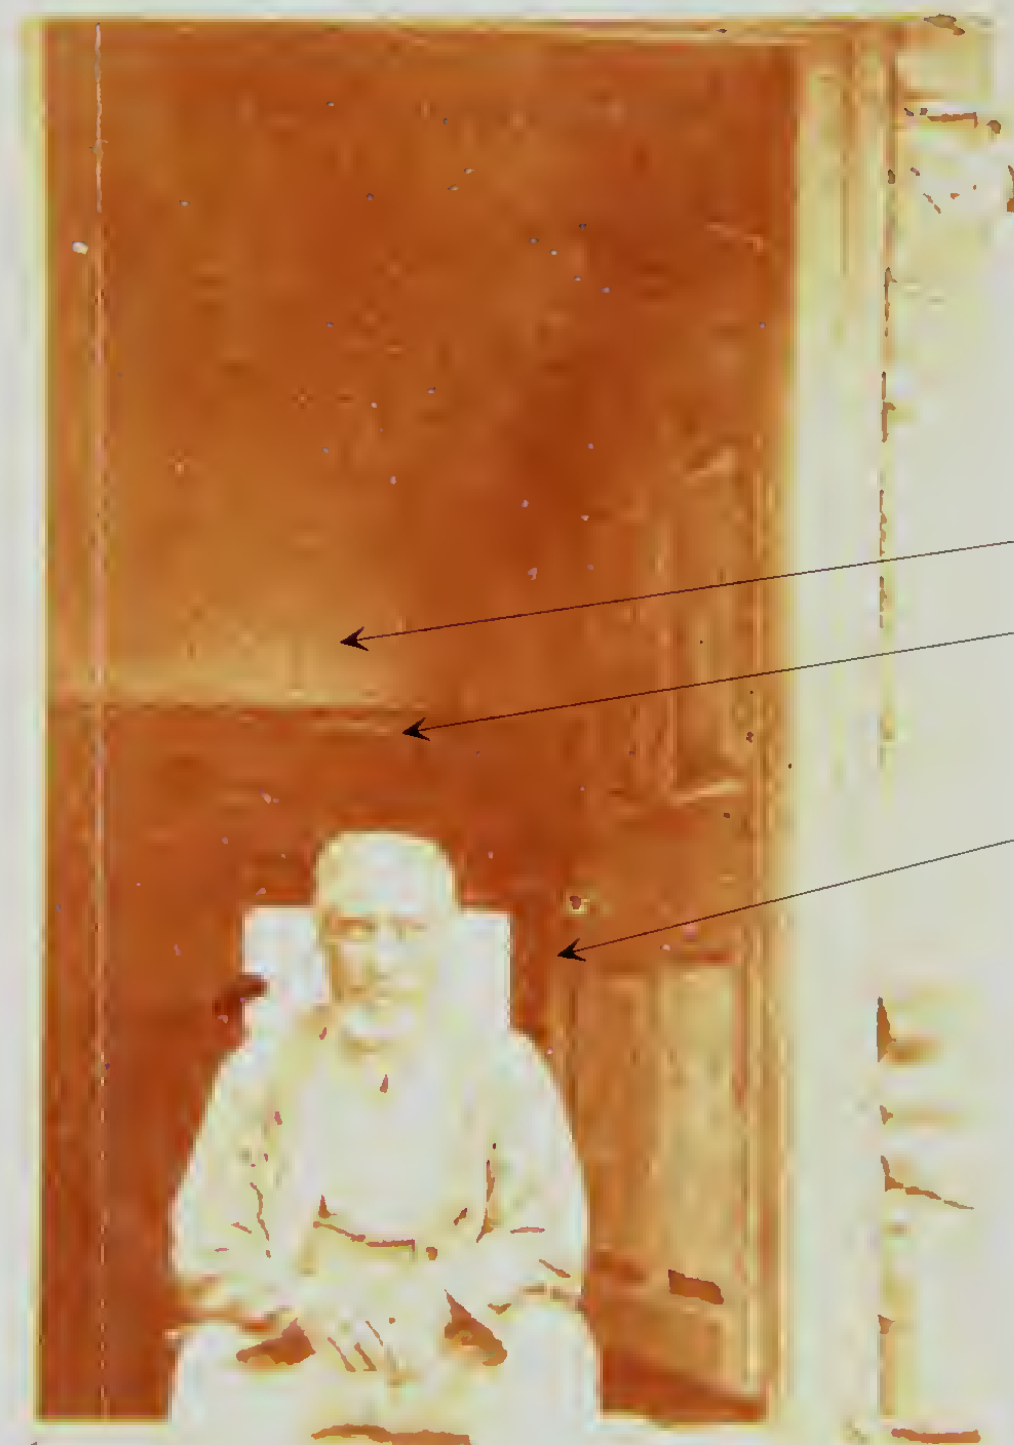
- ← Wide, horizontal board with beaded bottom edge
- ← Broken edge of plaster ceiling over kitchen
- ← Plaster return at north window

A lighter exposure of the 1865 photograph reveals additional details of the dark interior.

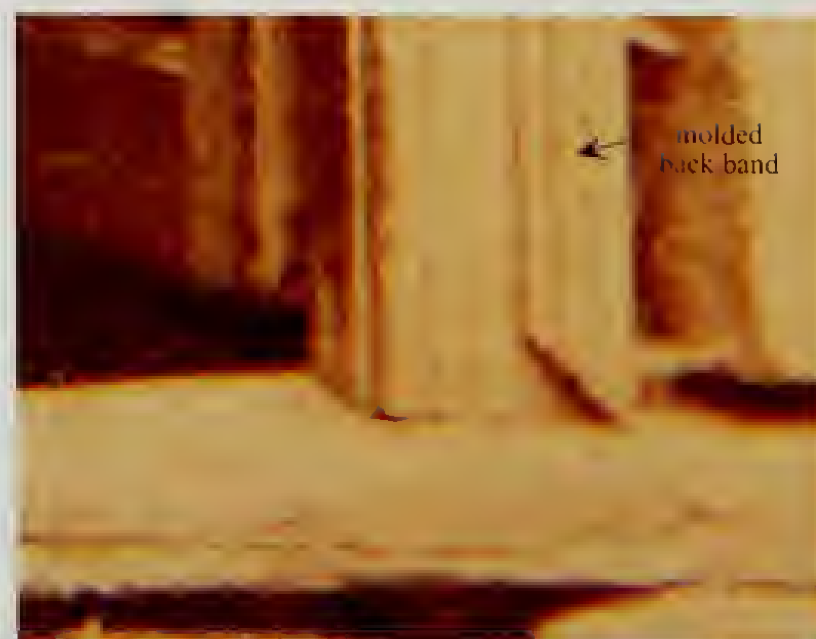
North Dependency, detail of 1865 photograph of molded back band

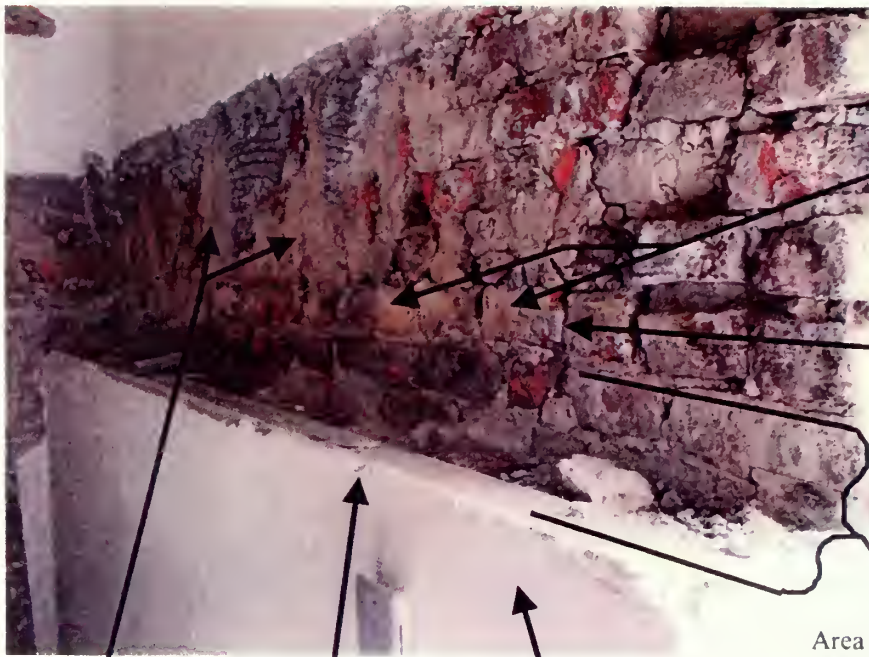
**A**

gold-yellow paint descending from original plaster to bare brick corresponding to area that upper level baseboard would have concealed

one of several unused nailing blocks for upper level baseboard that was not installed

Area of bare brick corresponding to where joists resting on the shoulder abutted the south wall. This area was originally concealed beneath the upper level floor and lower level ceiling

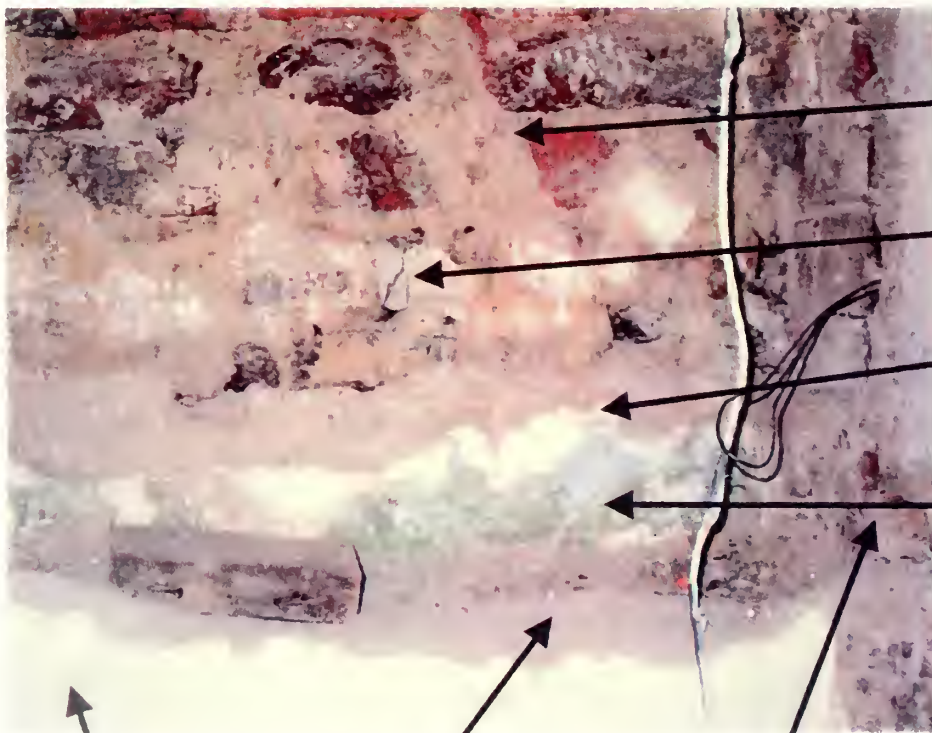
**B**

Original mortar and plaster

base board nailing block

west interior wall - south edge of infilled upper level door opening to center room

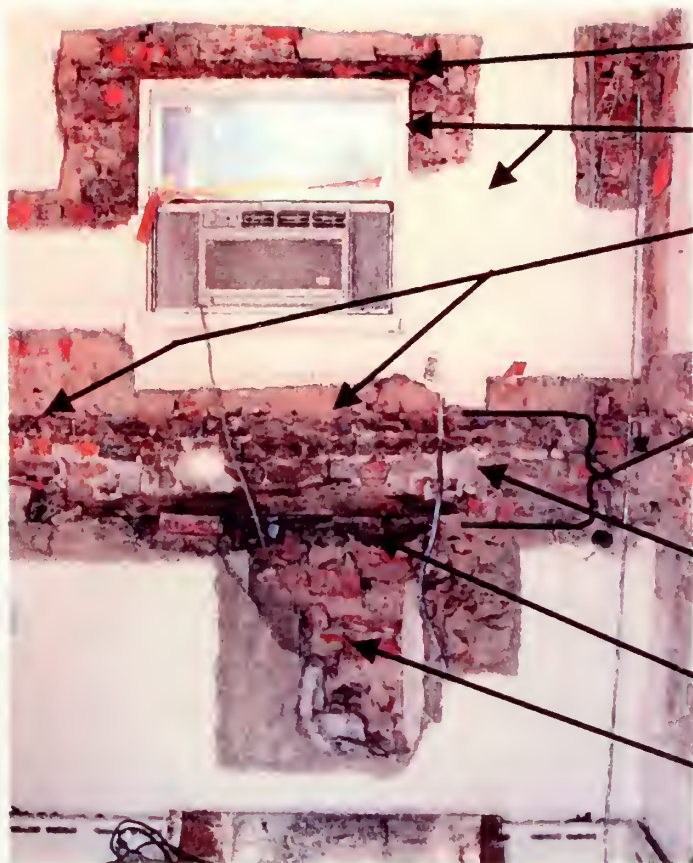
C

original wane-edged lintel  
for upper level window

1964 NPS window frame and  
plaster

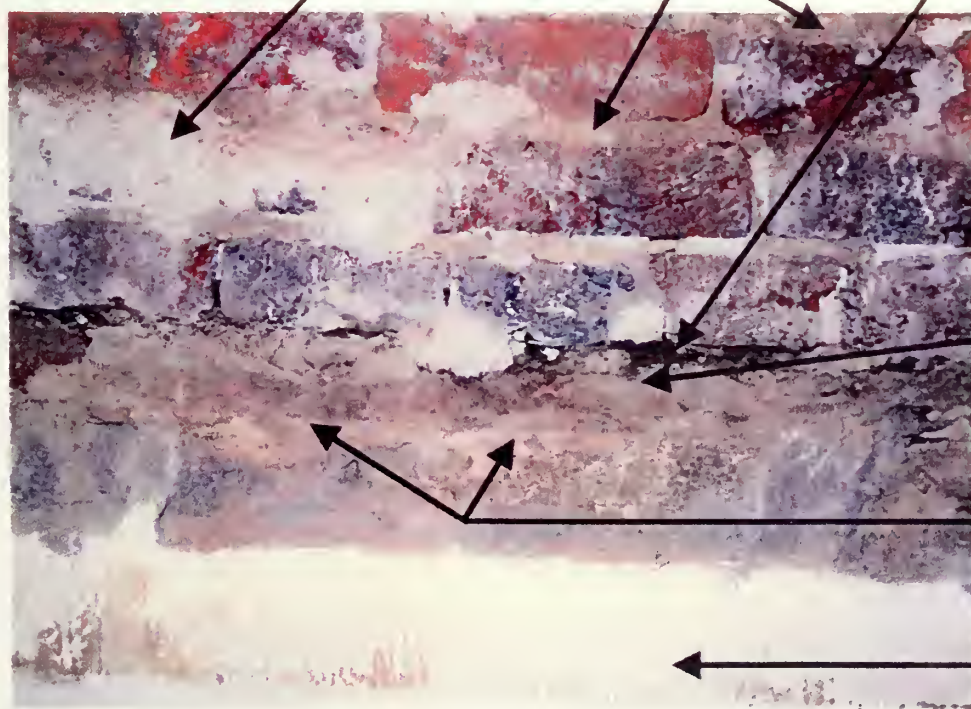
original mortar

collections of fibers and other  
occupation material originally  
trapped between floor joist  
and wall

possible  
imprint on  
plaster from  
original  
upper level  
floor joist

line where  
kitchen plaster  
wall met ceiling  
(note stained  
whitewash  
finish on wall)

1964 NPS  
plaster

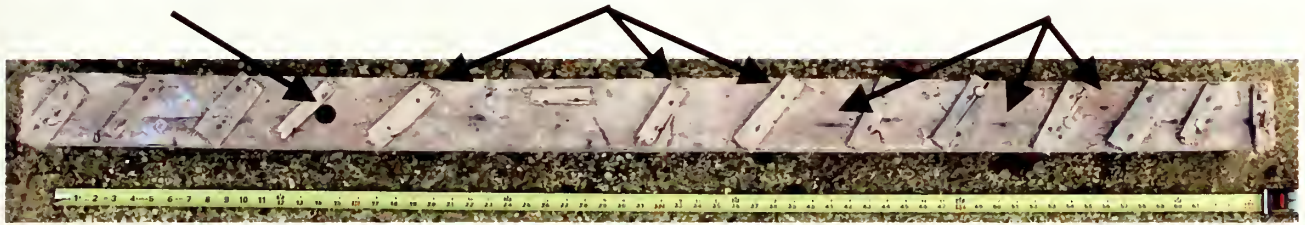
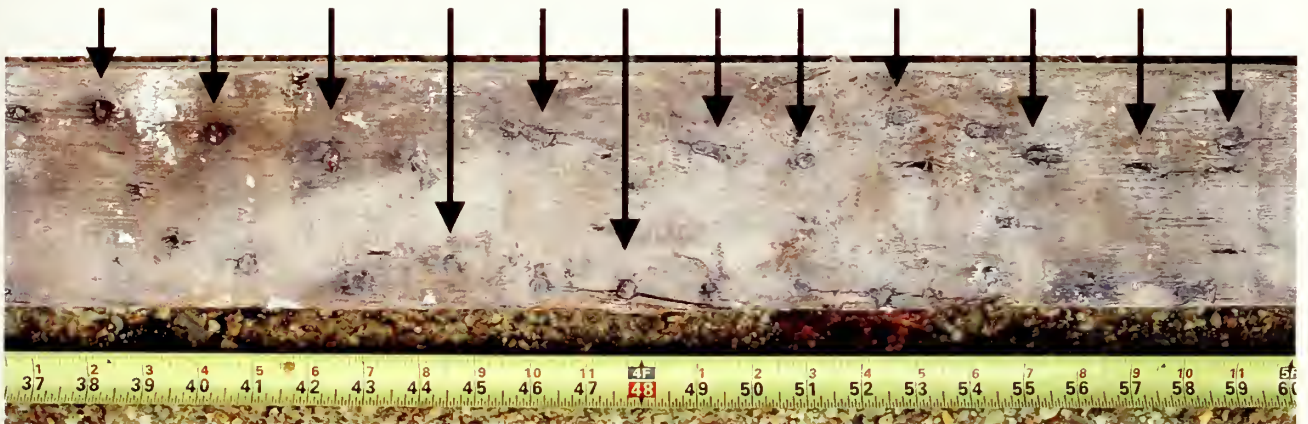
G

tightening hole

lath added when joist  
was reused as lintel

original floorboard  
nail holes

lath nails, nail holes and staining that correspond to the original position of the wood lath

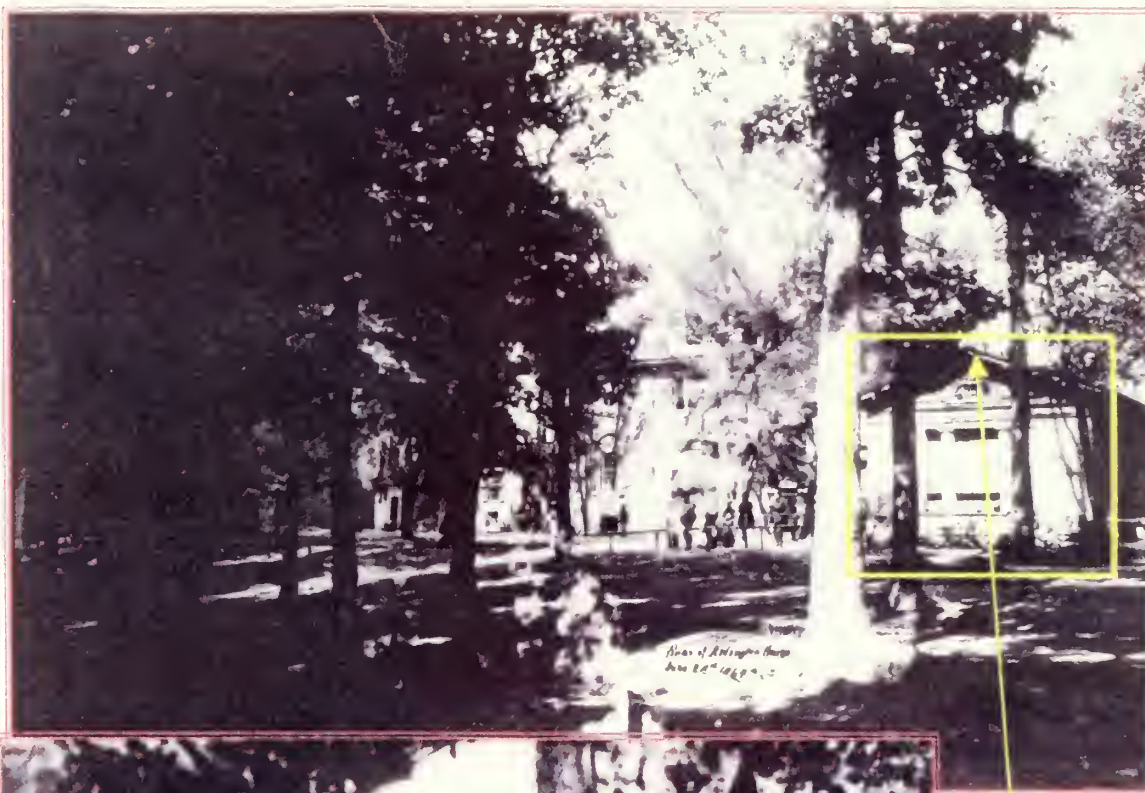
As blurred as it may be, we are looking at a chimney with stucco on the exterior shaft. The large cap modules are cut stone or a fired clay product and were likely stuccoed as well.

Review a clear photo under a 30x loupe lense and you can see the chimney once you find it. It is visible through the tree limbs and leaves.

I am going to say the rise off the peak is about 18"

In my earlier package of information I called the roof extension at 3" and with a loupe lense on a clear photograph you can clearly see the north slope comb at the peak of the roof clearly larger than three inches. I would push the comb out to minimum of 4" and it could go to six inches

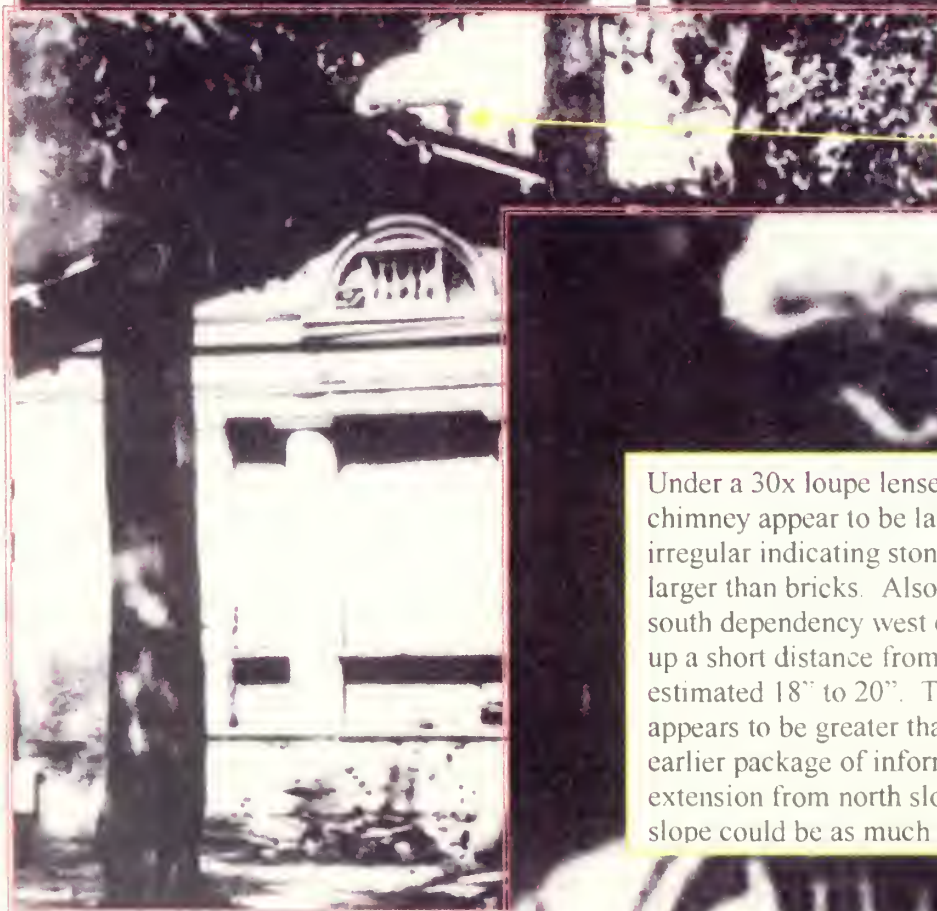
South Dependency Chimney

Under a 30x loupe lense, the modules of the chimney appear to be large and somewhat irregular indicating stone. They are definitely larger than bricks. Also, the chimney is the south dependency west chimney projecting up a short distance from the peak, an estimated 18" to 20". The peak combing appears to be greater than 3" called for in my earlier package of information. The extension from north slope out over south slope could be as much as 4 to 5".
