ANALYSIS OF THE HYDROLOGIC,
HYDRAULIC AND GEOMORPHIC ATTRIBUTES
OF THE YOSEMITE VALLEY FLOOD:
JANUARY 1-3, 1997

William L. Jackson
Gary M. Smillie
and
Michael W. Martin

**NATIONAL PARK SERVICE
WATER RESOURCES DIVISION
FORT COLLINS, COLORADO**

FEBRUARY 21, 1997

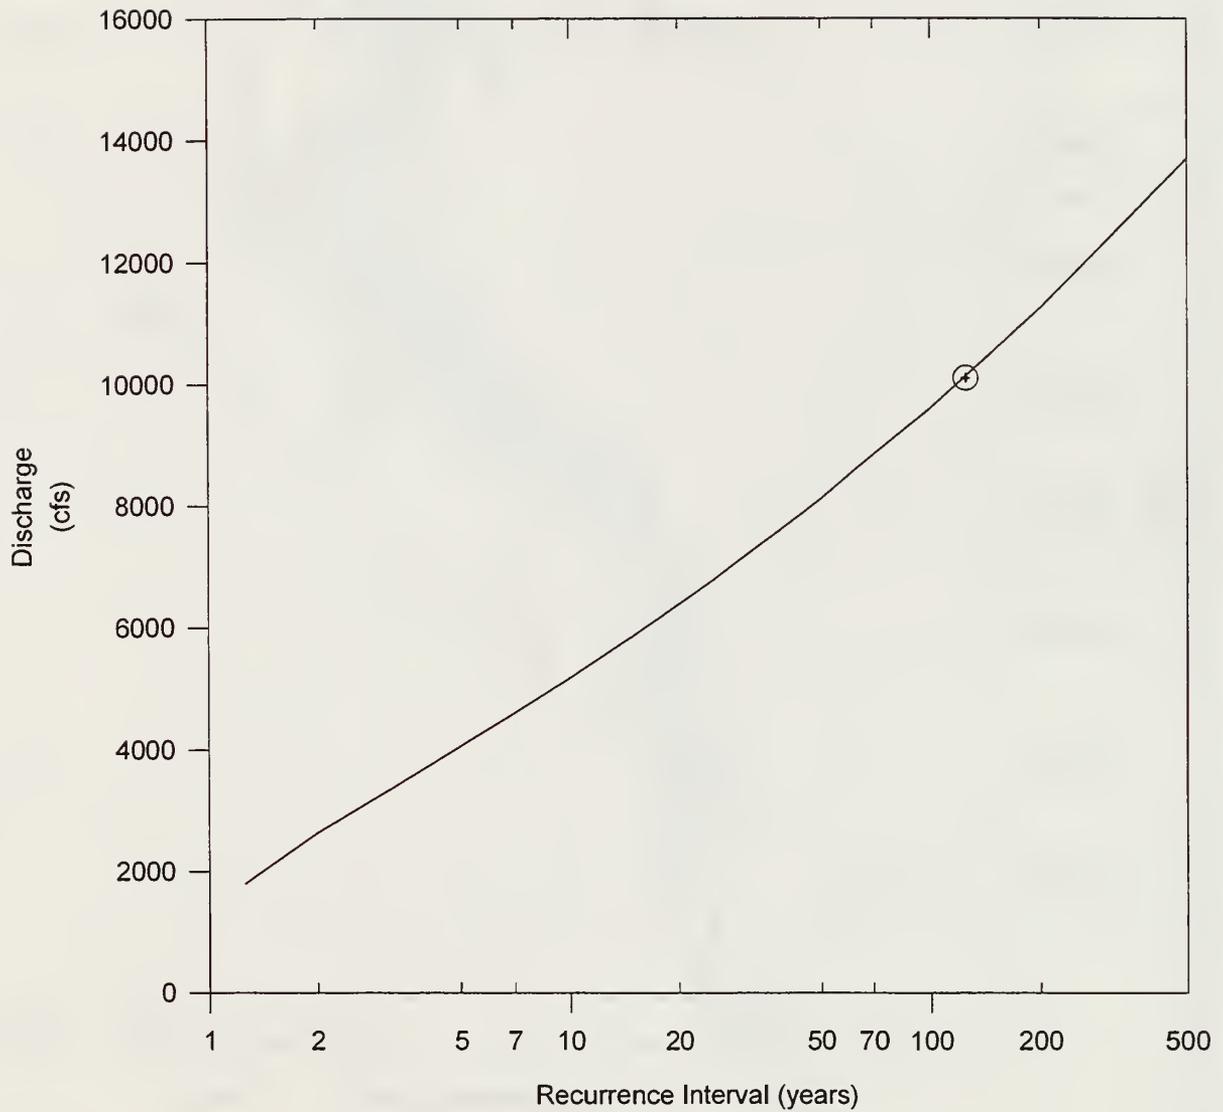
flood). The estimated flood frequency relationship for this gage derived from the log-Pearson analysis is shown in Figure 2. At this time, both the discharge estimate and the recurrence interval should be considered preliminary estimates subject to change when the USGS has an opportunity to incorporate more information into their estimates. The maximum stage, date and time of peak, however, are considered accurate at this time due to indications that the gage continued to operate throughout the flood.

Figure 2. Flood frequency relationship for Merced River at Happy Isles Bridge stream gage, showing magnitude of the January 1997 flood. Frequency curves computed by log-Pearson III analysis of annual peak flow series for period of record (exclusive of 1997) .

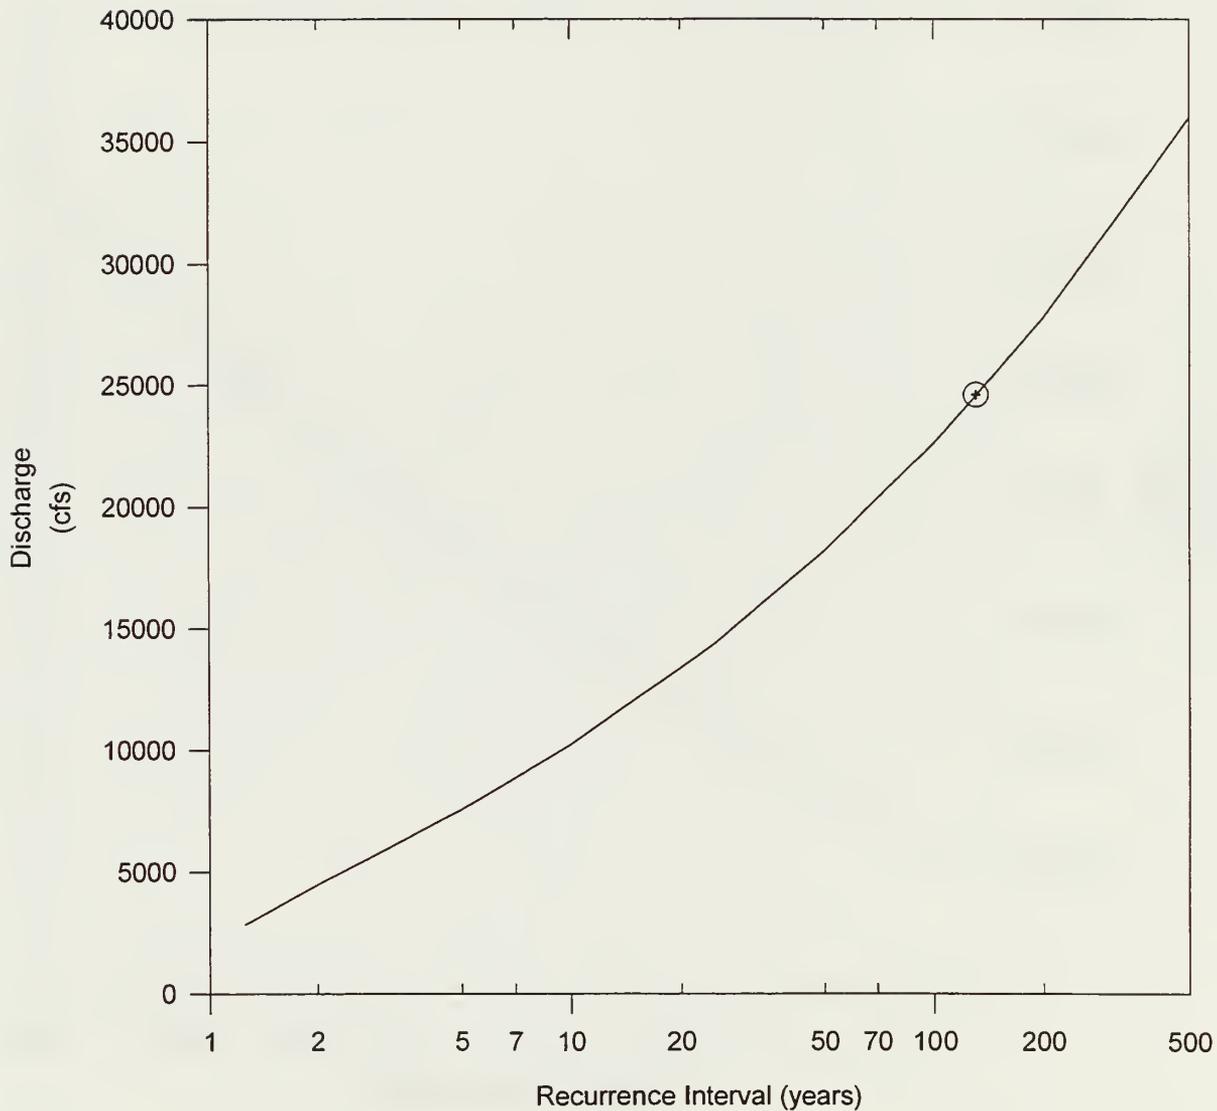
A log-Pearson Type III frequency distribution was fitted to the annual peak series at the Pohono streamgage for the record from 1917 to 1996. Based upon this analysis, a flood of the magnitude experienced on January 2 or 3, 1997, is estimated to be slightly larger than the one-percent-chance-flood (100-year flood) for the Merced River at Pohono Bridge. The estimated flood frequency relationship for this gage derived from the log-Pearson analysis is shown in Figure 3.

Figure 3. Flood frequency relationship for Merced River at Pohono Bridge stream gage, showing magnitude of the January 1997 flood. Frequency curves computed by log-Pearson III analysis of annual peak flow series for period of record (exclusive of 1997).

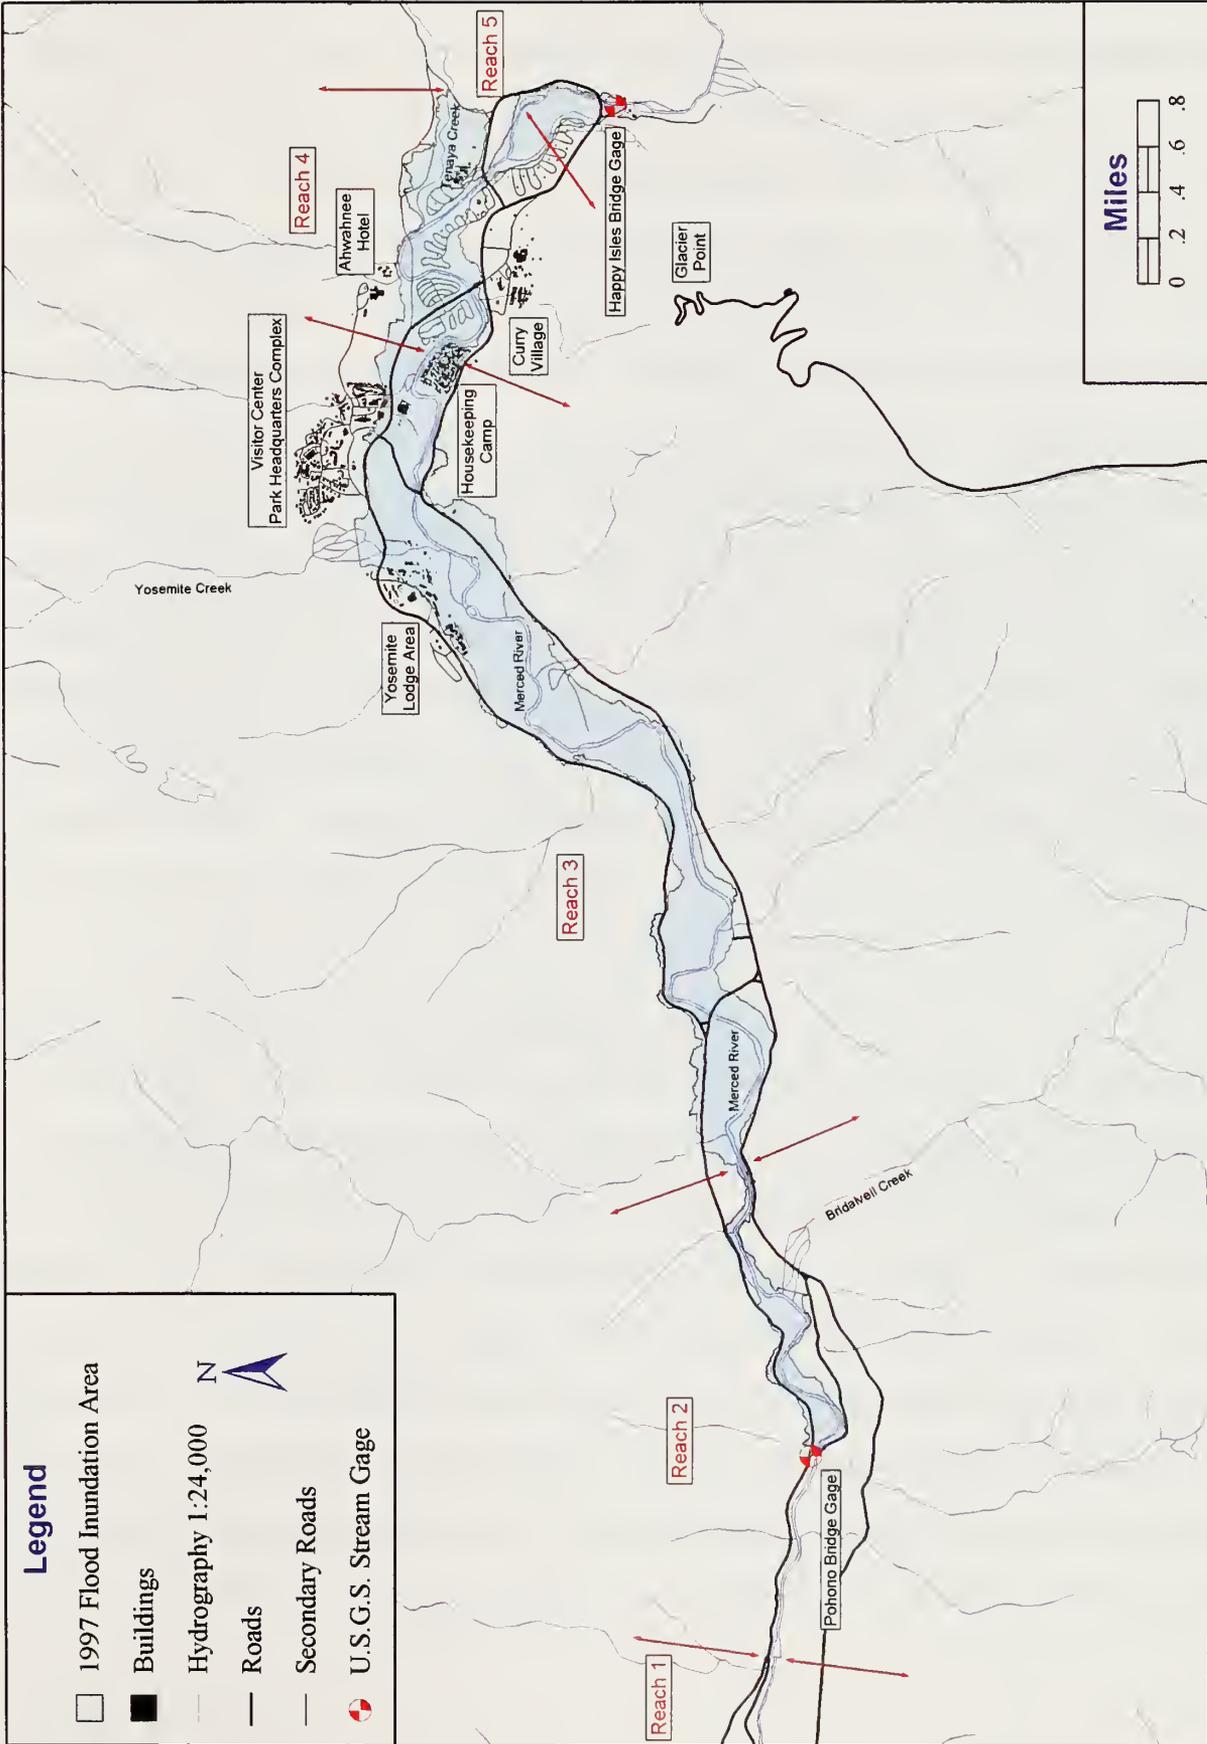
FIGURE 4. MAP DELINEATING FIVE GEOMORPHIC REACHES ALONG THE MERCED RIVER

the river and park infrastructure were affected differently by the flood, it is useful to divide the river into five geomorphically similar reaches (Figure 4). This section describes the primary geomorphic characteristics associated with each reach, the predominant types of infrastructure found in each reach, the general hydraulic conditions experienced during the flood event and the resultant general effects. Reach 1 extends upstream from the town of El Portal to the diversion dam located at the junction of the El Portal Road (Highway 120) and the Big Oak Flat Road (Highway 140). Reach 2 extends from this point up to El Capitan Moraine. Reach 3 extends upstream from El Capitan Moraine to the so-called Housekeeping area upstream from Sentinel Bridge. Reach 4 extends from the Housekeeping area upstream to above the confluence with Tenaya Creek. Reach 5 includes steep, narrow reaches of Tenaya Creek and the upper Merced River.

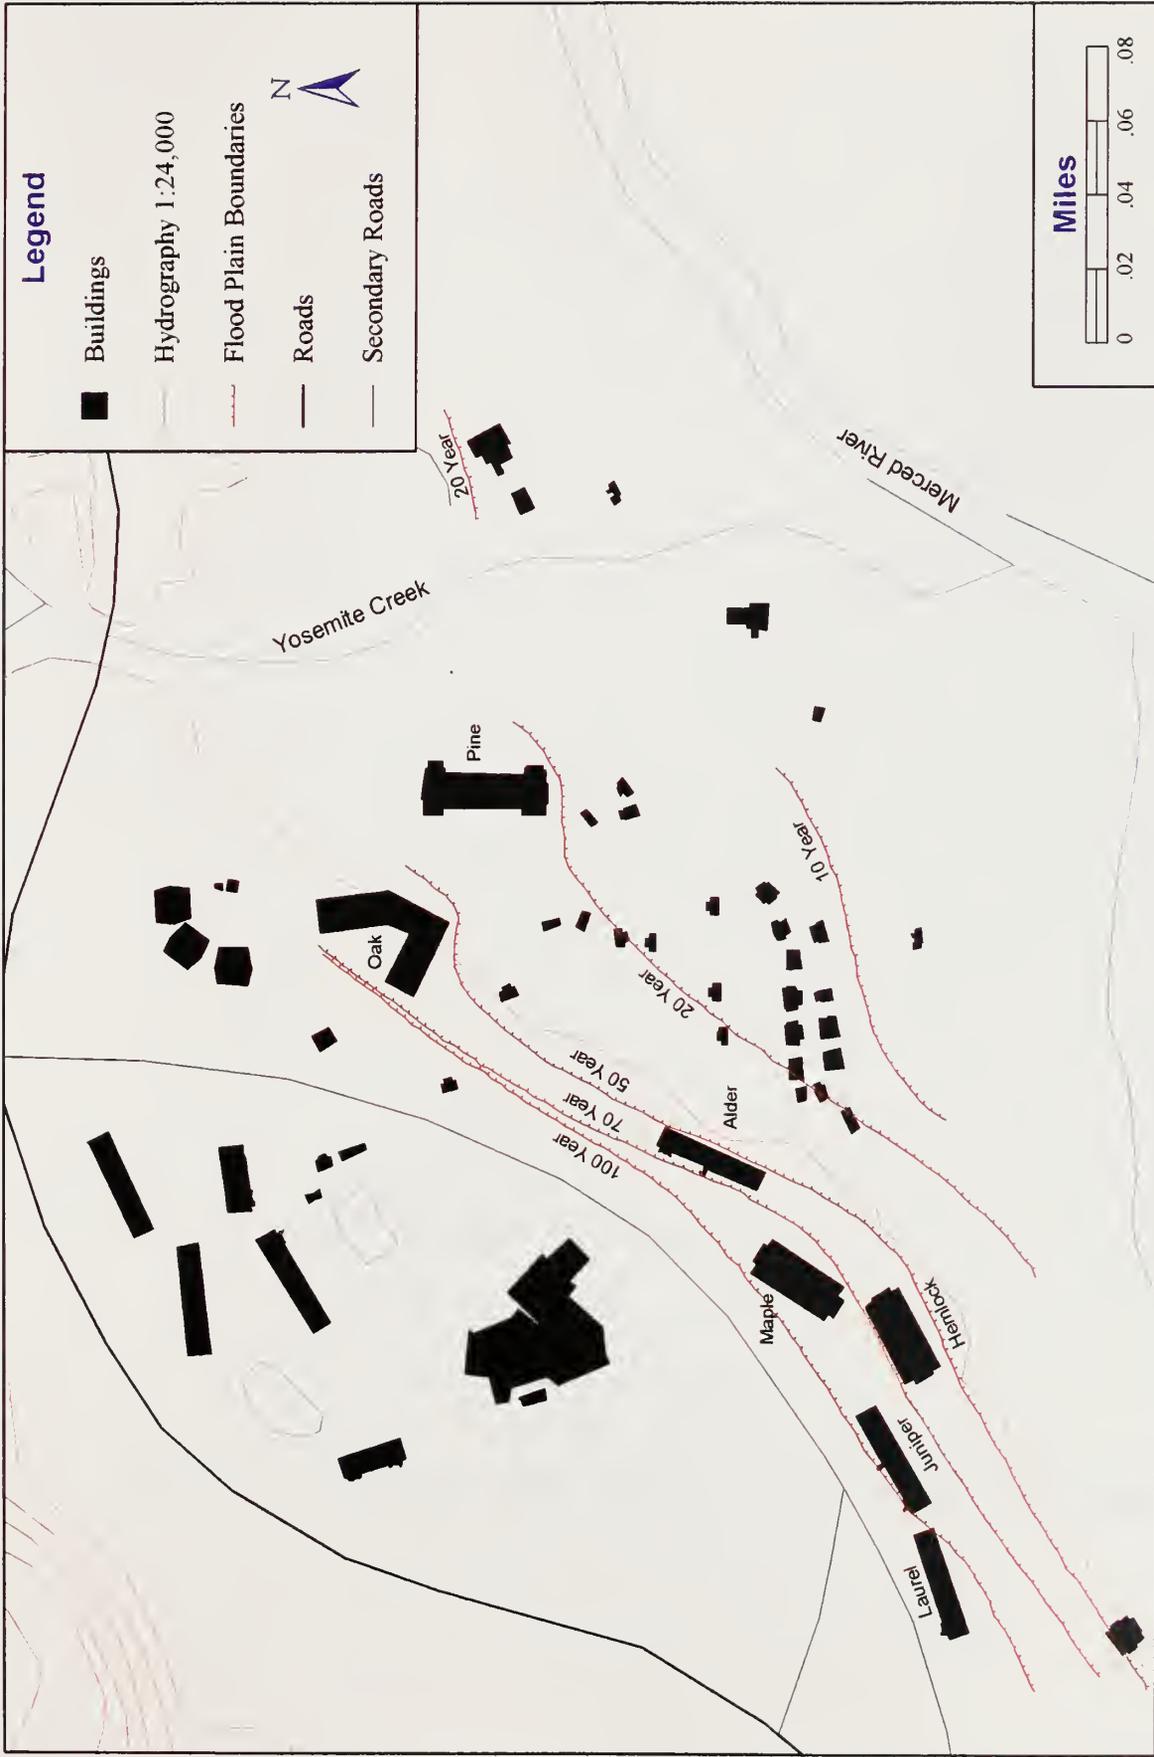
Using this relationship, individual structures were assigned a flood frequency based on the depth of flooding during this event. When all of the structures were tabulated, approximate floodplain boundaries were drafted on a base map using lodge units and their associated flood frequency as delineation points (Figure 12). From this map it is possible to estimate the frequency that particular areas of the lodge will be flooded. However, it is important to note that not all of the structures located in the lodge area are depicted on the base map. The area most prone to flooding is the "cabin without baths" section which is omitted from the base map. This area is located roughly due south of the Laurel and Juniper Cottages and contains at least four units located in the approximate 2-year floodplain, an additional 13 in the 5-year floodplain, and as many as 25 in the 10-year floodplain.

FIGURE 12. CLOSE UP MAP OF THE YOSEMITE LODGE AREA SHOWING APPROXIMATE FLOODPLAIN BOUNDARIES WITH ASSOCIATED FREQUENCIES

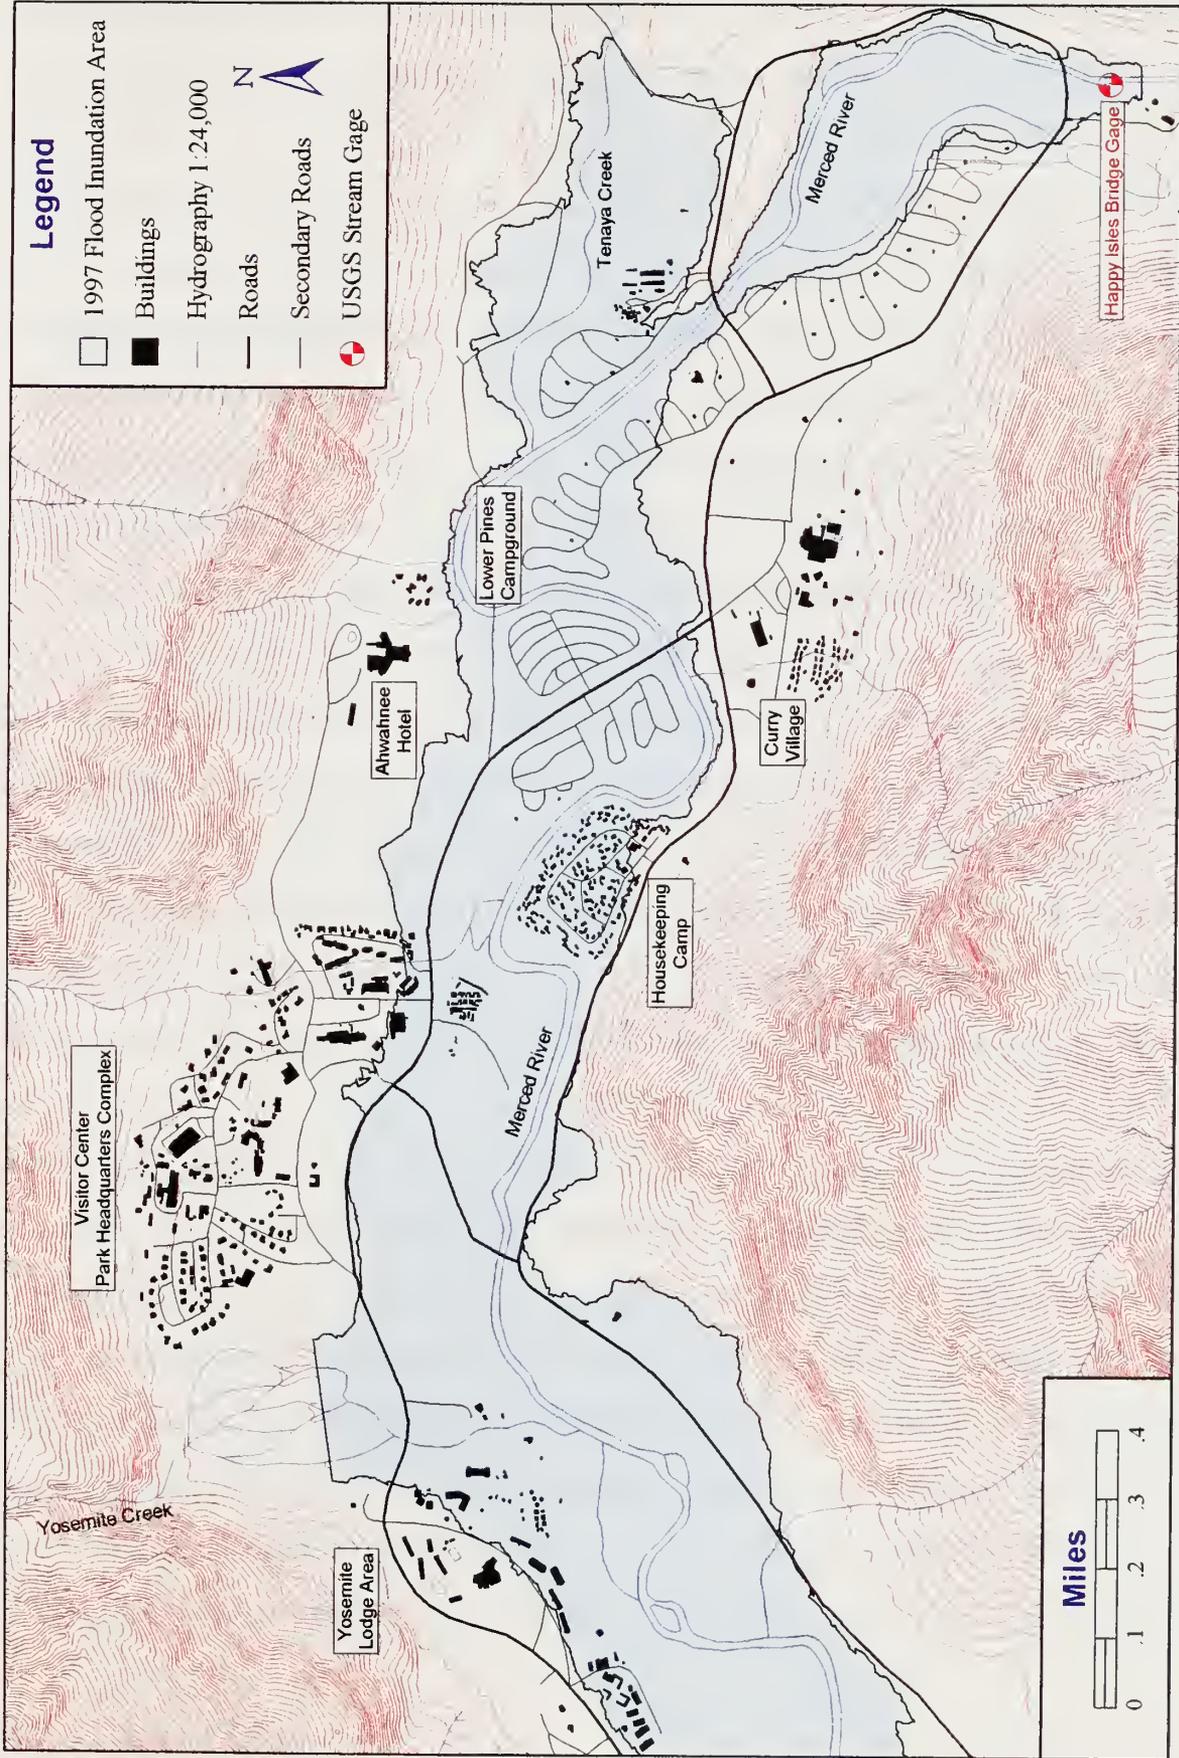
Almost the entire Yosemite Valley is a natural floodplain. A useful thing about this flood is that it permits an accurate delineation of the 100-year floodplain. This is especially useful in areas where park infrastructure is concentrated (Figure 14). It will be virtually impossible for all park infrastructure to be located outside the floodplain. The issue in Yosemite Valley is how best to occupy the floodplain in a way which minimizes impacts to park resources and the risk to infrastructure. In this regard, there are some important lessons to be learned from this flood.

FIGURE 14. THE 100-YEAR FLOODPLAIN IN THE AREA OF CONCENTRATED PARK DEVELOPMENT, AS DETERMINED FROM THE 1997 FLOOD.

interaction of flowing water and infrastructure, as much setback in the floodplain as possible is recommended.
