Hawaiian Volcanoes During 1951

GEOLOGICAL SURVEY BULLETIN 996-D

By GORDON A. MACDONALD and CHESTER K. WENTWORTH

*A report of the Hawaiian
Volcano Observatory*

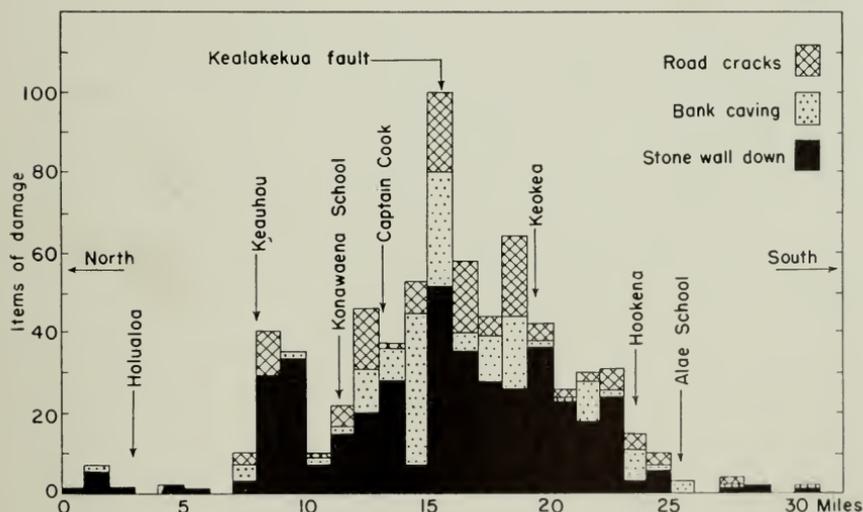
The distribution of abundance of rock slides in road cuts is shown in figure 43, in which it is represented by the portion of the columns labeled "bank caving." Like the other damage shown in the graph,

FIGURE 43.—Diagram showing the frequency distribution of three of the principal types of earthquake damage along the main highway. The arrows indicate the position on the highway of some villages and other features. Note the centering of damage near the Kealakekua fault.

it was greatest in the immediate vicinity of the Kealakekua fault, inland and a little south of Kealakekua Bay.

Damage to paved roads was of three general types: cracking of pavement, cracking and slumping of shoulders and separation of shoulders from pavement, and collapse of road cuts causing partial obstruction of the road. The latter has already been discussed under the heading "Rock slides." Minor cracking of shoulders occurred over an area extending about 10 miles north and 12 miles south of the approximate epicenter, and a few cracks were formed as far away as the northeastern side of Kilauea caldera, 47 miles from the epicenter. However, extensive pavement cracking and slumping was restricted to the area between Captain Cook and Hookena. The distribution of cracks in the road is shown in figure 43.

Some information bearing on the location of the epicenter can be derived from the study of damage by the earthquake. The general distribution of damage to roads, stone walls, and road cuts along the main highway is shown in figure 43. This is based on a count checked

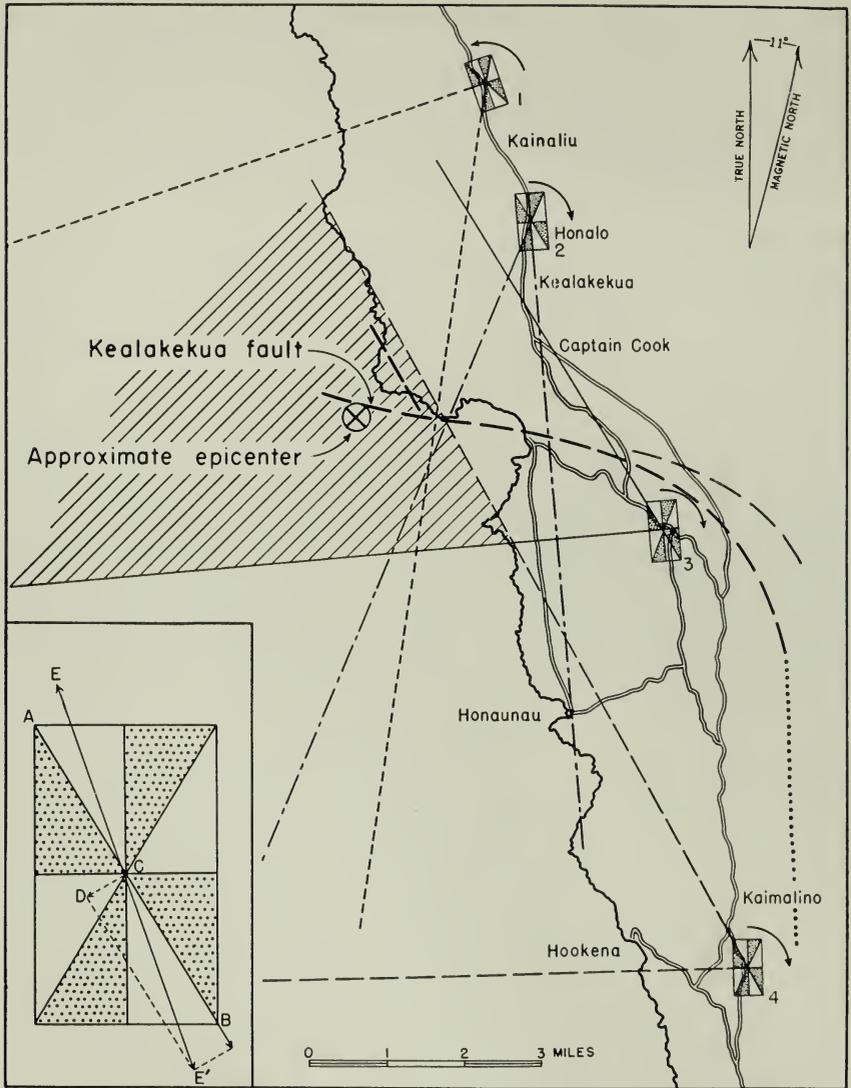
FIGURE 48.—Map of the central Kona area, showing the prevalent direction of rotation of monuments in cemeteries. The cemeteries are indicated on the map by numbers as follows: (1) Daifukuji, Honalo; (2) Hongwanji Mission, Kealakekua; (3) Hongwanji Mission, Kei; (4) Kalahiki Japanese. At each cemetery the arrow indicates the prevalent direction of rotation. The boundaries of the octants containing the direction toward the epicenter are prolonged. The cross-hatched area west of Captain Cook is that in which three or more of the octants overlap. The inset in the lower left is a diagram (after Imamura, 1937) of a horizontal cross section of a rectangular column, indicating the manner in which horizontal earthquake motion ($E-E'$) brings about rotation of the column.

In figure 48 is shown the prevalent direction of rotation of monuments in four cemeteries. Four other cemeteries were omitted either because no monuments were rotated or because the number was too small to yield a reliable statistical result. At each of the four cemeteries plotted the boundaries of the octants containing the direction toward the epicenter are prolonged. In an area west of the shoreline, from 2 miles south to 2 miles north of the approximate trace of the Kealakekua fault, three or more of the four significant octants overlap, and it is within this area of overlap that the epicenter should be situated.

The prevalent direction of rotation of columns in cemeteries indicates a location of the epicenter within the shaded offshore area in figure 48. This area contains the seaward extension of the Kealakekua fault.
