9 ROXBURY ROAD SCARSDALE, NEW YORK

WINDOWS

NUMBER 19

Repairing Steel Casement Windows

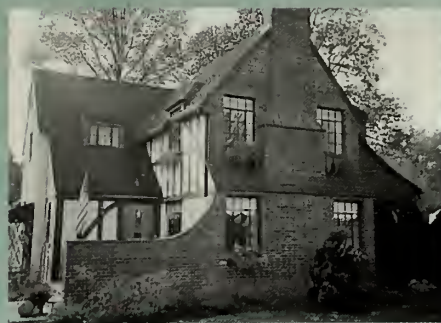
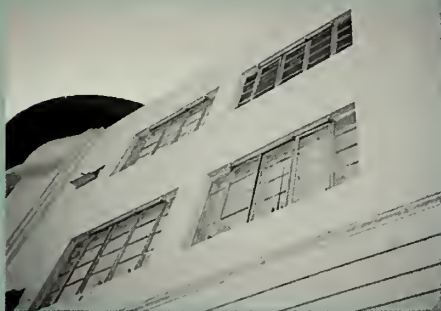
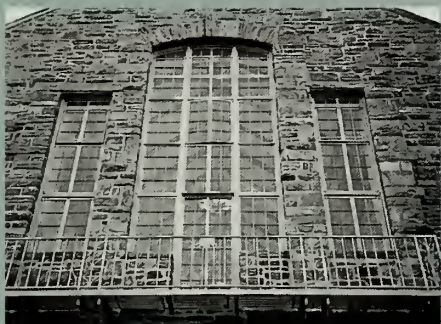
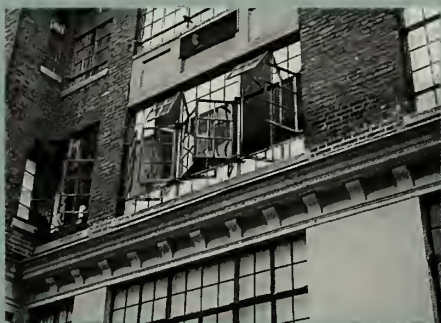
window-mounted units were to be removed from the four affected windows and the damaged areas of the sash and frame rebuilt with lengths of steel that matched the existing profiles.
