ROCK CREEK PARK

HORSE TRAIL STUDY

National Park Service • Department of Interior

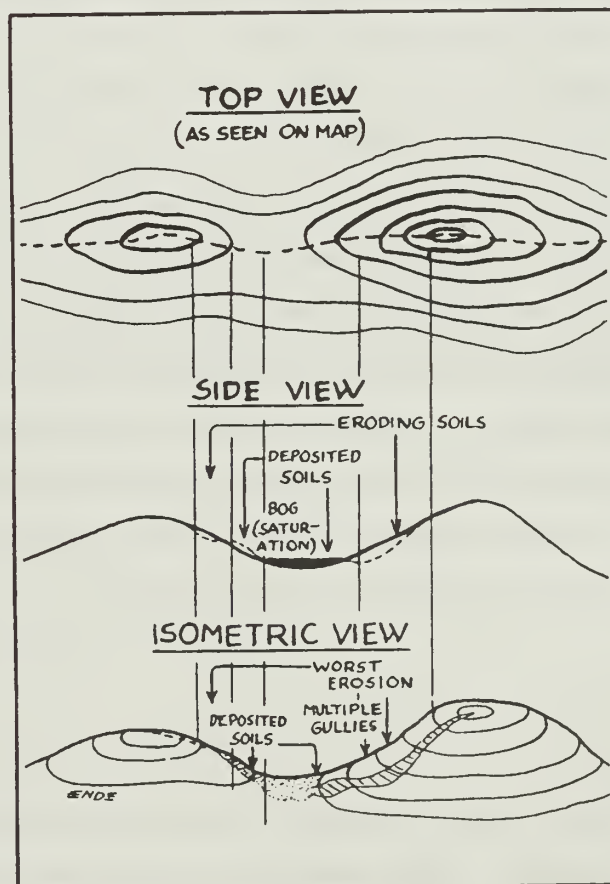
The drawing illustrates the two kinds of problems designers should avoid, showing where on a ridge crest they are most likely to occur. Erosion is most likely at the steepest point; saturation is most likely at the flattest point.

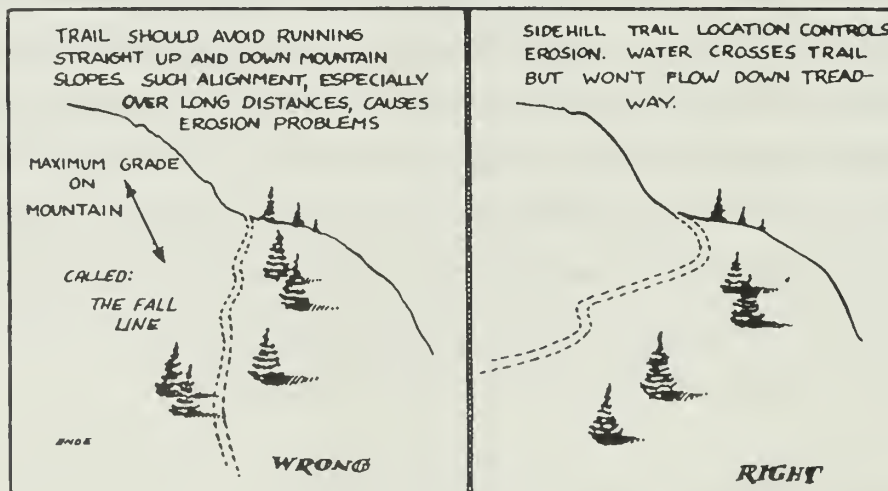
Proper Trail Design. Proper design of trails requires routing trails in a "side-hill" location, relatively parallel to the contour of the land. Trails should cross steep slopes at angles of 60 to 90° to the fall line or maximum landform gradient.

Trails located according to this design always have a low edge which permits outslipping of the trail tread for natural, continuous drainage with a minimal number of waterbars. Water would tend to drain from the low edge of the trail, rather than run down the trail with erosive effects. Several fine examples of such trail design exist in RCP: on the gradual section of the Black Horse Trail between Cross Trails 8 and 9 where the trail cuts across steep grades approximately 100 vertical feet above Rock Creek, at the "Horse Shoe Bend" on the Black Horse Trail north of Riley Spring Bridge, and on the White Horse Trail near Broad Branch where the trail, while steep for short stretches, always has a low drainable edge.

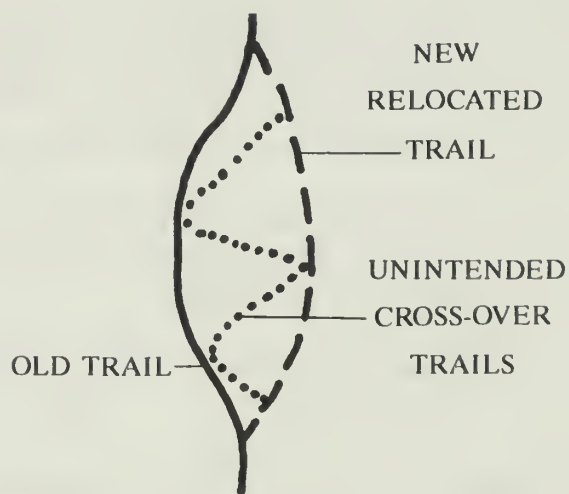
Wrong

regarding really striking out into new terrain. The result of a relocation not adequately separated from its older antecedent is two parallel routes, with both open to horse traffic, both deteriorating at the same rate, and with new crossover trails and confused users. To close an old route, the perception of the horse rider should be clearly understood. He/she should not "desire" using the old route because it appears shorter, easier, or more desirable. The "desire line" should follow the new route. The new route should be a dramatic change in direction and slope, or be a much easier and more desirable route, to be successfully used as a permanent relocation.

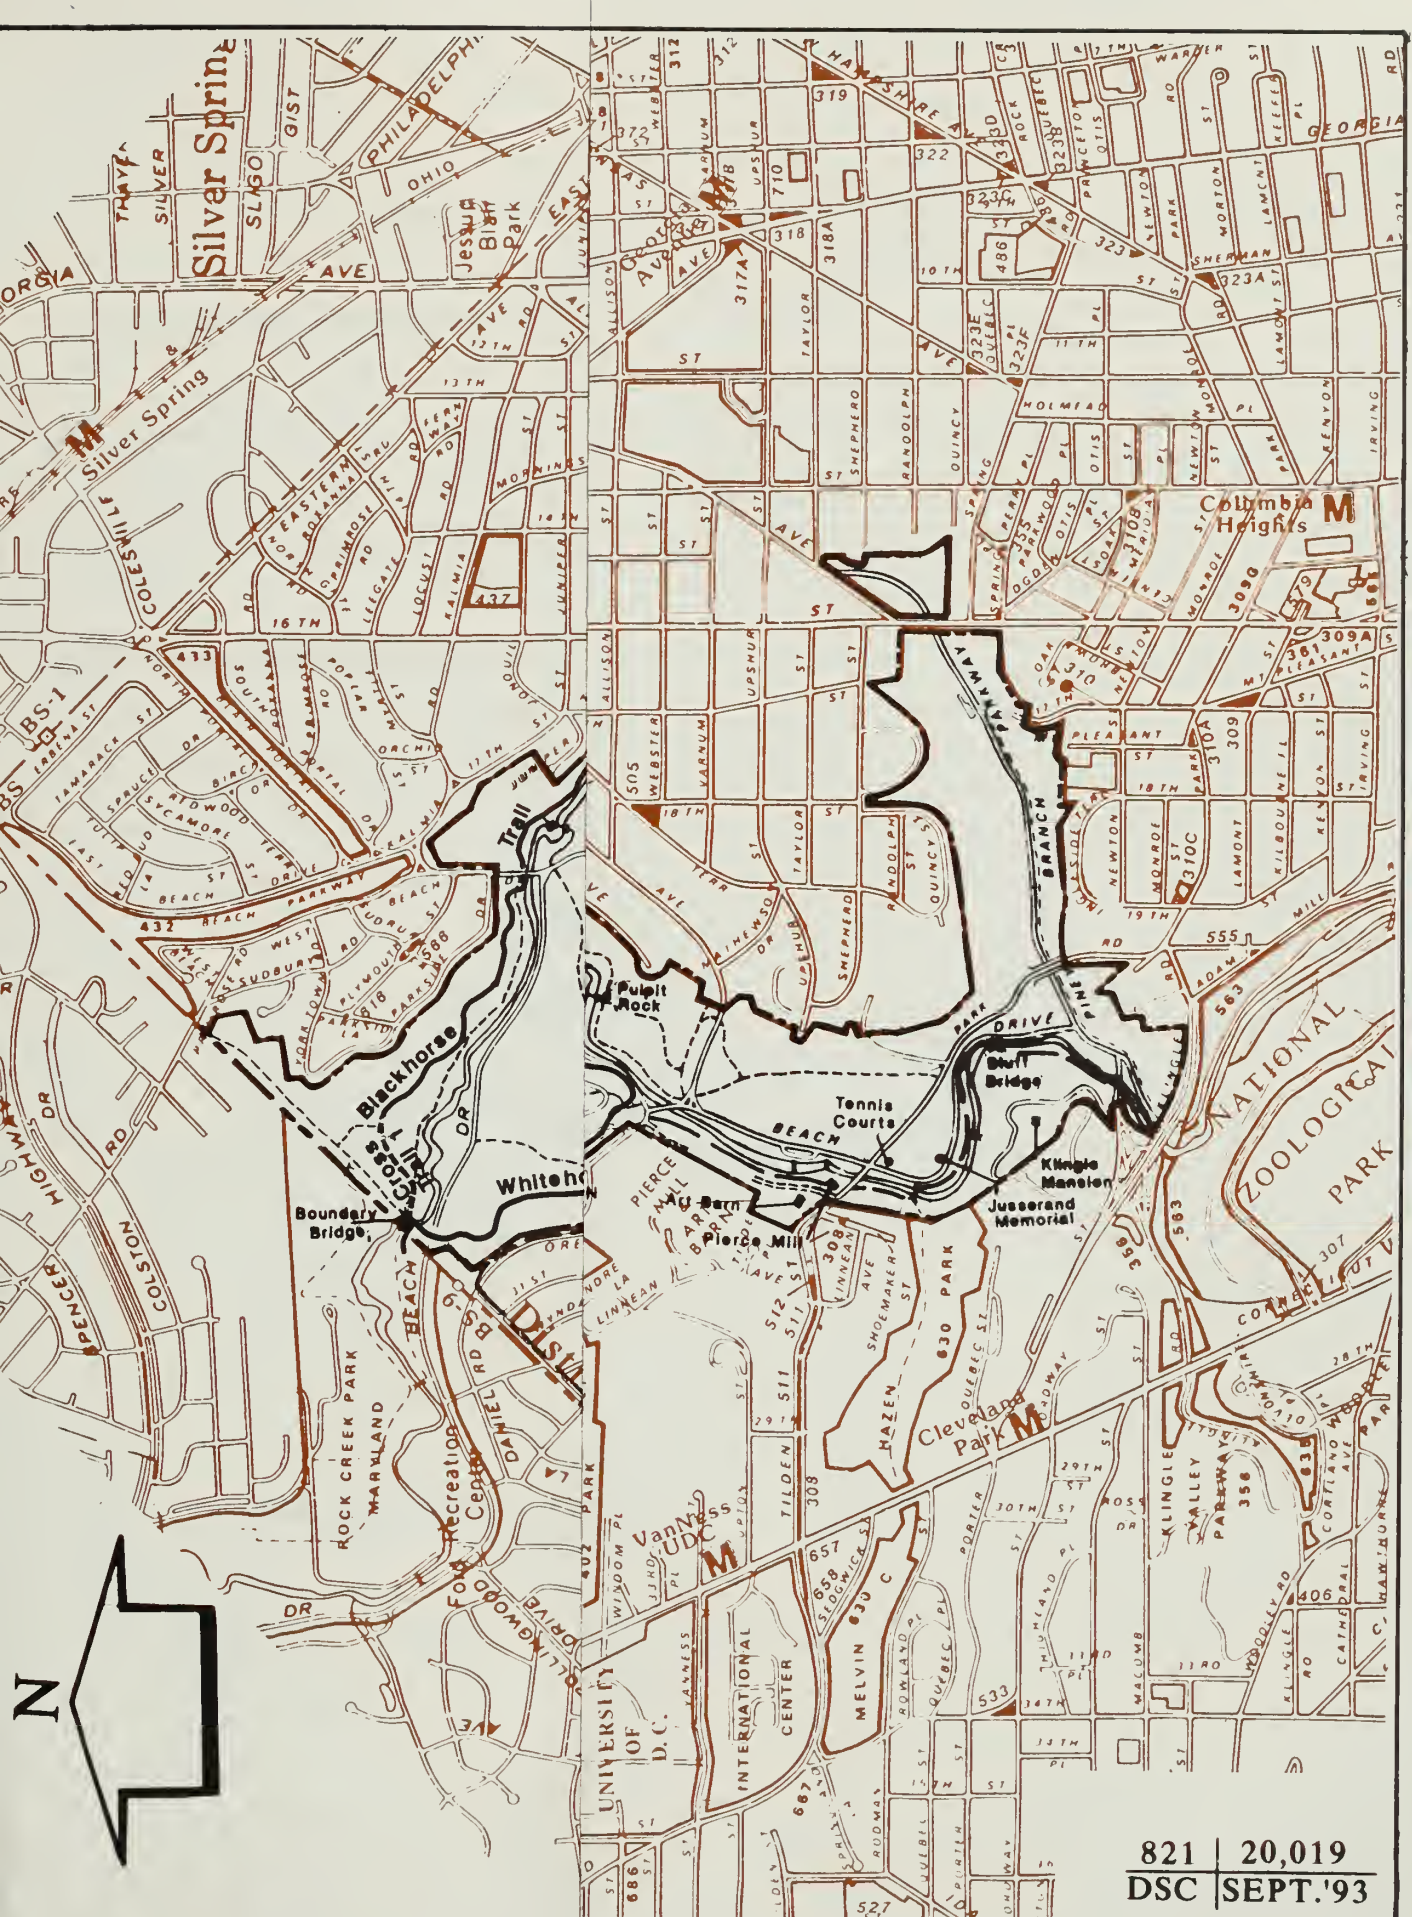
measurements on the segment south of Military Road show grades of 20%, and on the segment north of the road approximately 27%.

If the White Horse Trail was relocated to cross Military Road at the Oregon Avenue traffic light, use on both these erosive slopes parallel to Military Road could be dramatically reduced. A horse trail "walk button", similar in height above ground to those used in California, would need to be installed. If this relocation were installed, the sensitive sections of the existing White Horse Trail would become laterals similar in trail system characteristics to the cross trails. These two sections could even be periodically closed in wet weather, when trail impacts on soft soils are most severe, if an arterial alternative was available. This report cannot evaluate the public safety considerations of a decision to cross a main highway at-grade with an arterial trail. However, the environmental consideration would be served by routing the White Horse Trail in its thematic north/south orientation, to permanently bypass two long, steep, eroding and basically not maintainable slopes.

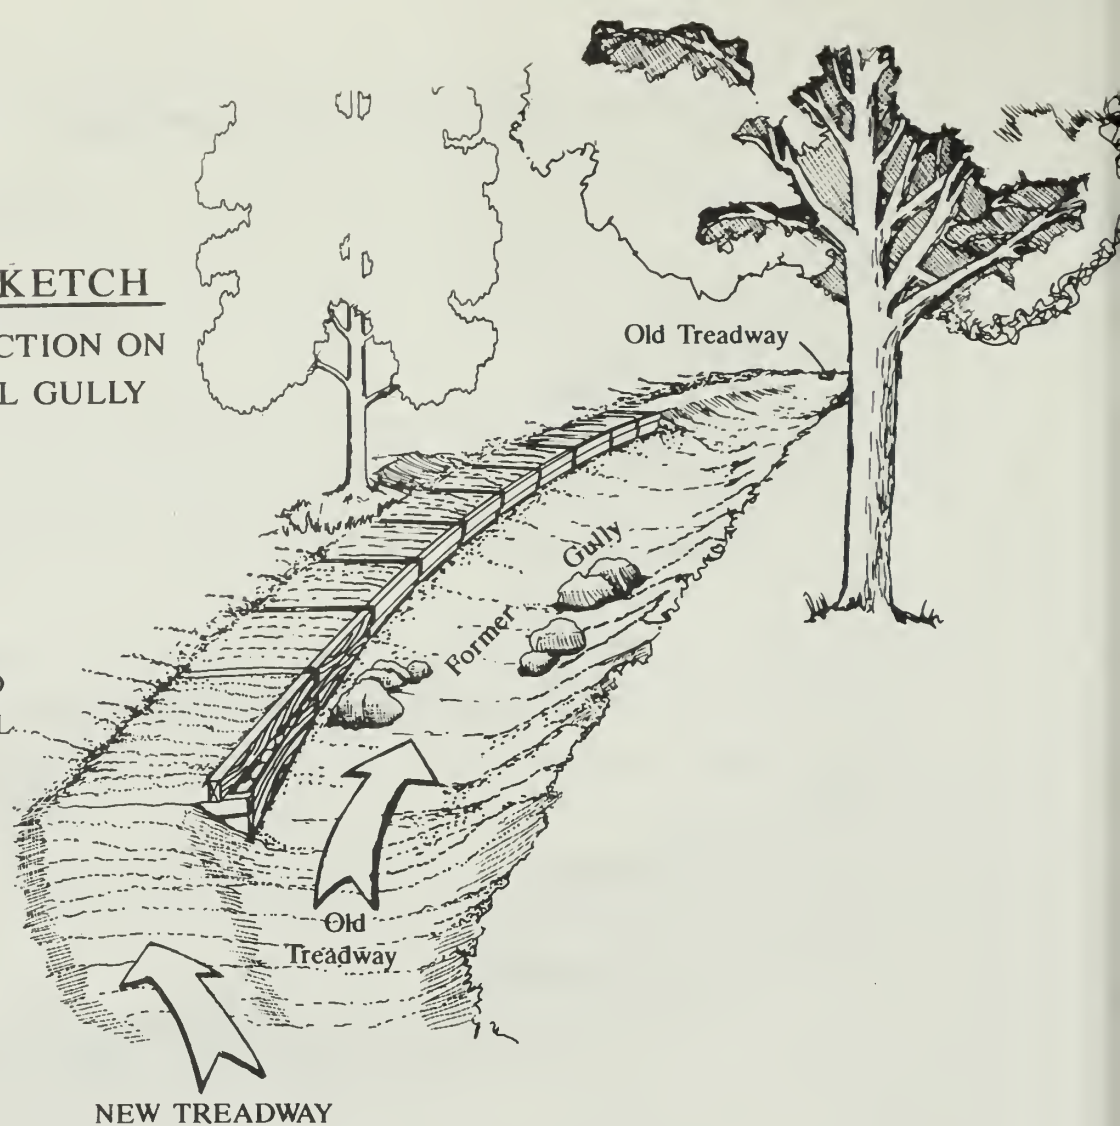
CONCEPT SKETCH

FORMER GULLY USED
TO DRAIN NEW TRAIL

CRIB CONSTRUCTION ON RIM OF TRAIL GULLY
