WATERSHED REHABILITATION IN THE AIRSTRIP CREEK BASIN

REDWOOD NATIONAL PARK WATERSHED REHABILITATION

TECHNICAL REPORT
FEBRUARY 1981

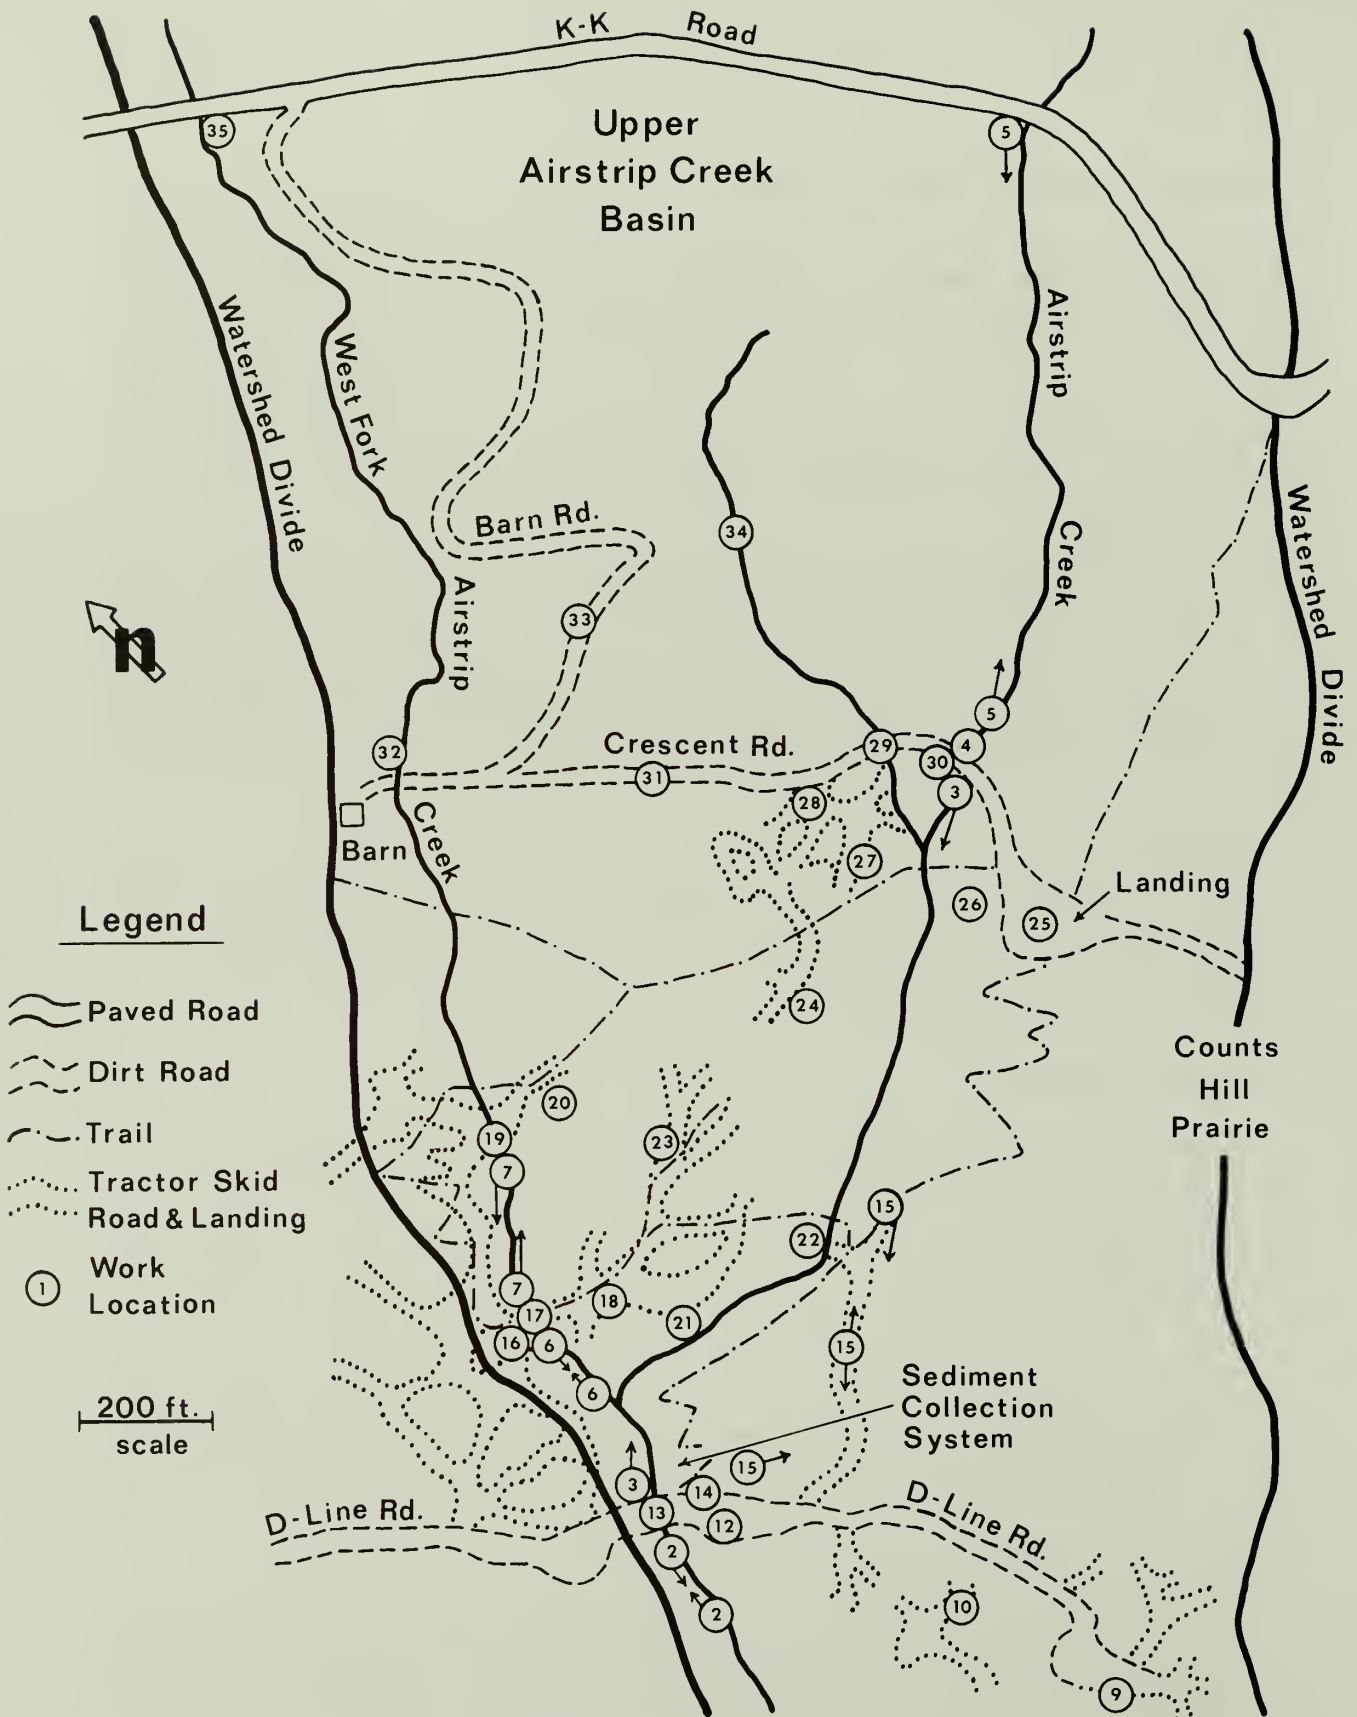
Figure 3

Hand dug waterbars (drainage troughs for diverting water off gullied roads or tractor trails) were a minor part of contract work. The contractor selected all waterbar locations. In total, 28 waterbars were built or rebuilt from existing tractor constructed waterbars (See Figure 3; Sites 31, 33).

Schematic map of the Airstrip Creek rehabilitation unit showing drainage pattern, road network, and work site locations.

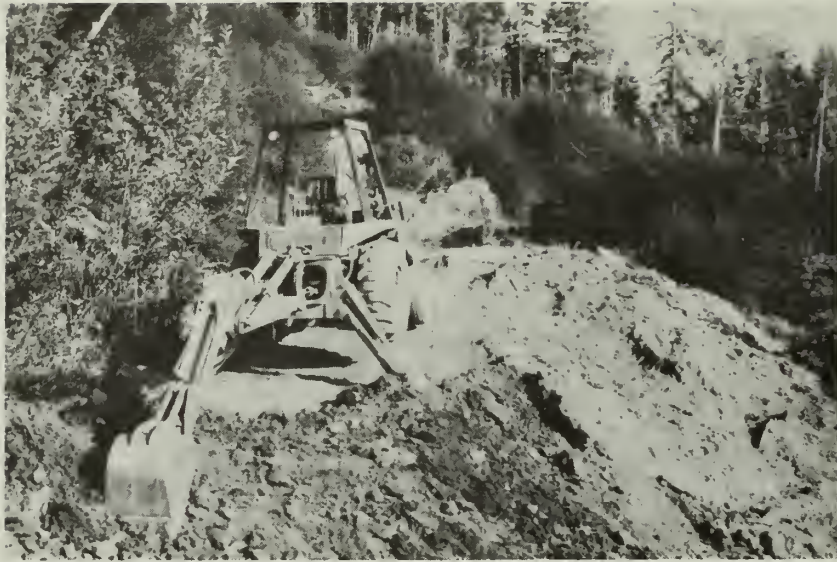
Figure 4

Debris removal from eight stream crossings was the major task of the contract and the only one which used heavy equipment extensively. At six major tractor crossings (Sites 13, 17, 19, 29, 30, 34), a backhoe excavated the channel to the approximate original channel shape. The contractor rented two different backhoes plus operators for the excavations. The first backhoe was track mounted and did not have an extendable arm on the bucket. It worked for 49.5 hours, or five days, at four tractor crossings. The second backhoe, a rubber tired Case 580-C Extindahoe (Figure 4), worked for 58.0 hours, or seven days, at all six crossings, including the four crossings that were insufficiently excavated by the first backhoe.

A rubber-tired Caterpillar 580-C backhoe with extendable arm excavated fill from the majority of the stream crossings on the Airstrip Creek rehabilitation unit.

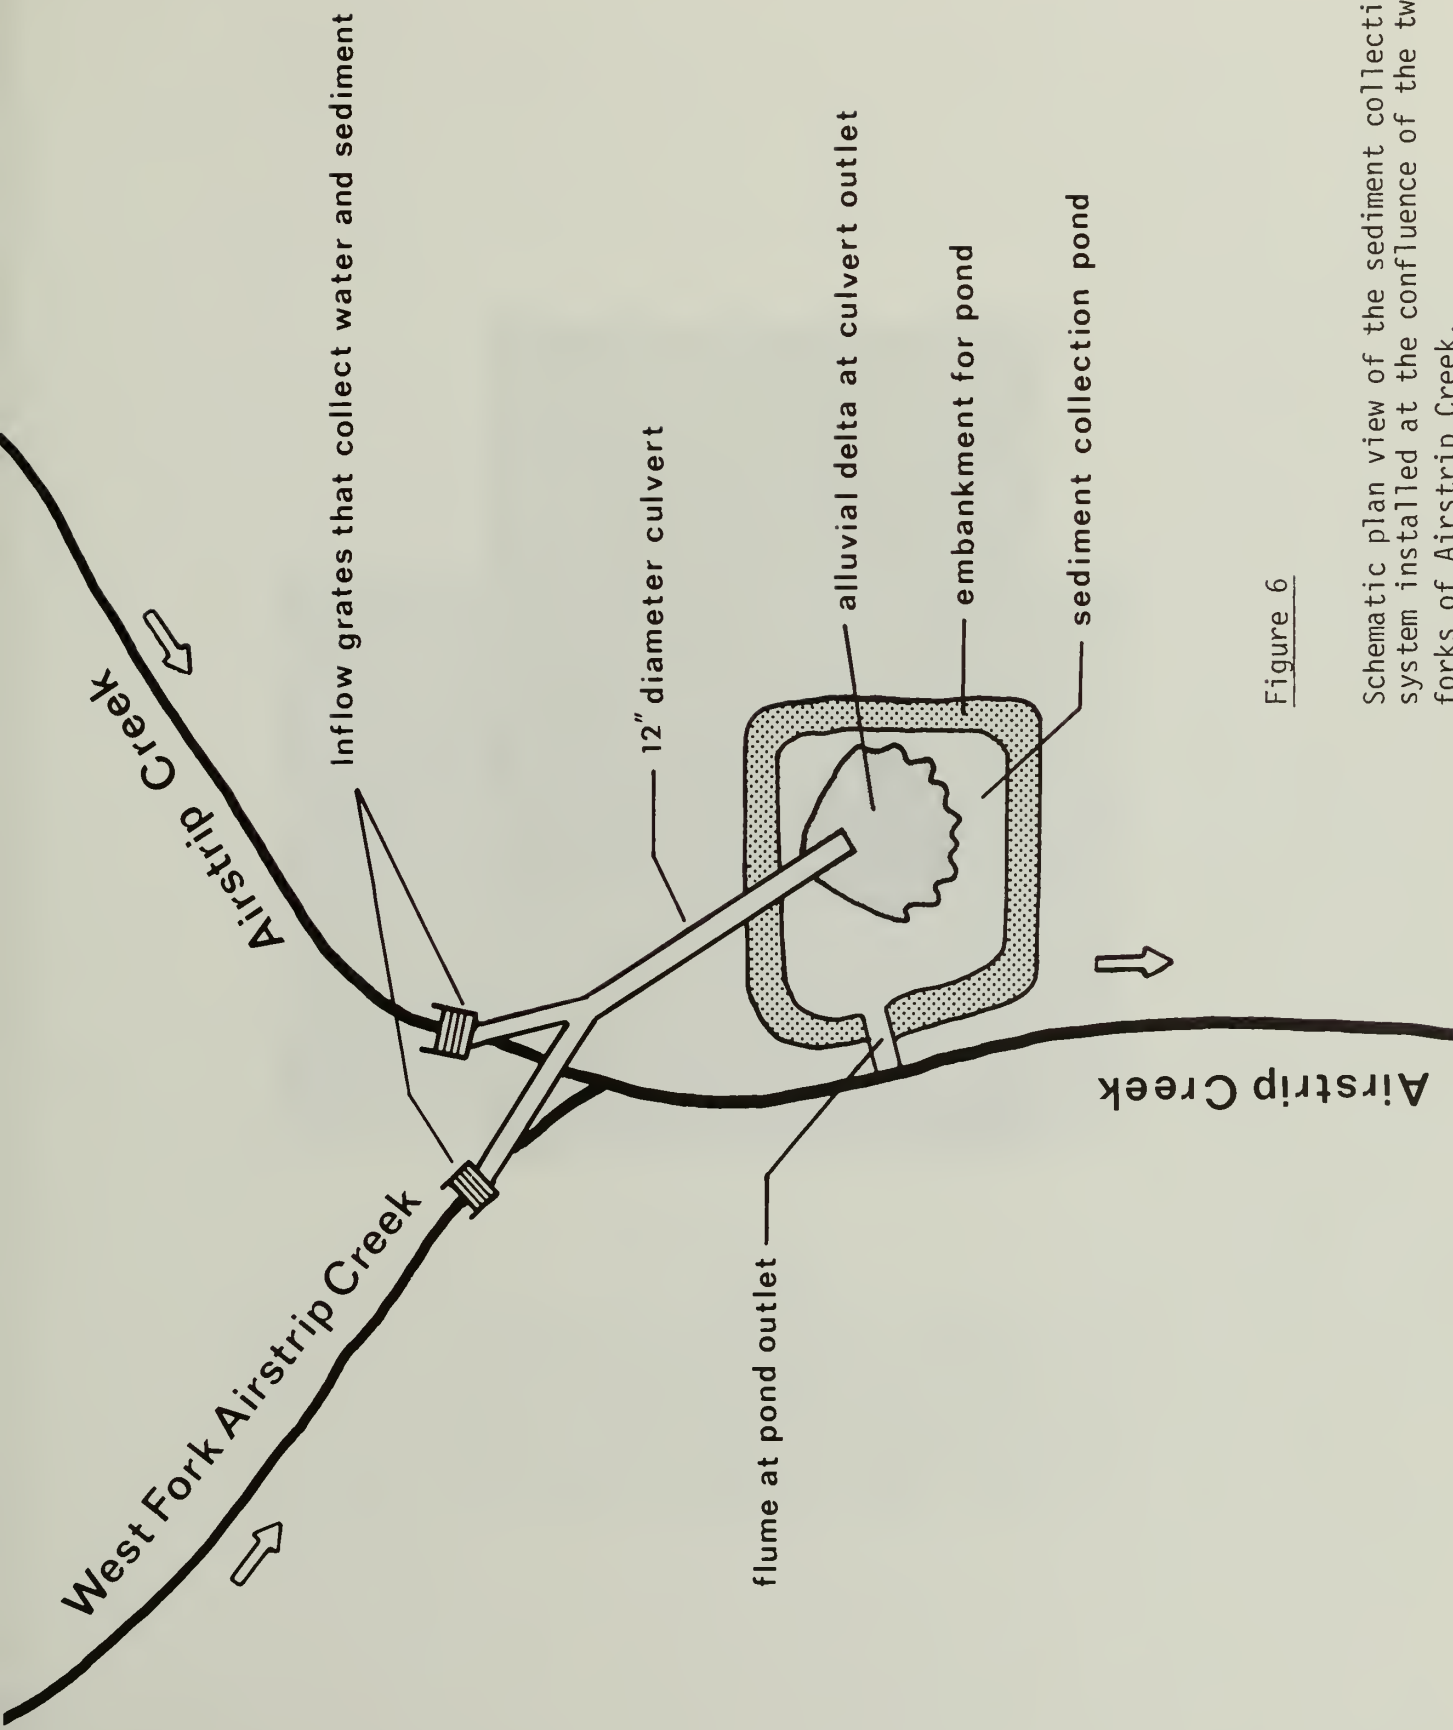
Figure 6

A sediment collection system was installed at the confluence of the two forks of Airstrip Creek (Figure 6). The purpose of the collection system was to capture and divert a portion of the bed load material of the stream and store this material in a collection pond built on a former log landing next to the stream. A D-8 Caterpillar tractor and operator, rented by the contractor, constructed the collection pond. In each fork of Airstrip Creek, a collection box with an adjustable grate captured a portion of the streamflow and bed load material (Figure 7). The water and sediment diverted from each fork travelled down a 200 foot, 12 inch diameter culvert collection pipe into a 205 cubic yard capacity sediment settling pond (Figure 8). A wooden flume conducted the outflow from the pond back into Airstrip Creek.

Schematic plan view of the sediment collection system installed at the confluence of the two forks of Airstrip Creek.

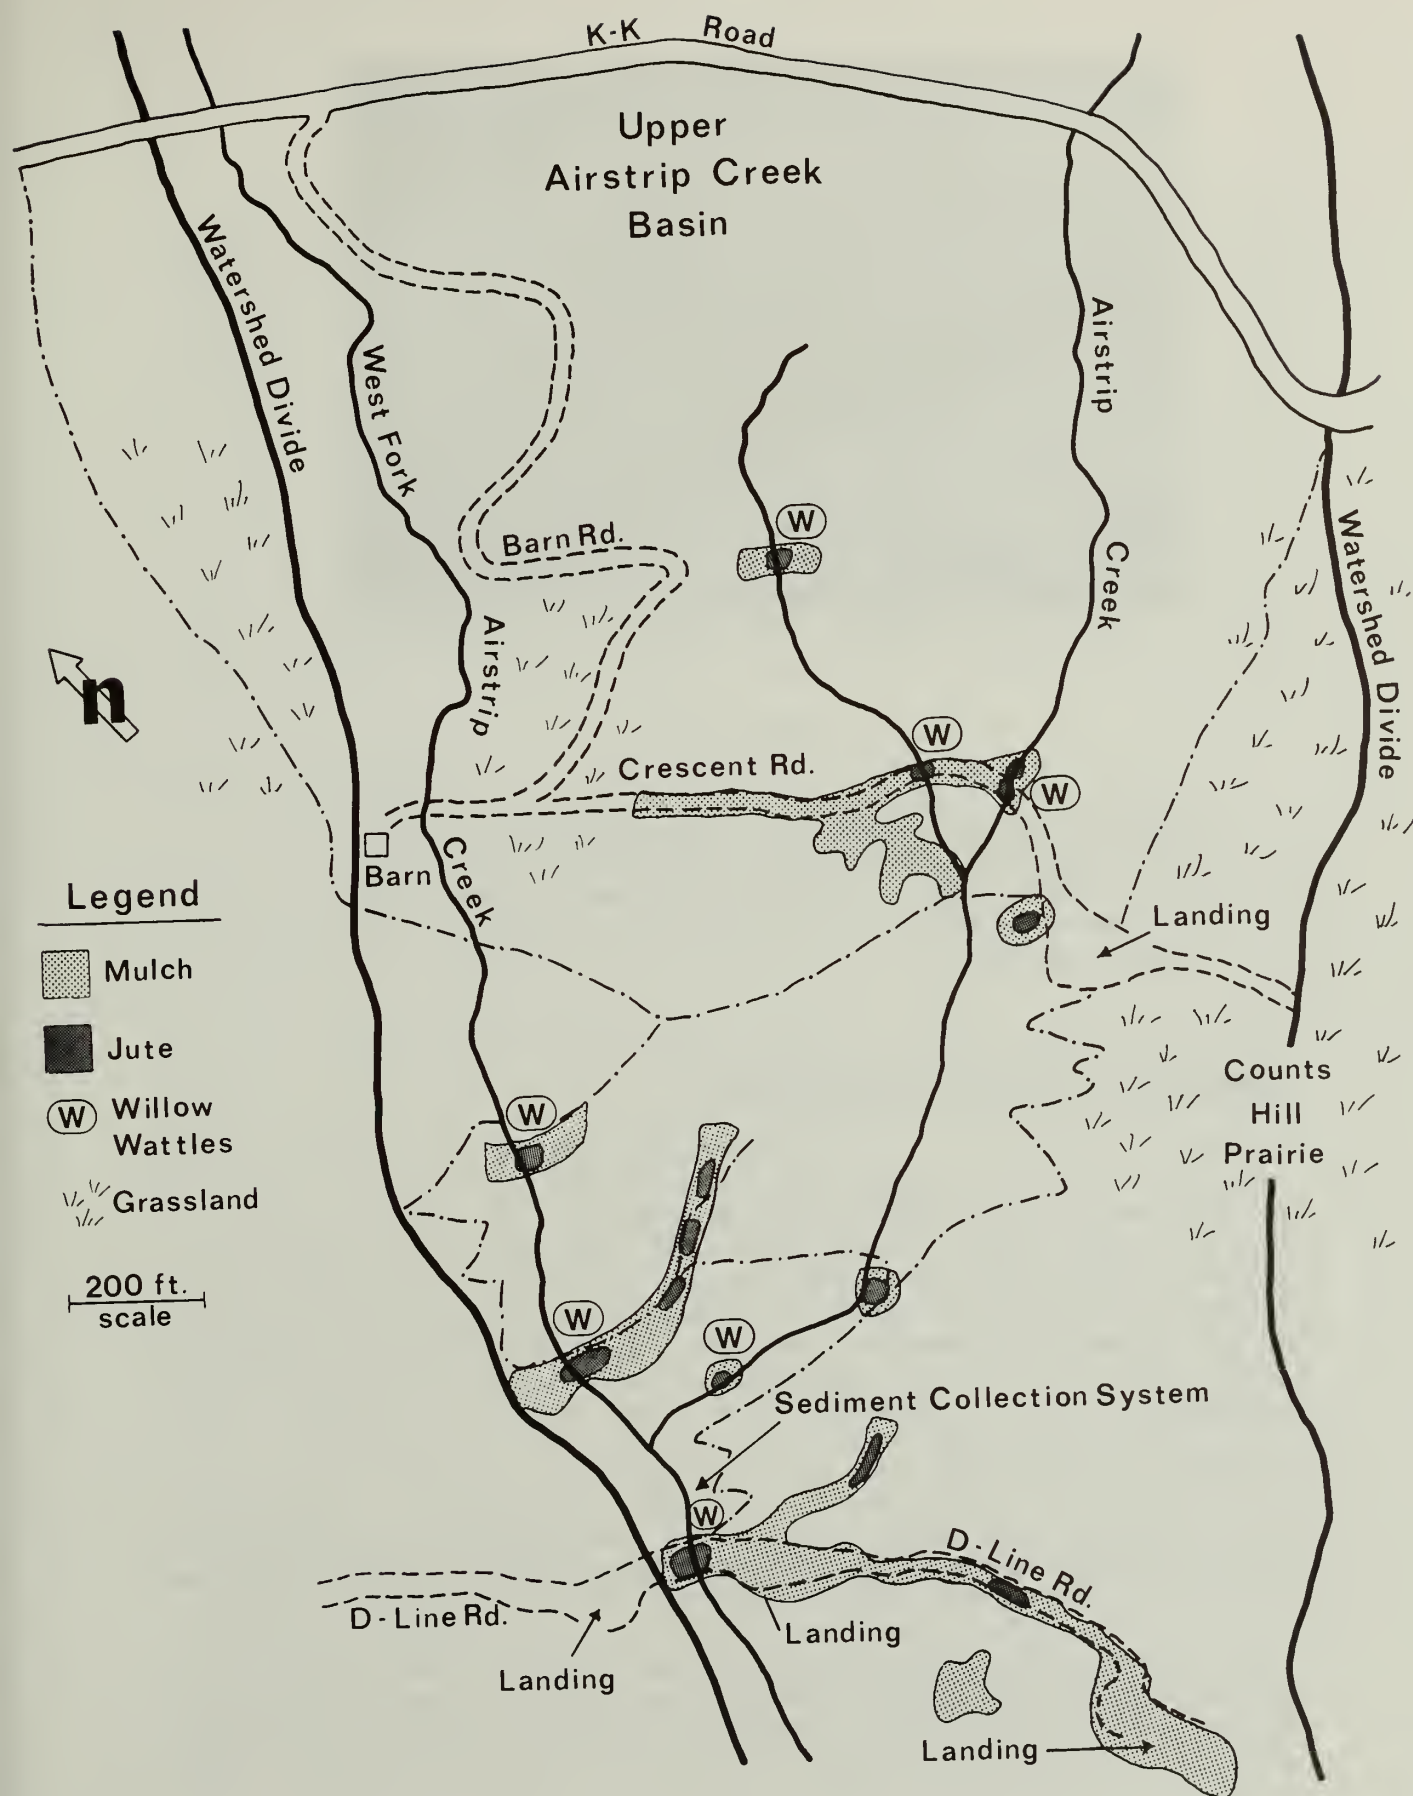
Figure 9

Heavy jute netting, composed of biodegradable hemp, was applied in a single layer on the sideslopes adjacent to the excavated channels and on a few bare tractor trails (Figures 9 and 10). The jute was laid down after the areas were seeded and mulched. Jute netting provides additional protection from rainsplash and rill erosion on steep, bare slopes, and jute helps hold down the mulch. The jute rolls were four feet wide and 225 foot long. The jute was staked in place with eight inch metal staples. The total area covered with jute was approximately 22,500 ft².

Location of mulch, jute netting and willow wattles on the Airstrip Creek rehabilitation unit.

On sideslopes of excavated stream crossings, the contractors used straw covered by jute netting as a ground cover for erosion control (Figure 9). This combination of straw mulch and jute net provided extremely effective slope protection against both rain-drop impact erosion and rilling. The straw-jute net cover kept fine soil particles in place on the surface, preventing the formation of a compact surface crust and pebble pedestals that characteristically result from high intensity rain falling on bare, recently disturbed soil. The preservation of a loose, open framework soil surface, plus the retention of moisture beneath the mulch, may aid in revegetation.

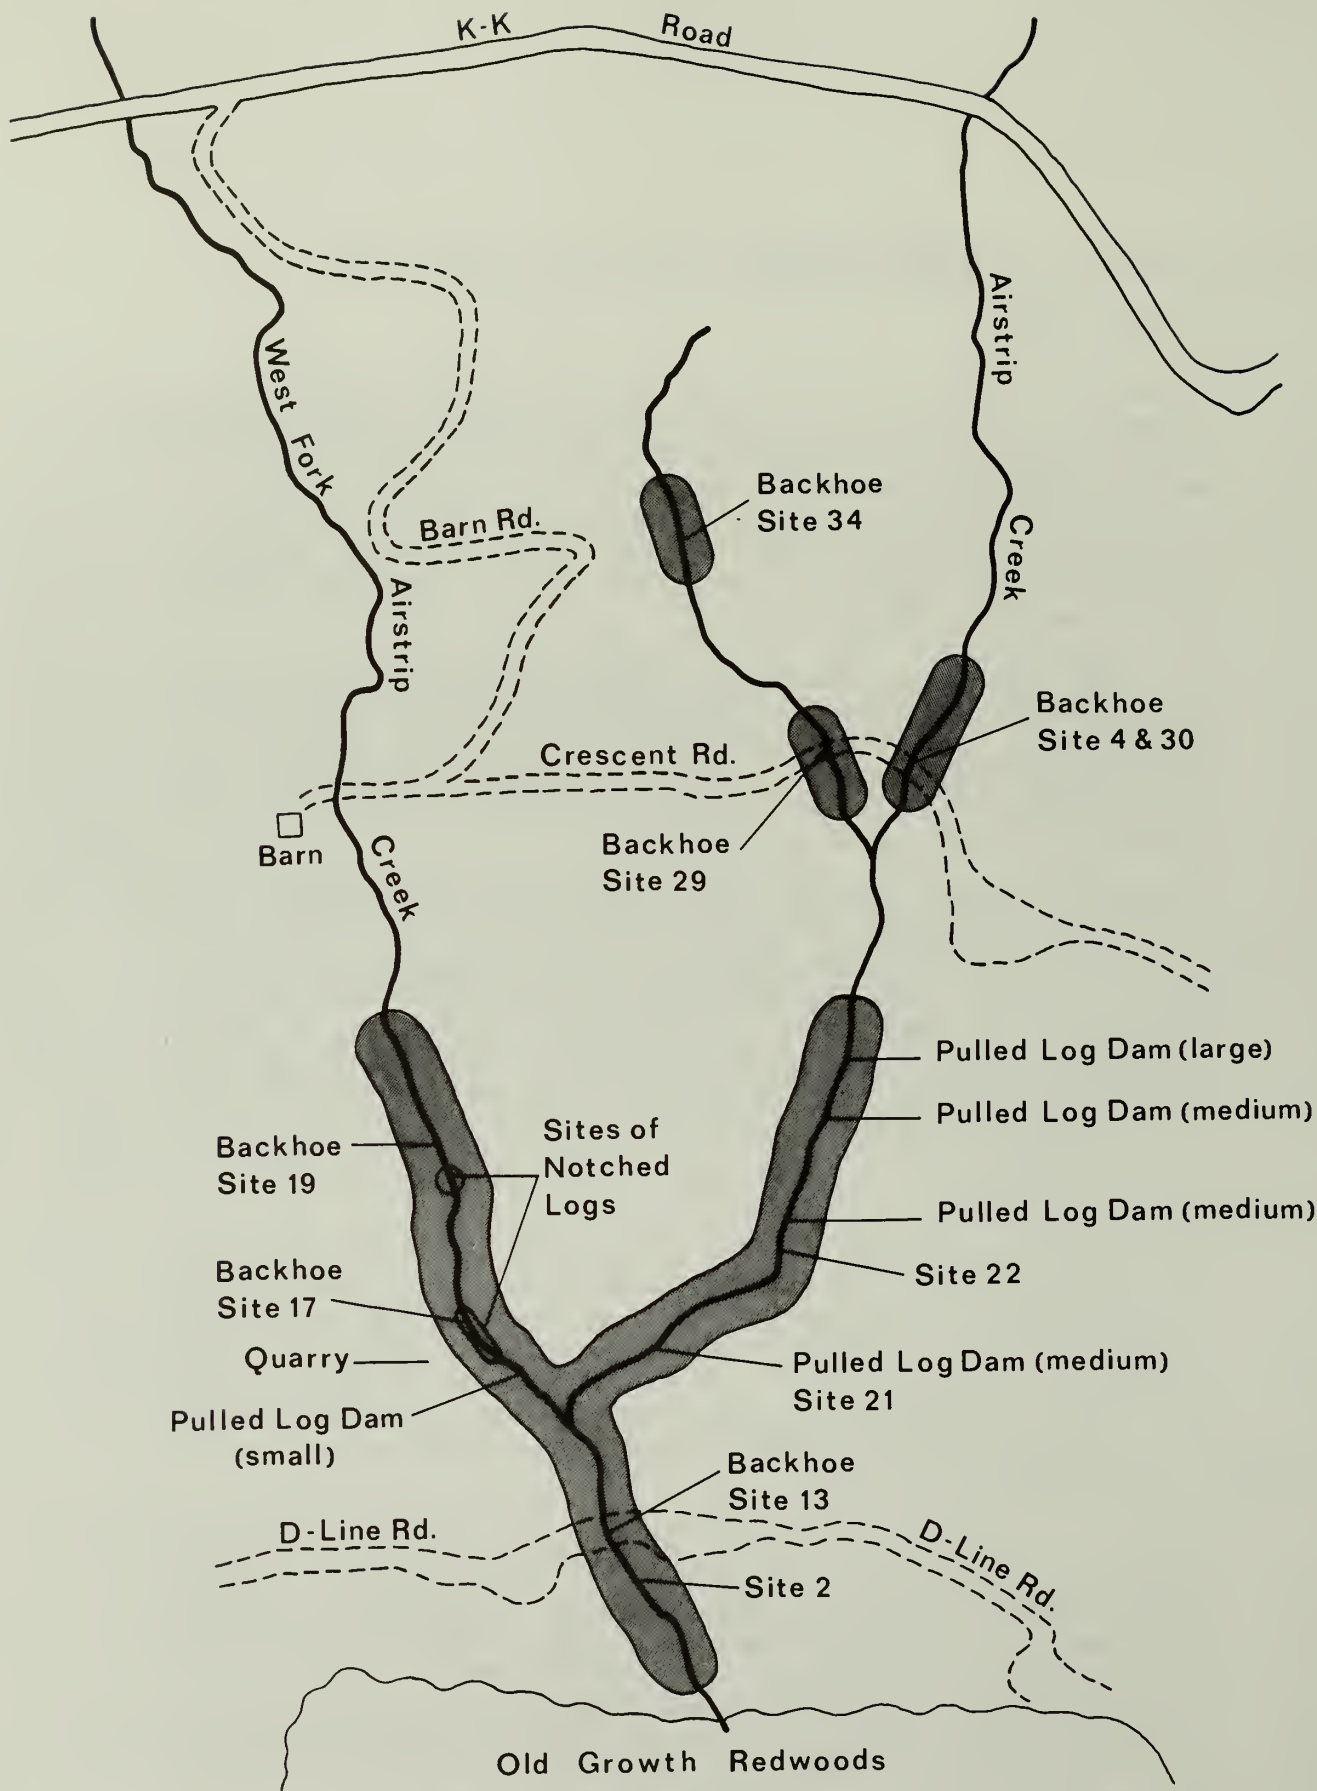
FIGURE 11

The contractor cleared a total of 4,200 feet of stream channel along the two forks of Airstrip Creek within the rehabilitation unit (Figure 11). Stream clearance was concentrated in the lower portion of the unit where the two forks flow through the more recently logged hillslopes. Airstrip Creek in this part of the basin is an intermittent stream, and clearance work was completed in the fall before the channel started to carry water from the winter rains.

Location map of stream clearance sites and backhoe channel excavation sites.
Airstrip Creek rehabilitation unit.

Debris removal from the six major tractor road stream crossings (Figure 11) was the single most effective rehabilitation measure in terms of minimizing the chances for continued severe erosion due to past logging disturbance. Prior to rehabilitation, fills in all crossings were partially eroded. Although the fills were partially vegetated, they had steep sided gullies with bare banks that were a sediment source at high streamflows. Most of the fills contained large logs, and water piped through the fills at low flows.
