ANSLEY WILCOX HOUSE

HISTORIC STRUCTURE REPORT

Theodore Roosevelt Inaugural
National Historic Site
Buffalo, New York

October 2006

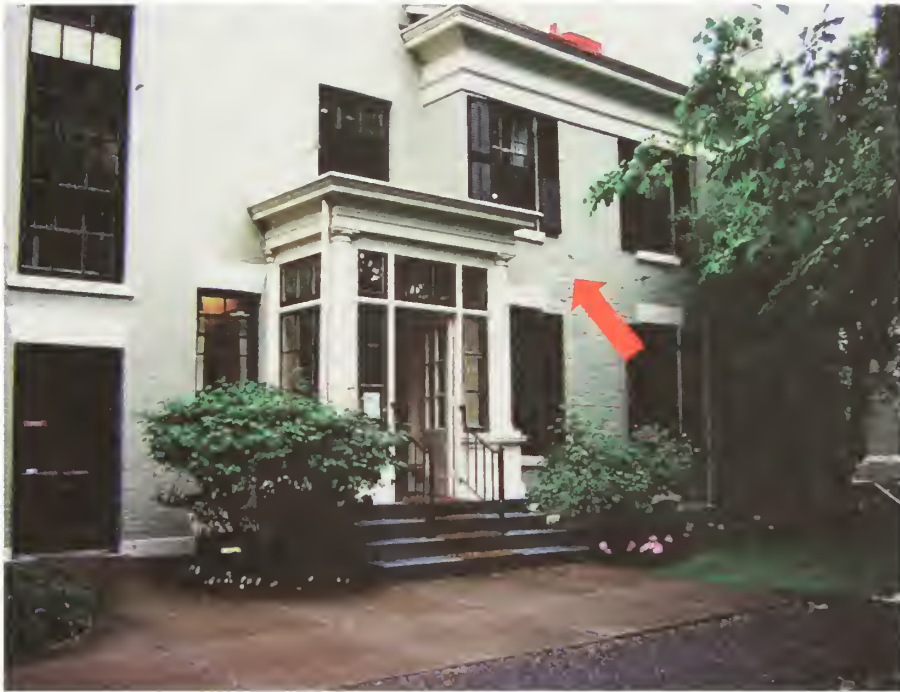
Figure 2.13. North elevation, location of brickwork scars from formerly attached barracks building.

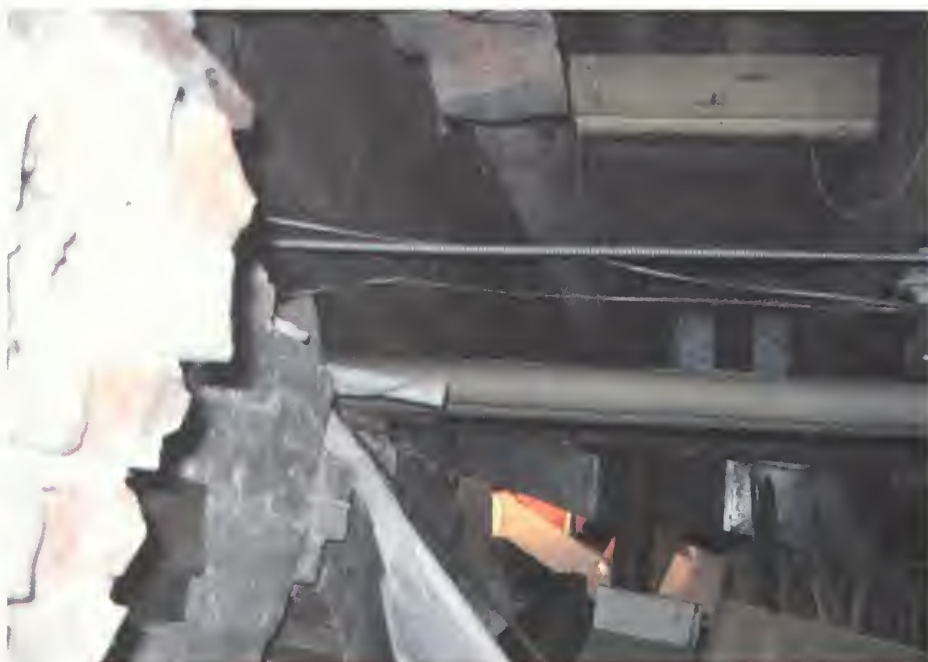
The first-floor framing is exposed. However, there are cut nails protruding from the underside of floor joists, suggesting that there was previously a plaster ceiling in the chamber. (See Figure 2.24.)

Figure 2.24. Room 001a (central brick furnace chamber), interior.

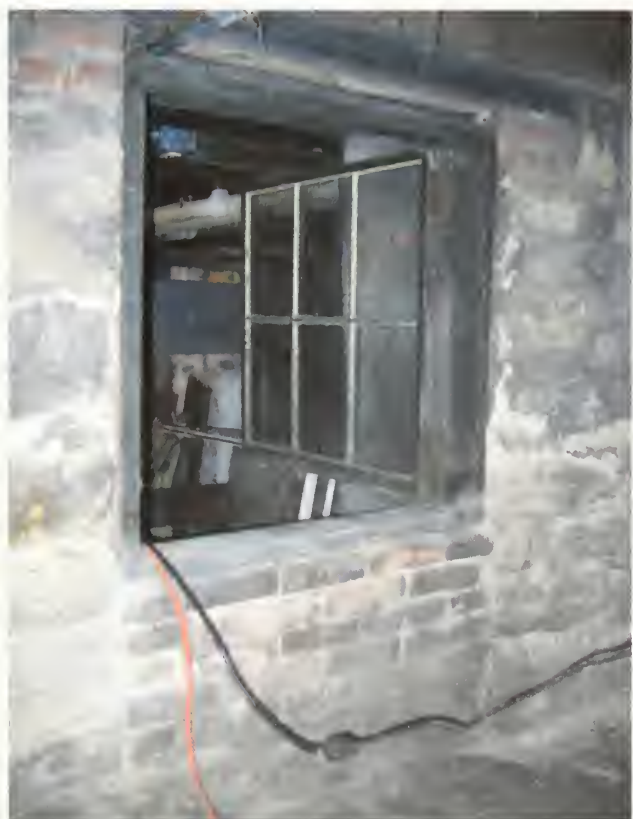
Figure 2.27. Room 001c (areaway
below west portico), showing brick
infill and casement window at
former doorway opening.

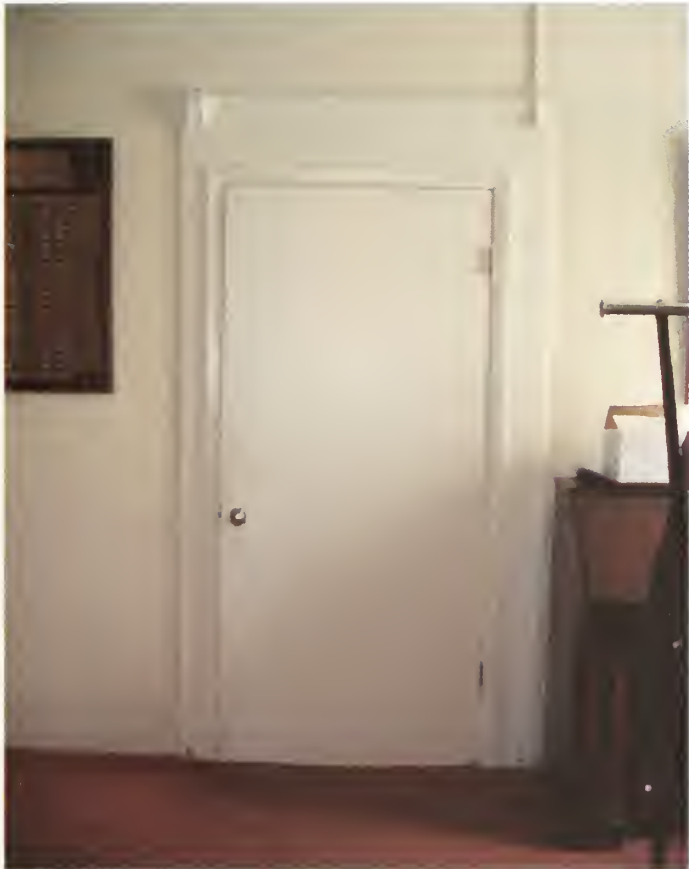
Figure 2.46. Room 112 (Kitchen), north wall, 1896 window opening converted to doorway.

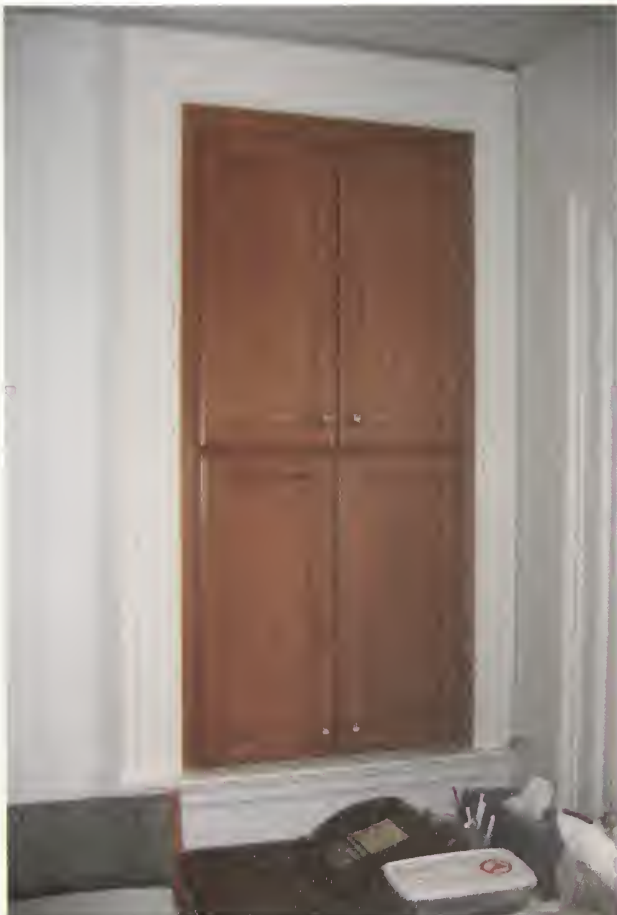
The west wall is furred plaster on original brick with its 1896 fabric remaining intact. In the center of the room is a doorway to the original part of the house, with flat molded and mitered casings. The door swings into the original structure – the reverse of the swing indicated on the 1896 drawings. At the north end of the west wall is a similar doorway that opens to a modern cabinet set into the doorway recess. (See Figure 2.59.) This doorway is labeled on the 1896

Figure 2.59. Room 204,
west wall, “old closet”
with modern cabinet
insert.

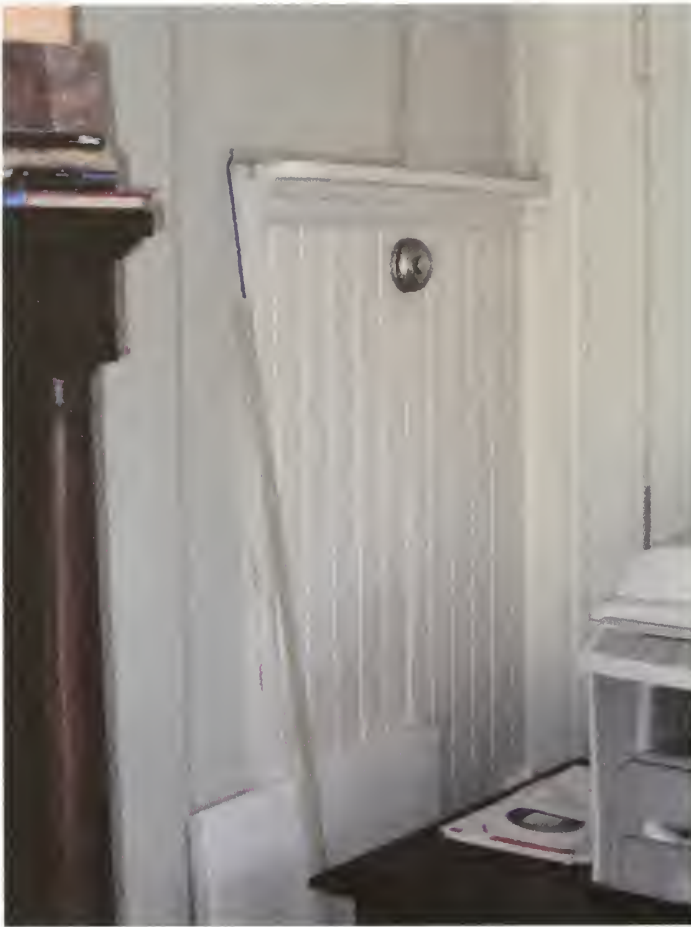
The present north wall consists of two sections, reflecting its 1896 construction. The west section is an 1896 frame partition with lath and plaster and a molded wood baseboard. A doorway connects to the Back Hall (room 203); it is cased with molded and mitered boards and plinth blocks, and has a paneled door. The east section was formerly a thin frame partition containing a wide opening to the walk- in closet in the southeast corner of the Back Hall. At the east end of the wall was the side of the chimney breast for the first- story Kitchen. This configuration is documented by the 1896 architectural drawings. The walk- in closet was removed after 1971, and the opening to it infilled with a frame partition and gypsum plasterboard. Remnants of a tongue- and- groove wood wainscot survive at the east end of the north wall, on the side of the chimney. It displays vertical "V"- groove boards, and a molded dado cap and shelf. (See Figure 2.60.) It probably dates to 1896.

Figure 2.60. Room 206,
wainscot remnant at north
end of east wall.

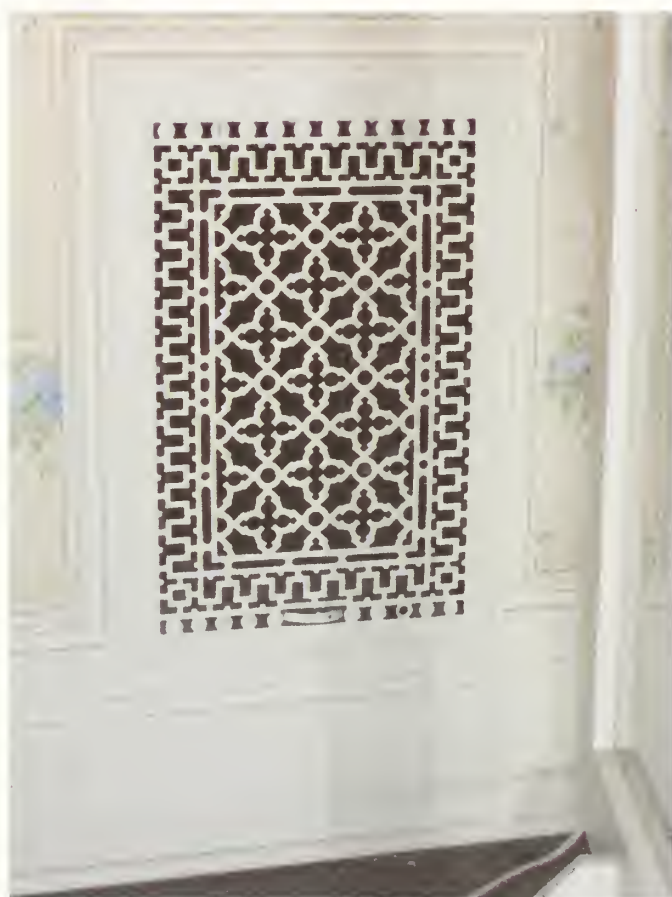
On the west wall are two doorways with paneled jambs and paneled wood doors. The south door is presently fixed and blocked from the adjacent room (room 206). Between the two doorways is an ornamented wall register, which is cased with molded wood boards matching the baseboards. (See Figure 2.63.) This is shown on the 1896 architectural drawings.

Figure 2.63. Room 207,
wall register.

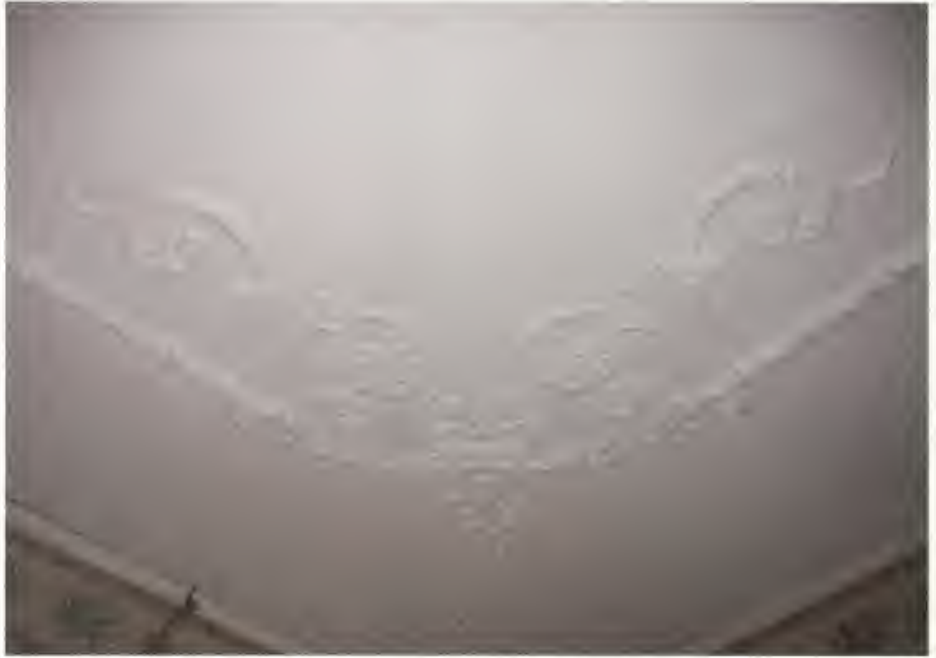
The ceiling is flat lath and plaster with plaster relief or appliqué ornament. (See Figure 2.64.)

Figure 2.64. Room 207, ceiling.

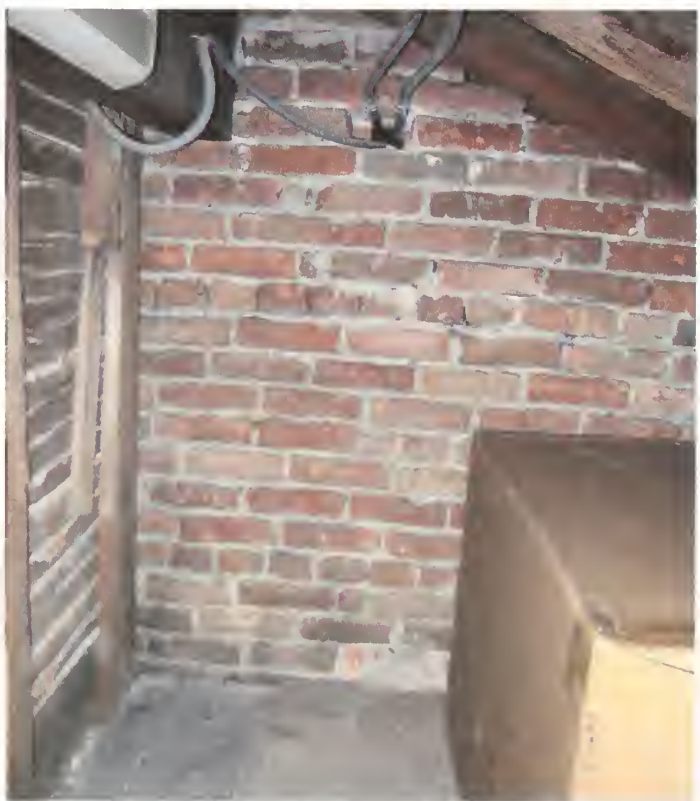
The east wall is the interior surface of the original brick gable end wall. (See Figure 2.70.) The end wall is three bricks (12 inches) thick. The brick is laid in common bond with headers at every eighth course. Individual bricks are regularly formed, but vary in color from pale salmon to deep red, suggesting a somewhat uneven temper. Joints are filled to the surface with bedding mortar and struck flush.

Figure 2.70. Room 308a, looking east toward original brick gable end wall.

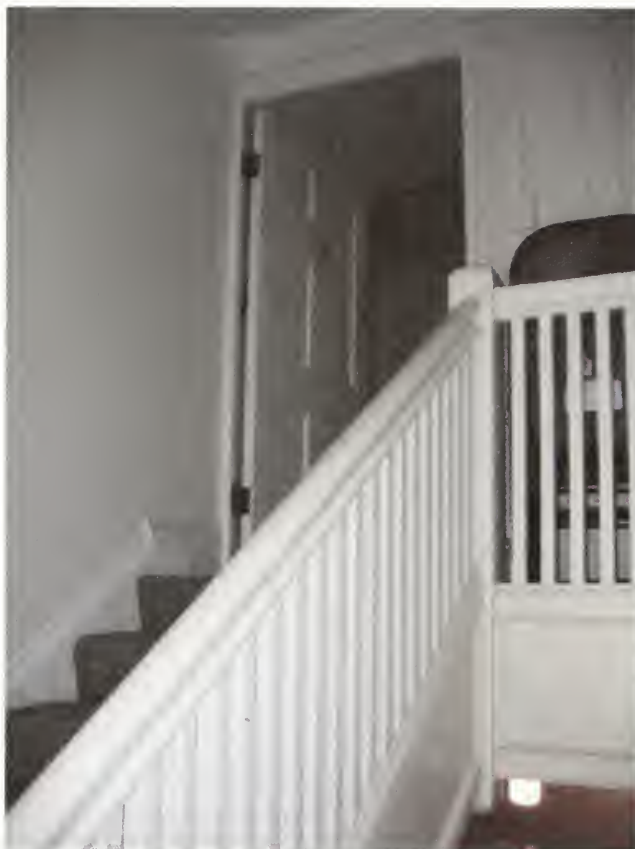
The east and west walls are 1896 frame partitions with lath and plaster finish. There are 8- inch- high molded baseboards on the east wall, and 9 ½- inch- high baseboards with a more complex molded profile on the west wall descending to the second story. No attempt was made to align and miter the sloped baseboard on the staircase with the level baseboard on the landings. This fact underscores the room's utilitarian character. (See Figures 2.72 and 2.73.)

Figure 2.72. Room 301
(North Staircase).

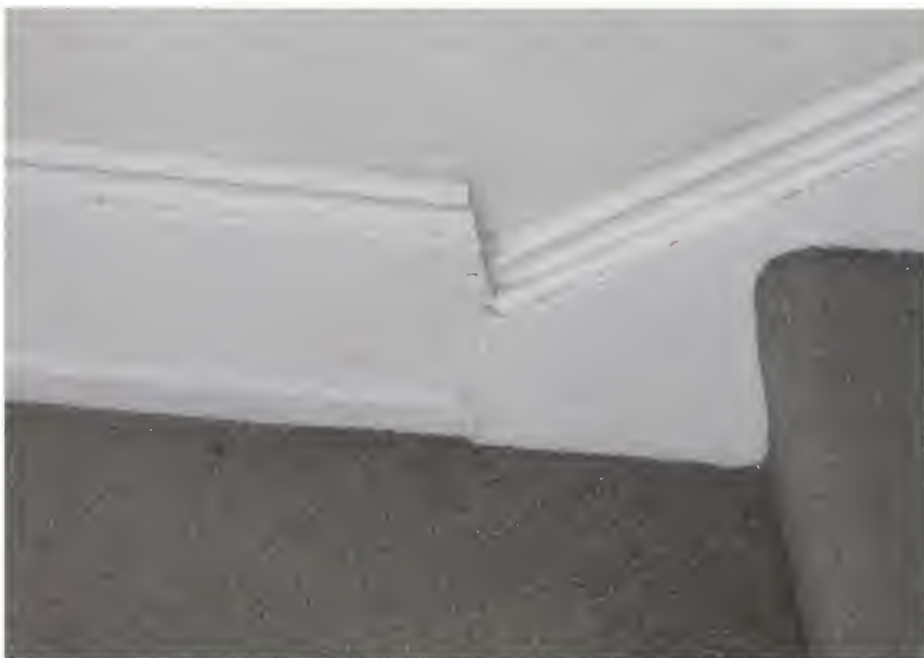
The inside stair stringer is raised above the tread nosings, and supports the balusters and handrail. The balustrade consists of newel posts 4 ¾ inches square at each landing, with a molded hand rail measuring 3 ¾ inches spanning between the newels. Balusters are 1¾ inches square and 3 inches on center. (See Figure 2.73.)

Figure 2.73. Room 301 (North Staircase), baseboard.

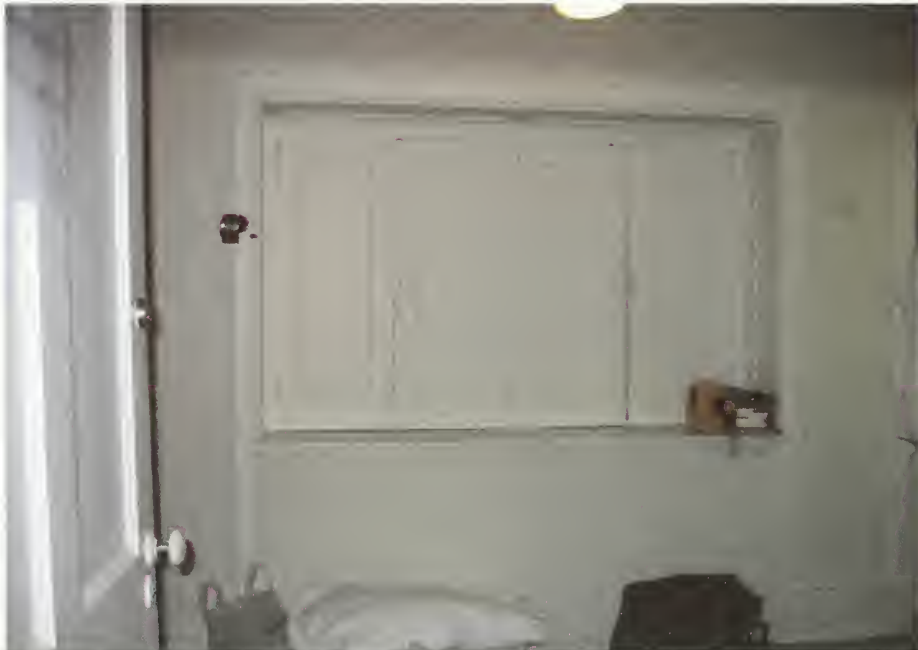
Opposite the staircase is a linen closet recessed into the south wall. (See Figure 2.75.) This closet consists of two compartments, each enclosed by a pair of paneled wood doors and lined with double- beaded cedar boards 5 inches wide. There are two wood shelves in each compartment. Below the doors is a plywood panel, where drawers were probably originally located. (See the description of the built- in cabinet in room 306.).

Figure 2.75. Room 302 (Hall), south- wall linen closet.
