WEST INDIA GOODS STORE

Salem Maritime
National Historic Site

Historic Structure Report

HISTORIC STRUCTURE REPORT Architectural Data

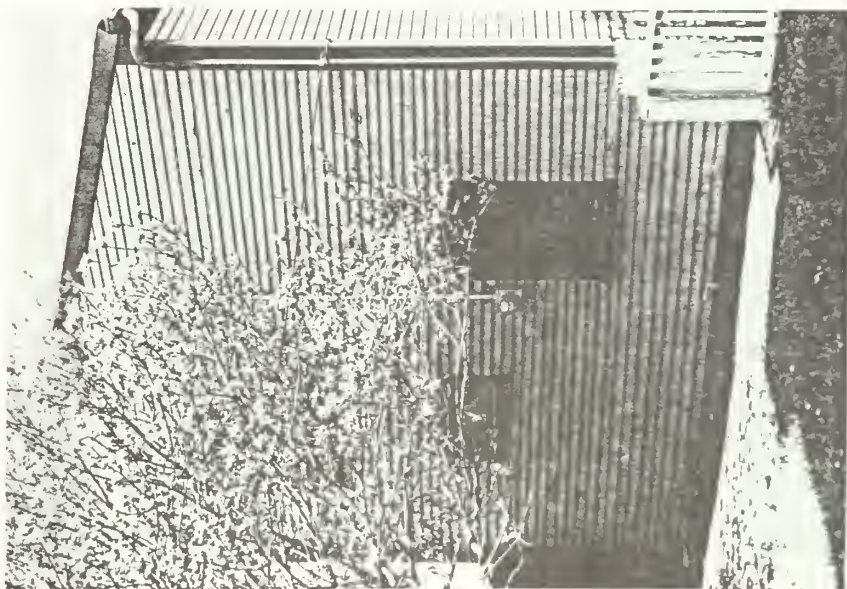
Figure 26. West India Goods Store, north elevation.

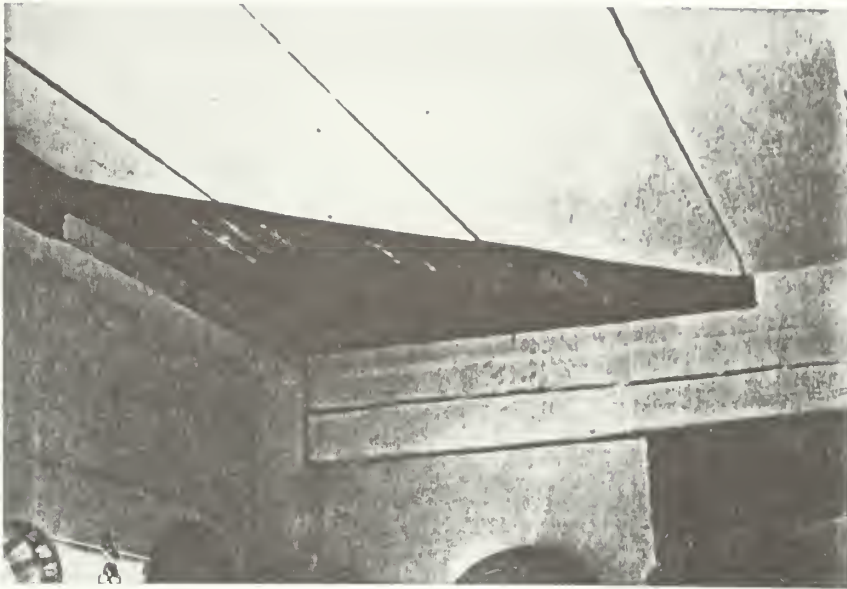
Figure 37. West India Goods Store, interior of first story, southwest corner of bay A, showing corner post, south girder, two west girts, horizontal angled brace, and wood ceiling finish.

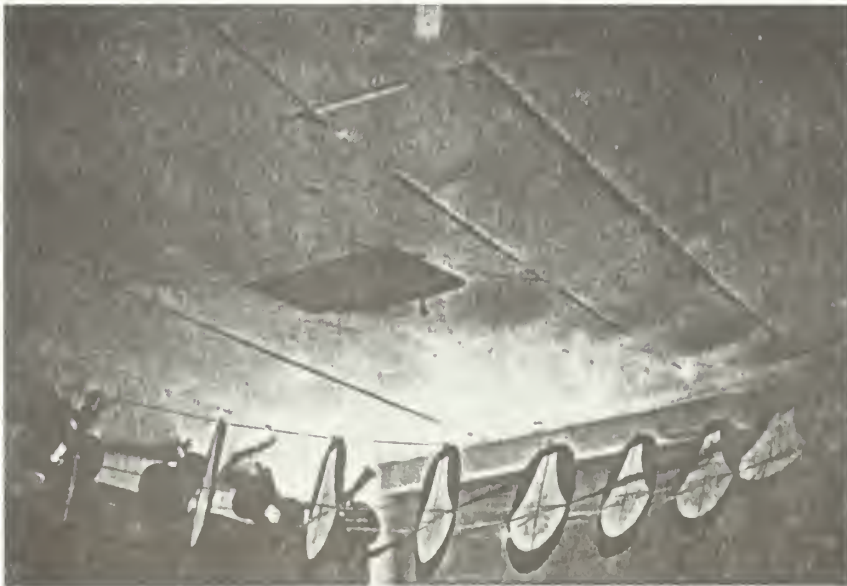
Figure 38. West India Goods Store, interior of first story, bay C, showing hole 12 by 9-1/2 inches cut in wood ceiling.

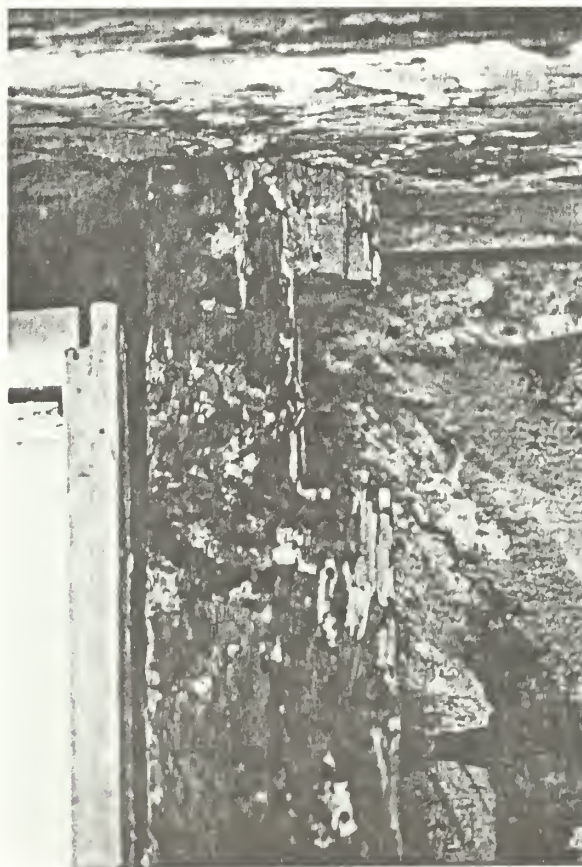
Figure 41. West India Goods Store, interior of second story, south wall, showing stud with cut to receive possible window head.

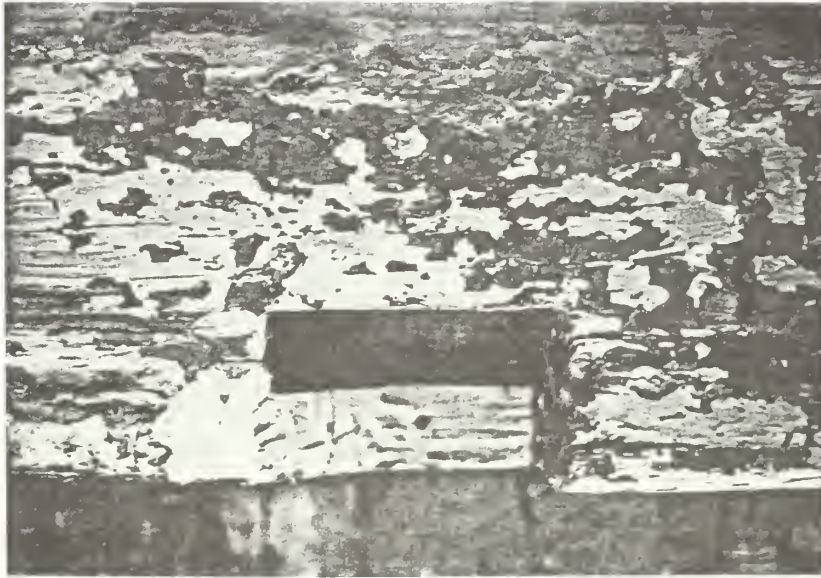
Figure 51. West India Goods Store, interior of second story, west wall looking west, post between bays A and B, showing cut made to accept partition framing.

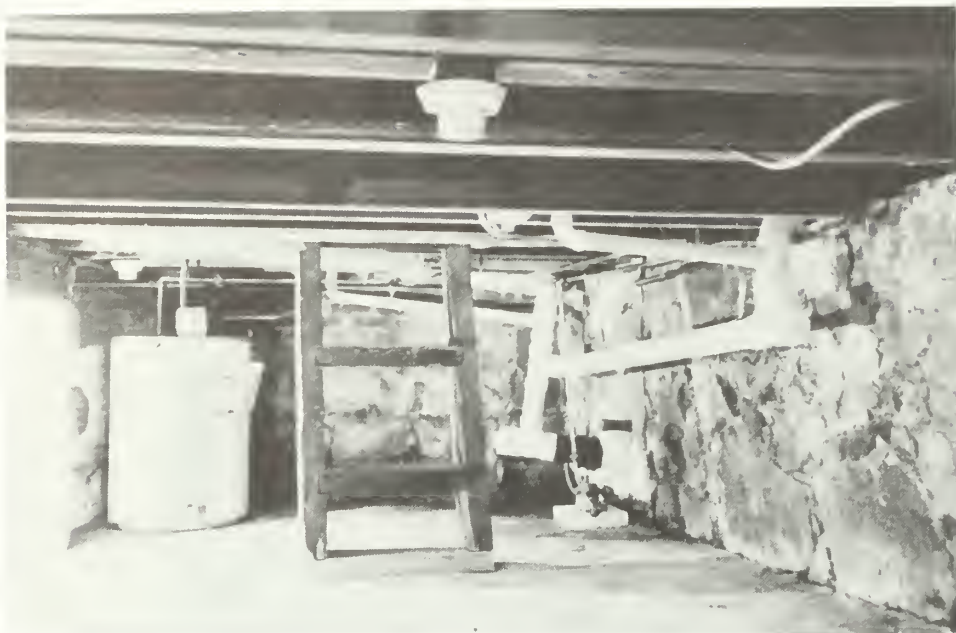
View of crawl space below first floor after the installation of the hot water heater, electrical, plumbing, heating and fire detection systems were completed. View shows east half of crawl space at north end.

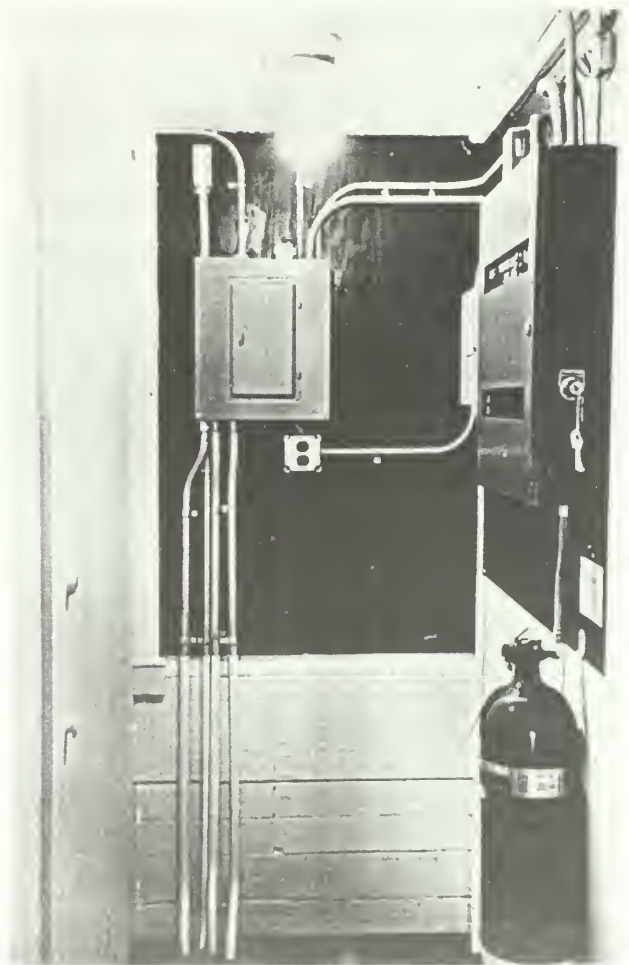
North wall, WIGS, first
floor.

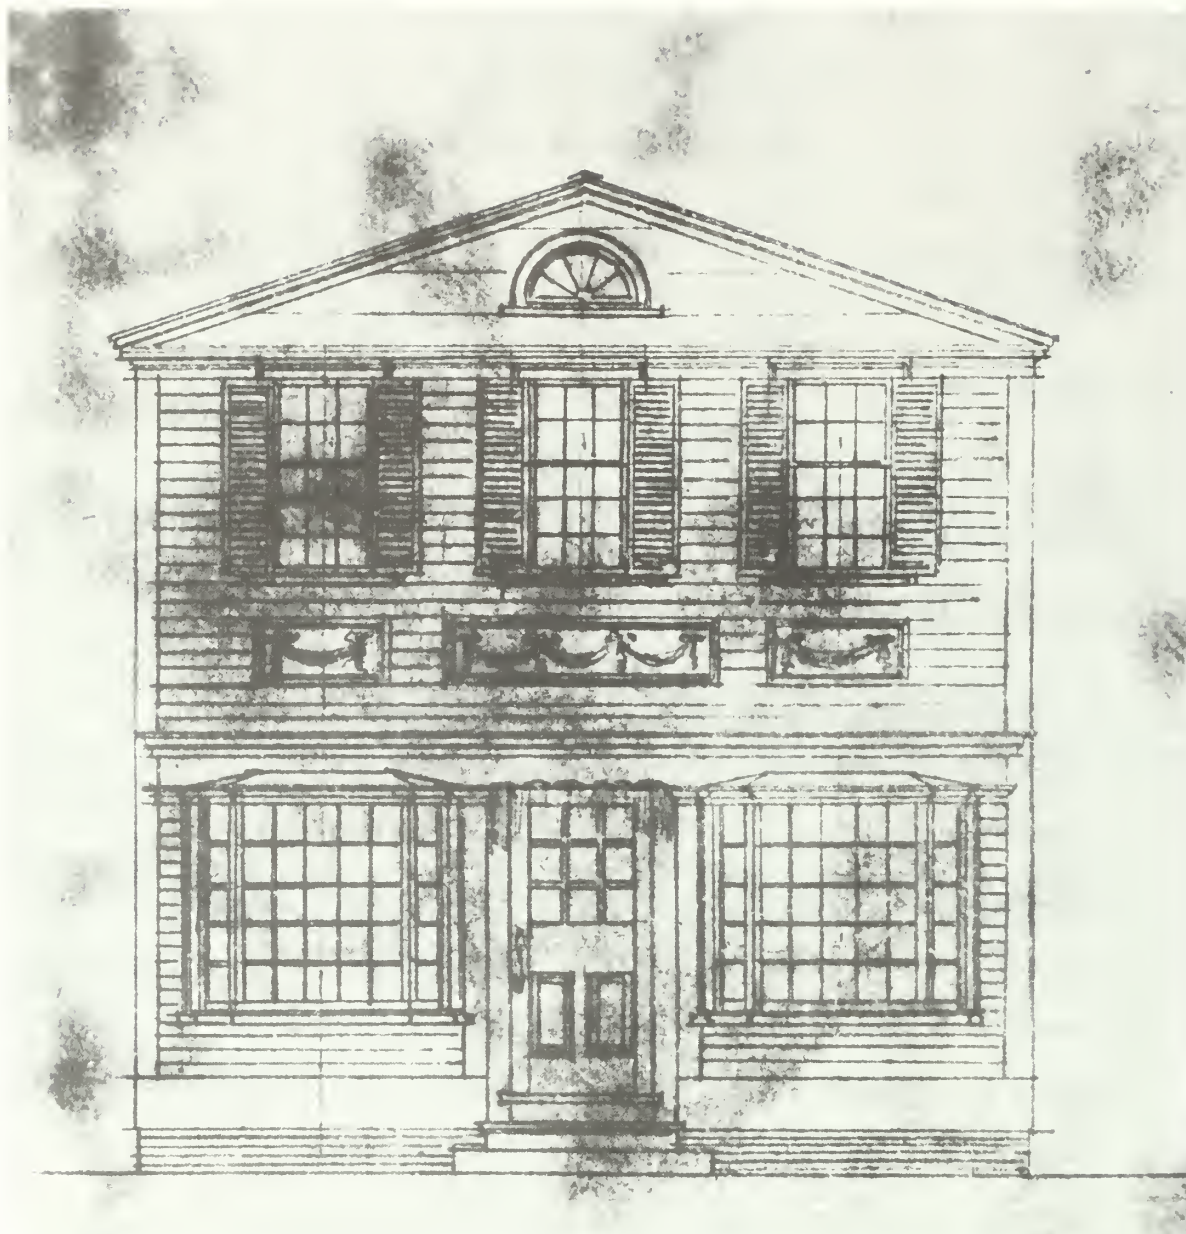
Design for repair and alteration of the old shop to the west of the Richard Derby House, Derby Street, Salem, Mass. By Mr. Alfred P. Shurrocks, June 1928.

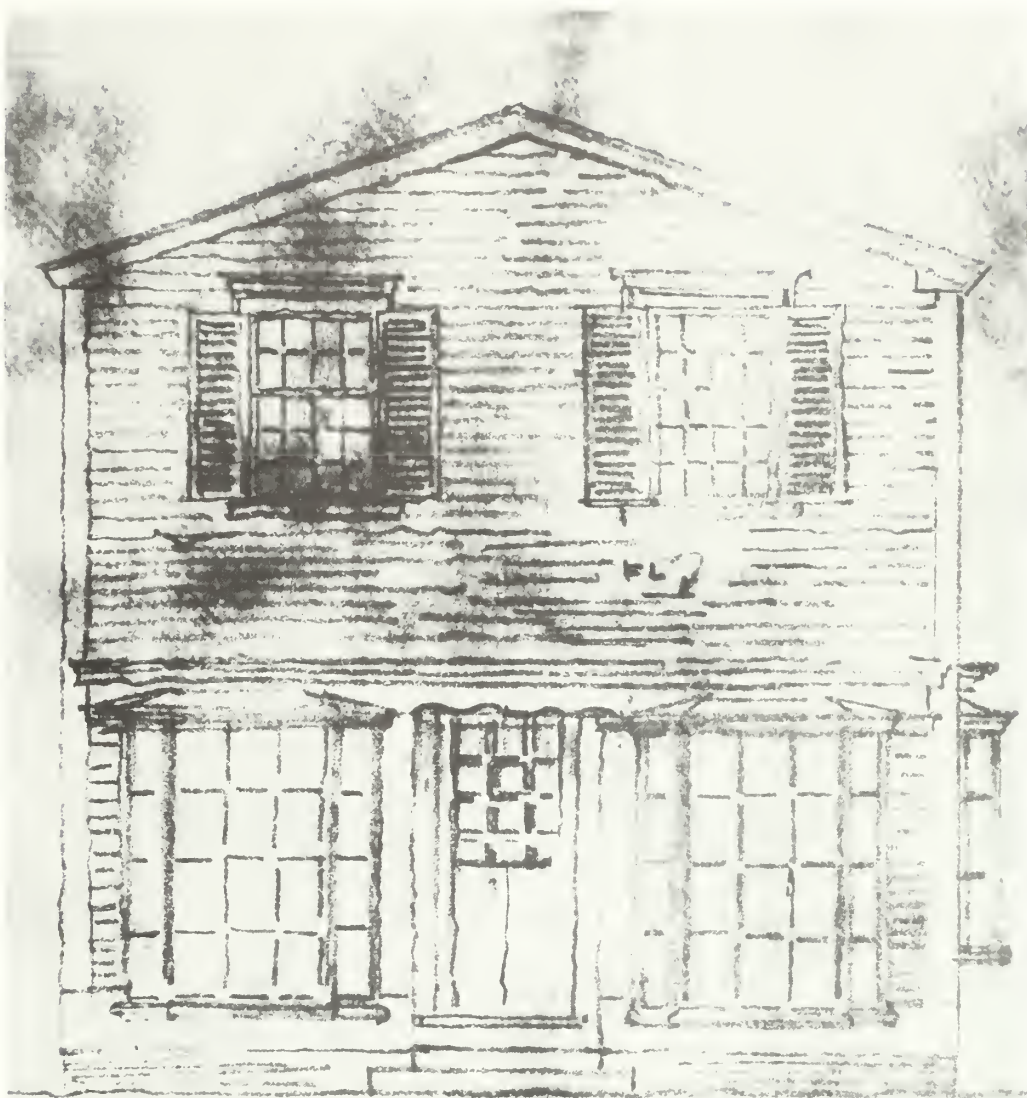
FRONT ELEVATION.

Design for repair and alteration of the old shop to the west of the Richard Derby House, Derby Street, Salem, Mass. By Mr. Alfred P. Shurrocks, June 1928.
