HISTORIC STRUCTURE REPORT

Architectural Data Section

LINDENWALD

MARTIN VAN BUREN NATIONAL HISTORIC SITE

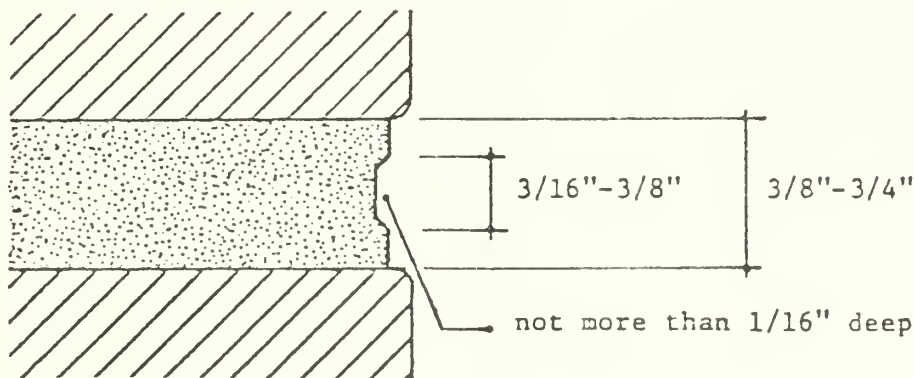
The 1797 mortar joints are tooled and ruled to create the profile shown below:

Most of the joints have been weathered to the extent that the joint profile is no longer perceptible. About 50 percent of the mortar joints are so deteriorated that they must be repointed. This deterioration is the result of a variety of causes: normal weathering, slight structural movements, and previous inappropriate repointing with Portland cement mortar. The 1797 brick mortar has been found to consist of roughly two parts lime, two parts sand, and one part fines (passing a no. 200 sieve).

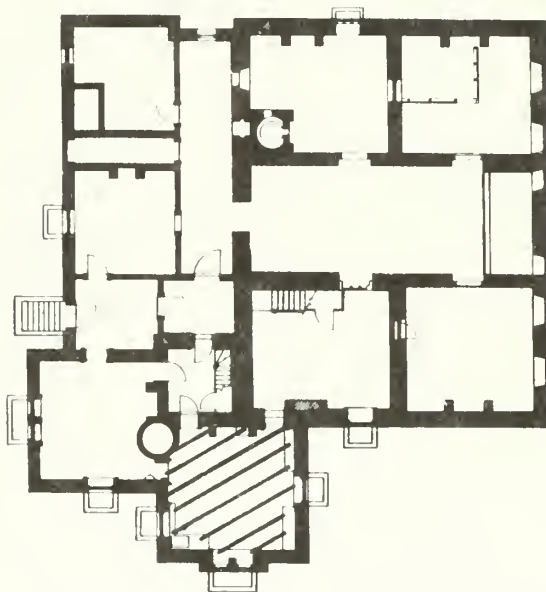
h. Room 006 - Kitchen

Room 006 is in the south bay of the ca. 1850 addition. It was the kitchen for the Van Buren household during the historic period. The evidence for this use consists of the cast-iron range and ovens in the north wall, the water supply, the cupboards, and the circular brick oven in the northwest corner of the room.

All of the plaster, lath, and furring strips are completely gone from the walls of this room. The exterior walls (east, south, and west) are of coursed rubble masonry with horizontal wood nailers incorporated into the construction for attachment of

- Return the shelving in room 114 to room 006.

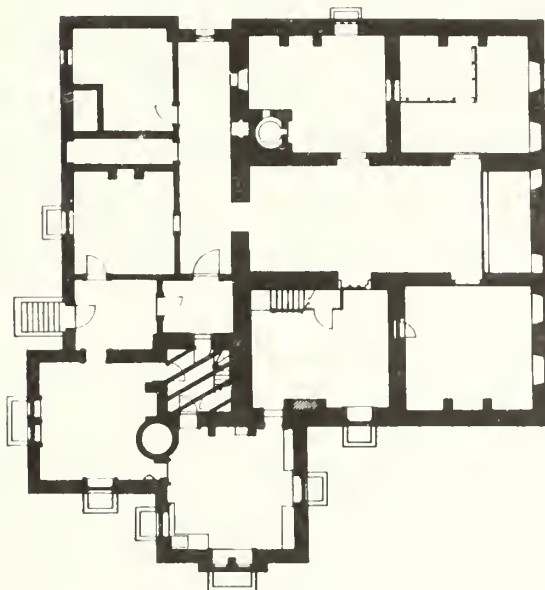
j. Room 008 - Stair Hall

Room 008 is the lowest level of the tower stair and the primary interior access to the basement. The walls of the room are whitewashed, two-coat plaster directly on masonry walls. The north and east walls are rubble stone construction; the south and west walls are brick. Aside from minor damage to the south wall (caused by rising damp) and to the northwest corner (probably caused by leaking pipes), the plaster and masonry are in good condition. The east wall under the stair consists of a board partition with a board-and-batten door, both of which have a painted wood-grain finish. The underside of the stair and the

east and south walls behind this board partition are finished with plaster and whitewash. Typical ca. 1850 baseboard for secondary spaces is found in the main part of the room and around the south and east walls under the stair, but not on the board partition. Thus, this partition is considered nonhistoric, as are similar partitions in room 005 and between rooms 113 and 117.

- Restore all woodwork to a cream color (Munsell 5Y 9/2, Benjamin Moore GB-60).

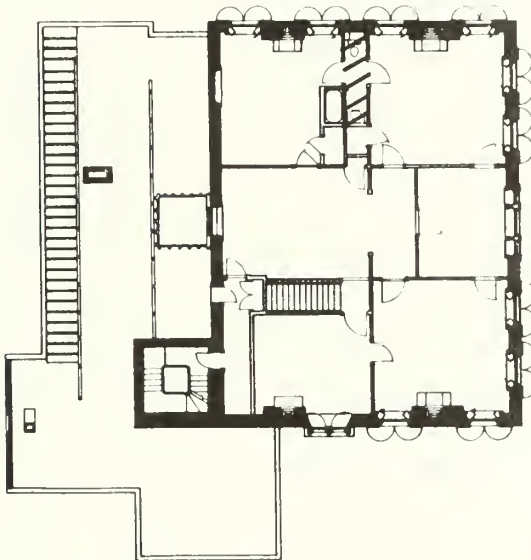
b. Rooms 202/203/204 - Closet/Bathroom/Closet

Room 202 was a closet built in the southeast corner of room 201 by Campbell, ca. 1960. This enclosure was removed by the park maintenance staff in 1978.

Rooms 203 and 204 are secondary spaces between the major north bedrooms, rooms 201 and 205. Room 203 (north of room 204) was enlarged to receive a bathtub by relocating a portion of the west wall farther west. This ca. 1960 work included the closet construction that created room 202. Plumbing for the toilet and sink fixtures in room 203 has been attributed to the DeProsse family through oral history and the 1938 DeProsse drawings.

Replace the floorboards.

Replace several baseboards.

Restore the woodwork to a cream color (Munsell 2.5Y 9/2, Benjamin Moore GB-30).

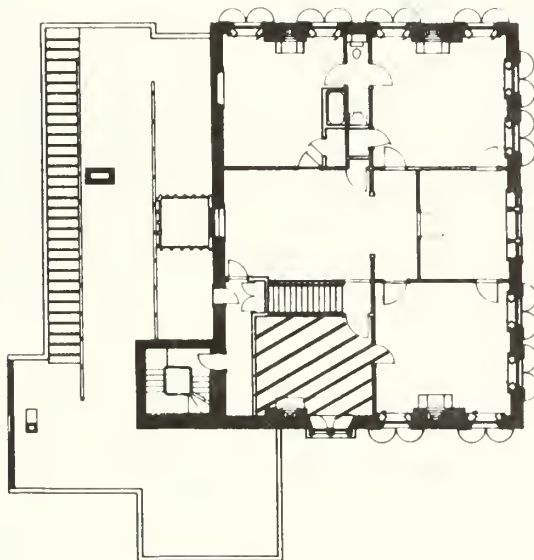
e. Room 210 - Chamber

This second-floor bedroom is in the southwest corner of the ca. 1797 house. Access is from a door opening in the north wall from the central hall (D215, see IP052). There is a door opening (D216) in the east wall leading into room 209, the southeast bedroom. The bay window in the south wall has two round-headed windows (W215, 216, see IP053). A chimney breast is also located in the south wall.

- Clean the shutter pulls and replace the center mullion hardware for securing shutters in a closed position.

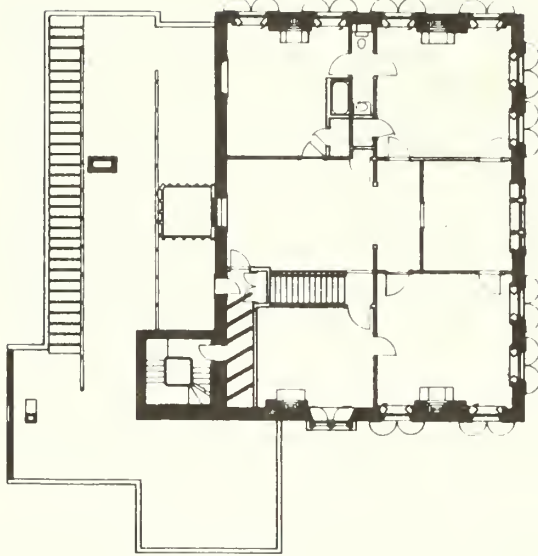
f. Room 211 - Hall

Room 211 occupies a narrow rectangular space in the extreme southwest corner of the 1797 house (see IP054). This passage from room 206 to the tower stair hall and to the Upjohn attic was separated from room 210 in 1849. The door from room 206 (D211) is in the north. Doors into room 213, the Upjohn attic (D212), and room 212, the tower stair hall (D214), are in the west wall. There is a closet in the north end of the east wall, and the lower portion of window 315 is in the south wall.

The ca. 1797 to 1849 use of this space was as part of the bedroom, room 210. The location of the west wall window was approximately 5' 4" from the south plaster wall. Infill masonry is currently exposed south of door 214, the probable location of a window in the ca. 1797 house.

- Restore all woodwork to a tan color (Munsell 10YR 8/2, Benjamin Moore GB-60).

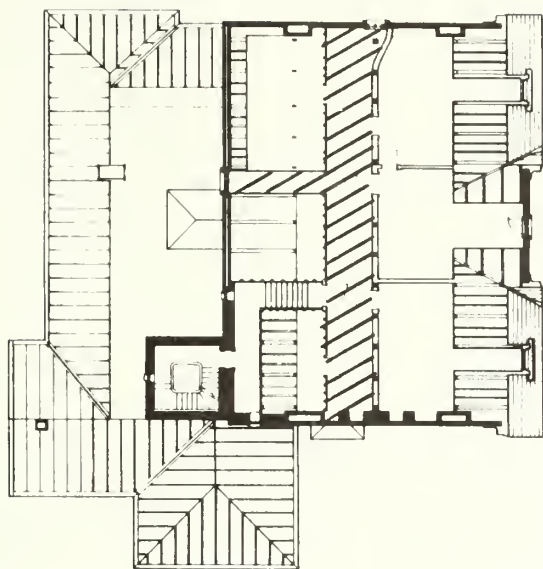
c. Room 302 - Hall

Room 302 is the T-shaped central hall of the third floor. The crossbar portion of the "T" is 6' 10" by 55' 4" oriented in a north-south direction, just west of the center of the building (see IP060). The stem of the "T" is 3' 1" by 12' 10" and extends in a westerly direction to window 307 in the west gable.

The walls are whitewashed two-coat plaster on circular-sawn wood lath except for the north end wall, which is three-coat plaster on brick, and the south end wall, which is two-coat plaster on brick. The baseboards are simple, planed 5-1/4" by 1" boards that were used as the

- In traffic areas, install insulation boards that can withstand foot traffic, and provide R30 insulation.

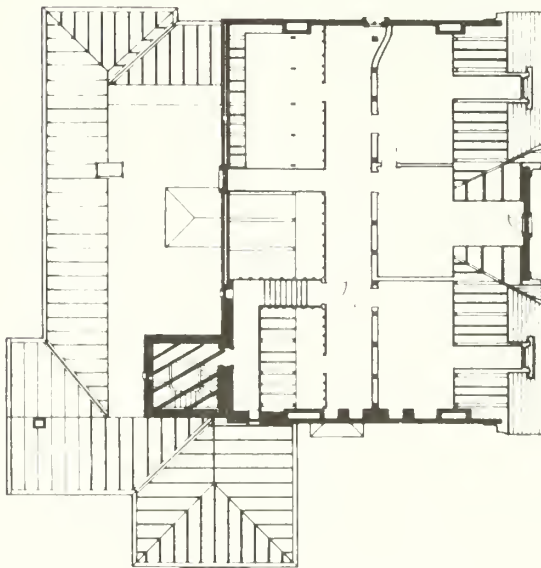
i. Room 308 - Tower Stair

Room 308 is the third-floor level of the tower stair. It is a square room approximately 9'8" by 9'10" whose only function was to provide vertical access to all the floors in the house.

The walls are a whitewashed three-coat plaster on wood lath on furring strips attached to the brick walls of the tower. The baseboard at the landing along the north wall and along the stairs below is the typical profile used in the more formal areas of the Upjohn (ca. 1849) addition. Along the east wall, above door 309 and all the way to the belvedere, the baseboard is the simple cavetto type found in the

The ceilings of this space are whitewashed two-coat plaster on wood lath attached to irregular nailers on the underside of the stair structure. The finished plaster follows the landings, straight runs, and winder portions of the stair in one smooth continuous surface with gradual transitions between areas of different slope and around corners. Some of this plaster has been damaged by water that penetrated through the tower deck. One already damaged area of plaster and lath was completely removed to allow an inspection of the stair structure (see IP-068, 069, and 070).

The preservation and restoration work recommended for room 308 includes the following items:

- Repair or replace all damaged or missing plaster or lath.

- Install a transparent barrier (of acrylic sheet) at the third-floor level to reduce heat loss through the tower, while maintaining visual continuity for visitors observing the tower stair from the first floor.

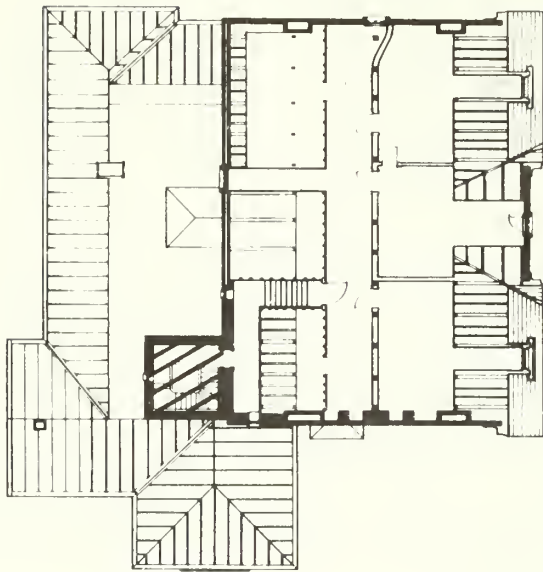
6. Fifth Floor - Belvedere

Room 501 is the open-air belvedere at the top of the ca. 1850 Italianate tower. The term "belvedere" is used because the only apparent historic function of the space was as a vantage point from which to enjoy the view of the Hudson River valley and the Catskill and Berkshire mountains.

The north and south walls are of solid brick construction with painted wood paneling as the interior finish. These walls carry roof loads down to the stronger, four-walled section of the tower below. The east and west walls are open with nonload-bearing columns at the middle of two arched openings and handrails

The preservation and restoration work recommended for room 501 includes the following items:
