EVALUATION OF 1978 REHABILITATION SITES AND EROSION CONTROL TECHNIQUES

REDWOOD NATIONAL PARK WATERSHED REHABILITATION

TECHNICAL REPORT
APRIL 1980

MARY ANN MADEJ,
HARVEY KELSEY, AND
WILLIAM WEAVER

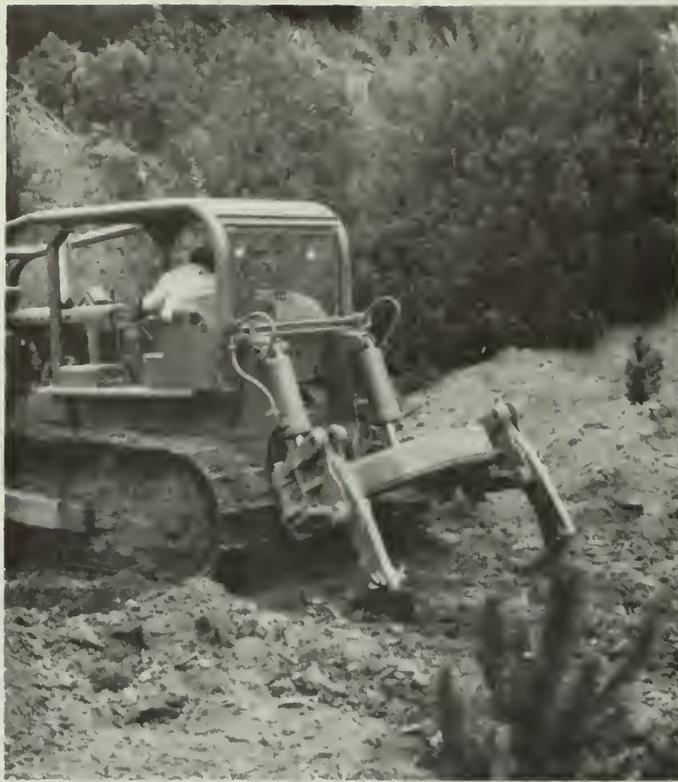
Figure 4: Most logging roads are surfaced with eight to twelve inches of rock and must be disaggregated to promote infiltration and revegetation. Here, a D-8 Cat decompacts the C-10 road with its ripper teeth.

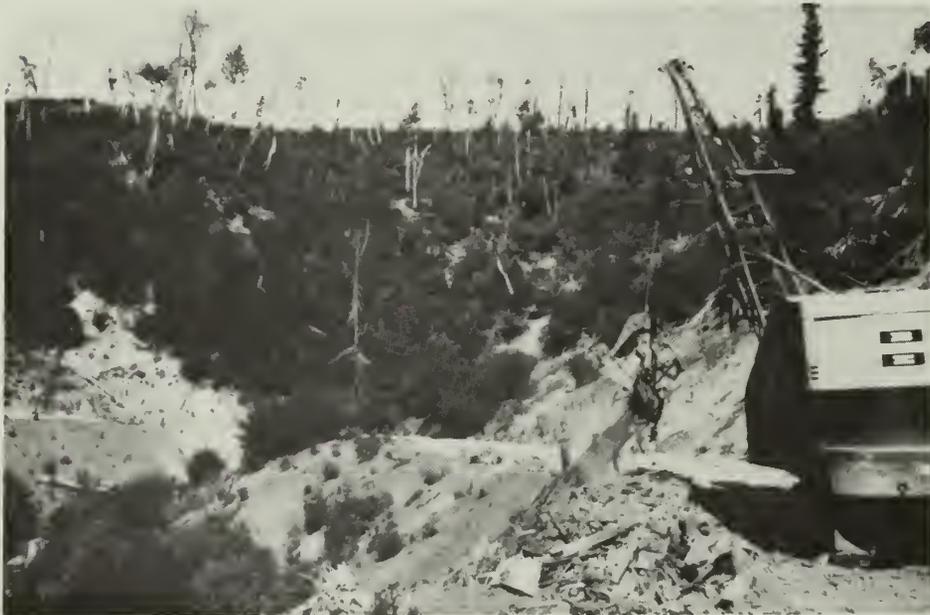
Figure 5: Because of its long reach, a dragline crane is used to lift unstable side cast road material and organic debris to the road bench.

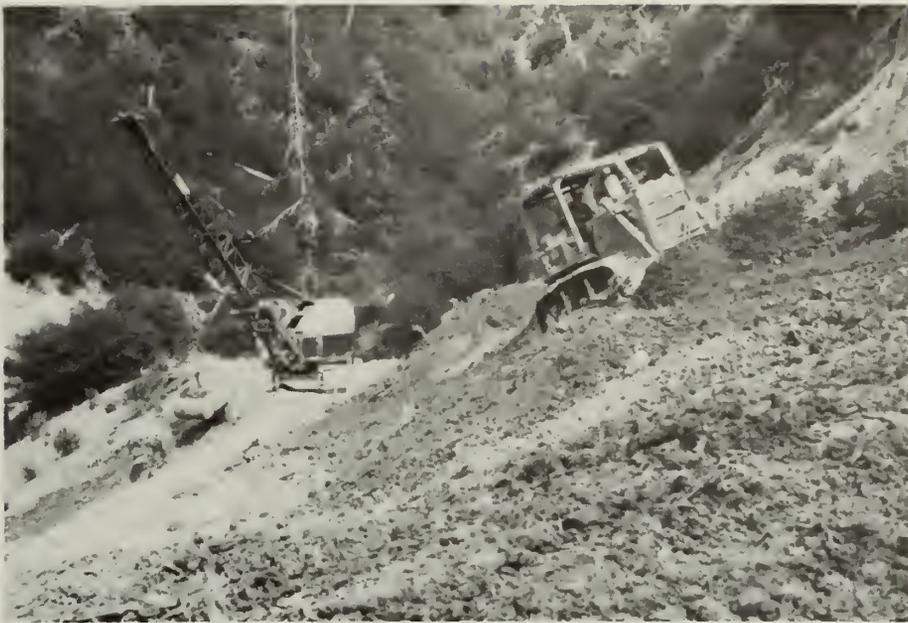
Figure 6: Excavated fill is piled along the inboard edge of the road and against the road cut bank. A tractor grades the fill to achieve a gentle outslope on the former road alignment.

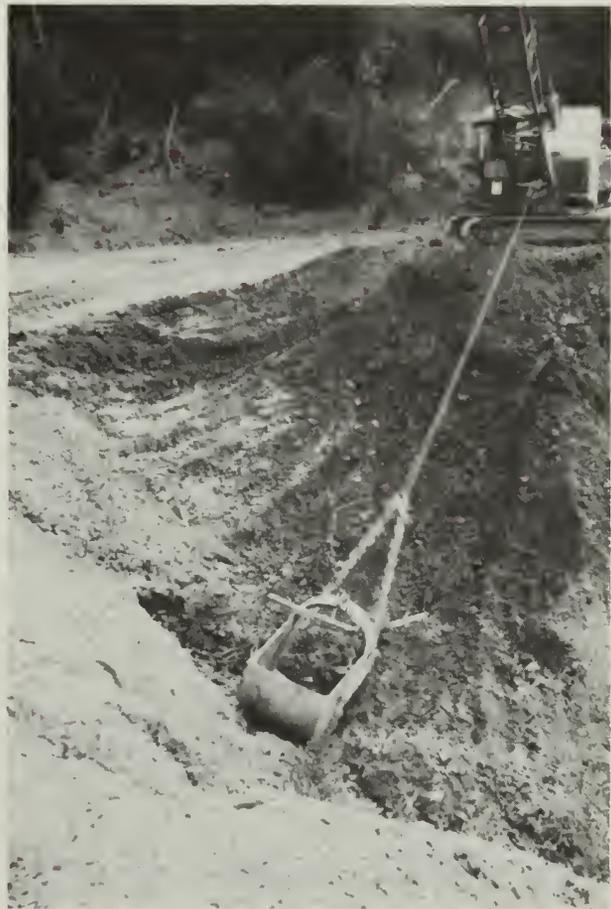
Figure 7: A dragline crane removes fill from a stream crossing and reshapes channel banks to a more stable configuration.

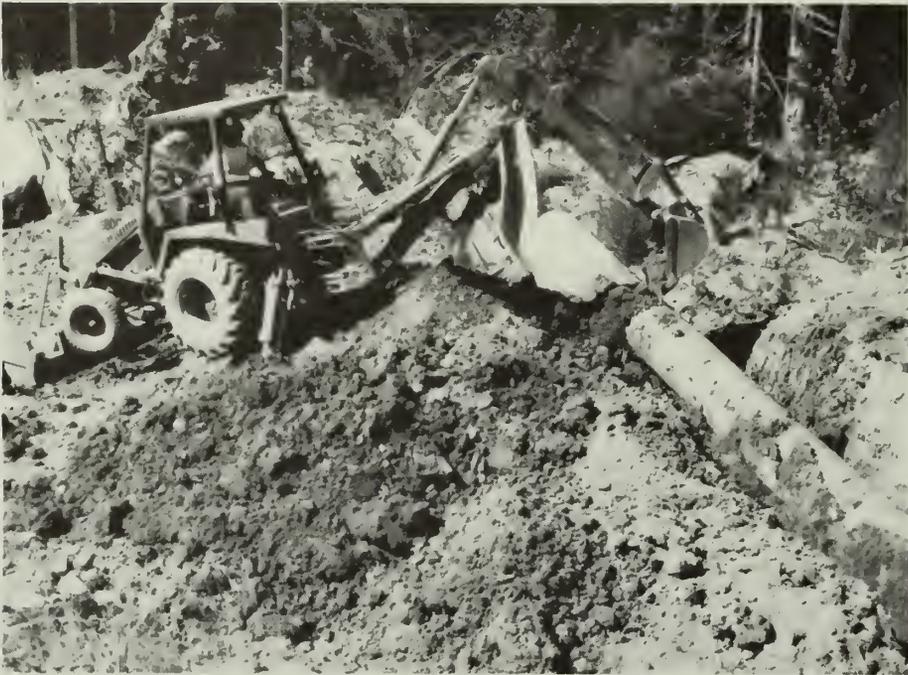
Figure 19: A backhoe excavated and removed culverts from the C-90 road, and smoothed out the resulting trough to form a cross road drain with gently sloping banks.

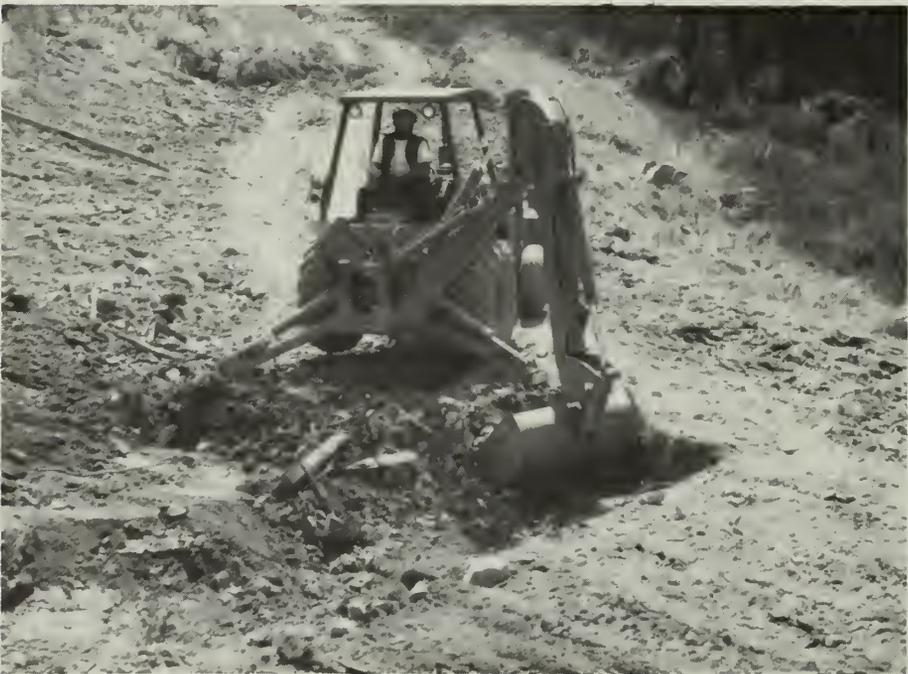
Figure 20: To prevent runoff from concentrating in the inboard ditch, cross road drains are excavated along the C-90 road by a backhoe.

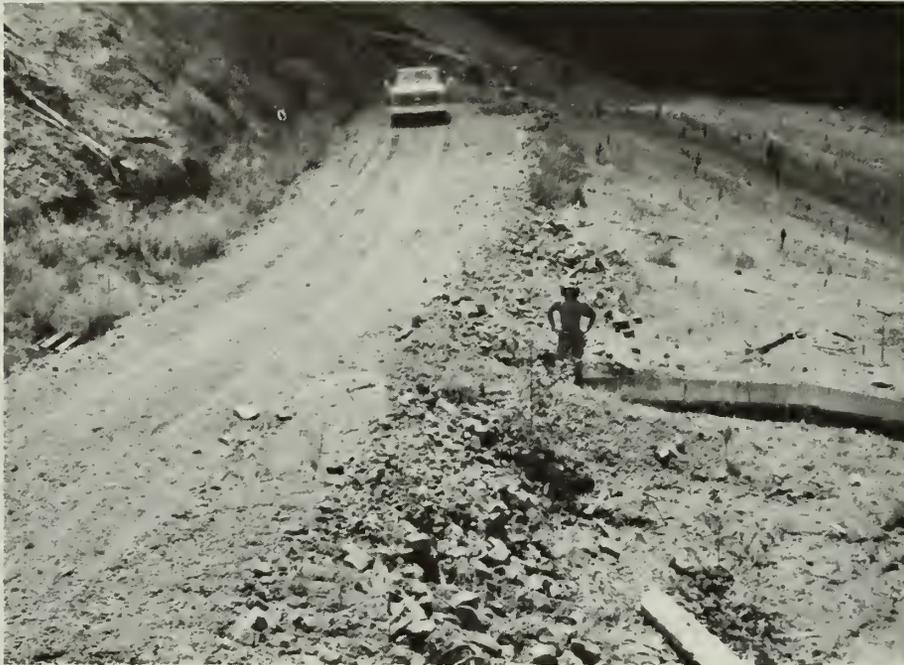
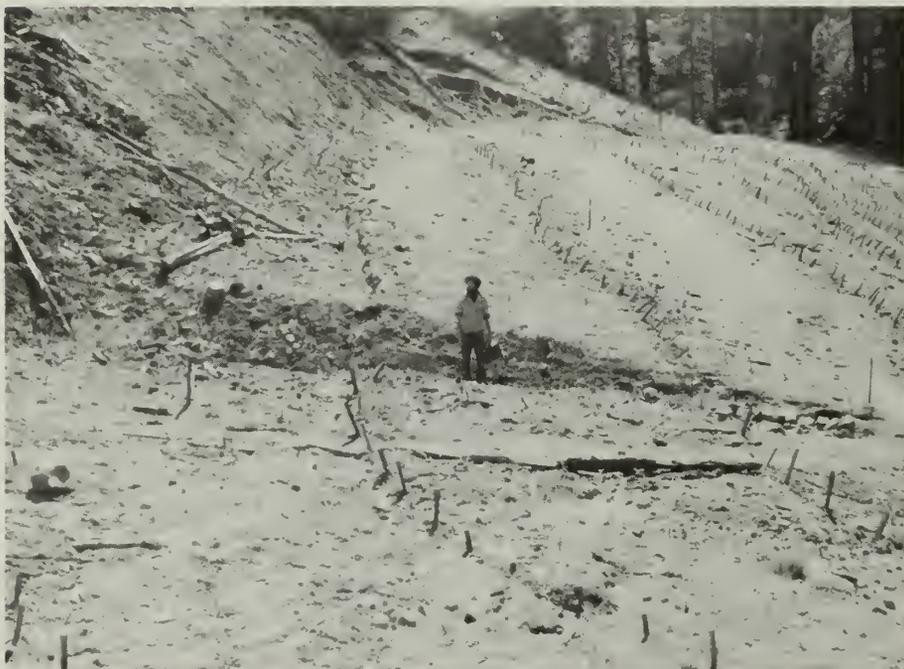
Figure 24: PP24 3/19/79

Figure 23: PP24 8/23/78
Before and after sequence of culvert removal
and road outsloping. A backhoe excavated a
cross road drain in the former culvert location.

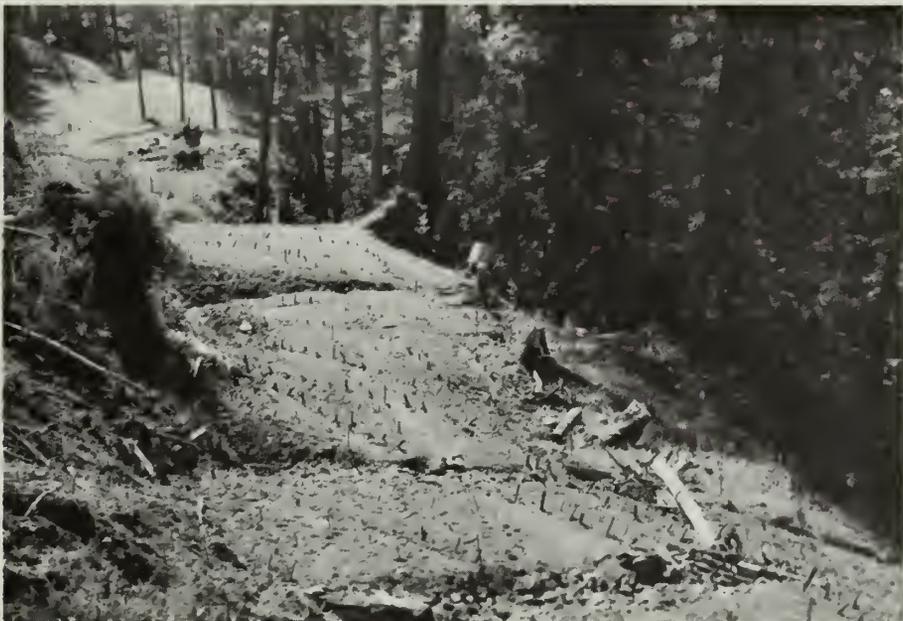
Figure 26: PP16c 3/19/79
After rehabilitation, C-90 road has been decompacted and outsloped, and the inboard ditch has been filled in. Surface runoff now crosses the removed road through cross road drains rather than concentrating and flowing along road alignment.

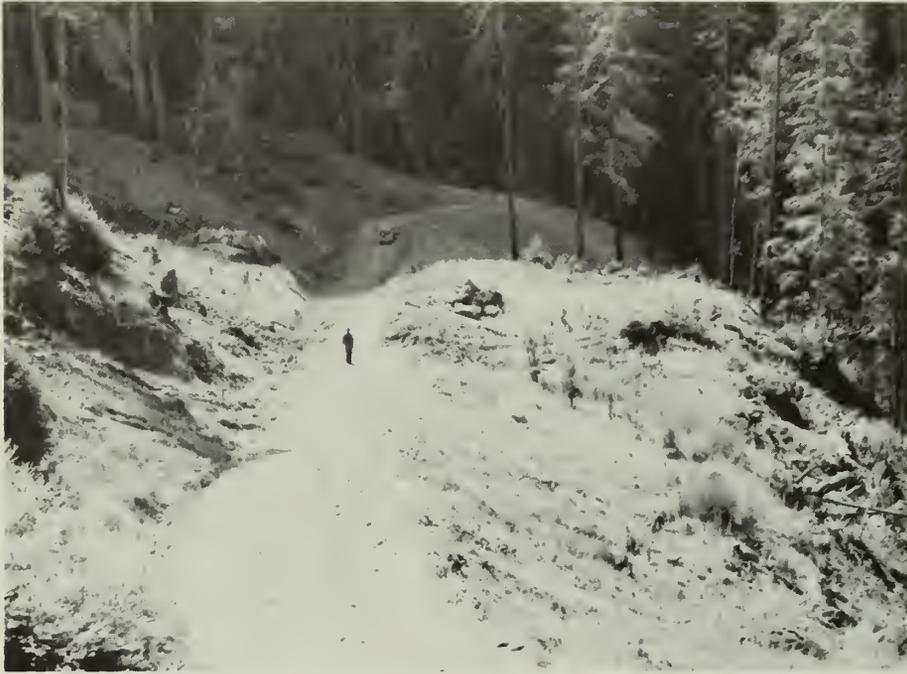
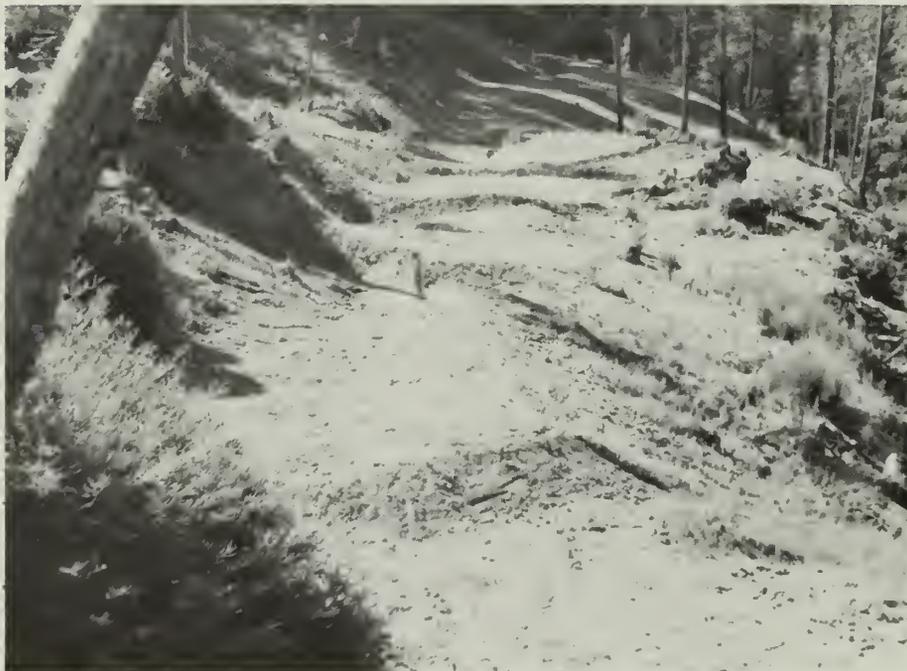
Figure 28: PP19b 3/19/79

Figure 27: PP19b 8/23/78
Before and after sequence showing removal of road and construction of cross road drains on a portion of the C-90 road.

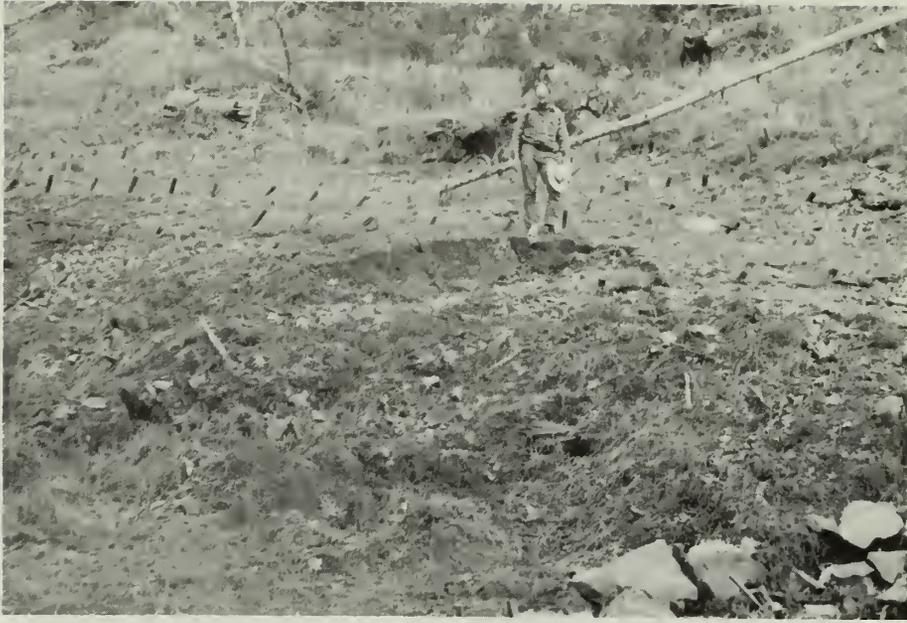
Figure 31: April, 1979.
A small slump occurred on a recently wattled slope in an area with few cross road drains.

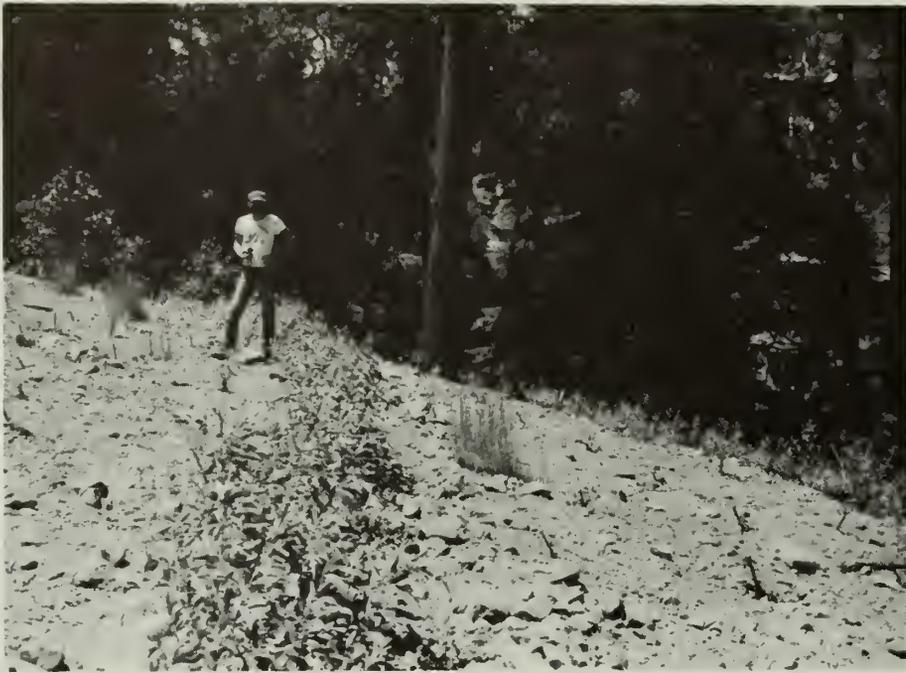
Figure 33: Willow wattles have sprouted vigorously on moist slopes on the Emerald Creek Rehabilitation Unit. Willows were planted 7 months before this photo was taken. Grass cover is sparse (1-2%).

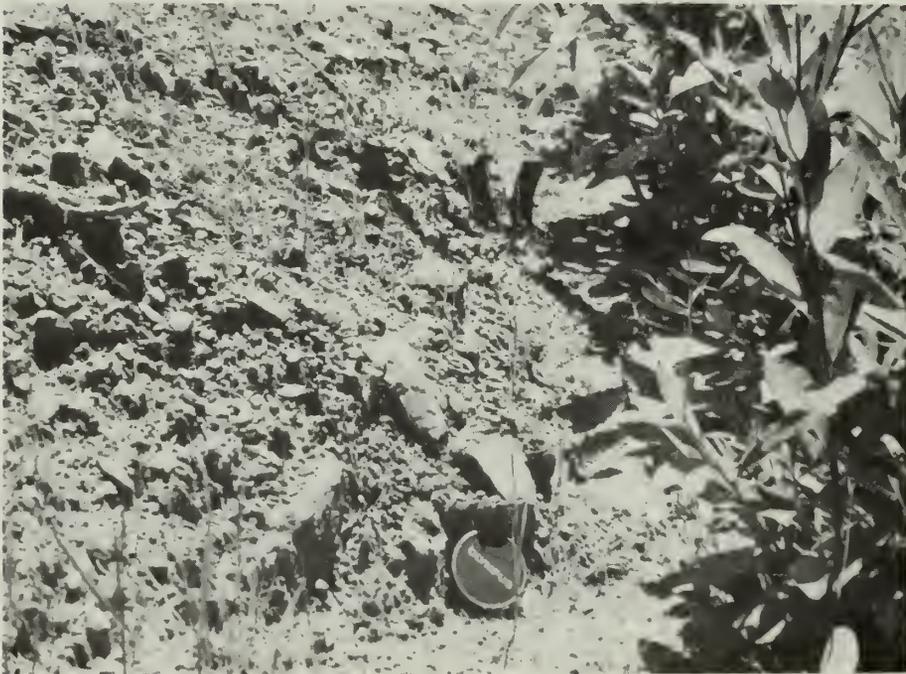
Willow wattles were built on most pulled road surfaces and on outsloped fill materials. Wattle terraces trapped sediment ranging from silts and clays to material 12 millimeters in

diameter (Figure 34). Few rills developed on wattled slopes, whereas they are more prevalent on similar slopes that are bare and unwattled.

Figure 34: Terraces upslope of willow wattles trap fine grained soil particles which are carried downslope by runoff. The wattles impede downslope soil movement and surface rilling by providing a physical barrier to runoff.

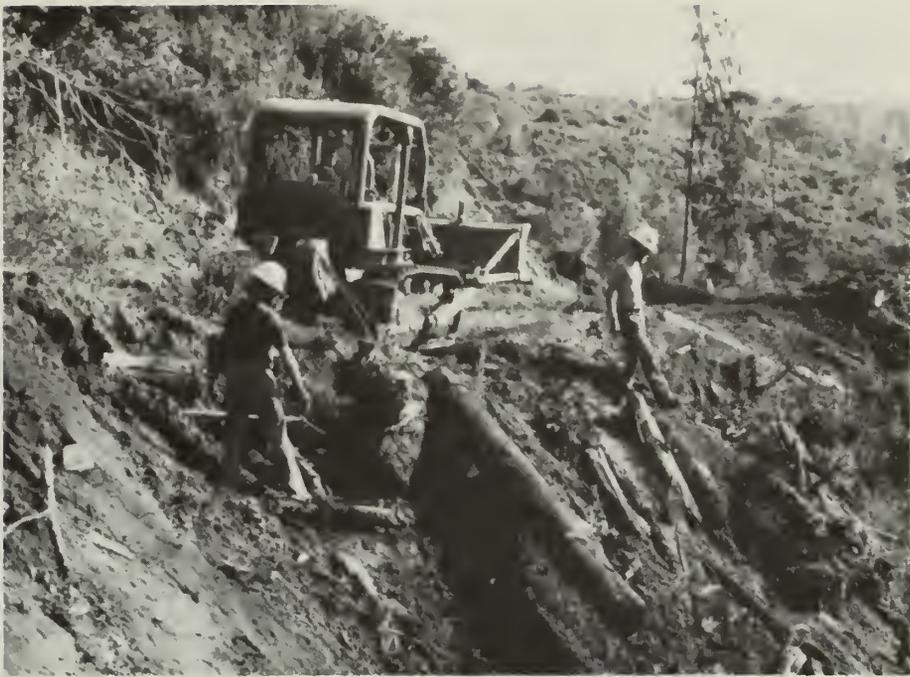
Figure 37: Organic debris that was incorporated in road fill is winched out of stream crossings by a caterpillar tractor.

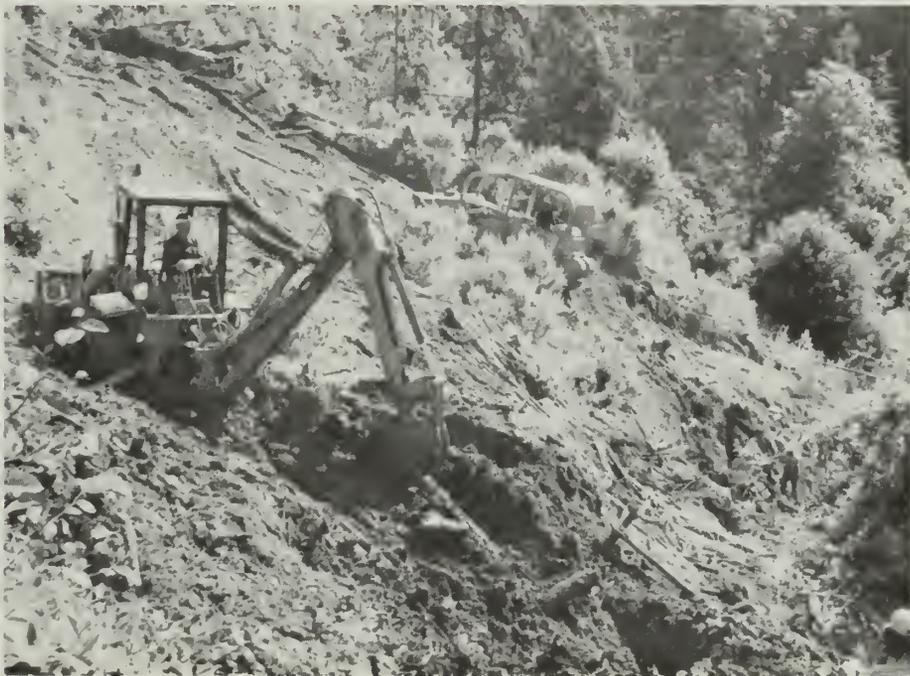
Figure 38: A small backhoe is used to excavate road fill and organic debris from stream crossings. Stream banks are recontoured to achieve stable slopes. The cat in the background of the picture is winching large debris from the channel before the backhoe does the 'finish-up' work in clearing the channel.

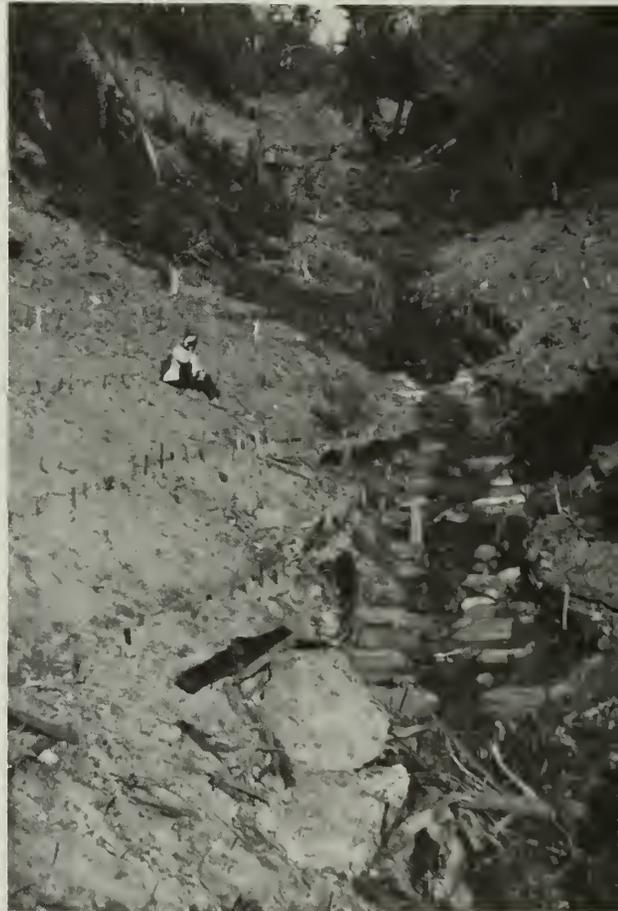
Figure 39: PPD6 9/7/78

Figures 39-44: The following 3 pairs of photographs are before and after sequences that show perennial stream channels filled with organic debris and fill material from skid roads prior to treatment. The second photo of each pair shows the same channel reach after debris is cleared and excavated and the slopes are recontoured. A small backhoe was used to clear channels, and a tractor aided in winching debris from channels.

Figure 40: 1/4/79
Stream crossing 7-K. Note series of check dams in channel and willow wattles on slope. (Note: this photo will be reshot to get the same perspective as 39).

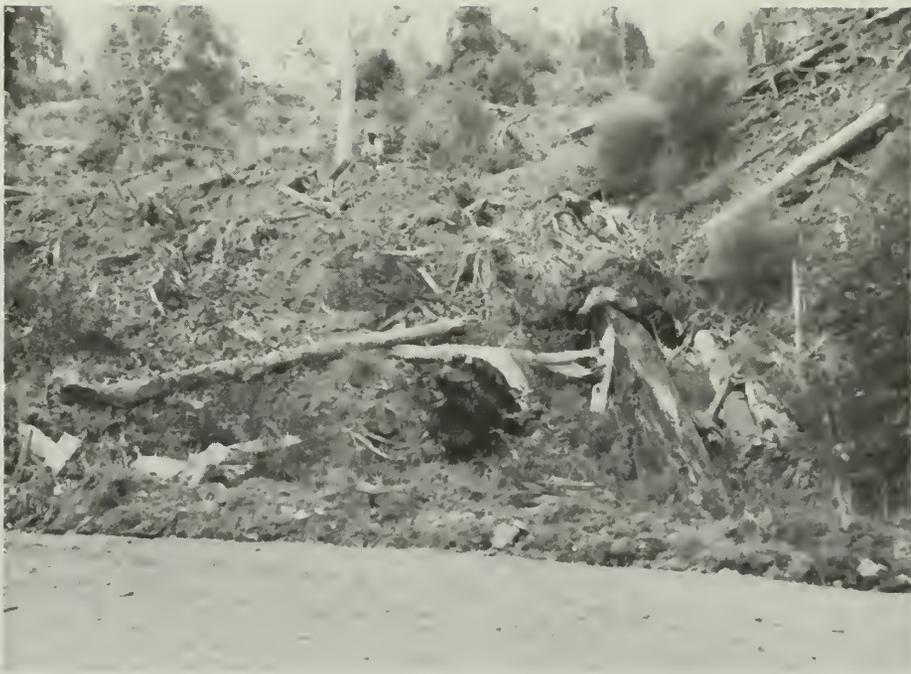
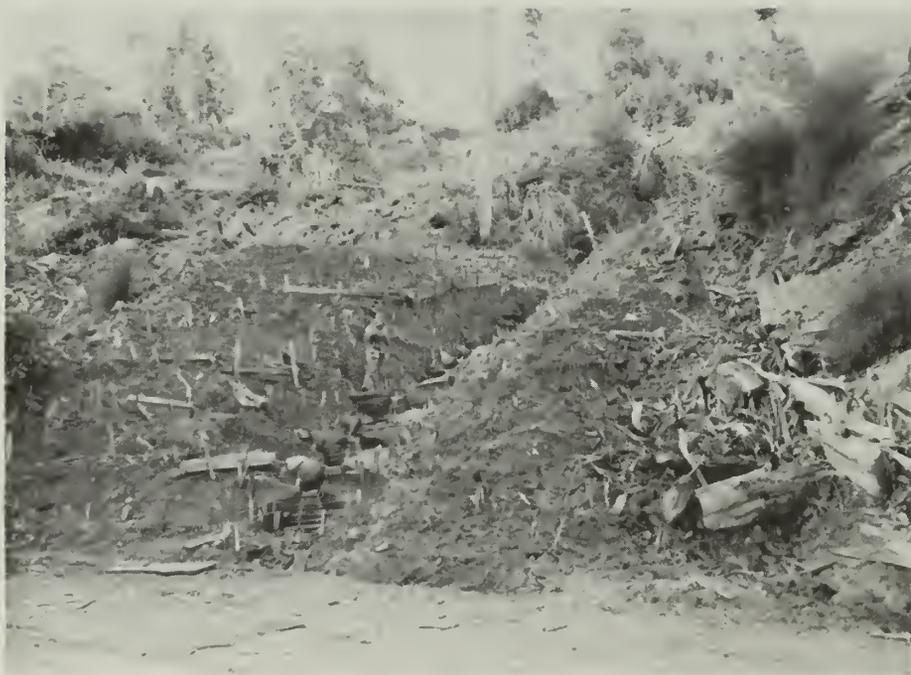
Figure 43: PPE17 9/7/78

Figure 44: 1/4/79
Note check dams in channel, willow wattles on slope, and staggered planter boxes staked into slope.

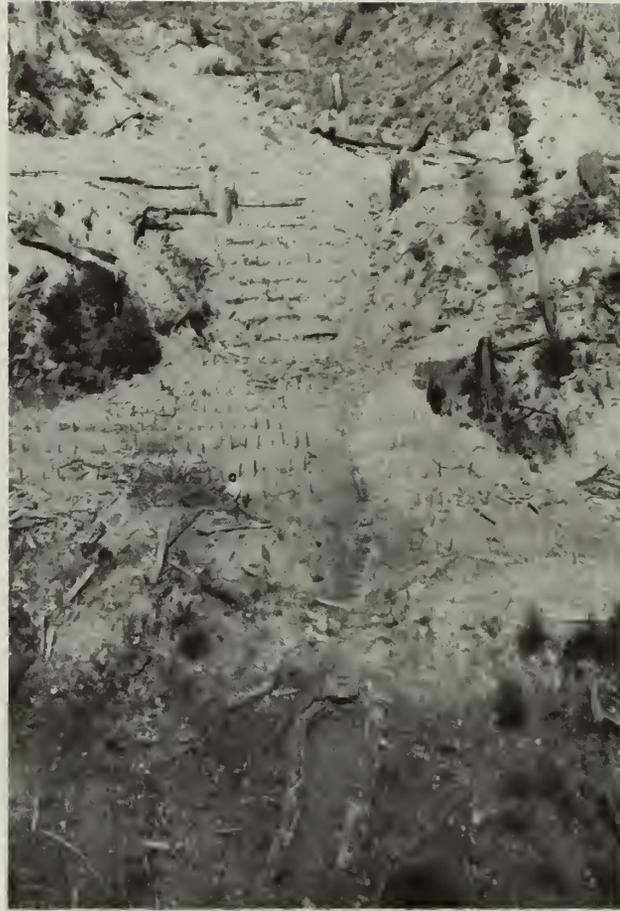
Figure 48: PPA1 1/4/79
After rehabilitation, unstable fill was removed, a small channel was cleared of debris, and slopes were willow wattled. A gully plug was installed at the headcut of a gully (lower center of photo) to prevent the headcut from migrating upstream. Details of the structure are given in Chapter IV.

By September, 1978, a long gully had developed on the Bond Creek Unit (Figure 48), and a six foot knickpoint in the gully was beginning to migrate upslope. A gully plug installed at the knickpoint protected the headcut from further migration and erosion while conveying water across the sensitive area (Figure 75). In this respect the gully plug was used as an alternative to a water ladder in treating this erosional problem.

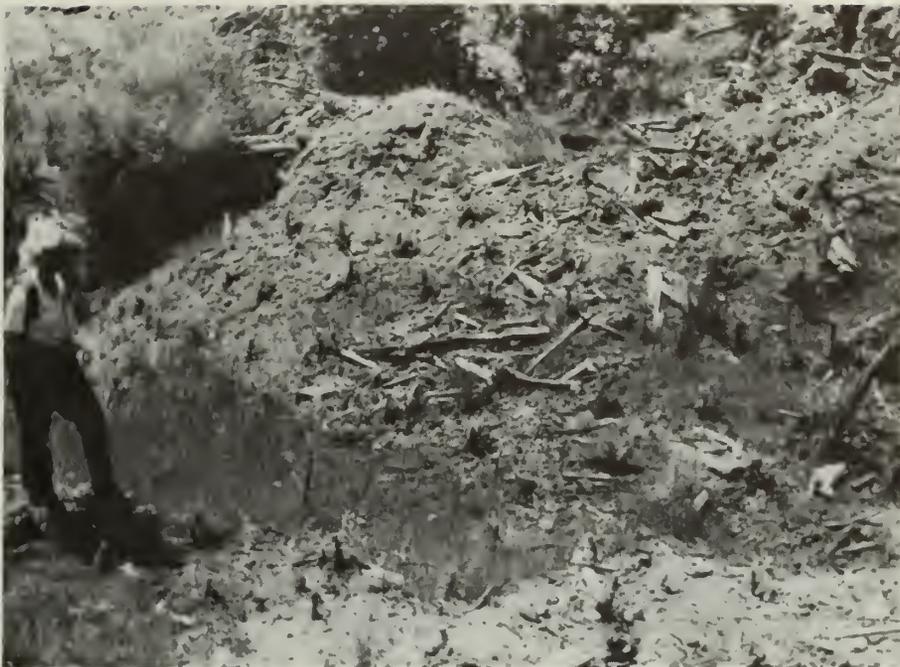
Figure 49: June, 1979
Bare ground on Upper Bond Creek's recently disturbed slopes were sprig planted with willows in December, 1978 at a three foot spacing. The stem cuttings are beginning to sprout.

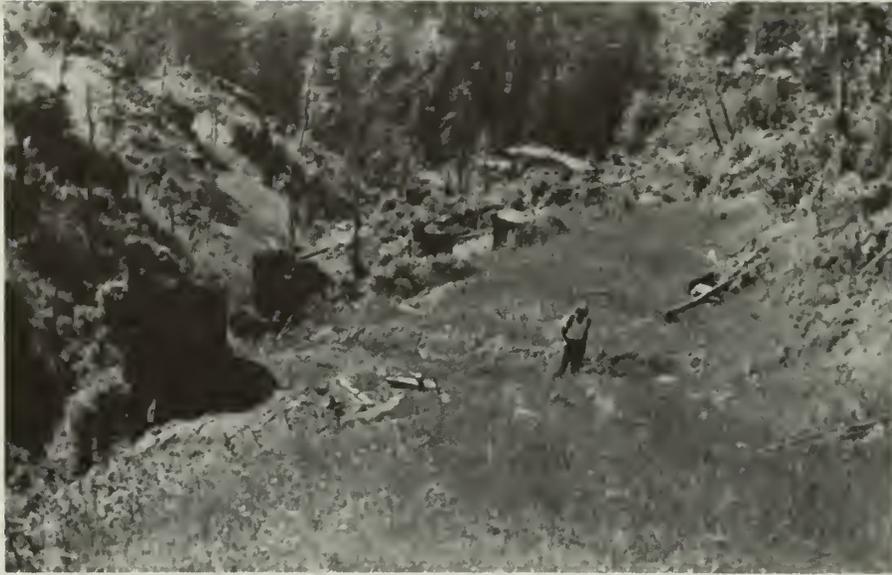
Figure 54: June, 1979
Skid road in Bond Creek Unit with thick stand of annual and perennial ryes and other grasses. The site was broadcast seeded in December, 1978. No rilling is present. Ground cover is about 70% of which 75% is perennial rye.

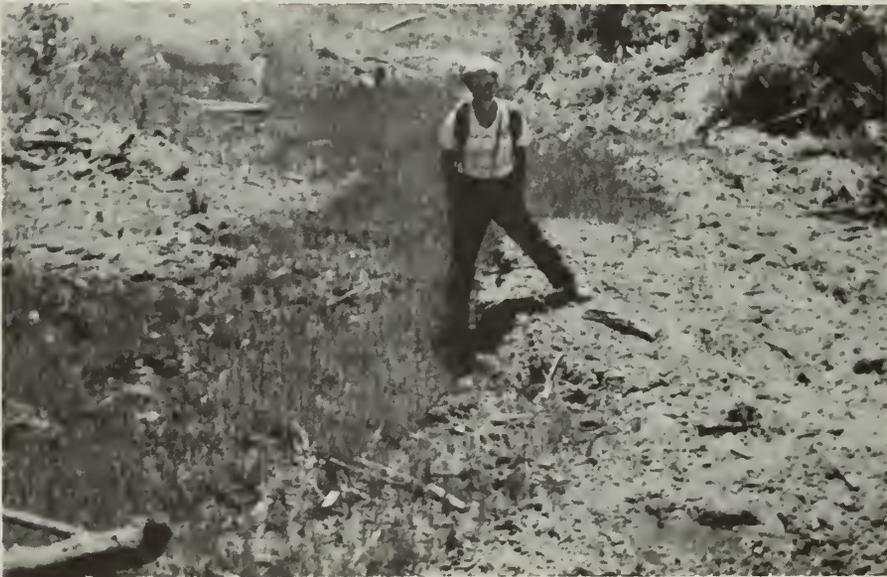
Figure 55: Grass seed and fertilizer were applied at equal rates on all areas of this skid road. The moist site on the left side of the photo has a fairly good grass cover developed; survival of grass is much poorer on the drier site on the right-hand side.

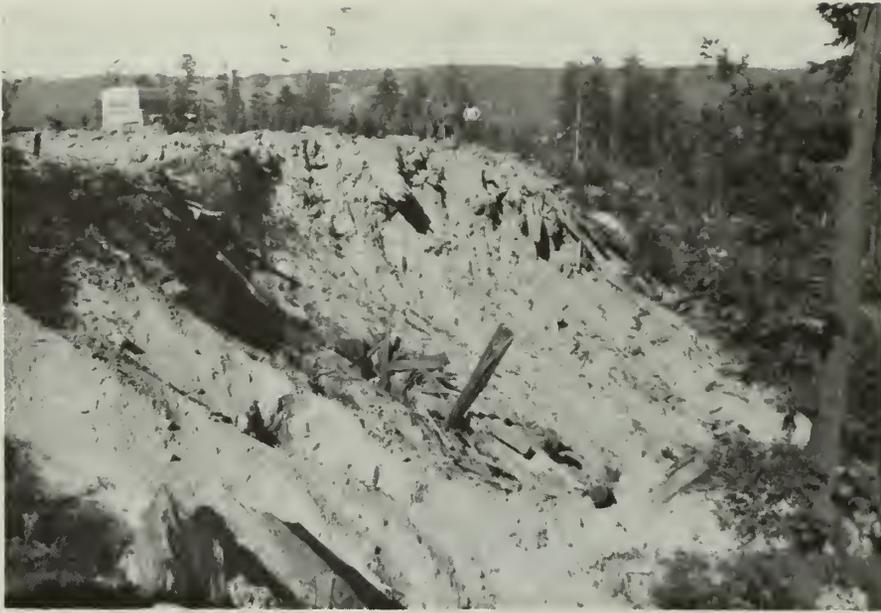
Figure 58: PP6 10/2/78
Before and after sequence showing the removal of the C-Line landing. The upper slopes have willow wattles; the steep lower slopes are protected by planter boxes.

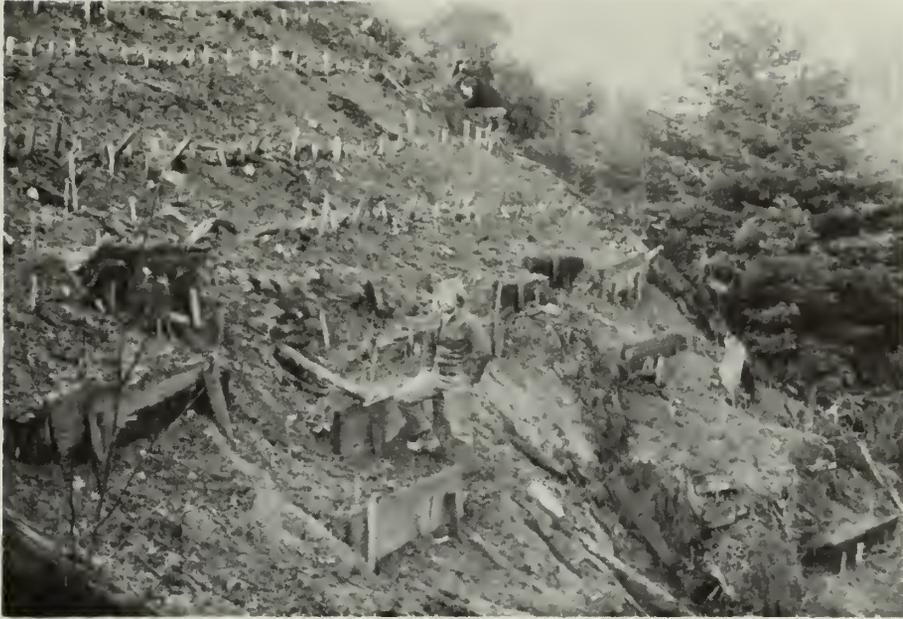
Erosion control structures have worked well on this site. Planter boxes (Figure 60) at the base of the recontoured slope are log and board barriers keyed into steep, infertile soil. They provide a protected, stable planting substrate in harsh areas. All planter boxes remained secure and stable throughout the winter, and they trapped small particles of soil moving downslope.

Figure 60: 12/7/78
At the base of the C-Line landing (Site 78-5), below rows of wattles, planter boxes were secured to the slope. They were backfilled with soil and planted with willow stem cuttings to promote revegetation on an otherwise harsh site.

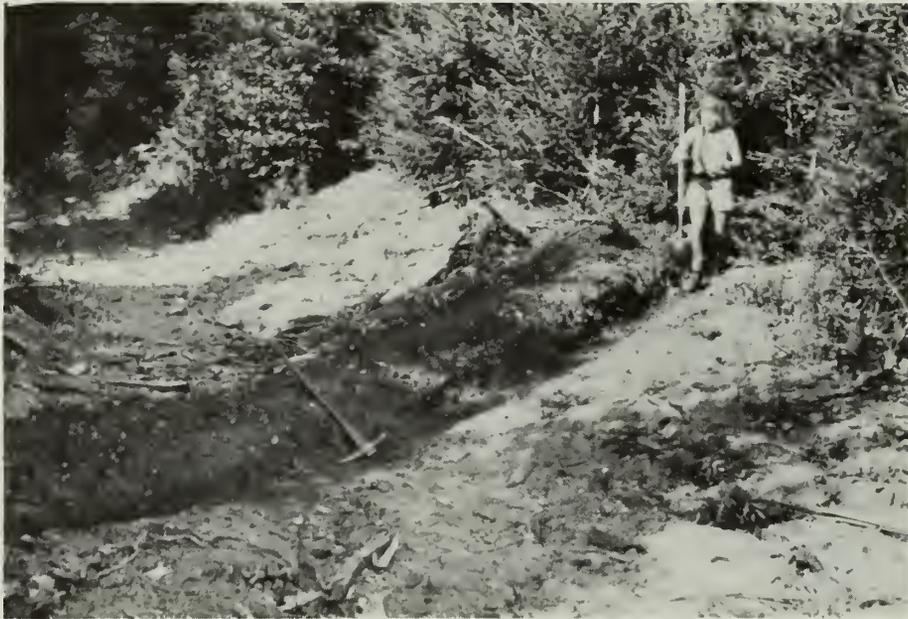
Waterbars on the Bond Creek Site were excavated by backhoe or hand-excavated. Fifteen waterbars were dug by backhoe on a main skid trail, at a cost of approximately \$2 per waterbar. In contrast, 12 waterbars were hand-constructed at a cost of \$30 per bar. An example of a hand-constructed waterbar on the Lower Bond Creek Unit is shown in Figure 61. Both types of waterbars effectively diverted winter runoff flows from skid trails onto vegetated areas.

Figure 61: June, 1979
A hand-constructed waterbar on the Lower Bond Creek Unit. Runoff from the skid road is diverted into heavily vegetated area behind the person in the photo.

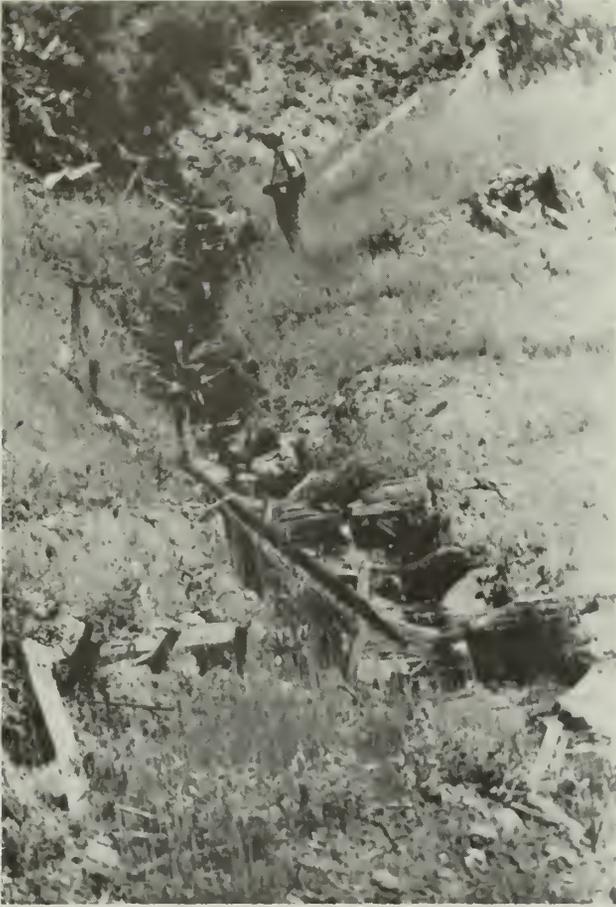
Figure 64: June, 1979

Check dams installed sequentially in a channel prevent failure of individual dams by downcutting at the base of a dam (Figures 62 and 64). The lowest check dam in a gully reach should be constructed on a non-erodible base, and all upstream dams should be placed so that the sediment fill behind the downstream dam abuts the base of the next upstream dam. Therefore, check dams and their trapped sediment totally cover the channel reach, and running water moves over one check dam step, through the energy dissipator device, and onto the next lower level of ponded sediment.

A series of check dams protect a stream channel cleared of road fill and organic debris on the Bond Creek Unit. All dams are well keyed into channel banks and bed. Dams are located so that sediment deposited behind one dam abuts against the base of the next upper check dam. In this manner, the entire disturbed reach of channel is protected from downcutting.

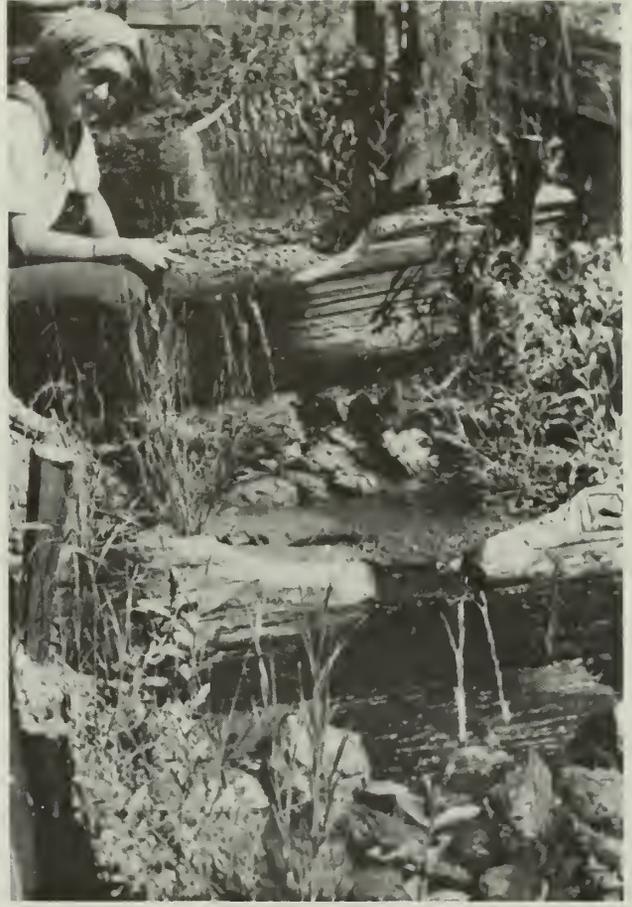
Figure 65:

A close-up view of a series of check dams in the Bond Creek Unit. Summer flow is draining through low-flow spillways. Catch basins upstream of the check dams are filled with sediment deposited during winter high flows. Both rocks and splashboards are used as energy dissipators. Note willow stem cuttings are sprouting and locally, grass is well established.

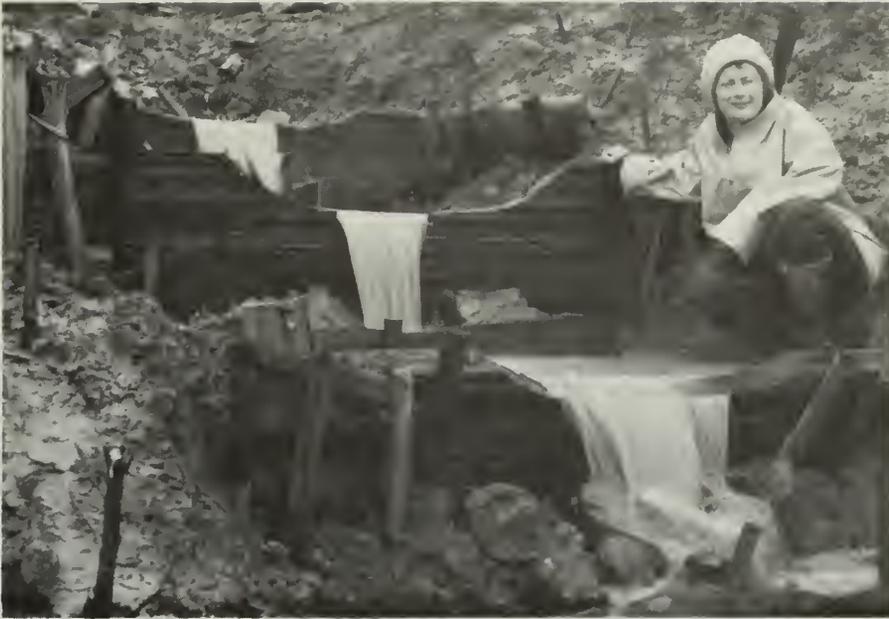
Figure 66: January, 1979
Miller Creek Unit check dams convey winter flows through broad, high-flow spillways. Large rocks are used as energy dissipators below spillways. Note willow stem cuttings on both channel banks.

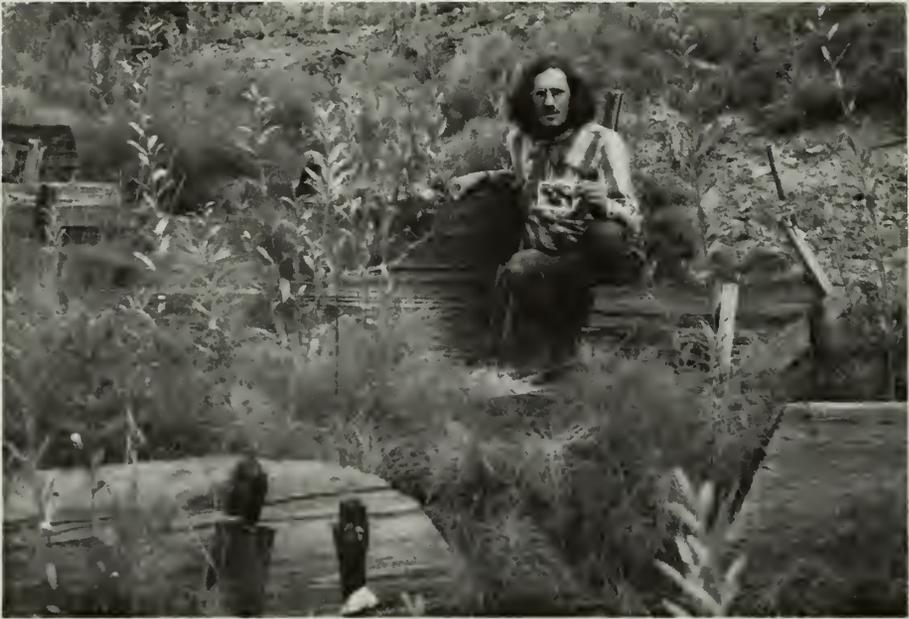
Figure 68: September, 1979
Same series of check dams as figure 66 showing
revegetation after one season. Willow (salix, spp.)
have sprouted from stem cuttings while horsetail
(Equisetum, spp.) invaded naturally.

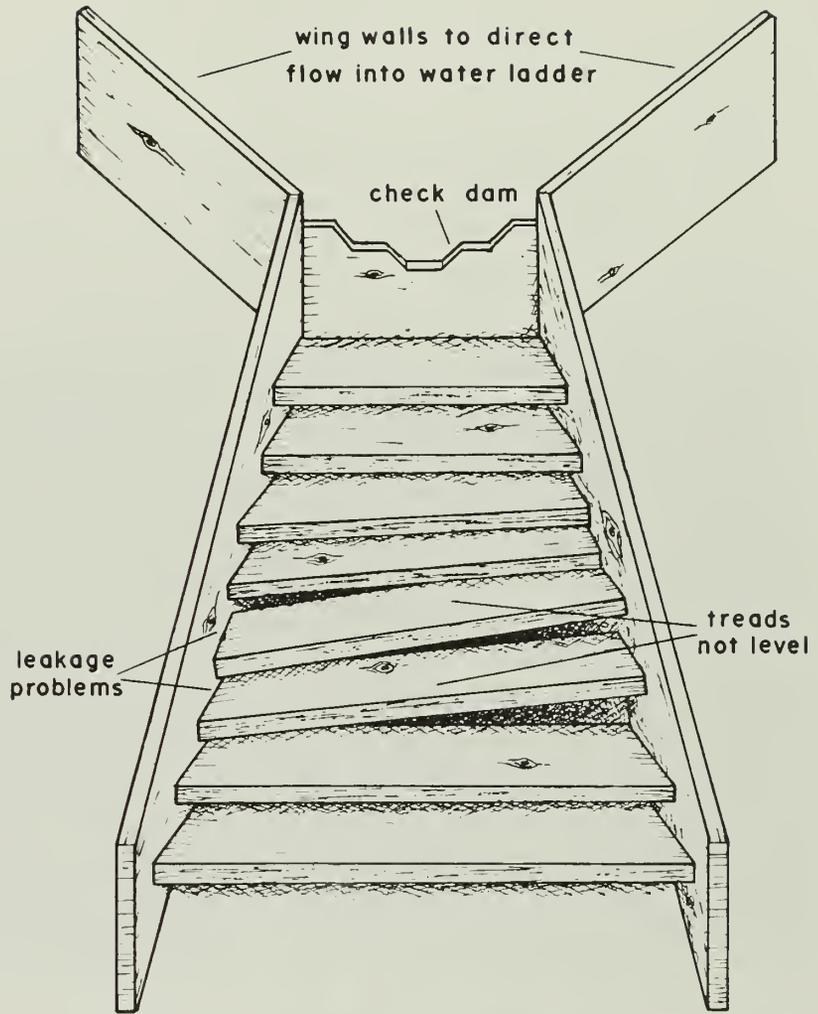
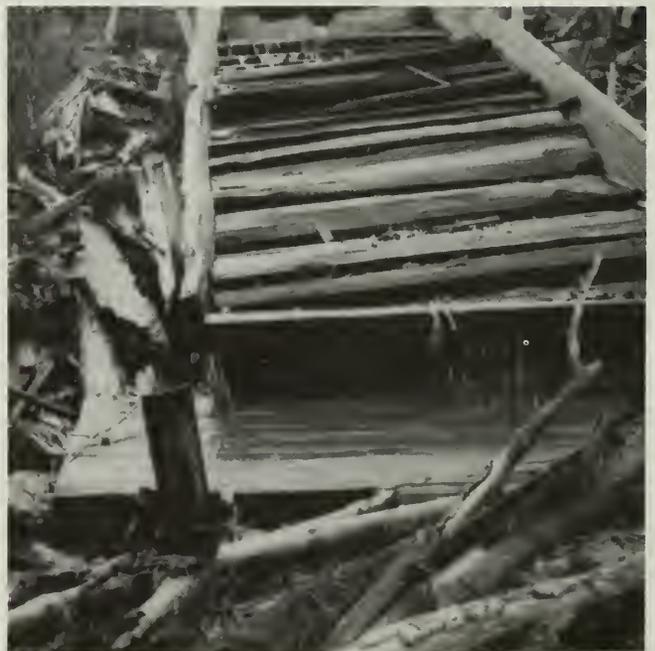
Figure 69:

Three designs of water ladders were used on the Miller Creek unit (see sketches). Type 1 was built of hand-split and hand-sawed redwood slabs. Because of the hand-split wood had an uneven surface, ladder treads were not flush with side pieces, and water seeped through these cracks to flow below the ladder. In addition, ladder treads were not level and water flowed towards the side of the ladder, accentuating leakage problems. Although the knickpoint under the top of the ladder was still protected, undercutting of the ladder would continue and eventually undermine the structure unless leakage problems were corrected. Solutions to the leakage problem include, nailing short slats of wood over and under the treads parallel and flush with the side pieces, caulking all cracks, or cutting grooves on top of the treads to direct low flow towards the center of the ladder. In June, 1979, a CETA work crew repaired the water ladder to prevent further leakage. Figure 69 shows a Type 1 water ladder before repairs were made.

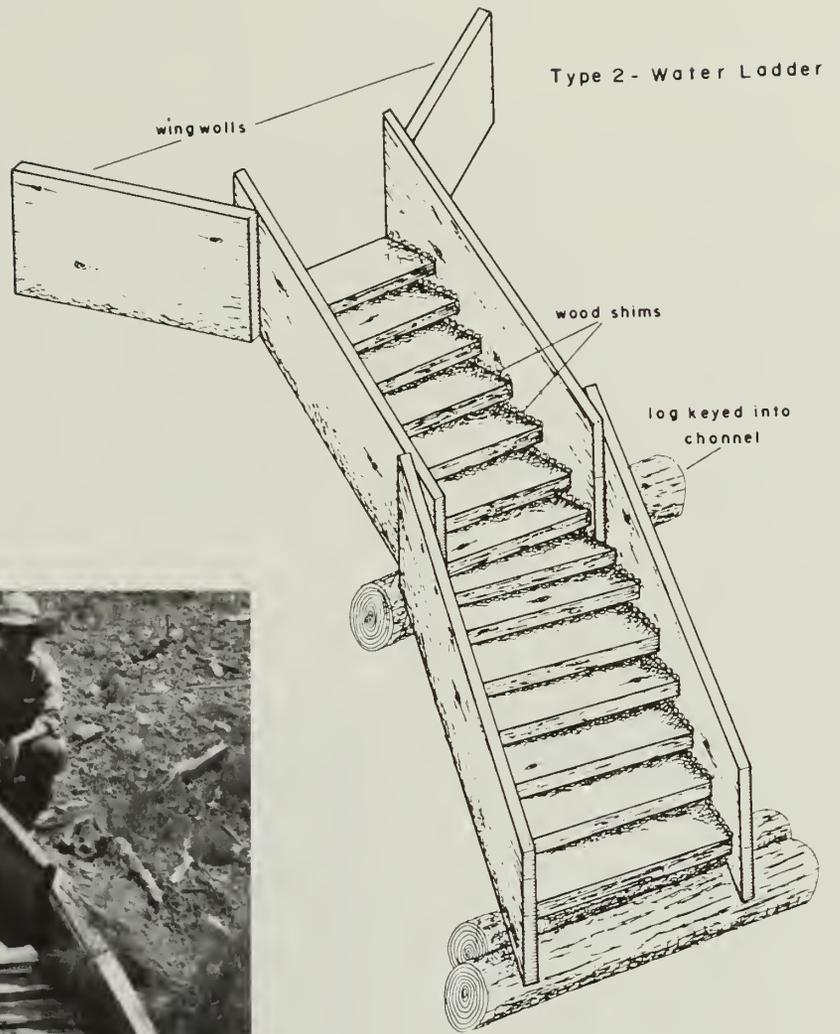
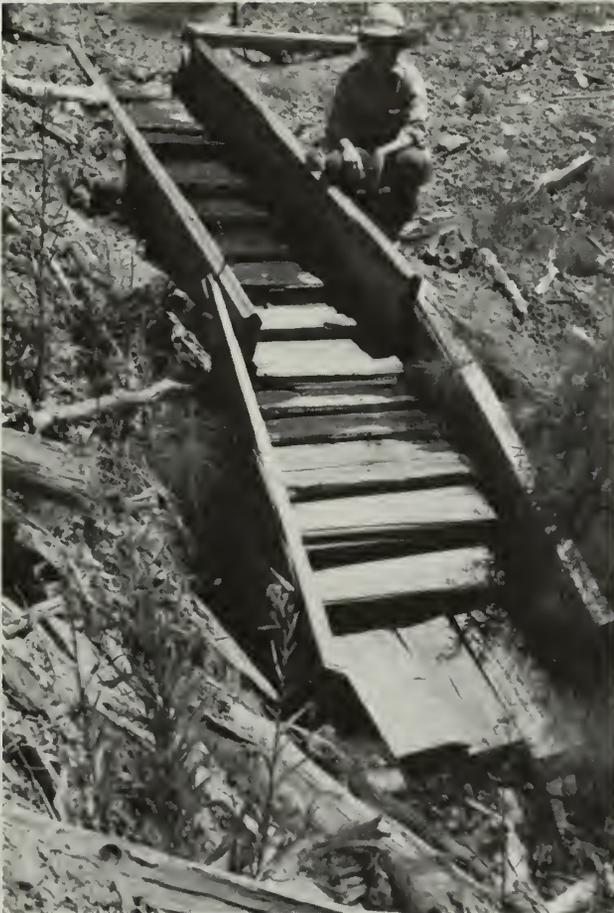
Figure 70: Type 2 Water Ladder

Type 2 water ladder (Figure 70) at Miller Creek is fully functional, and is also built from hand-split redwood. Wing walls above the ladder effectively directed flow over the ladder. The ladder is built in two overlapping sections, conforming to the channel configuration and in-channel debris. The ladder's top tread is keyed into

a partially buried log. Some scour (4 inches deep) occurred upstream of the log, but rocks were deposited in the scour hole. There is little danger of the entire log being undercut. The ladder was large enough for 1978-1979 winter flows; however, a large storm event would probably overtop the structure. Dry wood shims were hammered into all cracks. The shims swelled upon wetting and sealed the seams of the ladder, preventing almost all leakage. The energy dissipator at the foot of the ladder is composed of large logs in the channel (some were already keyed into the channel before the ladder was built). No downcutting occurred below the ladder.
