EVALUATION OF 1978 REHABILITATION SITES AND EROSION CONTROL TECHNIQUES

REDWOOD NATIONAL PARK WATERSHED REHABILITATION

TECHNICAL REPORT
APRIL 1980

MARY ANN MADEJ,
HARVEY KELSEY, AND
WILLIAM WEAVER

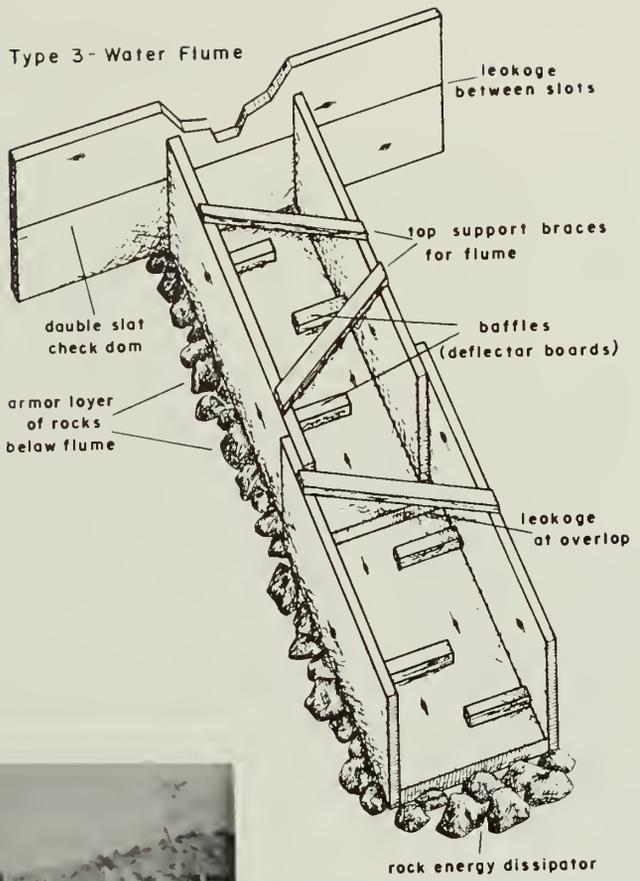
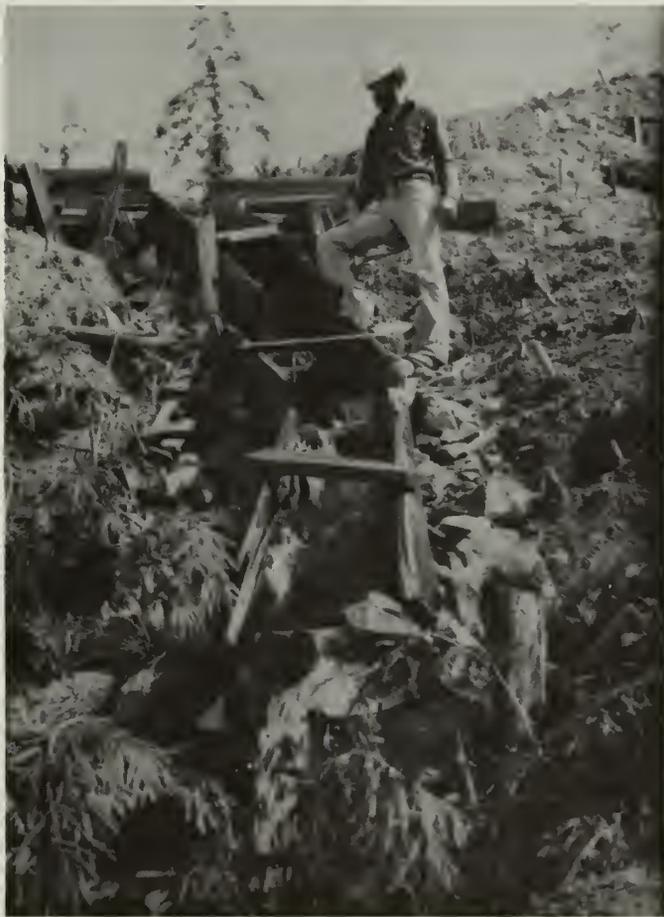
Figure 71: Type 3 Water Flume

Type 3 (Figure 71) was a water flume constructed at Miller Creek from milled redwood slabs. A check dam built at the top of the water flume directed water through its spillway into the flume. A layer of large rocks was used to line the channel bed, and the flume (three 7-foot sections) was installed on top of the rocks. Braces built across the top of the flume add support to the structure.

The Type 3 design developed several problems. Cracks between two slats of the check dam leaked water to the channel outside the flume. The flume's area (18x18 inches) is too small to handle high flows. The rocks under the flume settled and as a result, the flume shifted slightly. The three sections did not overlap adequately, and some leakage occurred. Some baffles or deflection boards in the flume caused water to jump over the sides at high flows. The flume's outlet did not face downstream, but was slightly directed towards the left bank. An energy dissipator of large rocks placed in and around a trash rack was not sufficient to prevent bank erosion below the flume.

To summarize, the most significant problem by far with Type 3 water flume was the small cross-sectional area of the flume that will not accommodate runoff generated by even a 10-year storm event. The flume will probably wash out, creating severe erosion at the break-in-slope and leading to the development of a gully headcut.

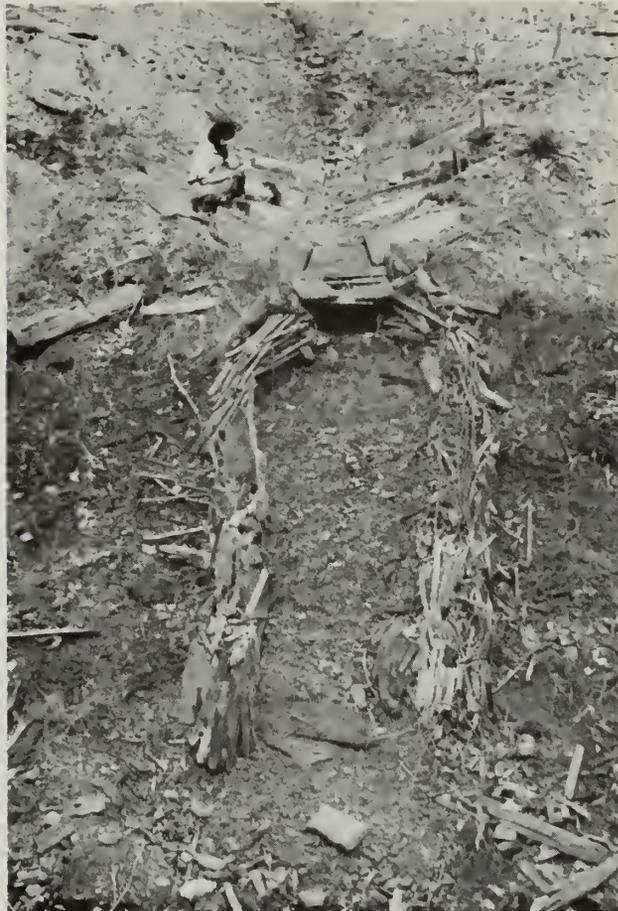
By September, 1978, a long gully had developed on the Bond Creek Unit (Figure 48), and a six foot knickpoint in the gully was beginning to migrate upslope. A gully plug installed at the knickpoint protected the headcut from further migration and erosion while conveying water across the sensitive area (Figure 75). In this respect the gully plug was used as an alternative to a water ladder in treating this erosional problem.

Figure 75: January, 1979
The gully plug on the Bond Creek Unit has collected a considerable amount of gravel and fine-grained material while protecting the headcut of the gully from migrating upstream. Three check dams with submerged spillways are located directly upstream of the gully plug (by the person in the photo) to prevent downcutting above the gully plug.

The gully carried heavy flows in winter and much sediment was transported to the gully plug. Fine particles ranging up to small gravel filtered through the chicken wire and were deposited in the debris below. Cobbles and large gravel were deposited and temporarily stored on the chicken wire or at the base of the gully. The gully plug was not designed to trap all sediment and some gravel will continue to be delivered to the stream channel below the gully plug.

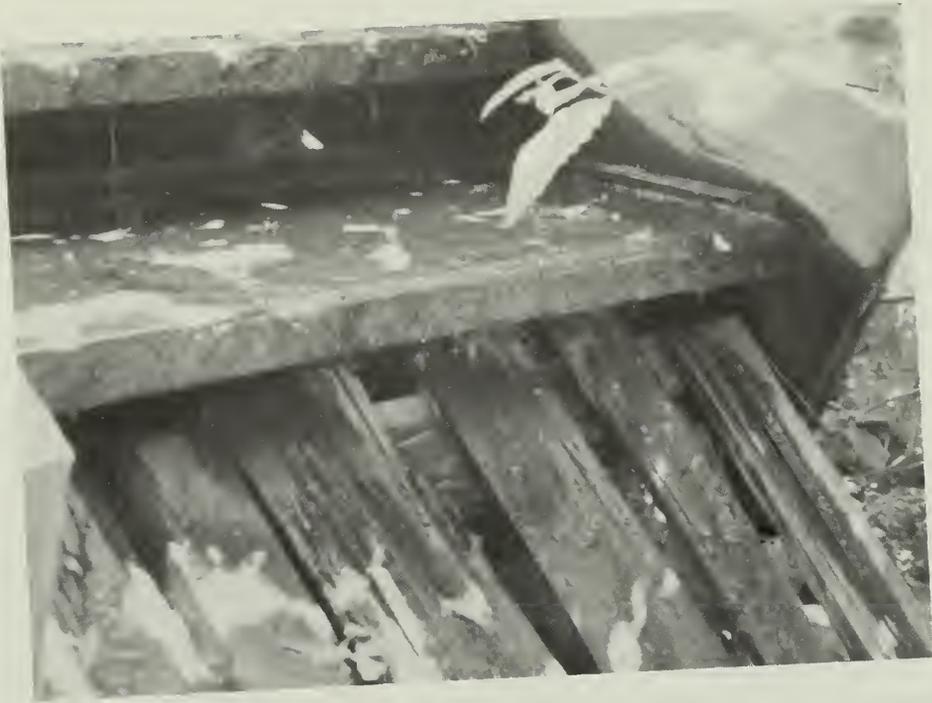
Figure 76. The 'grizzly' energy dissipator below a water ladder. Large rocks were placed under the slats of wood as well.

Water from the ladder drips down the slats or trickles through to the rocks below. No signs of undercutting are visible (Figure 76).

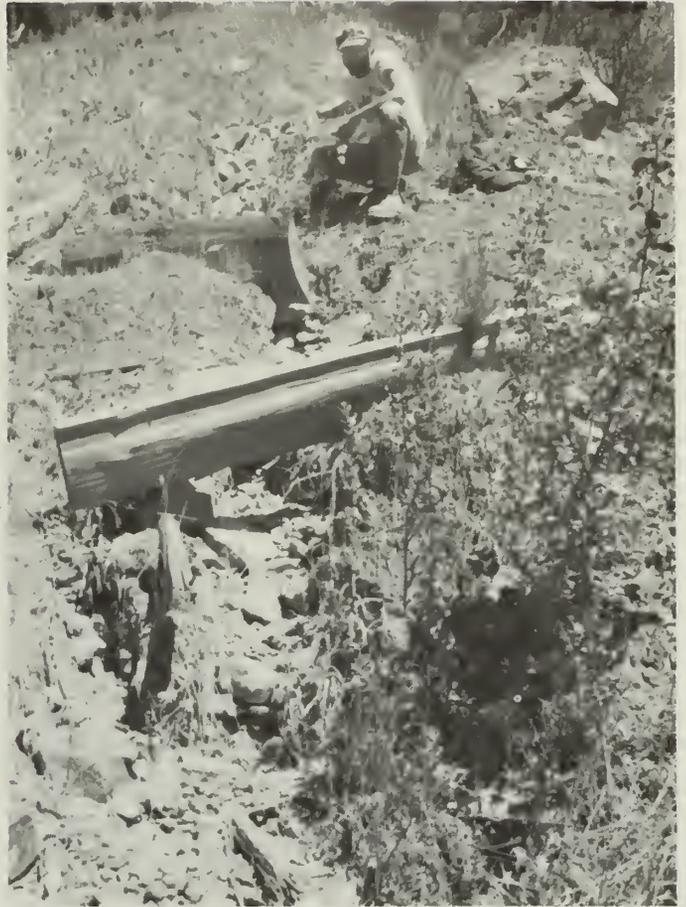
Another form of energy dissipation is a herringbone pattern of redwood slats staked into the ground and backfilled with rocks. Some slats were undercut by winter flows; others worked well. Success of the slats seems to depend on the pattern in which they are set (Figure 77). Alternating slats must overlap four to six inches and be fairly close together in order to effectively handle flows and minimize down-cutting (Figure 78). Rocks upstream of the redwood slats protect slats from the scouring action of unimpeded flow. Even with sufficient overlap herring bone dissipators do not prevent downcutting in the channel. They should not be used in place of a water ladder or check dams to prevent erosion in an area where downcutting is expected.

Figure 78: Emerald Creek
Herringbone energy dissipator
below cross road drain has
been undercut. In this case,
the distance between boards
was too large, and the
upstream sides of the slats
were not protected by rocks.

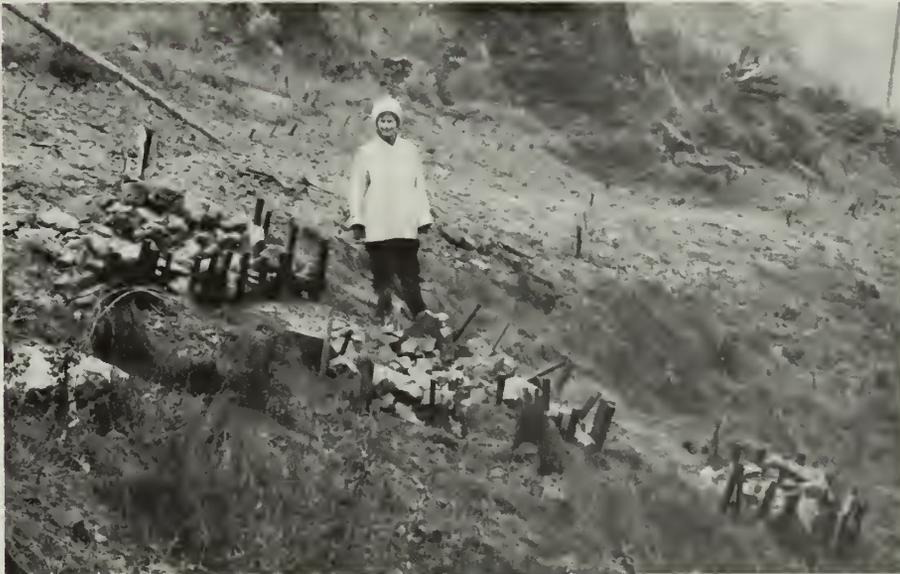
Successive piles of rock held in place by redwood stakes in the channel is another type of energy dissipator (Figure 79). This dissipator did not receive much flow, so its efficiency was not rigorously tested. Nevertheless, the dissipator did handle low-to-intermediate flows well, and no signs of undercutting are evident. More testing of all types of dissipators under high flow conditions is necessary.

Figure 79: Emerald Creek CRD 15
Piles of rock anchored to the slope below a cross road
drain, filter runoff through them and dissipate erosive
energy.

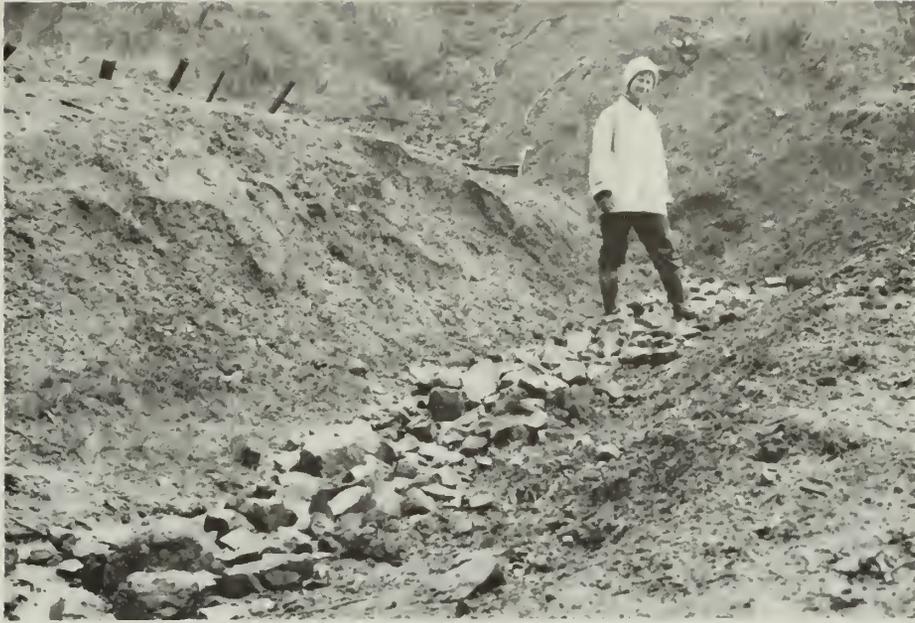
On Emerald Creek, manually placing large rocks (greater than four inches in diameter) in the crossroad drain channels protected the drains from downcutting. Because the lower three-quarters of the former C-90 Road had been rocked, a plentiful supply of suitable rocks was available. Over the winter, fine sediment settled in between the rocks, tightly packing them together, and armoring the channel bed (Figures 80 and 81).

Figure 80: Manually-placed coarse rock on the bed of a cross road drain prevents downcutting of the channel bed while allowing unhindered flow of runoff through the drain.

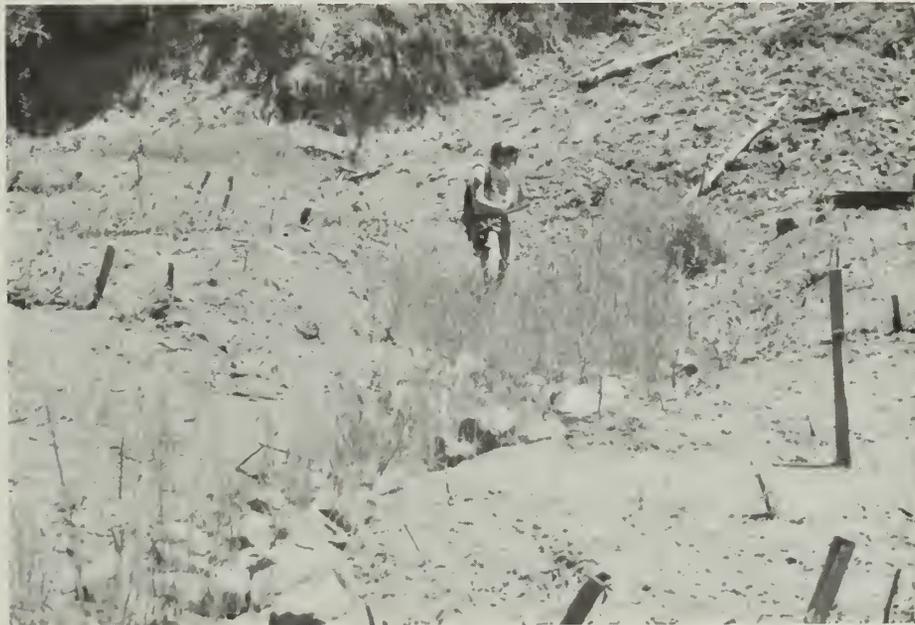
Figure 81: A thick stand of grass in a moist cross road drain adds support to the banks by its dense root mass. The grass and rocks trap fine soil particles that would otherwise be washed downstream.

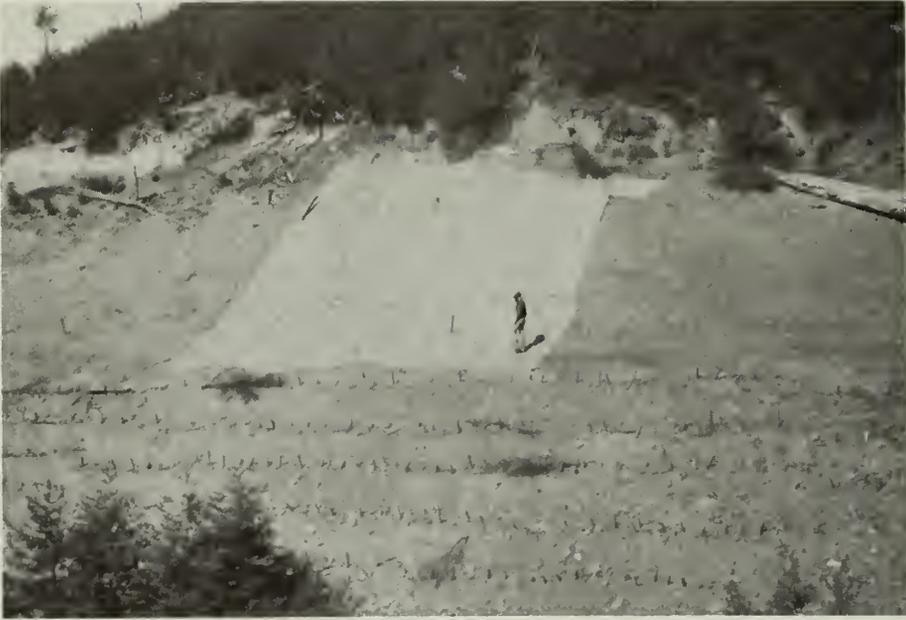
Three types of mulches were used on portions of the outsloped road in Upper Miller Creek, redwood chips, straw, and jute netting (see Figures 82, 83, 84). Mulched slopes (7700 square feet in all) were composed of the same soil material and had similar gradients (20 to 30%). Mulches were spread by hand, and cuttings of willow and other species were planted through the mulch to secure it to the slope.

In general, mulches have shifted slightly downslope over the winter, but little movement of large soil particles has occurred. In June the ground under the mulches (especially the redwood chip mulch) was moist, while on the control sites the soil was dry. Mulches prevented some rockfall from upslope from continuing downslope onto wattled areas. Mulches (especially the straw) also intercepted and dispersed rills originating upslope.

Figure 82: Redwood chip and brush mulch was spread on the outsloped road and Miller Creek, and was then covered with jute netting.

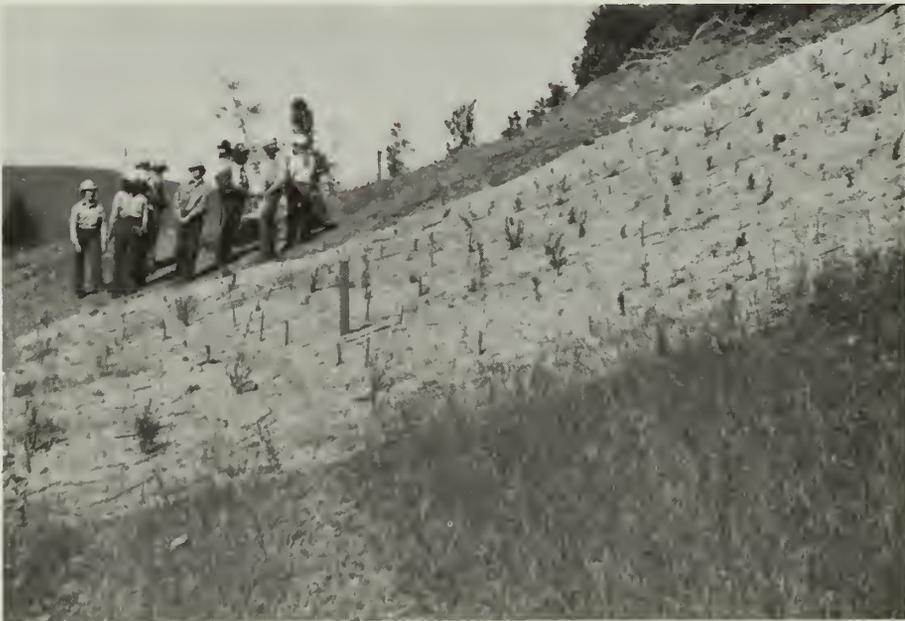
Jute netting without an under-layer of mulch was used on a steeper, rockier slope. The planter box directly below the jute netting was the only one on that slope that did not fill with dry ravel and rockfall over the winter months. Thus, jute netting seems to inhibit the downslope movement of soil particles which would otherwise be susceptible to dry ravel.

Figure 83: A close-up view at Miller Creek of the jute netting showing the stem cuttings which were used to secure the netting to the slope.

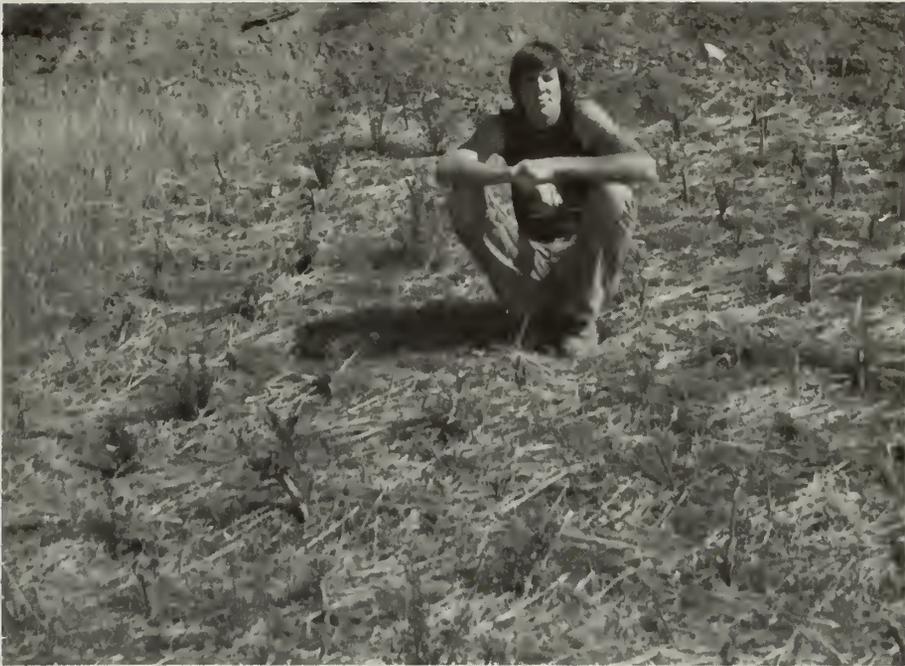
The effect of mulches on soil properties (texture, pH, nutrient levels, etc.) is not yet known, but will be tested more extensively in the future. Comparison data of seedling and stem cutting survival on straw-mulched versus control slopes are not yet available. Trace amounts of wild wheat (*Avena sativa*) found on the straw-mulched sites were probably introduced with the straw.

Figure 84: A close-up view of straw mulch and stem cuttings at Miller Creek Unit.
