Fort Sumter Historic Structure Assessment Report

FORT SUMTER
NATIONAL MONUMENT

National Park Service
November 30, 1992

DATE: INSPECTION AND CONDITION ASSESSMENT REPORT 1992

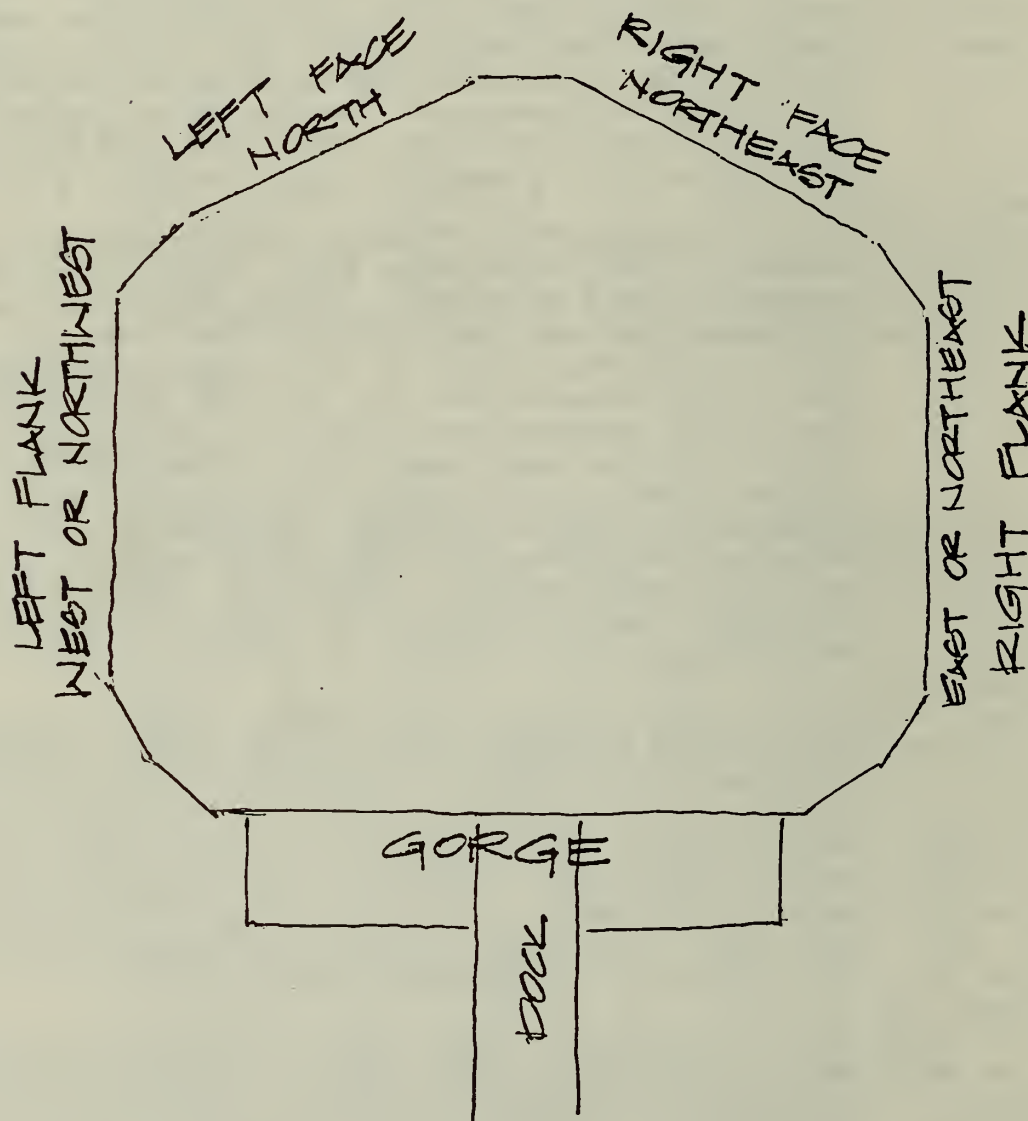
Fig. 1. Correlation between
Gillmore Cardinal Directions and Original
Wall designations

- A. Following an 1868 inspection, a plan of reconstruction was issued in early 1870, with work beginning in January of 1870. Major-General Q. A. Gillmore, who tried to destroy the fort in 1863-64, was now placed in charge of retrofitting it for coastal defense. Inspection of the fort in 1868, and as seen through historic photographs, drawings and historic Corps of Engineers Records, showed that approximately 120 linear feet (LF) of the left flank face and half of the left gorge wall angle still retained the full height to the terreplein. Fifty-four LF remained to the second tier level. The right flank, right flank angle and right gorge angle were destroyed from the fire of Battery Wagner, as were the left face casemates due to reverse fire.²⁵ This same report also addressed the parts of the wall in Cardinal directions. These descriptions are reused, to an extent, in this report. Reference is made to the enclosed sketch detailing the wall's cardinal direction and its historic nomenclature. (See Fig. 1)

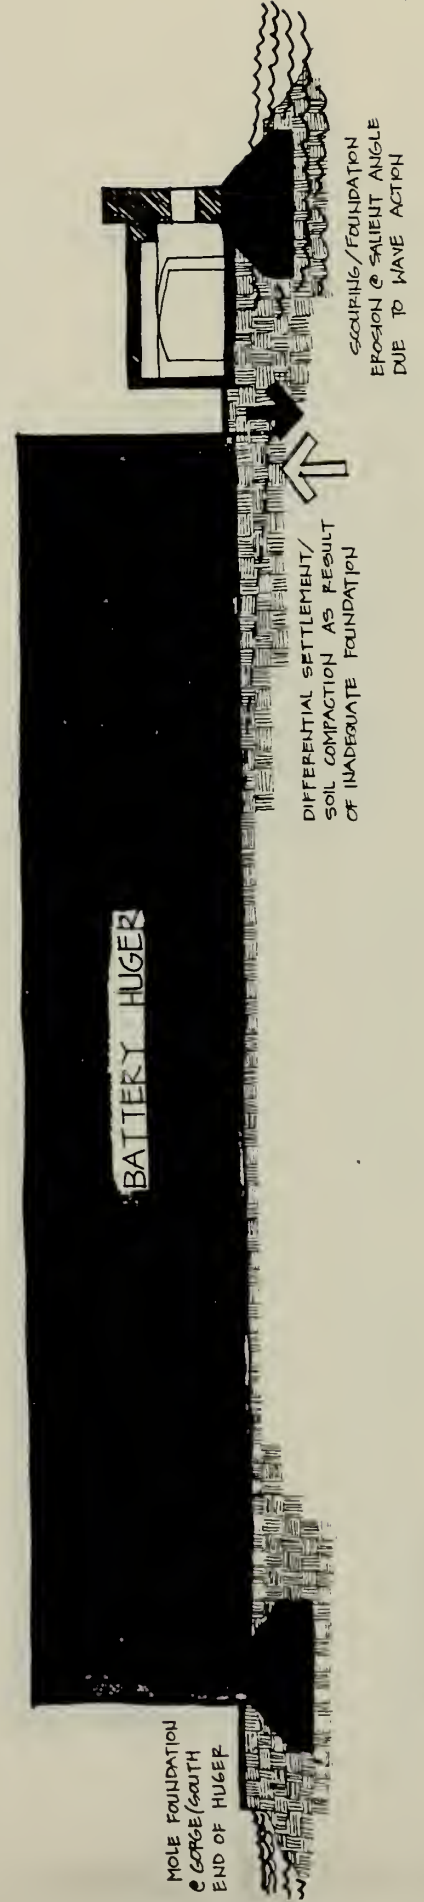
SITE SECTION

--- CEILING CRACKS
--- ROOF CRACKS

CONCEPTUAL MODEL		
STRUCTURAL FORCES	EVIDENCE	SOLUTION
A. TENSION, LATERAL MOVEMENT	INCLUSIVE	• TIE RODS • BUTTRESSES
B. COMPRESSION - EXCESSIVE LOADING, STRUCTURAL BENDING	NONE	• REBUILD W/ LIGHT. MATERIAL • REINFORCE VAULTS
C. ROTATION, OVERTURNING, DIFFERENTIAL SETTLEMENT	NONE	• STABILIZE FOUNDATION

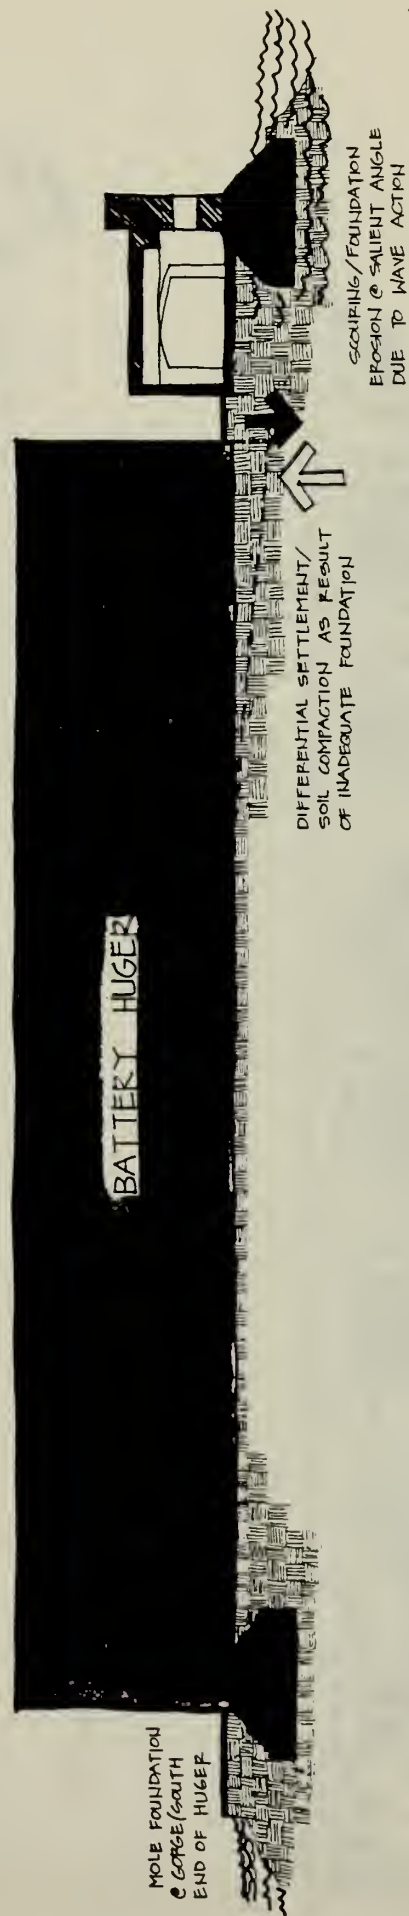
SITE SECTION

AXONOMETRIC OF RIGHT FACE
 - - - - - CEILING CRACKS
 - - - - - ROOF CRACKS

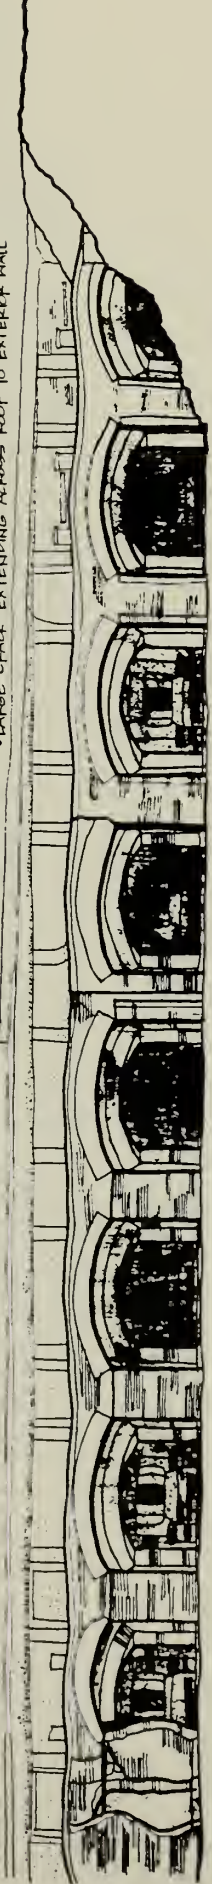
ELEVATION OF CASEMATES

• SEVERELY DETERIORATED
CASEMATE

• LARGE VERTICAL
CRACKS IN
TRANSVERSE ARCHES

• (VERTICAL) CEILING CRACKS & ROOF CRACKS PARALLEL TO EXTERIOR
WALL EXTENDING ENTIRE LENGTH OF RIGHT FACE

• LARGE CRACK EXTENDING ACROSS ROOF TO EXTERIOR WALL

1. BOMBARDMENT	CIVIL WAR	DAMAGED STRUCTURE	SEVERE COMPRESSIVE FORCES - INACTIVE
2. HEAVY EQUIP.	CASEMATE INFILL	ROOF CRACKS	
3. EARTHQUAKE	RECORDED 1806	UNABLE TO DOCUMENT DAMAGE OR EFFECT

<input checked="" type="checkbox"/> a. TIE IN TO EXISTING	-	-	EXCELLENT	NO	NO
<input type="checkbox"/> b. EXPANSION JOINT @ SALIENT ANGLE	-	\$1,000.	GOOD	NO	YES
<input checked="" type="checkbox"/> c. SEAL ROOF CRACKS (Etc.)	10	\$7,000.	GOOD	NO	NO
