UNITED FIRST PARISH CHURCH (UNITARIAN)

CHURCH OF THE PRESIDENTS

HISTORIC STRUCTURE REPORT

April 1996

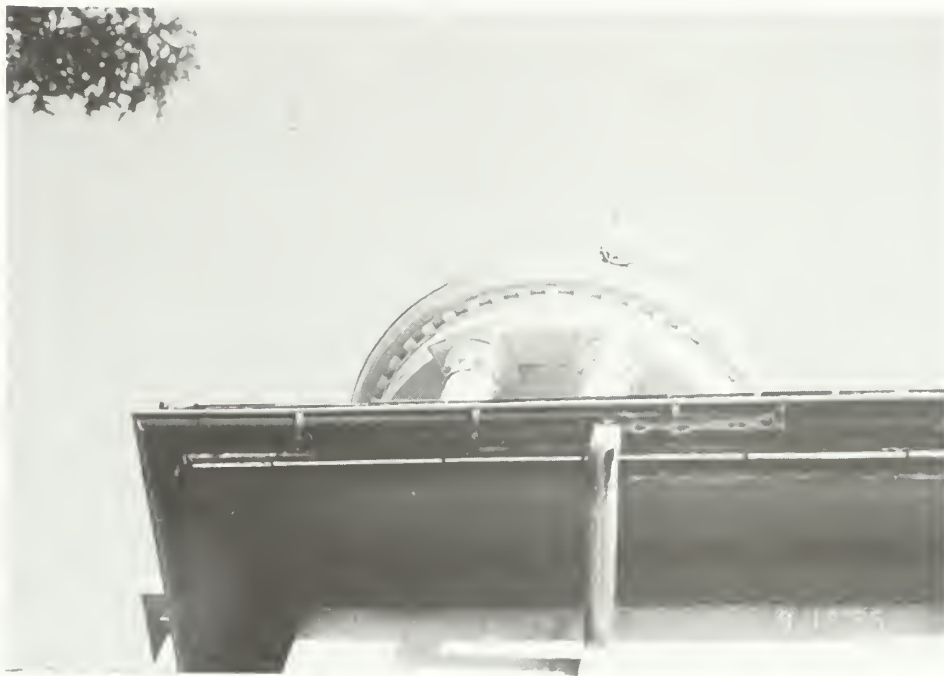
Figure 75. Church exterior: southwest corner of roof, showing hanging half-round copper gutter and rectangular downspout, with oxidation and pitting of the copper.

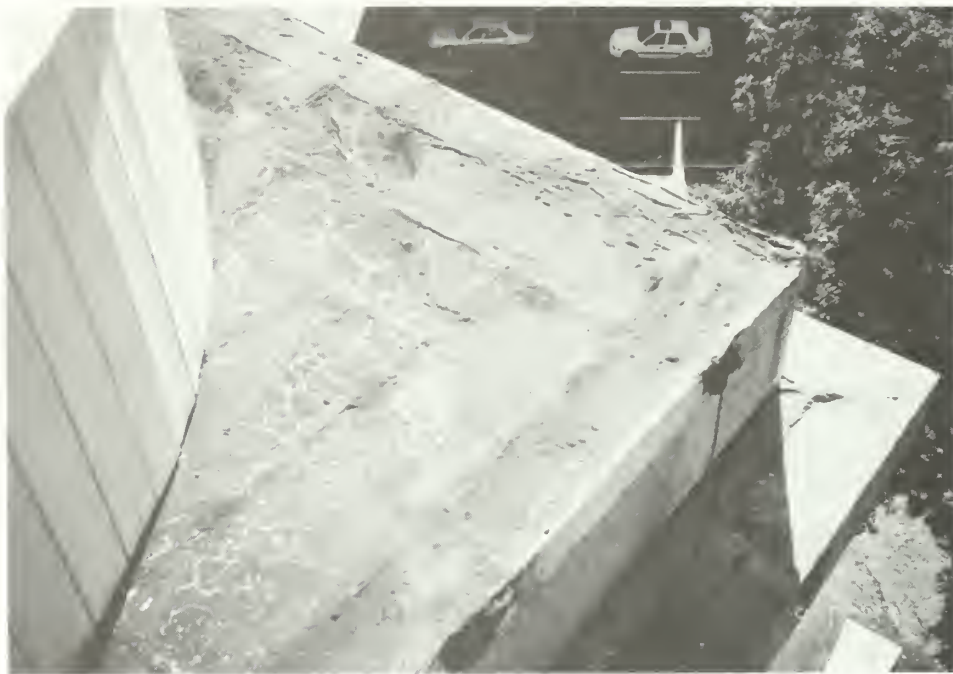
Figure 93. Tower exterior: belfry drum and roof of shaft at southwest corner. Roof of bituminous asphalt over flat-seam copper now weathered, dry, and brittle.
