WILSON'S BRIDGE

Chester County,
Pennsylvania

Preservation Tech Notes

Rehabilitating a Historic Truss Bridge Using a Fiber Reinforced Plastic Deck

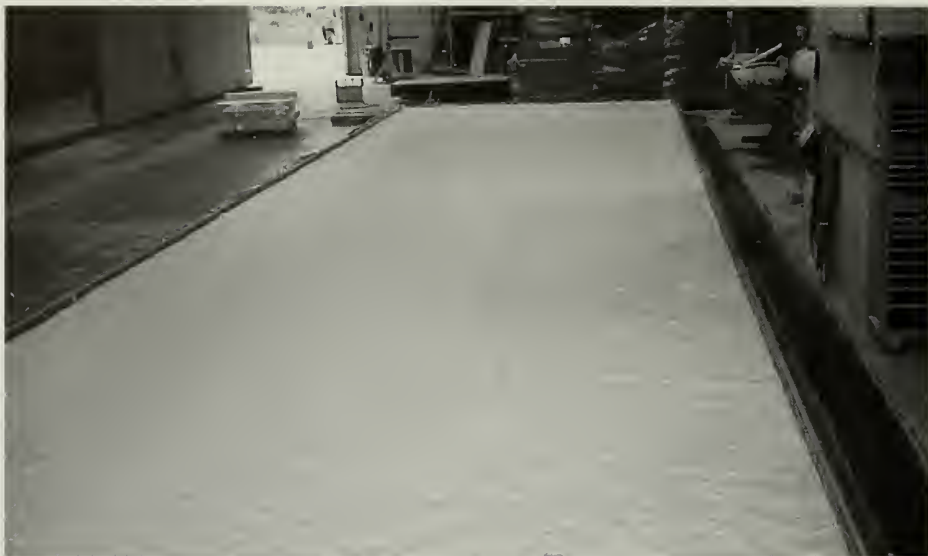
Figure 6. Taken at the composite manufacturer, this photo shows layers of fiberglass arranged around the deck core and placed in the mold. The mold was then infused with a resin that sealed the layers into a one-piece panel. Photo: Hayati Catbas, Hardcore Composites.

The manufacture of the FRP deck was made possible by a number of recent innovations in composite material production. The Wilson's Bridge deck was fabricated using an adaptation of the technique known as vacuum assisted resin transfer molding, or VARTM. In this technology, a plastic honeycomb core is sandwiched between fiber layers in a mold (*see figure 6*). The mold is sealed and a vacu-

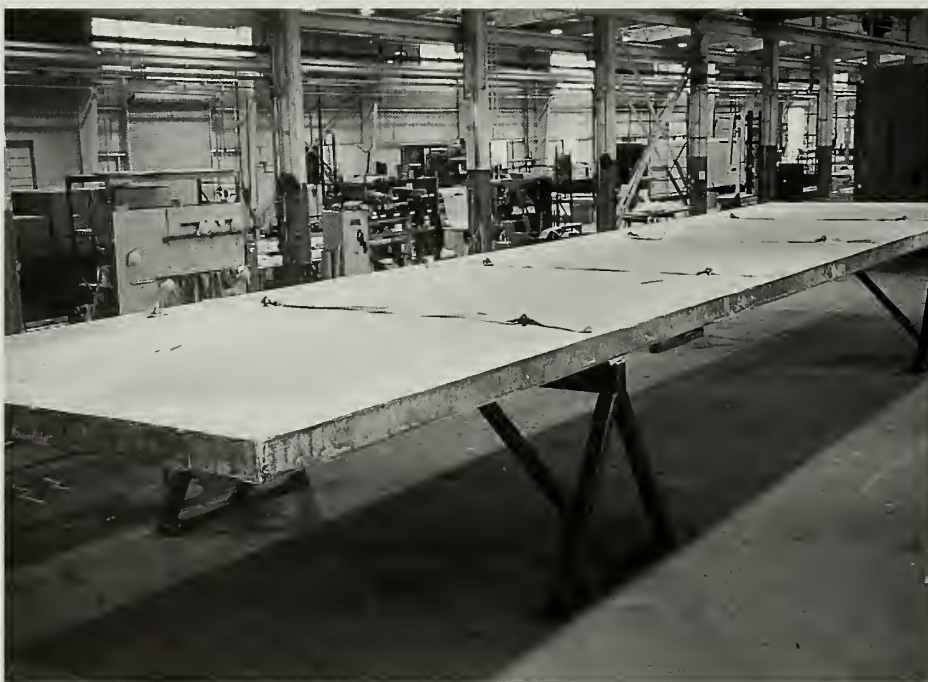
Figure 7. After the panel had set into a solid mass, workers removed it from the mold and sanded and finished all surfaces. The last steps included painting the deck and installing the oak plank wearing surface. Photo: Hayati Catbas, Hardcore Composites.

um removes air while drawing a resin into the mold and through the fiber/core sandwich. It sets into a uniform, seamless panel that is then sanded and finished (*see figure 7*). Closed vacuum infusion molding processes such as VARTM allow for the creation of three-dimensional structural elements that are extremely light yet durable.

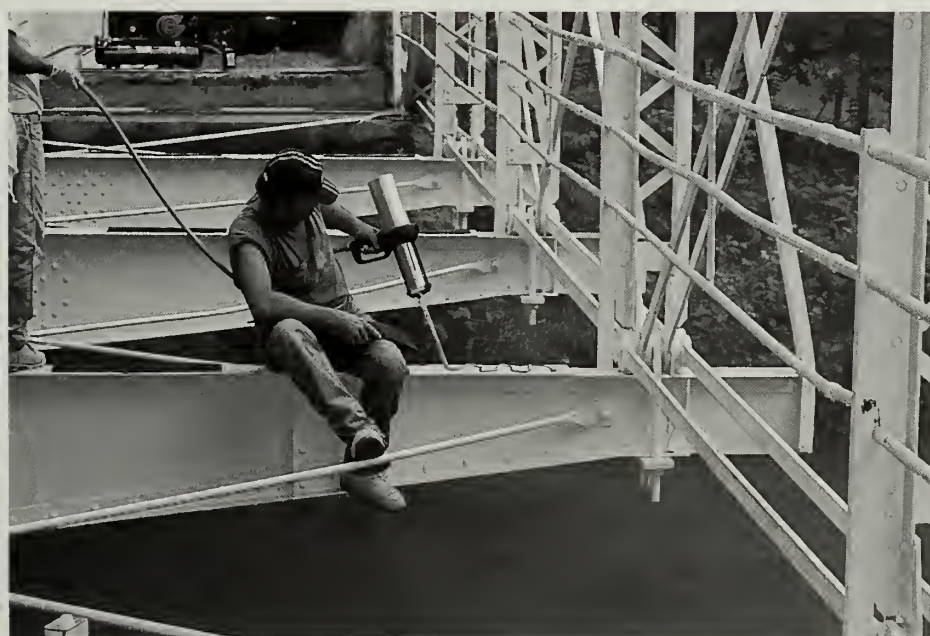
Figure 9. A worker applied adhesive to the floor beams where each of the bearing pads would be positioned. Four pads were installed on each floor beam to cushion the deck, evenly distribute loads to the floor beam and provide a secure fit between beam and deck.

were glued at regular intervals to the top surface of each floor beam (see figure 9). A twenty-ton crane then lifted the deck off the trailer bed and, with guidance from the workers, slowly lowered it into position (see figures 10 and 11). Lag bolts with steel clips were inserted into predrilled holes along the underside of the deck, securing the deck to each of the floor beams (see figure 12).

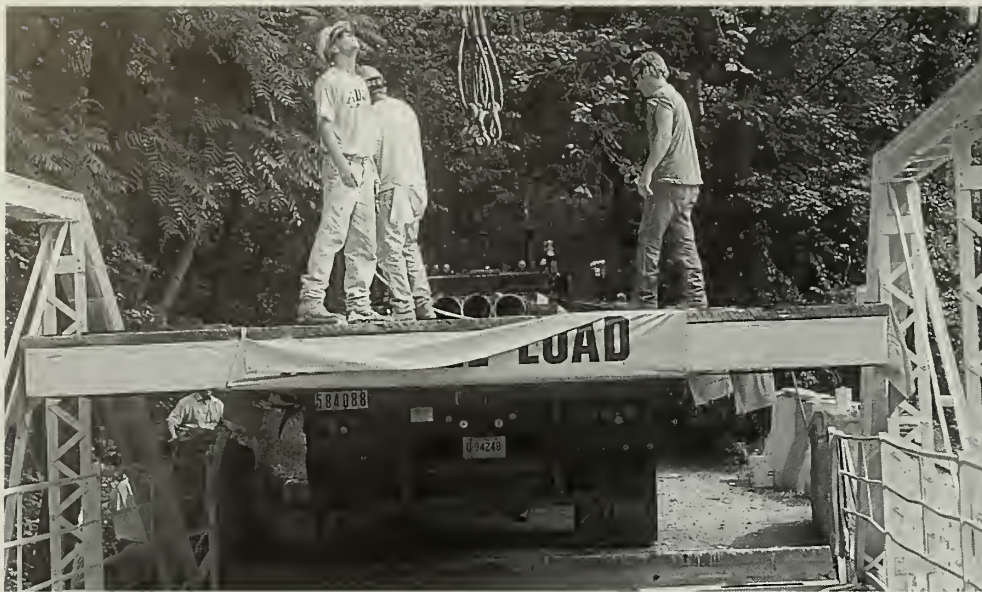
Figure 10. When the deck arrived at the site, the trailer was backed onto the bridge approach and crane cables secured to the deck. Although the road beyond that side of the bridge is a dead end, the truck driver was able to maneuver across a vacant site to get the deck on the opposite side of the creek.

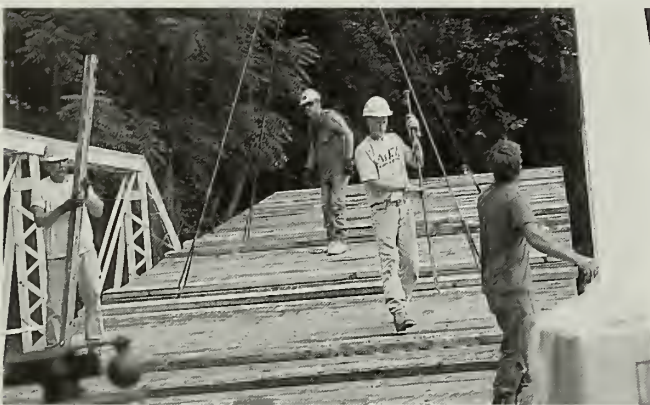
Figure 11. As the deck was lifted off the trailer and onto the floor beams, workers wedged timbers and bars along the sides to prevent the deck from damaging the truss and to help place the deck in position.

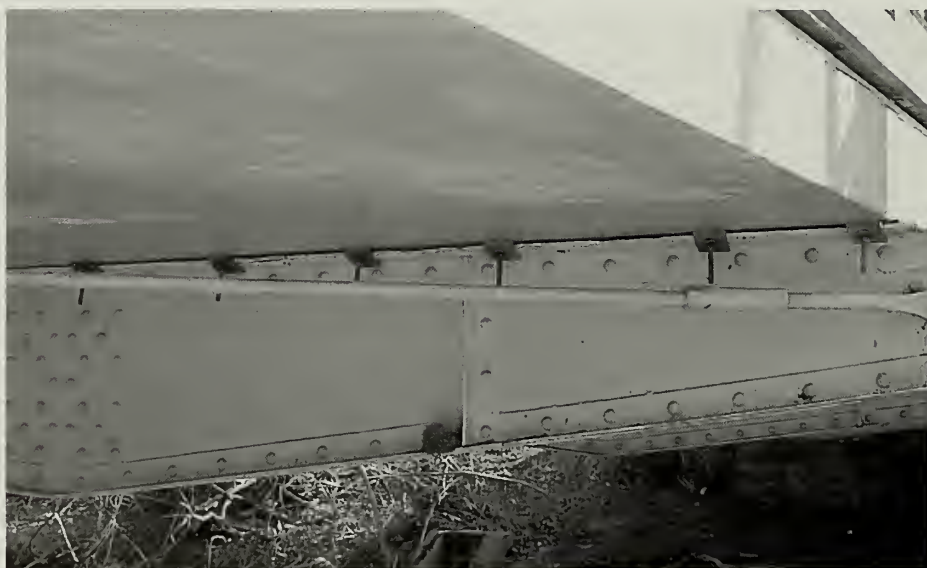
Figure 12. To secure the deck to each floor beam, lag bolts with steel clips were inserted into predrilled holes in the deck surface and fastened tight against the floor beam's upper flange.

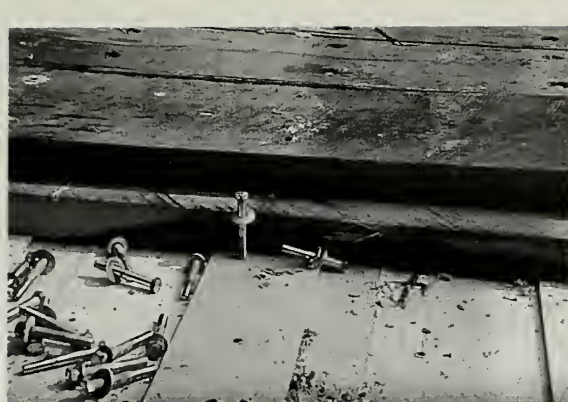
Figure 13. After the deck was locked to the floor beams and the crane cables removed, remaining oak planks that made up the wearing surface were bolted to the composite deck.

After the crane cables and fasteners used to lift the deck were removed, the remaining oak planks were attached to the deck with lag bolts (see figure 13). The use of a timber plank overlay was unusual for an FRP deck. Often these decks have a thin epoxy resin and aggregate surface that is susceptible to damage by snowplows. The timber deck used on Wilson's Bridge, however, is easily replaced when damaged or deteriorated. It also recreates the historic appearance of the bridge from the roadway.

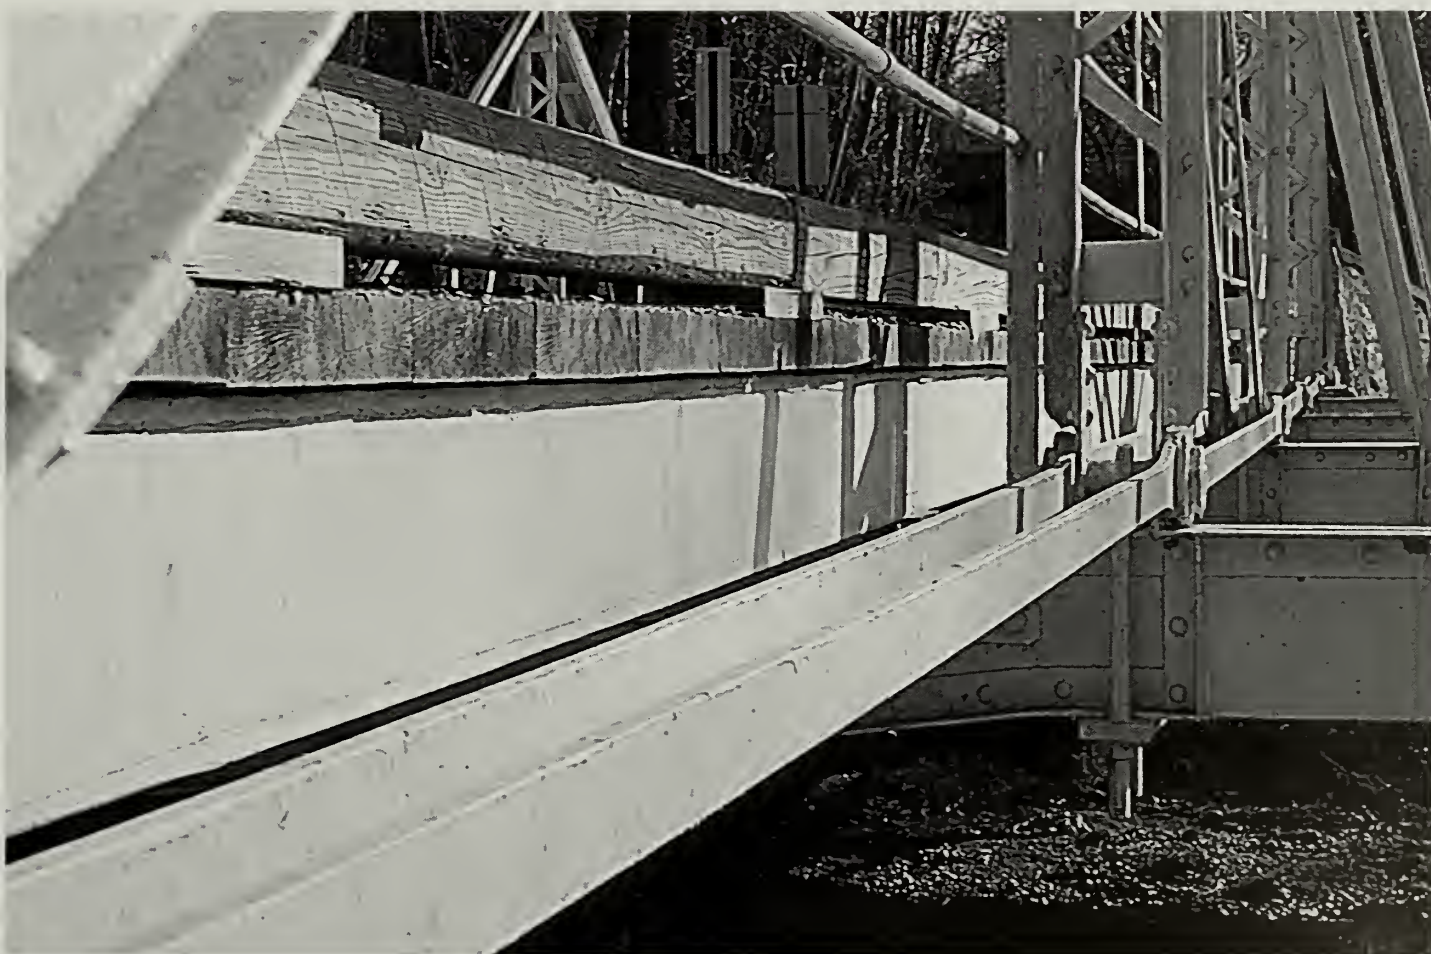
Figure 14. The composite deck, painted to match the superstructure, is visually compatible with the historic bridge as it originally appeared with timber stringers. The new deck and wearing surface are the same thickness as the previous system of steel stringers, nail-laminated deck, and bituminous surface. Photo: Chad Randl.

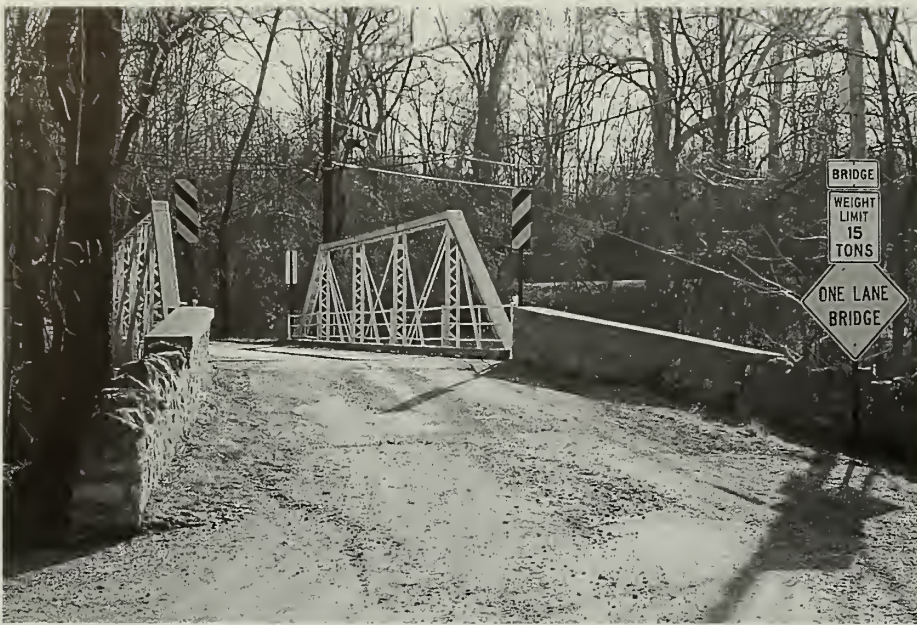
Figure 15. The landscape surrounding Wilson's Bridge has changed little since the span was constructed in the 1800s. The use of a composite deck and plank wearing surface in place of the deteriorated, fourth generation deck was an innovative solution that allowed the bridge to remain in place and in use with little change to its historic character. Photo: Chad Randl.
