Cultural Landscape Report for the Historic Motor Road System Acadia National Park

SITE HISTORY, EXISTING CONDITIONS, ANALYSIS, AND TREATMENT

Cultural Landscape Report For the Historic Motor Road System Acadia National Park

Jeffrey Killion Historical Landscape Architect

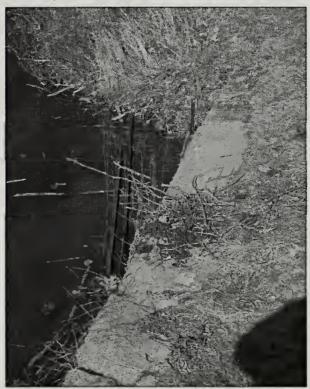
Although every effort was made to minimize damage to the landscape during design and construction, the presence of the historic motor roads has inevitably changed some drainage patterns and redirected some stream flows. Research conducted by park staff has revealed that the design of some of the culvert assemblies serving perennial streams are inhibiting fish migration patterns and may need to be modified (Figure 4.3). More studies are planned to further identify problem culverts and to recommend possible solutions. The use of "beaver foolers" at culverts is also on the increase, and discussions at the treatment workshop focused on regularly inspecting culverts near beaver activity (Figure 4.4). Wildlife breeding periods and wildlife mortality rates are also issues along the motor roads.

Figure 4.3. The culvert that conveys a perennial stream near the junction of Day Mountain Road Extension, Jordan Pond/Eagle Lake Road, and Stanley Brook Road has been identified by park staff as a possible impediment to fish. (Acad0300_13.227_Out(2), OCLP 2005)

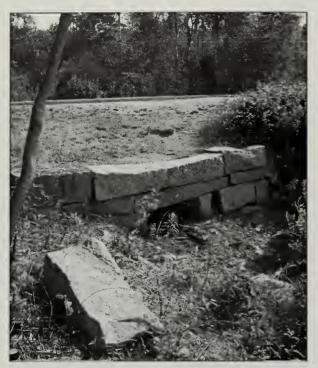
Figure 4.4. View of a new "beaver fooler" along Bureau of Public Roads Project 4A2, after the Precipice parking area. (IMG 0028, OCLP 2006)

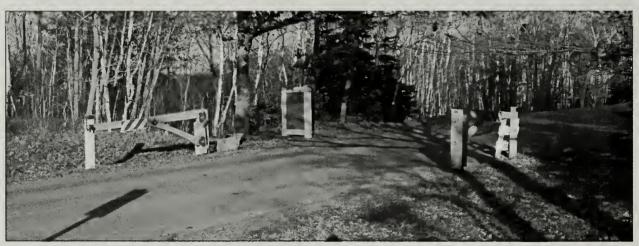
Bituminous paving on some of the roadside shoulders and especially in waterways has also altered the historic character of the motor roads. Historically there were no bituminous paved ditches on the motor roads, but these now outnumber the historic rubble waterways. In the late 1980s on Cadillac Mountain Road, bituminous waterways were installed to solve drainage problems caused by the steep and narrow shoulders, and in some cases the ditch pavement was extended to meet the edge of the paved traveled way. This has created a continuous cross-section of asphalt from ditch to ditch and has visually widened the motor road (Figure 4.6). Recommendations for paved waterways on the historic motor road system will aim to eliminate construction of additional bituminous waterways and replace existing bituminous waterways with mortared rubble waterways when the existing pavement fails.

Figure 4.6. A wider cross-section, caused by paved shoulders or by paved waterways, as shown here on Cadillac Mountain Road, is a psychological cue for motorists to drive faster. (Acad0013_ 2.290, OCLP 2005)

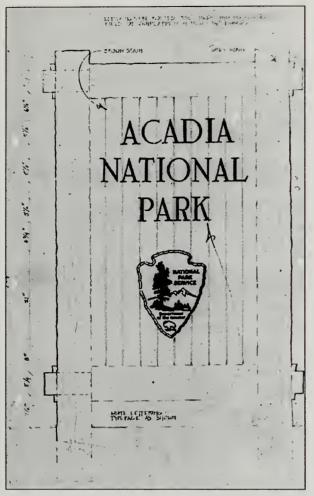
Figure 4.17. Sketch and detail for a new gate that is compatible with the rustic character of the historic motor road system and distinguishable from the historic gates. (OCLP 1993)

Though desirable, the replacement of all existing galvanized steel pipe gates with the historic gate detail is impractical due to considerations of funding and maintenance. However, the new gate detail would be appropriately installed in highly visible locations and major intersections to reinforce the intended gateway effect as well as the rustic character and the historic motor road system (Figure 4.17).
