HISTORIC STRUCTURE ASSESSMENT REPORT

SNEE FARM (MAIN HOUSE)

CHARLES PINKNEY NATIONAL HISTORIC SITE
Mount Pleasant, South Carolina

1997

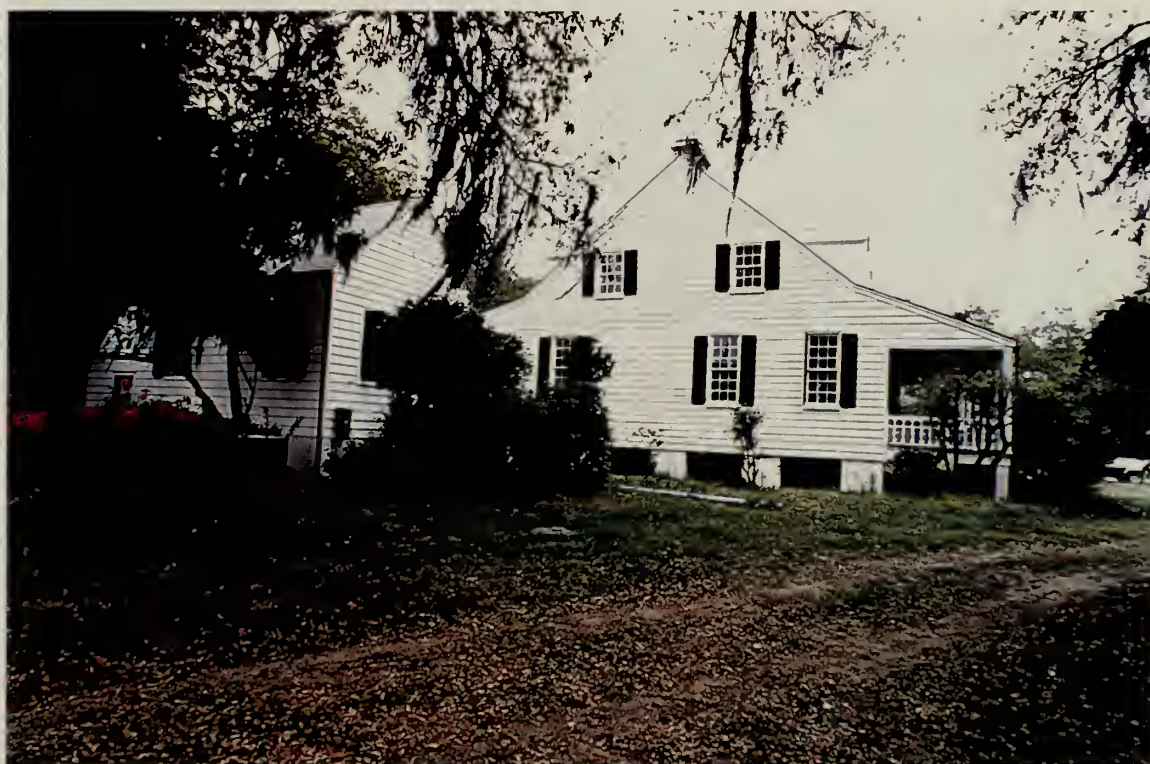
West elevation.

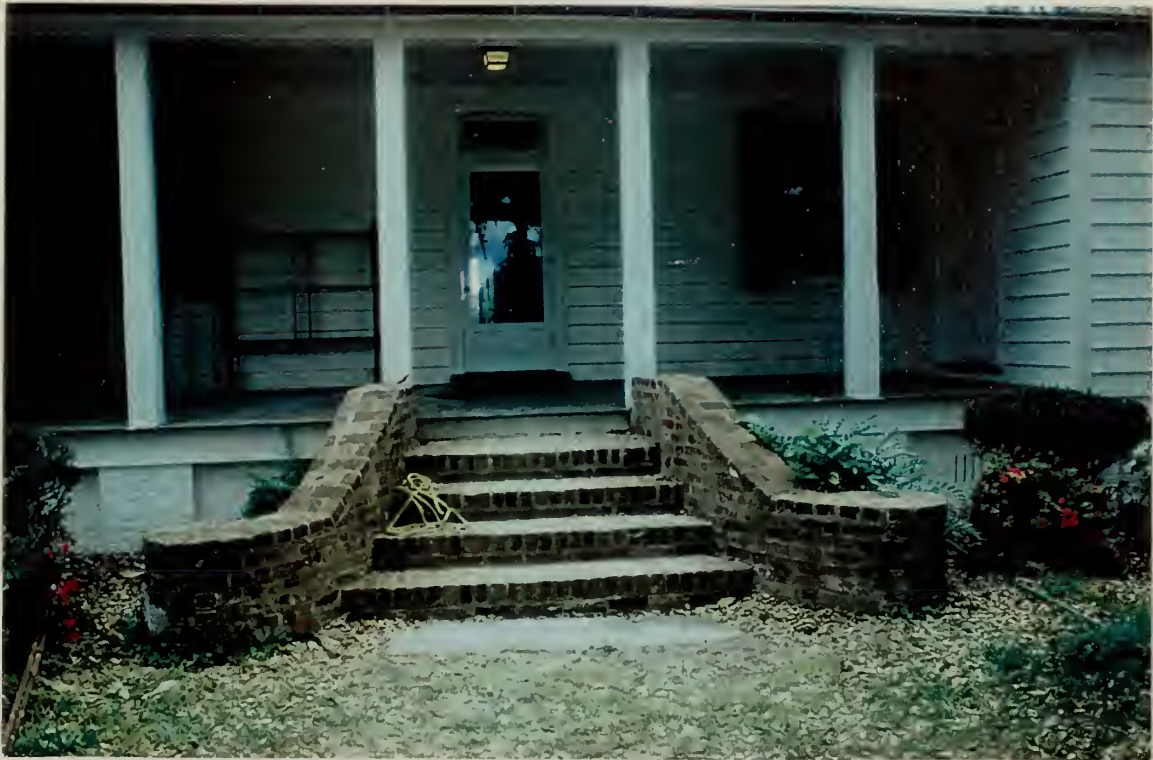
North porch with brick steps and stone treads. The steps at the base extending in a scroll to either side, lead to the porch. Posts are square and handrails and balustrades are removed to repair.

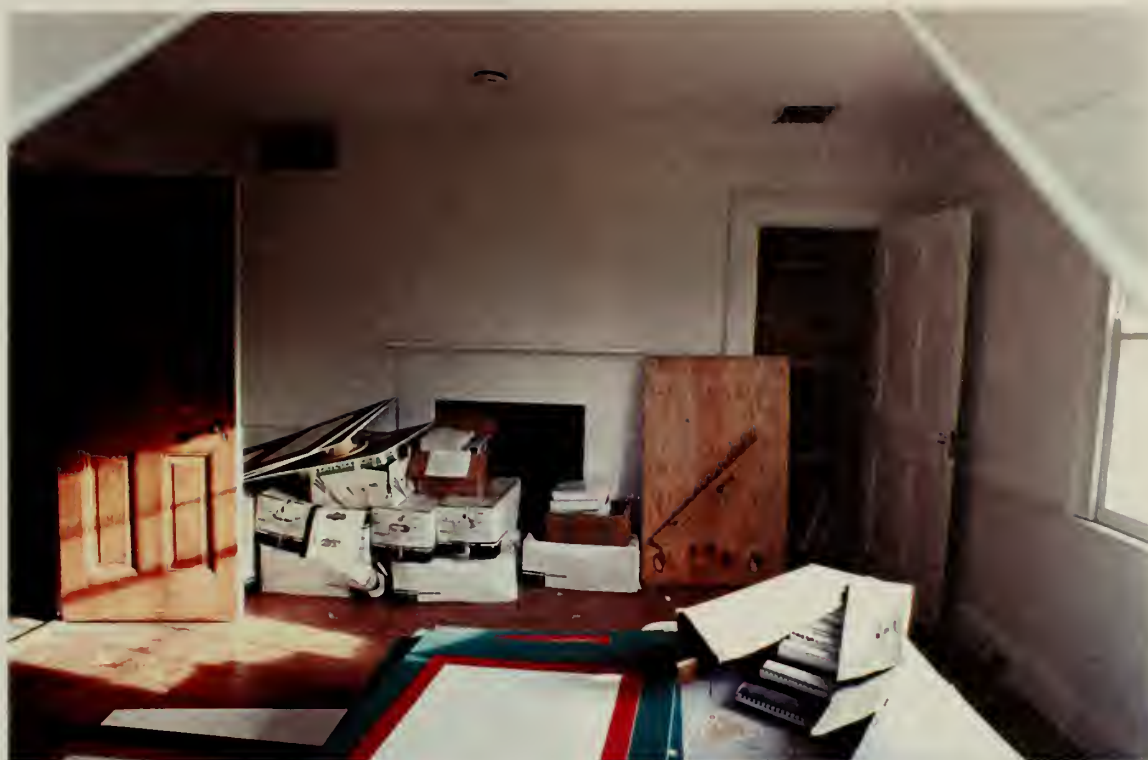
These photos show the interior part of the room on the second floor. It is not evident whether the dormer's board, trim, fire place mantel, wainscote, baseboard, door, and windows were painted or varnished.

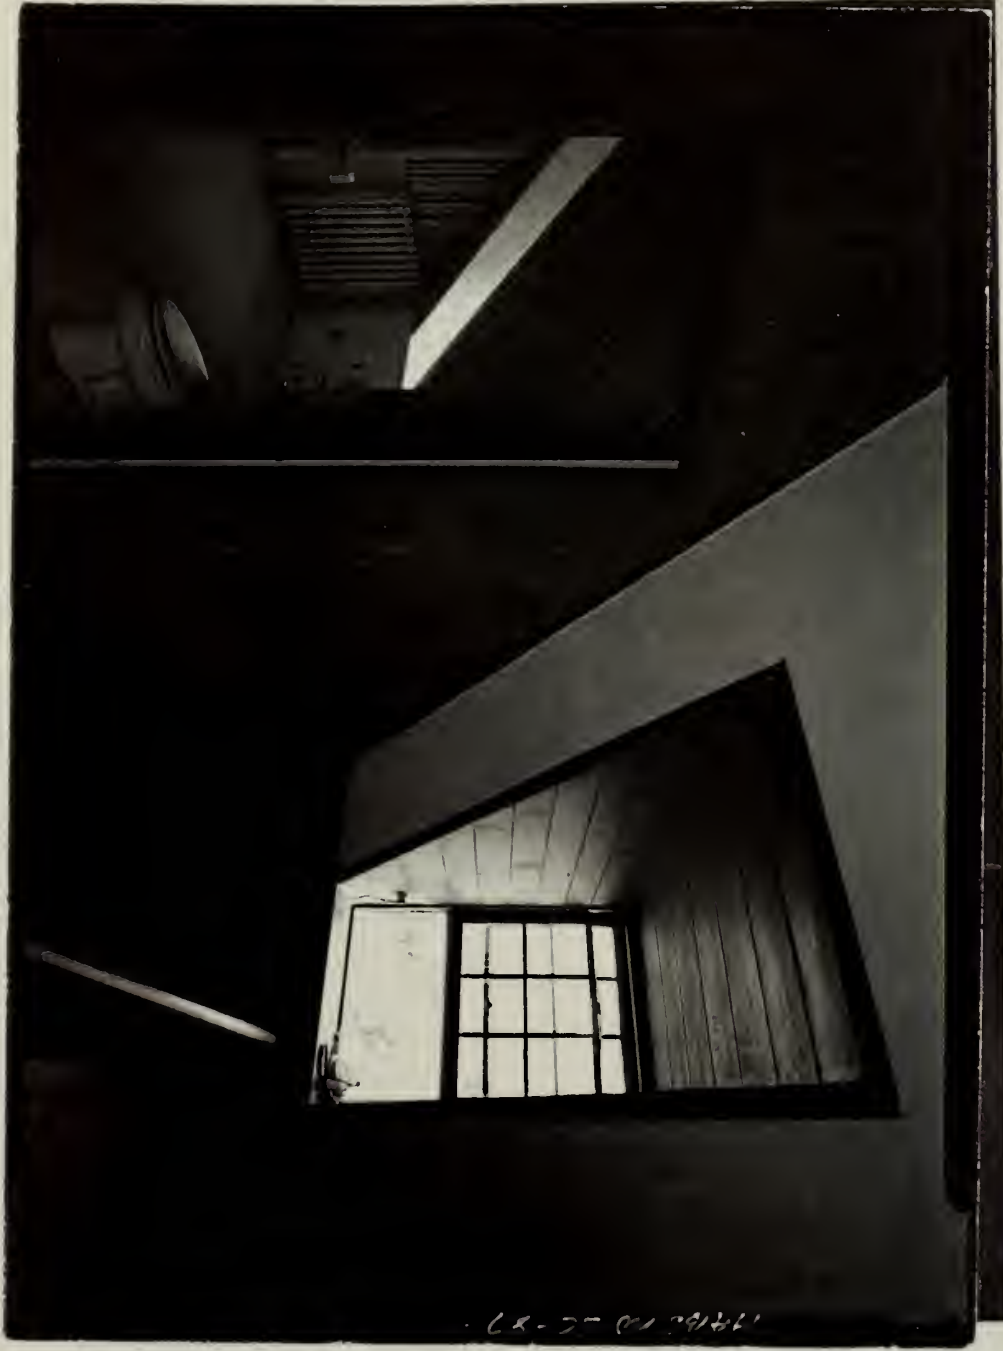
Photo shows the second floor bathroom and corridor dormer before the 1995 remodeling. Wood boards and trim in the area around the dormer window are varnished. It is not evident if varnish is the original finish or not.

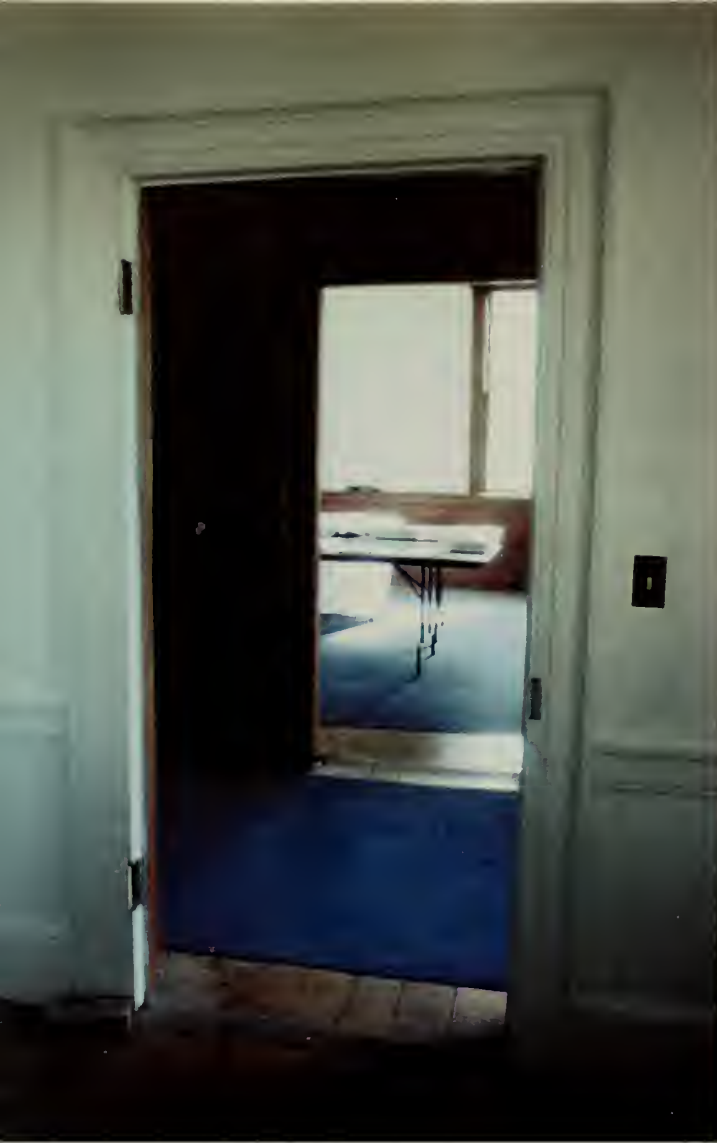
Photo shows the door's wood trim, wainscoting, and baseboard in the southeast room in the main building. Due to lack of a paint analysis, it is not evident if this color is the original color of the door, wainscoting and door trim.

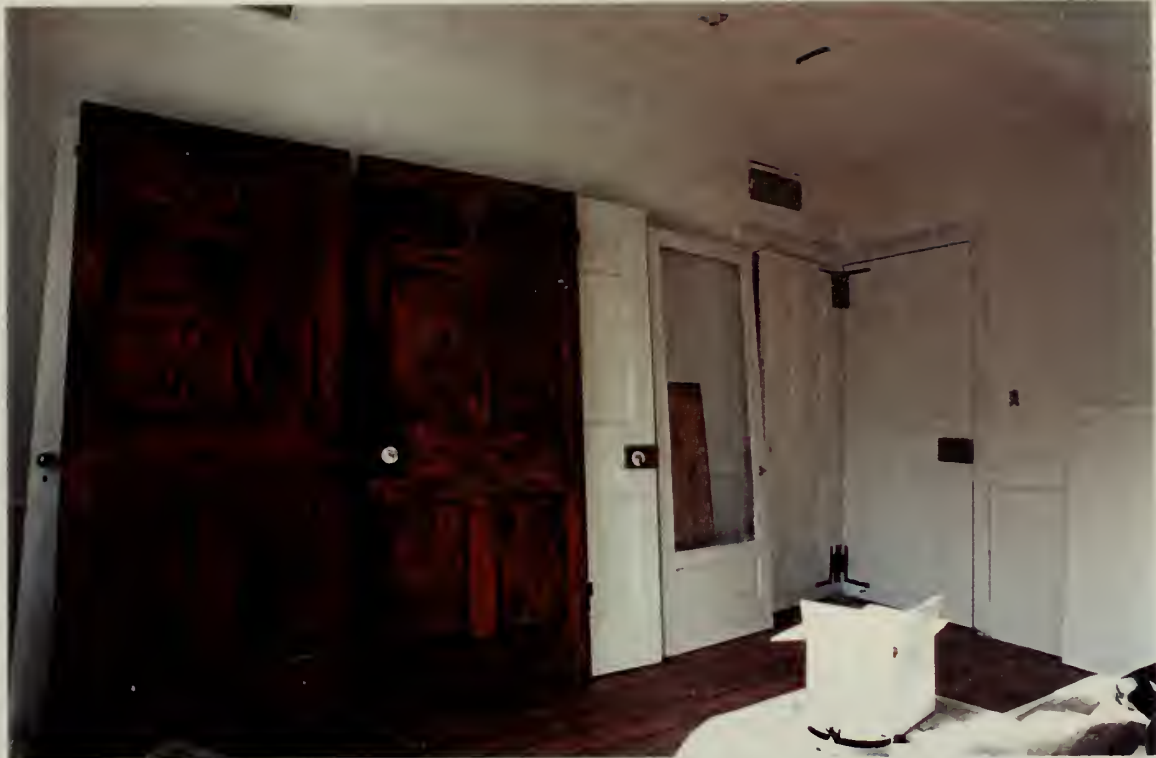
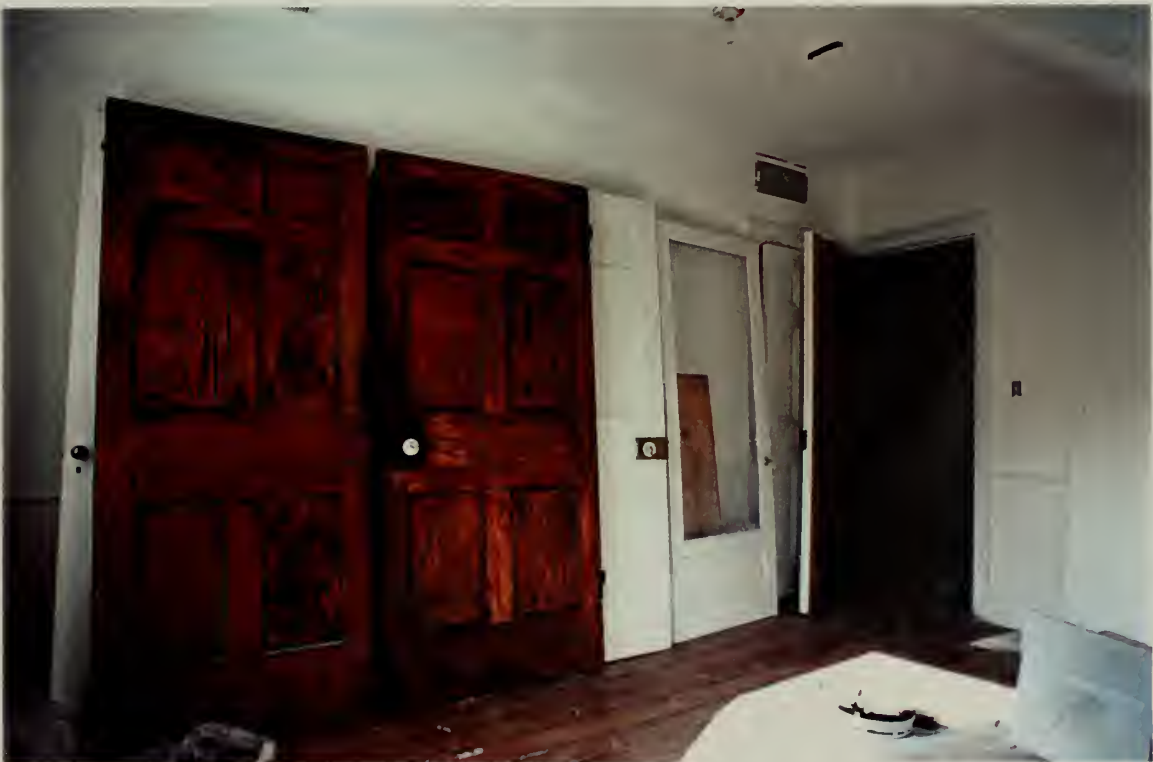
Photos show the original doors that belong to the southeast and southwest rooms on the first floor in the main building. Note the entrance door is painted on one side and the other side is varnished.

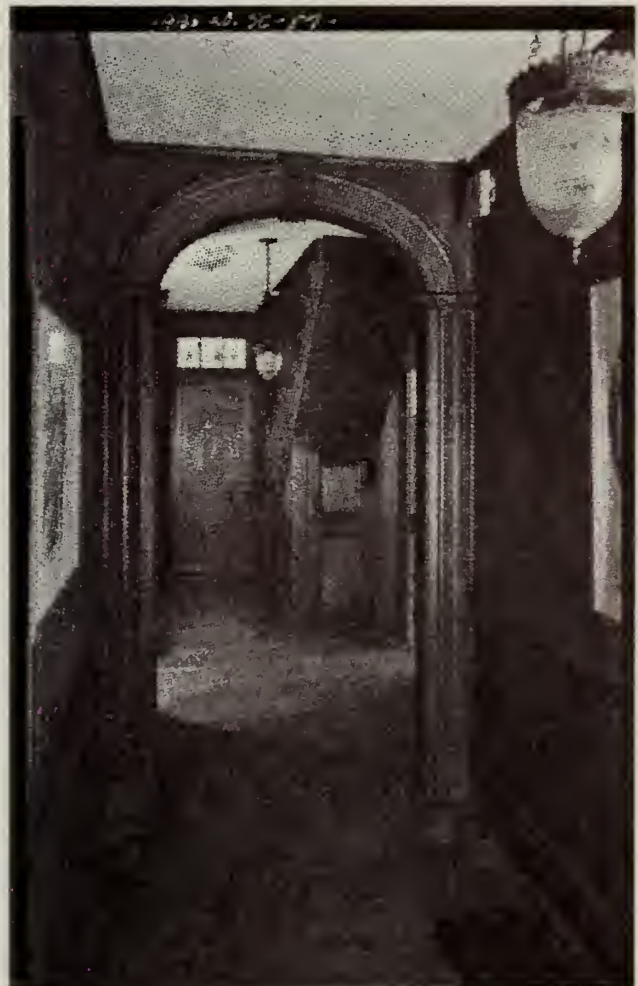
Photo shows the interior part of the main building attic. Note the original wood sheathing and the connection of the rafters. Rafters in the ridge are connected to each other by tenant and mortise with wood peg.
