THE  
KITCHEN BUILDING  
AND ASSOCIATED  
CHIMNEY STRUCTURE  
AT  
HAMPTON PLANTATION  
STATE PARK

McCLELLANVILLE, SOUTH CAROLINA

BUILDING SURVEY AND DOCUMENTATION  
SEPTEMBER / OCTOBER 1998

WILLIAM R. JUDD

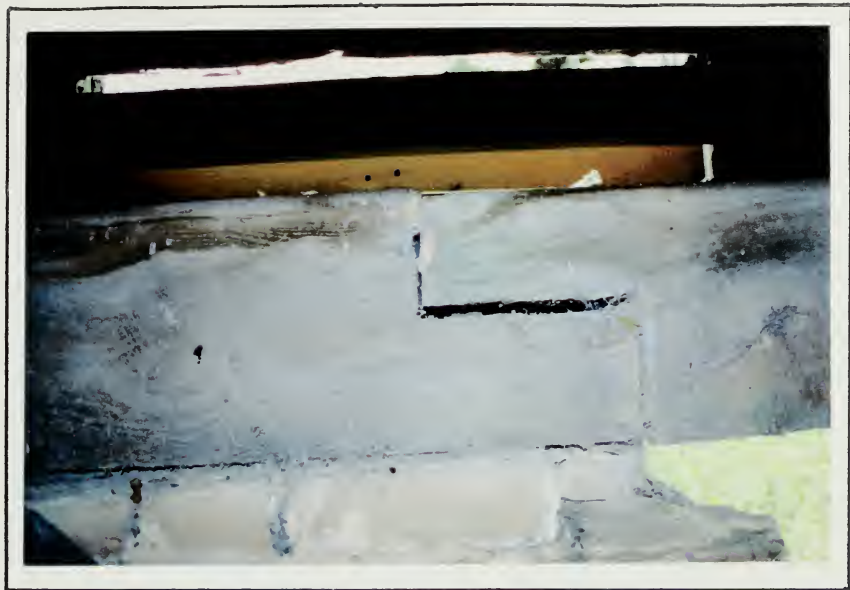
**Figure 15 –Sill Half Lap Joint**

The one item that appears to have been new and not re-used at the time of construction is the building's pine sill timbers which set upon the foundation walls. The perimeter sills are ten inches square and aligned along the outer edge of the foundation walls. Each sill timber of each wall has three half lapped joints within its length. (Figure 15) The spacing of these joints vary in distance, some as short as three feet. The timbers are toenailed together at each half lap with 20d wire nails.

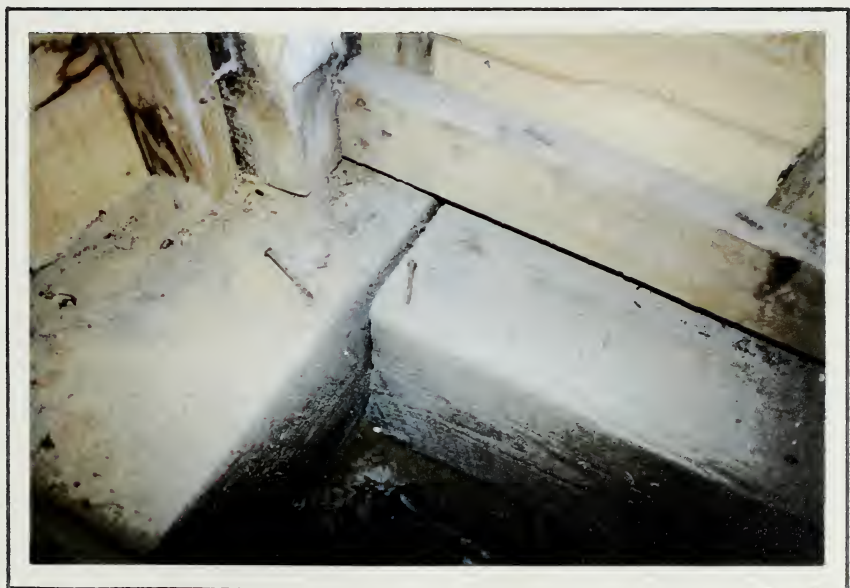
**Figure 16 –Sill corner Butt Joint**

The corner joints of the sill timbers are all butt joints (Figure 16) with exception to the southeast corner. Here the sills are connected with an end lap joint. All corner joints are toenailed together.

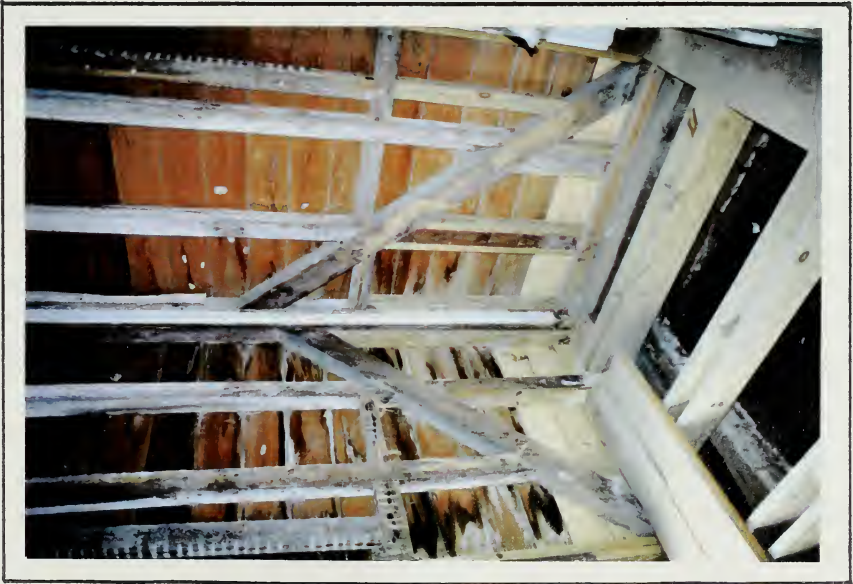
Figure 19 – Building's Corner Diagonal Bracing

The four corner uprights are 6" x 8" timbers. Each wall of each corner is diagonally braced with a 4" x 6" timber mortised and tenoned into the upright corner timber. (Figure 19) The bottom of each diagonal brace sets on top of the building's sill and are toenailed in place.

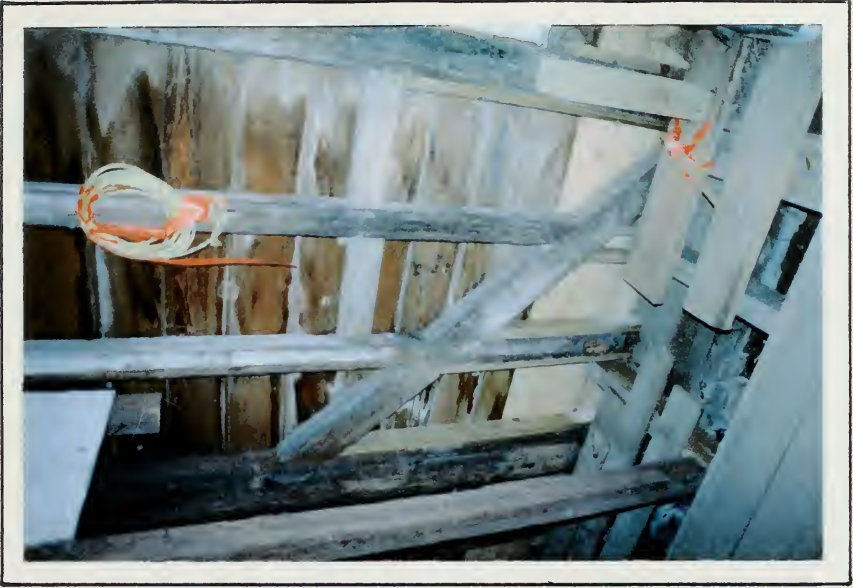
Figure 20 – East Mid-Wall Diagonal Bracing,  
West Wall Similar

An additional 6" x 8" upright timber, diagonally braced on one side only, is located approximately mid-point within the east exterior wall. (Figure 20) A similar feature is located within the west exterior wall. This upright timber measured 4' x 6".

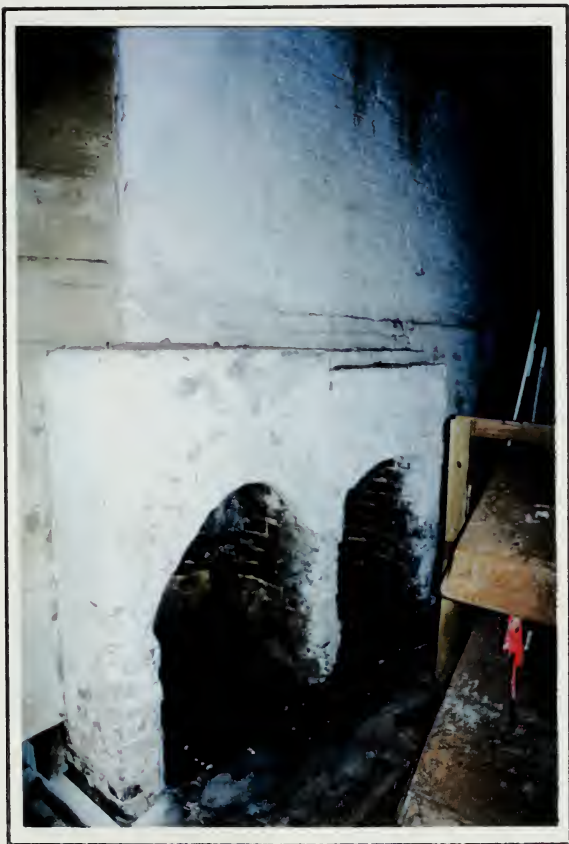
**Figure 27 –Side by Side Fireplaces in the  
Secondary Kitchen Area**

The smoke shelves in both fireplaces are similar to that in the main kitchen fireplace. No evidence of a crane or trammel bar was found in either fireplace. The flue from each fireplace angles to the right, side by side, then turns to rise vertically up through the chimney's stack.

The floor or inner hearths of both fireplaces are brick cemented together. They lay directly on earth fill. The outer hearth or main hearth is also of brick, skimmed with cement,

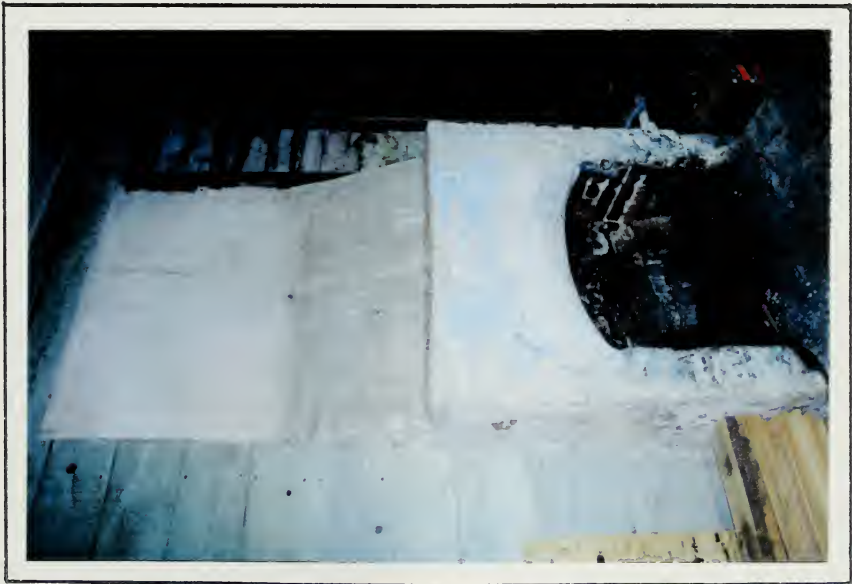
**Figure 30 – Stucco Finished Fireplace in  
Living Quarters - Room "D"**

A single fireplace located on the west side of the chimney structure projects 19-1/2" into the rear room of the living quarters (room "D"). Its function was solely to supply heat to the room and living areas. (Figure 30)

During the documentation of the fireplace in room "D", the front hearth and its header joist collapsed revealing its construction details. (Figure 31) The area was left as is and not cleared of this debris. This accident can provide an opportunity for further investigations of this area concerning the original floor level like that found in the main kitchen area.

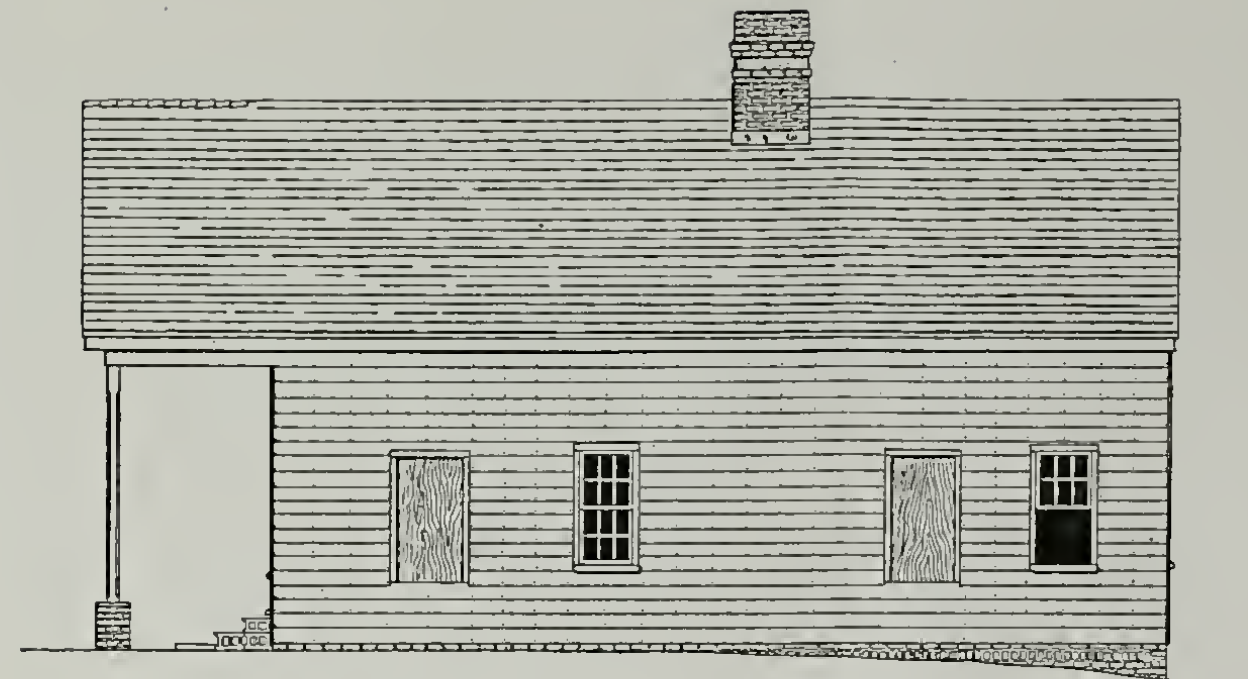
— EAST ELEVATION —

GENERAL NOTES:  
 1- DOORS - BOARD AND BATTEN CONSTRUCTION.  
 2- WINDOWS - MIS-MATCHED - NOT ORIGINAL.  
 EVEN SOME SASHES ARE MIS-MATCHED  
 WITHIN THE SAME WINDOW.

NOTE: TWO WINDOW OPENINGS APPEAR TO HAVE  
 BEEN ALTERED AT AN EARLIER TIME  
 INTO DOOR OPENINGS. THESE ARE  
 PRESENTLY BOARDED SHUT.

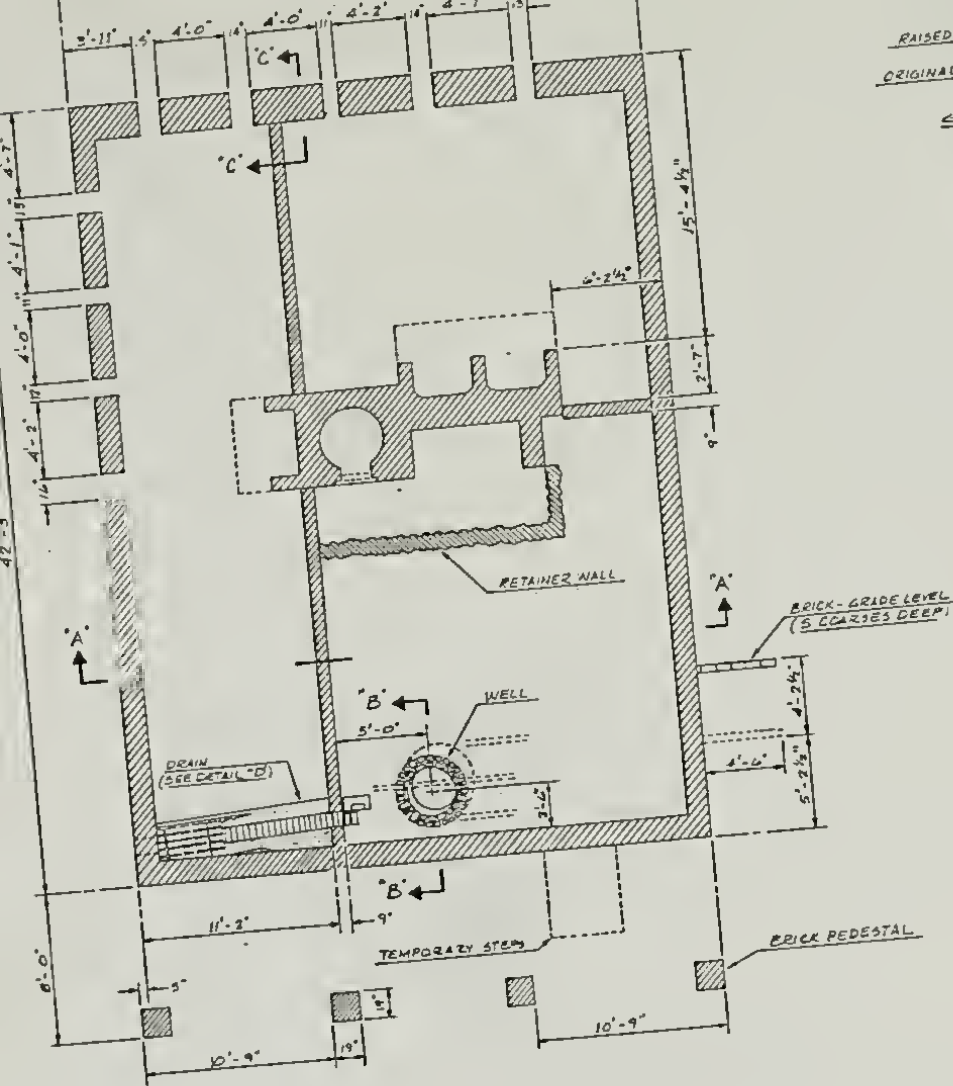
— FOUNDATION PLAN —

1. THE GRADE LEVEL SURROUNDING THE BUILDING VARIES BELOW THE TOP OF THE FOUNDATION WALLS FROM 2' AT THE SOUTHEAST CORNER TO 30' AT THE NORTHWEST CORNER.
2. ARCHAEOLOGICAL INVESTIGATIONS SUGGEST ORIGINAL BUILDING WHICH SAT UPON THIS FOUNDATION WAS DESTROYED BY FIRE. THE HEIGHT OF THE FOUNDATION WAS THEN RAISED THREE BRICK COARSE OR APPROXIMATELY 12" HIGHER AND THE PRESENT BUILDING CONSTRUCTED UPON IT. THIS AREA IS DEPICTED IN THIS DRAWING BY NARROW CROSS-HATCHING

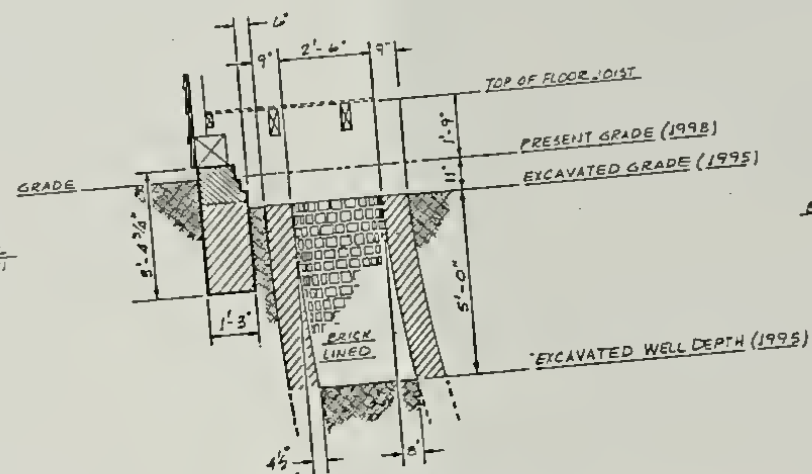
— SECTION "B-B" —

NOTE: WELL'S DEPTH ANGLES OFF TO THE NORTHEAST.
