Ruins Stabilization in the Southwestern United States

RUINS STABILIZATION IN THE SOUTHWESTERN UNITED STATES

National Park Service
U. S. Department of the Interior
Washington 1974

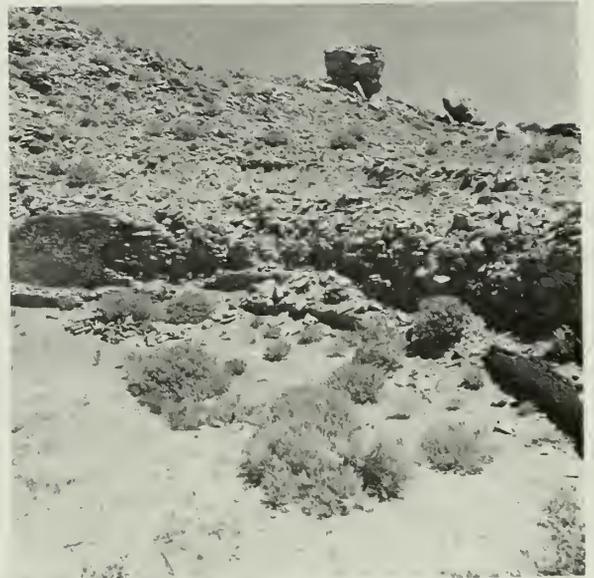
Regardless of the condition in which standing walls are found, it must be remembered that the entire depth of the wall is seldom exposed, and that the exposed portions—which form a base over which the stabilization is being done—have been subject to nearly all the forces listed above, i.e., surface weathering, construction over loose fill or partial walls, breakdown or theft of wood members, erosion at the base, buckling from pressure, excavation, and backfill (fig. 5).

FIGURE 5. Clearing of depressed areas leaves them open to surface runoff and rapid destruction. (The Great Kiva, Kin Nahasbas Ruin, Chaco Canyon National Monument, N. M.)

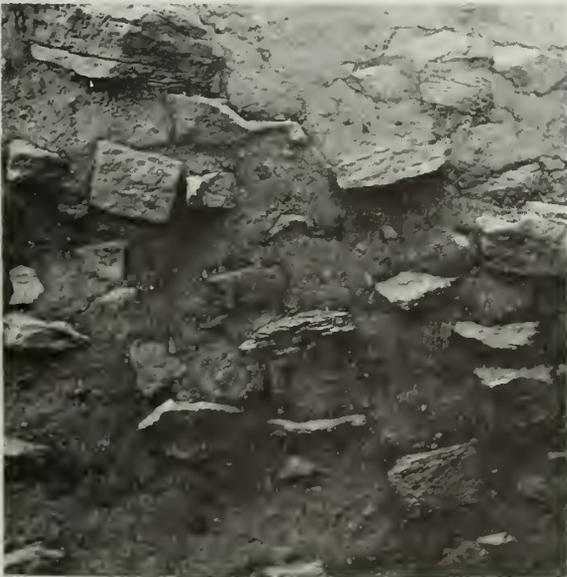
cations where large amounts of mortar must be left exposed; these include heavy grouting of exposed longitudinal sections where facing is not replaced (figs. 8 and 9).

FIGURE 8. The use of heavy grouting to replace native soil between random stone; after 10 years exposure to the elements. (West Ruin, Aztec Ruins National Monument, N. M.)

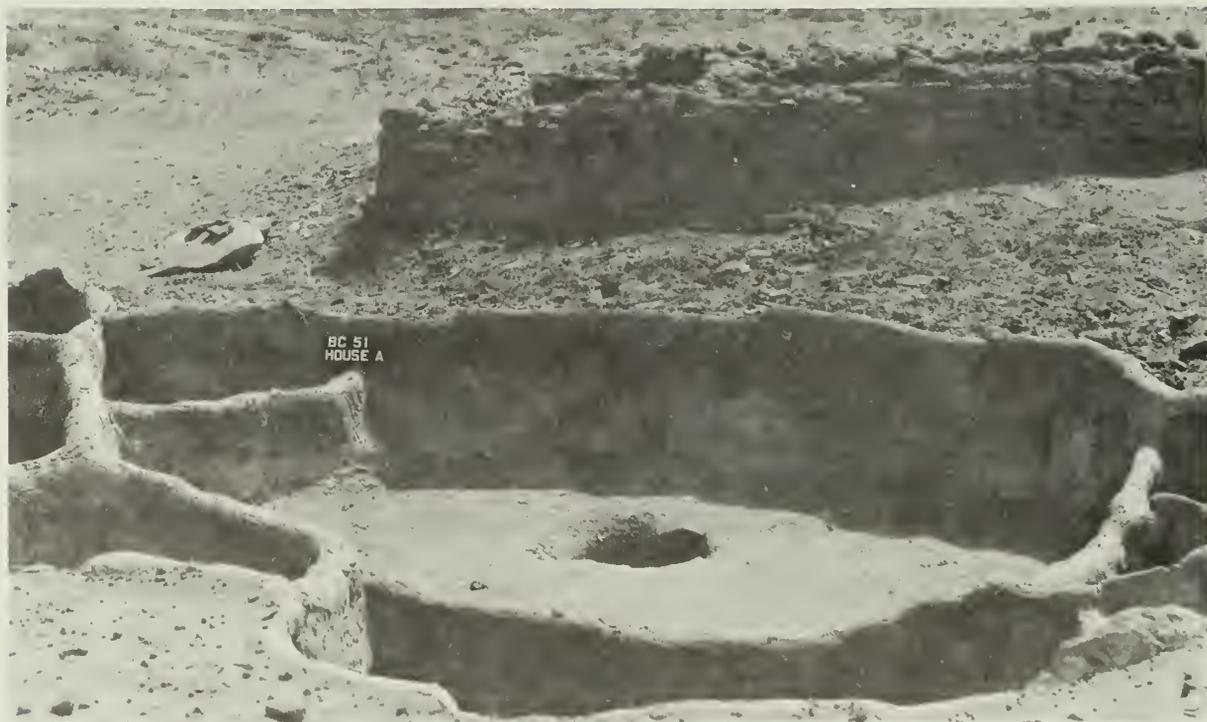
FIGURE 9. Soil-cement in heavy cross section; shown here for the repair of slab-house walls. (Basket Maker III pithouse, Site Bc-51, Chaco Canyon National Monument, N. M.)

The prehistoric wall was dampened and the mix placed between it and the form (fig. 53) well tamped in place to fill undercut spots. It was placed at a depth sufficient to cover the rise of the wall face and was then sloped to conform to the irregular, sloping surface of the wall top. After curing, the forms were removed and when completely dry the entire surface was treated with silicone water repellent (fig. 54). This use of heavier, self-supporting coverings of native materials parallels the already proven use of heavy sections of soil-cement in the repair of pit houses and for making facings in cuts in soft fill (figs. 9 and 10).

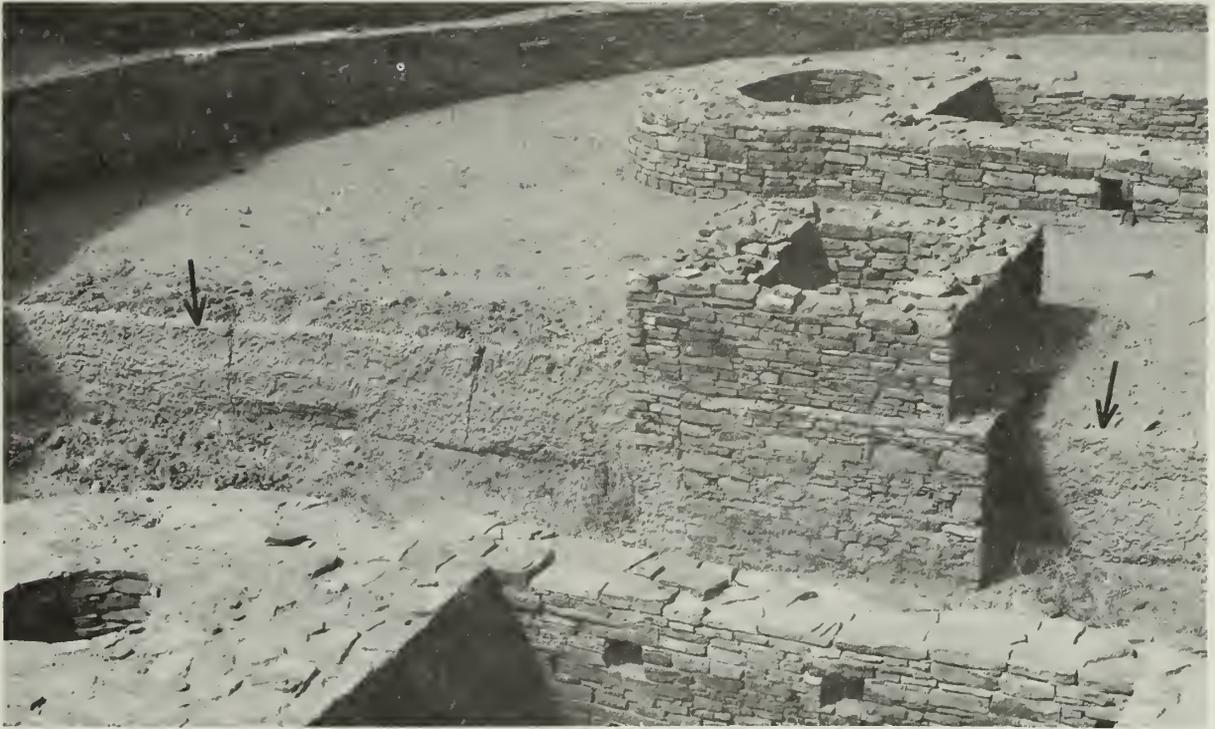
Soil-cement is particularly suited to large repair sections in monolithic soil structures, and is also valuable in stabilizing the sides or ends of cuts in excavations which must be left open for interpretive purposes (fig. 10).

FIGURE 10. Formed soil-cement in retaining sections of fill which must be stabilized to show portions of structures on varying levels. (Great Kiva in the plaza of Chetro Kettle Ruin, Chaco Canyon National Monument, N. M.)

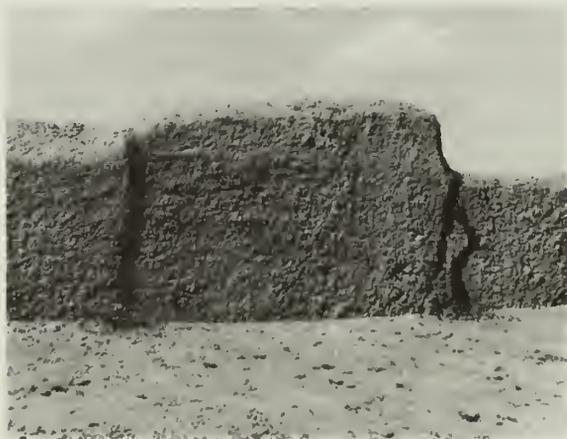
To date, applications of silicone water repellents have been made on the following structures: south wall of the "Big House" at Casa Grande and numerous walls in Compound A (figs. 13, 14) which had been previously covered with a soil-cement coating, and heavy soil-cement sections in Compound B. At Tumacacori the entire granary was treated and an application was made on the patched upper surface of the barrel-vault roof on the sacristy.

FIGURE 14. West wall of Compound A one year after the application of silicone waterproofing. Two hairline cracks were filled. The untreated smears of plaster have absorbed moisture, while the treated wall remains dry. (Casa Grande Ruins National Monument, Ariz.)

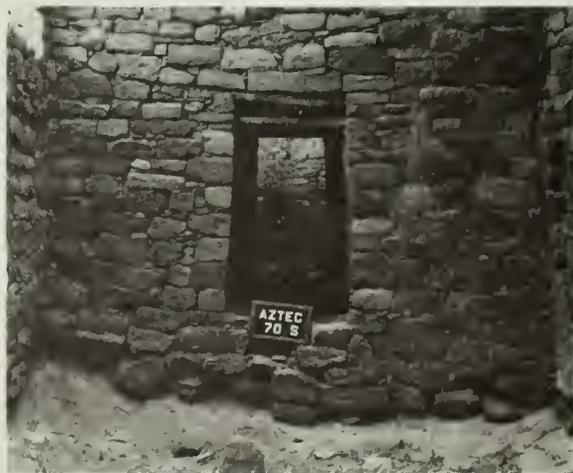
A similar evaluation was made of 19 walls (not retaining fill) constructed of and repaired with the same class of soft stone as in the 21 tested which retained fill. Fifteen remained in good condition. Four showed large wet areas where failure of drainage lines had impounded water (figs. 17 and 18).

FIGURE 17. Basal erosion from capillary moisture is particularly damaging in the interiors of excavated sites where drainage is poor. (West Ruin, Aztec Ruins National Monument, Ariz.)

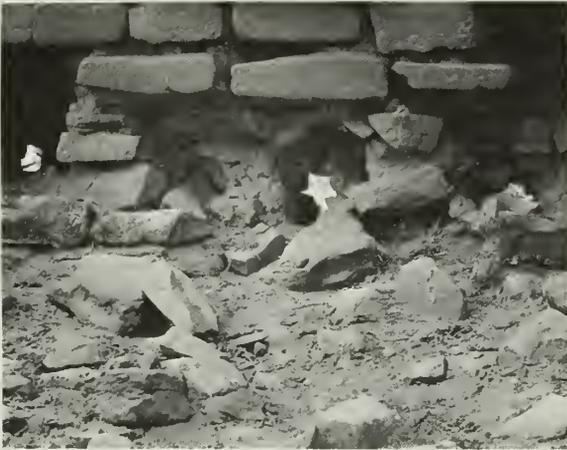
FIGURE 18. The severe undermining and basal erosion of a wall resulting from capillary moisture. If left untreated, such walls soon collapse. (West Ruin, Aztec Ruins National Monument, N. M.)

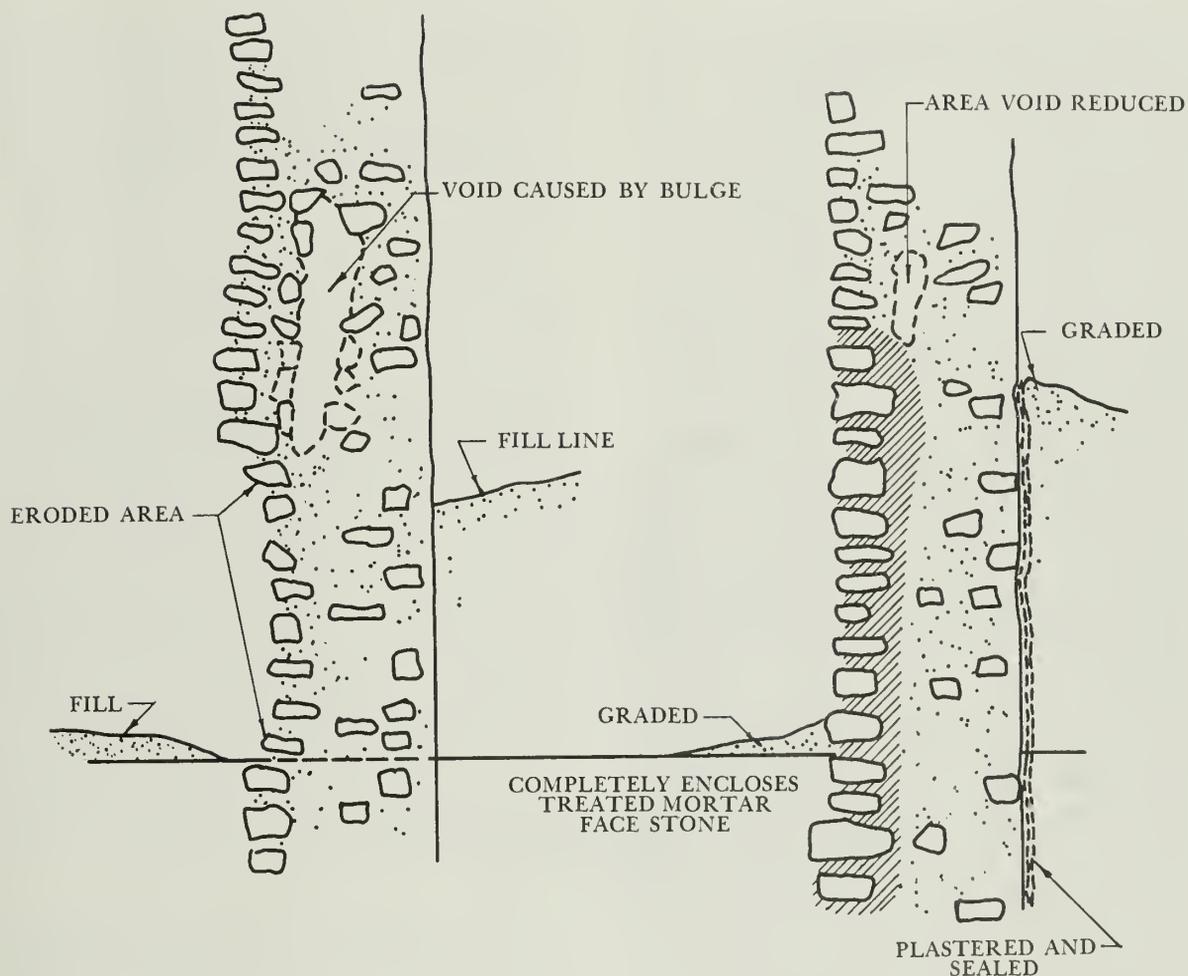
FIGURE 19. Field control of moisture erosion. Wall depicted in section at left before treatment; following stabilization at right.

In laying out stabilization for a wall deteriorating from moisture erosion, consideration must be given to any proposed changes in the fill level (fig. 19). Where the eroded wall also retains fill, the treated mortar should extend somewhat higher than the eroded area to insure against possible increases in the capillary rise. Thus, it is better to include too much rather than too little mortar in the area stabilized. While this might violate the precept of keeping the replacement of prehistoric or original material at a minimum, it is desirable that the replacement be made all at one time rather than over a period of years, as moisture works its way around too small a patch.

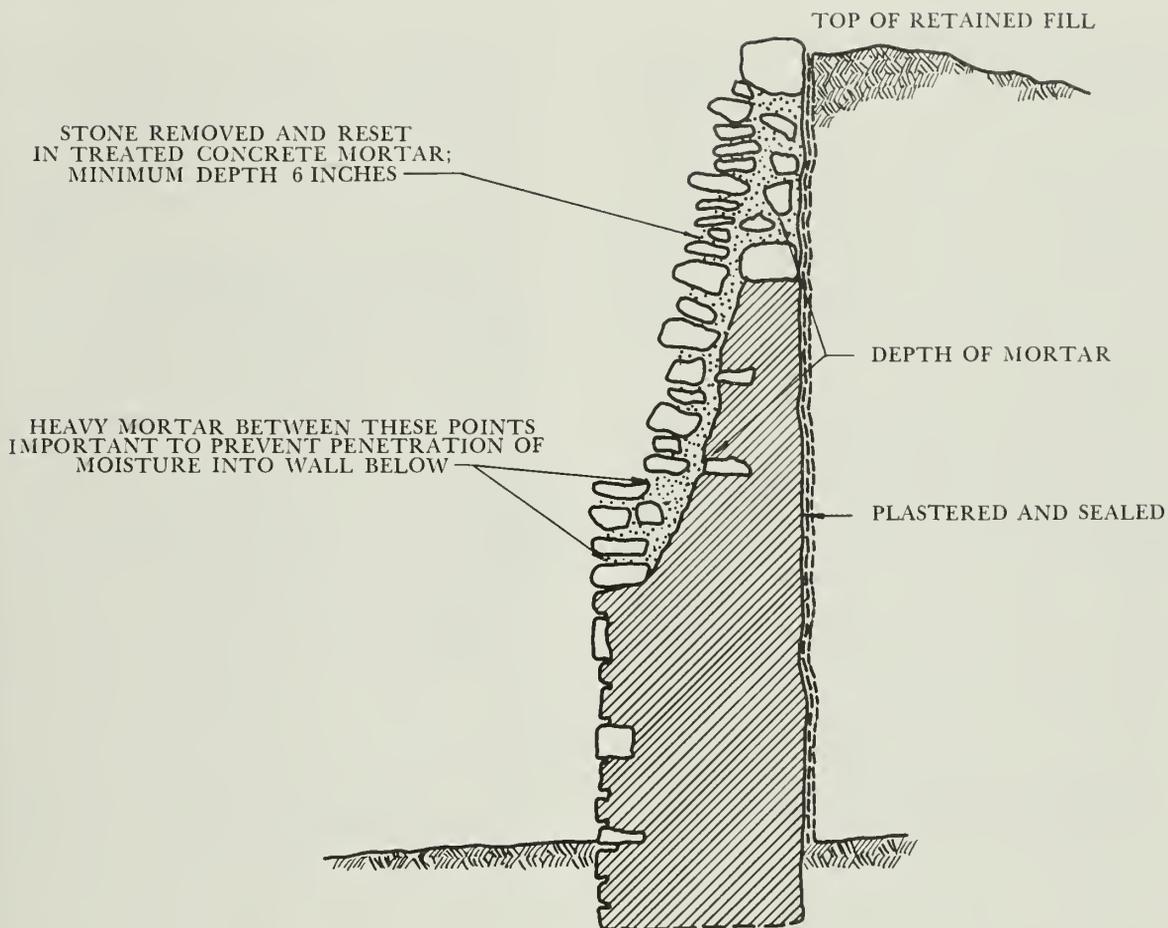
FIGURE 20. The application of waterproofed cement mortar to an oblique wall.

Relaying the oblique surface in a moisture-resistant cement mortar is more effective from the point of general appearance (fig. 20). The only drawback to this method is that large areas of the waterproofed mortar will be exposed. It is difficult, if not impossible, to color cement mortars containing emulsified asphalt. Special waterproof cements, however, can be colored.

In resetting stone on an oblique face it is best to lay the work out in vertical strips rather than in horizontal sections. This aids in maintaining the slope, and it is easier to match the pattern of the adjacent surface. The same method as that used in setting repairs in the face is employed—each exposed face stone is well bedded in the treated concrete mortar. This will mean that the entire vertical section must be taken down and relaid, rather than merely cleaning out the soil mortar and grouting the interstices with mortar. Depth of mortar will vary with the height of the wall and the size of stone used, but it is suggested that a thickness of 6 inches be taken as a minimum.

The point of greatest weakness in such an installation is at the bottom where the slope joins the remaining vertical face (if any) of the wall. At this point the vertical face must be taken down and the upper three to four courses reset in the

water-resistant mortar. Extra care must be taken at this point to prevent accumulated water from the slope entering the lower wall.

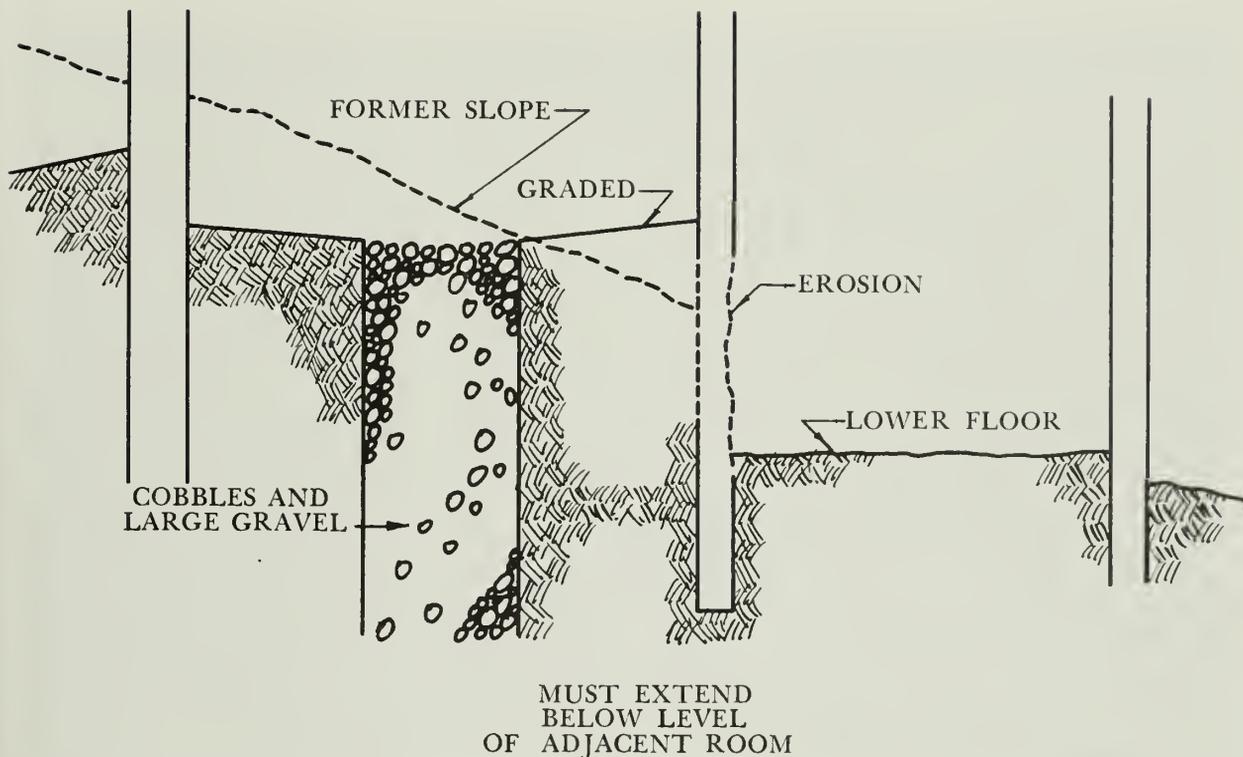
FIGURE 21. Construction of a dry-barrel (in section). Note that it has been carried well below the adjacent floor levels.

A dry-barrel is usually constructed at the center of a room or confined space (fig. 21). A circular hole 3 to 4 feet in diameter is dug to a depth which is at least 3 feet below the lowest level in adjoining rooms. The hole is then backfilled with random stone or gravel with fairly well graded material at the top to prevent the entrance of large amounts of silt or fine material. The surrounding surface is graded to the sides of the dry-barrel.

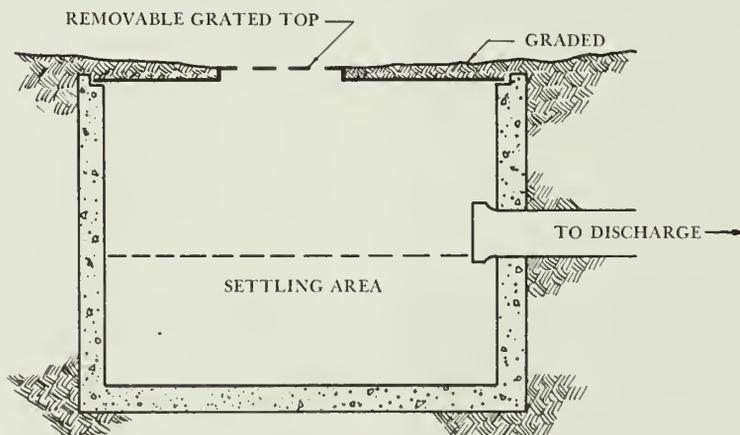
The preferred drain is one with a small concrete settling box covered with a grate, the tile line extending from the side of the settling box (fig. 22). Tile lines through walls are preferred to "weep holes," in spite of the fact that their appearance is not as satisfactory. Weep holes tend to admit water into the masonry unless very well constructed. While the necessities of appearance would seem to dictate concealed or very unobtrusive lines emptying from a small area, annual inspection of numerous sites has demonstrated that such lines are simply not maintained, and that an obtrusive line which empties surface water from an area provides far better protection than a concealed line which has become inoperative through accumulations of sand or cinders.

FIGURE 22. A settling type inlet for drain lines.

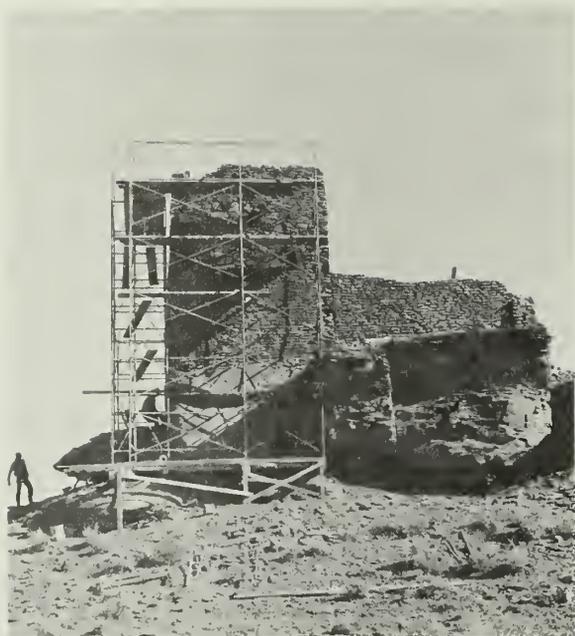
FIGURE 27. Scaffolding in place at completion of respalling and grouting large wall surfaces. (Wukoki Ruin, Wupatki National Monument, Ariz.)

Where masonry walls containing a large proportion of spalls or chinking on the surface are subject to extreme weathering in exposed locations, surface repair may become a time-consuming project. As the spalling is lost to weathering, the soil mortar between individual stones is then exposed. It weathers far more rapidly than did the spalling, and decay of the wall is accelerated. Loose and softened soil mortar must be scraped from between the individual stones, the space then partially filled with cement mortar and the spalls tapped into place in the mortar. Large walls require considerable equipment and an experienced crew (fig. 27).

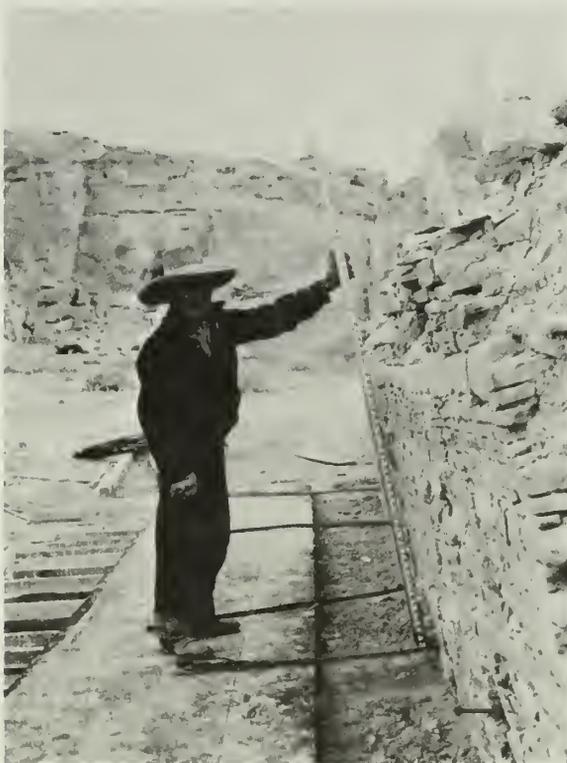
FIGURE 33. Beginning realignment. Cables have been placed through the base of the wall to be tied to the jacks. Note bolt, lower right, for holding frame against wall. (Pueblo Bonito, Chaco Canyon National Monument, N. M.)

Realignment of distorted, out-of-plumb walls is seldom practicable unless the wall is in otherwise good condition (figs. 33, 34, and 35). If the wall has to be realigned and is in poor condition, it must first be strongly repaired with a soil mortar. Do not repair the wall with cement or stabilized soil mortars. Considerable time, care, and equipment are required to realign a wall of any size. The general requirements are, first, that the wall must be completely formed on both sides and, secondly, that it be thoroughly damp if it is not to be cracked further or distorted in some other directions. The steps taken should include:

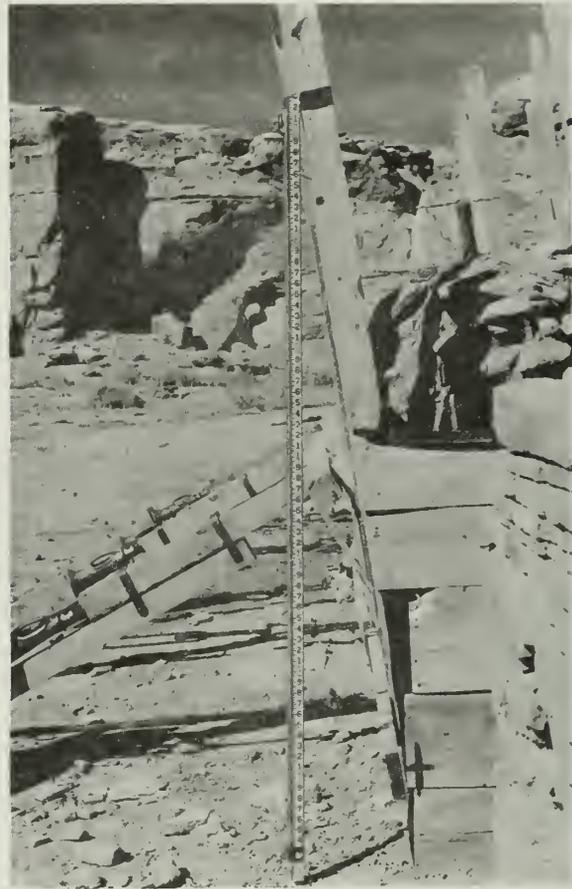
FIGURE 34. Realignment of wall depicted in figure 33. The framework is in place on both sides and is tied together. Frame lined with asphalt paper, space between frame and wall packed with sand. Note that the five screw jacks in sleeves bear against a 4 x 4 timber to distribute pressure.

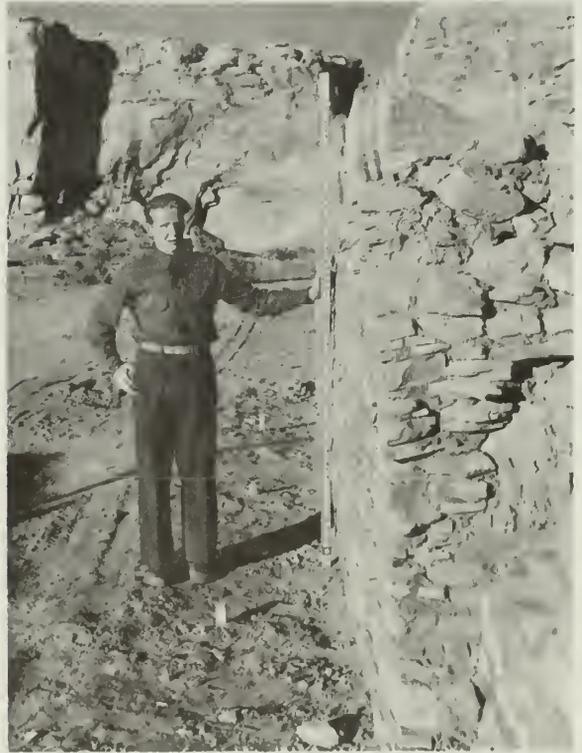
FIGURE 35. The wall depicted in figures 33 and 34 after pressure had been applied for three weeks by means of jacks in sleeves.

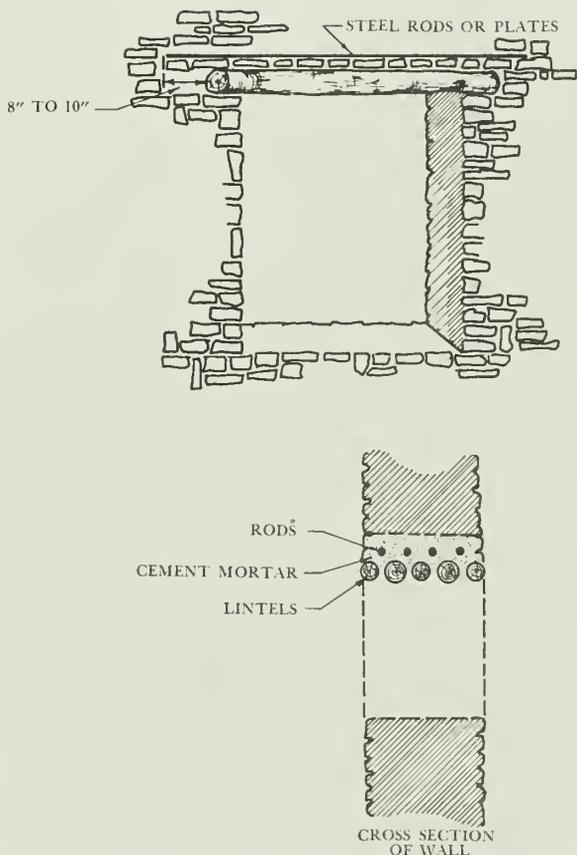
FIGURE 36. The placement of reinforcing in concrete mortar over pole lintels.

remove the timbers and replace them, either with wood or cast members. Rebuild the wall where necessary. Where wood is the replacing material, some reinforcing effort must be made. In short spans, steel plates may be set above the lintels. In longer spans the wall above the wood must be set in reinforced concrete mortar. In any case, the steps are the same (fig. 36):

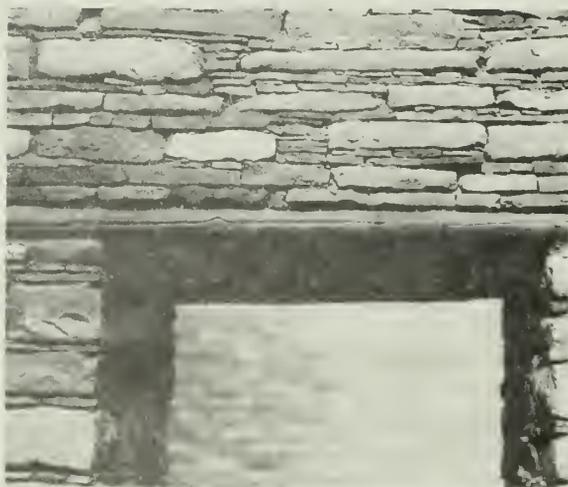
FIGURE 37. The cast concrete lintels have the same appearance as the originals from which they were cast. (Chetro Kettle Ruin, Chaco Canyon National Monument, N. M.)

masonry. The use of cast lintels and poles eliminates many of the above difficulties. They permit the replacement of wood with little disturbance; they provide a strong, rigid and very durable member. Cast lintels take the same surface and texture as the wood from which cast. With a little care they may be stained to faithfully reproduce the original (fig. 37).

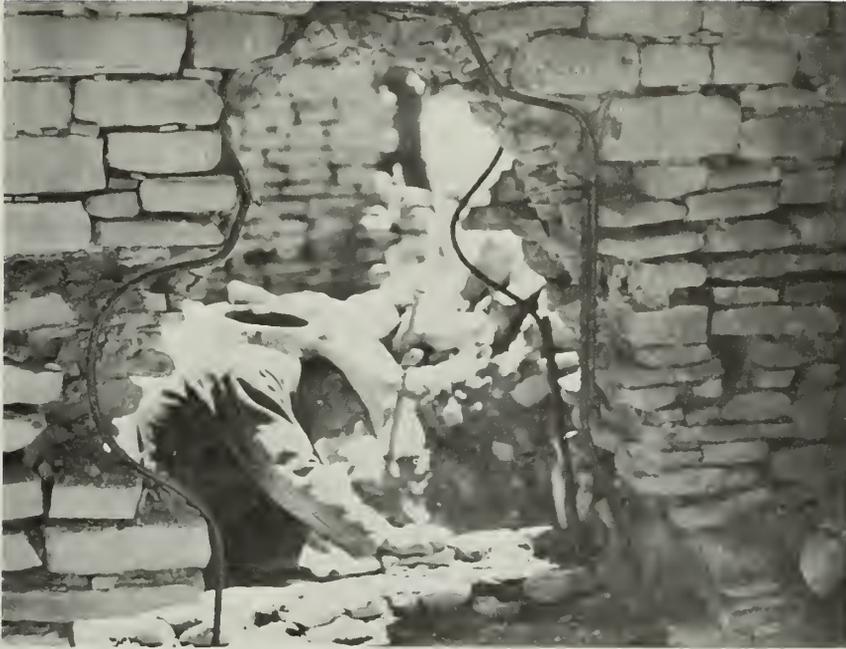
FIGURE 39. Integral members. Starting a reinforced arch section, rods have been bent to fit the contours of the break and are wired in place. The workman is laying the courses across the bottom of the break in concrete mortar to provide a solid base for the reinforced section. Above this level, masonry on the perimeter of the hole will be laid in concrete mortar which will also surround the steel rods. Masonry in the center of the hole will be laid dry or with a minimum of soil mortar; its only function will be to support masonry laid in cement until the latter has set. This dry masonry will then be removed. (Pueblo Alto, Chaco Canyon National Monument, N. M.)

outlines of the break. One piece goes on each side of the wall and just far enough inside the opening to allow a covering face of masonry. The two ends of each piece will rest on the masonry just laid across the bottom of the opening (fig. 39).

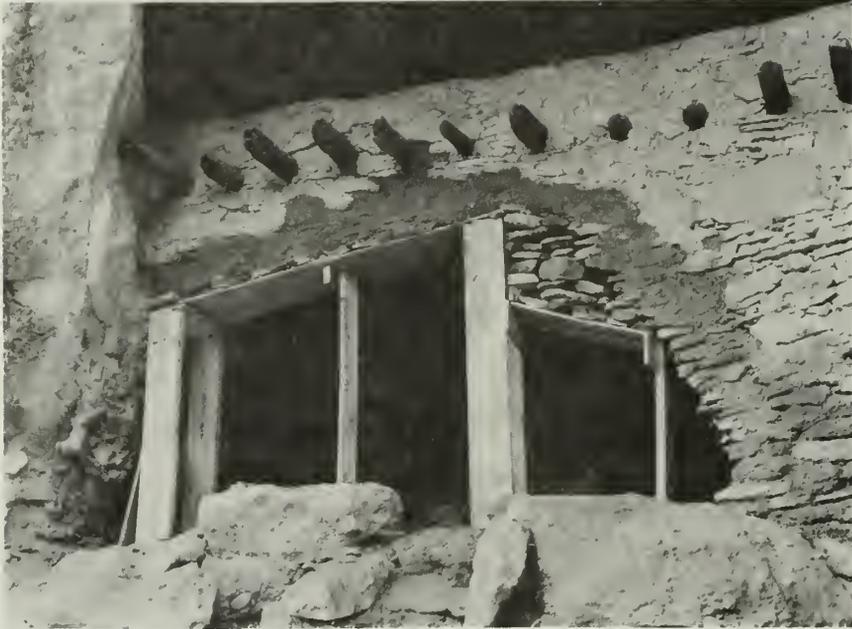
FIGURE 40. Integral member; a large reinforced arch section. The size of the break through the wall precluded filling the center with dry masonry as support, and the timber framework was substituted. The heavily reinforced band is socketed in the cliff wall at the left side, and based on bedrock at the right. The integral member has just been finished and the mortar has not yet dried. After the mortar has set the timber framework, the dry masonry at the right and that on top of the horizontal plank were removed. The large hole with its original outline remained. (Gila Cliff Dwellings National Monument, N. M)

tected from further breakdown by the reinforced band (fig. 40).

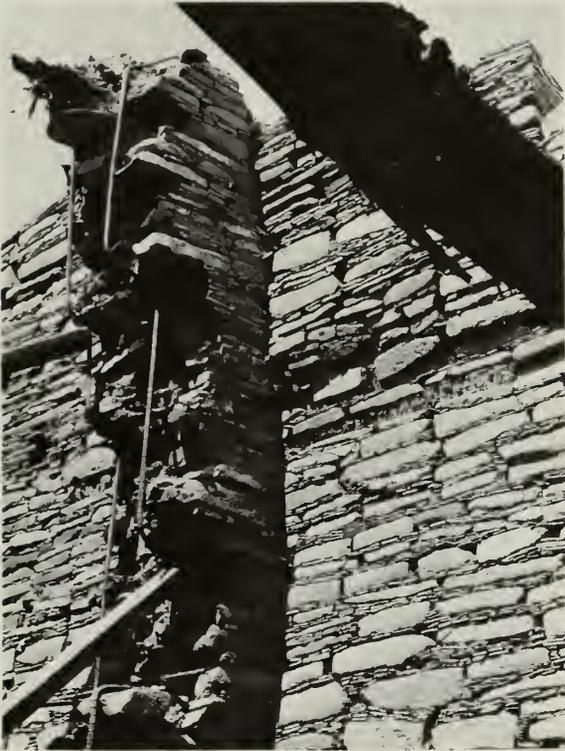
FIGURE 41. Integral members; steel in place for a narrow vertical section. The steel must be tied in securely to the cross wall at the top to provide support for the overhanging area. Some support will be required for the vertical strip of masonry as it is being laid, and until the concrete mortar has set. (Chetro Kettle Ruin, Chaco Canyon National Monument.)

The principal application of these members is to tie together sections of separated and out-of-plumb walls, to reinforce walls against which there is pressure of retained fill, to re-lay overhanging and precarious sections, and to provide support over horizontal logs (figs. 41, 42, and 43). Since conditions and structures vary so greatly, it is difficult to anticipate all possible applications. In general, the requirements are:

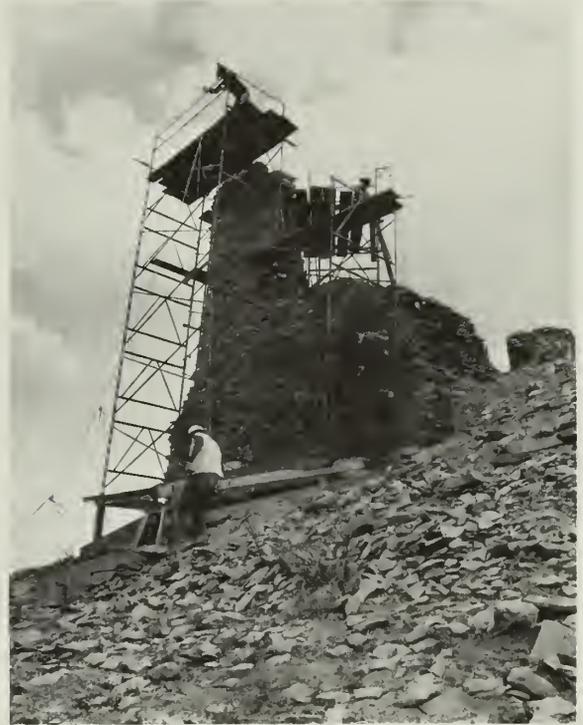
FIGURE 42. Reinforced integral members are important in the stabilization of spirelike structures such as this at the Tower Kiva, Kin Ya-a Ruin, Chaco Canyon National Monument, N. M. Considerable strength must be added without serious or objectionable alterations of the original profile.

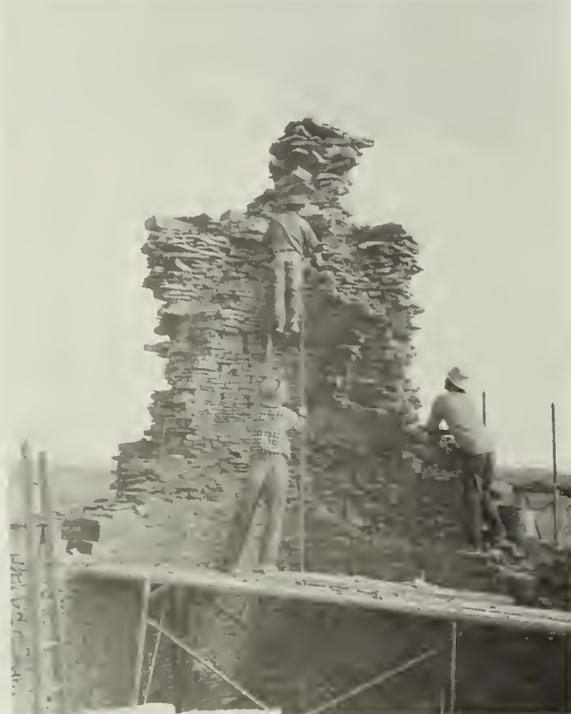
FIGURE 43. The placement of reinforcing in the third story portion of the structure shown in figure 42. The purpose is to reinforce heavily the vertical capping which will be placed up exposed ends of the wall to prevent further erosion, and to tie this part of the wall together.

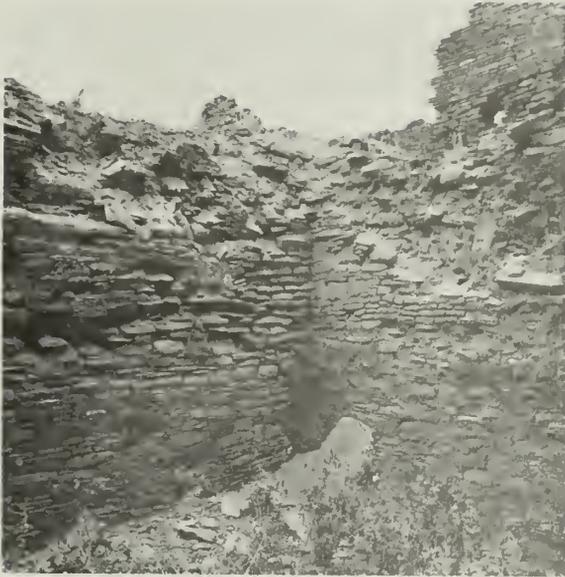
FIGURE 44. In many cases such as that depicted above it will be difficult to draw a distinction between general wall repairs and capping. This wall will have to be carried up to the level of the outside fill to prevent further washing over the top. Whatever type of mortar is used for such wall repairs, the top courses must be set in a cement mortar to provide as durable and waterproof a cap as possible. (Pueblo del Arroyo, Chaco Canyon National Monument, N.M.)

good bond with sound masonry (of stone, brick or adobe) below (figs. 44 and 45). Where regular units are employed in coursed walls, a sound, even surface must be reached or built up on which to place the flashing. In most cases, sufficient courses should be removed to provide the desired depth of capping without the addition of new units. Where the upper levels of a patch are to form a cap, new stone or other units must be employed (fig. 46).

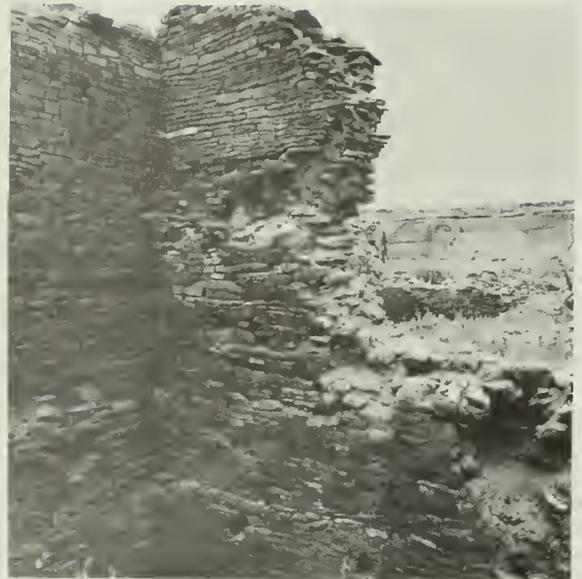
FIGURE 45. Patching of this hole at Pueblo del Arroyo will be combined with a short section of horizontal capping plus vertical capping for the exposed and weathered vertical rise of wall.

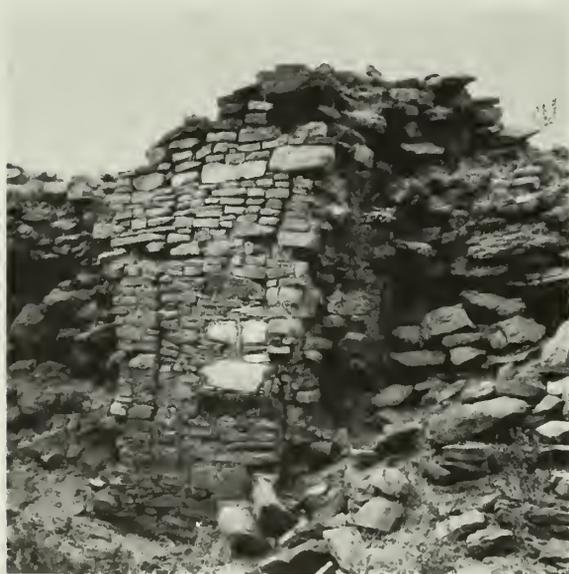
FIGURE 46. A good deal of repair masonry must be laid to fill breaks and support undercut areas in this wall at Pueblo del Arroyo. Some support must also be provided for the embedded timbers. Soil or masonry cement mortars may be used for the major part of this work. The upper courses however must be laid in concrete mortar as capping to halt further washing from the top. In this example, damage was started by surface water from adjacent, unexcavated fill and every effort should be made to prevent erosion.

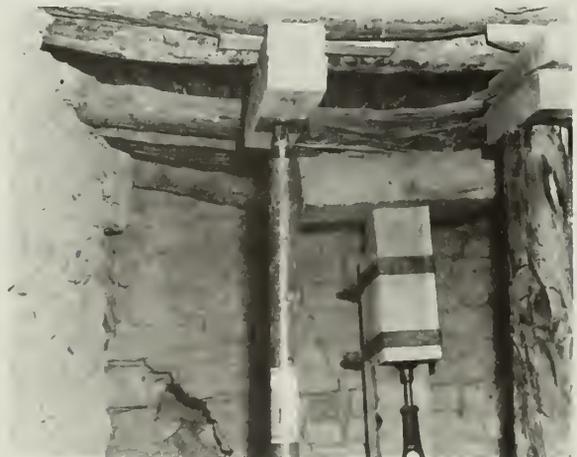
FIGURE 47. Temporary support of cracked and broken roof beams by means of jacks and timber props. Approximately 6 feet of overburden lay on this ceiling. The temporary supports were in place for several years before the overburden could be removed and a protective roofing constructed. (East Ruin, Aztec Ruins National Monument, N.M.)

From this and similar experience with difficult roofs evolved the coverings designed for and installed over 14 prehistoric ceilings in the East Ruin of Aztec during 1957 (figs. 47 and 48). These were in an unexcavated site where the only previous protective measure taken was the temporary bracing of cracked and broken timbers.

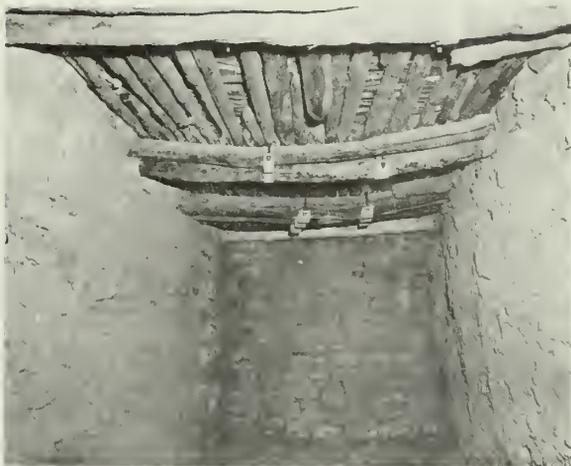
FIGURE 48. The ceiling shown in figure 47 after removal of the overburden and construction of a slab roof which protected the ceiling and permitted support of broken beams. The bolts are fastened in the slab above, and were taken up enough to transfer most of the weight from the old ceiling beams to the new roof.

If the prehistoric ceiling has been subjected to heavy overburden or has been wet, it will probably require support from the protective slab, a provision which must be made when the slab is first being laid out. Support may consist of bolts which extend up through the center of broken or cracked beams or by pairs of bolts, one on each side of the beam to support a hanger under the beam. Bolts should have ample threads (threaded rod is preferable to standard bolts) so that they can be taken up sufficiently to support most

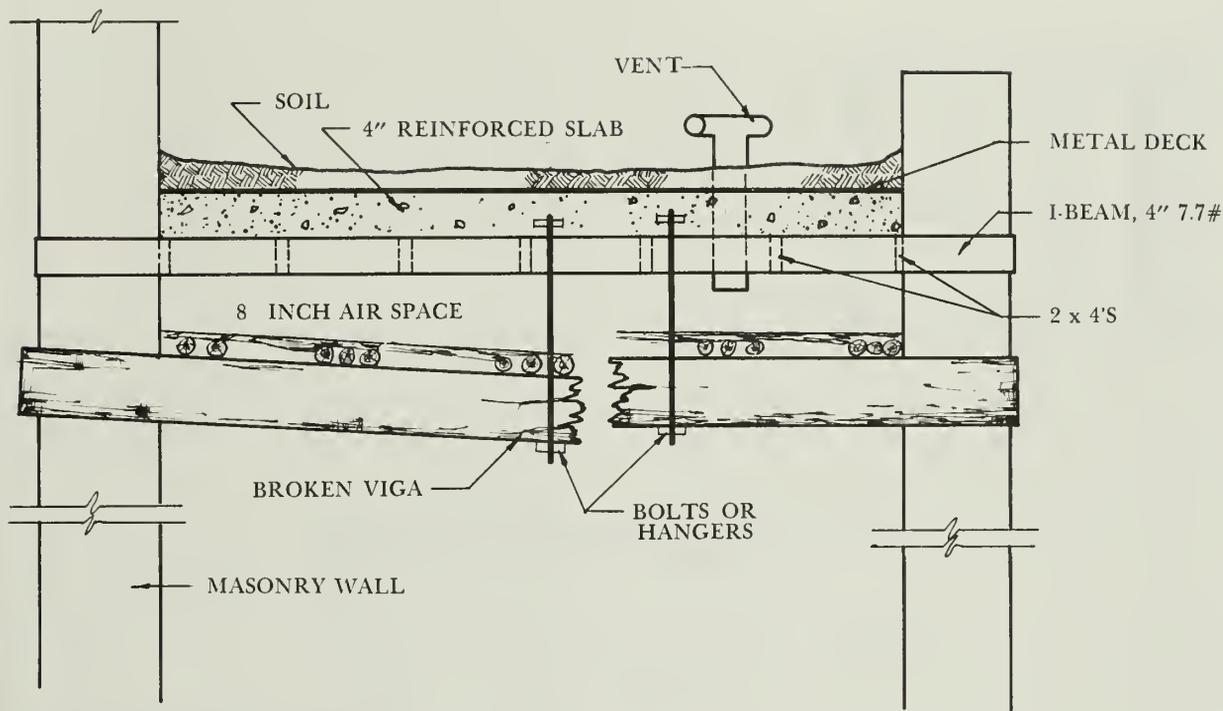
FIGURE 49. Typical roof covering and support employed at Aztec Ruins National Monument.

The general design of slab-type roofings are shown in figures 49, 50, and 51. No part of the new roofing may be supported by the aboriginal ceiling either during or after construction. This requires that the construction be self-supporting during the time that the concrete is being poured. Ordinarily, concrete forms for floors and decks are supported during pouring by vertical members from below, and the supports and forms are removed after the concrete has set. However, this is not possible in the placement of slabs over existing roofs where the space between the new slab and the old ceiling is usually less than a foot, and there is no means of access between the two.

The basic members of the new roofing should be steel I-beams. Their construction permits the wood members of the roofing, the rafters or purlins, to be inset in the sides of the beams. Thus, there is no wood separating the concrete from the main supporting members. Wood left in this position would rot and allow the roof to settle. Dimensions of the I-beams are determined by the span, the placement of beams and the type of

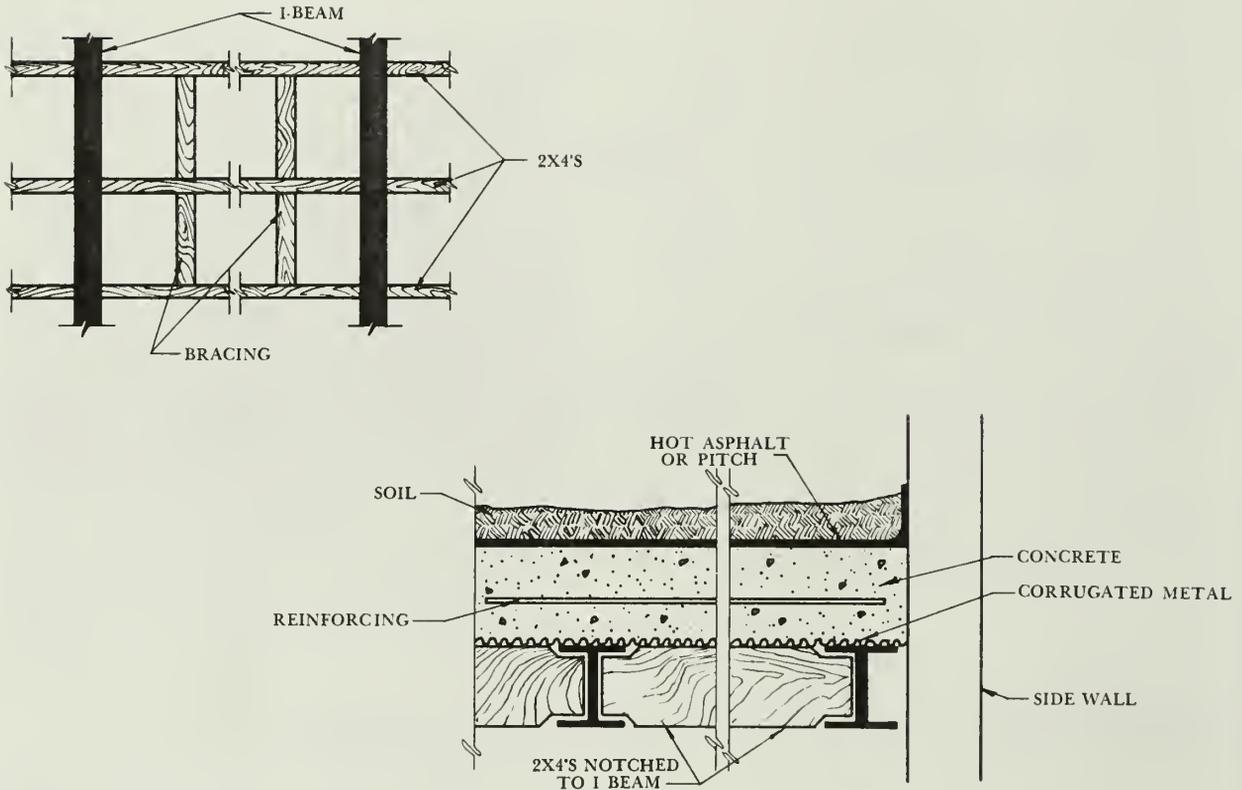
FIGURE 50. Details of roof supports (in section) at Aztec Ruins National Monument.

Whatever concrete is used should contain reinforcing, the amounts depending somewhat upon size and weight of the sections of the ceiling below. For example, in the roofs with beams on 4-foot centers, No. 4 rebar was placed on 8-inch centers at right angles to the I-beams. Number 3

rebar was used at right angles again, the short dimension of the slab, on 18-inch centers. Concrete slabs will usually be about 3 inches thick and the reinforcing should be above the center, supported on "chairs" of steel or similar material. All reinforcing should be securely tied. It is preferable to purchase the reinforcing cut to length and the ends bent if desired.

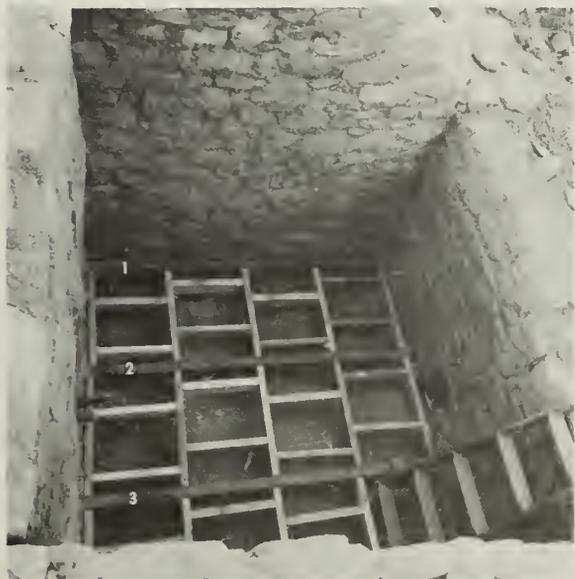
FIGURE 51. Construction of a slab covering. The numbered members are I-beams run through heavy masonry walls. The longitudinal members are 2 x 4's inset in the I-beams as purlins. Corrugated metal decking will be nailed to the wood as a base for a concrete slab. A covered vent will be provided through the concrete. Drainage will be provided by tile line through the wall at the right. (East Ruin, Aztec Ruins National Monument, N.M.)

In pouring the slab, every effort should be made to produce as dense and watertight concrete as is possible. The water-cement ratio of normal concrete should be strictly controlled. When poured, the material should be well-rod-ded and the top screeded, i.e., leveled out to grade to a true, even surface. Whether of normal or lightweight type, it must be damp cured for no less than three days and in hot weather protected from excessive drying for a longer period.

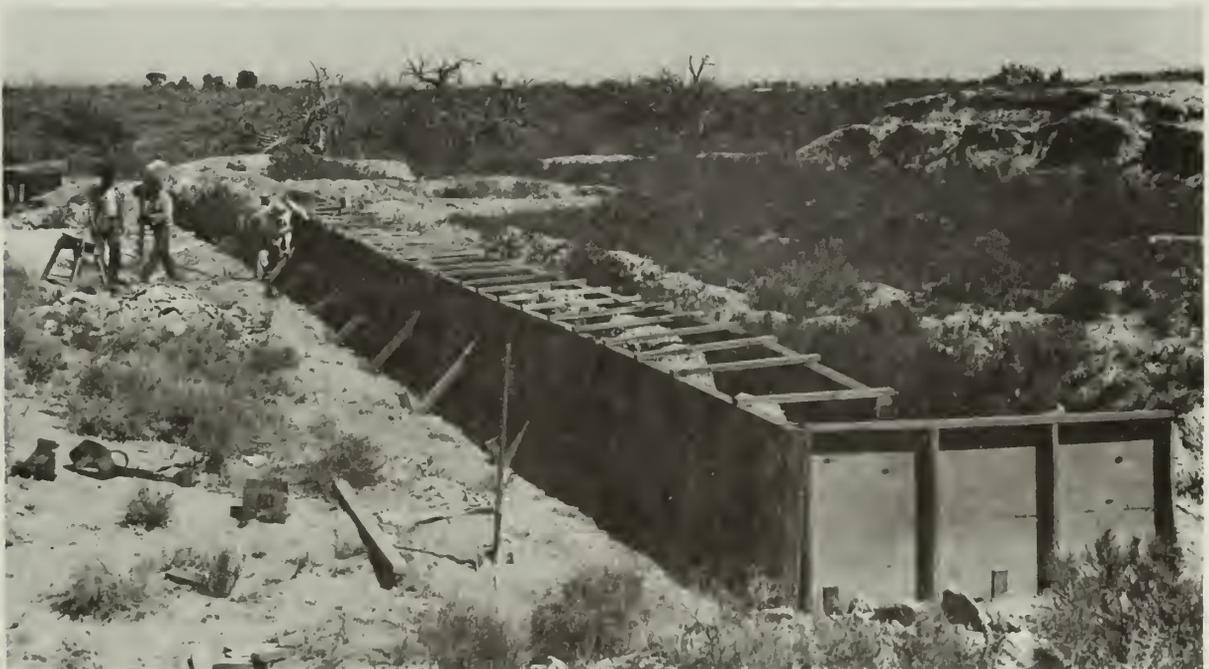
FIGURE 52. Placement of forms for stabilization of a wall with caliche-based soil cement. The forms are braced at the sides and tied at the top. (Compound B, Casa Grande Ruins National Monument, Ariz.)

Since long experience at Casa Grande has demonstrated that it is impossible to make a thin covering of either cement, stucco, or soil-cement which will adhere to the original wall or will not crack and remain waterproof, a slightly different approach has been tried recently on exposed walls of Compound B.

In all caliche walls, i.e., those of high lime soil content encountered in Compound B, weathering had greatly reduced the original width above the surface of the ground. Both sides of the wall were trenched until the original width was reached at depths up to 18 inches. Forms of heavy plywood, reinforced with 2x4's, were then placed at the edge of the wall rising vertically from the uneroded subsurface line (fig. 52). The space between the remaining wall surface and the forms was wide enough so that the caliche-cement would be sufficiently thick to stand by itself, and not be dependent on the aboriginal wall for support. General requirements for placing concrete forms were followed: they were oiled, and securely braced.
