Ruins Stabilization in the Southwestern United States

RUINS STABILIZATION IN THE SOUTHWESTERN UNITED STATES

National Park Service
U. S. Department of the Interior
Washington 1974

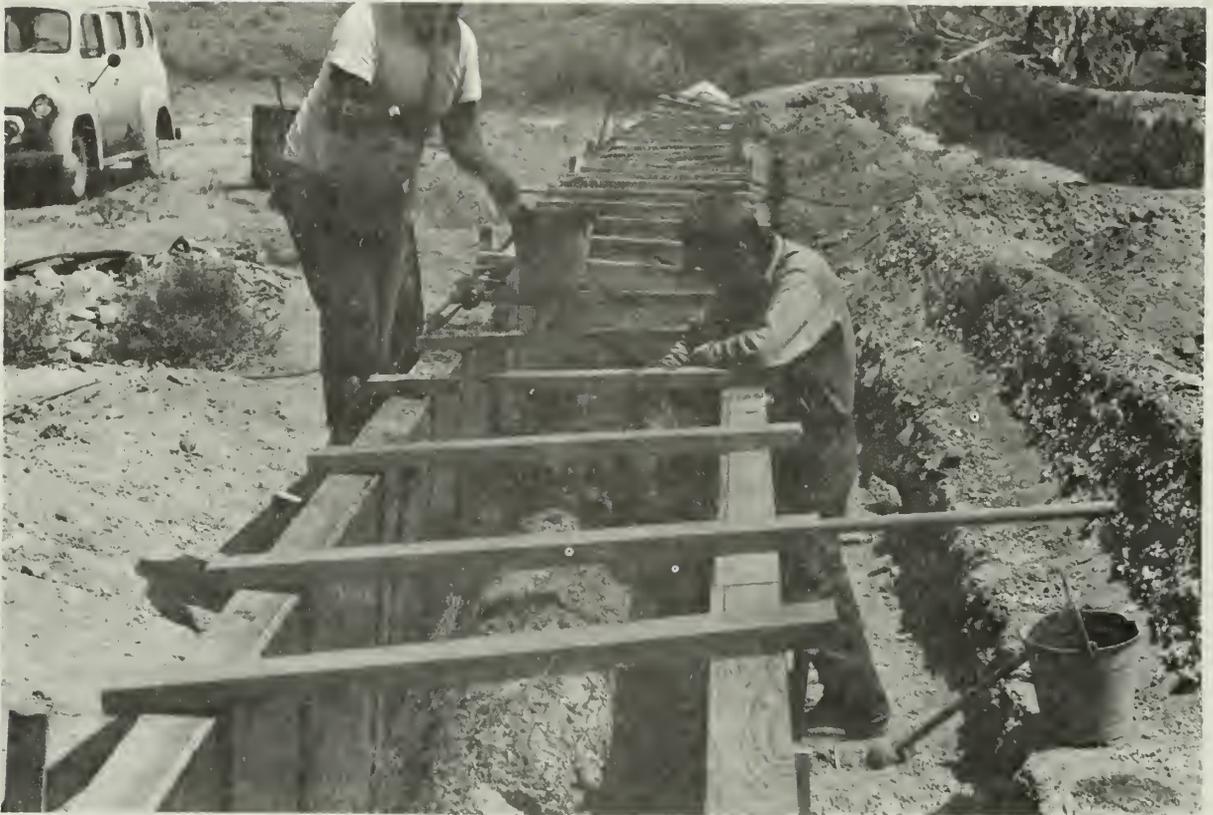
FIGURE 53. The start of placing caliche-cement mix over the wall depicted in figure 52. Note that the forms follow the irregular line of the wall.

The prehistoric wall was dampened and the mix placed between it and the form (fig. 53) well tamped in place to fill undercut spots. It was placed at a depth sufficient to cover the rise of the wall face and was then sloped to conform to the irregular, sloping surface of the wall top. After curing, the forms were removed and when completely dry the entire surface was treated with silicone water repellent (fig. 54). This use of heavier, self-supporting coverings of native materials parallels the already proven use of heavy sections of soil-cement in the repair of pit houses and for making facings in cuts in soft fill (figs. 9 and 10).

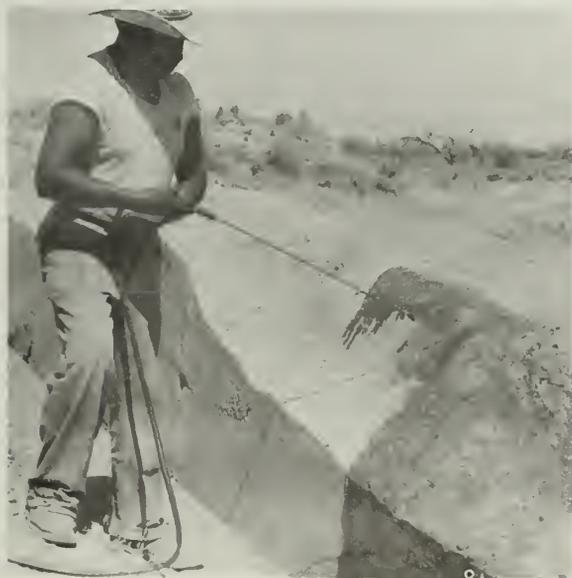
FIGURE 54. The application of a silicone water repellent. It is applied in a coarse stream, sufficient to produce a rundown of from 6 to 8 inches. (Casa Grande Ruins National Monument, Ariz.)

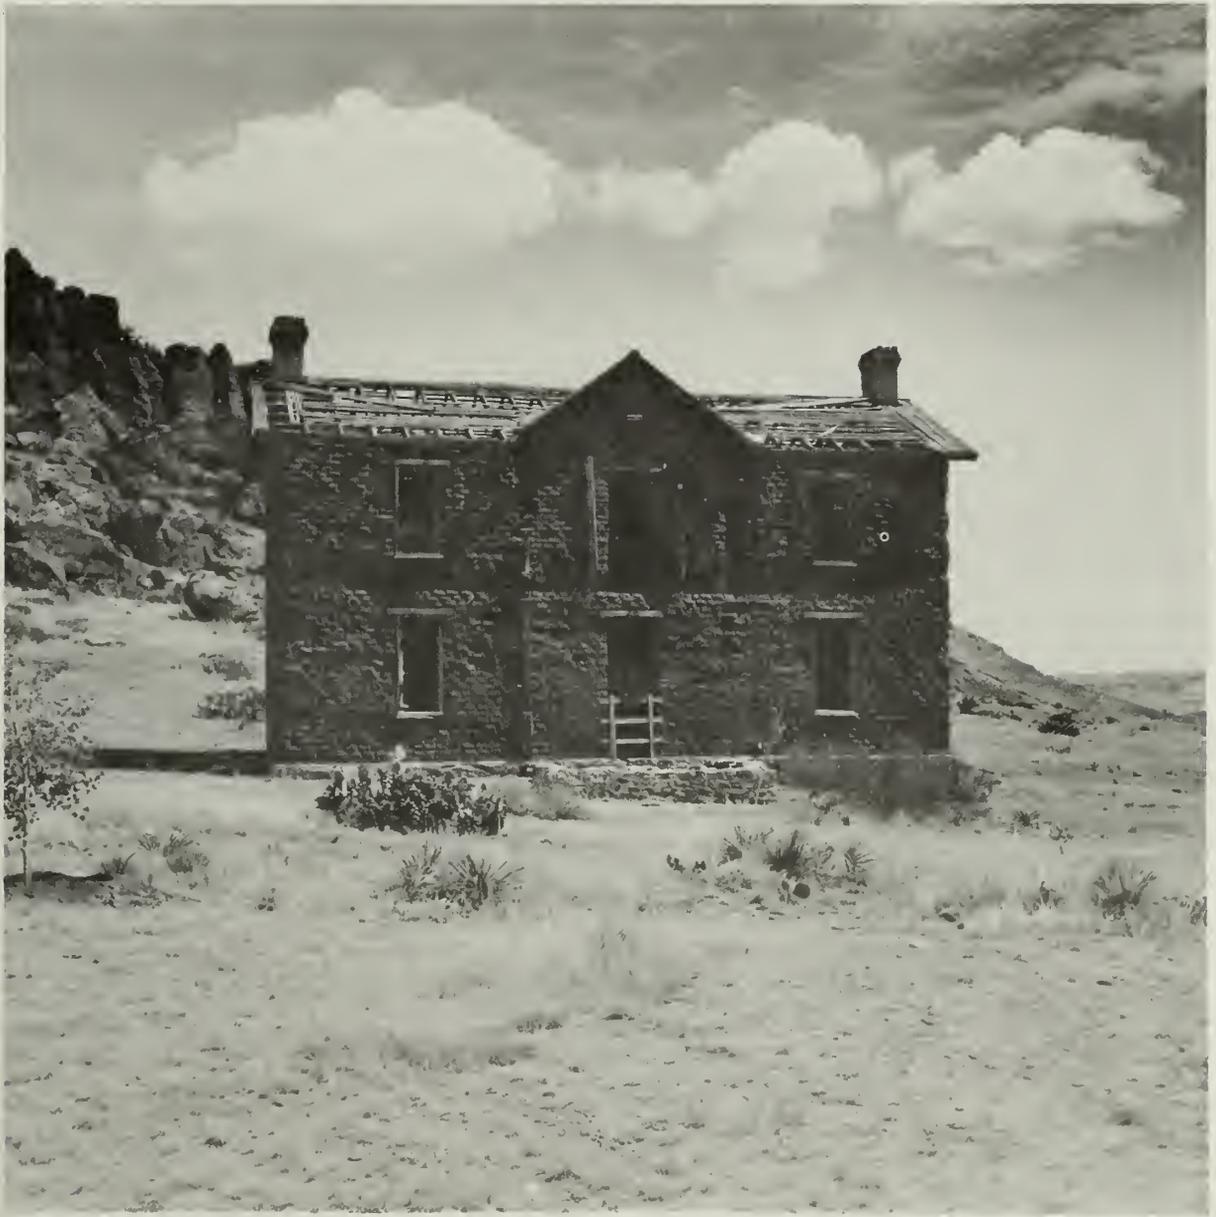
FIGURE 58. Building HB-15, a non-commissioned officers quarters at Fort Davis National Historic Site, before combined stabilization and modified restoration work was accomplished by the National Park Service.

FIGURE 59. Building HB-15 and its outbuilding, a kitchen, following modified restoration by the National Park Service. Soil-cement adobes simulating original adobes were used as modular units of repair. Compare with figure 58.

This construction restored the exteriors of two 2-story buildings to their original appearance. The tops of the walls, weakened by erosion, were rebuilt and capped with reinforced concrete-bearing beams to support new roofs. Where exterior faces of adobe walls were severely weathered, a masonry veneer was added to rebuild the wall section to its original thickness using soil-cement units colored and textured to match the existing adobes. New wood porches were added to the exterior entrances, and doors and windows restored to the openings to secure the buildings. Thus the structures are interpreted as part of the historic scene. A self-guiding trail provides access and supplies necessary for interpretation.

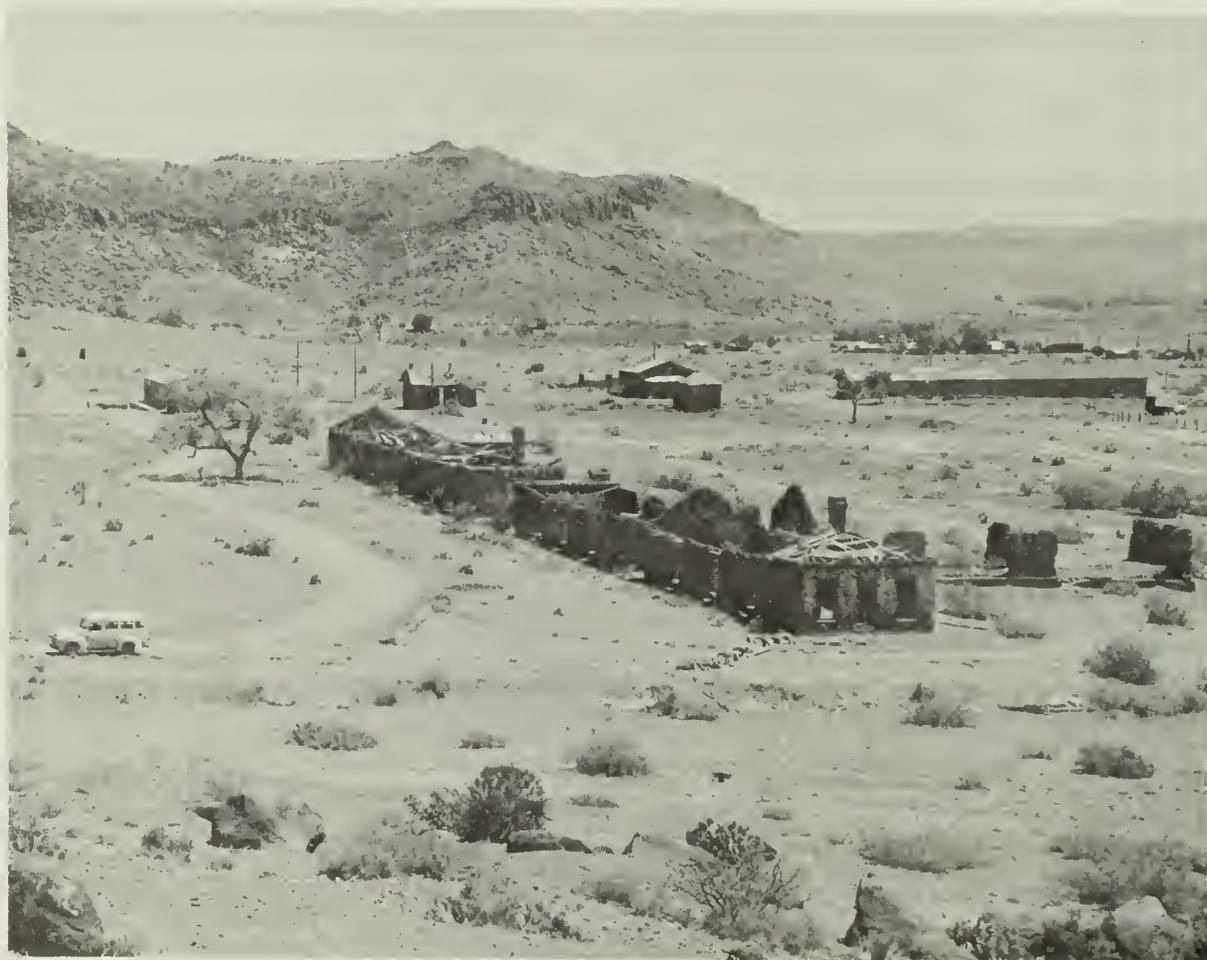
FIGURE 60. The 1870 enlisted men's barracks (in right foreground), Fort Davis National Historic Site. The photo was taken in 1960, before National Park Service status. Historic documents, drawings, and photographs provided ample evidence on which to base a restoration.

The visitor center at Fort Davis is an adaptive restoration. The 1870 enlisted men's barracks, which was a roofless, ruinous shell in 1964, was left virtually intact and a modern veneer of soil-cement bricks built around it. Some sections of original adobe walls were pared down so that the veneer would make up the original width. Bearing beams and integral support were provided for the modern though authentic roof. The restored portion of the exterior was faithfully preserved in both form and detail, while the interior was converted to modern, functional use (figs. 60 and 61). A small, glass-enclosed framework on the interior of the restored barracks shows an original portion of adobe wall for viewing by visitors.

FIGURE 61. A view of the Fort Davis barracks after restoration. The ruinous shell seen in figure 60 was veneered with hand molded soil cement bricks, 4" x 4" x 12". They were made with one part portland cement (untinted), three parts unwashed sand, and three parts native soil. The bricks laid in masonry mortar with rough joints, set with spalls, were wire-brushed. Original walls were pared down where required to accommodate the veneer brick and to retain original wall dimensions and thickness. Bond beams were installed at roof line to support the restored, hipped, shingled roof. The soil cement brick walls were painted with white cement paint, although originally they were whitewashed. The building is used functionally today as the Visitor Center. Cost of the restoration: \$129,000 or \$12.90 per square foot.

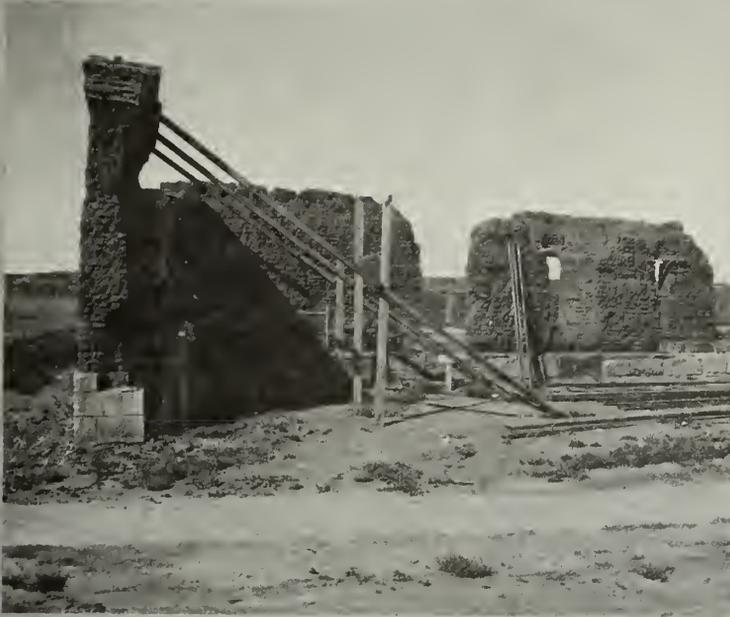
BUILDING 3-330,
ROOM 331,
WING WALL,
BEFORE
STABILIZATION

FIGURE 64. All ruins stabilization records should include before and after pictures attached to separate sheets such as the ones above for Fort Union National Monument.

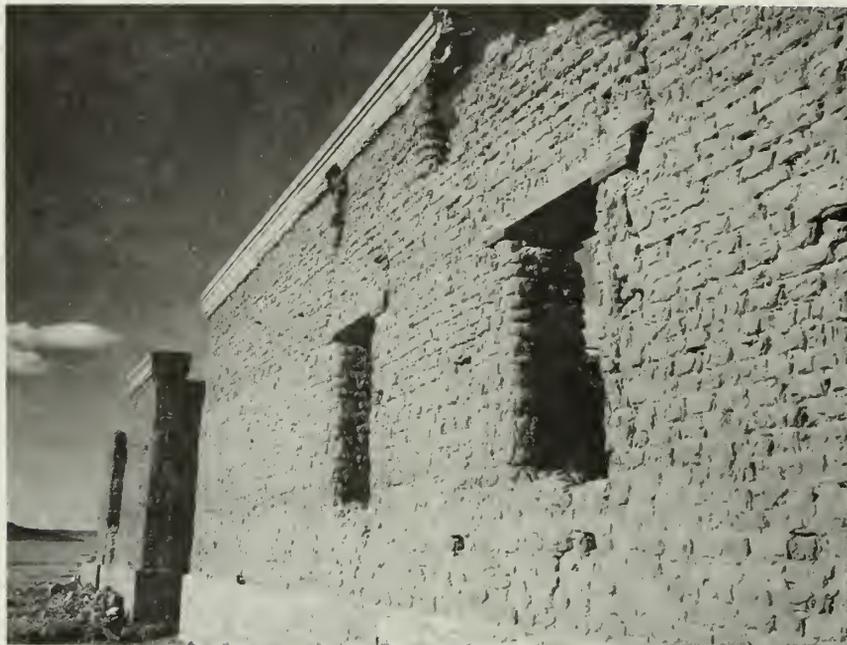
FIGURE 65. Building 3-450 (left) and building 3-440, west walls and coping, before stabilization. Fort Union National Monument.

An angle-iron framework, whose components were welded together, was then erected in the channels of both walls. The supporting base plate of 1/8" x 2" strap iron was placed in the lowest horizontal channel of all walls, and rests directly on the rock wall foundations. The vertical members (of 1/8" x 2" angle-iron in the west wall, and 1/8" x 1 1/4" angle-iron in the abutting wall) are supported at their lower ends by the strap iron. All other horizontal members except those at the top of the walls are 1/8" x 3/4" angle-iron.

At the top of that section of coping-bearing wall north of the abutting wall, two horizontal members of 1/8" x 2" angle-iron were welded in place. One is directly opposite the base of the

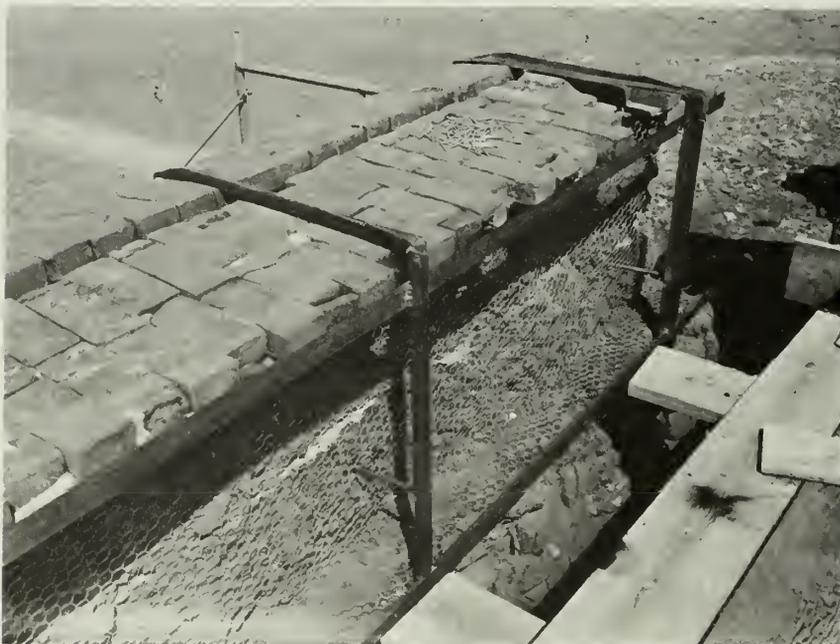
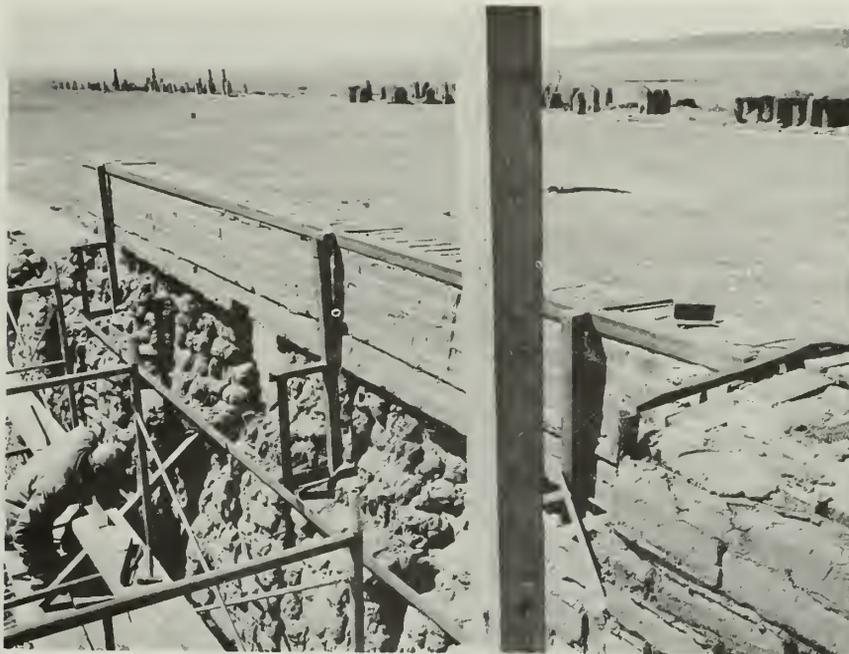
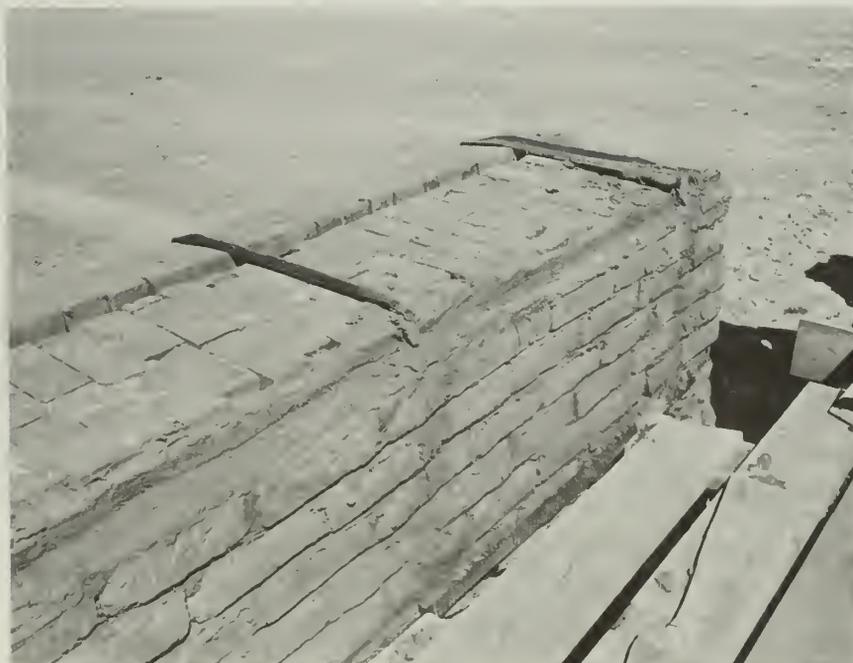
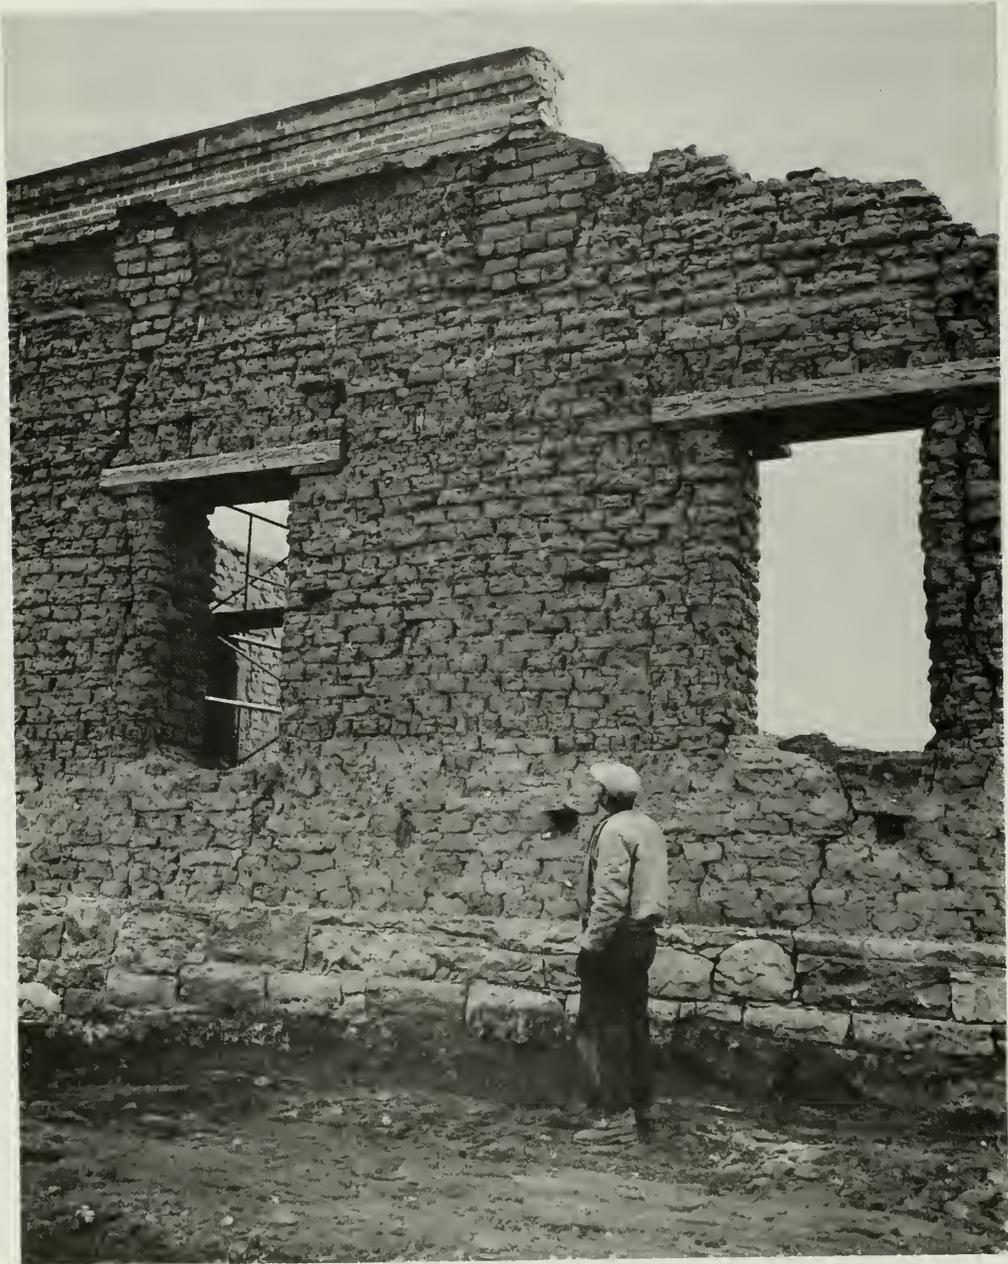
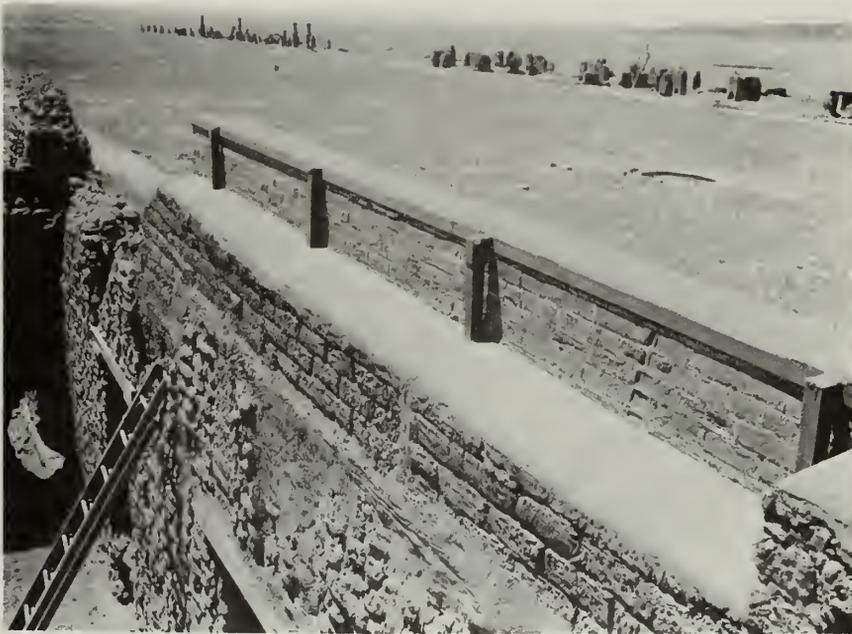
FIGURE 66. Building 3-440, coping on west wall, during stabilization, Fort Union National Monument.

FIGURE 67. Building 3-440, coping on west wall, during stabilization. Fort Union National Monument.

FIGURE 68. Building 3-440, coping on west wall, during stabilization. Fort Union National Monument.

FIGURE 69. Building 3-440, west wall and coping, during stabilization. Fort Union National Monument.

FIGURE 70. Building 3-440, south half of coping on west wall, during stabilization. Fort Union National Monument.

The top of the wall under the brick veneer cap was almost completely eroded out. The area was cleaned of loose material, squared up and lined with metal lath. It was then rebuilt with soil-cement brick to provide a solid wall between the vertical members and the heavy, solid coping. There are no free-standing (and thus visible) steel members in this part of the wall, and thus maximum rigidity was provided.

solid brick coping which is present now only on the west side of the wall. The other is immediately below and supports the horizontal veneer of brick which forms the top of this half of the coping, and which extends across the top to the east side of the wall. From the rigid framework on the east side of the wall, 1/8" x 2" modified angle-iron "hooks" extend across the top of the coping and down the west side about 7". These serve to hold the coping in place by preventing it from leaning outward at the top. To prevent the coping from dropping through collapse of the underlying adobe, only an edge of which supports the coping, a 1/8" x 2" angle-iron member was placed horizontally beneath the coping to provide support. It is secured to the framework on the opposite side of the wall by short lengths of 1/2" reinforcing rod, welded in place at each end. The remainder of this half of the framework is secured in a similar manner: an average of 3 short sections of 1/2" reinforcing rod for each vertical member penetrate the wall through drilled holes, and are welded to 6"-long strips of 1/8" x 2" strap iron sunk into the west side of the wall and to the vertical members in the east side.

The south half of the coping is more massive in construction than the north half, and there is no veneer or brick over the inner (east) portion of the adobe wall. Although the method of securing the coping at the top of the angle-iron framework is similar to that used to support the north half of the coping, more rigid construction was necessary because the vertical supports are free-standing for the top 22", approximately. Also, these top sections are offset to the west a distance of 10" from the vertical axes of the lower portions in such a manner as to place the side of the upper portions against the coping.

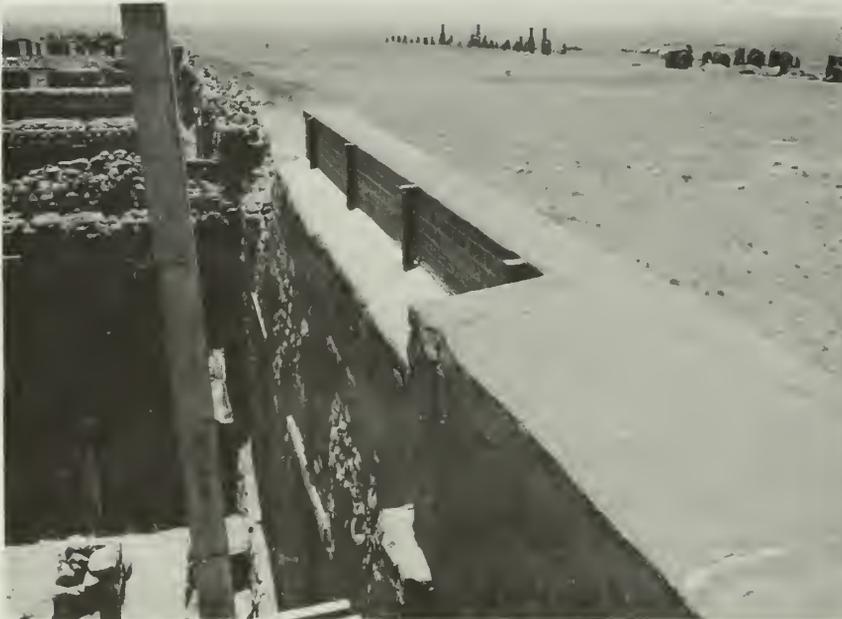
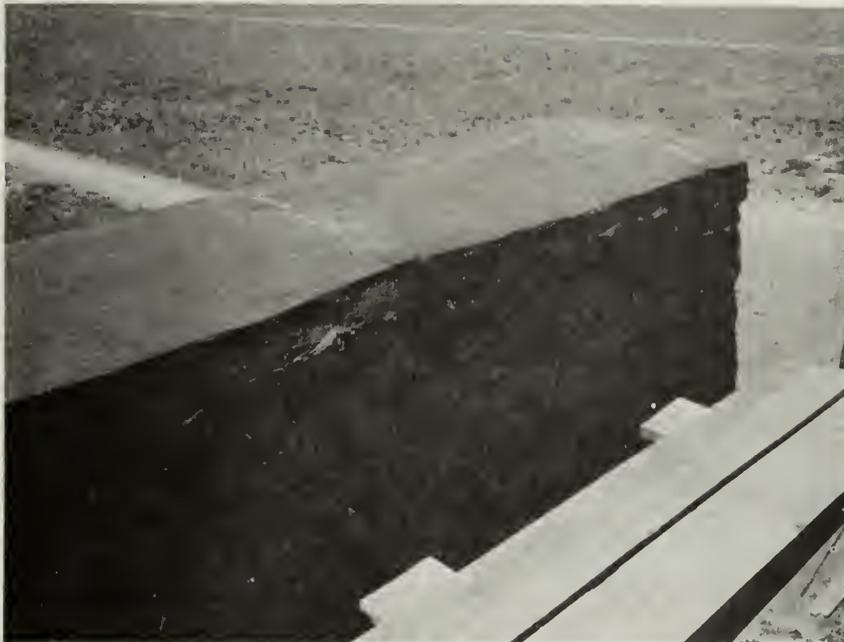
FIGURE 72. Building 3-440, coping on west wall, after stabilization. Fort Union National Monument.

FIGURE 73. Building 3-440, coping on west wall, after stabilization. Fort Union National Monument.

thick was placed over the top of the whole coping. The cap extends down over both edges the thickness of one brick. This extension was possible because the width of the top course of brick is less than that of the next-to-top course. When dry, the cement was painted with burnt sienna and raw umber in Exterior Stucco Finish (adobe) to render the cap less obvious.

To provide a better bond between metal, concrete and soil-cement all the angle-iron which was to be enclosed by the rebuilt portions of the wall or by refilling of the channels was first covered with metal lath. (Exposed sections of angle-iron were painted with red lead darkened with burnt sienna and raw umber.) Then all channels in the adobe wall were filled with colored soil-cement.

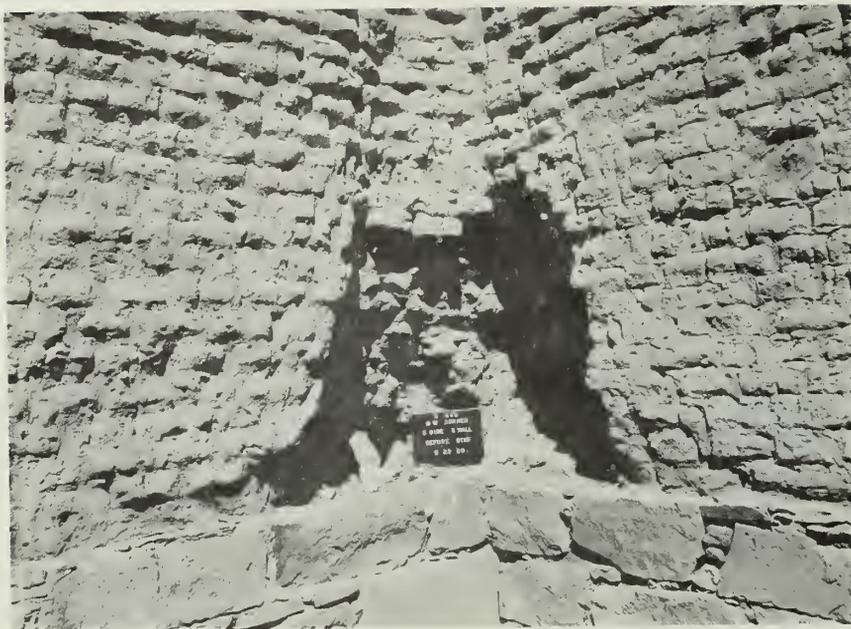
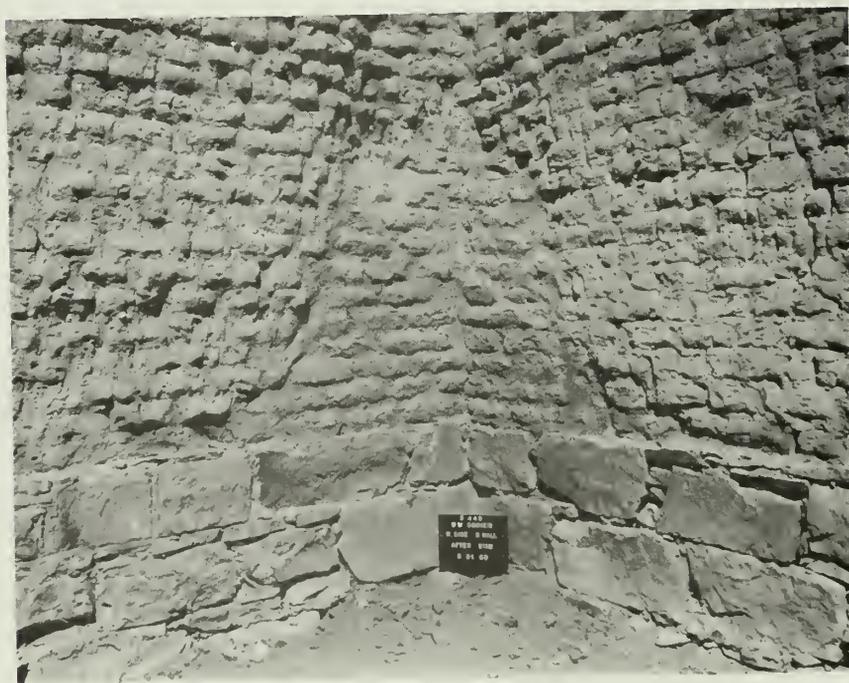
FIGURE 75. Building 3-440, southwest corner, before stabilization. Fort Union National Monument.

FIGURE 76. Building 3-440, southwest corner, after stabilization. Fort Union National Monument.

of 1/8" x 2" angle-iron. The rectangles formed were incorporated into the wall proper, by rebuilding this section with soil-cement brick up to and through the rectangles. (The upper sections of wall had eroded out, leaving the coping balanced on just a few inches of adobe.) Two large holes in the wall under the coping were also filled with soil-cement brick.

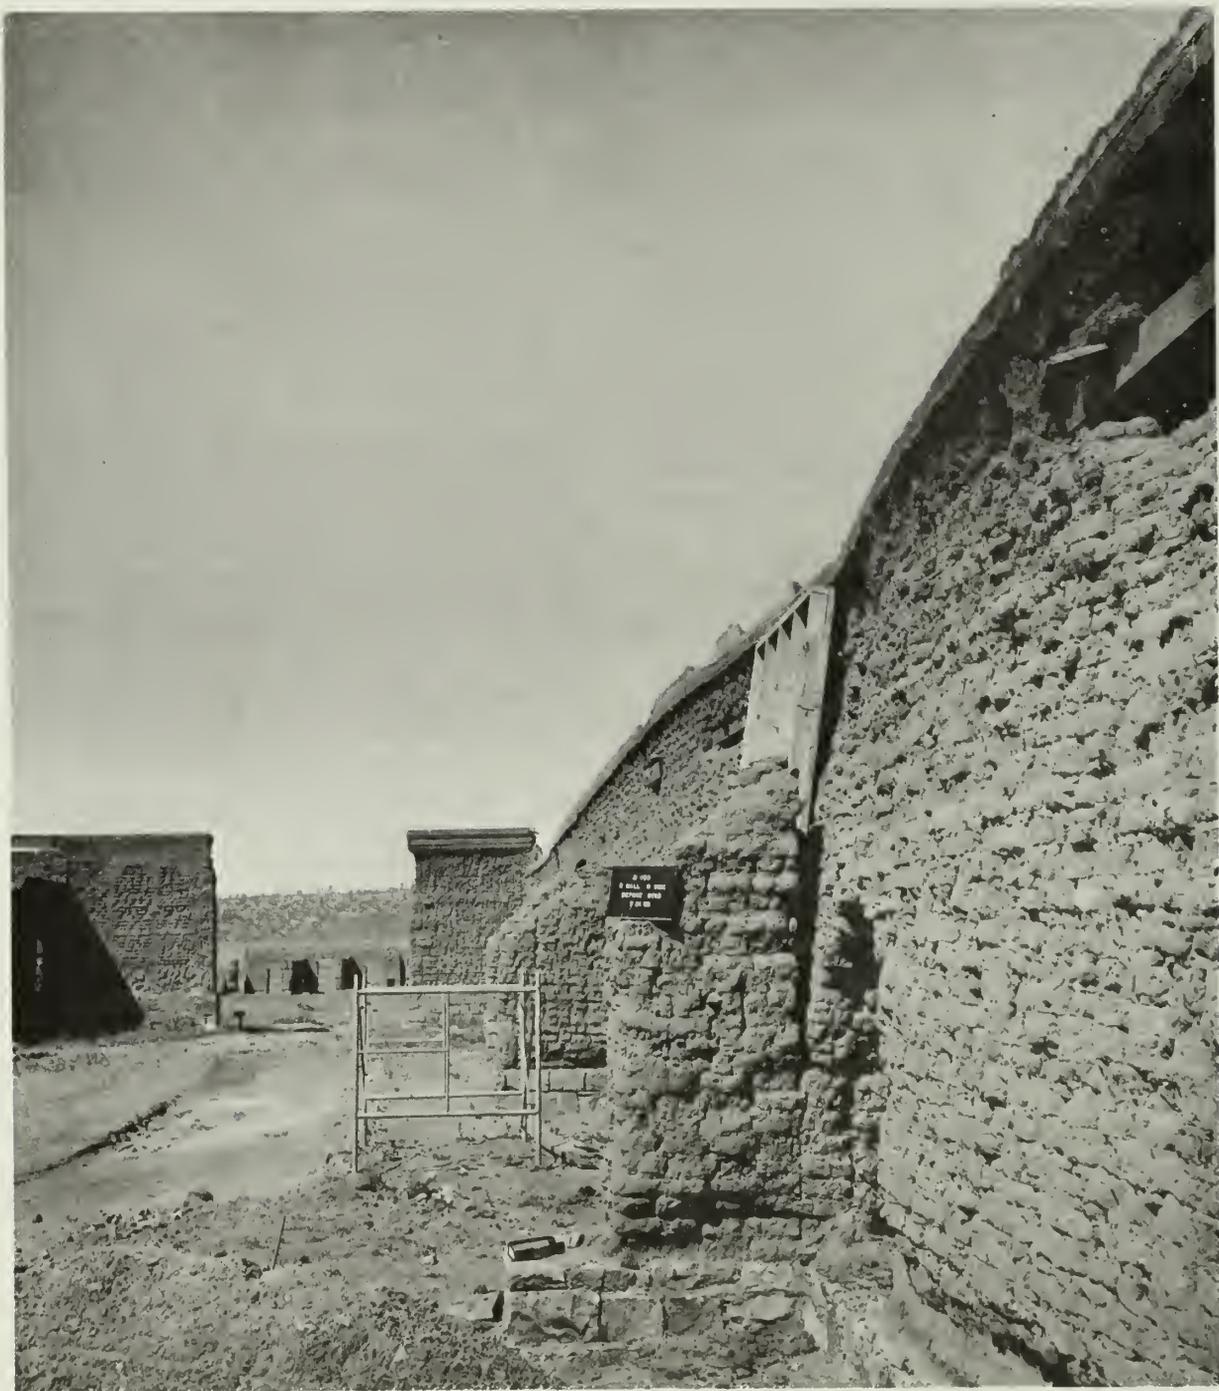
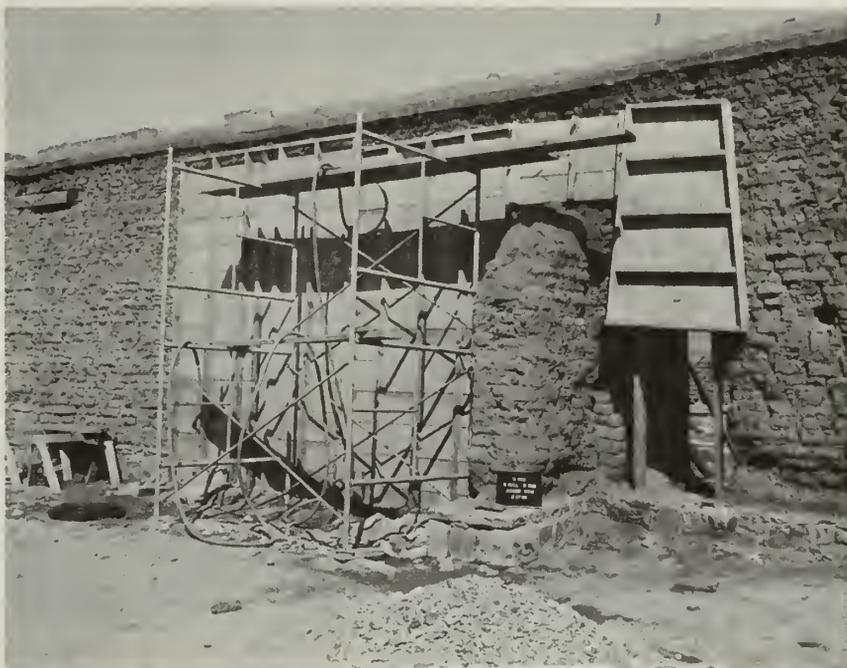
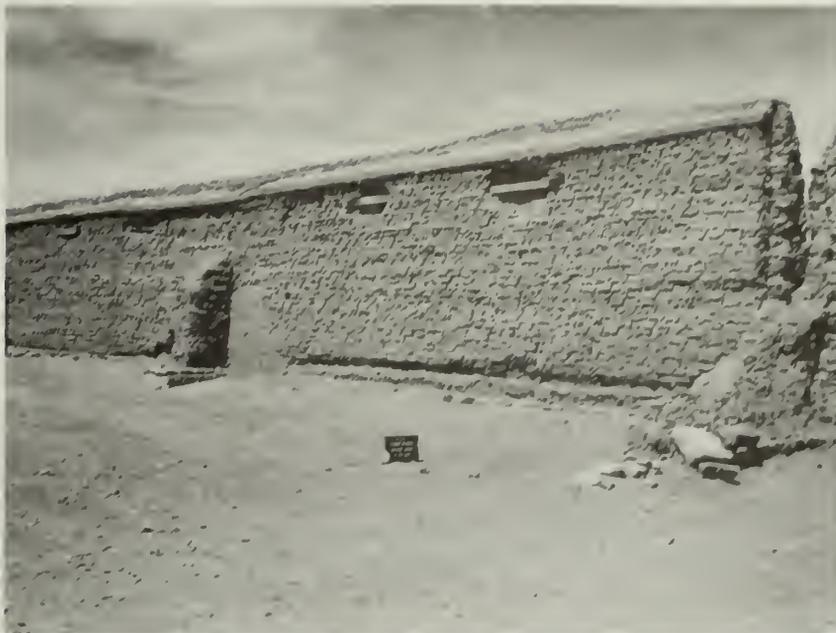
Condition on date work started. Masonry: *Massive south wall bulging northward. Only extreme west end of north wall standing. East and west walls in good condition but all walls needed capping to prevent further deterioration from penetration of moisture. Small north wall section leaning northward several inches out of plumb.*

FIGURE 77. Building 3-450, Room 451, south side of south wall, before stabilization. Fort Union National Monument.

FIGURE 78. Building 3-450, Room 451, south side of south wall, during stabilization. Fort Union National Monument.

FIGURE 81. Building 3-450, Room 451, south side of south wall, after stabilization. Fort Union National Monument.

Materials, construction, and technique in making repairs or accomplishing job: *South wall: A portion of the south wall was realigned in order to prevent collapse. The section, near the east end of the wall, bowed to the north about 12" at the top. Four wooden forms were completed and put in place on the bulge, two on either side of the wall. They were lined with asphalt roofing felt, wired together through the wall with No. 9 black wire, and then the space between form and wall was packed with damp sand. Two mine roof jacks and one heavy-duty jack were used to move the wall. The jacks push against the wall by means of long sections of 2" pipe (mine roof jacks) and 4" x 4" timber (truck jack). After pushing the wall into plumb the jacketing was removed from both sides of the wall and stabilization was begun by placing six upright steel members, and two horizontal members of the same material, with a steel strap along the bottom seated upon the stone foundation. The wall's brick coping is being held in place by seven steel rods looped about it and welded to the steel members on the wall's north side. The steel on the north side of the wall is secured by rods through the wall that are held in place by short steel straps. A hole in the wall was filled with regular adobes, cracks were grouted, steel was covered with adobe, the coping was secured, and adobes were laid along the top of the wall preliminarily to capping.*

were welded perpendicular to 2' lengths of 2" x 2" angle-iron, and looped at the other ends. These were placed in the holes which were then filled with concrete, reinforced with heavy wire. The wall was then jacked into plumb with mine jacks. A 15' length of 1 1/2" x 1 1/2" angle-iron was placed horizontally against the outside of the wall, near the top just above the lintel. The angle-iron was held in place by long bolts made by welding 5/8" carriage bolts on one end of 44" lengths of 1/2" reinforcing rod; these same rods were looped on the other ends to accommodate the 4" steel cable that was then attached to the deadmen. Turnbuckles on the two 16' cables allow for tightening.

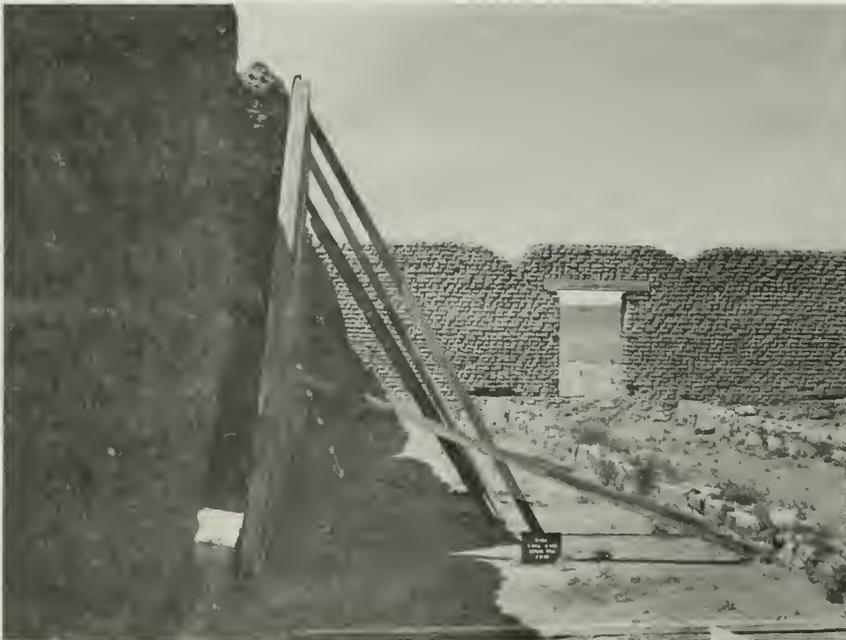
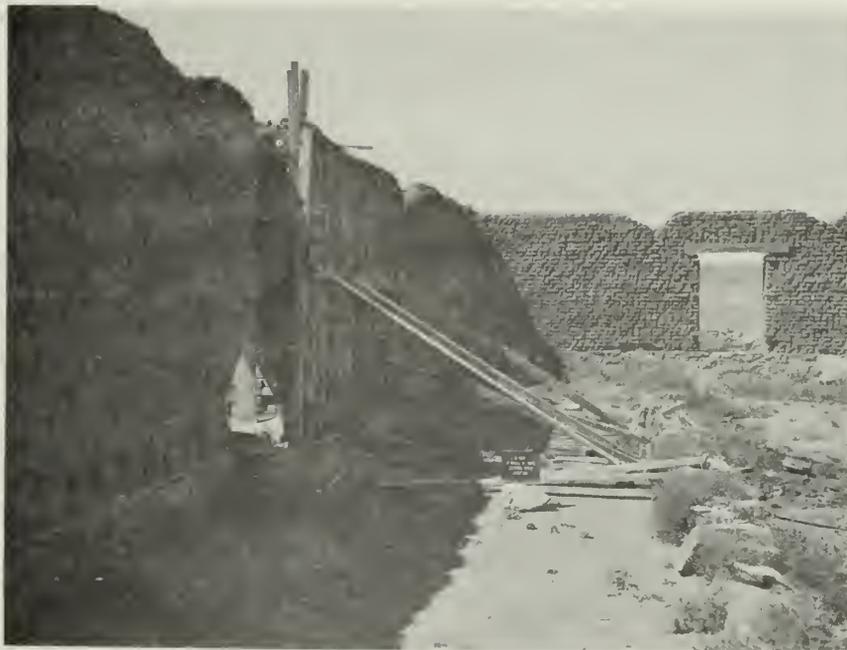
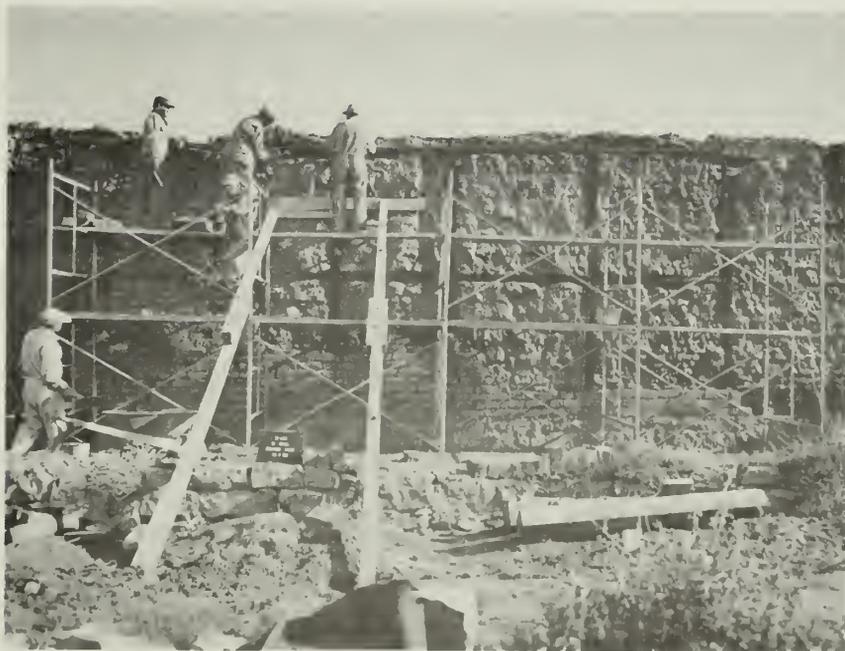
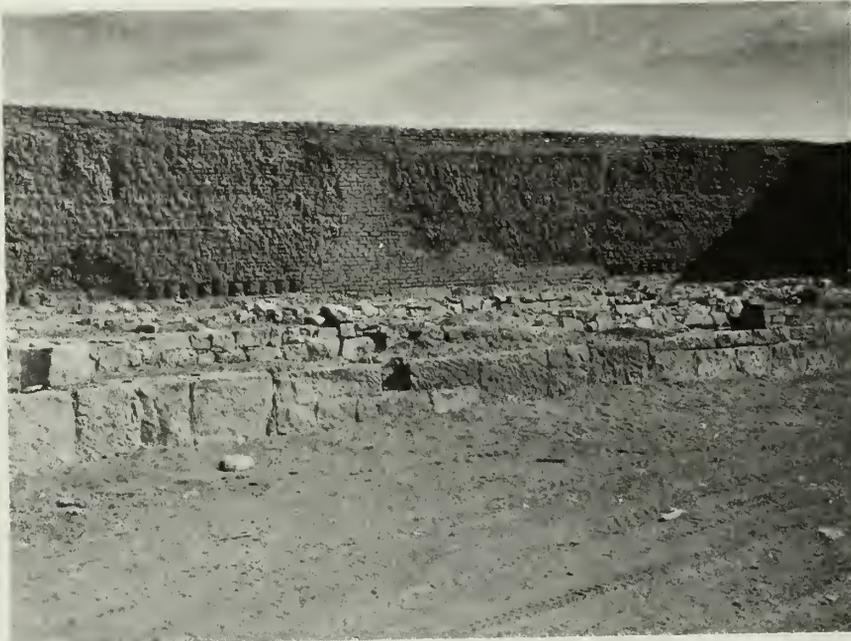
FIGURE 82. Building 3-450, Room 451, north side of south wall, before stabilization. Fort Union National Monument.

FIGURE 83. Building 3-450, Room 451, north side of south wall, during stabilization. Fort Union National Monument.

FIGURE 84. Building 3-450, Room 451, north side of south wall, during stabilization. Fort Union National Monument.

FIGURE 85. Building 3-450, Room 451, north side of south wall, after stabilization. Fort Union National Monument.

North and south walls: Capped (see introduction for detailed explanation of technique) and grouted with soil-cement. Missing adobes above windows were replaced and lintel timbers were replaced where missing. Sprayed with Dow Corning 772 diluted in water at a ratio of 1 to 9.

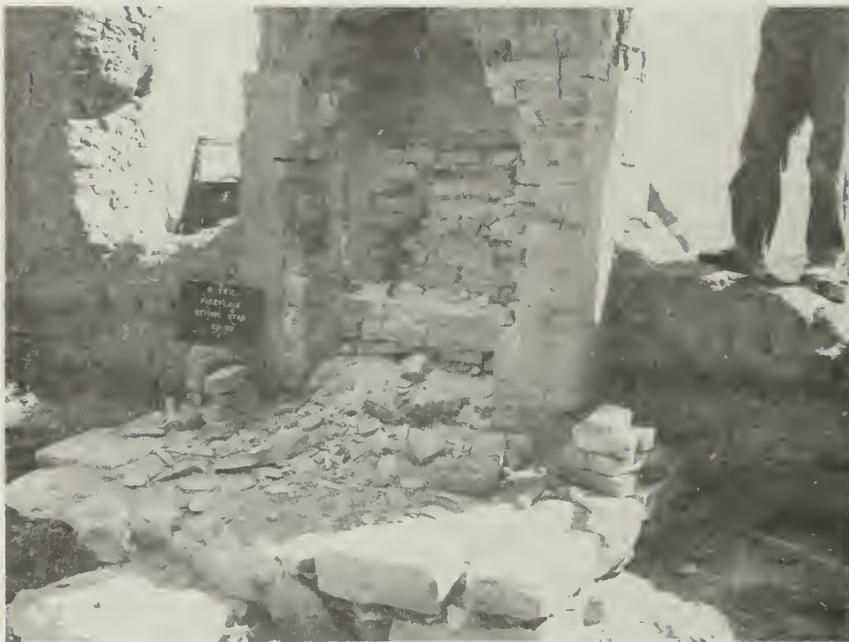
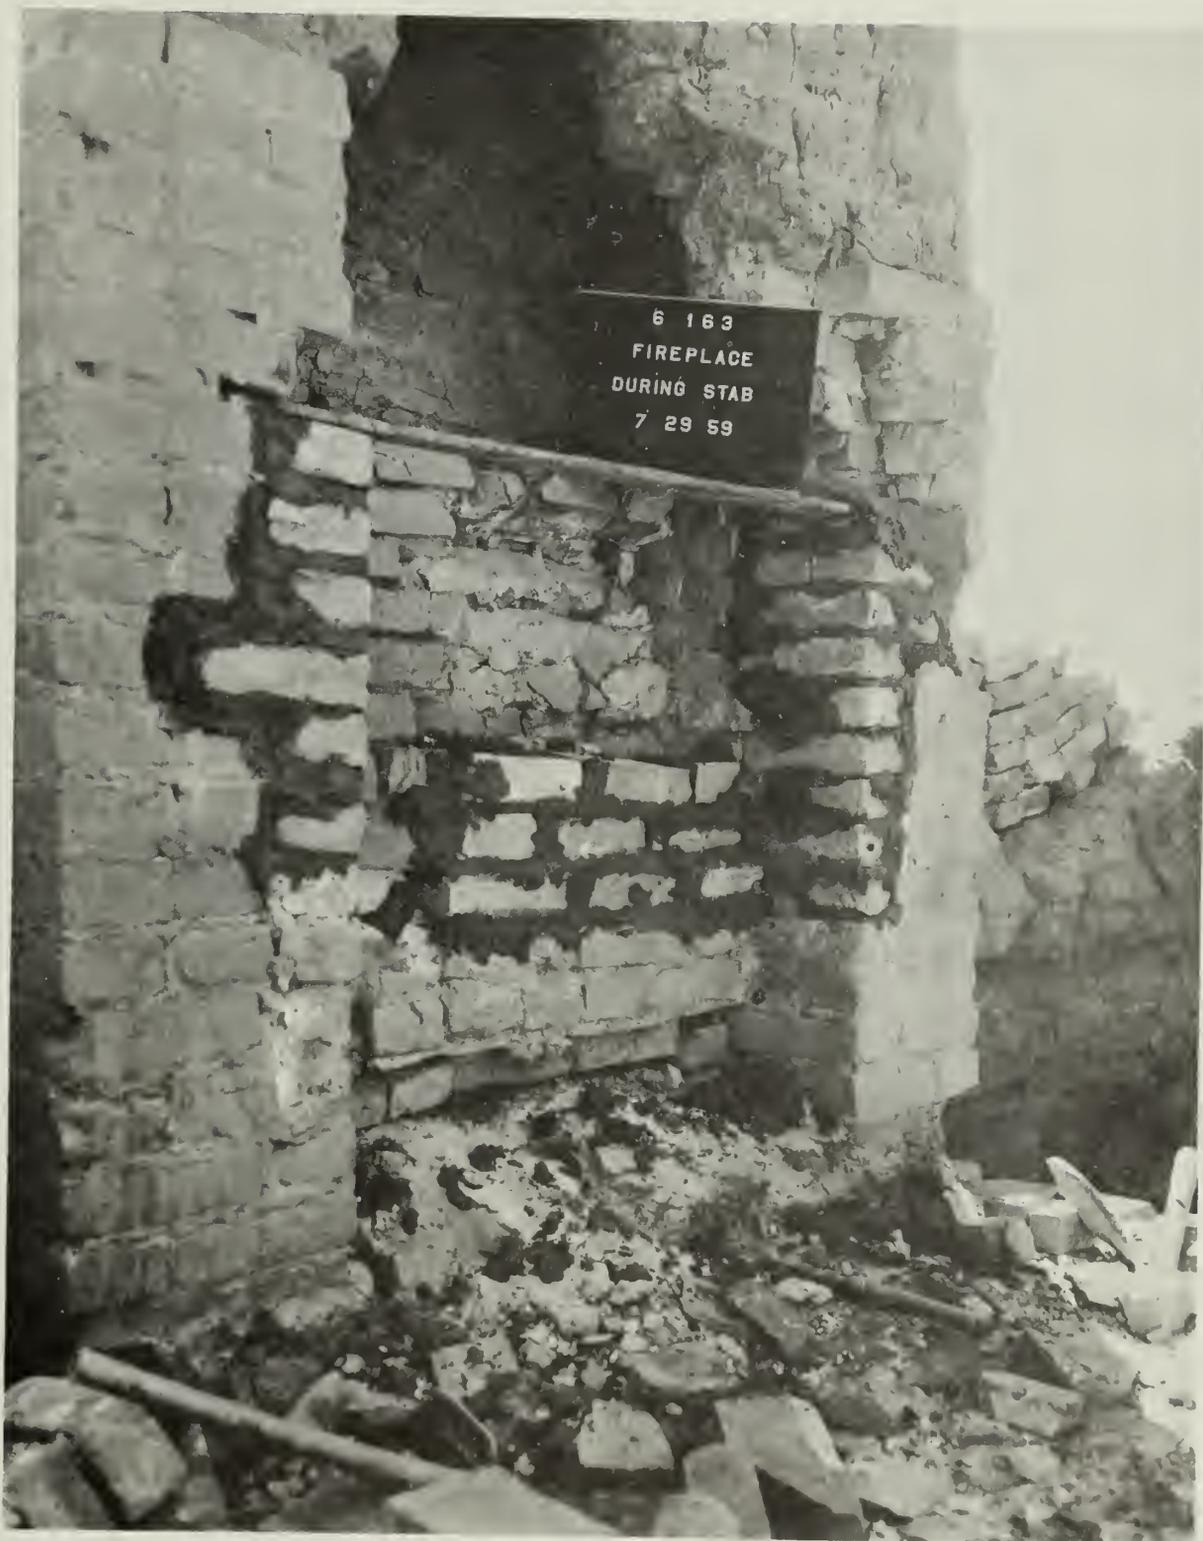
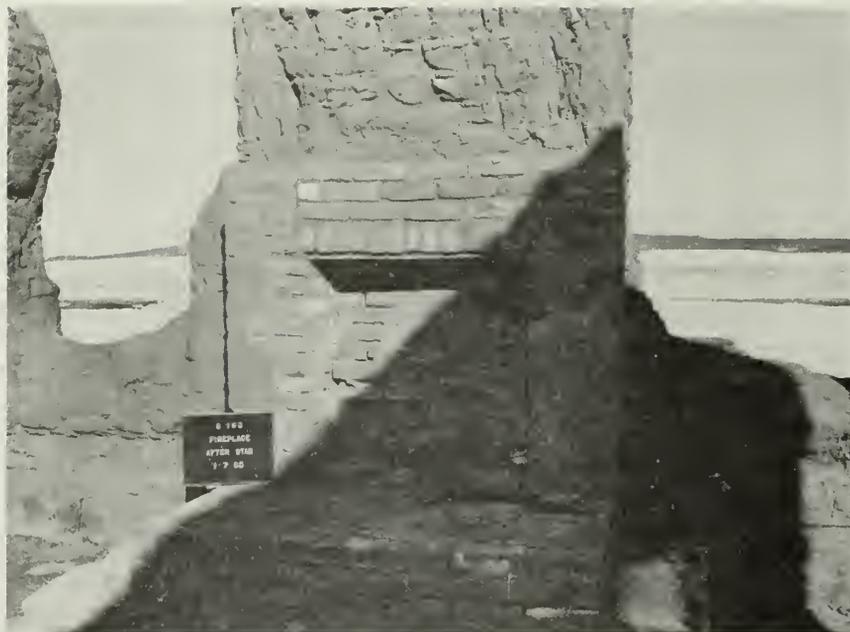
Details (notes on doorways, lintels, etc.): *Chimney and fire-place in east wall. North wall is south wall of rooms 161 and 162. Fireplace badly weakened by missing bricks. Loose bricks in chimney remnant. Brick hearth missing.*

FIGURE 93. Building 6-160, Room 163, fireplace in east wall, before stabilization. Fort Union National Monument.

FIGURE 94. Building 6-160, Room 163, fireplace in east wall, during stabilization. Historic bricks are being reset in soil-cement mortar. Fort Union National Monument.

FIGURE 95. Building 6-160, Room 163, fireplace in east wall, after stabilization. Soil-cement mortar used to reset bricks was brushed to prevent shine. Fort Union National Monument.

Materials, construction, and technique in making repairs or accomplishing job: *East wall: Missing foundation stones replaced in fireplace, brick hearth rebuilt with historic brick, missing fireplace brick reset in soil-cement mortar. Missing adobes were replaced in the north, east, and south sides of the flue. The small chimney remnant stabilized by resetting loose bricks in soil-cement mortar and replacing several missing bricks.*
