Ruins Stabilization in the Southwestern United States

RUINS STABILIZATION IN THE SOUTHWESTERN UNITED STATES

National Park Service
U. S. Department of the Interior
Washington 1974

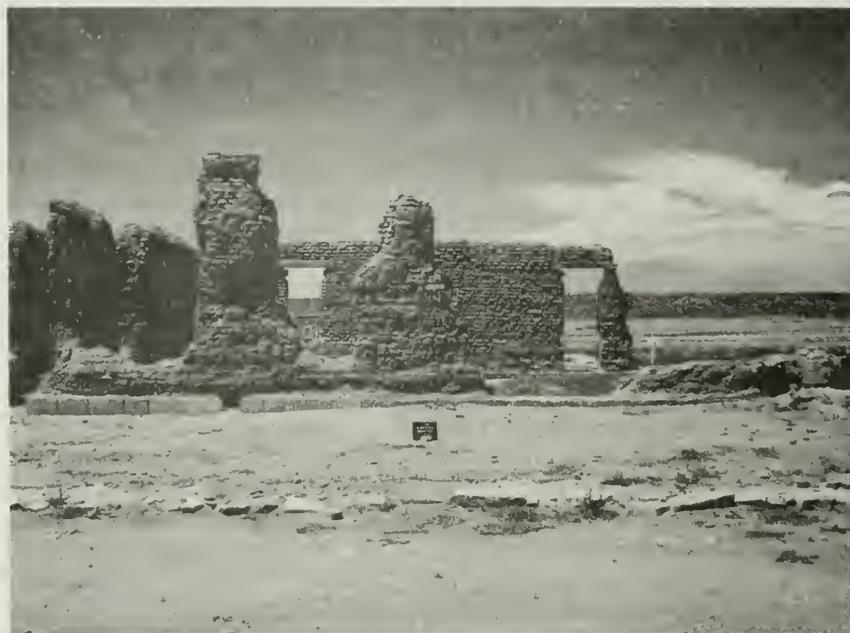
Condition on date work started. Masonry: *Nearly all of east wall missing except for flue. Many adobes missing from all sides of adobe flue. North wall in good condition. Lintels missing from window in south wall. West wall in good condition.*

FIGURE 96. Building 6-160, east side of east wall, before stabilization. Fort Union National Monument.

Materials, construction, and technique in making repairs or accomplishing job: *East wall: Missing foundation stones replaced in fireplace, brick hearth rebuilt with historic brick, missing fireplace brick reset in soil-cement mortar. Missing adobes were replaced in the north, east, and south sides of the flue. The small chimney remnant stabilized by resetting loose bricks in soil-cement mortar and replacing several missing bricks.*

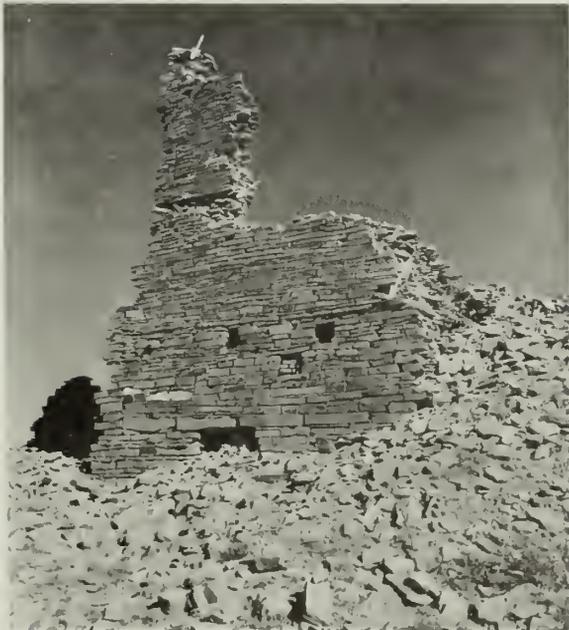
FIGURE 101. Tower Kiva, north wall exterior. Note large hole at base, and eroded insets (arrows) where second, third and fourth stories were slightly stepped back.

Considering its spectacular height, the wall is in good condition, but must be strengthened by repairing, reinforcing and capping to preserve its present condition.

Materials, construction, etc.: The Tower Kiva, north wall exterior. The high, sloping east and west wall stubs were capped, extending the east stub slightly eastward to provide a short but strong buttress section. Two integral members were placed in the west stub where it rises vertically, beginning at the second story level, the members extending to those rising from the east wall. The second and third story ledges or insets were repaired. The several openings including the two square beam holes, and the ventilator beneath them, and the beam holes at the east side were all repaired. The large hole at the base of the wall was filled with repair masonry in cement, the rough interior core being set in cement and the face stones laid in matching tinted cement. Following the above work, the entire wall face was grouted, pointed, and respalled. It was necessary to reset a few loose stones here and there in the facing.

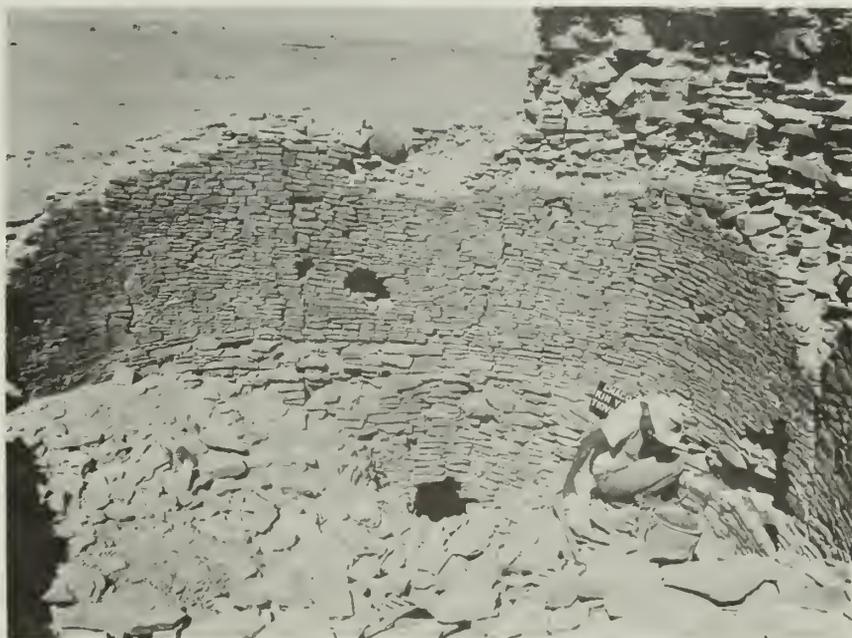
FIGURE 104. Another view showing general condition of lower part of interior.

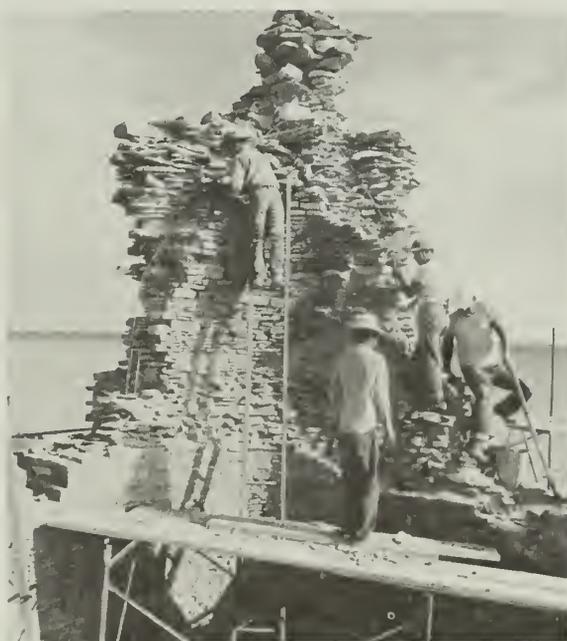
FIGURE 107. Tower Kiva, interior northeast corner, during installation of integral members to strengthen the highest wall section.

East wall, interior. The south half of the top was horizontally capped. The vertical or sharply sloping north half was reinforced with paired integral members which arch up and cross over near the top spire and are joined with those from the north wall. Circular wall facing grouted and pointed and stones reset as needed. Large hole in center at fill line patched.

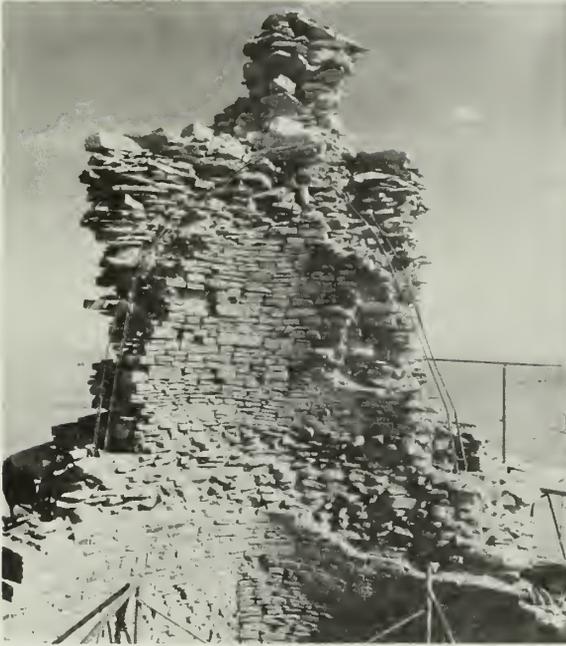
FIGURE 108. Upper portion of Tower Kiva, northeast corner interior, after the integral members were anchored in masonry.

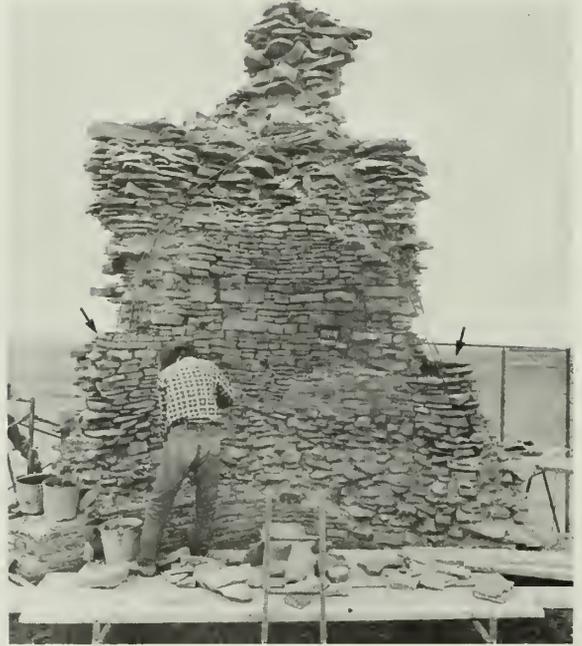
FIGURE 109. Beginning the vertical, reinforced capping (arrows).

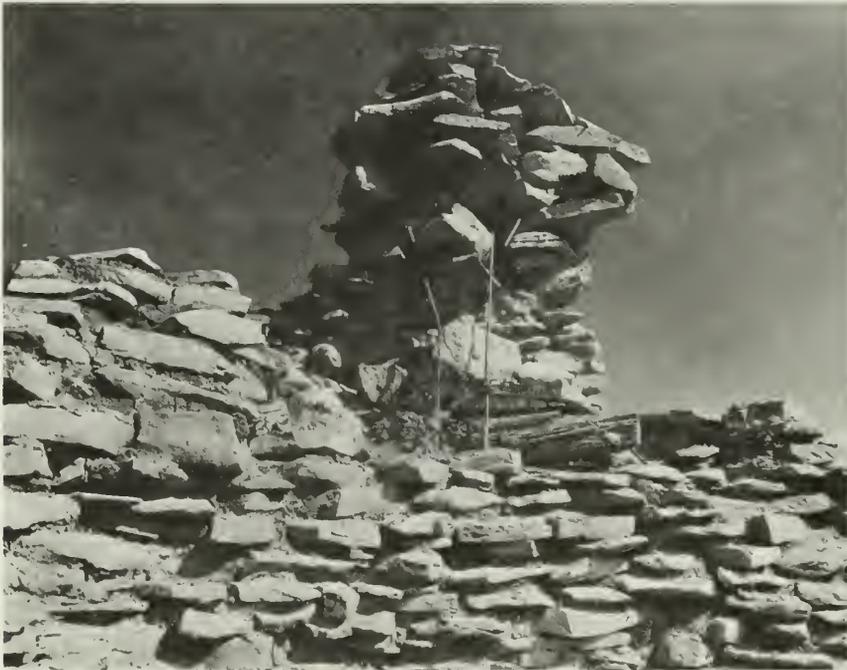
FIGURE 110. Integral members in the form of a T were installed in this top fragment of core masonry after the lower wall section had been strengthened to that point.

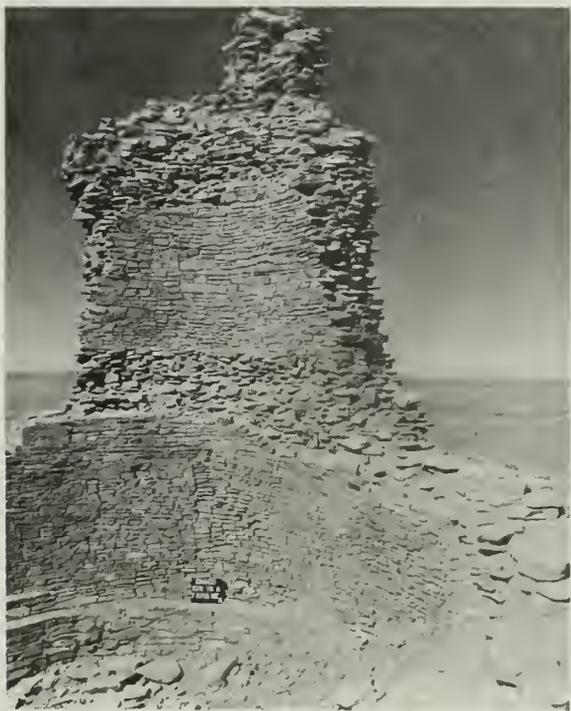
FIGURE 111. The wall at completion of stabilization. The wall is considerably strengthened and tightened, without a serious or objectionable alteration of the original profile.

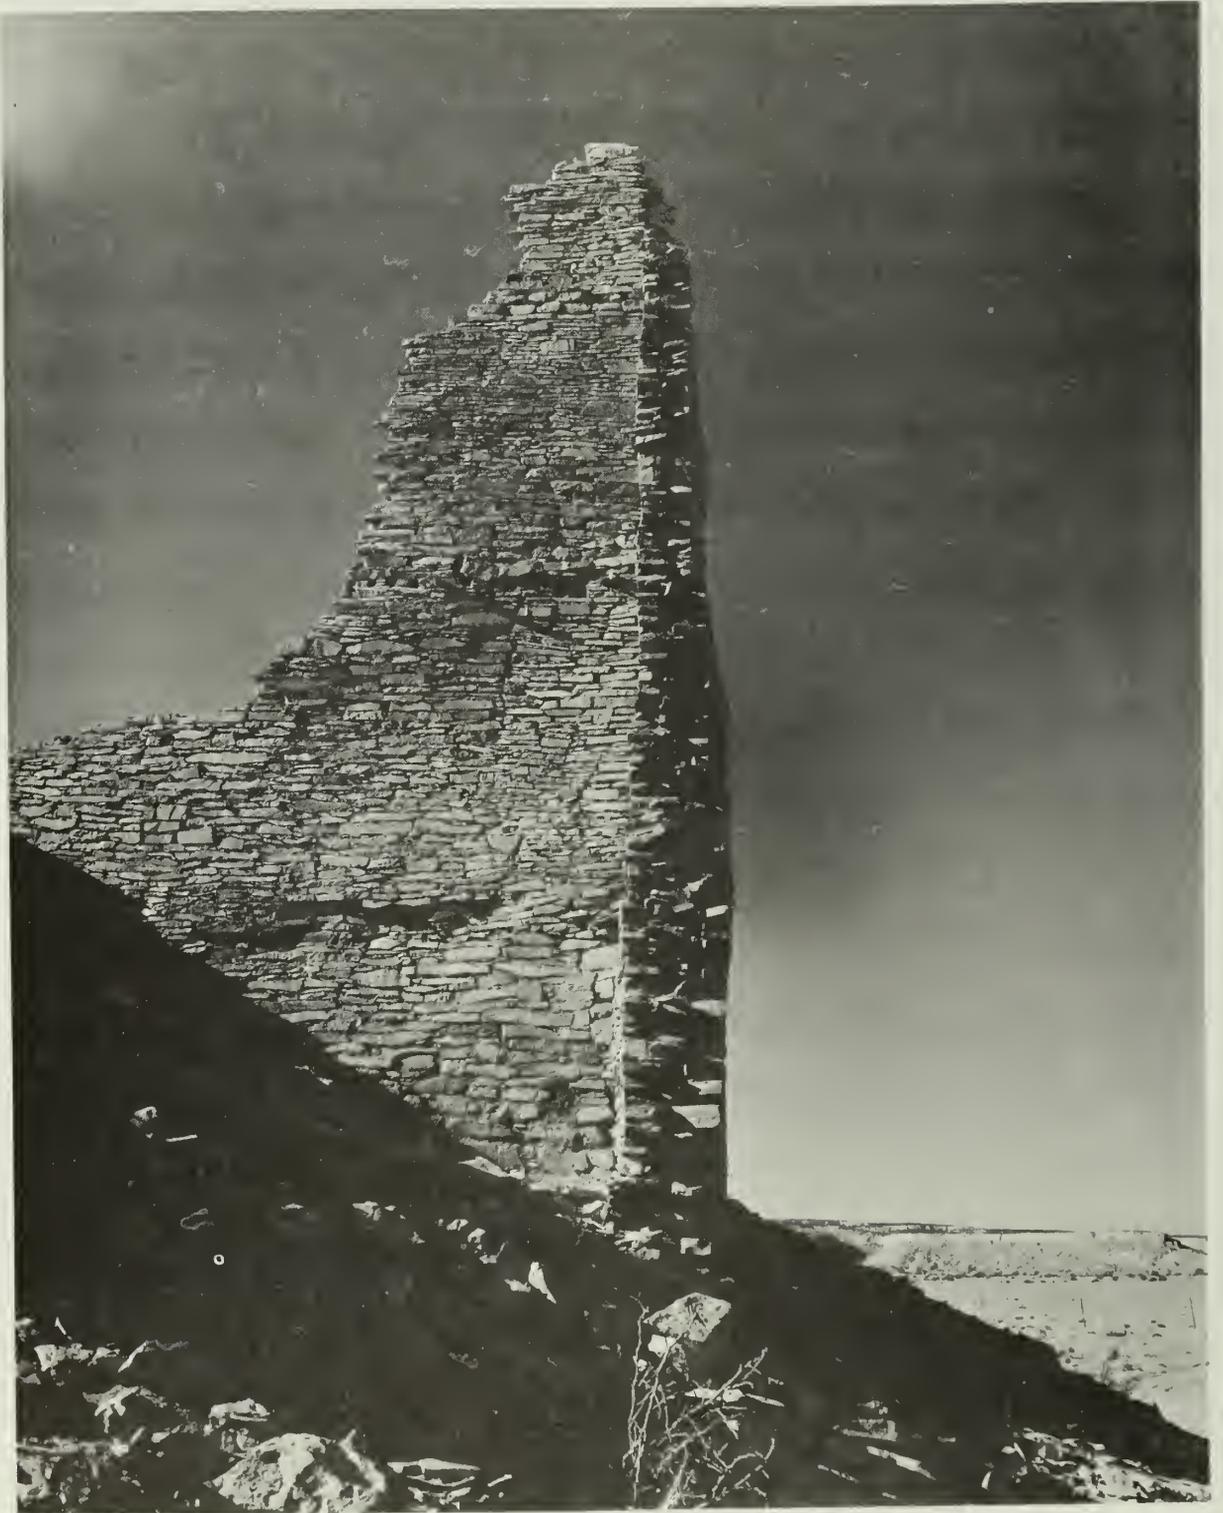
FIGURE 113. View of Tower Kiva showing vertical cap.

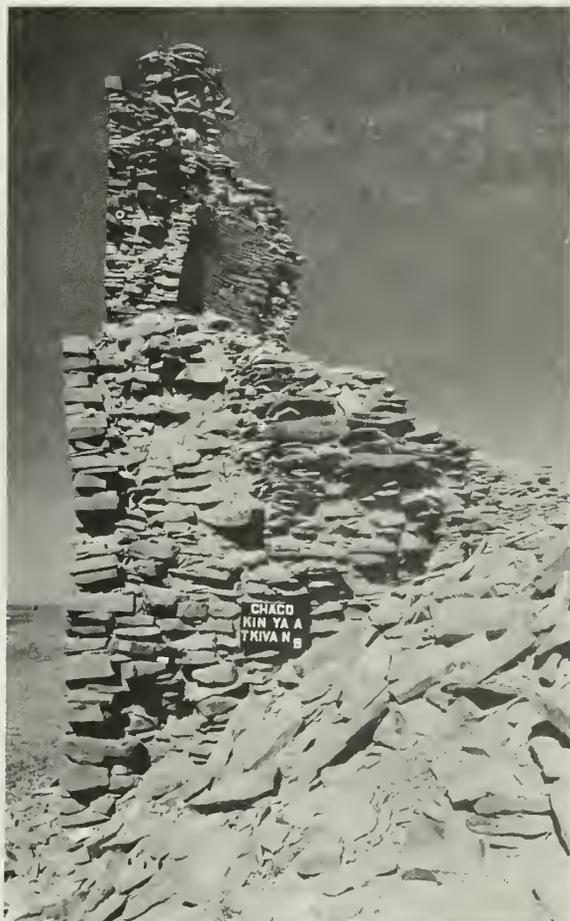
FIGURE 115. Tower Kiva, northwest corner.

Condition, description: The Tower Kiva, west wall. The straight wall here encloses the west portion of the circular kiva. The kiva corners enclosed are exposed to a height of 6' above present fill line. Exterior wall facing is either missing or pretty well covered by fill. A 4' thick section of rough core is exposed at the northwest corner. At the center of the west wall and level with fill both inside and outside the room, is a large U-

shaped opening probably caused by breakdown to timbers embedded in this wall which provided support for the ceiling in the room to the west. The wall core at this U-shaped opening is thin, loose, and porous and is deteriorating rapidly. Visitors who climb to the Tower Kiva enter the circular chamber at this point. Note: visitation to this little known area may be infrequent but there were three or four visitor groups at the ruins during our project within a period of one month.

Materials, construction, etc.: The Tower Kiva, west wall. Both northwest and southwest kiva corners were cleared of surface debris, and capped. The northwest outside corner was excavated until good foundation was encountered, and then the exterior facing was reset to a depth of 18 to 20 courses at the north end, and to a depth of 4 to 5 courses at the south end. The exposed core and veneer around the U-shaped opening in the central section was reset (figs. 115-117).

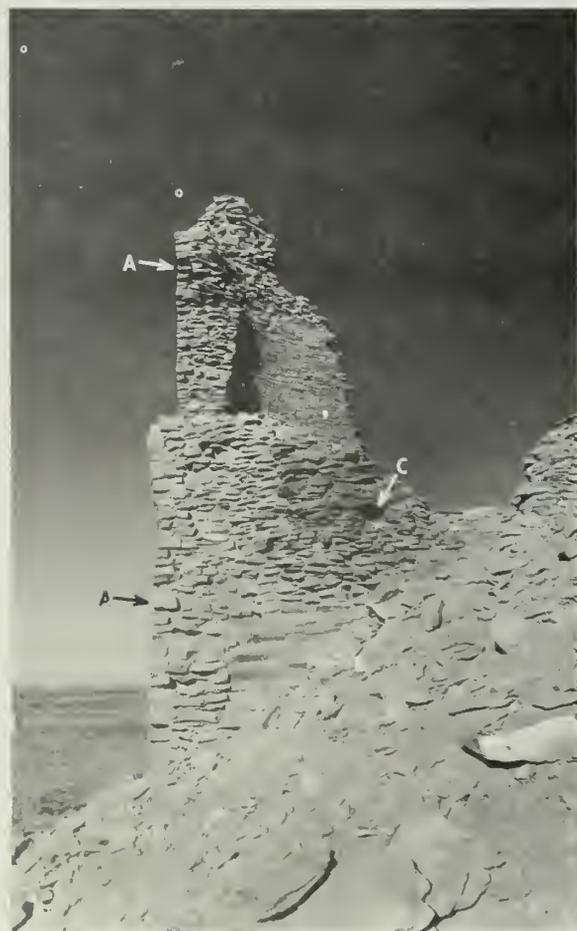
FIGURE 116. North wall stub capped (arrows A), lower portion of west wall facing reset (B), and exposed portion of thick core grouted (C).

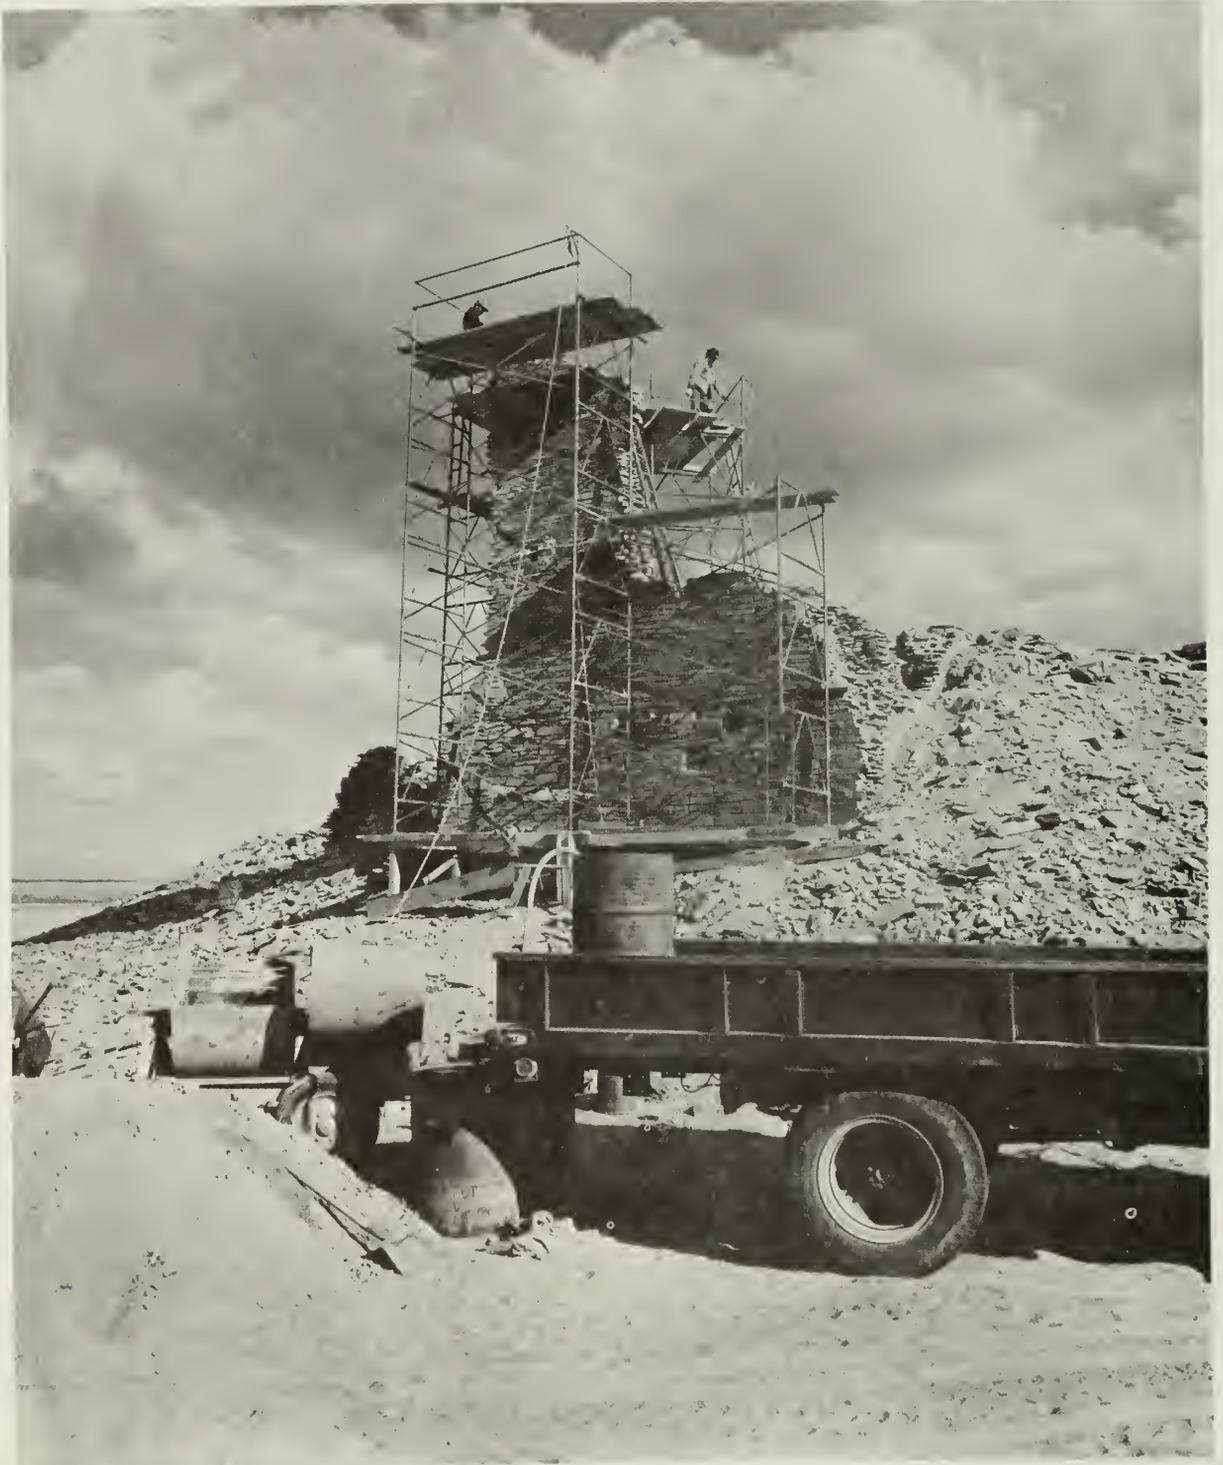
FIGURE 118. Work on the highest portion of the tower. The scaffolding completely surrounded the structure. To provide maximum safety for the workmen, the three sets of scaffolding were anchored at the bases and across the top and through midsections.

Figures 118 and 119 illustrate some work in progress on the Tower Kiva. Note the use and adaptability of tubular steel scaffolding.

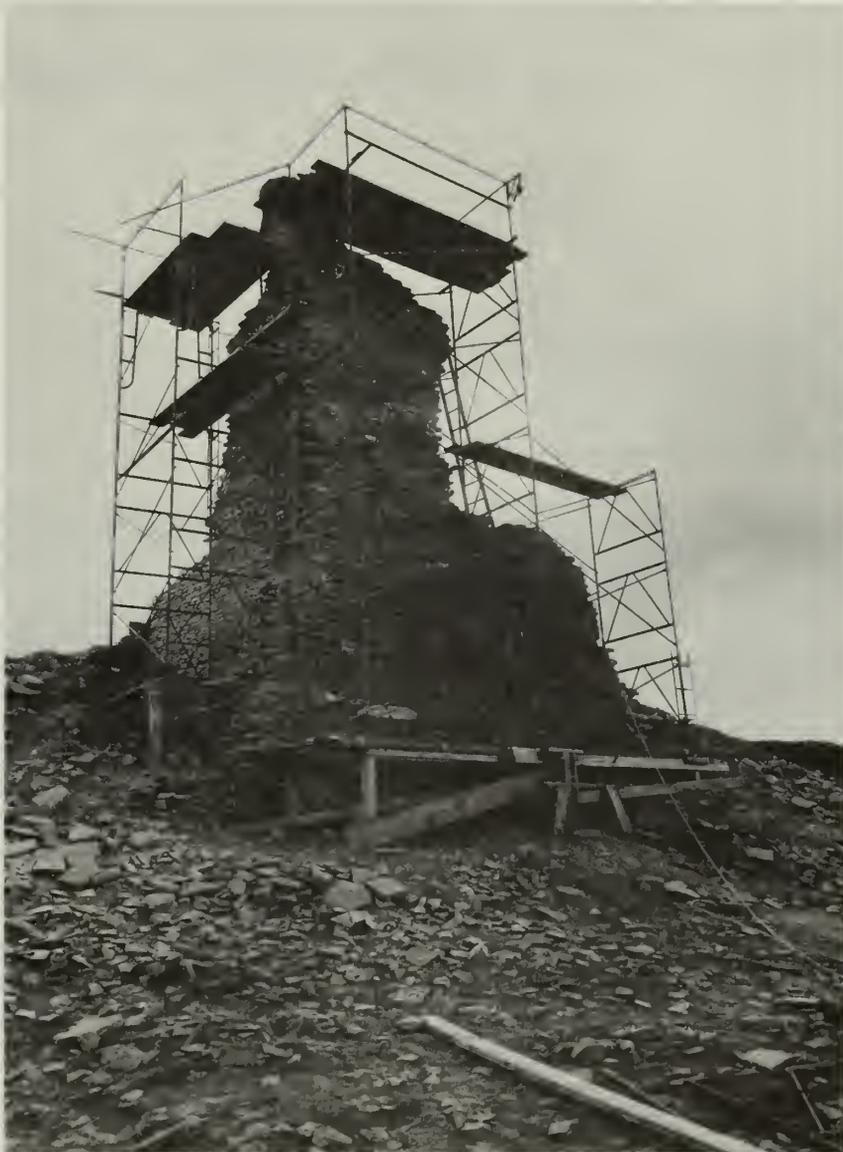
FIGURE 119. Tower Kiva. Scaffolding was anchored on firm and level bases built of heavy timbers.

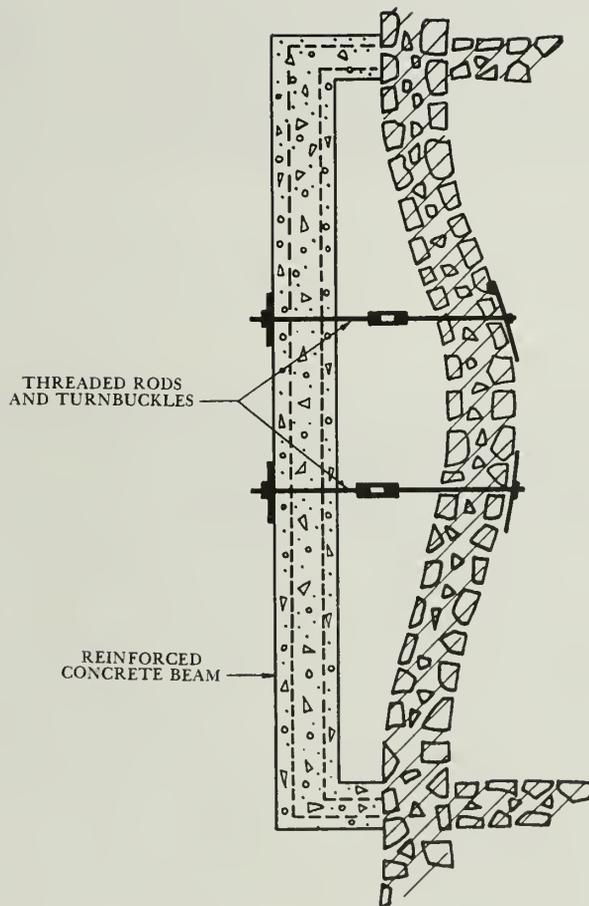
Ancient masonry: North wall above the ledge leans precariously into the room. East and west walls have eroded and are loose at the top. Footings of all four walls are undercut by erosion. Beam holes are eroding where beams have decayed.

FIGURE 121. Plan of reinforced beam to realign and hold north wall, Room 27, Talus Unit No. 1 (not to scale).

Materials, construction, and technique in making repairs or accomplishing job: *Part of the center section of the leaning wall was removed. A horizontal slab of steel-reinforced concrete was poured so as to abut against the junction on the partition walls. Steel rods were fastened through both wall and slab with turnbuckles between. Using the turnbuckles, the wall was pulled back to nearly vertical position. The stones removed were then replaced in tinted cement. East and west walls had already been patched and strongly capped to bear the load. New stones were set in cement around the wall footings. The beam holes were patched in tinted cement.*

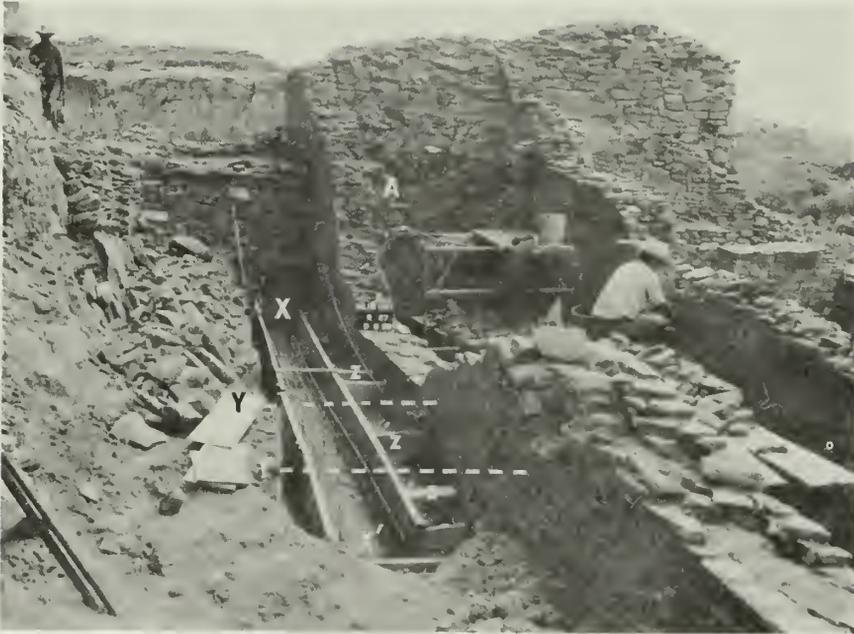
FIGURE 122. Construction of concrete beam shown in figure 121. The frame is complete and reinforcing rods are in place. X—X1- beam, Y—location of threaded rods and turnbuckles, Z—temporary braces. The ends of the beam bear against the wall at each side of the bulged area at points where the wall is braced against movement by partition walls. That at the east shown as A.

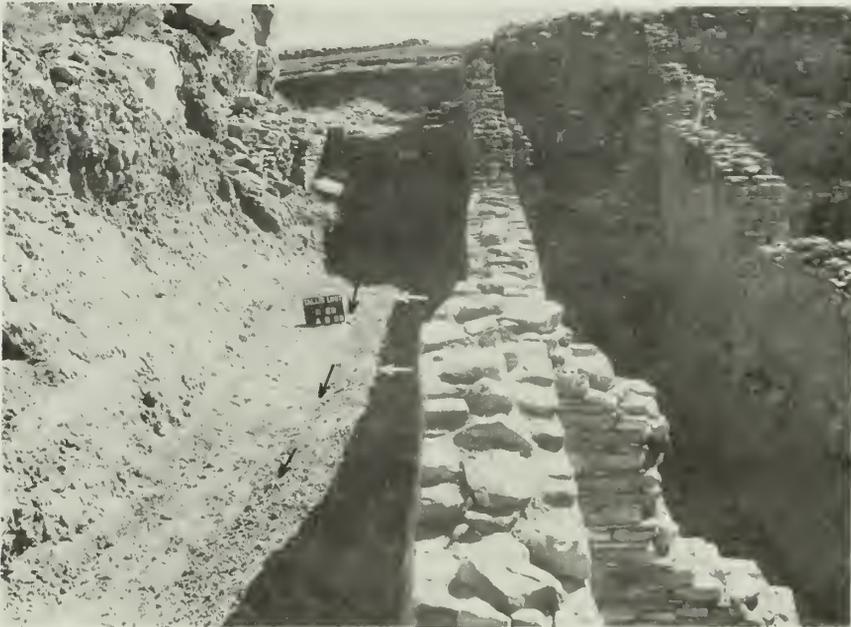
FIGURE 123. This wall in Talus Unit No. 1 has been pulled back into line; the capping is straightened up. The concrete beam dug into Room 28 is covered and the surface of this room (arrows) is graded to carry surface runoff away from the damaged wall.

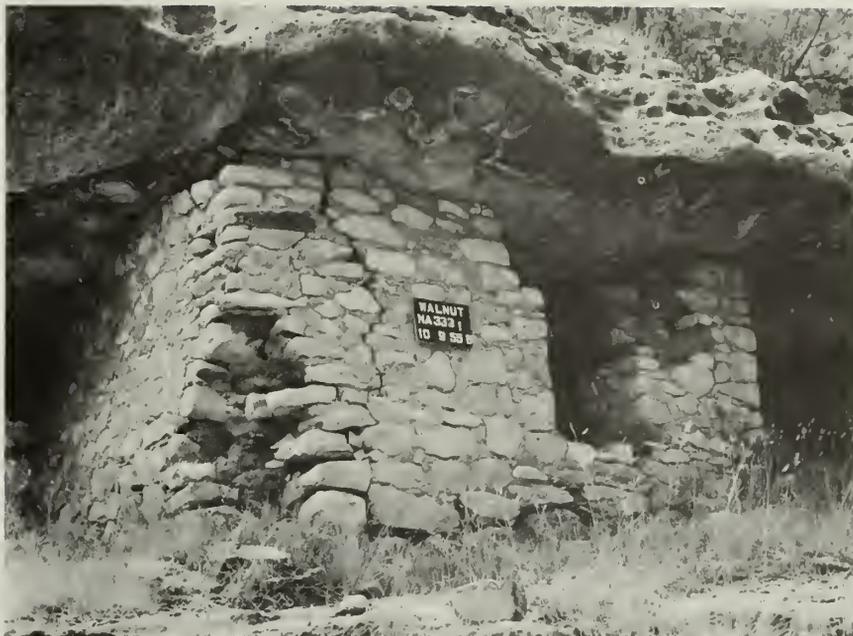
Condition on date when work started. *Ancient masonry: Fair. North Wall: In poorest condition. A large hole beginning at foundation and extending to midsection caused by pot hunters has made this wall extremely weak, and collapsed all of the eastern third except a fragile corner one stone wide. East Wall: Good except for eroded foundation, and the lower third of southeast corner which has collapsed. The V-shaped hole over doorway needs grouting on the north side.*

FIGURE 125. Room 1, east exposure, before replacement of fallen corner. (Walnut Canyon National Monument)

Materials, construction, and technique in making repairs or accomplishing job: *North Wall: The large hole measuring 3' x 4' was filled with repair masonry to save the upper section, and the northeast corner was buttressed also to preserve it. Repair work stained with black mortar color to match original.*

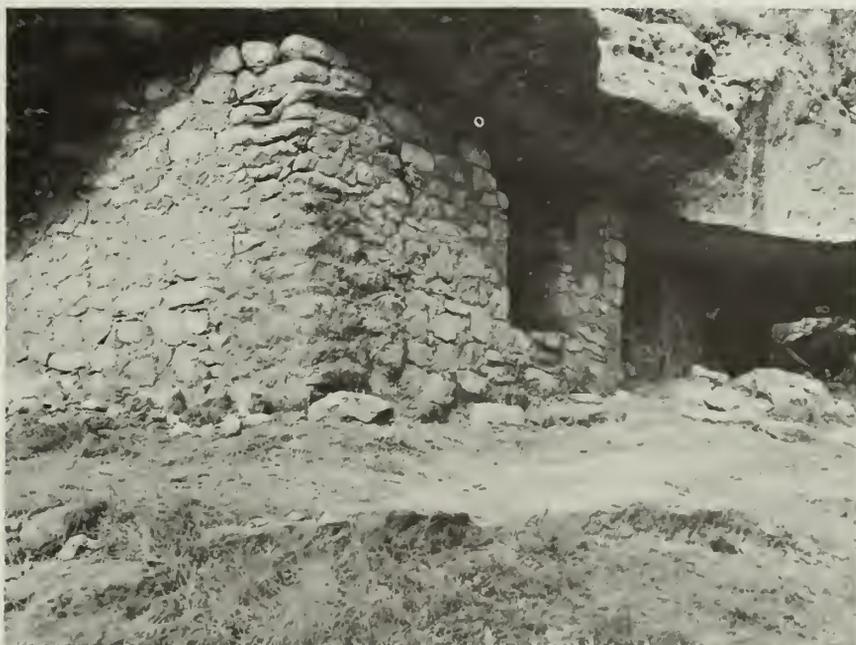
FIGURE 126. Room 1, east exposure, after replacement of fallen corner. The deeply eroded wall base was grouted, and the area above the doorway was partially reset. (Walnut Canyon National Monument)

East Wall: Entire foundation one stone high was grouted and pointed. The south wall also had a few small holes along the foundation row where original soil-mortar had eroded and these were filled. Sill and wall area below door grouted and pointed.
