Arlington House, The Robert E. Lee Memorial

South Dependency Historic Structure Report

Report prepared by Charles Fisher, Chad Randl and Kaaren Staveteig

2010-0053-P

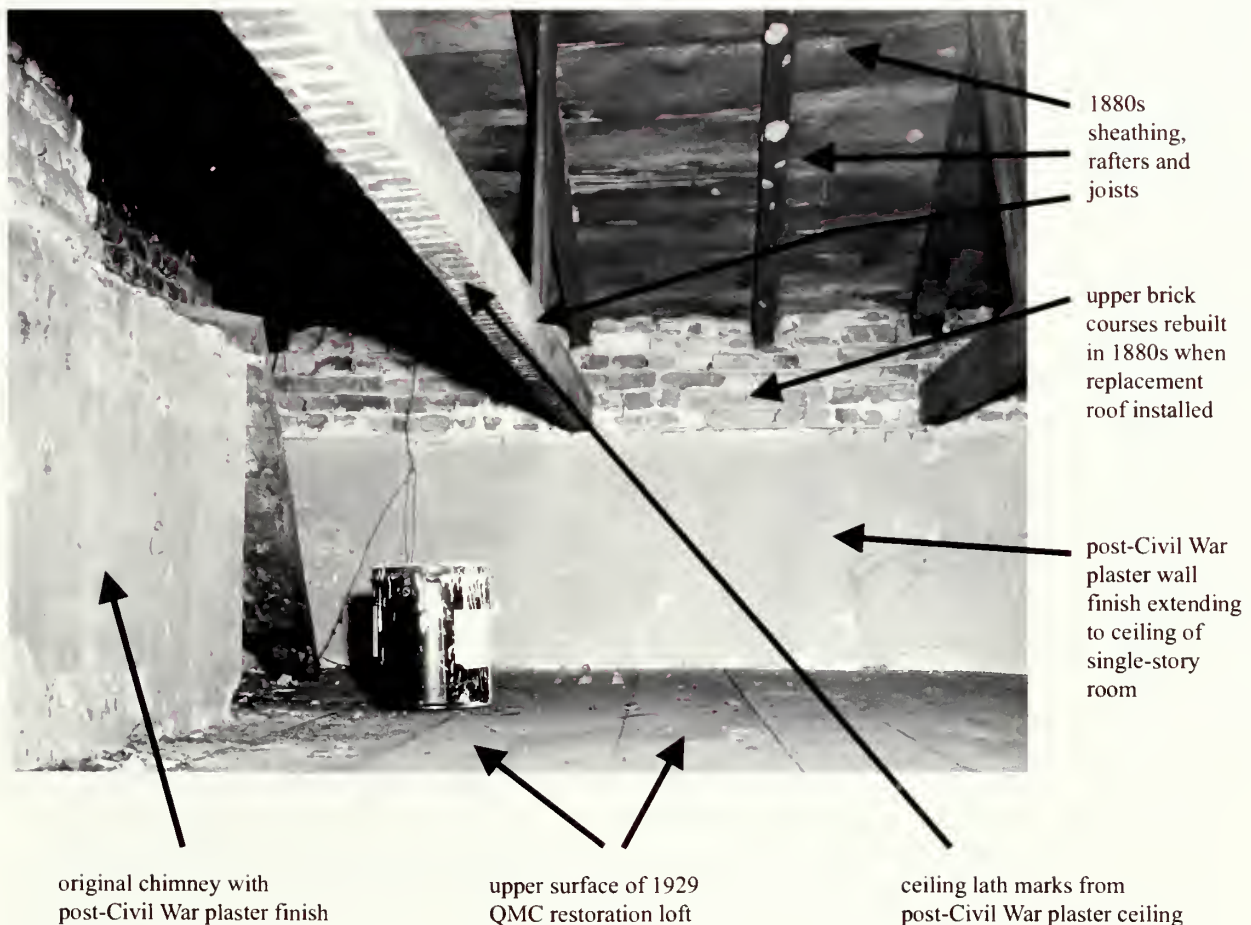
Figure 15. South Dependency, east room, 1957, space above QMC loft. When the QMC installed a loft in 1929, they closed off this upper area from view. Lath marks on the 1885 roof joists indicate the presence of a finished ceiling and layers of plaster date from the time after the Civil War when this space was a single level room. The roof system and portions of the historic plaster survive today above the west room loft.

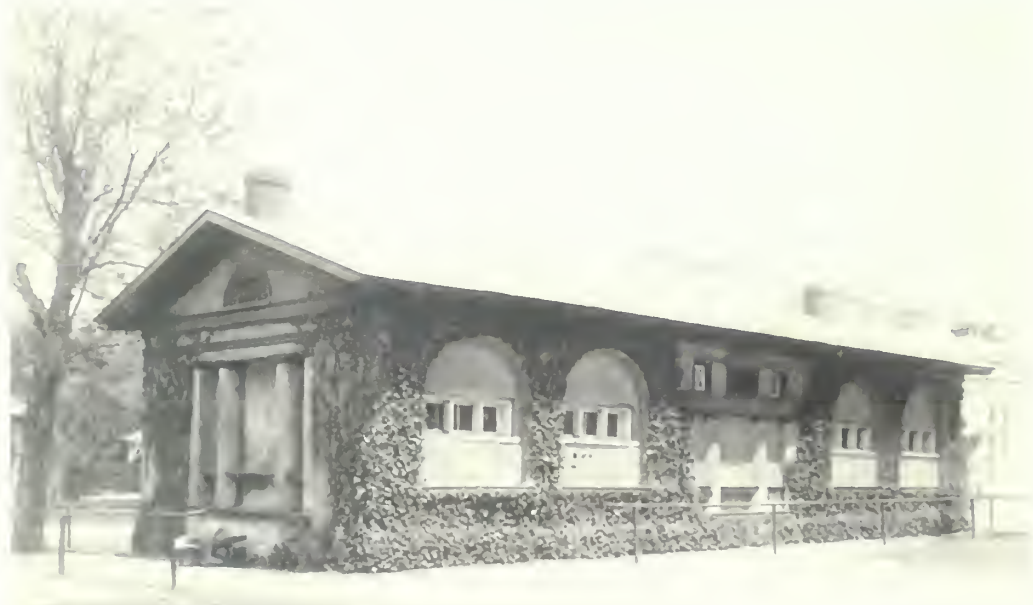
photograph of the southwest corner of the building shows it almost entirely covered in ivy. Only the recessed arches (areas corresponding to the smooth stucco finish) are free of growth. Another photograph, taken around the same time and from the same angle, also shows this growth covering the south elevation with

Figure 16. South Dependency, south elevation, 1897. Note the dark color of the moldings on the west elevation and portions of the south elevation. The offset between the window sash and the window mullions currently found on the building are also visible here.

the exception of the recessed arches and center square niche (Figure 16). The ivy wraps around the corner of the west elevation.

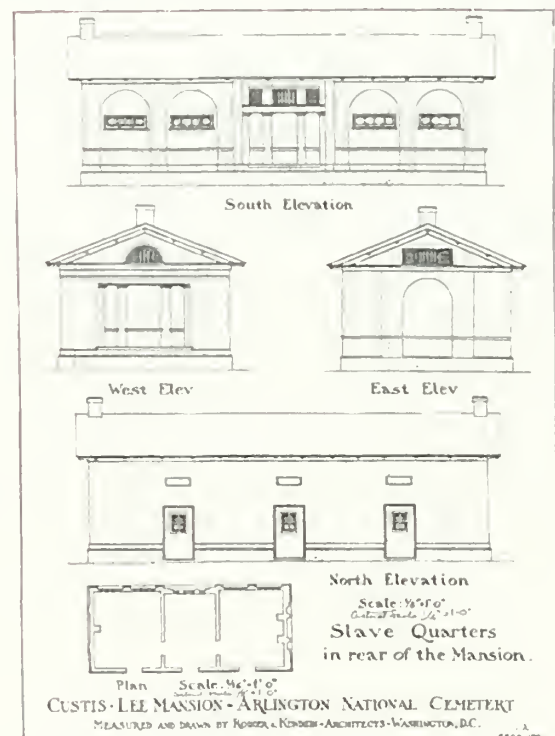
Figure 17. South Dependency, Rodier drawings, 1924. Note that the interior openings, created for the Gray family and linking all three rooms, are still present.

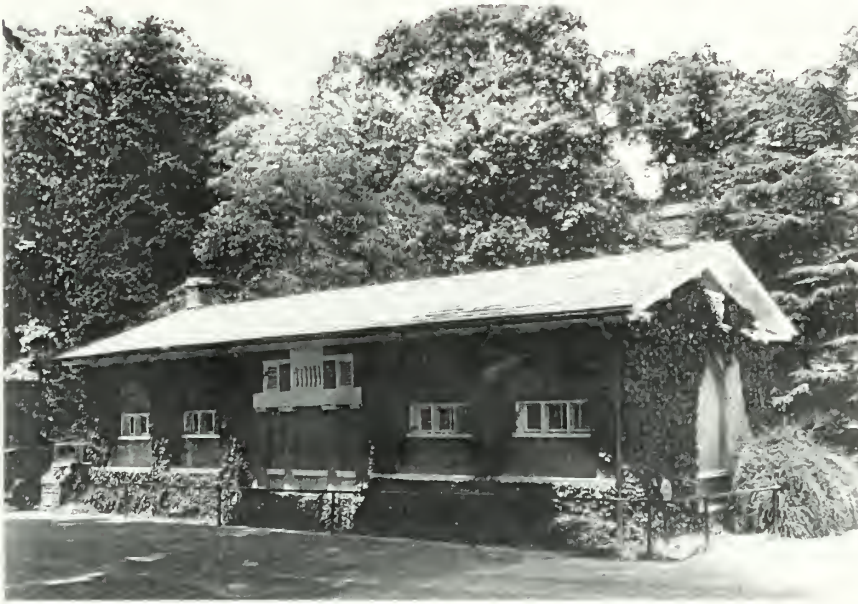
Figure 19. South Dependency, southeast elevation, 1931. Taken toward the end of the QMC restoration, the photograph reveals that the exterior of the building was largely unchanged as a result of the new work.

continuing work on the mansion is mentioned. By June 1932, no work on any of the buildings was identified in the monthly reports.⁴⁸ Other sources, however, indicate that the restoration work was finished in March 1930.⁴⁹ A photograph of the east and south elevations dated 1931, does not show any ongoing work around the exterior (Figure 19). Yet along the west corner of the south elevation, a stack of bricks suggests that work is continuing nearby or perhaps within the building. The photograph does show extensive ivy coverage along both the south and east elevations. From this, it can be inferred that the restoration project did not include significant work (if any) on the rough cast wall finish in these areas.

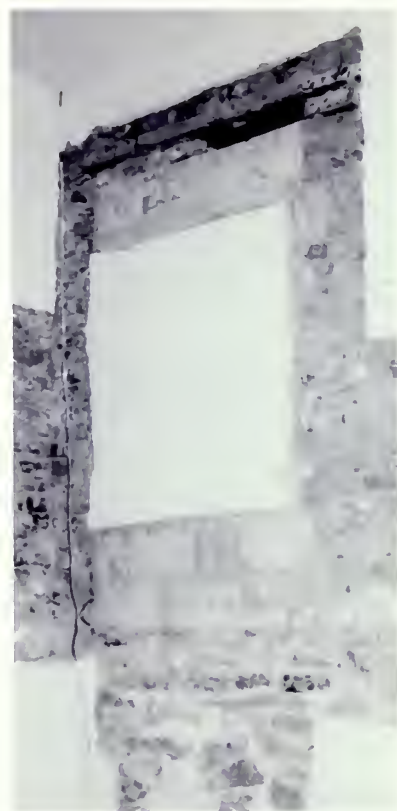
Figure 20. Infilled door opening in center room. This passage had been cut after 1860 to permit the Gray family full use of the three rooms

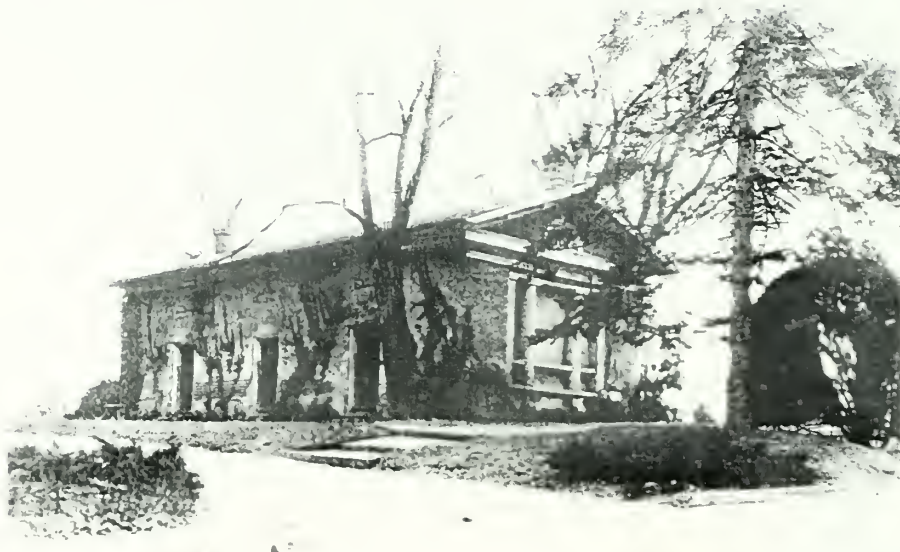
A photograph of the northwest corner of the South Dependency, taken from the road behind Arlington looking southeast, shows the buildings appearance in 1938 (Figure 24). It had two chimneys, metal wire grates in front of the open doors, limited ivy coverage on north elevation, and a stucco finish on the stone foundation. Most interesting, the lower three feet of the north elevation brick wall, directly above the foundation is missing the rough cast finish. This condition suggests either that the restoration did not include work on the rough cast exterior finish and that the spalled finish is a result of many years of rising damp and wear, or that the rising damp was so severe that just seven years after the restoration was complete, the finish had already failed in these areas.

Figure 24. 1938 photograph of northwest corner of the South Dependency.

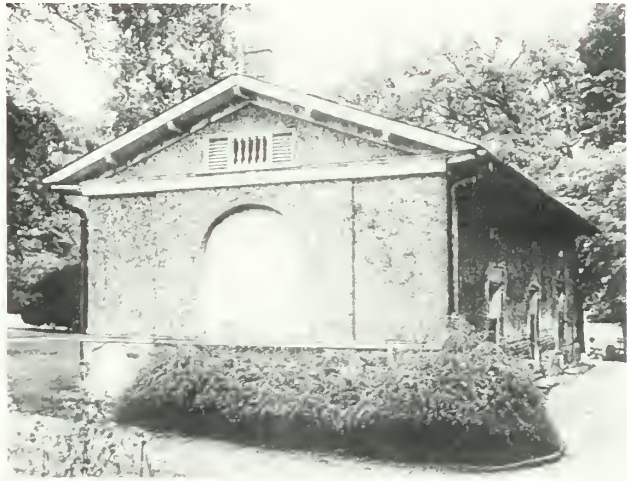
Figure 26 (top right). Northeast corner, 1957, exterior conditions before the NPS restoration.

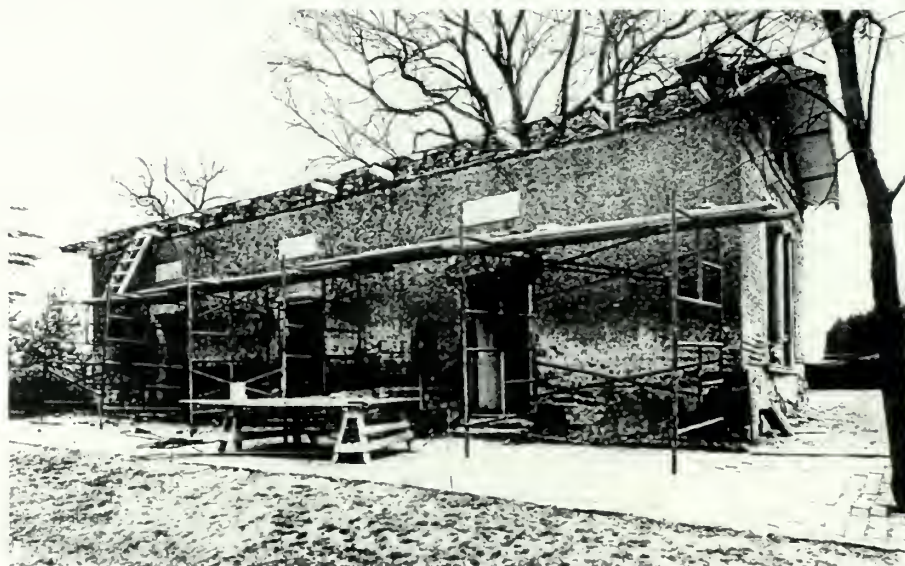
Figure 28. South Dependency, north elevation, showing NPS restoration underway. Note removal of roof sheathing, soffits, cave outriggers, and other wood moldings, March 26, 1959.

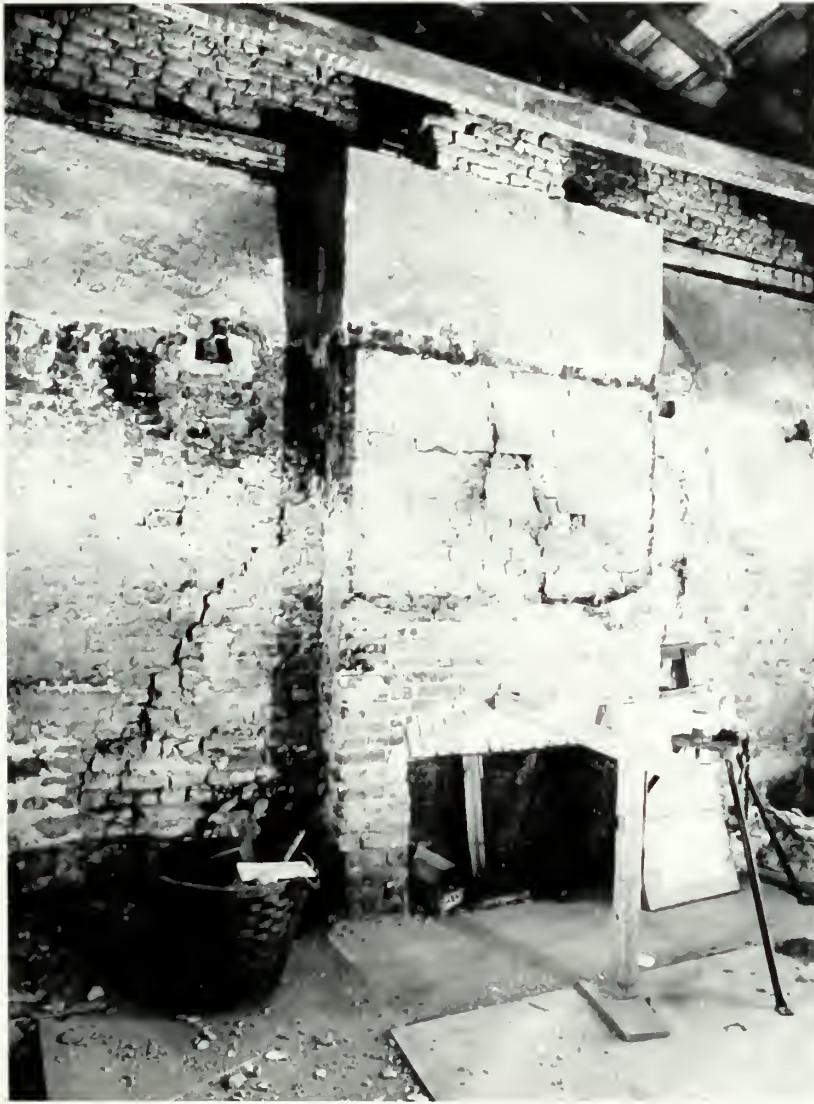
Figure 29 (left). West room, west wall, April 24, 1959 showing NPS restoration work in progress. Note the lower portion of the fireplace partially rebuilt by the QMC in 1929. Most of the upper chimney is original to the structure. The QMC restoration loft is removed exposing the joist pockets that the QMC asserted were original. Also note the plaster and lath marks above that date to the post-Civil War era when the QMC removed the historic loft and converted the space to a single level.

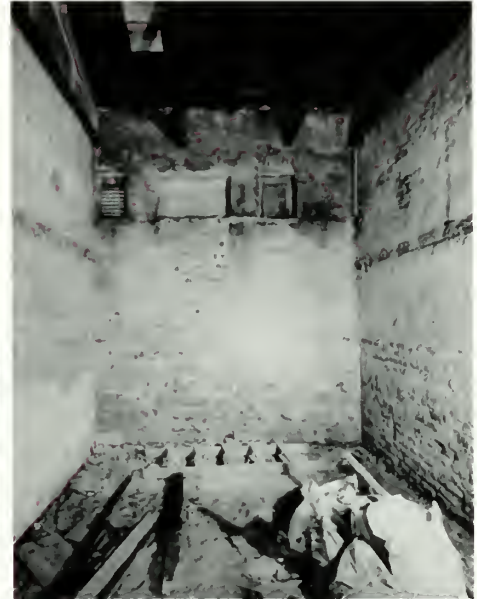
Figure 30 (above). Center room, April 24, 1959 showing removal of QMC smokehouse exhibit during NPS restoration. The 1880s roof structure is seen above and sections of original plaster are visible on the walls.

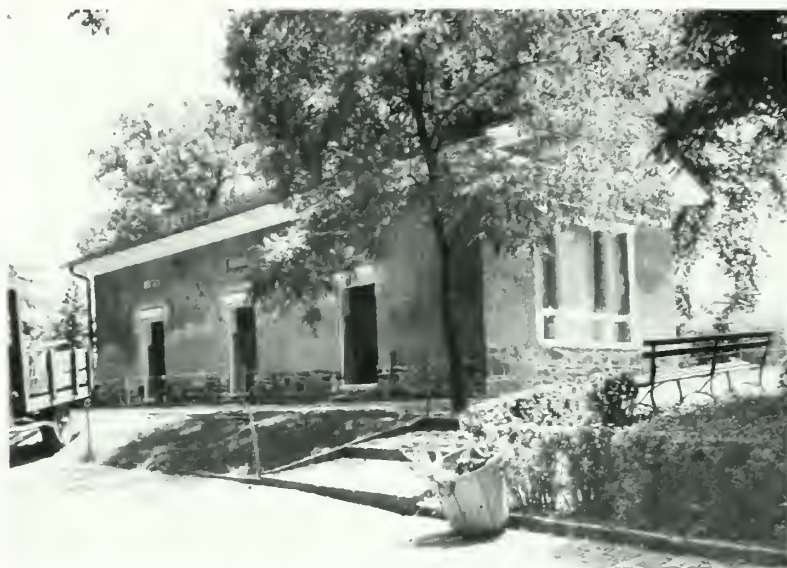
Figure 31. Southwest corner, June 1959 showing exterior following NPS restoration, including new door cornices, repaired roughcast and woodwork, and repointed masonry foundation.

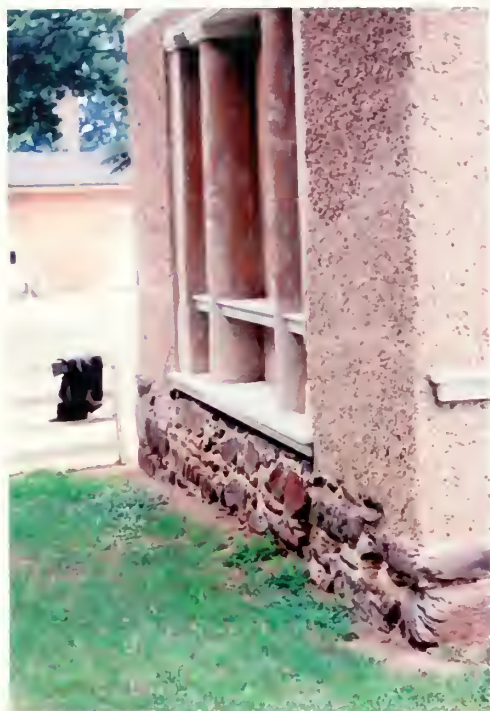
Figure 2. West elevation showing grade and grass ground cover.

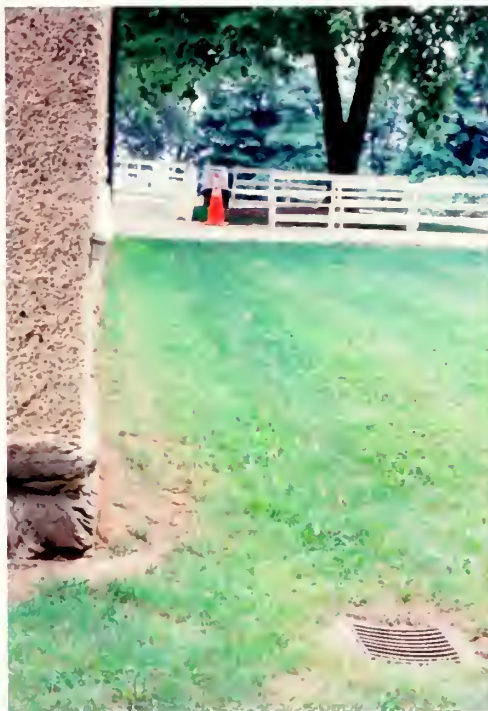
Figure 3. South elevation showing the problematic grade slope and an underground drain cover.

and south facades of the building is covered with dirt and grass (Figures 2 and 3). The grade on the south, immediate to the building, slopes away from the building, however, four feet out, the grade changes and slopes back towards the building, from south to north. A depressed area where the two grade changes meet is above the underground drains which were installed primarily to carry away the water runoff from the roof and the lawn on the west side which slopes toward the building.

Ponding water following heavy rains has been an ongoing problem and has been partially addressed in the past through the addition of gutters, underground drains, changes to grade, and varying paving materials. Rising damp and deterioration of the rough cast finish on the exterior walls indicate continuing problems.

Recommendations: The grade on the south elevation needs to be corrected. The four foot slope away from the building is insufficient to address the water migration from the south lawn and garden. The ground surface on the south should be regraded, banking the surface drainage farther away from the building. An exploratory trench should be dug along the foundation to determine how moisture is penetrating and migrating. Additional underground drains may be needed to redirect the moisture. Larger gutters and an additional downspout would improve the roof drainage and reduce water ponding in times of heavy rain.

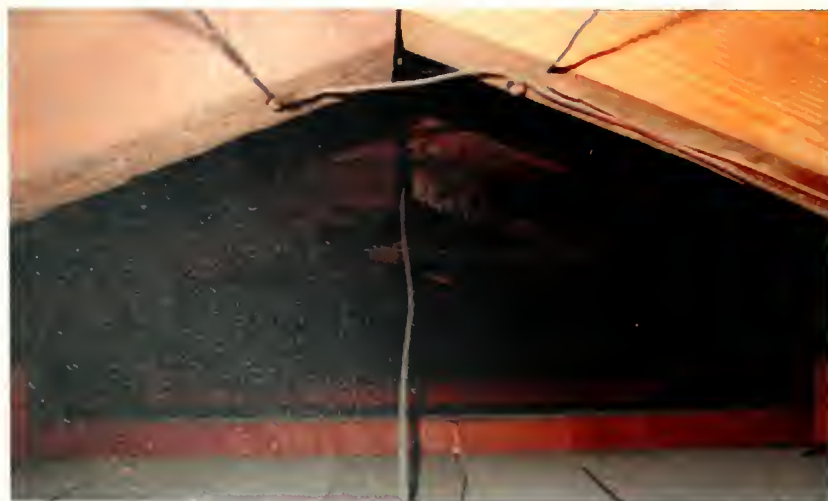
Figure 7. Counterbalanced rafter design roof construction without a ridge board dates to the 1880s.

The roof structure in the South Dependency was accessible for inspection in the west room and only partially in the center room. Much of the current roof framing in the building, with the exception of the 1958 era reinforcements, appears to date to the 1880s. Counterbalanced rafters and ceiling joists, with 1"x 6" chords and ties at alternating rafters, form the 12/5 pitch roof structure (Figure 7).

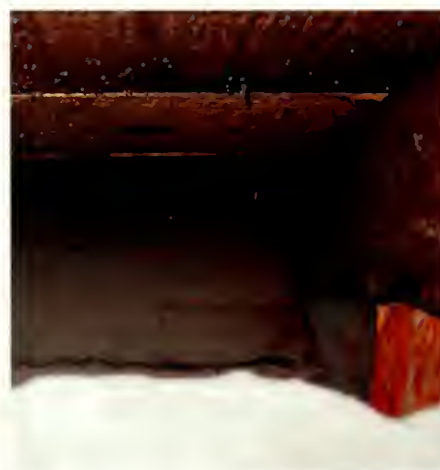
Figure 8. Outrigger formed from continuous ceiling rafters that cantilevered past the bearing walls.

Thirteen of the eave outriggers are original and were formed from continuous ceiling joists that cantilevered past the bearing walls. Others were replicated in 1958 by butting new outriggers to the square cut of the ceiling joist at the edge of the bearing wall (Figure 8). These newer outriggers are fastened to the ceiling joist with a 1"x 5" plate on each face in the attic of the west room. Pairs of vertical chords were added on each side of the roof rafters, connecting them to the new modillions.

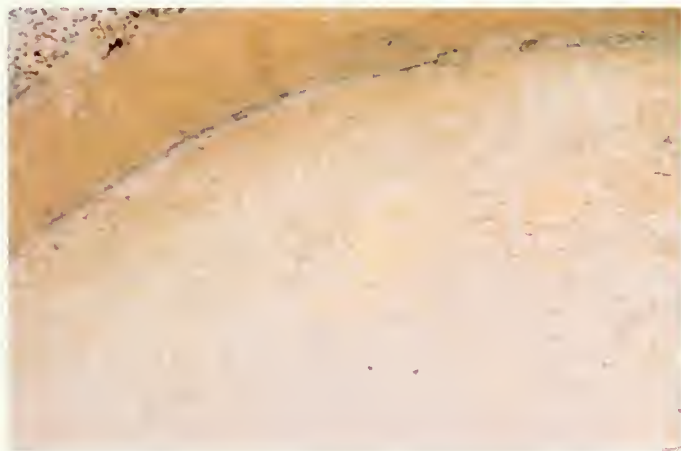
The recessed ornamented niches on the east, south, and west elevations are finished with the painted skim-coat stucco. Various patches of smooth stucco of varying mixes have been applied to the recessed niches over the years (Figure 12). Three different applications have been identified thus far. The earliest smooth stucco is a soft render of pure white binder above a yellow base coat integrated with small pieces of lime (shells) and tiny stones. Coatings include a white oil base under a medium yellow distemper topped by a layer of rose tan with a mottle of *tera cotta*. This mix is primarily

Figure 12. Within the wall niches of the south elevation, top coatings of beige and orange paint are visible.

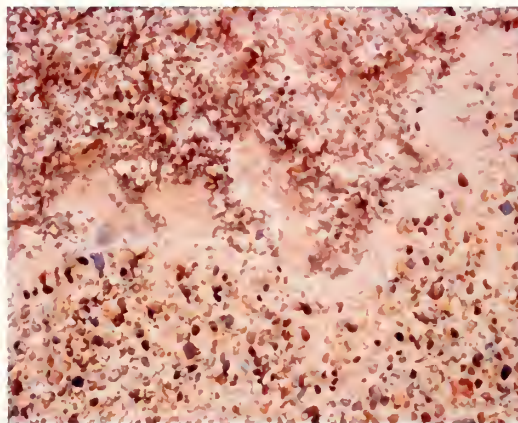
Figure 14. Rough cast is produced by mixing a cementing composition or matrix with aggregate/stones. It is applied by literally throwing the material on the wall. At least four distinct rough cast finishes have been identified.

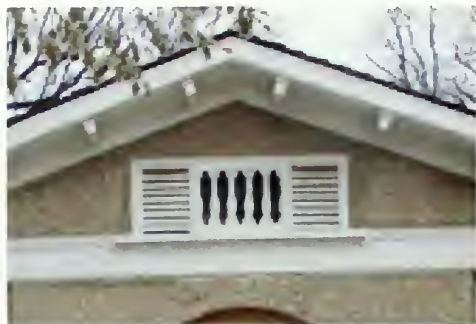
Figure 21. Attic vent on east end needs to be cleaned and painted

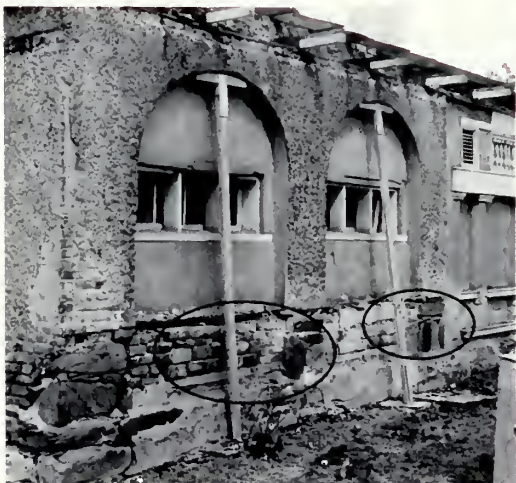
Figure 25. The 1958 photographs, showing stucco removed from lower portion of west arched bay, reveal the presence of a wood nailer strip near the bottom of the stone foundation wall.

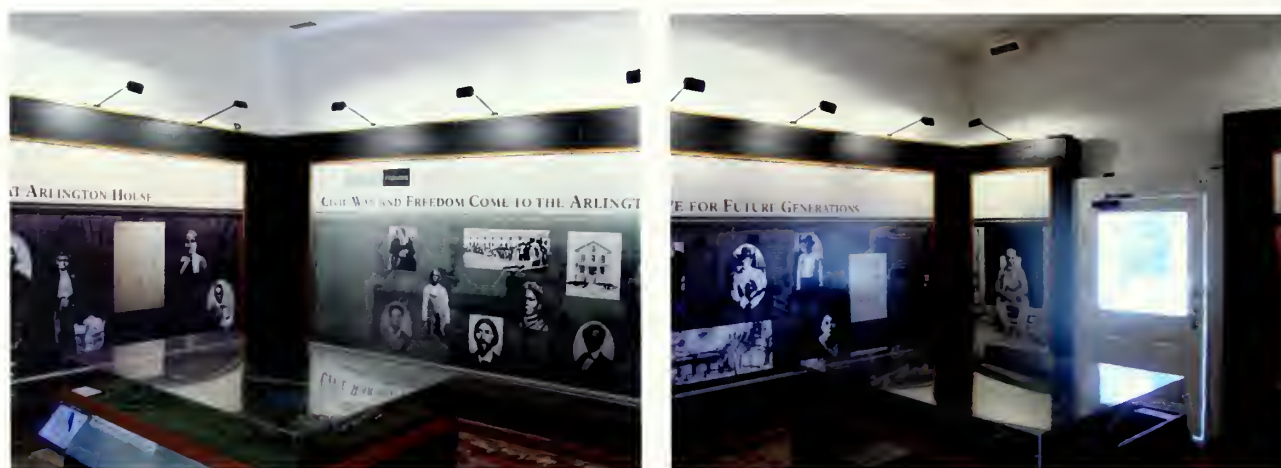
Deficiencies: Access to this room for physical investigations was extremely limited. Rising damp should be addressed in this room.

Figure 29. The space is currently used as exhibit space.

Recommendations: The treatment plan calls for the restoration of this room to a mid-nineteenth century storeroom with features similar to those found in the west room of the building (*see Part IIA, page 11*). Many questions remain as to the location and size of features such as the fireplace and ships ladder, wall and floor treatments, etc. due to the limited access allowed during our study. If the restoration plans are not timely, stabilization of this room is advised. Water management and ventilation issues should be addressed. Windows should be uncovered and made operable and utilized to better ventilate the space. A more efficient gutter and exterior drainage system is needed. (*see "gutters" and "Site" for necessary drainage work*). Loose plaster should be removed and replaced to match the historic. Where plaster has failed, stonework should be examined for the integrity of mortar joints and repaired as needed. Plaster walls should be sounded for areas of adhesion failure. When removing loose plaster, care should be taken to preserve in place all sound historic plaster beneath. The door and door jamb should be replaced with ones to match the 1860s appearance.

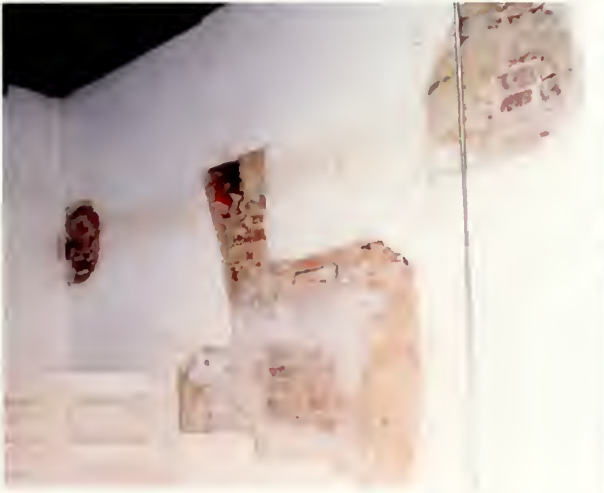
Figure 30. Southwest corner showing evidence of the nineteenth century opening in the west wall which postdates 1860.

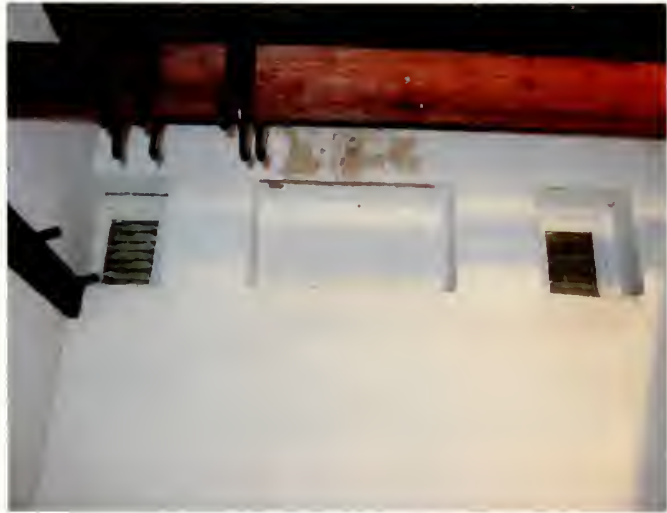
Figure 31. South wall showing historic vents and center niche.

Deficiencies: The walls in this room show signs of rising damp.

Recommendations: The treatment plan calls for the restoration of this space as a mid nineteenth century smoke room. This includes the creation of a false assembly of skip sheathing roof lath to be installed above the exposed joists and rafters in the center room. This would re-establish the underside appearance of a mid-nineteenth century roof while retaining the existing late nineteenth century roof system. The plan also calls for restoration of the historic plaster, the three center beams for hanging meats and the firepit/hearth (*see Part 2A, page 10*). Areas with early plaster should be consolidated by applying a bonding agent such as a Plasterweld mixture of 1/2 resinous emulsion to 1/2 water. The surface should first be carefully cleaned with air from a no-pressure airhose followed by the application of Plasterweld with a soft brush. If NPS decides to keep also a portion of the original plaster on the lower walls exposed for interpretation purposes, a perforated frame with a plexiglass sheet can be affixed to the wall for protection of the original plaster. The installation should allow for air flow between the plaster face and the plexiglass. If the restoration work proposed is not timely,

stabilization of the space is advised. This would include water management and ventilation issues. The south wall vents should be made operable and utilized to improve air flow in the room. A more efficient roof gutter and exterior drainage system will help (*see "Gutters" and "Site" for necessary drainage work*). Loose plaster should be removed and replaced to match historic. Where plaster has failed, examine stonework for integrity of mortar joints and repair as needed. Walls need to be re-pointed in some lower areas. When removing loose plaster, care should be taken to protect fragments of sound historic plaster. The door and door jamb should be replaced with ones to match the 1860s appearance. The 1959 channels boxed out to permit mechanical ductwork near the eaves and ridge should be removed.

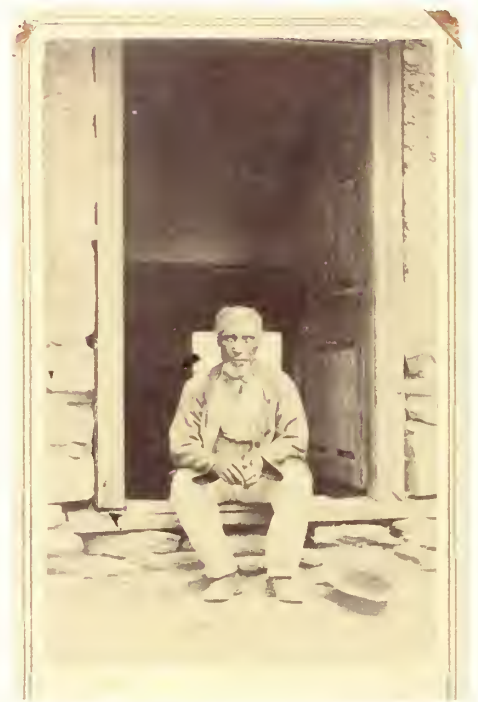
Figure 1. Photograph of Uncle Joe taken in front of the North Dependency.

The reproduction doors, jambs, headers, and sills on the South Dependency will match that specified for the North Dependency. The Ultimate Treatment Plan calls for using the North Dependency center room door frame (as seen in the 1864 photograph) as the basis for the three openings on the South Dependency, while the the door to the east room (as seen in the 1864 Army photograph and the Uncle Joe photograph)

should be the basis for all three of the South Dependency reproduction doors. Each replacement door should match the original raised panel door's dimensions and materials. See Appendix F for detailed drawings of the reproduction door, doorjambs, header, and sill.

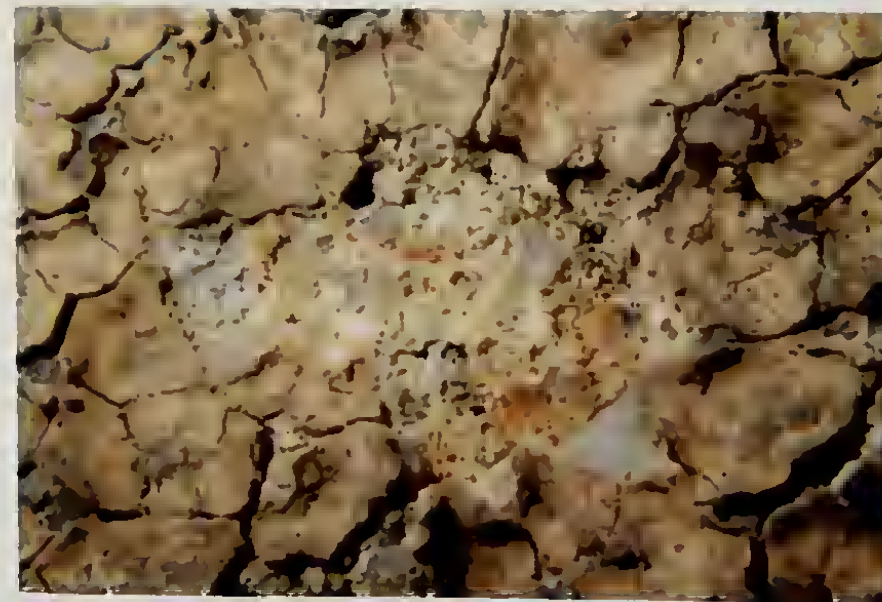
South Dependency, micrograph of finishes on pebble-dash stucco

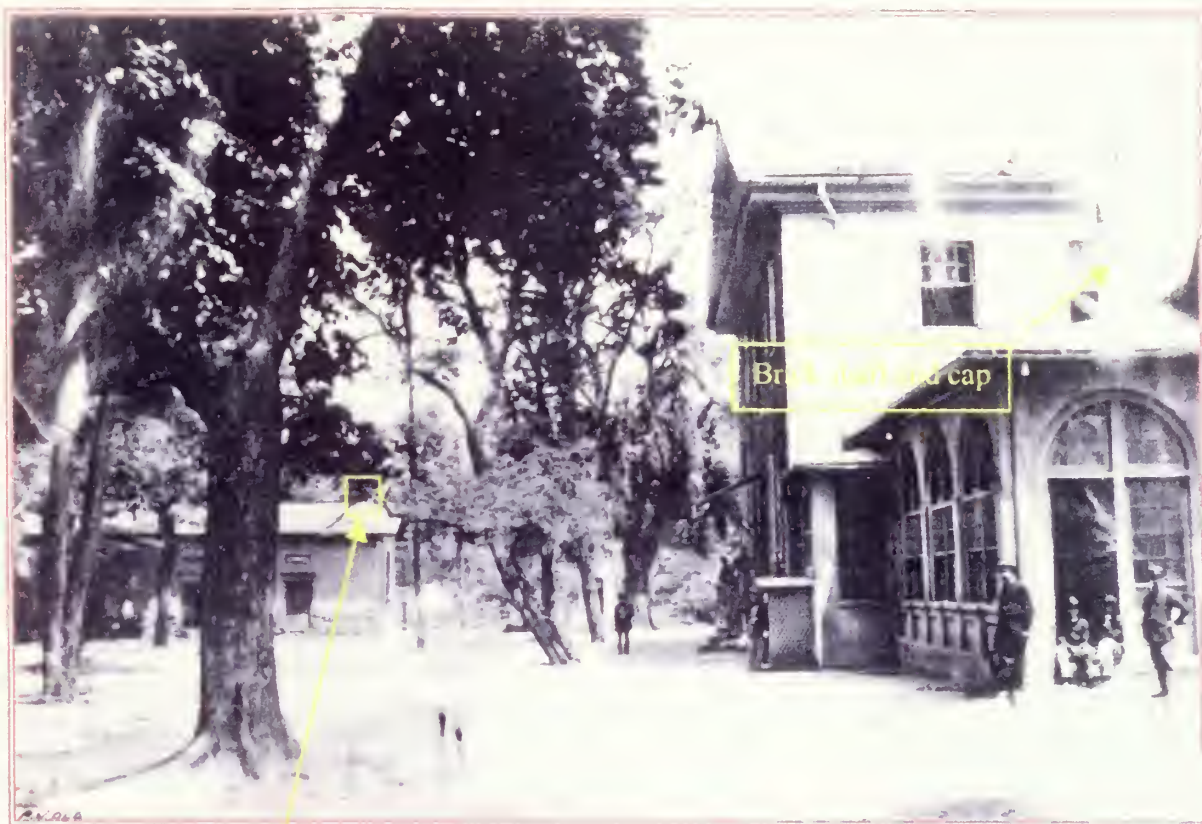
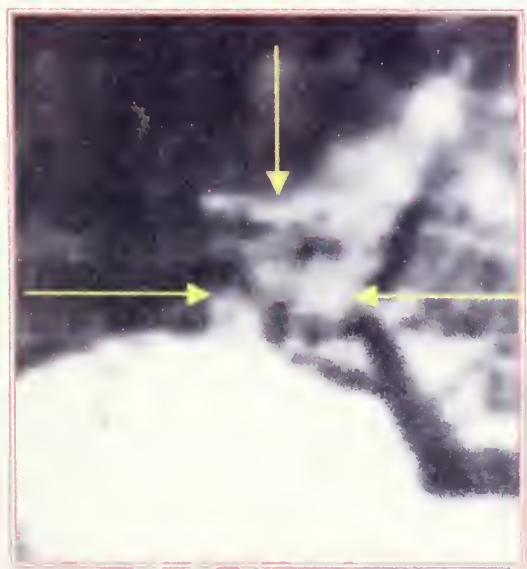
As blurred as it may be, we are looking at a chimney with stucco on the exterior shaft. The large cap modules are cut stone or a fired clay product and were likely stuccoed as well.

Review a clear photo under a 30x loupe lens and you can see the chimney once you find it. It is visible through the tree limbs and leaves.

I am going to say the rise off the peak is about 18".

In my earlier package of information I called the roof extension at 3" and with a loupe lens on a clear photograph you can clearly see the north slope comb at the peak of the roof clearly larger than three inches. I would push the comb out to minimum of 4" and it could go to six inches

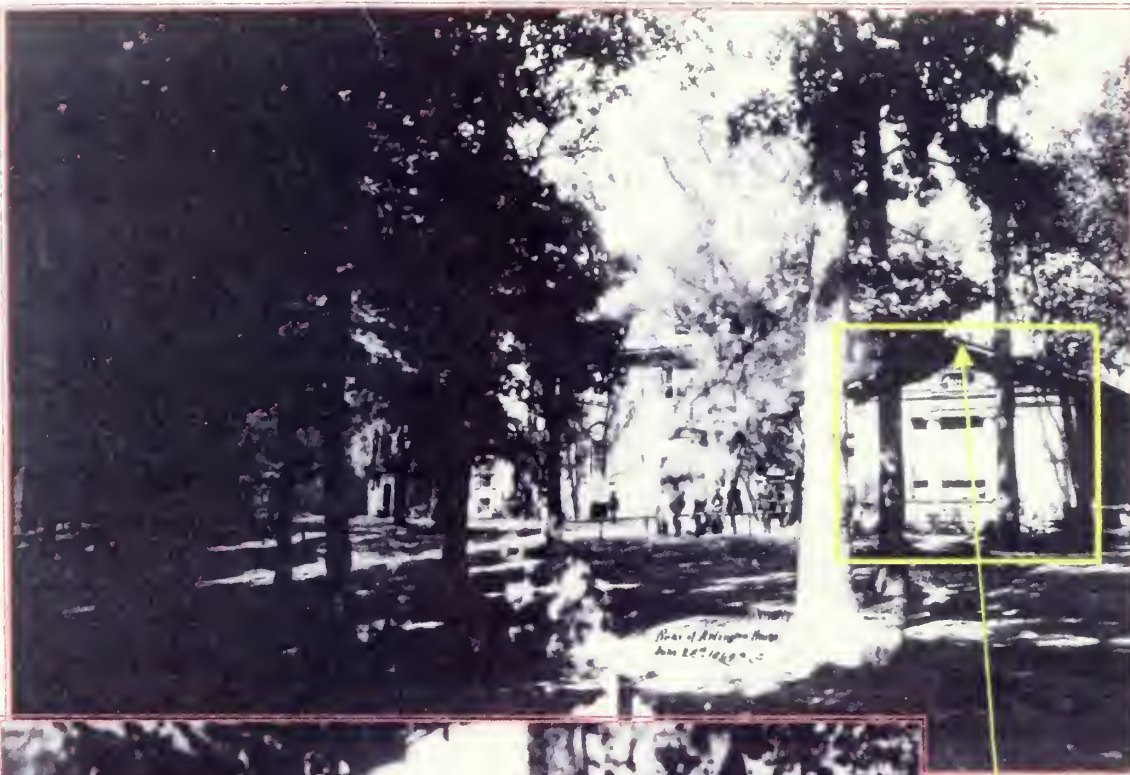
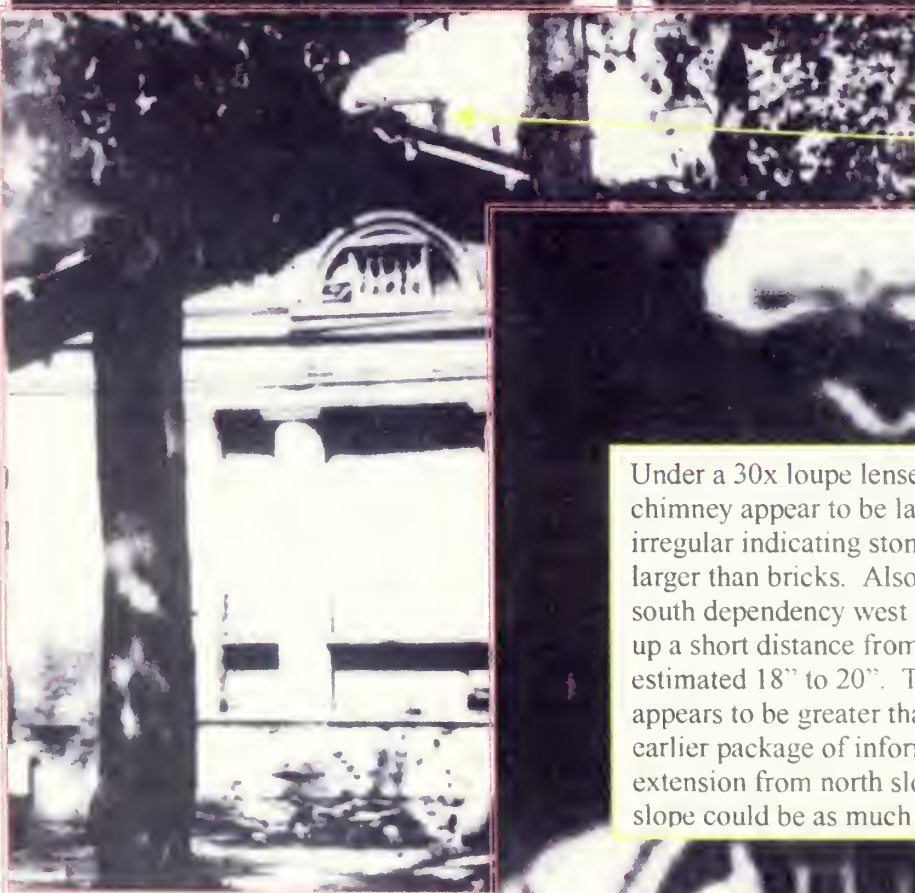
South Dependency Chimney

Under a 30x loupe lense, the modules of the chimney appear to be large and somewhat irregular indicating stone. They are definitely larger than bricks. Also, the chimney is the south dependency west chimney projecting up a short distance from the peak, an estimated 18" to 20". The peak combing appears to be greater than 3" called for in my earlier package of information. The extension from north slope out over south slope could be as much as 4 to 5".

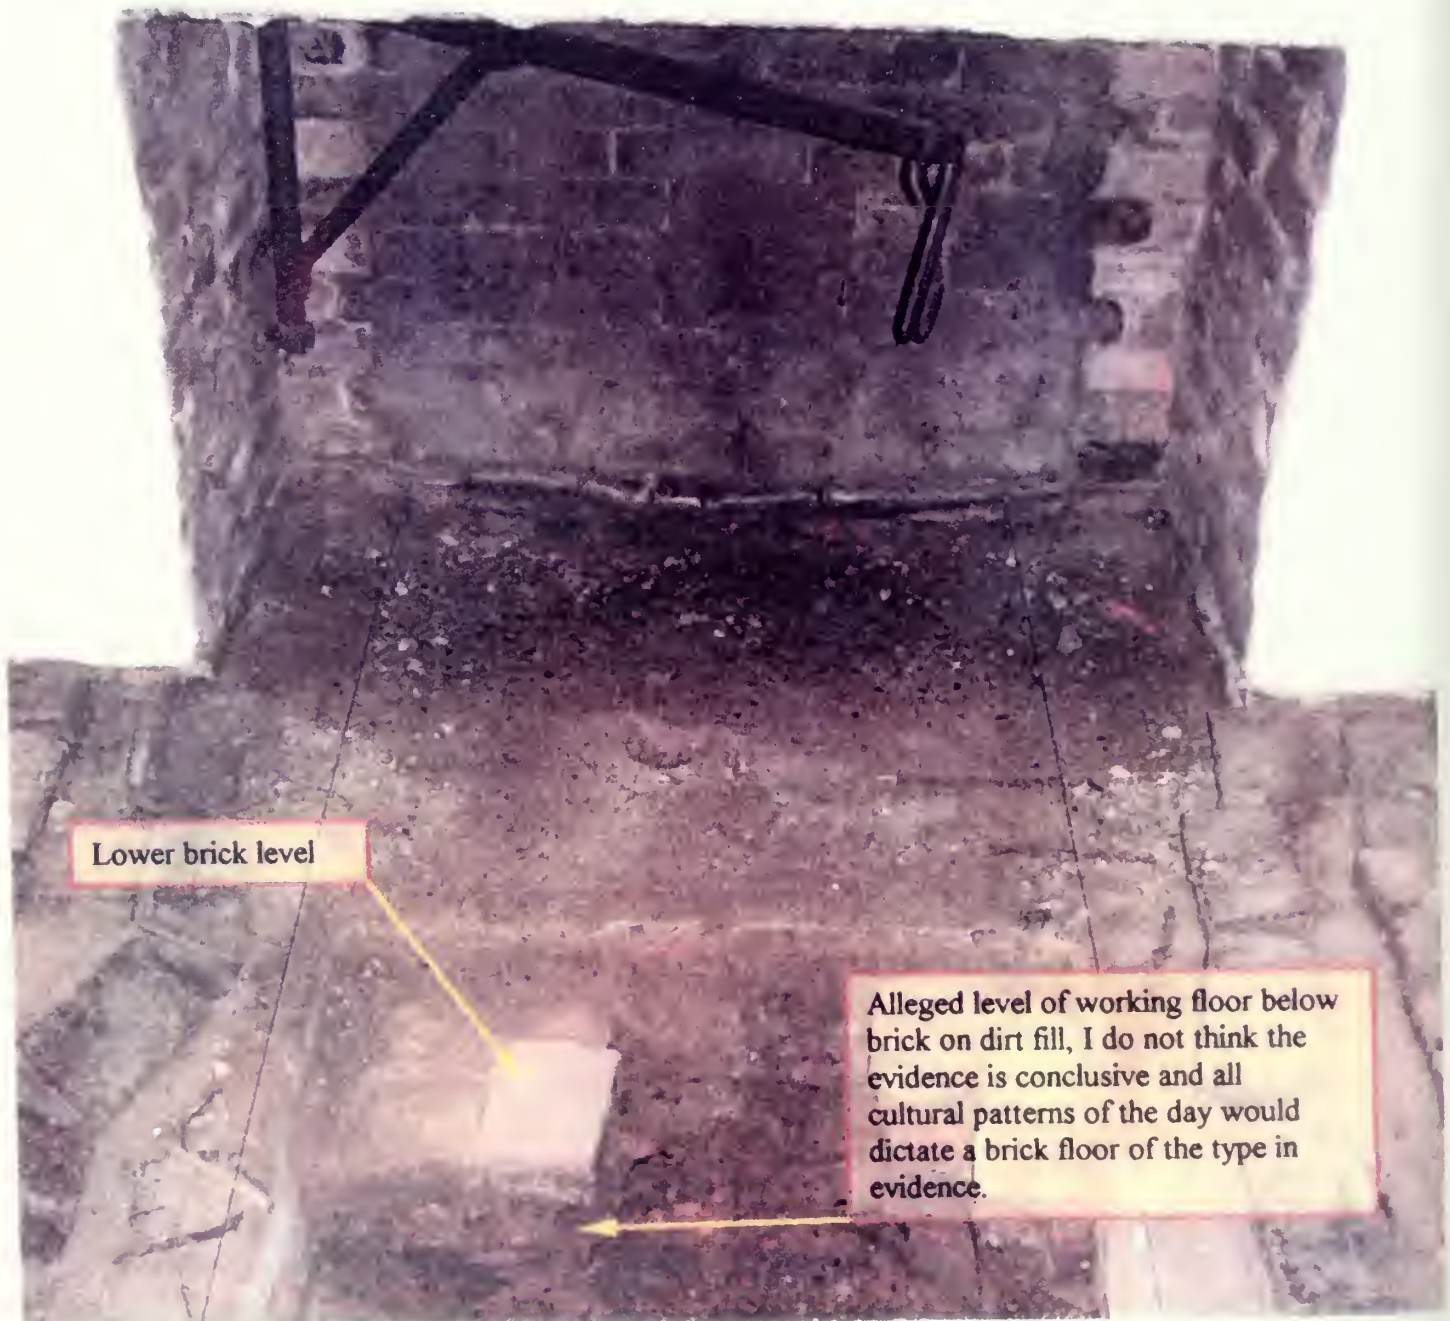
South dependency: Selina's Fireplace and Fireboard

There was some discussion that the original working floor level was below the level of the existing brick. I find this hard to believe, but should this information be correct, the opening of the box, while near its original upper opening height, would have been another 2-1/2" +/- in height making the overall opening to flue ratio 6.78% making the current firebox flue system almost inoperable. The flue to firebox opening ratio should be between 8.75% to 1 or 12% maximum with the optimum ratio being 10% for a perfect draw. Simply stated, the flue at its narrowest constriction should be about 10% of the firebox opening size. Any draw ratio smaller than 8.75% or larger than 12% and the chances are the chimney will not draw causing a smoky interior. It was not at all unusual for a kitchen or cooking fireplace to be a smoker since they almost always had square box corners along the back wall of the box, but they did understand ratios between openings and flues.

The original flue size was approximately 7" by 17" as best we could determine the sizes the day we visited the site. This would dictate a firebox opening of 1,190 SI (square inches) for a perfect 10% draw.

Lacking any further definitive evidence from archaeological evidence that the sides of the box were splayed, I recommend the box be kept square and the opening adjusted to make the flue draw properly. I would not go any lower than a 9% draw. My best guess would be the box opening should be about 36" wide with plastered sides and about 36" high or lower by an inch or two from whatever the finished surface of the floor will be.

The back wall of the firebox would also have been plastered, but I recommend you not plaster the back wall if you intend to use the firebox for heating or cooking purposes. If the box will never be used, it is appropriate to plaster the entire box in a roughcast type plaster pattern.

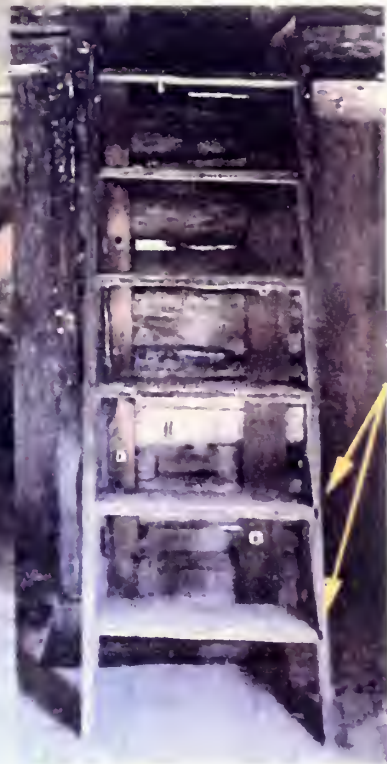
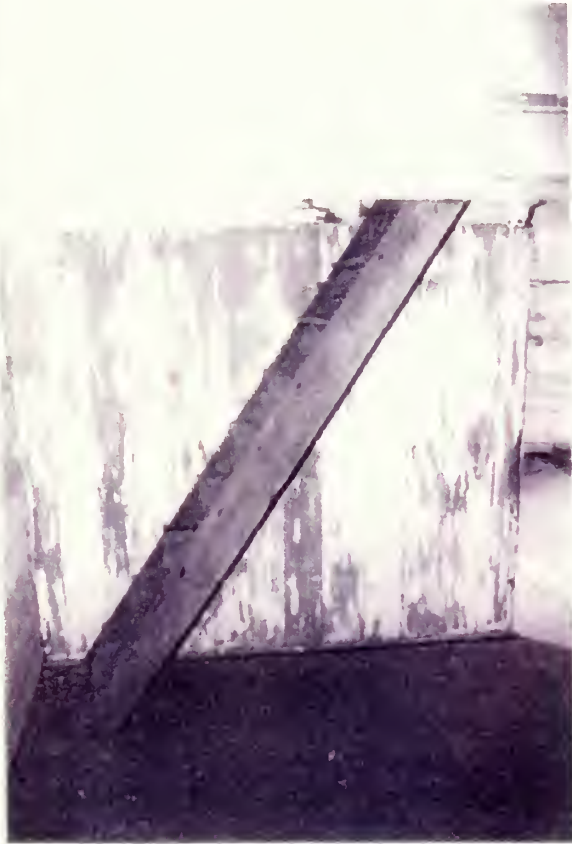
Only the upper portion of the original loft stairs remains. The lower platform and two stairs were missing.

The steep angle of the stairs was approximately 60 degrees. The rise from tread to tread was 11".

The total rise from floor to loft was 8'3". There were only eight treads between the two floors.

The treads were dadoed into the closed carriages.

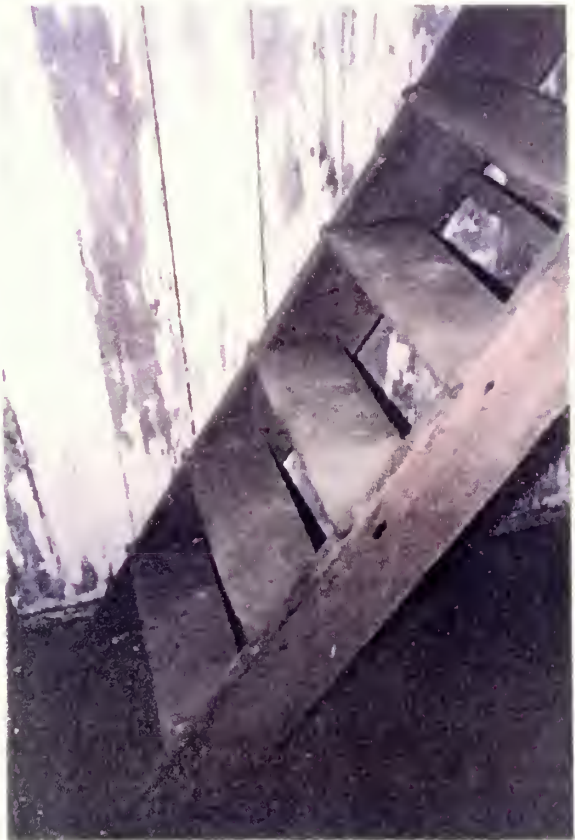
Image 4.85 WC. Ladder stairs located in northwest bedroom R103 against south wall. Made of black walnut expertly hand planed smooth by a master craftsman and nailed together with hand wrought, rose head, spoon bit nails dated 1802-1803. Originally the bottom edge of the stairs touched the east log wall. During the 1979 restoration, the little stairs was reset a few inches west of its original location.

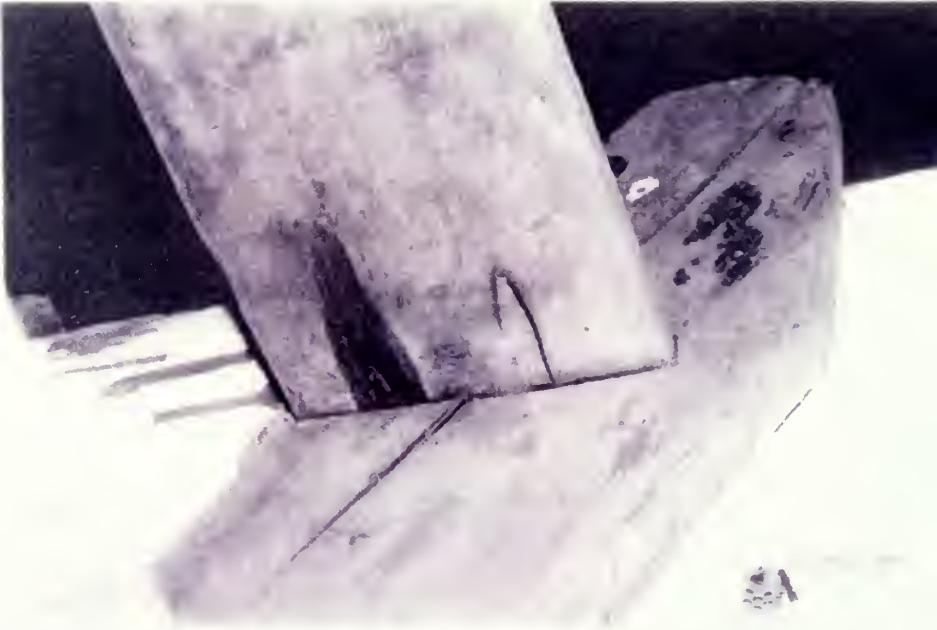
Image 4.86 WC. Ladder stairs, lower half showing each tread nailed once at each end near front edge of stringer. Treads were nosed out over front edge of stringers.

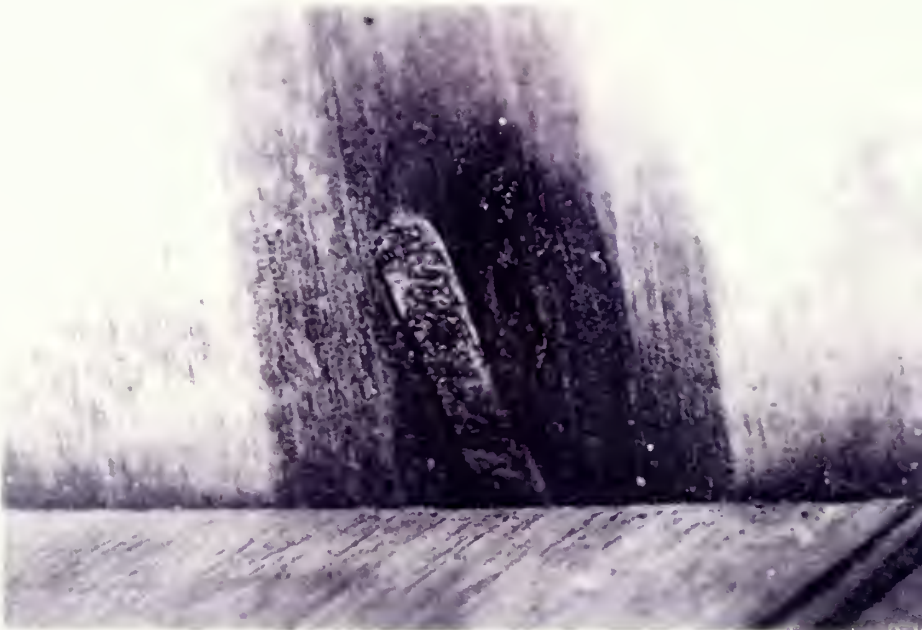
Image 4.87 WC. Underneath side of top tread at south end the split wood revealed a spoon bit nail end used to fasten the stringers to the treads. The treads were set into a recessed dado for support.
