Arlington House, The Robert E. Lee Memorial

South Dependency Historic Structure Report

Report prepared by Charles Fisher, Chad Randl and Kaaren Staveteig

2010-0053-P

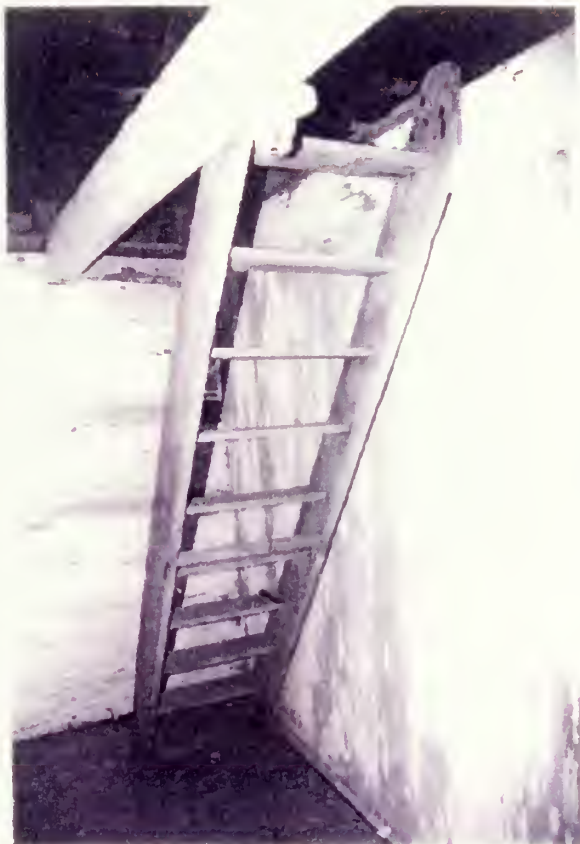
Image 4.88 WC. West Cabin, attic stairs, spoon bit end of hand wrought nail sticking under top tread. Nail dated 1802-1803.

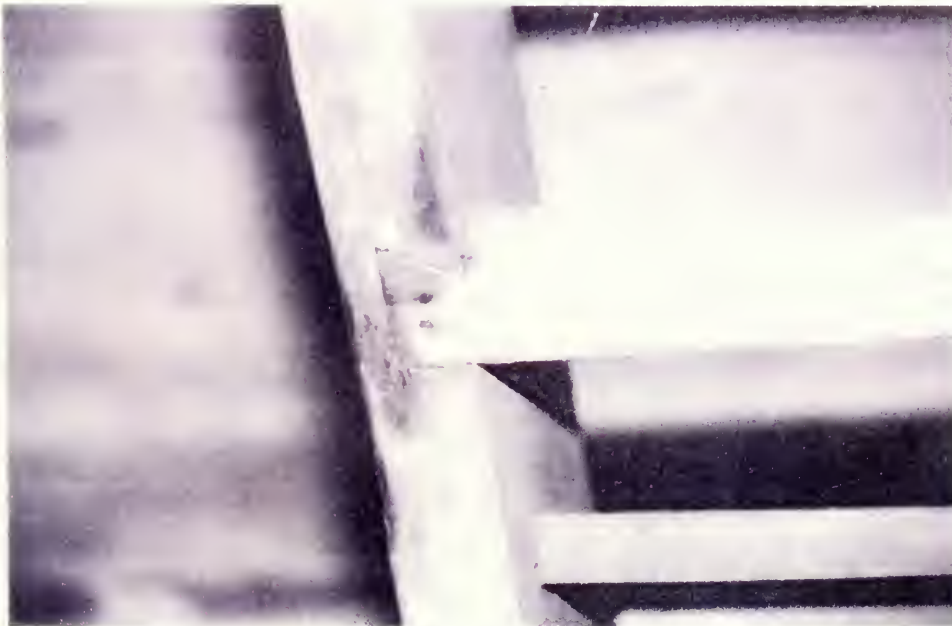
Image 4.89 WC. Back side of ladder/stairs located in northeast bedroom R103. Just above the fourth tread up from floor was a stabilizer bar to keep the lower edges of the stringers sturdy. The top ends of the stringers were originally down lower, flush with the tops of the attic joists.

Image 4.90 WC. On the backside of the ladder/stairs was a stabilizer bar. A close up view of the north end of the bar with a delicately cut half dovetail notch into side of stringer. Each end of the stabilizer bar was nailed with two small brads. Note too that the tread dado does not extend through the width of the closed stringer. The back of the treads stopped in the dado prior to reaching the backside of the stair carriage.

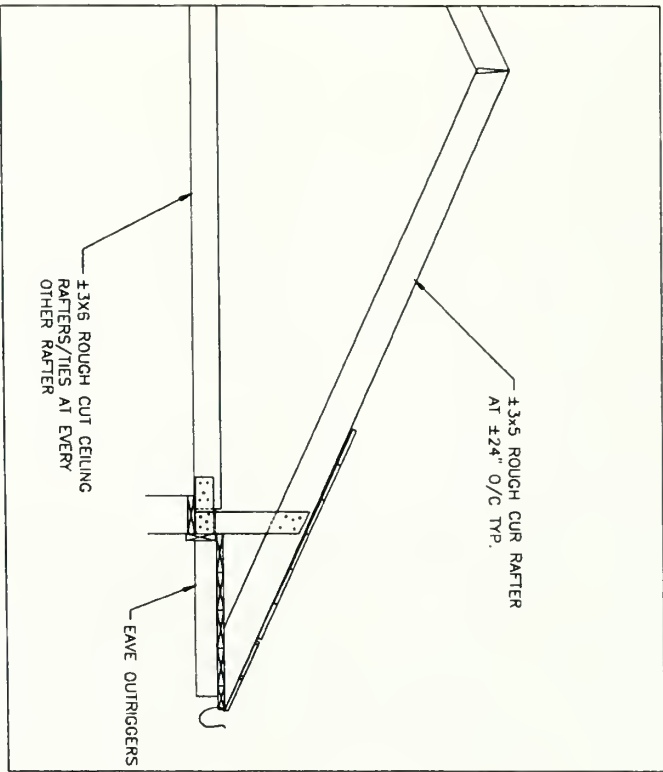
1 ROOF FRAMING
S1S1 N.T.S.

We observed the connection detail between the rafters and the ceiling/ties joist (See attached sketch and photographs). At the site, Chuck Fisher noted that the roof has a heavy cement-like tile and that the roof diaphragm has deflected along the ridge of the roof.

The original eave outriggers were probably formed from continuous ceiling joists that cantilevered past the bearing walls. Due to weather exposure, the outriggers may have rotted. Later construction repaired or restored the eaves by attaching new outriggers that butt to the square cut of the ceiling joist at the bearing wall's edge. The new outriggers are fastened to the ceiling joist with $\pm 1 \times 5$ lumber plates on each face. During the same repair period, pairs of vertical wood plates were added on each side of the roof rafters, connecting them to the new outriggers. This arrangement completes a rudimentary truss formed by the roof rafters and the ceiling joist. Nails and friction between the rough cuts of the ends of the rafters connect the rudimentary trusses.

During this site visit, no actual measurements were taken to determine the moisture content of the wood framing or the air. The interior plenum appeared dry. This state is ideal for wood framing as it prevents rot. The timber framing appears to be in excellent condition.

The deflection, noted by Chuck Fisher, appears to be the result of the creep effect, caused by long term loading on timber members. We do not recommend, (without a structural evaluation) taking-out this deflection during tile roof replacement, because other members may get overloaded. Unless the timbers are replaced with new ones, natural deformations due to creep should be left alone.

Based on this visual inspection, and without the benefit of testing, it is our opinion that the rafters appear to have sufficient strength and are capable of carrying the existing loads provided the moisture content of the interior plenum be maintained with little or no variations. Changing the roof covering from cement tile to wood shakes will reduce the dead load and improve the capacity of the rafters to carry live (snow) loads. However, environmental conditions may change and moisture may fluctuate. These environmental changes may alter the dimension of the timber members, which will readjust by creeping, creaking and dislodging some of the fasteners (nails, pegs, etc). As long as the changes are not severe, the timbers will remain stable and not lose strength. We recommend that changes be kept to a minimum during reconstruction.

We also recommend engaging a professional structural engineer during construction to assess the health of the structure, and to provide small non-intrusive repairs as needed.
