Comet

Submerged Cultural Resources Site Report

Channel Islands National Park

Submerged Resources Center
Professional Reports
Number 17

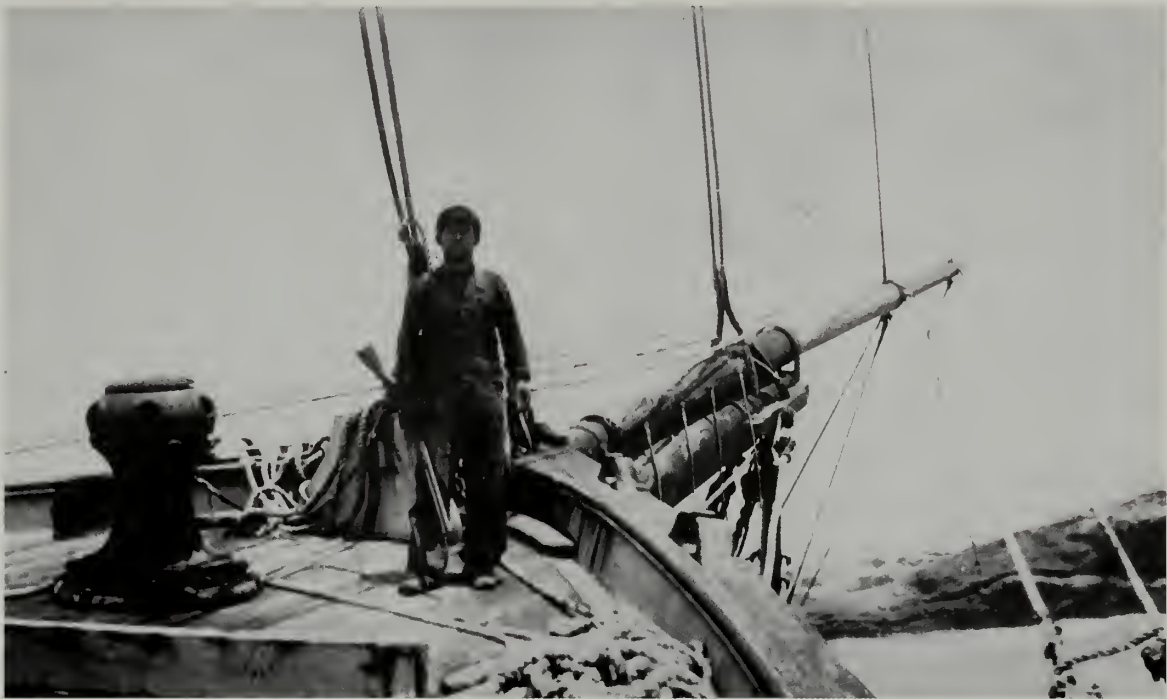
Figure 3.6. Unidentified man on *Comet*'s forecastle deck. Note the capstan which is still mounted in the same location today. Also, note the rock ledge in the background which can be compared to Figure 3.8. Photo courtesy of Santa Barbara Museum of Natural History.

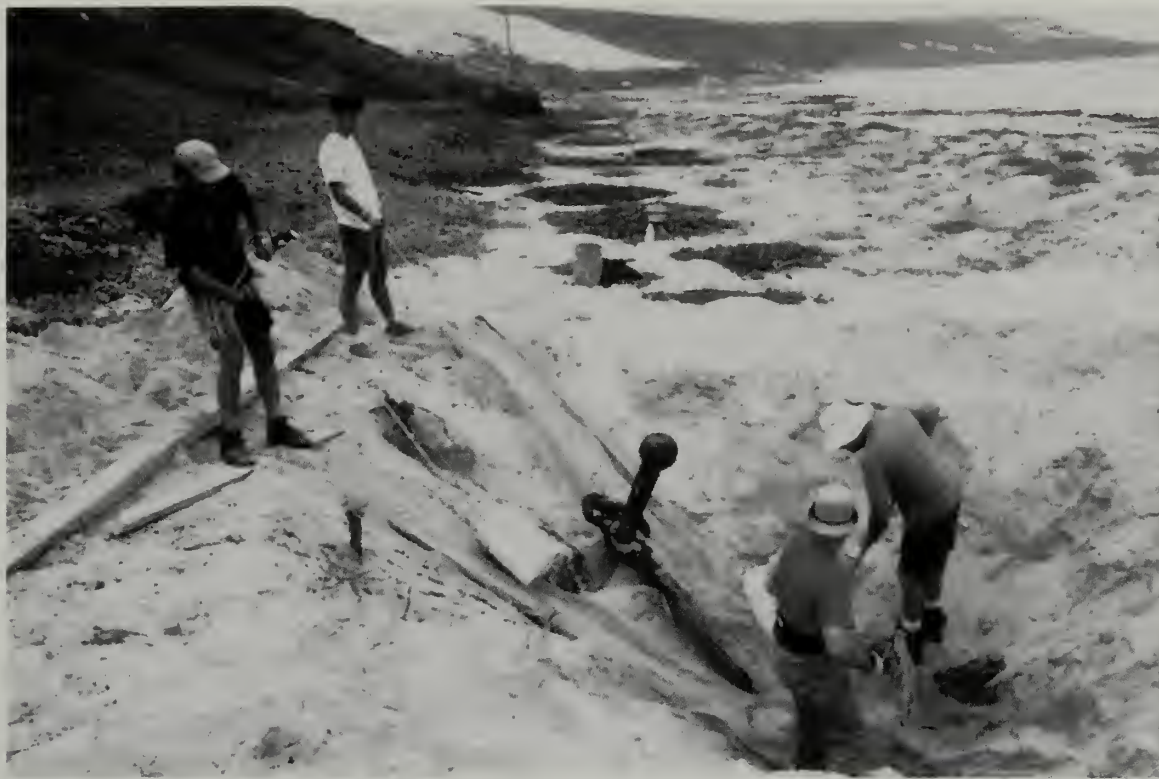
Archeologists and volunteers spent several days digging (Figure 3.9), which uncovered the anchor and a few unidentified timbers. Although the timbers located are certainly from *Comet*, no details could be recorded because the walls of the hole kept collapsing as the timbers were exposed. In total, about 16 m³ of sand were removed from a hole 6.4 m in diameter at the top and 2.1 m deep. The exposed anchor

Figure 3.9. Volunteers working to expose *Comet* wreckage in October 1993. Just the tip of the anchor stock was exposed before digging began. NPS photo by Matt Russell.

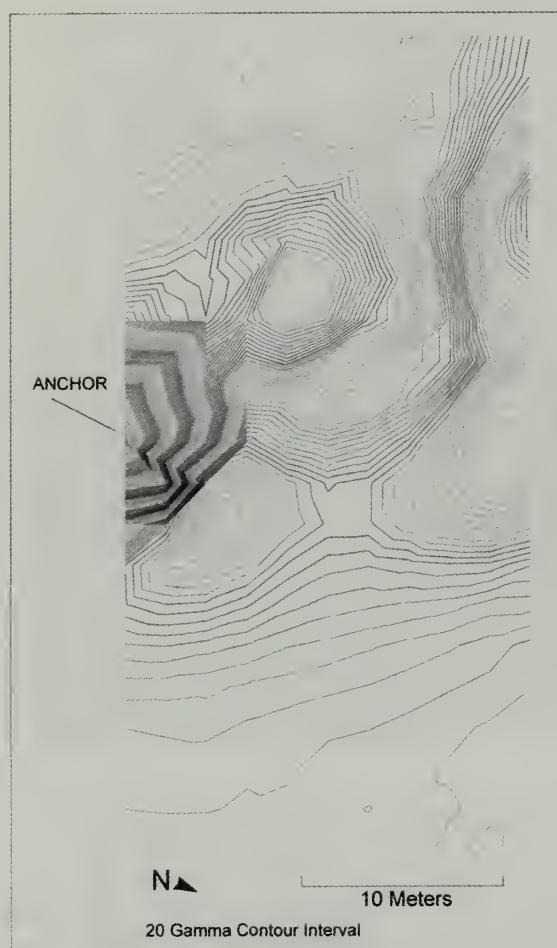
region just east of the anchor is relatively quiet. The anchor itself shows up as a very large anomaly, greater than 2,000 gammas (nanoteslas). Adjacent to the anchor to the north is a distinct, several-hundred-gamma anomaly. The area northwest showed a series of large anomalies that extended throughout the rest of the survey area. Although it is impossible to determine exactly what caused the anomalies, the contour map represents a highly concentrated area of magnetic intensity around the anchor (Figure 3.10). These anomalies surrounding the anchor indicate that structure appearing in the 1984 photographs was still extant.

Figure 3.10. *Comet* site magnetometer data. The survey block is 40 m by 20 m.

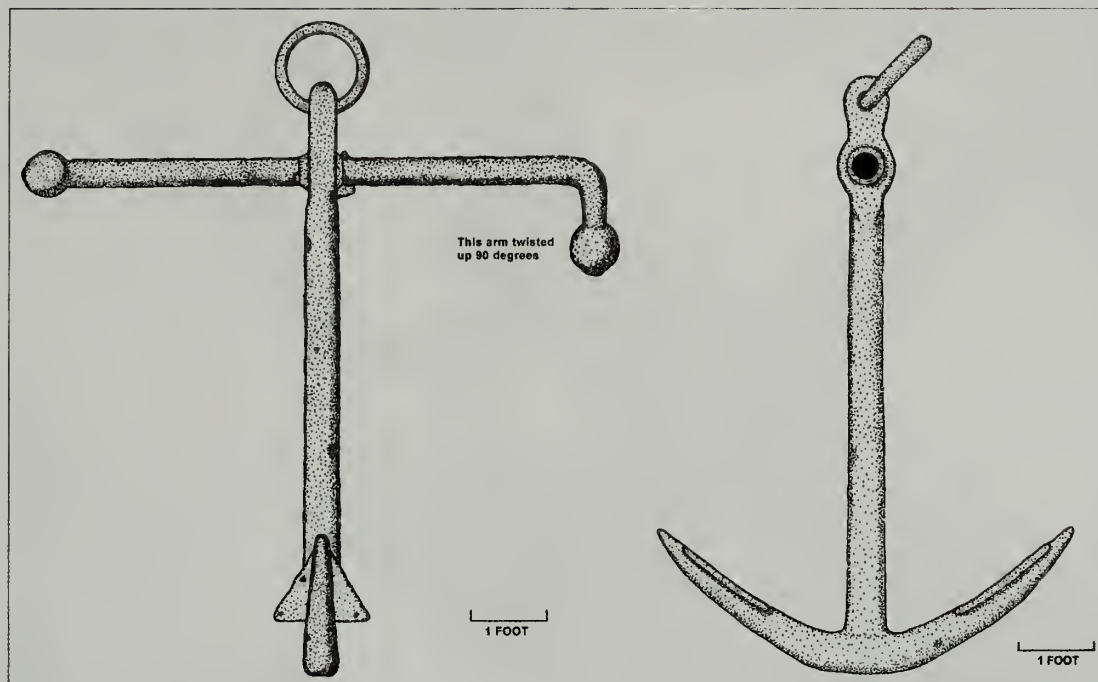
is iron, with a collapsible iron stock (Figures 3.11–3.13). The anchor is fitted with a ring, but no cable is present. The overall length is 7 ft. 11 in.; stock length is 7 ft. 9½ in. Anchor arms are 3 ft. long, with 5 ft. 6 in. between palm tips. The palms measure 1 ft. 3¾ in. wide by 1 ft. 6 in. long, and 1¼ in. thick.

Figure 3.11. *Comet's* anchor. Drawing by Matt Russell.

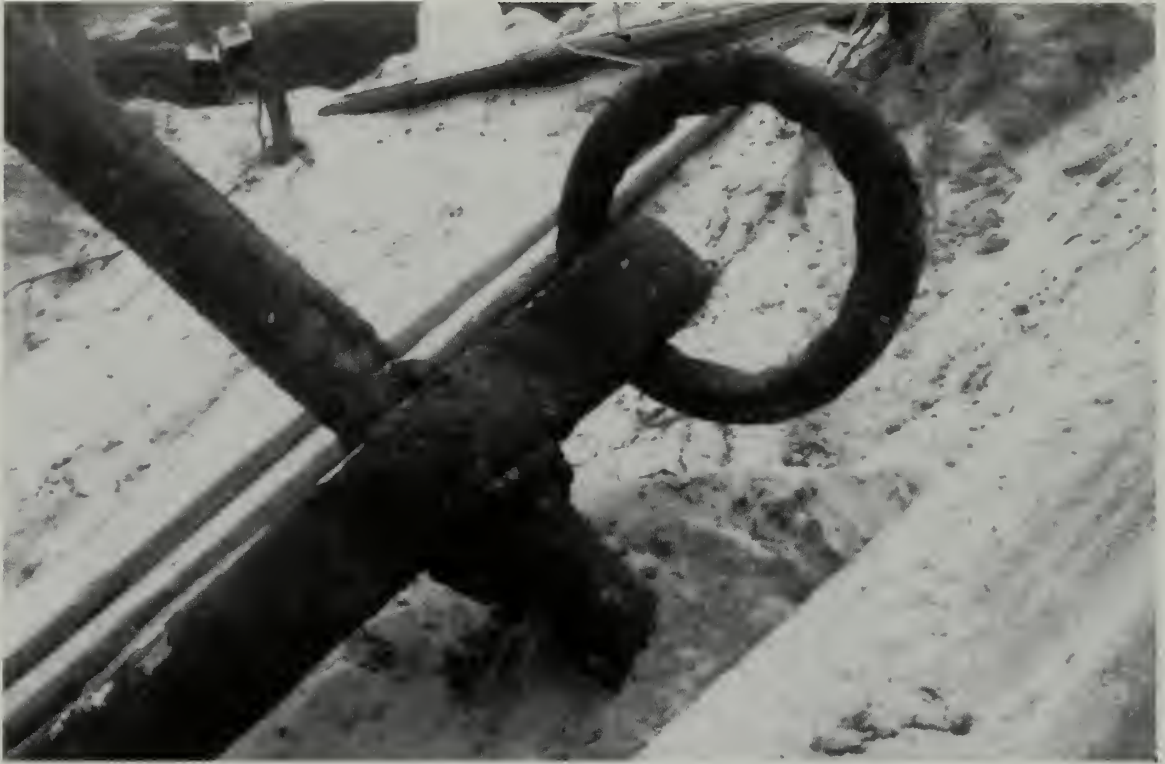
Figure 3.13. *Comet's* anchor ring. NPS photo by Matt Russell.

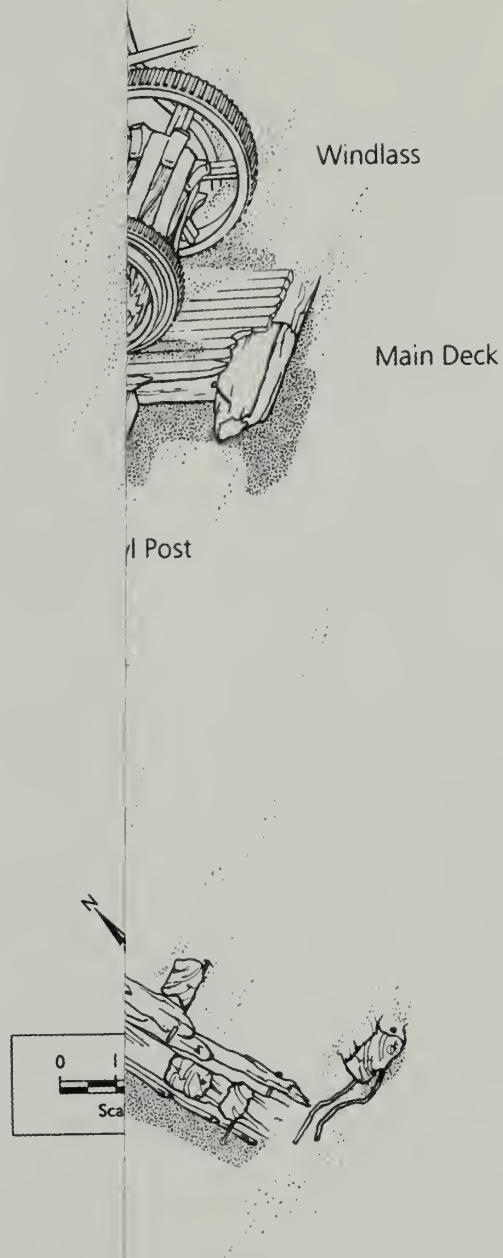
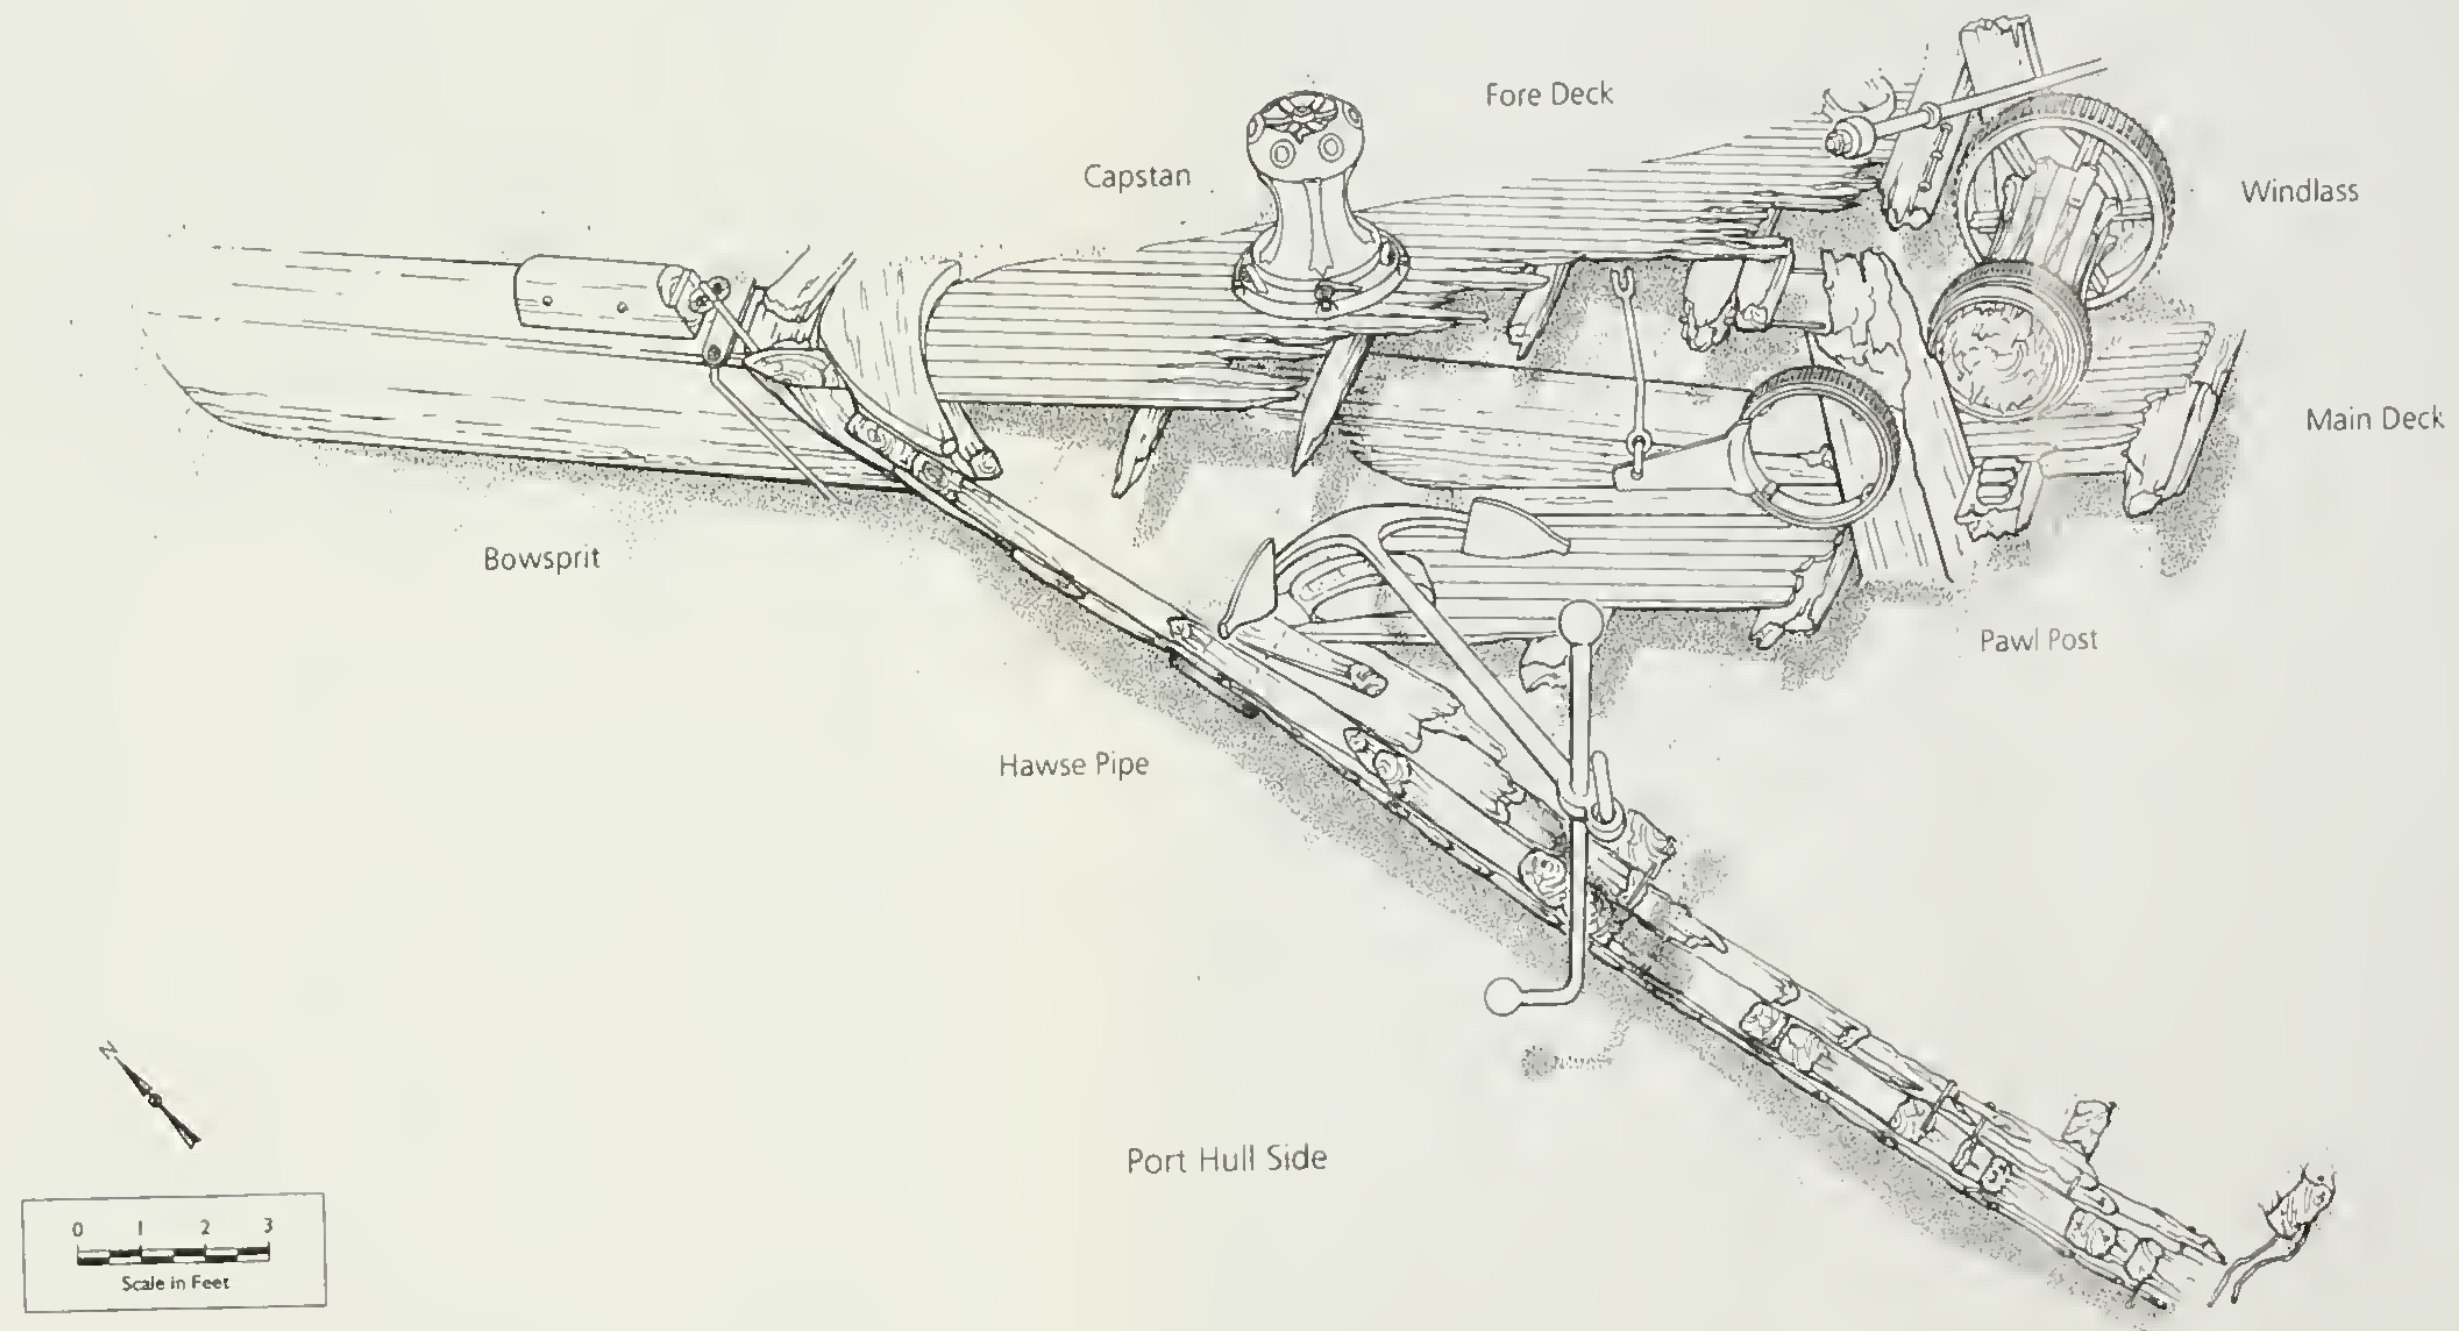
Figure 4.7. *Comet* site plan. Field drawing by Matt Russell. Final drawing by Robert Turner.

Nearly all *Comet*'s original bow structure and related features are represented on the site (Figure 4.7). Exposed structural elements include port-bow framing and outer-hull planking; the partially intact forecastle deck and forecastle-deck beams; the partially intact main deck and main-deck beams below the forecastle deck; the pawl post (sometimes called a pawl bitt or Samson post) extending through the main deck and broken off at the forecastle-deck level; the bowsprit, extending from where it is stepped into the pawl post's forward face to about 19 ft. forward of the bow; the forecastle- and main-deck deck-hooks and waterway hooks; and several bow pointers. Other features present are bow rigging elements and ground tackle features including an anchor; the capstan mounted in its original location on the forecastle deck; the intact log windlass' starboard half, still mounted in its original location on the main deck, along with the iron parts of the windlass' port half; the port bow stopper or riding chock; and the port hawse pipe. Although more of the wreck is exposed than the 1984 photographs show, much of the starboard bow still lies deeply buried in the sand and was not documented.

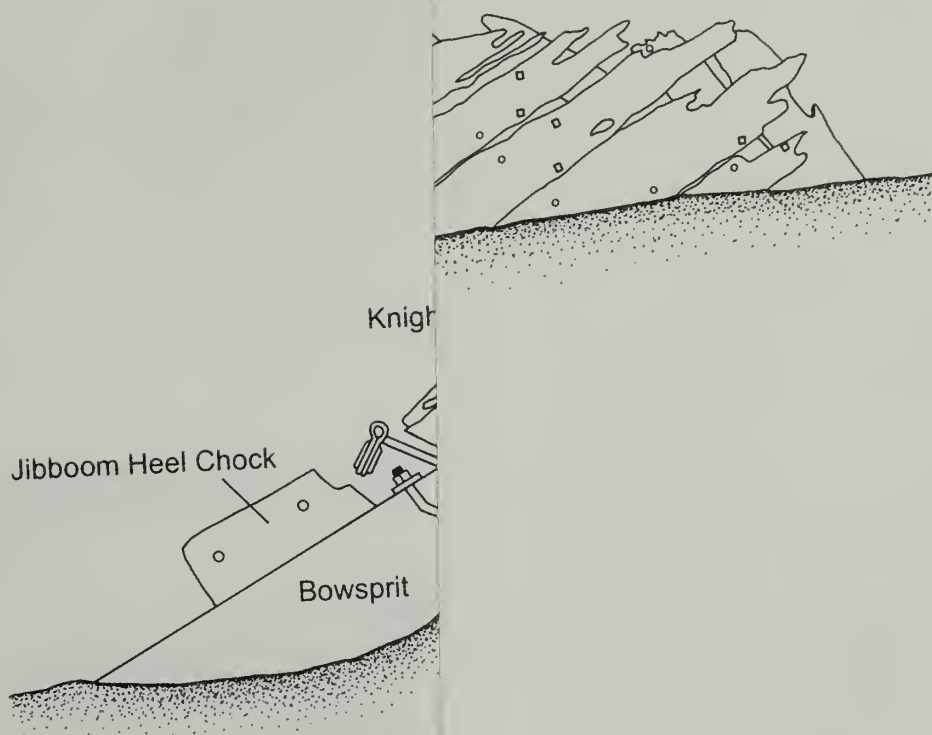
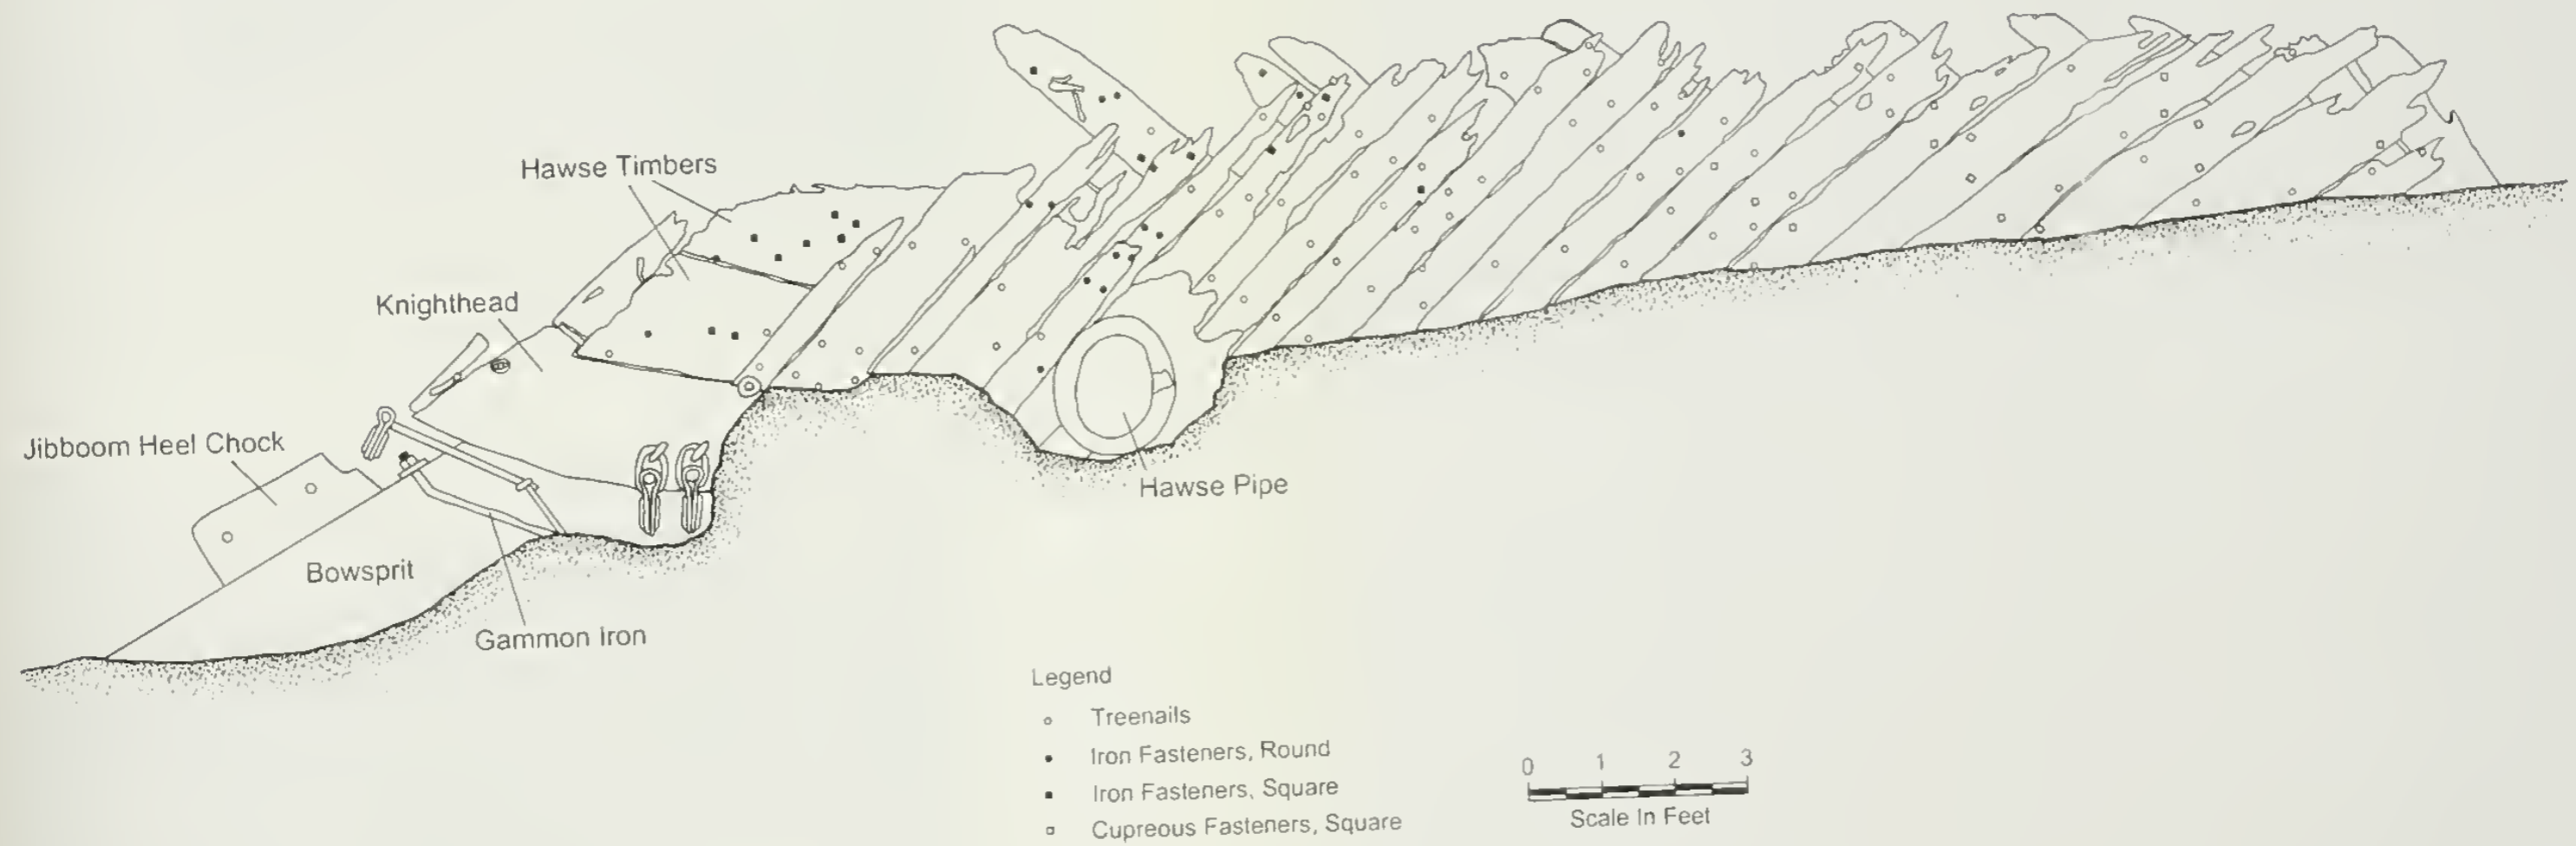
Figure 4.11. *Comet* port elevation drawing. Drawing by Jim Bradford.

Although it was difficult to verify because of limited access and complex angles involved, the six frame pairs are most likely all cant frames as opposed to half frames (Figure 4.11; see Figure 4.10). At their greatest dimension, which was closest to the sand, each frame measured 9½ in. sided and 10 in. molded. Each frame's molded dimension at the top, approximately main-deck level, was 8 in. *Comet's* contract specifies frames as sided 10 in. and molded 13 in. at the keel and 6½ in. at the deck (J. Porter Shaw Library, San Francisco [JPSL], Hall Brothers Shipyard Contract No. 49, 1886). *Rules for the Construction of Wooden Vessels* stipulates a 400-ton vessel built of "yellow fir" should have top timbers (frames at deck-level) sided 8 in. and molded 7½ in. (American Shipmasters' Association 1879:xxviii). Taking into account timber erosion from natural weathering, *Comet's* cant frames' sided dimension matches that specified in the contract and exceeds that given in the rules; molded

dimensions exceed both the contract and rules, but this is possibly only true for the cant frames, as no square frames were present to be examined. Individual frames making up each frame pair were fastened together with treenails measuring between 1¼ and 1½ in. in diameter. A combination of treenails and iron drift pins fasten the outer hull planking, frames and ceiling planking together. Forward of the forward-most frame pair is what appears to be a single frame, but it is likely its adjacent frame member is broken below the sand line and could not be observed. This makes a total of six frame pairs represented on site.

A total of 21 outer hull planks were recorded, varying in width from 5 in. to 1 ft. 2 in. and from 1 to 2 in. thick (see Figure 4.11). *Comet*'s contract states planking should be 4 in. thick, while *Rules for the Construction of Wooden Vessels* specifies it should be 3½ in. thick (JPSL 1886; American Shipmasters' Association 1879:xxviii). Erosion likely accounts for the difference between *Comet*'s outer hull planking thickness and the thickness recorded in historical documents. Outer hull planks were fastened to the frames with a combination of treenails, round iron fasteners,

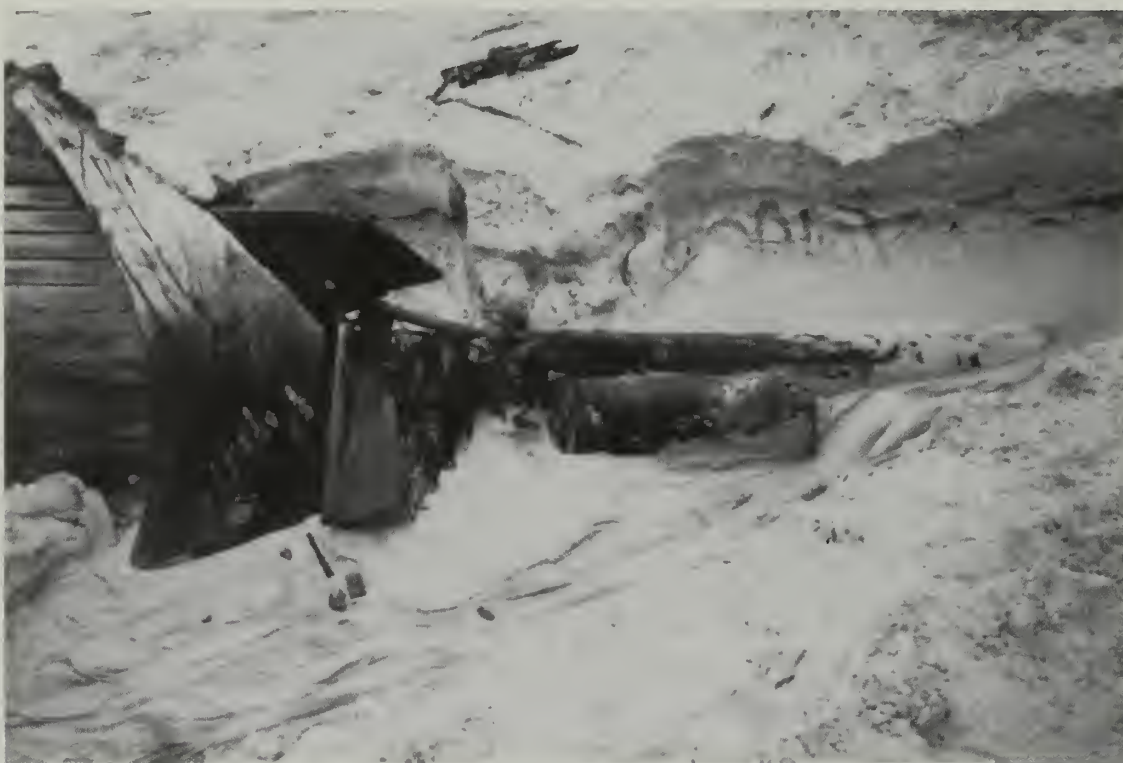
Figure 4.14. Top view of *Comet*'s knighthead (to the lower right of the white float), bowsprit and jibboom heel chock. NPS photo by Matt Russell.

Just forward of the knighthead, set up around the bowsprit, is the gammoning or gammon iron (see Figures 4.13 and 4.14). The gammoning secures the bowsprit to the stempost and counters the upward lift of the foremast

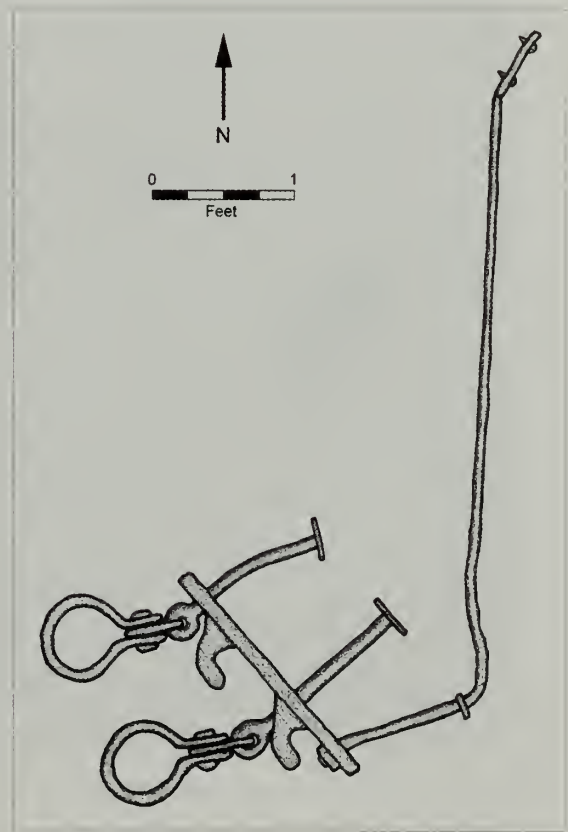
though not identical, rigging elements on the foresides of its catheads, which support the jibboom guys (Figure 4.28). In addition, historical photos of *Comet* wrecked in Simonton Cove give indirect evidence for this identification. Although the photos do not show the cathead or this particular element, they depict the jibboom guys coming to a point that can only be on the foresides of the catheads (see Figures 3.6 and 3.7). The iron hooks are called jib stay hooks (Greenhill and Manning 1995:103), and the iron rod was a brace between the cathead and the rail (Chapelle 1973:398). The rod's angle identifies this object coming from the port, rather than the starboard, cathead.

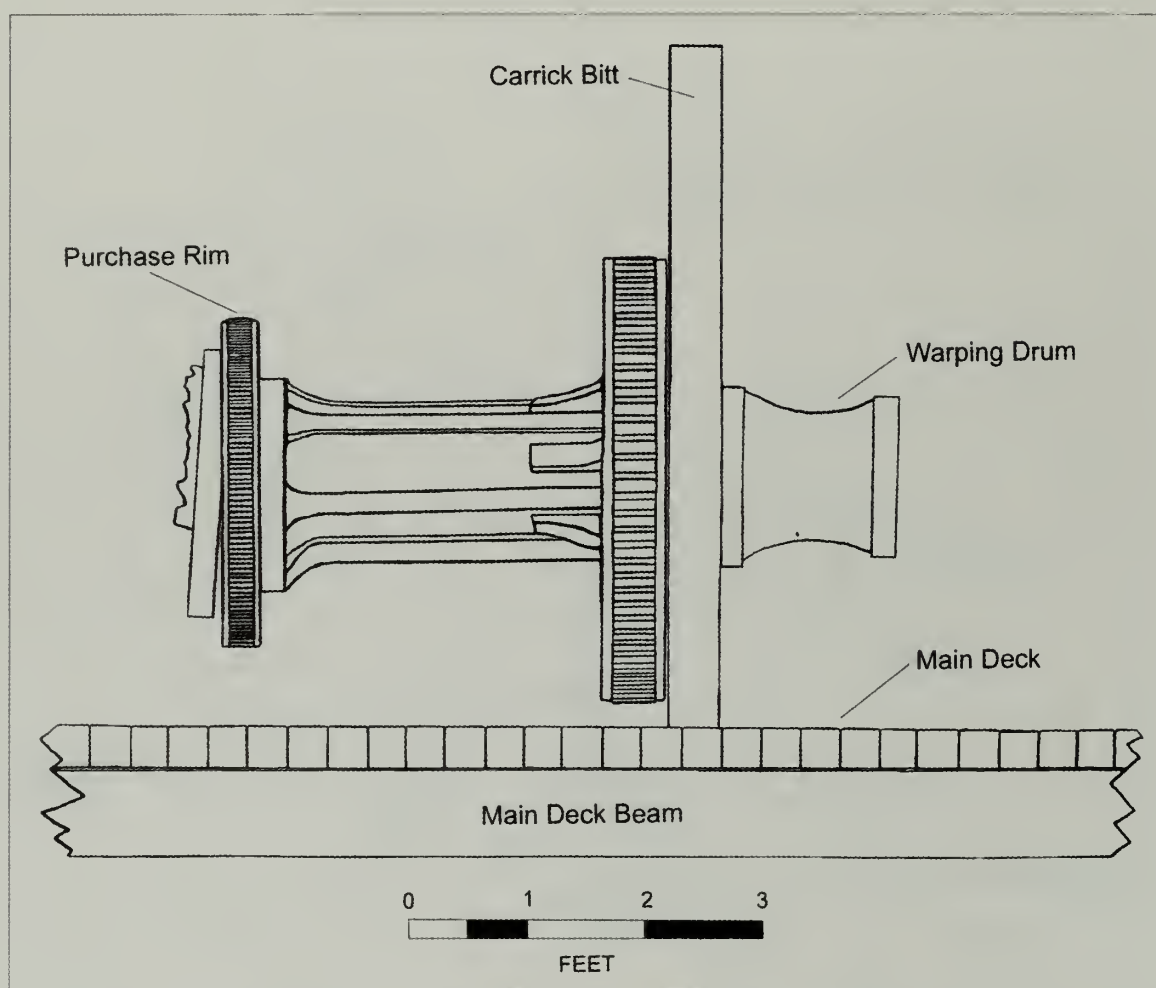
Comet’s windlass is mounted on the schooner’s main deck, just aft of the pawl post (Figure 4.35 and 4.36). It has a wooden windlass barrel with iron whelps supported by hardwood carrick bitts, and it was worked with two iron purchase rims (with 1 ft. 11½ in., or 23½ in., inside diameter) and purchase arms connected by iron purchase rods to a pivoting rocker, or crosshead, mechanism that was originally mounted above the windlass on the forecastle deck (Figure 4.37) (Chapelle 1973:669–680; Paasch 1890:Plate 70). Just forward of the pawl post at forecastle-deck level are two fasteners and the remains of a block that supported the crosshead on the forecastle deck. On either side of the pawl post are openings in the forecastle deck where the purchase rods connected the windlass purchase arms to the rocker on the forecastle above.

Figure 4.36. *Comet's* windlass, elevation view looking forward on main deck. Drawing by Jim Bradford and Matt Russell.

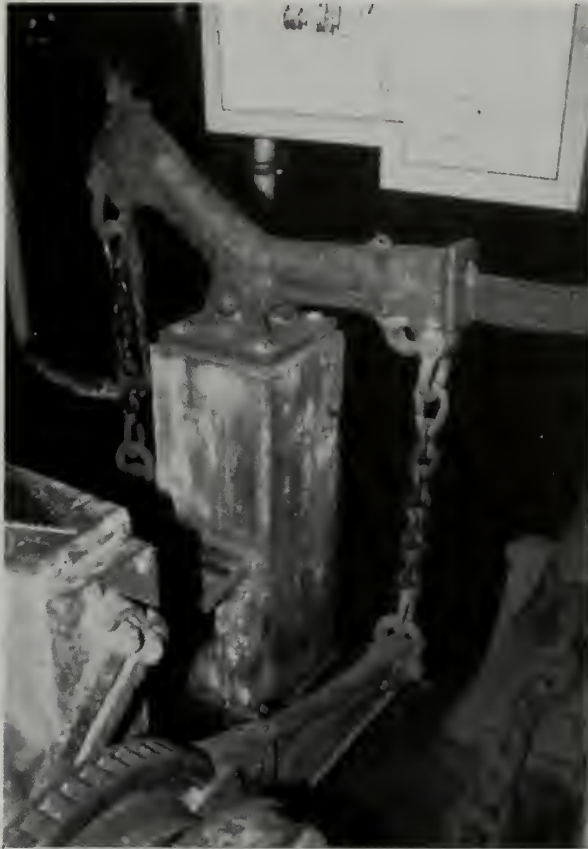
Figure 4.37. Pivoting rocker, or crosshead, mechanism connected to a windlass purchase arm with chain. *Comet* was equipped with a similar windlass type. NPS photo by Matt Russell.

9½ in. long. The fasteners are probably from the windlass' port side, the link chain is possibly from the messenger chain or connected the purchase arm with the rocker (see Figure 4.37), and the iron bar is possibly part of one of the pump-brake hand levers.

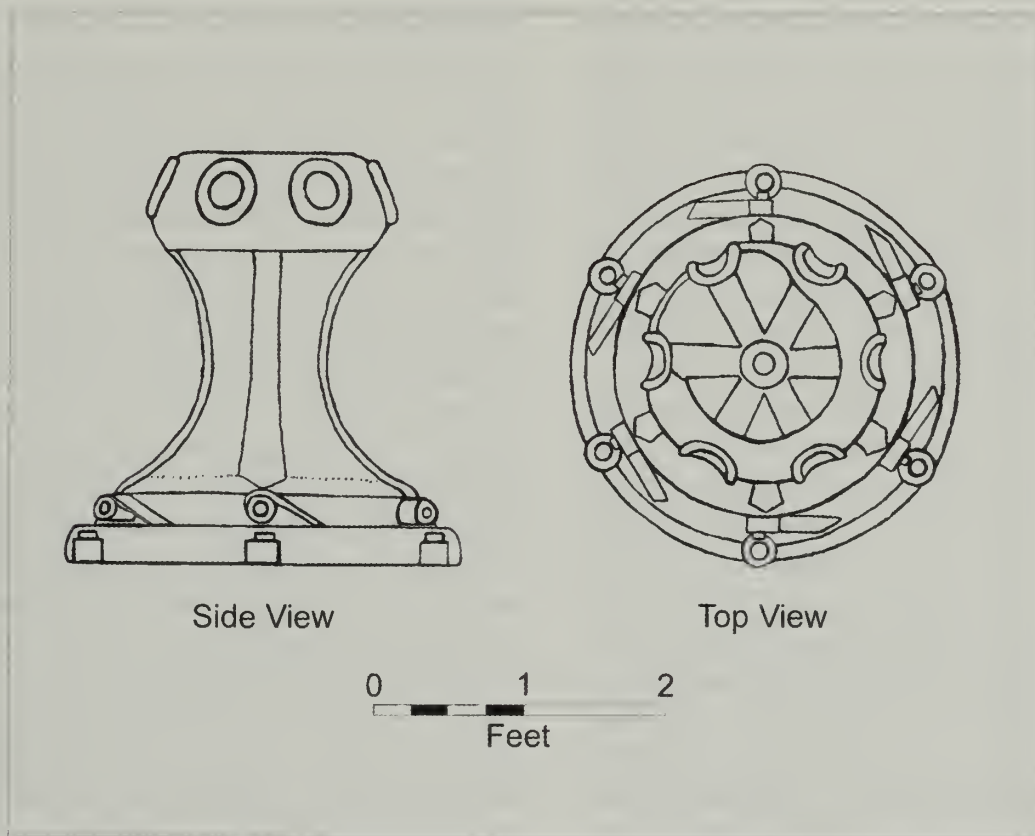
Figure 4.45. *Comet's* capstan. Drawing by Jim Bradford.

A hand-powered capstan is mounted in the center of the forecastle deck (Figures 4.44 and 4.45). It is not linked to the windlass, so is not technically part of the ground tackle. It was used for warping only, including such tasks as handling lines and assisting with raising sail (Campbell 1974:135). The capstan is 2 ft. 10 in. tall, with a 2 ft. 8-in. diameter base and 1 ft. 8-in. diameter head. This is presumably the “#3 capstan” specified in *Comet's* contract.

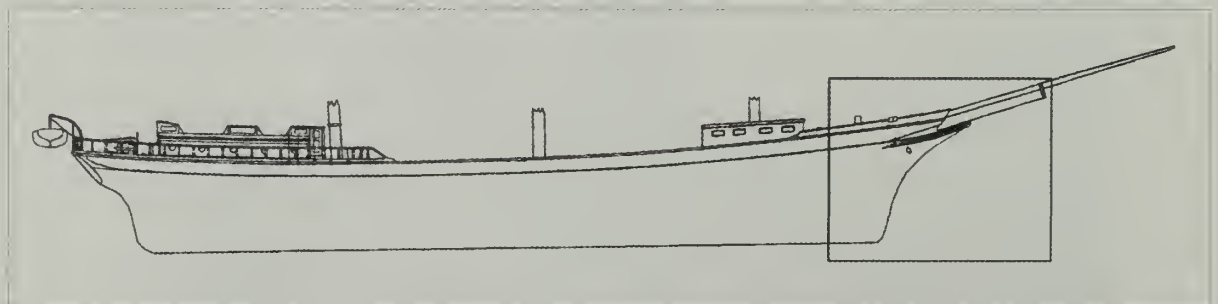
After it broke free from the rest of the hull, the bow rotated 90° to face seaward, and possibly shifted closer to the embankment behind the beach. The bow must have detached from the hull before it rotated because there would not have been enough room on the beach for the entire vessel to rotate. After it broke free and rotated, the bow section heeled over to starboard and filled with sand to the level reflected in preserved structure observed on site during this study. Much of the port bow was exposed to the elements, and was, in effect,

Figure 4.46. Area of *Comet*'s preserved hull.

“sheared off” by natural deterioration. Exposed wood portions of the wreck, such as the port sides of the outer hull, forecastle deck, main deck and windlass, deteriorated and were removed from the site, probably by natural processes. This natural “shearing” process must have taken place after the bow broke away, rotated and heeled to starboard because of the evident “line” of preservation and the position of the iron features within the wreck site. Major iron features, including the anchor, port windlass hardware, and port cathead rigging element, appear to have essentially dropped to their current locations as their wooden support structures deteriorated. For example, the cathead rigging element dropped outside the hull when the cathead deteriorated, and the windlass’ port-side hardware fell to its current location on the main deck against the bowsprit when the port half of the wooden windlass barrel deteriorated.
