HISTORIC STRUCTURES REPORT

CROOK HOUSE

SEPTEMBER 1984

SAN JUAN ISLAND
NATIONAL
HISTORICAL PARK

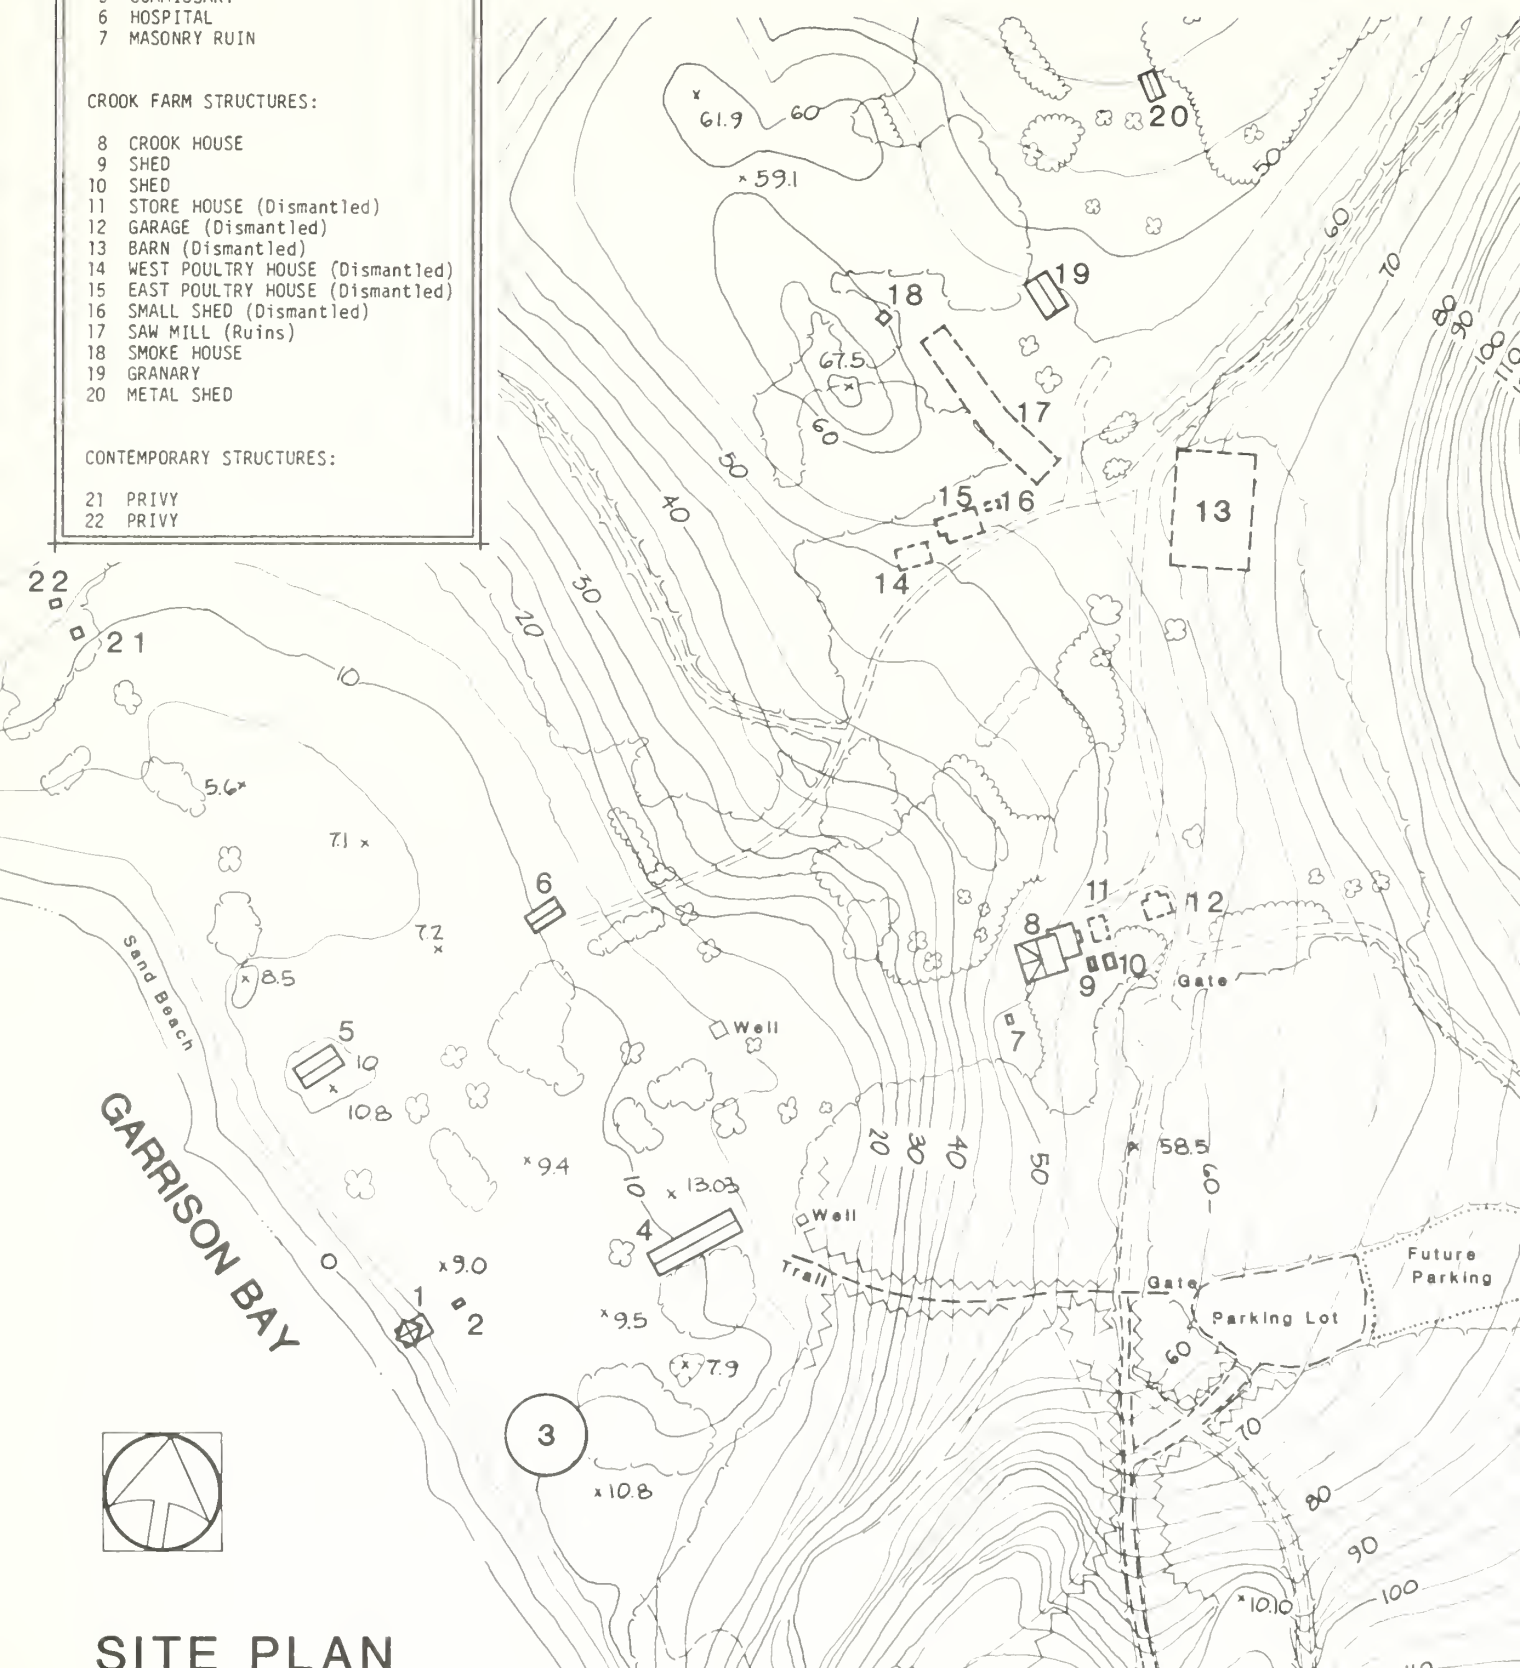
FIGURE 25

A short steep climb up the grassy knoll terminates at the west end porch of the Crook house. The English Camp masonry ruins sit to the southwest of the house. A path leads around the north side of the house to the back entry on the east side.

Remains of several outbuildings are present throughout the grounds to the east of the house, and two other plywood sheds sit partially

hidden in the dense brush to the southeast. These structures and remains are but a few of the clues to the historic landscape of the Crook homestead.
