THE STILLWATER ROAD (SHEA) BRIDGE Cumberland, Rhode Island

METALS NUMBER 4

Rehabilitating a Historic Iron Bridge

Joseph P. Saldibar, III

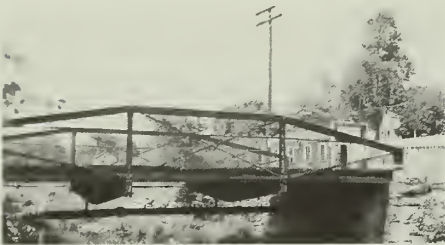
Figure 1. The Stillwater Road Bridge is shown on its original site in Smithfield, Rhode Island, in 1942. Following the decision to replace the historic iron bridge, it was subsequently dismantled, rehabilitated, moved, and re-assembled in nearby Cumberland. Photo: Rhode Island Department of Public Works.

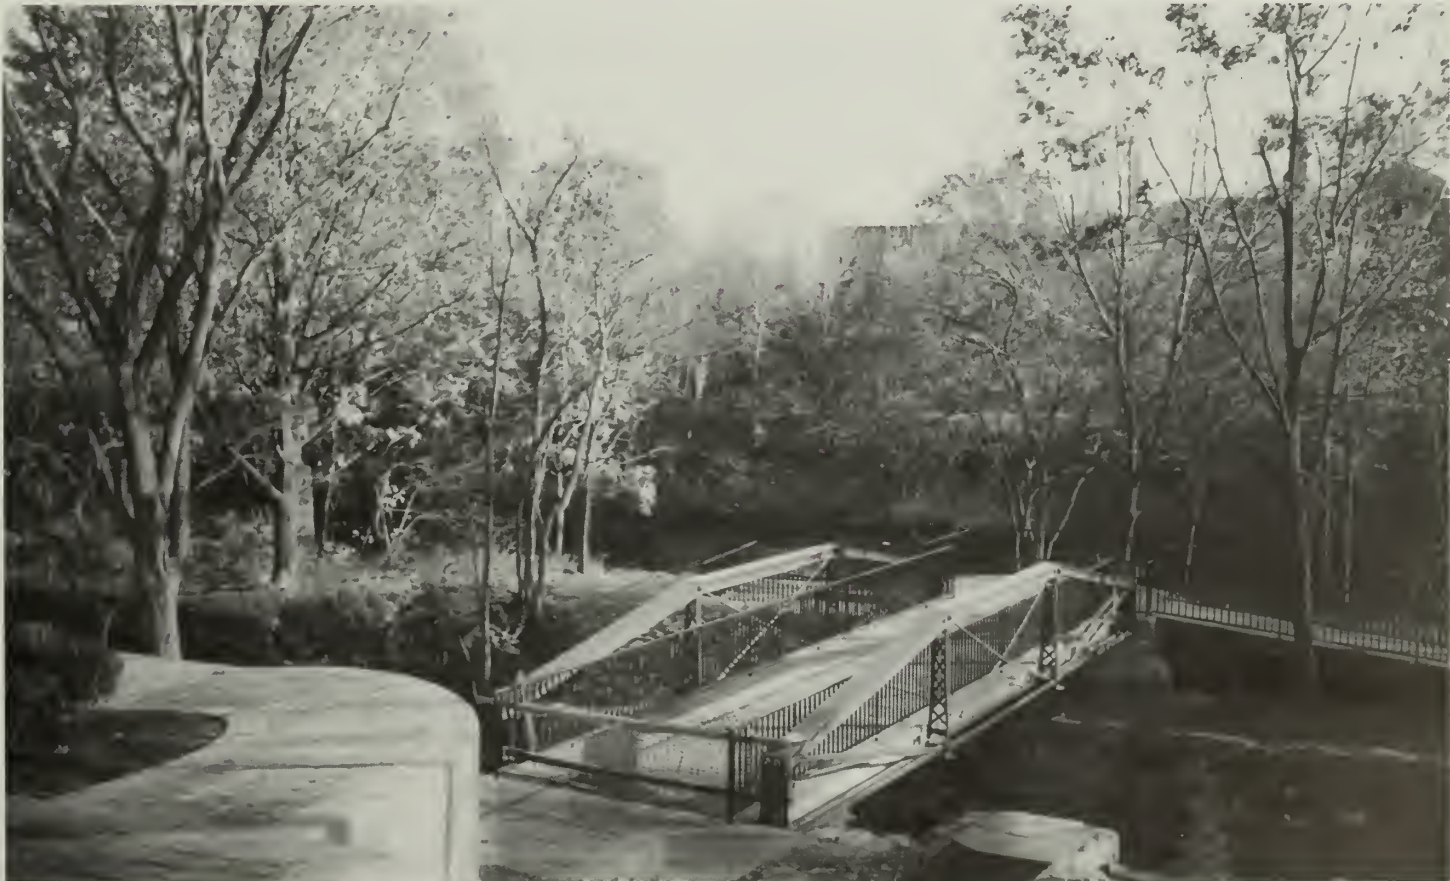
Figure 11. Valley Falls Heritage Park (left) as it is viewed today. The park is part of the Blackstone River Valley National Heritage Corridor, and is a welcome addition to downtown Cumberland, Rhode Island. Photo: Joseph P. Saldibar, III.
