**ENVIRONMENTAL ASSESSMENT
NOVEMBER, 2002**

**AGUA FRIA CREEK RESTORATION PROJECT
EL MALPAIS NATIONAL MONUMENT
NEW MEXICO**

DEVELOP A COMPREHENSIVE RESTORATION
PLAN FOR AGUA FRIA CREEK

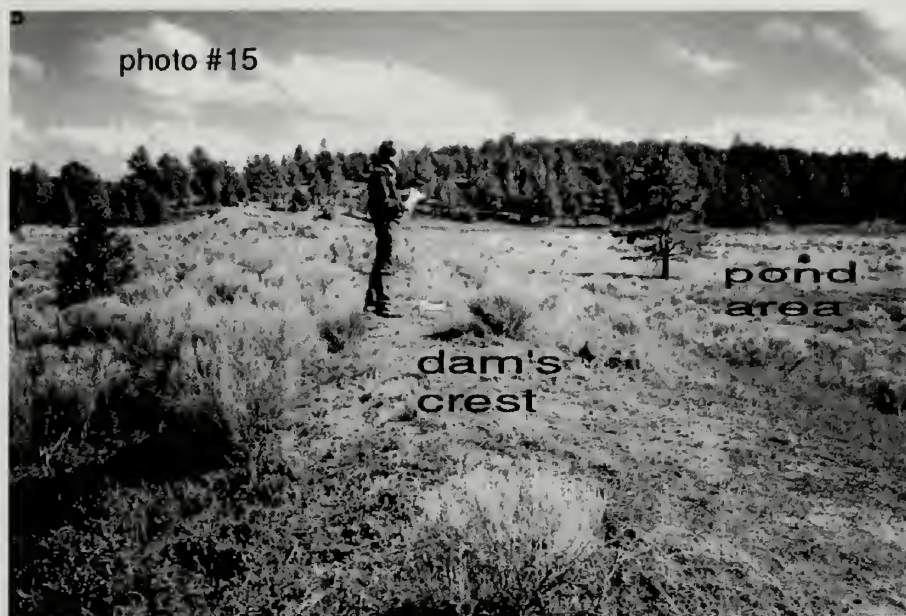
(Photo 1 of Fig 1.a). Looking east along the crest of Dam 30. This dam, constructed in the 1930's, is about 900 ft long by 15-20 ft high, located on a small tributary of Agua Fria Creek and fed by a diversion ditch. The old ditch is breached, so the dam remains dry.

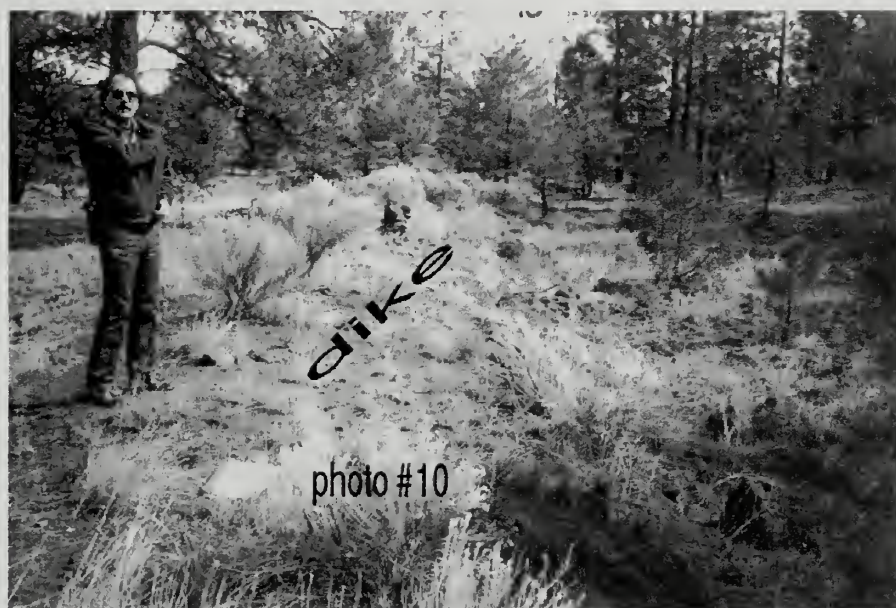
(Photo 2 of Fig 1.a). Looking northwest along "Pine Dike" from its southeast end.

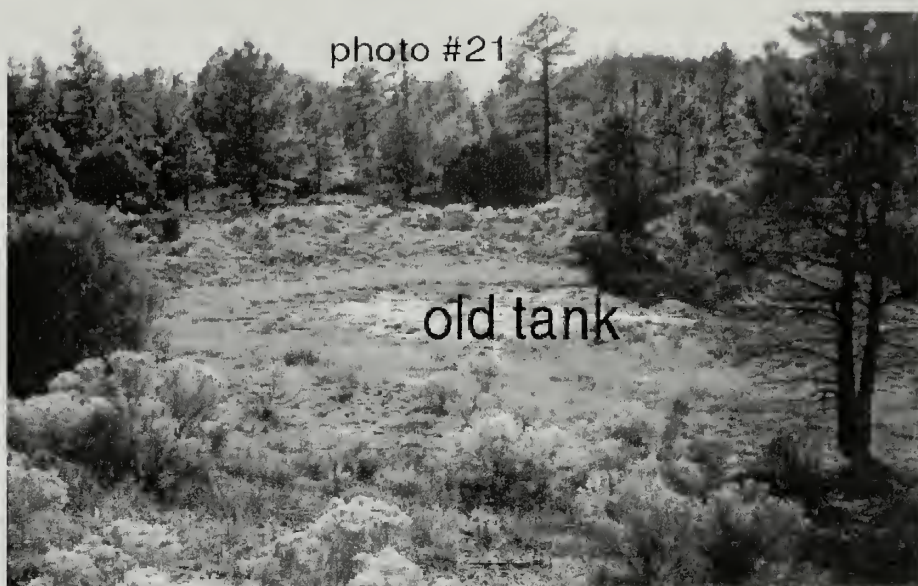
(Photo 3 of Fig 1.a). A view looking south into Stock Tank 28

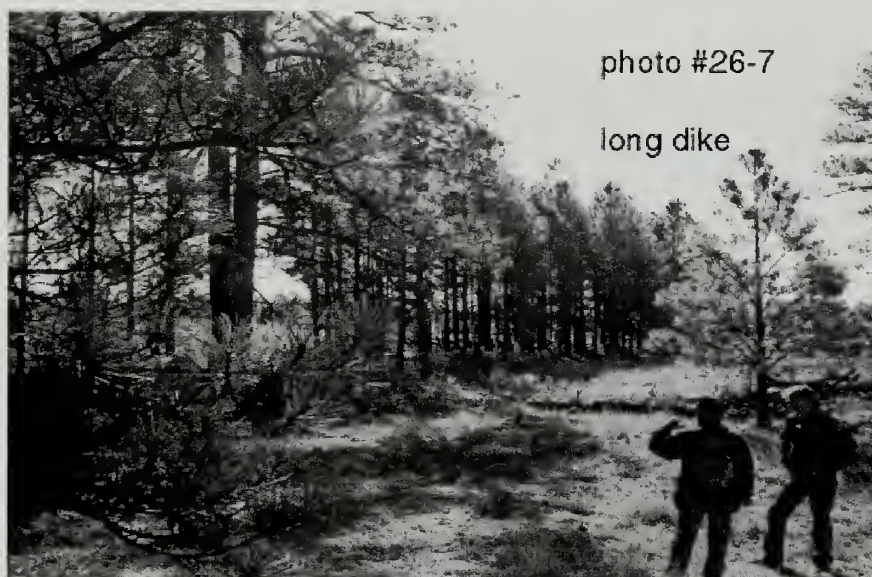
(Photo 4 of Fig 1.a). A view of the tall pines growing along "Pine Dike," looking northwest. The pines sprouted after the dike was constructed (in 1957).

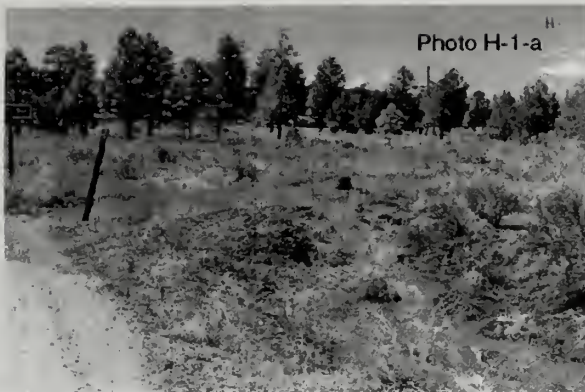
Photo H-1-a

To the left, springtime flooding from the north flows into the west edge of the El Calderon Parking Lot area.

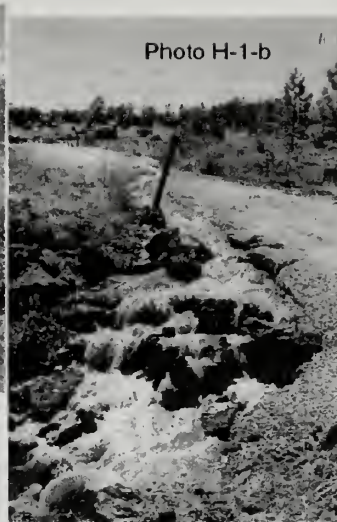
Photo H-1-b

On the right, the flooding flows along the El Calderon Parking Lot road.

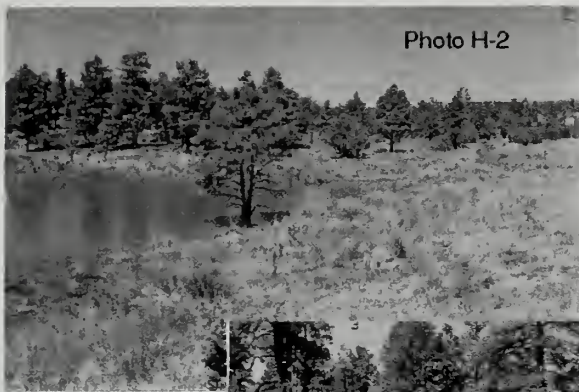
Photo H-2

To the left (#H-2), Stock Tank 28, holds springtime flood waters.

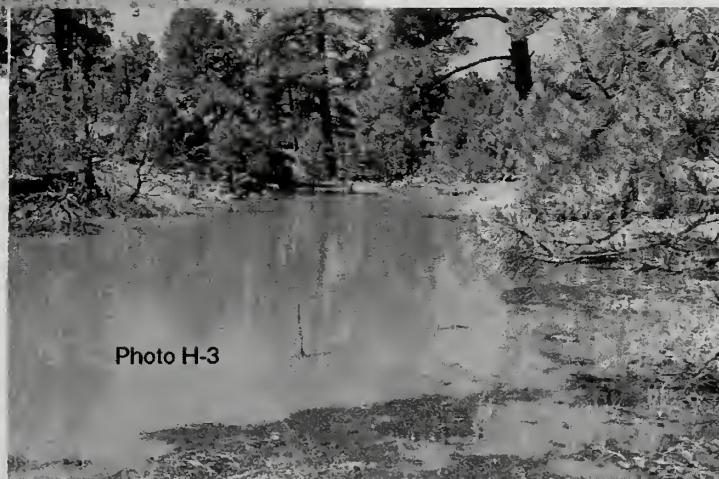
Photo H-3

To the right (#H-3), the springtime runoff flows behind "Pine Dike."

Figure 1.b. Flooding in the project area in 1998 (photos by El Malpais Chief Ranger Herschel Schulz, 1998).

Today none of the stock ponds, ditches, or other structures are maintained or managed, and all but one (Pine Dike) are breached and out of order. All are eroding. These structures disrupt the natural flow regime of the creek, contributing to problems including: safety hazards from flooding and mud; flooding damage to the El Calderon Parking Lot; water and sediment impacts on caves, silting of lava tubes and other geologic features; and disruption of riparian habitats and meadow ecosystems. The photographs of Figure 1.b provide scenes of the periodic flooding in the proposed project area.

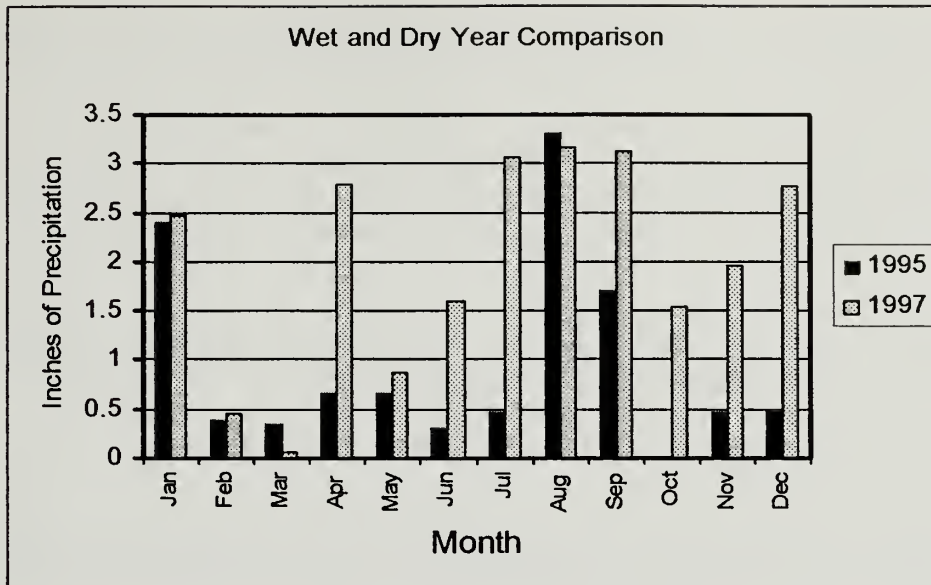
Figure 3.7.1.a
Comparison of the wettest ('97) and driest year ('95) in the 1992-2001 decade in the proposed project area (data from the Information Center, immediately adjacent to the proposed project).

PRECIPITATION: The weather patterns at ELMA are typical of most of New Mexico, with at least half the year's precipitation falling during the summer months. During 1992-2001, the precipitation in the proposed project area ranged from about 11 to 24 inches per year, so was highly variable. Table 3.7.1.b shows these data. Monthly variation also is enormous, as seen in Figure 3.7.1.a.
