protection alternatives
development concept plan/environmental asesment

CAPE HATTERAS LIGHTHOUSE COMPLEX
CAPE HATTERAS

June 1989

UNITED STATES DEPARTMENT OF THE INTERIOR / NATIONAL PARK SERVICE

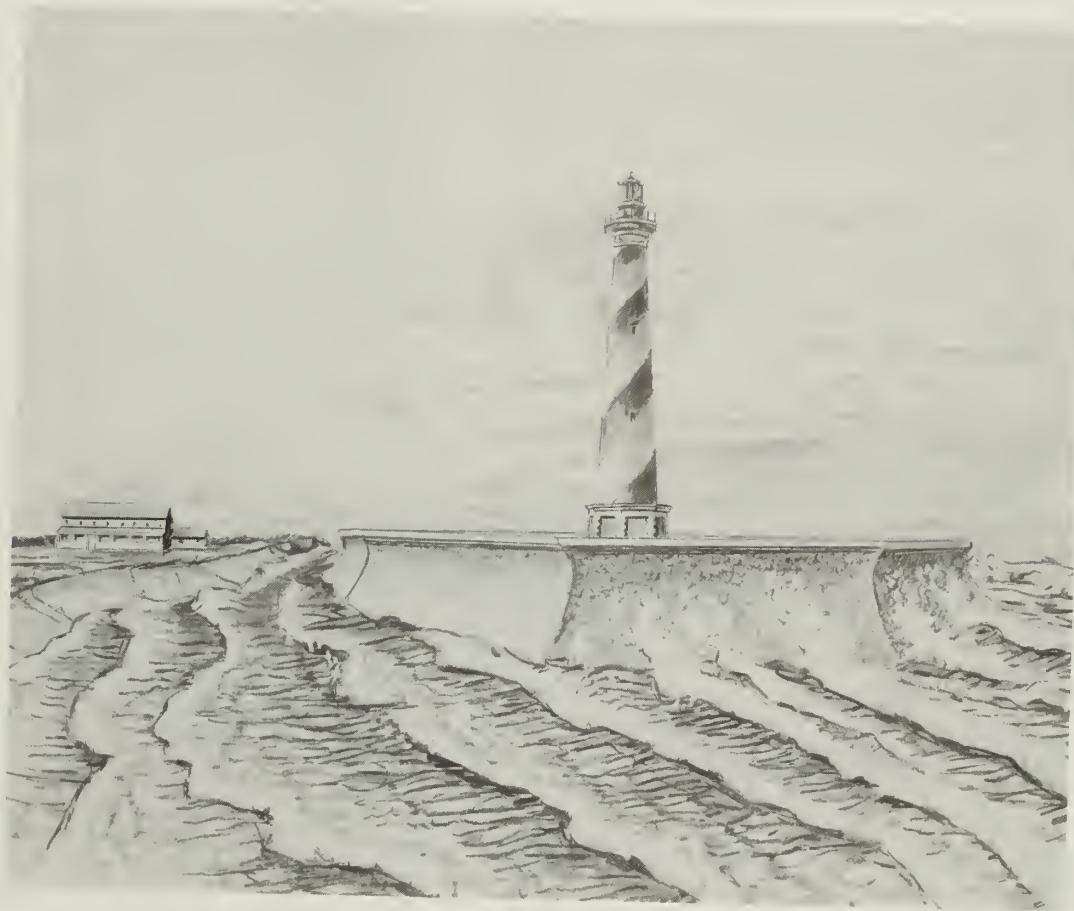
ALTERNATIVE 2

SEAWALL WITH REVETMENT

At first, only the six seaward facets of the seawall would be constructed, although the subterranean sheetpile cutoff wall and revetment would be built to encircle the structure. The remaining area would provide public access until the encroaching sea forced construction of flood walls to ultimately seal the landward side. Eventually, as the ocean enclosed the revetted seawall, the lighthouse and oil house would become detached from the two keepers' quarters and their historical association would be lost. As the sea continued eroding the shoreline, the lighthouse and seawall would become an island and the associated structures would have to be relocated, additionally impairing the integrity of the historic relationship. Aesthetically, the lighthouse site would be further
