AGUA FRIA CREEK RESTORATION PROJECT
EL MALPAIS NATIONAL MONUMENT
NEW MEXICO

ENVIRONMENTAL ASSESSMENT

DEVELOP A COMPREHENSIVE RESTORATION
PLAN FOR AGUA FRIA CREEK

AUGUST 2002 DRAFT

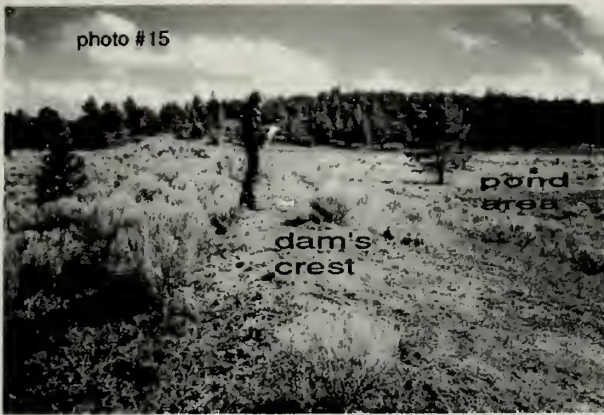
1. Looking east along the crest of Dam 30. This dam was constructed in the 1930's, apparently as a public works project. It is about 900 ft long by 15-20 ft high, on a small tributary of Agua Fria Creek. It was originally fed by a diversion ditch; however, the old ditch is breached, so the dam remains dry.

By far the most visible structure of the project area is a large dam about 900 feet across and 15-20 feet tall (Figure 1.1), located on a small tributary of the creek. This dam apparently was constructed as a public works conservation project during the late 1930's. The dam's old feeder ditch, which runs along a hillside, is breached; consequently the dam collects very little water and its storage area of about 40 acres never fills. The dam's hydrologic impact is essentially nil.

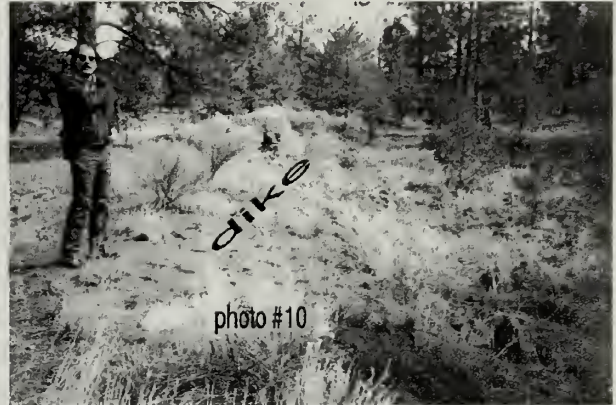
2. Looking northwest along "Pine Dike" from its southwest end.

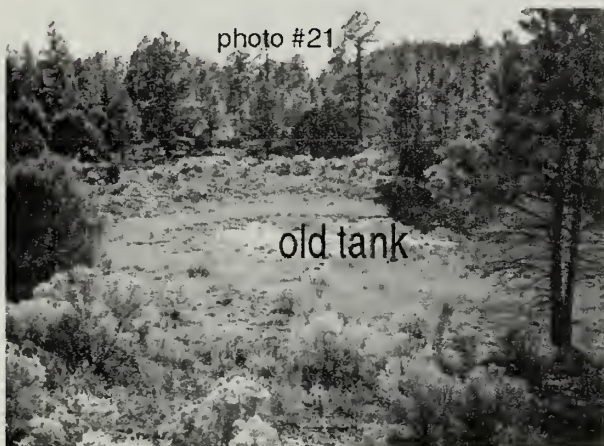
3. A view looking south into Stock Tank 28

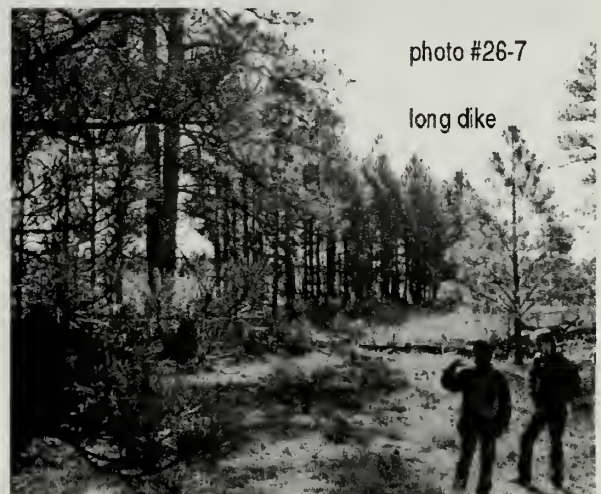
Figure 1.1. Views of old structures in the project area.

4. A view of the tall pines growing along "Pine Dike," looking northwest. The pines sprouted after the dike was constructed. The dike was constructed in 1957 according to aerial photographs, coring of the pines for age, and construction records obtained from the highway department.

1. Mid-low elevation ponderosa pine woodland (*Pinus ponderosa*): Younger ponderosas are growing well in the area, for example, on the Pine Dike (Figure 1.1). Good examples of large ponderosas are found throughout the project area (note report cover photo). This type of forest has a well developed grass understory. Much of the proposed project area is a mixture of the ponderosa pine and piñon woodland (#2 group, below).

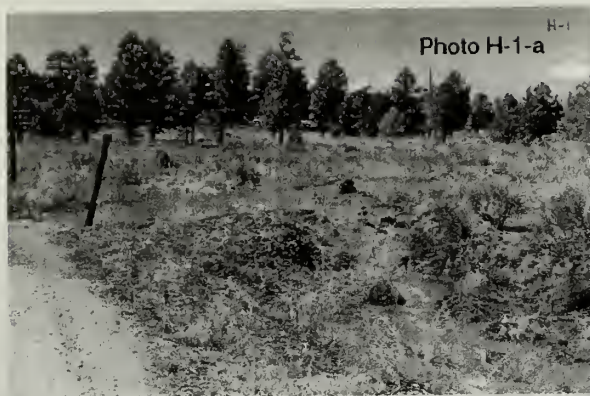
To the left, springtime flooding from the north flows into the west edge of the El Calderon Parking Lot area.

On the right, the flooding flows along the El Calderon Parking Lot road.

Figure 1.2. Flooding in the project area in 1998 (photos by El Malpais Chief Ranger Herschel Schulz, 1998).

Lava tubes are another important geomorphic feature in the project area. Tubes form in the flows when lava cools and hardens. A tube can stay intact as a cave, or its roof may collapse, creating an open depression or collapsed structure. Both tubes and collapsed structures are common in the proposed project area. Some are periodically flooded. The artificial Pine Dike upstream (Figure 1.4) diverts Agua Fria Creek down toward the El Calderon Parking lot, where caves and collapsed structures can be flooded. Figure 1.2's Photo H-1b shows flood waters pouring into open tubes near the El Calderon Parking Lot.

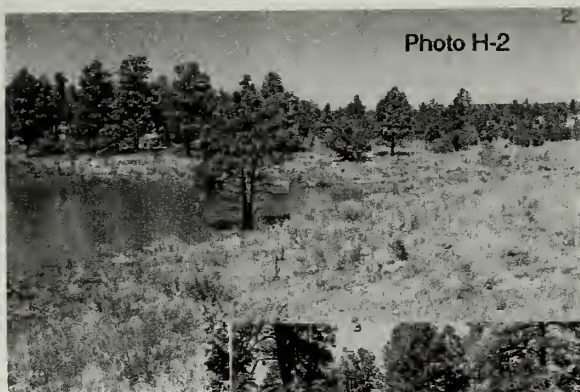
To the left (#H-2), Stock Tank 28, holds springtime flood waters.

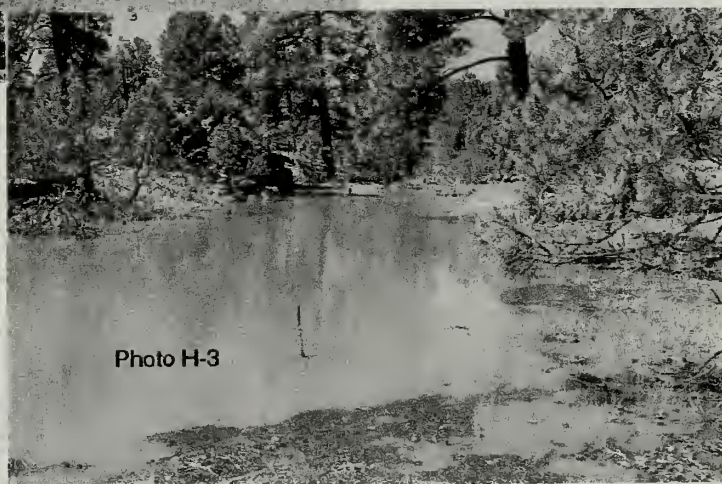
To the right (#H-3), the springtime runoff flows behind "Pine Dike."

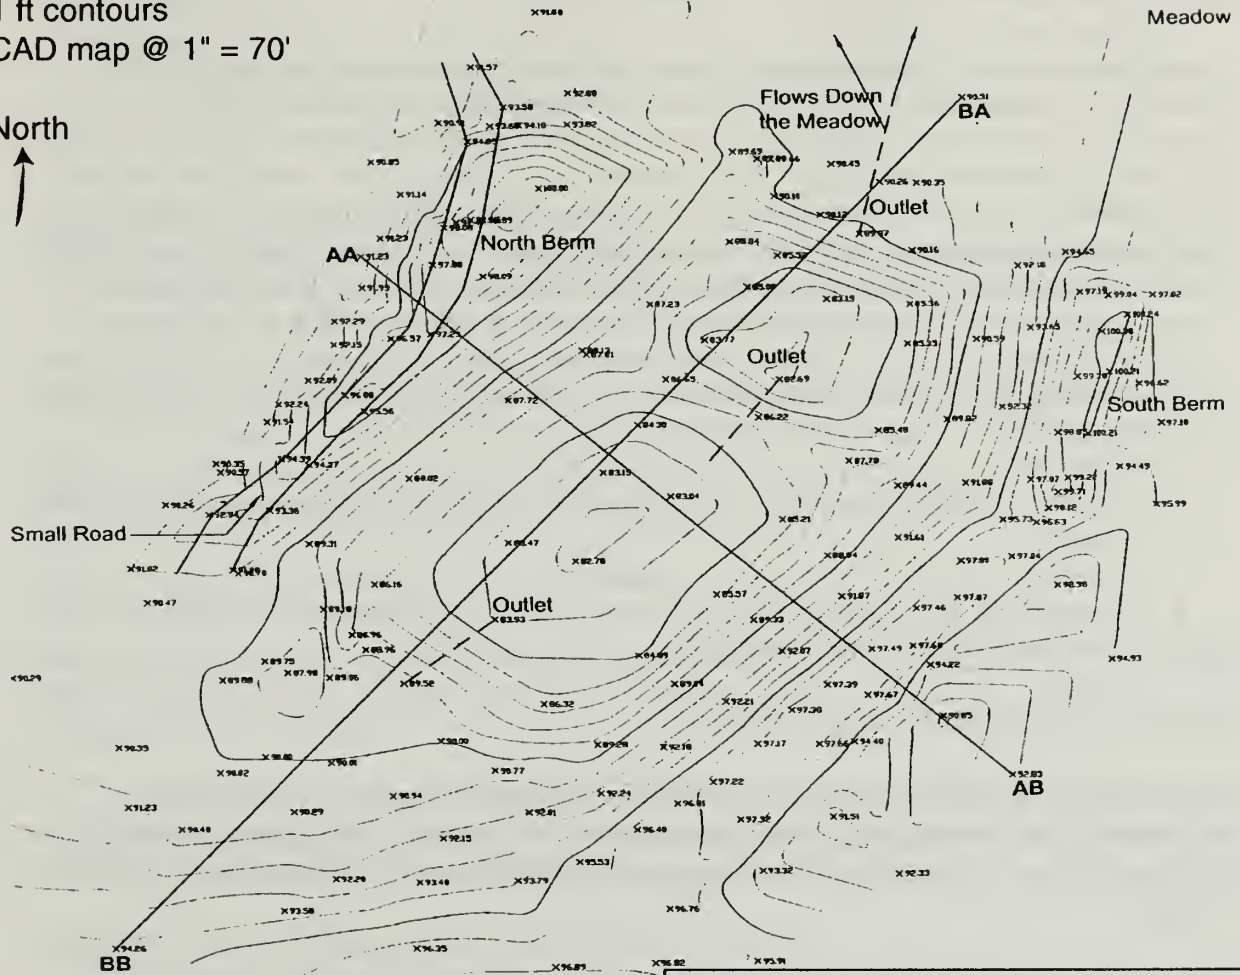
Stock Tank 19-2

The actual CAD maps include details at a larger scale for field use, with cross sections, cut and fill volumes, and a projected map of the new surface after restoration.

Figure 3.2. Example extracted from one of the CAD maps prepared for each of the five treatment sites.

The team also surveyed detailed topographic maps of each of the five treatment sites, using a "Total Station" instrument, importing the data into Computer Assisted Design (CAD) software to prepare contours, cross sections, and earth movement volumes for each site. The maps and calculations provided designs for earth work and cut-fill volumes for the recommendations report. Figure 3.2 is an example copied from a section of one of the site topographic maps.

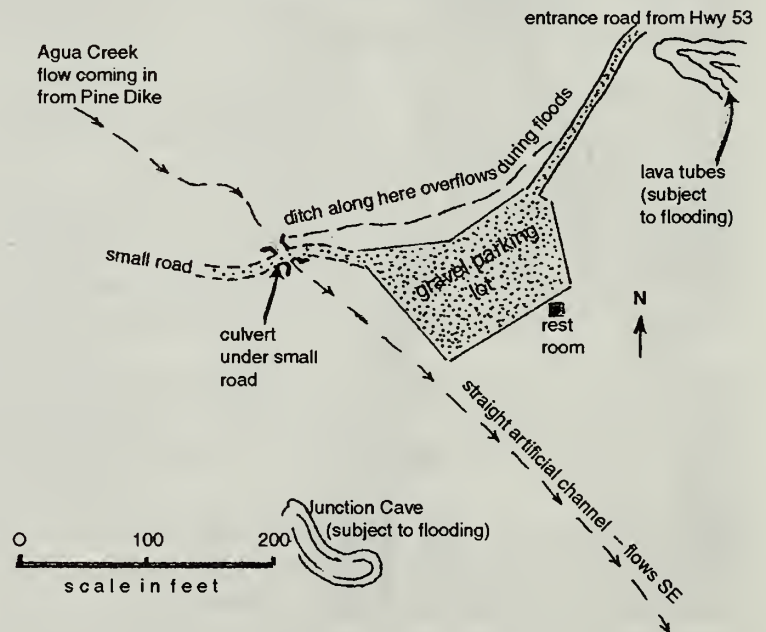
Figure 3.7.1.d. Drawing of flooding at the parking lot (to scale).

8. THE EL CALDERON PARKING LOT AREA: Flooding at the El Calderon Parking Lot has been a problem about every five years when springtime runoff fills the creek. Figure 3.7.1.d provides an overview of the flooding (note that Figure 1.2 shows photographs of the area in flood). Ditching near the parking lot was added at some time in the past, but the ditches and culverts in the parking lot area do not have adequate capacity for the floods.

The culvert at the beginning of the primitive road and ditching on the west side of the parking lot also has a channel capacity of less than 50 cfs (Figure 3.7.1.d). So when floods exceed the capacity of the ditch, overflows can go into
