Technical Preservation Services
Preservation Assistance Division
National Park Service
U.S. Department of the Interior
Washington, D.C.

Interpreting
the Secretary of the Interior's
Standards for Rehabilitation

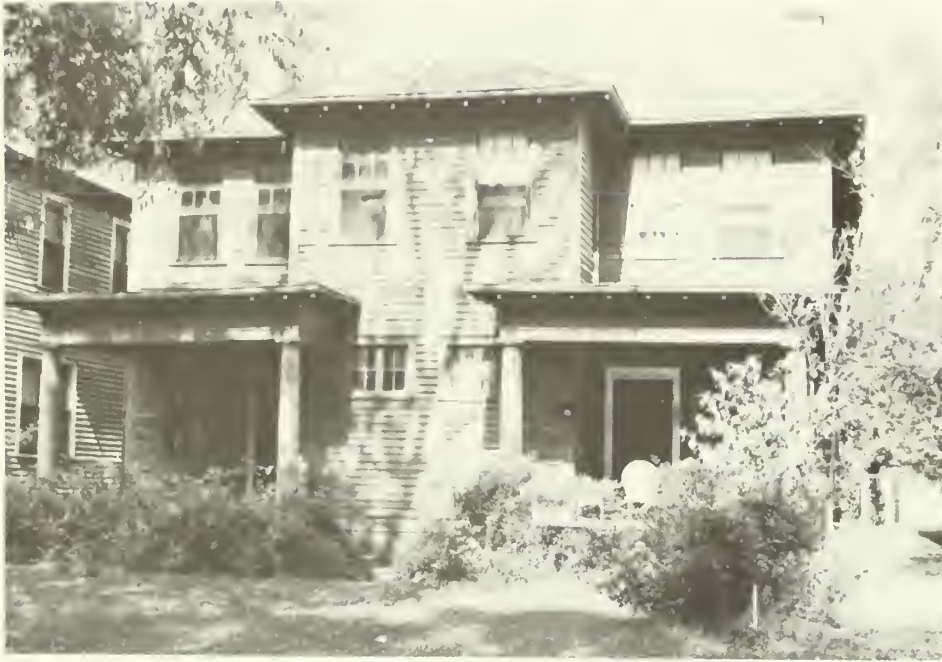
1. Prior to rehabilitation, the historic twin porch design and center projecting bay were strong architectural features.

The sole justification for the porch alteration was the need to alleviate water accumulation at the steps. Traditionally, such porch roofs were pitched away from the steps and the building in order to properly shed water; the owner should have thus repaired the porch and added gutters and downspouts, as necessary, to correct the water problem.

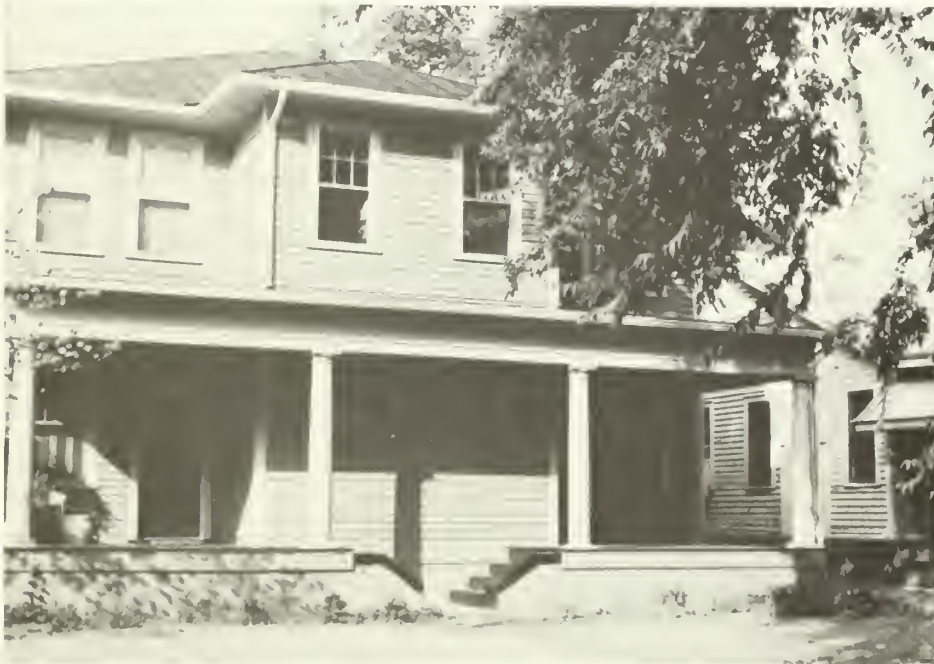
2. In connecting the two historic porches, the twin porch design was lost; a strong horizontal element was created by the large continuous porch; and the sense of a duplex building was diminished. To obtain certification, the owner agreed to restore the porch.

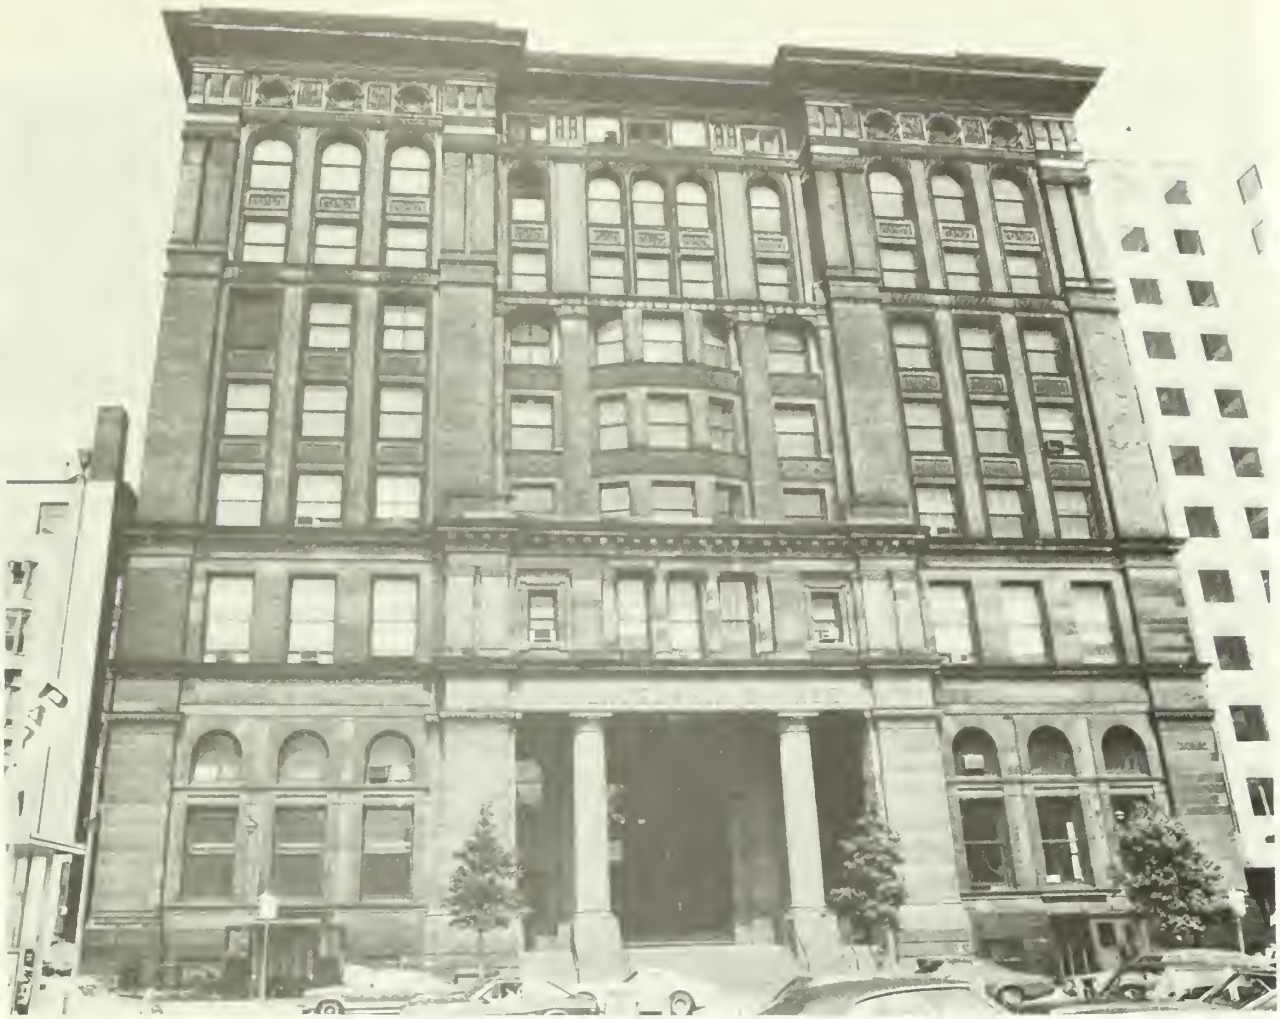
1. East elevation showing wooden vestibules flanking main entrance, added c. 1920.

Application: A nine-story, late Victorian brick and brownstone commercial building located in a historic district within a large northeastern city was being rehabilitated for use as a multi-purpose business and shopping complex (see illus. 1). When the proposal for extensive interior and exterior work was forwarded by the State Historic Preservation Officer to NPS for review, NPS concurred with the State's general assessment of nonconformance with the Secretary's Standards and denied certification, listing violations of Standards 2, 5, 6, and 9. Exterior work cited for nonconformance included window alterations and the design for new glass canopies to cover areaways flanking a main entrance. Nonconforming interior work included demolition of an existing skylight; large cuts in the main floor; introduction of a mezzanine; and construction of two curved staircases linking the interior levels.

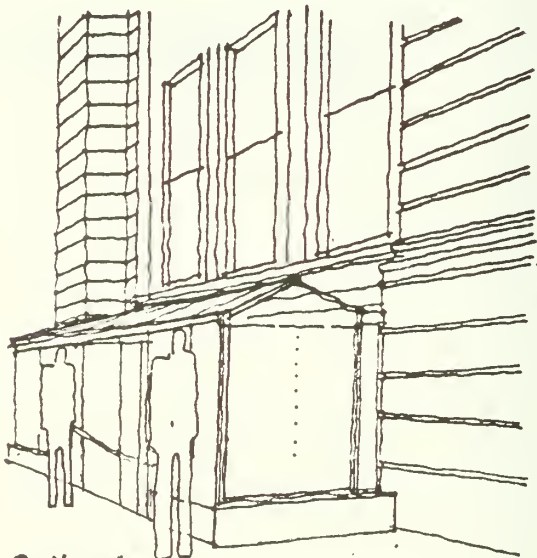
5. Final canopy designs (Option A and B), both of which NPS approved. The Option A design was ultimately constructed.

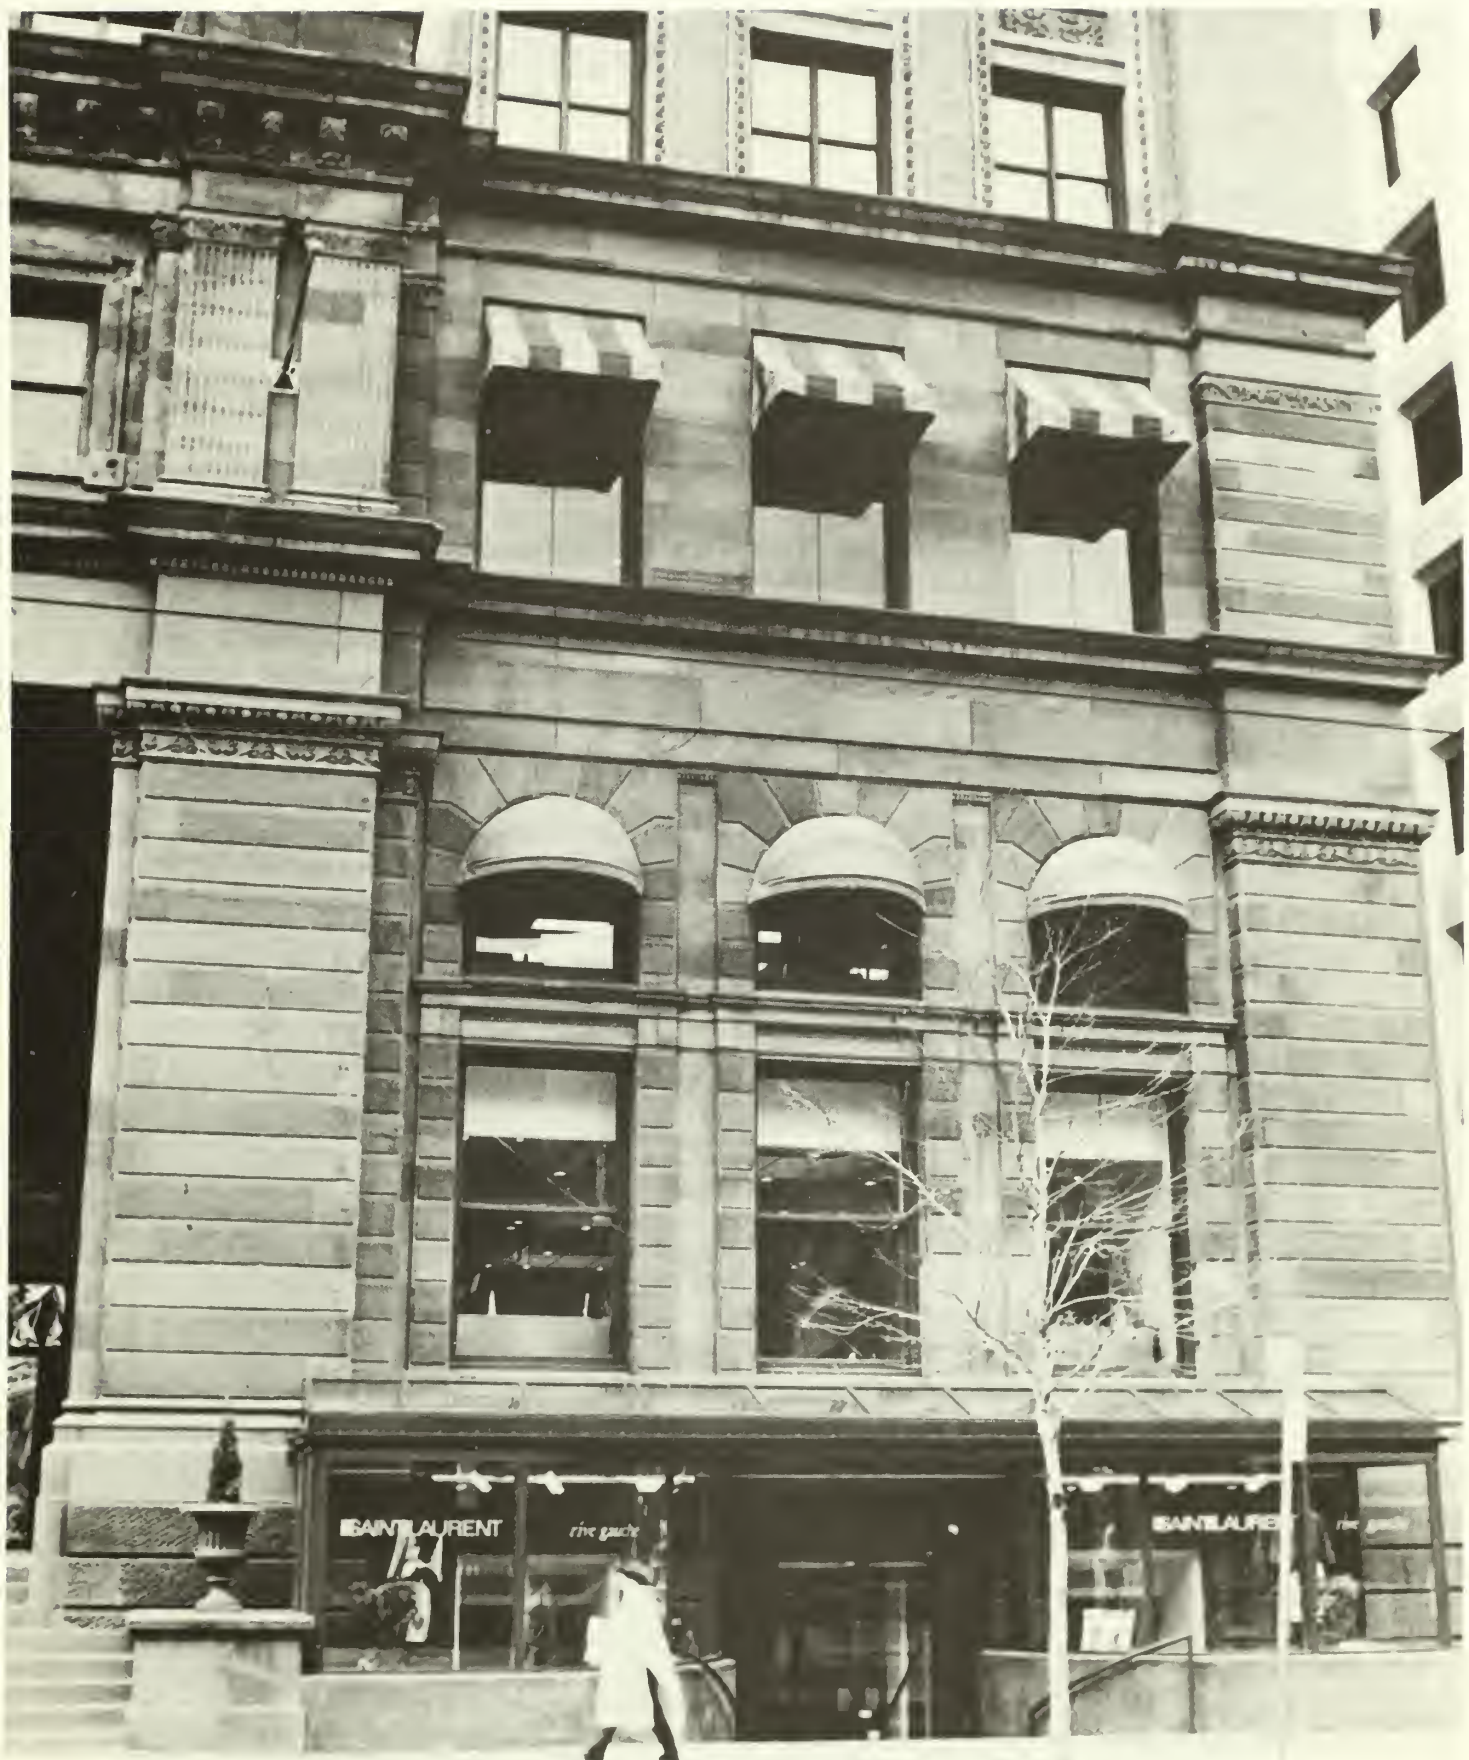
6. The Option A entrance canopy in place.

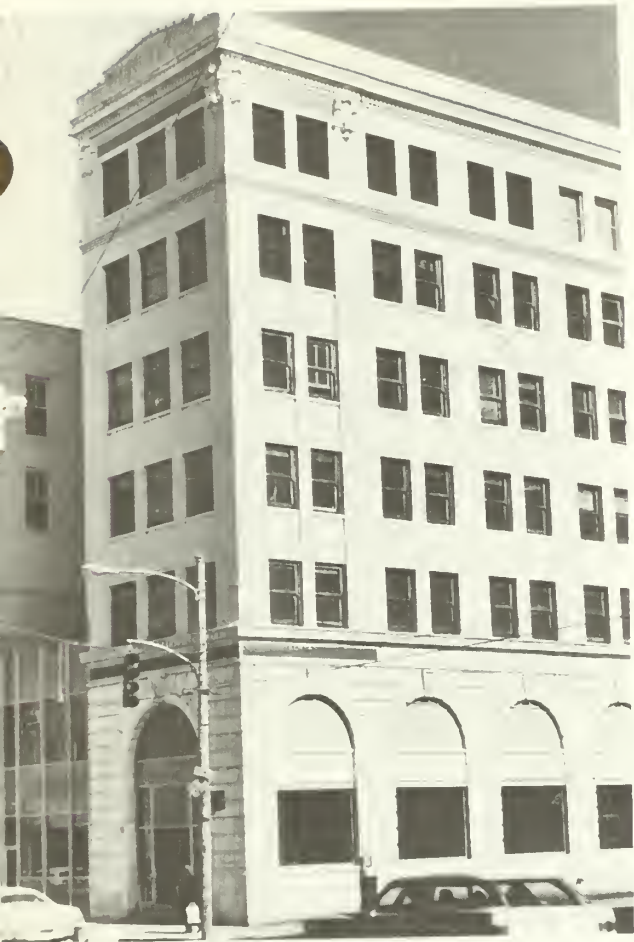
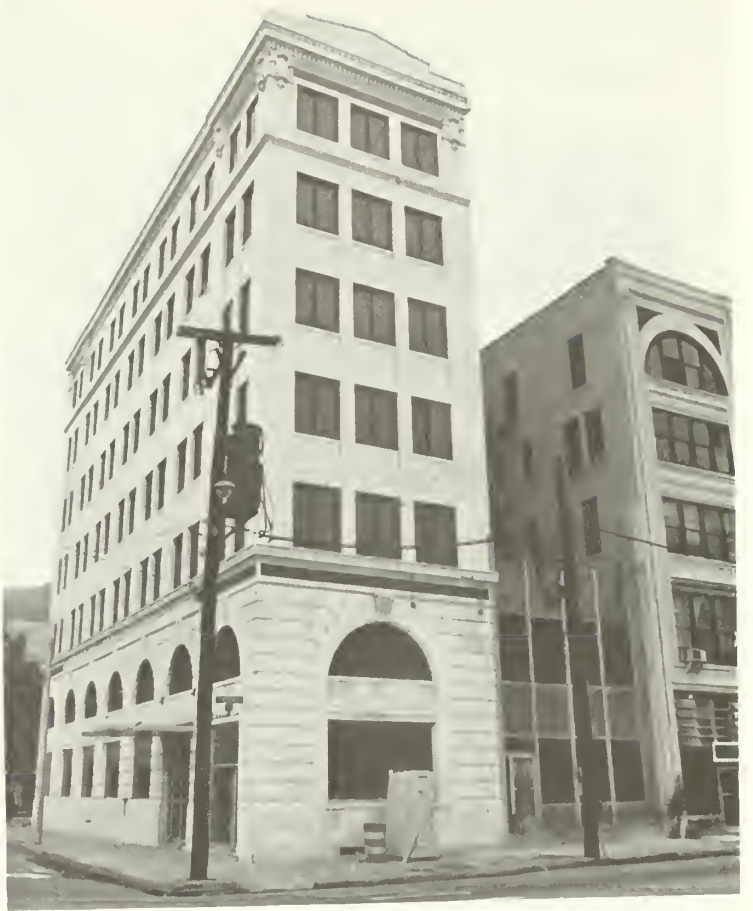
1. The original windows were of clear glazing and were of a one over one pane configuration.

2. New windows with dark tinted glass and a vertical division on the upper floors were not in keeping with the character of the building.

In the course of rehabilitating the building for mixed commercial and residential use, the double-hung clear-glazed wooden windows were removed (and stored) and replaced with metal windows with a single vertical division created by a meeting rail. In addition, a dark tinted glass was used in place of the original clear glazing (see illus. 2 and 3). The change in the design and the use of dark tinted glass gave the new windows a strong contemporary look not in keeping with the historic character of the building. Upon submitting a certification application, the owner was advised that the window alterations did not meet numbers 2, 5, 6 and 9 of the Secretary's Standards.

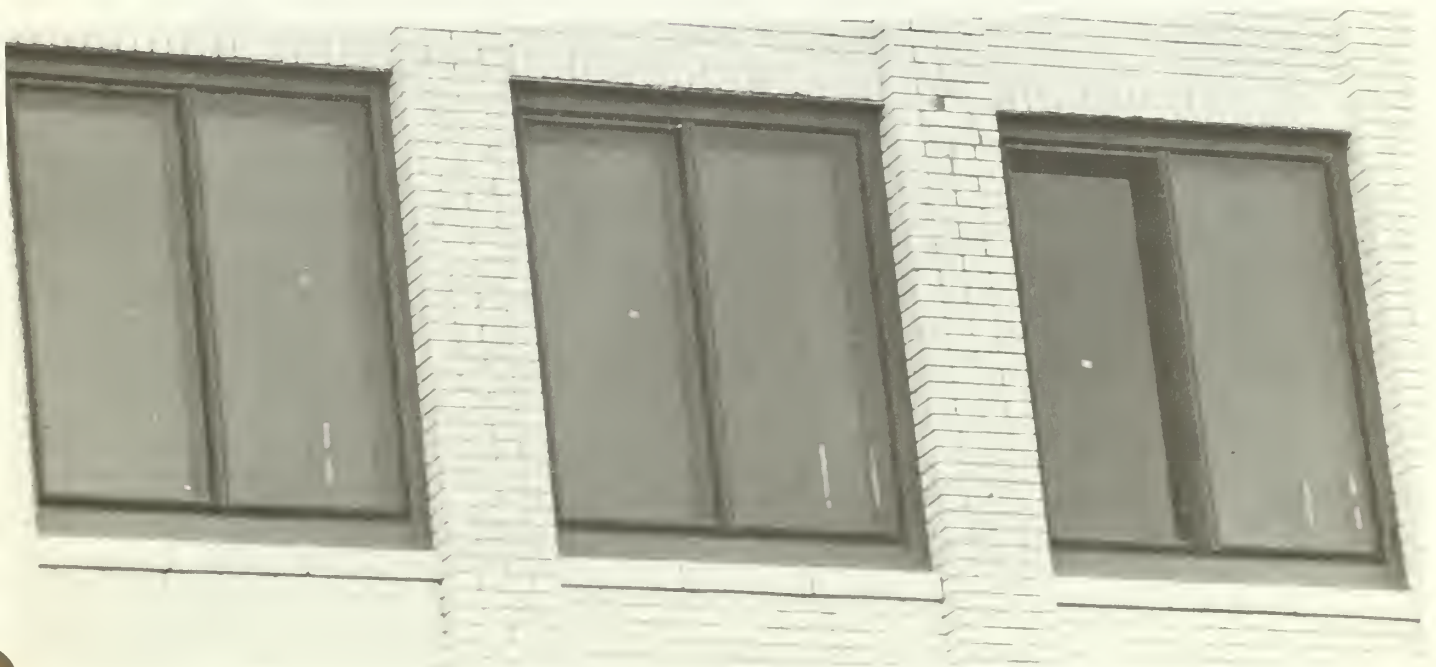
3. Close-up view shows the vertical division used in the new windows.

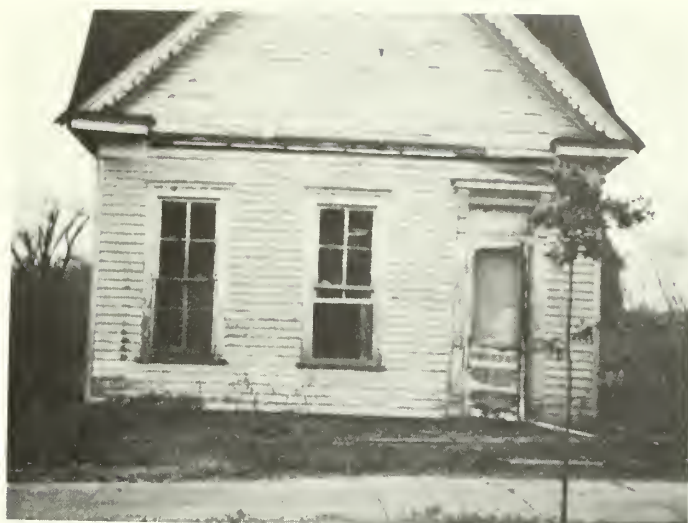
4. The 1880s cottage was in deteriorated condition prior to rehabilitation. Ghost marks of missing porch are evident. The original 2 over 2 windows had survived on the front and were to be repaired according to the plans submitted to NPS for prior review.

Plans for the rehabilitation of a small late nineteenth century cottage, located in a historic district in the South, were submitted prior to undertaking the work. After the determination was made by NPS that the proposed work met the Standards, the owner elected to revise the plans to include the removal of the two original first floor windows and subsequent replacement with floor-to-ceiling windows (see illus. 4 and 5). Upon completing the work and requesting final certification the owner was advised by NPS that the introduction of the new sash and exterior shutters which extend to the porch floor created a design feature that never existed in this particular structure and gave the building an inappropriate historic appearance. Moreover, NPS indicated to the owner that this particular type of window generally was found in buildings of an earlier period in that area.

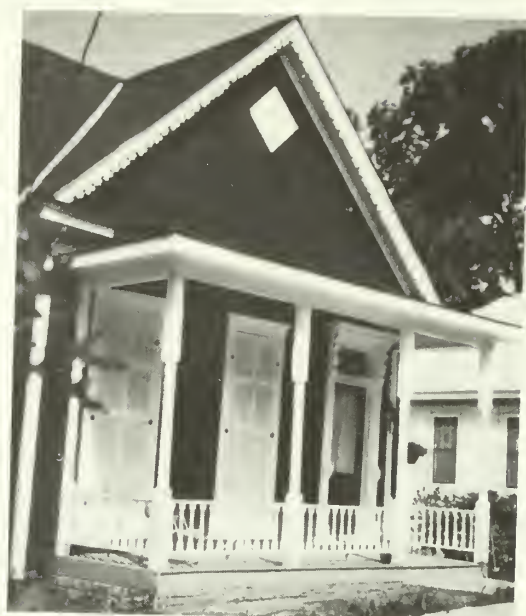
5. In the course of rehabilitation the owner elected to remove the original windows and install new ones in a historic design which extended to the first floor. Full-length blinds were also added.

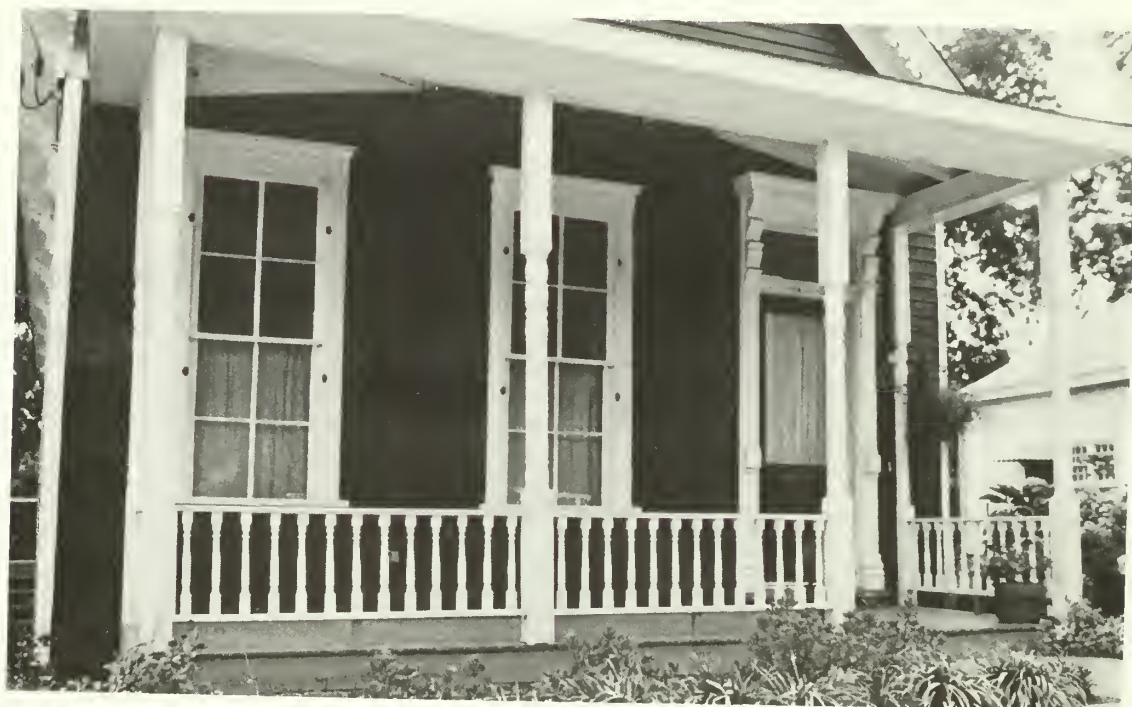
6. After the work was determined not to meet the Standards because of the window alterations, the owner proceeded to reinstall the original ones and thus obtained certification.

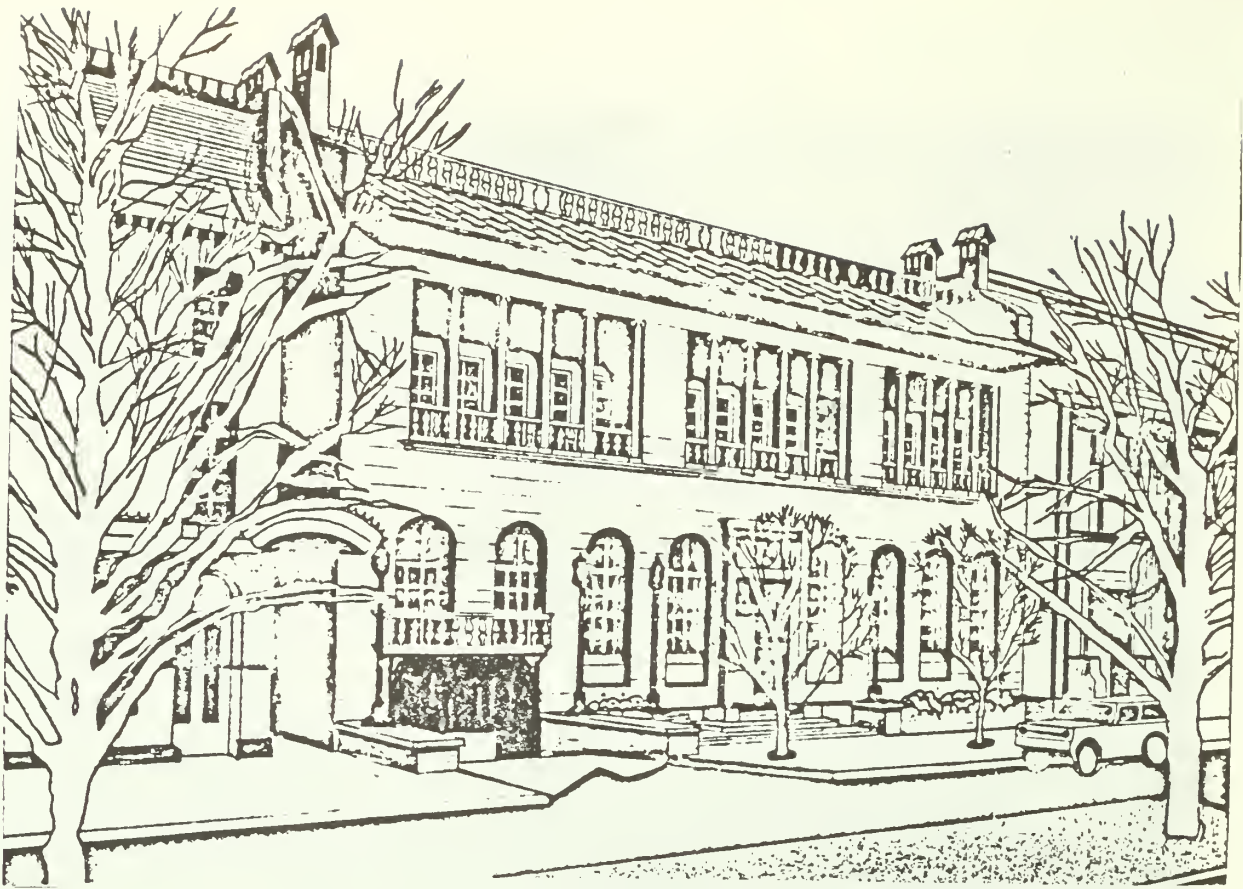
3. The original parking entrance proposed for the facade. The balustrade over the entrance was intended to serve as a visual "connector" to similar original features on the facade. The library slated for partial demolition is located behind the proposed entrance.

The introduction of the garage entrance on the principal facade alters the character of that well-detailed, Second Renaissance Revival-style facade. Not only does it result in the demolition and removal of historic material of significance, but it would also interrupt the rhythm and balance that is characteristic of this symmetrical facade (Standard 2). In addition, significant architectural features of the library--the bookcases, fireplace mantel, and decorative frieze--would be lost if the garage entrance is constructed as proposed (Standard 5). The Standards recommend a compatible use for a building that requires minimal alteration (Standard 1). Parking which requires a major opening on a principal facade cannot be considered a compatible use requiring minimal alterations. It is irreversible and destroys the form and integrity of that facade. The essential form and integrity of the structure should be unimpaired should alterations be removed in the future (Standard 10). While this office recognizes the arguments presented on the parking issue, the rehabilitation still must be consistent with the historic character of the structure and the Standards.

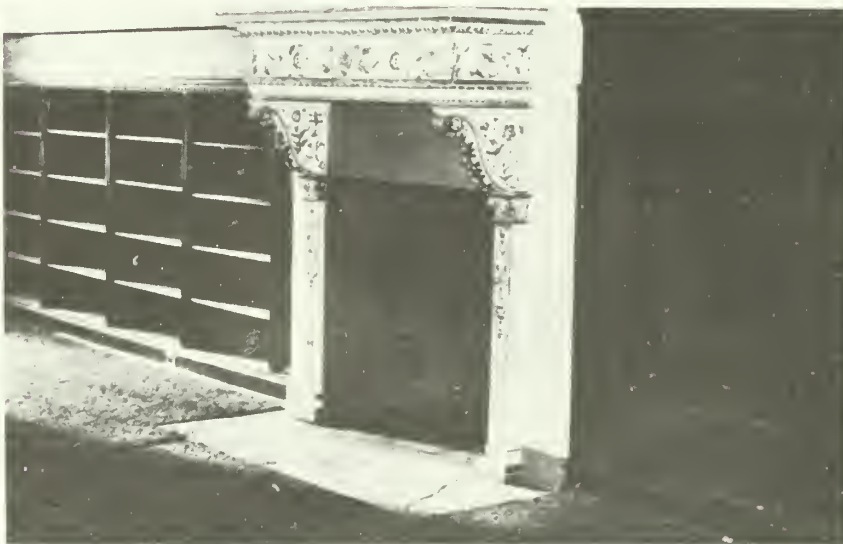
4. The parking entrance through the library would have necessitated removal of the fireplace and bookshelves.

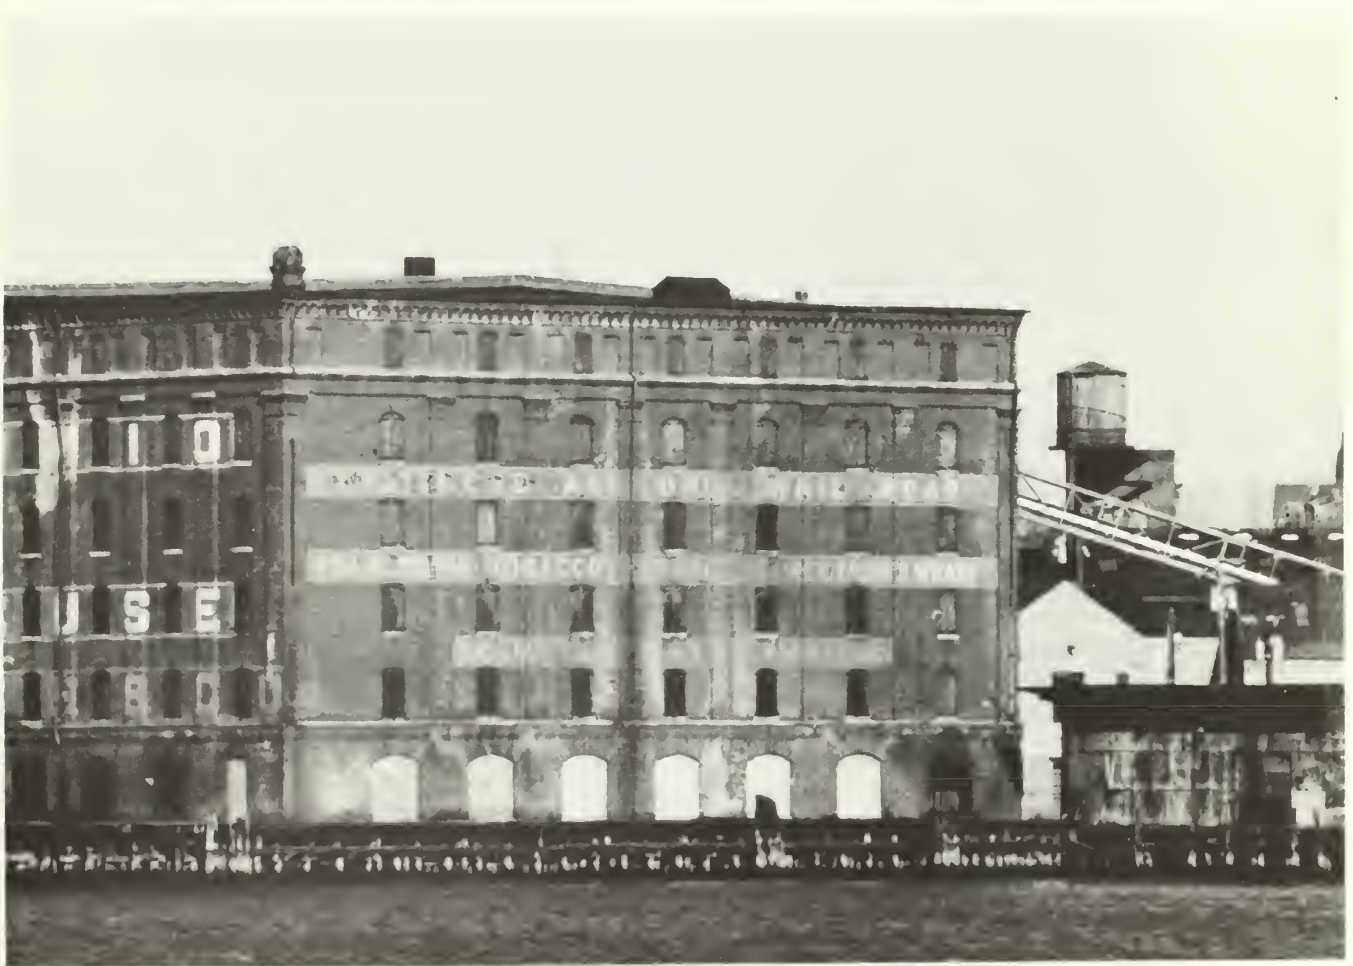
1. The existing south elevation of the 1890s warehouse building with its alternating bands of pilasters and window openings. The size of the openings decreases as the building progresses from the base to the top floor. The brickwork was quite sophisticated for a warehouse structure.

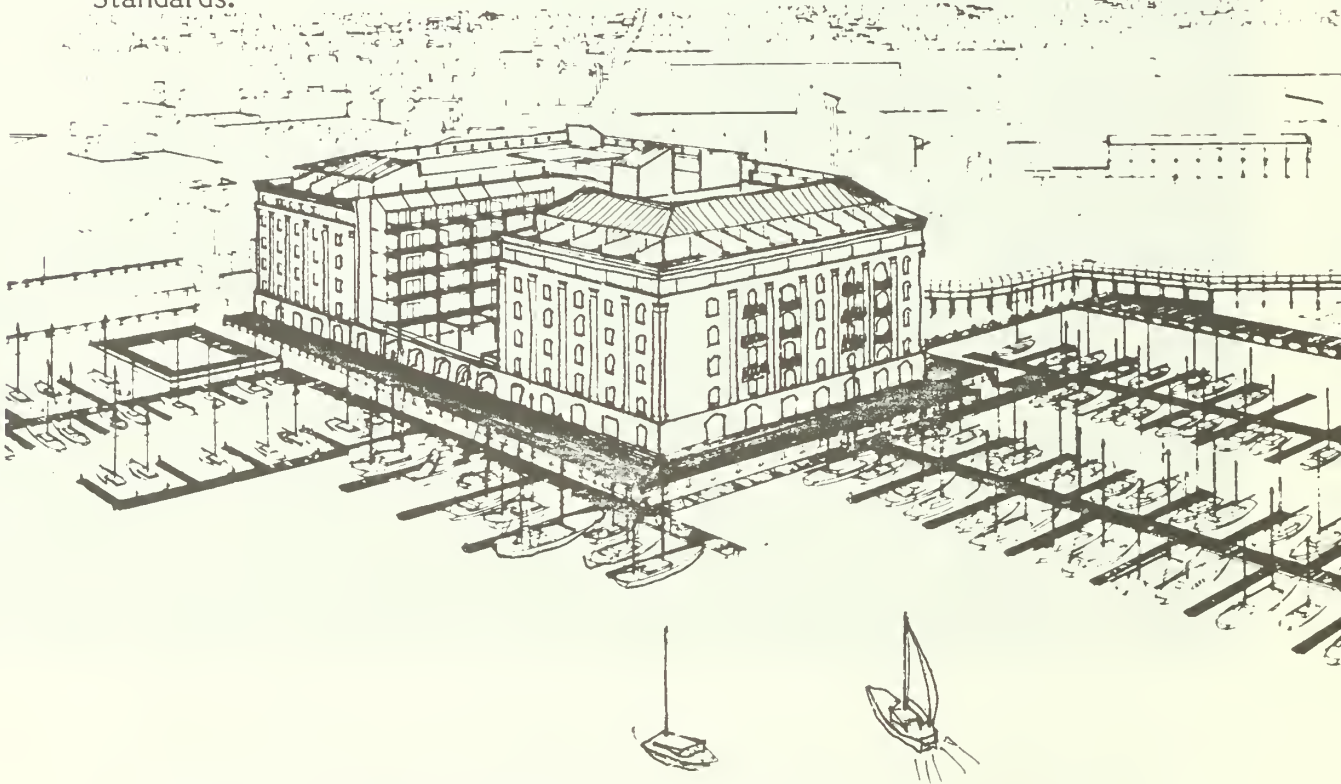
3. Perspective view of the proposed changes shows the large courtyard and the removal of seven bays of the waterfront facade in order to provide a water view for 85% of the apartment units. The hearing officer determined that the loss of significant original historic material and the drastic change in character created with the new "U" shaped plan did not meet the Standards. The projecting balconies and widened windows were also cited as not meeting the Standards. The setback rooftop addition, however, was not a concern as it would not have been visible from the street level of the historic district.

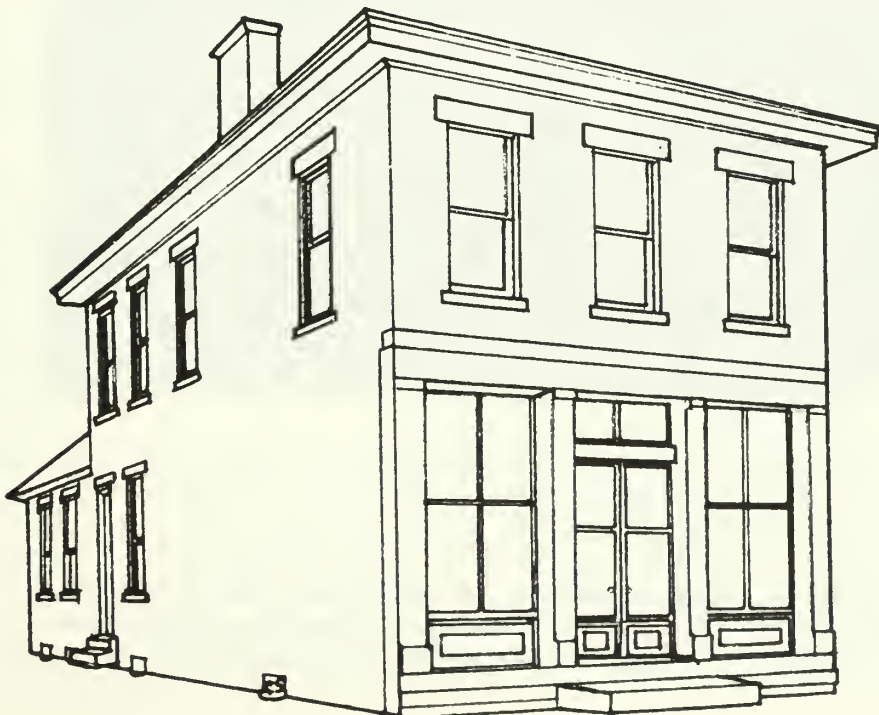
1a. and 1b. Historic photograph (1a) showing original three-bay storefront building (ca.1880-1890). With minor alterations, this storefront survived until most recent rehabilitation. Side door led to second floor apartments. Drawing (1b) shows the building's main features clearly.

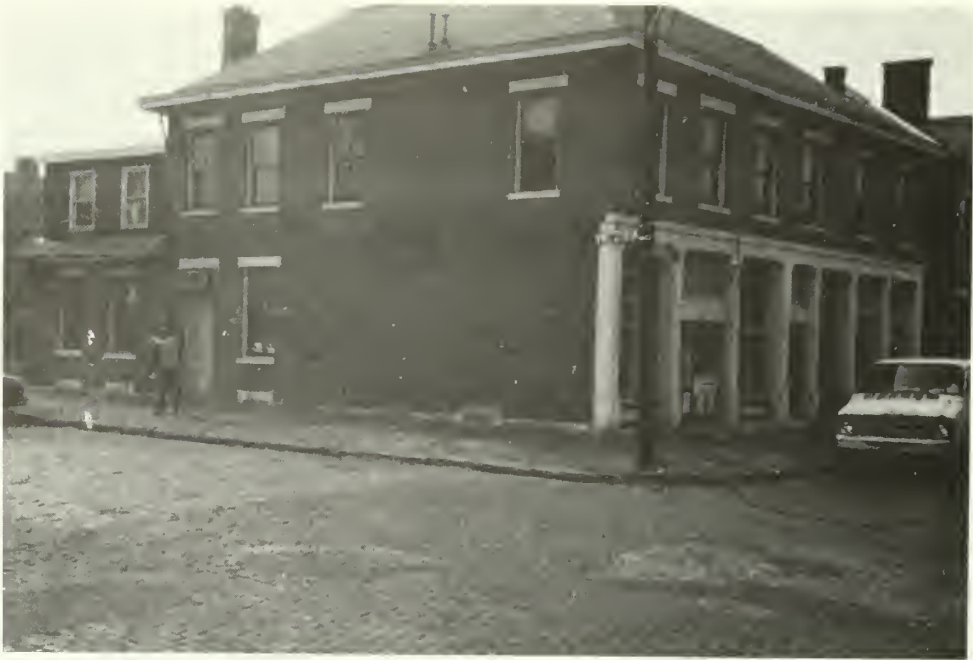
2a. and 2b. Building as it looked after ca. 1900 enlargement. Two identical storefronts (double doors flanked by window bays) were separated by a bay containing a single door.

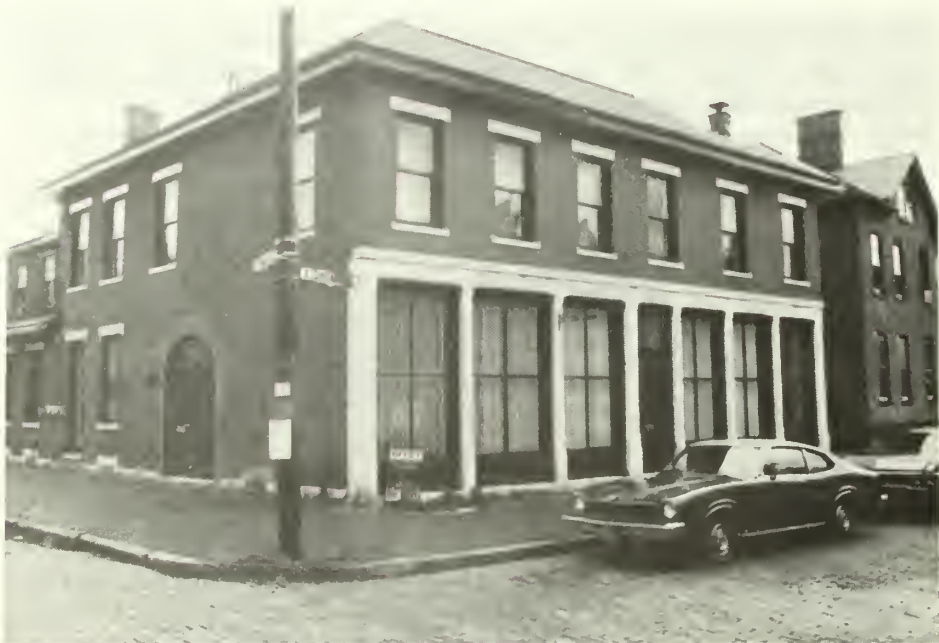
3a. and 3b. After rehabilitation. Double doors on the front have been replaced with windows, an arched side entrance has been cut, and the former side entrance has been replaced with a window.

In the most recent rehabilitation, which converted the building to office space, the owners replaced the two sets of double doors with windows copied from those existing in other bays of the storefronts. To accommodate ground floor offices, an arched entrance was added to the side elevation (see illus. 3). The design for this doorway echoed an interior doorway and an arched entrance on a neighboring building. The original side entrance was replaced with a window.

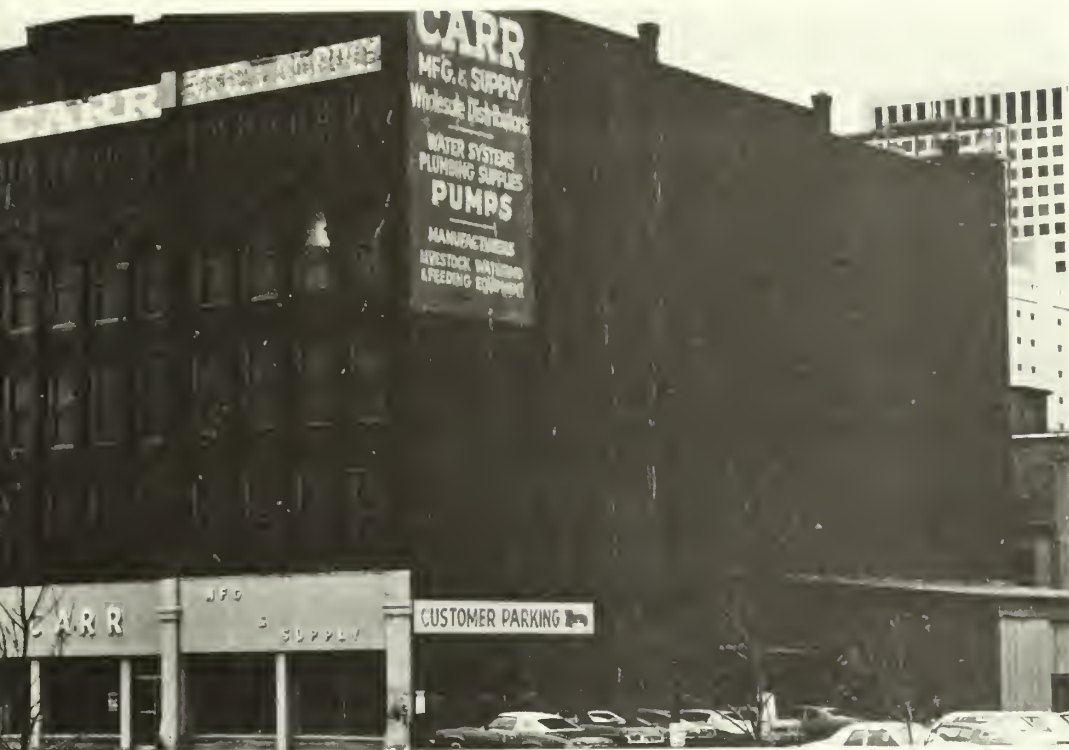
1. North and west facades of warehouse.
The 1960's storefronts are non-significant.

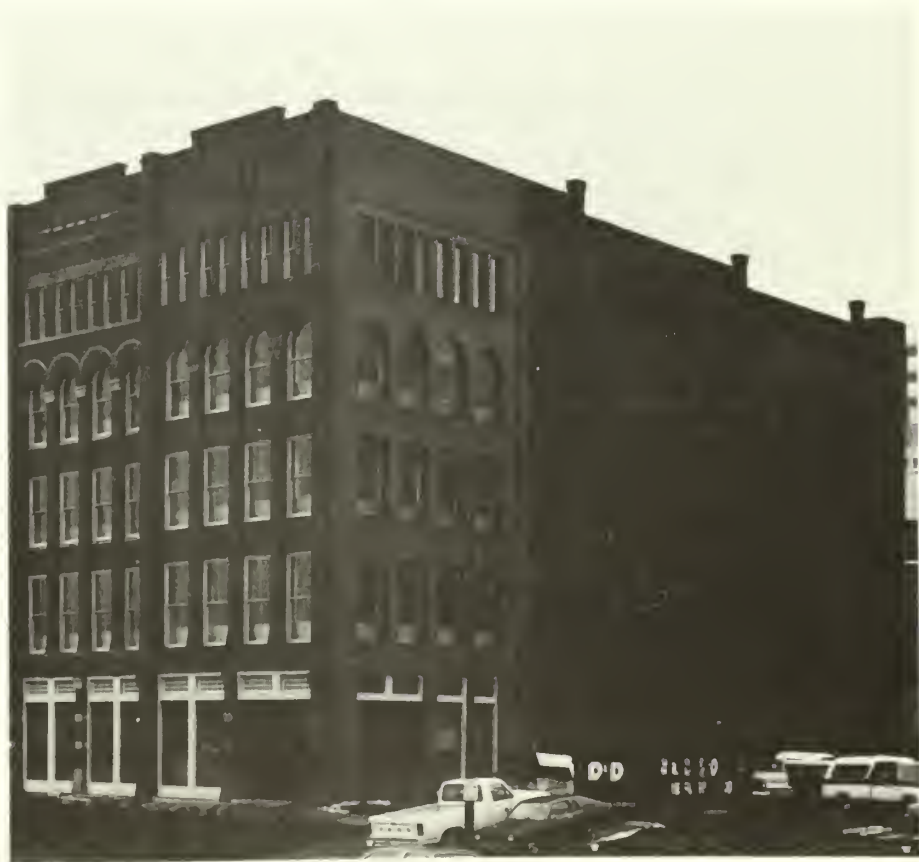
2. New windows and entrance on west facade. Certification was conditional upon owner adding a wooden column in center of westernmost storefront.

The rehabilitation, developed in close cooperation with the State, incorporates the new window openings into the rebuilt section of the west wall. The new windows are similar in size, shape, and rhythm to the windows on the primary north wall but the brickwork, sash, and glazing are clearly contemporary. The new brickwork is a slightly different color from the original and flush around the new windows rather than projecting; the sash is aluminum and a different color from the original, and the glazing is single-light. In rehabilitating the north facade, the owner carefully repaired the existing 2-over-2 wooden double-hung sash (see illus. 2).

The non-significant 1960's storefronts were removed and replacement storefronts were constructed, although the new use of the building might not include retail on the first floor. The replacement storefronts incorporate new matching brick and stone piers and new wooden windows and multi-light transoms. The newly constructed west wall also incorporates two "storefront bays" but uses a less decorative brick pier and plain transoms in order to continue the differentiation between the historic north facade and the contemporary section of the west wall. The entrance was moved from its 1960's location in the center of the north facade to the northwest corner of the building. Access is through open storefront bays from both the north and west which create a recessed entrance at the corner of the building (see illus. 2).

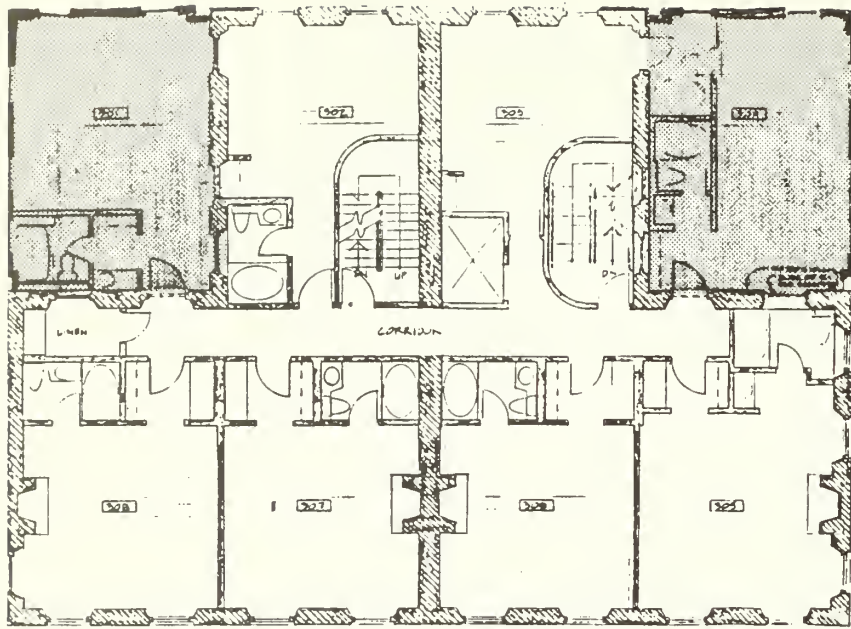
Illustration #3. TYPICAL FLOOR PLAN. The proposed infill plan (shaded) would respect the historic materials by leaving the original rear walls exposed within the new addition. The existing window and door openings would be left in place, as much as possible. In addition, recessed panels would be used as a connector infill between the original building and the additions in order to clearly differentiate the new construction from the historic structure.

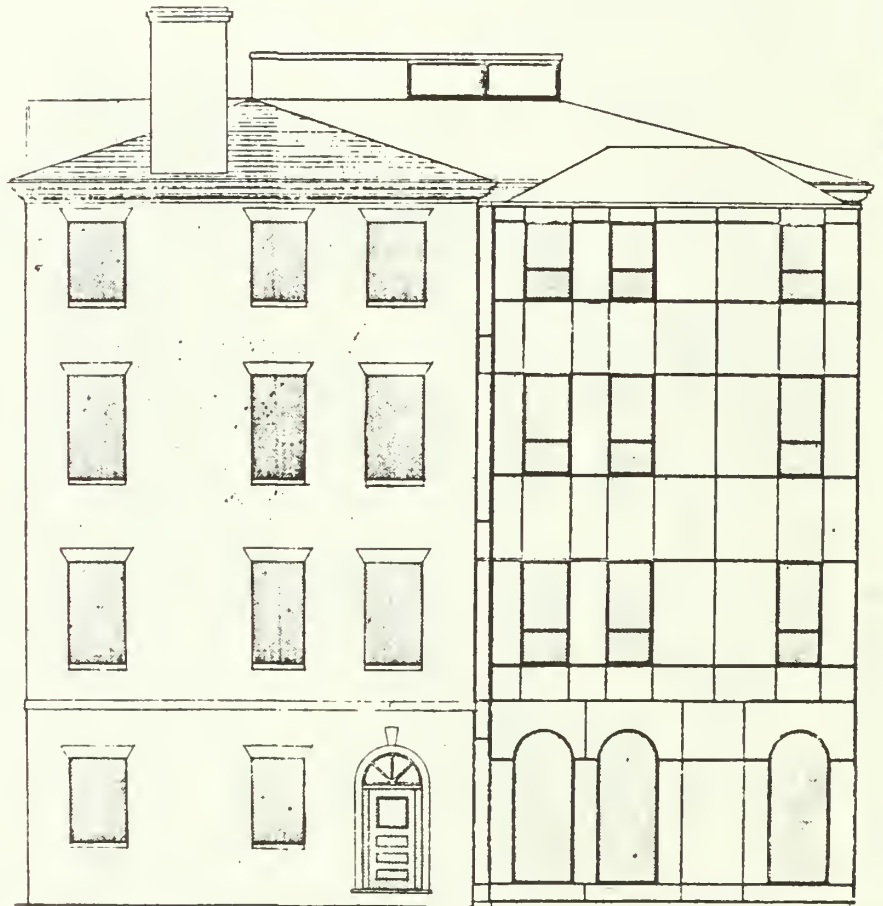
Illustration #4. ELEVATION

The new 4 story addition visible from the street would be compatible in scale and proportion with the historic structure. The pattern of window and door openings in the new addition would reflect the rhythm in the historic facade. The use of a modern panel system, as opposed to detailed brickwork, would clearly separate the new construction from the historic resource. The use of a separate hipped roof for the addition would retain the scale of the property and would eliminate damage to the historic roof and cornice.

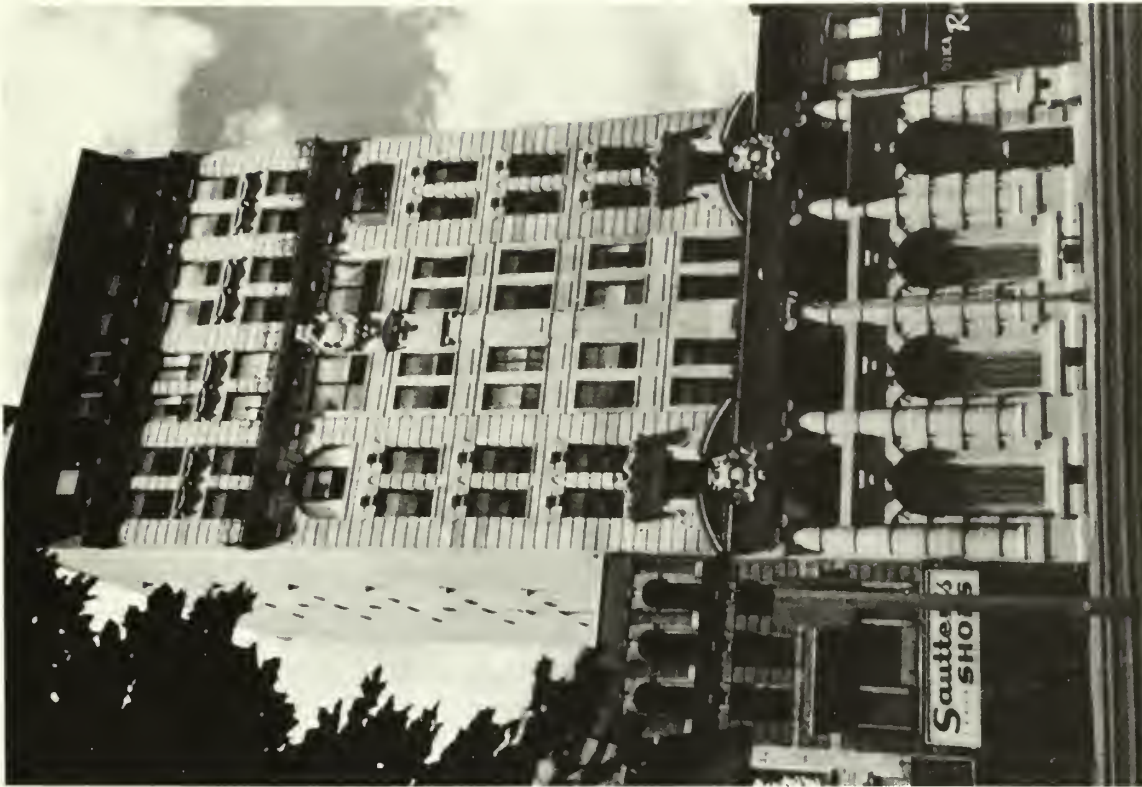
AFTER

Replacement sash now feature a lower meeting rail. The side lights in the arched windows were also replaced with fixed single pane glazing. The top floor is in a shadow; it was not altered by the project work.

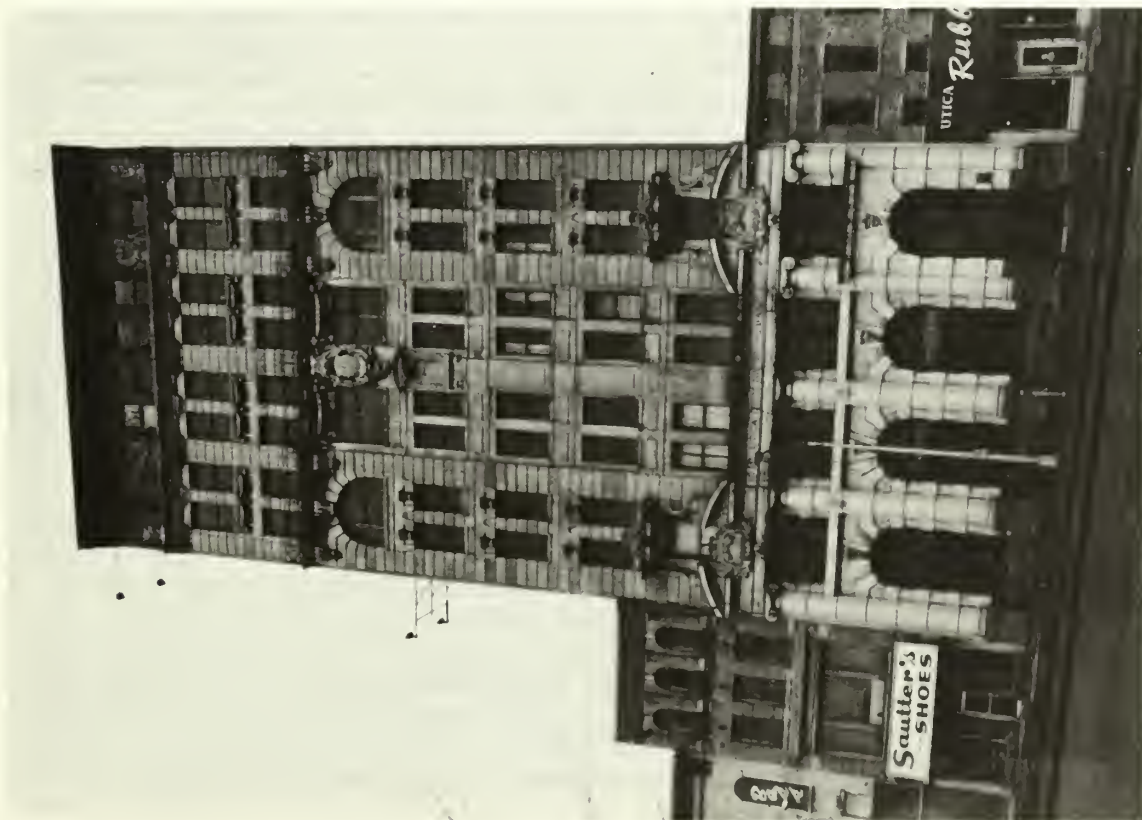
BEFORE

Original double hung window sash featured a mid-level, horizontal meeting rail.
