Technical Preservation Services
Preservation Assistance Division
National Park Service
U.S. Department of the Interior
Washington, D.C.

Interpreting
the Secretary of the Interior's
Standards for Rehabilitation

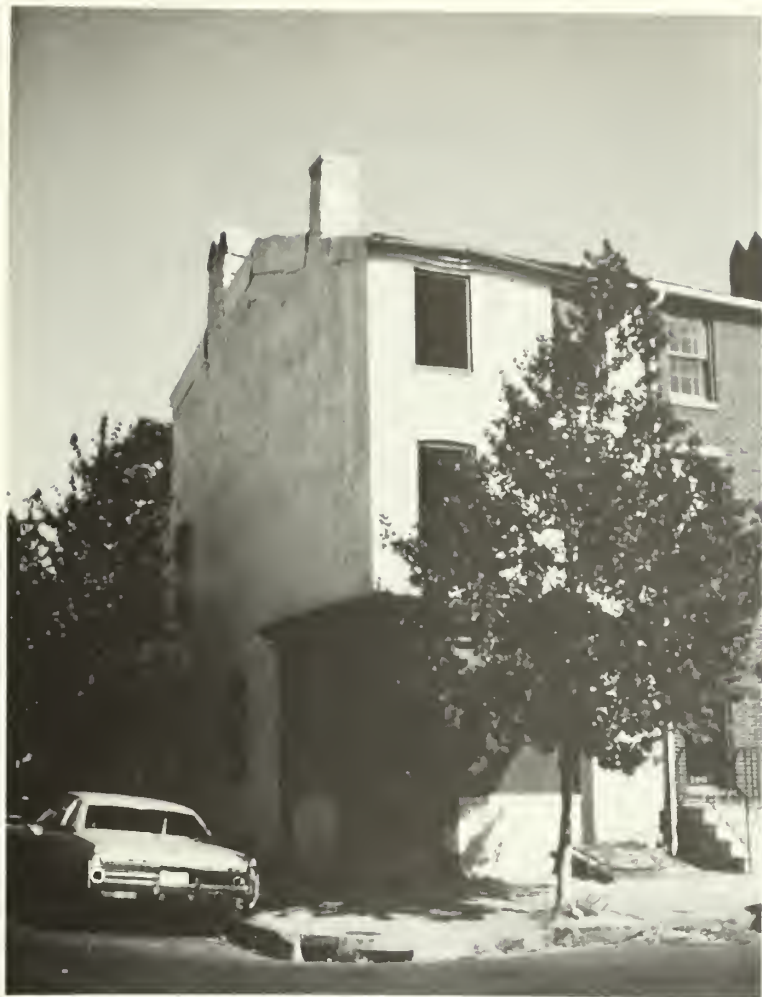
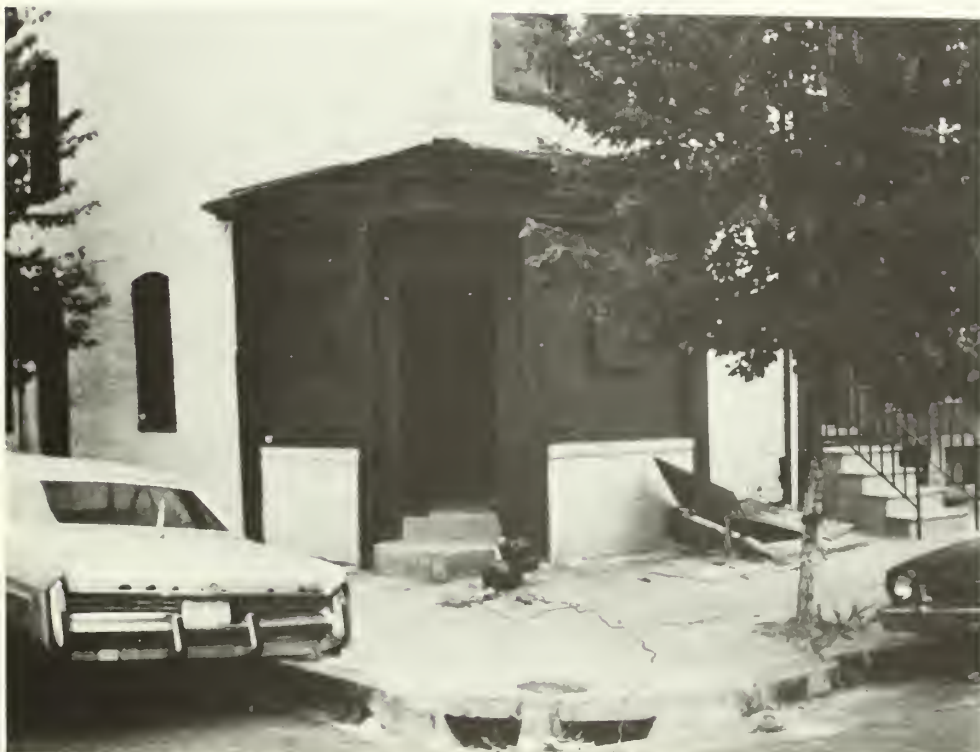
1. and 2. Before rehabilitation. The corner grocery store had its original diagonal entrance and flanking plate glass windows. Although the storefront remained intact, the base had been filled with brick and the plate glass boarded over.

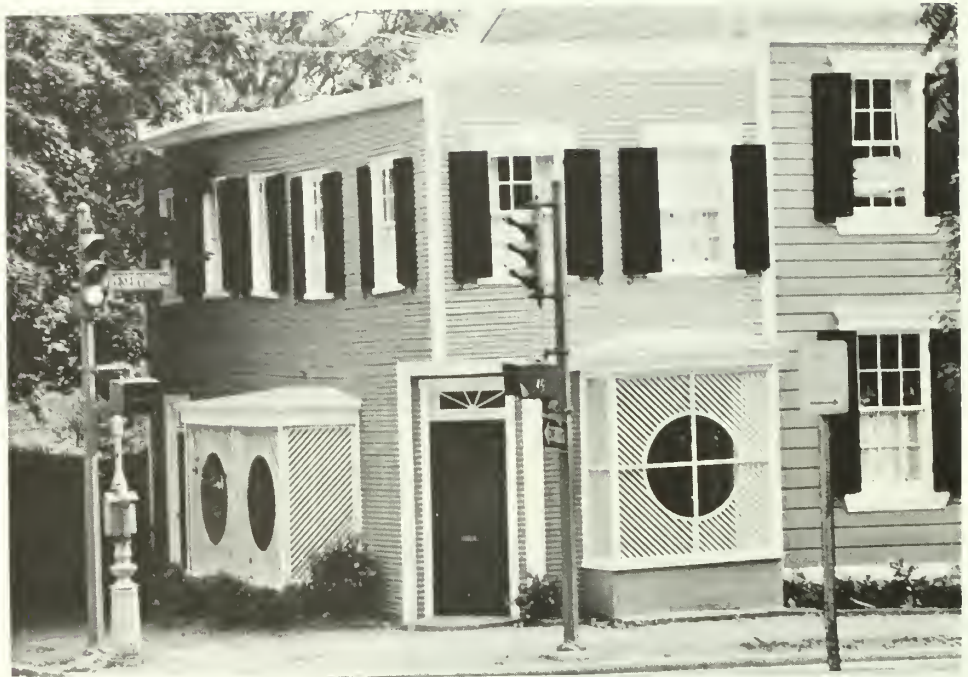
7. Wood lattice installed inside the display windows increases privacy from the street without sacrificing the commercial character of the building.

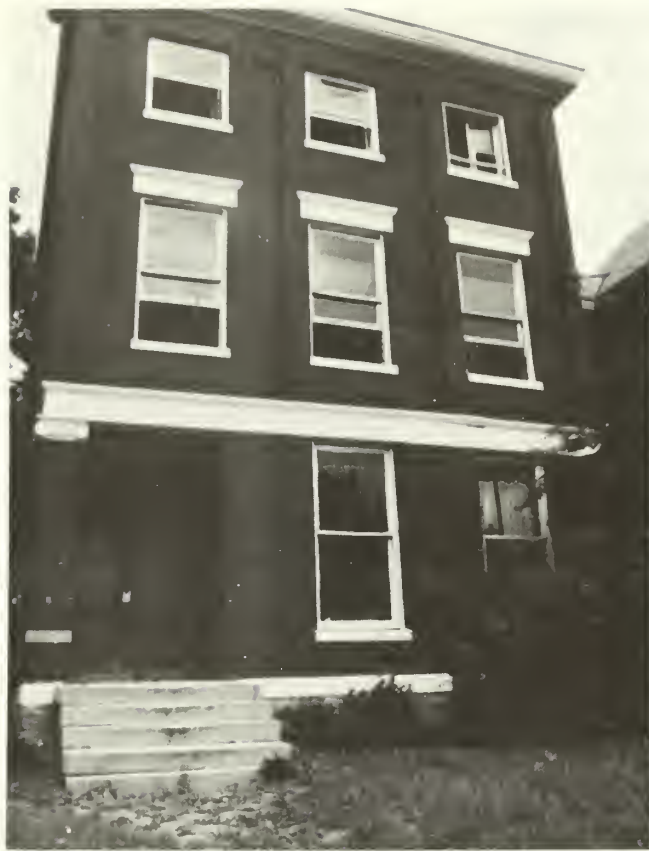
1. The townhouse, with its simple detailing, pictured before rehabilitation. The owner's proposal for exterior work was considered to be in conformance with the Secretary's Standards.

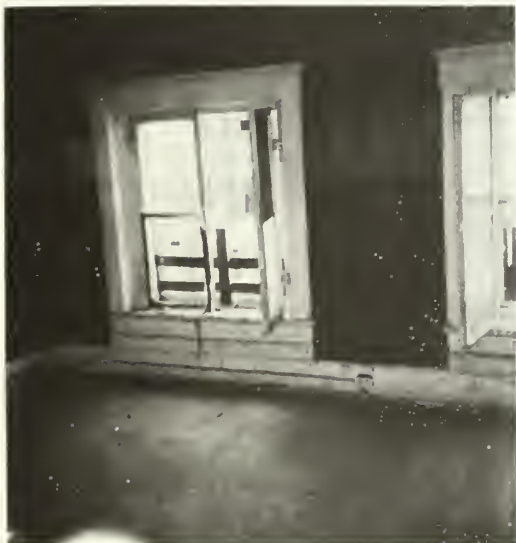
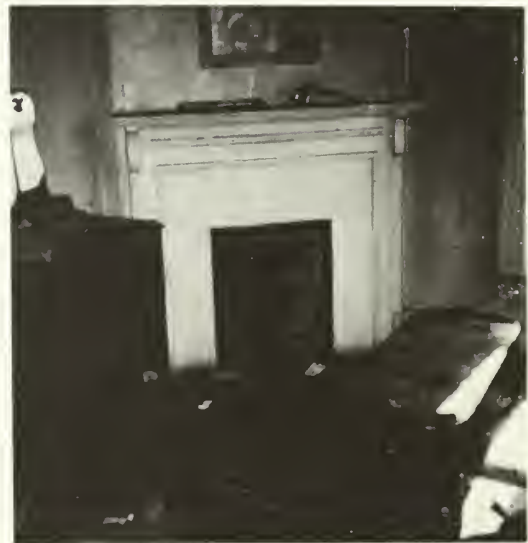
2. Modest interior detailing, such as window and baseboard trim, and diagonally placed mantels contribute to the historic character of the 1894 townhouse and thus should have been preserved to the greatest extent possible.

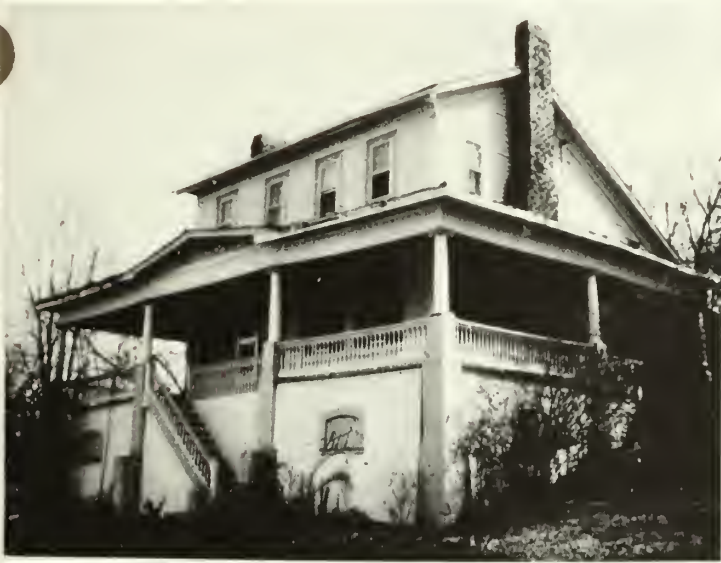
5. An 1830 structure with its large 1910 wrap-around porch characterized by columns resting on brick piers, highly decorative central pediment and turned balusters. The porch was in a deteriorated, but still repairable, condition prior to rehabilitation work.

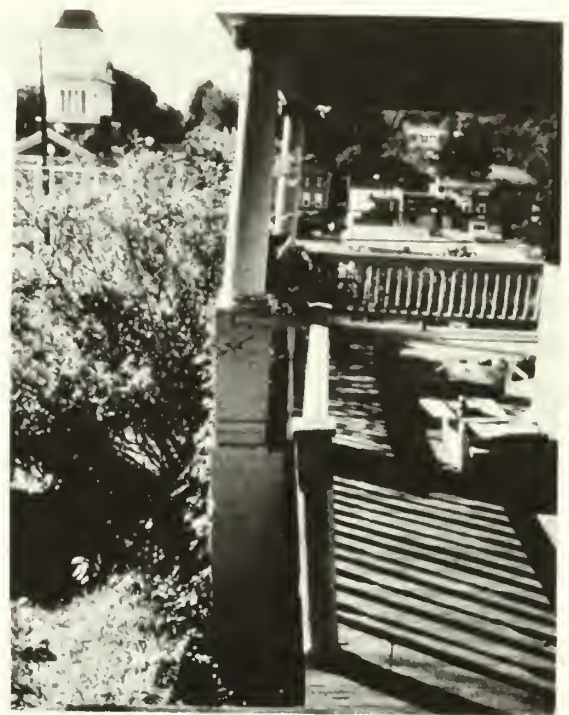
6. A detail of the 1910 porch shows structural problems that need to be corrected. The owner assessed the 1910 front porch as unreparable, which led to its removal.

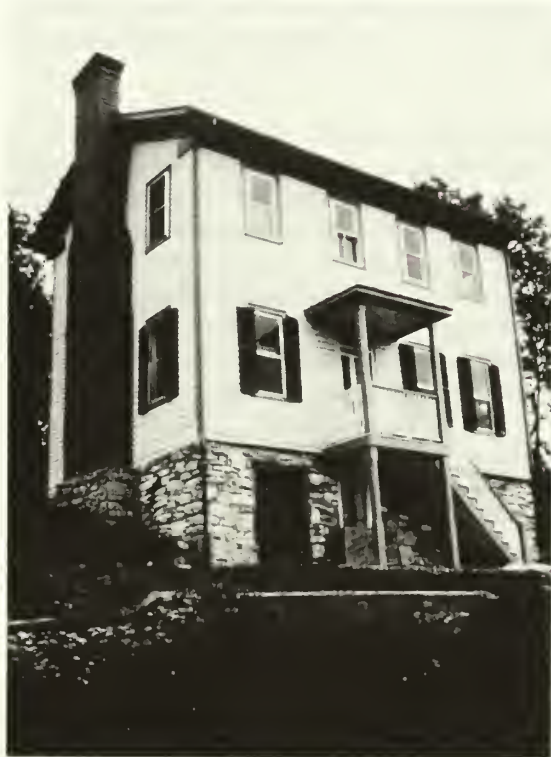
7. The replacement front porch--conjectural in design--was constructed after demolition of the historic porch. NPS concluded that because the 1910 porch was an important character-defining feature and was repairable, it should have been retained. The project was denied certification of rehabilitation for tax benefits.

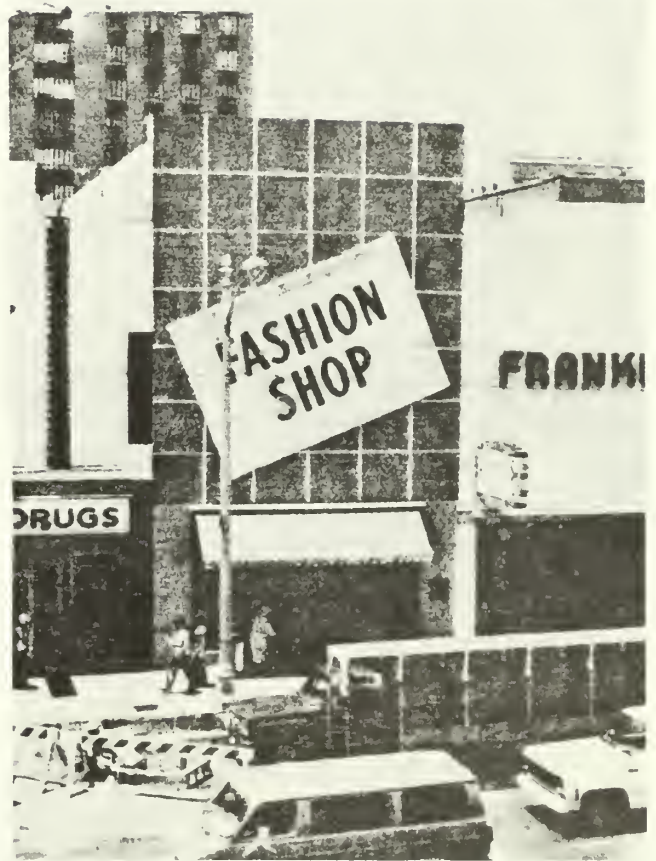
2. A 1967 storefront alteration involved installation of a stucco false front on the upper levels; stone at the ground level had been removed as the result of the installation of an aluminum and glass entry in the 1950s.

Application: A ca. 1870 stone Gothic Revival structure (see illus. 1) was being rehabilitated for re-use as an office building. A 1967 "modernization" of the building's facade for retail use had involved installation of a stucco false front on the upper level of the building. When the false front was subsequently removed as part of the new work, the owner found that the castellated stone at the top of the building had been removed; the historic decorative bands had been chipped away to permit installation of the stucco work; the window sills and jambs were damaged; and several holes had been bored into the stone to anchor the false front. Stone on the ground level of the building had been removed as the result of a 1950s installation of an aluminum and glass entry and merchandise and display area (see illus. 2 and 3).

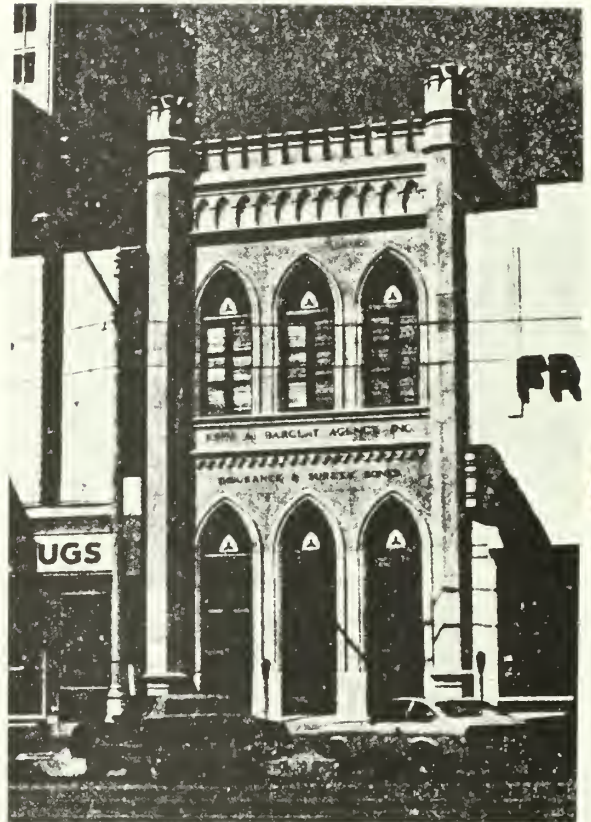
4. This photograph shows a totally reconstructed facade using all new material. NPS recommended denial of the project for tax benefits because it was determined that the damaged upper level could have been repaired. An unacceptable loss of historic material on a significant facade was specifically mentioned in the denial letter.

Based on his evaluation of the overall damages to the stone as a result of the combined alterations, the owner concluded that the entire facade was essentially beyond repair and that partial replacement of the historic material would not be possible without leaving a splotchy, uneven facade--an appearance he felt was unacceptable. The report specifically cited the unavailability of matching limestone, potential structural consequences of replacing only the damaged stone, and the high cost of repair over replacement. As a result of this assessment, the owners elected to demolish both damaged and intact historic limestone from the primary facade by cutting it back to a depth of 5 inches, then re-build the facade with an all new stone veneer in order to achieve an even, uniform appearance (see illus. 4).

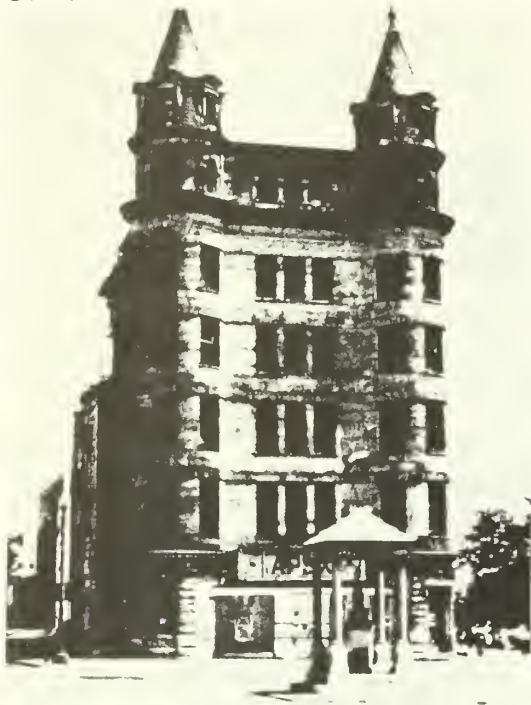
1. This photograph of the west elevation shows the 1880 addition of flush ashlar brownstone above the rough-cut brownstone of the first floor. Because the historic brownstone on this wall was basically sound, only repainting was required.

Application: An 1860s rusticated ashlar brownstone commercial building, altered in 1880 with the addition of a flush ashlar brownstone facade on the west, was purchased for rehabilitation for office use (see illus. 1). The building had been derelict and vandalized for several years—in addition to the total lack of maintenance—and, as a result, was severely damaged and deteriorated. Within the three exterior walls (south, west, and north), which consist of 14-inch thick loadbearing masonry of two wythes of brick faced with brownstone, the mortar was failing between the brick and the stone. The brownstone was spalling on both the north and south walls, with the condition much worse on the north (see illus. 2 and 3). The building had been painted in the past, possibly in an effort to stop water penetration. On the interior, the majority of the distinguishing architectural detailing had been removed as a result of deterioration,

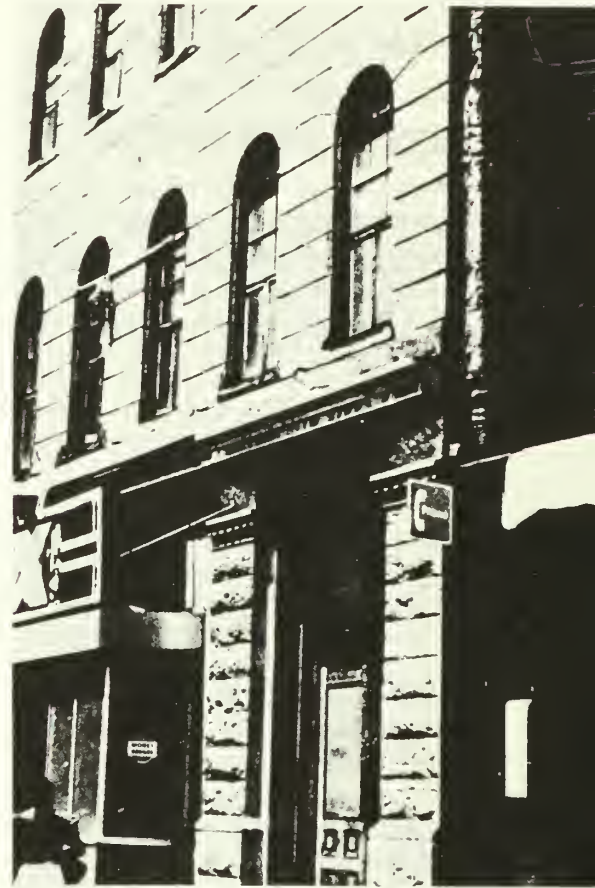
2. The brownstone of the south wall was not as deteriorated and could be retained in place and structurally strengthened by stainless steel pins tying cementitious patches to the sound stone beneath. Limiting the patching to the beveled edges of the stone blocks where the greatest amount of deterioration had occurred was considered a sensitive preservation solution because it left the historic material both intact and visible.

Subsequently, two structural engineers sought ways to preserve more of the historic material. It was confirmed that the north and south walls were out-of-plumb. To ascertain the reason for the apparent structural problems, more holes were bored so that the condition of the walls could be thoroughly investigated. The findings were that the north wall had lost its loadbearing capacity because of the advanced deterioration of the stone, brick, and iron anchors; however, the engineers' solution was to rebuild the wall only from the second floor up rather than the entire wall as initially proposed. Since the materials were not salvageable, the replacement wall would be all new materials. Cast-stone over concrete block was selected as a compatible substitute material with the facing cast-stone to simulate the historic brownstone. The re-evaluation of the structural and preservation problems of the building led to the conclusion by the architect and engineer that the south wall could be retained in place with the use of stainless-steel pins tying cementitious patches to the sound brownstone beneath. The bulk of the patching would be at the beveled edges of the ashlar blocks where the worst erosion had occurred, leaving the majority of the historic material intact and visible.

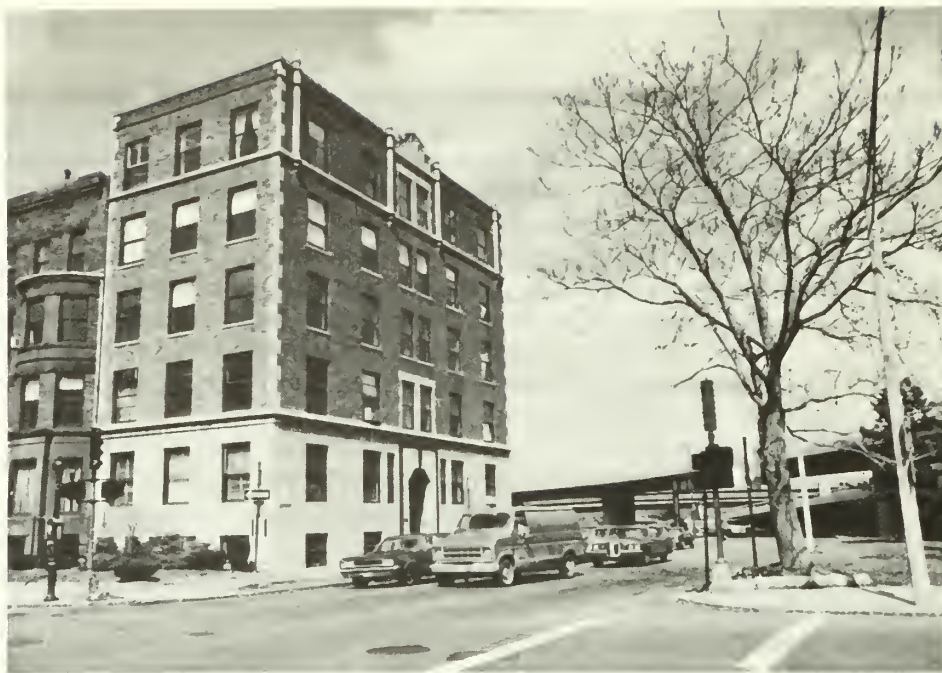
1. This 20th century building served as an anchor at the end of the small historic district and had three highly visible facades. Note how the location, design, and even the color of the wooden sash and frames matched that of the adjacent older properties.

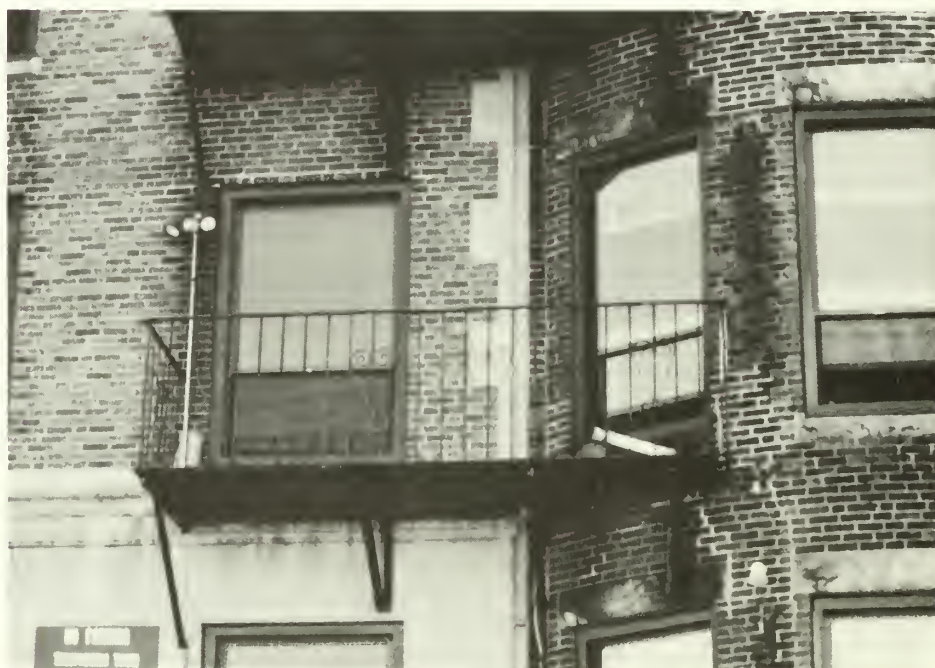
2. This is a close-up view of the contemporary window units which were installed. They had flat framing detail, bronze-anodized finish, tinted glass, and a lowered meeting rail.

Because the windows were determined by the owner to be unrepairable, they were removed and replacement units were selected and installed. The replacement windows had flat frames devoid of molding detail, a bronze-anodized finish, and a fixed upper and operable lower sash. Further, the location of the meeting rail was lowered--for ease of operation of the large sash--so that the lower sash was only 1/3 rather than 1/2 the size of the historic window (see illus. 2). The owner also chose tinted glass which she felt was justified in order to lessen the visual impact of an adjacent elevated highway.

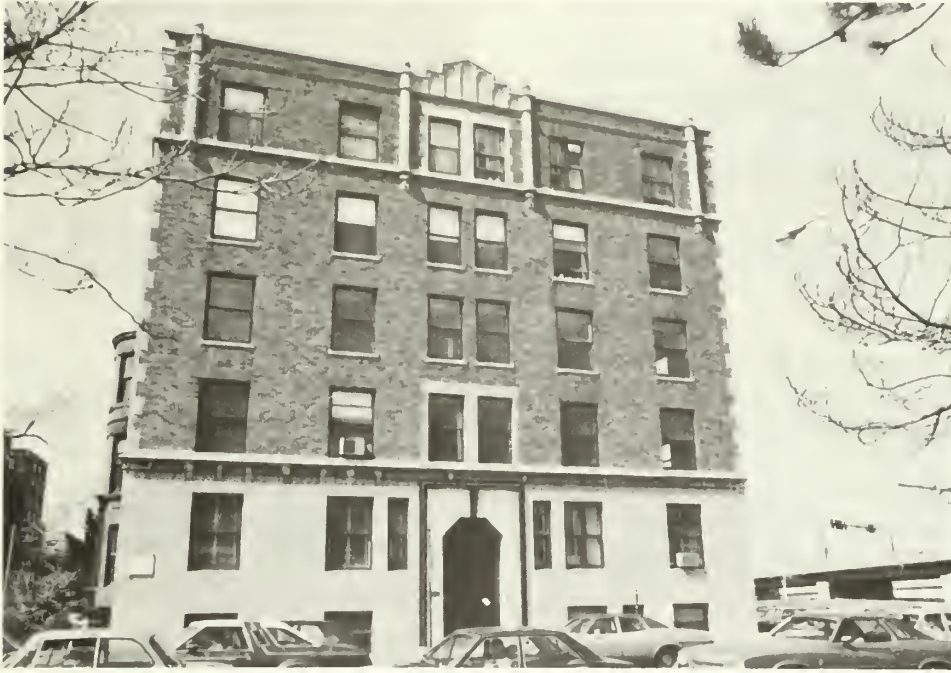
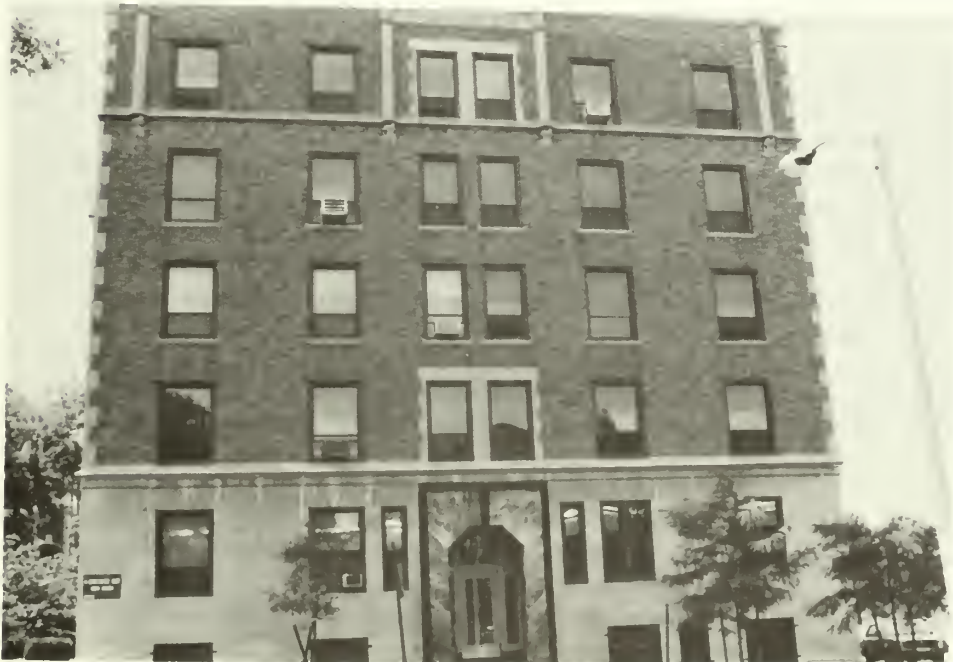
3. Below is a comparison view of "before" and "after" rehabilitation which shows the impact of the window changes. While relocation of the meeting rail was the most pronounced alteration, the tinted glass, lack of trim around the frames, increased width of the anodized aluminum frames, and loss of other detail were cited in denial of the project for preservation tax benefits.

...The historic windows, with clear planes in a 1/1 configuration contributed to the restrained character of the building. "Before" photographs show all of the 1/1 windows in place, and no documentation was provided with the Part 2 application to show that the existing units could not have been repaired and retained. Had replacement proven necessary, the appropriate treatment would have been to use new units which matched the configuration, color, and other visual qualities of the historic windows. Instead, the replacement windows selected employ a lowered meeting rail (in a 2/3 to 1/3 configuration) and tinted glass. As a result, the replacement windows are incompatible with and detract from the historic character (see illus. 3).

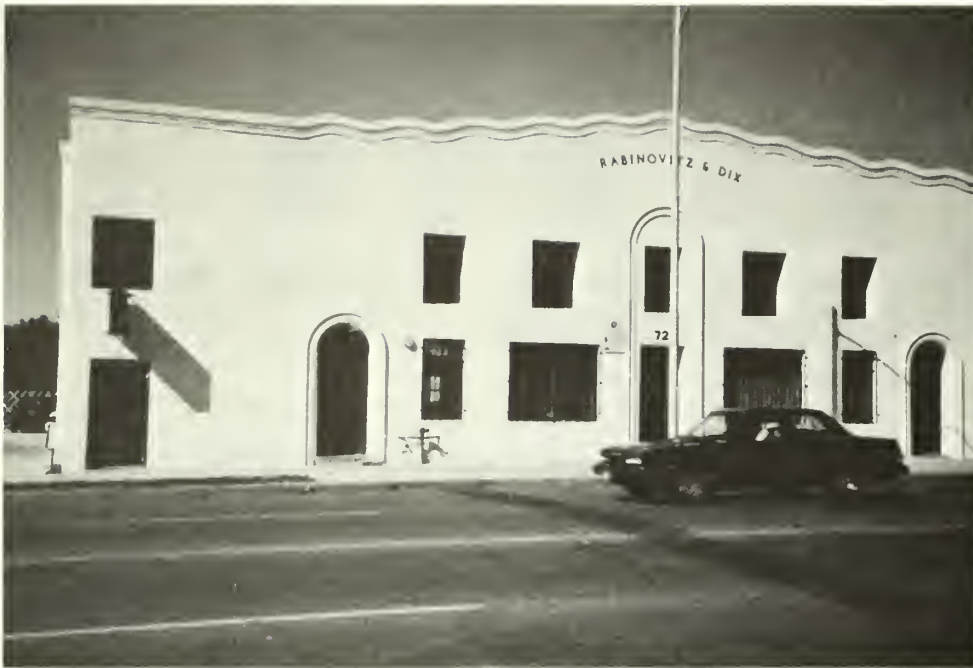
2. This view of the southeast corner of the primary elevation shows the new addition that enclosed an existing stair. The addition extends from the termination of the historic building, which is defined by the waved parapet cap.

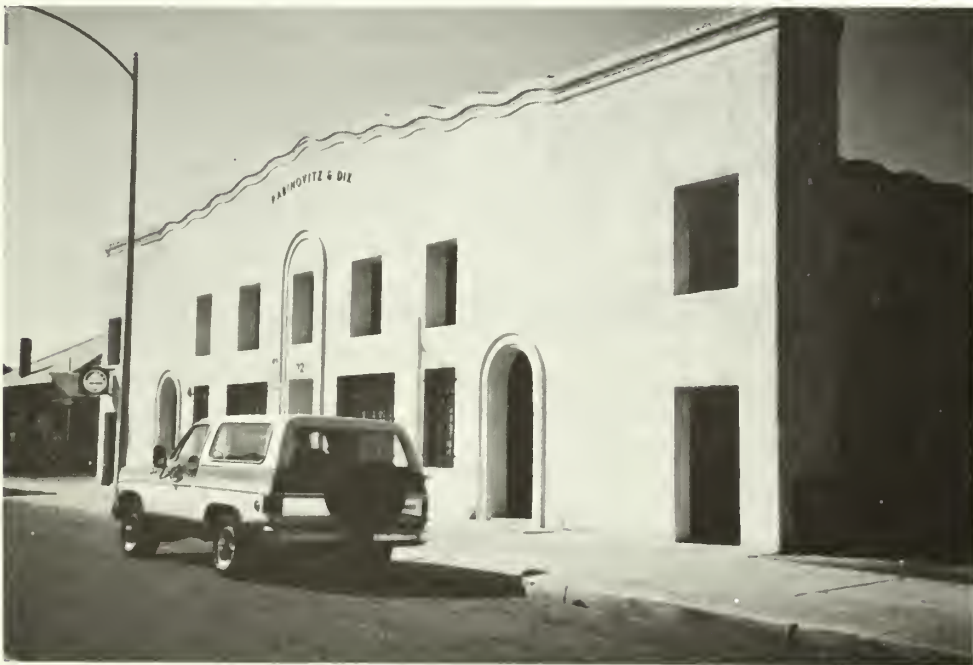
3. This view of the northeast corner of the primary elevation shows the added wing wall that was built to visually balance the new addition on the southeast corner. Again, the addition extends from the end of the historic building, as defined by the waved parapet cap. Both additions increased the total length of the historic building by one-third and made indistinguishable what was historic and what was new construction.

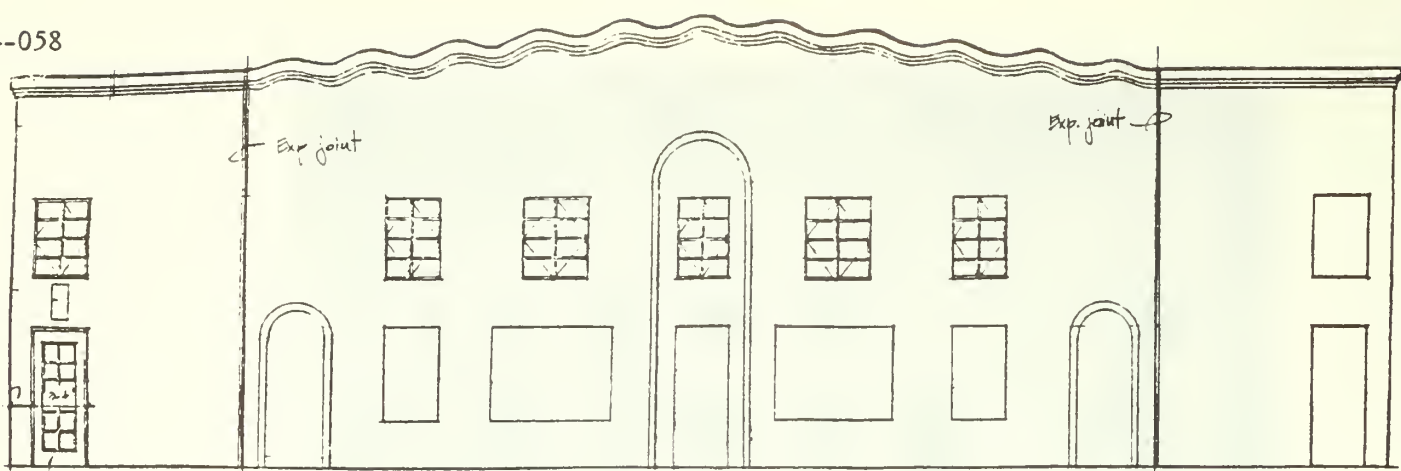
4. Scheme "A" was proposed by the developer to make the project meet the Standards. This change in the design would simply have provided expansion joints to show the difference between the historic building and the new additions. The proposal was rejected.

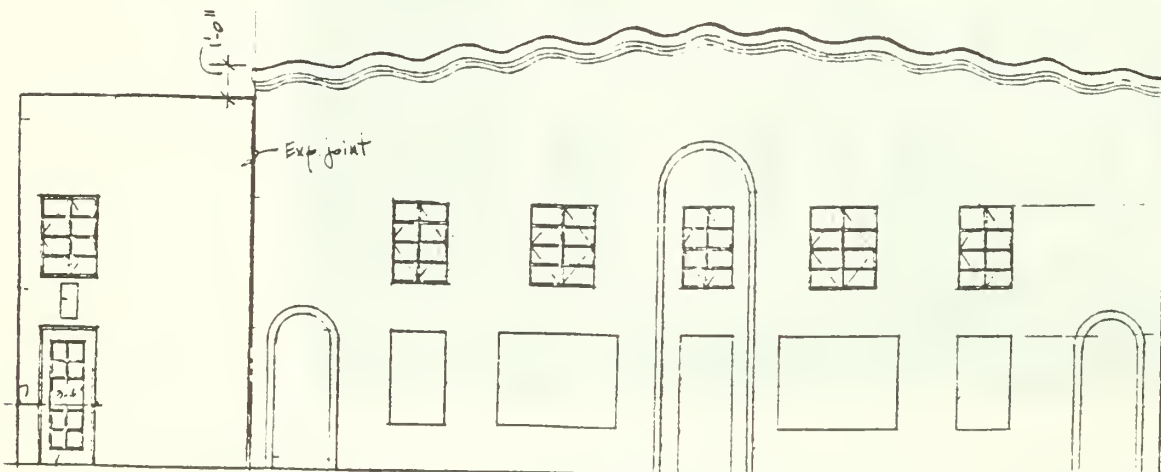
6. Scheme "C" represents those changes to the design that would have to be made to bring the project into conformance with the Standards. The Chief Appeals Officer specifically listed as requirements for certification a widened expansion joint; demolition of the northeast corner wing wall; lowering the parapet on the stair tower; and further distinguishing the new addition from the historic facade by use of a different paint color.

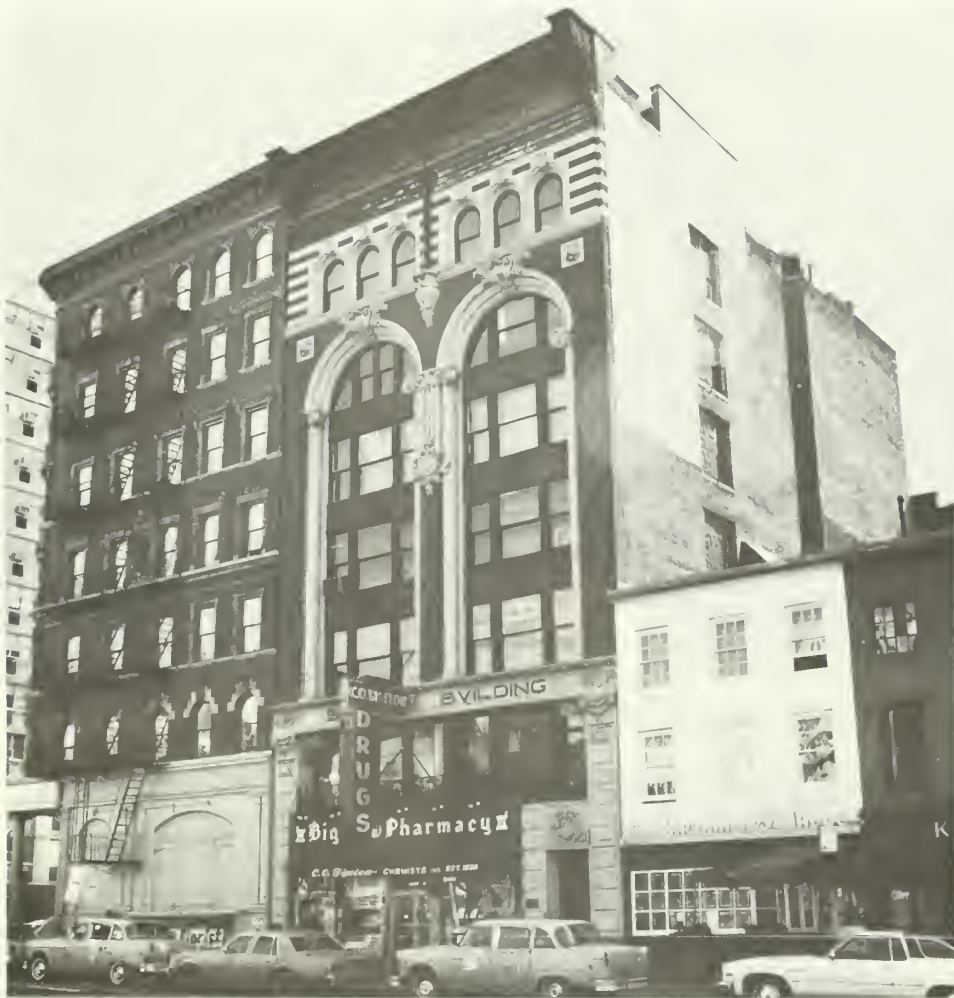
1. Rehabilitation project work on an early 20th century building focused upon meeting health and safety code requirements for the new use.

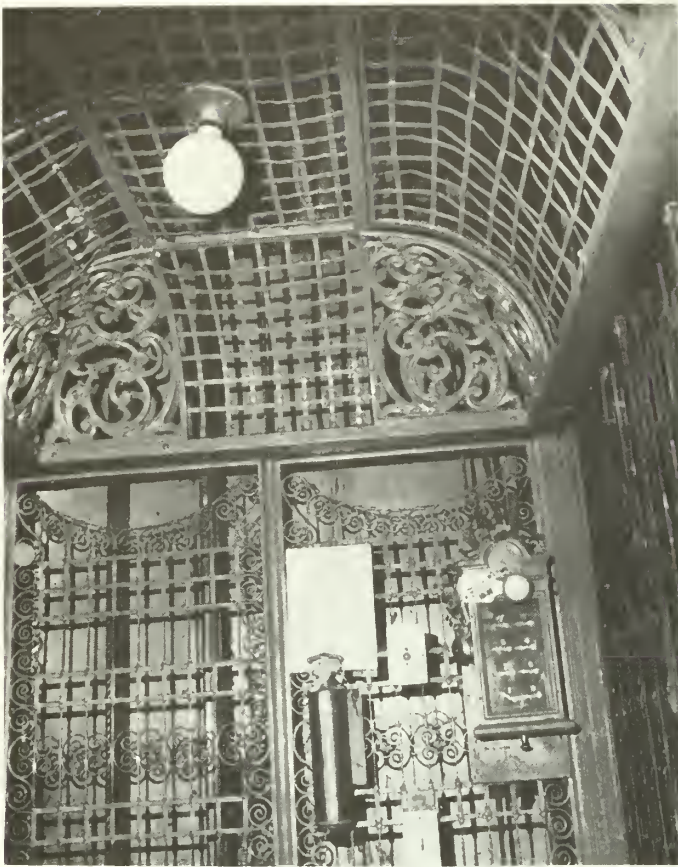
2. This shows a detail of the open dome, manually-operated elevator with its highly decorative iron grill work. Because an enclosed cab was required by State law, the historic elevator was found to be in violation of ANSI building code standards. The consulting engineer thus recommended its removal and replacement with a modern elevator.

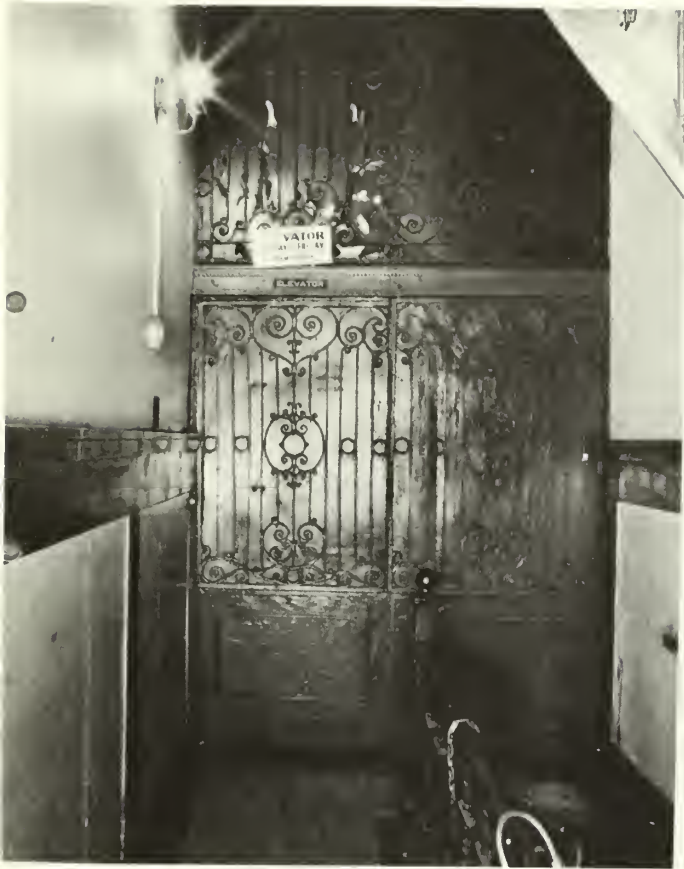
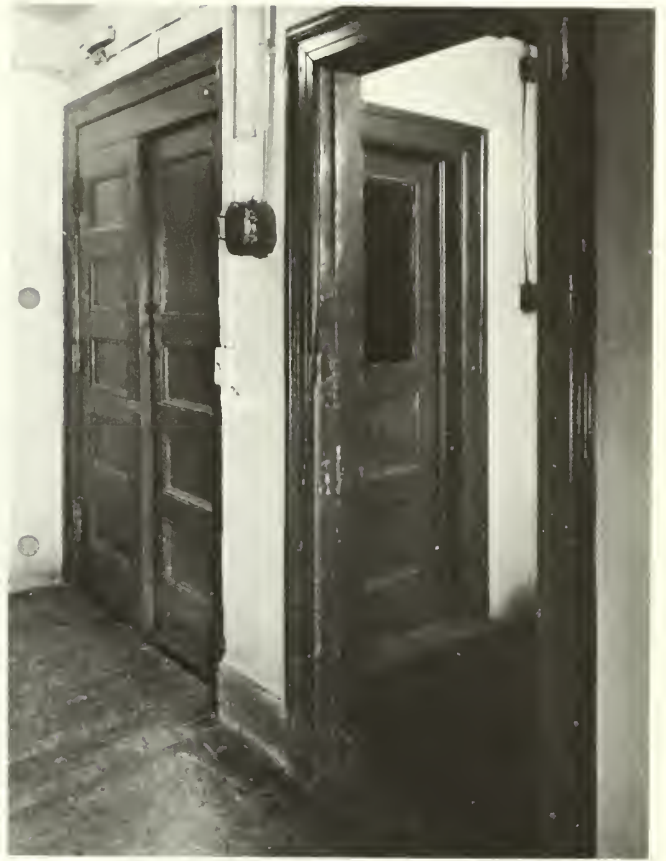
4 and 5. The decoratively detailed elevator doors in the lobby (left) were to be removed as part of the code-required elevator replacement as well as the simpler, panelled doors on floors 3-7 on the west side (right).

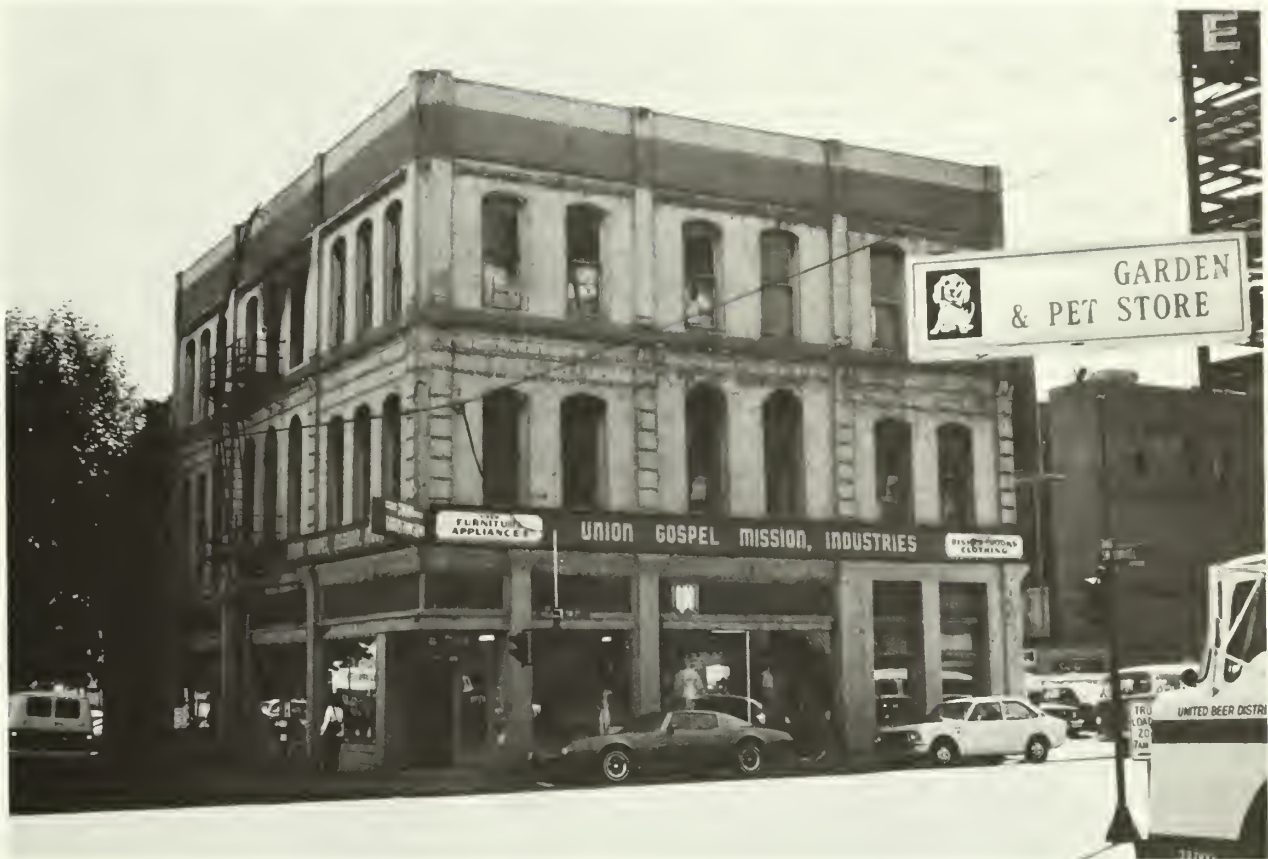
1. The building prior to rehabilitation was a three-story structure prominently located on a corner site in a National Register district noted for late 19th century commercial structures. Originally built in 1884 as a two-story brick building, a third floor was added in 1890, the building was stuccoed and an elaborate projecting cornice was applied. The cornice was lost in the mid-twentieth century and the building suffered a serious fire on the third floor prior to the rehabilitation.

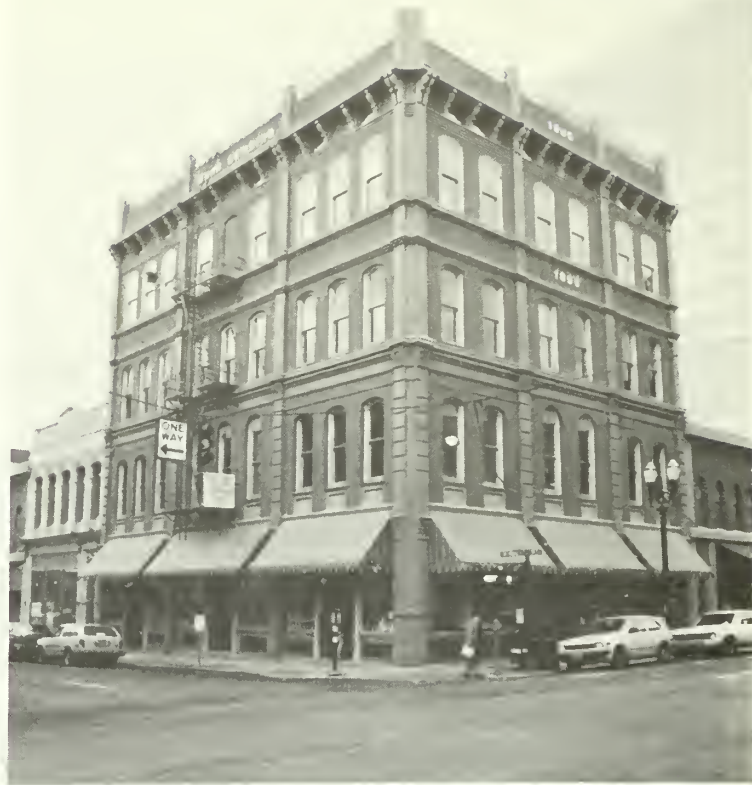
2. The historic building received a one and a half story addition to accommodate eight loft bedroom apartments over the retail and office space. Note the change in scale and the dramatic vertical emphasis as a result of the new rooftop addition. As the overall mass, scale and proportional relationships of the building were significantly altered, the project was denied certification.

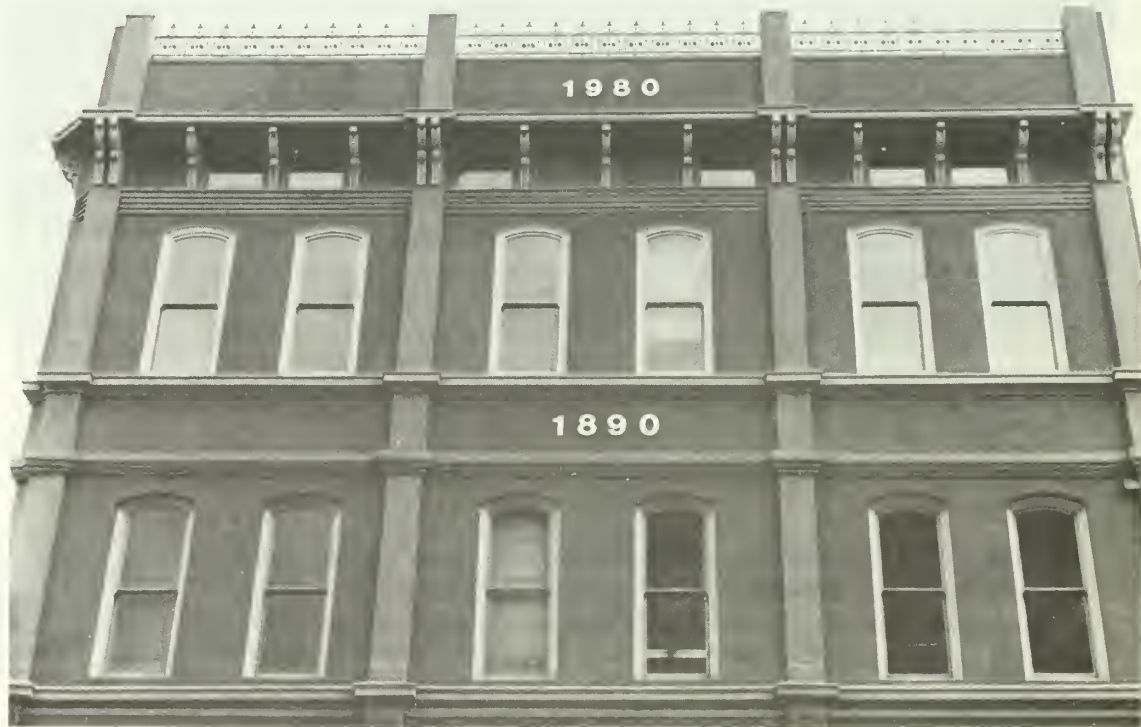
3. The new rooftop addition is not differentiated from the historic resource except by the use of applied dates. The addition is flush with the exterior walls and has adopted historicized features including wrought iron cresting, bracketed cornice, jack-arch windows, pilasters and beltcourses. In this case, however, the addition so altered the scale and massing of the building, that even if the addition had been contemporary in design, it could not have been certified.

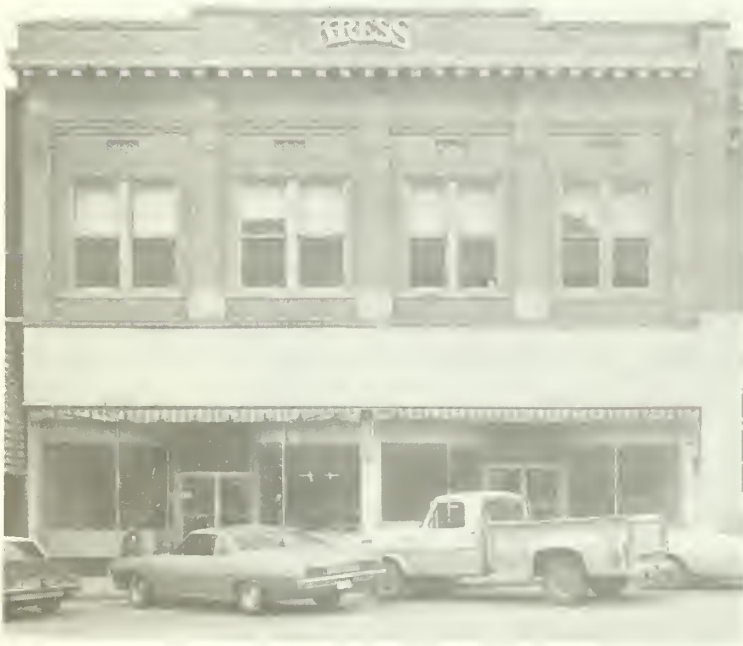
1. Prior to rehabilitation, the 1930s Kress Company storefront had survived in place with nice curved entrances although the transoms had been covered over.

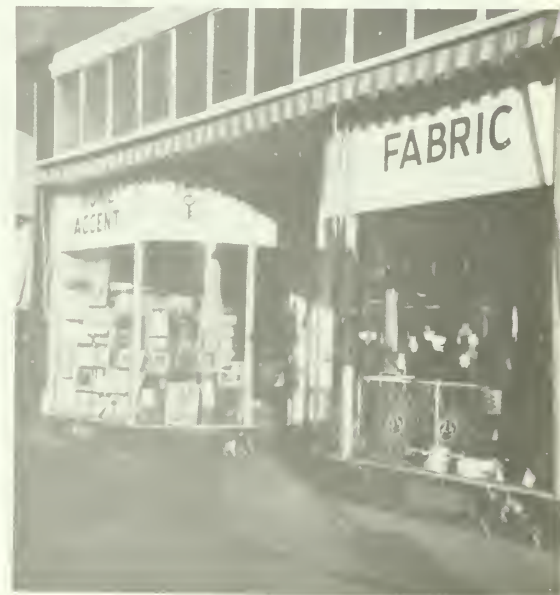
2. Very little change to the 1930s storefront had occurred prior to rehabilitation as evidenced by this historic photograph.

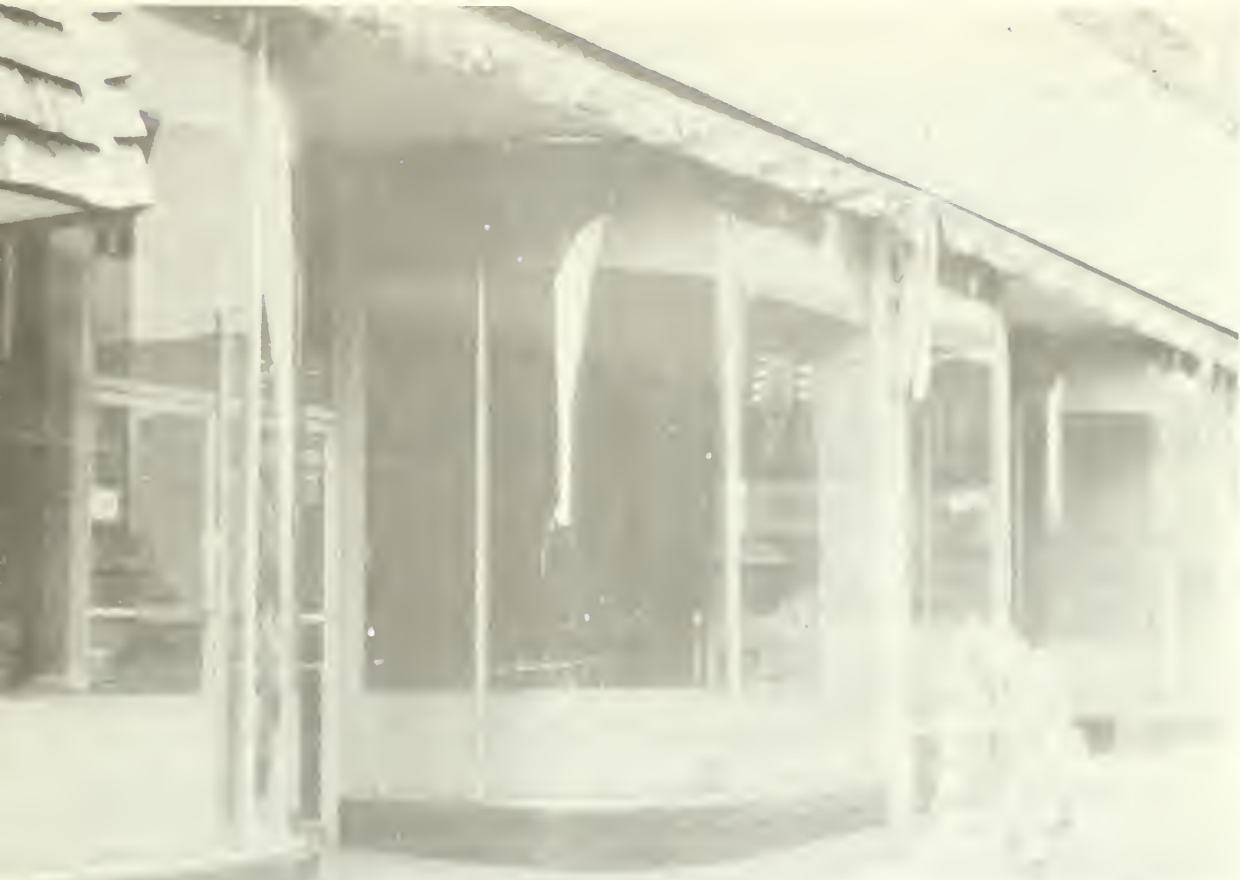
3. The entire storefront was replaced following breakage, during rehabilitation of one of the curved sheets of glass. Expediency and difficulty in locating a manufacturers of curved glass were cited by the owner as reasons for the change.
