Technical Preservation Services
Preservation Assistance Division
National Park Service
U.S. Department of the Interior
Washington, D.C.

Interpreting
the Secretary of the Interior's
Standards for Rehabilitation

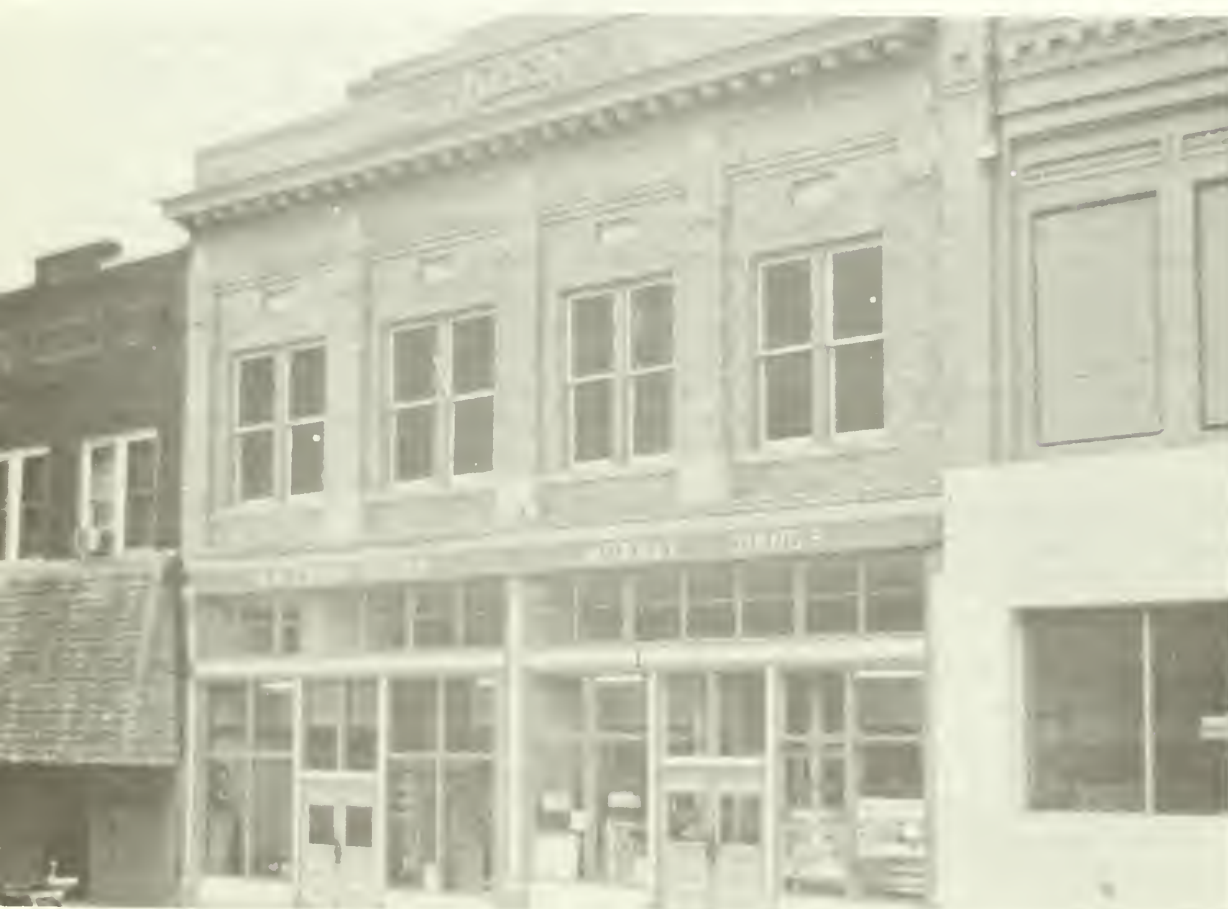
4. View of storefront after rehabilitation showing conjectural appearance of the original storefront — note inappropriate detailing of the transoms and small size of the doors.

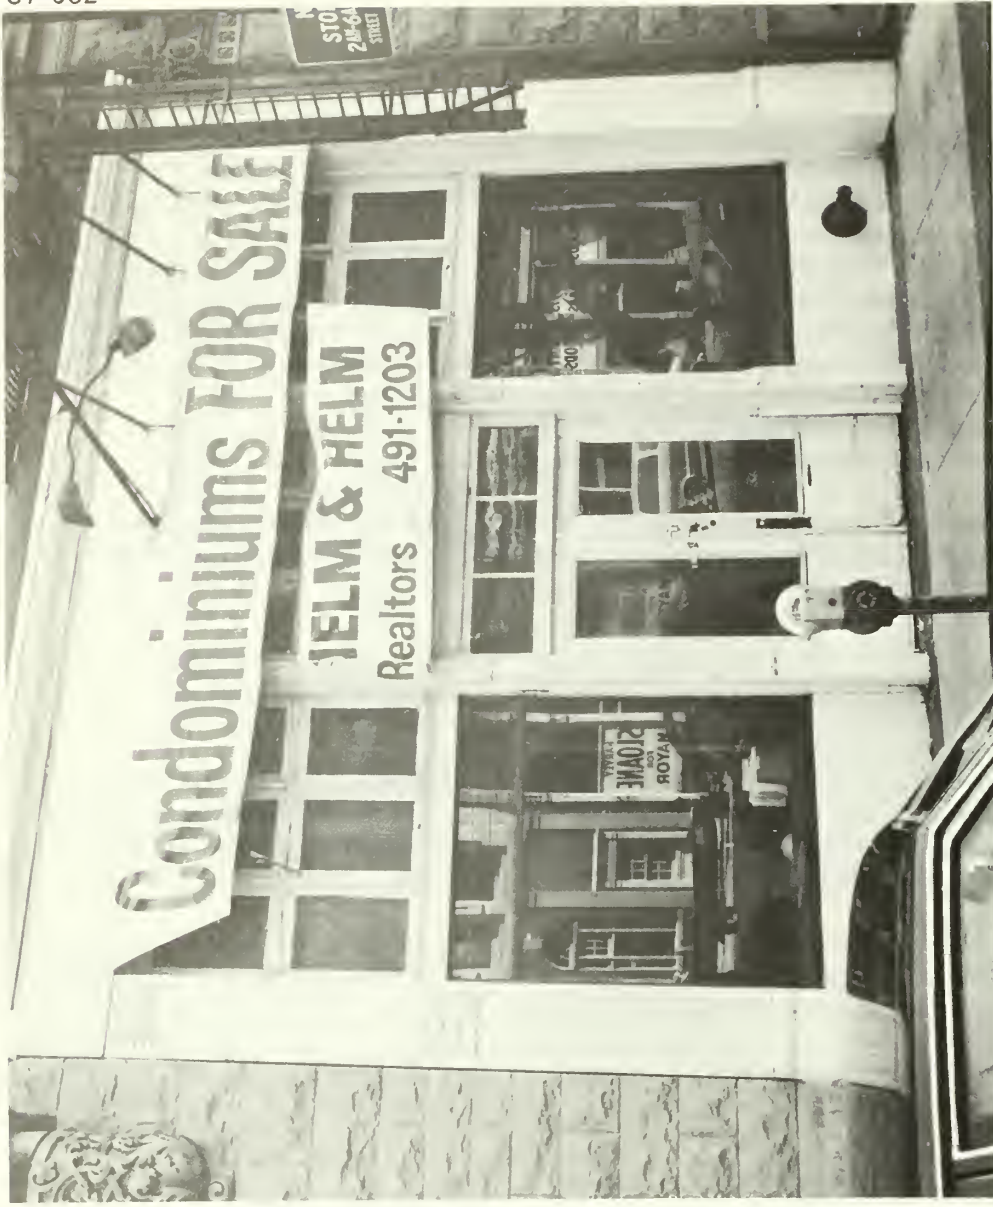
2. The owner removed the nonoriginal elements of the storefront, including plain concrete block kick panels beneath the display windows, standard non-decorative woodwork and glazing in the transoms and display window sash, and the unadorned double doors. Although the proposal was denied by the region, it was ultimately overturned on appeal. The Chief Appeals Officer concluded that the later storefront elements did not display any special significance, and could thus be removed. The original portions of the storefront--the distinctive cast-iron columns, pilasters, and cornice--were retained, preserved, and integrated into a compatible, contemporary storefront design.

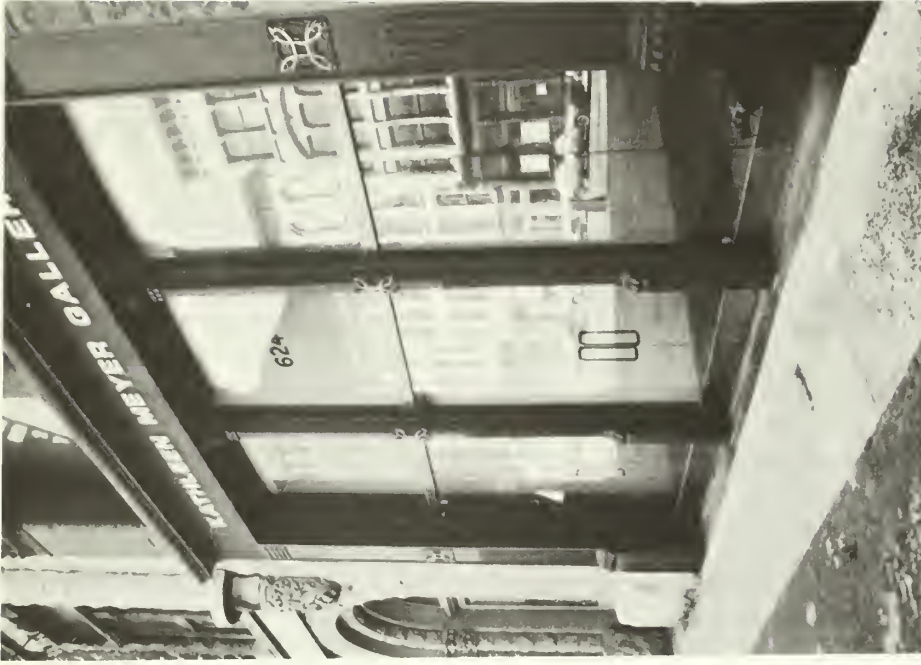
3 and 4. Overall and detail views, after installation of the compatible new storefront features. Note the 1930s-1940s features have been replaced, while the new design successfully retains the 3-bay division defined by the decorative cast-iron columns and cornice. The original cast-iron storefront elements have been painted dark brown as well as upper level window trim and cornice.

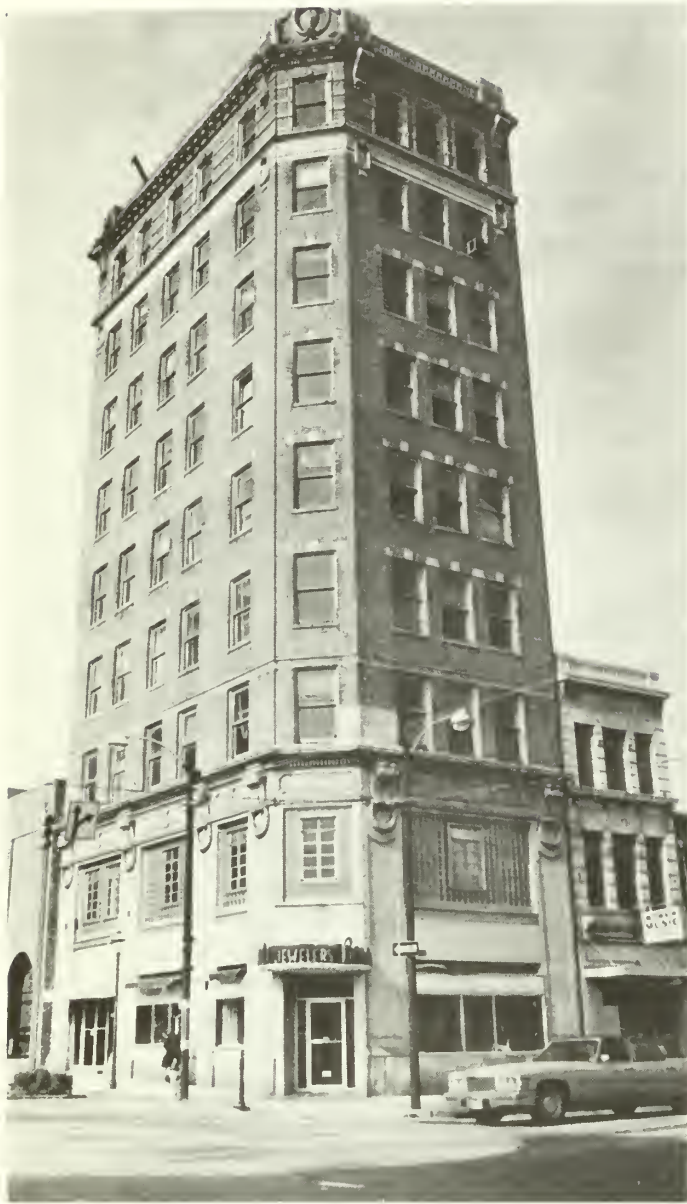
1. Nine story bank and office building before rehabilitation. Note uniformity of brick color.

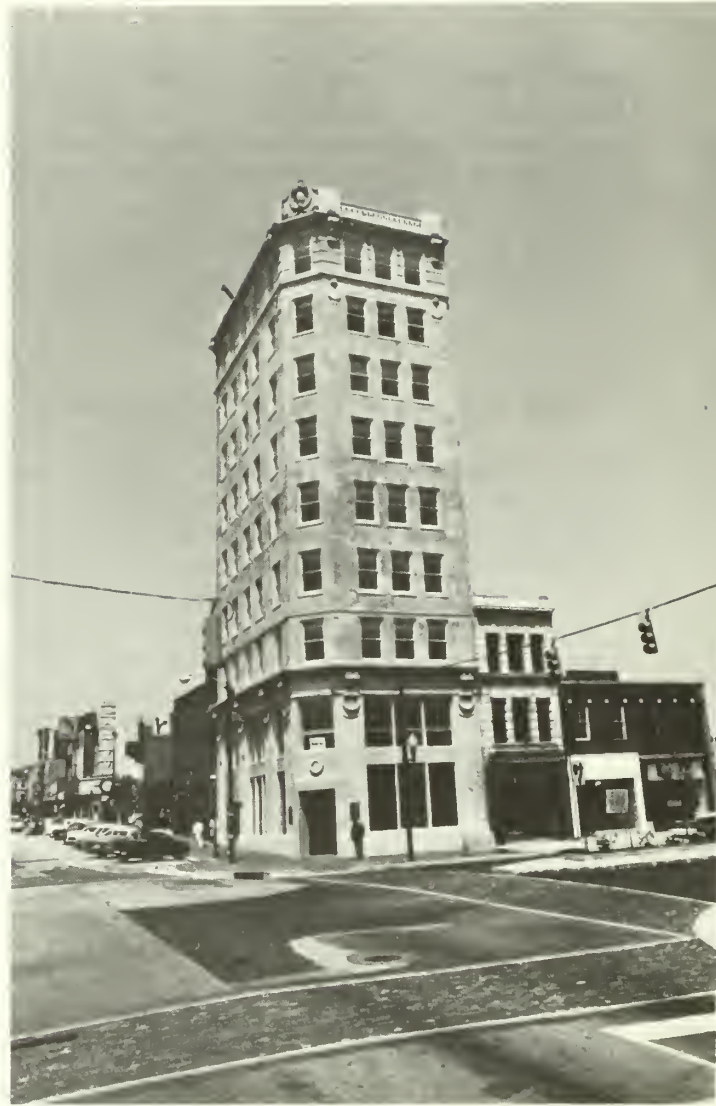
2. Office building after chemical cleaning showing splotchy and discolored brick.

When the completed project was submitted to the National Park Service for final review, however, it was denied certification on the basis of the cleaning techniques which had resulted in "severe discoloration and splotching of the brick surfaces" (see illus. 2). The region's denial letter went on to say: "The brick was apparently cleaned with an inappropriate chemical cleaner which was not adequately tested before its use, contrary to the recommendations contained in the Secretary's Guidelines for Rehabilitating Historic Buildings. Although the physical damage to the brick was not documented, the region felt that the visual change to the brick surface was sufficient to deny the project, citing violation of Standards 7 and 2.

After careful review of the project, the Chief Appeals Officer sustained the region's decision, stating that: "I concur with the regional office's finding that this treatment (cleaning of the exterior brickwork) 'has so altered the appearance of the building as to detract from its historic character.' Standard 7 permits only the gentlest means of surface cleaning... Close-up photographs showing the conditions of the brick before and after this process (the second cleaning) were not submitted, nor were technical details of the cleaning methods and substances made available. Nevertheless, it is convincingly evident from the extent and degree of the persistent discoloration that the brickwork was subjected to unacceptably harsh cleaning. Accordingly, I find a violation of Standard 7."

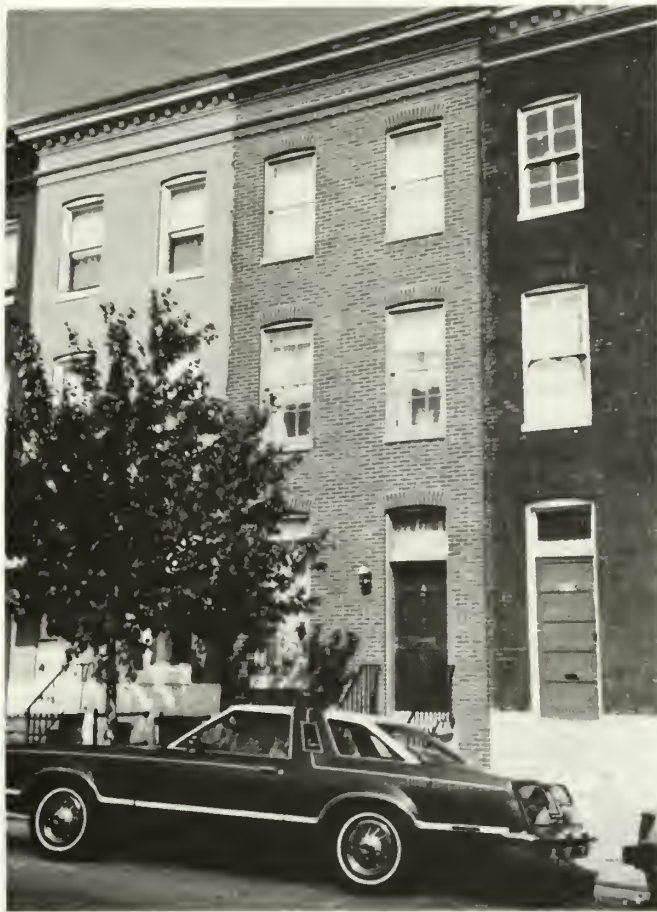
3. Brick rowhouse in center after paint removal using sodium hydroxide stands out conspicuously from its still painted neighbors.

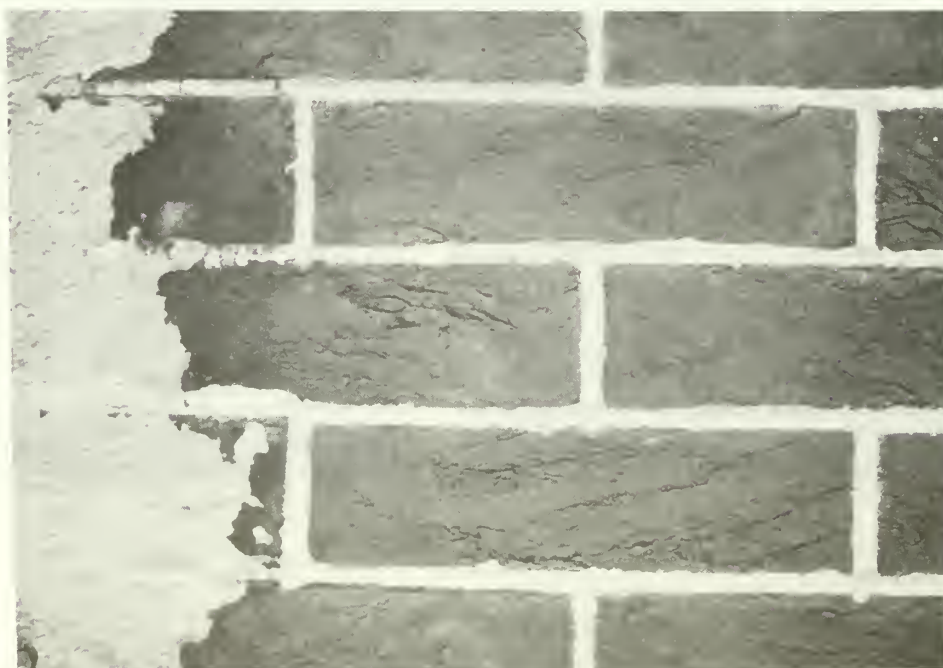
5. Close-up view of chemically cleaned brick showing deep ridges and newly abraded texture.

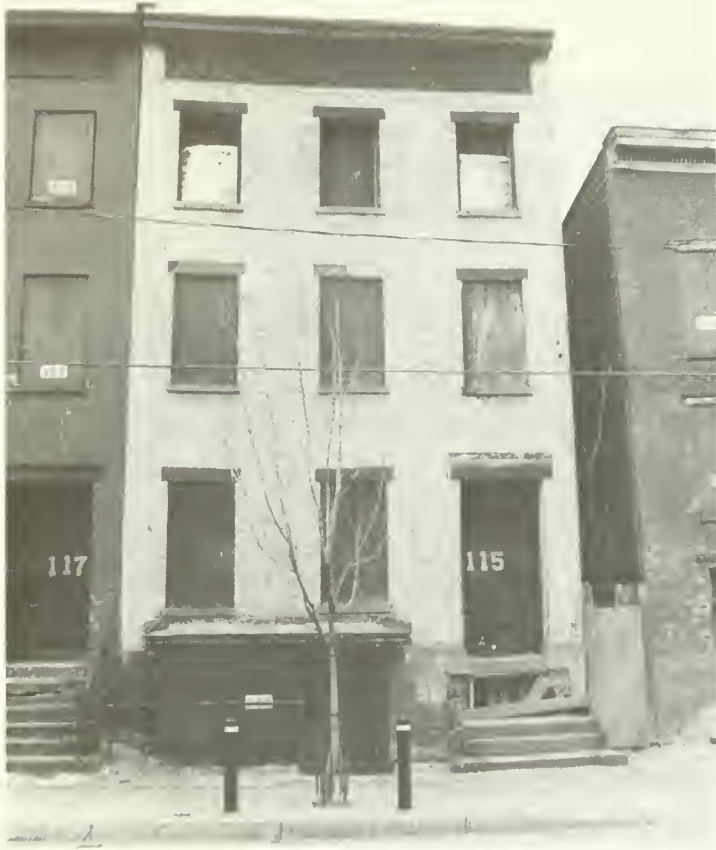
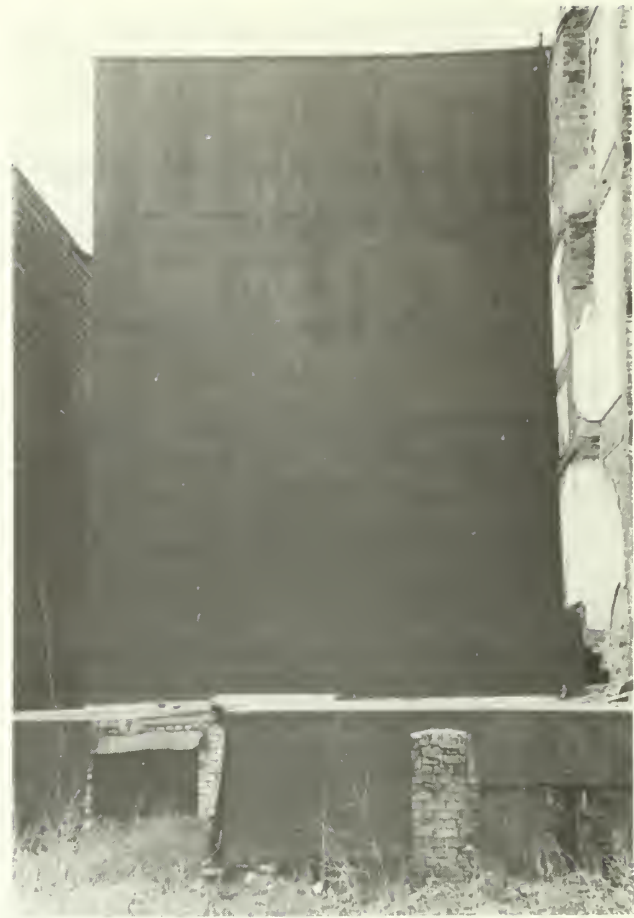
1. Although photographic documentation submitted with the Part 1 application showed some deterioration and loss on the primary elevation, NPS determined that the building exhibited sufficient "integrity" to qualify as a certified historic structure.

2. Limited demolition at the rear of the building had already occurred and protective boards had been applied.

Application: A deteriorated, three-story, three-bay wide brick structure built in 1843 was certified in the Part 1 application as contributing to the significance of the registered historic district--a 13 block area of 19th century Federal and Greek Revival structures (see illus. 1,2,3,4).

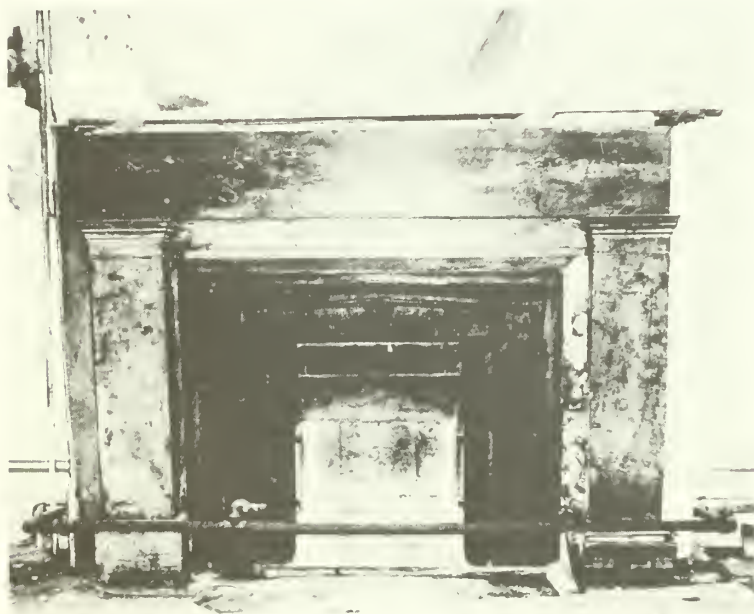
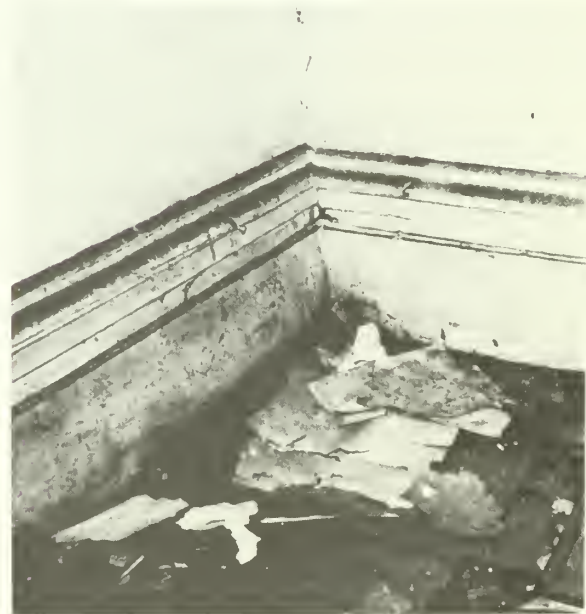
3, 4. The interior, with intact trim and mantels helped define the character of this simple, mid-19th century structure.

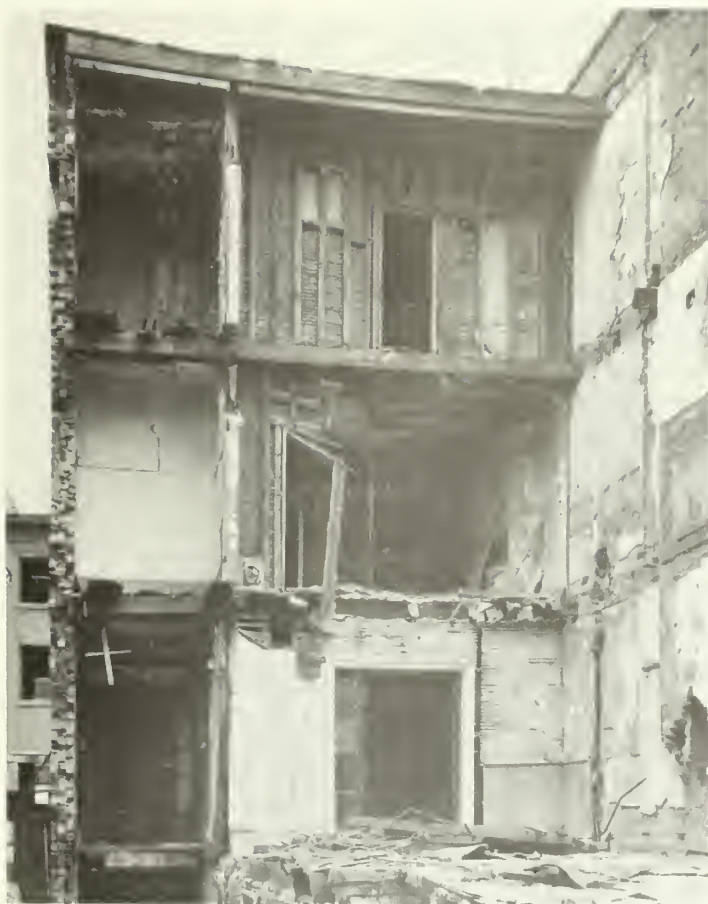
5. Crucial to the decertification of the structure were additional photographs documenting the condition of the rear of the building prior to rehabilitation. After removal of the boards, this new information showed that barely 1/3 of the building remained.

The amended application also included new photographic documentation that revealed the severely deteriorated condition of previously blocked-up portions of the rear of the building and the extent of damage and loss of both exterior and interior features. This portion of the building had not been assessed in the initial application, but was assumed to be substantially intact when Part 1 certification was issued. The newly submitted photographic documentation called into question the integrity of design, materials, and workmanship of the building, and it was decided to re-evaluate the Part 1 certification (see illus. 5,6,7). Following re-assessment, a second letter was sent to the owner, explaining the region's findings:

The new photographic documentation that you submitted shows that barely one-third of the building was standing at the time rehabilitation work commenced. As a result of the building's extremely deteriorated condition, significant architectural features are too deteriorated to be preserved on the remaining portion of the building. In addition, nearly all interior finishes are to be replaced and rebuilt using new materials. As a result of the new information, we have determined that No. 2 of the "Standards for Evaluating Significance Within Registered Historic Districts" has been met (e.g., the structure does not contribute to the significance of the district) and, therefore, the building cannot qualify as a "certified historic structure." This decision supersedes the earlier decision...Since the building does not qualify as a "certified historic structure," in accordance with Department of Interior regulations, the project is not eligible for certification of rehabilitation.

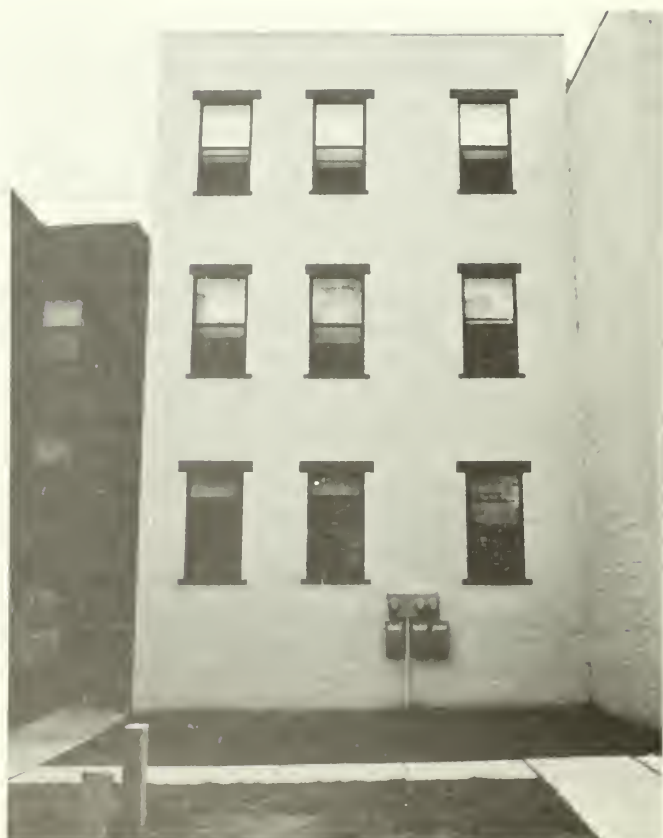
7. The rear of the building and major portions of the interior required extensive replacement of historic material with new material.

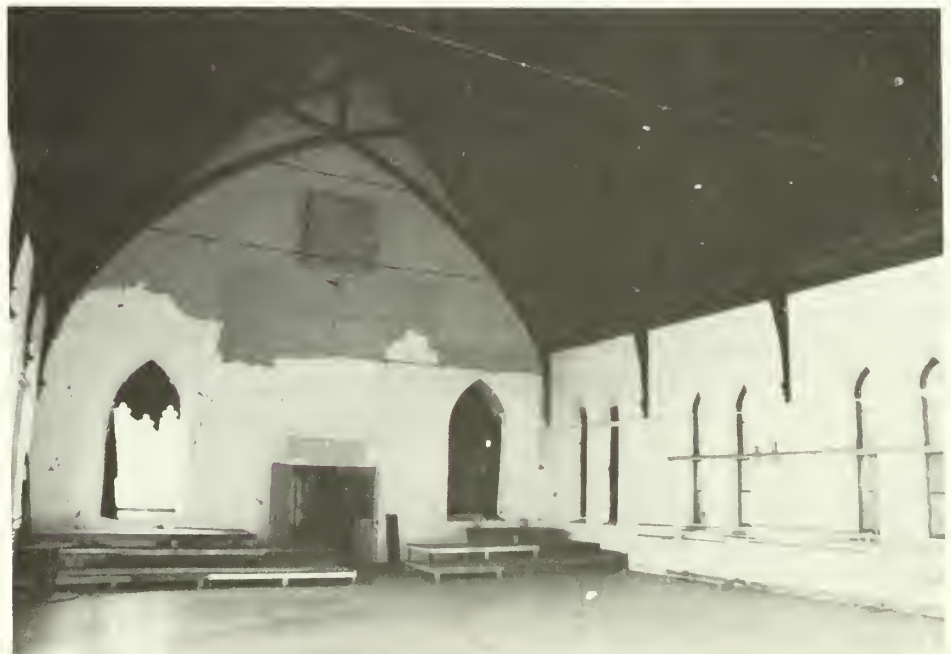
1 and 2. Interior of the church at the time rehabilitation planning commenced. Remaining features include regularly spaced windows, roof structure and exposed scissor trusses, original floor to ceiling height. Only the church furnishings had been removed.

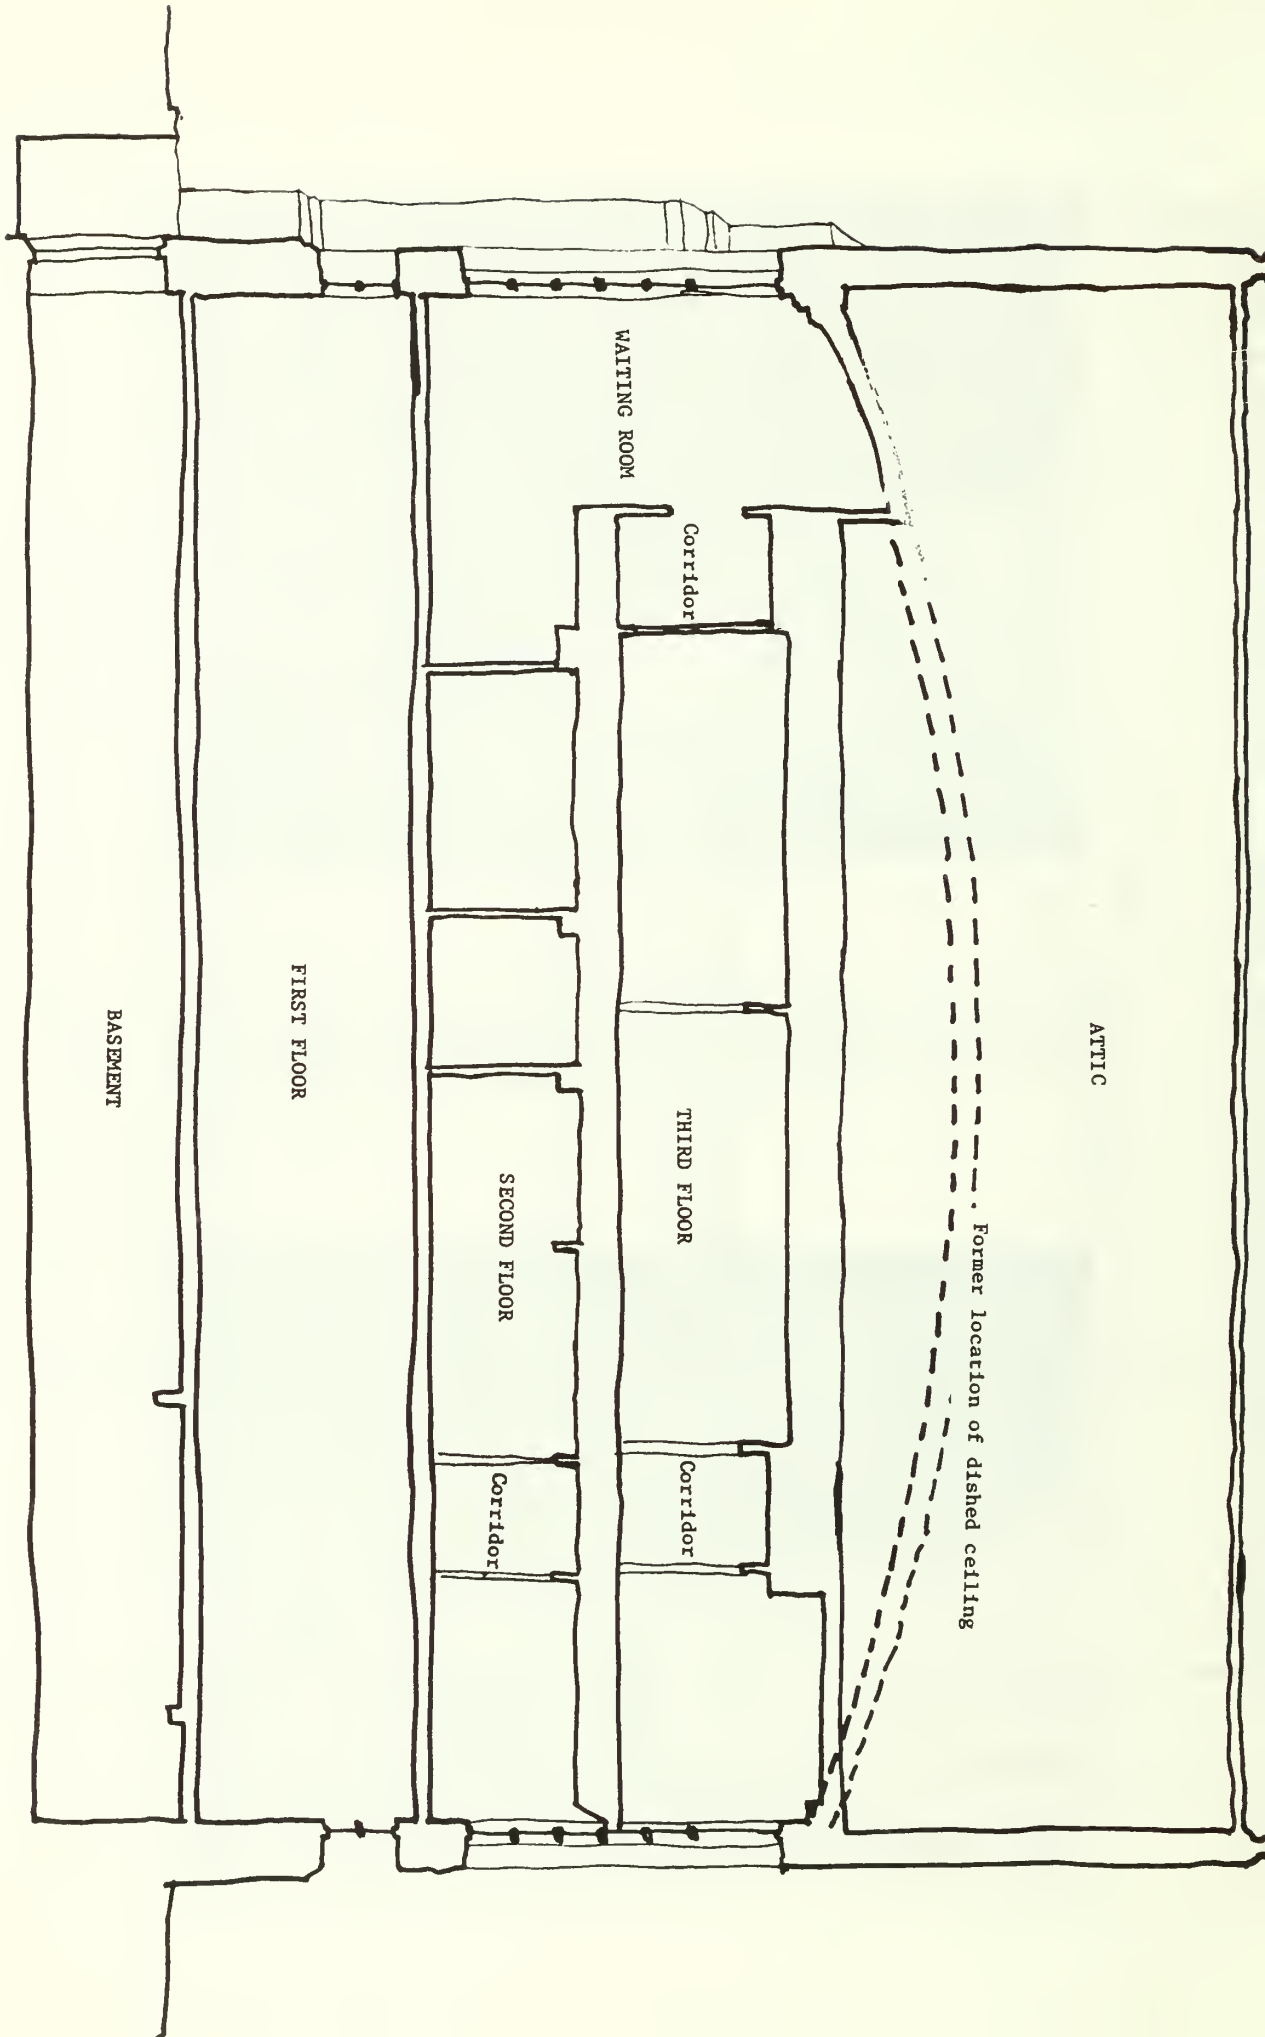
4. Section of Octagon sanctuary space with proposal to add floors and partitions for the new use as offices. Two-story waiting room with reconstructed plaster details on left of sketch.

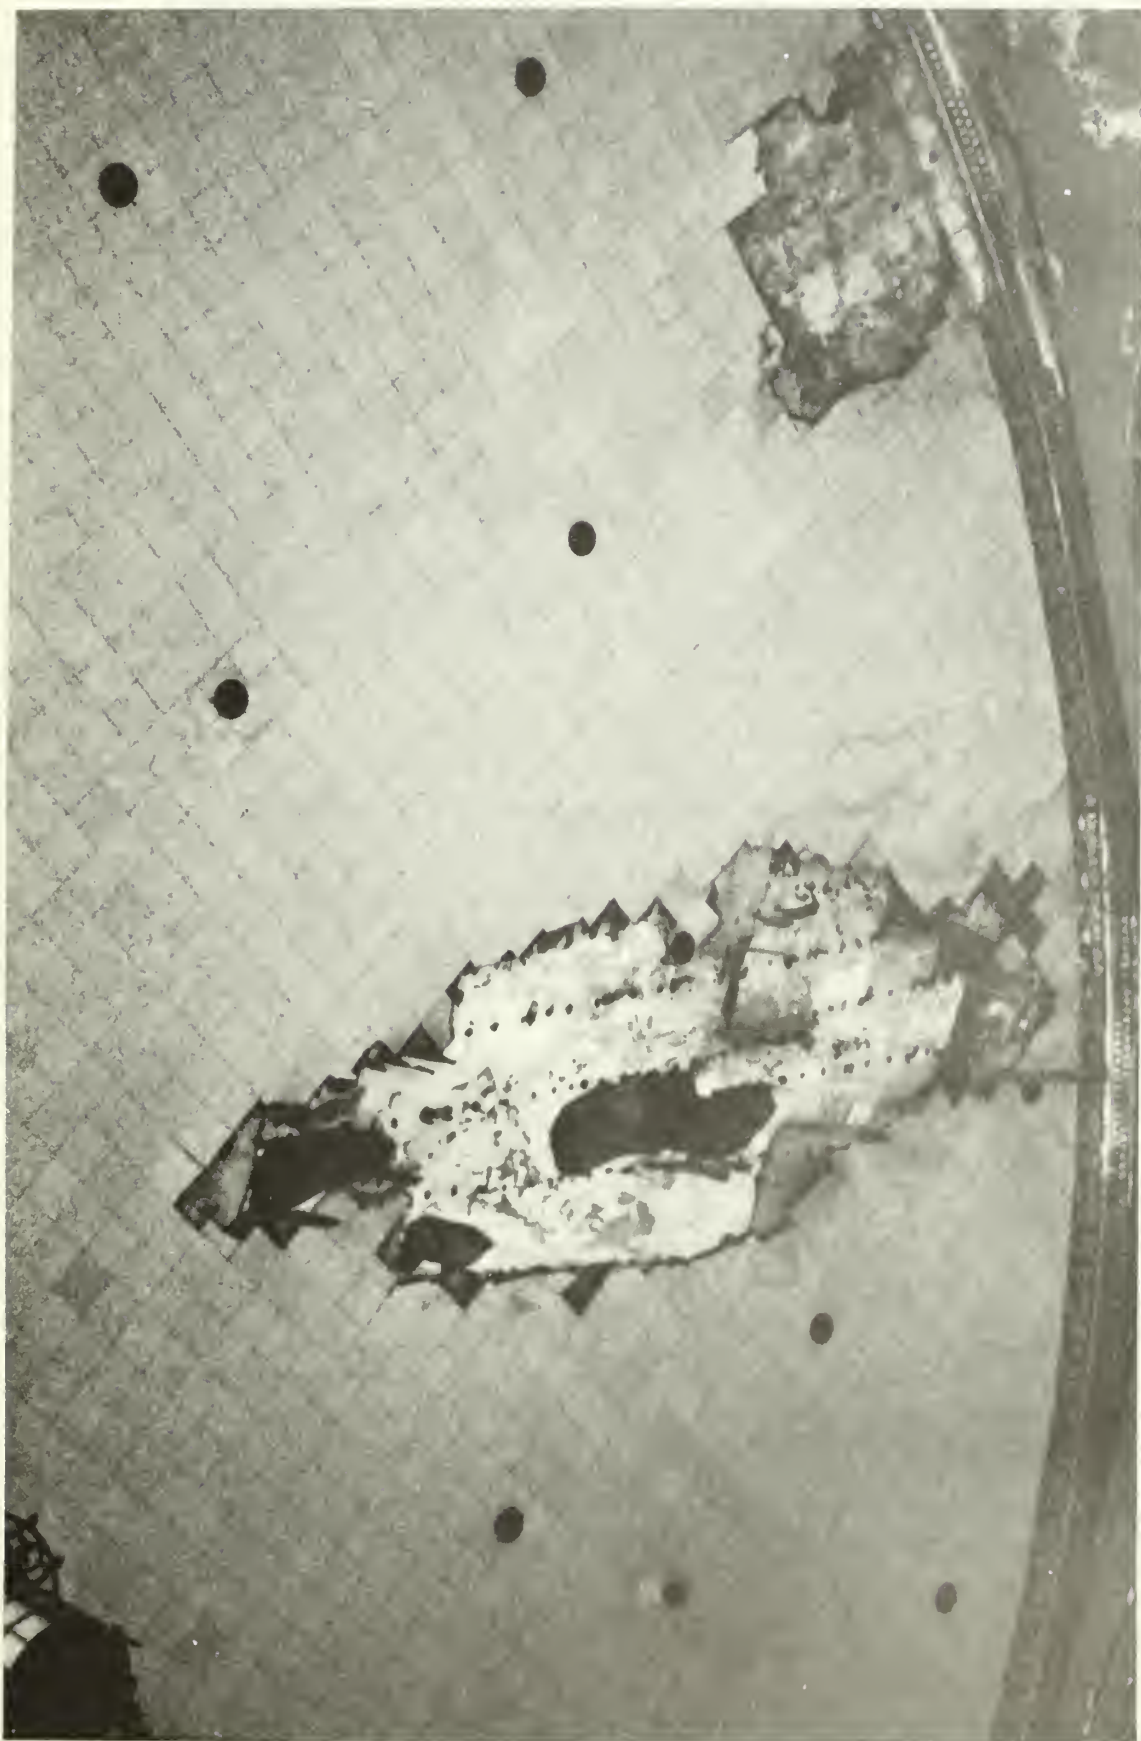
5. Damaged ceiling, due to moisture from roof leaks, buildup of pigeon droppings above, and lack of heat.

In appealing the regional denial, the owners stated that the dished ceiling plaster and lath (as well as the applied acoustical tile) would have to be removed, as they were soaked with water from the numerous roof leaks, and had a thick layer (as much as one foot) of pigeon excrement above. Further, due to water penetration and freeze-thaw cycles, the decorative plaster on the sanctuary walls was severely damaged and so unstable as to be unable to withstand even the slightest impact.

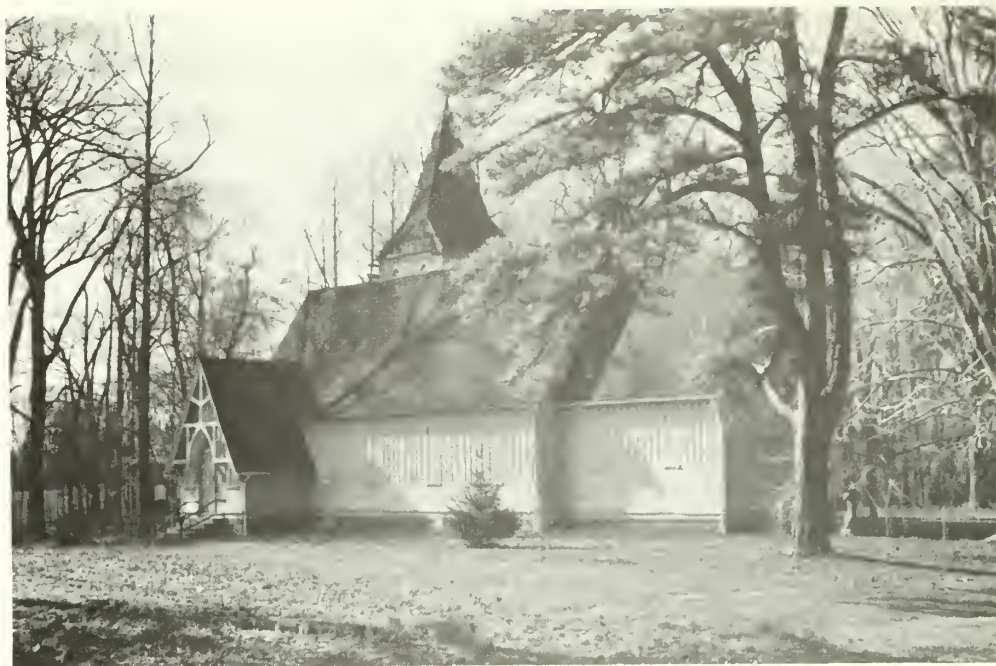
1. South elevation of church before rehabilitation.

Application: A small turn-of-the-century board and batten Gothic Revival church located on a rural wooded site had stood vacant and unused for nearly thirty years (see illus. 1-2). Built on the brick foundation of an earlier church constructed in the 1870's, the church has a nave 5 bays in length covered by a steeply pitched gable roof. The gabled entrance porch on the south side of the nave is distinguished by stickwork detailing outlining the gable. Lancet windows light the nave, and the 2-bay long apse features a tripartite stained glass window opposite a pair of stained glass windows with a stained glass roundel above on the west end of the church. The vestry room, a small gabled section (matching the entrance porch) projects off the north side of the apse. A square bell tower with a shingled spire dominates the north side of the nave opposite the entrance porch. The simple interior is highlighted by exposed oak roof beams, arched trusses, and matchboard ceiling and wainscotting (see ill. 3-4). Individually listed on the National Register, this building had essentially retained most of its original fabric, as well as its form and pristine country setting, all of which contributed to its historic character. The church did not have plumbing, electricity or a modern heating system when the owner purchased it with the intention of converting it into an artist's studio and residence.

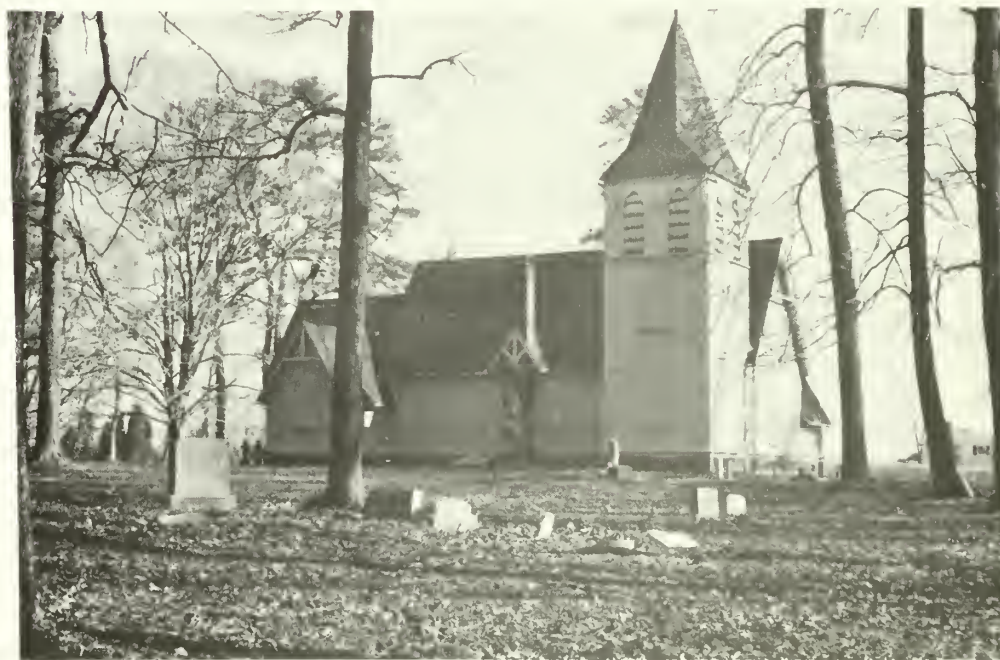
2. North elevation of church before rehabilitation.

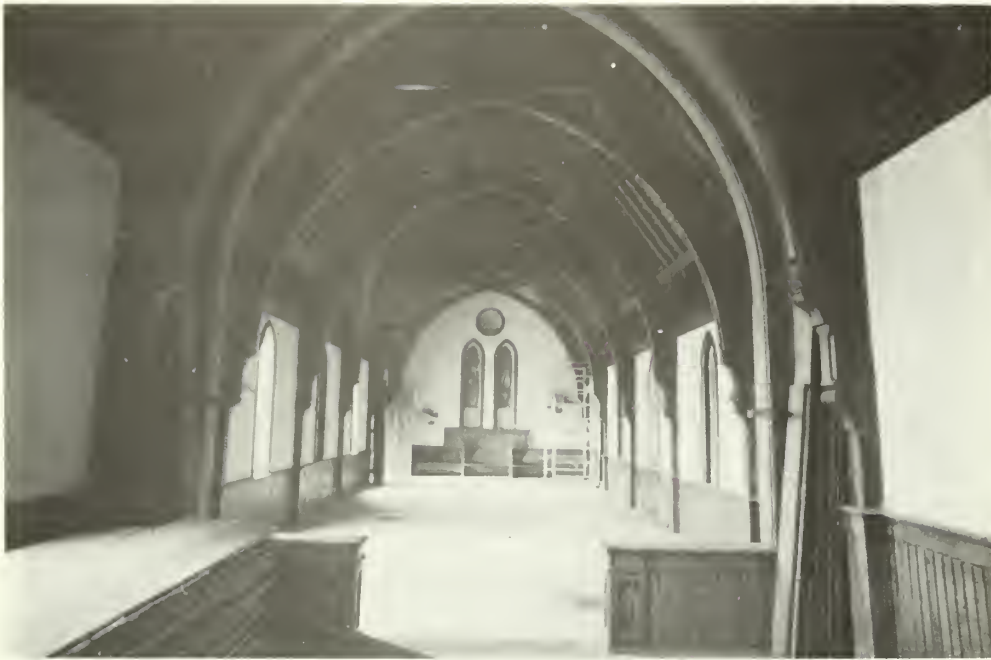
3. View of nave looking west toward baptistry before rehabilitation.

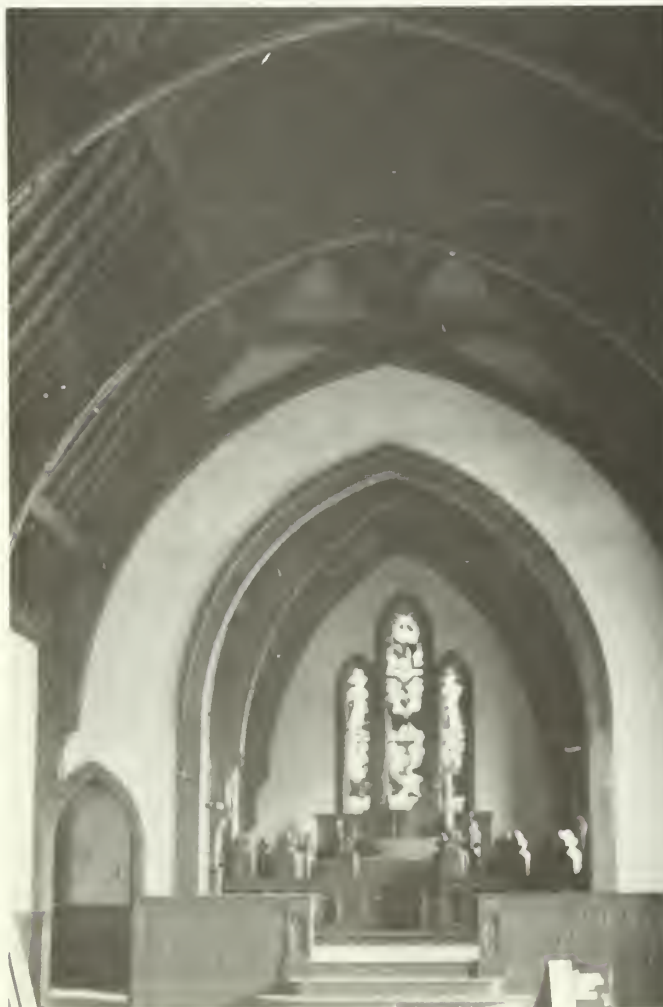
4. View of nave looking east into apse and sanctuary before rehabilitation.

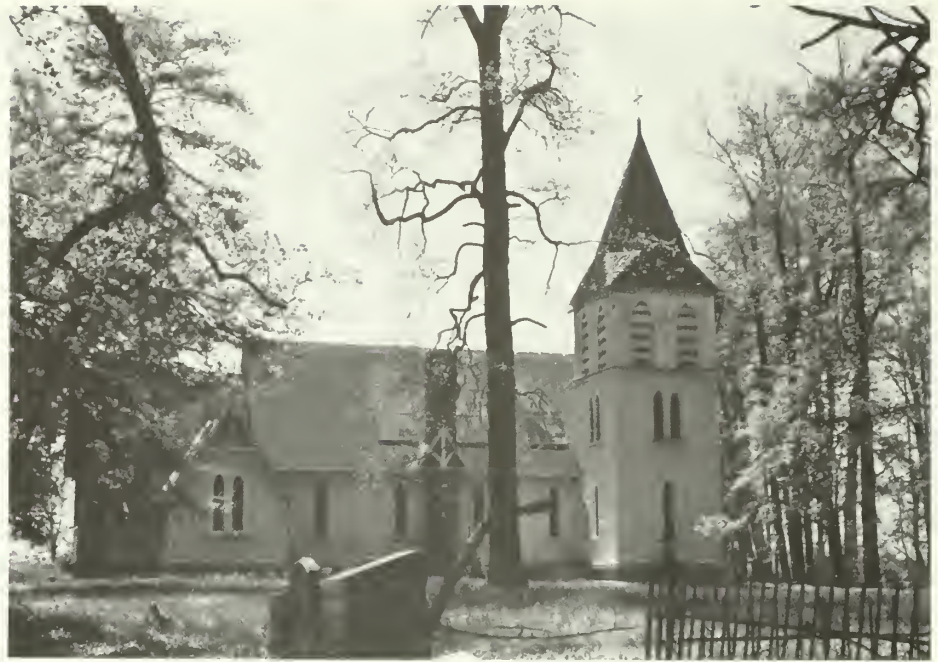
5. North elevation showing new skylights inserted in nave roof after rehabilitation.

The owner appealed the denial, arguing that the skylights were not highly visible on the exterior to passers-by, as that elevation of the church faces onto an abandoned cemetery, not a public-right-of-way. Furthermore, their installation did not result in extensive loss of historic fabric because materials removed were used to patch damaged areas of the roof. The owner also stated that the mezzanine and stairway inserted in the chancel and the bathroom and storage sheds in the nave were sensitively designed and compatible with the historic character of the church (see illus. 5-6).

The sky lights were introduced directly behind the bell tower in the north slope of the roof which faces away from the principal approach to the building; they are not obtrusive from the exterior, nor are they so numerous as to adversely affect the character of the interior. The mezzanine, circular stair and sheds were introduced to the interior with minimal damage to the historic fabric. While the chancel arch was partially enclosed in inserting the mezzanine, the windows in the east wall remain visible through the glass panels and open circular stair. The pendant sheds constructed in the nave similarly respect the axial lines and tunnel-like view of the church interior from the west end towards the east. In fact the slope of the shed roofs focuses the lines of sight toward the chancel and the windows beyond (see illus. 6). The changes made to the interior of this building are consistent with the historic character of this historic structure, and I find them in conformance with the Secretary of the Interior's "Standards for Rehabilitation."

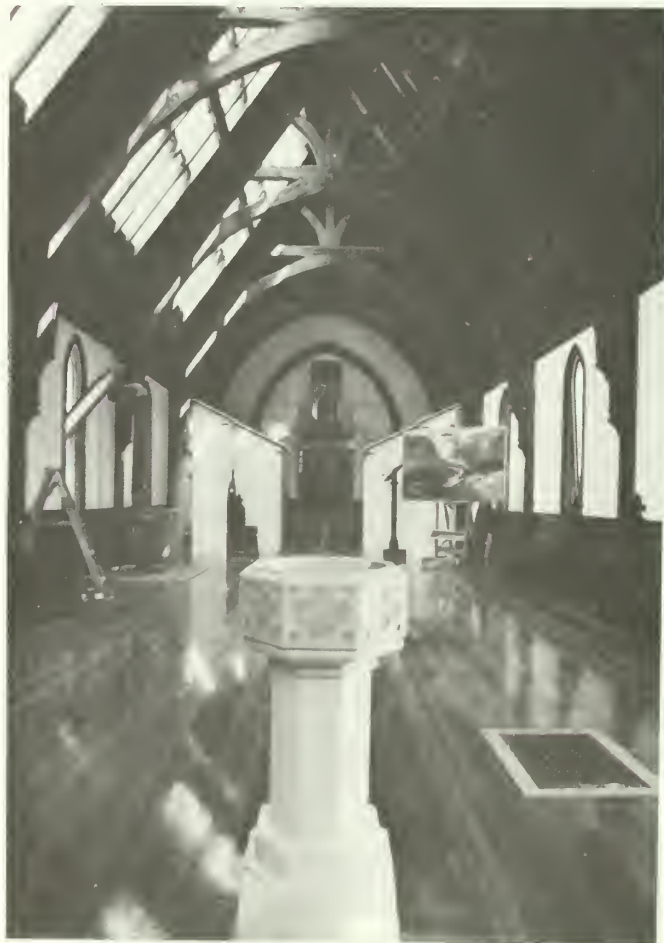
6. View of nave looking east. Note the 2 new sheds in front of and on either side of spiral stairs in center of sanctuary arch leading to mezzanine.

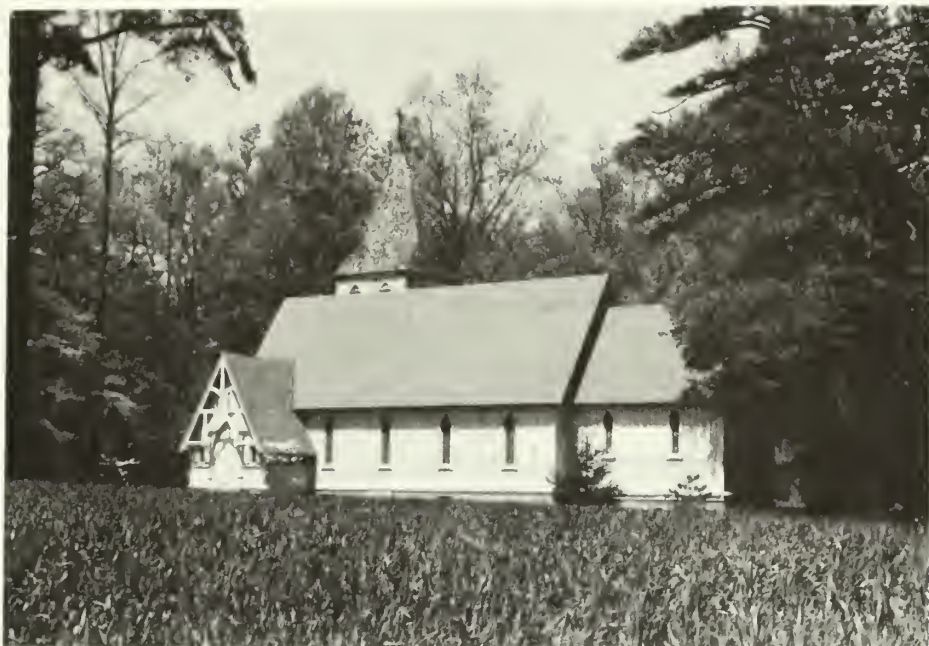
7. South elevation of church after rehabilitation.

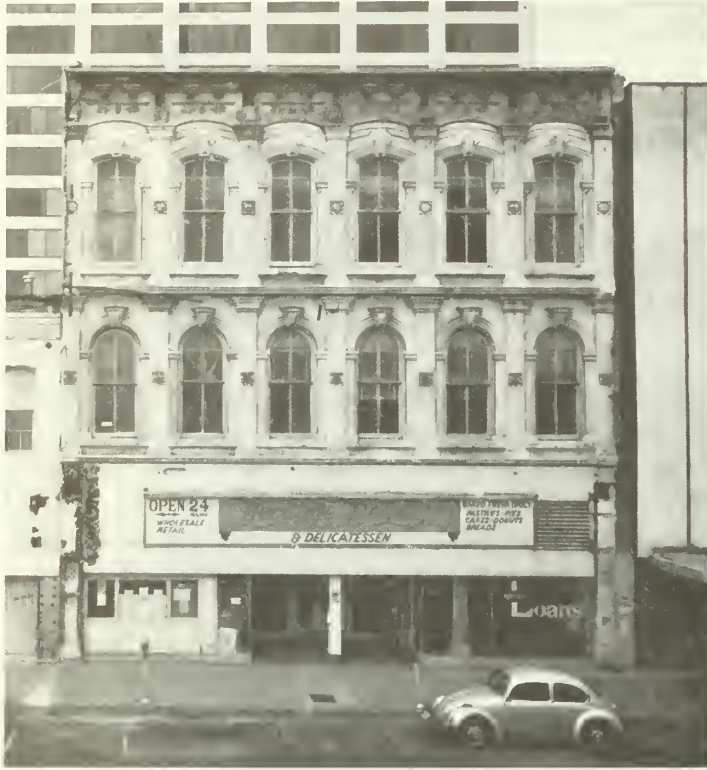
1. At the outset of rehabilitation, an 1866 limestone building was missing its ornamental cornice; and the ground level storefront had been extensively altered.

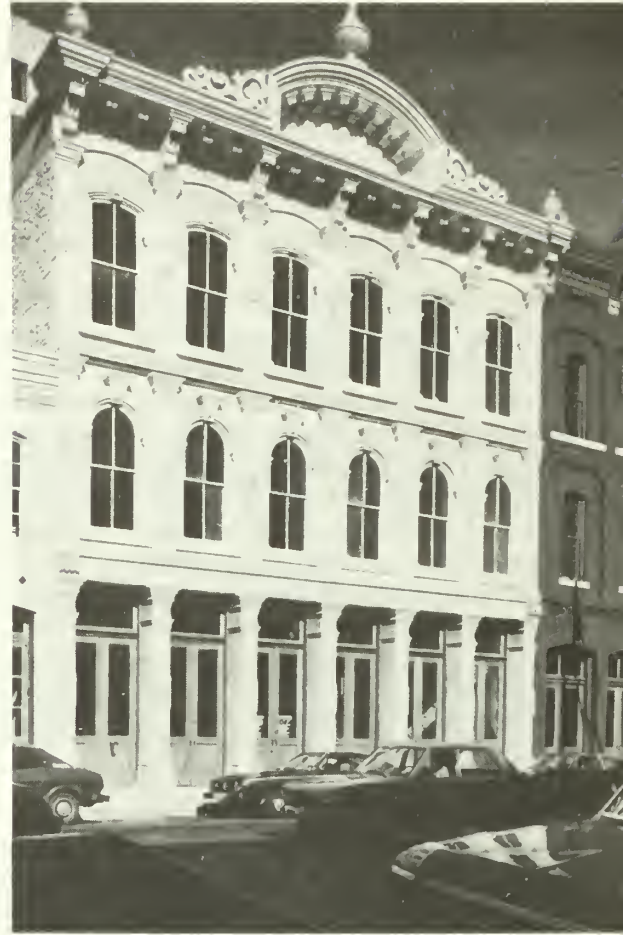
3. In addition to restoration of the storefront using matching materials, this photograph of finished work shows an acceptable use of substitute material (in this case, fiberglass) to fabricate the missing pressed metal cornice.
