Technical Preservation Services
Preservation Assistance Division
National Park Service
U.S. Department of the Interior
Washington, D.C.

Interpreting
the Secretary of the Interior's
Standards for Rehabilitation

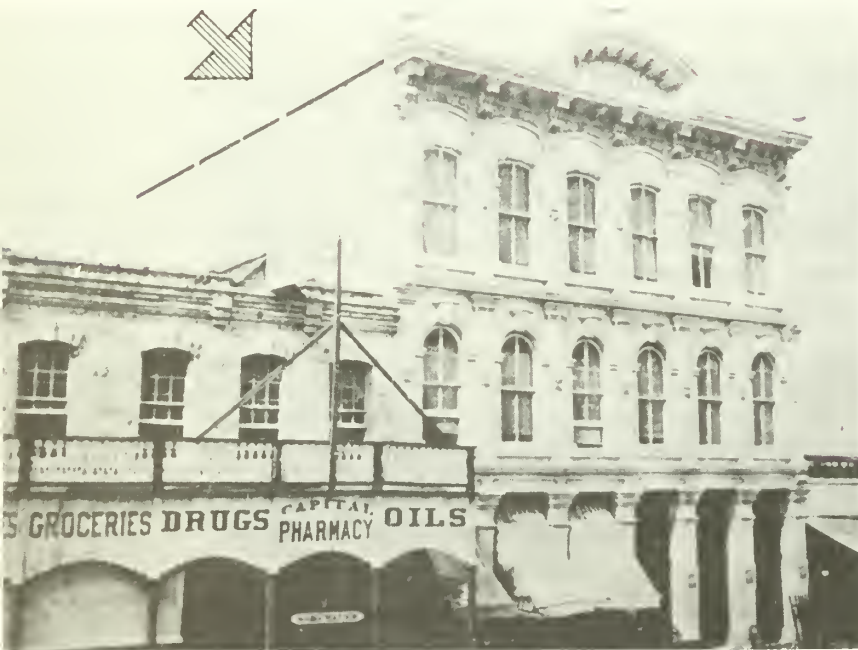
2. Based on the availability of this and other photographic documentation, the owners were able to accurately restore both the cornice and the storefront to their historic configuration.

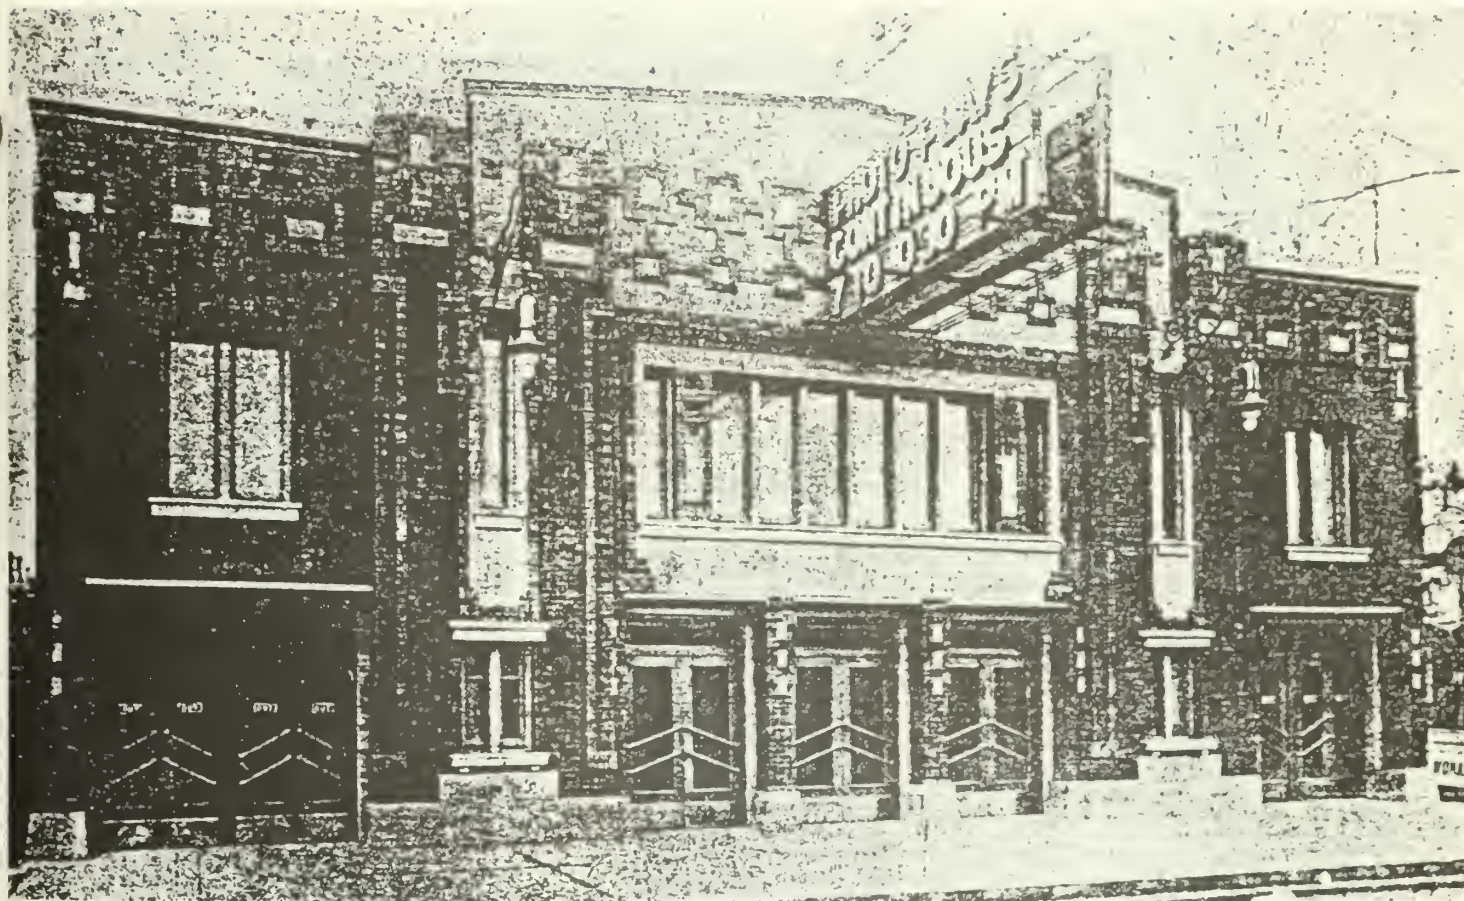
4. Historic photograph of the theatre's facade as it appeared in 1913. Note the glazed wooden double doors, repetitive features that, together with the distinctive rectangular openings themselves and the patterned brickwork, define the architectural character of the building.

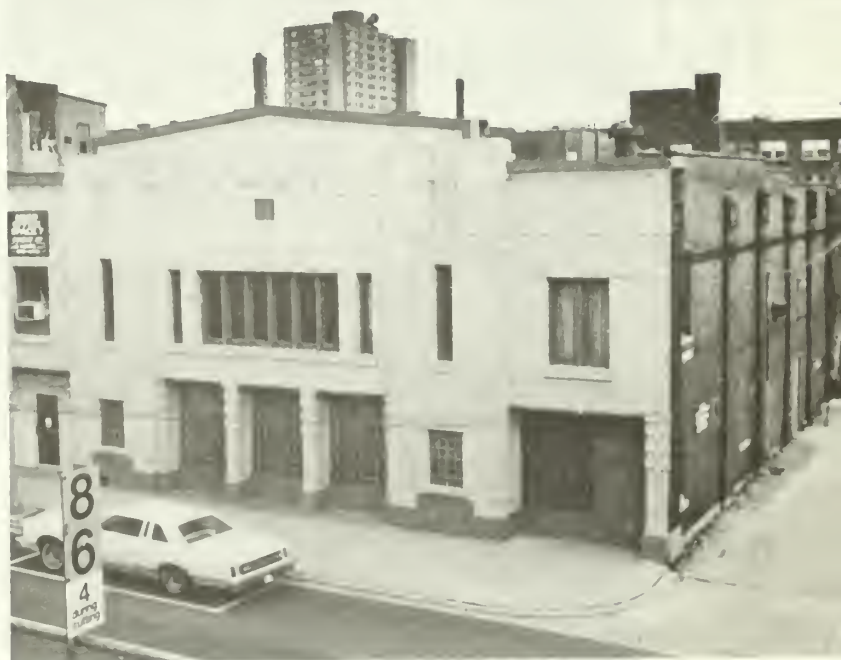
5. Theatre building as it appeared at the commencement of rehabilitation. The wooden doors had been removed in an earlier "renovation" and the openings filled-in with glass block. In addition, the masonry was painted a uniform gray. The stone sills cover a 22-inch-thick concrete floor inside.

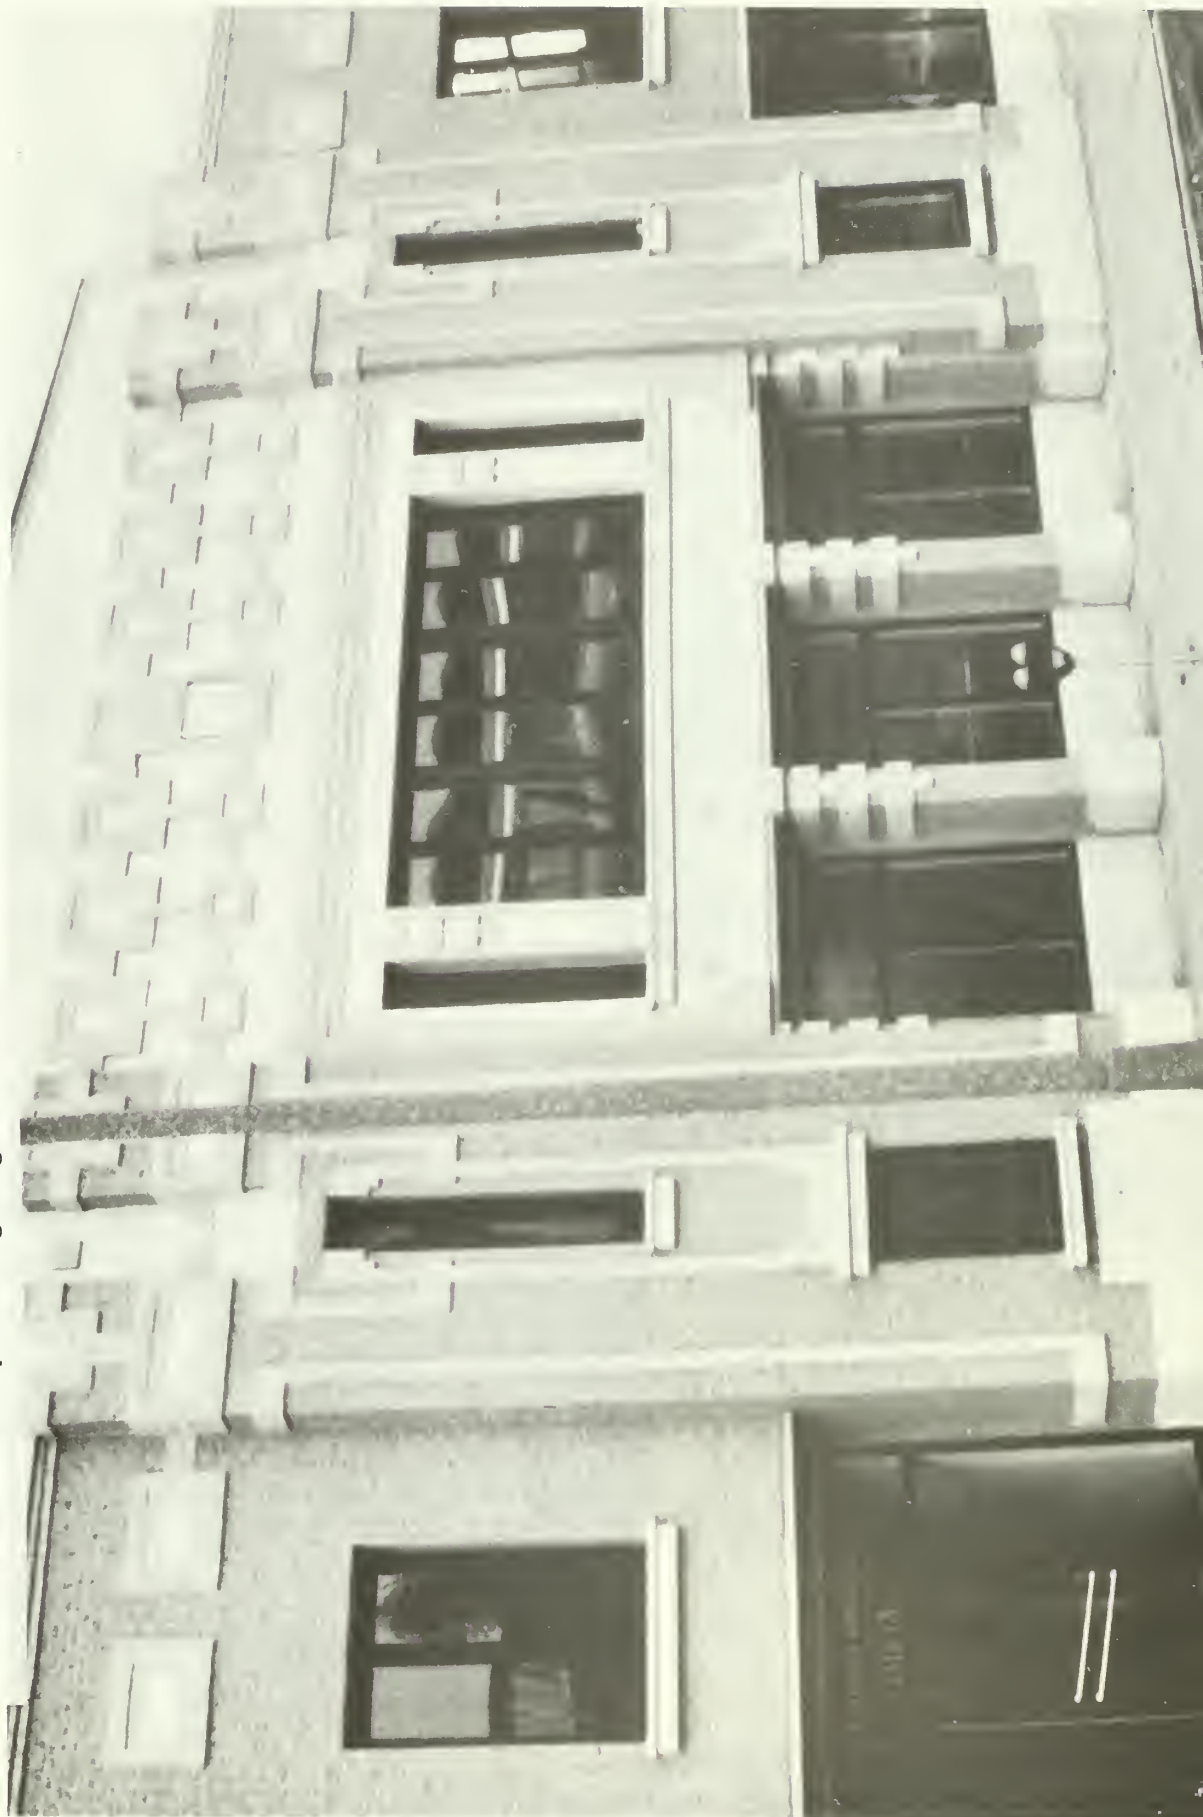
6. Rehabilitated facade. After removing the nonsignificant glass block infill, the owners elected not to restore the wooden double doors, but instead, to install new, simply detailed steel windows that respect the regularized openings. The brick has been painted to approximate the original colors so that the patterning is again evident.

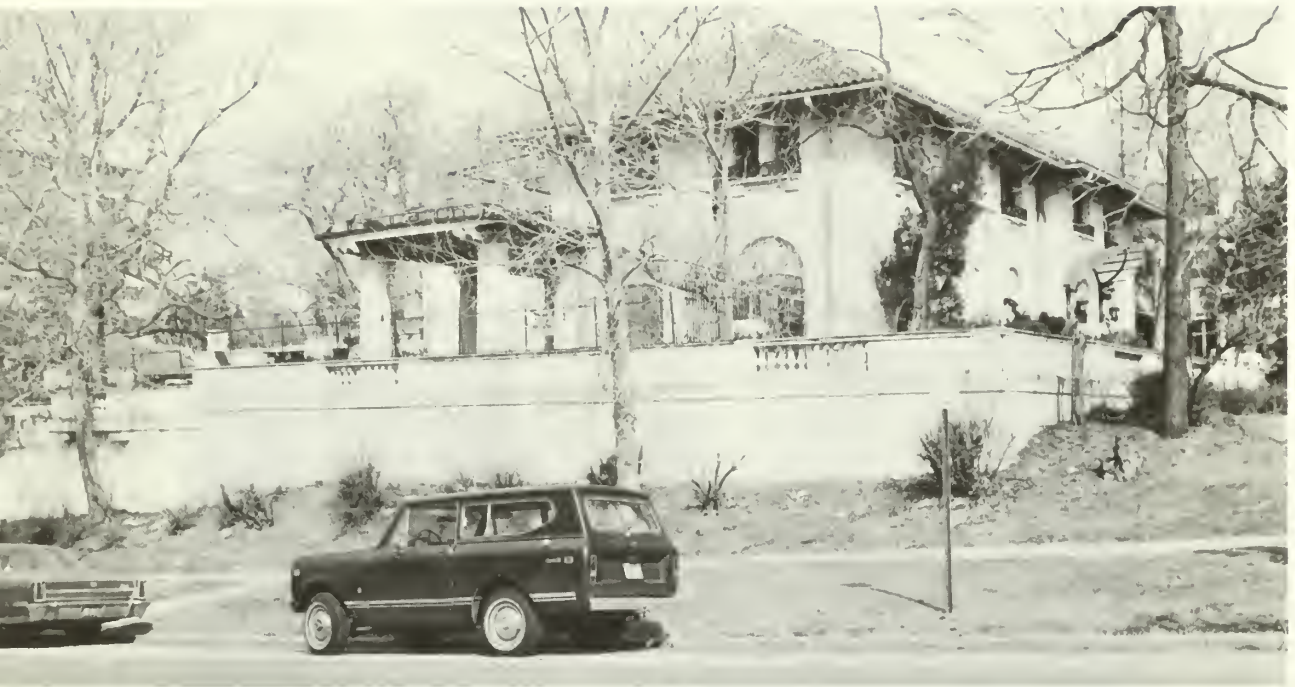
1. Side view of the house, showing the retaining wall around the site and the front terrace.

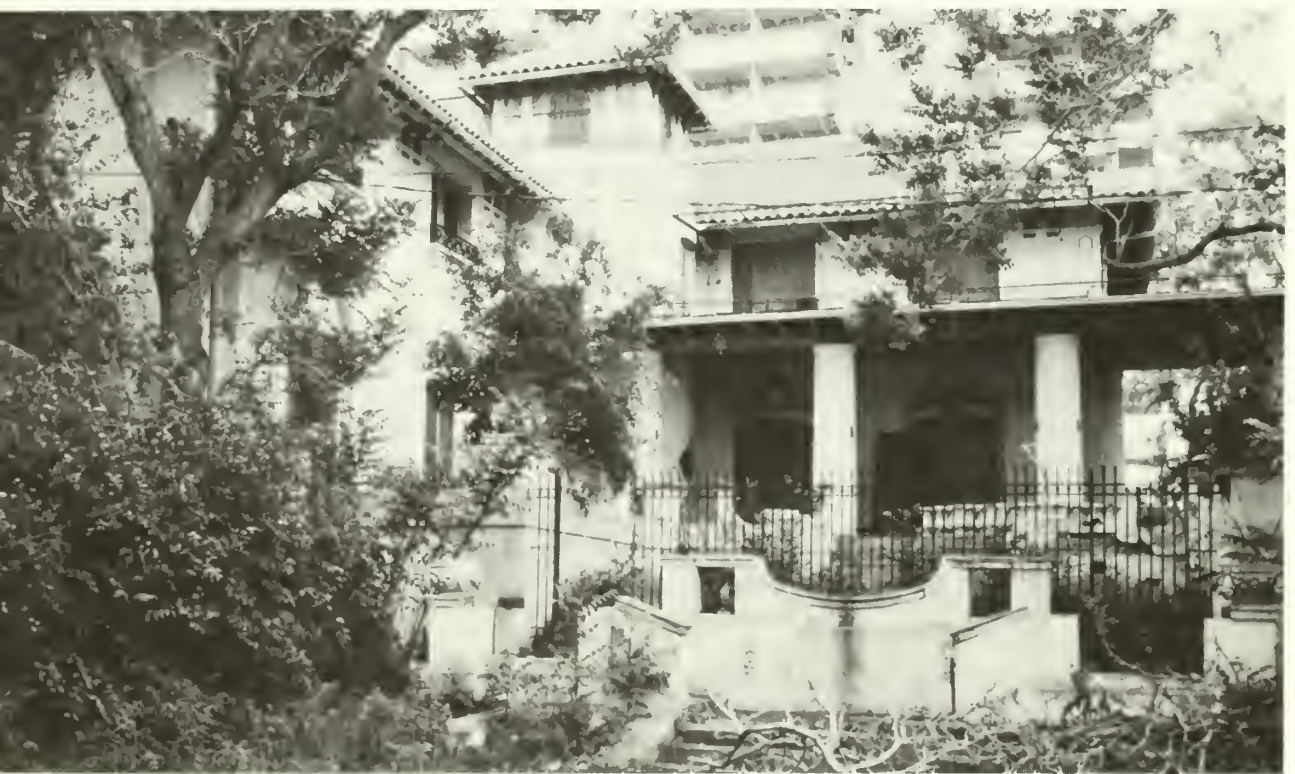
2. View of the rear of the house before rehabilitation began. There is a rear terrace with a pergola and a small walled garden with ornamental walls and an iron fence.

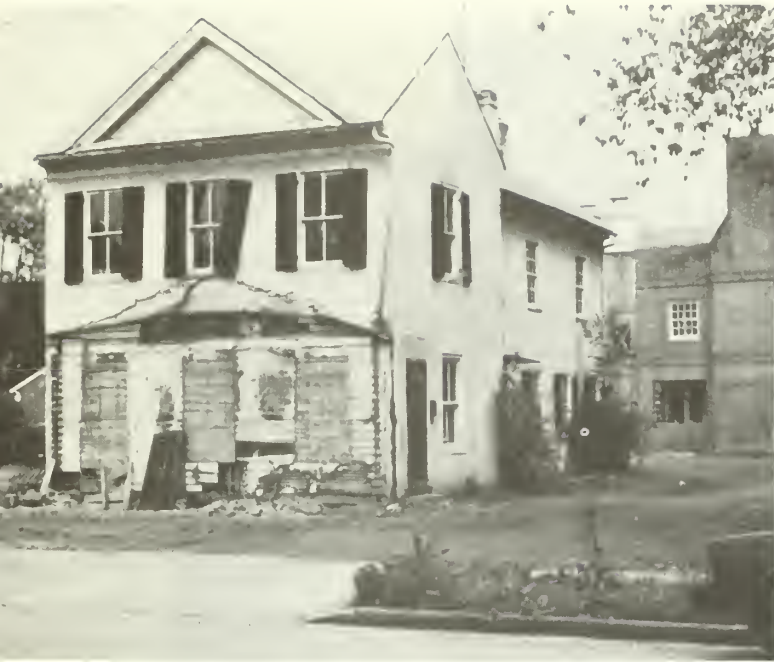
1. Front and side elevations of a ca. 1865-1870 wood frame building prior to rehabilitation. Stucco had been applied over the exterior wood at a later date and had caused rotting and termite infestation of historic wood. The building was certified as meeting Part 1 integrity requirements in its deteriorated and damaged condition.

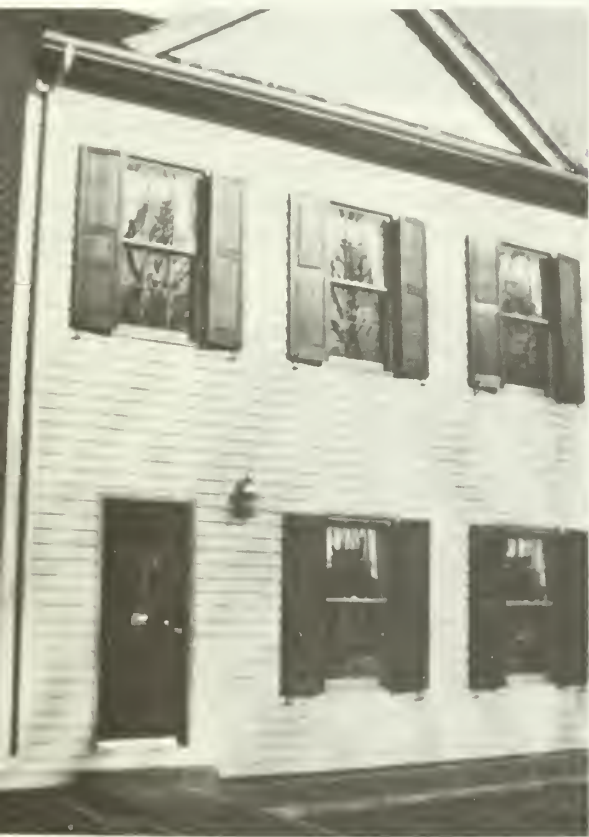
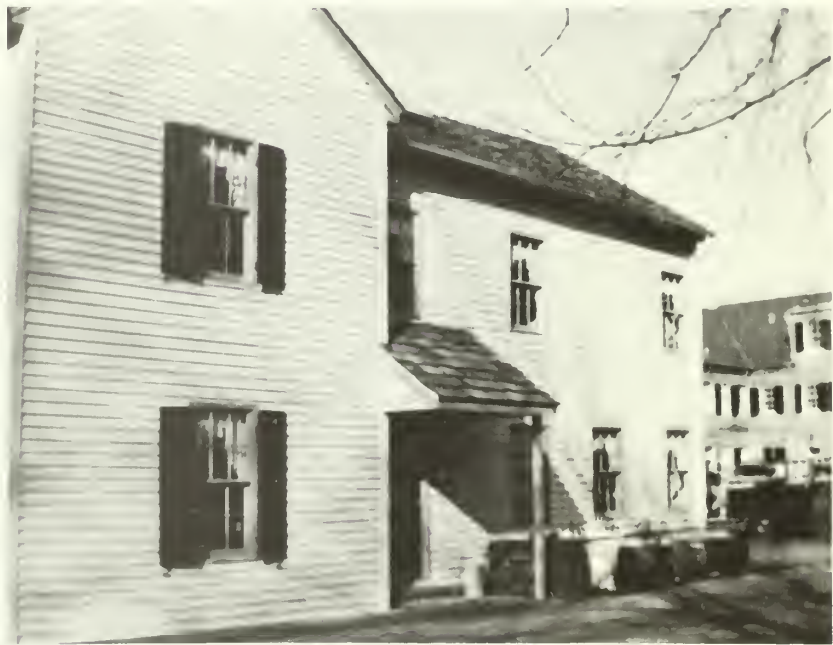
2, 3. The same building shown after rehabilitation is essentially new construction. Rather than targeted replacement of deteriorated materials, the owner replaced all of the siding, roofing, windows, sills, shutters, and trim. Some of the replacement features, such as the use of thick, cedar shakes on the roof and side porch were considered inappropriate. The owner was denied Part 2 certification on appeal. As a result of material loss during rehabilitation and the earlier loss of interior features and spaces, the Part 1 certification was also withdrawn because the building could no longer meet integrity requirements.

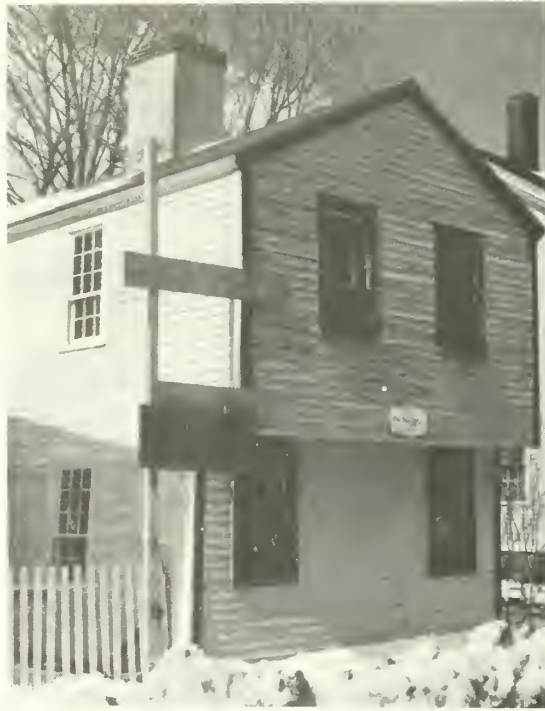
4. A ca. 1769 building was certified in the Part 1 application in its existing condition, which involved extensively deteriorated exterior wood clapboarding, sheathing and window sash. On the interior, some original framing members were intact, while others were repaired or replaced.

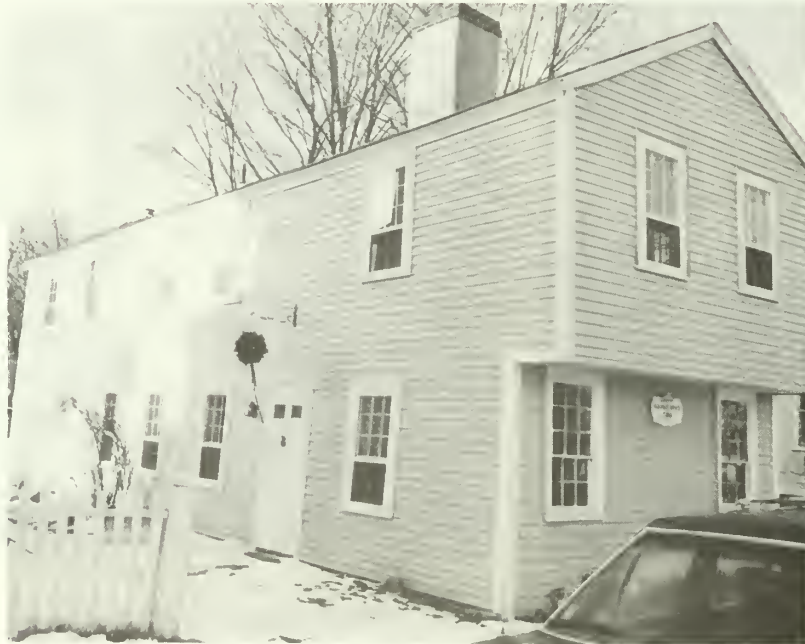
5. Completed exterior work shows the extent of replacement of deteriorated exterior wood materials and features. All siding and sheathing was replaced with new wood. Window sash and frames are also new. The applicant documented areas that needed to be replaced because of extensive deterioration as well as those portions, such as the cornice molding, that could be retained and preserved.

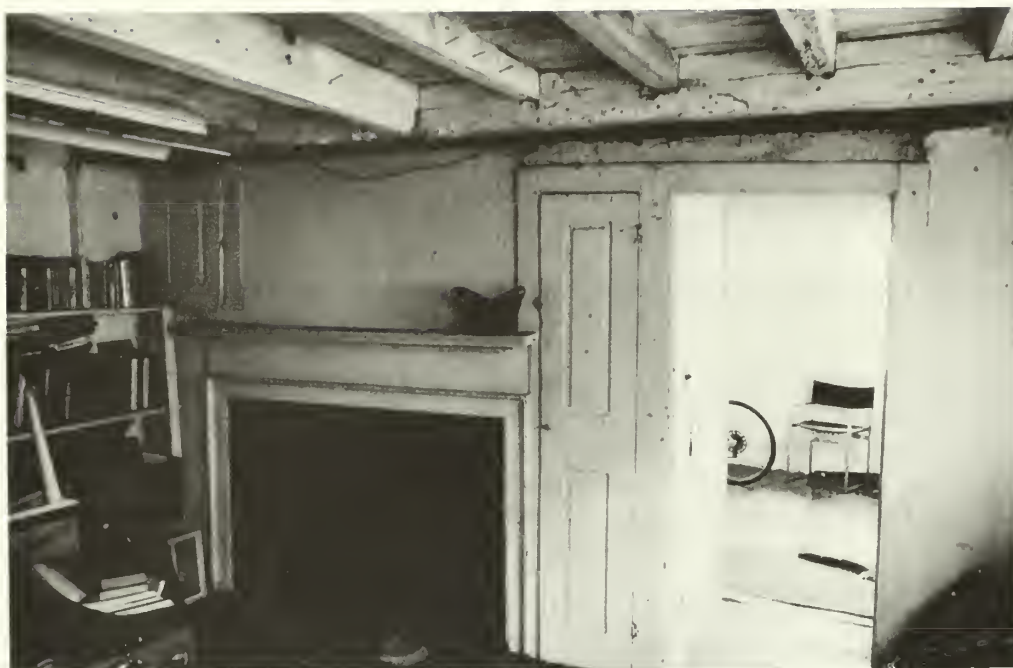
6. An early pegged-braced structural system, fireplace with bee-hive oven, and cupboards are shown. If the extant, significant interior had not been factored into the evaluation to offset extensive loss of exterior materials, overall preservation requirements for Part 2 would not have been satisfied.

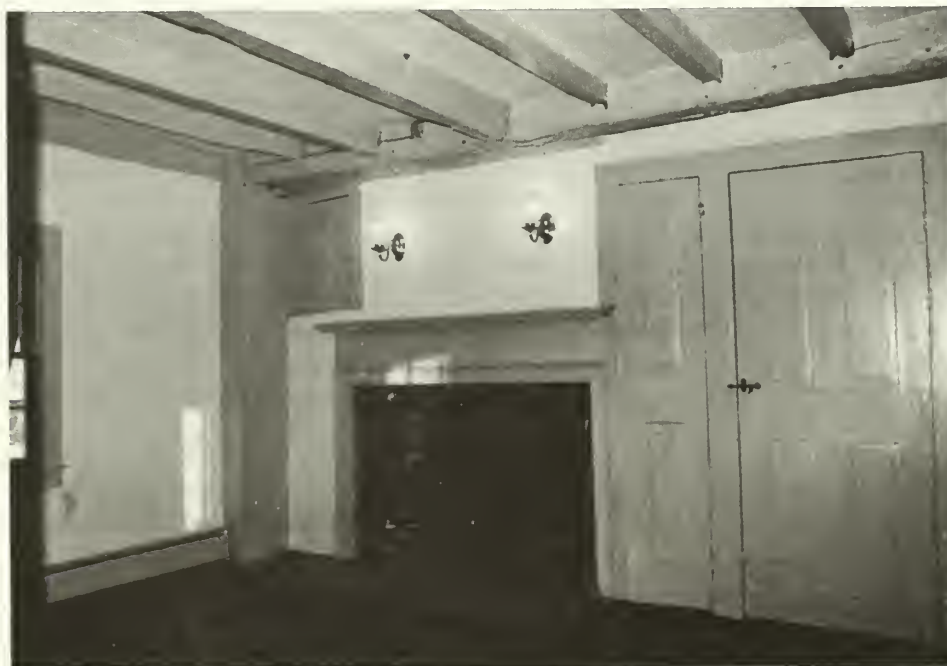
7. The same room shown above after completion of the work. On appeal, it was concluded that the building's highly significant interior, including materials, features, spaces, and an early structural system had been identified prior to rehabilitation, then carefully retained and preserved.

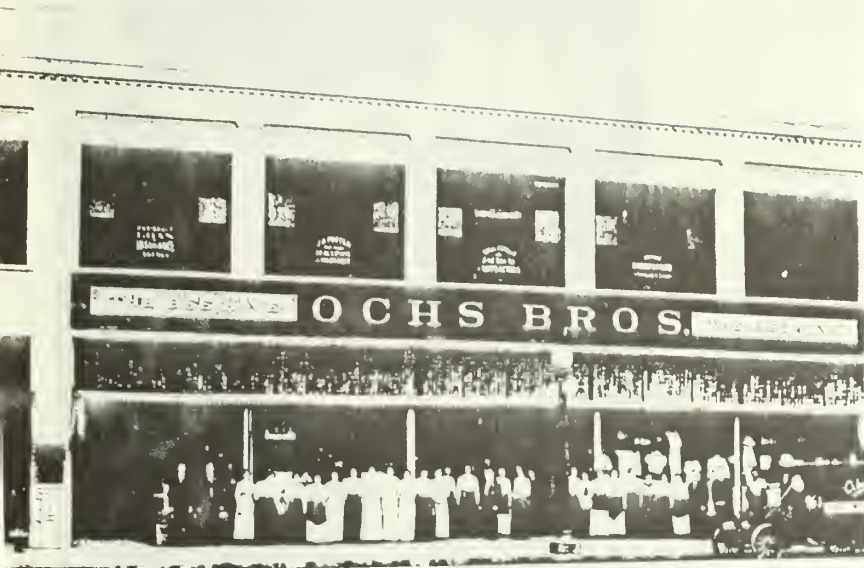
1. Early 1900s photograph of the Ochs Building shows the storefront in its historic design prior to a series of renovations, the last of which totally obscured the facade.

Application: Part 1 certification was requested for a two-story masonry building in a historic district. A photograph of the 1908 department store (see illus. 1) was submitted together with photographs of the existing appearance. In its current condition, however, it did not convey historic, architectural, or cultural

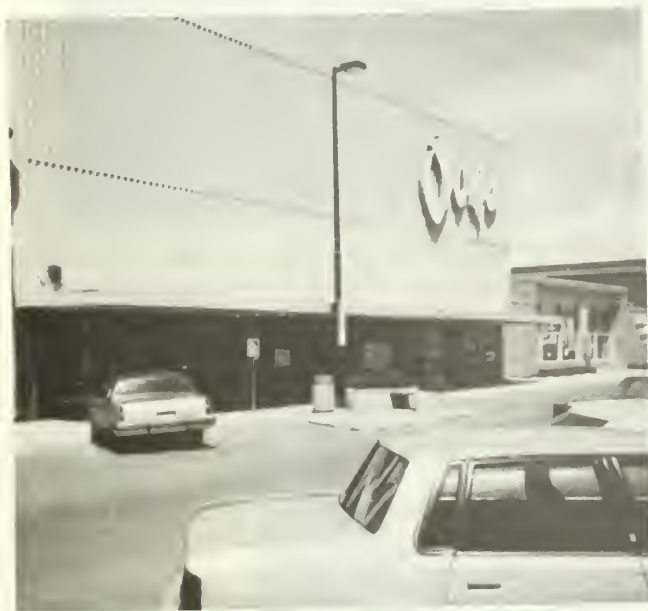
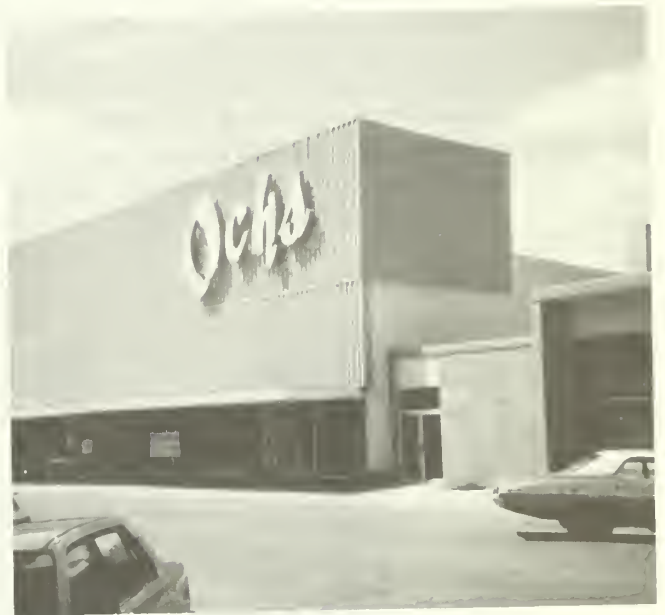
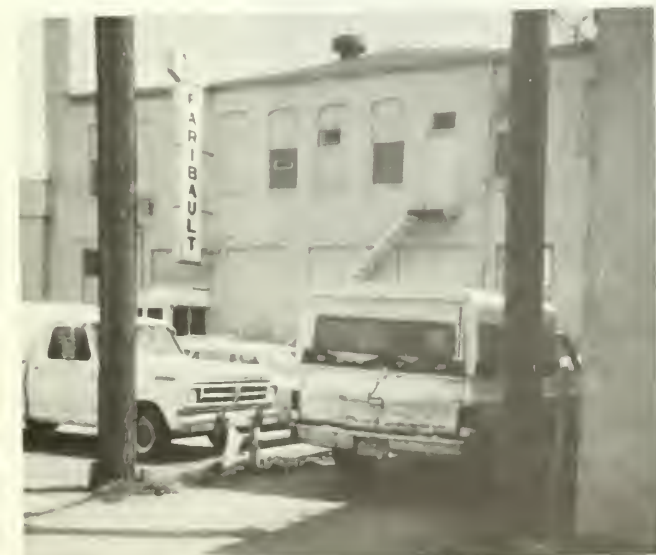
2, 3, 4. The department store shown as submitted for Part 1 evaluation, with a false front obscuring the primary elevation and enamelled metal squares covering the secondary elevation. A photograph of the rear elevation showed a portion of the building's historic material that had not been obscured. This elevation, however, was not of any particular architectural or historic significance.

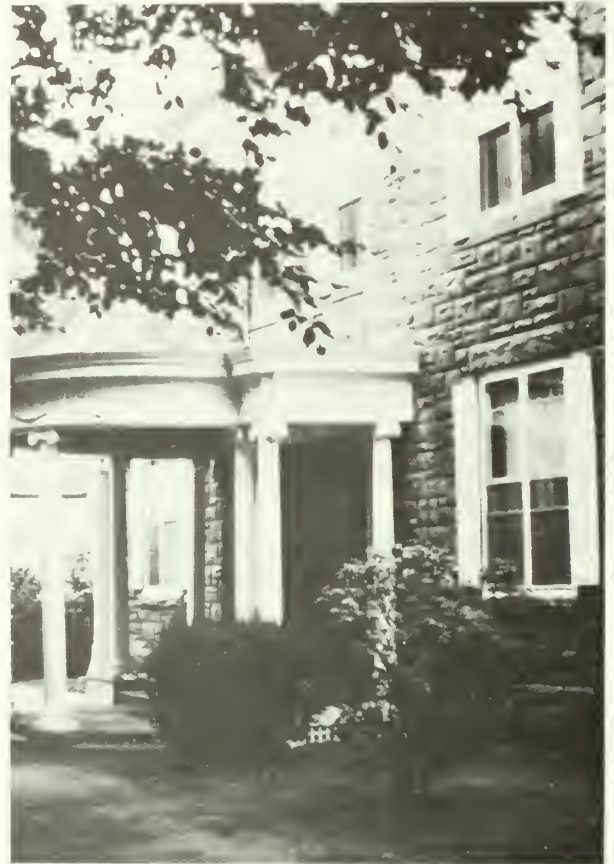
5. A photograph of a portion of the primary facade reveals a highly decorative porch, but also shows the nonhistoric concrete veneer, and aluminum sash and shutters.

In a second case, an owner submitted a Part 1 and Part 2 application with photographs of a 2 1/2 story, hip-roofed, frame and masonry building in a tree-lined district of similarly scaled residences. Photographs and a narrative explained that the building had been covered with a concrete veneered covering, and that the wood window sash and shutters had also been replaced with new aluminum "features" (see illus. 5). It was acknowledged in the application that these changes to the building did not contribute to its overall architectural appearance and historic integrity. Documentation also included several photographs of the interior showing raised paneling, parquet floors, tiled fireplaces, and intricate plaster cornice moldings and, in fact, the application emphasized the interior's significance.

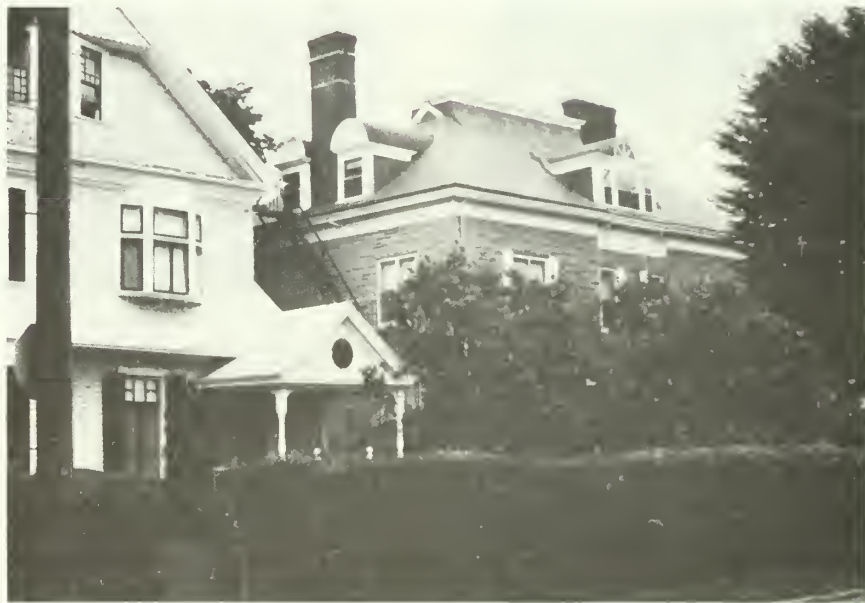
6. The building is shown here on the right in relationship to another building in the district. Although the historic wood sheathing has been obscured with formstone that is heavy and gray in appearance, the surviving physical characteristics of the rest of the building were sufficient to convey historic and architectural significance. This includes the roof shape and materials, and a decorative cornice and portico. Part I was issued. In the rehabilitation, the concrete veneer was simply patched and retained as part of overall work.

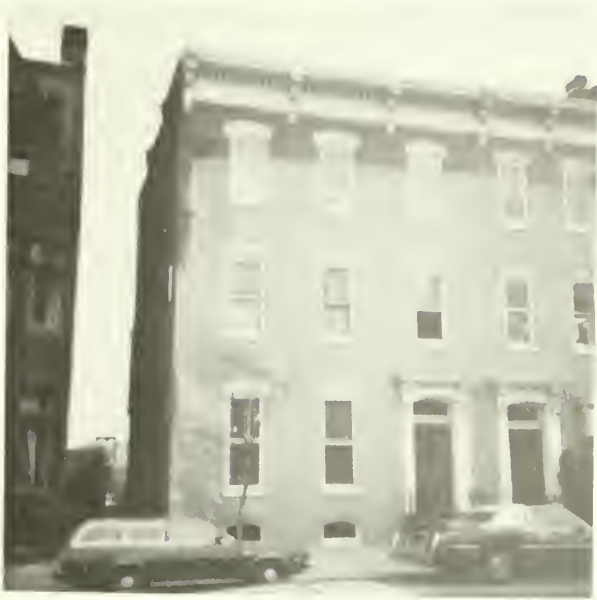
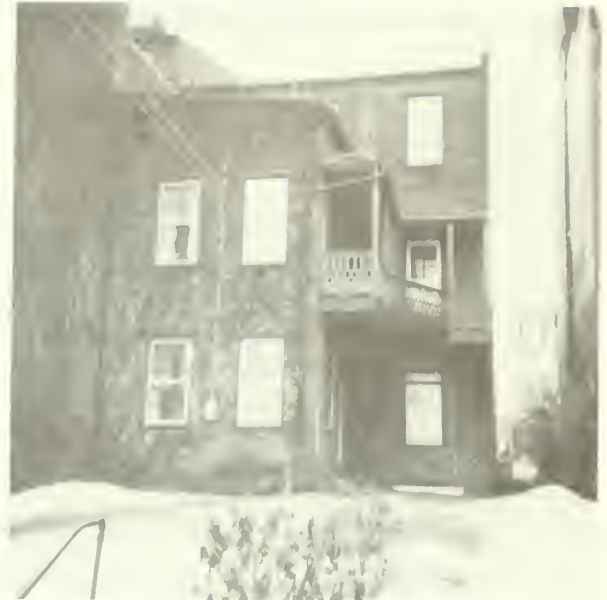
1, 2. The 3-story brick rowhouse, front and rear elevations, prior to conversion into a dress shop. Although many rear elevations are not particularly distinctive, this one featured a second story gallery and brick kitchen wing that were characteristic of the rear elevations of other residences in the district. Demolition of the wing and gallery preceded construction of a massive new addition that interrupted the former visual unity of the neighborhood.

Rehabilitation of the building essentially involved work to convert the residence into a dress shop. The owner felt that the existing interior space was inadequate for the retail operation, and, as a result demolished the historic rear ell and two-story porch preparatory to building a much larger addition in its place (see illus. 3).

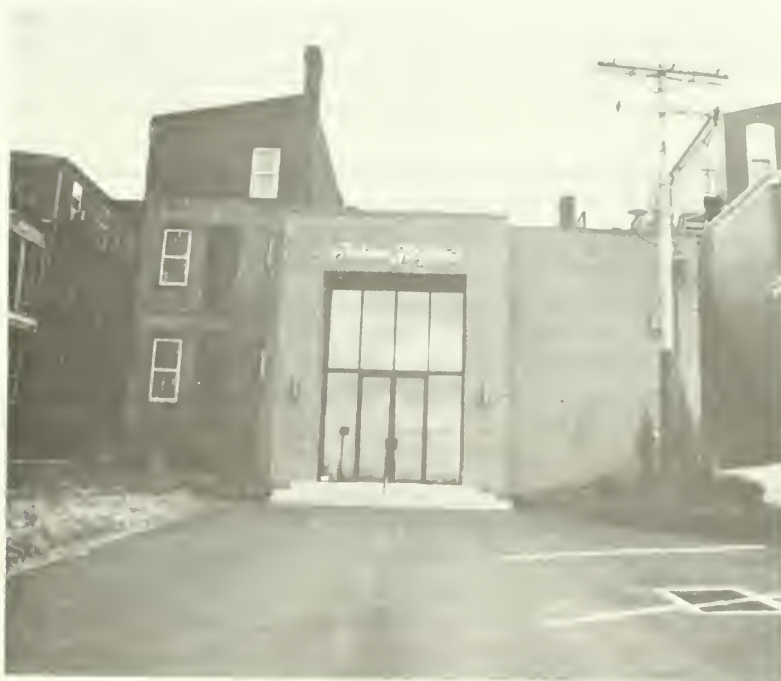
3. Completed work, rear elevation. The project was denied, largely based on demolition of the rear wing and porch and construction of a large addition that changed both the exterior form and interior plan.

The historic rear wing and second-story porch were demolished due to alleged severe structural deterioration; the extent of deterioration, however, was not substantiated in the course of the meeting. Furthermore, the design of the new rear wing is not compatible with the building or the district. In mass, proportion, and scale it differs drastically from what was there before and stands as an intrusion in the texture of the neighborhood, the character of which can be appreciated from the rear parking lots as well as from the street. The addition of this wing also resulted in significant change in the spatial arrangement of the first floor interiors. Accordingly, despite some exemplary preservation of interior details, I have found that the work does not satisfy the "Standards for Rehabilitation."

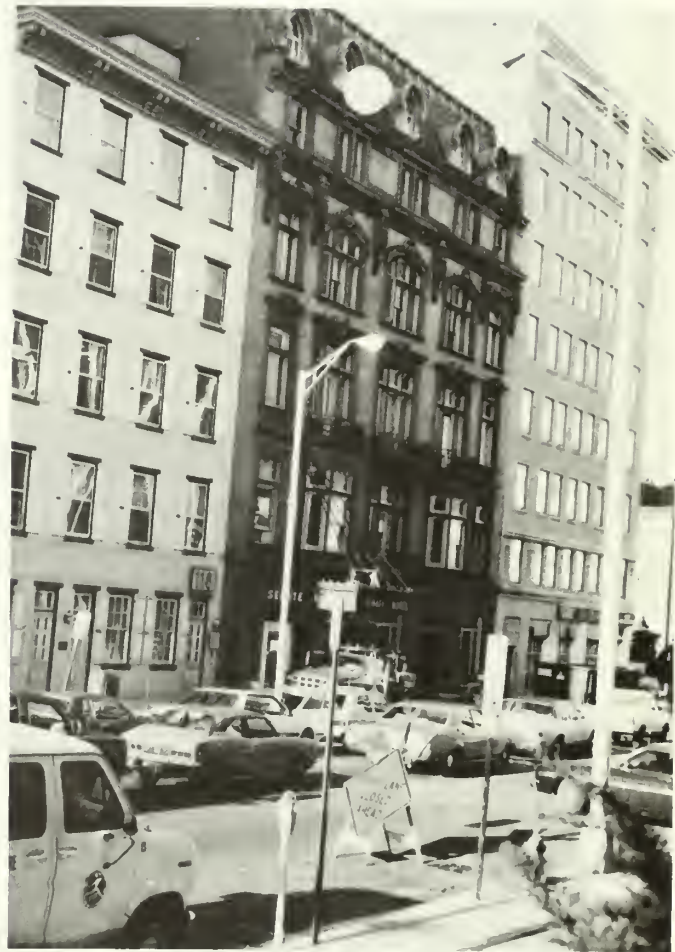
2. During rehabilitation into an office building the first floor is being reconstructed according to the original architectural drawings.

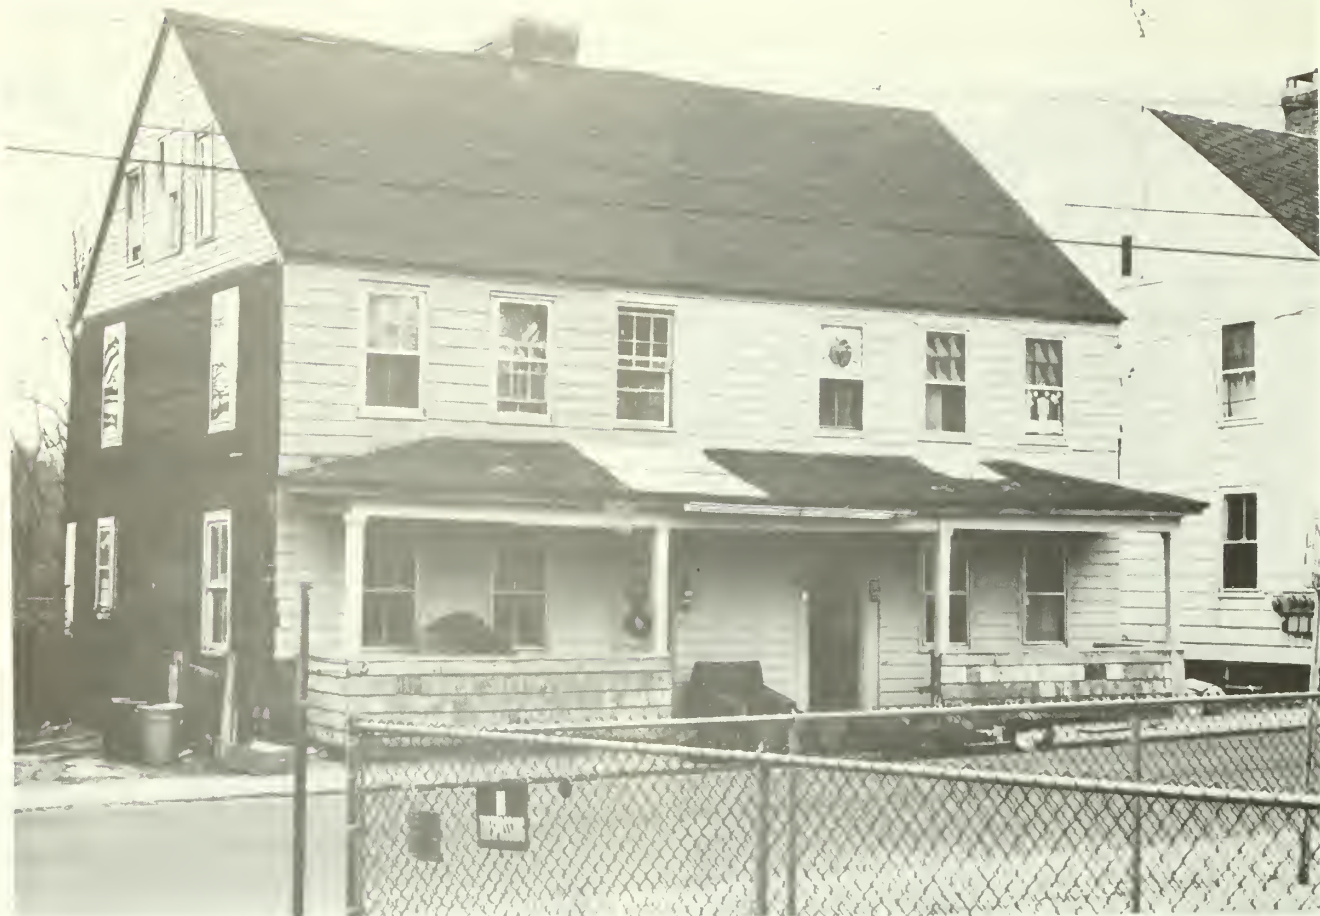
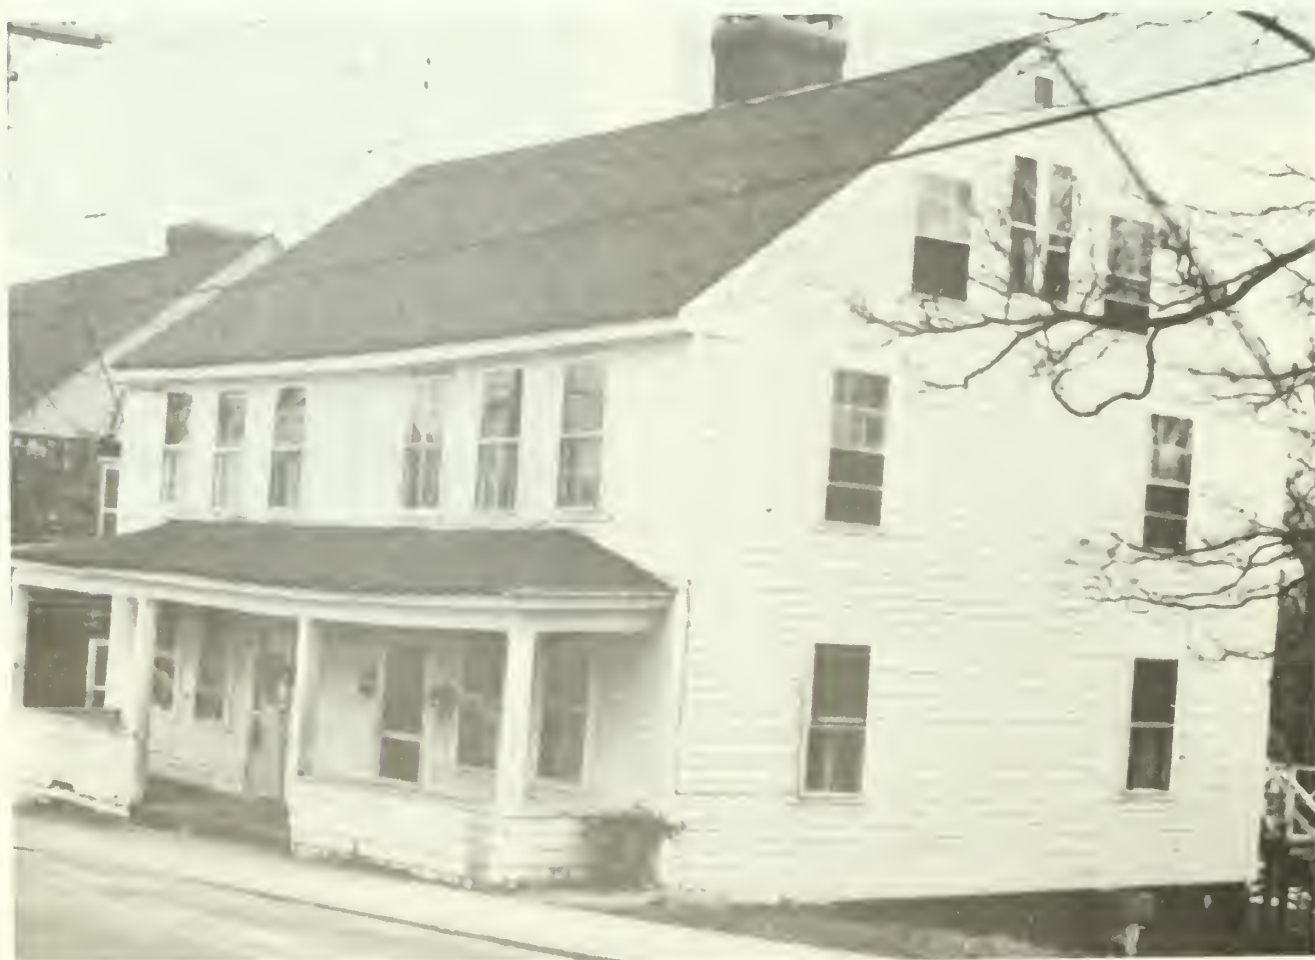
3-4. The two houses before rehabilitation. Because the porches were added after the historic district's period of significance, their removal was one option.

The owners appealed the regional decision, because they felt the rehabilitation met the Standards. At the appeal meeting the owners defended removal of the porches on the basis that the porches were poorly constructed of inappropriate materials which at the time of the rehabilitation were found to be too deteriorated to repair, and not of sufficient quality or workmanship to retain. Most importantly, however, research had revealed the fact that the porches in question were first depicted on the Sanborn insurance map of 1926, but did not yet appear on the map of 1914. Thus, the maps clearly showed that the porches had been built in the twentieth century, outside the period of significance of the district.

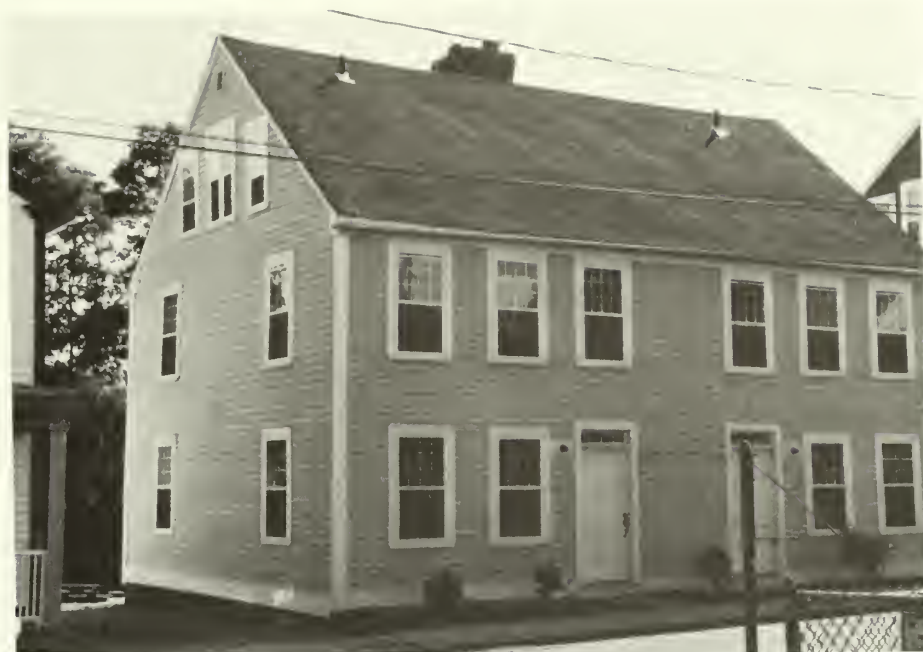
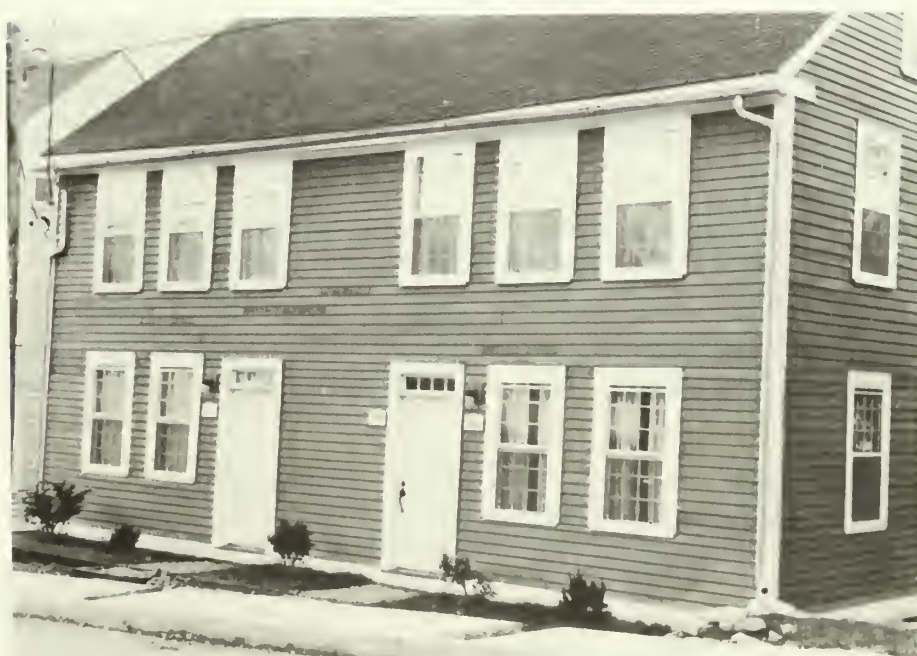
5-6. The two houses after rehabilitation, their porches removed to reveal the original early nineteenth-century character. (Twelve over twelve window replacement was based on remaining original sash still extant in several of the third floor windows.)
