Technical Preservation Services
Preservation Assistance Division
National Park Service
U.S. Department of the Interior
Washington, D.C.

Interpreting
the Secretary of the Interior's
Standards for Rehabilitation

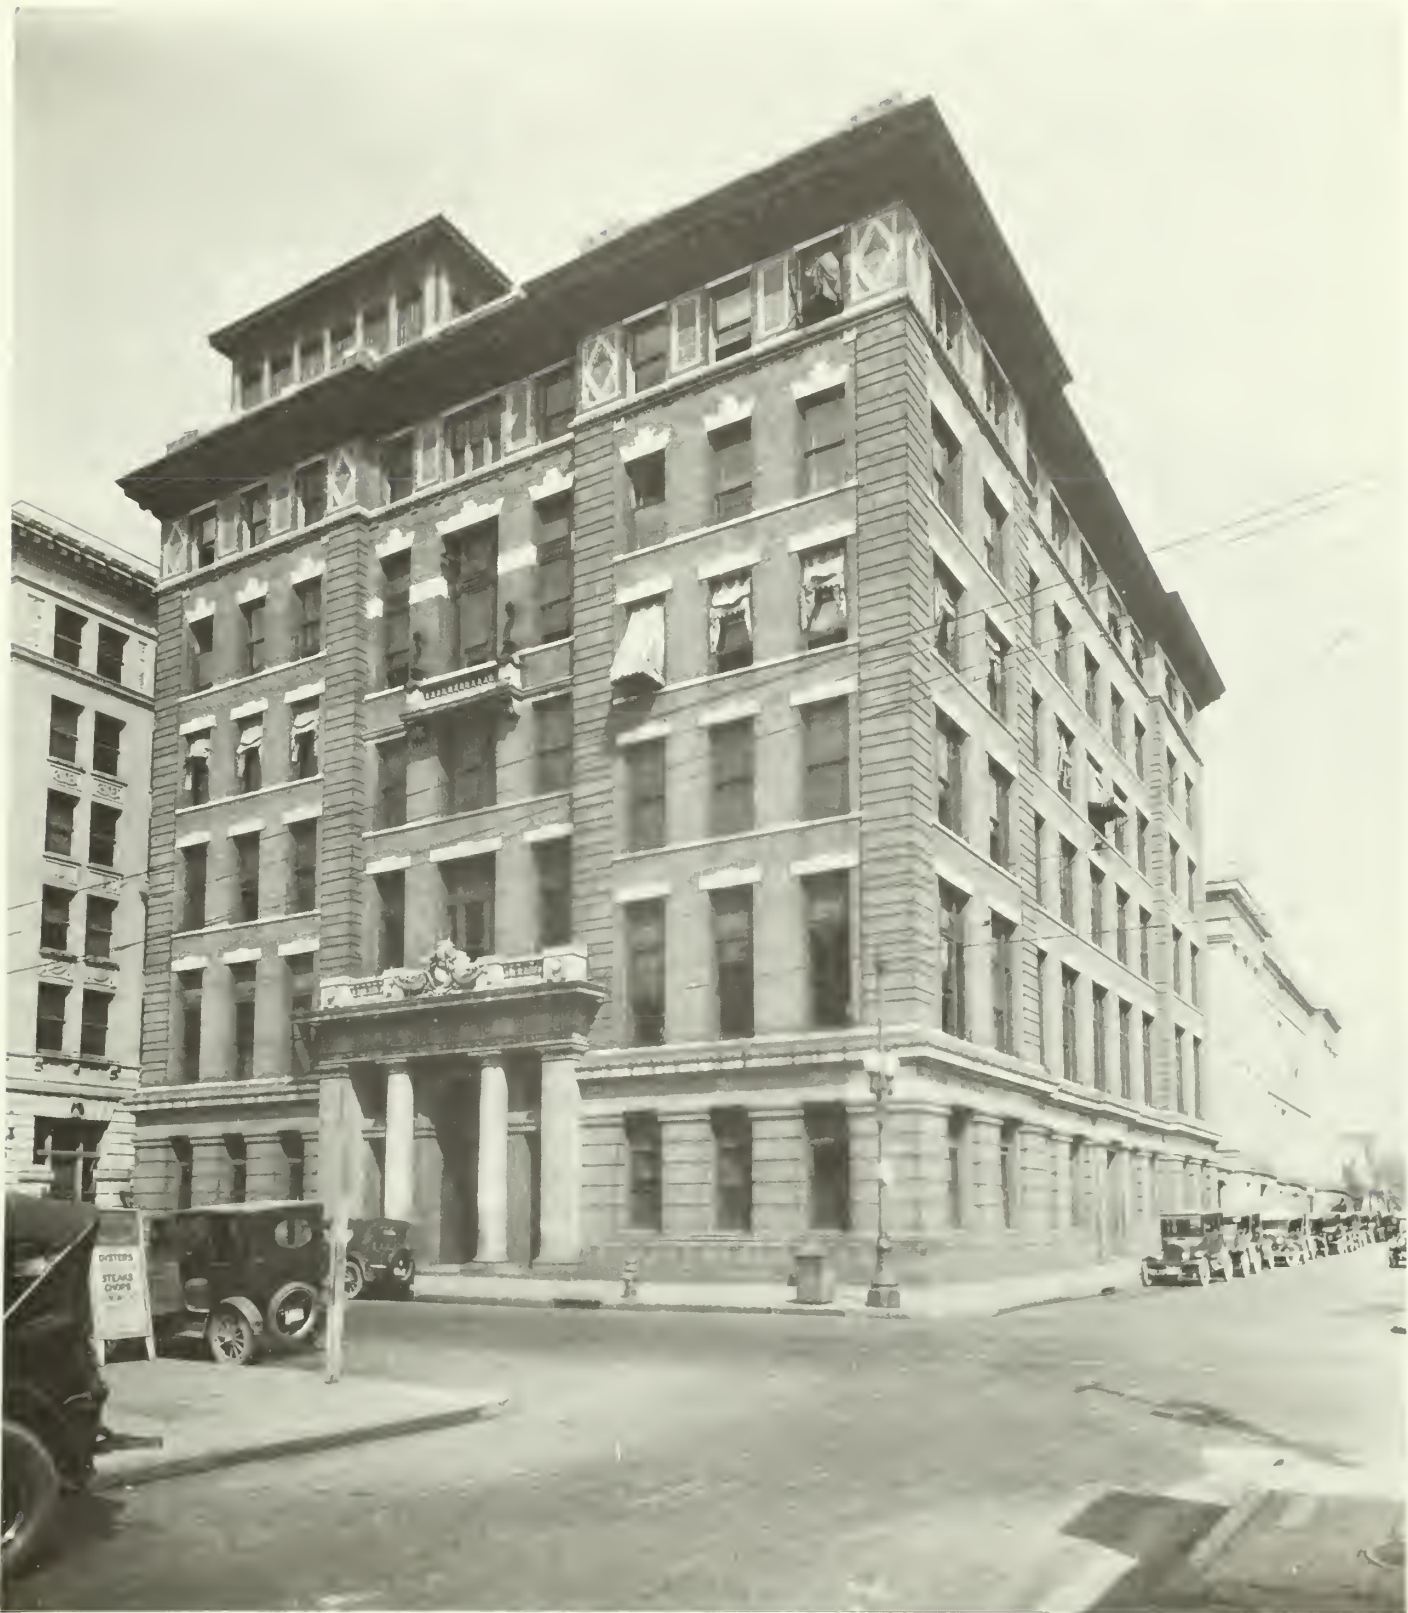
1. This former City Hall, shown here in a 1925 photograph, has changed little over the years on the exterior with the exception of an old rooftop addition off to the left. The building has a prominent corner location and is highly visible not only at the intersection of two busy thoroughfares but also from down the streets as well.

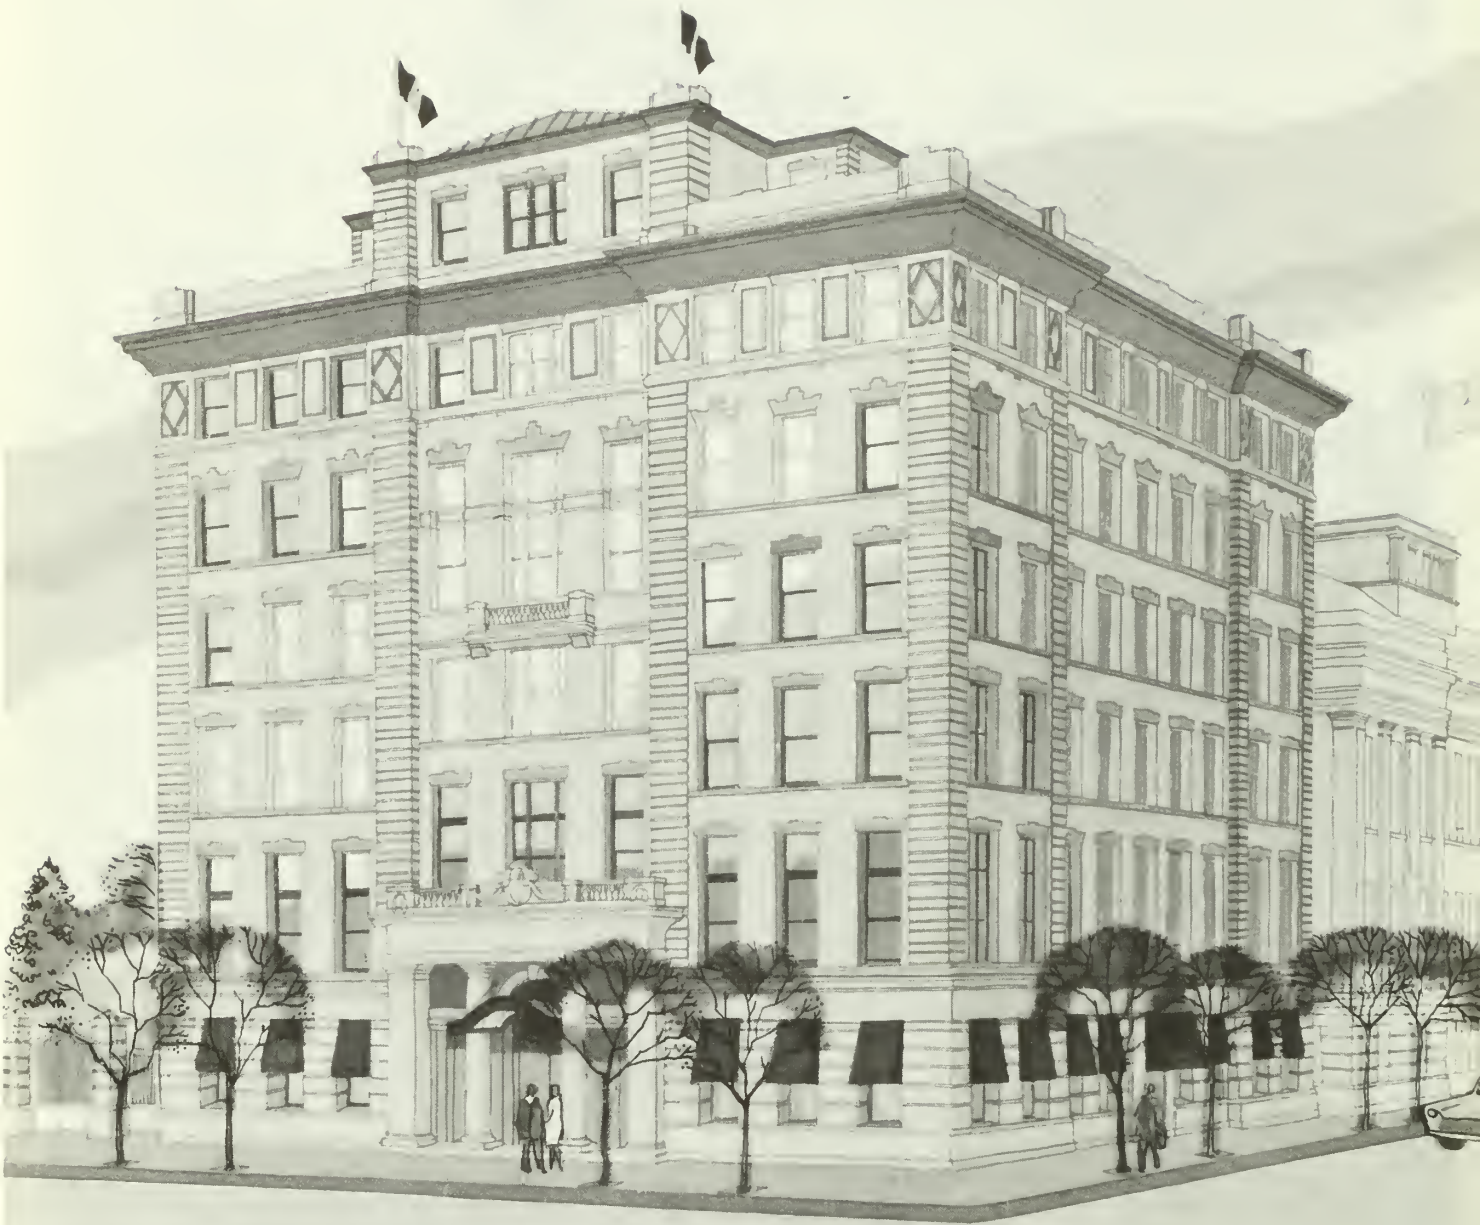
2. The proposed penthouse addition with the three bay portion across the front was determined not to meet the Standards for Rehabilitation. The change in the form of the building; the conscious attempt to tie the addition to the historic building through use of replicative detailing; and the alterations to the historic roof balustrade, were all factors cited by the National Park Service.

Issue: Rooftop additions proposed for larger urban buildings raise certain preservation issues. First, there is the concern over material loss -- to what extent significant historic features such as cornices will be altered and how much of the roof system and the building's structural framework will be altered, damaged, or destroyed. A second preservation issue is the visual impact of the addition on the historic character of the building. The size, scale, material, color and detailing of the proposed addition may individually or collectively impact other distinctive historic qualities of the building. Finally, an addition is often designed so as to appear to be an important and integral part of the historic design -- a treatment which can compromise the historic character of the structure and as a result preclude the project from obtaining certification of rehabilitation.

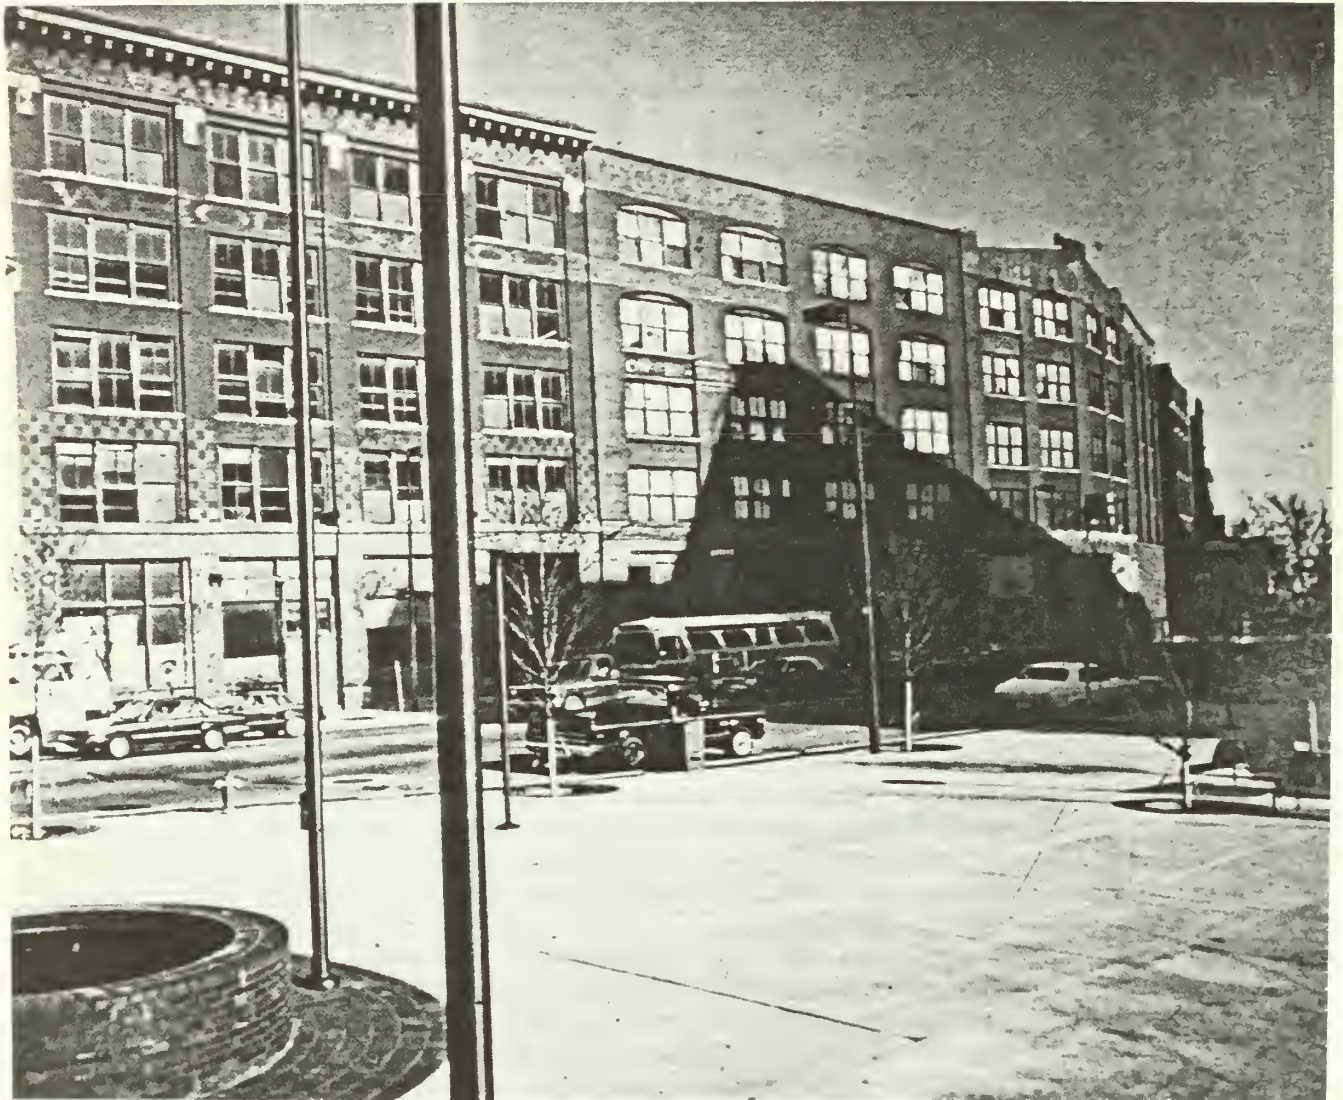
1. Case No.1: This view is looking south along the major street. Note the bend in the warehouse row as the buildings follow this road. This two block row of eight buildings is the last remaining row of industrial warehouses in the city.

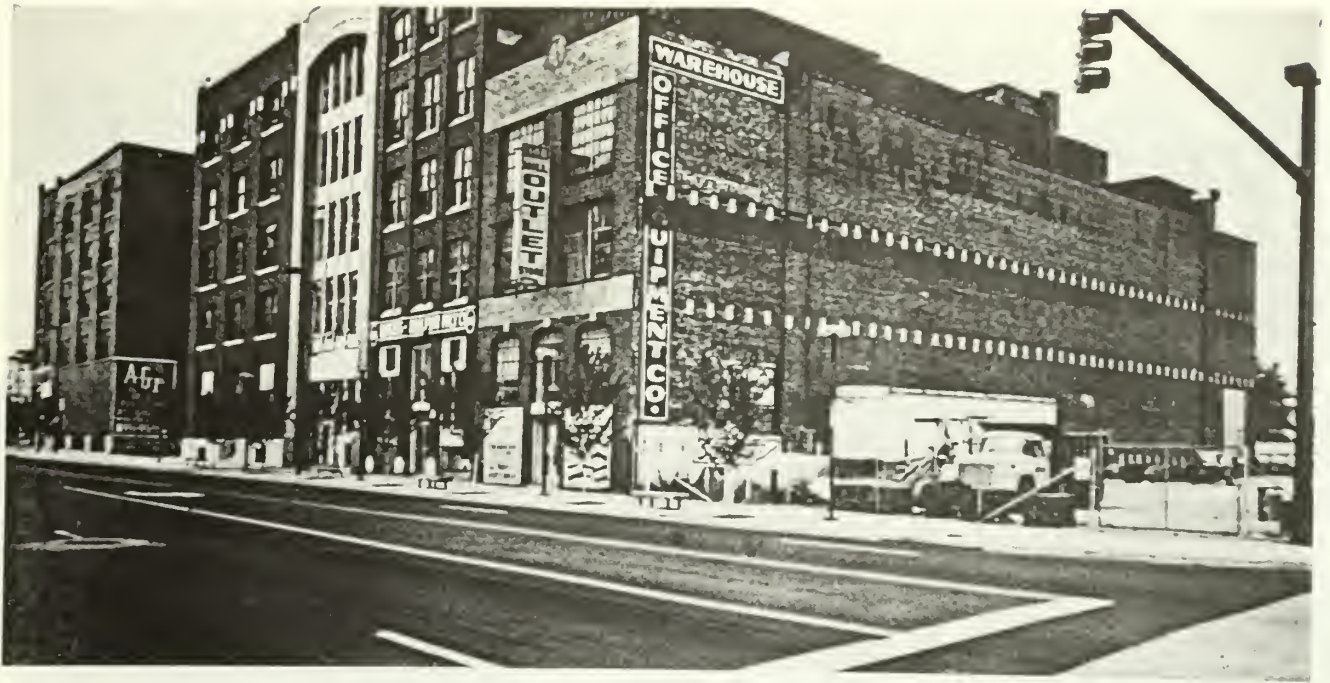
2. This view of a portion of the historic district is looking north. Note the road which divides the district into two blocks. This is the site of the proposed new addition and "pedway."

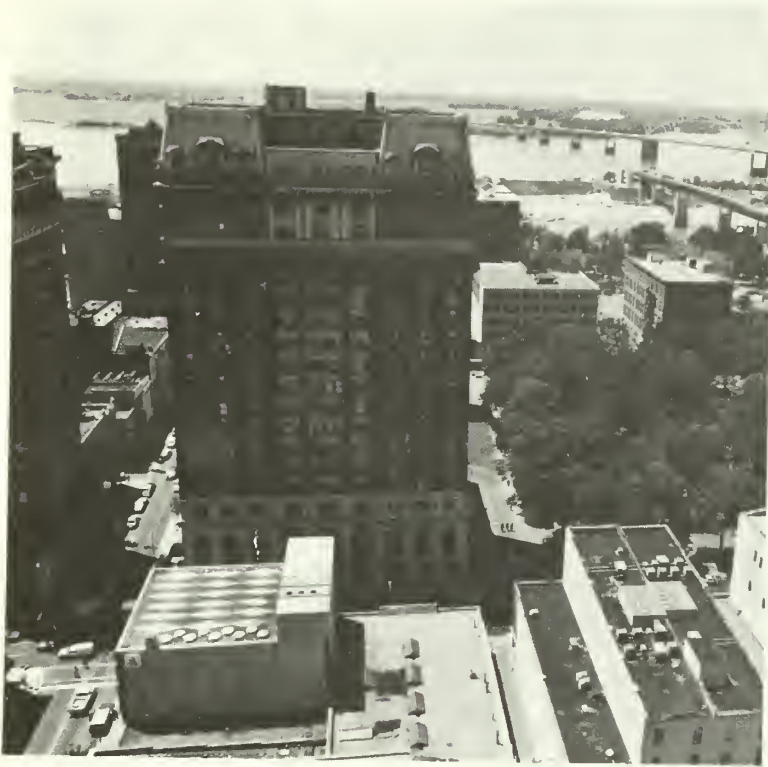
4. Case No.2: This 20-story building is individually listed as well as being located within a registered historic district. The proposed "pedway" would enter the arched window in the limestone base four bays from the corner closest to the park.
