OFFICERS CLUB BUILDING No. 114

HISTORIC STRUCTURE REPORT

Sandy Hook Unit Gateway National Recreation Area

James J. Lee III
Architectural Conservator

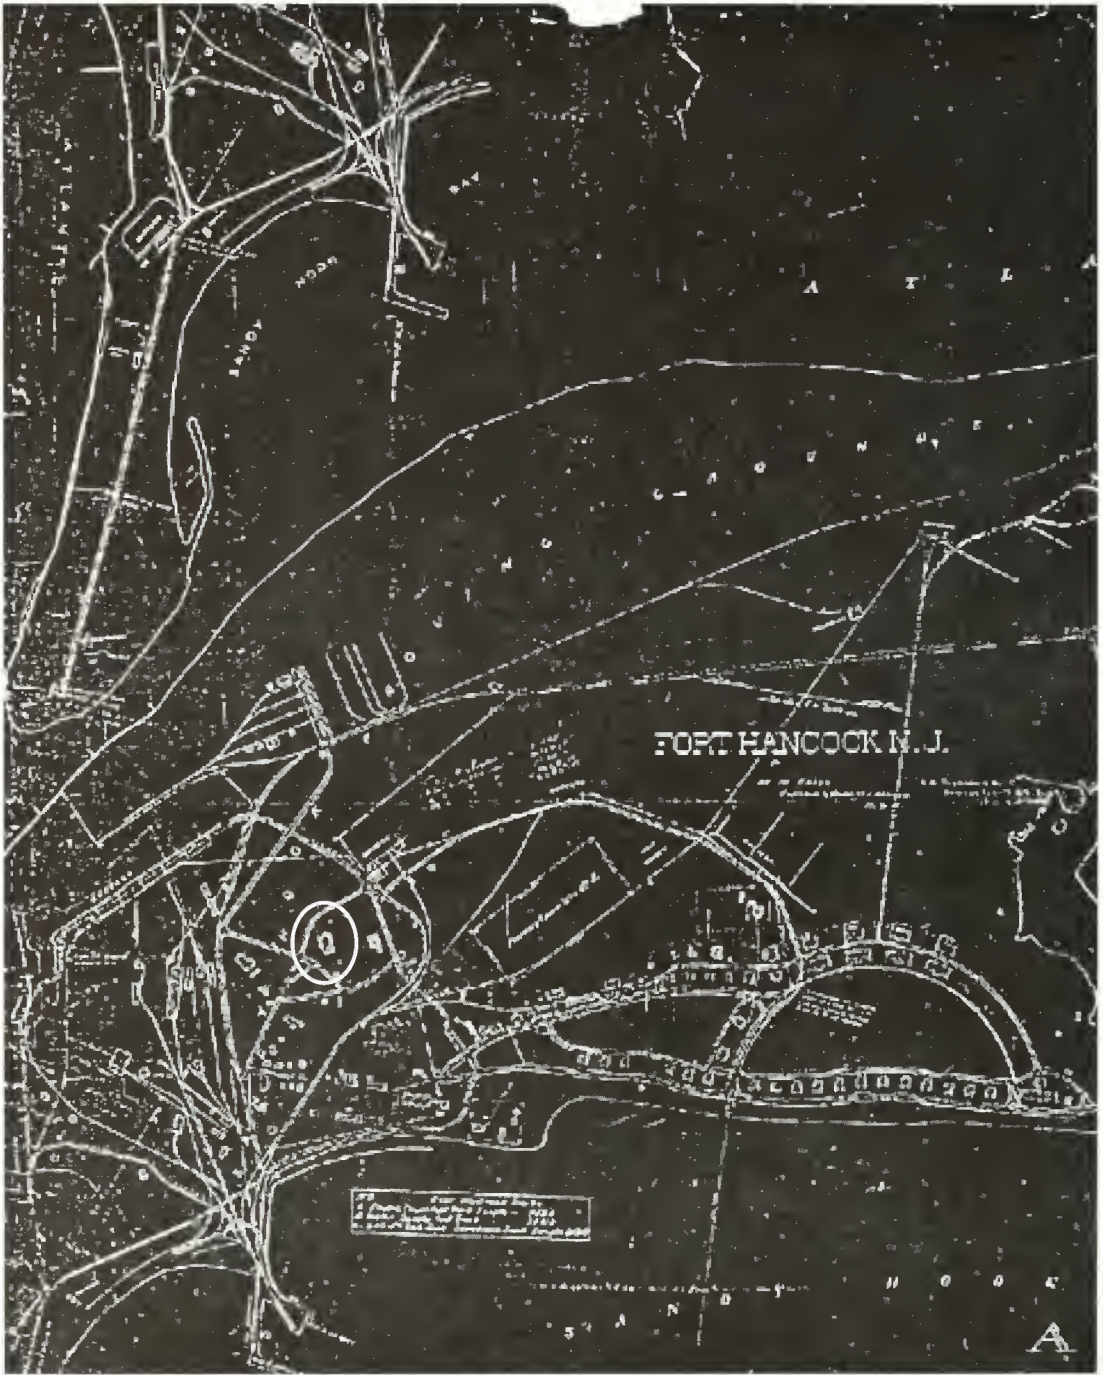
Figure 9. Map of Fort Hancock, March 21, 1908; Officers Club is indicated with a circle.

The completion of the Sandy Hook Mortar Battery in 1894 and Battery Potter in 1895 marked the first of many gun batteries constructed at Sandy Hook prior to World War I. During the period 1901- 1916, Fort Hancock was garrisoned by four to six companies of the U.S. Coast Artillery, whose job was the "care and use of the fixed and movable elements of land and coast fortifications, including the submarine mine and torpedo defenses."²⁸ In addition, the Coast Artillery and the National Guard held training, practice, drills, and exercises at the post.²⁹ Some 25 permanent buildings were added to the post during this period, as evidenced by period site plans and photographs (figs. 9- 10).

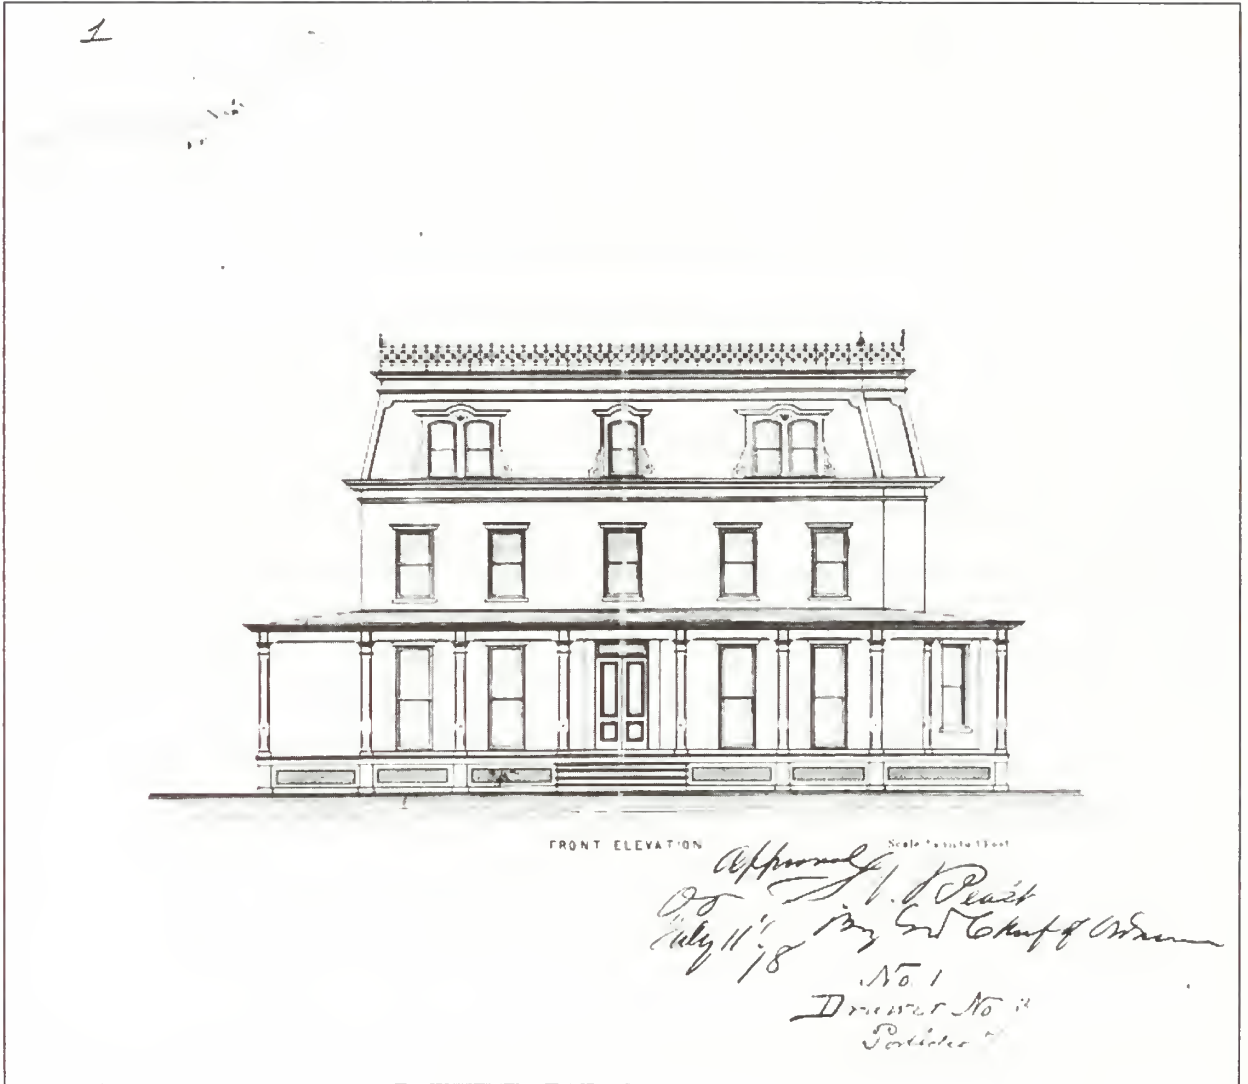
Figure 11. "Officers' Quarters," proposed front elevation plan, July 1878.

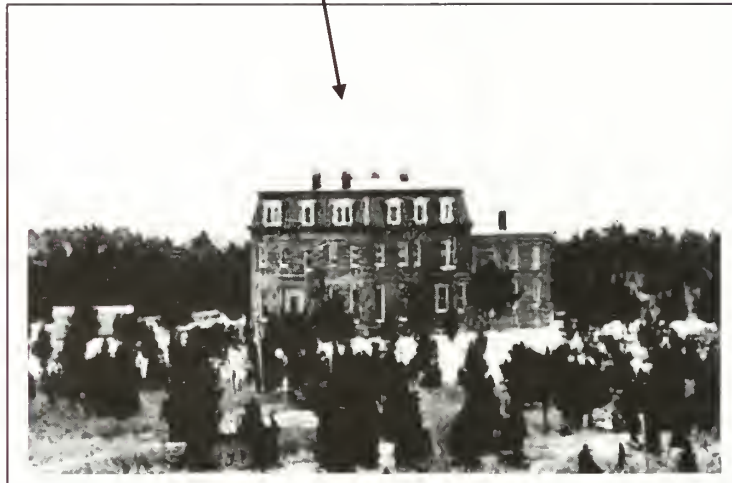
Figure 18. Detail of the Officers Club, north and east elevations; note the absence of the piazza.

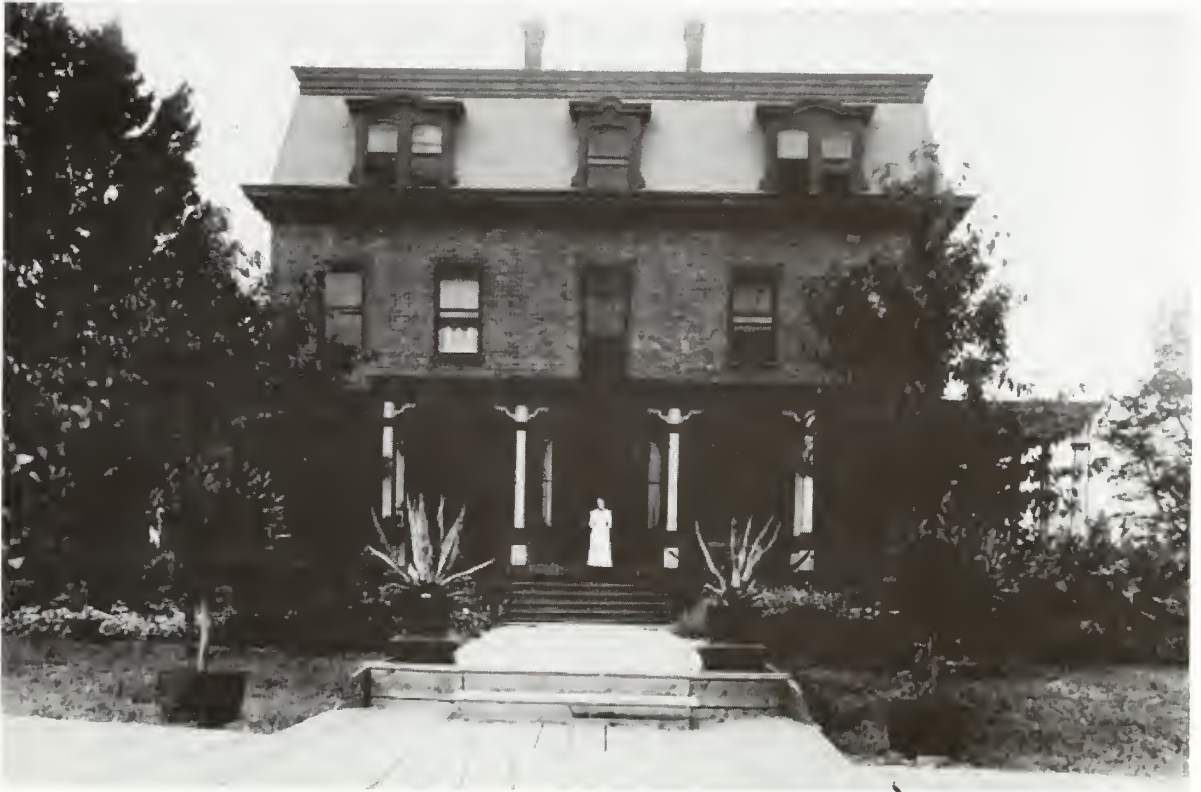
Figure 19. Officers Club, east/front facade, ca. 1900.

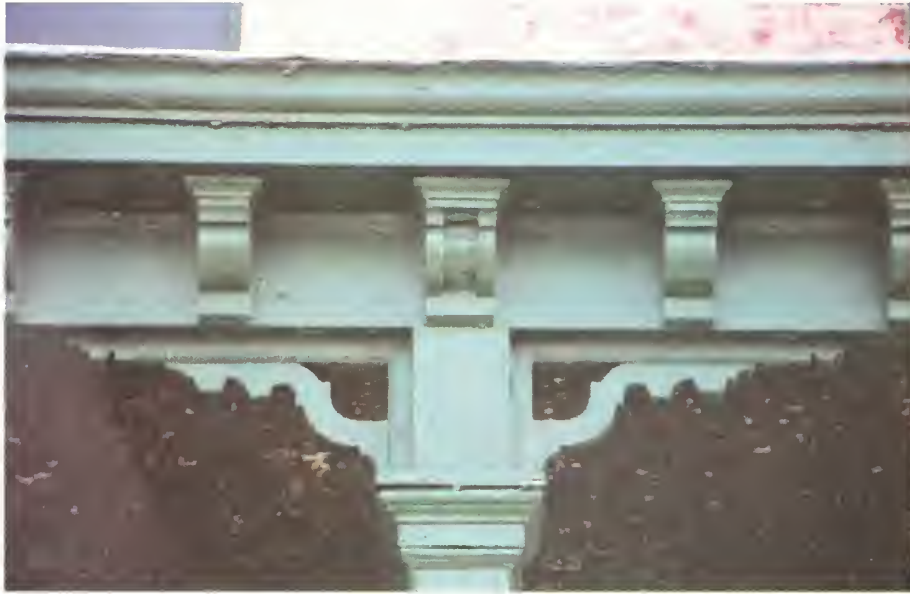
Figure 22. Officers Club, north elevation, piazza brackets, 2005.

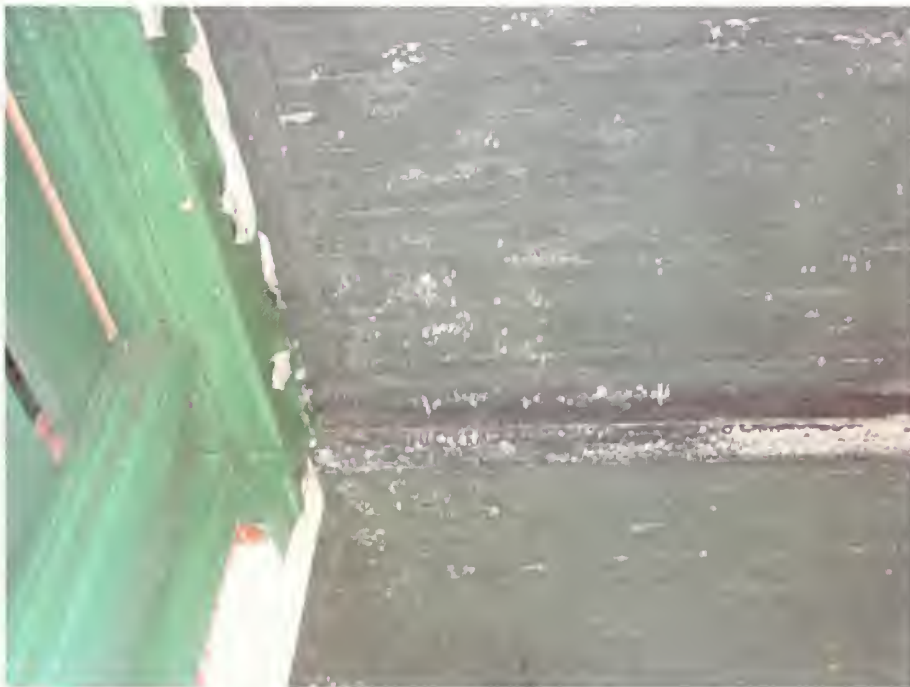
Figure 23. Officers Club, east façade , piazza ceiling, 2005.

23.	Officers Club, east facade, piazza ceiling. NPS photograph, 2005	57
24.	Officers Club, east façade, showing front entrance; detail from figure 19, circa 1900. Courtesy of Monmouth County Historical Association, George Moss Collection [84.17.7 (F 0- 8)].....	58

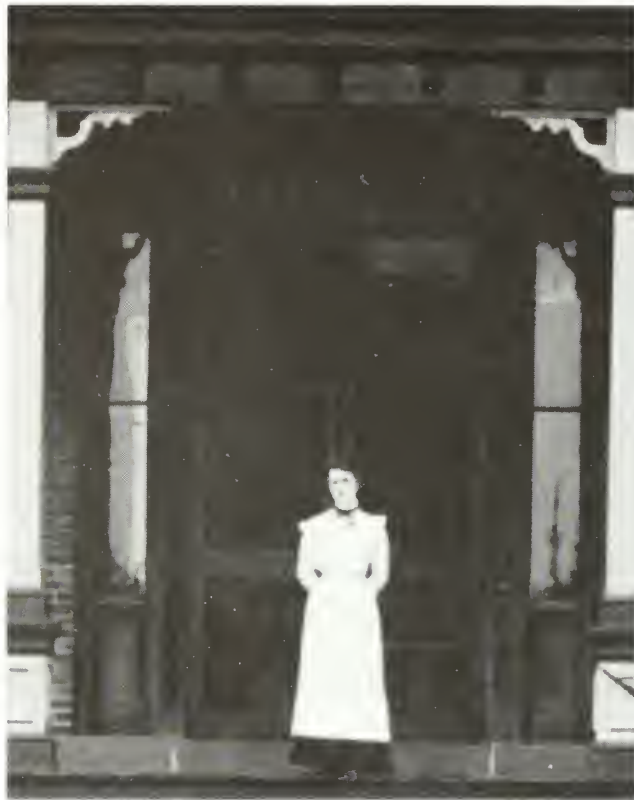
Figure 24. Officers Club, east façade, showing front entrance, ca. 1900.

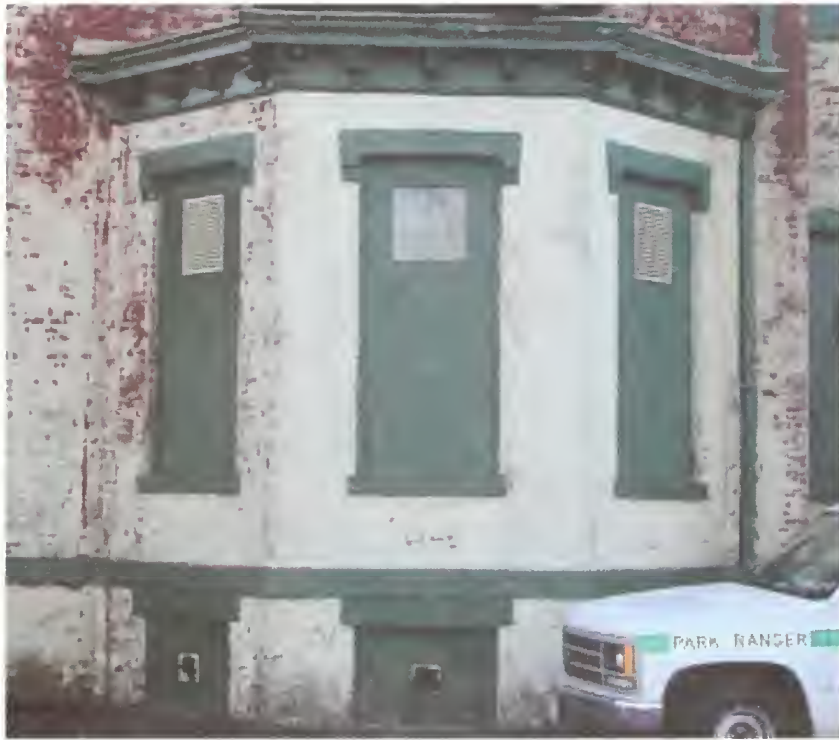
Figure 26. Officers Club, north elevation, bay window, 2005.

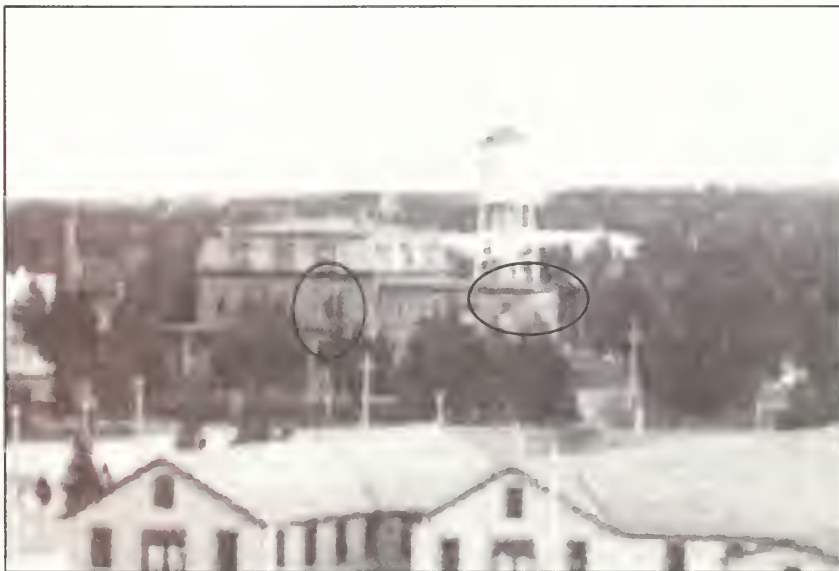
Figure 27. Officers Club, showing window openings, ca. 1904.

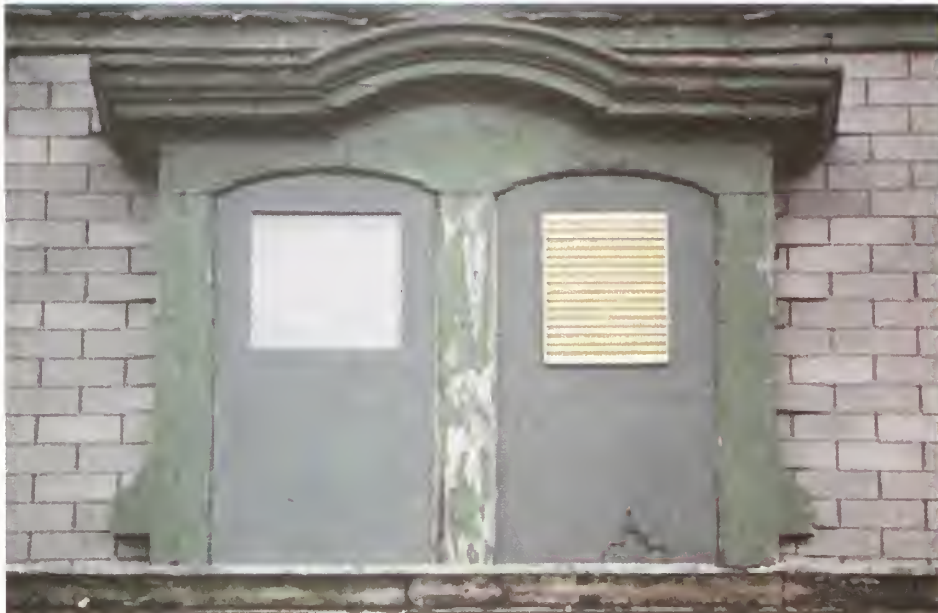
Figure 28. Officers Club, east elevation of mansard roof, showing dormer with paired windows, 2005.

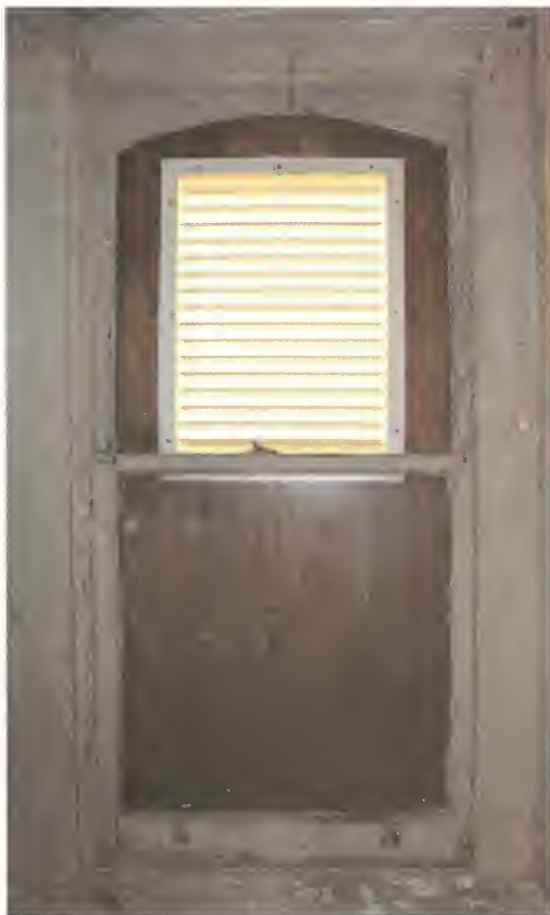
Figure 29. Officers Club, interior side of dormer sashes with arched top rail, 2005.

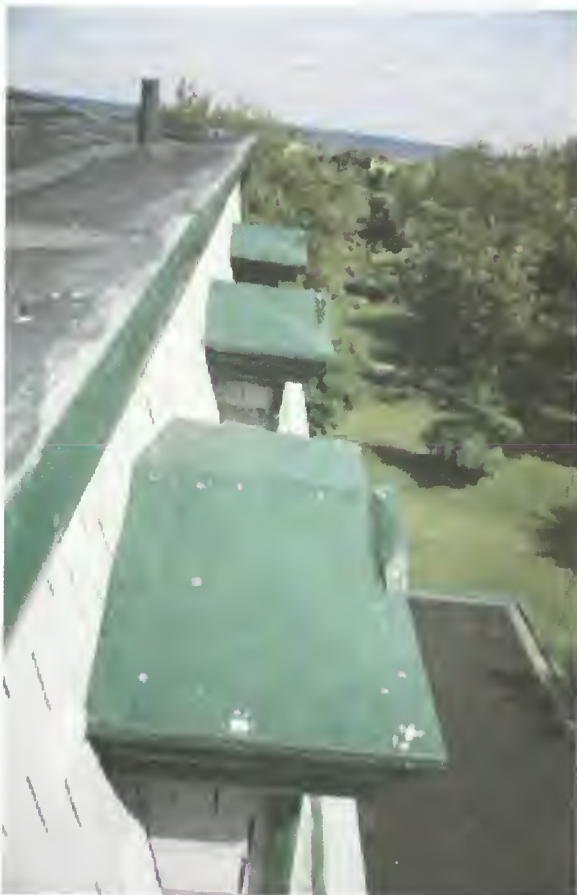
Figure 33. Officers Club, mansard roof, dormer roofing material, 1992.

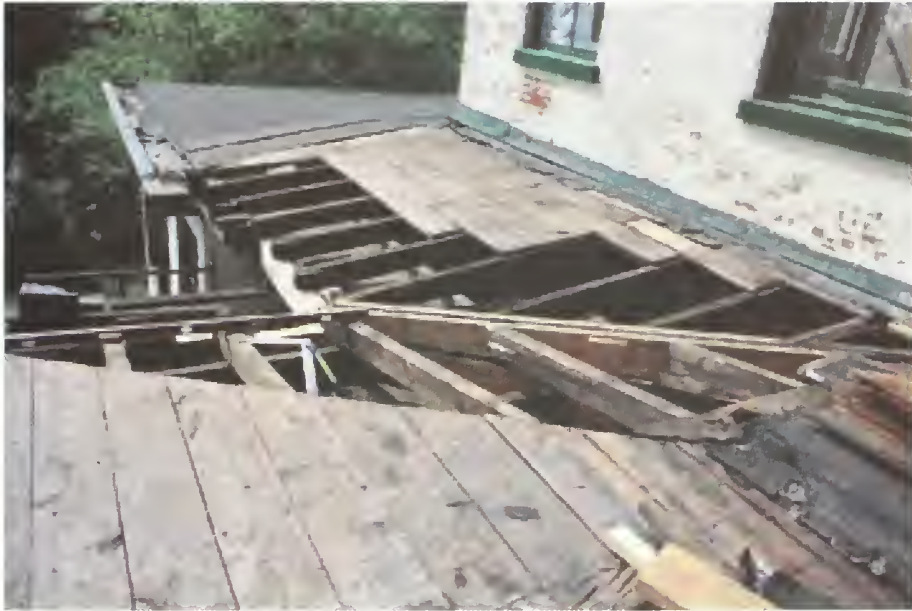
Figure 34. Officers Club, east façade, piazza roof, showing original framing and repairs, 1991.

34.	Officers Club, east facade, piazza roof, showing original framing and repairs. NPS photograph by C. Thomas Ballos, Sept. 1, 1991; from <i>Completion Report</i> , 1993	63

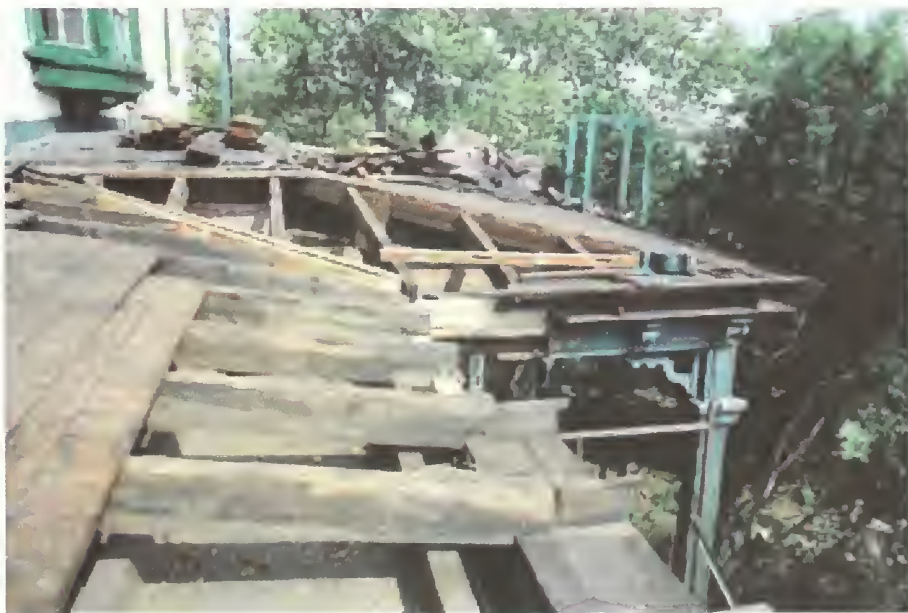
Figure 35. Officers Club, east facade, piazza roof, showing original framing with extended rafters for integral gutters.

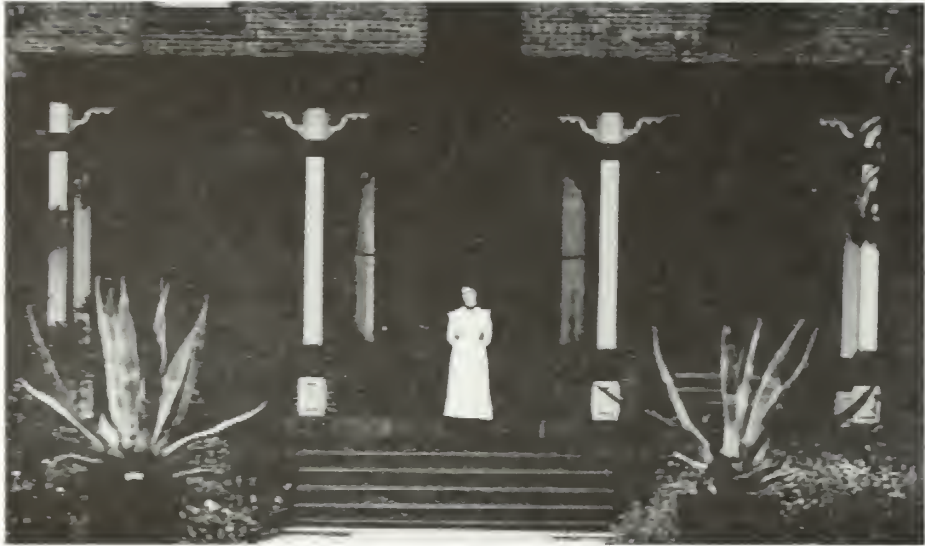
Figure 36. Officers Club. east- facade piazza. showing period paint scheme. ca. 1900.

36.	Officers Club, east- façade piazza, showing period paint scheme; detail from figure 19, circa 1900. Courtesy of Monmouth County Historical Association, George Moss Collection [84.17.7 (F 0- 8)].....	64

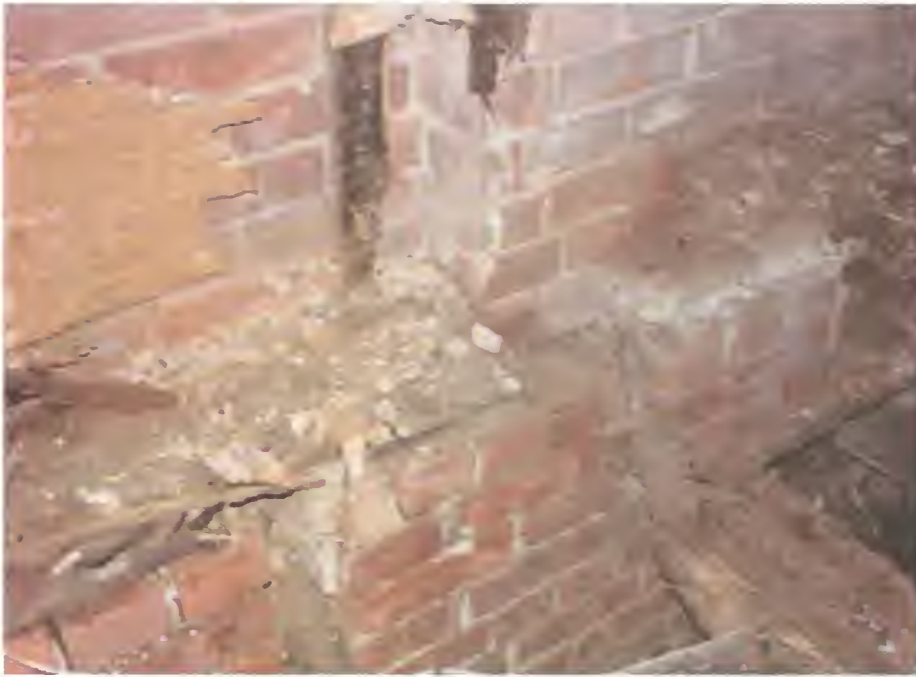
Figure 38. Officers Club, showing exterior bearing-wall construction at transition from first story to second story; also shows pockets in masonry for framing, 2005.

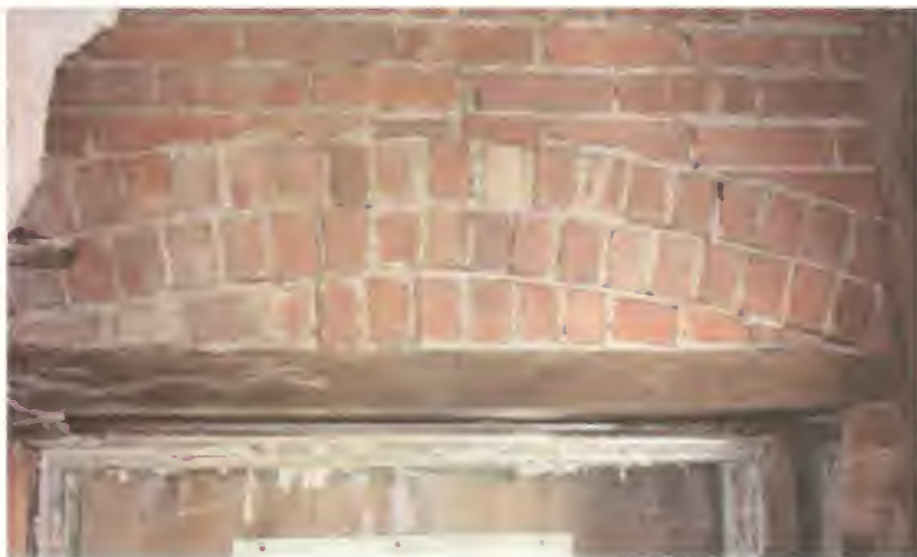
Figure 39. Officers Club, typical brick relieving arch above window opening, as seen from Ladies' Lounge (Room 103), 2005.

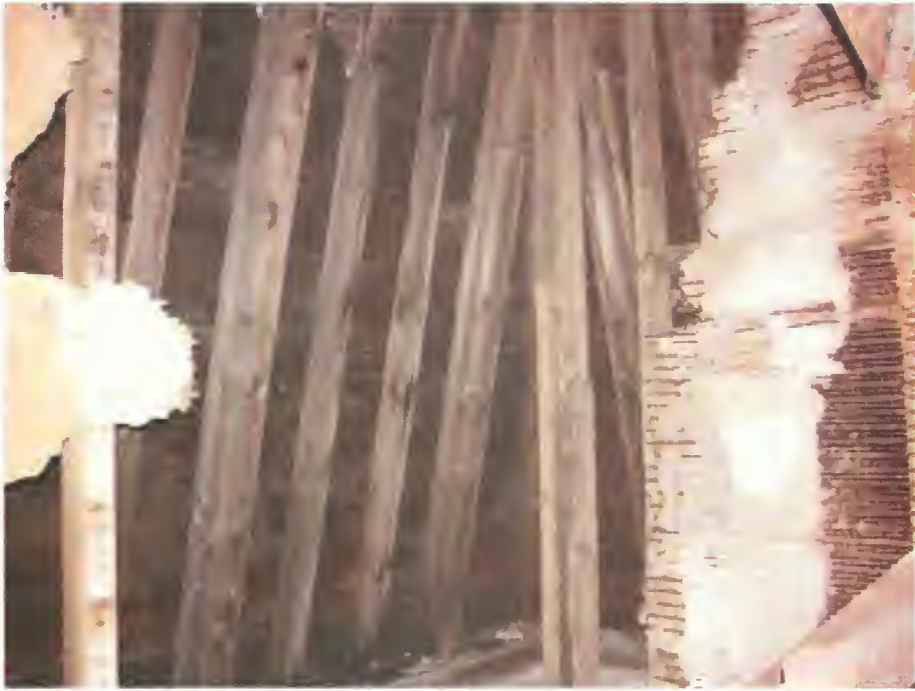
Figure 40. Officers Club, attic, showing framing of lower slope of mansard roof with alternating jack rafters, 2005.

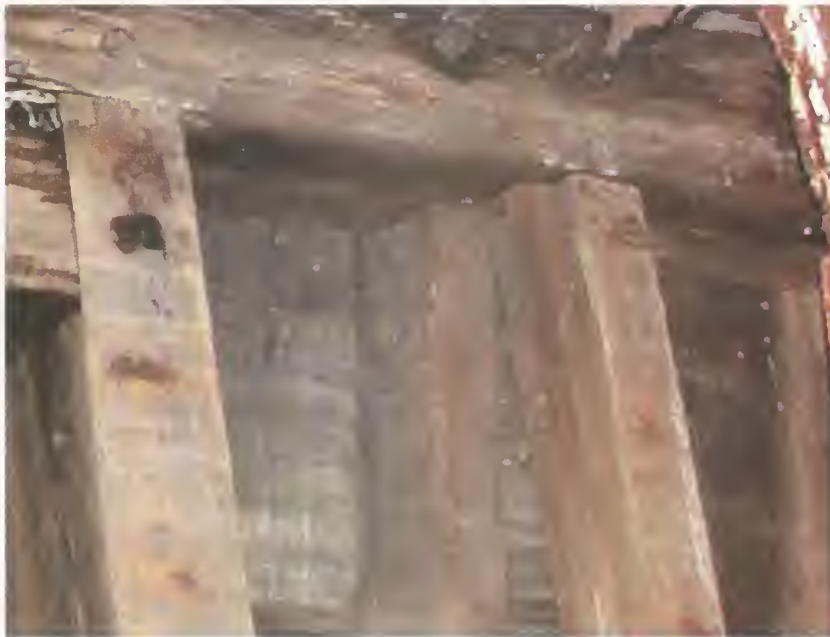
Figure 41. Officers Club, attic framing detail, showing joinery of wall stud and jack rafter into upper plate of mansard roof, 2005.

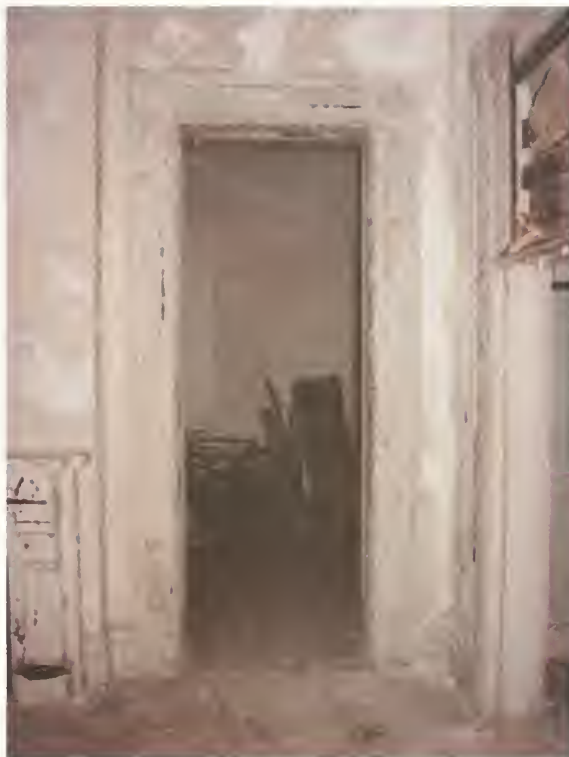
Figure 43. Officers Club, Ladies' Lounge (Room 103), looking south at typical doorway, 2005.

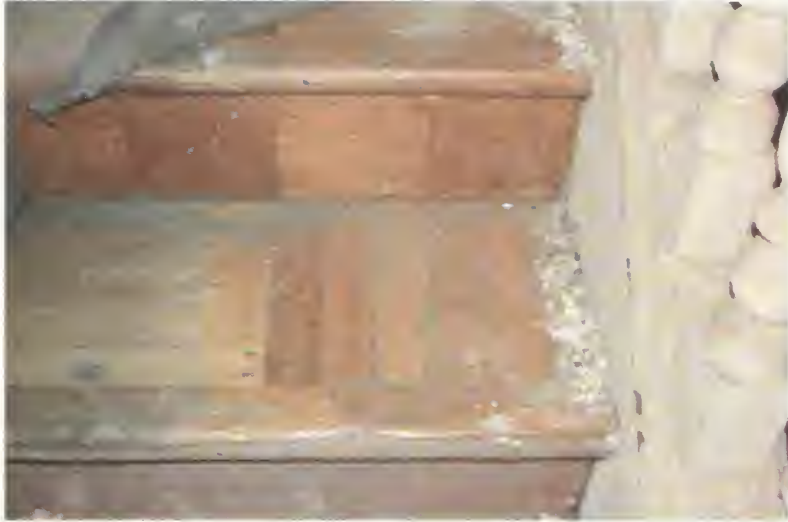
Figure 44. Officers Club, center hallway (Room 102), stairway, showing parquet pattern on treads and risers, 2005.

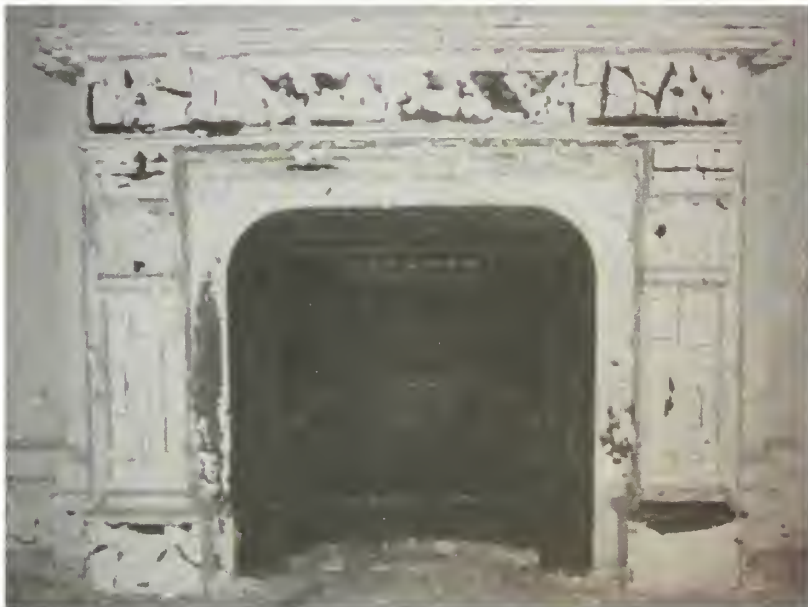
Figure 45. Officers Club, Ladies' Lounge (Room 103), south- wall fireplace, 2005.

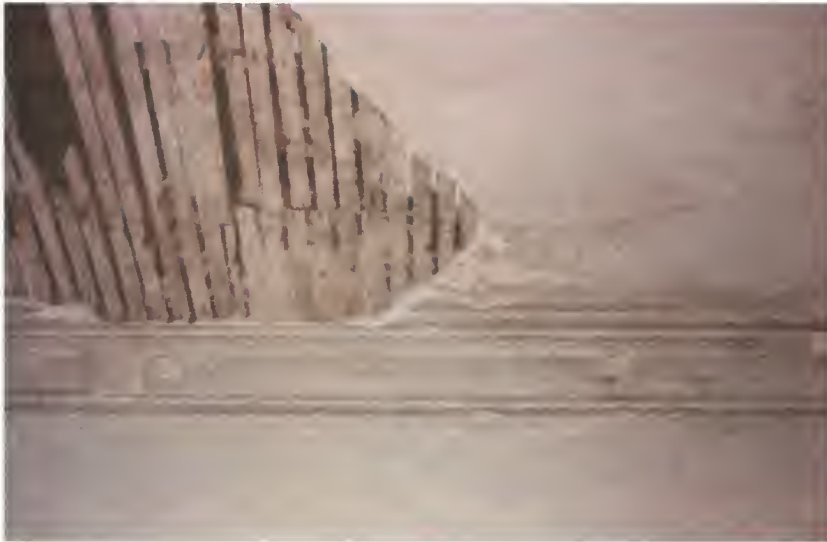
Figure 46. Officers Club, second- story center hallway (Room 201), ceiling plaster on wood lath, 2005.

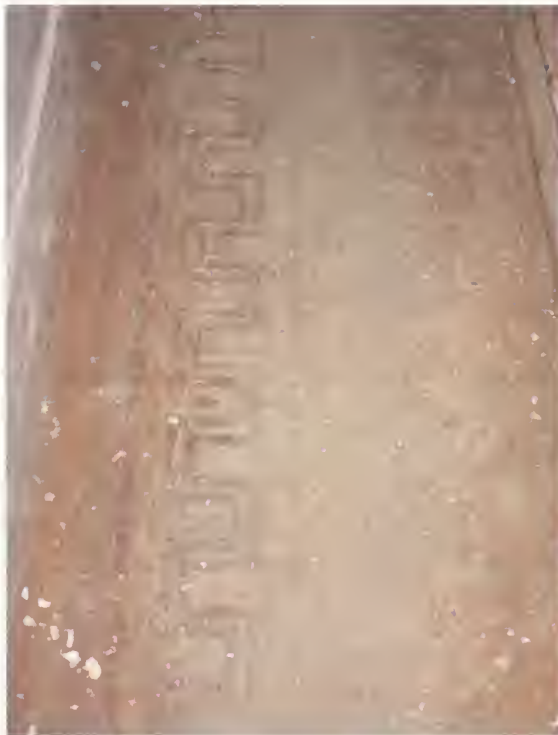
Figure 47. Officers Club, second- story center hallway (Room 201), parquetry floor, 2005.

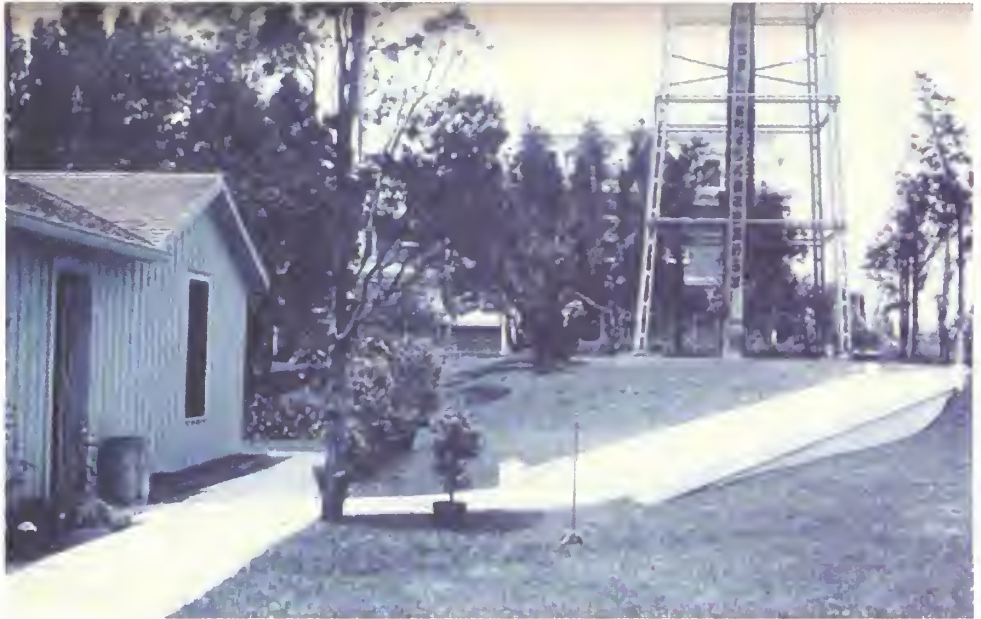
Figure 49. Sandy Hook Proving Ground, Greenhouse, with Officers Club in background, south elevation; note details of rounded porch.

The “broad porch” proposed for the south elevation of the Dining Room was constructed as part of the addition.⁸⁵ It is no longer extant, but examination of historic site plans and photographs reveals the porch’s design and materials (figs. 48- 50). The most distinctive feature of the porch was a half-round bay on the south elevation. Porch details included a classical balustrade with turned balusters and Doric columns, and it was apparently equipped with awnings and screens. The details of the porch reflected the “Colonial style” Major Smith had mentioned in his letter to the Chief of Ordnance. Of the archival materials reviewed, the photograph from ca. 1909 (fig. 49) of the Greenhouse, with the Officers Club in the background, was the first to document the exterior after the ca.- 1905 addition.

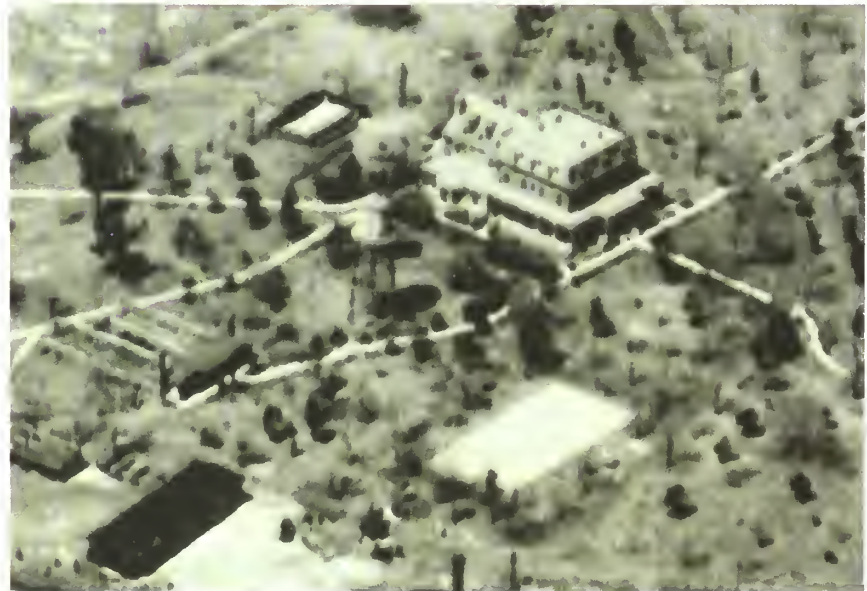
Figure 50. Detail of figure 64, showing Officers Club, 1924.

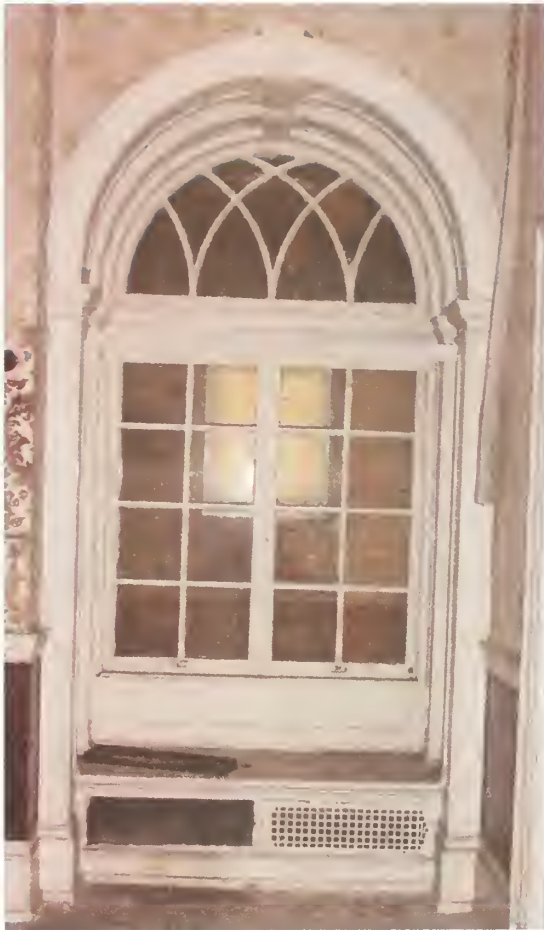
Figure 51. Officers Club, west- elevation window W124, seen from the Dining Room (Room 106), 2005.

The windows of the addition also demonstrated the changes to the building. The two first-story windows (W124 and W125) of the Dining Room (Room 106) were arched, with a design unique to the building (fig. 51). Each window's lower sash was one unit with a wide center mullion, which made it resemble a pair of casement windows. There were eight lights on either side of the center mullion. The upper sash was arched with intersecting lancet- arch muntins. The lower sash was operative and the upper sash was fixed. The windows were set in a rectangular rough opening measuring 57 inches wide by 93 ½ inches high and surrounded by wood trim. The lintels and sills of these windows, as well as others in this addition, copied the same design as the original elements. However, the builders used both brownstone and limestone for these elements: the window sill of W125 was limestone, and the lintel of W124 was brownstone. Comparative paint research on selected exterior window surrounds further supports the field evidence. The surrounds of W109 (on the main block) and W123 (on the west end of the ell) have greater accumulations of paint than does the surround of W125, on the addition to the ell (Appendix C). The paint evidence discovered on the windows of the Dining Room (Room 106) forms the basis for the exterior trim color for the period.

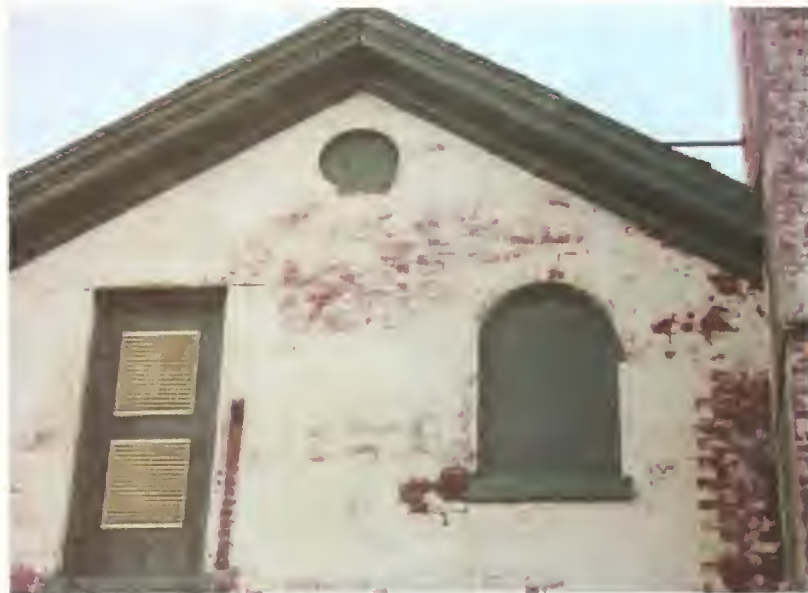
Figure 52. Officers Club, west elevation of rear ell, ca.- 1905 portion; shows oculus window (W311) and arched window (W312) in gable end, 2005.

The ca.- 1905 addition also included window openings at the second- story and attic levels. On the second story, the west- elevation windows matched the existing rear- ell openings in size and trim details. The south- elevation windows were two oriel windows. Though no longer extant, these windows were well- documented in photographs and drawings, and framing evidence for them was found within the framing of a later roof. At the attic level, the builders constructed an arched window and an oculus window on the west elevation (fig. 52).

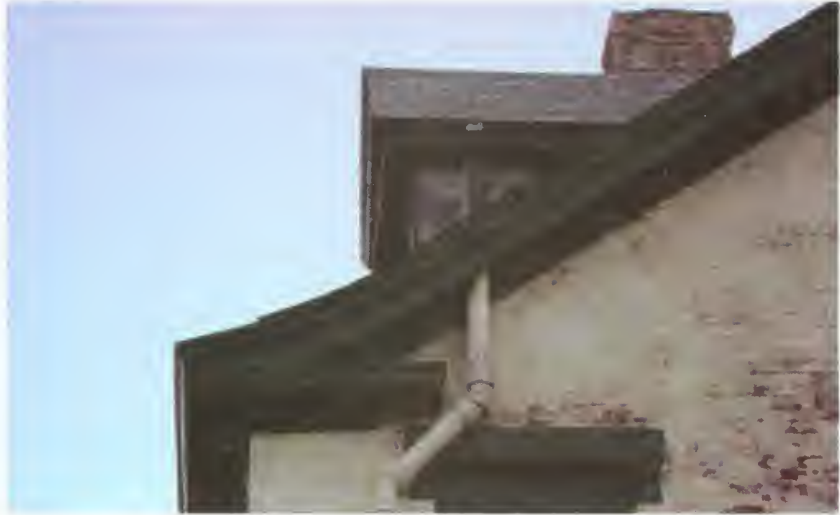
Figure 53. Officers Club, west elevation of rear ell, flared eave of ca.- 1905 addition, 2005.

The gable roof of the addition also incorporated some stylistic changes. The roof was constructed with flared eaves, which had its origins in the Dutch Colonial style and was incorporated in the Colonial Revival style (fig. 53). The north and south elevations of the rear ell's roof were each pierced with three symmetrically placed dormers. These were gabled dormers with an articulated pediment and composite moldings (fig. 54).

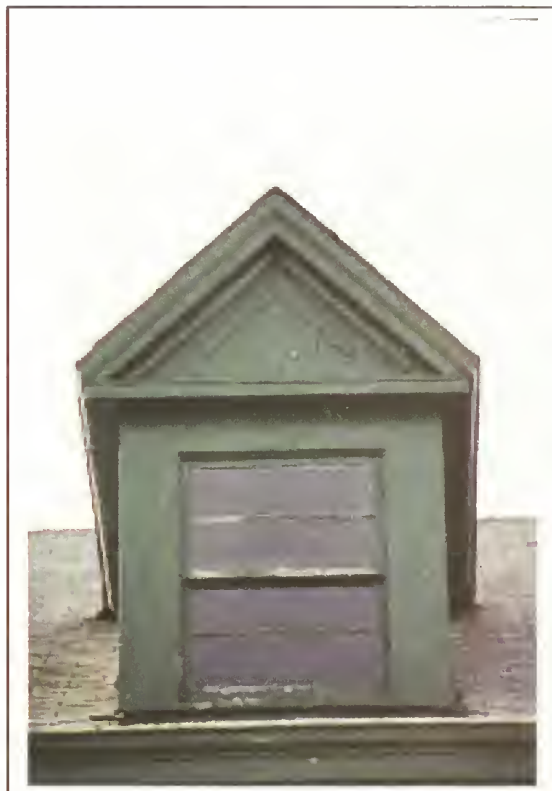
Figure 54. Officers Club, north elevation of rear ell, showing dormer of ca.- 1905 addition, 2005.

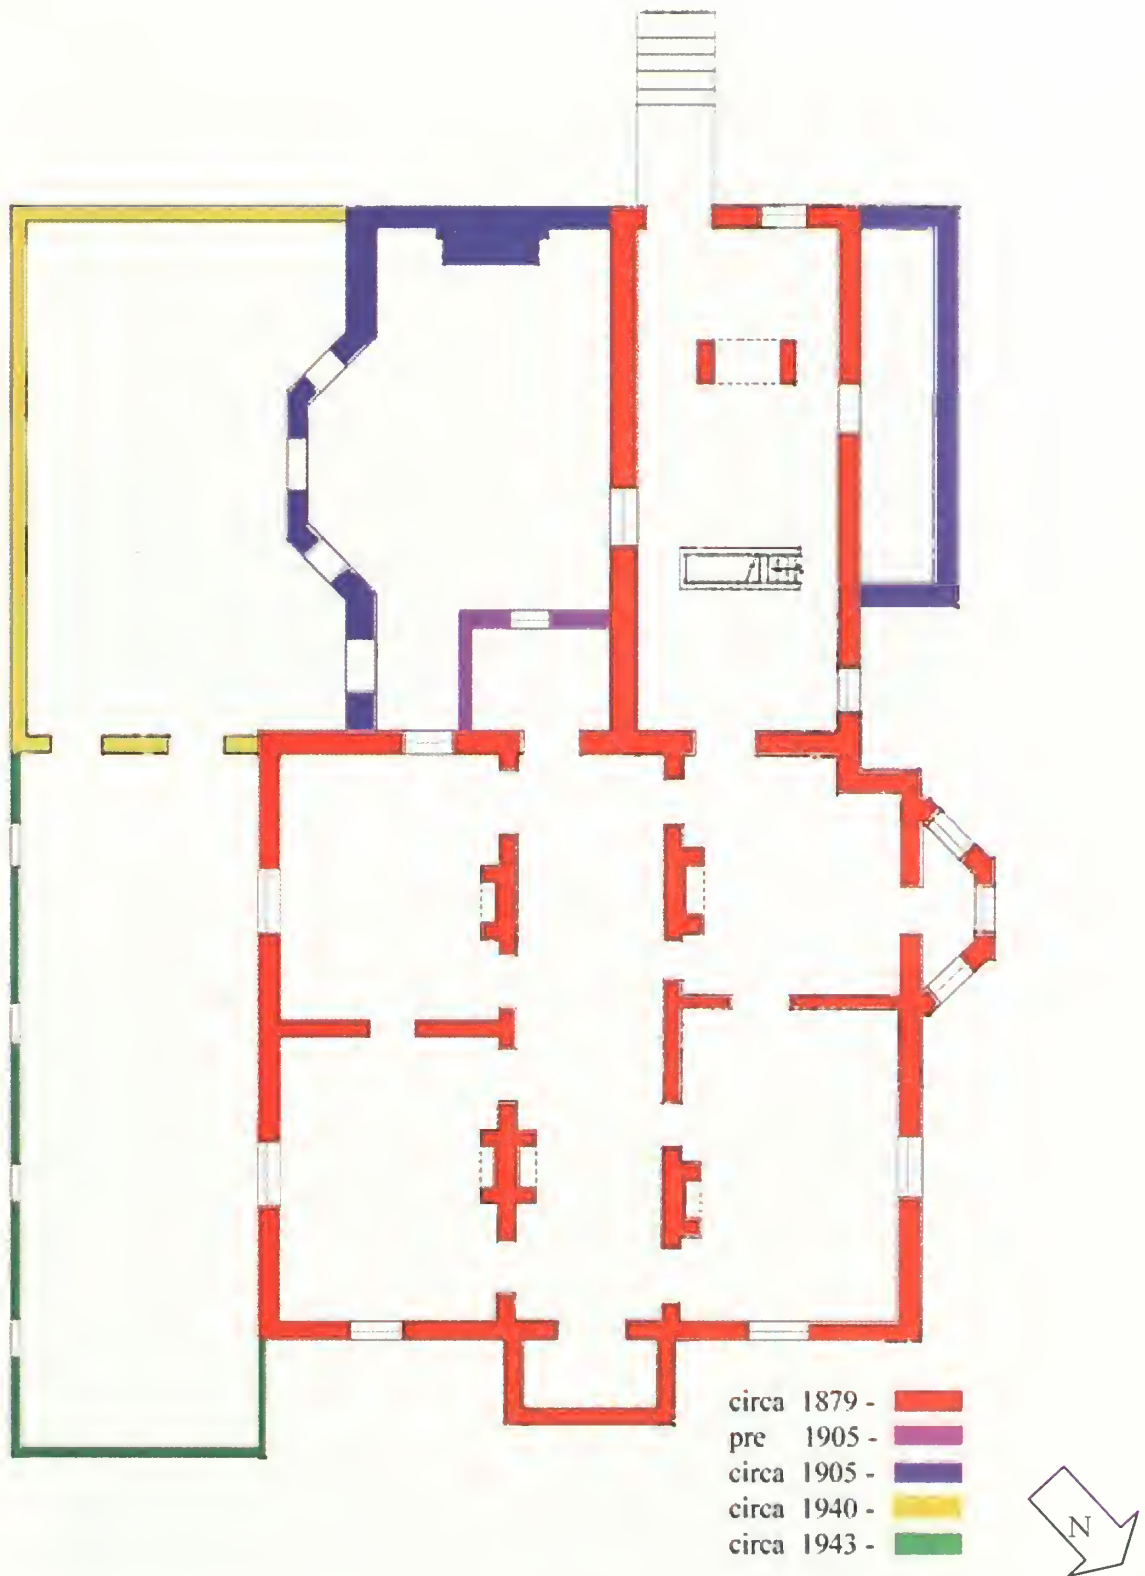
Figure 55. Officers Club, basement plan illustrating original appearance and alterations (not to scale).

Examination of the existing foundation, and the bearing partition walls in the basement and on the first and second stories of the rear ell, shows further evidence of the addition (fig. 55). The south exterior wall of the original rear ell, which was brick and extended from the basement level through the second story, became the extant partition wall between the Kitchen (Room 105) and the Dining Room (Room 106). The foundations of the main block of the structure and the original rear ell were connected and had full basements, which were accessed from the west- elevation bulkhead of the rear ell. By contrast, the basement of the addition to the rear ell was built with only a crawl space, and was only accessible through an existing basement window.

Upon close examination, one photograph reveals the outlines of a large bay window facing south (fig. 56). This is supported by the shape of the ca.- 1905 foundation, which was constructed with a three- sided projection on the south elevation (fig. 55). The bay was designed to take full advantage of the southern exposure of the Dining Room (Room 106). The bay- window opening was framed with a classical archway composed of a large segmental arch with Composite- order pilasters and entablature. The archway was balanced by a symmetrically placed arch on the north wall, which framed a niche for a sideboard and, at the time of the photograph, a moose head.

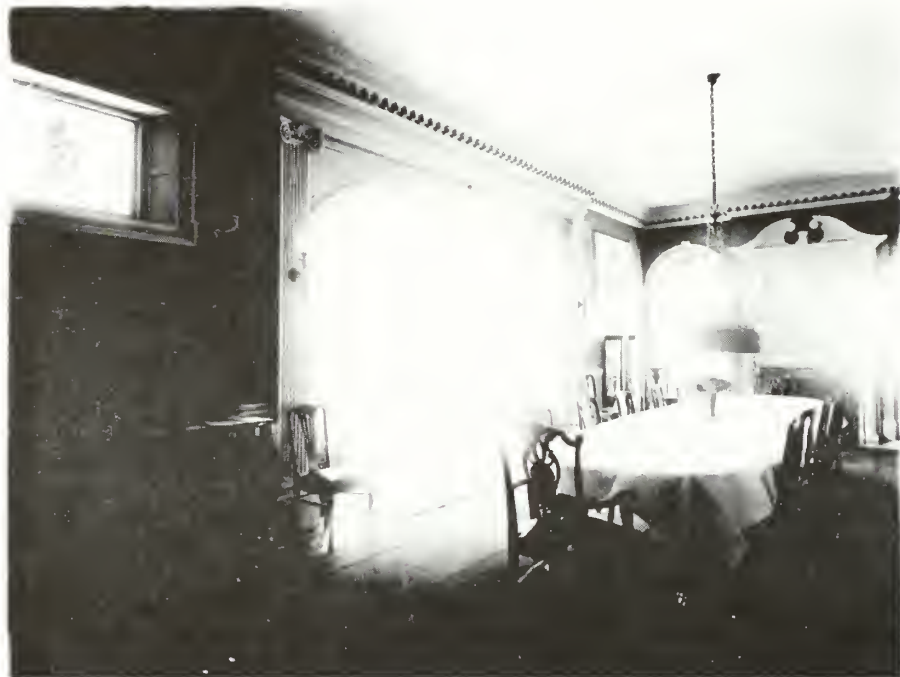
Figure 56. Officers Club, Dining Room (Room 106), view of south and west walls, ca. 1905.

The brief description of the addition by Major Smith, which included the orientation and style of the Dining Room (Room 106), is supported by the earliest photographs of the room (figs. 56 - 57). They were most likely taken soon after the completion of the Dining Room, and they reveal several aspects of the room's initial appearance. Among these are the outline of the original south- elevation bay window, the early mantelpiece and overmantel, the period trim and decorative schemes, the plaster ceiling, early lighting fixtures, and the original fenestration. All reflect the Colonial Revival style, and clearly illustrate the stylistic change from the period of original construction to the period of the addition.

As noted in the previous section, the Officers Club was wired for electricity in 1897. The note submitted to the Appropriations Committee with the funding request on June 30, 1903, stated that the new addition would include electrical work.⁸⁶ The ca.- 1905 photographs of the room show wall sconces and a chandelier, which most likely dated from the construction of the addition (figs. 56- 57). The same wall sconces were visible in photographs through the 1960's.
