OFFICERS CLUB BUILDING No. 114

HISTORIC STRUCTURE REPORT

Sandy Hook Unit Gateway National Recreation Area

James J. Lee III
Architectural Conservator

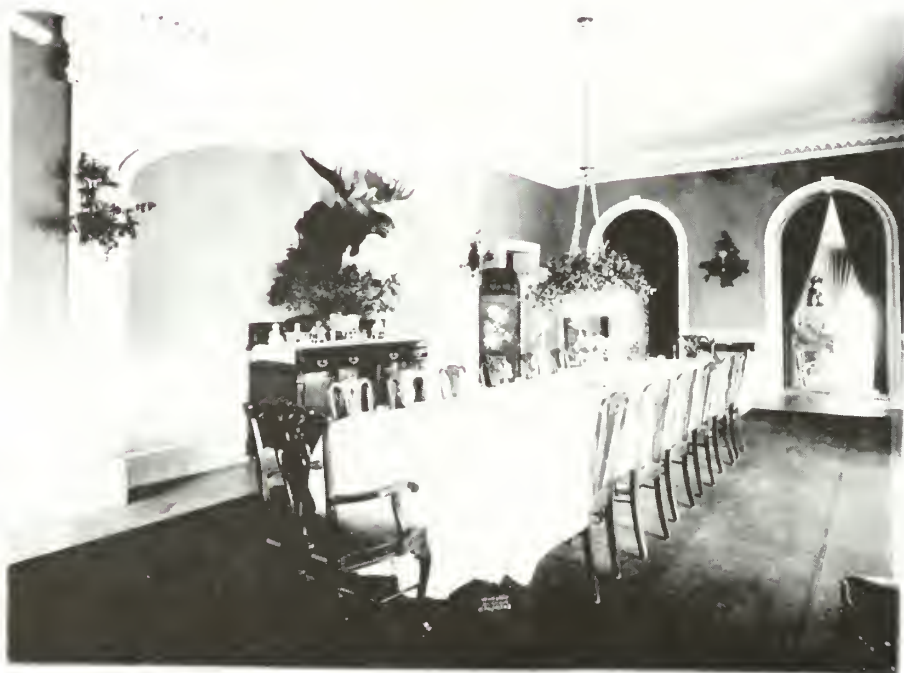
Figure 57. Officers Club, Dining Room (Room 106), view of north and east walls, ca. 1905.

The brief description of the addition by Major Smith, which included the orientation and style of the Dining Room (Room 106), is supported by the earliest photographs of the room (figs. 56 - 57). They were most likely taken soon after the completion of the Dining Room, and they reveal several aspects of the room's initial appearance. Among these are the outline of the original south- elevation bay window, the early mantelpiece and overmantel, the period trim and decorative schemes, the plaster ceiling, early lighting fixtures, and the original fenestration. All reflect the Colonial Revival style, and clearly illustrate the stylistic change from the period of original construction to the period of the addition.

As noted in the previous section, the Officers Club was wired for electricity in 1897. The note submitted to the Appropriations Committee with the funding request on June 30, 1903, stated that the new addition would include electrical work.⁸⁶ The ca.- 1905 photographs of the room show wall sconces and a chandelier, which most likely dated from the construction of the addition (figs. 56- 57). The same wall sconces were visible in photographs through the 1960's.

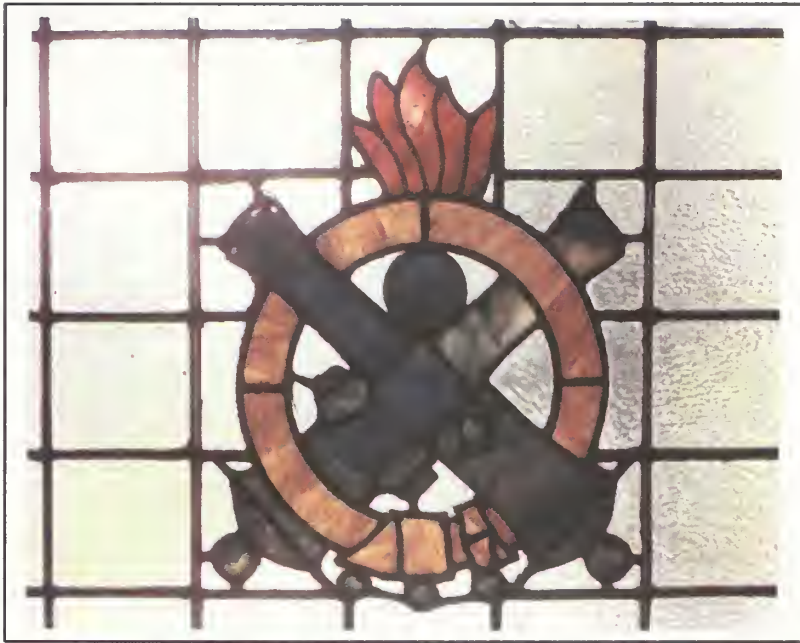
Figure 58. Stained-glass window from Officers Club, ca.- 1905 Dining Room addition (Room 106), incorporating Ordnance Corps insignia.

The arched window openings along the west side of the room were surrounded with molded archways. This same trim was echoed on the east wall for the casings of the doorways to the hallway and Lounge. Other doorway and window casings were molded with crossettes, or ears. A unique decorative detail of the Dining Room (Room 106) was the two smaller windows on the south elevation. Within the openings were lead- camed windows with the insignia of the Ordnance Corps depicted in stained glass (fig. 58).

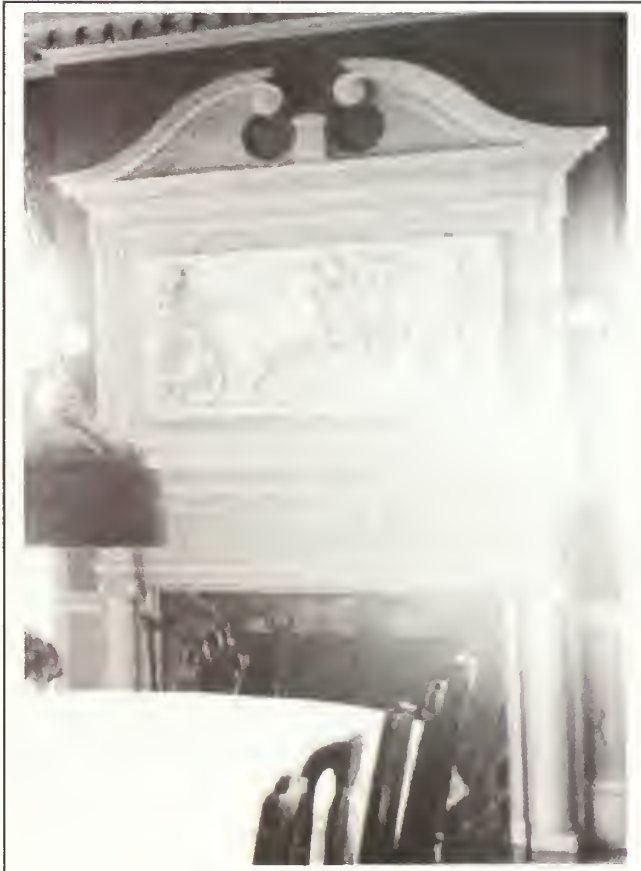
Figure 59. Officers Club, Dining Room (Room 106), detail of fireplace and mantelpiece, ca. 1905.

The ca.- 1905 fireplace was constructed with classical elements that included a marble surround, engaged Ionic columns, and a classical entablature. The overmantel pediment and relief included a broken swan- neck pediment and a bas- relief depicting a chariot (fig. 59).

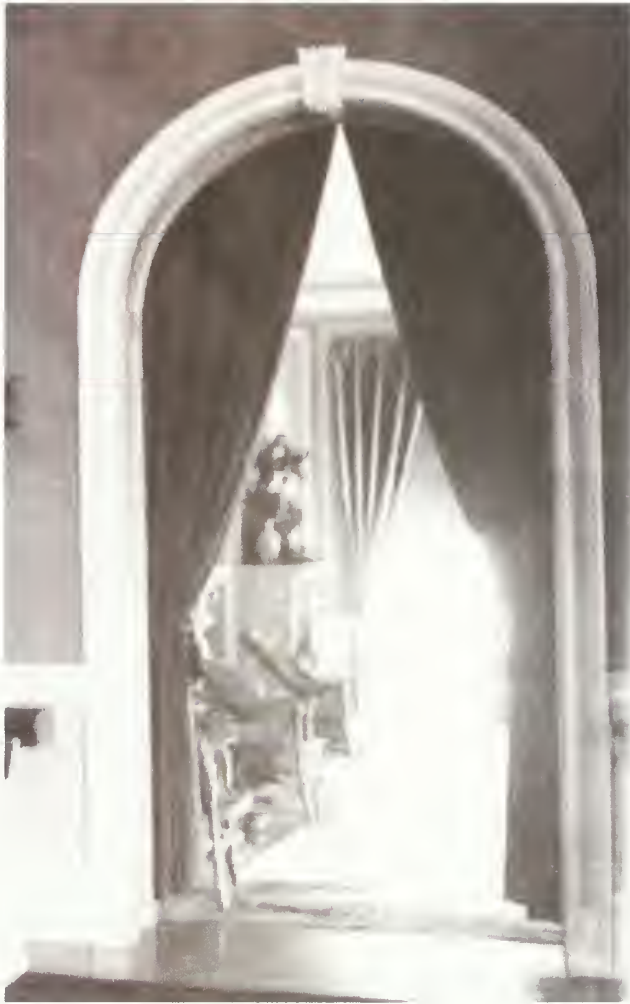
Figure 62. Officers Club, doorway from Dining Room (Room 106) to Lounge (Room 108), ca. 1905.

The floor in the Lounge (Room 108) was seen to be carpeted in the ca.- 1905 historic photograph (fig. 62).

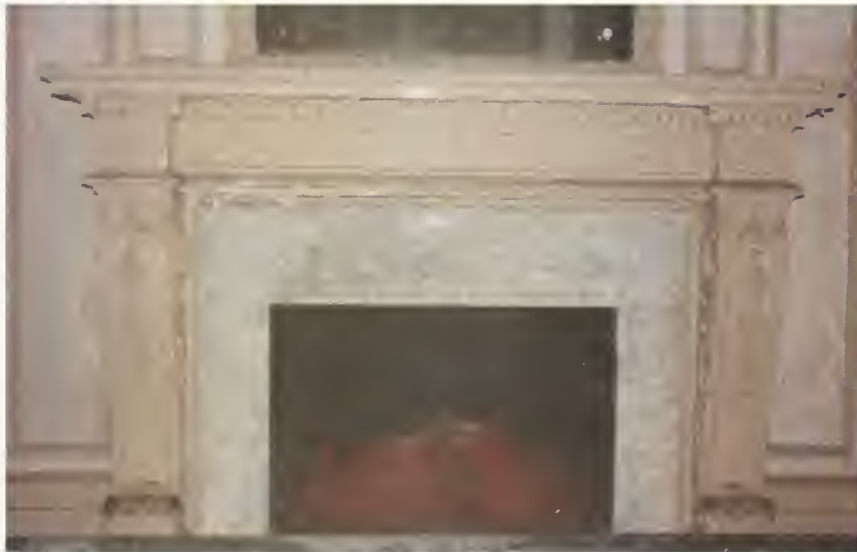
Figure 63. Officers Club, Lounge (Room 108), fireplace surround and mantelpiece, 2005.

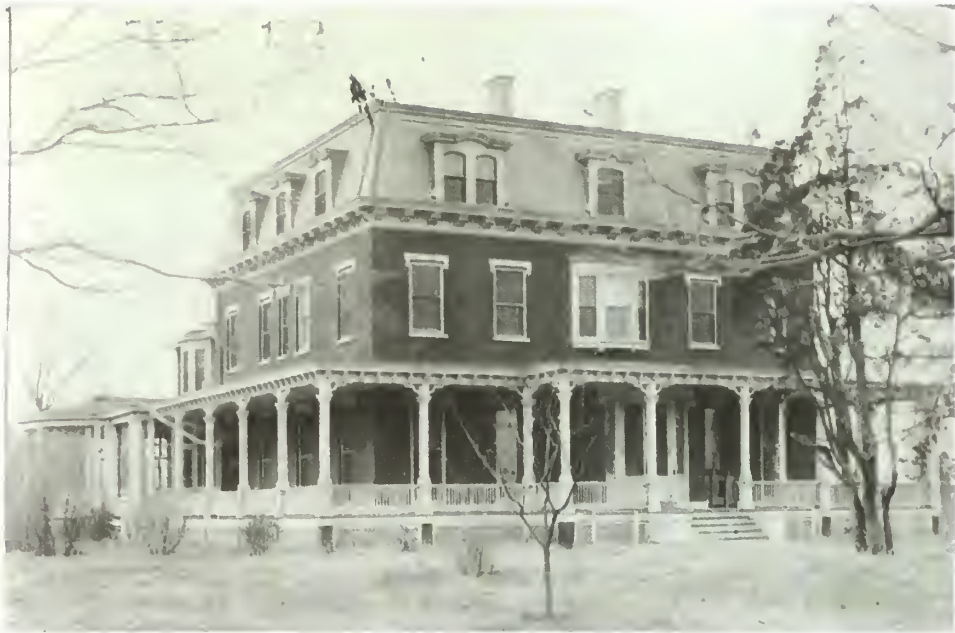
Figure 65. Officers Club, east façade and south elevation, "Feb 1922"; note enclosed porch.

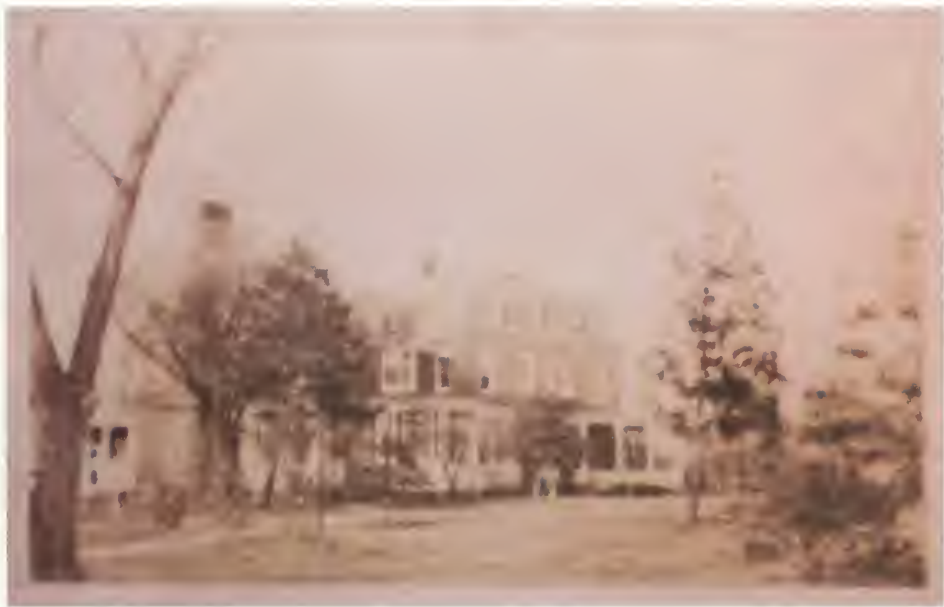
Figure 66. Officers Club, west and south elevations, ca. 1940; note enclosed porch.

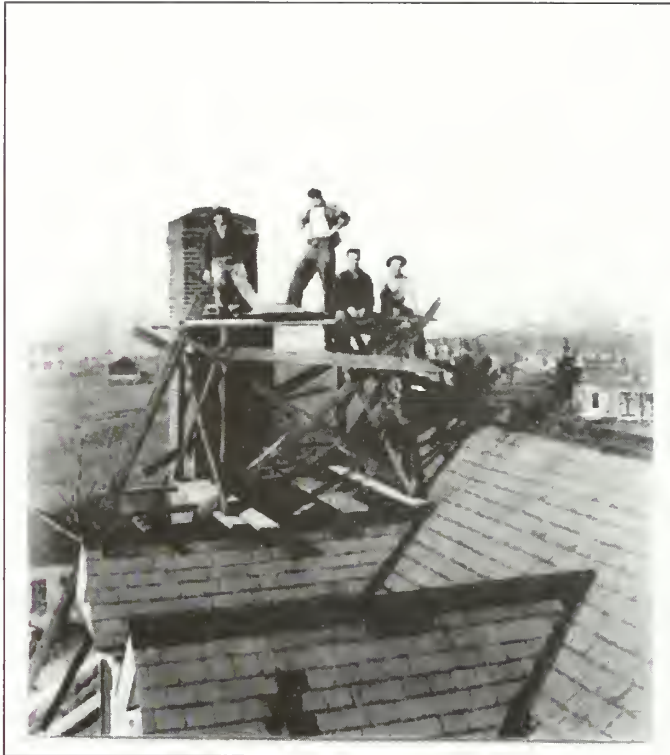
Figure 67. Officers Club, chimney work on rear- ell gable roof, ca. 1937.

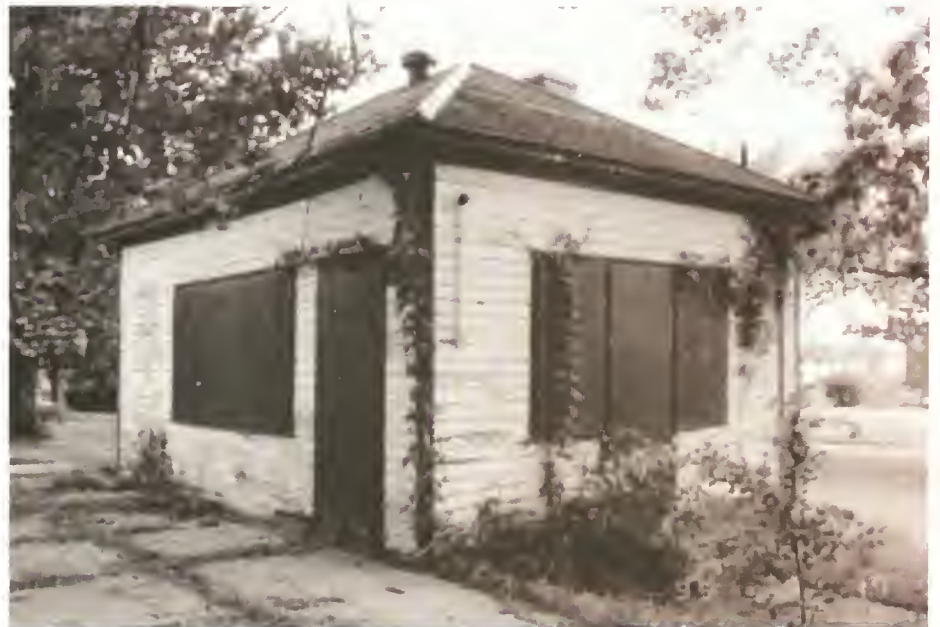
Figure 81. Laundry/Caddy House, Building No. 113, 1995.

Building No. 113 (figs. 80- 81) was constructed in 1905 just west of the Officers Club (fig. 48), to serve as a laundry for the officers of the Ordnance Department.¹¹⁸ It was a one- story wood-framed structure built on a poured concrete foundation. The building had a hip roof, which was covered with green asphalt shingles at the time of research was performed for this report. Building No. 113 was clad with clapboards and had wooden double- hung sashes. The structure had triple sets of windows on both its south and east elevations. The center window in both sets had double- hung, eight- over- eight sashes, which were flanked by double- hung, six- over- six sashes. Other windows on the building had double- hung, six- over- six sashes.

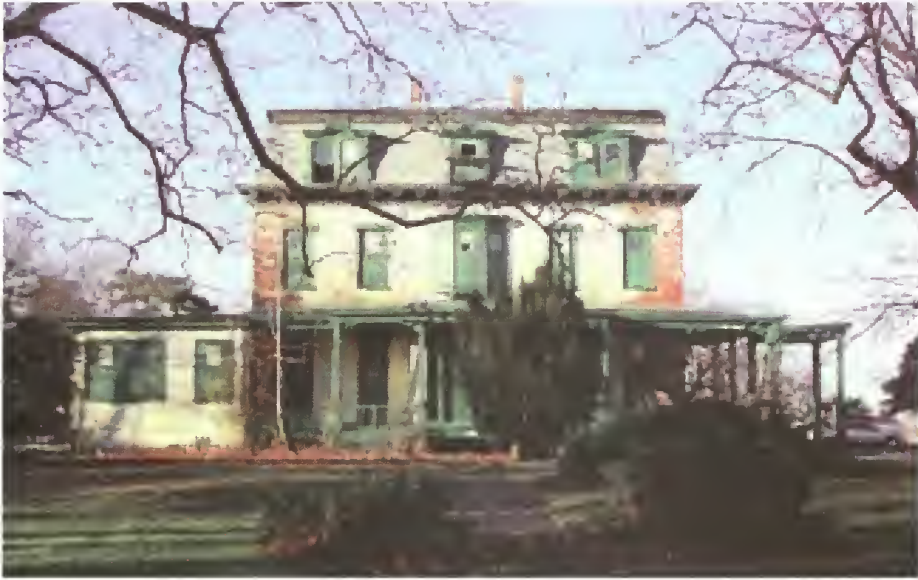
Figure 82. Officers Club, east facade, 2004.

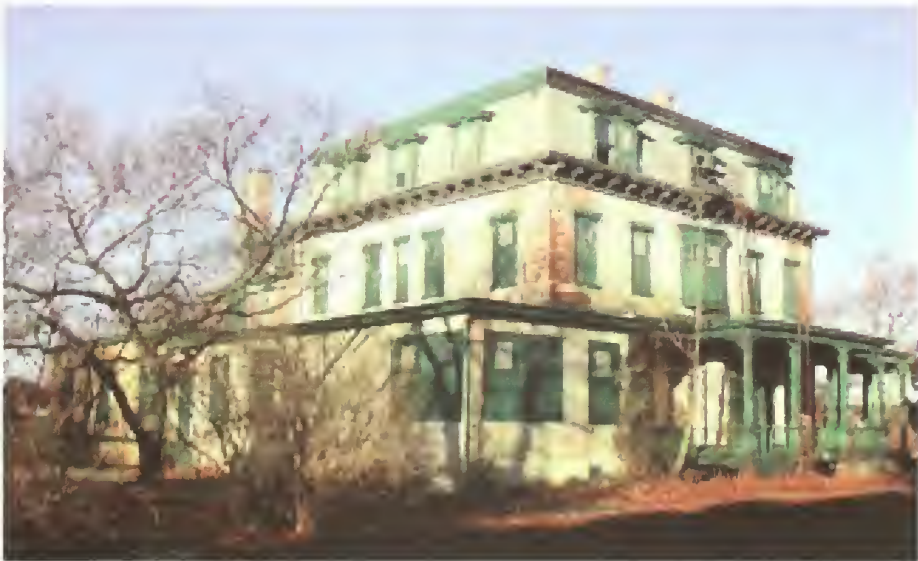
Figure 83. Officers Club, east façade and south elevation, 2004.

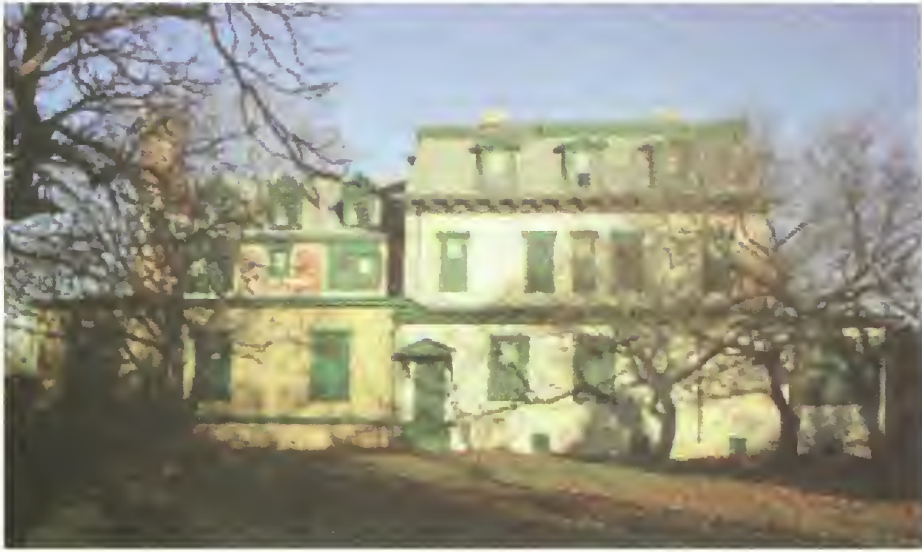
Figure 84. Officers Club, south elevation, 2004.

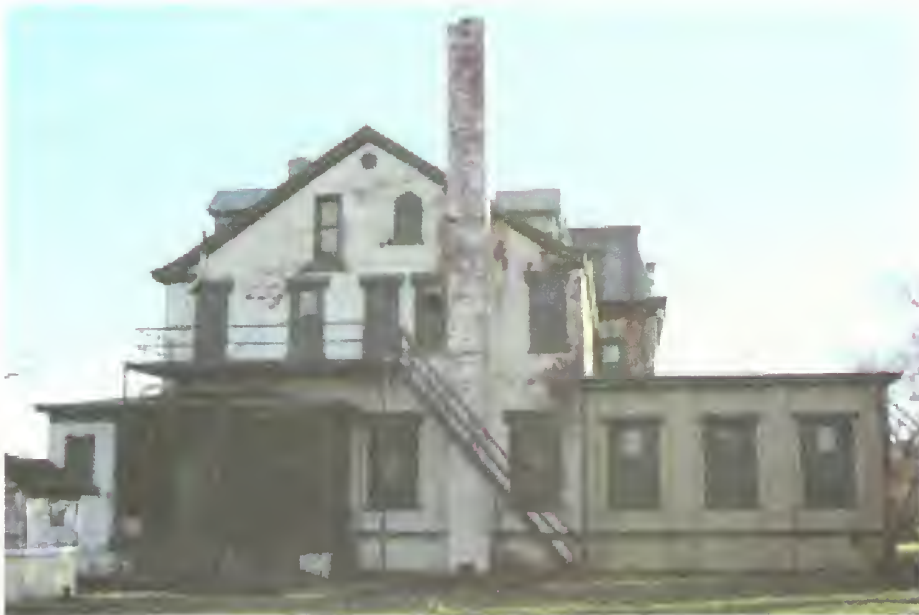
Figure 85. Officers Club, west elevation, 2004.

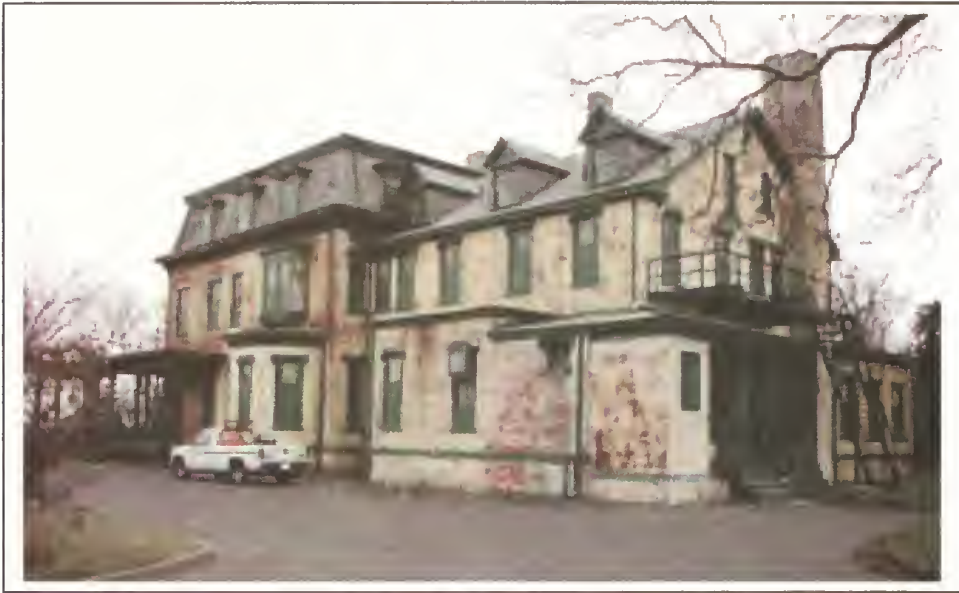
Figure 86. Officers Club, north and west elevations, 2004.

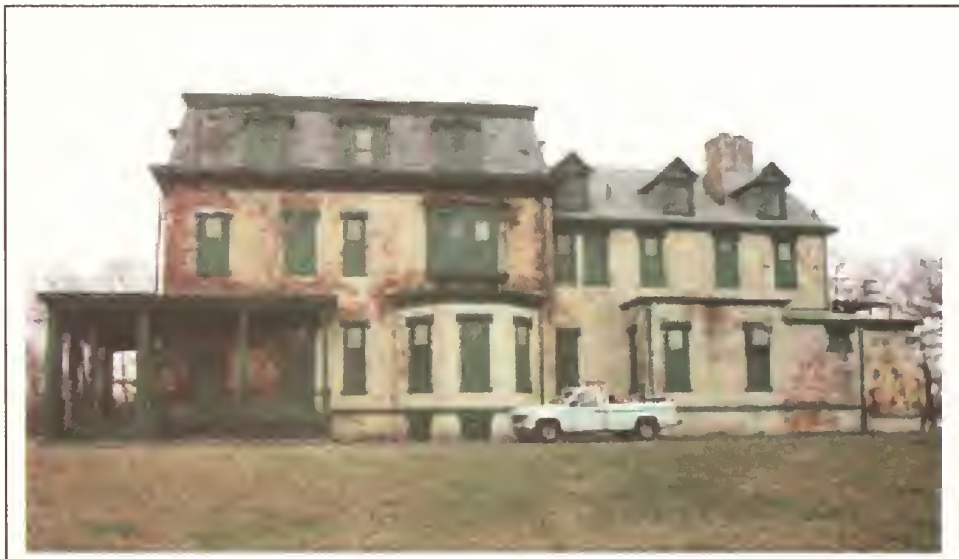
Figure 87. Officers Club, north elevation, 2004.
