HISTORIC STRUCTURE REPORT - ARCHITECTURAL BAYA SECTION FORT MOULTRIE

FORT SUMTER NATIONAL MONUMENT

CHARLESTON SOUTH CAROLINA

SOUTHEAST REGIONAL OFFICE
OFFICE OF PROFESSIONAL SERVICES
PLANNING AND DESIGN DIVISION
NATIONAL PARK SERVICE
UNITED STATES DEPARTMENT OF THE INTERIOR

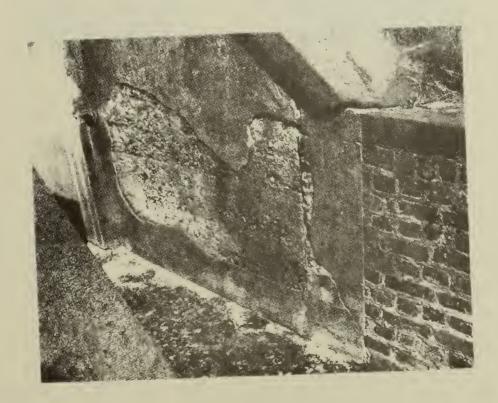
PHOTO 5

Deterioration of Concrete Surfaces of Sally Port

The brick and granite aggregate concrete roofs of the Sally Port have suffered deterioration of the surfaces, leaving them rough and exposing the aggregate. (Photo 5) Wherever any of the other underground structures' roofs have been exposed to the weather through loss of the super-incumbent earth cover, the concrete surface has eroded and deteriorated. (Photo 6)

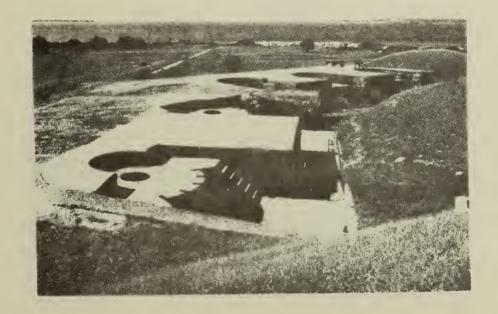
PHOTO 9
Battery Bingham in Foreground
Battery McCorkle in Background

Of the three Endicott Batteries (Battery Bingham, Battery McCorkle and Battery Lord), Battery Bingham is in the best condition. (Photo 9) All of the exposed steel and iron work is in very good condition, well painted and smooth surfaced, showing few signs of corrosive action. (Photo 10)

Structures erected during this period were Battery Bingham, Battery McCorkle and Battery Lord. These are all brick or granite-aggregate concrete structures and with the exception of Battery Lord, are in good structural condition. (Photos 9, 10, 11, 12 and 13)

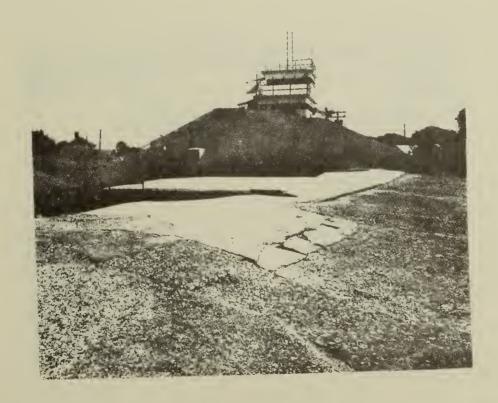
PHOTO 11

Note Surface Deterioration, Cracking and Subsidence,

HECP/HDCP in Background

The concrete of this battery is in good condition. The surfaces are generally sound and smooth, although broken by numerous but insignificant hairline cracks and exhibiting minor surface spalling. The concrete blast apron is in fair condition. There has been subsidence and cracking and the entire surface has eroded, exposing the granite aggregate. (Photo 11)

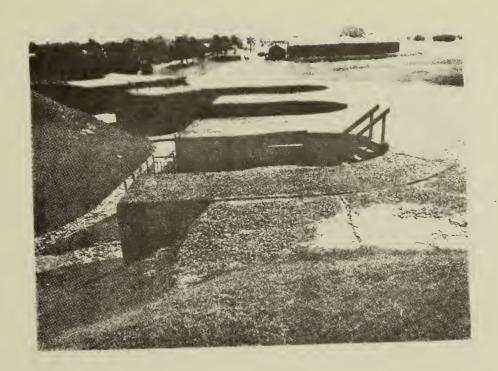
РНОТО 12

Battery McCorkle in Foreground. Note Remaining Original Smooth Surface in Lower Right Hand Margin.

Battery Bingham in immediate Background and Battery Jasper in Far Background

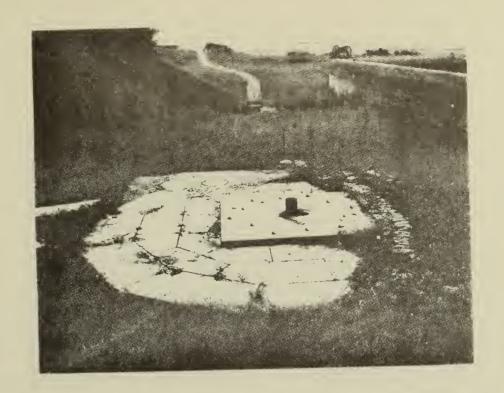
PHOTO 17
Gun Positions 9 (Pintle on Left) and 10
Fort Sumter in Far Background

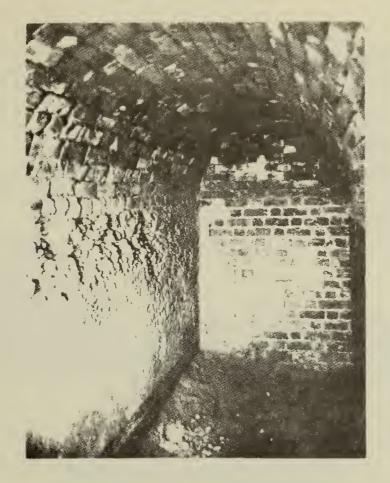
PHOTO 27
HECP/HDCP Detail of Northeast Corner Showing Condition

(Photo 19 and 27).

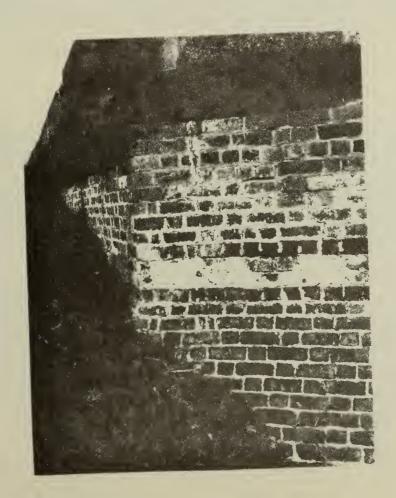
PHOTO 30
Red Free-Stone Lintle, North Opening of Old Storage Magazine

The transverse section on Mansfield's 1830 drawing shows the doorway to be rectangular in shape while Bowman's drawings of 1839 and 1840 show it to be a segmental arch. Investigation of the present fabric finds a red free-stone lintle over the north window opening (Photo 30) and the fragments of one in the south doorway. The doorway lintle was apparently removed between 1830 and 1840 and a segmental arch constructed. This type of stone was subject to great deterioration due to the humidity in the Charleston area. Bowman, in writing to Totten in 1836 stated "...Red free-stone, I find will not withstand this climate --- The soles of the embrasures in Castle Pinckney have lost nearly half an inch of their thickness already by disintegration." (22) This phenomenon is manifested by the lintle of the north window in the old Storage Magazine at Fort Moultrie.

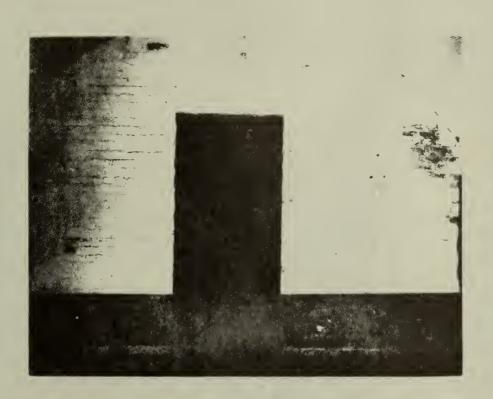
PHOTO 35
Magazine with Front Entrance in Far Background

roof. (Photo 35)
