Technical Preservation Services  
Preservation Assistance Division  
National Park Service  
U.S. Department of the Interior  
Washington, D.C.

Interpreting  
the Secretary of the Interior's  
Standards for Rehabilitation

Volume III

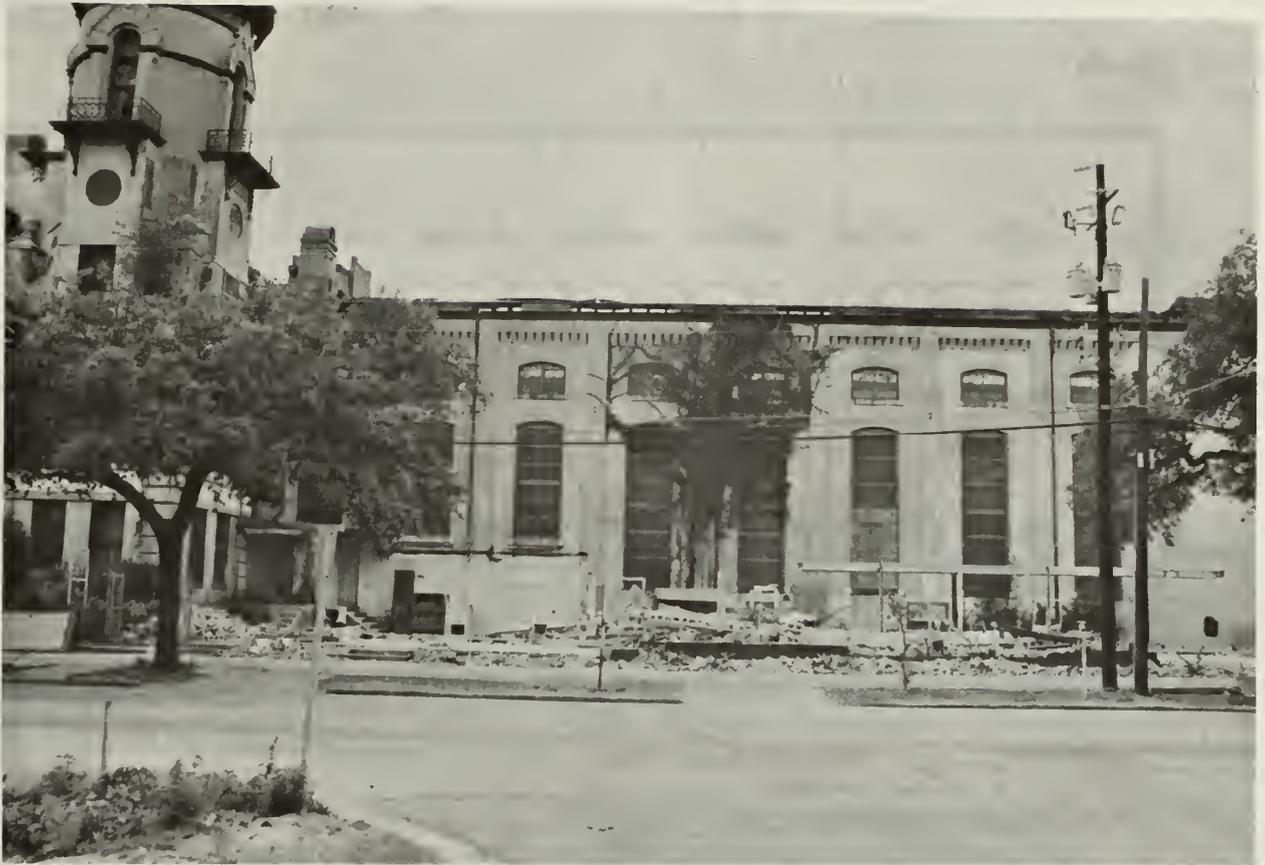
1. The property undergoing rehabilitation consisted of a three-story warden's house (partially visible, left) and a four-story cell block.

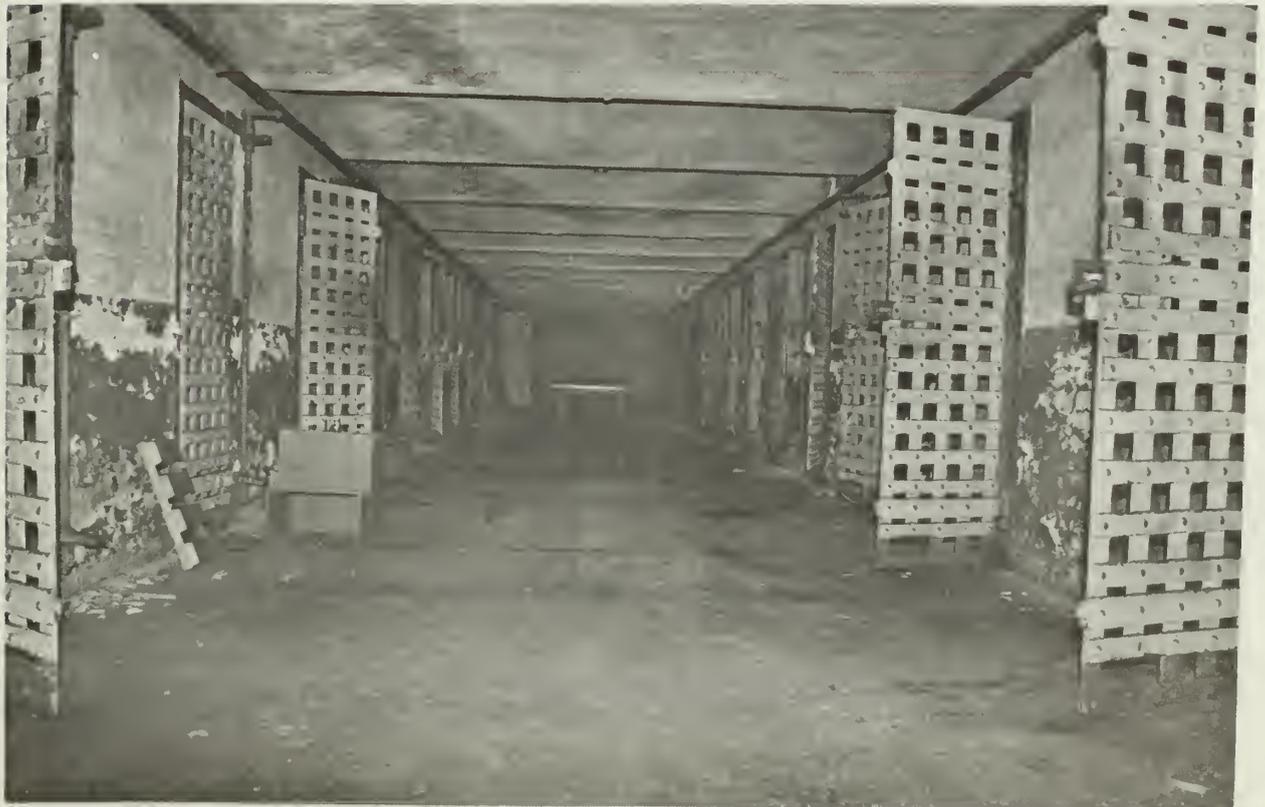
2. Interior of the cell block. Cells were 5' x 8', separated by 18" load-bearing walls.

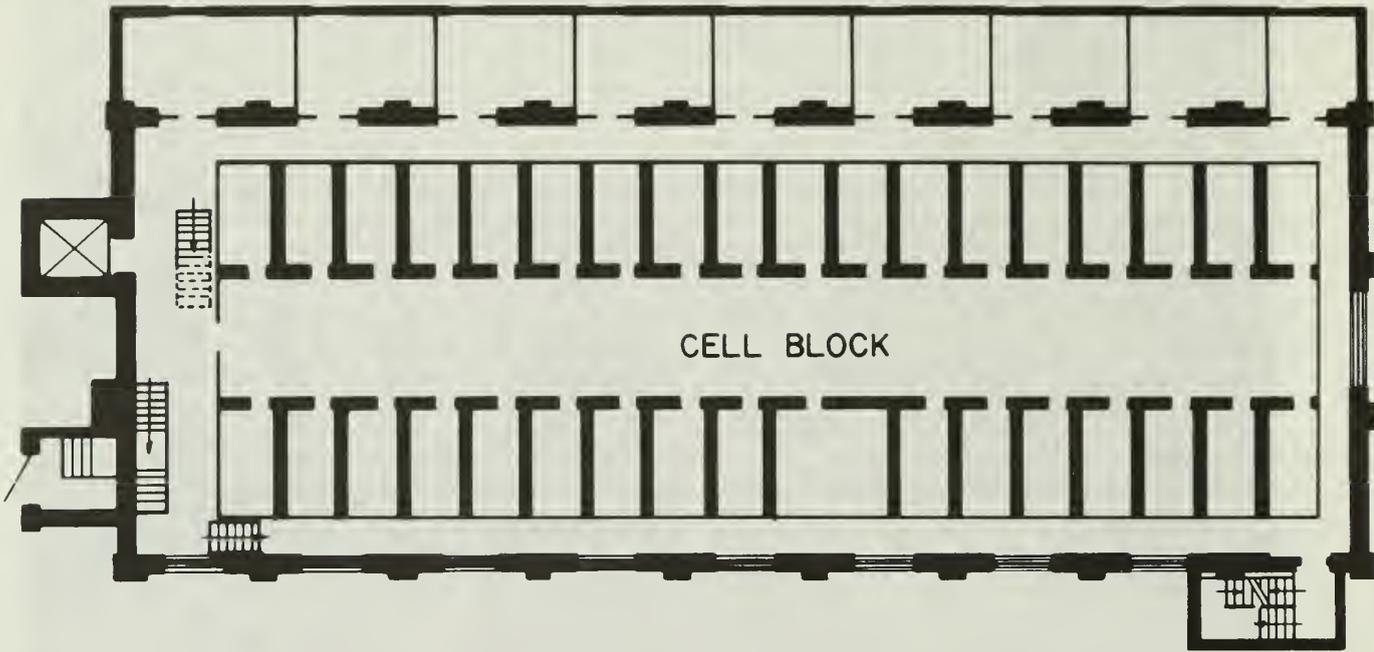
3. Floor plan before rehabilitation. Section at top of page added in the 1950s.

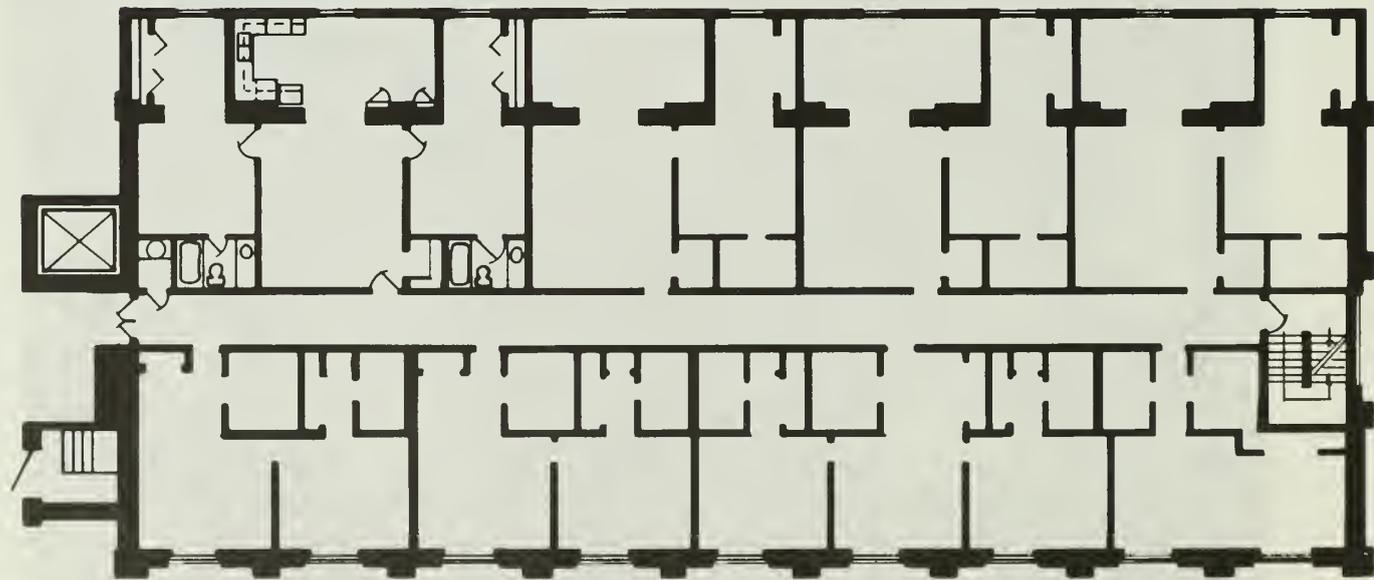
4. Floor plan showing proposed insertion of apartments and removal of nearly all interior fabric.

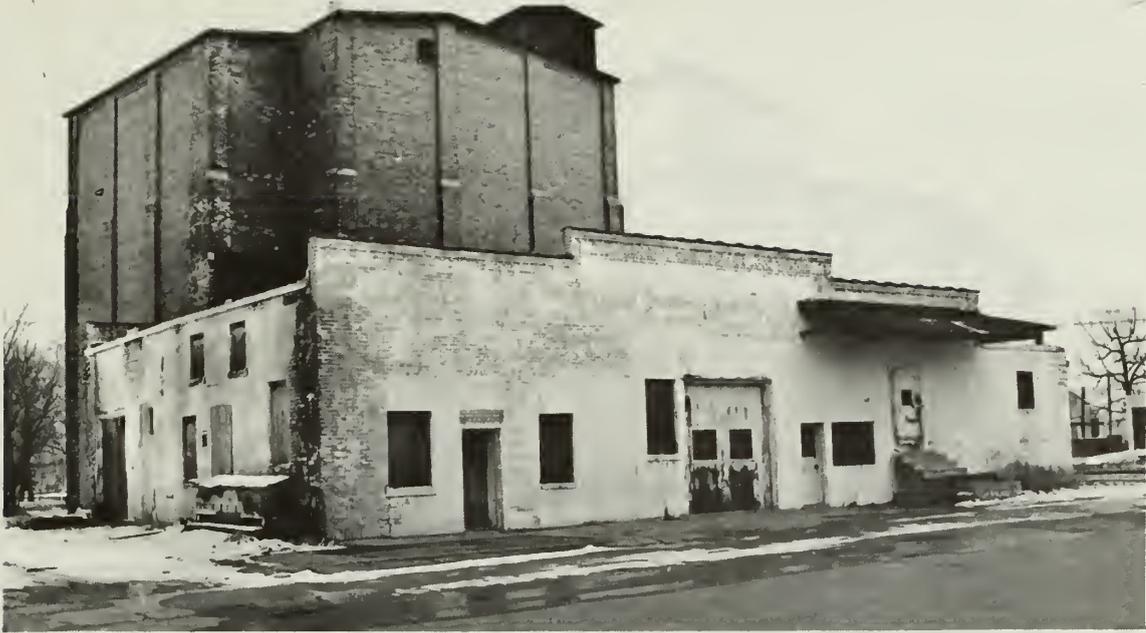
1. The historically important 1920s ice company firm consisted of a low rectangular structure together with a 50 foot high, ice storage house. Neither structure may seem to be of particular architectural "attraction." The simplicity of construction and lack of decorative detailing, however, parallel a specific use for that period of our commercial history.

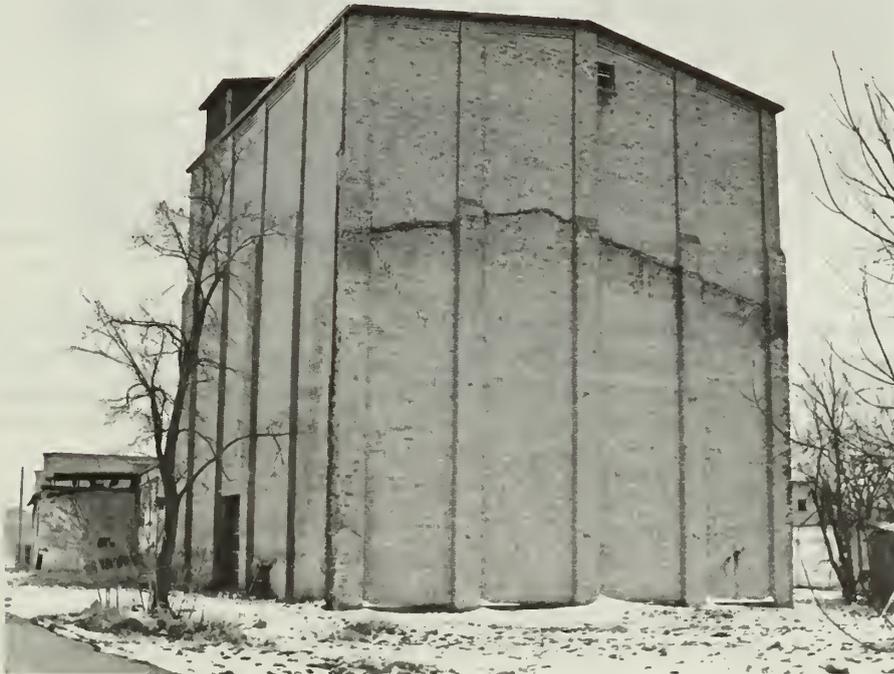
2. Ice storage house prior to rehabilitation. The massive brick structure was historically designed and constructed to be windowless on all four sides in order to enhance thermal efficiency. (The one opening seen near the top of the building is a small attic vent).

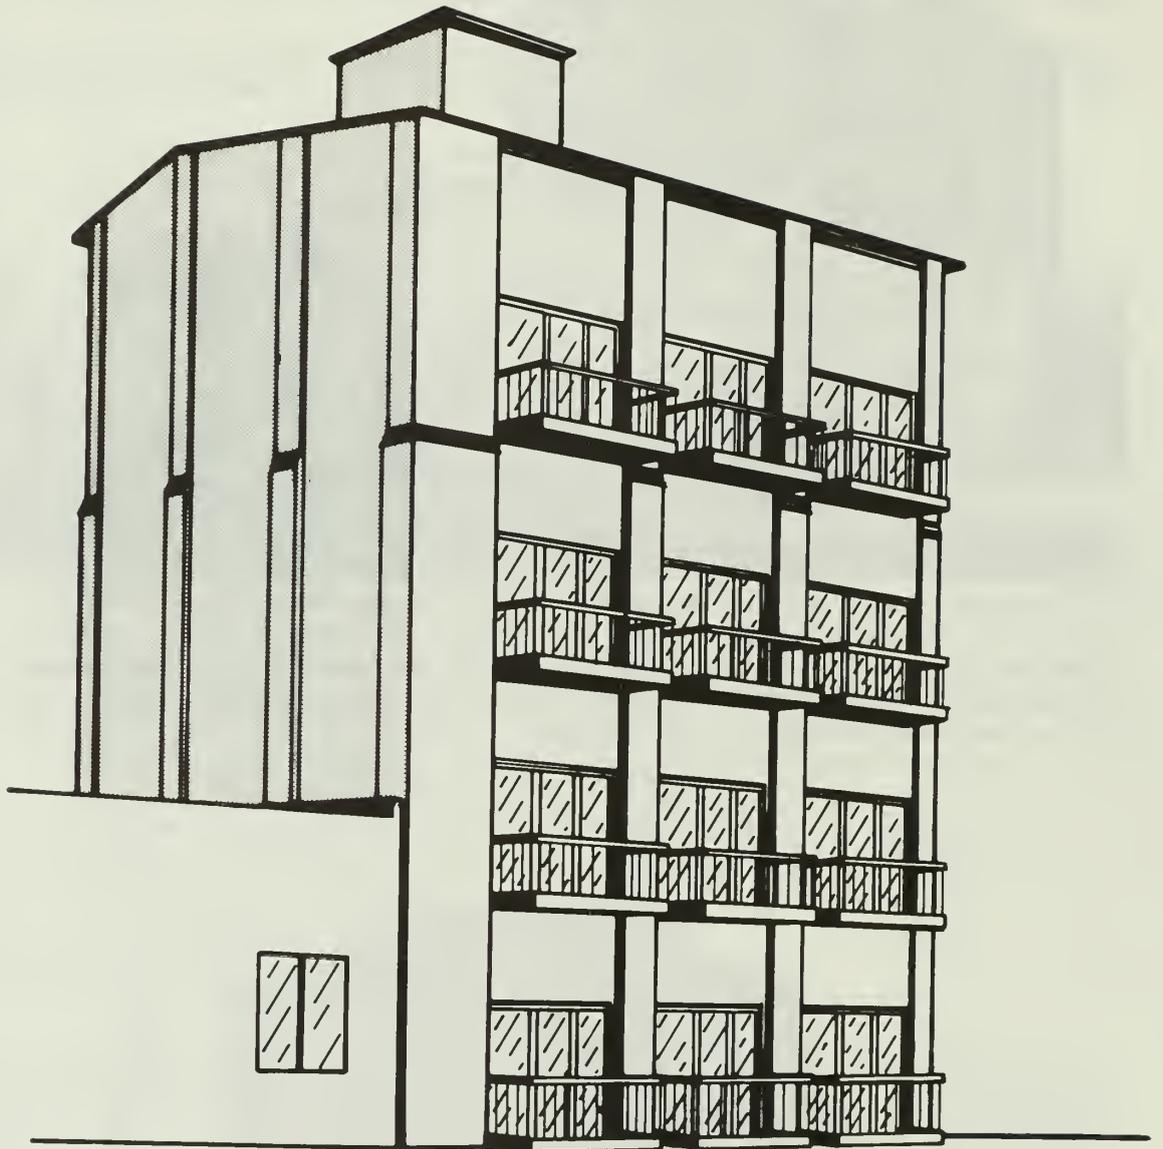
3. The rehabilitation proposal involved cutting windows on two highly visible side elevations and adding balconies. The National Park Service determined that the degree of change to accommodate this particular re-use proposal was not consistent with the historic character of the building; thus, approval was denied.

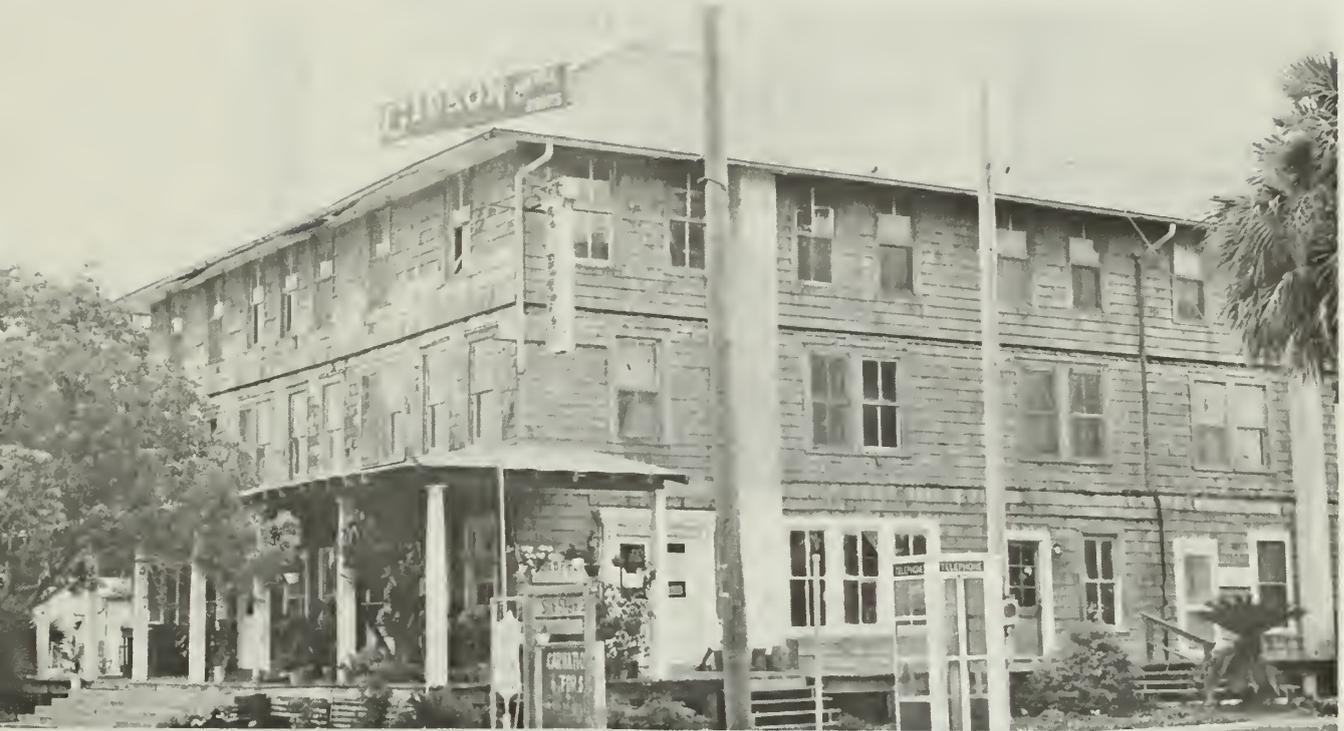
2. The hotel in 1984, prior to rehabilitation. The cupola and dormers are missing, and although a one-story front porch spans the primary elevation, it bears little resemblance to the two-story historic porch shown in the 1907 photograph. The hotel was certified as contributing to the significance of the historic district in its existing condition.

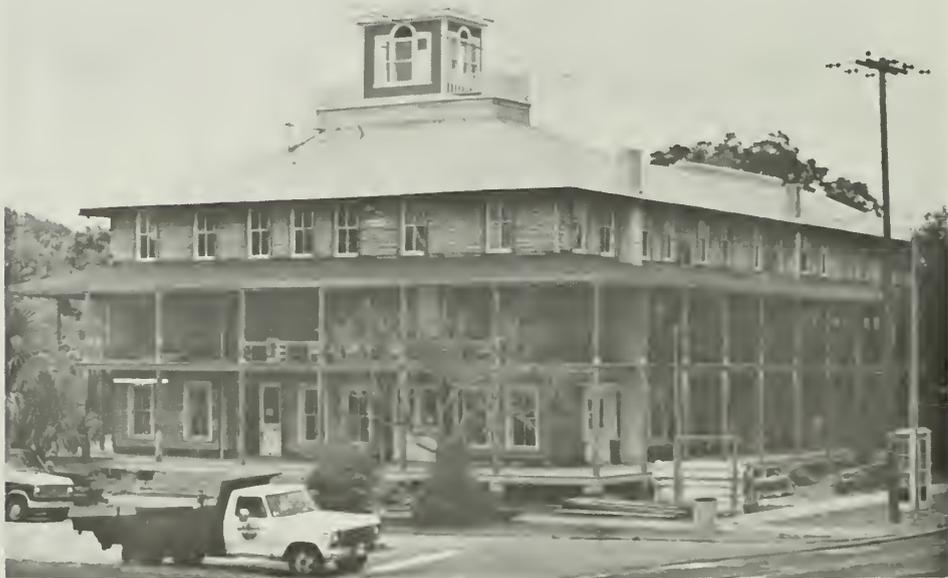
5. Hotel under rehabilitation for tax benefits. The restored cupola and two story front porch can be seen. On appeal, the Region's denial was upheld. There was neither photographic documentation nor physical evidence to support restoration of the building to the appearance shown here. The result was a "selective" restoration of architectural features that--while commercially appealing--could not be historically documented to the 1907 or the 1920 appearance.

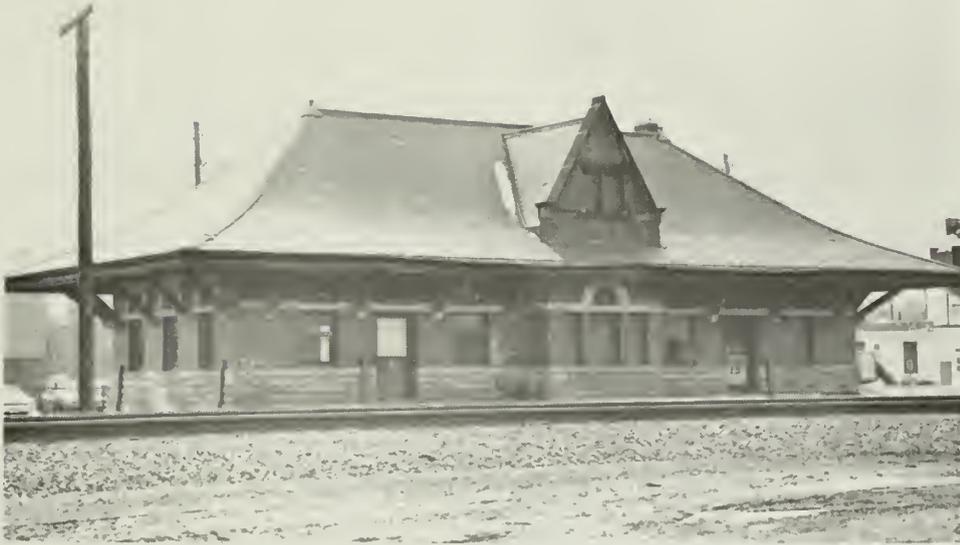
1. Pre-rehabilitation view of building from railroad tracks: Note brackets, stone corbels and stringcourses. These features occur on all sides of the building.

**Application:** A small, circa 1900 railroad depot which is individually listed on the National Register was rehabilitated as a restaurant. The character and picturesque quality of this depot prior to rehabilitation (see illus. 1) was largely defined by the conspicuous, slate-covered, hipped roof that projected broadly beyond the exterior walls to shelter the station's platform. The exterior walls on four sides of the building were decoratively treated with a quarry-faced limestone foundation, smooth red brick, and limestone stringcourses and window moldings. The use of these multi-colored materials and architectural features such as arched windows, leaded glass transoms, and wood brackets on stone corbels served to link the visually rich exterior walls with the prominent roof.

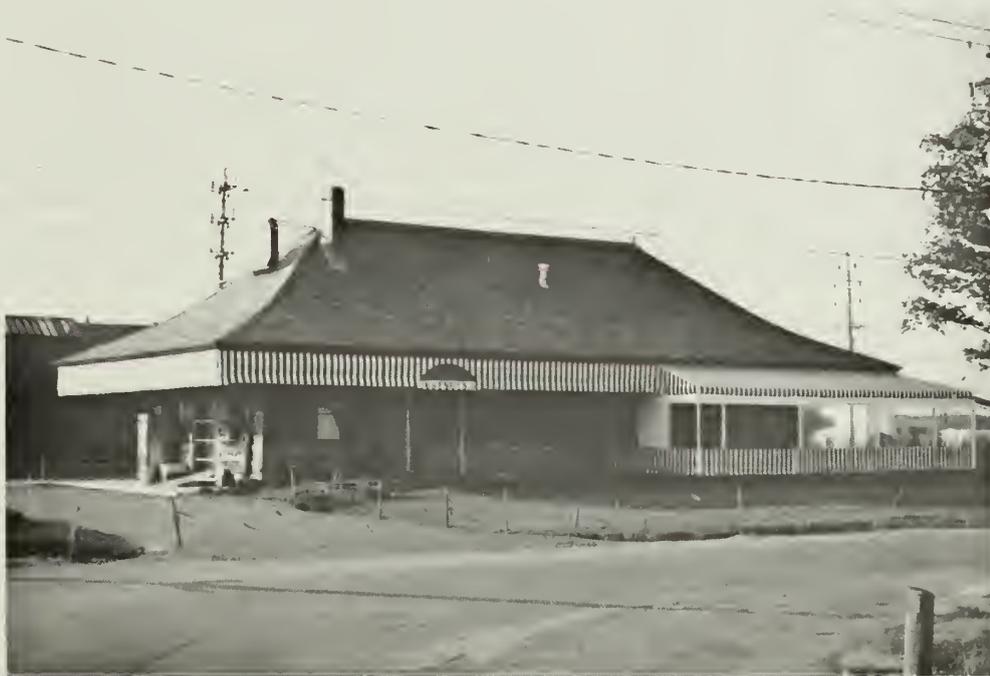
2. Post-rehabilitation view of the new addition and awnings from street. The addition and awnings obscure a substantial portion of the exterior.

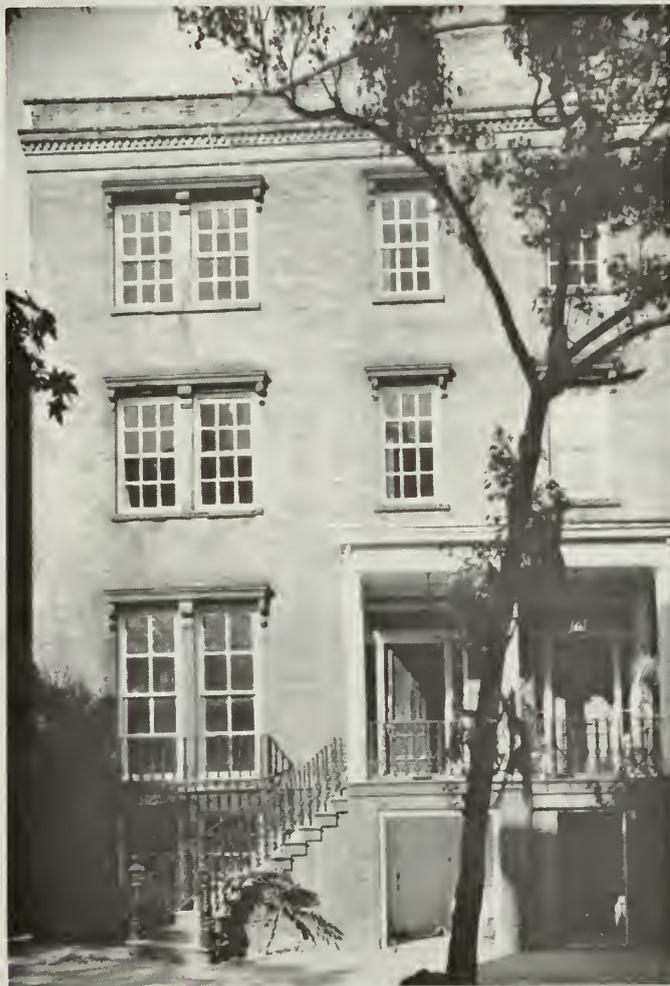
1. Building facade: This duplex rowhouse featured a formal series of 3 parlor rooms on the 2nd floor.

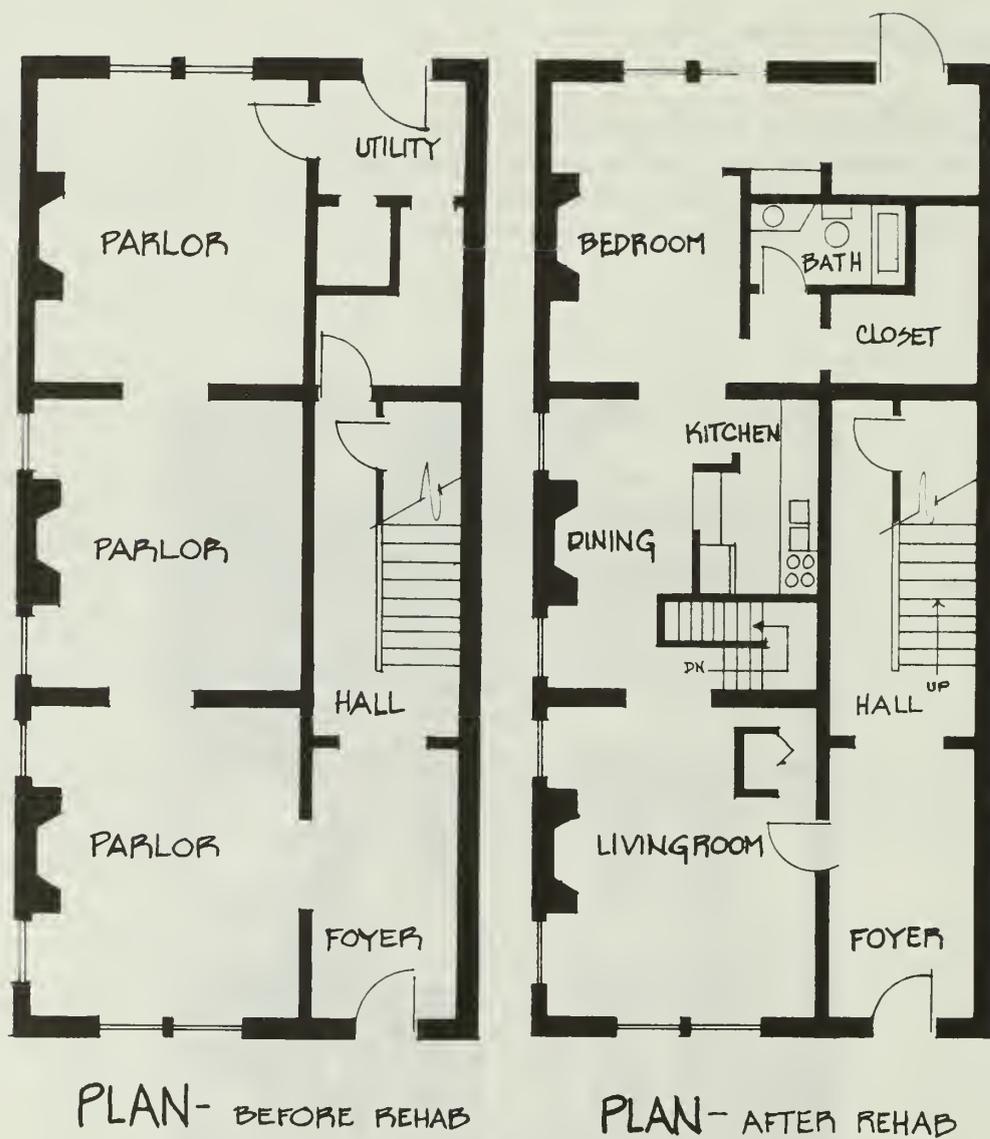
2. 2nd floor plan: Originally a side hall plan with 3 parlor rooms all of similar dimensions. Note extensive new construction in these rooms, especially stair and kitchen in center parlor room, and new wall for bathroom in rear parlor.

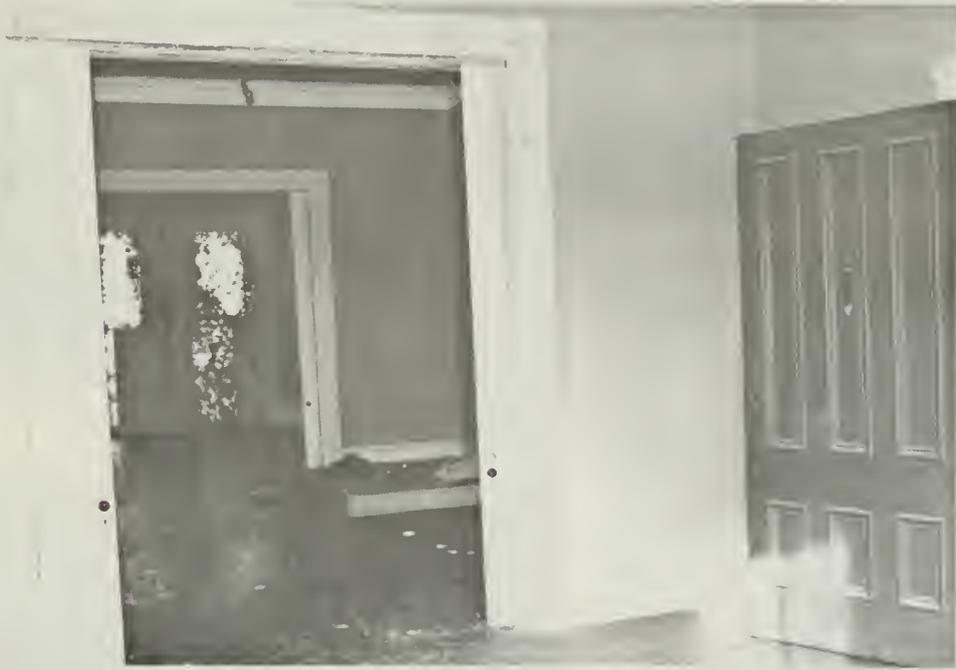
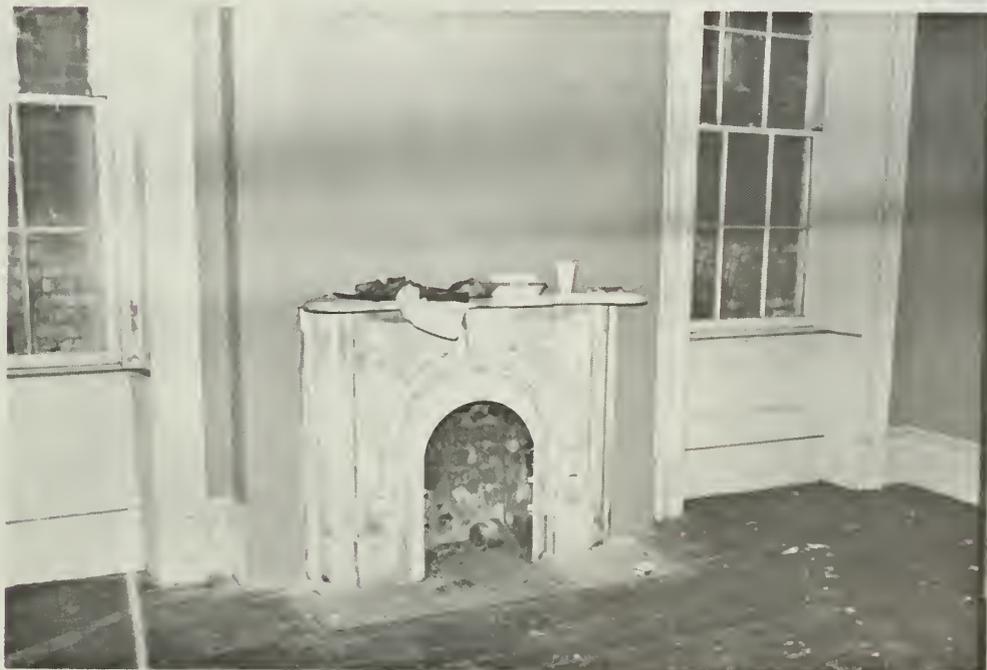
3 and 4. Pre-rehabilitation: 2nd floor.  
Note view through 3 parlor rooms divided by pocket doors.  
Center parlor room below now houses a staircase and kitchen.

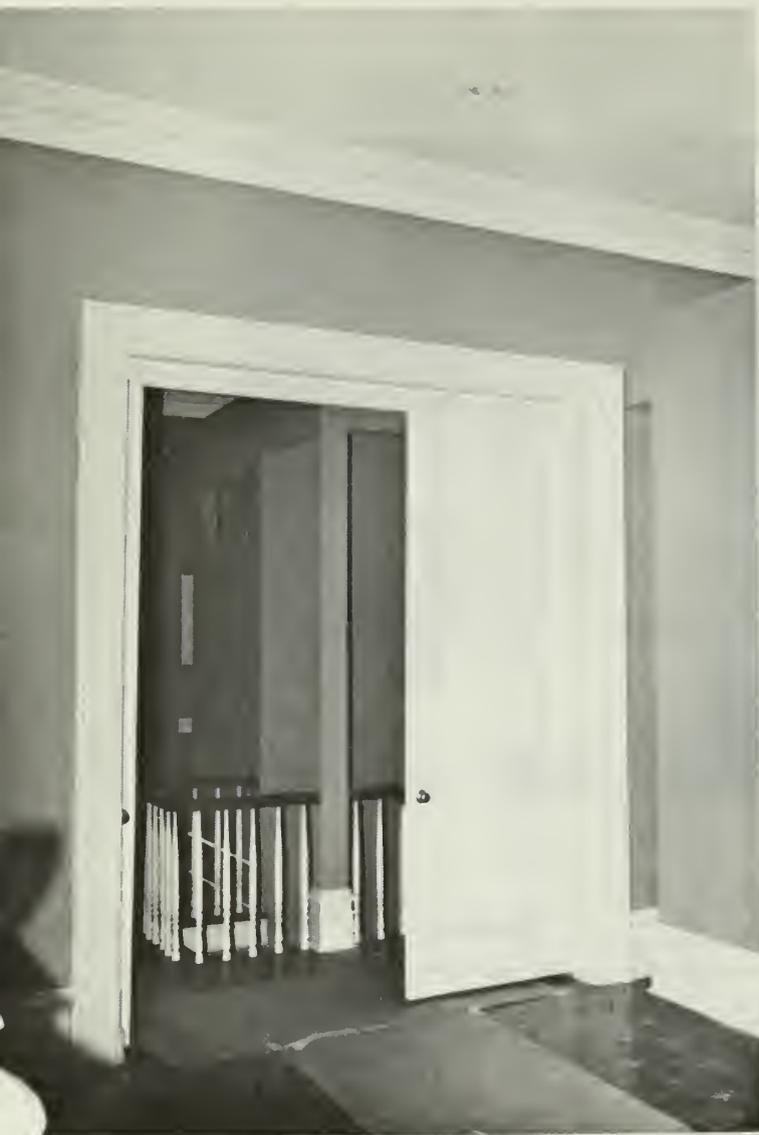
5. Post-rehabilitation: 2nd floor. Note new staircase and partition in center parlor room, new freestanding partition to the right of parlor door in front room.

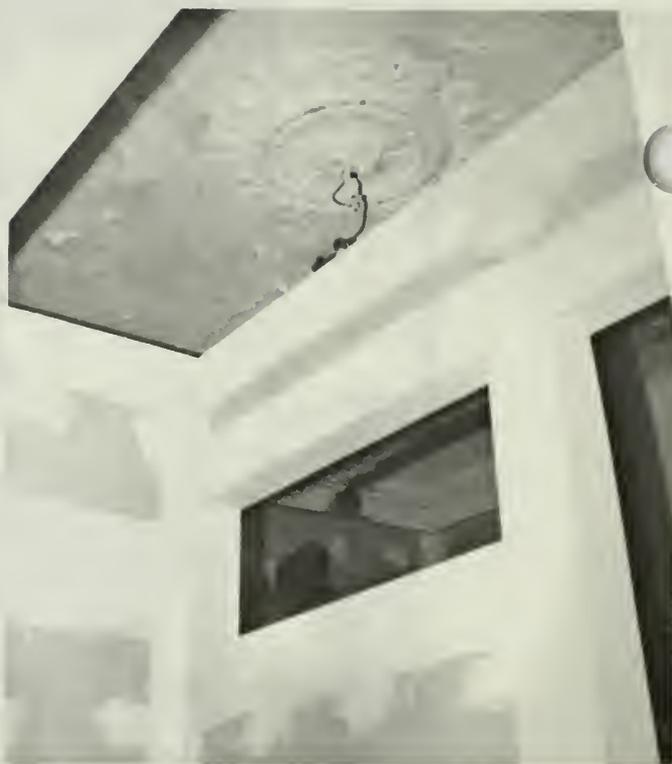
6. Work in progress: Center parlor. New partition wall for kitchen designed not to abut historic ceiling, yet is centrally located in room

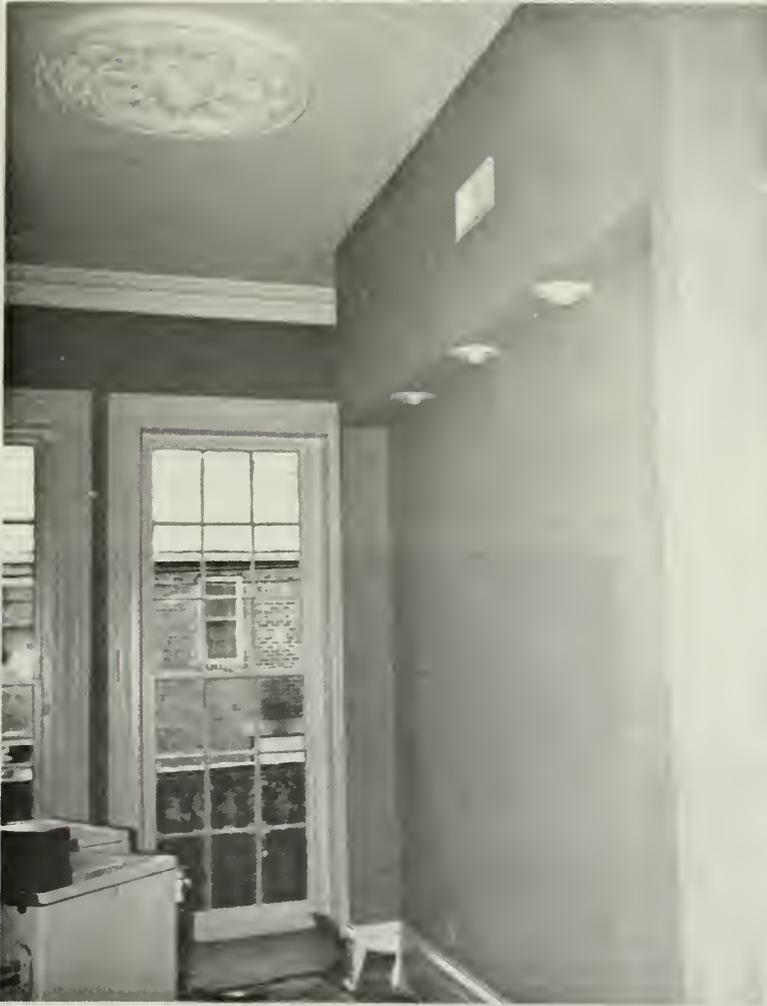
7. Post-rehabilitation: Rear parlor room.  
New partition divides previously square room.

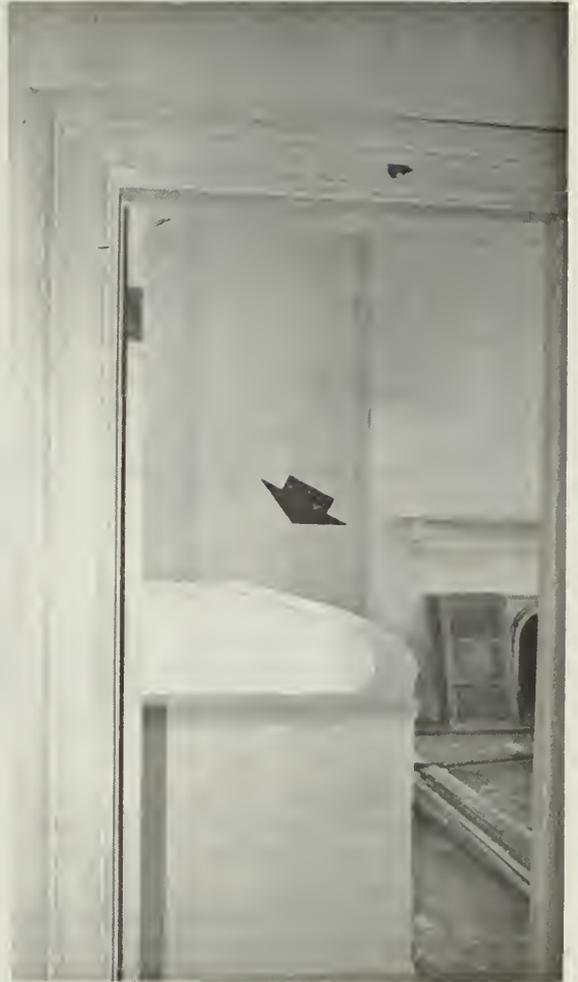
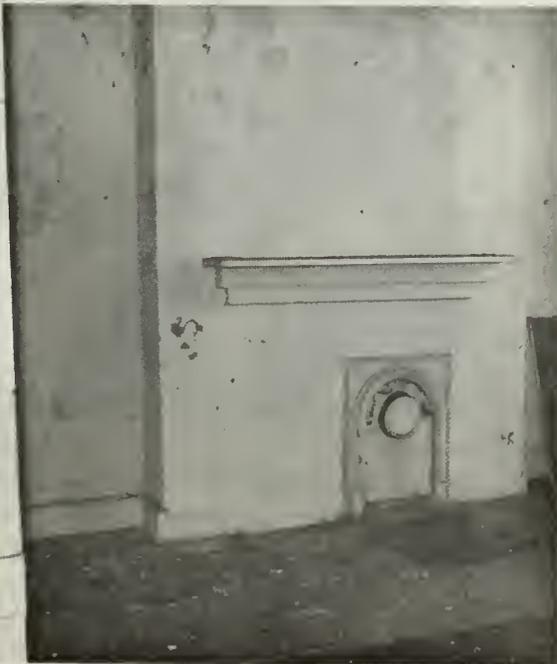
8 and 9. Fourth floor room,  
pre-rehabilitation (left) and  
in-progress (above). Note the  
insertion of the new staircase  
into the original bedroom in  
the post-rehab view.

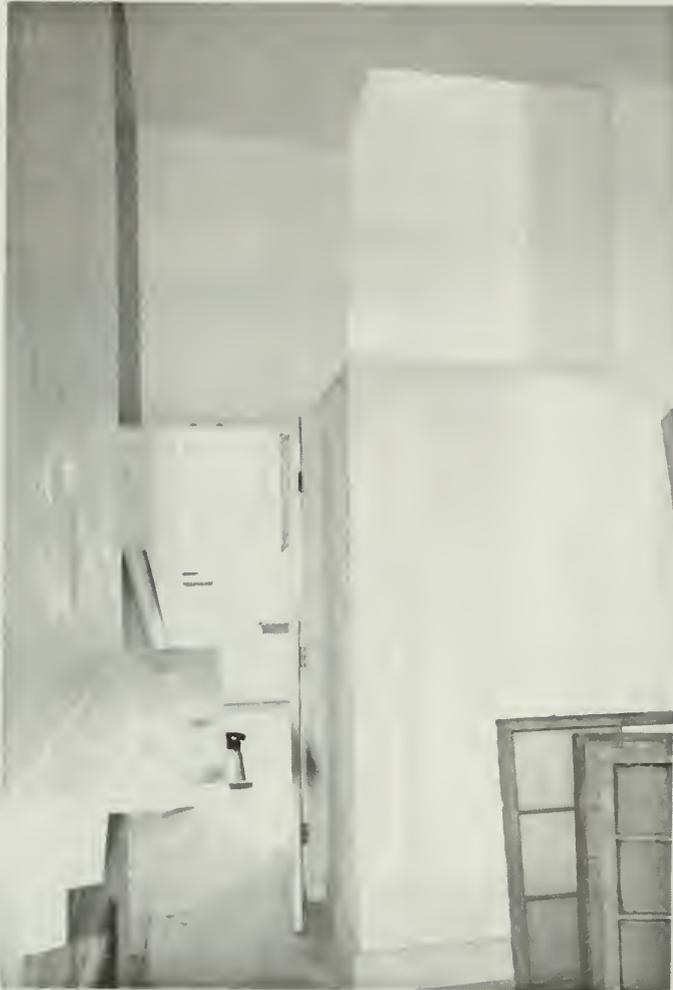
10. Work in progress on third floor showing penetration of wall between historic bedrooms, new staircase inserted in room and view to fourth floor above.

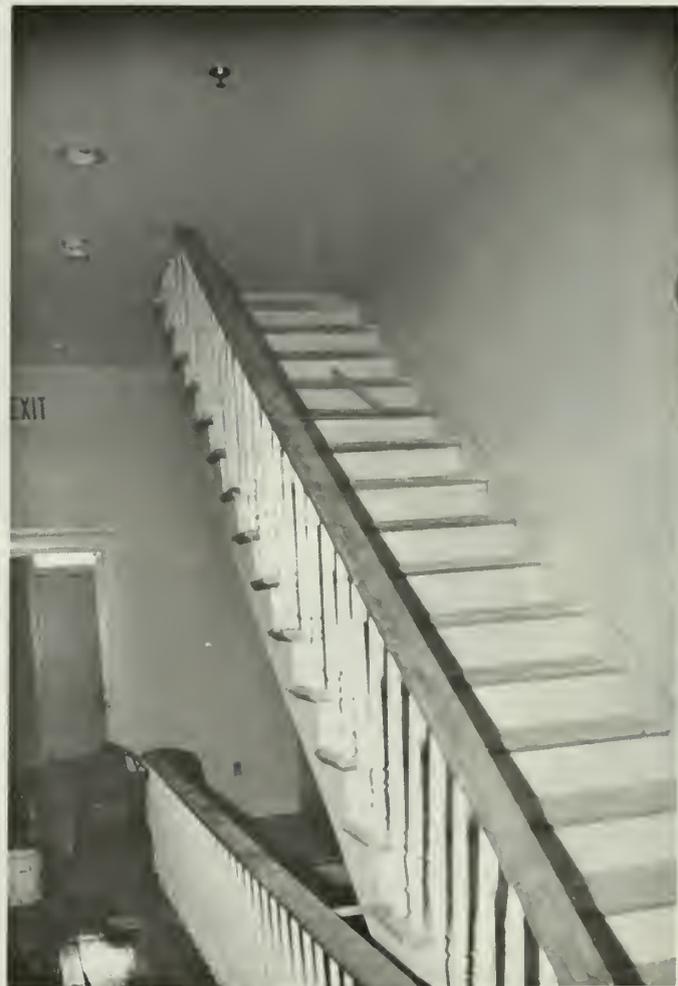
11. Post-rehabilitation view of original staircase maintained as a part of rehabilitation, but fourth floor is floored above, preventing access.

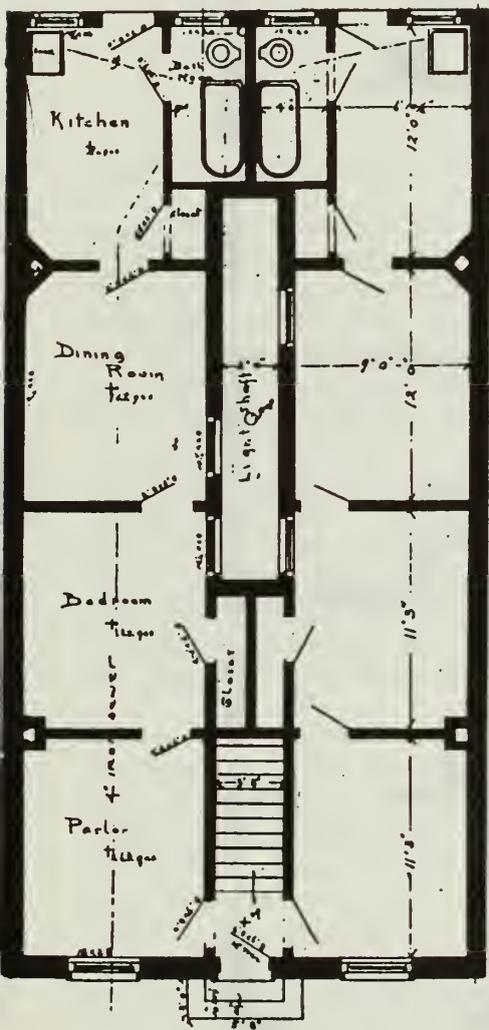
Original Plan  
1st Floor

1. Original floor plan showing the two first floor "flats" separated by center staircase and lightshaft. Note that lightshaft was completely enclosed, and not visible from the rear of the building.

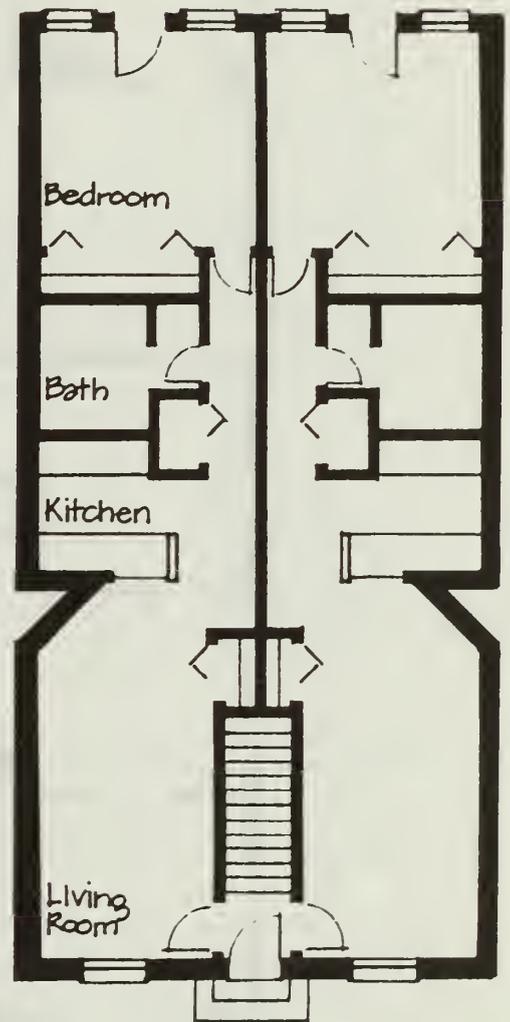
New Plan  
1st Floor

2. New floor plan after rehabilitation shows that although lightshaft has been eliminated, basic concept of "railroad flat" remains.

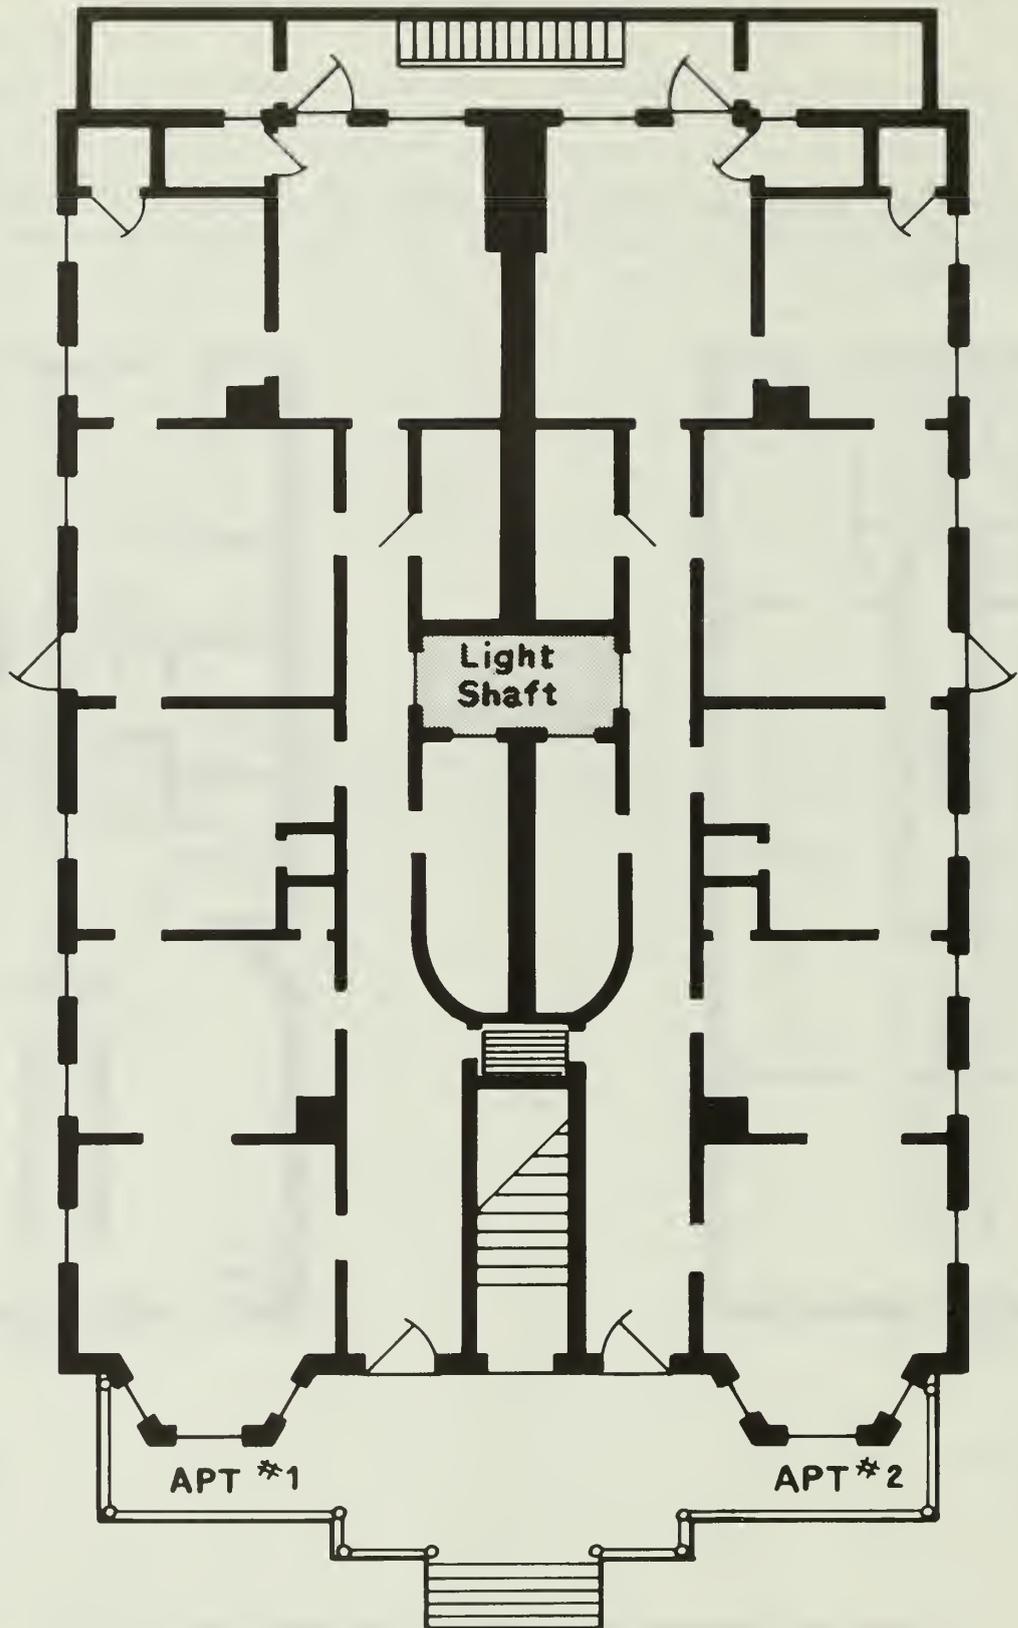
3. This original floor plan shows the lightshaft (shaded) that was determined not to be a character-defining feature and therefore eliminated in the rehabilitation of these two identical apartment buildings.

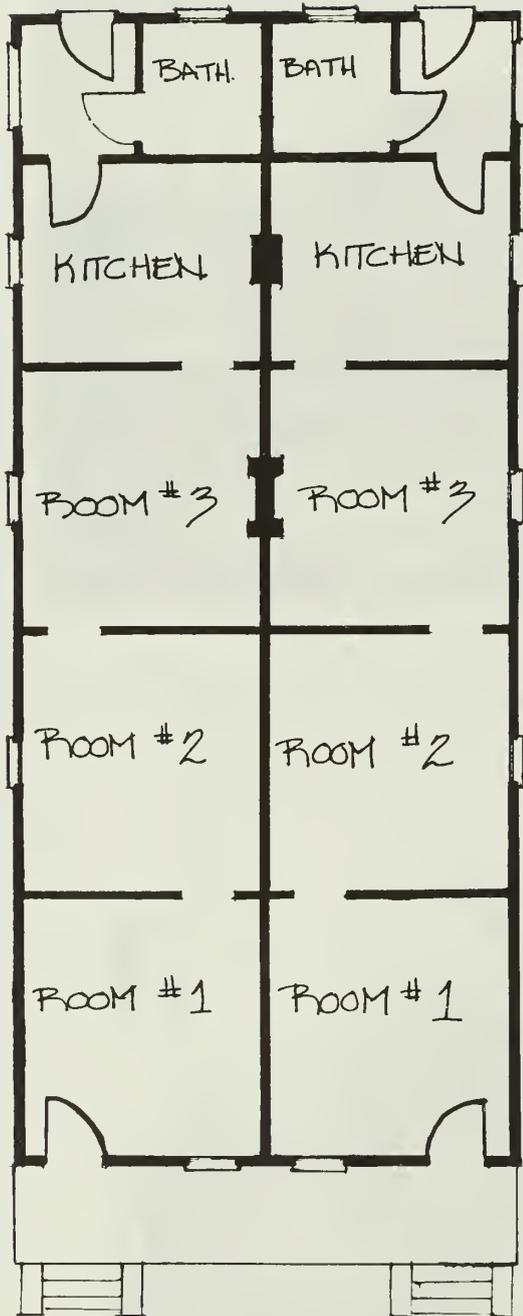
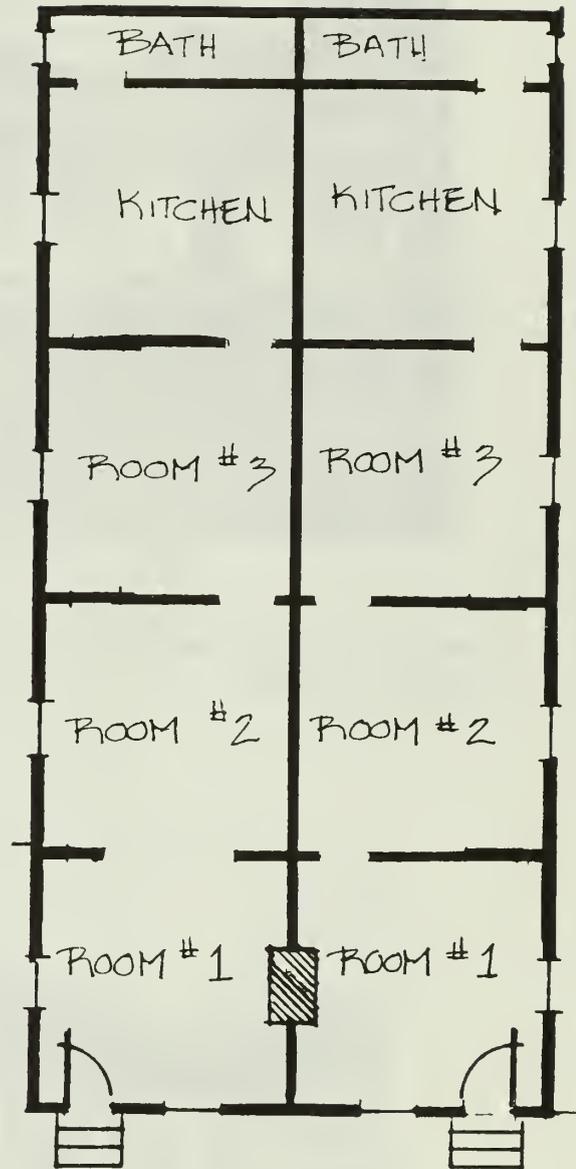
3 and 4. Before rehabilitation floor plans of 1900 building (left) and 1890 building (right).

Applications: Both projects discussed here are double "shotgun" cottages whose characteristic room arrangement remained intact despite some deterioration of features and finishes (see illus. 1 and 2). The first was built ca. 1900; the second dates from ca. 1890. The original plan of each building is a rectangle having a dividing party wall down the middle with four rooms arranged in linear fashion on each side. Sheds containing bathrooms had been added onto the rear of each building (see illus. 3 and 4). Each building was rehabilitated for continued use as residential apartments.

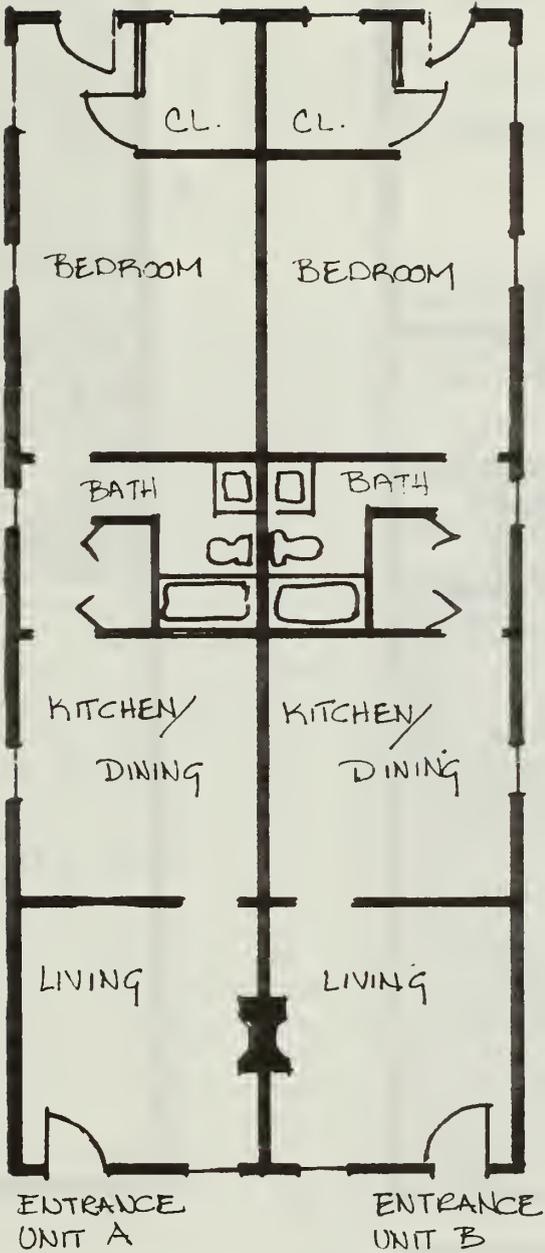
5. After rehabilitation floor plan of 1900 building.
