Technical Preservation Services  
Preservation Assistance Division  
National Park Service  
U.S. Department of the Interior  
Washington, D.C.

Interpreting  
the Secretary of the Interior's  
Standards for Rehabilitation

Volume III

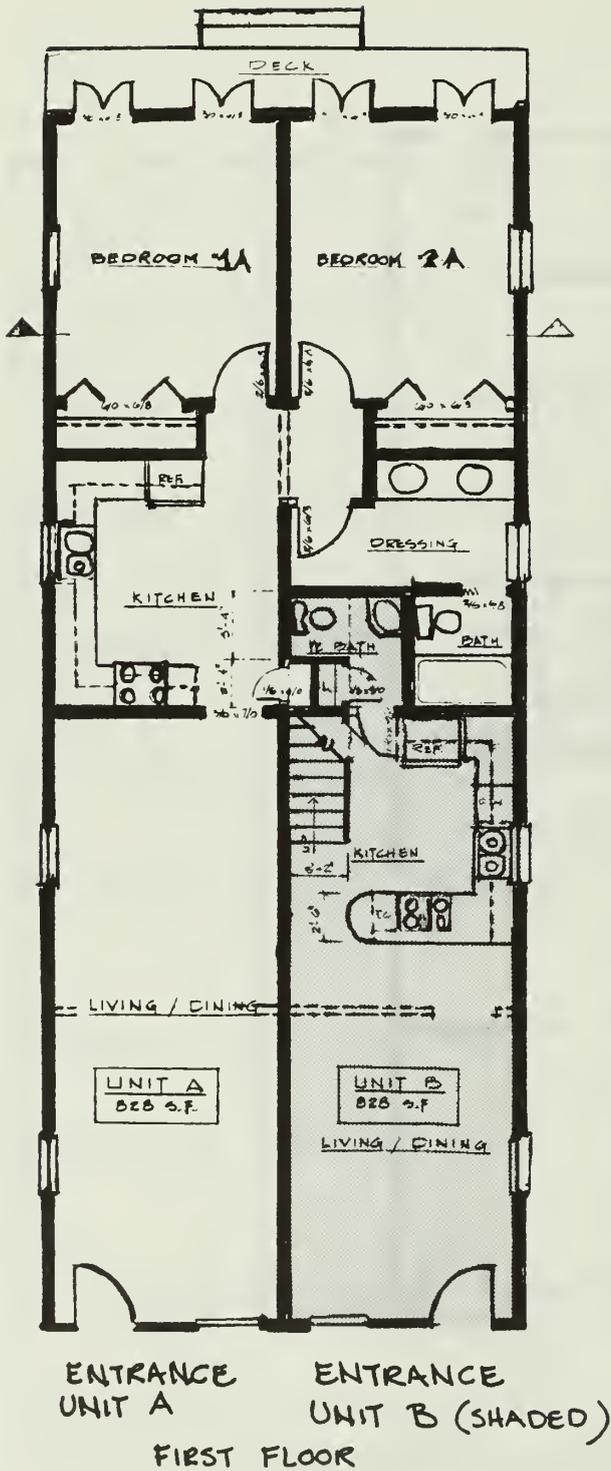
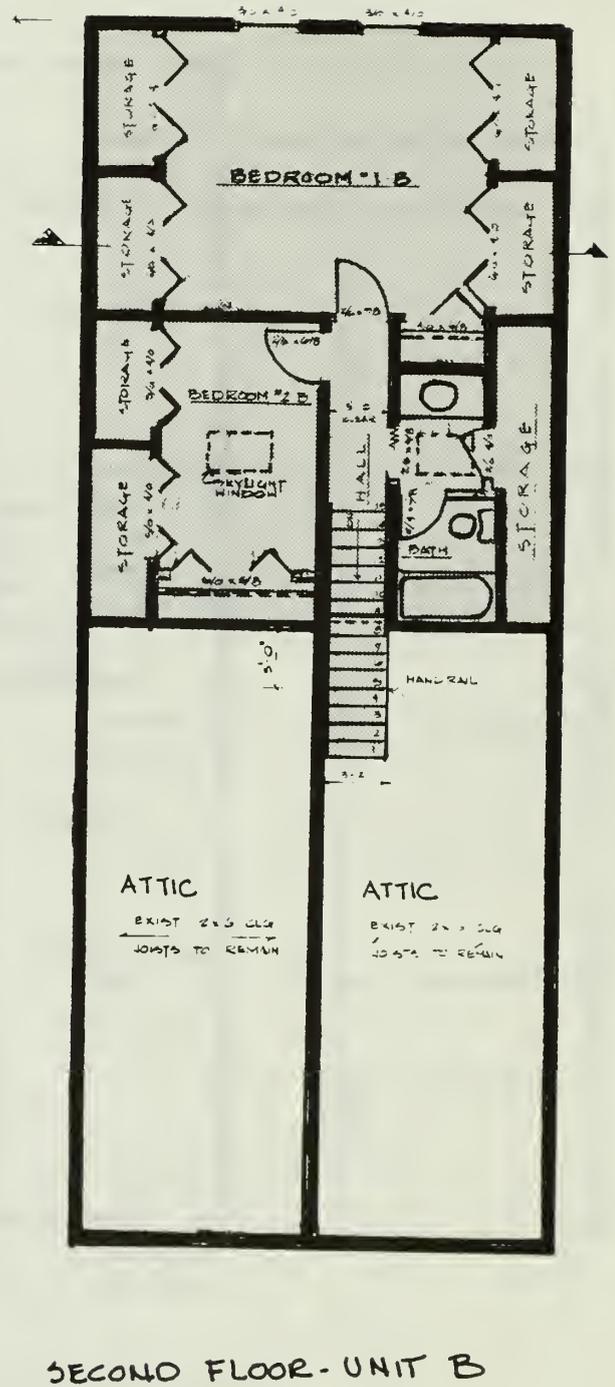
6a and 6b. After rehabilitation floor plan of 1890 building. The unit on the left now extends across the full width of the building in the rear half. To regain the floor space thus lost in the right unit, a stair was added, further altering the plan of this simple structure.

order to enlarge the apartments, the plan was further altered by incorporating almost the entire rear half of the right unit into the left unit. The floor space lost to the right unit was regained through the addition of a stair to the attic, into which two bedrooms were added. In this project the damage done to the historic character of this modest building is extreme. The units no longer convey a sense of the original "shotgun" plan. Construction of the stair in the right unit has further drastically altered the structure by introducing a vertical element missing from the historic plan. Finally, the division between the halves of the building was effectively destroyed in the rear half of the building. Accordingly, the project fails to meet the Secretary of the Interior's "Standards for Rehabilitation."

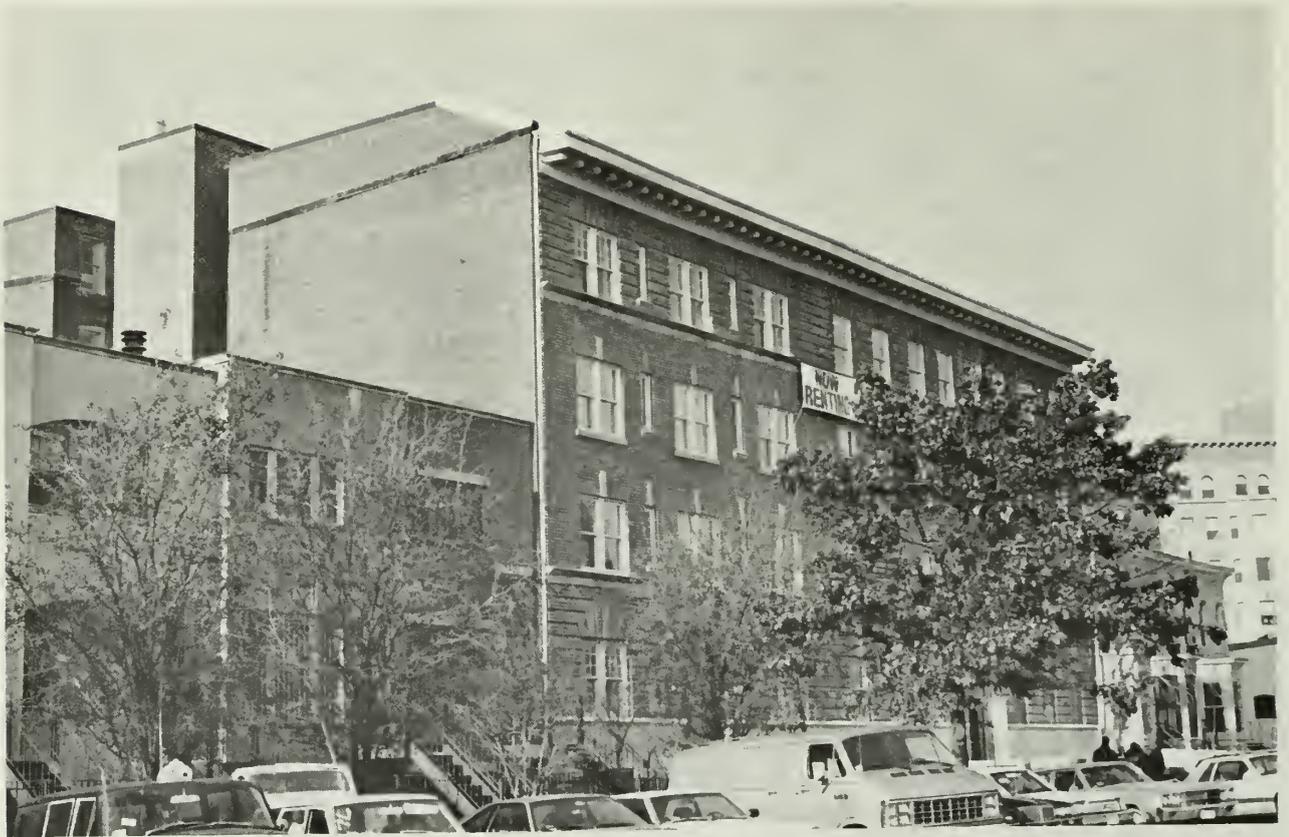
2. New rooftop addition and stairtower visible on the south elevation.

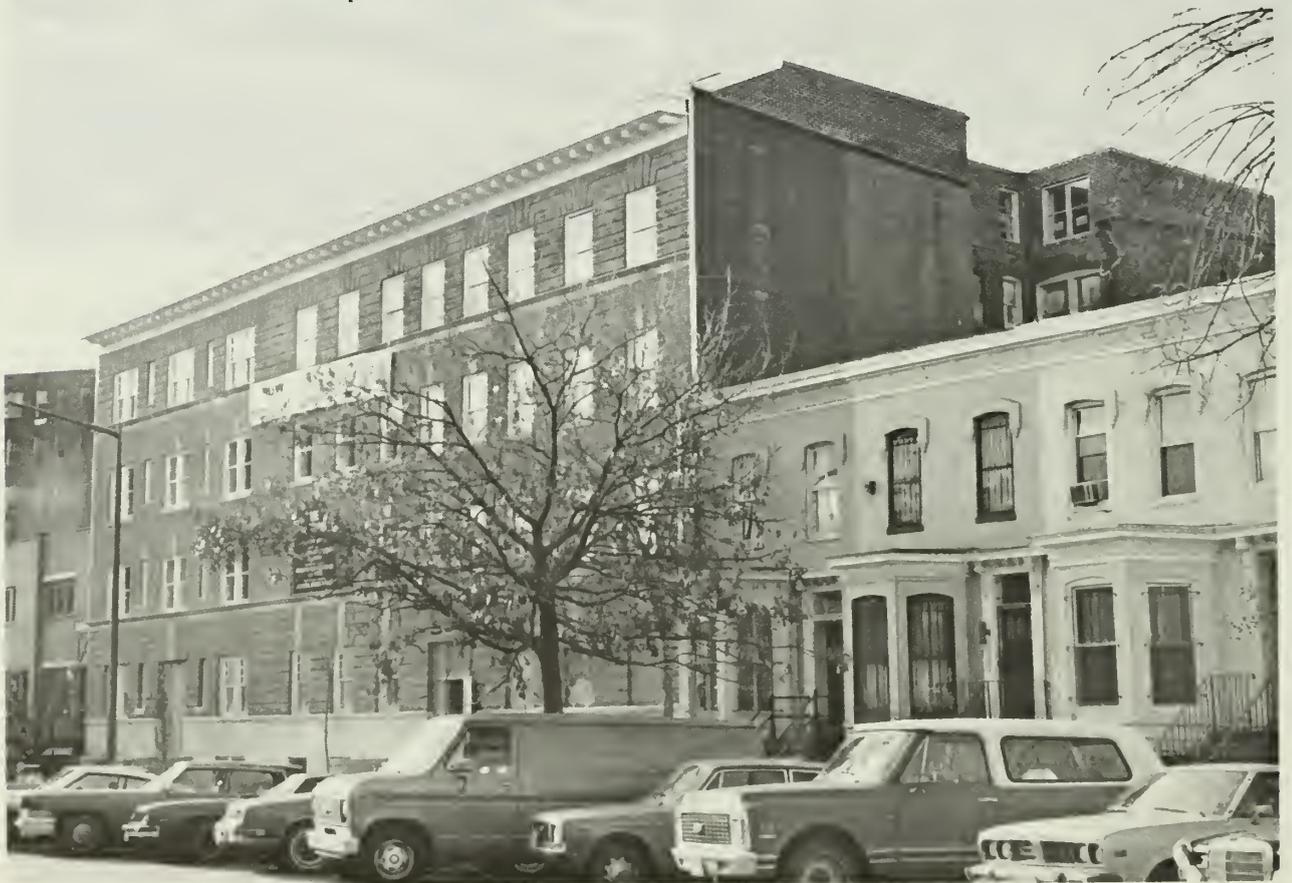
3. New rooftop addition visible on the north elevation.

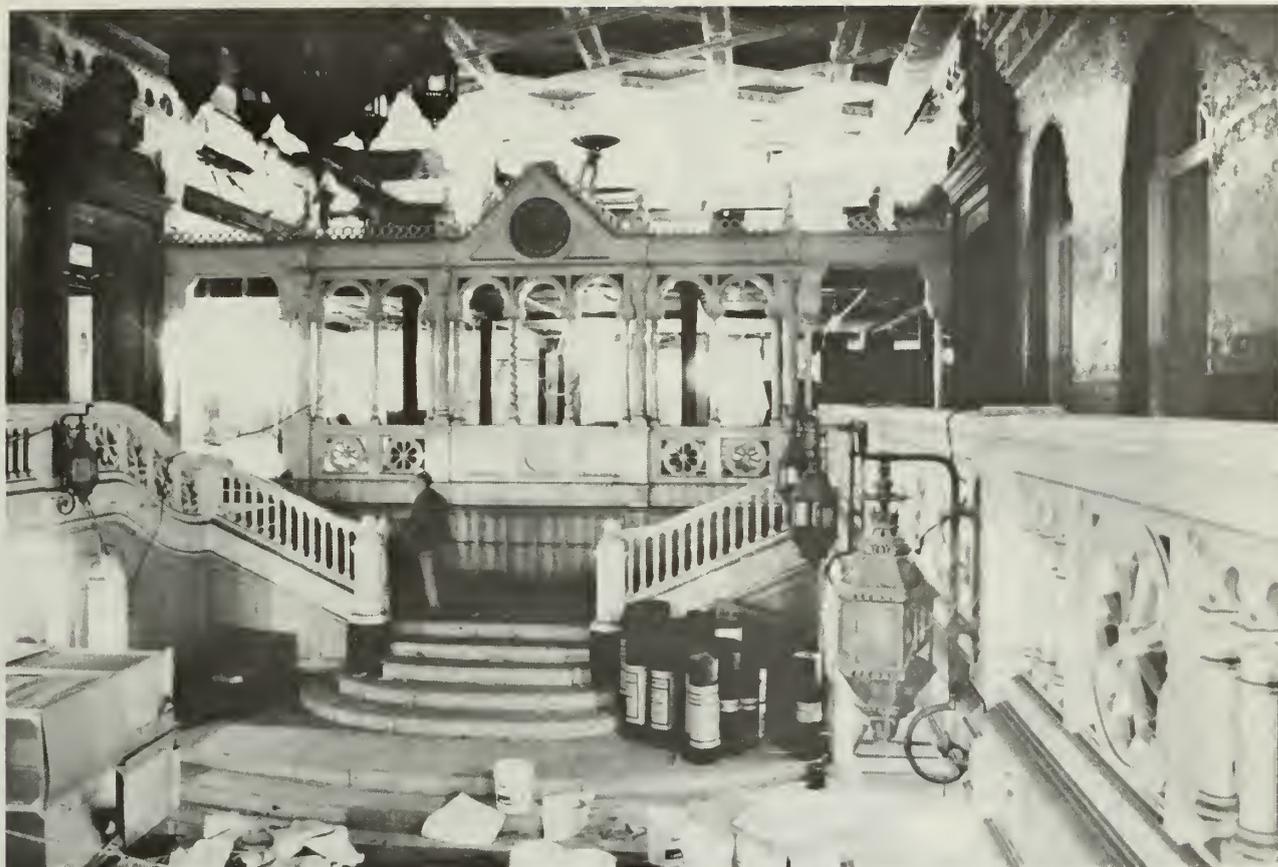
1. Lobby before rehabilitation. Ornamental screen at top of stairs leads to two other formal open spaces, the palm room and the dining room.

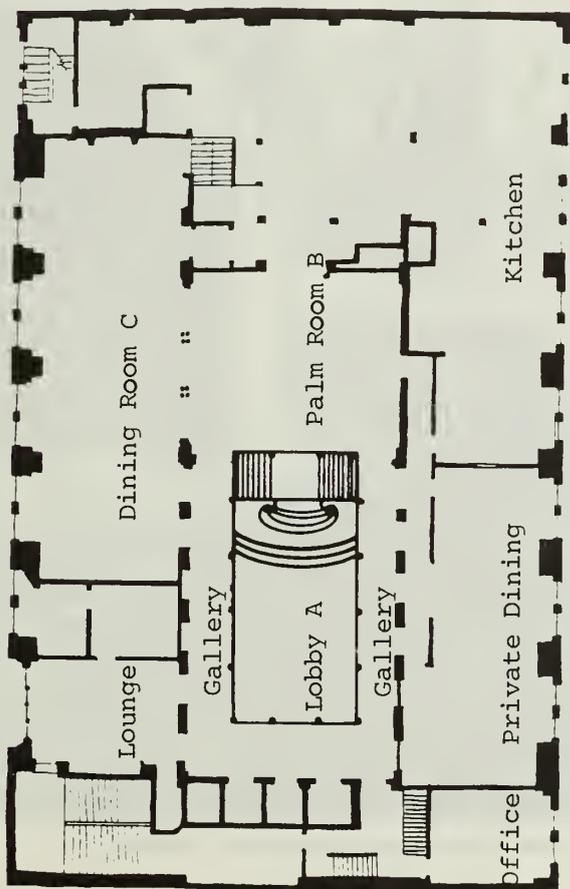
2. Plan of lobby (A), adjoining palm room (B) and dining room (C) before rehabilitation.

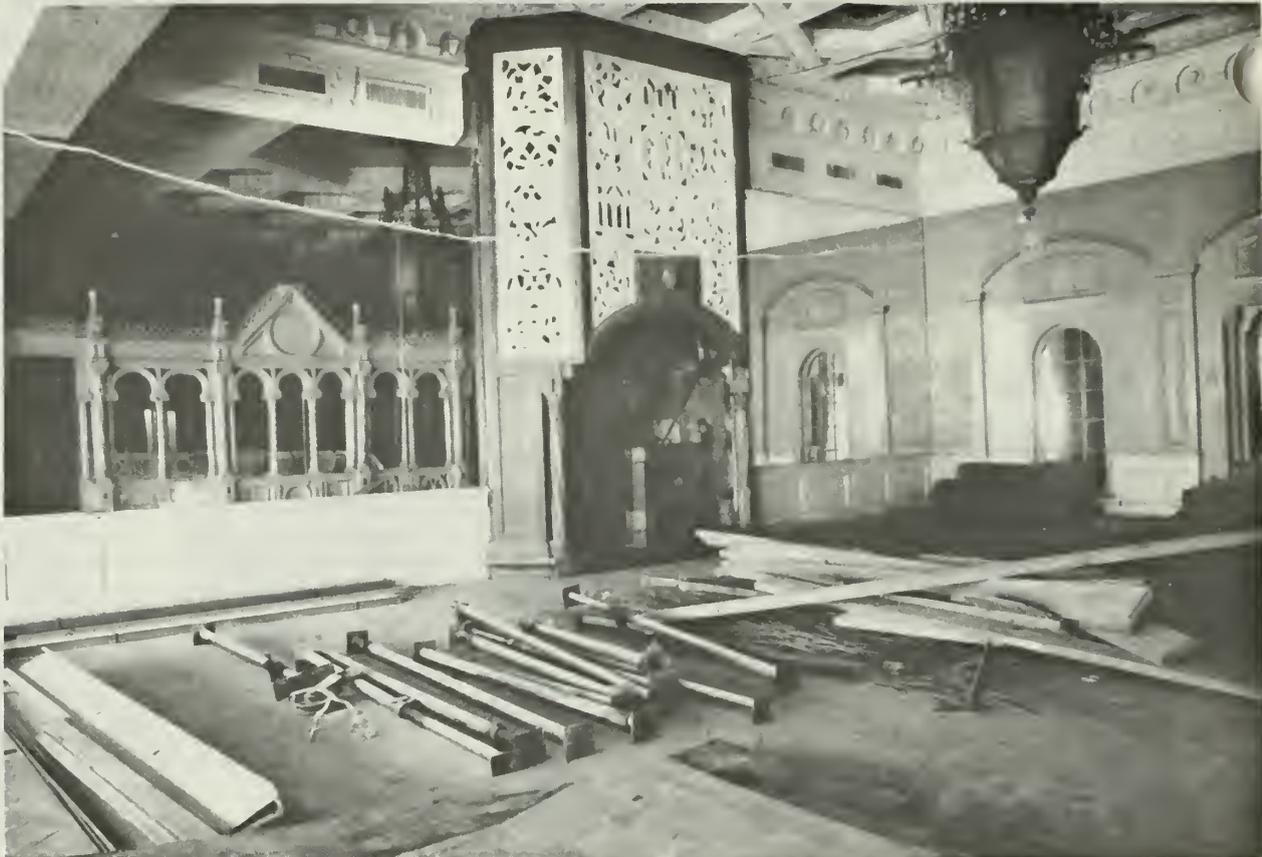
3. Palm court beyond lobby stair. Ornamental screen between the lobby and this room is reflected in mirrored wall at the left of the fireplace. All features were removed from this room in the rehabilitation.

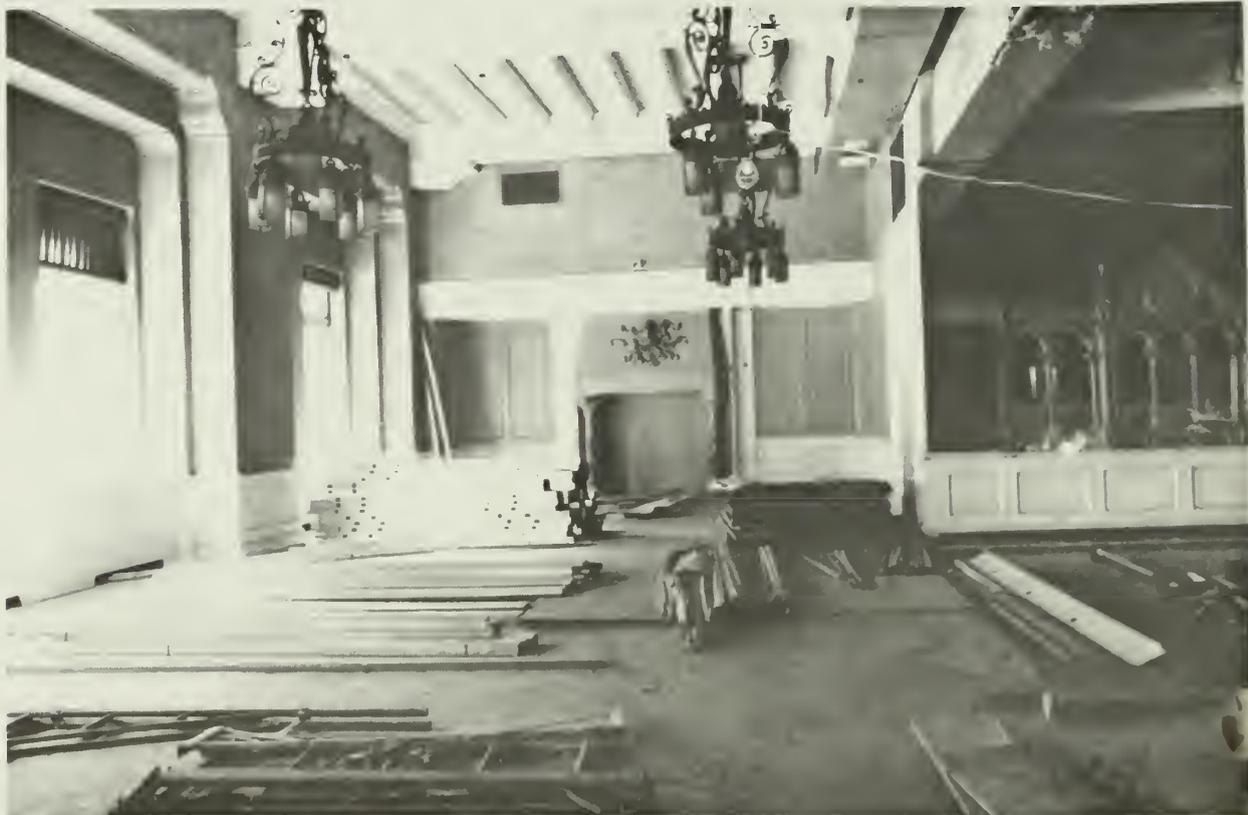
4. Dining room, before rehabilitation, and adjoining palm room (right).

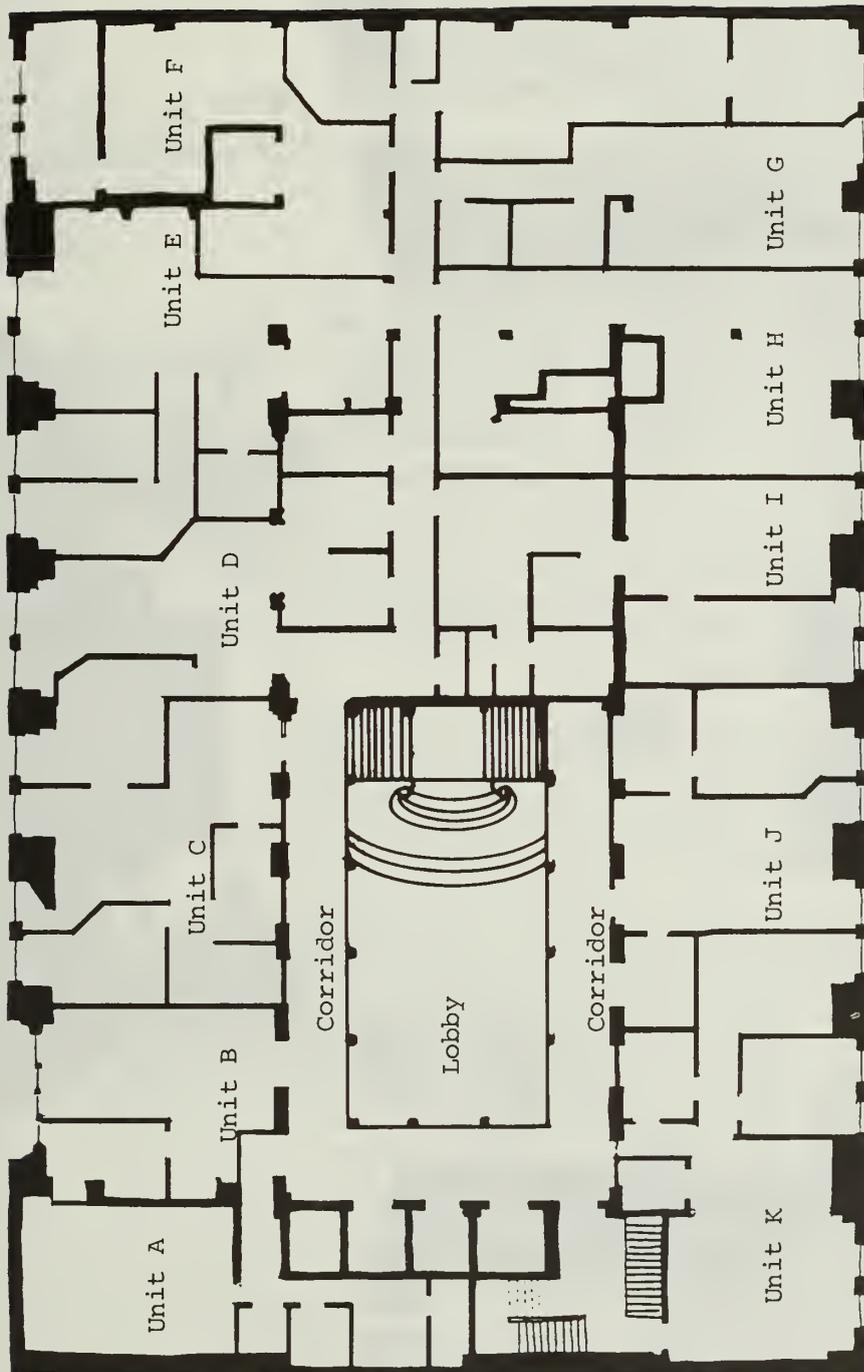
5. Lobby and adjoining spaces after rehabilitation. The palm room and dining room have been subdivided. A new partition directly behind the decorative screen has destroyed the progression of spaces that marked the original design.

The insertion of a solid partition behind the open screen effectively cut off the lobby from the palm room. The damage wrought by the rehabilitation to the individual spaces thus exceeded the demolition of individual features or their incorporation into smaller rooms. The rehabilitation destroyed the formal organization of the spaces themselves. The progression from the grand, three-story lobby, up the elaborate split stair into the palm room and adjoining dining room was lost, and the historic character of the building irreparably harmed.

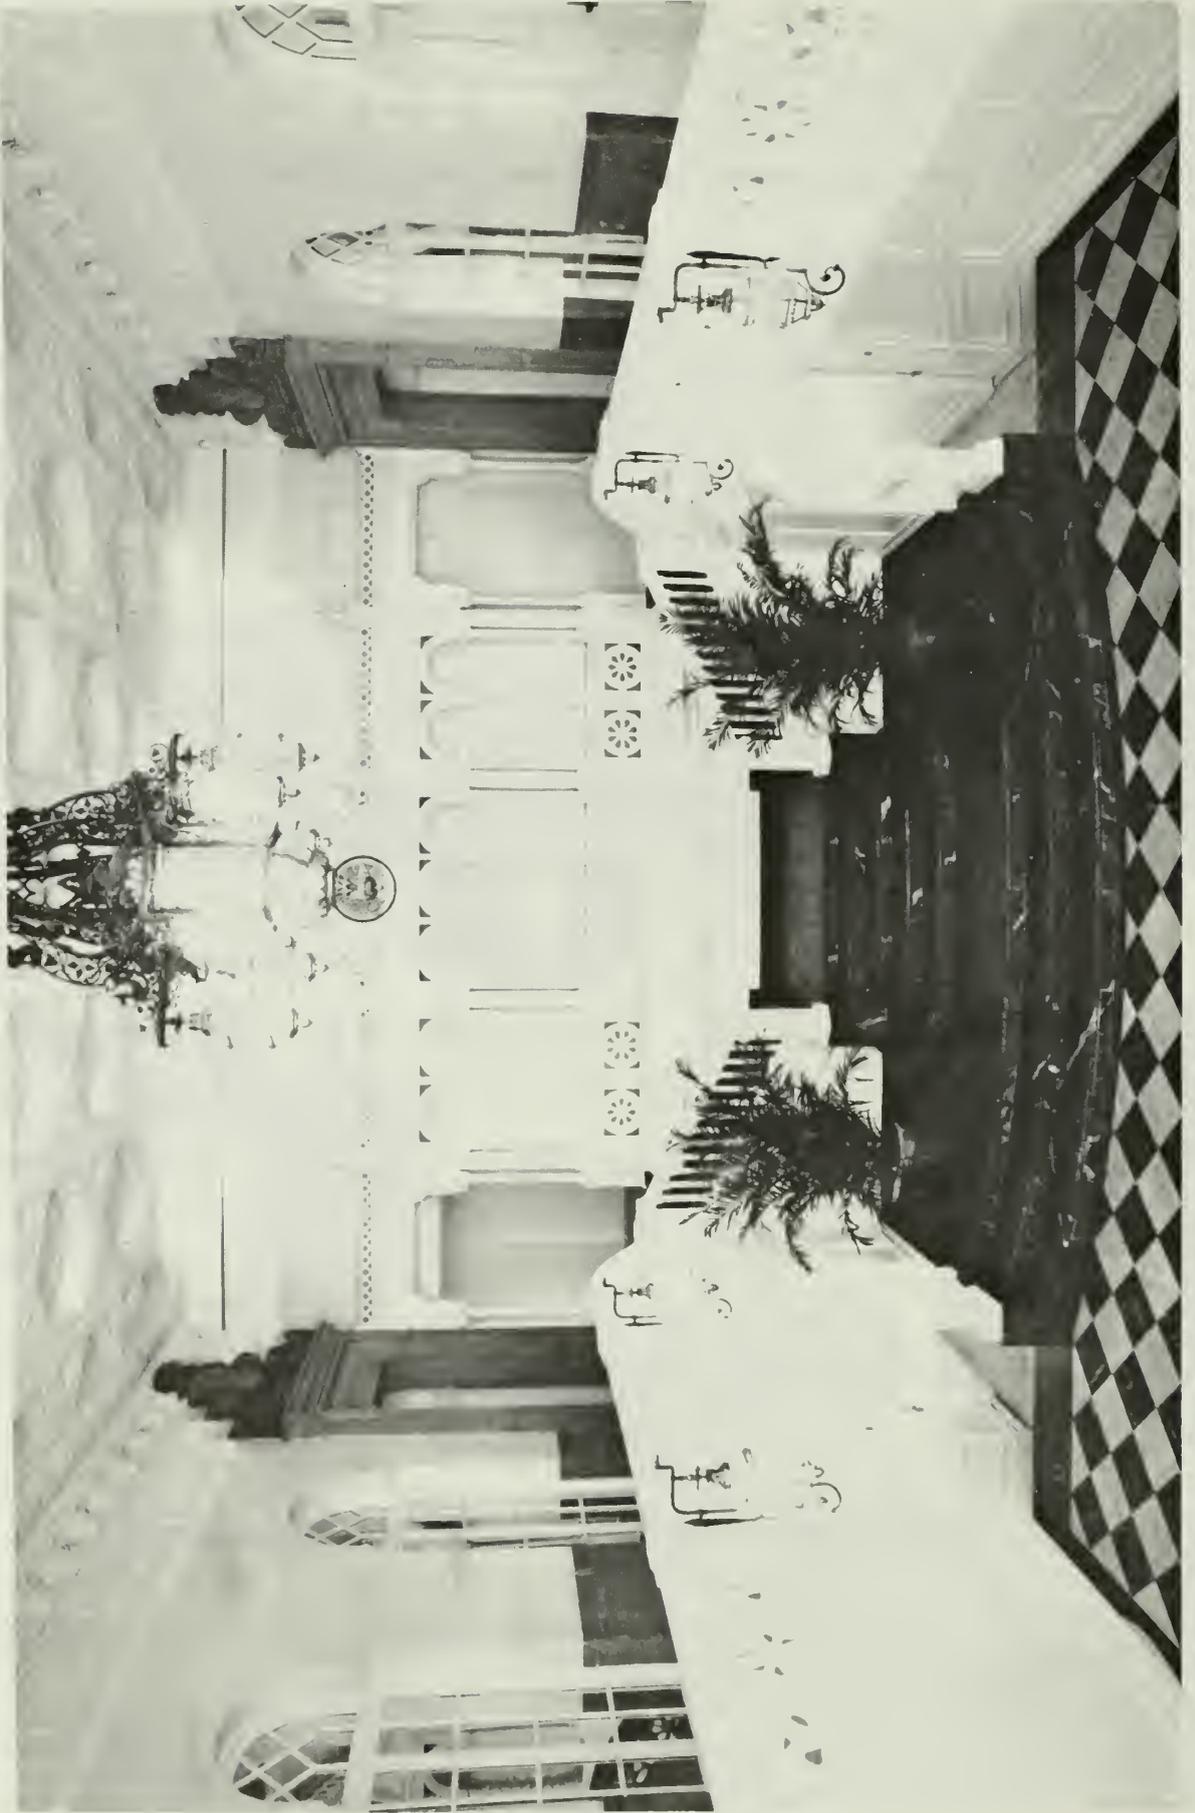
6. Lobby after rehabilitation. Partition behind screen closes off palm room and dining

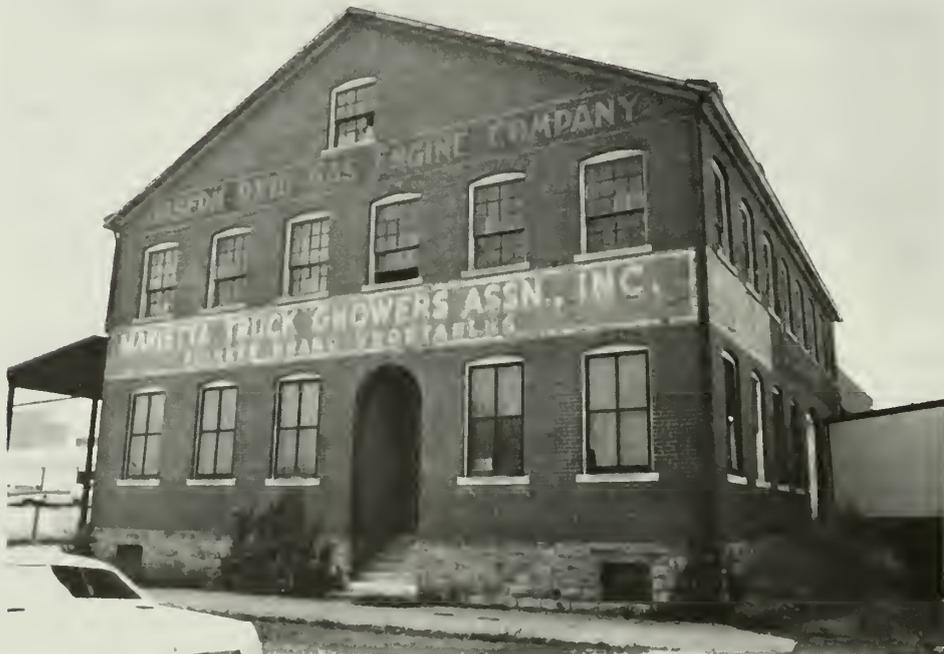
1. Front elevation of the 1880 manufacturing facility as it appeared prior to the rehabilitation.

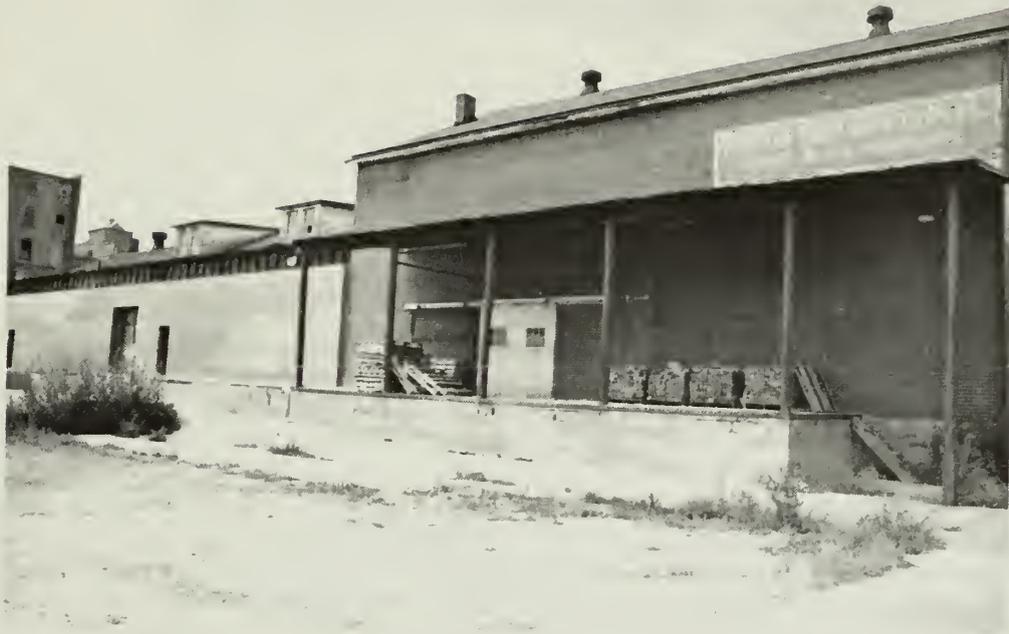
2. South side elevation of the building with roof-covered loading dock prior to rehabilitation.

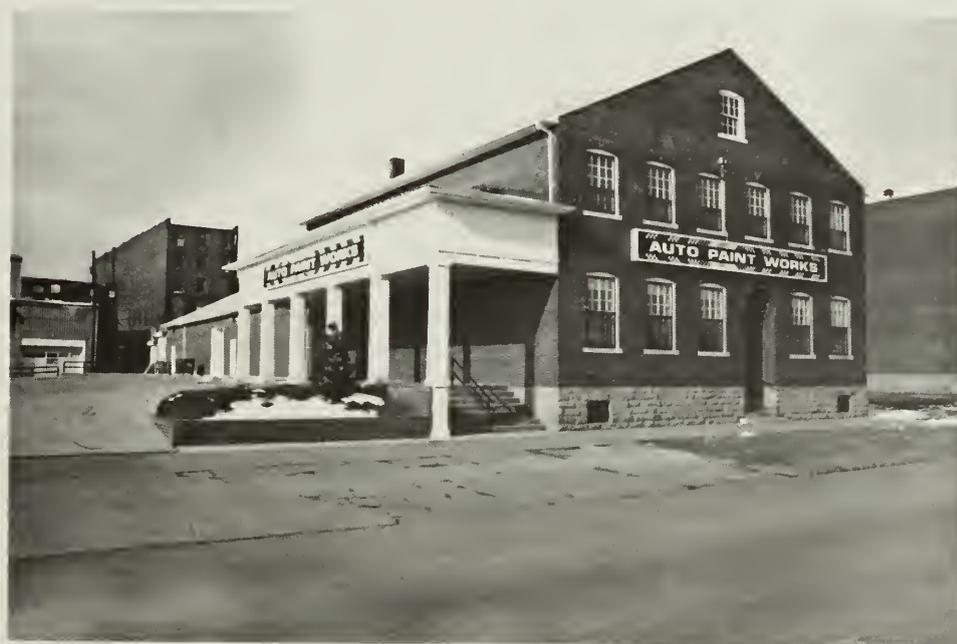
3. Photograph of building after rehabilitation with construction of portico.

The new porch, which retained and boxed in the surviving pipe columns from the old roof, is located in the same general location as that roof (see illus. 3). However, it differs from the old in design and scale. It has larger columns and is three feet taller, thereby dominating the south side and front of the building. The new portico fails to meet Standard 9, in that its size and scale are out of proportion to the historic building. The new portico also departs from the industrial character of the building. With its deep entablature and massive formal columns, the new portico creates more monumental, classical architecture than is consistent with the function and historic character of this modest industrial building. The new portico hints of the Greek Revival, an architectural phenomenon much earlier than the date when this building was constructed.

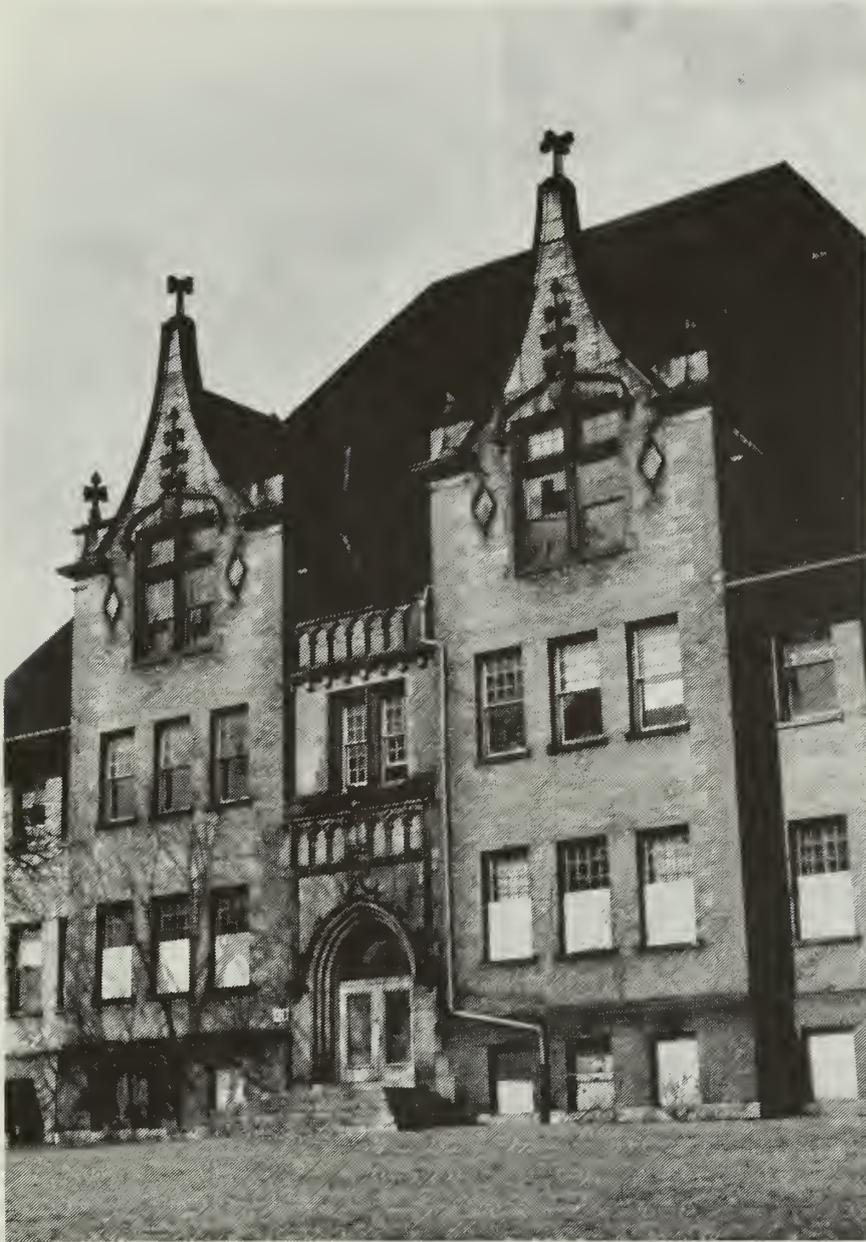
1. The former school building is characterized by its distinctive form--massive yet only three stories in height--its twin towers, unusual arch-shaped entrance and series of large-scale, twelve-over one windows that were designed to provide maximum daylight in the classrooms.

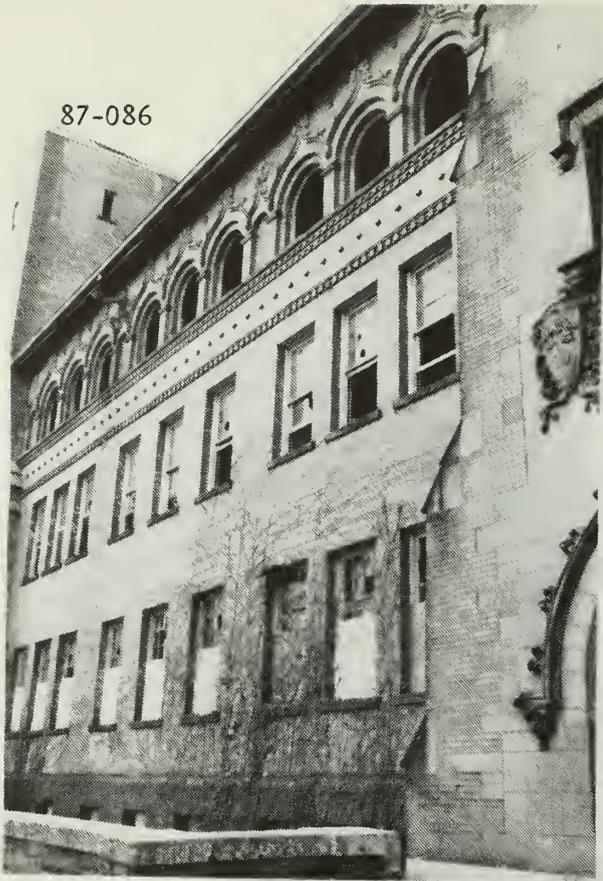
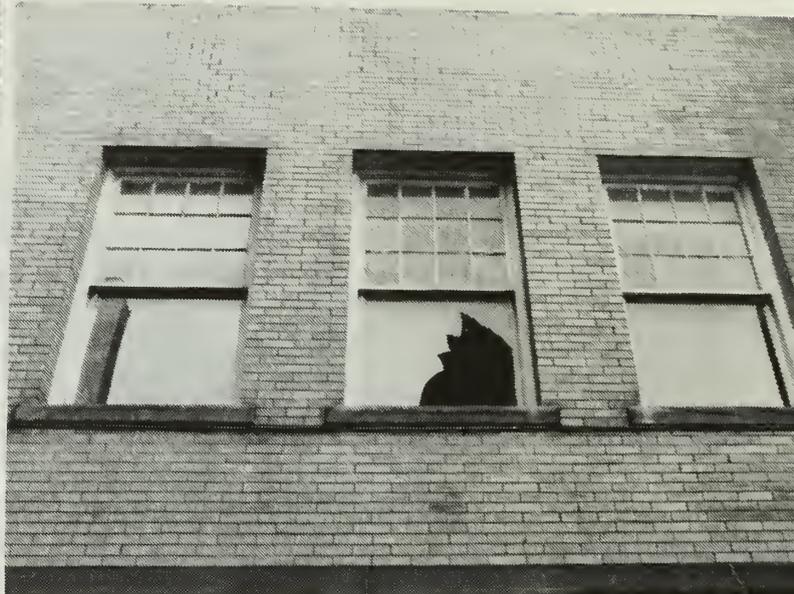
2. and 3. The windows and window openings as one would see them close to the building's walkway entrance establish the importance of their design and detail.

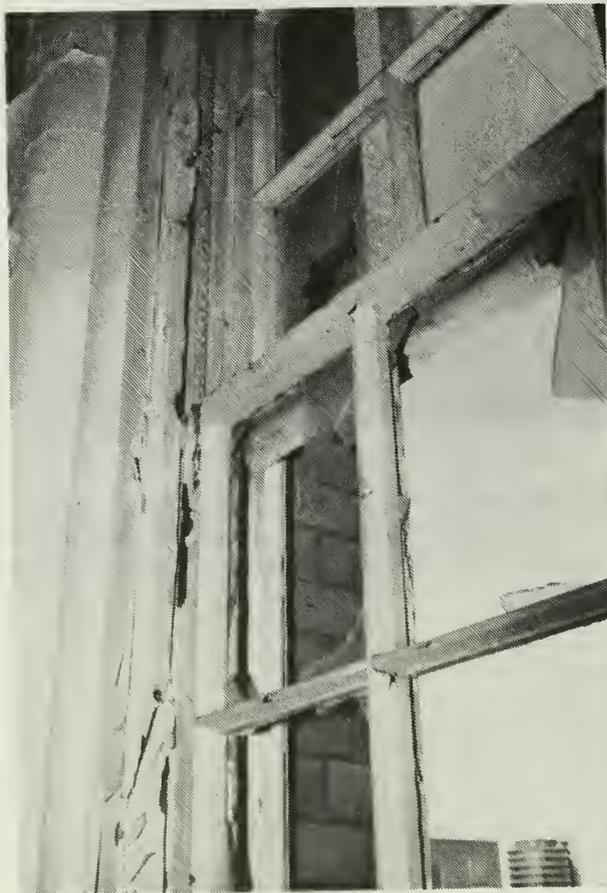
4. From inside as well, the detail, design features, shadow lines and finishes are all part of the character of the window. If a historic window is so deteriorated that it needs to be replaced, a matching replacement window is the most appropriate choice to meet the Secretary's Standards within a rehabilitation project.

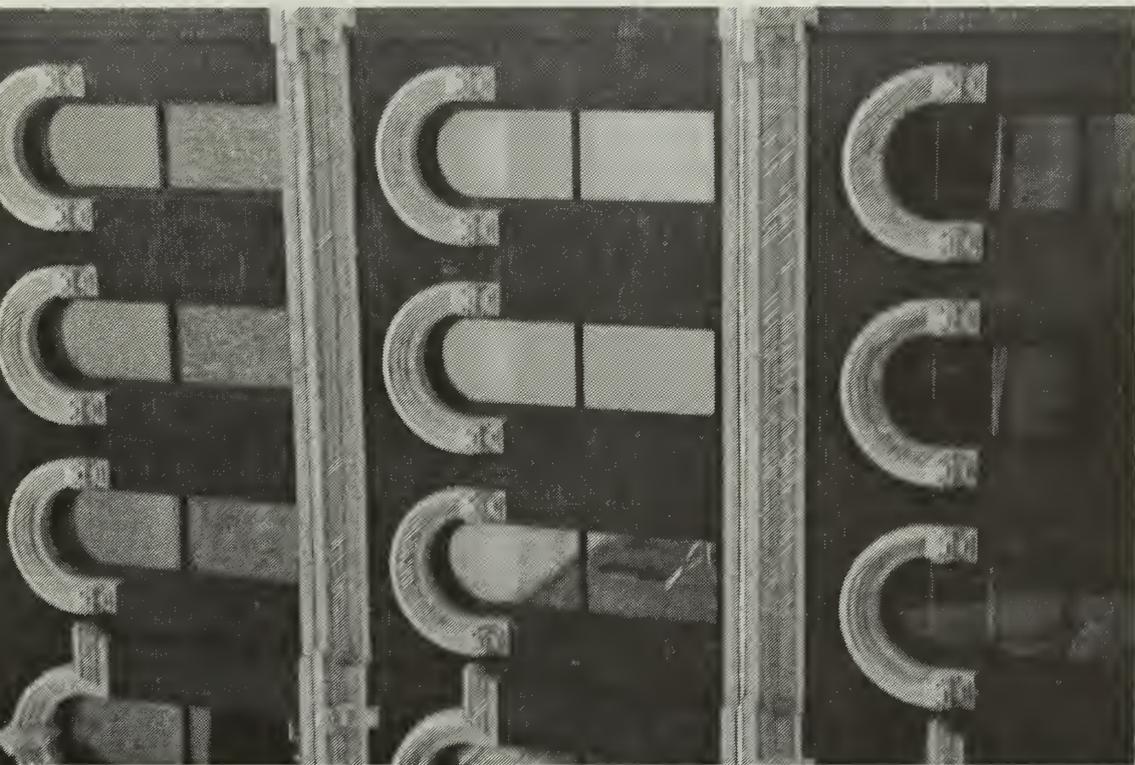
2. After rehabilitation and installation of the new windows, the "eyebrows" seem to float--disconnected--above the dark brown fixed sash.

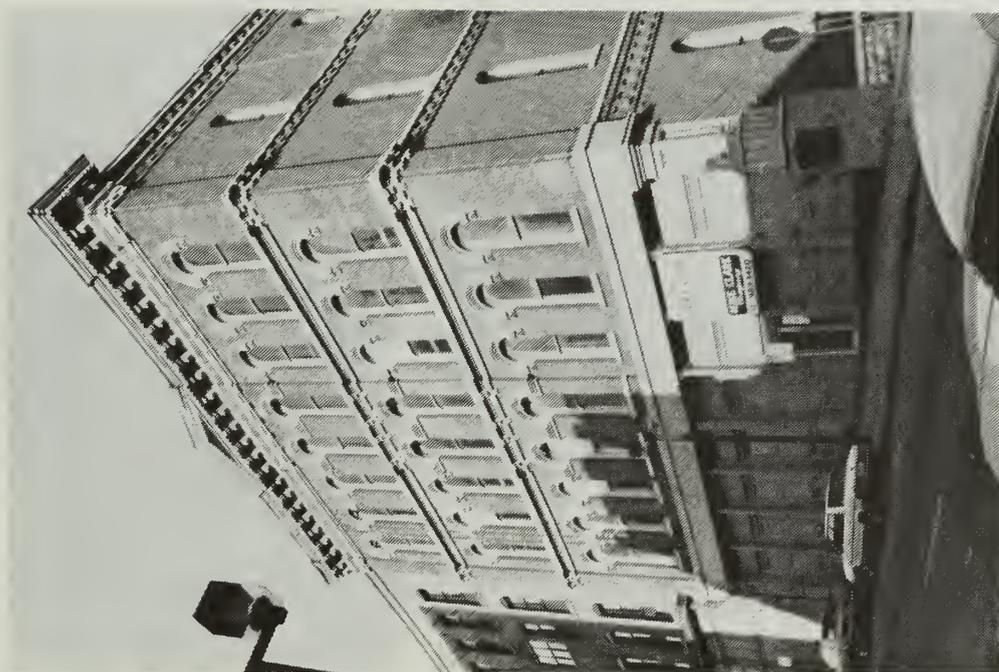
1. Before rehabilitation, the front elevation of the 1875 commercial building is shown with its distinctive "eyebrow" ornamentation framing the one-over-one, circle-top, double hung windows. Because the sash and eyebrows are all painted a light color, they are perceived historically as a unified design component.

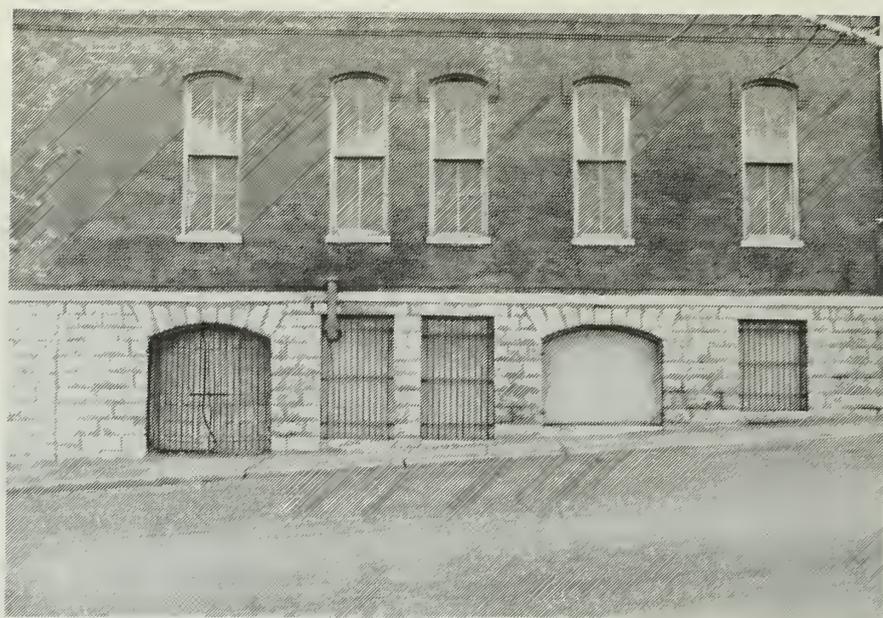
3. Before rehabilitation, the windows on another street elevation were four-over-four units that feature delicate, attenuated muntins. The historic window is a double-hung design; the shadow line that the meeting rail casts at the center of the two-part window is a distinctive quality.

Before and after photographs revealed several design deficiencies in the new window. Where one over one double-hung windows had existed historically on the building's primary facade, the replacement windows were a "fixed" design with both upper and lower sash on the same plane; the horizontal piece applied as a meeting rail is actually flat, and consequently unable to cast the familiar shadow line of the historic window. Finally, there was a dramatic difference in color, from a light cream color to dark brown (see illus. 1 and 2). On another key facade, where there had been historic four-over-four double-hung windows, fixed sash were installed, the light divisions were altered, wider muntins were used, and the color of the windows was changed (see illus. 3, 4 and 5).

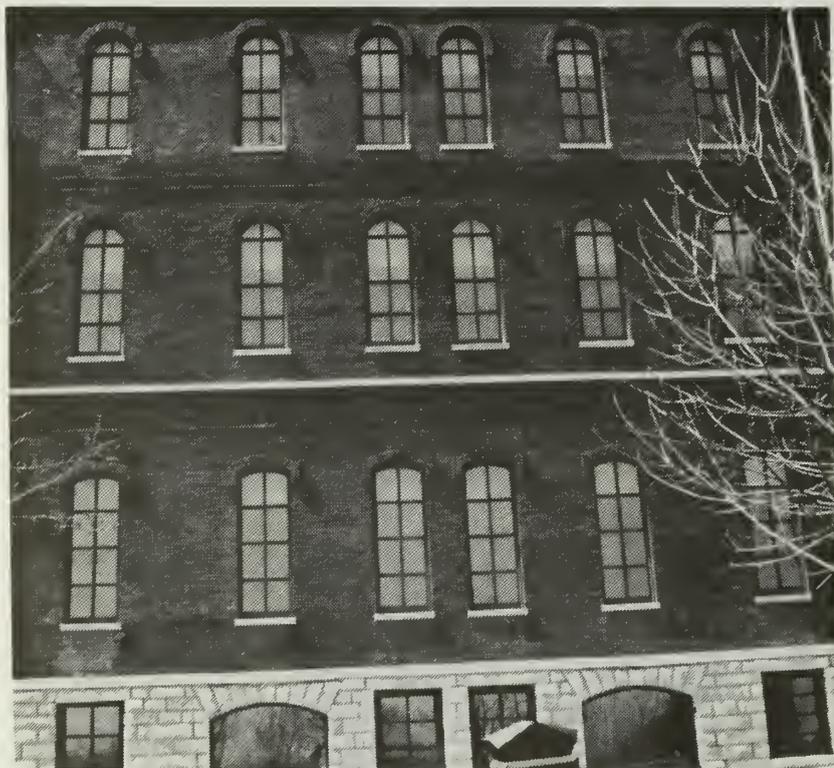
4 and 5. After rehabilitation, there is a striking change in the appearance of the entire facade due to the installation of inappropriate replacement windows. In addition to the obvious color disparity, the unit is noticeably on one plane rather than double-hung. The muntins are also much heavier and there is no meeting rail.
