Technical Preservation Services  
Preservation Assistance Division  
National Park Service  
U.S. Department of the Interior  
Washington, D.C.

Interpreting  
the Secretary of the Interior's  
Standards for Rehabilitation

Volume III

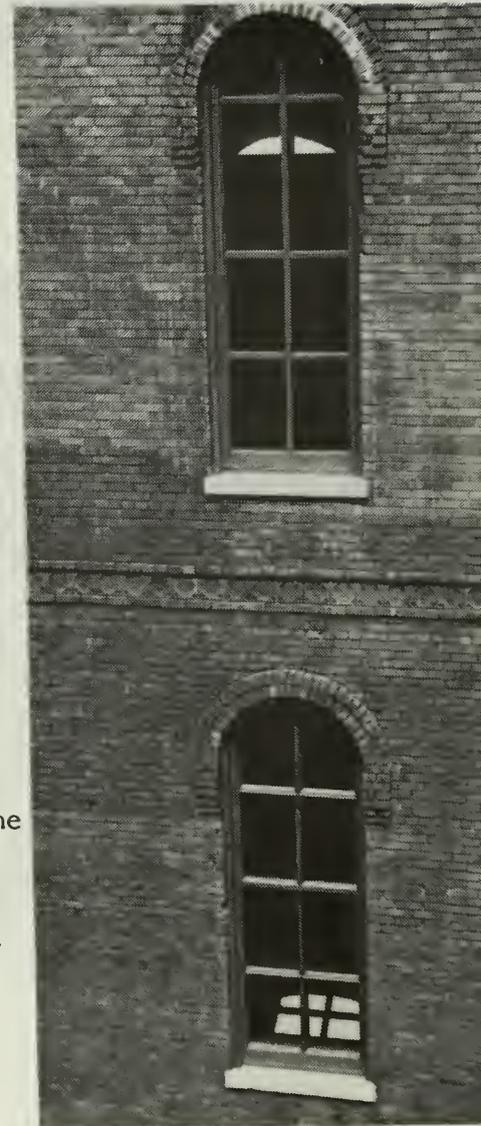
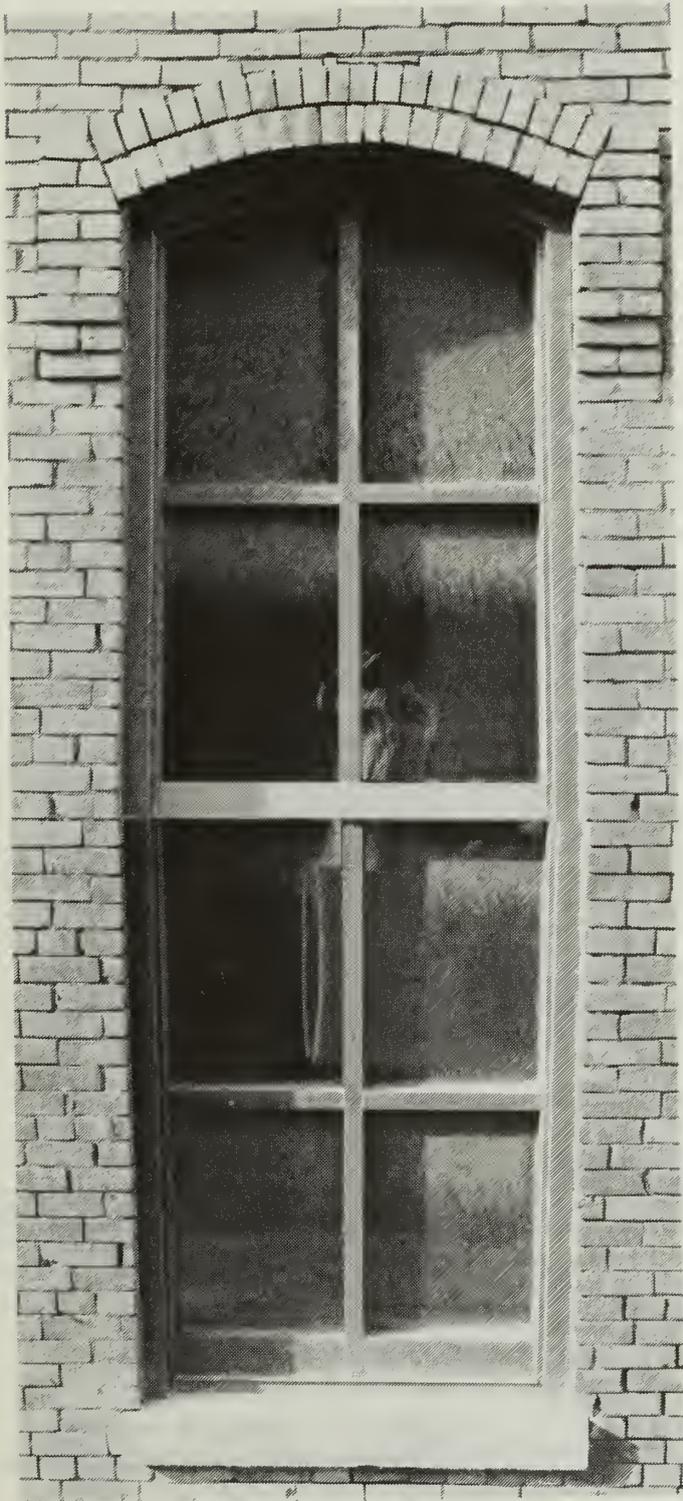
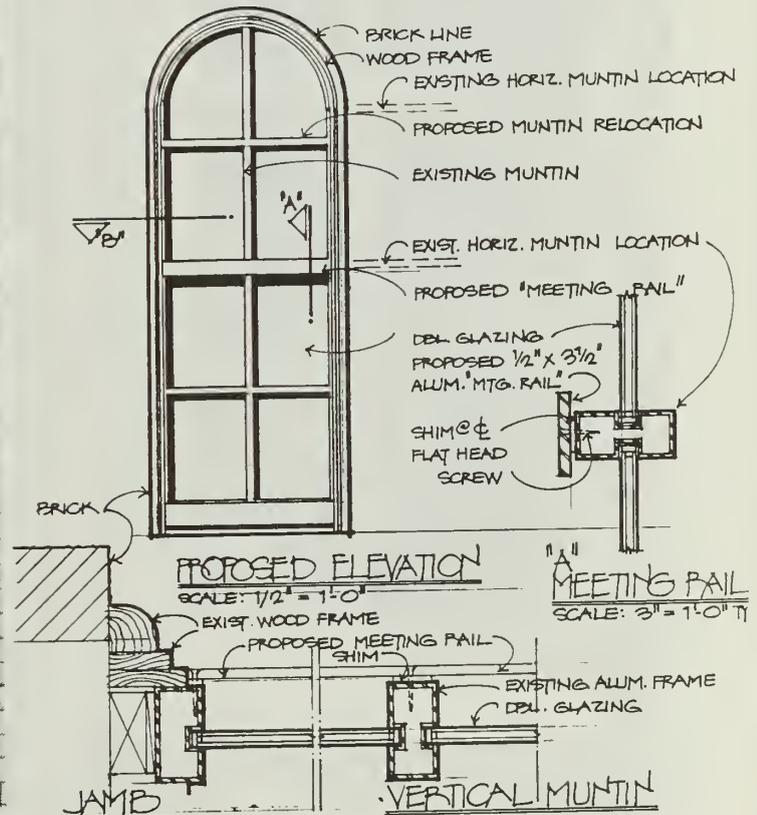
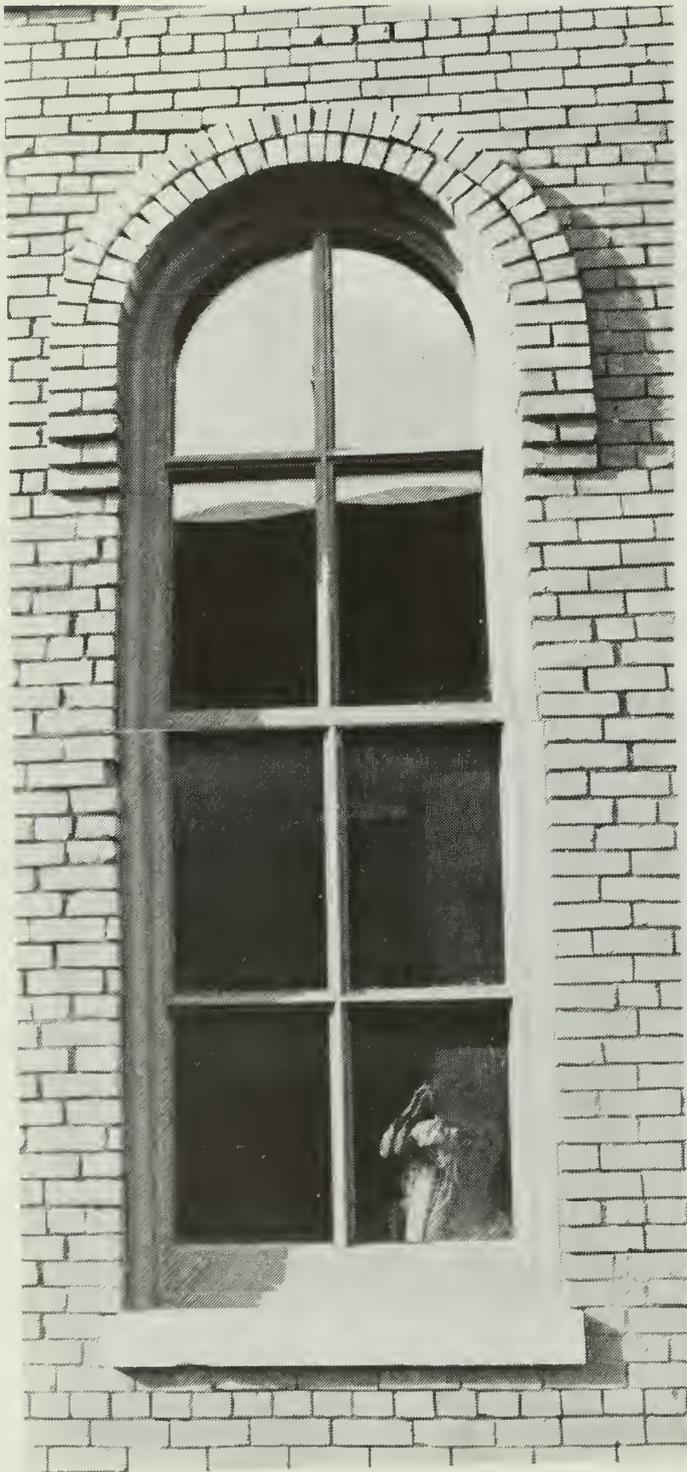
PROPOSED TREATMENT FOR "MEETING RAIL"

6. In an attempt to bring the inappropriate four-over-four replacement units (see 4 and 5.) into conformance with the Standards, two alternatives were proposed. In proposal A, the horizontal muntin at the top would be relocated so that all eight lights would be of equal size like the original. A 3 1/2" wide aluminum strip would be applied in an attempt to recapture some aspects of the meeting rail. Even after these adjustments, however, the upper and lower sash would read as a single, fixed unit; the muntins are also too wide and too flat.

REMOVE TOP HORIZONTAL MUNTIN & GLASS

RESTRUCTURE WINDOW SO TOP HORIZONTAL MUNTIN IS 1/2 MIDWAY BETWEEN TOP SASH SECTION

APPLY WOOD TRIM SECTION TO PAINTED MUNTINS

APPLY 3/4" THICK x FULL WIDTH (OF EXISTING SECTION) WOOD SECTIONS TO HORIZONTAL & VERTICAL PERIMETER SECTIONS & TO HORIZONTAL MEETING PAUL COLOR TO BE BRONZE

After NPS denial, the applicant sought to bring the replacement windows into conformance by a series of cosmetic changes, including relocating the horizontal muntin at the top of the four-over-four window, and applying wood trim to the aluminum muntins in an attempt to create a thinner appearance (see illus. 6 and 7). This proposal was also rejected by NPS on appeal. In a final letter to the owner, the Chief Appeals Officer explained:

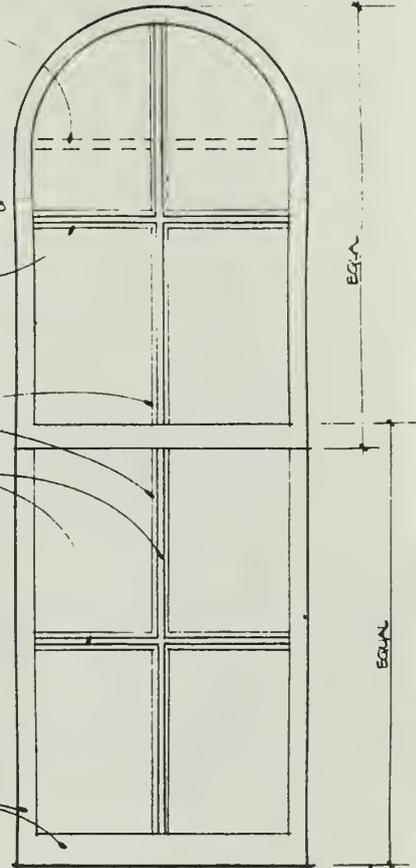
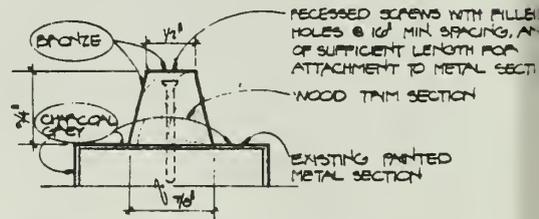
**FRAME ELEVATION**

**WOOD TRIM DETAIL**

7. In alternative B, proposed changes included installation of a wood brick molding. In an attempt to make the muntin appear thinner and visually recessed, the wide aluminum muntins would be painted a charcoal gray; trapezoidal shaped wood strips would also be applied to the existing flat muntin and painted to match the existing window color. Even making these modifications, the replacement window did not match the detailing of the historic window--the depth of the frame and muntin was still far too shallow, and the muntin profile and width was still inappropriate. This proposal was also rejected.

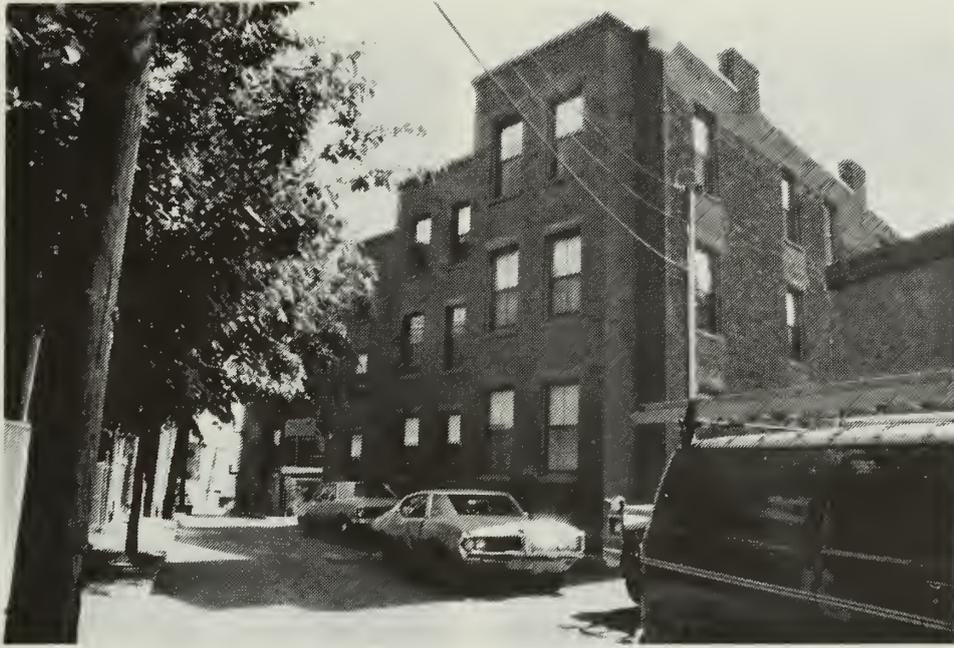
1. Pre-rehabilitation photograph of workers' rowhouses (front elevation).

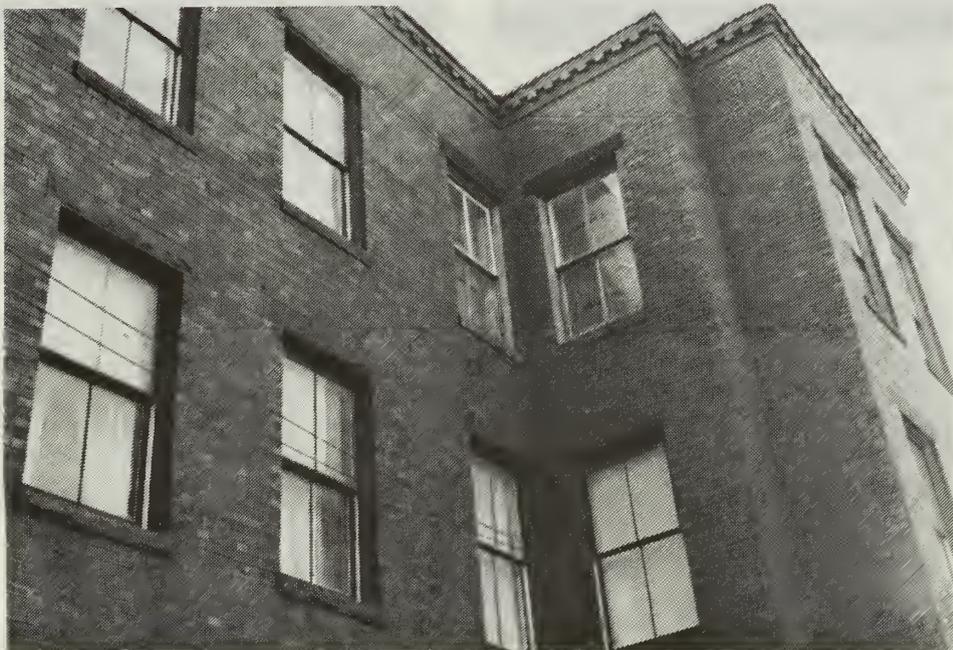
2. Pre-rehabilitation photograph of historic two-over-two double-hung windows that had a thin vertical muntin and wooden molding (brick molding) around the frame.

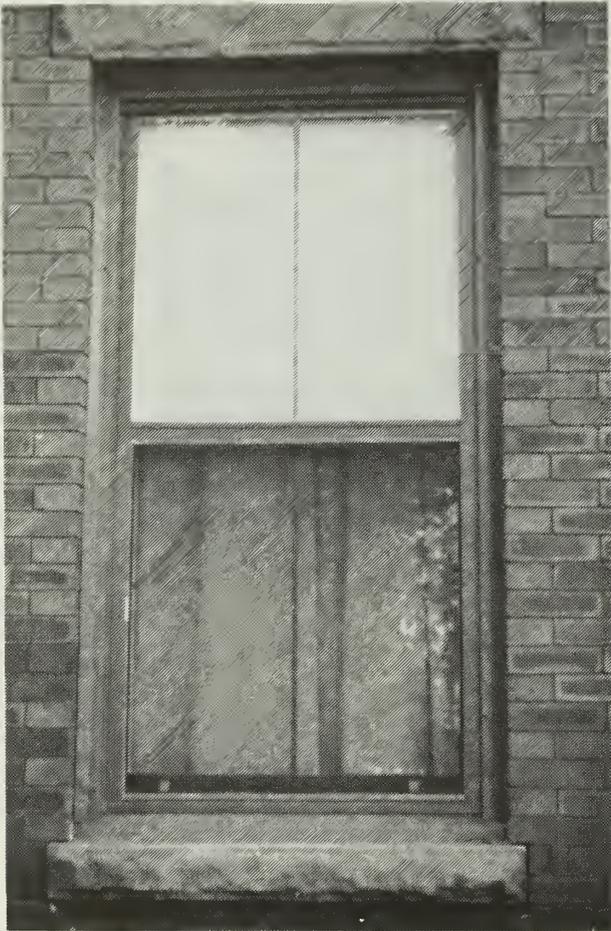
3. Post-rehabilitation photograph of aluminum replacement window. The vertical muntin was sandwiched within the insulating glass and the double-hung appearance changed since the screen panel was installed directly below the fixed upper sash.

In the course of the rehabilitation, all the historic wood window sash, which were deteriorated and not salvageable, were replaced. The replacement windows installed consisted of a single-hung aluminum window with fixed upper sash and a screen panel placed directly below the upper sash in the same plane, a meeting rail considerably wider than the original, muntins sandwiched between the glass, and a bronze colored finish (see illus. 3). These windows were determined not to meet Standard 6 in that they did not match the existing windows in design, color, profile, and muntin configuration.

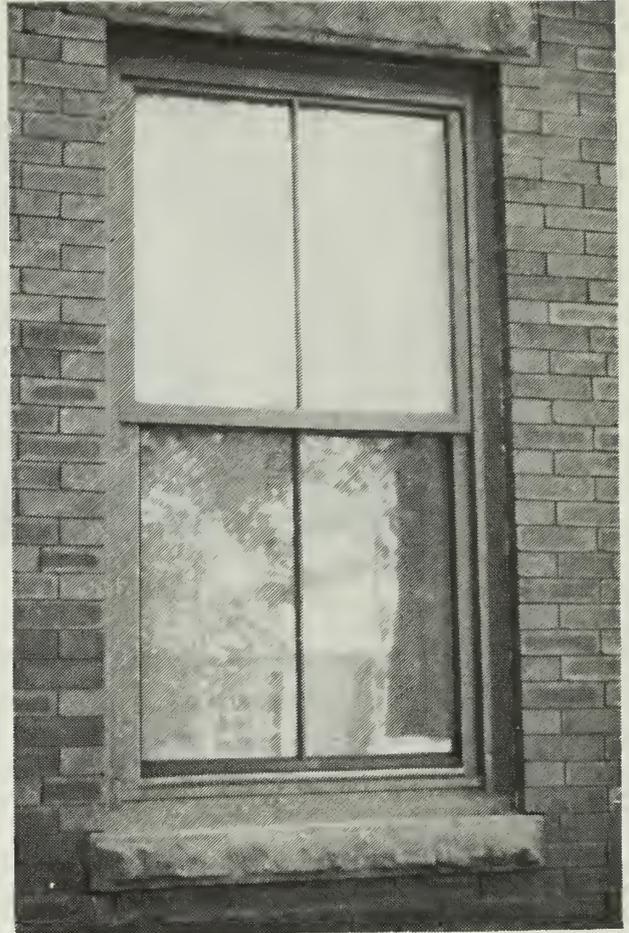
4. Aluminum replacement window with a wood mock-up of an applied unglazed sash frame and muntin placed over the upper aluminum sash. The applied frame and muntin look like temporary add-ons, rather than matching the historic sash.

milled of wood and applied over the existing flush metal sections of the new aluminum windows (see illus. 4). However, it was determined that this modification did not capture the historic appearance of the existing wood windows. Wood frames fabricated with central dividing muntins and applied to each window would not faithfully duplicate the configuration of the old windows and would read as a temporary treatment, rather than an integral component of the sash. In view of the proximity and visibility of these windows to the street, any superficial or cosmetic change to the existing replacement sash, regardless of material, would not be consistent with the historic character of this building.

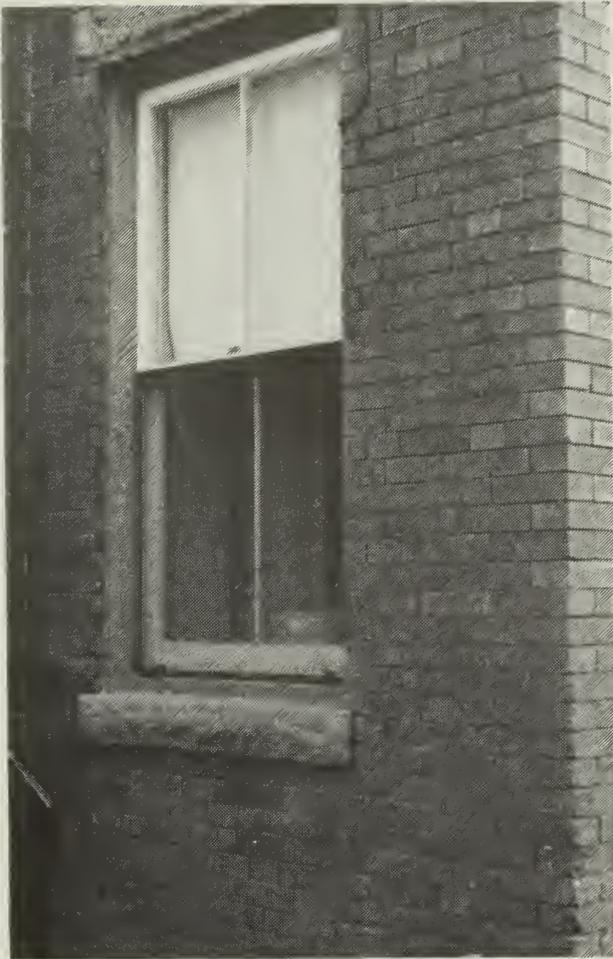
5. New wood replacement window as approved. If possible further refinement (although not required in this case) would have been to install the half screen on the inside rather than on the front of the upper and lower sash.

To bring this rehabilitation into conformance with the Standards, the owner decided to replace the new aluminum windows, which were clearly visible from the street, with new wood sash duplicating the originals in size, profile, muntin configuration, and composition (see illus. 5 and 6). With the new wooden sash in place, the project was subsequently certified.

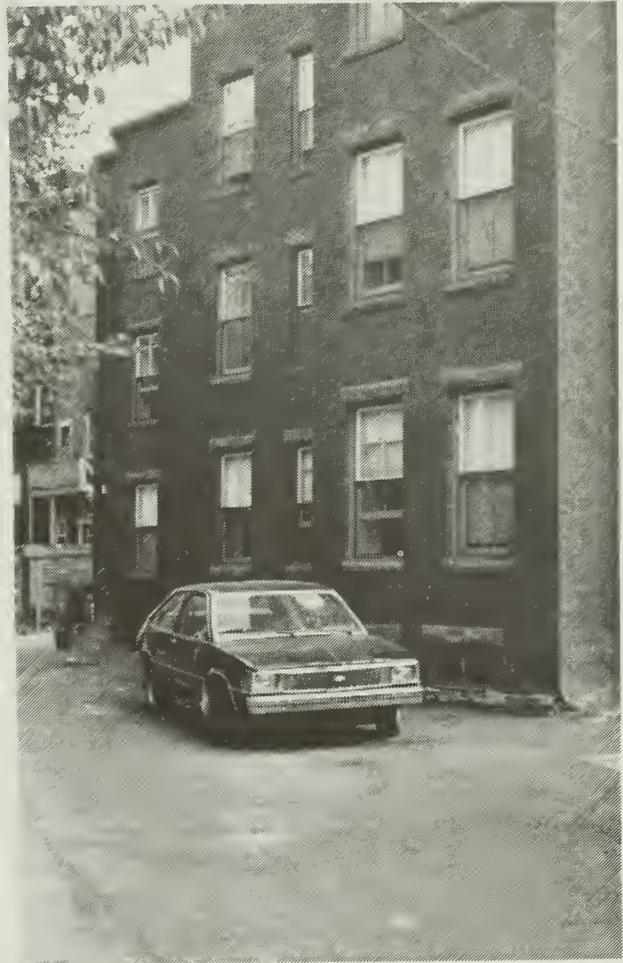
6. Post-rehabilitation photograph of historic rowhouses with matching wood windows.

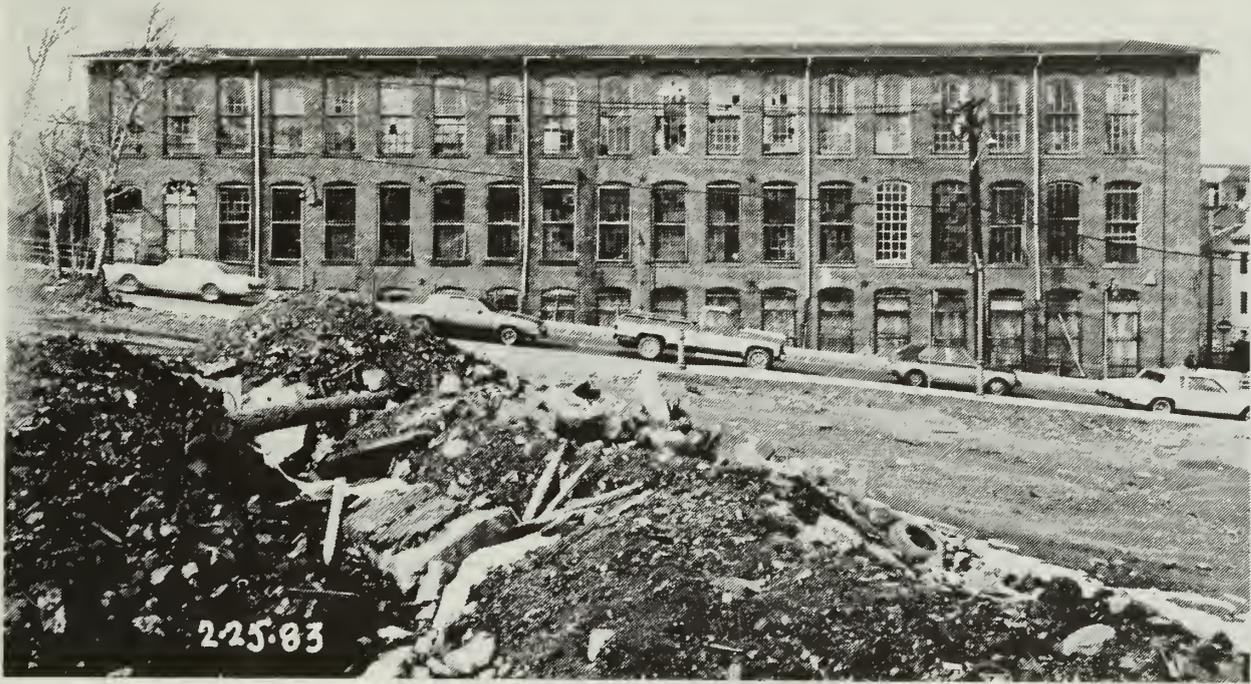
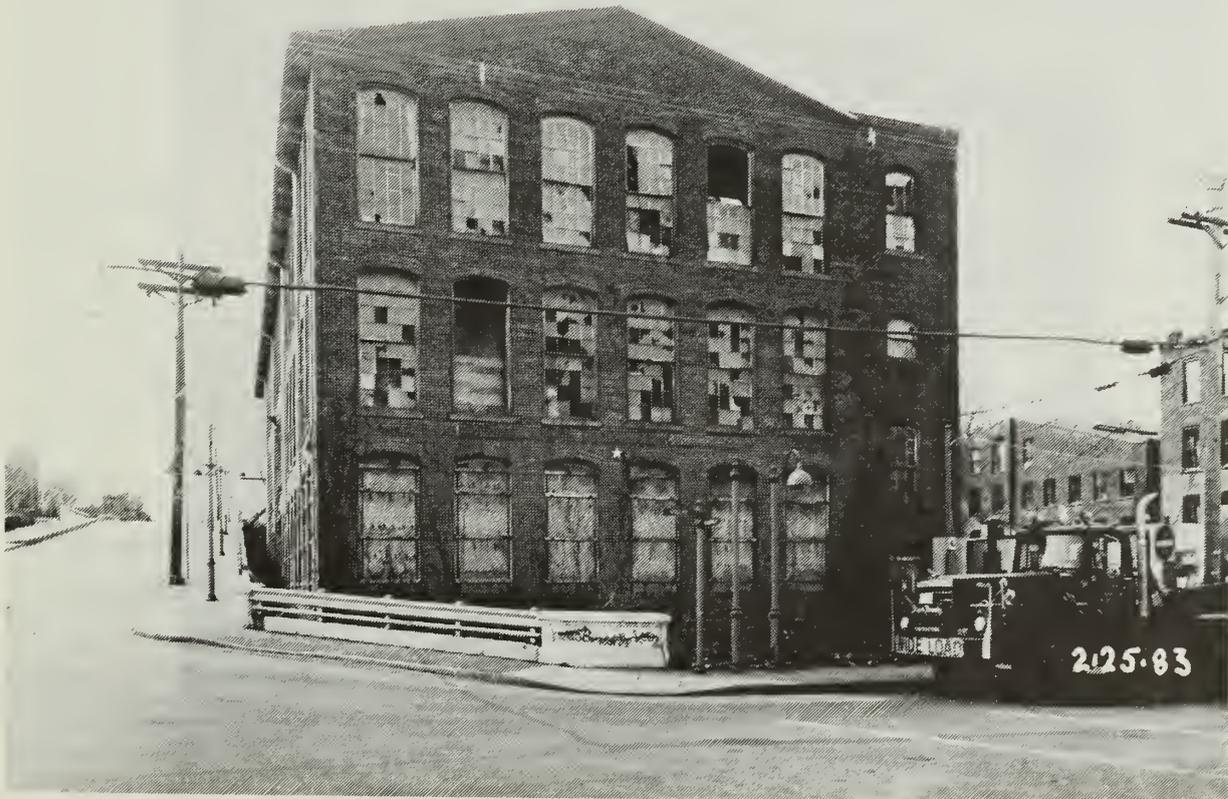
1.

1-2. Pre-rehabilitation view of the building showing deteriorated 16-over-16 windows. Note previous owner's effort to duplicate arch-headed sash with sample unit on 2nd floor. In the view below, note how the upper and lower sash are set on different planes, a characteristic feature of double-hung windows.

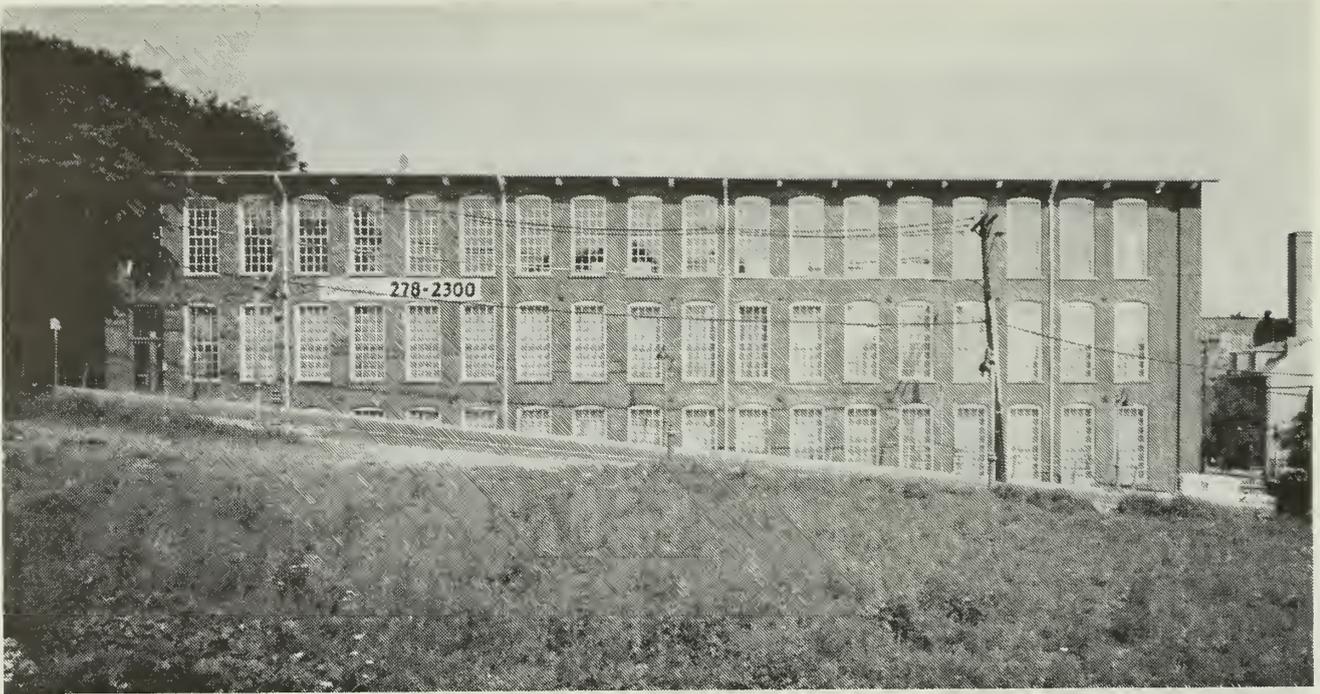
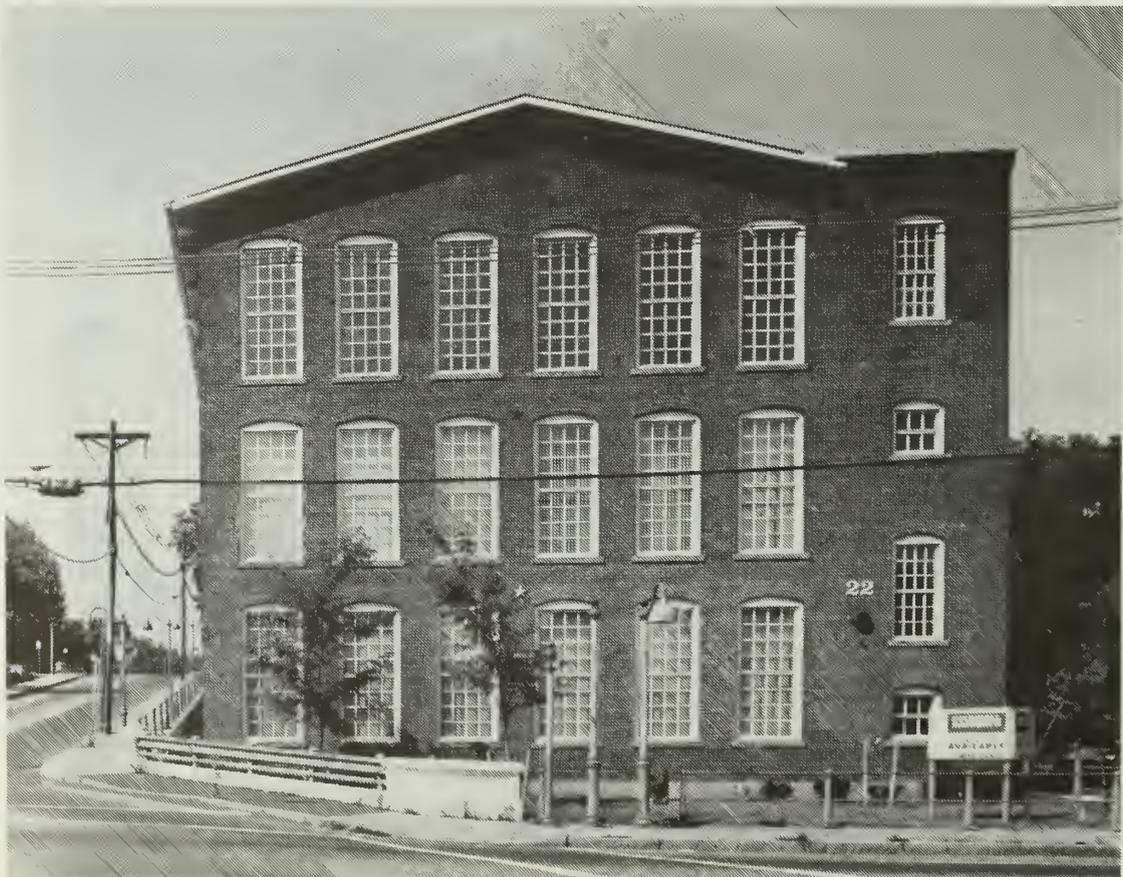
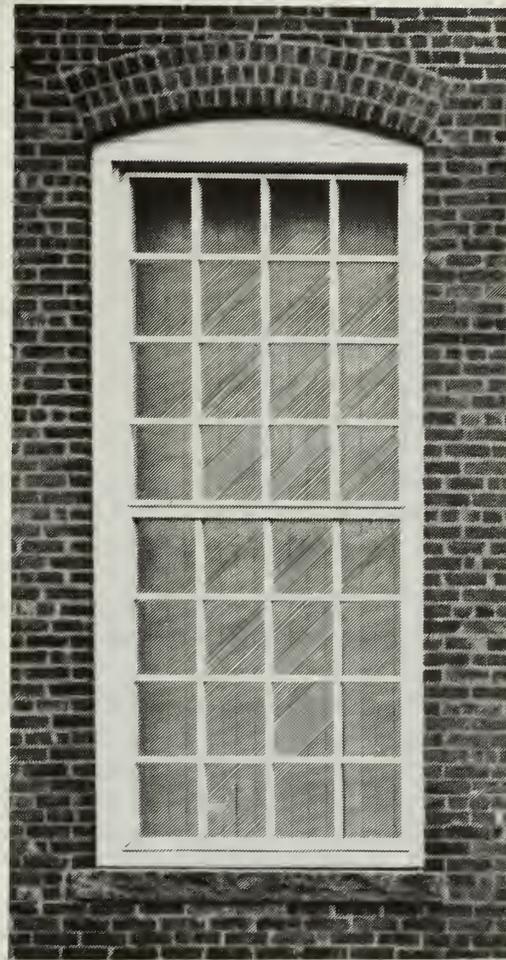
3.

3-5. Post-rehabilitation view of the building showing replacement windows. In 5, note how the reduction in depth of the meeting rail has produced a flat appearance to the window. The appearance of a historic double-hung window with sash on different planes and a heavy shadow line created by the meeting rail has been lost.

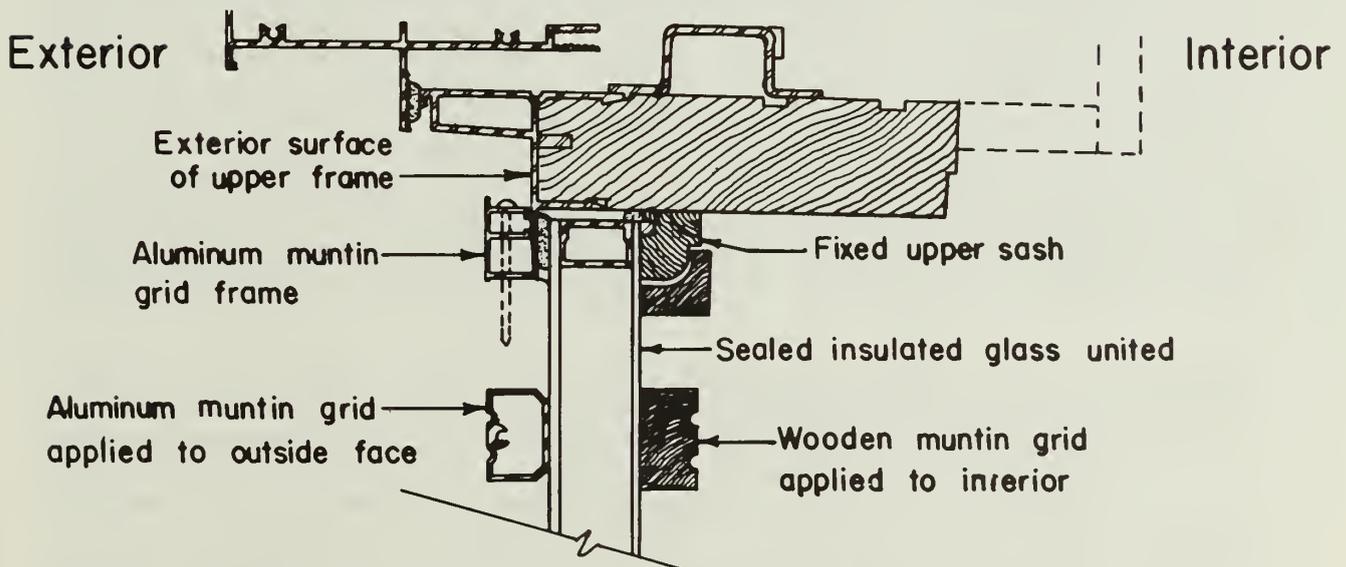
### Vertical Section of Replacement Window

6. Shop drawing showing applied muntin grid projecting beyond the exterior surface of the sash. Also note rectangular shape and the two grooves on the interior and exterior muntin grids which produce the ribbed appearance and additional shadow lines that did not exist on the historic windows.

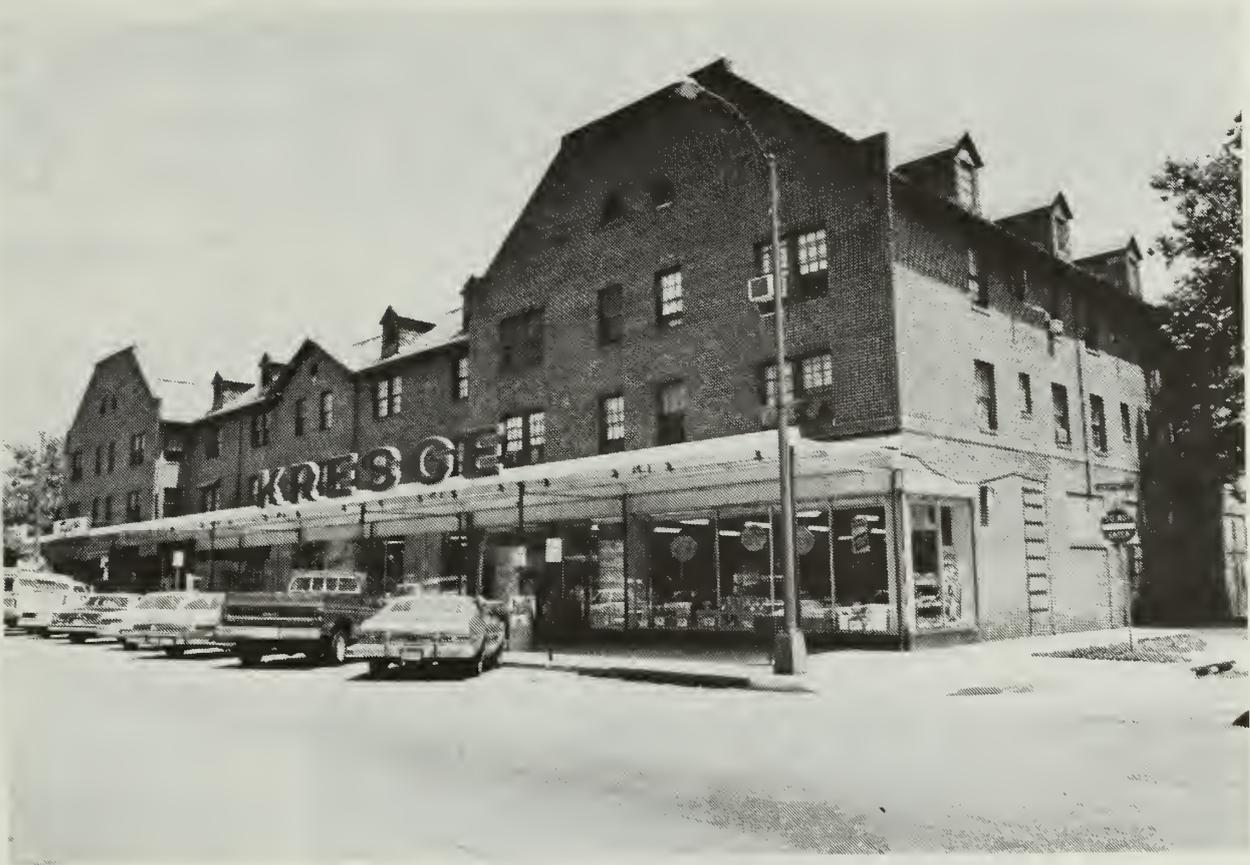
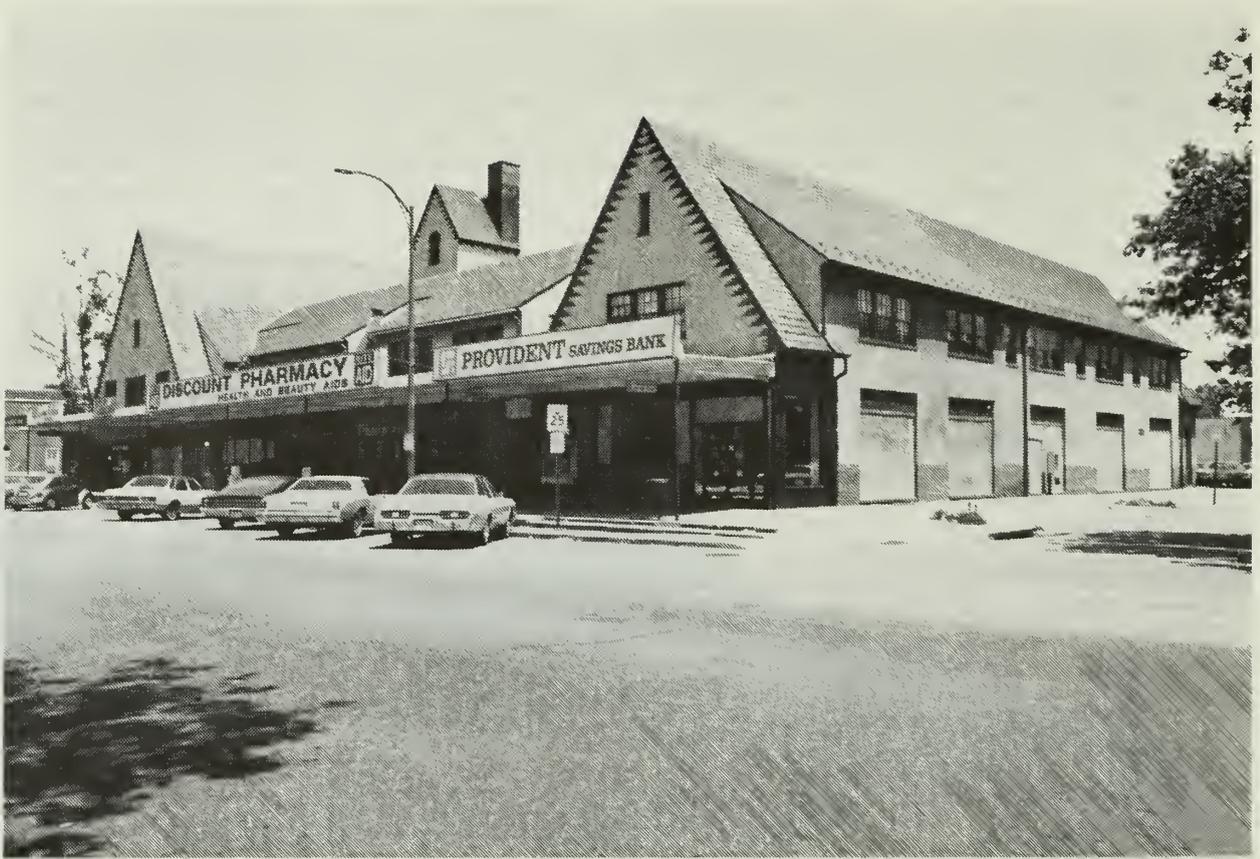
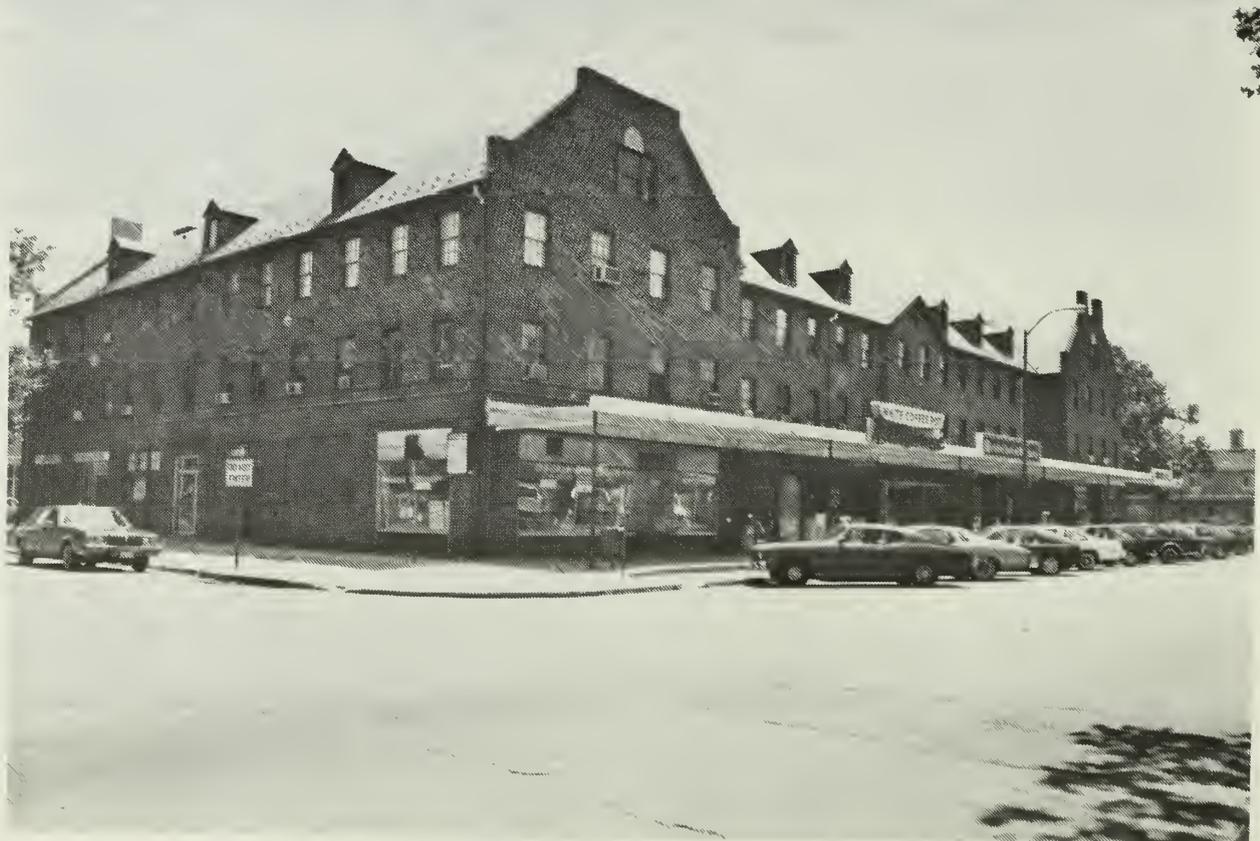
Building 1

1-3 Pre-rehabilitation views demonstrate the residential scale of the second and third floor windows. Note how the dark color of the window sash and frames makes the windows less prominent on the upper floors of buildings 2 and 3.

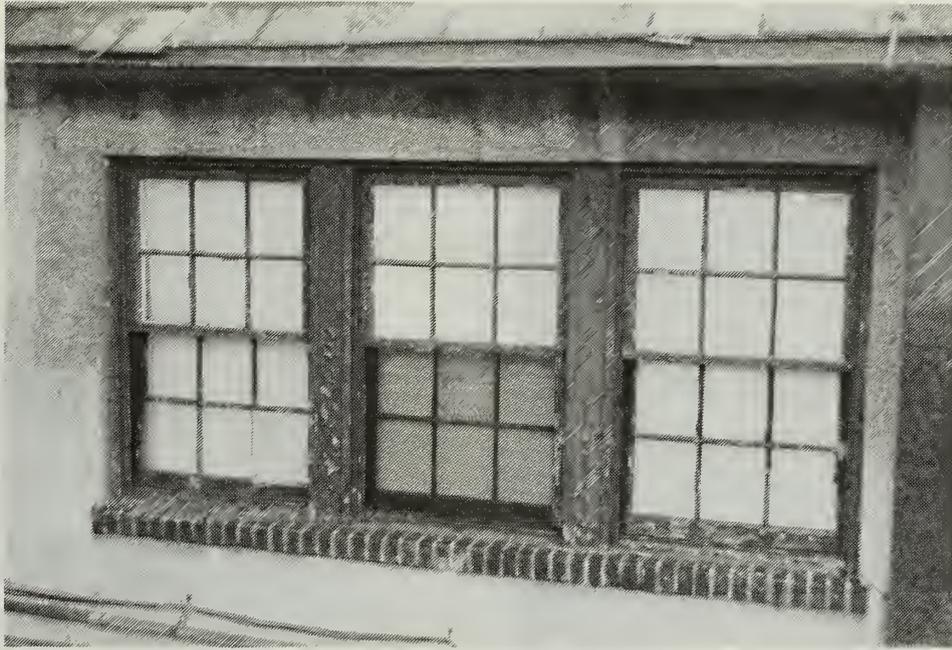
4-5. Pre-rehabilitation views of the deteriorated historic windows. Note beaded mullion above, thin muntins, meeting rails and sash on paired windows and the simple double-hung window below.

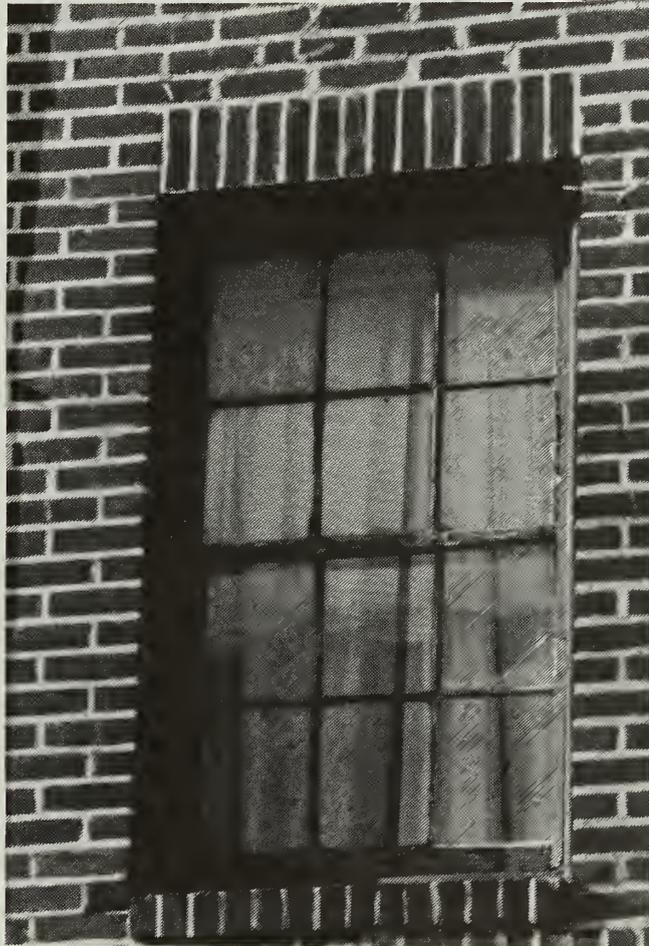
6. Proposed replacement window, exterior. Note rectangular panning, extensive subframe creating additional shadow lines. Compare the meeting rail and muntin dimensions with the historic sash in 4-5.

Aluminum, double-hung windows with attached metal grids on the exterior and interior to simulate muntins were chosen to replace the originals (see illus. 6-7). Several of these windows were installed to evaluate their effectiveness in matching the adjacent historic windows. These windows were, however, determined not to adequately duplicate the visual qualities of the historic windows in their color, proportion, size, and installation detail of the originals. A light ivory color was chosen, rather than the dark green of the historic sash, causing the windows to stand out against the facade rather than to recede as the dark-colored historic sash had done (see illus. 8). The new

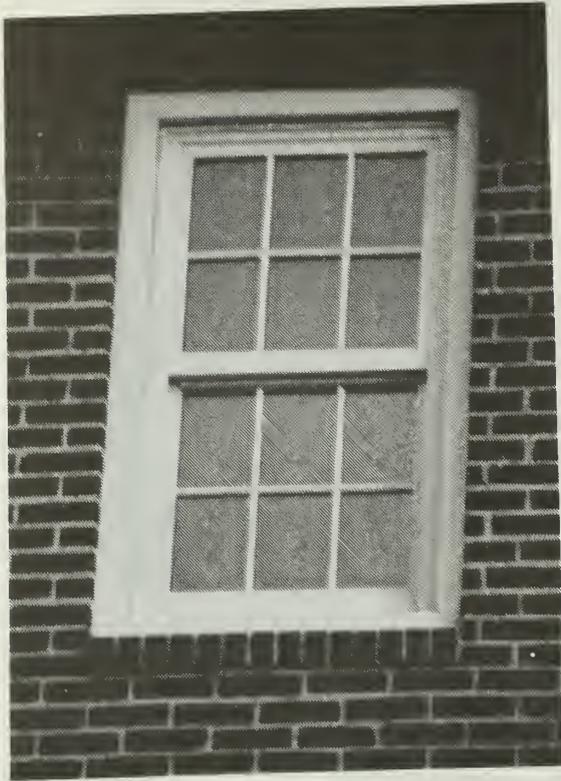
7. Proposed replacement window, interior. Note the three layers of metal comprising the subframe, and the decreased size of the sash and glazed surface within the opening.

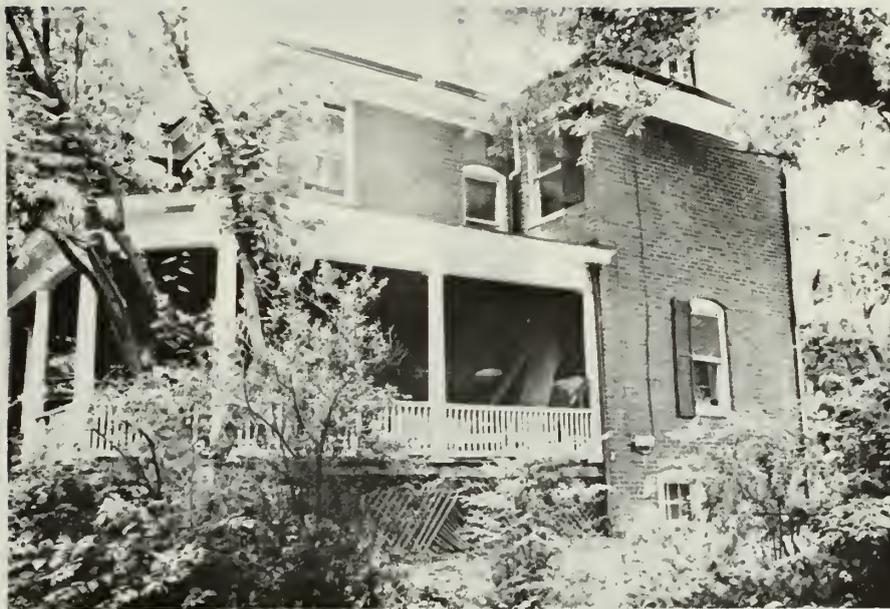
1. The c. 1915 freestanding residential structure is visible from all four sides; an unadorned brick side wall is a foil for the most distinguishing feature of the house--the wood wraparound porch.

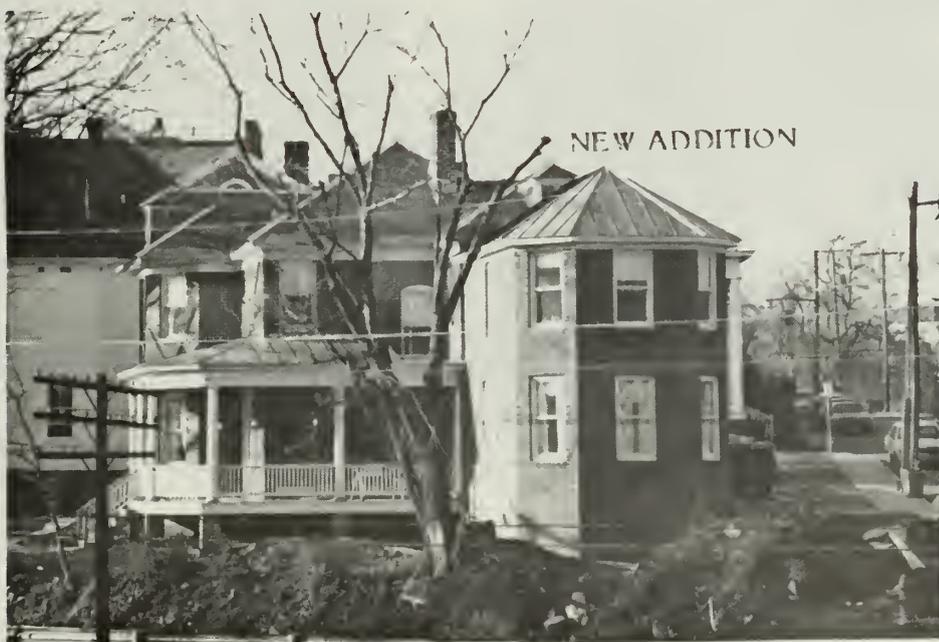
2. A new dormitory wing has been constructed on the side elevation shown in illustration 1. Because of its height, degree of projection, distinctive shape, and high visibility, the new addition has become the dominant feature of the house and has changed the historic character.

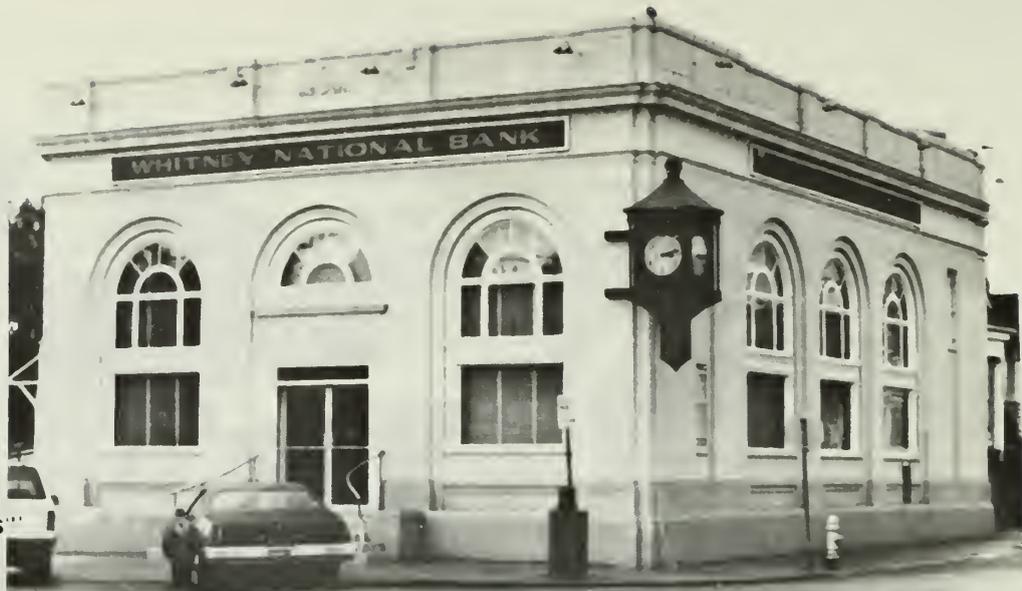
3. This freestanding bank structure, located at a major intersection in the district, was readily identifiable before rehabilitation by its simple rectangular form and its large, arched openings.

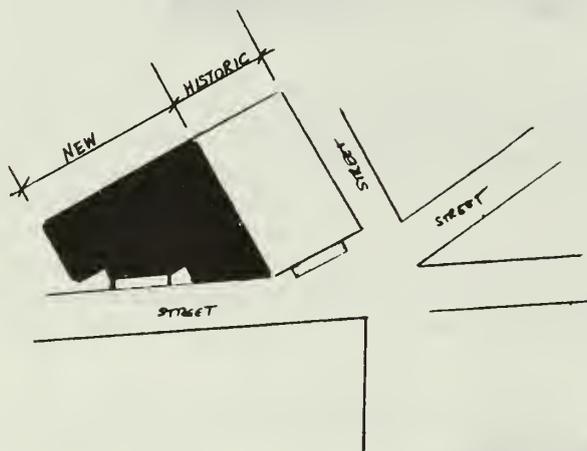
4. The historic bank and new bank addition are shown in relationship to the surrounding streets in the district. The previously rectangular form of the freestanding bank has been dramatically altered by both the size and shape of the addition.

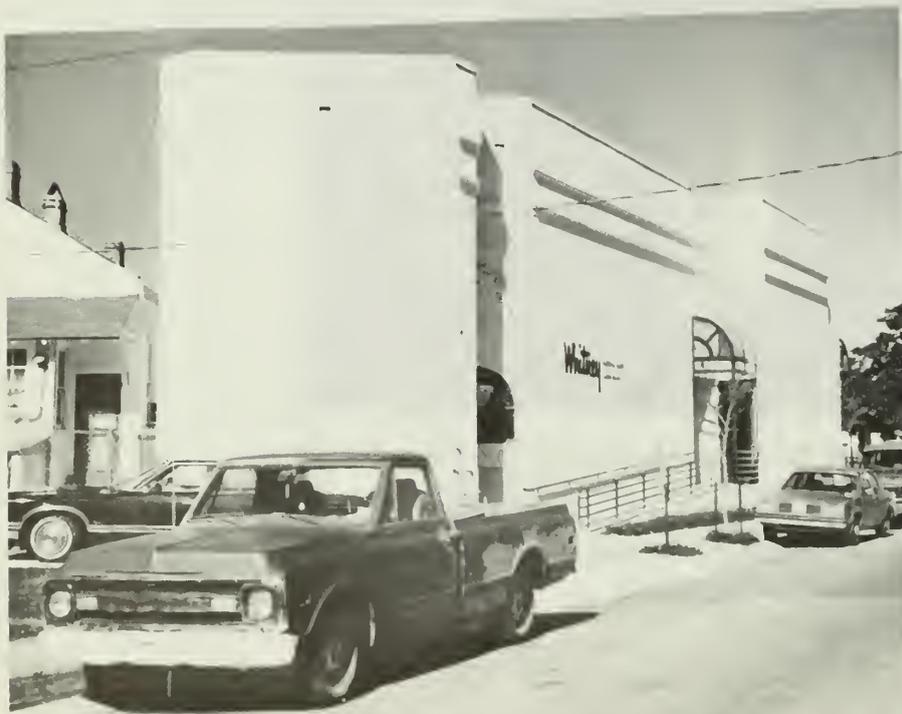
5. Even with a setback, appropriate height, compatible materials, and clear differentiation between new and old, the new work now dominates the resource and the setting. The historic bank can no longer be seen from a major side street.
