Technical Preservation Services  
Preservation Assistance Division  
National Park Service  
U.S. Department of the Interior  
Washington, D.C.

Interpreting  
the Secretary of the Interior's  
Standards for Rehabilitation

Volume III

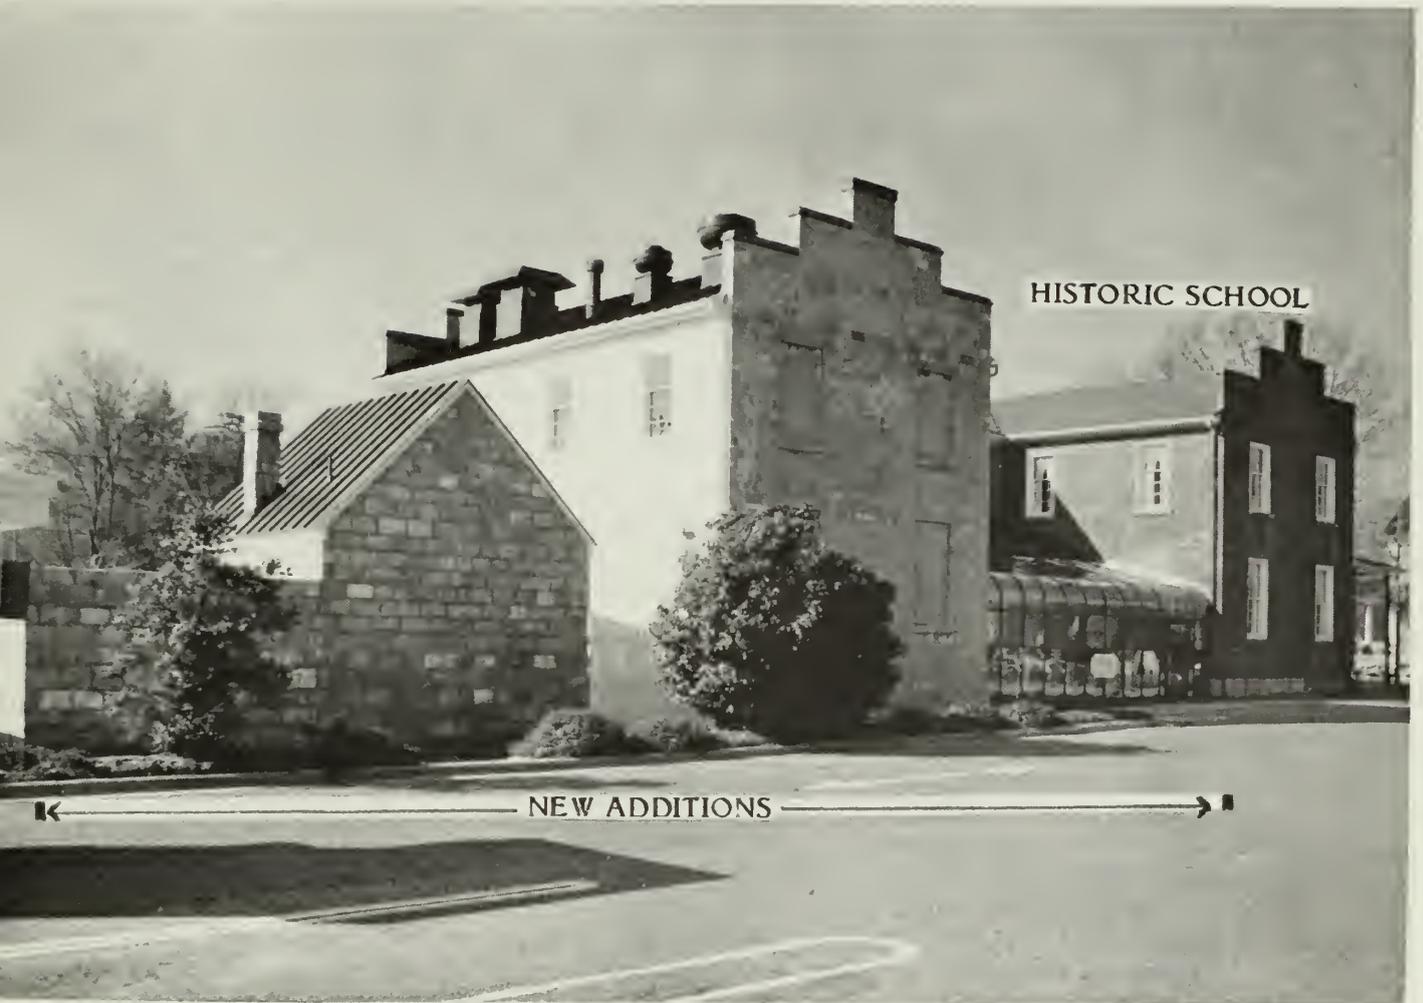
6. The side and rear elevation of the 1839 brick school building are shown here on the far right (the later ell is not visible) together with three new components added as part of the rehabilitation project--a greenhouse, a kitchen building with stepped gables matching the historic building, and a storage building. Because the new addition has changed the historic character to a dramatic degree, the project was denied tax incentives. A smaller kitchen wing--planned and sited differently--could have been in conformance with the Standards. The greenhouse itself was not an issue.

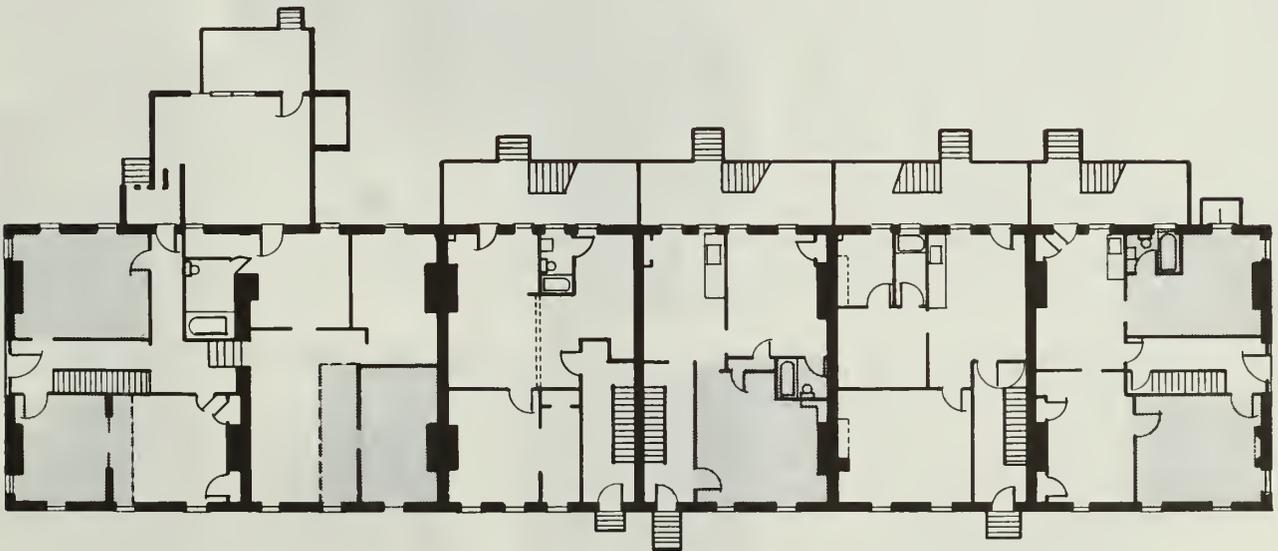
2. The plan shows room size and arrangement; units converted to two-story spaces by cutting through the first floor are denoted by shadowing.

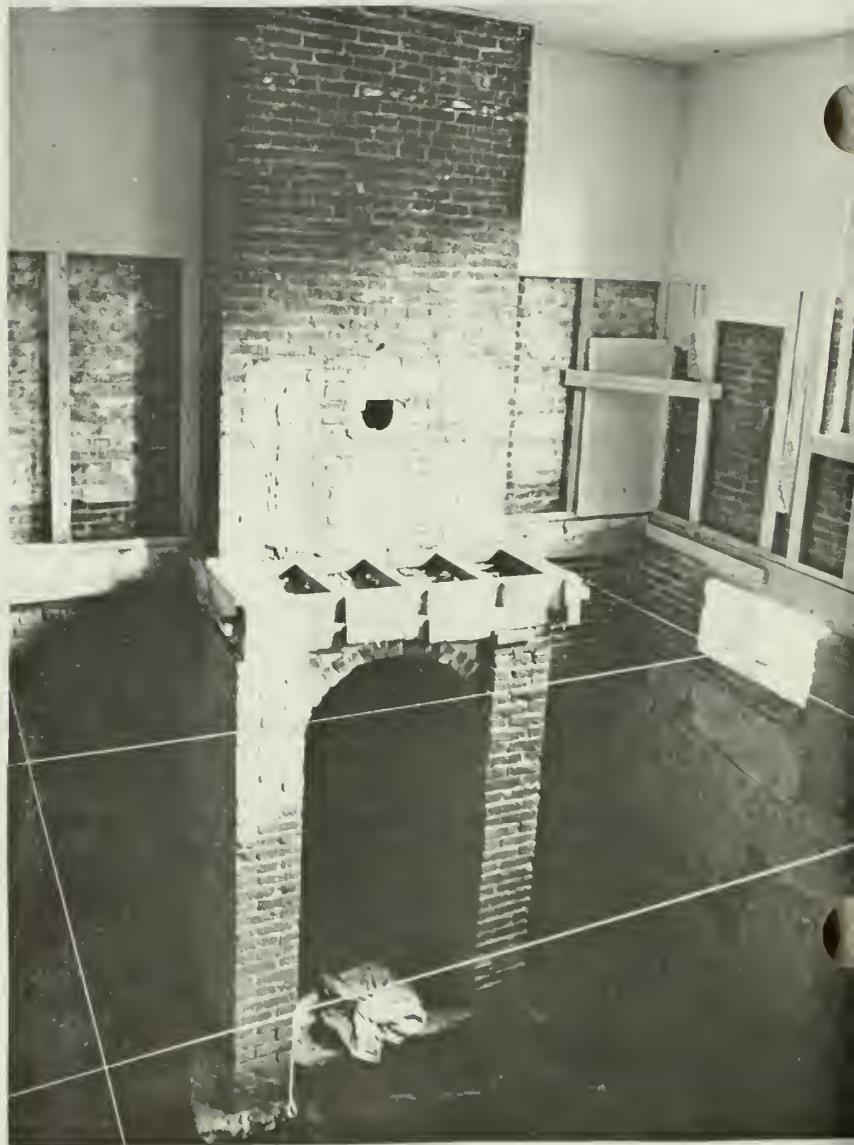
4. As part of the rehabilitation, the historic space was dramatically redefined by removing the first story floor, revealing the basement level. Two separate rectangular spaces were then made into one rehabilitated living unit. This inappropriate treatment violated both Standards 2 and 9.

The character of the historic interior spaces appears to have been easily adaptable for modern residential use. Unfortunately, during the course of your rehabilitation work on these units, large portions of the first floors were removed in order to create two-story spaces. The creation of those two-story spaces required the destruction of both historic material and the distinguishing spatial concept of the most significant areas of each house, in violation of Standard 2.

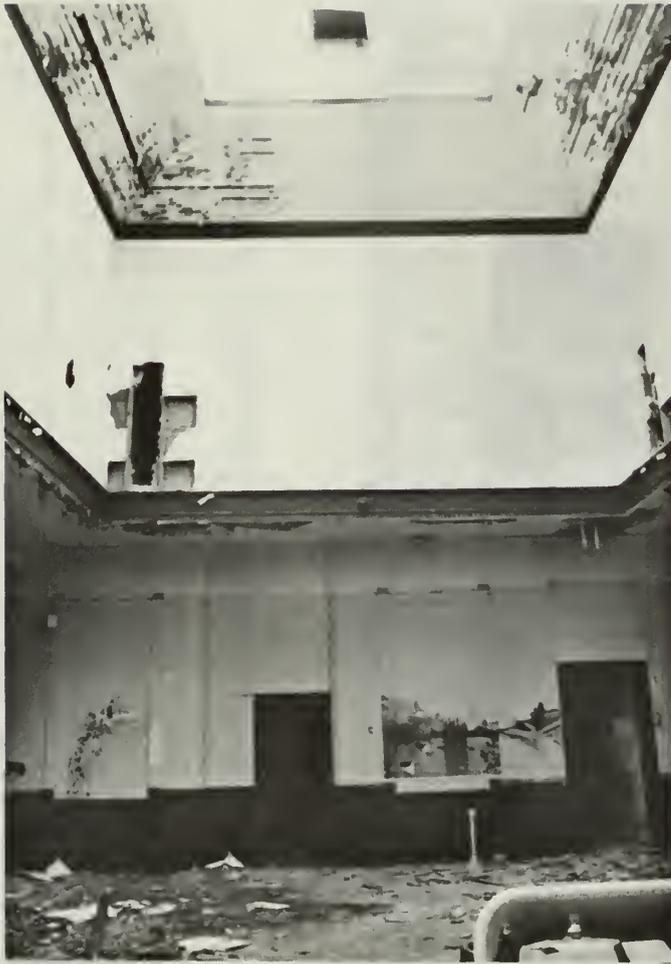
3. View of central space showing atrium extending through the second and third floors, with skylight above. The second floor doors shown lead to rooms beyond. Windows have been blocked in, but their configuration is still apparent from the surrounding trim. On the third floor the open hallway had been partitioned.

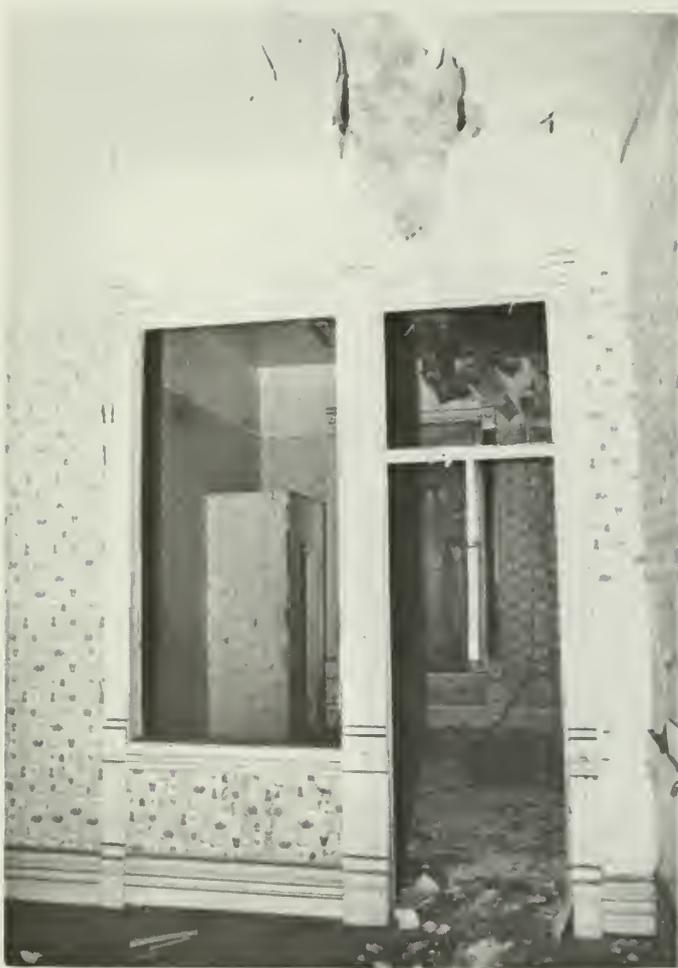
4. Interior rooms were fitted with windows and doors with transoms to borrow light from both the exterior window walls and the rooms facing the lighted atrium.

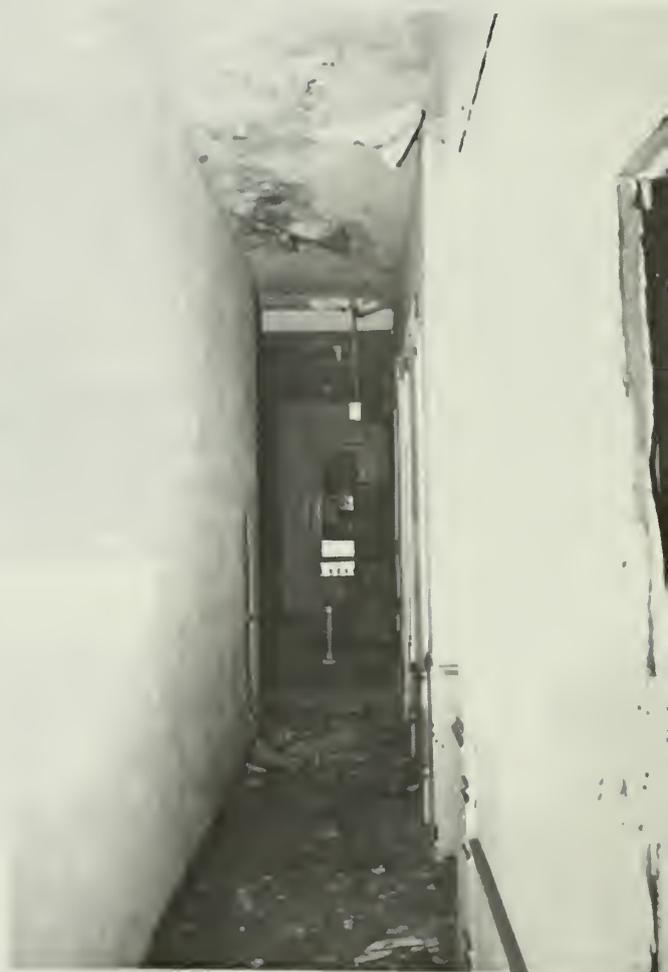
5. On the third floor, the historic hallway, originally open, had been fitted with a solid partition; the offices behind it, however, were relatively unaltered.

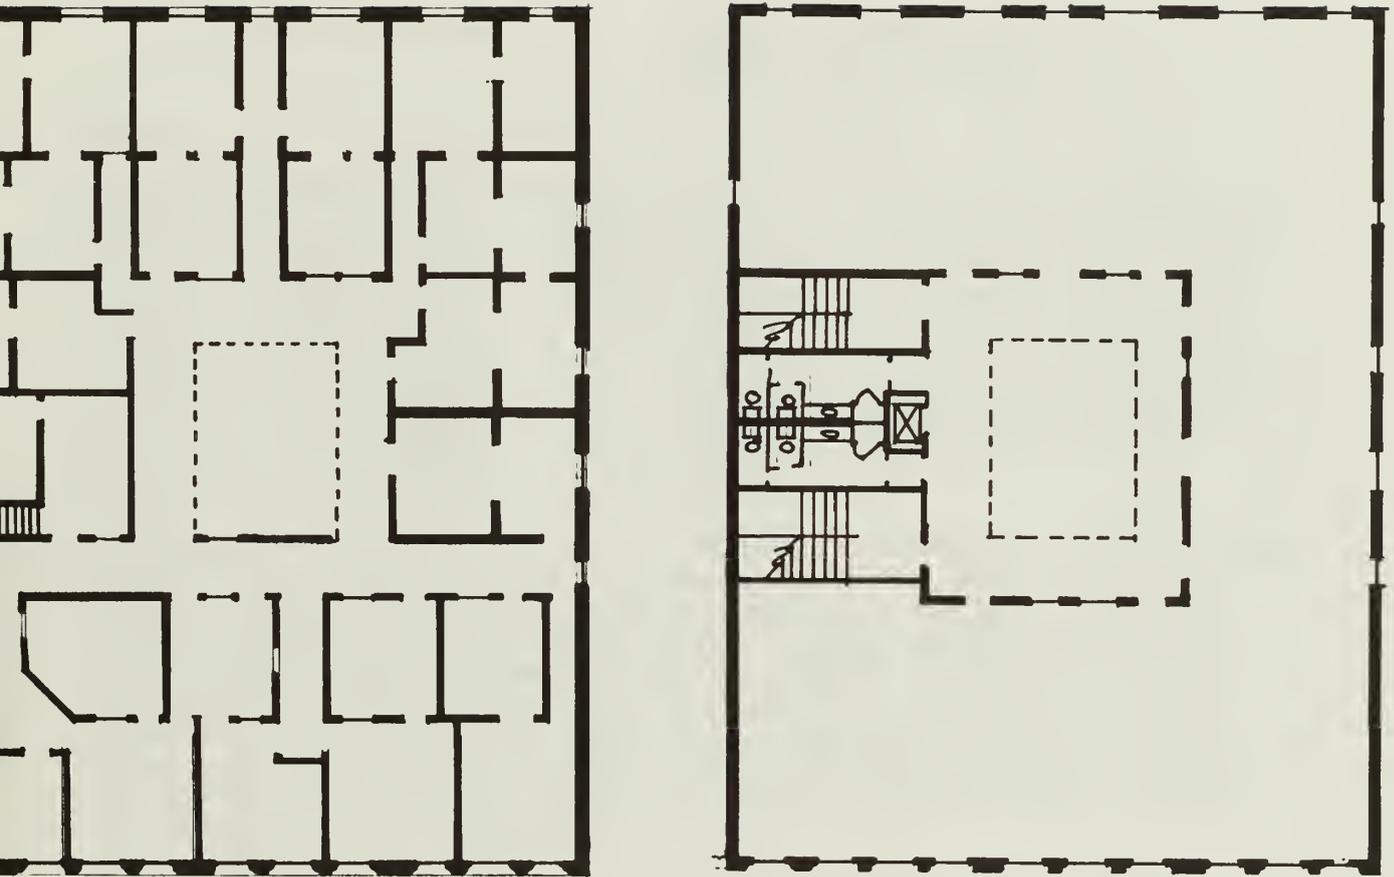
6 and 7. Historic second floor plan of atrium, hallway and inner and outer rings of rooms (left). In the proposed rehabilitation (right), this distinctive arrangement would be destroyed.

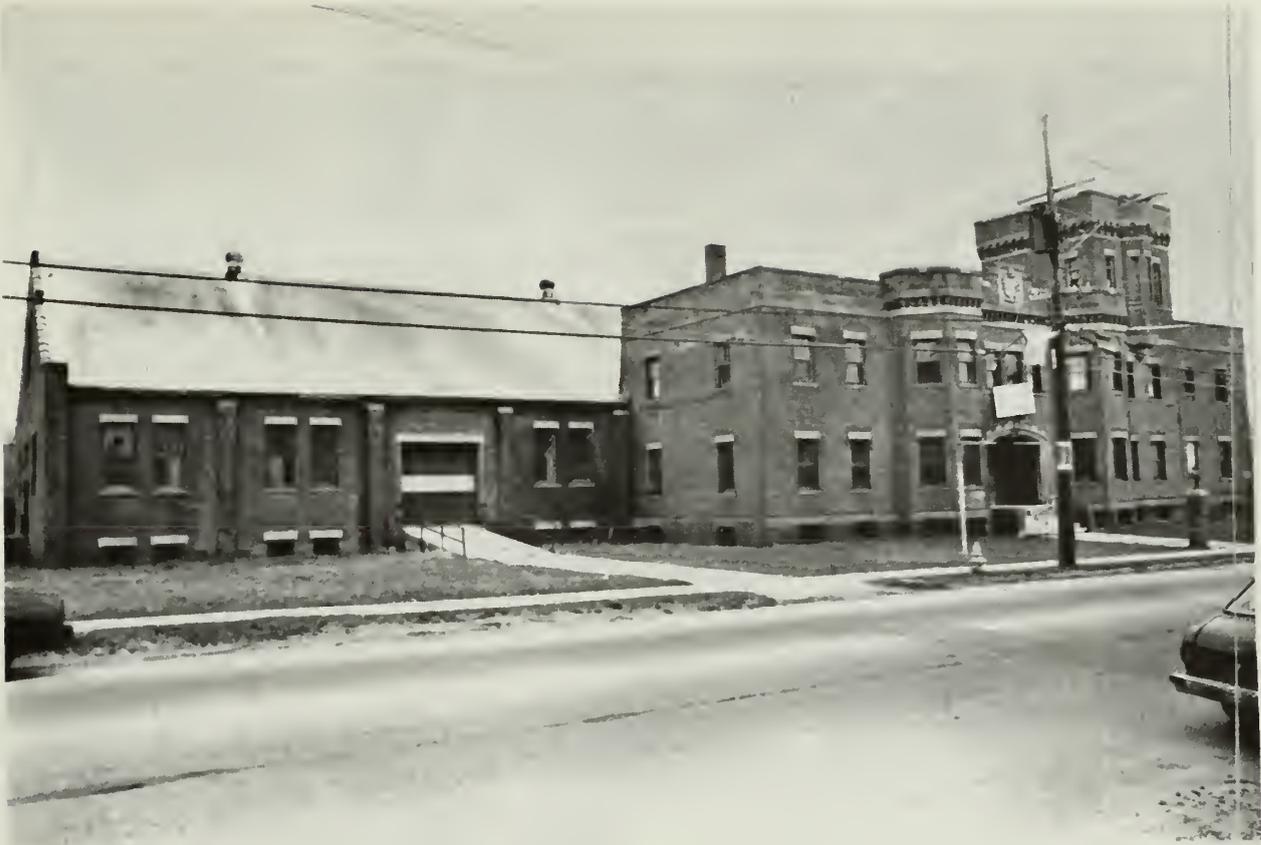
1. The facade of the armory before rehabilitation. The gable-roofed drill shed extends four bays beyond the head house with its three-story tower and three-sided corbelled bay.

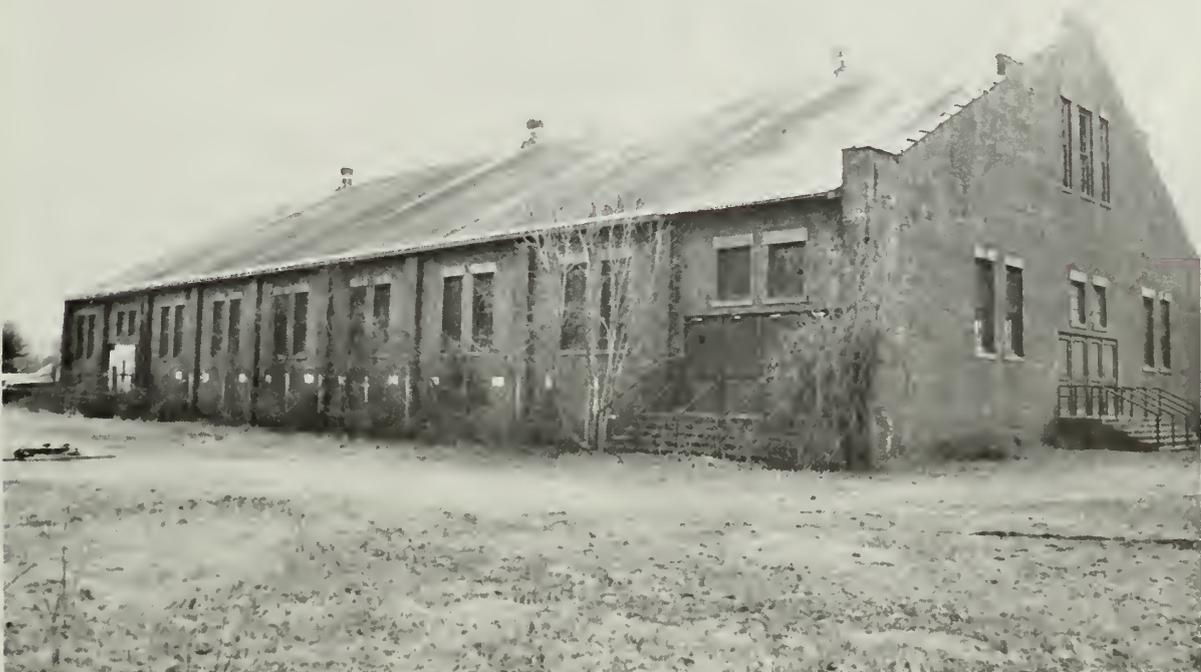
2. The rear elevation of the drill shed. Note the paired, nine-over-nine wood sash windows and the high sills which provide much of the character.

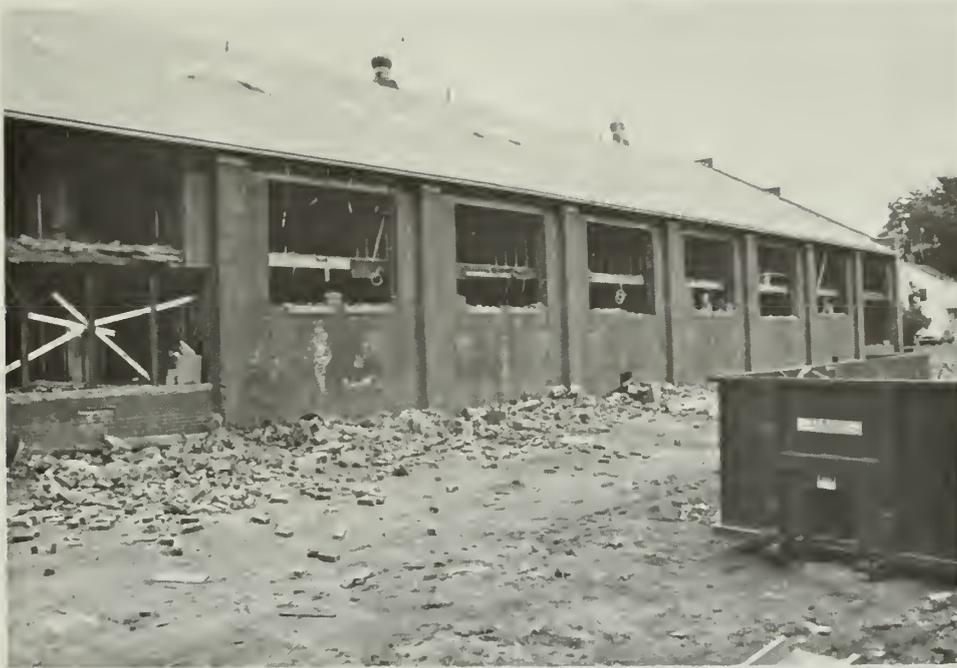
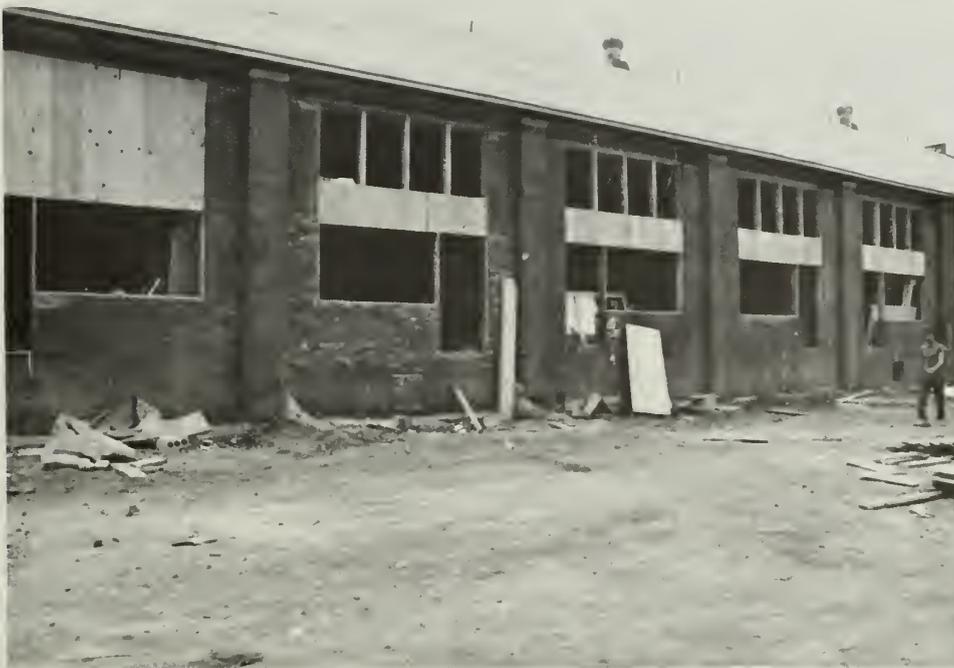
5-6. The rear elevation of the drill shed during rehabilitation. Note the extensive loss of brick, and how the character has changed with the removal of the multi-paned wood sash and the creation of large openings.

The drastic changes to the fenestration of the rear elevation were cited as cause for denial. The existing historic window openings could have been altered in a manner that would have provided light and access to the rear apartments while still leaving enough brick to maintain the character of the rear wall. Instead, as the project was carried out, the wholesale removal of the sash and most of the brick between the piers added up to a significant loss of historic fabric. However, it is the change in character of the rear elevation that is most damaging. Installation of the prefabricated panels resulted in unacceptable changes in: color and texture (brick red to stark white, smooth panels); materials (brick and wooden window sash to prefabricated panels and aluminum windows); composition (distinctly vertical to distinctly horizontal); and design (industrial to residential). Addition of the wooden decks further obscured what remained of the brick, and emphasized the incongruous domestic appearance of the rear elevation. Furthermore, the elevation now is highly visible to those entering the apartments from the parking lot, and to neighboring houses.

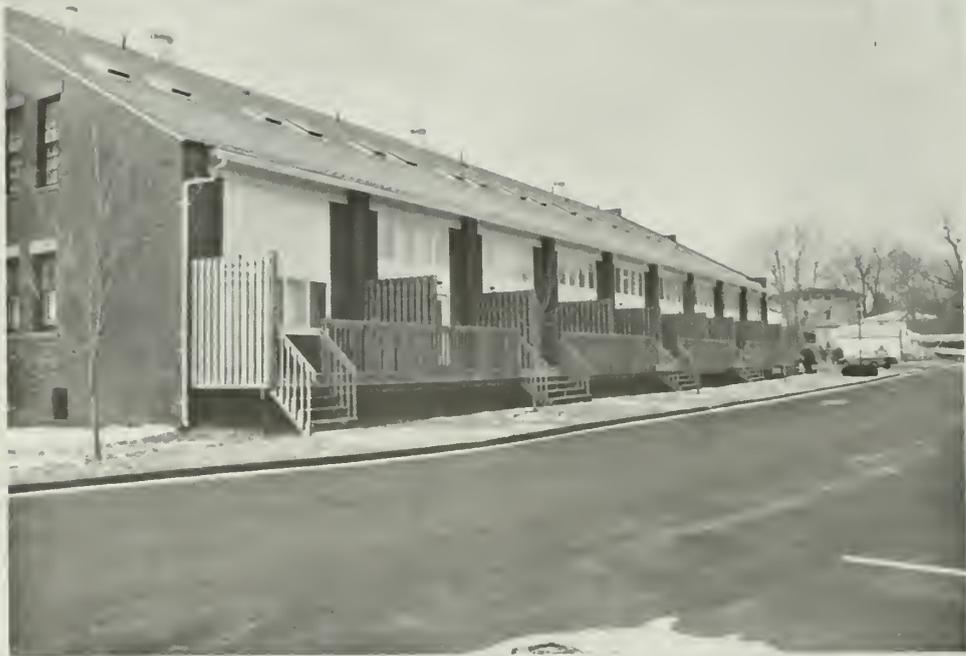
7. The rear of the drill shed showing the completed rehabilitation with the new skylights in the roof, the prefabricated panels filling the former bricked areas, and the new wood decks and privacy fences facing onto a parking lot at the rear of the property.

Despite several alterations made in the 1950s and some deterioration and vandalism which occurred during the nearly 15 years the buildings had been vacant, the armory had survived in a remarkably intact state prior to rehabilitation. The interior of the head house, including a large entrance hall, company parlor, and numerous small rooms on both floors, easily accommodated the apartment conversion which was accomplished with a minimal loss of historic fabric and character. The interior of the 75 x 300 feet drill shed was a completely open space with exposed steel trusses and a suspended gallery at one end (see illus. 4). During the rehabilitation this large open space was converted into twenty apartments by creating two floor levels. To provide light into these apartments, skylights were added to the rear of the roof of the drill shed, and the rear wall was reconfigured by removing the original paired nine-over-nine wood sash windows along with a substantial amount of brick between the piers (see illus. 5-6). Nine prefabricated, panelled units which incorporated walls, windows and doors were inserted in these newly made openings along the entire length of the rear elevation. Wooden decks with privacy screens and steps to the parking lot were added for the first floor apartments (see illus. 7).

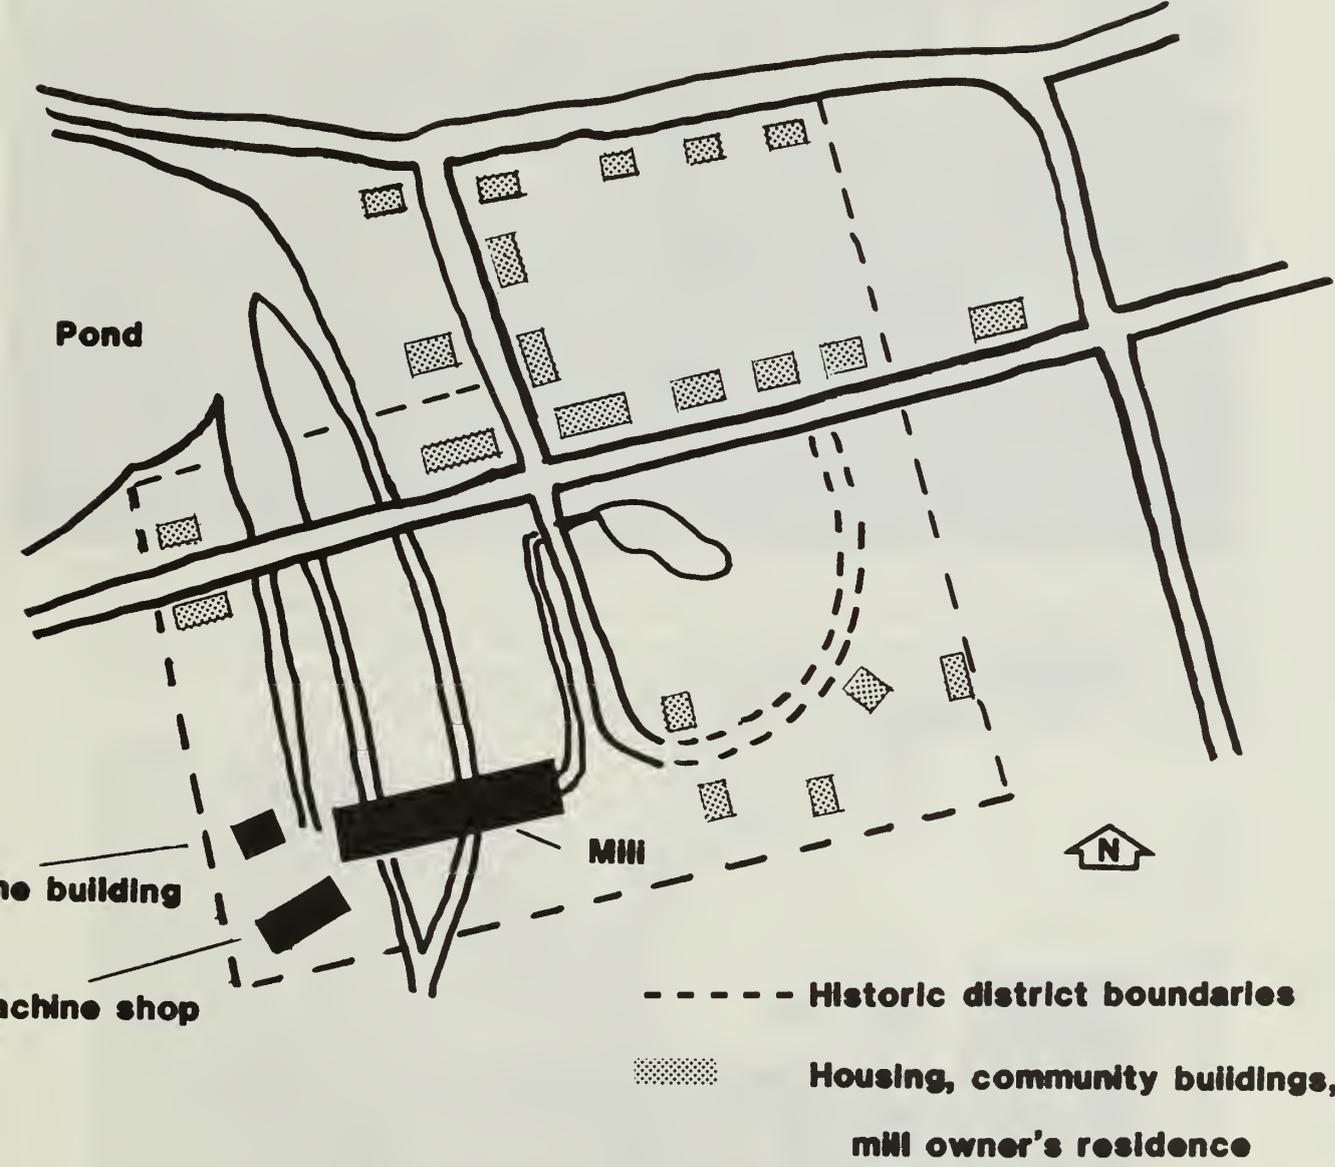
**PRE-REHAB SITE PLAN**

1. Site plan of the district prior to rehabilitation. Note location of the mill and mill-related buildings in the SW corner of the district.

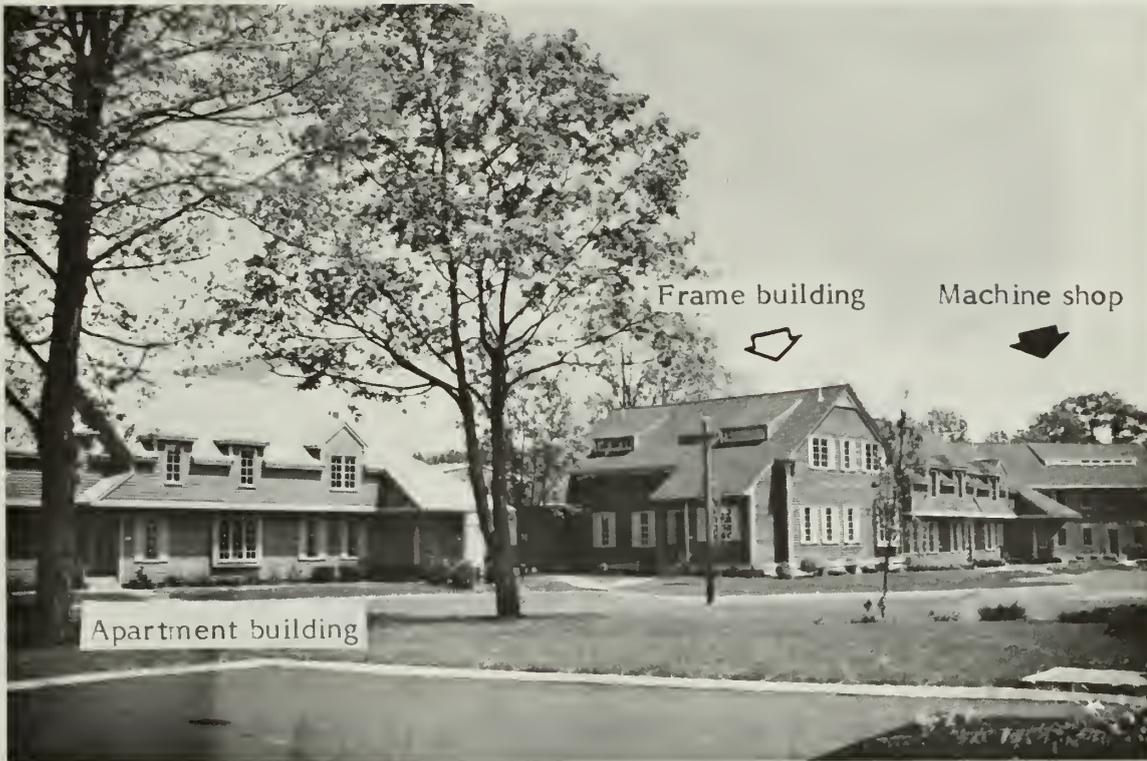
4. Post-rehabilitation view of machine shop and frame building. Note alterations to the frame building and new construction in the previous open space. The new construction introduces a variety of architectural forms and features not found on the historic buildings in the district.

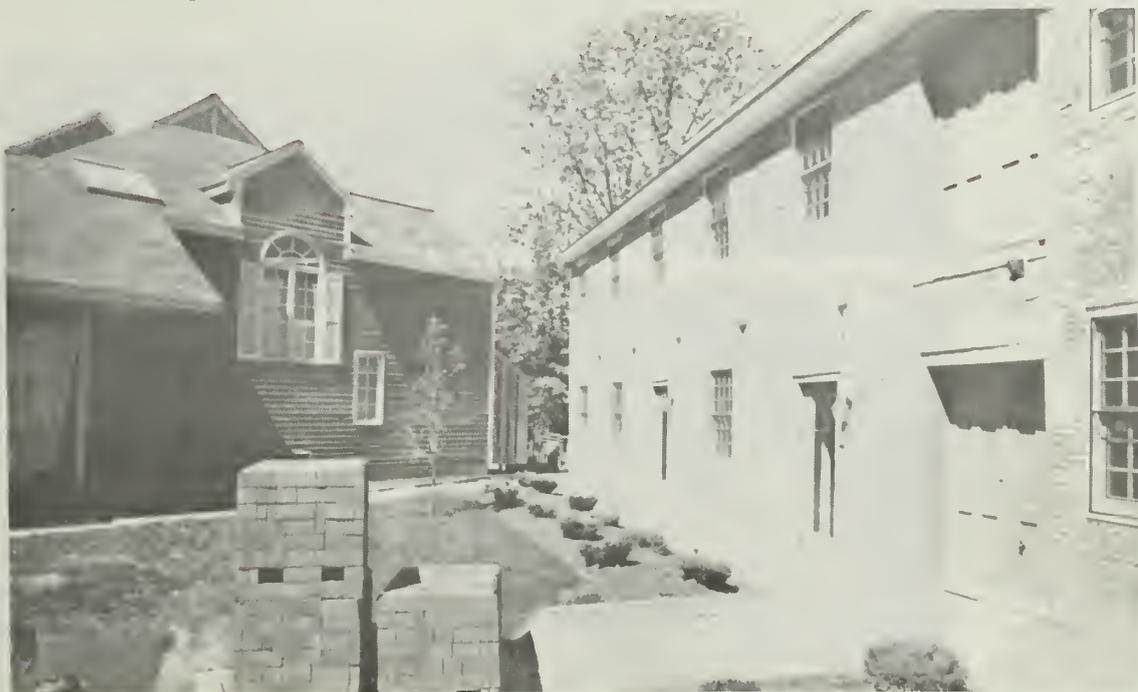
5. Note how close the frame building's new addition is located to the machine shop. A wood deck links the two structures. The new addition has created a more densely developed environment than existed prior to rehabilitation, obstructs the visibility of the machine shop, and has introduced architectural forms and features not found on historic buildings in the district. The new construction, therefore, has changed the visual qualities characteristic of the setting of this district.

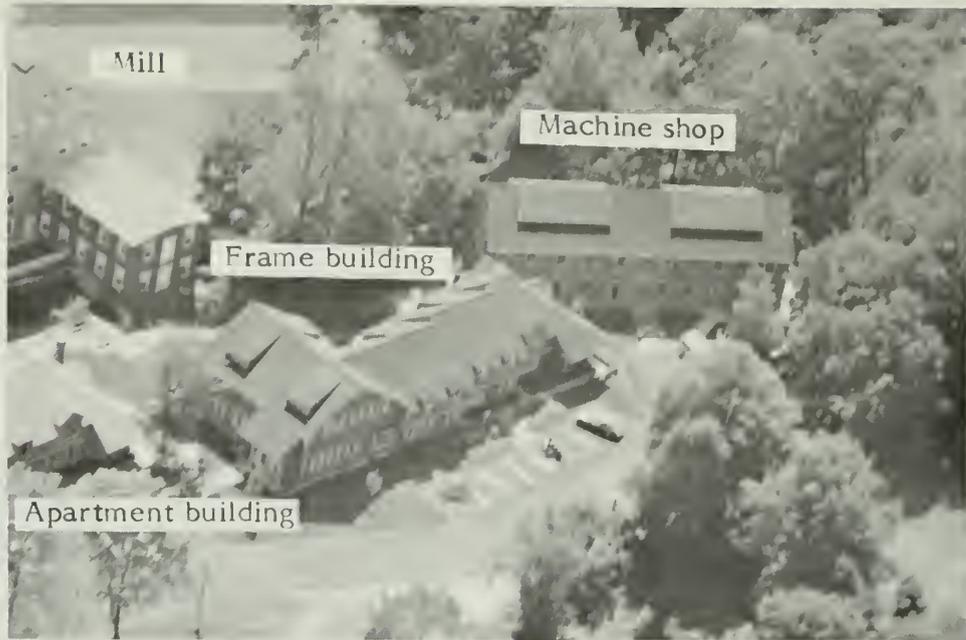
6. Aerial view of this portion of the district showing the alterations to the frame building, and a portion of the free-standing new construction on the left. The machine shop is in the center right of the picture, and the mill is located in the upper left corner. Note the more densely developed environment immediately in front of the machine shop.

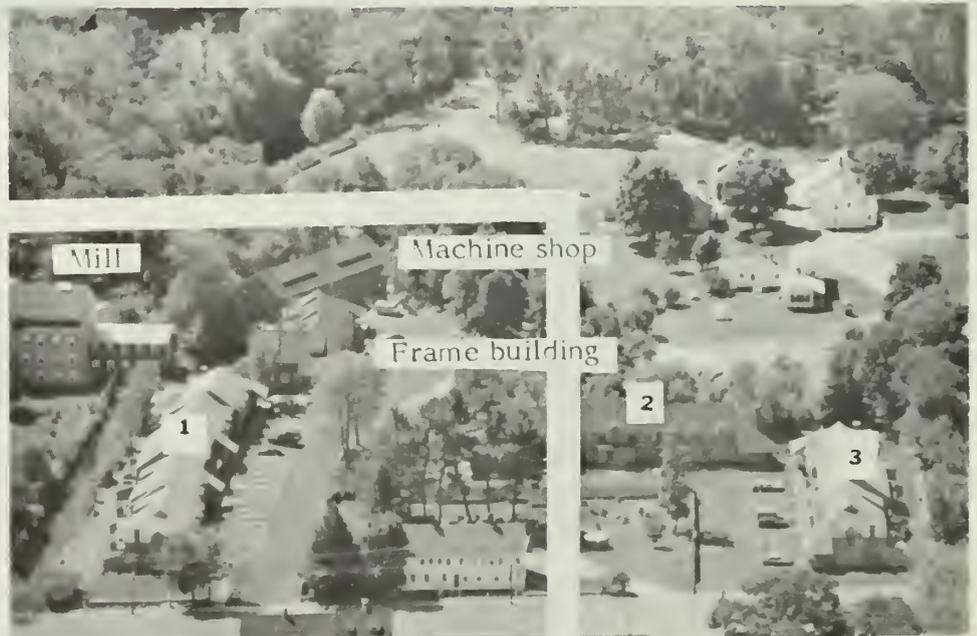
7. Aerial view showing blocks of new construction identified as 1, 2, and 3. White line is the approximate boundary of this part of the district.

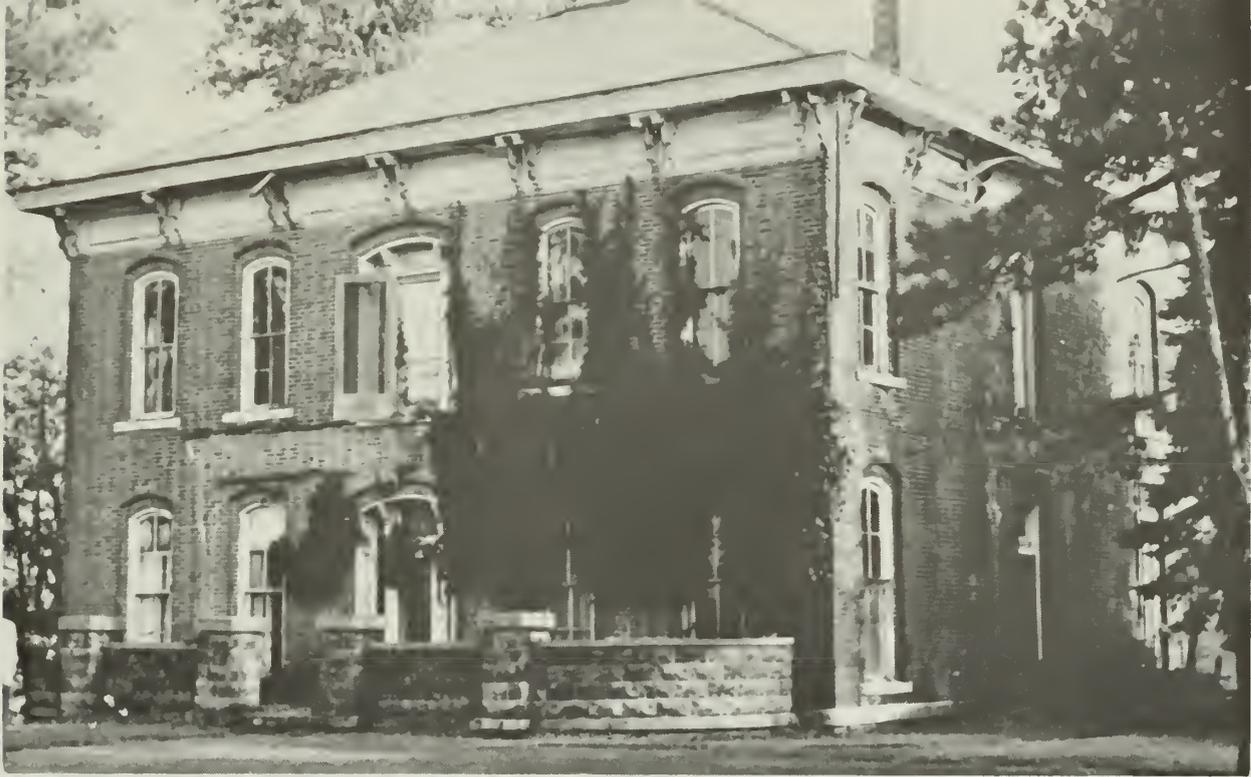
1. The house as it appeared when acquired by the current owner. Note the "ghost" outline of a porch on the front, the second floor exterior doors, and the elliptical cast stone terrace.

fact that exterior doors remained on the second story that had apparently opened out onto porch roofs) provided clues to the fact that porches had ever existed. Although the original porches were gone, a later, elliptical terrace surrounded by a low, rusticated cast-stone wall, probably constructed around the turn of the century, existed on the primary facade of the house at the start of the rehabilitation.

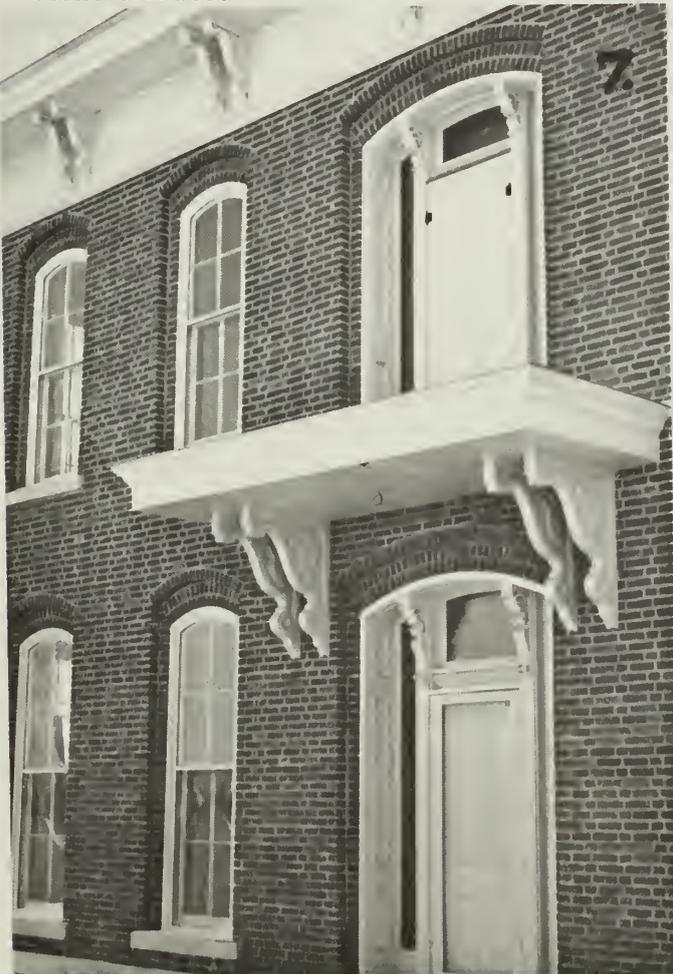
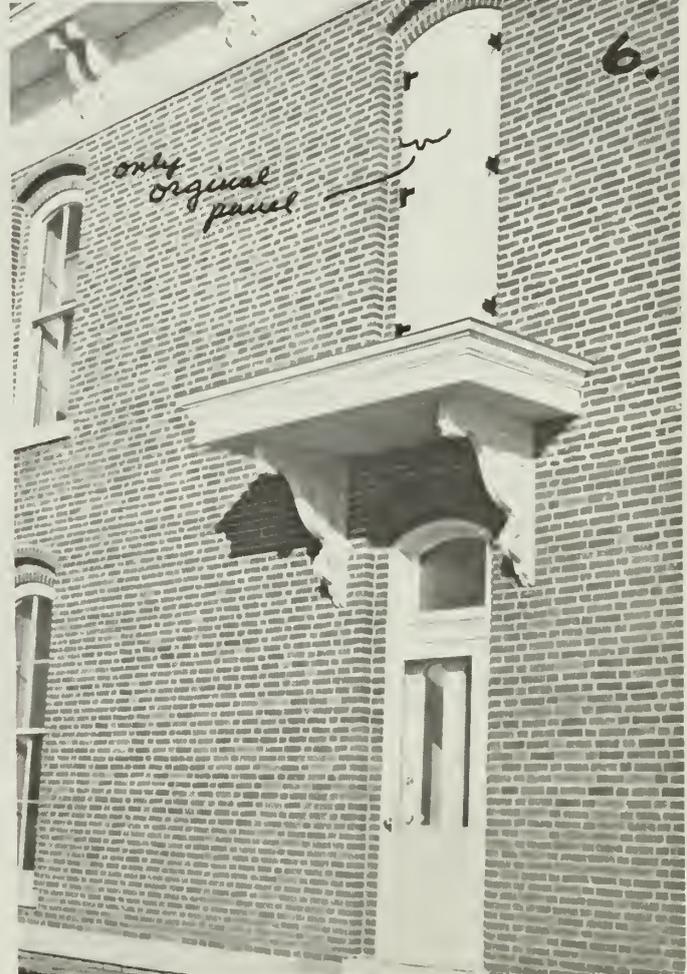
2-3. The reconstructed front porch (left) and the side porch (right). Their designs were based on bracket fragments found on the property combined with area residents' descriptions of the porches as they remembered them, but did not match the "ghost" outlines that had existed on the brick prior to cleaning.

As part of the rehabilitation, the owner removed this elliptical terrace and wall from the front of the house and decided to "reconstruct" the original porches. Instead of using the very distinct "ghost" outlines (which had been removed by the owner during cleaning of the exterior brick), the owner used pieces of wood brackets found on the property as models to construct new porches. These bracket fragments, the owner speculated, came from the "original" porches that had been described by area residents as preceding those porches which had left their physical profile on the brick (see illus. 2-3).

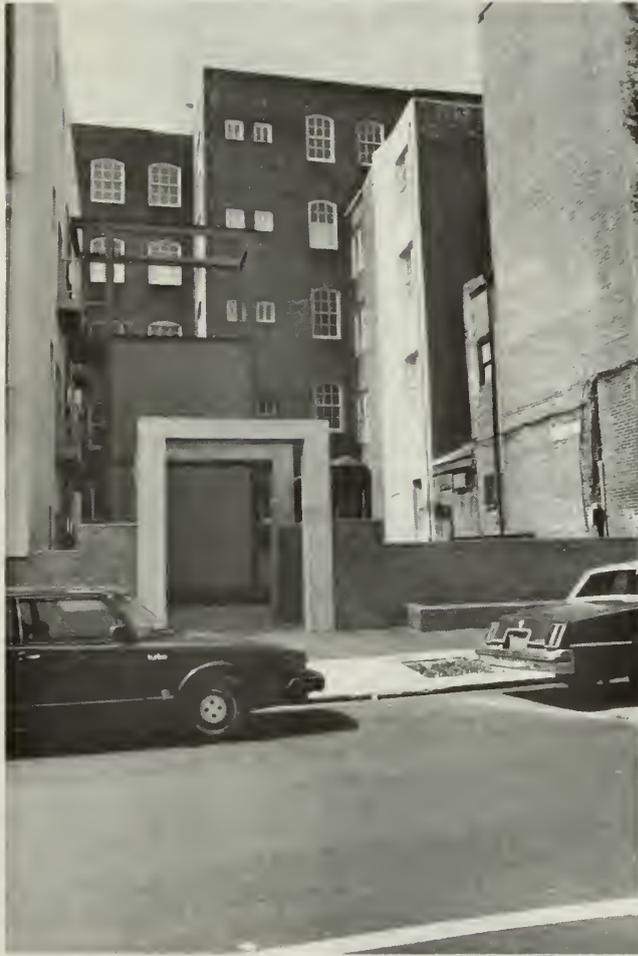
3. Entrance pavilion, front wall and stairtower are prominent new site features.

In addition, the prominence of the new work serves to diminish the prominence of the principal historic structure to which it is attached. The effect is that the historic building seems an appendage to the new entrance pavilion and stairtower rather than the reverse (see illus. 7). As a result, the project fails to meet the Secretary of the Interior's Standards for Rehabilitation.

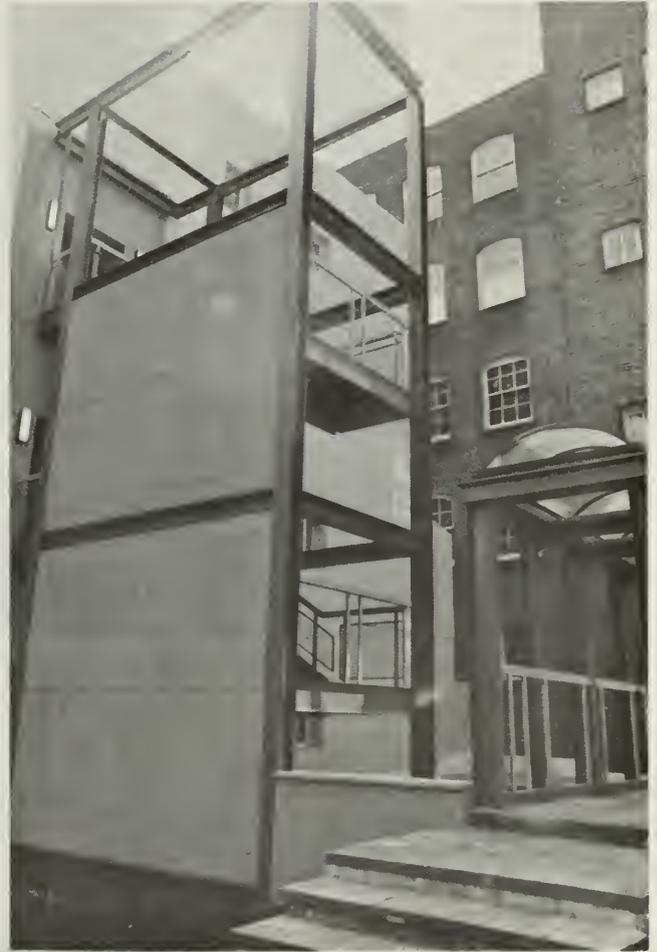
4. Stairtower provides fire exit from building at left.

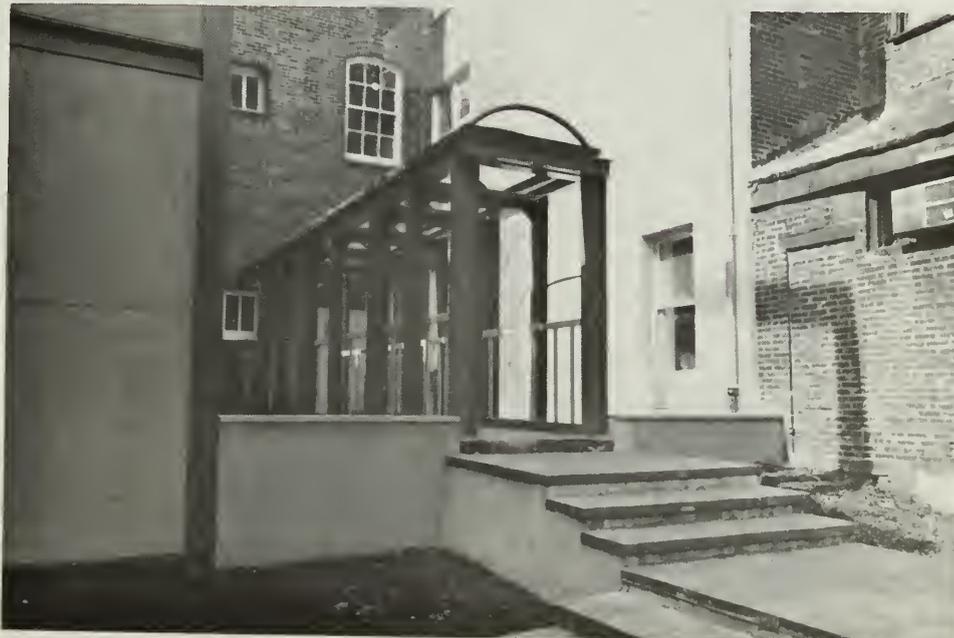
5. Covered walkway serves as the principal entrance to all four rehabilitated structures.

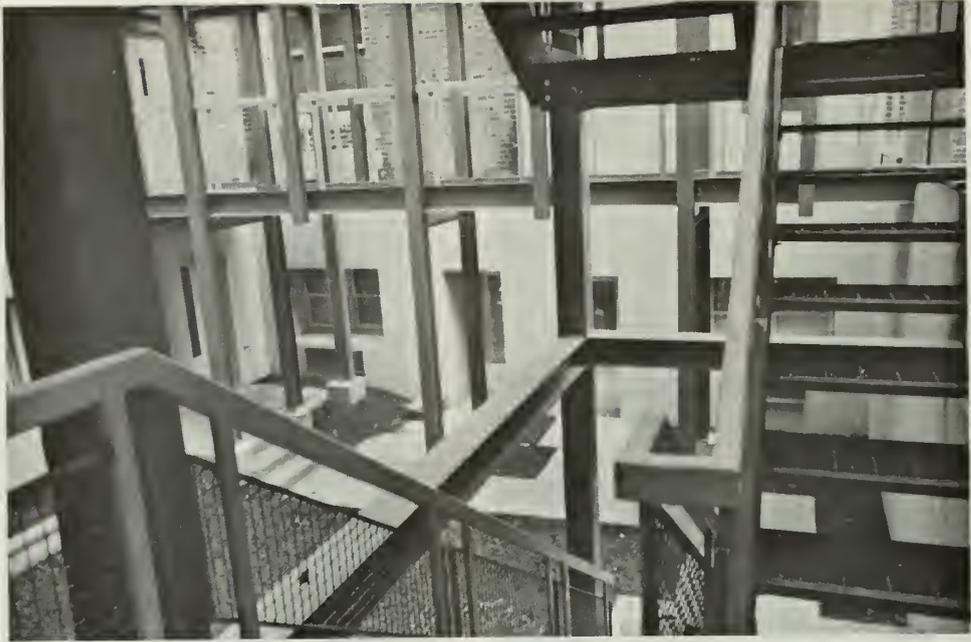
6. The covered walkway spans a courtyard excavated for new below-grade apartments.

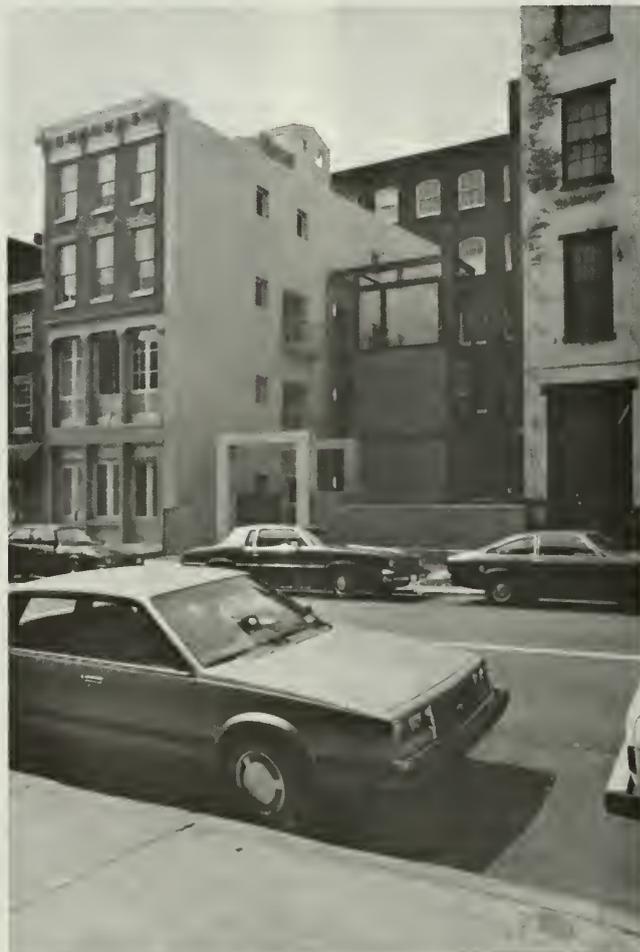
7. The new site work subordinates the independent historic building to a larger composition of radically new and incompatible elements.
