Technical Preservation Services  
Preservation Assistance Division  
National Park Service  
U.S. Department of the Interior  
Washington, D.C.

Interpreting  
the Secretary of the Interior's  
Standards for Rehabilitation

Volume III

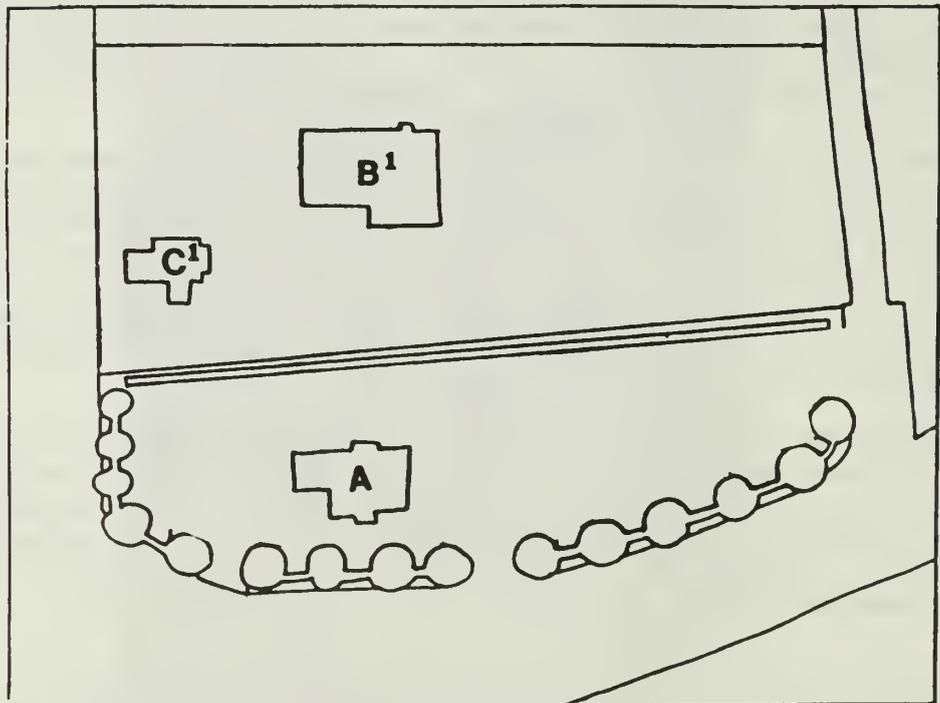
2. Site plan before rehabilitation began. The 1900 house (A) stood alone on its lot. On the adjoining property stood another large house (B1) and a dependent cottage (C1).

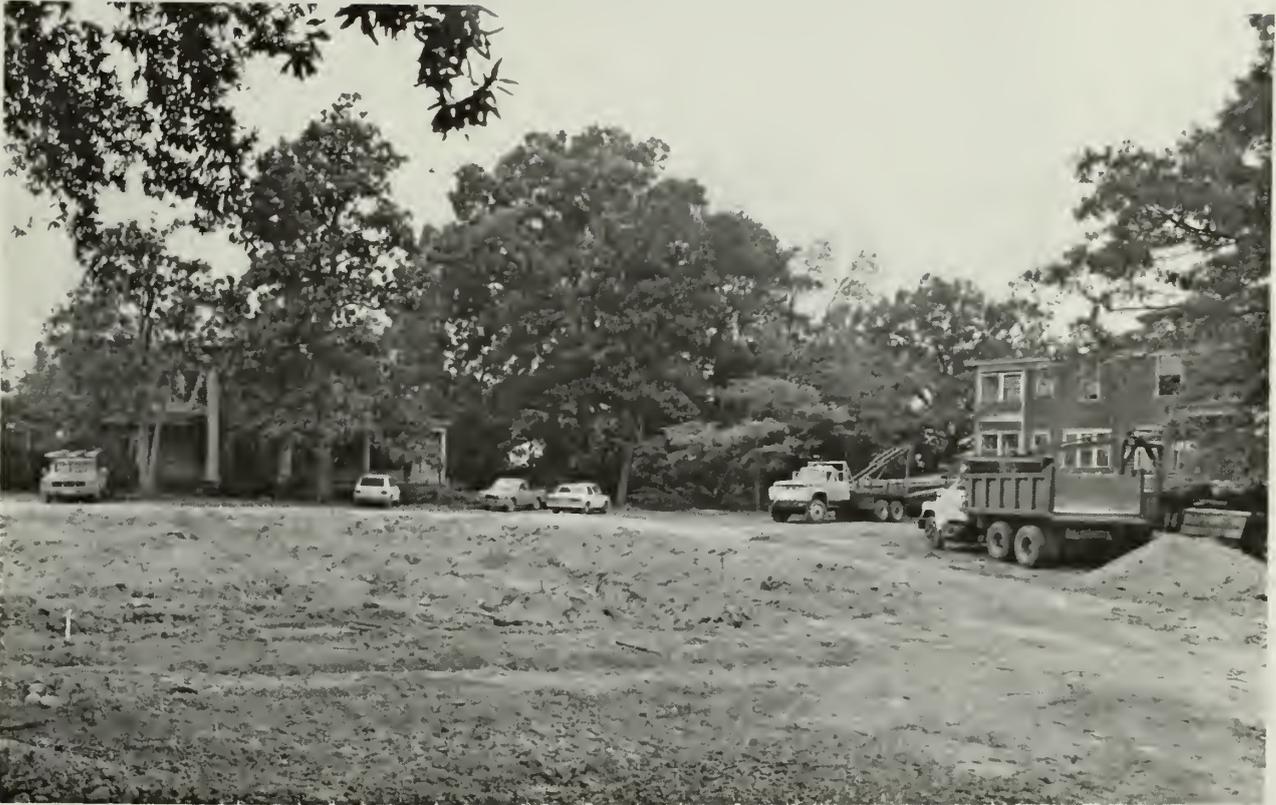
3. The front yard of the mansion has been prepared for the relocation of the neighboring house, seen at right.

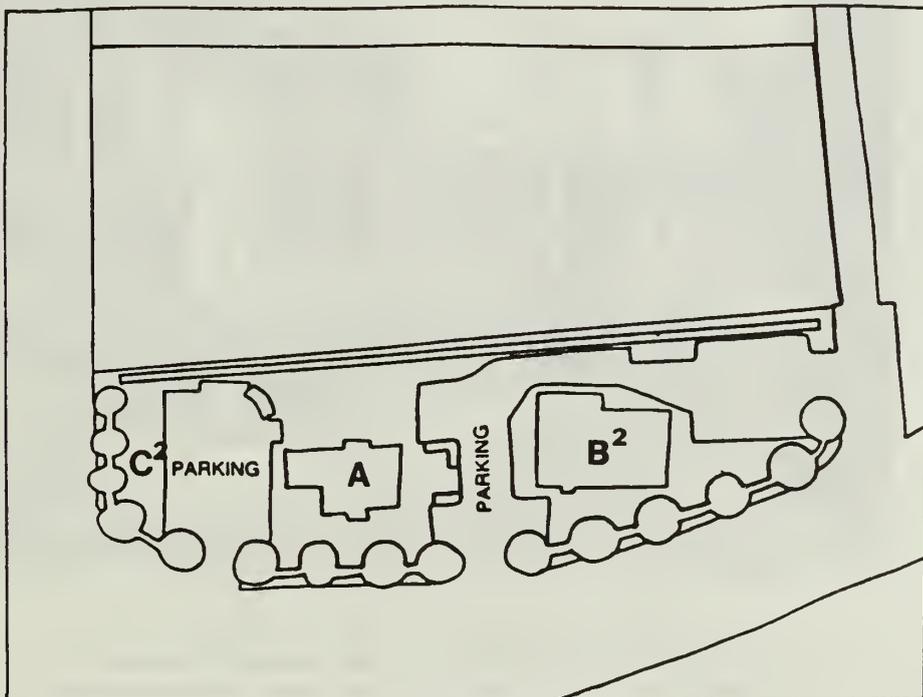
4. Site plan after relocation of buildings. The neighboring house was moved and turned around (B2) to face the 1900 building (A) across a paved parking lot. The cottage associated with the moved house was relocated (C2) behind the 1900 building.

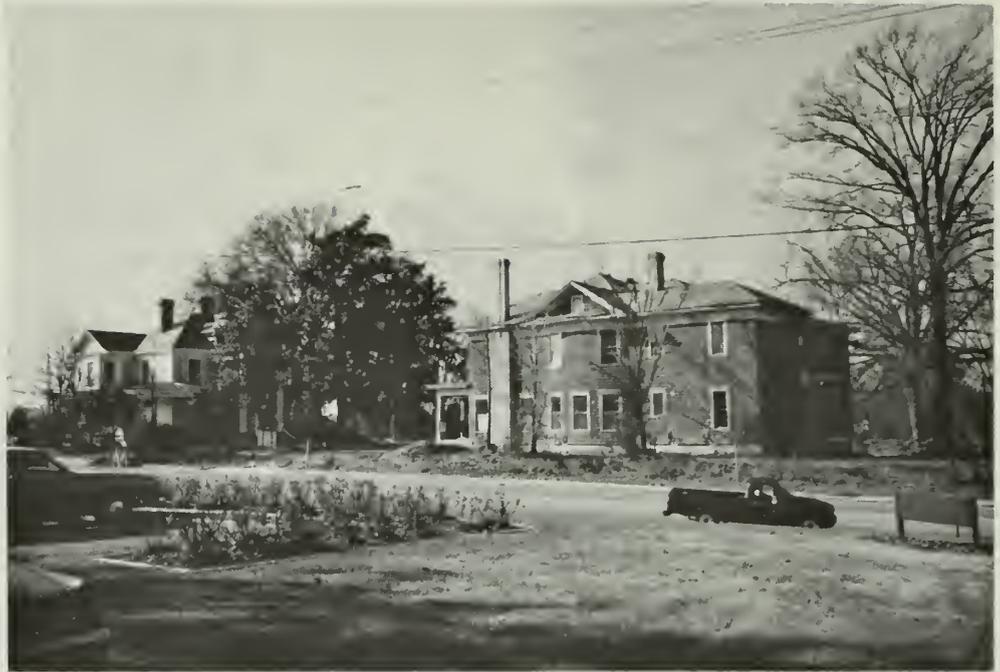
5. Turned 180 degrees, the moved building faces the historic one from a distance of 60 feet.

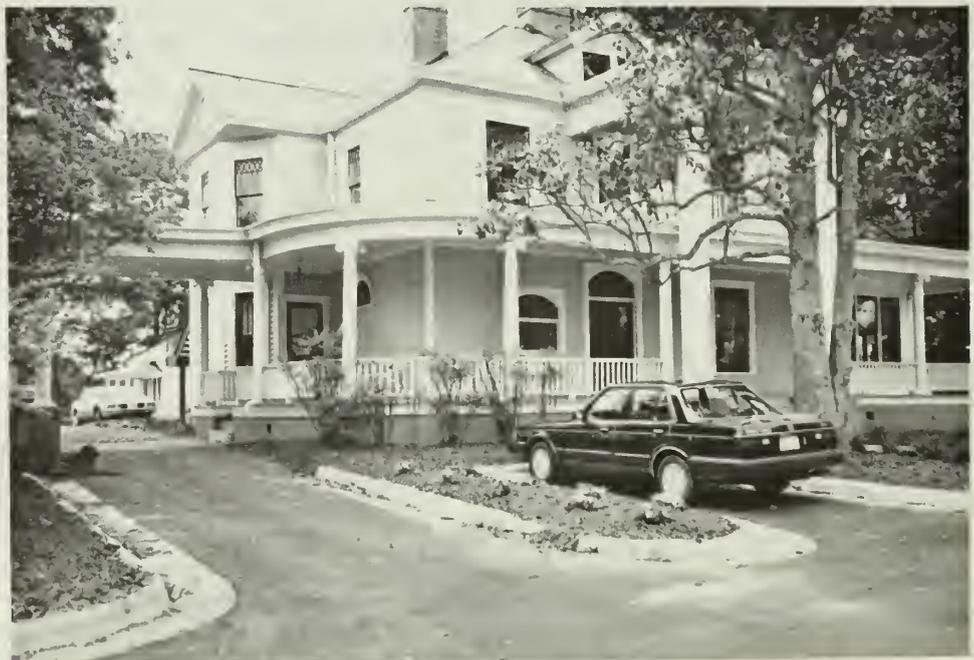
6. The parking lot completes the drastic alteration of the setting. The second relocated structure is seen through the porte-cochere at left

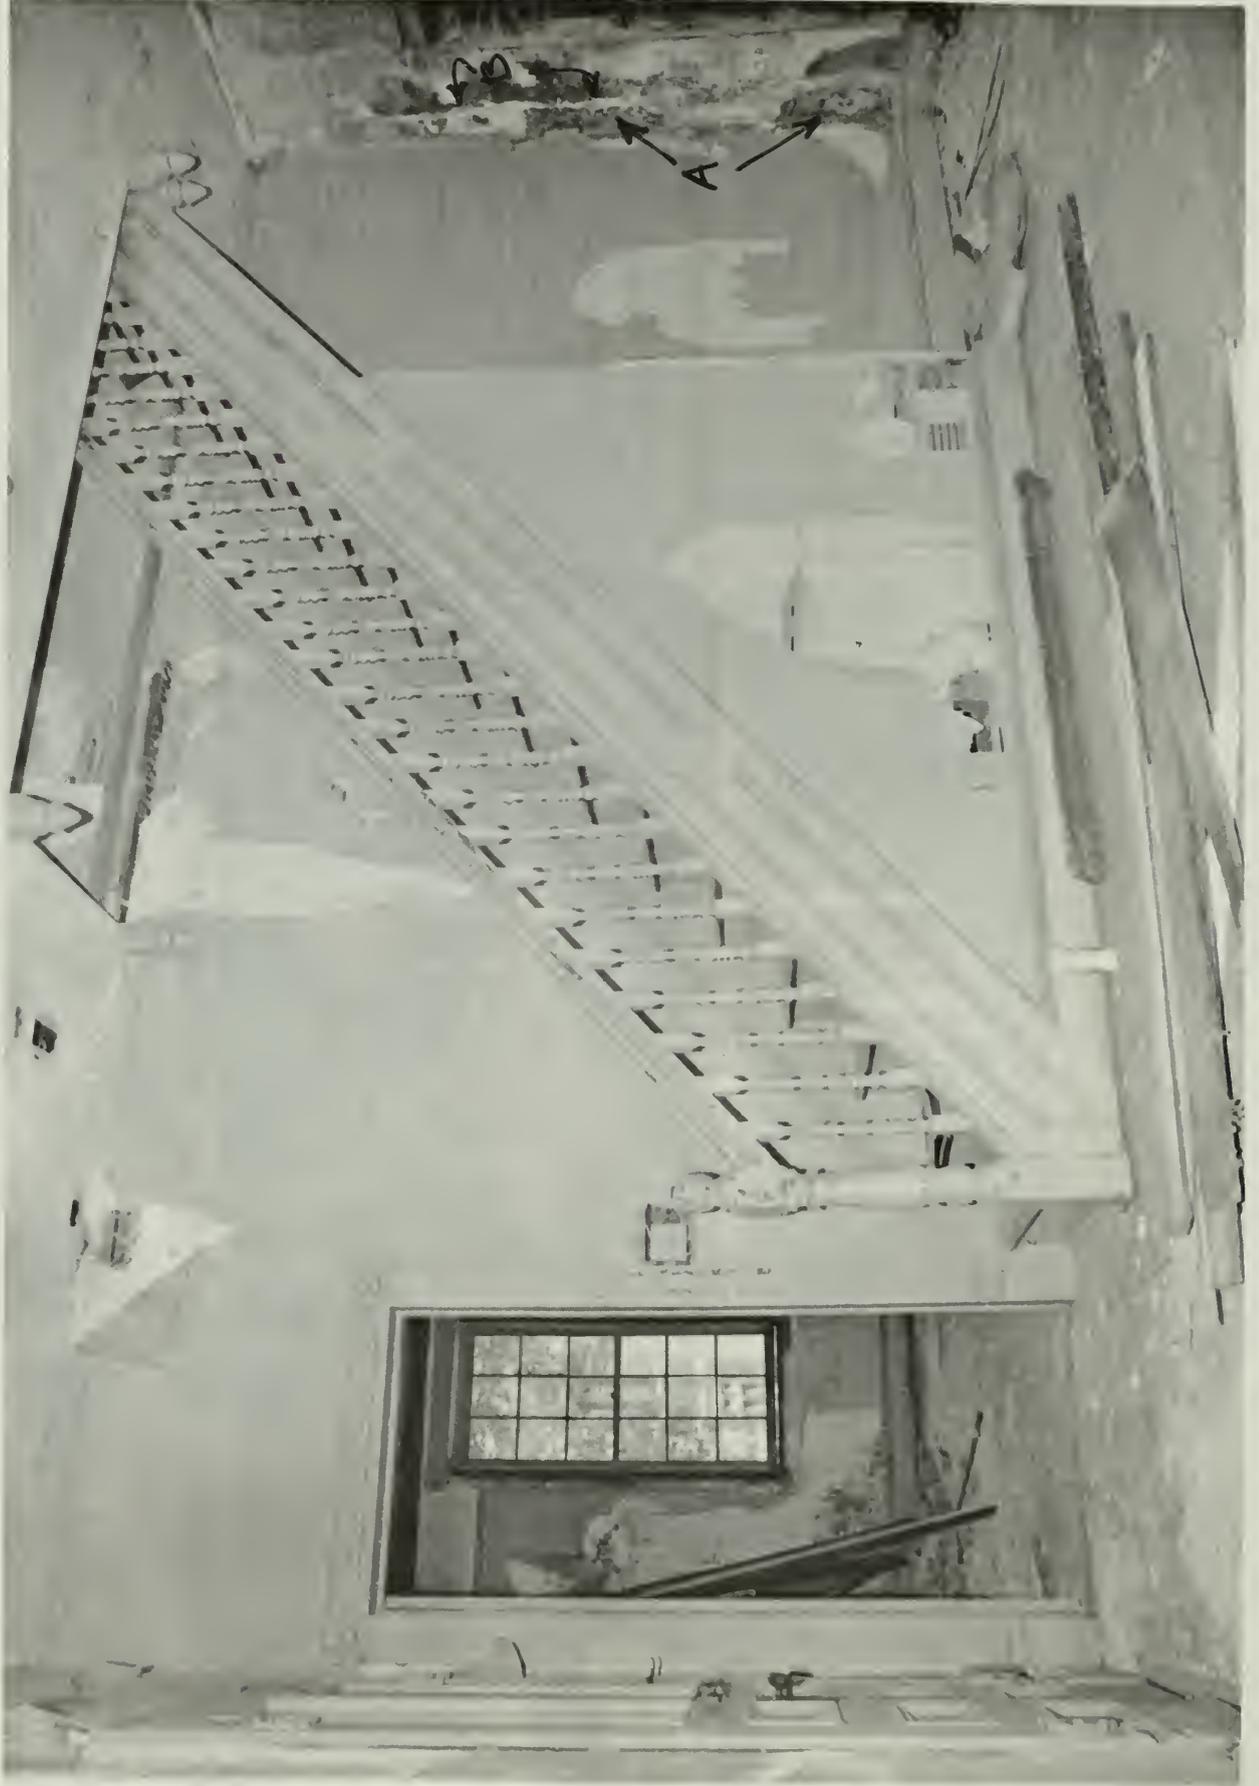
2. Circa 1912 stair prior to rehabilitation. Moldings, floor plan, and other detailing are all 20th century.

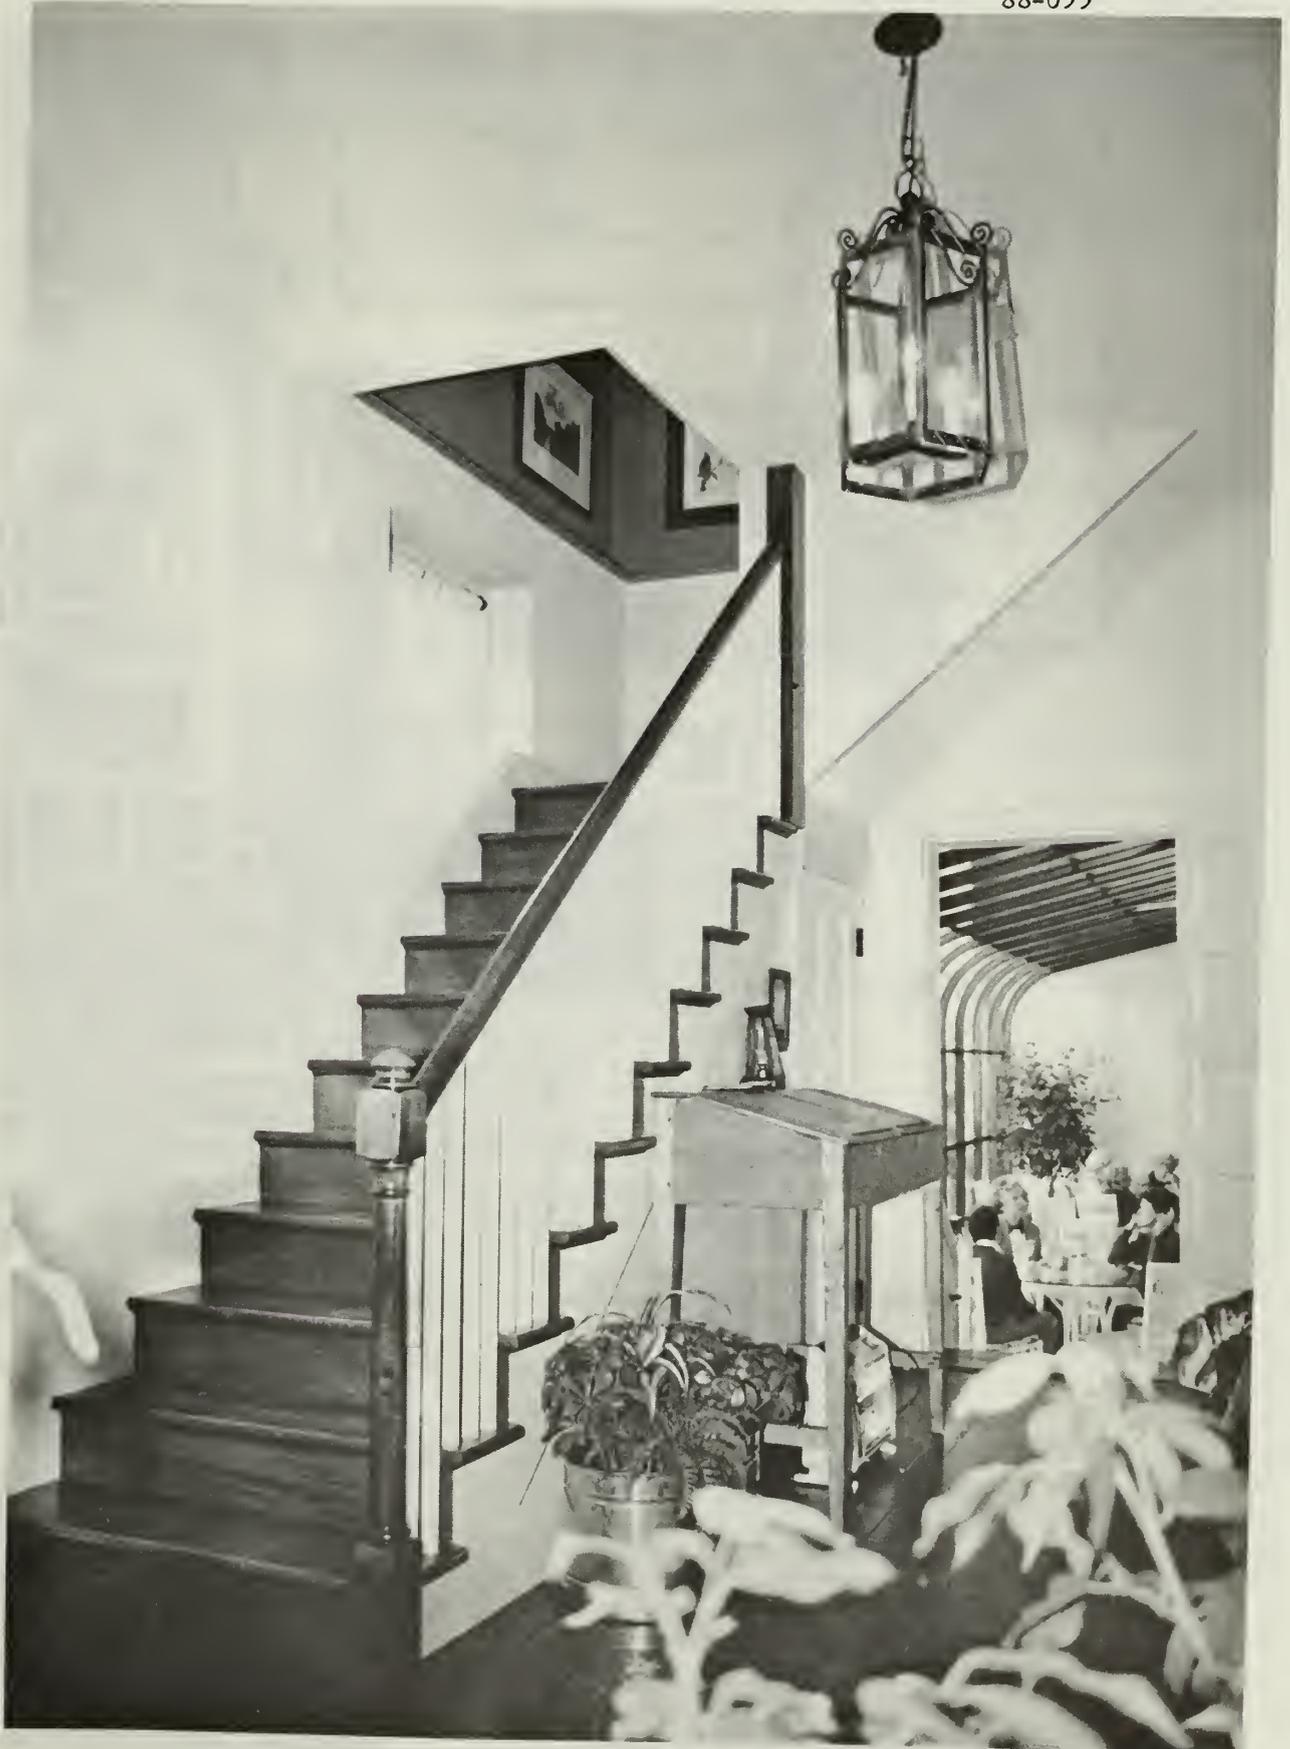
3. New stair after rehabilitation. Design of stair was not based on historic evidence.

1839 and 1870. The ca. 1870 porch, however, was retained and preserved, as was the ca. 1912 rear ell addition. Although the new stair was based on scattered ghost marks and fragments of the original stair, there was no evidence of what the original bannister and newel post looked like, and as a result the new appearance is conjectural (see illus. 3). Also conjectural is the design of the new front door which was installed to replace two ca. 1912 doors. The only evidence existing for the front door was three hinges found near the suspected location of the original door.

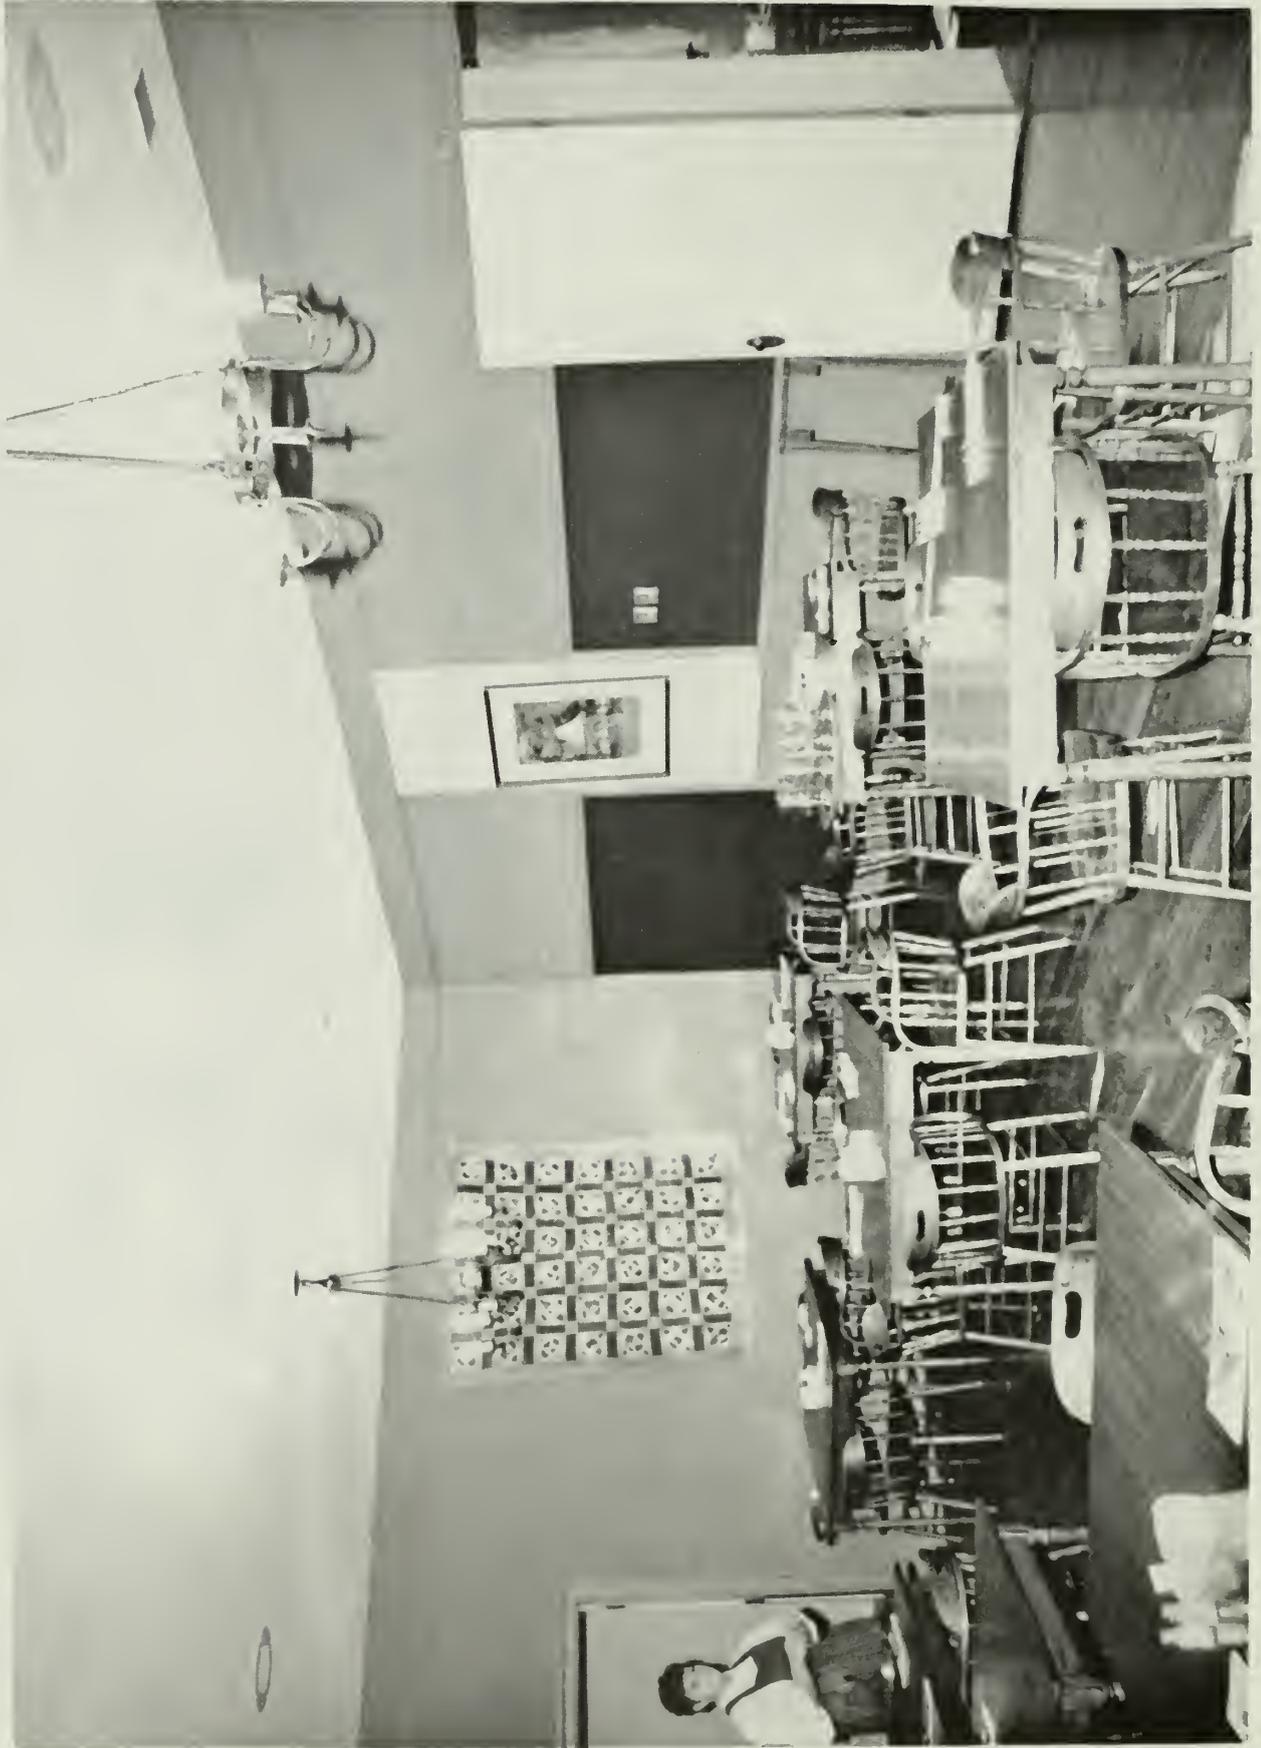
4. Main dining room in first floor of restaurant after rehabilitation. Note ca. 1912 door and molding remain, and ca. 1839 window

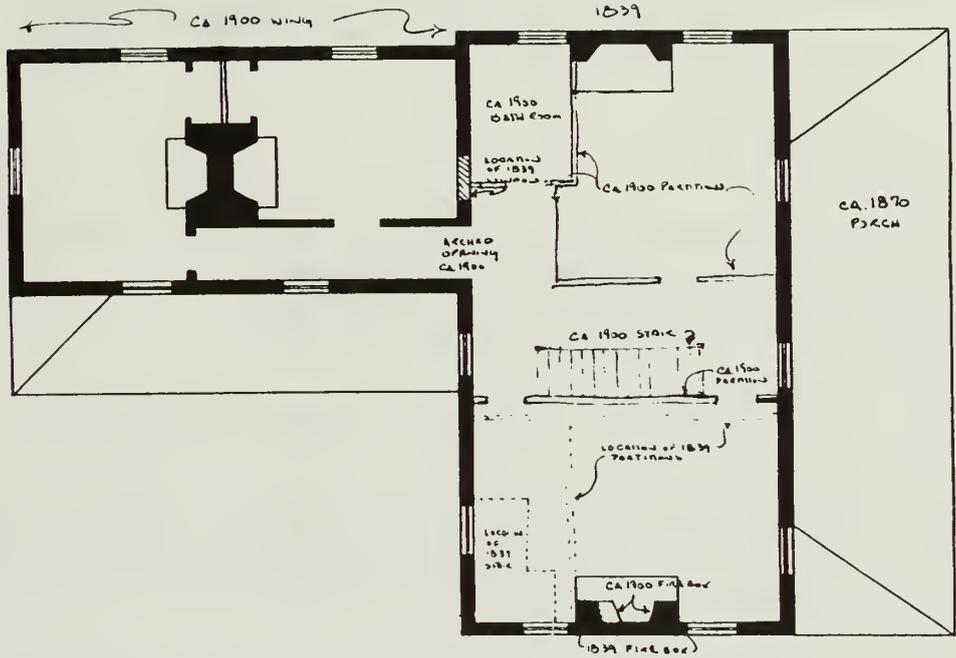
5. Second floor plan prior to rehabilitation.

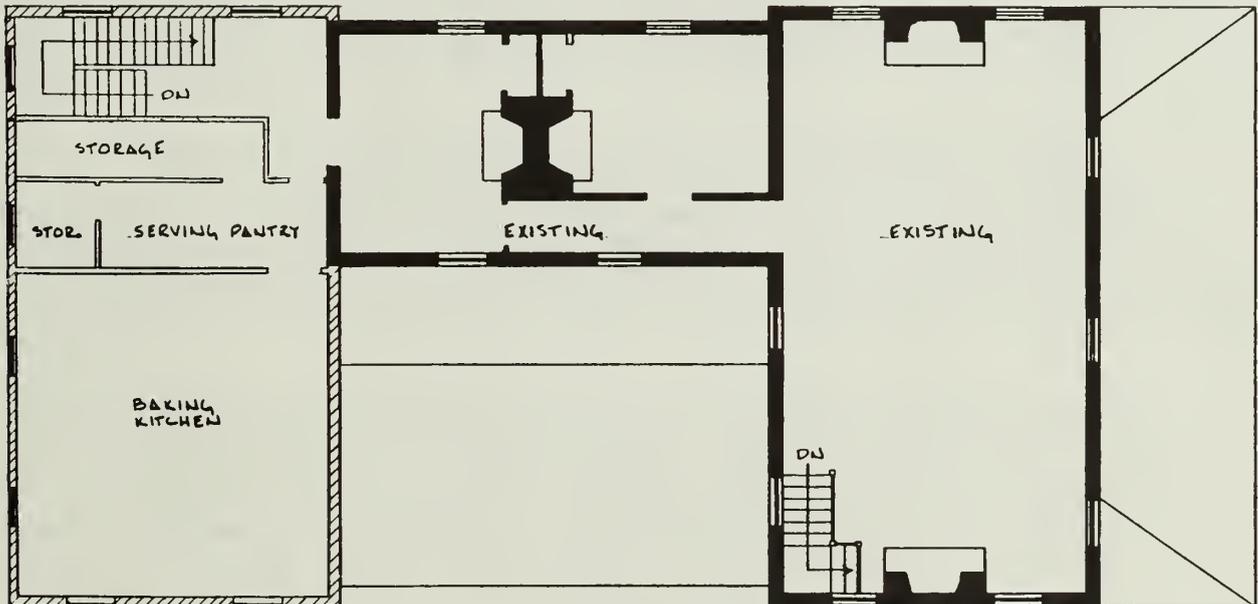
6. Second floor plan after rehabilitation. Note 1839 partitions and window were not reinstalled.

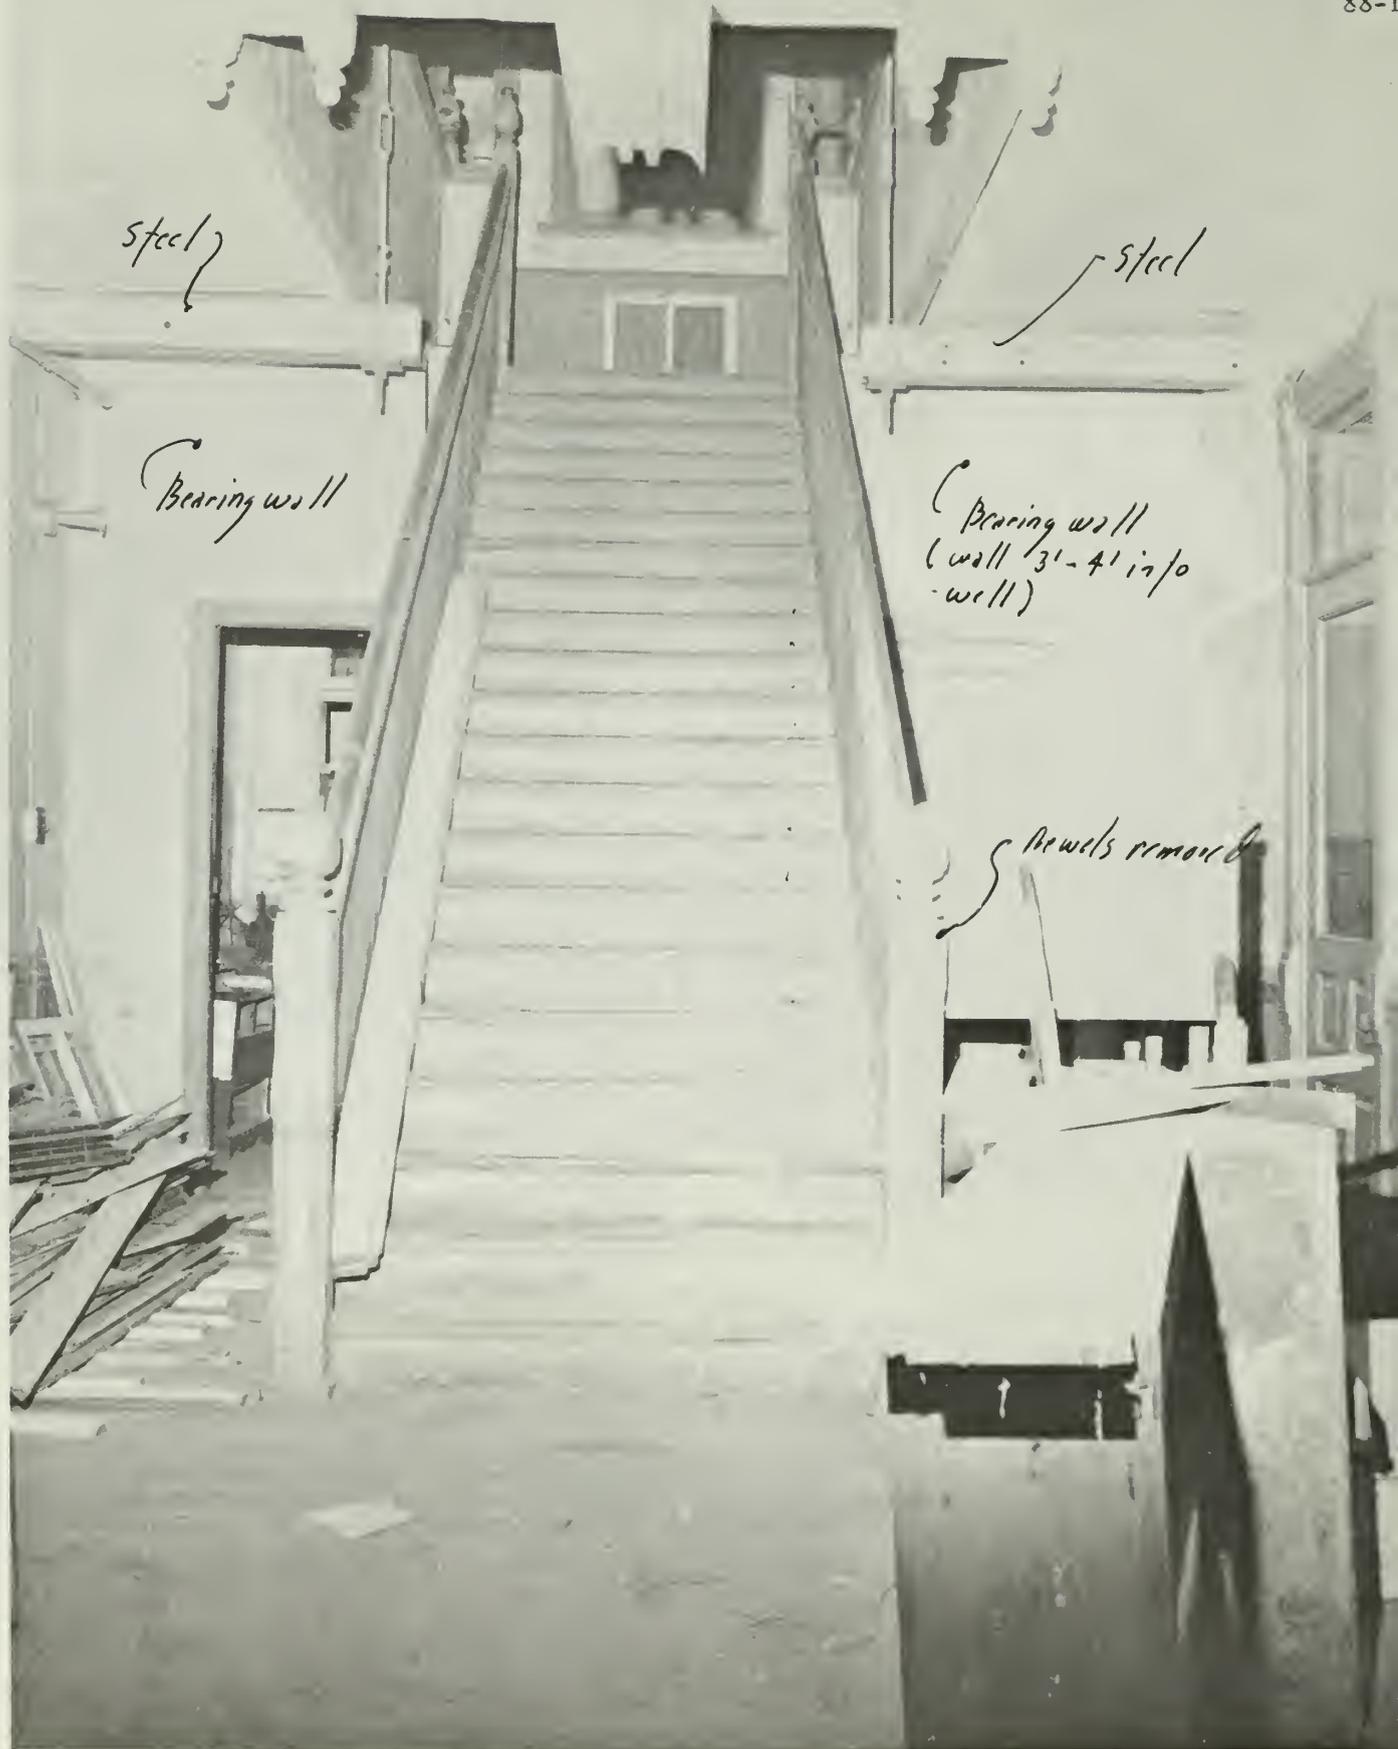
2. Pre-rehabilitation photograph of first floor center stair and hall. This stair was removed in the process of rehabilitation.

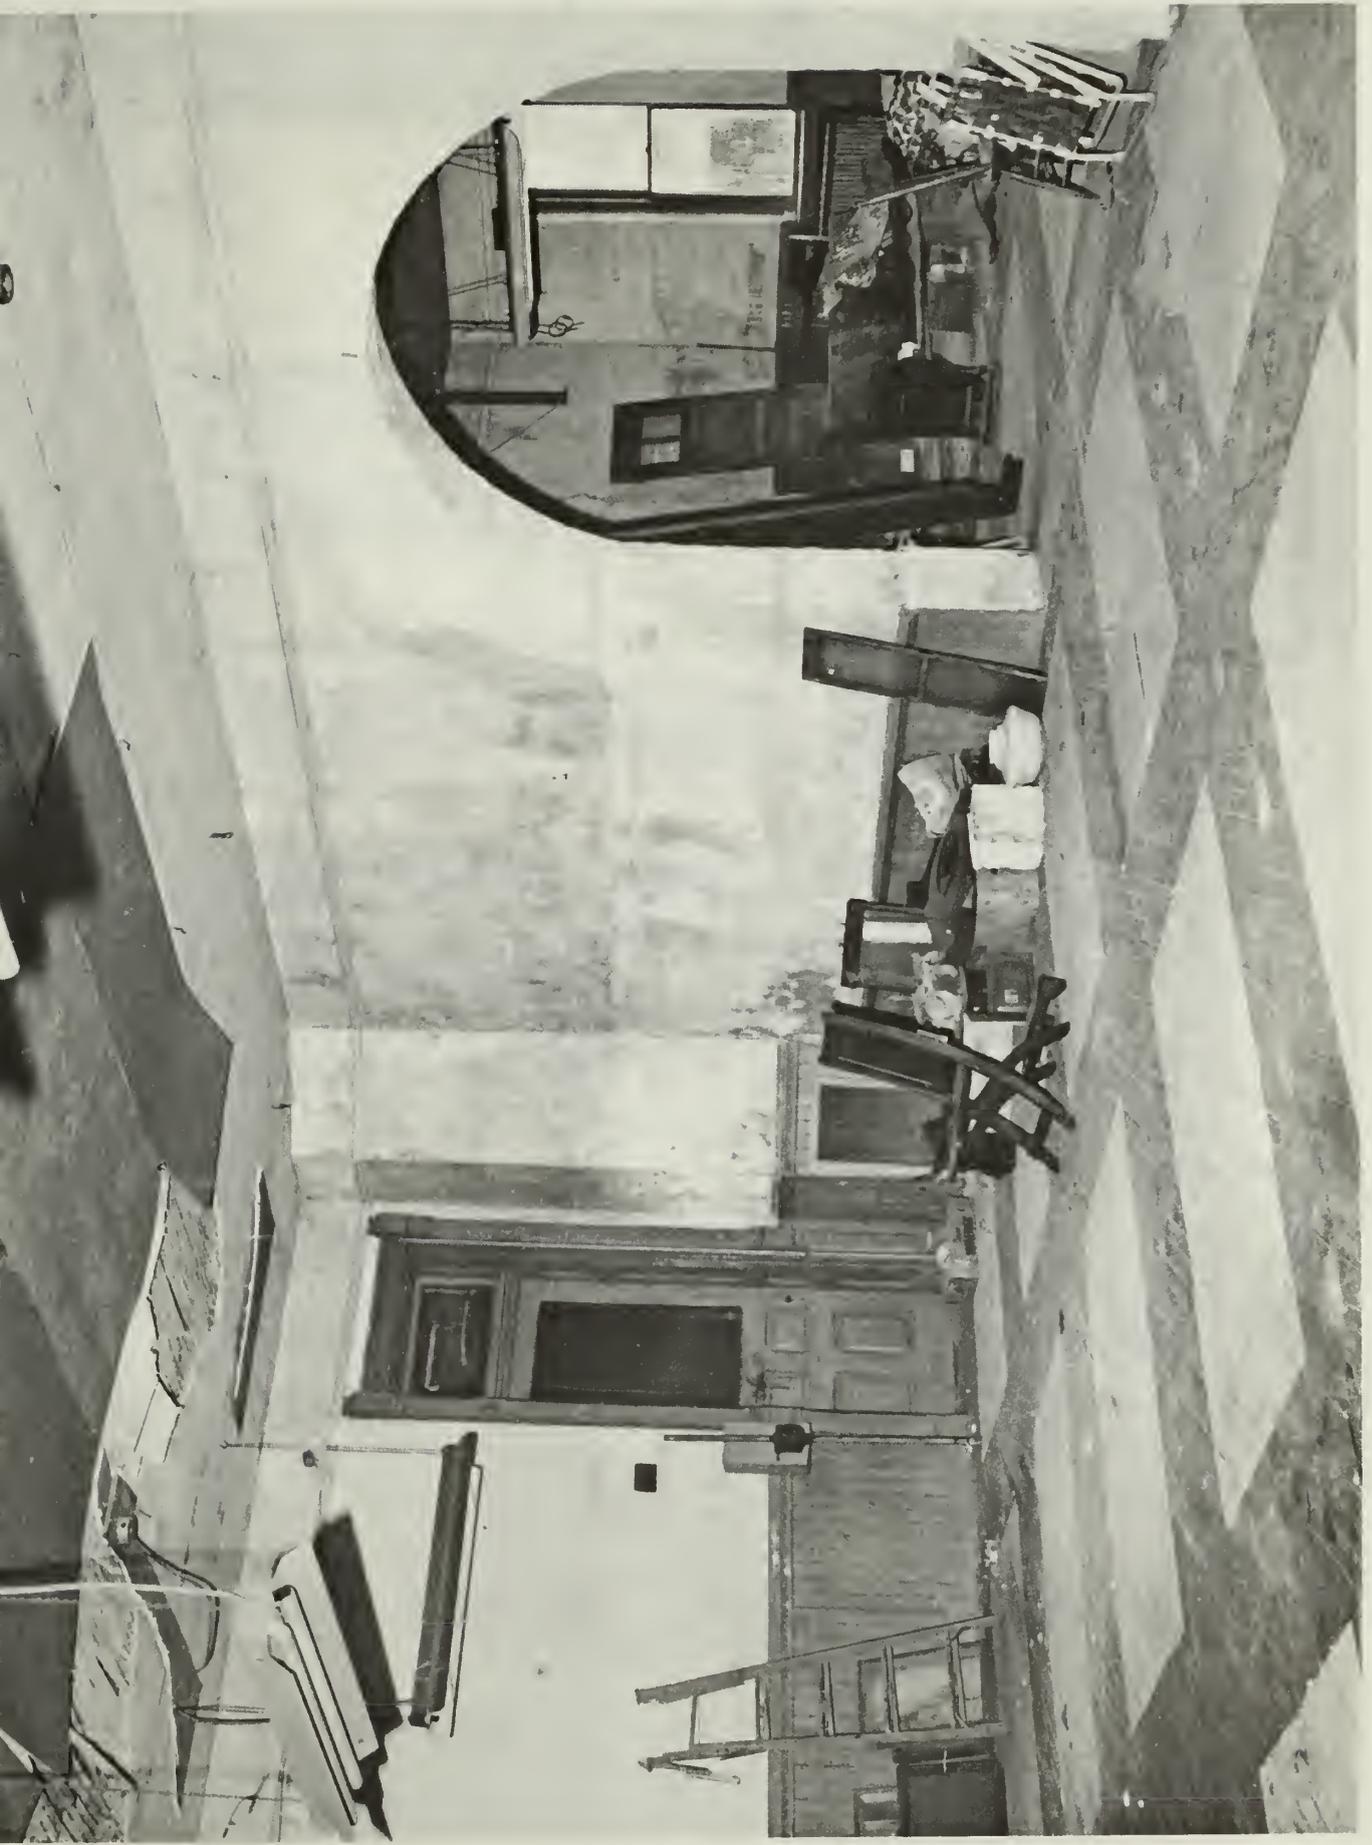
3. View of interior first floor classroom prior to rehabilitation. Arched opening between classrooms was added after original construction.

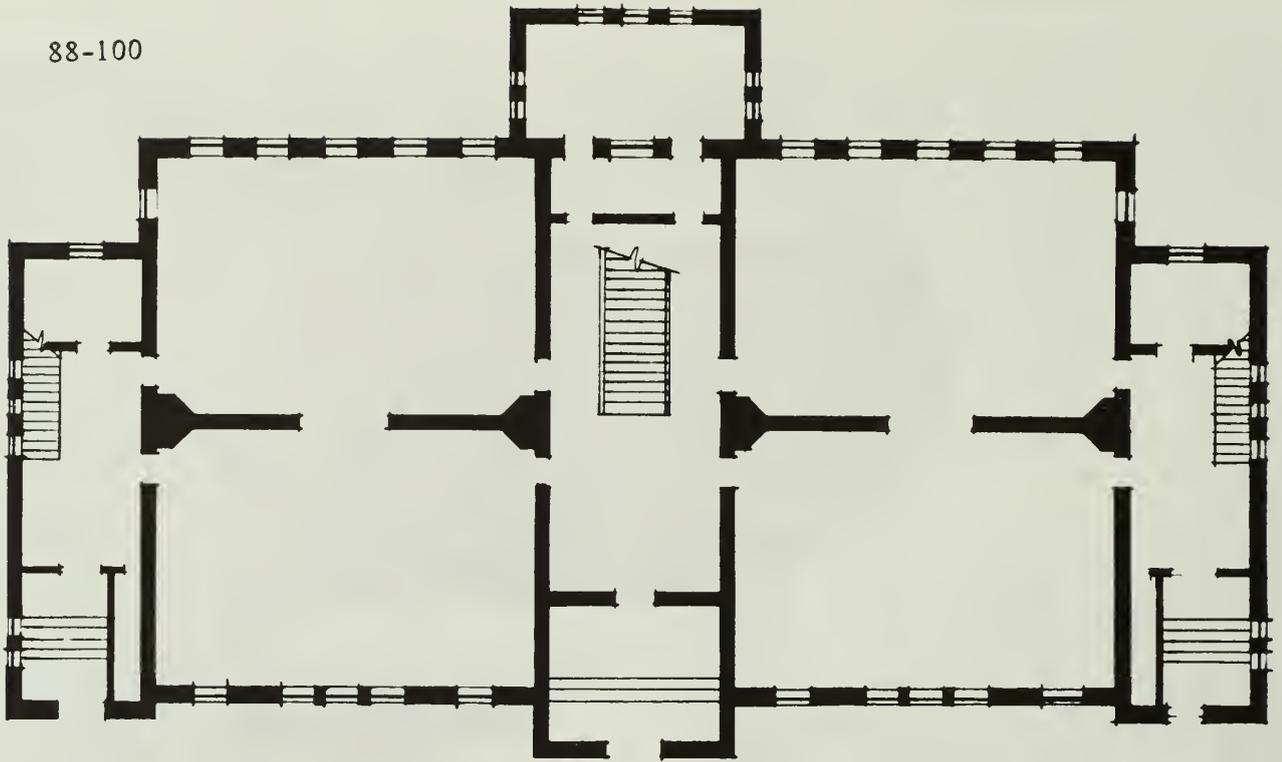
4. Floor plan of first floor prior to rehabilitation.

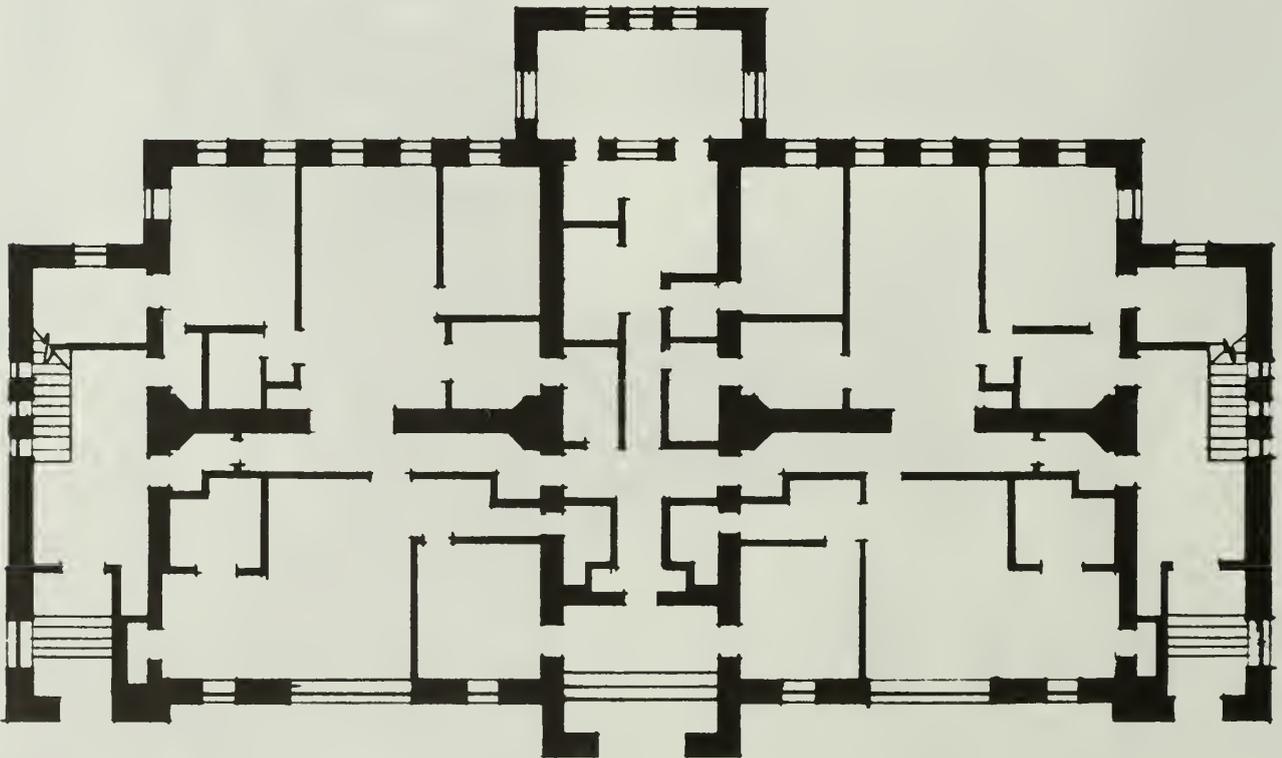
5. Floor plan of first floor after rehabilitation. Classrooms and hallway have been subdivided into apartments.

Another distinctive feature that was characteristic to this building type was the panelled wainscotting found throughout the interior. However in the rehabilitation, the interior face of the exterior walls was furred out and significant amounts of wainscotting were subsequently covered (see illus. 6). This treatment has caused the wainscotting to appear fragmented and dis-continuous. The remaining wainscotting appears to be randomly placed, and together with the significant subdivision of the classrooms prevents a clear understanding of the original classrooms' design and space.

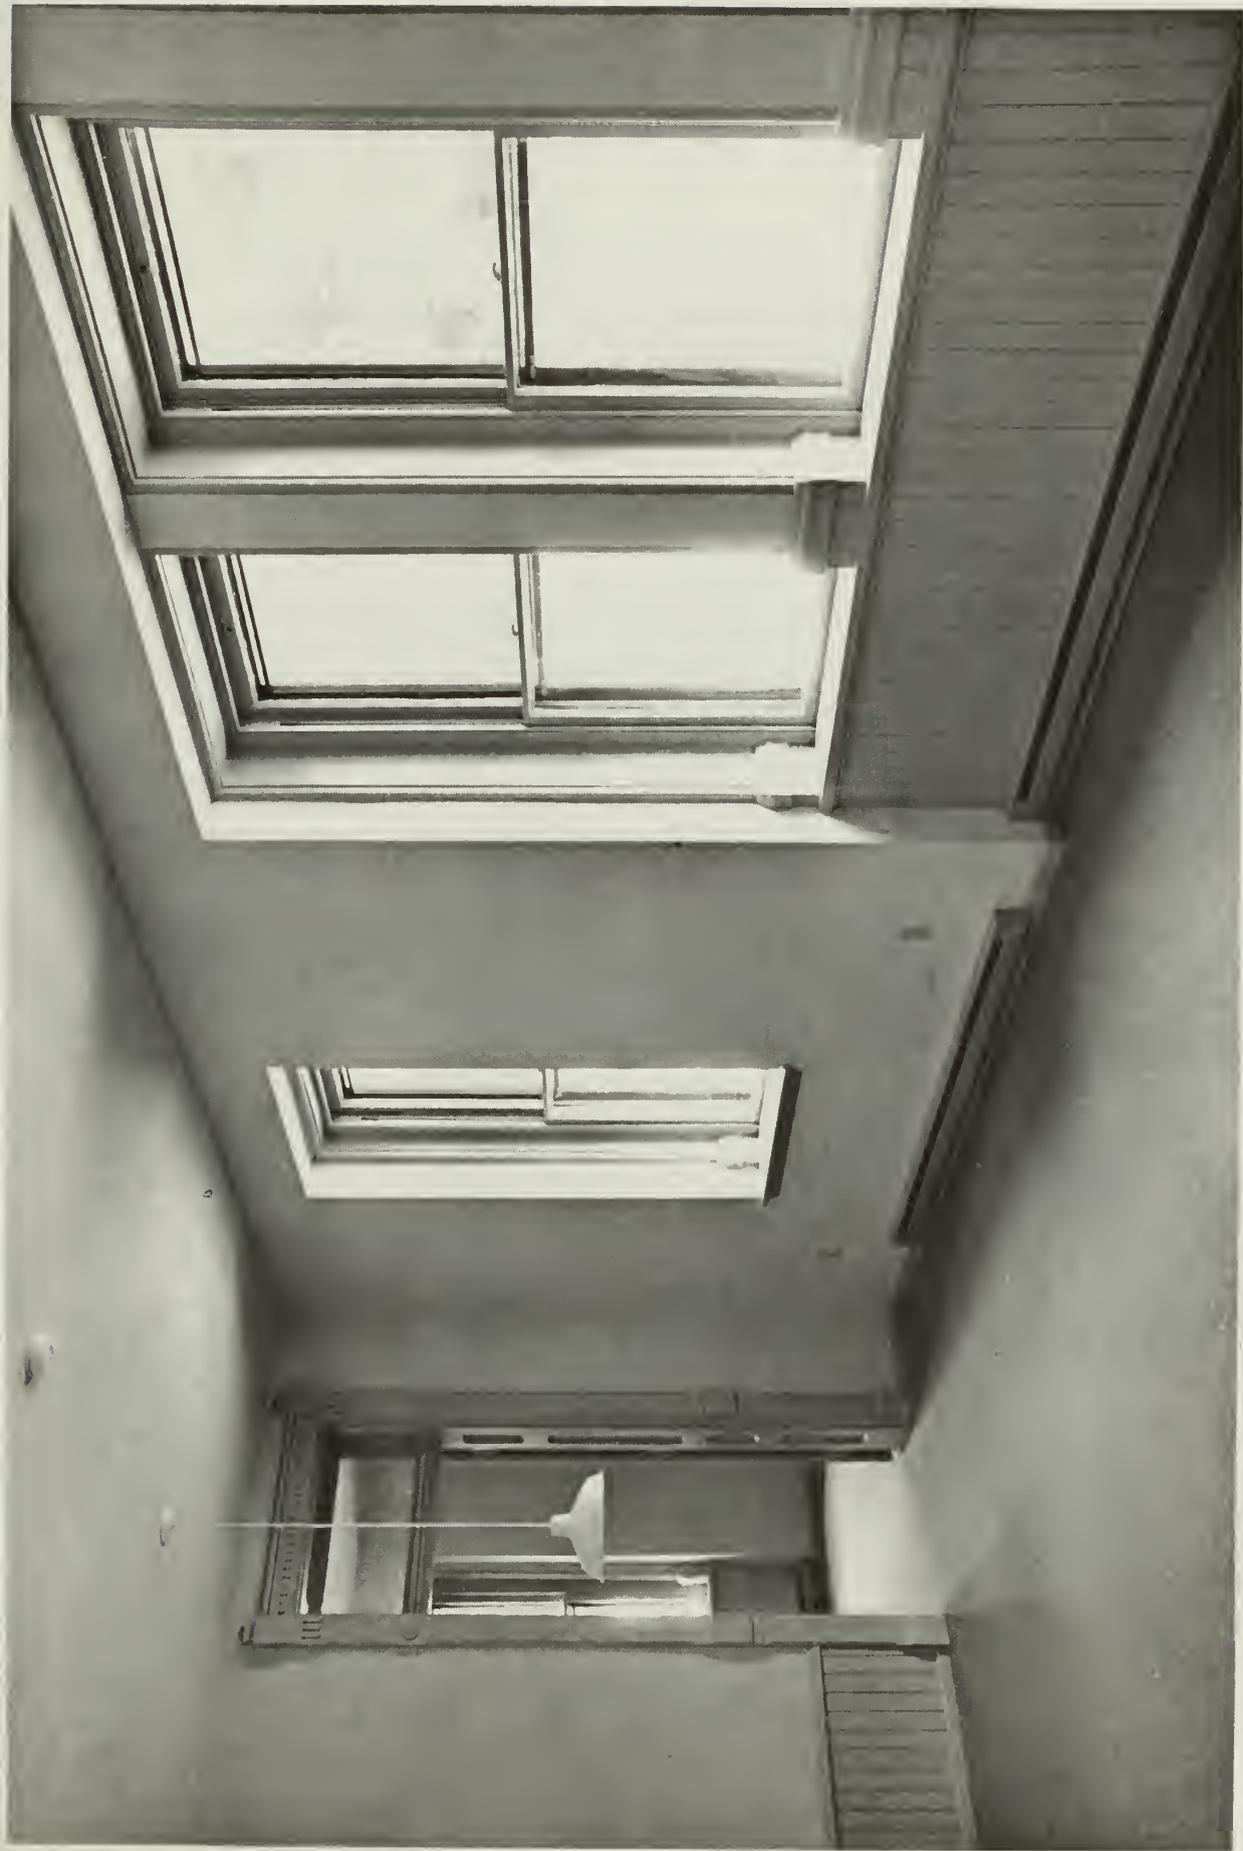
6. Third floor classroom as modified for apartments in rehabilitation.

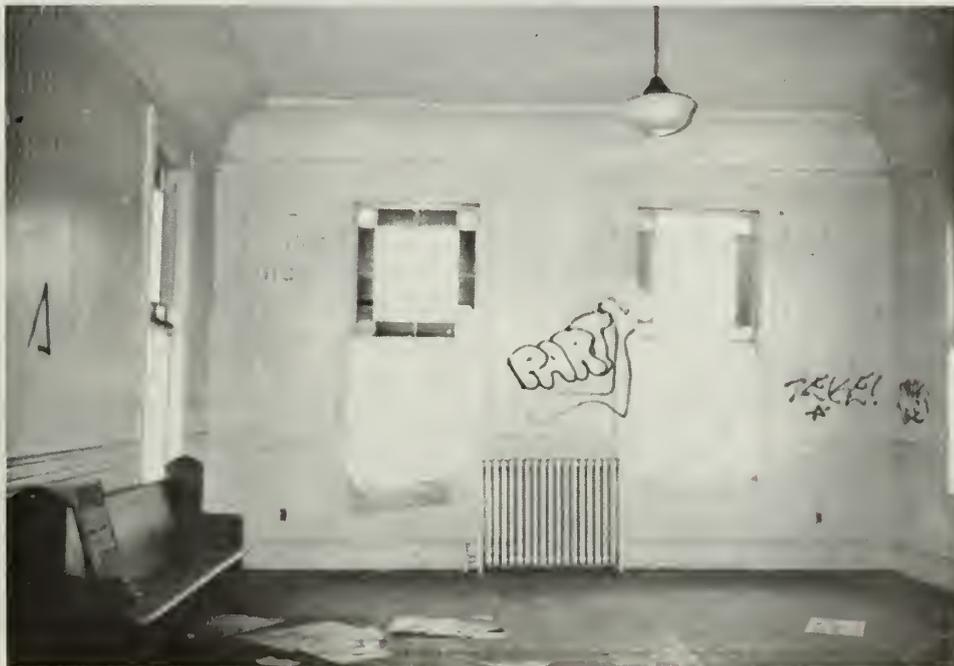
2. Interior view of waiting room prior to rehabilitation. Note wooden ceiling and wide covered cornice.

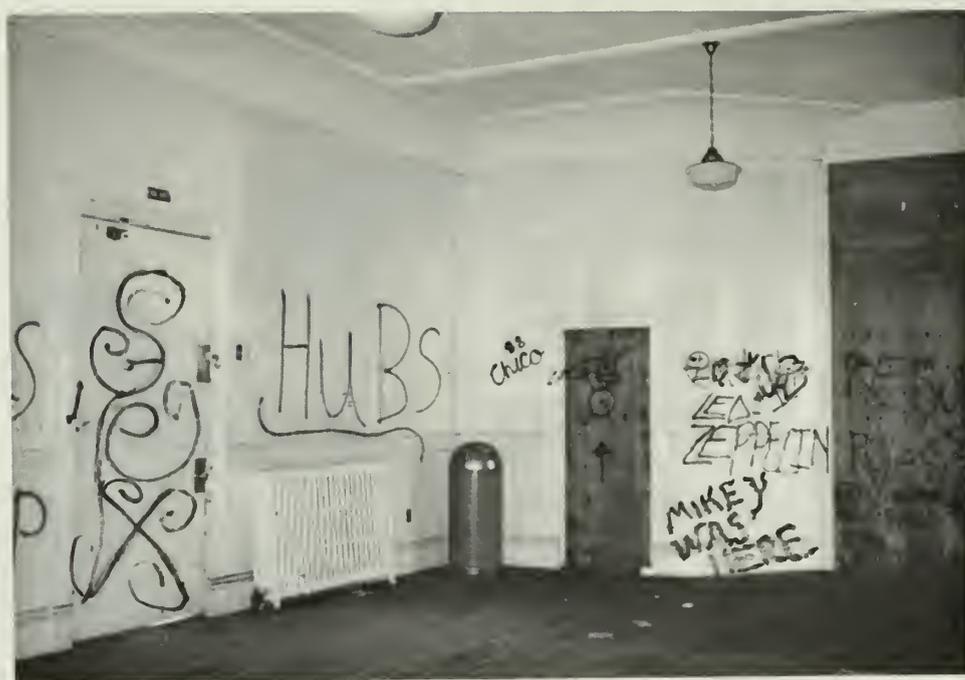
3. Interior view of ticket booth prior to rehabilitation. This historic feature was removed in the process of rehabilitation.
