Technical Preservation Services  
Preservation Assistance Division  
National Park Service  
U.S. Department of the Interior  
Washington, D.C.

Interpreting  
the Secretary of the Interior's  
Standards for Rehabilitation

Volume III

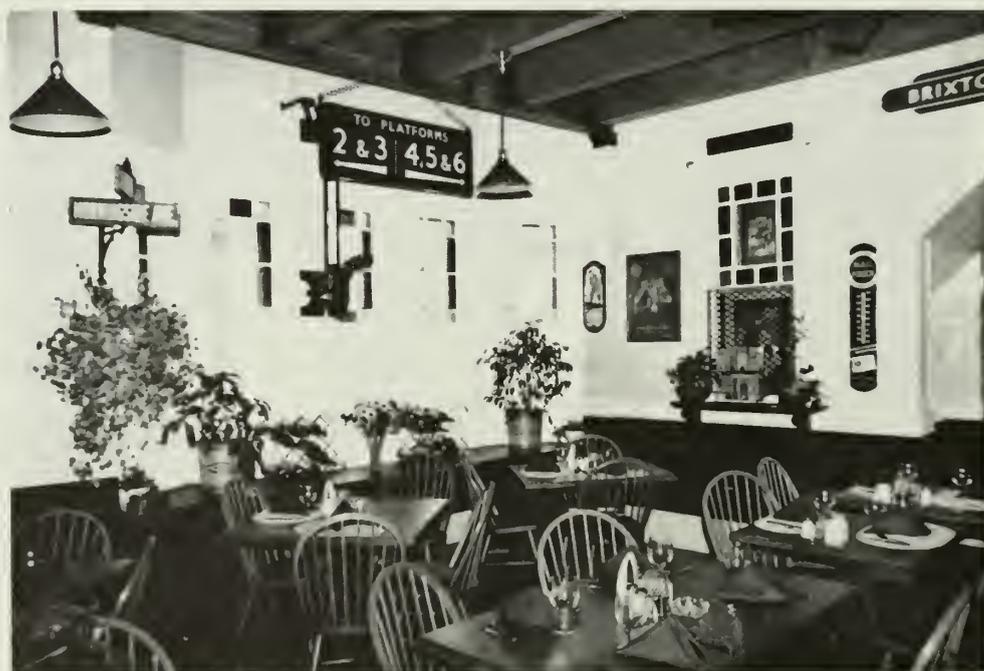
4. Post-rehabilitation view of waiting room after the removal of ticket booth. Note ticket booth window relocated in new stair wall.

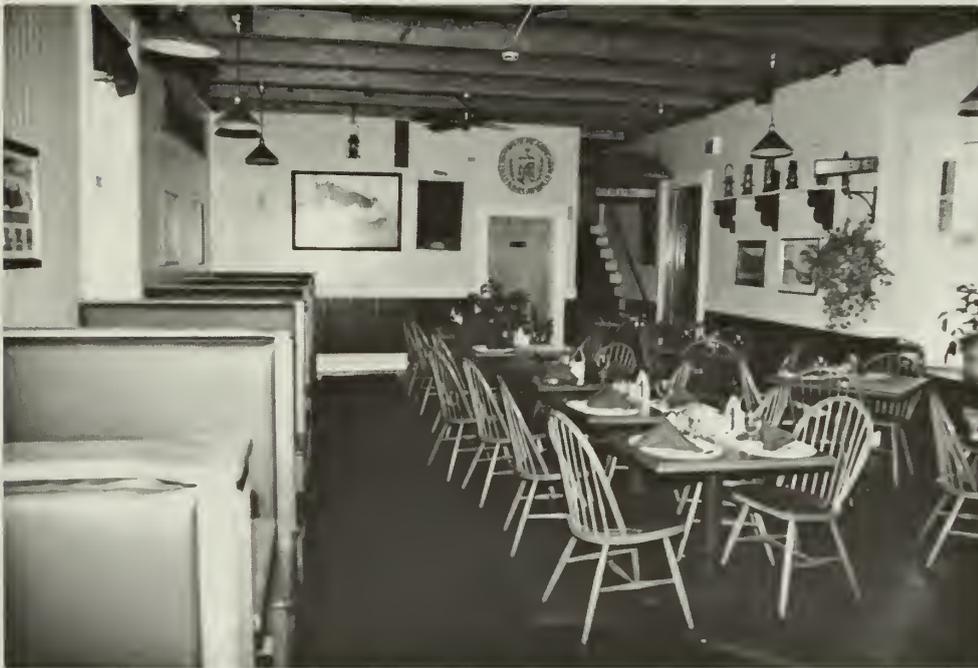
5. Post-rehabilitation view of waiting room. Note the removal of existing ceiling, and the addition of exposed ceiling joists above.

The ceiling of the depot which was removed to install a functional second floor above, was replaced with new ceiling joists dropped below the original first floor ceiling (see illus. 5 & 6). The new unfinished and exposed wood joists are not in keeping with the character of the previously finished waiting room. Further compromising the room was the insertion of restrooms and a staircase at one end of the waiting room; two end windows were obliterated and the distinctive waiting room was reduced by approximately 1/4 to 1/3. Although some detailing was retained on the interior, it was extensively reconfigured, and the new features added were incompatible to the building. As a result, the existing 19th century interior lost its integrity and historic character.

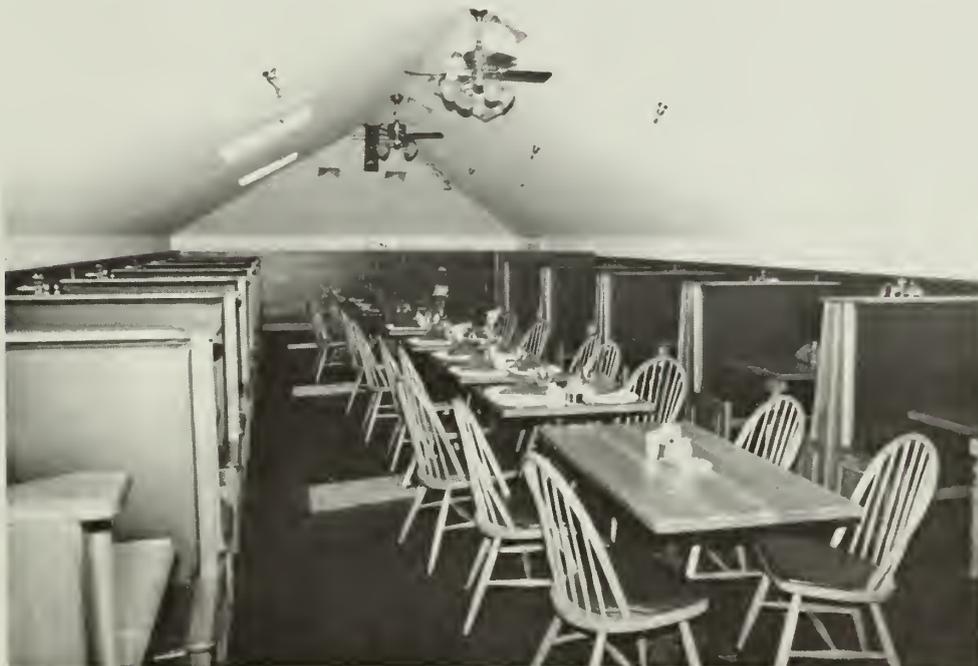
6. Post-rehabilitation view of second floor. Original attic space converted to restaurant space by lowering the ceiling below.

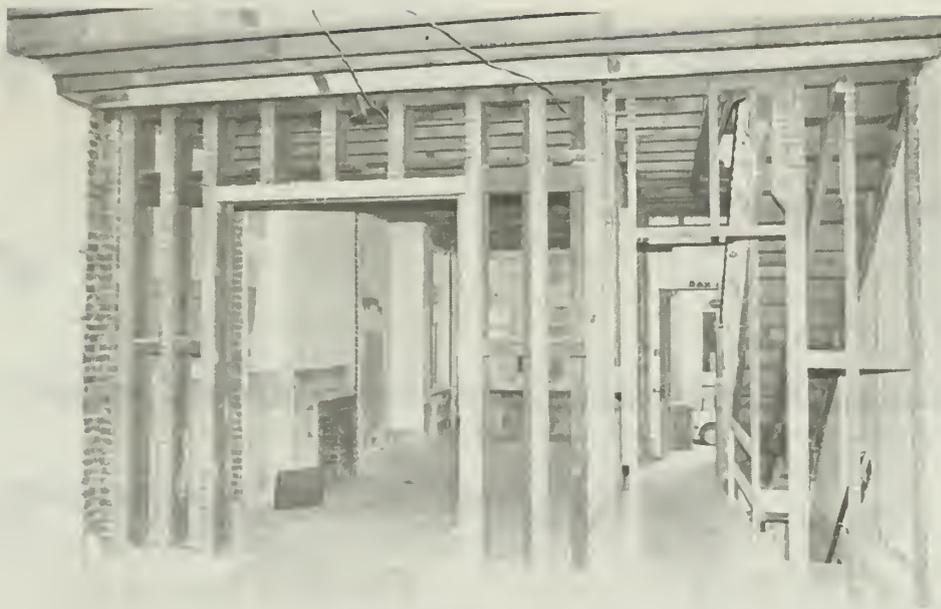
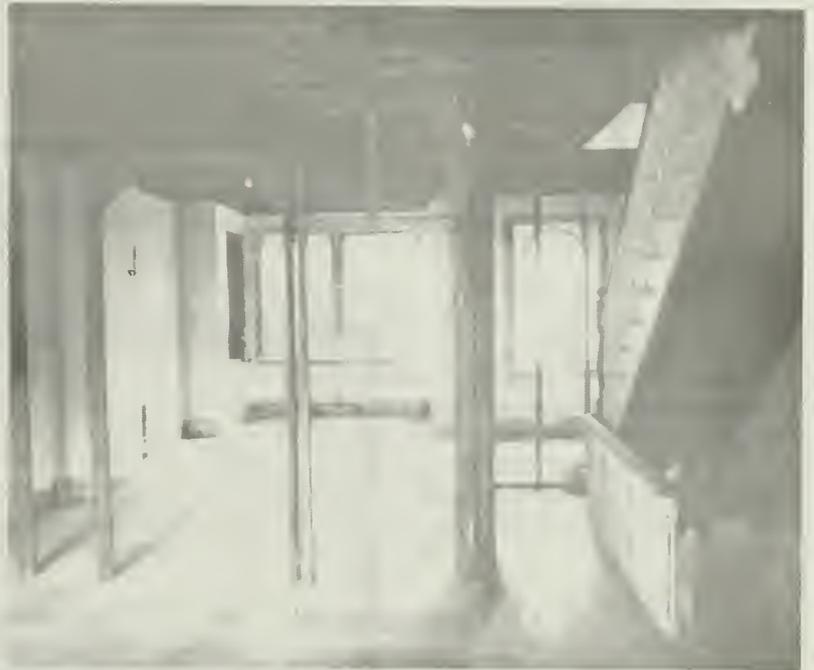
2. The interior of the house after it had been "gutted" by the previous owner. The photographs of all 3 floors are taken from the same location on each floor, and show views toward the front of the house. The new owner was able to repair and reuse wood trim (here, shown piled behind the stairs on the third floor), that had been removed by the previous owner.

Despite the existing shell-like condition of most of the interior, the new owner restored the historic staircase (although code compliance necessitated several changes) and repaired and reused the woodwork and trim that had been removed by the previous owner. Because the rehabilitation also included a careful restoration of the exterior, which was the major remaining character-defining aspect of the building through which it contributed to the significance of the historic district, the rehabilitation was certified.

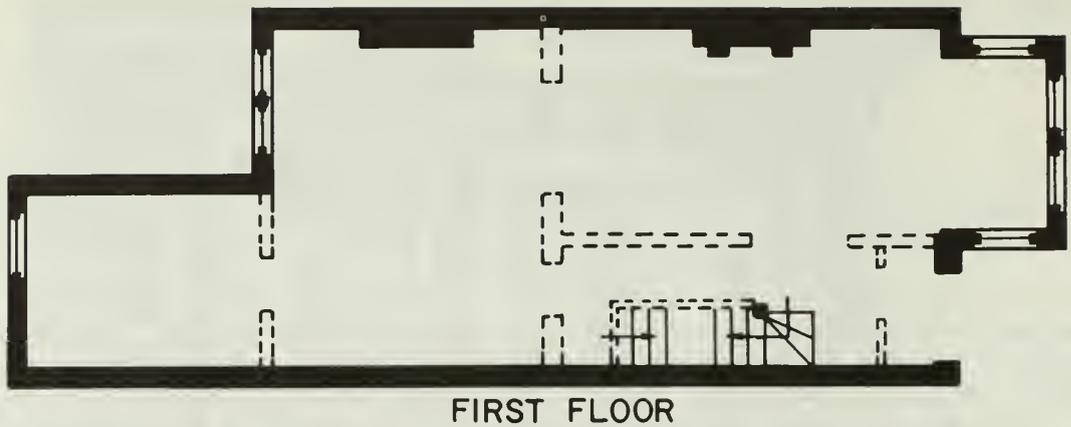
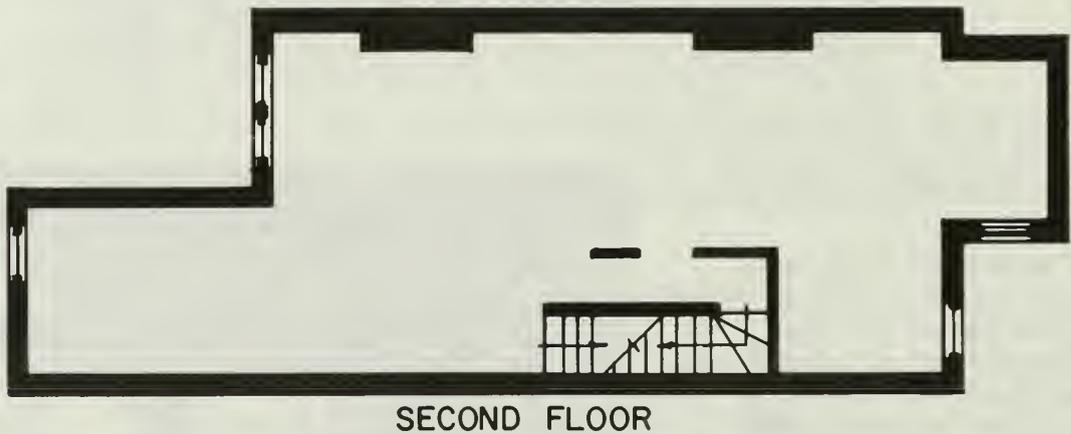
3. Floor plans of the interior prior to rehabilitation. The fireplaces had been removed during previous renovations. Dashed lines represent open stud walls.

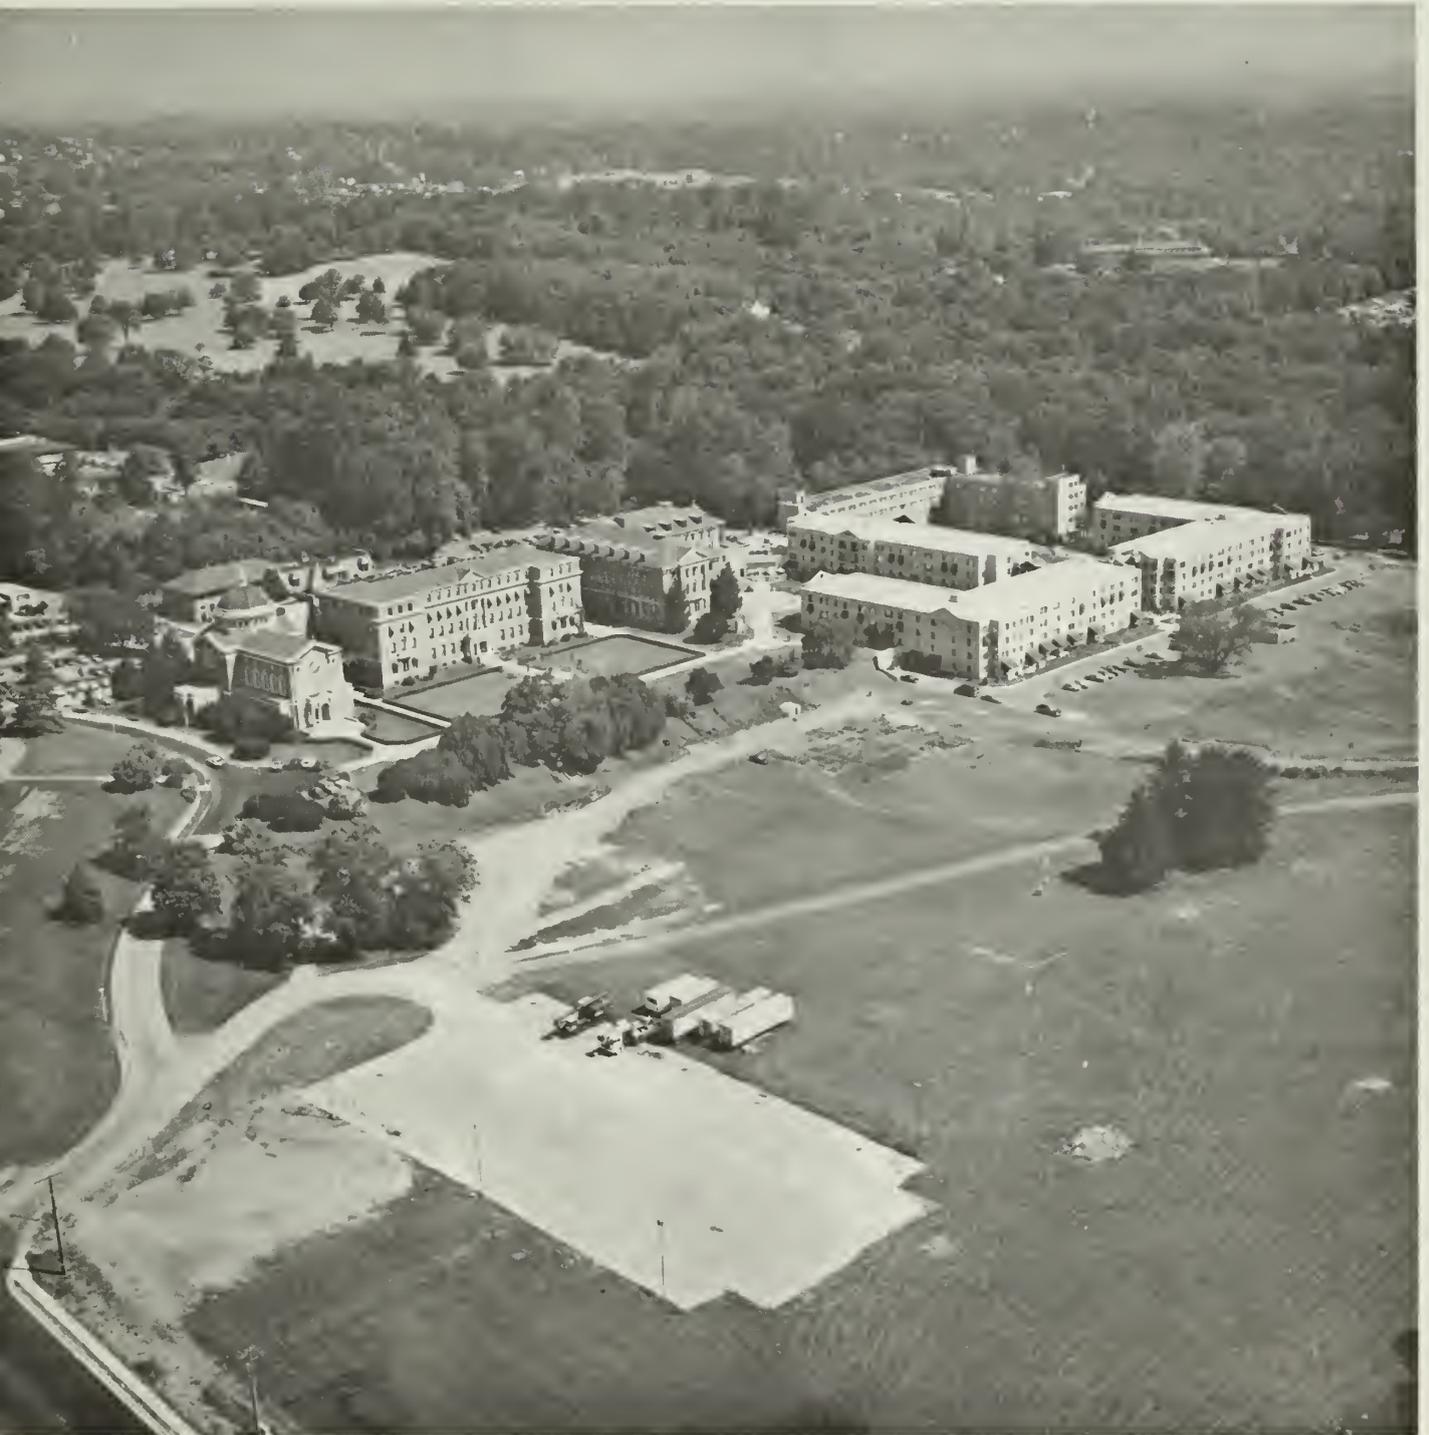
2. Aerial view of campus. The three new buildings at right visually sever the end building from the rest of the row, thereby drastically diminishing its historic character.

Although the new construction is generally sympathetic to the neighboring historic buildings in size, scale, color, materials, and design, it fails to meet Standards 2 and 9 of the Standards for Rehabilitation because of its impact on the site and environment of the building it obscures.

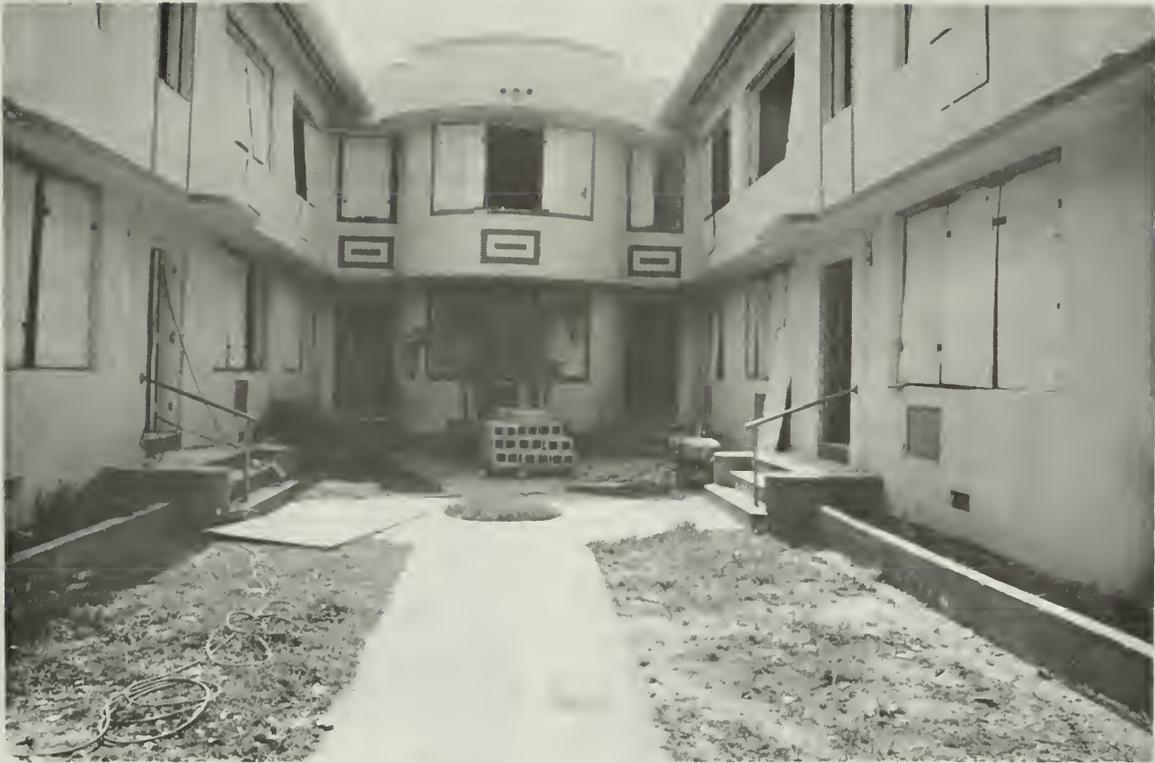
1. The primary entrances to this early 1940s Moderne apartment building are located in the courtyard of the U-shaped structure. Note the overall plainness of the building before rehabilitation, which is highlighted only by horizontal banding and raised geometric panels.

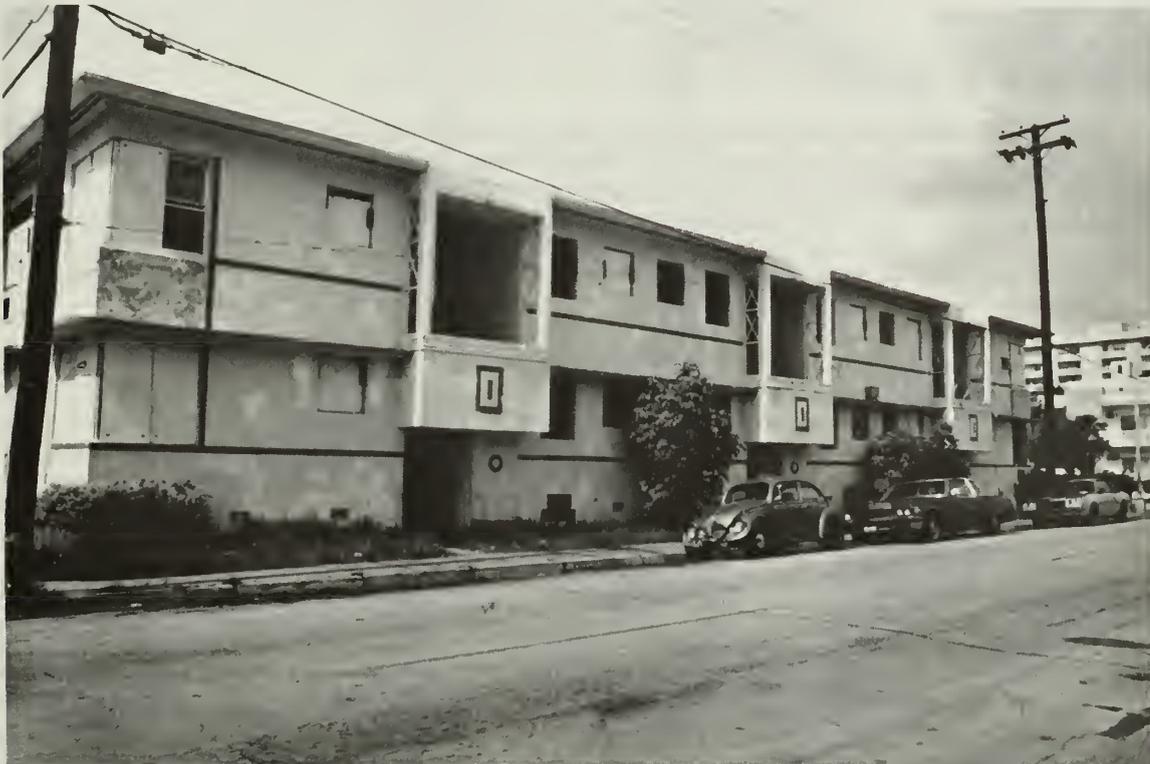
2. The street elevation of the building where patch repair work has already begun shows the decorative panels of local stone under the second story windows at either end of the building.

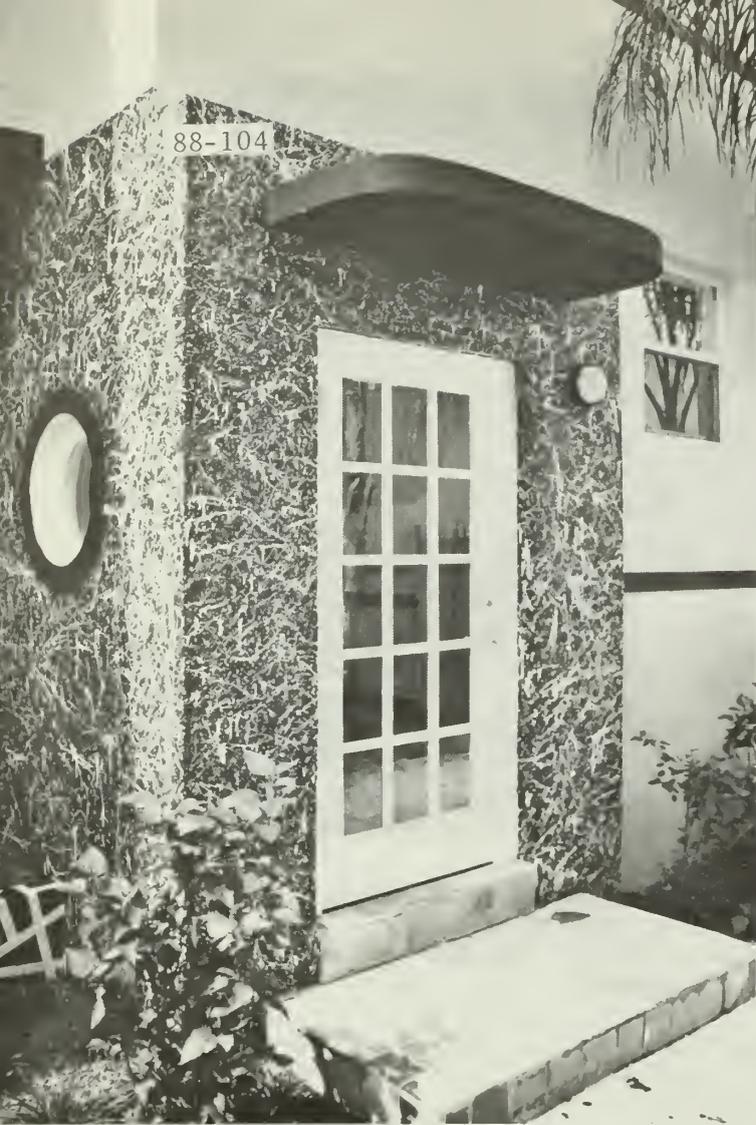
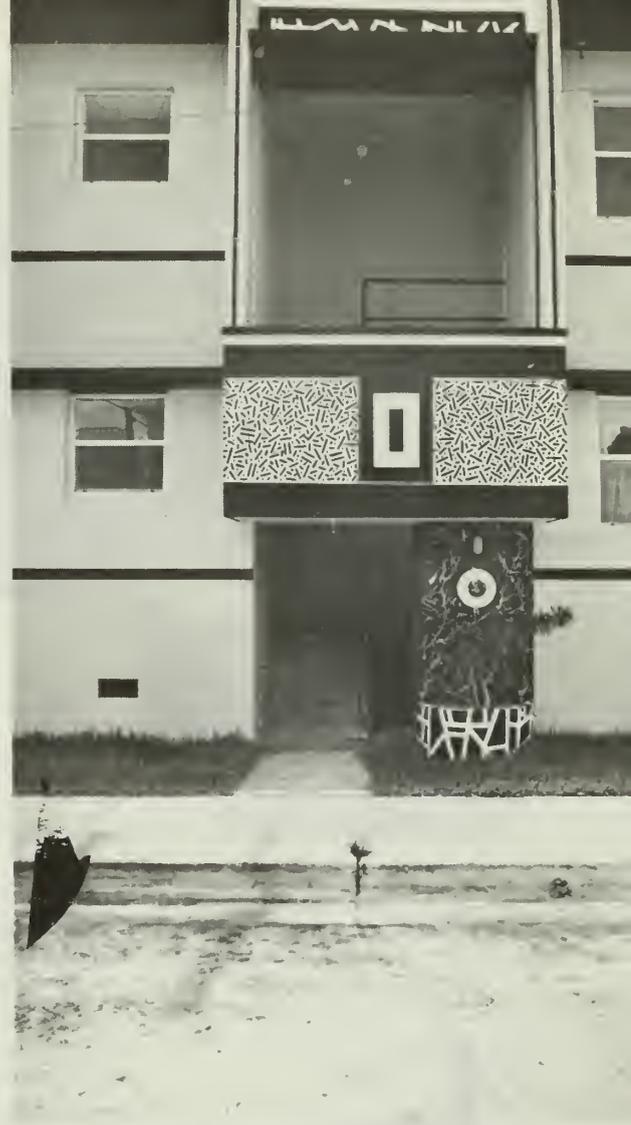
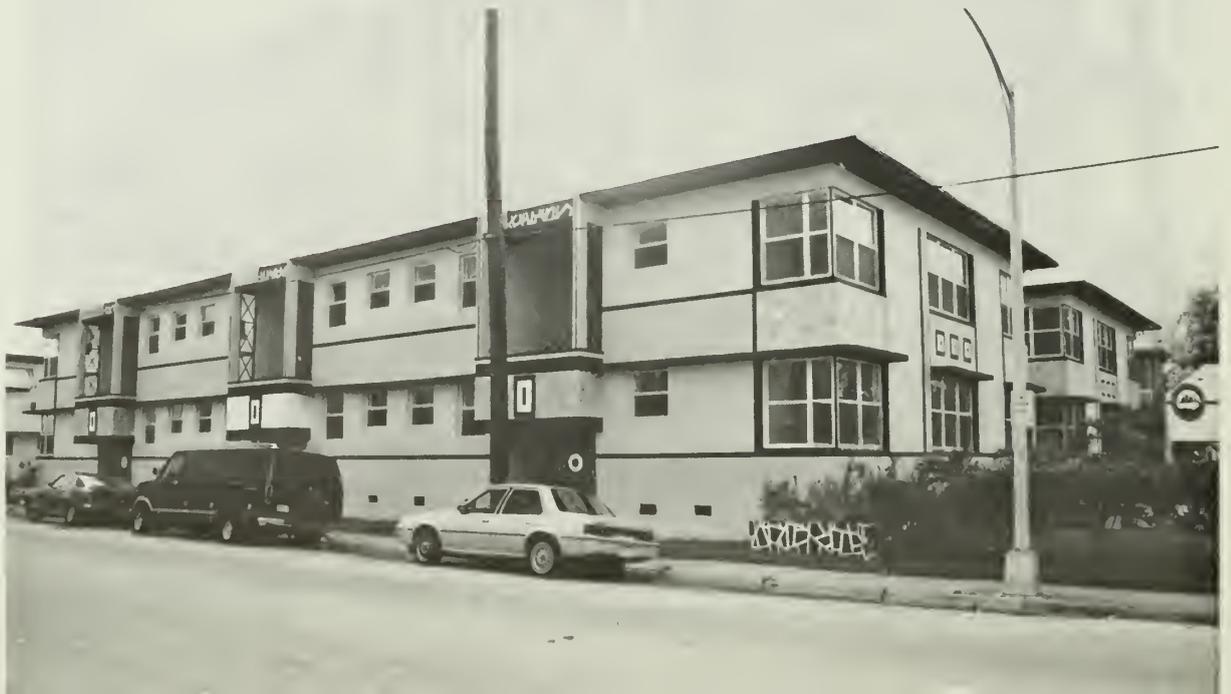
3-5. After rehabilitation the character of the building has been greatly changed by the application of a variety of decorative painted finishes, in particular the "faux" stone surfaces around doors, the contemporary patterned design used above doors and on balconies, and the "cracked tile" pattern on the planters that surround the building.

As part of the rehabilitation, the exterior stucco, which had been repaired and patched as necessary, was painted as the owner himself stated, in a "fanciful and sportive manner." Prior to rehabilitation, the building had been painted beige with a few of its decorative features highlighted in a darker brown. After rehabilitation, the wall surfaces of this building had been transformed by the application of numerous colors and decorative painted and patterned surfaces (see illus. 3-5). Wall surfaces were painted in alternating horizontal bands of aqua, yellow and pink, and projecting horizontal overhangs and the raised geometric panels were boldly outlined in black. Most notable was the use of paint to create contemporary stylized patterning, exaggerated illusionistic stone textures on door surrounds and above door panels, and a "cracked-tile" pattern above second-story stairwells and on planters surrounding the base of the building.

Consequently, as no evidence was presented to indicate that this type of exterior decorative painting had ever existed on this particular building, nor indeed on any building located in the historic district, it was determined that the decorative painted abstract patterns and faux finishes applied during the rehabilitation were inconsistent with the historic character of the building, and the historic district. The plain, unpatterned aqua, yellow, and pink colors on the walls were not considered objectionable, or in violation of the Standards, although it is most unlikely that they would have existed historically either in such a combination, or in such intense colors.

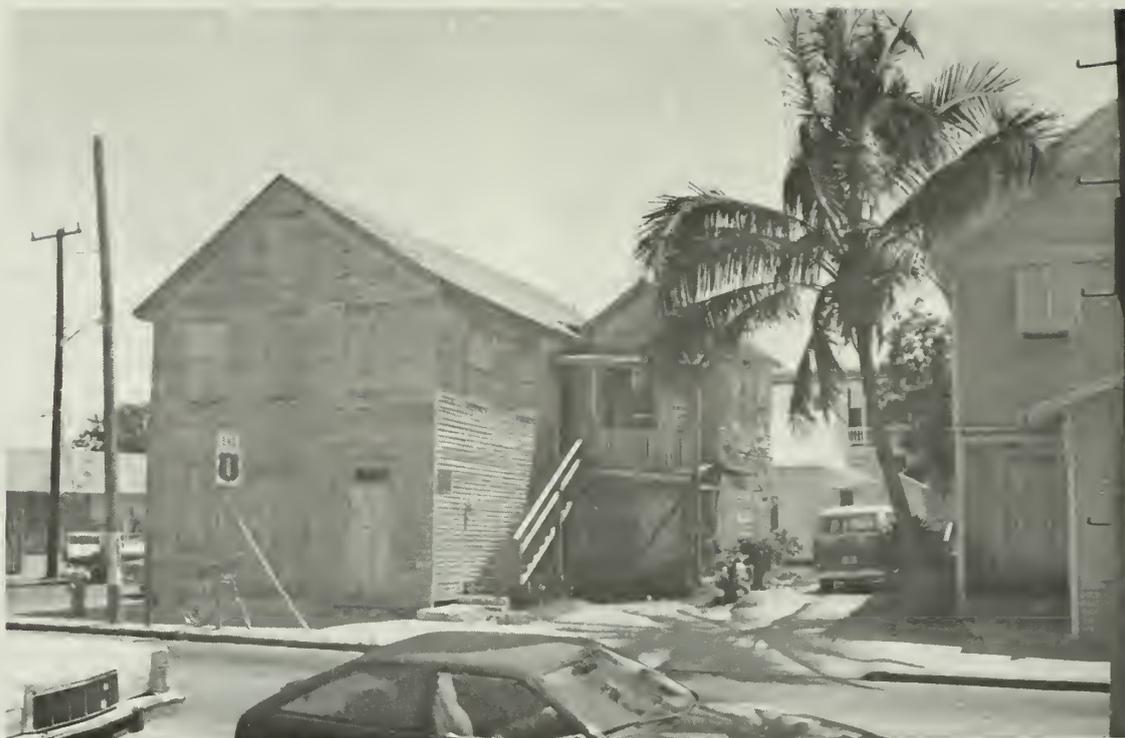
1. This view shows the exterior staircase in place before rehabilitation. Although this staircase was a replacement of the original, the feature was significant because it had remained in the same location and because it announced a separate use and function for the second floor of the ell.

The existing staircase was constructed within the last fifteen years; no remnant of the original feature had survived to guide replication and photographic documentation was unavailable. In view of the Standard's cautions against reproductions which are purely conjectural, the owner maintained that any attempt to reconstruct a staircase would misrepresent the original type. Because the narrow width and deteriorated condition of the staircase made it undesirable to retain, the decision was made to remove the staircase entirely with no attempt at reconstruction.

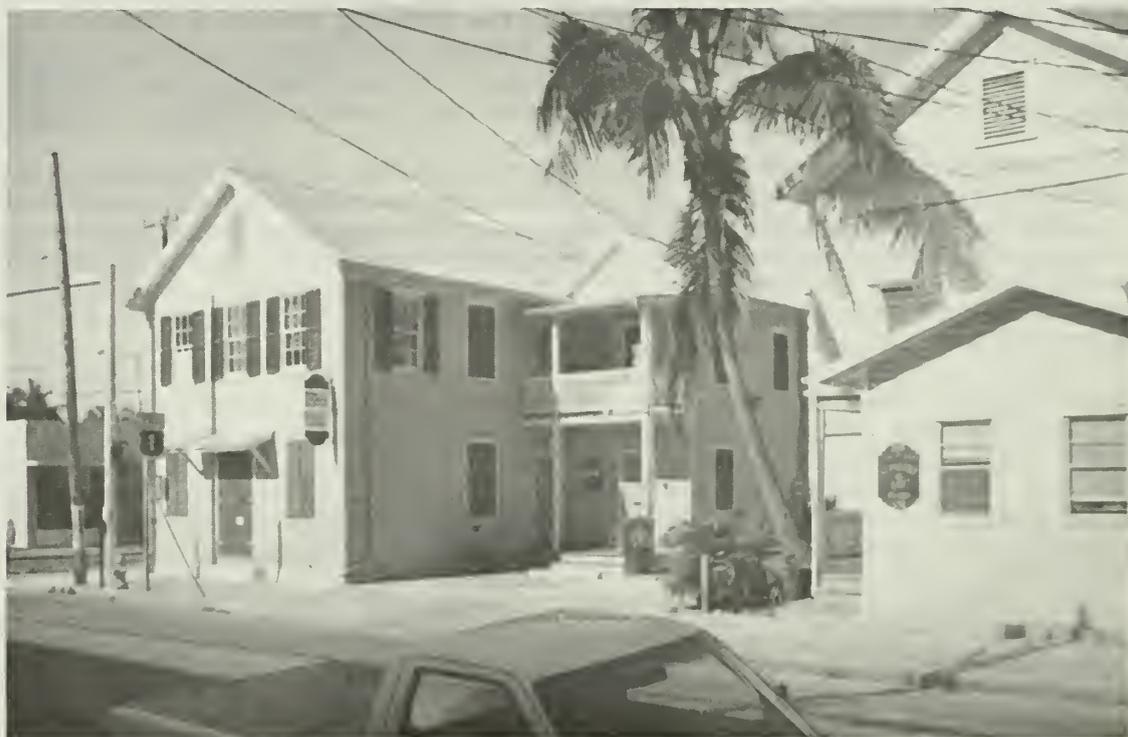
2. With the removal of the staircase there is no longer an indication of the second floor's independence from the first. The two floors of the ell addition appear to be functionally integrated.

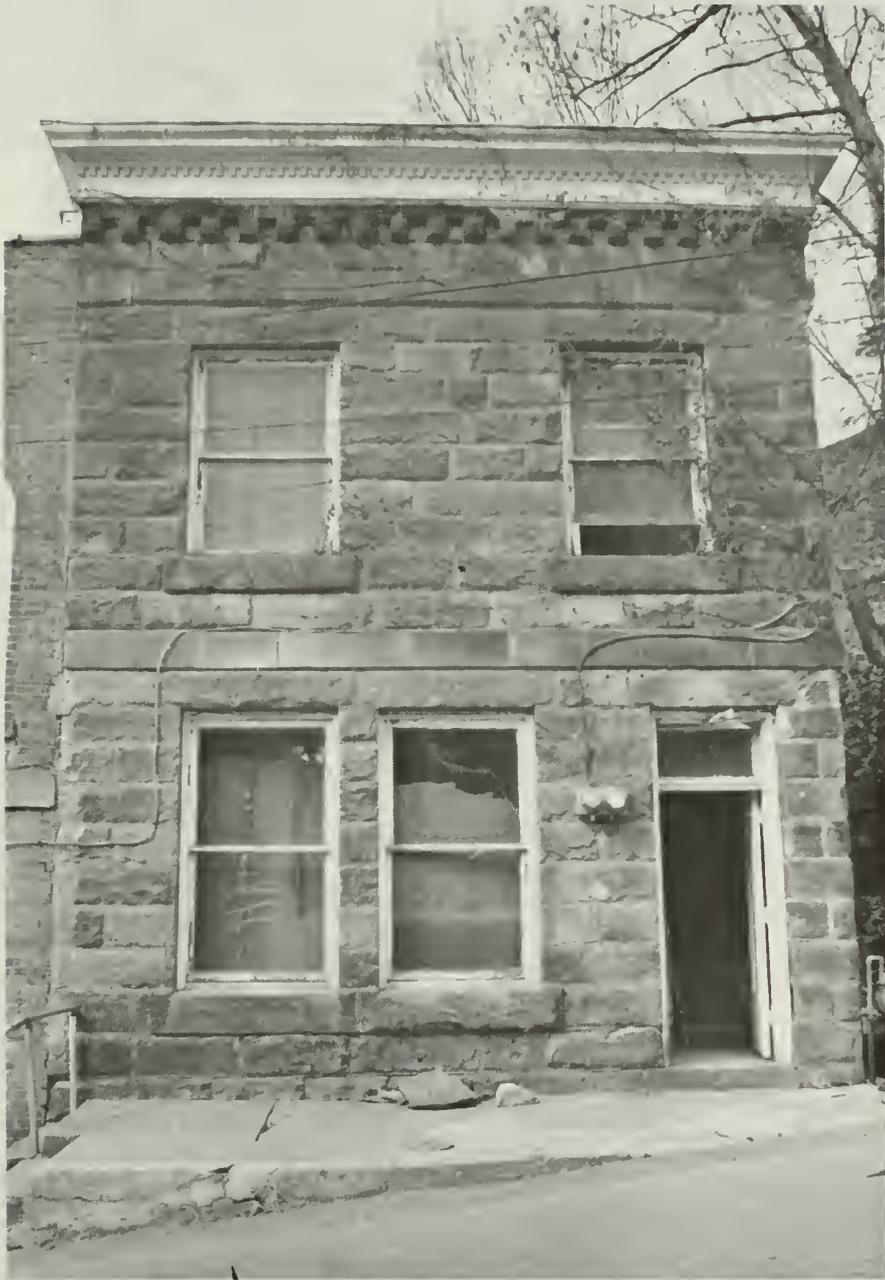
1. This small, semi-detached building was constructed in 1891 as a law office. A narrow walkway to the rear separates the building from the steep hill that abuts it on the right.

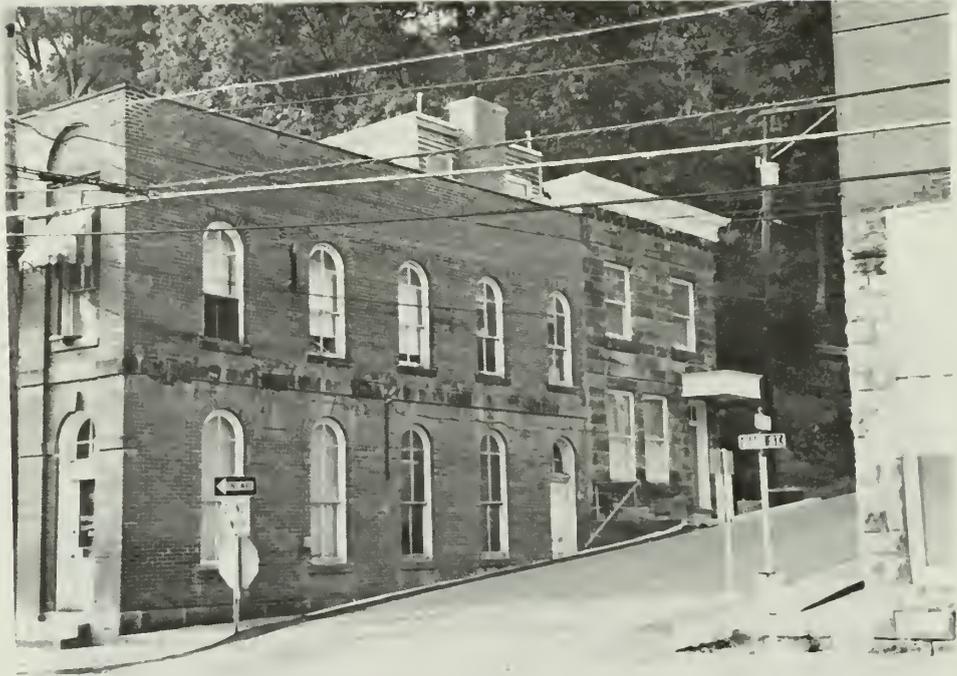
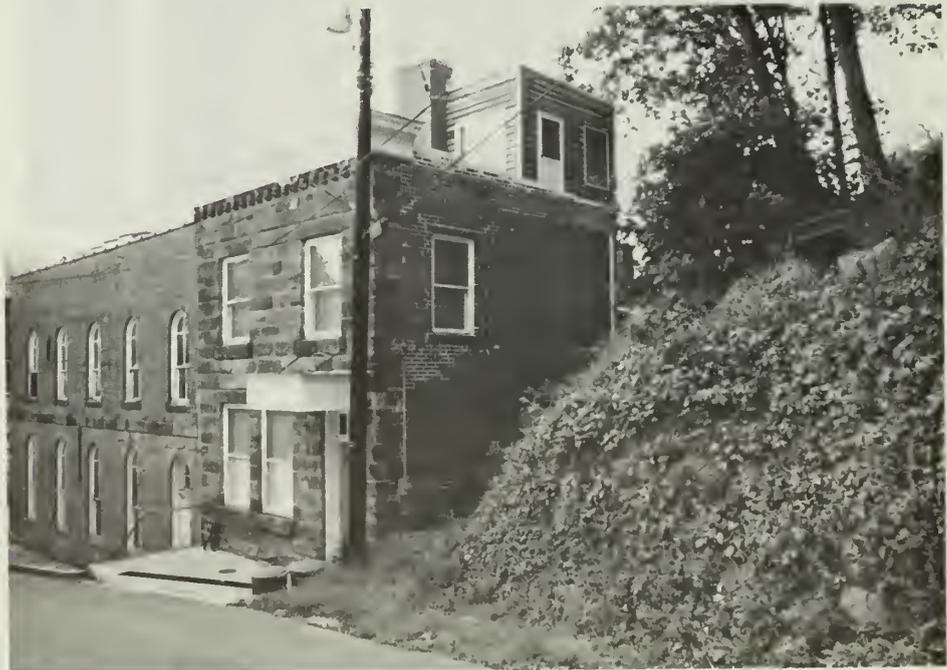
2-3. After rehabilitation, the new rooftop addition is highly visible within the historic district, both from below the building at the main intersection at the foot of the hill, and from above the building higher on the hillside.

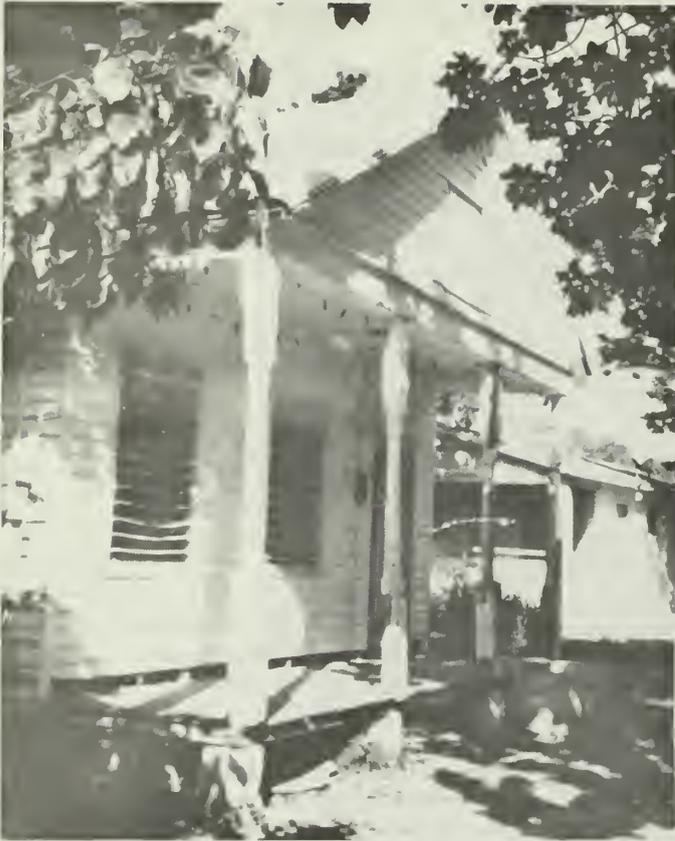
1. Simple turned posts and plain windows were the only expressive details of the vernacular frame building.

**Application:** In a historic district of vernacular wood frame dwellings, the main facade of a small, single story, simply detailed 1900 building was elaborated with details suggesting the Greek Revival style (see illus 1.) Triangular pediments were added to the window heads, and simple turned posts were replaced with square, Doric posts (see illus 2.) The resultant changes undermined the vernacular simplicity of the Victorian structure. Although buildings within the historic district built about the same time were fitted with Greek Revival details, they were without exception larger, more imposing structures. No other authentic examples of modest, similarly adorned structures could be found. However, even if such examples could be cited, the evidence would not prove that this building ever had these particular features.

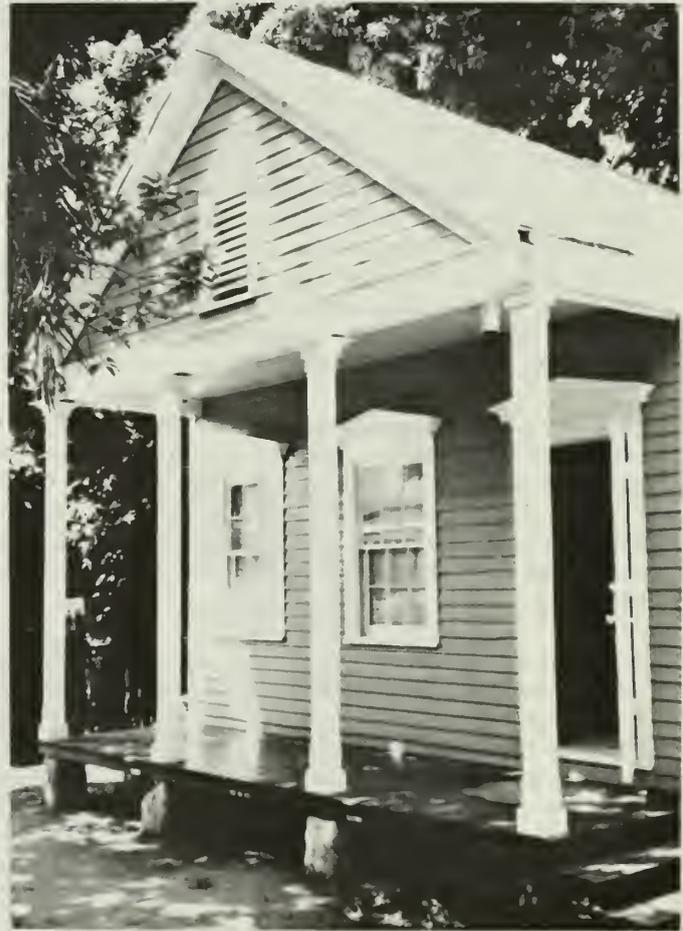
2. The dramatic shift in appearance from a vernacular structure to a higher style building is achieved with Greek Revival posts and triangular window pediments. The building was not originally fitted with these details, nor is there any occurrence of these features on a facade of this size within the district.

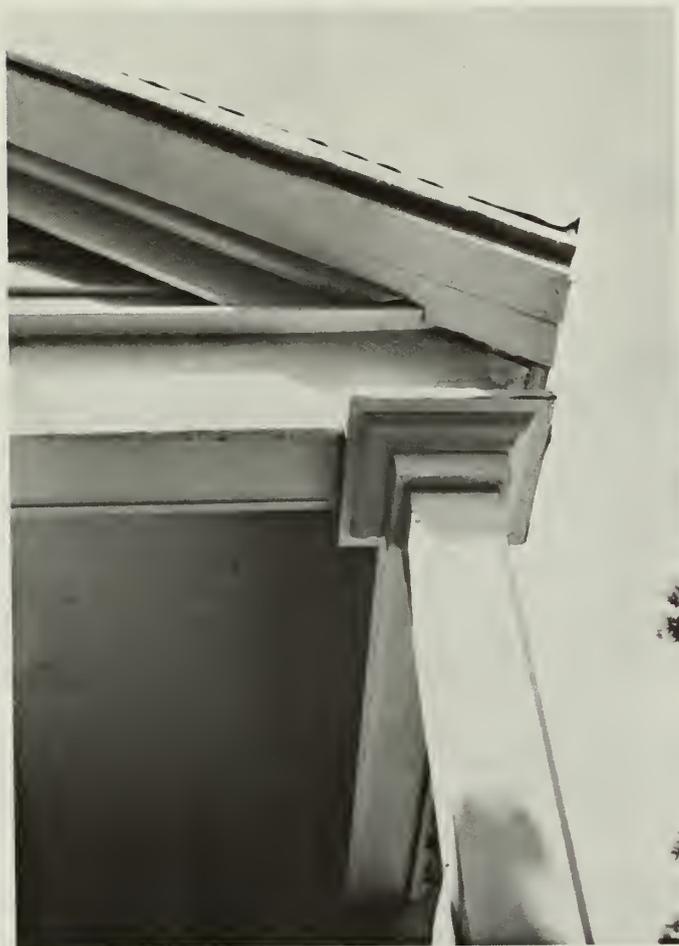
3. Not only have the added features created a non-historic appearance for the facade, but the size of the new capitals does not conform to the narrower dimensions of the overlying gable and causes an awkward overlap of the cornice. Compare with the photograph taken before rehabilitation which reveals the compatible proportions of the turned posts and the gable it supports.

The use of unprecedented details on this small facade is also historically and visually improper because the proportions of the new features create awkward junctures with the existing cornice. For example, the capitals of the posts are improperly scaled and project beyond the gable soffit (see illus 3.) The building's new presentation as a Greek temple is also unsuccessful due to the lack of entablature and requisite Classical cornices and moldings that would normally be found in the overlying gable of a true Greek Revival building.

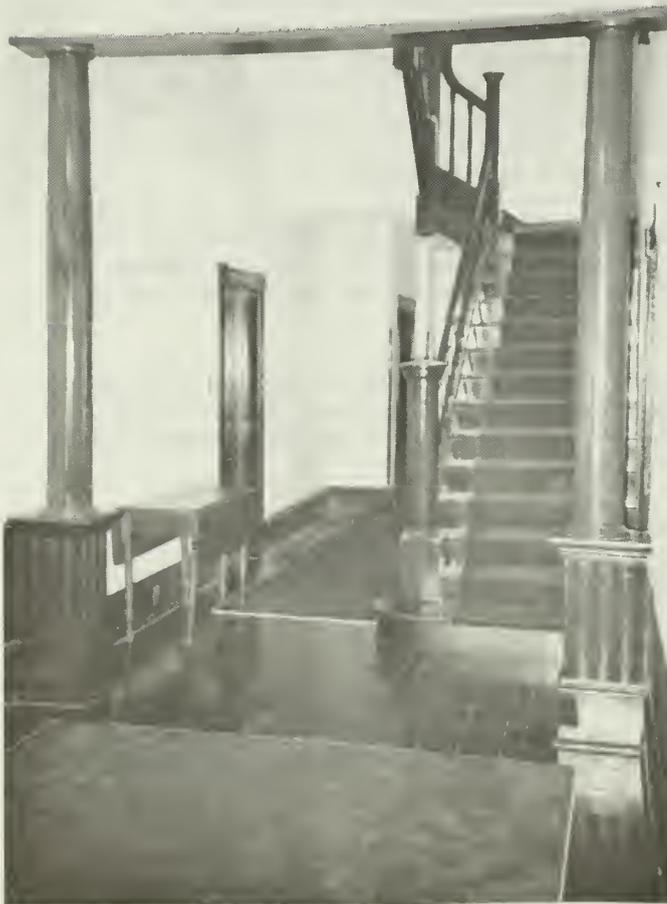
1. The only primary space on the first floor left unaffected after rehabilitation was the central hall, shown here with its original ceiling height and column divider.

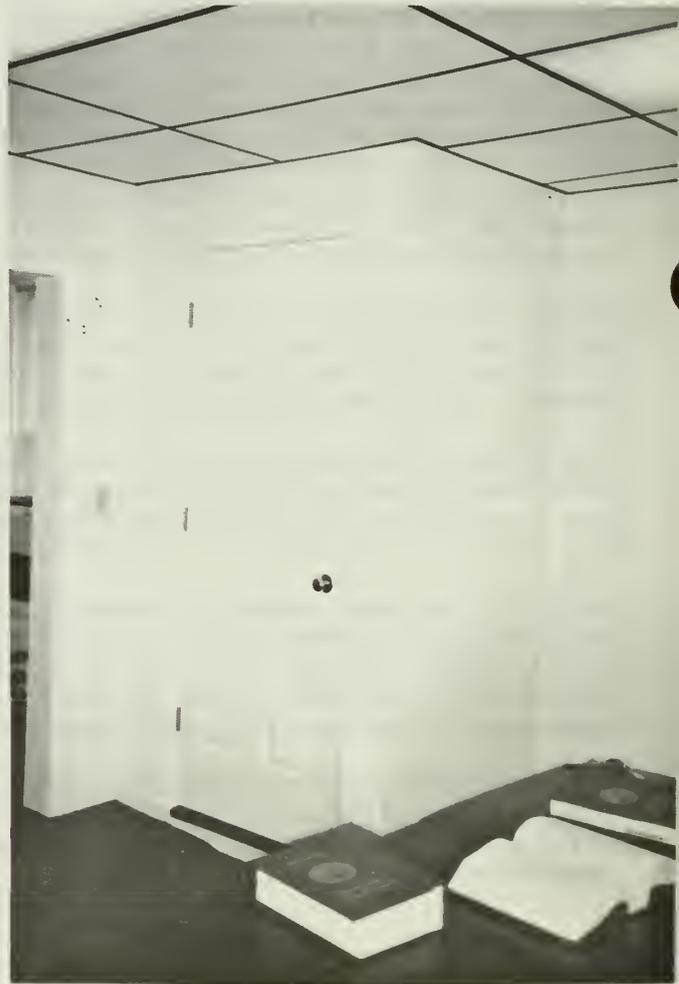
2. This view shows the distracting metal grid and ceiling illumination of the new dropped ceiling.

**Issue:** Dropped ceilings are often installed in historic buildings to cover up materials in need of repair, to reduce energy costs, and to provide an enclosure for HVAC ducts and lighting. However, they are generally not appropriate for historic buildings. Contemporary dropped ceilings can diminish the architectural character of a building in a number of ways. First, they often destroy or obscure architectural ornamentation. Decorative details such as plaster cornices, ceiling medallions, and picture molds are frequently removed or damaged during installation of dropped ceilings, while other historic features such as exposed beams are simply concealed. Lowered ceilings can also have the effect of altering and, in many cases, radically changing room proportions. After a dropped ceiling is inserted, doorways, windows, and other openings can appear to "crowd the ceiling." Finally, since dropped ceilings are often visible from the outside, they can also adversely affect the exterior of the building as well as the interior.

The project did not retain the architectural character and therefore failed to meet the Standards for Rehabilitation. In this particular case, there was no permanent damage to the historic materials, so the rehabilitation could potentially meet the Standards if the owner were to install a plasterboard ceiling more consistent with the original room proportions, preferably at the minimum required clearance for the HVAC system. One method to better integrate HVAC systems is the use of wall and ceiling chases. Failure to minimize the impact of the HVAC system and dropped ceiling may violate Standard 2.
