# Rim Drive Cultural Landscape Report Crater Lake National Park, Oregon

Stephen R. Mark  
Jerry Watson

USDI – National Park Service

2009

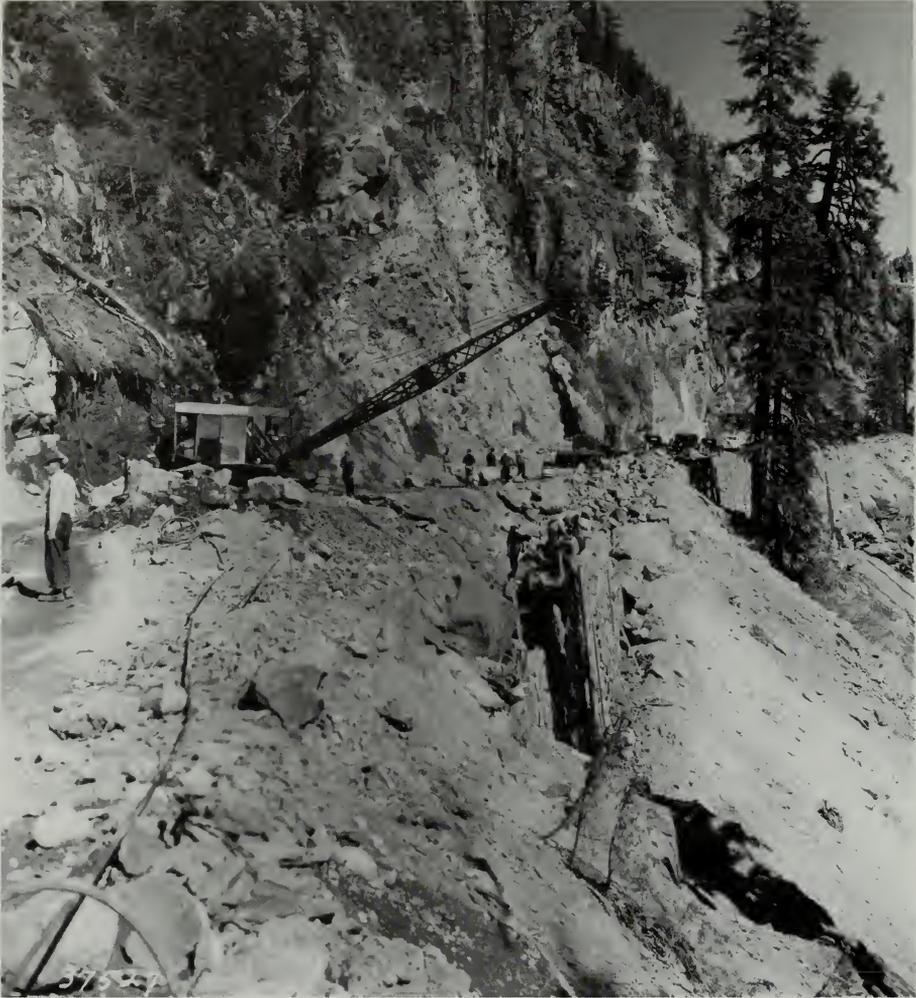
Building a retaining wall as part of grading Rim Drive on Dutton Cliff. Wendall C. Struble, Bureau of Public Roads; courtesy of Federal Highway Administration, Vancouver, Washington.

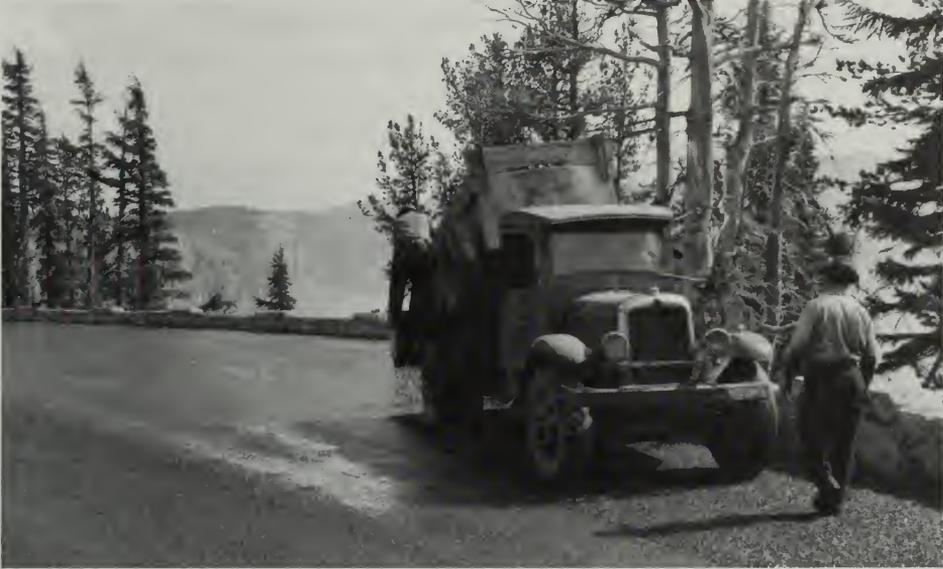
Crew paving with half-inch minus top coat, 1938. *W. C. Struble, Bureau of Public Roads; courtesy of Wade Johnston, FHWA.*

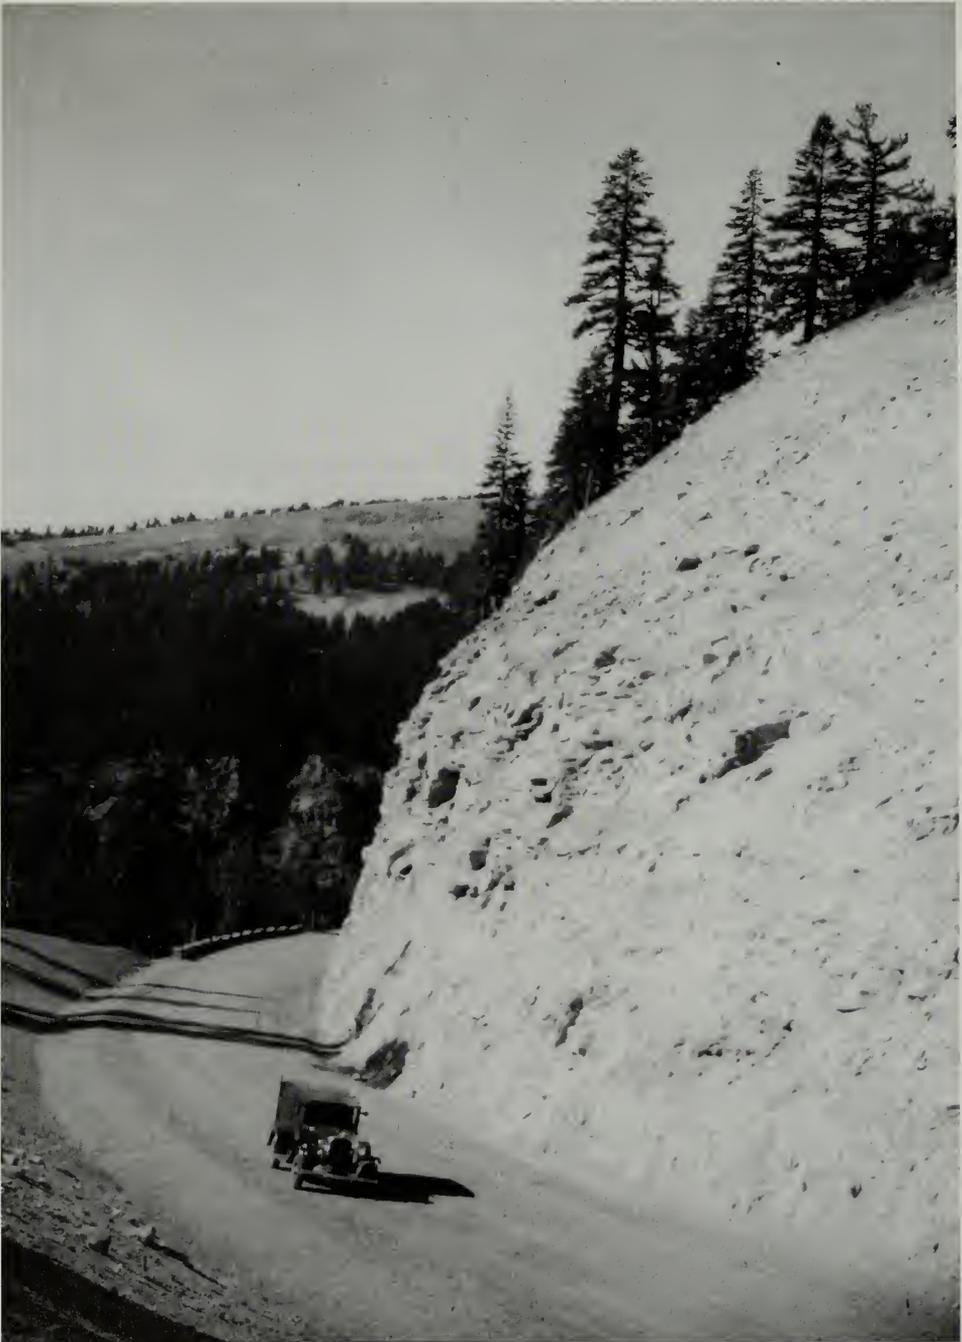
Part of road segment 7C-1 below Anderson Point contained the heaviest cut on Rim Drive. A slide here in 1942 required considerable scaling to stabilize this slope. *Struble, BPR-FHWA.*

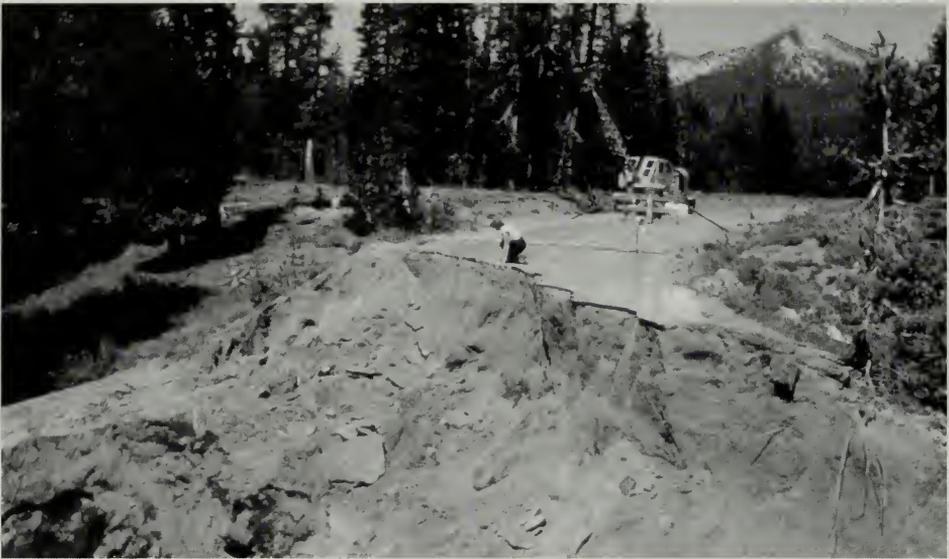
Cross drainage failure on the East Rim Drive, 1950s. *CLNPMAC, 8898.*

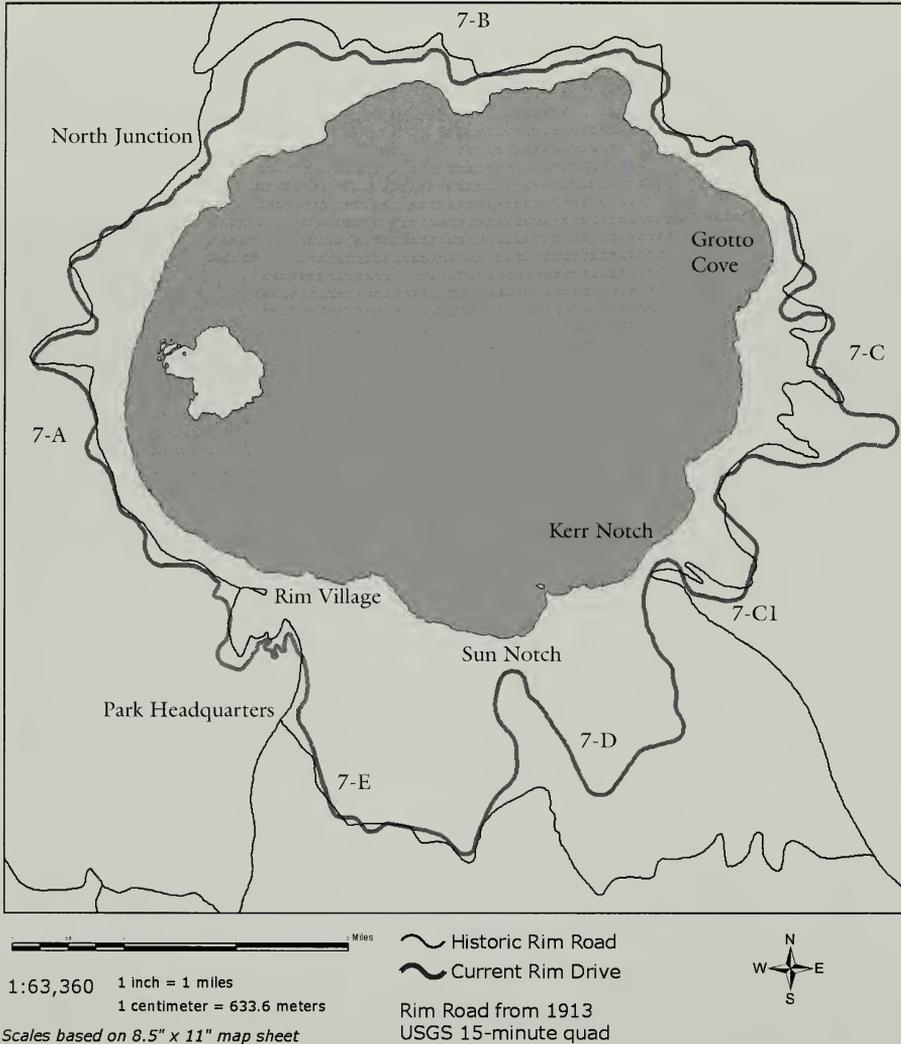
Locations of old Rim Road and Rim Drive. *Chris Wayne, NPS.*

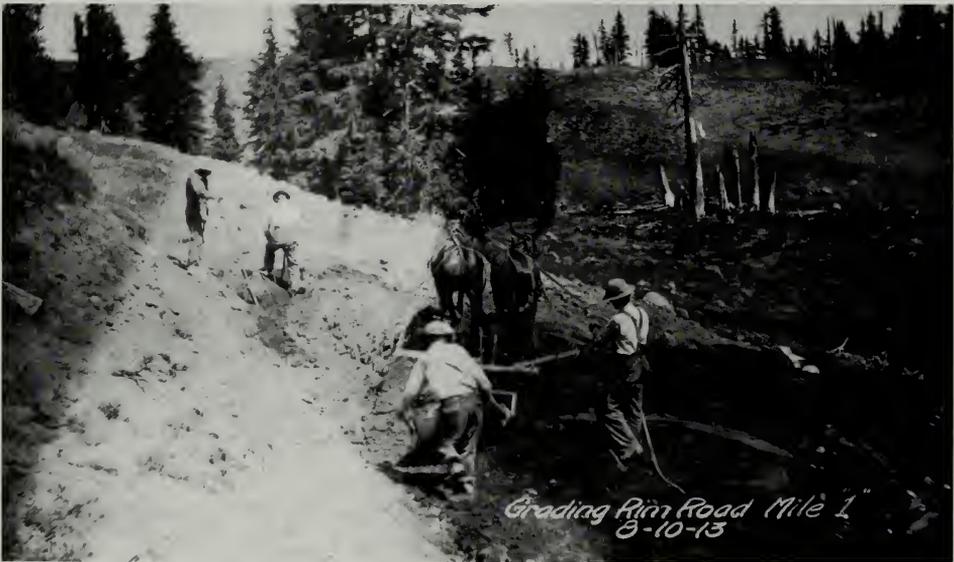
Grading with a team, note the use of a plow. *National Archives and Records Administration (NARA), Record Group (RG77), Washington, DC.*

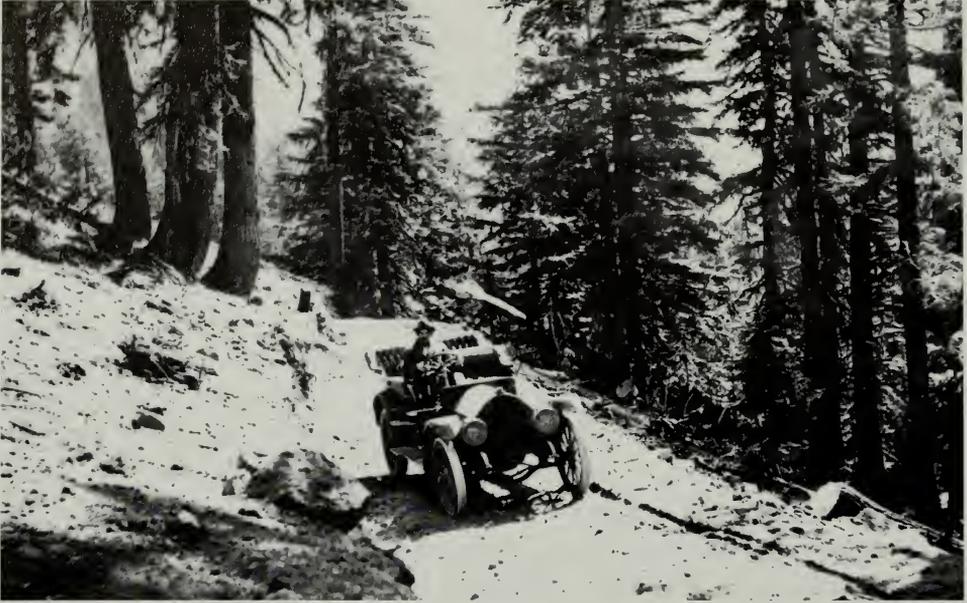
Automobile on newly graded section of the old Rim Road, 1913. *NARA, RG77, DC.*

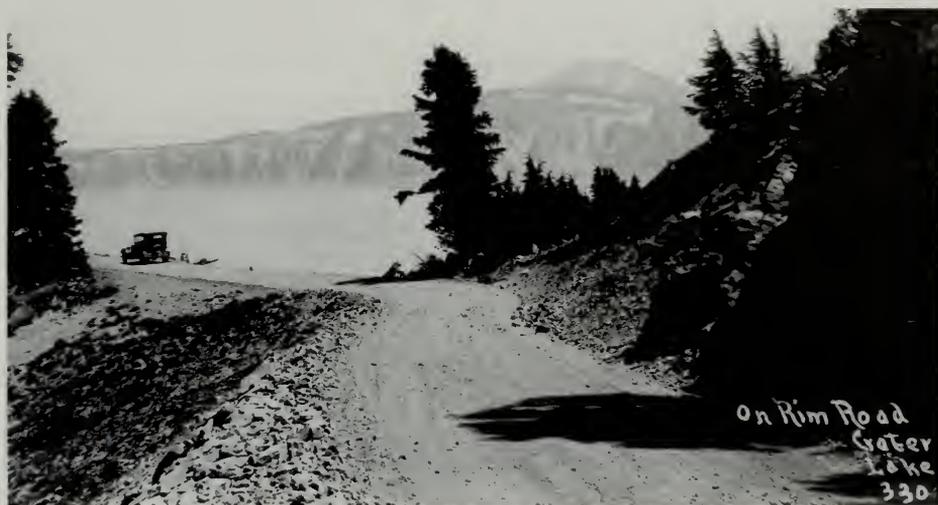
One of the viewpoints along the western part of the Rim Road. Note the rather narrow roadway in relation to the car. *Frank Patterson, Alex Sparrow Collection, Southern Oregon Historical Society (SOHS).*

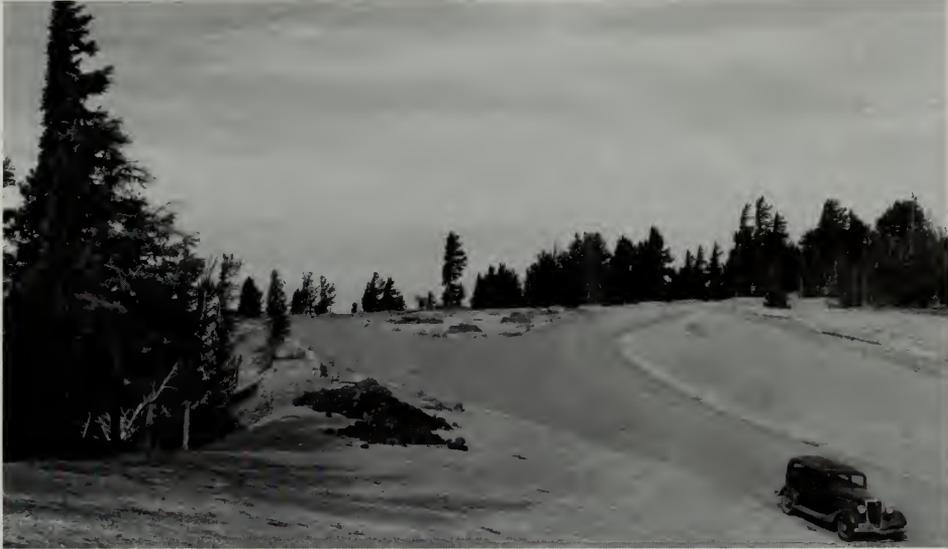
Reflection Point, one of the substations in road segment 7-C1. *Francis G. Lange, NARA, RG 79, Pacific Southwest Region, San Bruno, California (SB).*

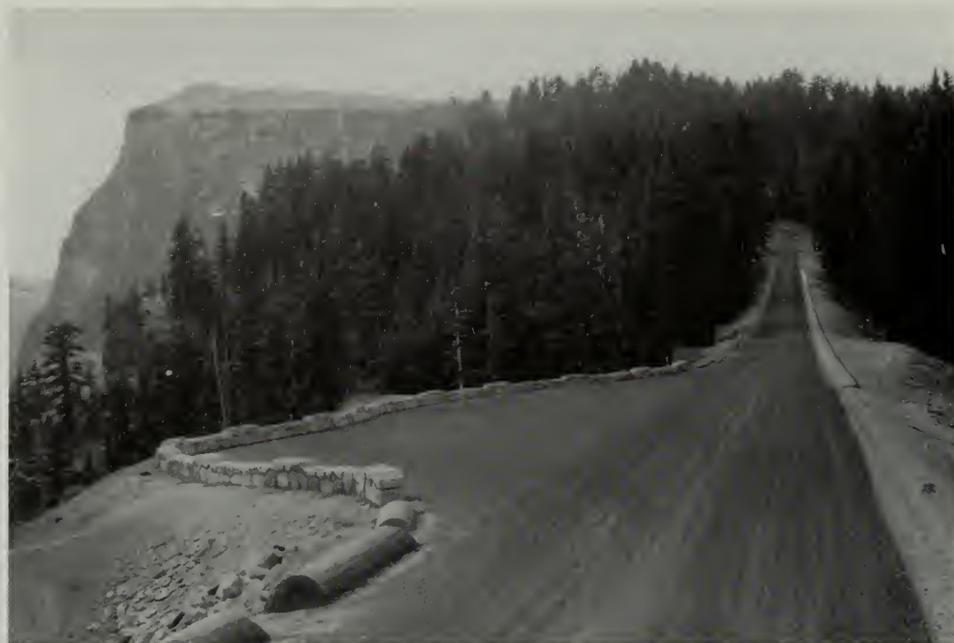
Parking area over Steel Bay, on the north side of Crater Lake, with Llao Rock in the distance. *Lange, NARA, RG 79, SB.*

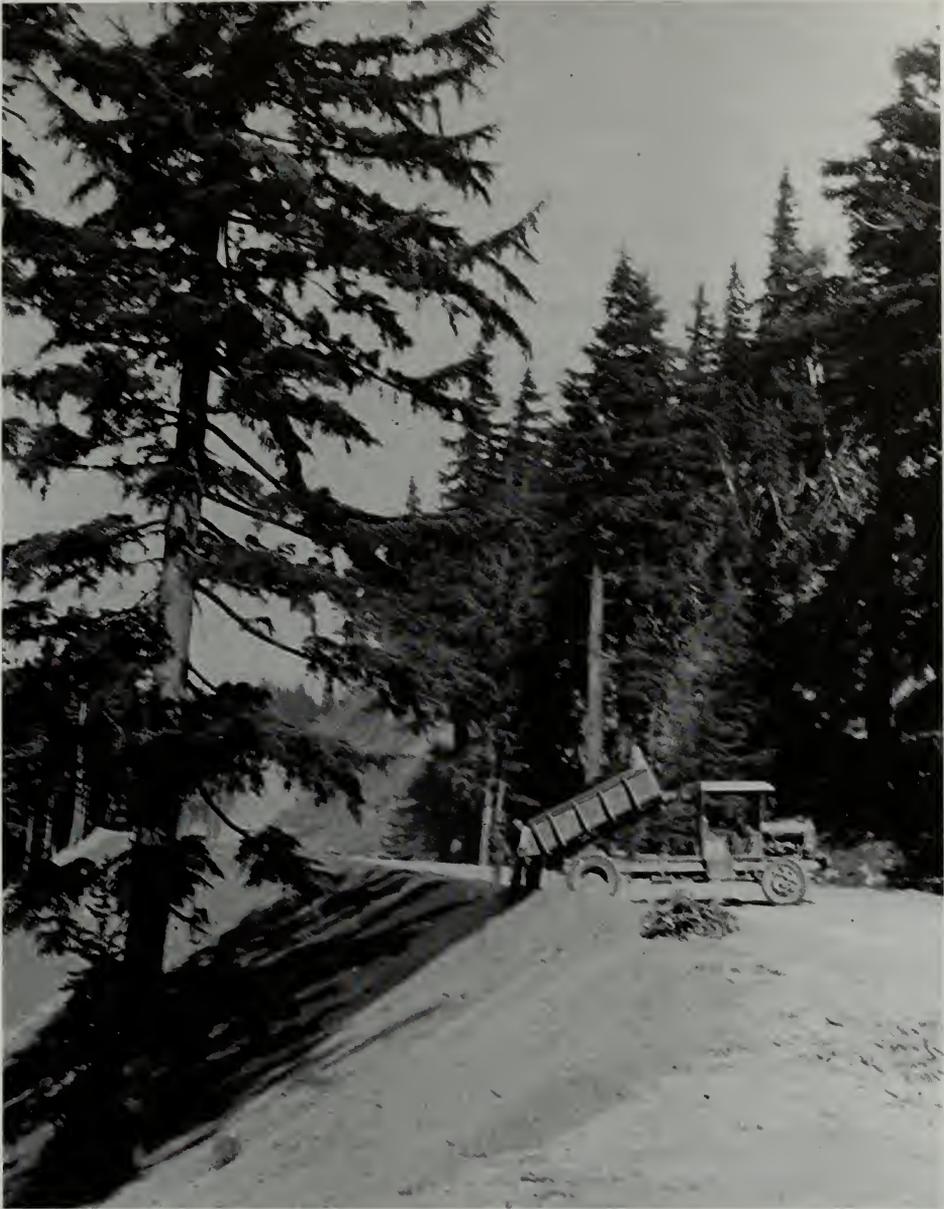
Placing dark soil on a fill, 1935. *Lange, NARA, RG 79, SB.*

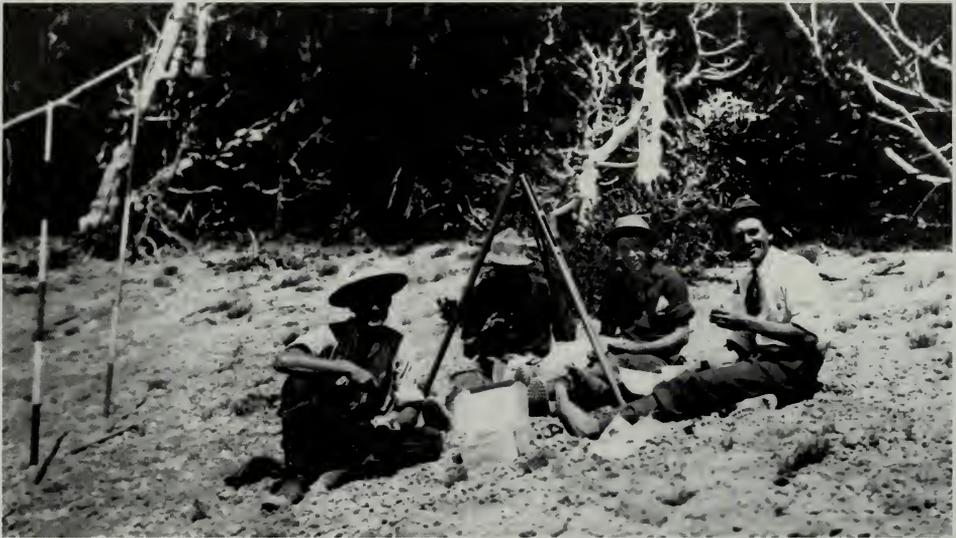
Road location survey party on the north side of Crater Lake. *G.V. Robinson, CLNPMAC.*

Once initiated, projects followed a familiar sequence that began with road location. After reconnaissance, engineers did a preliminary survey (or P-line) of road location to obtain topography for representative cross sections. The P-line allowed for curvature and connecting tangents to be placed by “projection” back in the office, a step resulting in the semi-final location (or L-line). Staking in the field or final road location, necessitated the establishment of benchmarks on the ground, as well as any adjustments to grade or positioning of cross-drainage. All stages of road location were subject to NPS approval, with most of the changes provided by landscape architects.

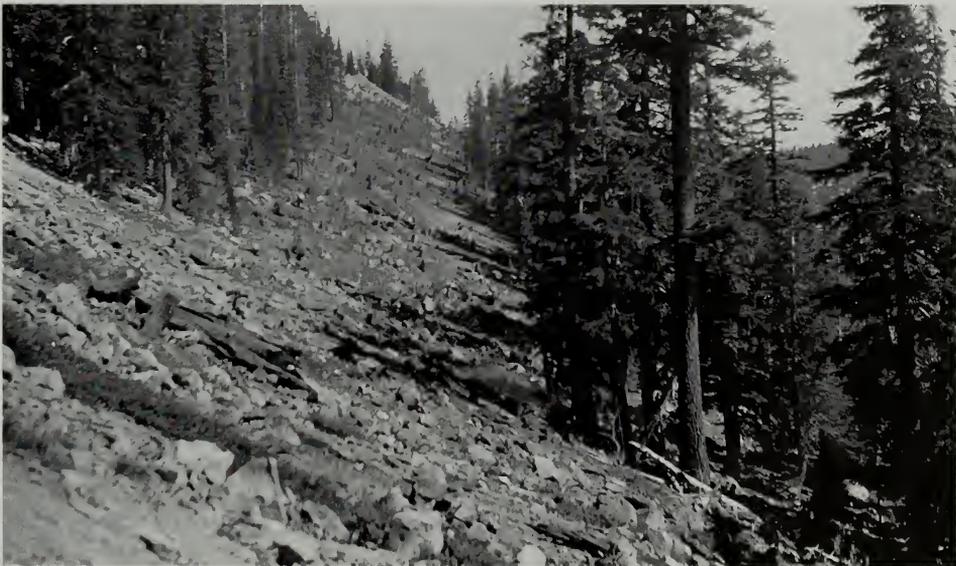
Clearing and grubbing between Kerr Notch and Anderson Point, 1935. *Lange, NARA RG 79, SB.*

Road construction consisted of three types of contracts beginning with the grading phase. Each contained numerous items bid on the basis of unit prices for each. BPR engineers, in consultation with NPS engineers and landscape architects, provided estimates for the items, starting with clearing vegetation from the roadbed. Removing stumps and other obstacles to rough grading through blasting or burning constituted a separate item called grubbing. The subsequent rough grading with heavy

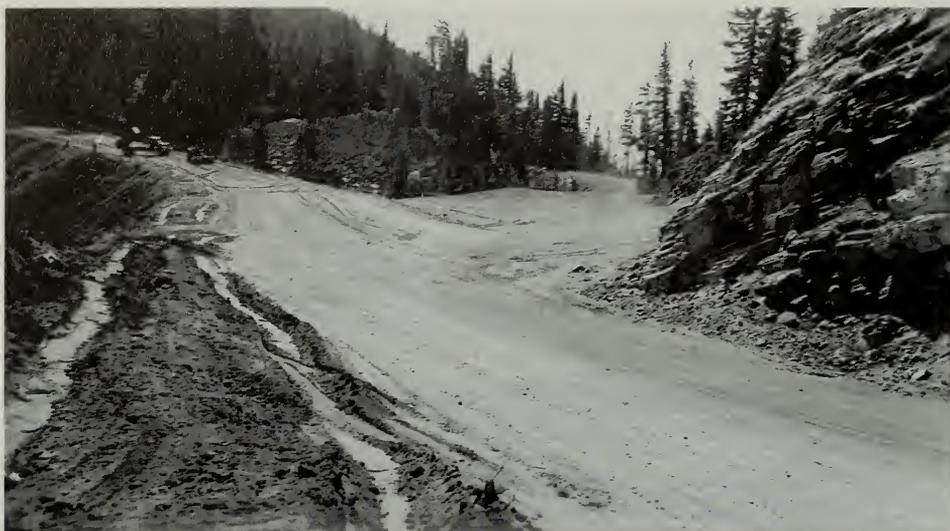
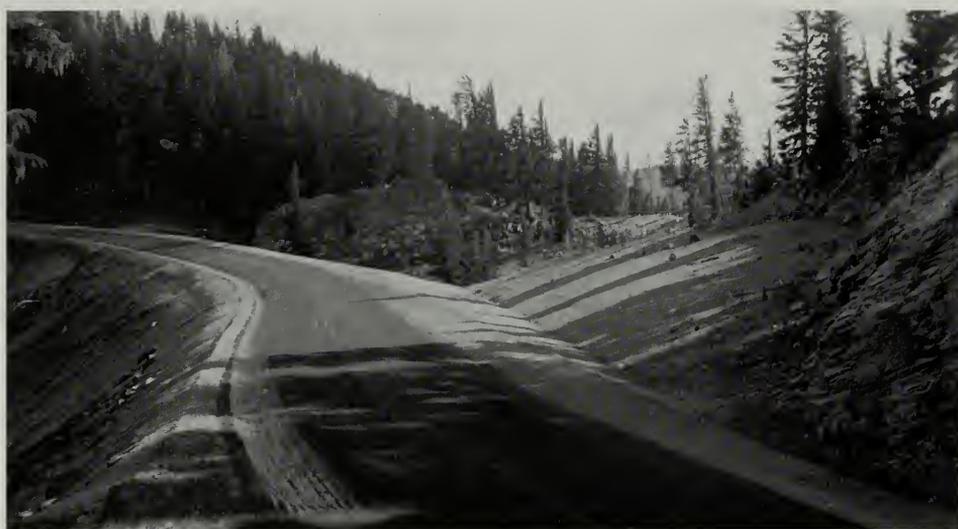
Old road obliteration through use of bank sloping along the northern part of Rim Drive.  
*Lange photo pair, CLNPMAC.*

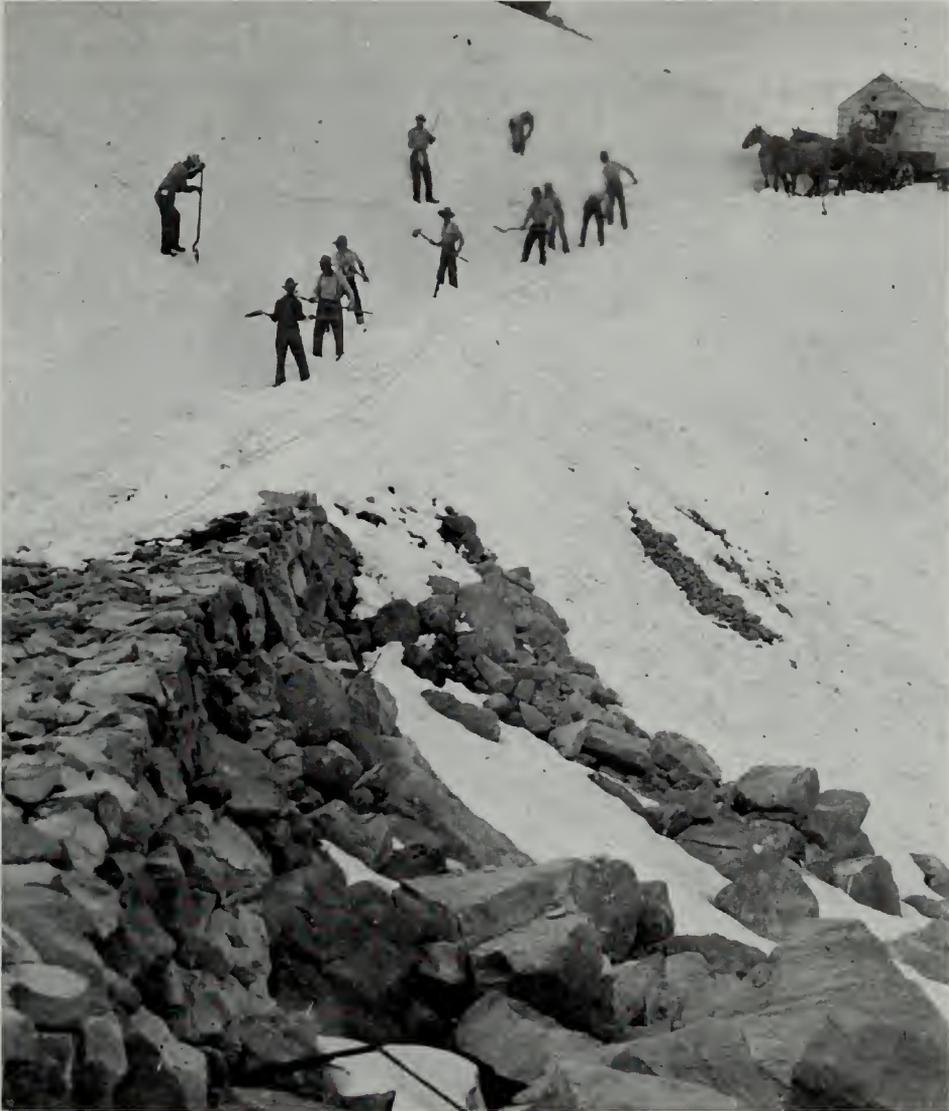
Snow removal on the Rim Road below the Watchman, July 1917. *Earl Russell Bush, CLNPMAC, 8885.*

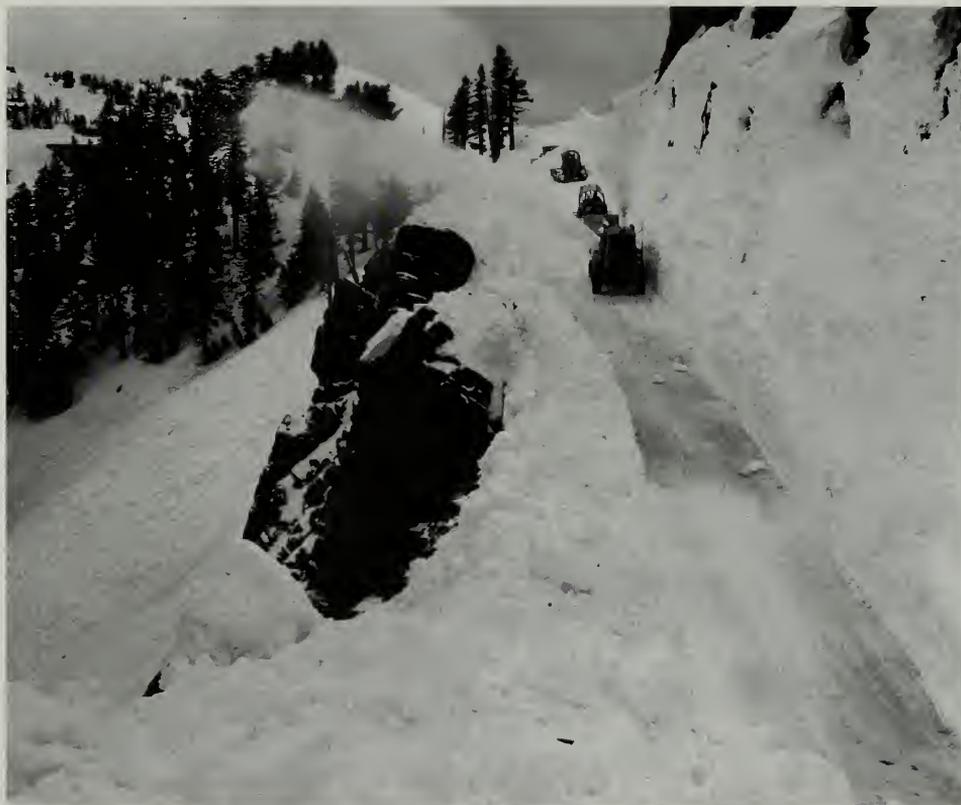
Snow removal on Rim Drive below the Watchman, May 1958. *Rundell, CLNPMAC, 8885.*

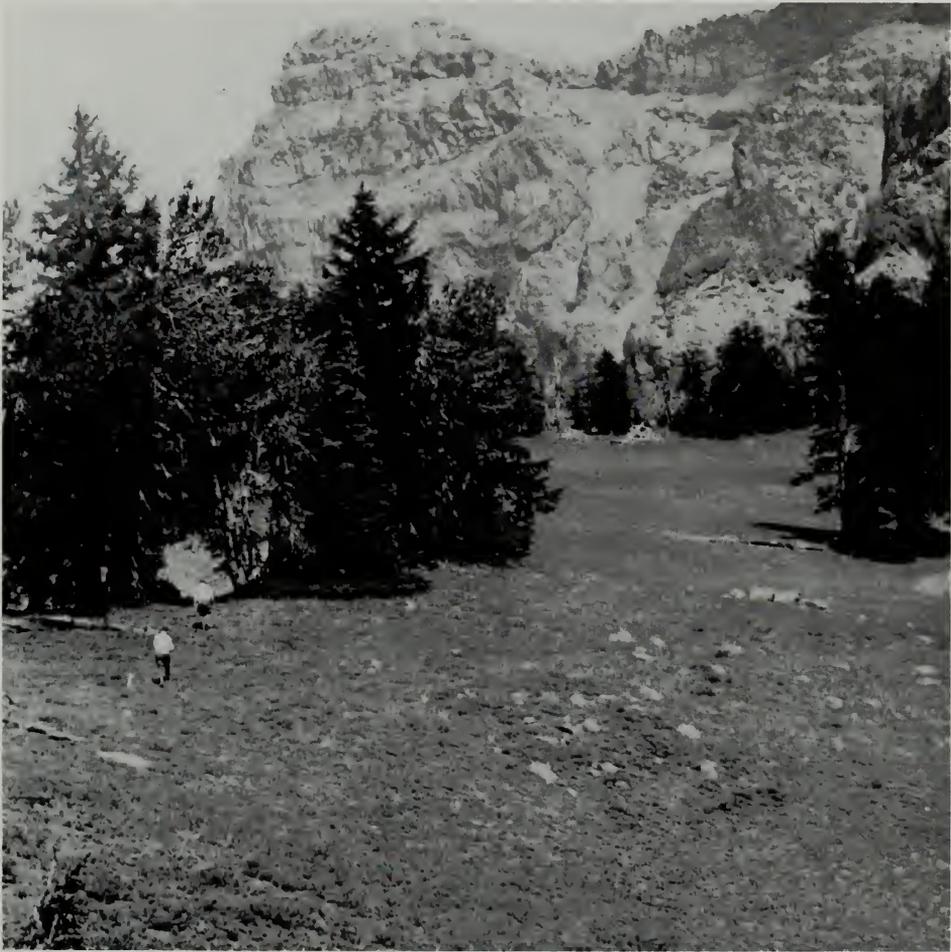
Sun Notch in the summer of 1931. Note the engineer's stake next to the figure at center left. *Merel Sager, NARA, RG 79, SB.*

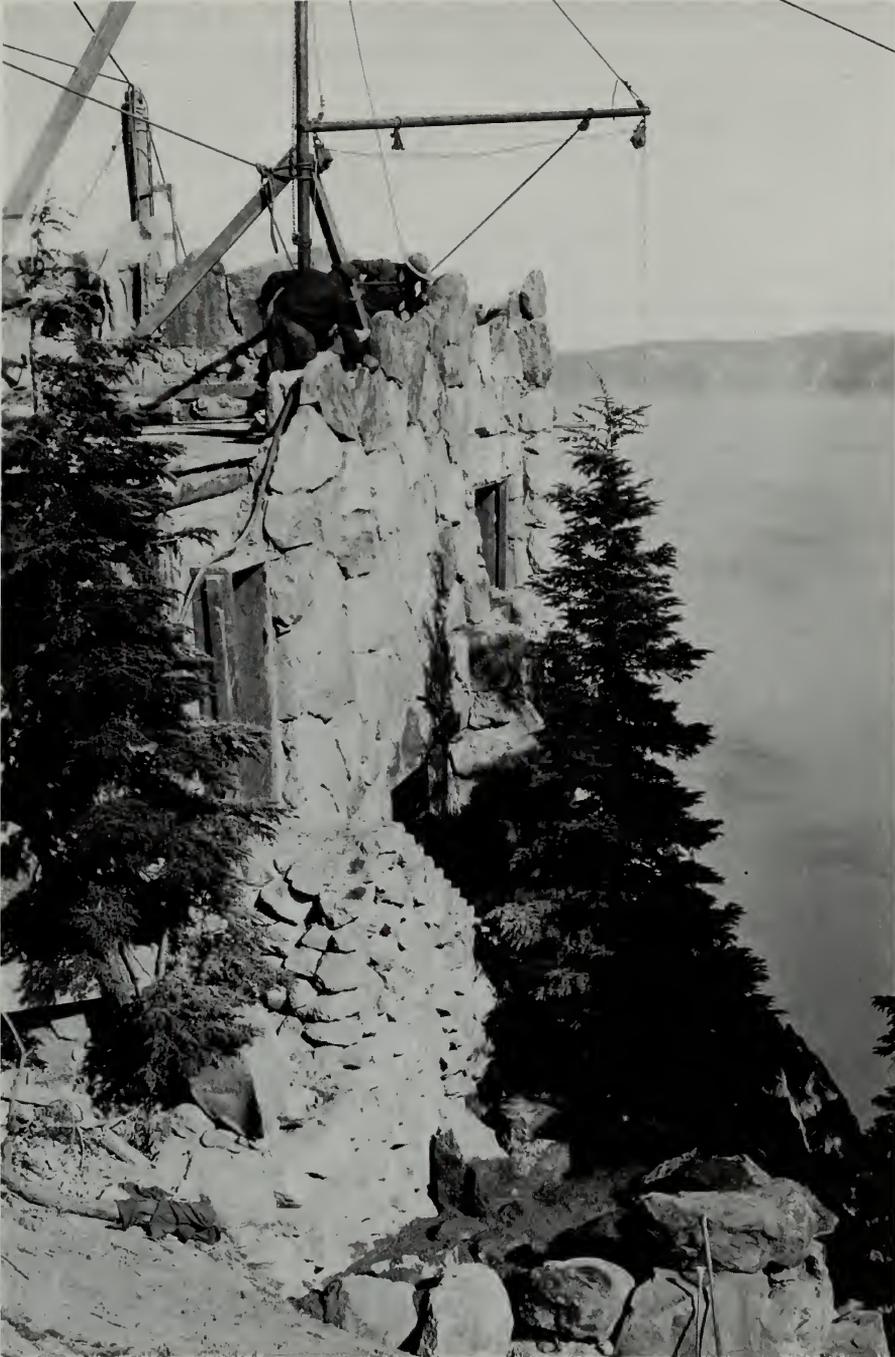
Building the Sinnott Memorial, 1930. *CLNPMAC*, 8885.

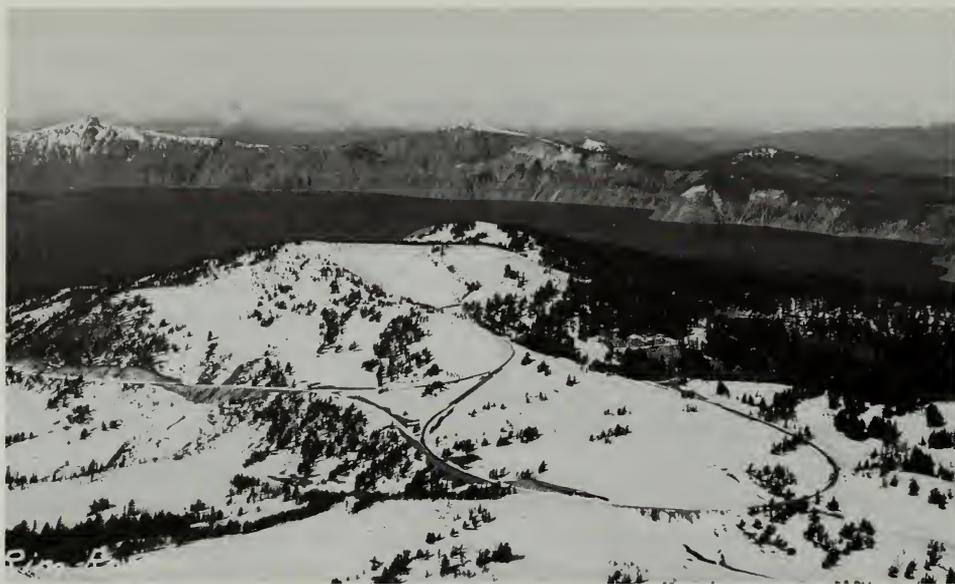
Rim Drive's location in the vicinity of Cloudcap. Note the wye intersection and spur road to summit in the center of photo.

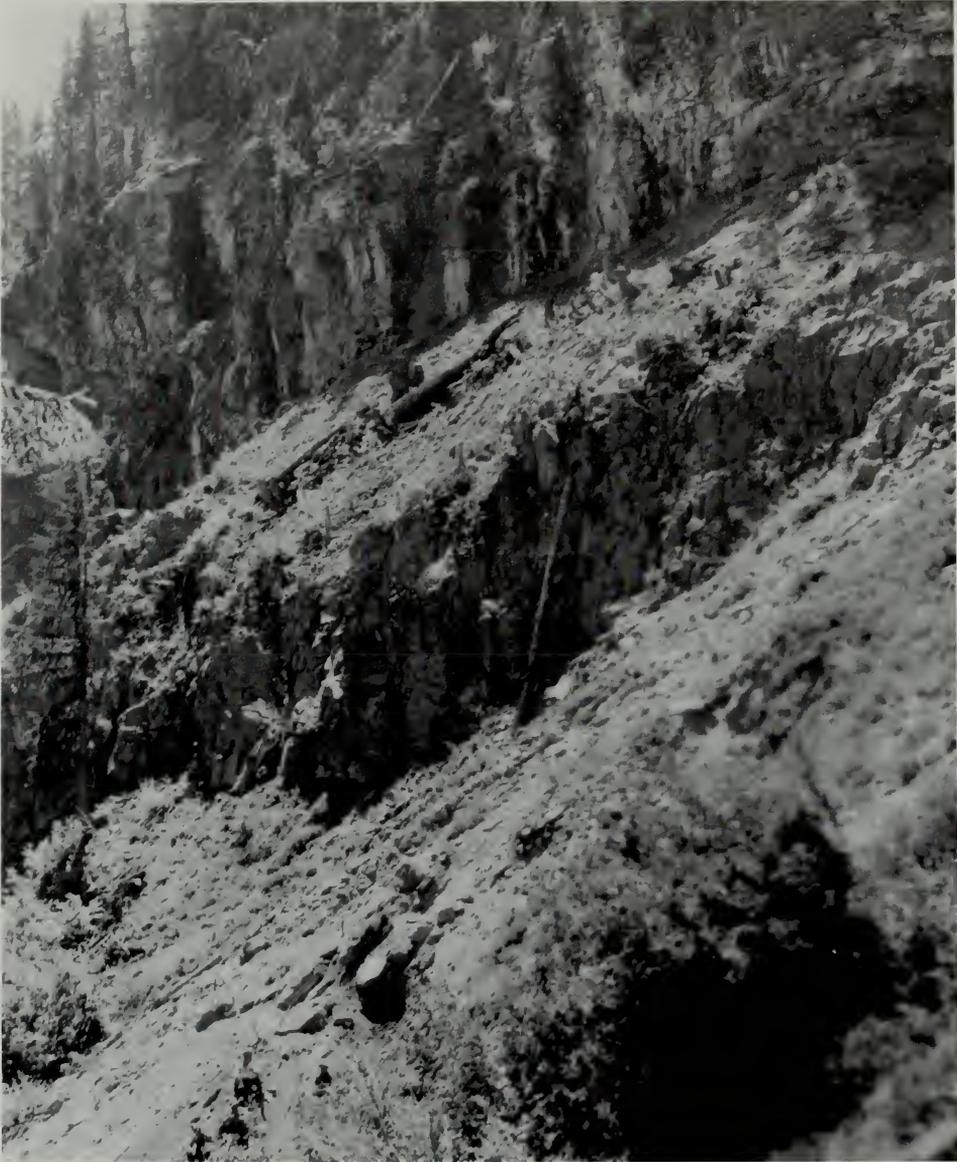
Section of Dutton Cliff at road station 470 prior to rough grading, 1936. *Lange, NARA, RG 79, SB.*

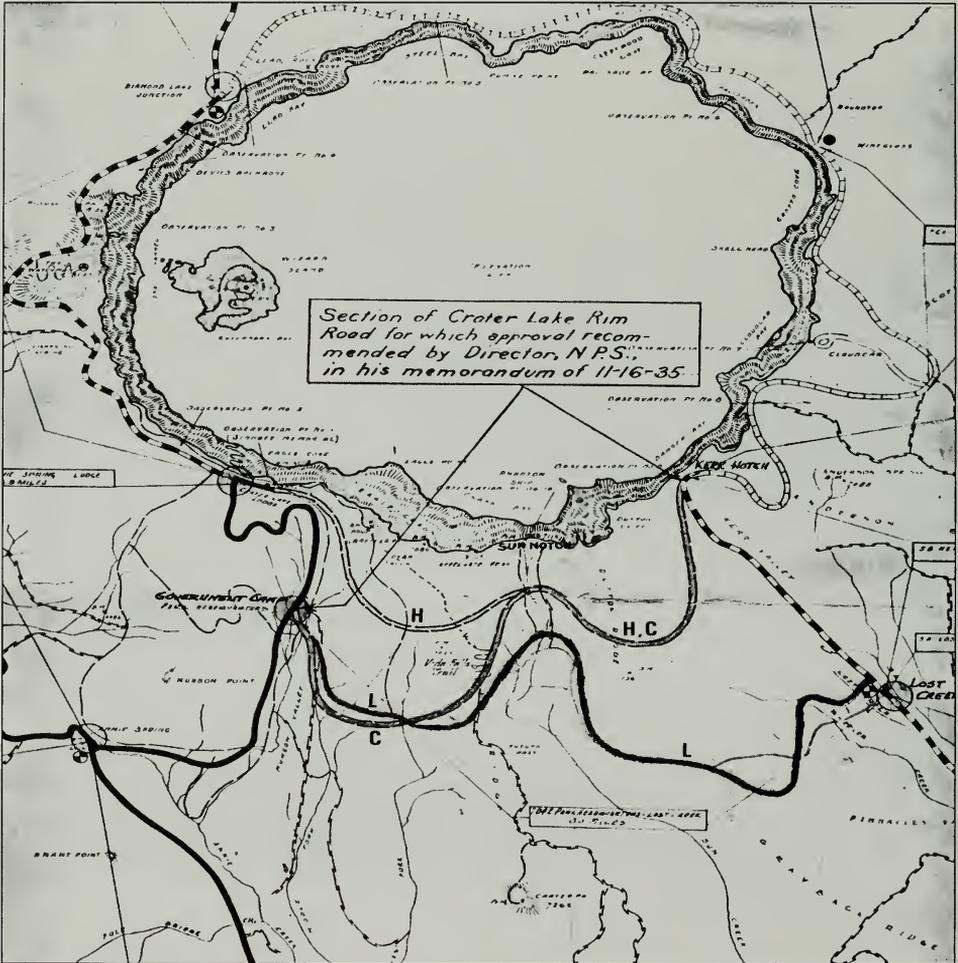
A master plan sheet of 1936 with the park’s road system shows how the “combination line” (marked “C”) borrowed from both the “high line” (“H”) and “low line” (“L”). CLNPMAC.

to Sun Meadow, then joining the present road [from Lost Creek] at the Vidae Falls.” This amounted to a “combination line,” one that Canfield strongly supported when he asked Cammerer to transfer funds originally programmed for the low line route and instead put them toward building segment 7-D. Lange again warned that such a road would “deface and permanently injure” the cliffs of Dutton Ridge, though he injected some levity into the situation by offering BPR the paraphrase “You take the high line and I’ll take the low line,” sung to the tune of “Loch Lomond.”

Cammerer went ahead with recommending the “combination line” of a high 7-D and a low 7-E to Ickes on November 16, 1935. The secretary approved it several weeks later and his office issued a press release to that effect.<sup>22</sup> Sargent confidently anticipated the decision by completing the fieldwork for what he called the “final located line” between Kerr Notch and Vidae Falls by late October, so that plans could be completed over the winter. Engineers estimated this stretch of 5.5 miles as the most time consuming portion of Rim Drive to build, so BPR divided it into three units (as 7-D1, 7-D2, and 7-E1) for the purposes of bids on future grading contracts. Sargent also ran a P-line of 4.3 miles for the last segment of Rim Drive, one connecting Vidae Falls with Park Headquarters, in the fall of 1935. His successor, Wendell C. Struble, revised the line over the following summer to eliminate about a mile of road construction, mainly because he and Lange agreed that the new line effectively reduced the scar width of 7-E2 as seen from Crater Lake Lodge.

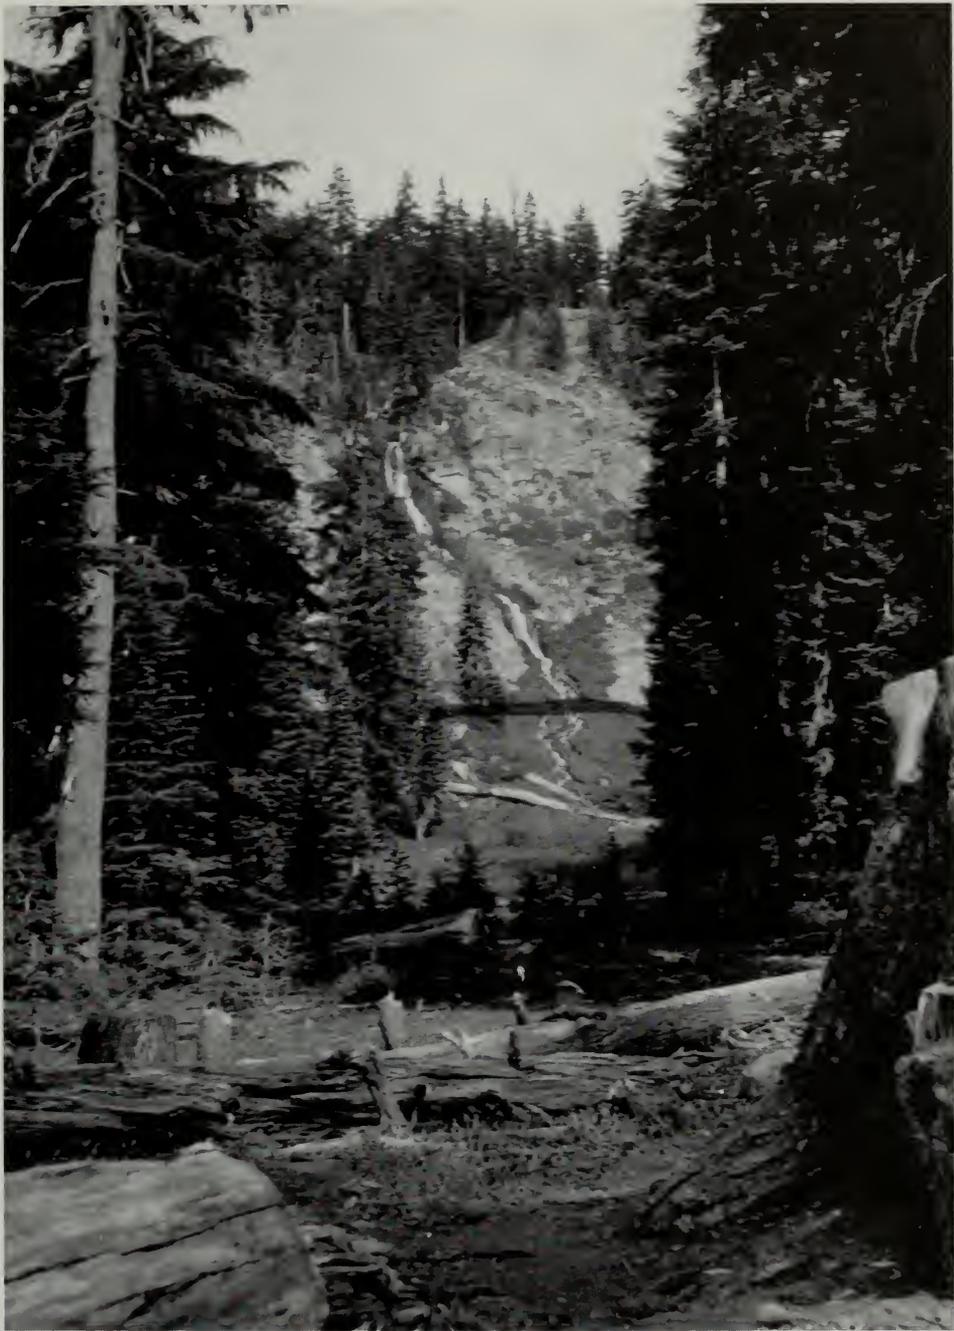
Horizontal line at center was intended to show the location of a proposed bridge to span the road crossing at Vidae Falls. *Lange, NARA, R6 79, SB.*

The problem of how to approach Vidae Falls from Sun Notch and then cross the creek remained, since Vint pointed out that Sargent’s line came too close to the falls and made any road crossing involving a fill too noticeable. He recommended that the line follow an approach road down to the proposed Sun Creek Campground (a development intended for the interfluvium between Vidae and Sun creeks near the old Rim Road), so that any fill used to span Vidae Creek might then be less obvious. A higher location required a bridge, Vint noted, one preferably built of logs. Canfield questioned the cost in relation to an expected life of 15 years, while also suggesting some revisions to a design used for the log bridge built over Goodbye Creek (located two miles south of Park Headquarters) in 1929.

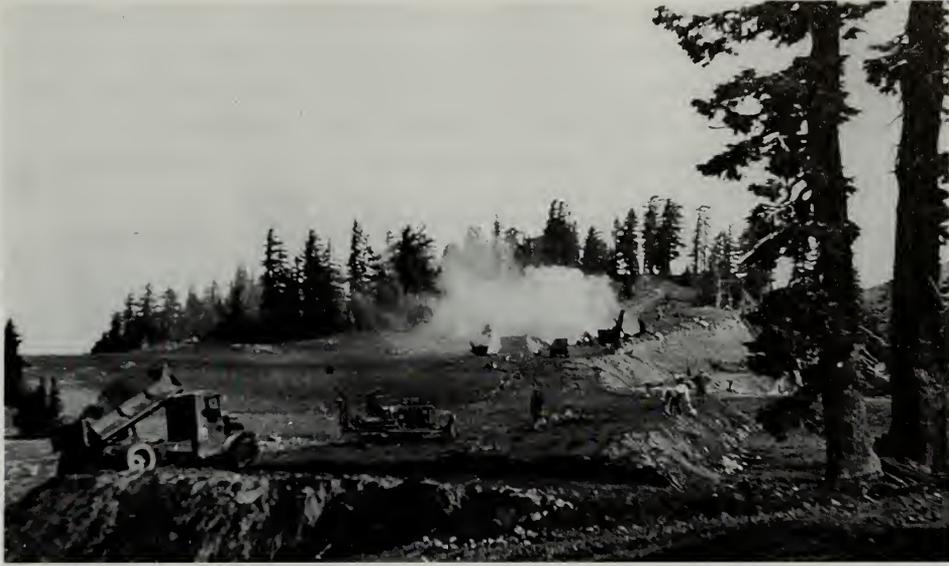
Rough grading along segment 7-A during the summer of 1932. *Sager, NARA, RG 79, SB.*

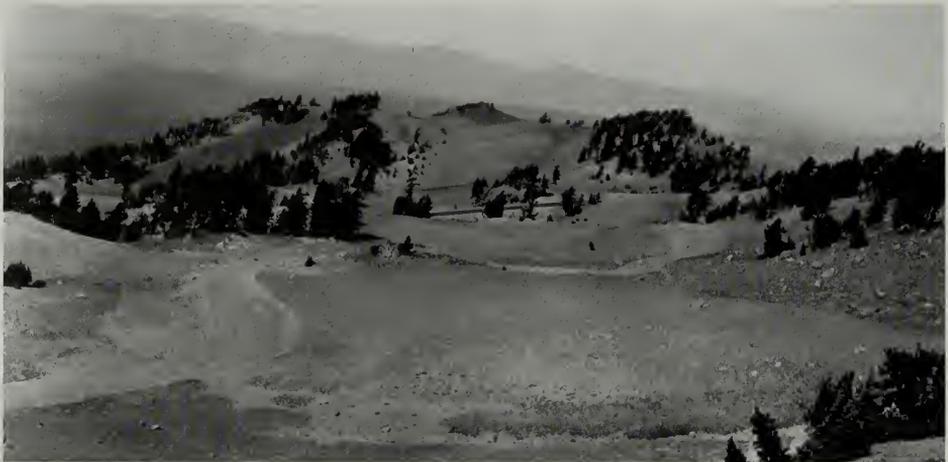
View of the Rim Road in foreground from Hillman Peak with a section of Rim Drive (the horizontal line at center) in the distance. *Lange, NARA, RG 79, SB.*

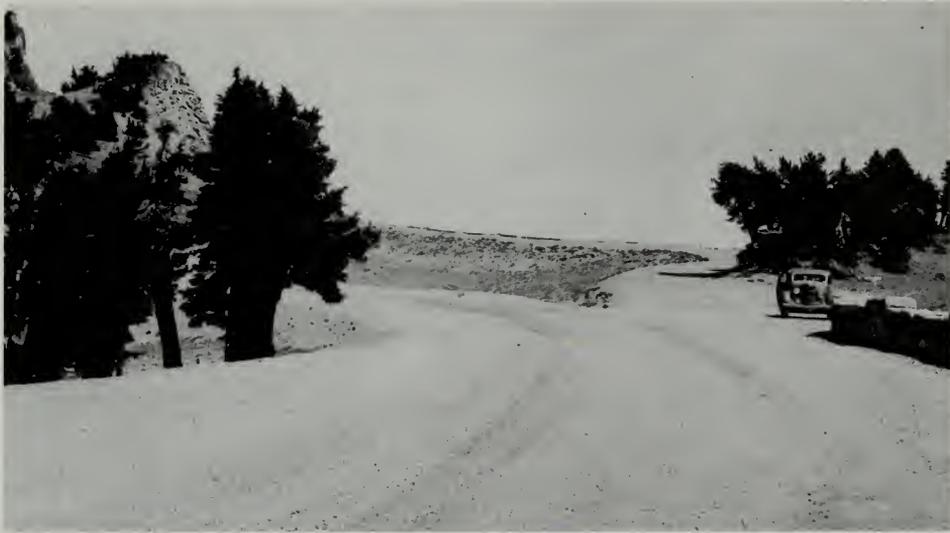
The sparse vegetation at road station 200 (later known as the “Watchman Overlook”) made the old road especially difficult to hide with planting. *Lange, CLNPMAC.*

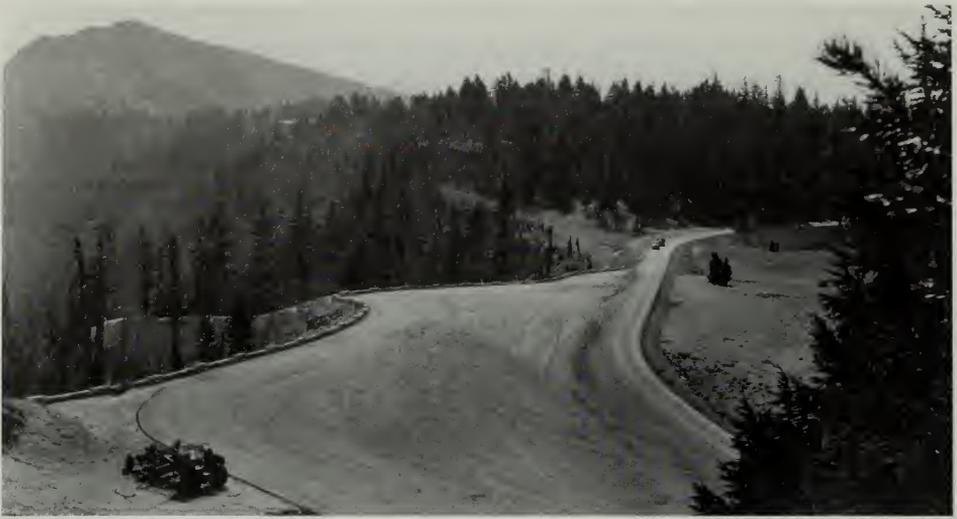
Masonry guardrail delineating the Discovery Point parking area, 1935. *Lange, NARA, RG 79, SB.*

A subcontractor, Angelo Doveri of Klamath Falls, handled construction of the guardrails. The resident landscape architect for the season of 1934, Armin Doerner, described a slow start during the late spring and early summer. He found that different workers each tried to express “his own ideas about masonry,” so it proved difficult to obtain “a uniform type of wall” at first. When Doerner and the BPR inspector finally agreed on the style wanted, the work improved and it proceeded at a faster pace. Sargent and Doerner agreed to the locations of the walls, starting with two relatively short ones near Rim Village and another of some 500 feet in length at the Discovery Point Overlook. By the final inspection in October, Doerner thought the guardrail had a “very pleasing” appearance aside from some imperfections. One was the trimming, which made it difficult to obtain the specified amount of weathered surface. Achieving the desired variety of color in the walls became problematic when quarrying all of the rock from the same locality.

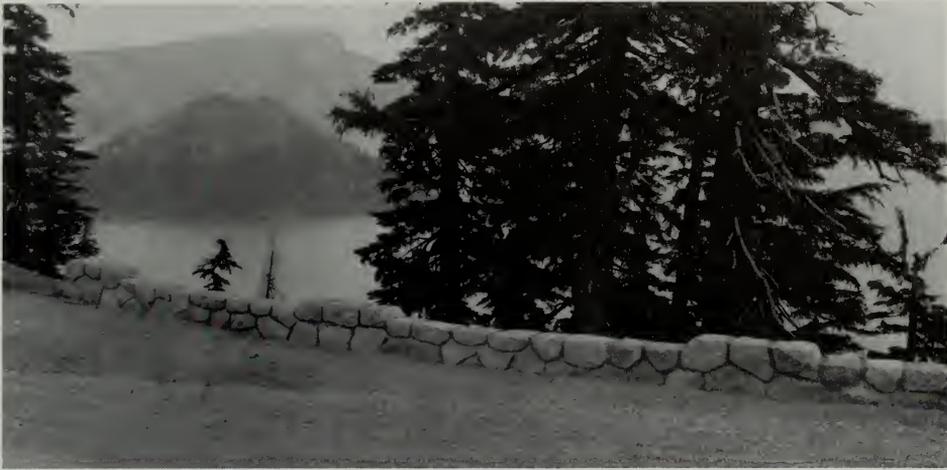
A section of masonry guardrail at the Discovery Point parking area, 1934. Note the relatively uniform color of the wall. *Armin W. Doerner, NARA, RG 79, SB.*
