# Rim Drive Cultural Landscape Report Crater Lake National Park, Oregon

Stephen R. Mark  
Jerry Watson

USDI – National Park Service

2009

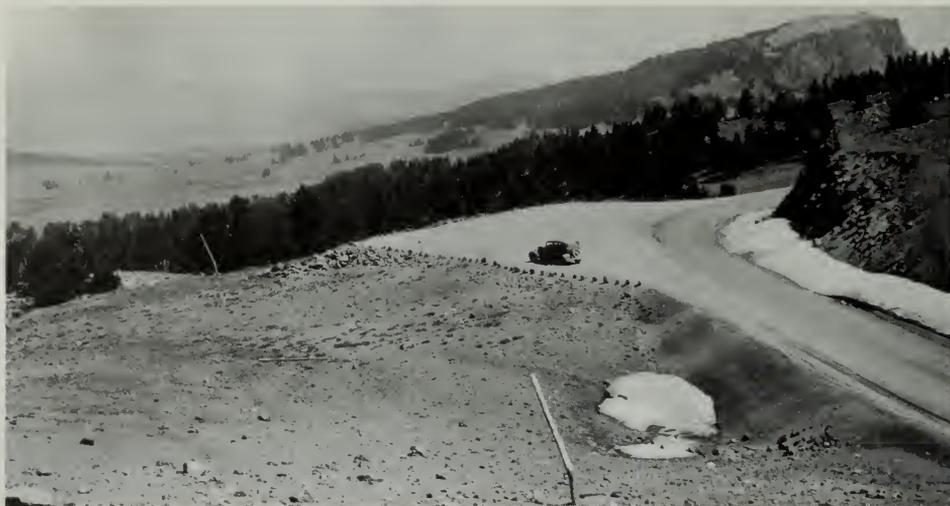
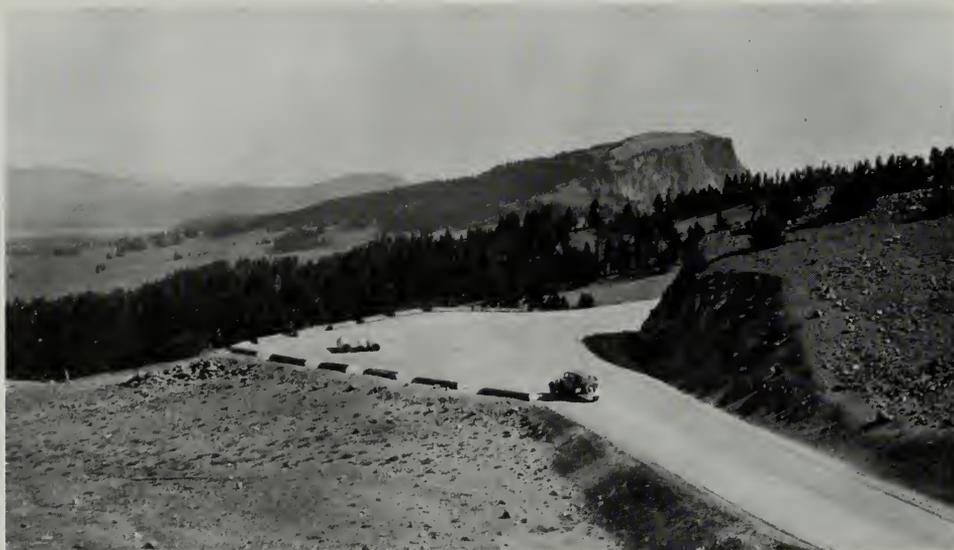
Views of road station 230 (later known as the “Diamond Lake Overlook”) before placement of log guardrail (top) and after placement of log guardrail (bottom). *Lange, NARA, RG 79, SB.*

been delineated with irregularly spaced boulders having jugged ends. Their appearance put this substation markedly out of character with the rest of Rim Drive, so Lange prevailed on a CCC crew who partly buried treated logs to line the outer edge of the overlook in 1936. Each of the logs was chamfered at each end (BPR referenced it as Type A-4) to provide better visual transition when spaced at regular intervals, since Lange hoped to bring weathered boulders to the site and alternate them with the logs. This treatment represented something of a stopgap measure in the absence of masonry guardrail.

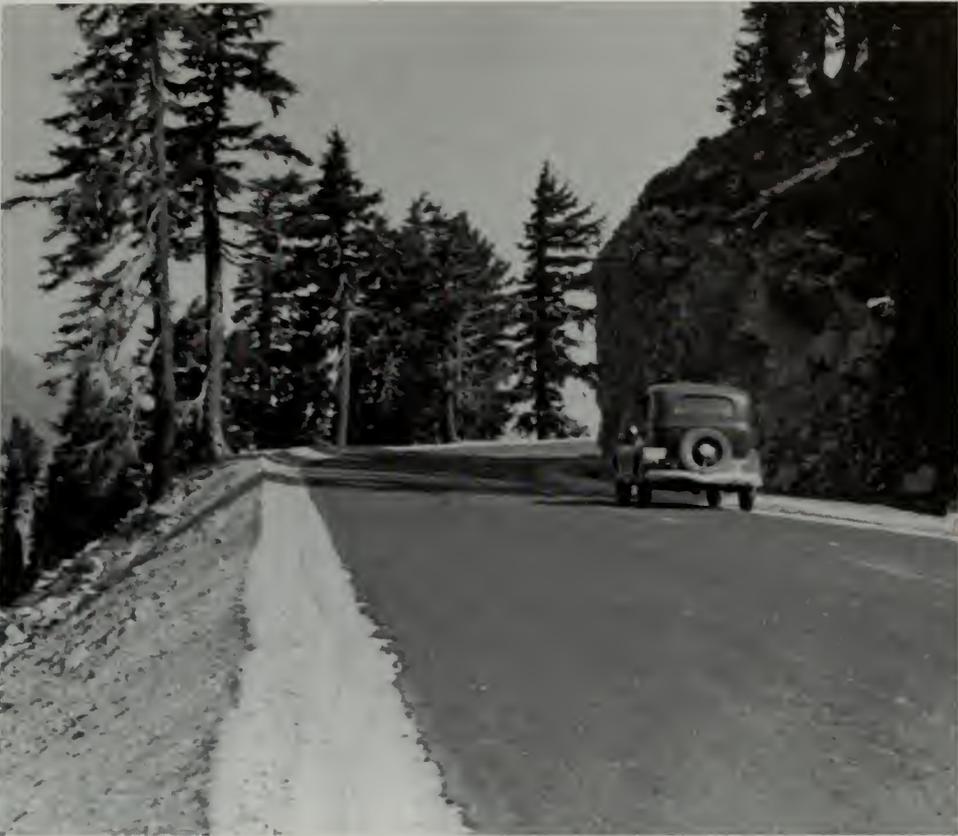
Bituminous mat at road station 260 in 1935. *Lange, NARA, RG 79, SB.*

BPR awarded the contract for paving 7-A to J.C. Compton of McMinnville, who then started giving the road a bituminous surface treatment. This job consisted of several steps, with the first being the spreading of aggregate (or “prime coat,” as Lange called it). The laying of a bituminous “mat” of at least three inches in depth came next, one extending over the entire roadway and parking areas. Lange thought

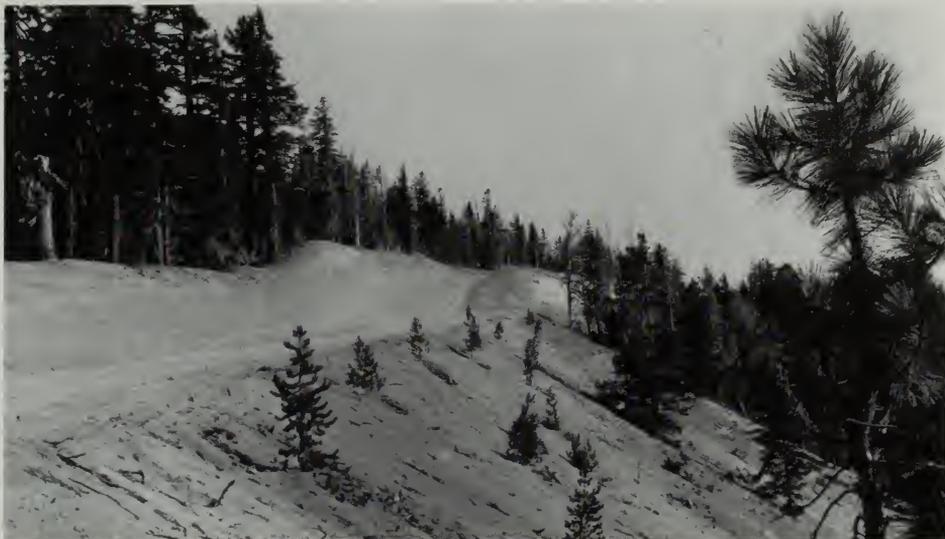
Trees planted to stabilize fill. *Lange, NARA, RG 79, SB.*

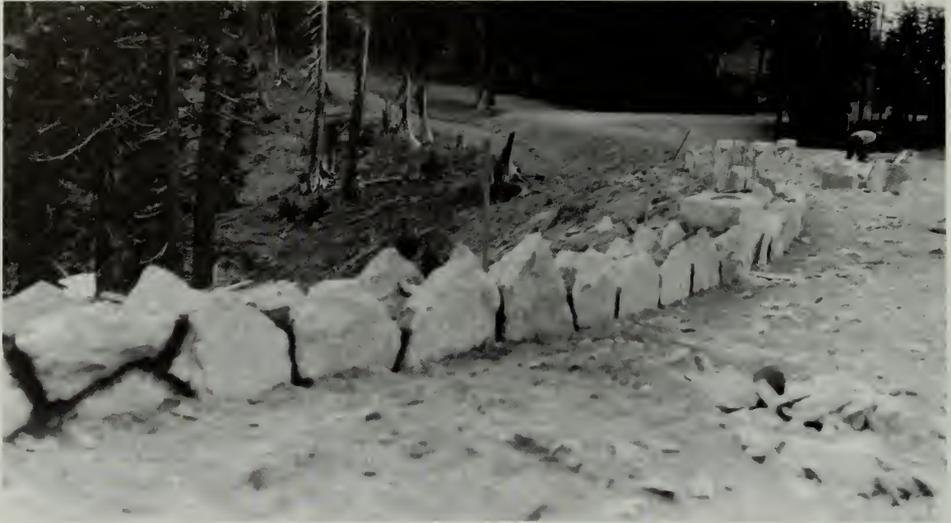
Building masonry guardrail in segment 7-B, 1934. *Doerner, NARA, RG 79, SB*

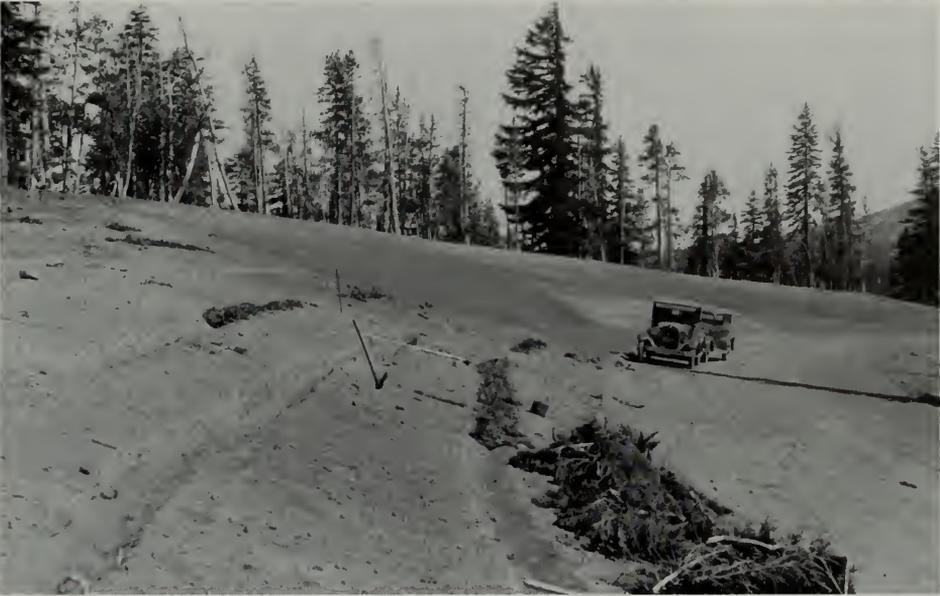
One of the steps taken in special planting at road stations 1039-1045 involved trenches filled with hemlock branches to hold the dark top soil. Planting of sedges and trees followed placement of the top soil so as to diminish the intense red color seen from Cloudcap and the size of this daylighted slope. *Lange, NARA, RG 79, SB.*

Grading and widening the roadway also necessitated what Lange called “special planting” aimed at large slopes exposed by construction. The foreman and his crew treated two sections of segment 7-B in 1935, with the first located near the Wine-glass road camp where they treated a cut slope with some trees and dark soil so as to diminish the intensity of the vivid red color seen from Cloudcap.<sup>28</sup> Work began by digging parallel trenches filled with mountain hemlock branches to hold the “new soil” and aid establishment of trees transplanted at the site. This procedure was also used to conceal a white line created by grading near Steel Point that could be seen from the Crater Lake Lodge.<sup>29</sup>

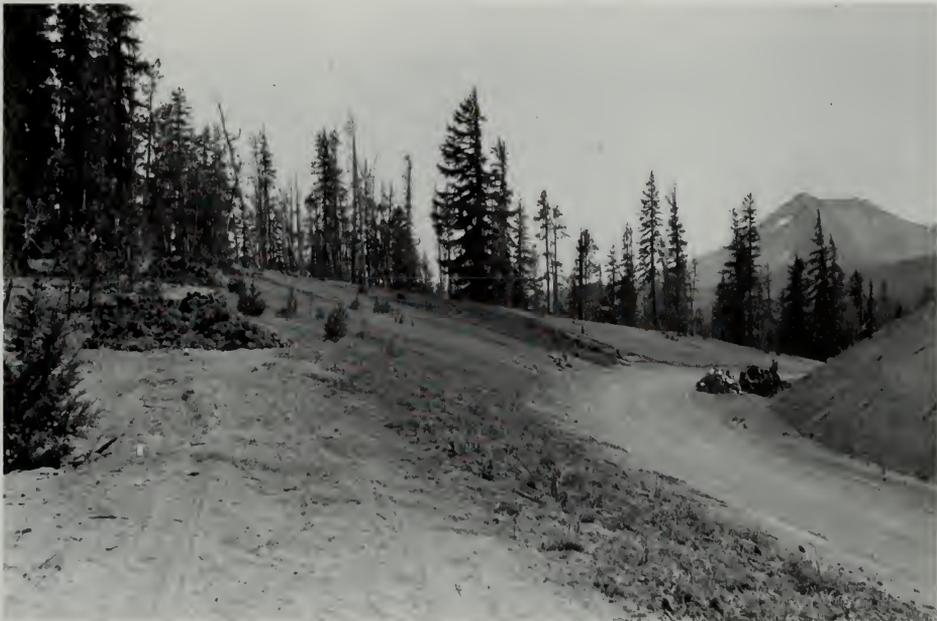
Top soil placement following planting of sedges and trees. *Lange, NARA, RG79, SB.*

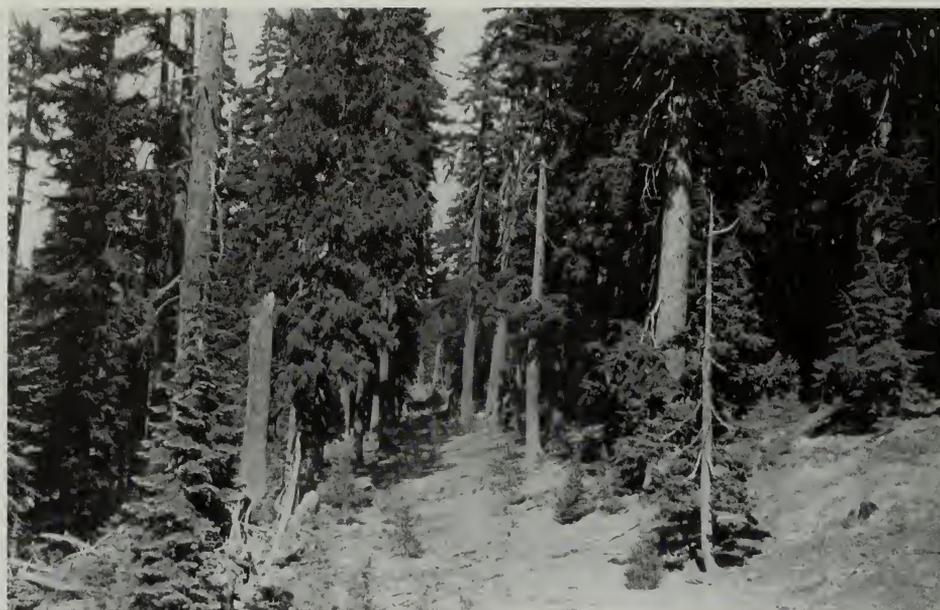
Old road obliteration through tree planting and placement of duff at road station 1140, 1935. *Doerner, NARA, RG 79, SB.*

the natural appearance of new road construction” because it went beyond planting the ends of old road segments as was done during the grading of 7-A. With a crew of four to ten men, the landscape foreman planted approximately 100 whitebark pine and 50 lodgepole pine over 1.2 miles of old roadbed in 1935. The difficult growing conditions meant that some 75 cubic yards of soil covering was used in conjunction with a scheme that included spreading duff and small branches so as to eventually produce a “uniform” line of planting “unnoticeable to all but those accustomed to the old road location.” Lange took a number of photographs to show the effectiveness and appearance of such efforts, as part of his plan to obliterate ten miles of old road. He estimated this multi-year project needed roughly 5,000 trees as well as 2,000 loads of soil, and required the services of two or three supervisors and twenty laborers.

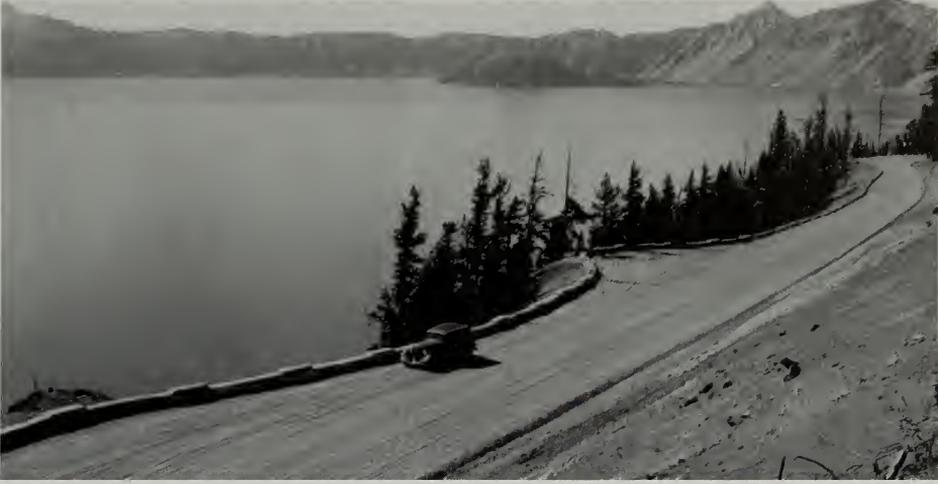
Guardrail lining Rim Drive near road station 1043 (Cleetwood Cove vicinity) during the surfacing phase of building segment 7-B, 1936. *Lange, NARA, RG 79, SB.*

Milne's subcontractor for the masonry guardrails made good progress in only two months on the job in 1935, completing almost half of the stipulated 450 lineal yards in segment 7-B. Lange seemed pleased with the pace at which work on the guardrails proceeded, but he commented that the first sections of wall built where the road first touched the rim east of Llao Rock were not entirely satisfactory. Within a short time, however, he remarked about how this item became "exceedingly well done" and included photographs in his annual report of some representative guardrails from this road segment. Failure to provide such barriers, especially

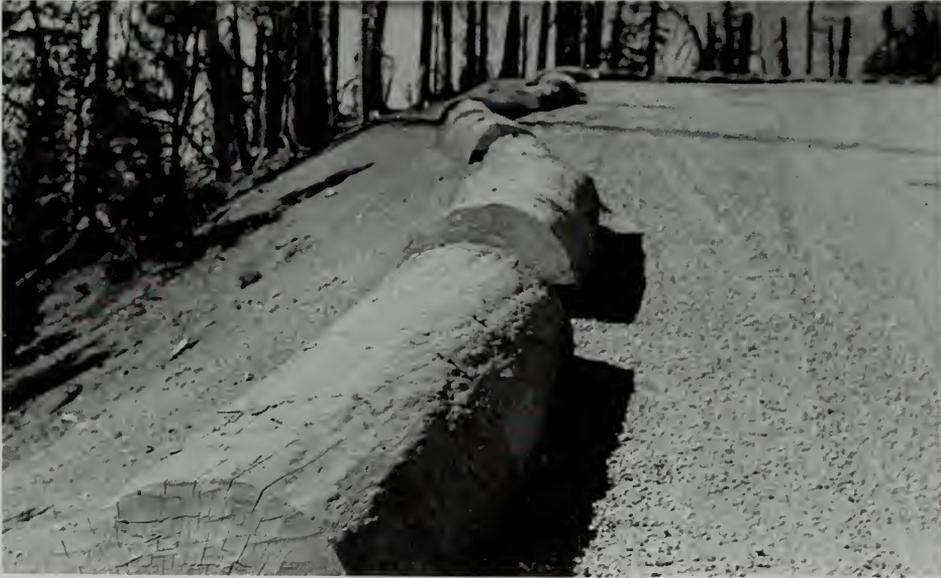
Log guardrail near road station 1045 in 1936. *Lange, NARA, RG 79, SB.*

where the road ran close to a precipice concerned Lange, though he did not cast blame for the oversight. He instead called for the NPS or BPR to provide some rule for such areas in future contracts, whether the remedy lay in stone masonry or partially buried logs in combination with seated boulders.

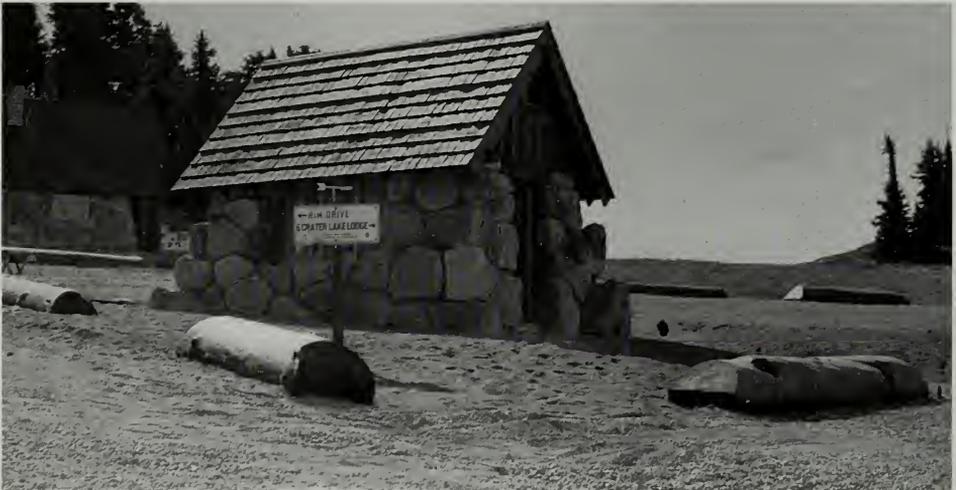
Treated logs used to define the road wye at the North Junction, 1936. Lange, NARA, RG 79, SB.

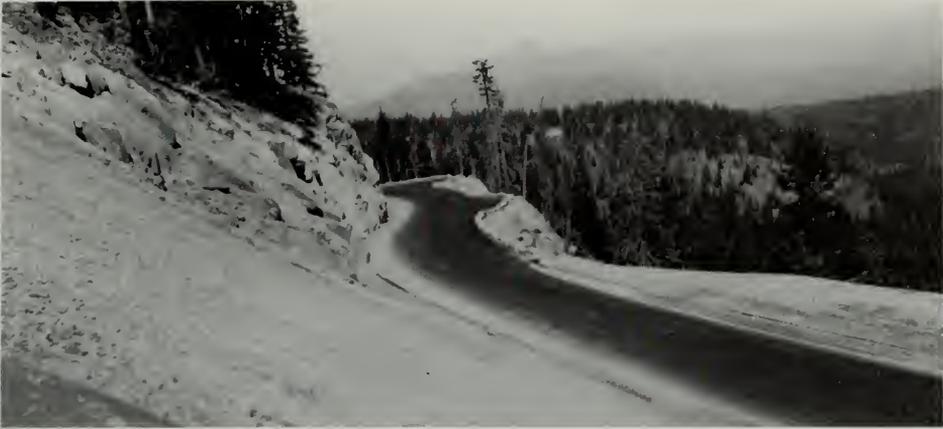
Small parking areas near Scott Bluffs after completion of surfacing, 1938. *Lange, NARA, RG 79, SB.*

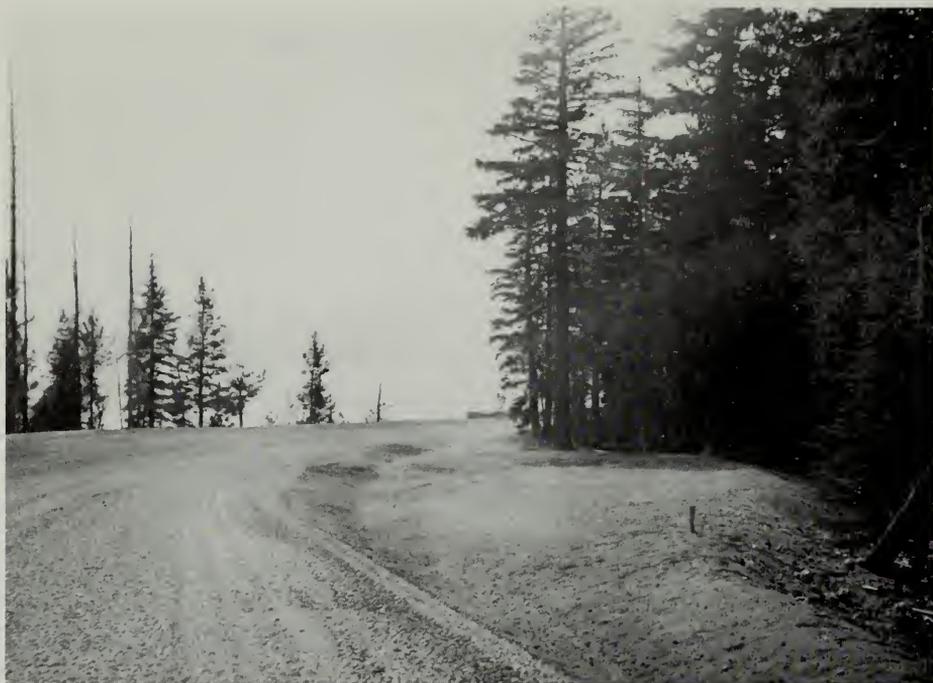
An example of a parking area unintentionally created by a low-angle cut. *Lange, CLNPMAC.*

two associated problems that rose to the top of his list to correct over the following summer. One resulted from cuts where one side of the cut was too low in height to be properly sloped. He acknowledged that a number of landscaped parking areas were necessary for visitors to enjoy the scenery and make repairs to their vehicles if necessary, but any proliferation of unintended parking areas detracted from Rim Drive being able to harmonize with its surroundings. Lange wanted these areas converted into slope banks where at all possible, and then showed an example of the recommended treatment in his annual report for 1936.<sup>32</sup>

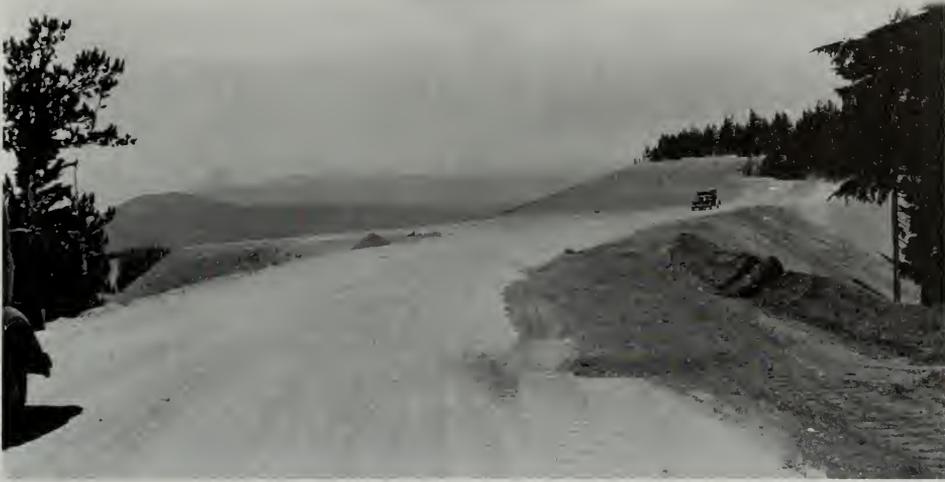
Skell Head parking overlook prior to landscape treatment, 1935. *Lange, NARA, RG79, SB.*

An even larger problem stemmed from daylighting prominent viewpoints in segment 7-C for fill material, thereby compounding the challenge of having to obliterate old road on soils that tested virtually sterile. Lange began making an argument for extensive landscape treatment of what he began to call “parking overlooks” in 7-C and 7-C1 as part of his season ending report for 1935. He pointed to certain examples, such as the excessive daylighting at Skell Head, in identifying five localities for special landscape treatment as part of a future surfacing contract.

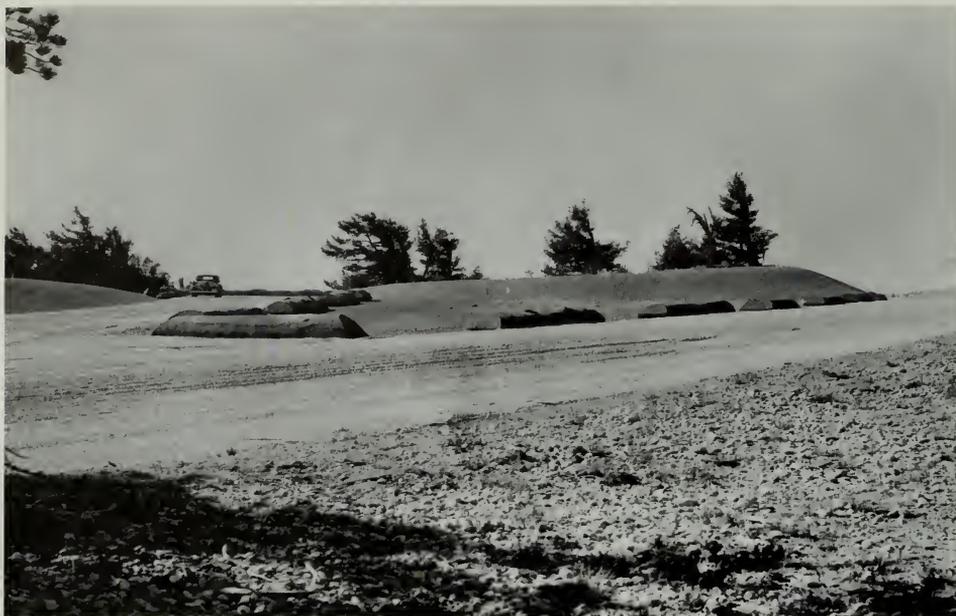
Cloudcap parking overlook, 1936. *Lange, NARA, RG 79, SB.*

Lange made preliminary sketches of five “parking overlooks,” going somewhat beyond what had become the standard treatment for viewpoints along Rim Drive. In addition to masonry guardrail to delineate the edge of the rim for motorists, Lange added a bituminous walk running the full length of the wall as well as a stone curb to separate the viewing platform from parking. Each of the five overlooks featured an island defined by a combination of weathered boulders and logs so as to protect a small amount of planting that consisted of native shrubs and trees. He argued that the islands helped to diminish the size of each of the daylighted overlooks, thereby placed each of them into proper scale in relation to Rim Drive. They also provided greater safety by separating motorists using the road from those leaving or entering each overlook.

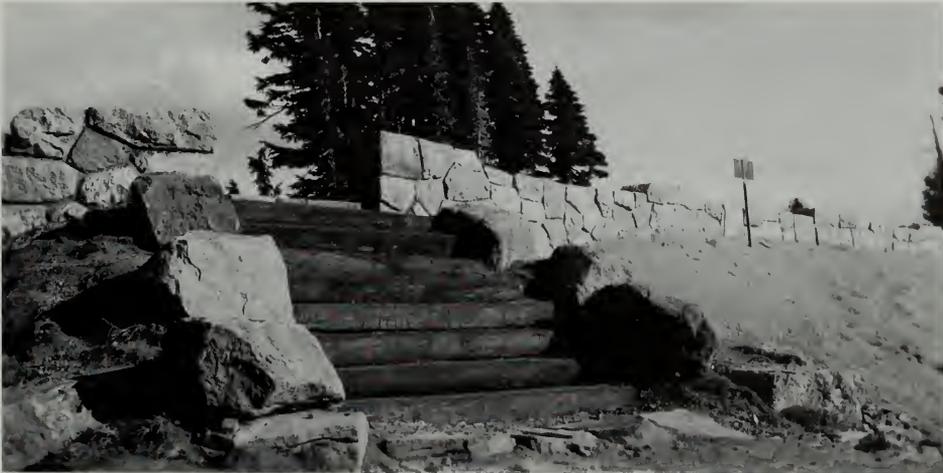
Completed log steps between the parking overlook and trail to Sentinel Point, 1938. *Lange, CLNPMAC*

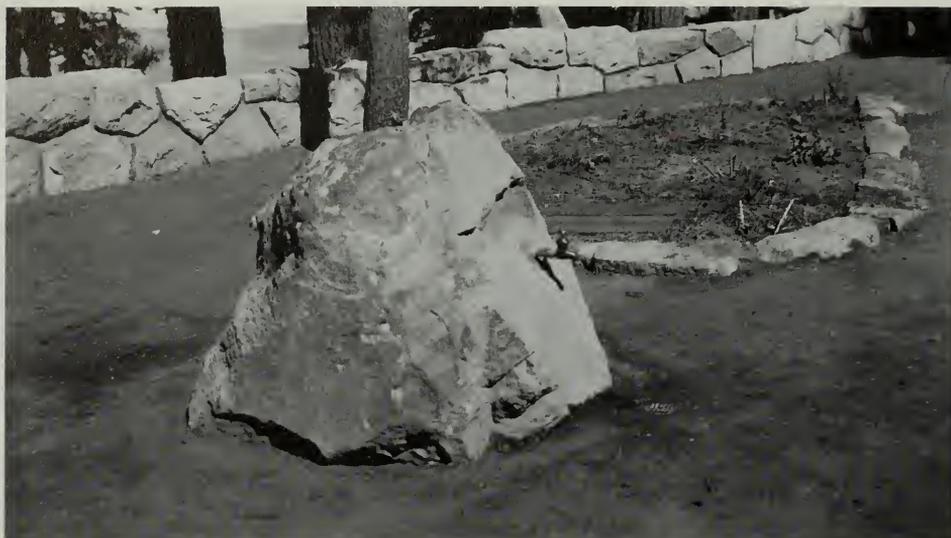
Drinking fountain and planting bed at Kerr Notch, 1938. *Lange, CLNPMAC.*

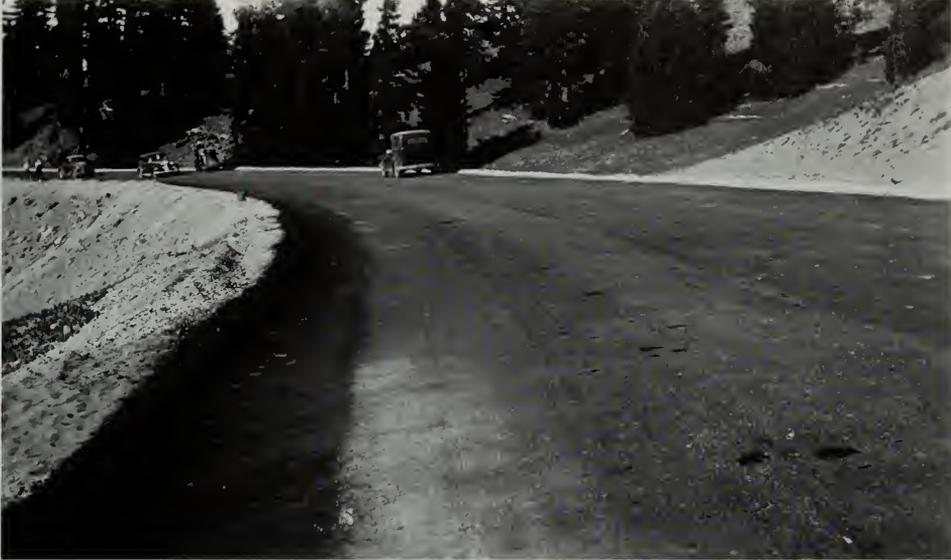
Section of ditch near the Diamond Lake Junction after an initial step in paving, the application of plant mix. *Lange, CLNPMAC.*

set at five inches below the seal coat, with an actual level depth of three inches in the paved gutter.<sup>35</sup> Lange commented that the gutters had an “excellent appearance” in his report for September 1938, but the contractor returned in 1939 to do additional sealing because cold weather the previous fall caused some cracking.<sup>36</sup>

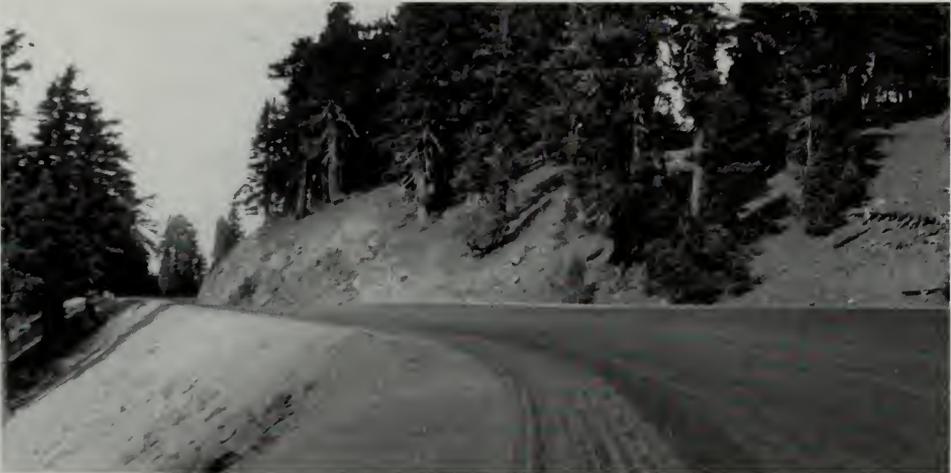
View of the adjacent road section showing finished treatment with seal coat given to both the ditch and travel lanes. *Lange, NARA, RG79, SB.*

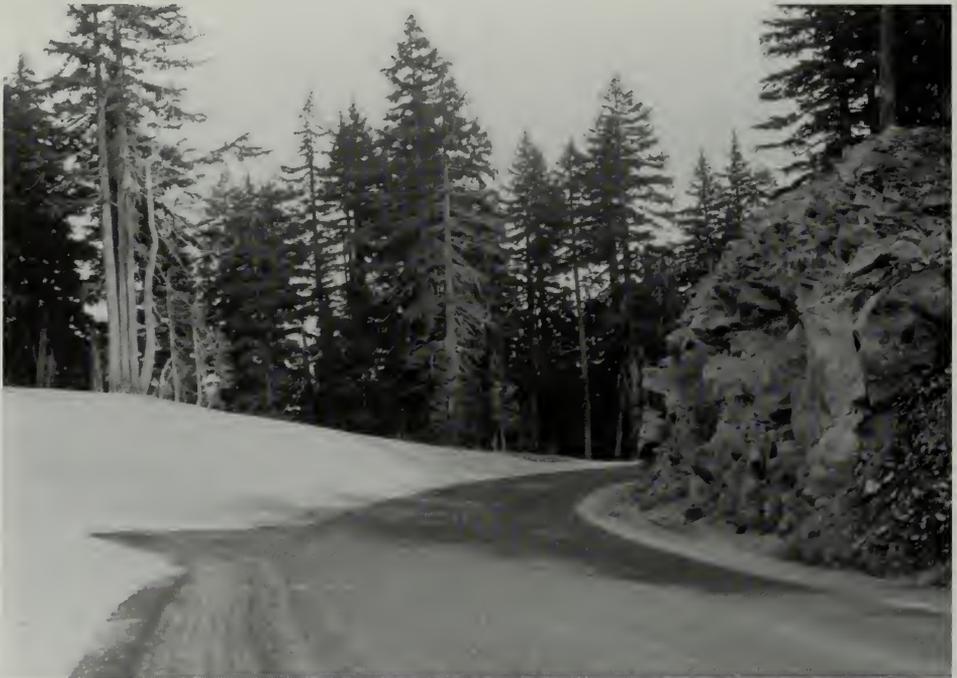
Termination of paved gutter into a catch basin at center left. *Lange, NARA, RG 79, SB.*

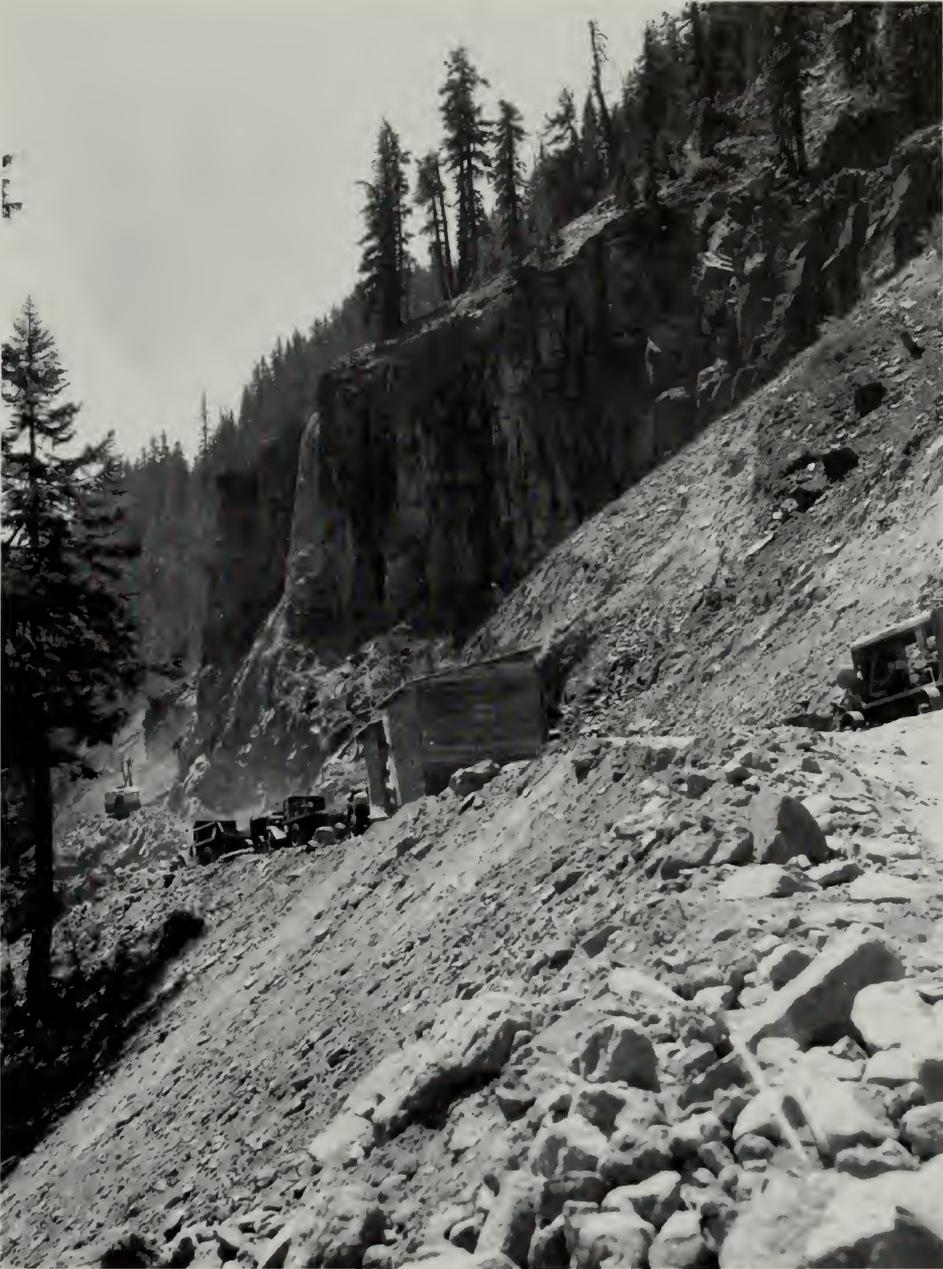
Building the “pioneer” road through 7-D1 during the summer of 1937 involved major excavation in the cut across the face of Dutton Cliff. The line of rock below the road in the foreground represents an attempt to catch material before it fell further downhill and picked up speed. *Lange, NARA, RG 79, SB.*

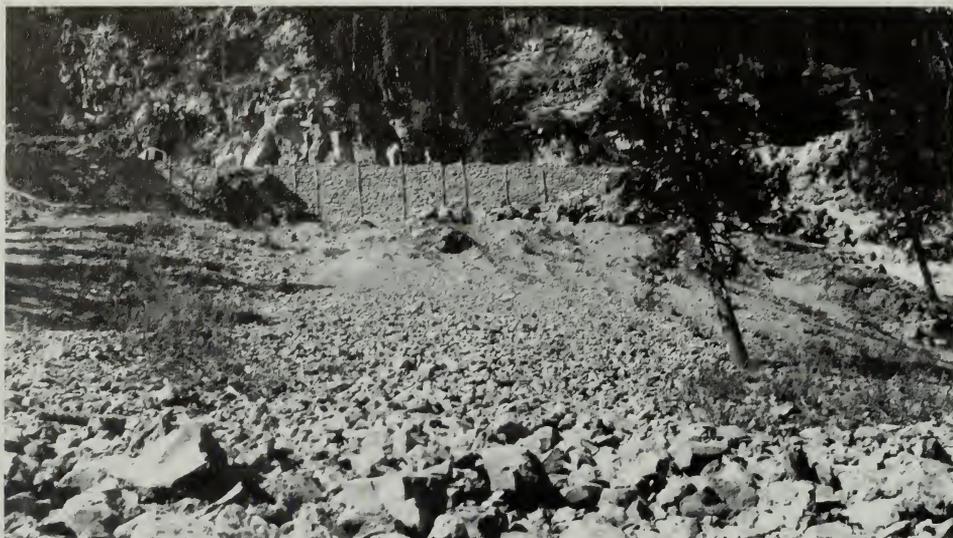
Subcontractors built a masonry retaining wall in 1938 to connect hand placed walls erected the previous summer. Lange liked how the walls looked, but made repeated mention of the damage to trees from falling rock brought by road building. *Lange, NARA, RG 79, SB.*

Orino completed most of the rough grading in 7-D1 during the 1938 season, but all of the time allotted for the contract had long since elapsed. A somewhat sympathetic Lange explained that the number and size of the retaining walls needed along the eastern side of Dutton Ridge justified an extension. The hand placed walls

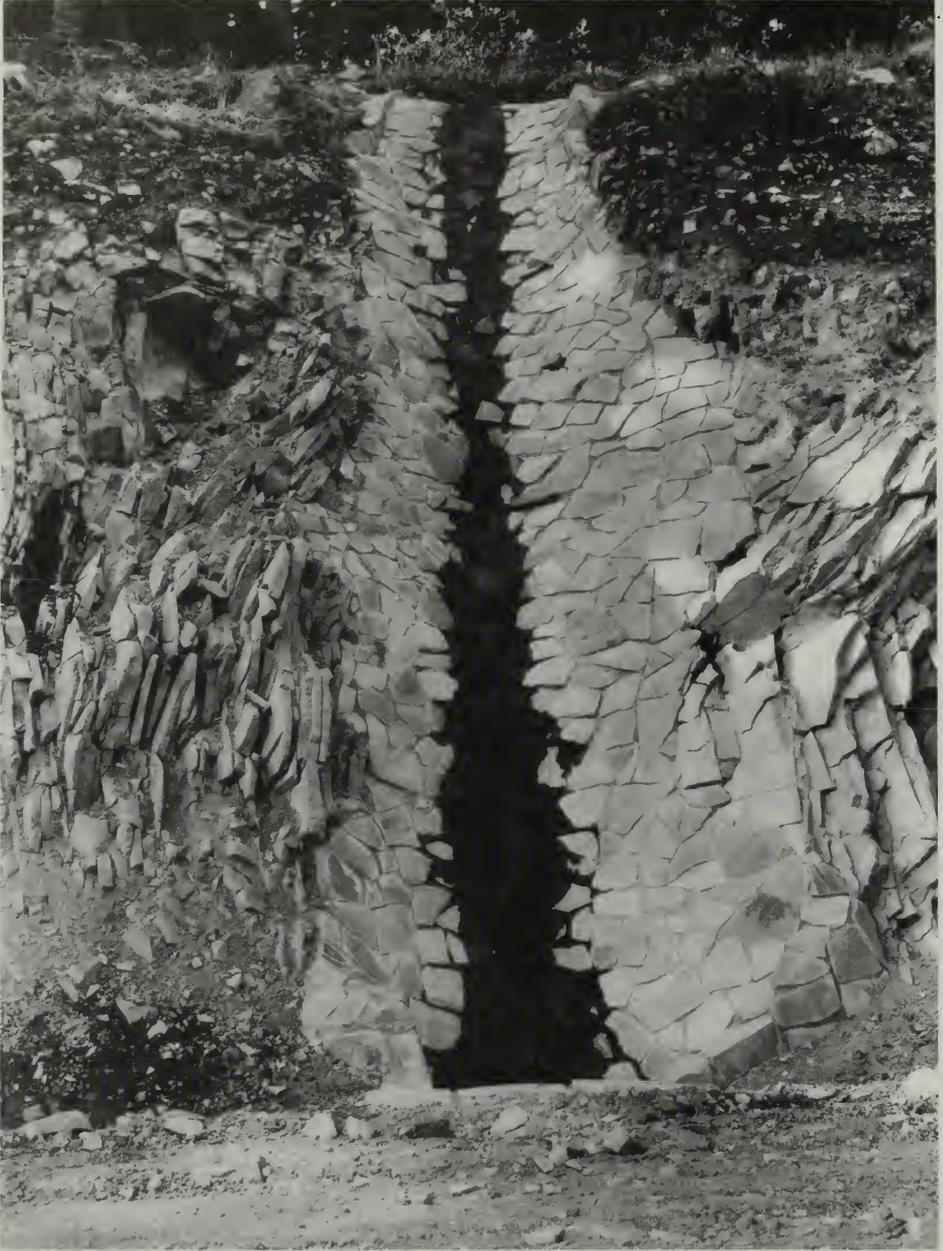
A “spillway” built in segment 7-D2, 1937. *Lange NARA, RG 79, SB*

Lange seemed particularly pleased with the masonry features along 7-D2, making special reference to what later became known as “spillways,” in his season-ending report for 1937. He included a photograph showing a floor laid to catch run off derived from continual seepage on slopes, to be connected with a culvert as part of cross drainage. The masonry component of this grading contract was otherwise limited to building culvert headwalls, most of which appeared along the south side of Dutton Ridge, where snowmelt created seasonal runoff.

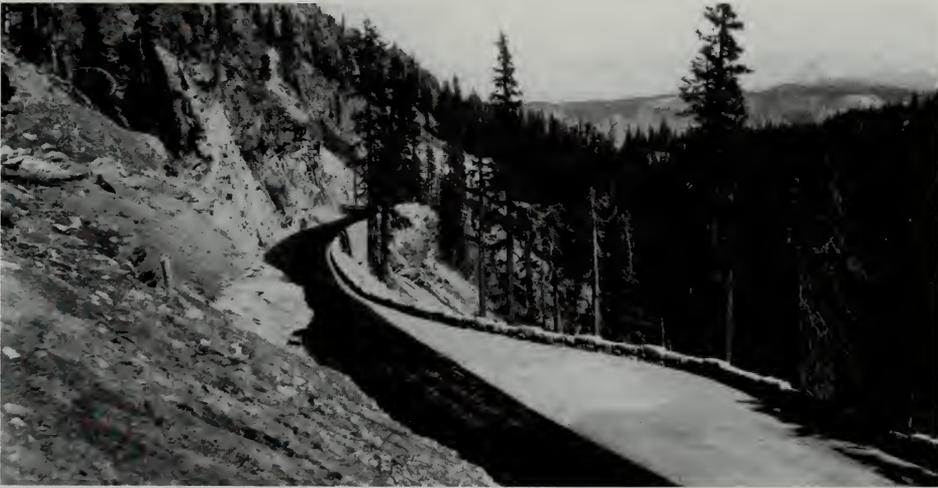
Oil treatment placed on segment 7-D1 in 1939 prior to surfacing in the vicinity of road station 460 where both the lake and Kerr Valley can be seen. *Lange, NARA, RG 79, SB.*

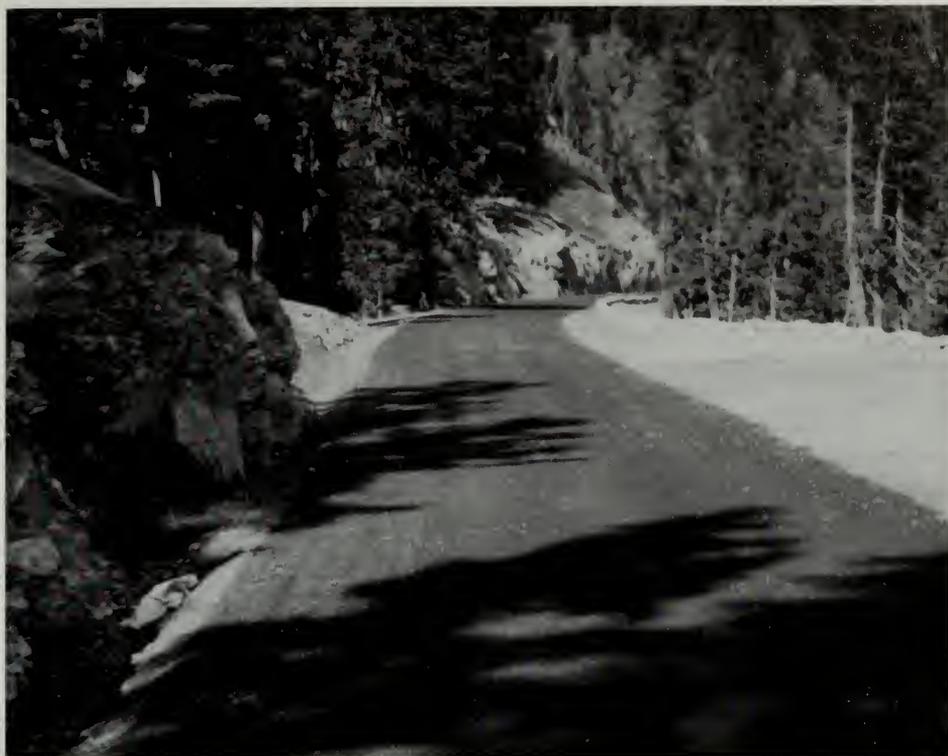
Lange's photo of oil treatment of the roadway in segment 7-D1 was meant to convey the idea for parking areas to have a lighter color finish than that of the road when finally paved. *Lange, NARA, RG 79, SB.*

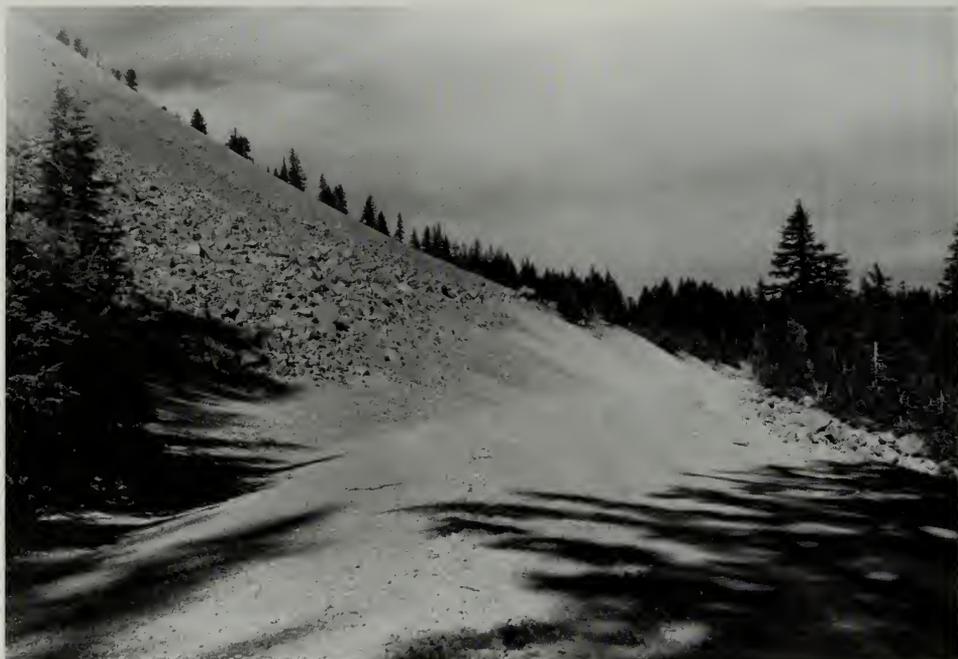
Bank sloping through a slide below Applegate Peak in segment 7-E1, 1937. Warping at road margin to the right. *Lange, NARA, RG 79, SB.*

Dunn and Baker completed all of the rough grading and most of the finish portion of the contract in 7-E1 during the 1937 season. Just over a mile in length, 7-E1 turned out to be relatively easy work. In running above the western margin of Sun Meadow and along the bottom of a slide on the flank of Applegate Peak, the new road provided Lange with an opportunity to show a particularly good example of

bank sloping through a heavy rock slide. The only other landscape item that he or the superintendent noted in 7-E1 concerned the need to obliterate an old “motor trail” improved by the CCC in 1933, one that started toward Sun Notch where the old Rim Road crossed Sun Creek.<sup>43</sup>

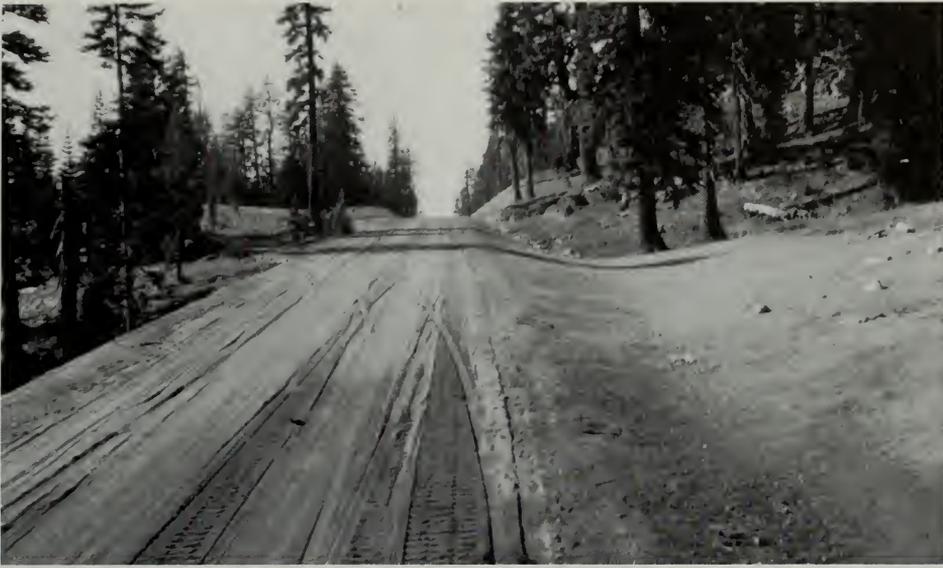
Ditch and slope treatment along segment 7-E2, 1938. *Lange, NARA, RG 79, SB.*

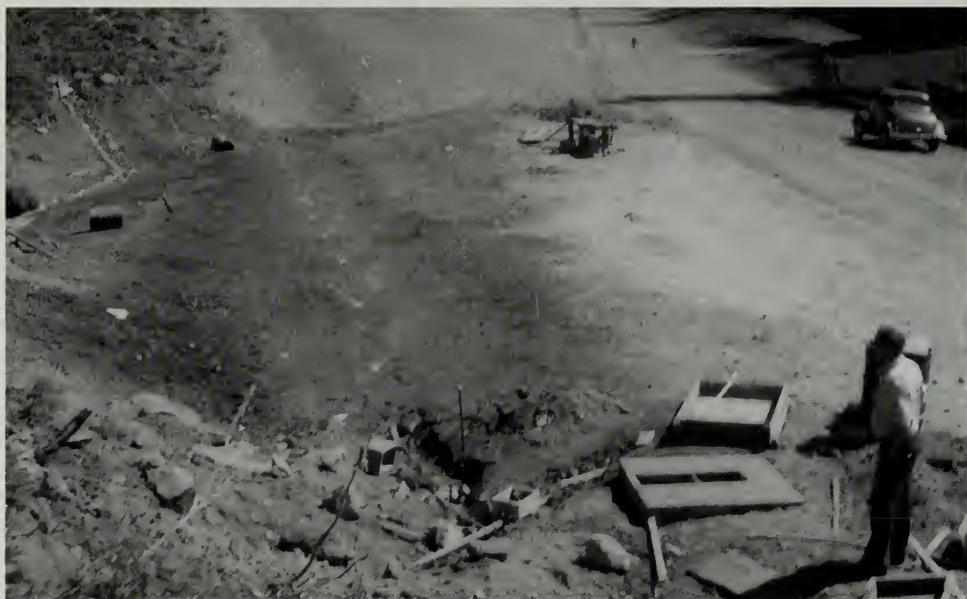
Site of future parking area at the “base” of Vidae Falls, 1938. The intersection of Rim Drive with a road to the proposed Sun Creek Campground is shown at top right. *Lange, CLNPMAC.*

Plans for a stopping point beneath the waterfall called for widening the road fill on the upstream (or northern) side of Rim Drive, so as to allow for parallel parking. Installation of a stone drinking fountain at this parking area came in July 1939, but construction of additional landscape features had to wait until the subsequent surfacing contract was let. These included building a raised walk four feet wide in front of Vidae Falls, and separated from the roadway by a stone curb. Just as they had in 7-D, Lange and other NPS landscape architects anticipated distinguishing the Vidae Falls parking area from Rim Drive through the use of pavement having a rougher texture and somewhat lighter color finish.<sup>45</sup>

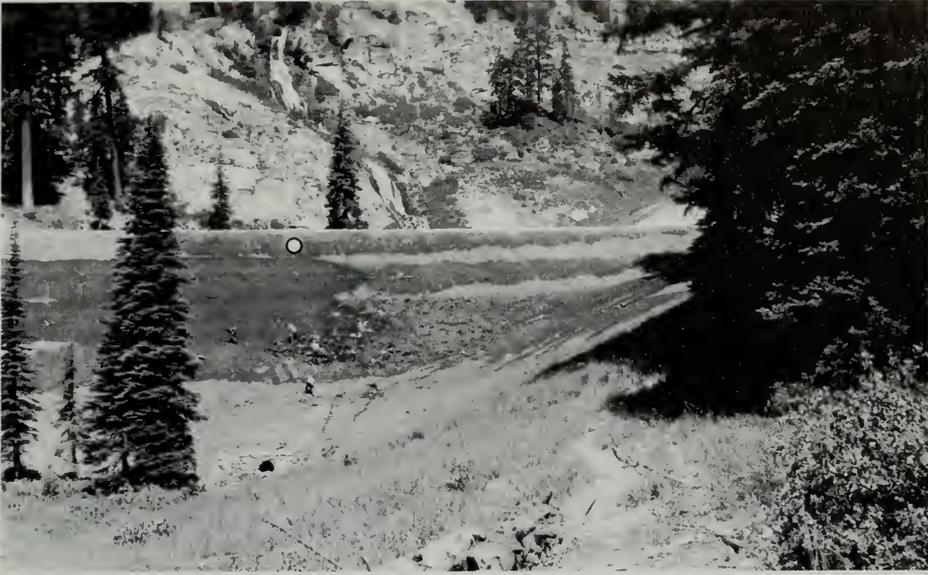
Planting the fill “below” Vidae Falls, 1939. Darker areas indicate the sprinkler system in operation. *Lange, CLNPMAC.*

Introduction of the fill spanning Vidae Creek constituted what Lange termed as the “major landscape problem” in 7-E2. He reported that it required more than 1,000 yards of topsoil in preparation for planting the entire slope as part of making the fill conform to surrounding terrain. This effort required more than 5,000 plants, shrubs, and trees. Al Lathrop, formerly one of Lange’s assistants for CCC work, had charge of a crew numbering ten men and paid by the contractor. They needed sixteen days to plant a mix of species that included willows, mountain hemlock, huckleberry, purple-flower honeysuckle (twinberry), and spirea. A sprinkling system was needed so that the plantings on the fill could initially be watered every day, then two or three times per week until early autumn. Lange described the source of water as a “reservoir” built at the “head” of Vidae Falls, located about 100 feet above the fill and out of sight from Rim Drive. From there a three inch line was placed to one side of the falls and connected to smaller lines spaced about 30 feet on centers across the planted slopes of the fill. He estimated it might take two or three seasons for the planting beds to provide the desired effect.<sup>46</sup>

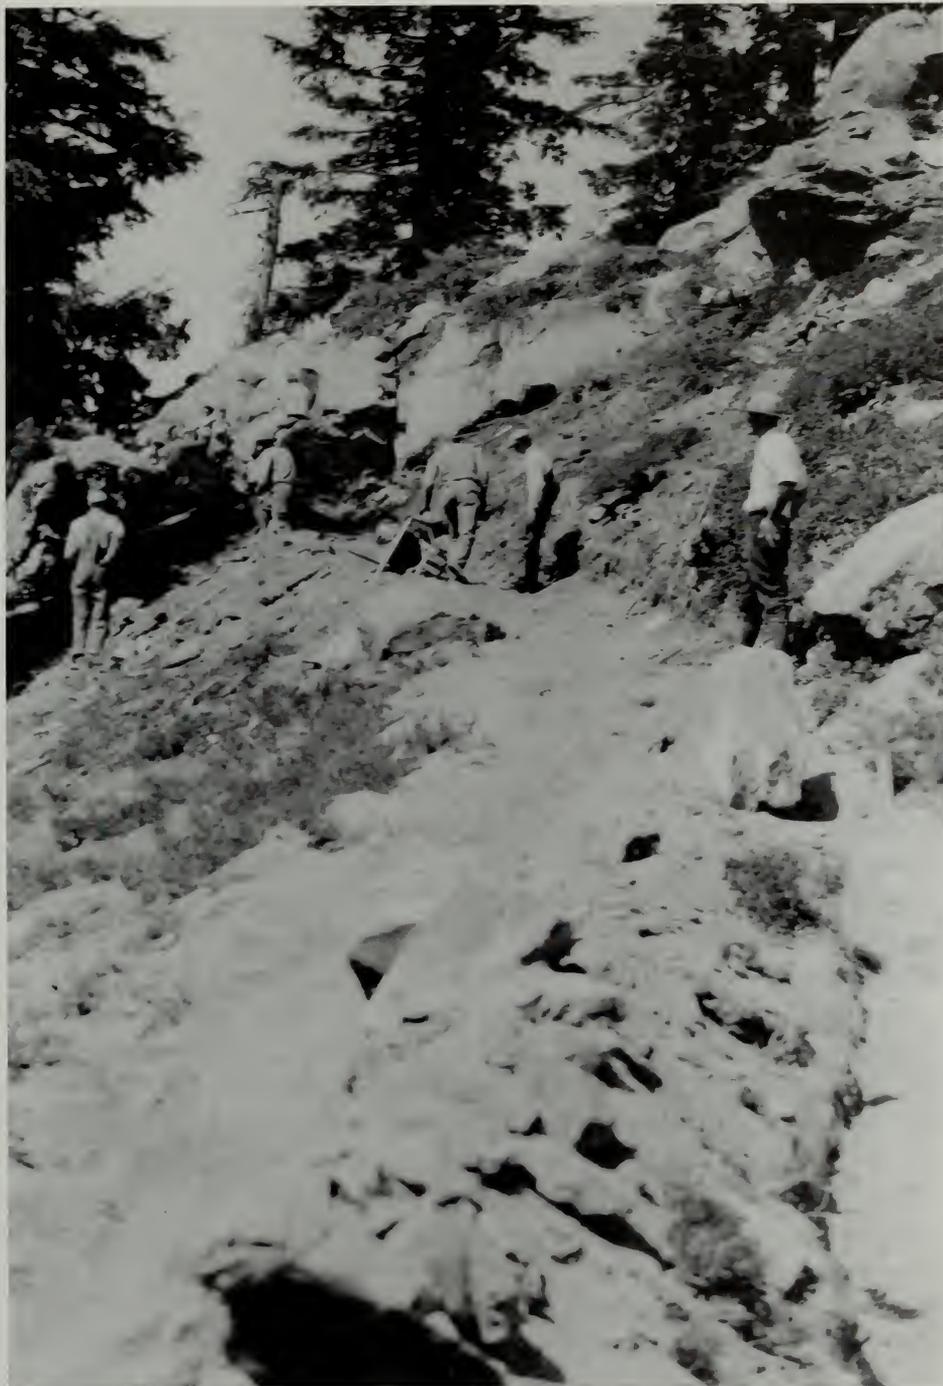
Crew building the Discovery Point Trail, 1932. *Sager, NARA, RG 79, SB.*

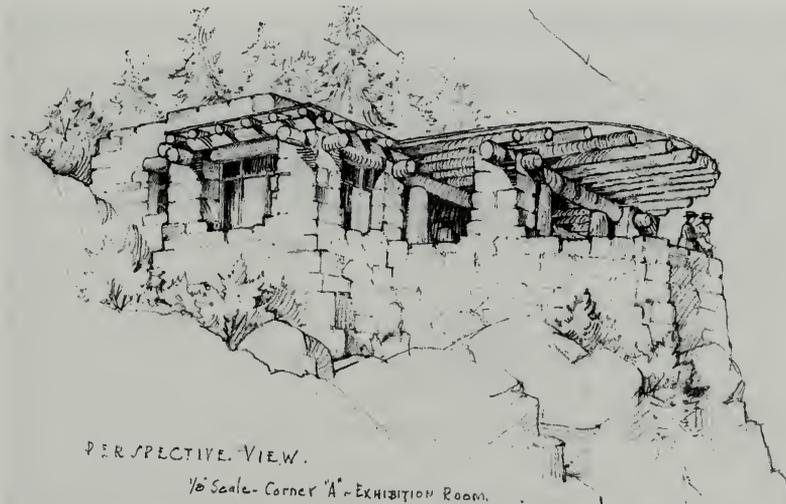
Preliminary sketch of the Sinnott Memorial by A. Paul Brown, 1929. At that point the design showed great affinity to the Yavapai Station at the Grand Canyon. *Lange, CLNPMAC, 10137.*

Built in 1930, the Sinnott Memorial’s design borrowed heavily from the slightly larger Yavapai Station erected on the south rim of the Grand Canyon in 1927. Merriam was the main force behind both buildings and saw to it that each incorporated an open porch or parapet along with an enclosed display room or museum. Merel Sager drew the plans for the Sinnott Memorial, but Merriam expressed the underlying purpose of the building as
