# Rim Drive Cultural Landscape Report Crater Lake National Park, Oregon

Stephen R. Mark  
Jerry Watson

USDI – National Park Service

2009

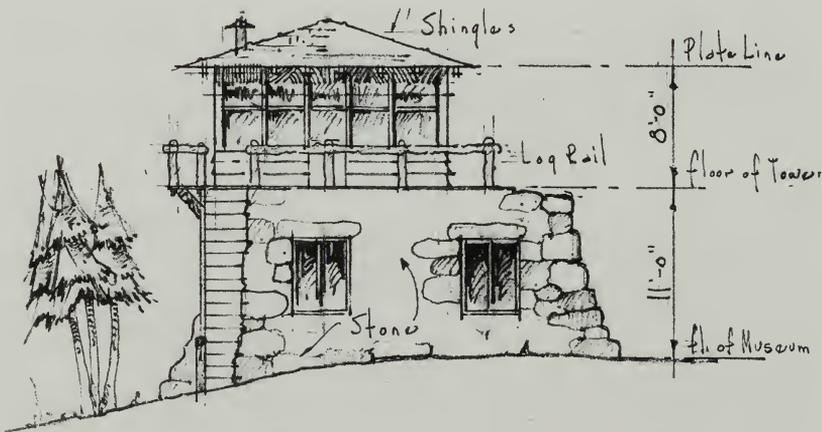
Sketch of the Watchman Lookout by Lange, June 1931. *CLNPMAC*, 10137.

Apparent success with reaching visitors at the Yavapai Station prompted NPS Chief Naturalist Ansel Hall to suggest in early 1930 that a fire lookout planned for the Watchman be enlarged to accommodate an “educational lookout station or branch museum” on the lower floor.<sup>54</sup> Albright and Merriam received copies of Hall’s letter to Solinsky, and by March, landscape architect Charles E. Peterson had prepared a sketch for the building that included an elevated lookout with a “trailside museum” adjoining it but at ground level next to a “terrace” on the lake side. After making a more definite study of the building’s location, Sager sent Hall a revised sketch by Lange in June 1931 incorporating all three elements. An allotment of \$5,000 and the final drawings prepared by Lange allowed laborers to complete most of the building that summer. Work at the site continued in 1932, at which time workmen built a masonry parapet wall around the point in front of the building along with a bituminous walk. Hall installed field glasses for the use of visitors, as part of reinforcing the dual purpose of the structure.

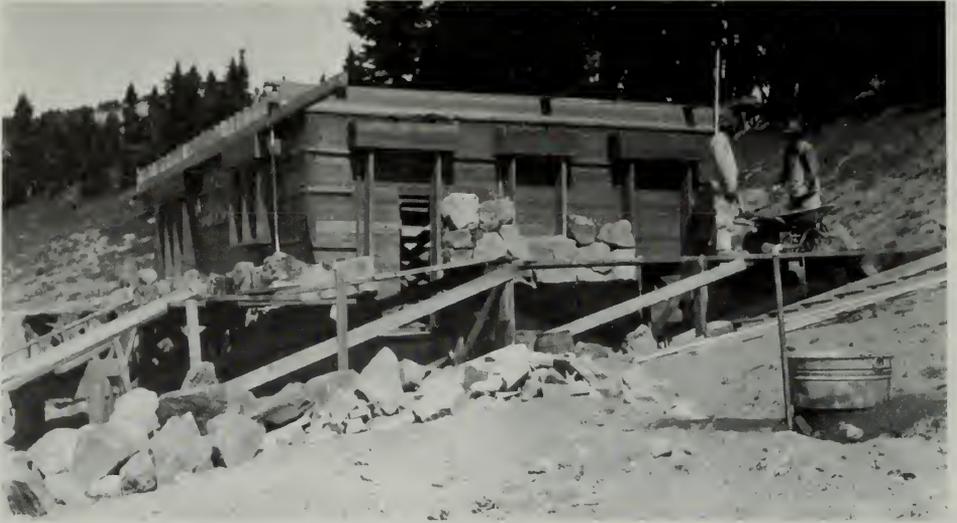
The North House with construction in progress, 1930. *CLNPMAC, 8889-147.*

Visitors arriving through the park's north entrance obtained their first view of Crater Lake at the Diamond Lake Junction, where the NPS a ranger station had been built that became known to employees as the "North House" in 1930. The initial design for exterior walls called for logs, but Sager drew the final plans to specify the use of stone masonry in line with the precedent established at Rim Village. It contained public restrooms, made possible by piping water from a spring located near the Devil's Backbone, with an office situated between them. In being slightly recessed into a gentle slope back from the rim, the structure provided an attractive seasonal residence that could also double as a visitor contact facility. Nevertheless, the park's master plan started calling for its removal in 1939, since improvement of the North Entrance Road (route 8) in the interim allowed for fee booth and associated quarters to be located next to the park boundary.

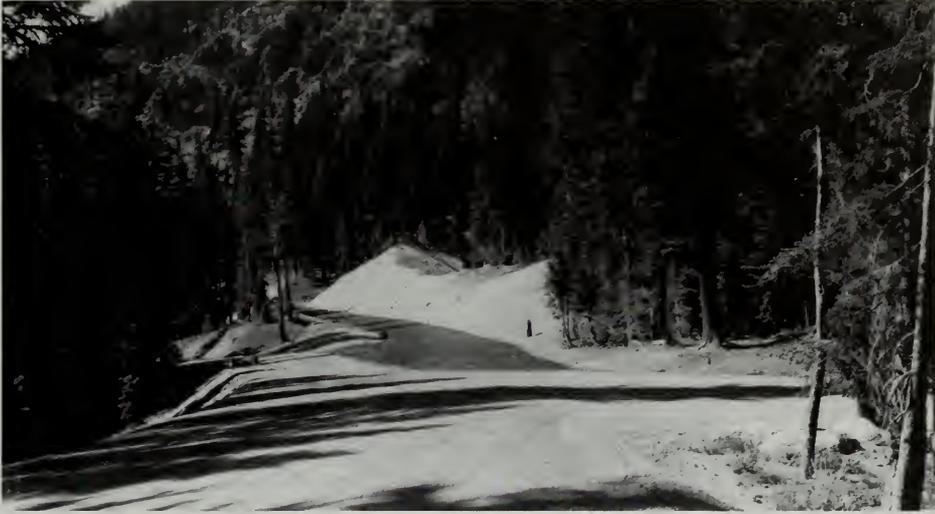
Site of the proposed checking station near Kerr Notch, 1939. The Pinnacles Road is at left, with Rim Drive (segment 7-D1) at center. *Lange, NARA, RG 79, SB.*

A development seen as complementary to the Diamond Lake Junction was briefly considered for Kerr Notch near the end of 1936, though not referenced in the site plan by Lange for a parking overlook. Envisioned for the junction of Rim Drive and the East Entrance Road, a ranger station similar in size and appearance to the North House would take the place of a log structure built in 1917 near the park boundary some seven miles distant. Crews razed the latter structure in 1938, but the new ranger station at Kerr Notch did not materialize even though the building could have used the same water system that allowed use of a drinking fountain at the parking overlook.

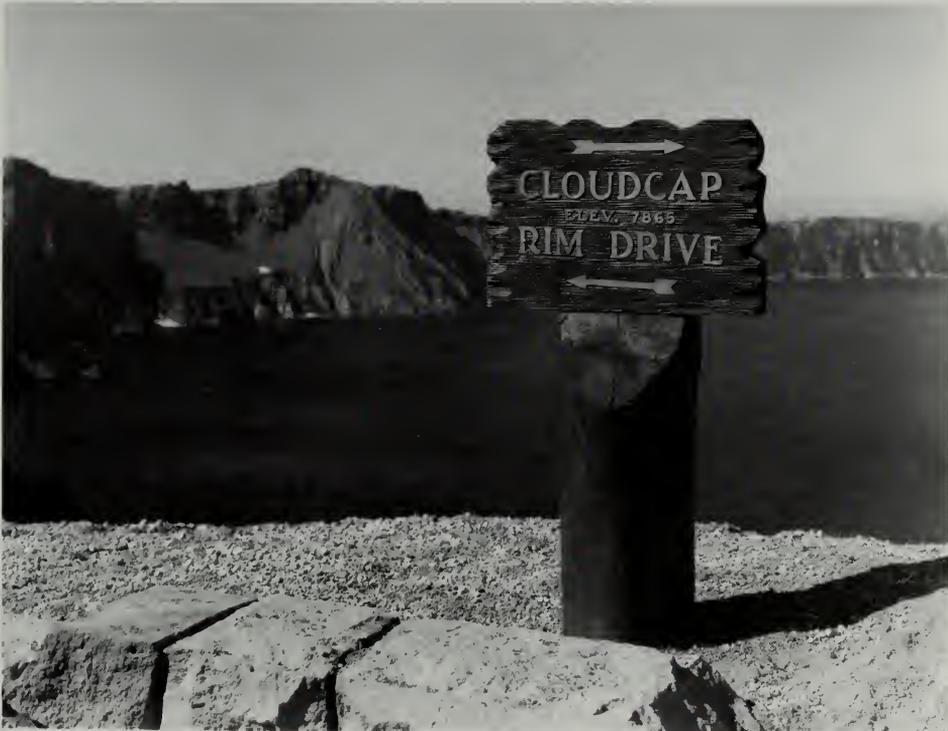
A typical directional sign placed along segment 7-C1, 1938. *Lange, NARA, RG 79, SB.*

Customized signage for Rim Drive evolved from a CCC project begun in 1936 at Park Headquarters that aimed to replace various types of metal signs posted throughout the park. Enrollees produced hand-carved wood signs of varying sizes with raised letters painted chrome orange (for visibility at night) against a dark brown background, based on Lange's drawings of entrance, directional and building signs. Their production and placement greatly accelerated over the summer of 1938 after establishing an outdoor workshop at the CCC camp near Annie Spring. Lange reported that 200 signs had been completed by November, including some that identified parking areas and points of interest on Rim Drive. Through photographs in his season-ending report, he attempted to show how this type of sign possessed good visibility, if properly placed, for conveying mileage and direction on Rim Drive. These examples included signs mounted in triangular configuration at road junctions and others slotted into bollards.

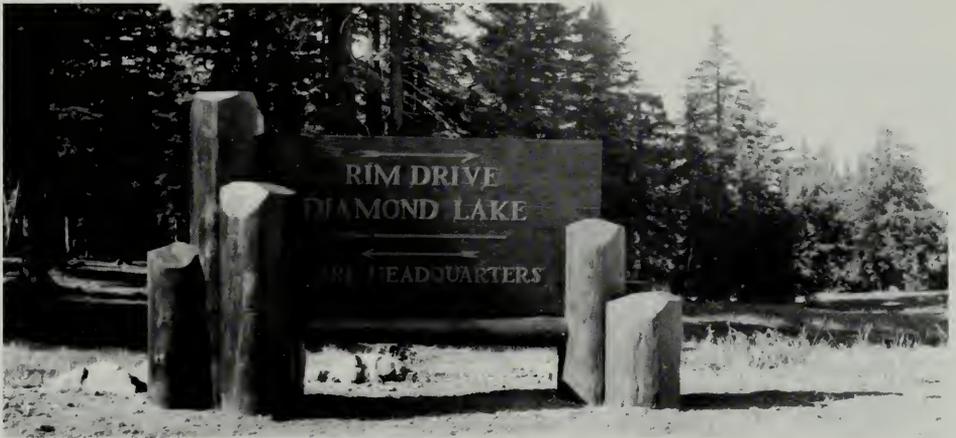
Directional sign slotted into bollards near Rim Village, 1938. *Lange, NARA, RG 79, SB.*

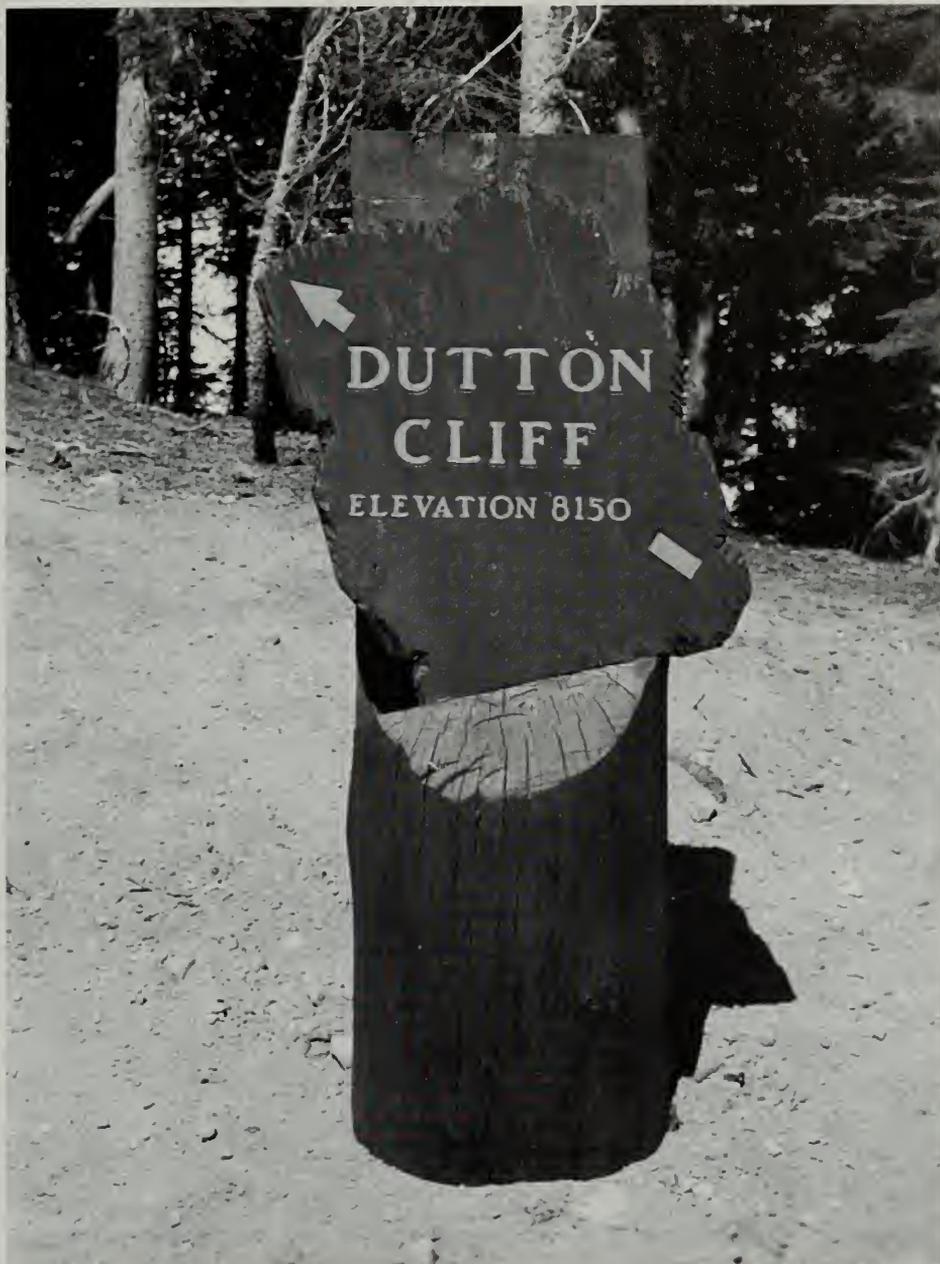
Sign used to indicate a point of interest, 1939. *Lange, CLNPMAC, 8885-4078.*

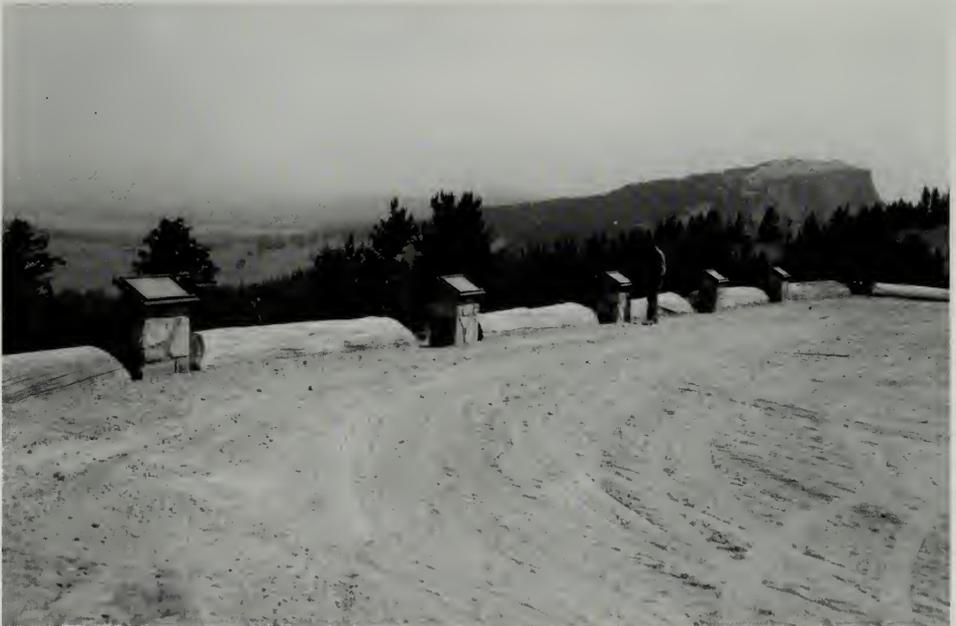
The “Diamond Lake Overlook,” with wayside exhibits place between the log guardrails in 1959. *CLNPMAC*.

Construction of stone bases for the wayside exhibits began in 1958 under a contract, with work taking place intermittently through the next four seasons. In most places complementary to the masonry guardrails, the five bases built at the Diamond Lake Overlook were free standing at first, filling the gaps originally left for placing boulders between the log barriers. A new masonry parapet was built to incorporate the bases at this site by 1963, but it and another section of guardrail added over the following decade failed to match the original masonry guardrail constructed elsewhere along Rim Drive.<sup>61</sup>

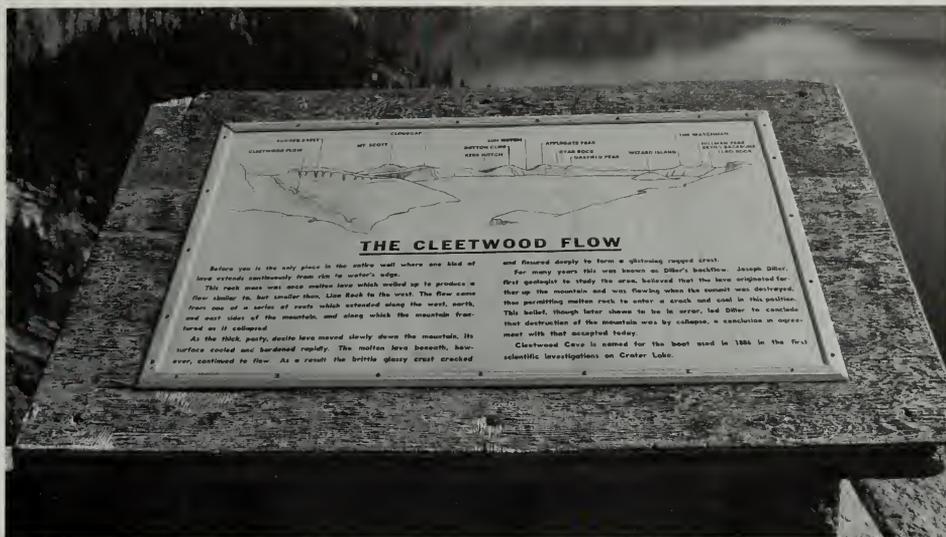
Metalphoto interpretive plaque. *Jerry Watson.*

The interpretive panels proved to be the most problematic part of wayside exhibits since the routed plastic could not hold up to direct sun, windblown pumice, moisture, and vandalism. Routed aluminum soon became the favored material in some locations, but the NPS began replacing panels with the more durable metalphoto plaques by 1966. The latter type of interpretive marker lasted for more than two decades before these were superseded by a new set of fiberglass exhibit panels beginning in 1987. Neither generation of wayside exhibit panels, however, achieved the thematic unity in their content as envisioned by the interpretive concept statement composed for the park's master plan in 1972.<sup>62</sup>

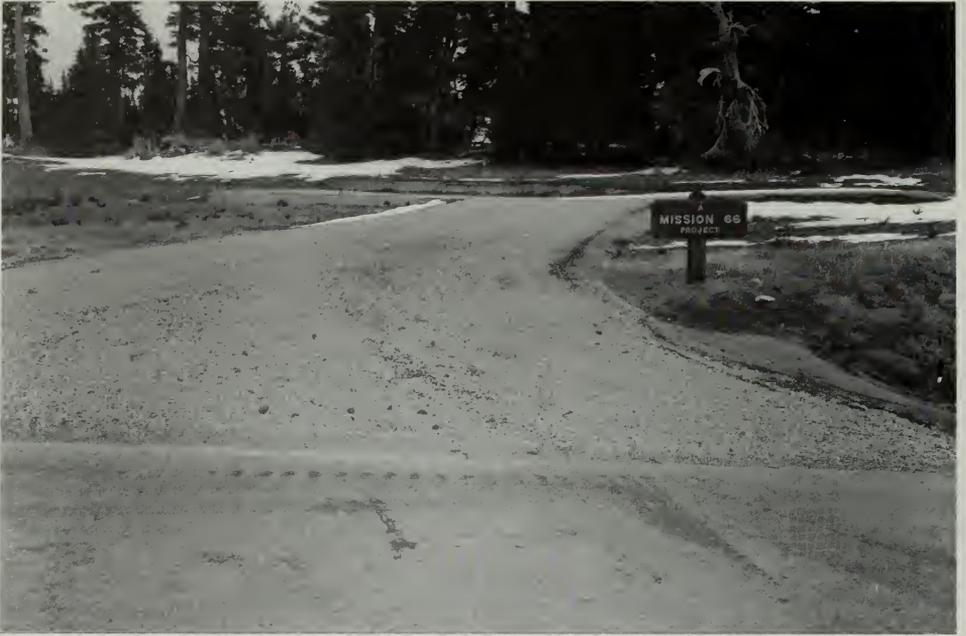
Road grading at the Discovery Point picnic area, 1957. *CLNPMAC, 8885-631.*

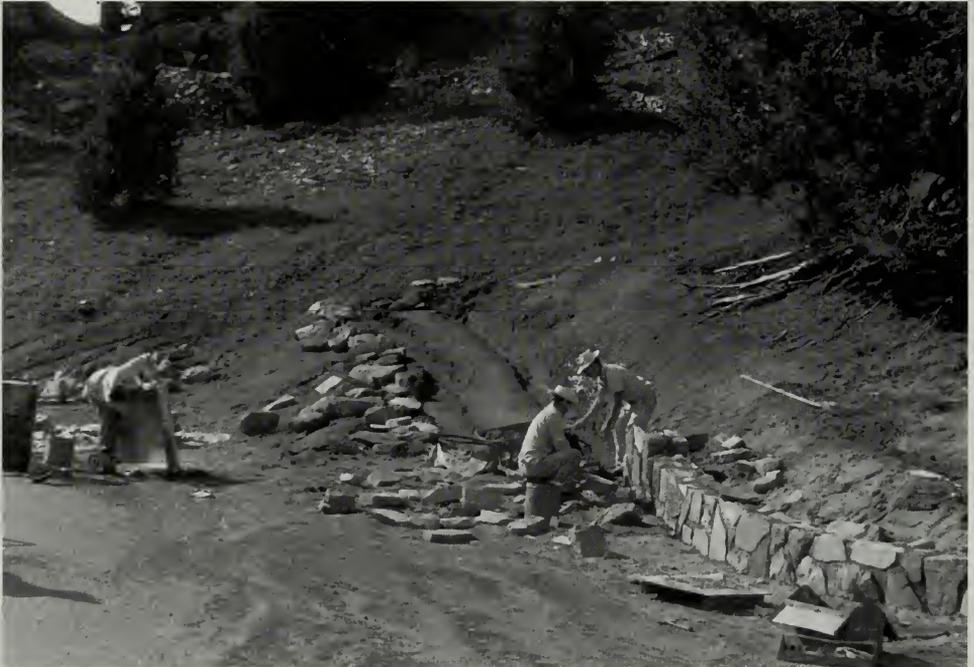
Contractors building masonry wall on the Discovery Point Trail, 1958. *Rundell, CLNPMAC.*

Other changes along segment 7-A also affected related original designed features in the form of trails, buildings, and signs. Funding from Mission 66 allowed contractors to repair parts of the Discovery Point Trail (a project that included adding masonry wall near the parking area) and to pave the path leading from an unsurfaced parking area near the Devil's Backbone to the top of that volcanic dike. The most ambitious trail project along the west Rim Drive, however, took place in 1994. It aimed to provide hikers on the Pacific Crest Trail with an alternative to a route through the park that followed a series of fire roads and lacked any view of Crater Lake. By connecting the Discovery Point Trail with pieces of the old Rim Road, this alternative route required volunteers and day labor to build 2.5 miles of new tread in order for hikers to reach the Diamond Lake Junction on a trail.<sup>69</sup>

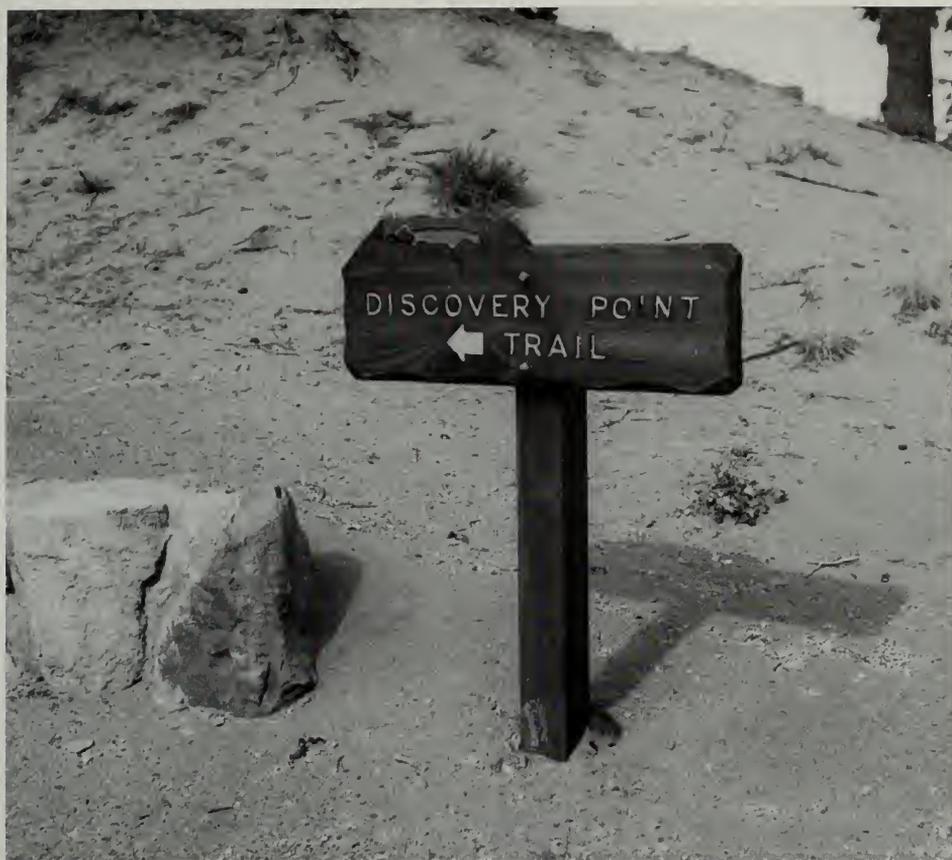
Resident landscape Architect John S. Adams developed a new style of routed wood sign for trailheads like the one near Discovery Point during the early years of Mission 66. *Bruce Black, CLNPMAC, 8885-393.*

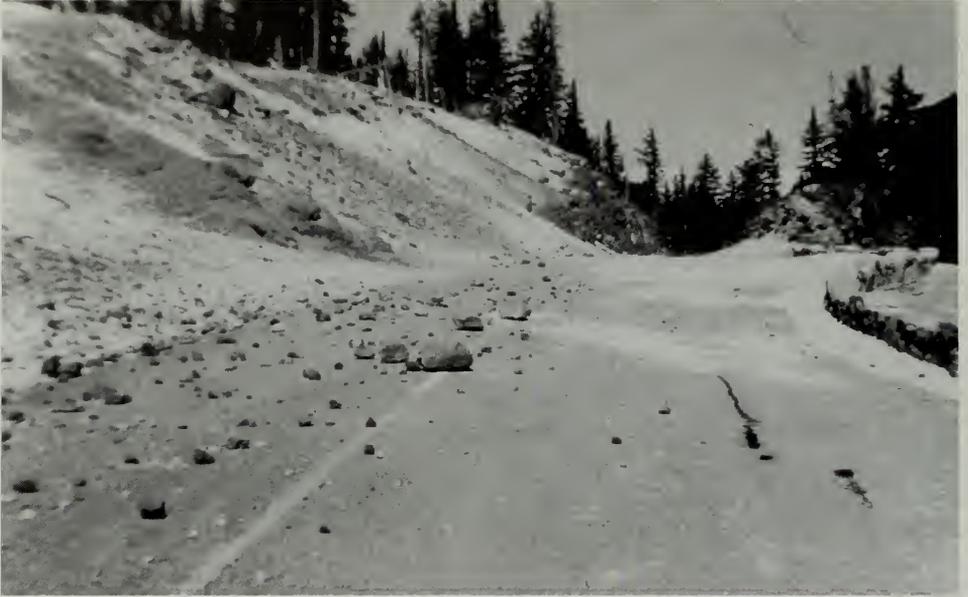
Raveling on the road cut above Cleetwood Cove. *CLNPMAC 8898*.

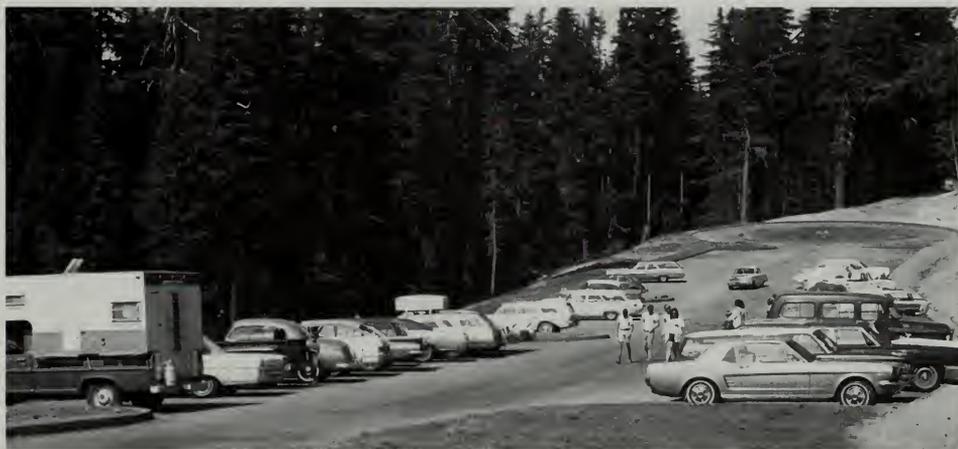
Cleetwood Cove parking area, 1967. *K. R. Cranson, CLNPMAC.*

Parking at the Cleetwood Cove trailhead initially consisted of simply widening the road shoulders, but this solution quickly became inadequate. The resident NPS landscape architect, Joseph T. Clark, responded in July 1961 with a site plan for a lot holding 100 cars. He proposed an assembly area at the trailhead, one to be separated from the road by metal guardrail. The plan also called for an elongated parking area across Rim Drive from the trailhead, oriented perpendicular to the road instead of parallel. With an adequate entranceway, the parking lot site might also be large enough to allow development of a picnic area with some 30 tables or even a

Grading the lot above Cleetwood Cove began in the fall of 1961, but lack of water effectively limited development of amenities other than parking to portable toilets and five picnic tables. These facilities became inadequate as the number of boat tours increased over the next two decades, so landscape architect Joe Dunstan sketched several alternatives aimed at relieving poor circulation and overcrowding in 1991, primarily as a starting point in design. Little in the way of changes resulted from this effort, with the only additional development at the site resulting from a spillage problem associated with fuel delivery to the tour boats. The Fee Demonstration Program thus funded construction of a fuel transfer building faced with cut stone situated between the parking lot and Rim Drive in 1998.

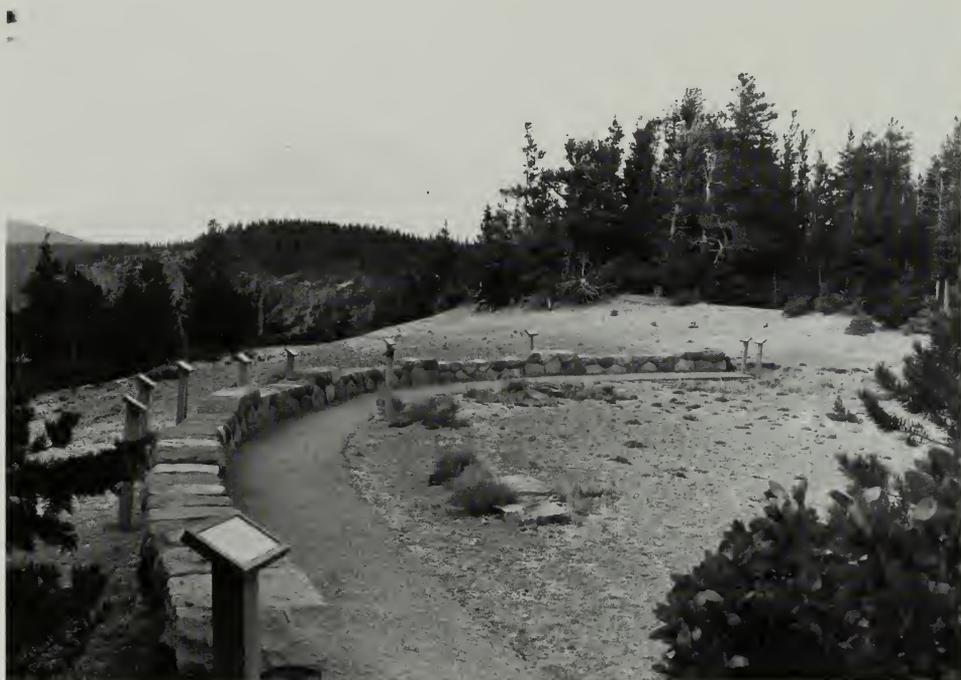
The Grotto Cove Nature Trail with masonry guardrail and metal photo plaques, 1968.  
*Cranson, CLNPMAC, 8885-2019.*

Cove Nature Trail) this type of interpretation persisted for only a decade. Established in 1968 to promote handicapped accessibility, the trail made use of small metal photo plaques mounted on posts along a masonry guardrail in order to identify plants along a paved walk originally built as part of the parking overlook.<sup>73</sup> Panels on stone bases appeared at five other points along segments 7-C and 7-C1 during Mission 66, with the only divergence from this type of marker being a wood routed signboard placed near the road loop on Cloudcap.

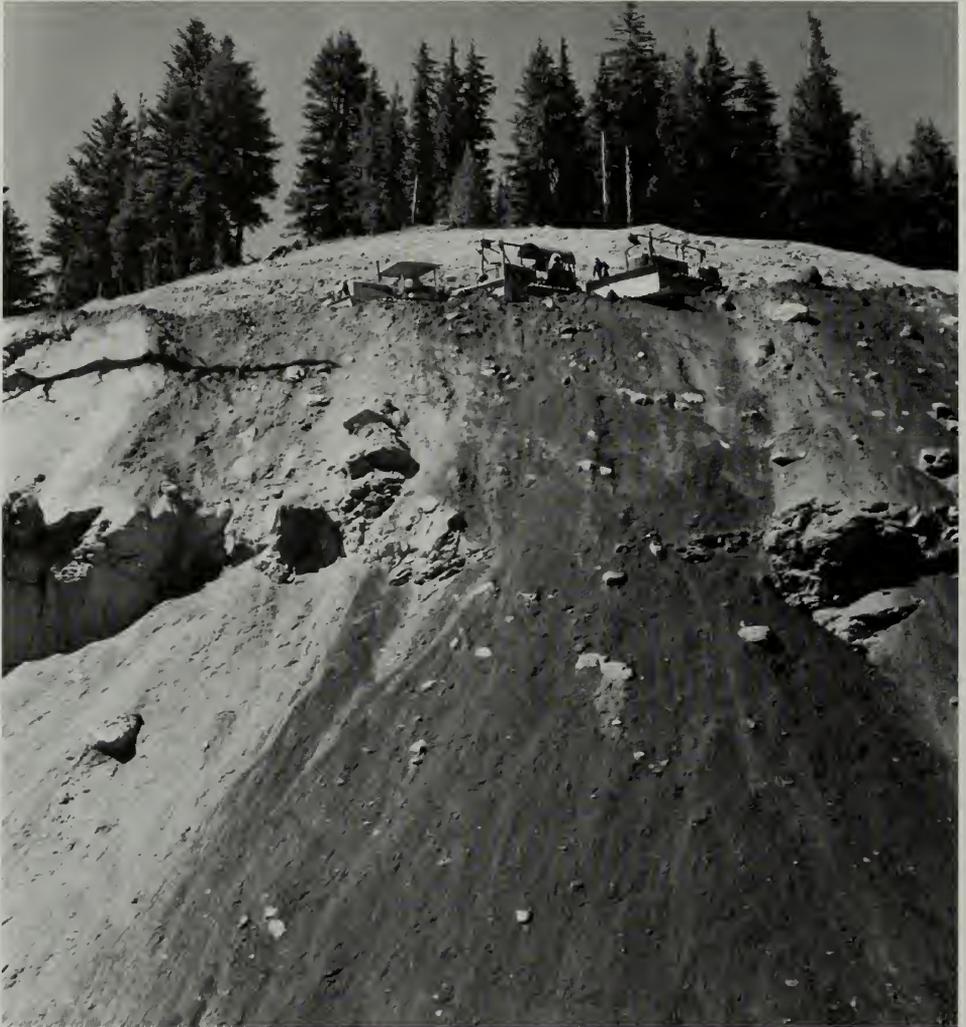
Scaling on Anderson Point, 1952. *CLNPMAC, 8885-4379.*

Paving of segment 7-C1 (along with 7-D and 7-E) during Mission 66 in some ways represented belated completion of the road construction begun more than 25 years earlier. In the interim, BPR helped the NPS address the most persistent maintenance problem on Rim Drive over the first decade or so of the road's existence, slides at Anderson Point that periodically closed the road. Through a minor change in alignment and measures aimed at slope stabilization, BPR engineers supervised laborers hired by the NPS so as to reduce the incidence of future slides at this location over the summer of 1952. Roughly 100 lineal feet of masonry guardrail replaced an earlier stone barrier along this section the following year in order to complete the project.<sup>75</sup>

<sup>75</sup> Much of the work involved excavating the slope above the road and placing a rock embankment below it; Plans for Proposed Project No. 7-C1, Slope Stabilization, Crater Lake Rim Road, 1951, sheets 2 and 3 of 13. The slope is described by H.S. Shilko in a memorandum to the regional engineer, BPR, March 26, 1952, pp. 1-2. Only one other change to the designed landscape in 7-C1 was noted during the Mission 66 period. This consisted of removing trees and leveling a small area at the Kerr Notch Parking Area as part of expanding it; Superintendent’s Monthly Report, July 9, 1958, p. 6. Removing the steps leading to the Sentinel Point Trail and an opening in the in the masonry guardrail went undocumented, as did the disappearance of signs built by the CCC during the 1970s.

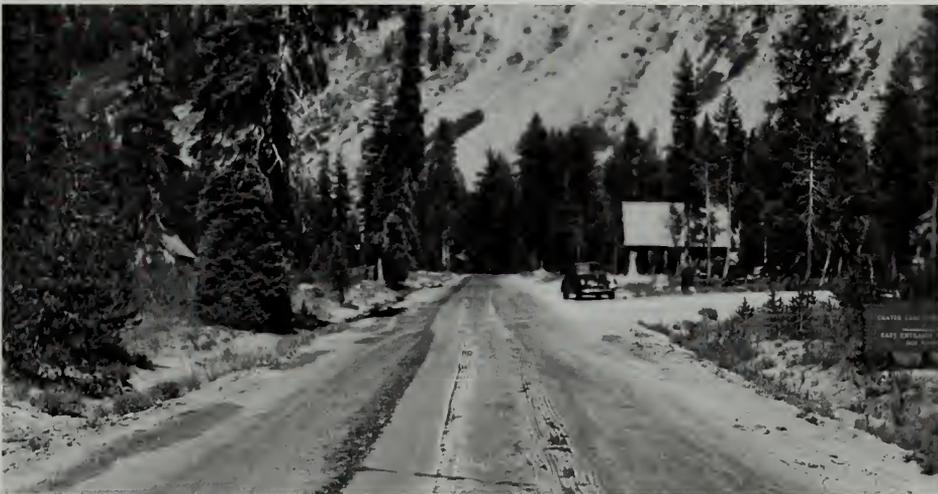
Terminus of Rim Drive at Park Headquarters during the mid 1950s. This intersection was realigned northward in 1958 to a point where it ran through the gas station building at right. CLNPMAC, 8885.

Aside from one road realignment near the intersection where Rim Drive terminated at Park Headquarters, virtually all of the postwar changes in this road segment took place in the vicinity of Vidae Falls.<sup>77</sup> Development of the Mazama Campground as a major Mission 66 project turned the attention of park officials away from overnight facilities below Vidae Falls, though grading for a picnic area took place in 1958 where the campground road built in concert with segment 7-E met the old Rim Road. Lack of adequate cross drainage for the loop road at this picnic area eventually led to rehabilitation of the site in 2001, a project that included placement of a vault toilet and new tables. At that point, the trailhead for the route to Crater Peak also became part of the picnic area, largely because parking for hikers had previously been situated on a blind curve near Tututni Pass.

<sup>77</sup> Realignment in 1958 moved the road junction near headquarters about 200 feet north of its former location; John S. Adams, Drawing CL – 2267, “Suggested Road Relocation,” December 5, 1955, two sheets, Item 189, catalog 8899, CLNPMAC. It also resulted in obliteration of two buildings, a service station and restroom, constructed in 1926. A new gas station with restrooms was constructed that year across from the junction, but removed in 1991. The one change that took place at the Vidae Falls Parking Area was removal of the drinking fountain sometime after 1953, though the water system stayed largely in place. The fountain’s demise may have stemmed from contamination found in water samples; Superintendent’s Monthly Report, September 7, 1960, p. 4.

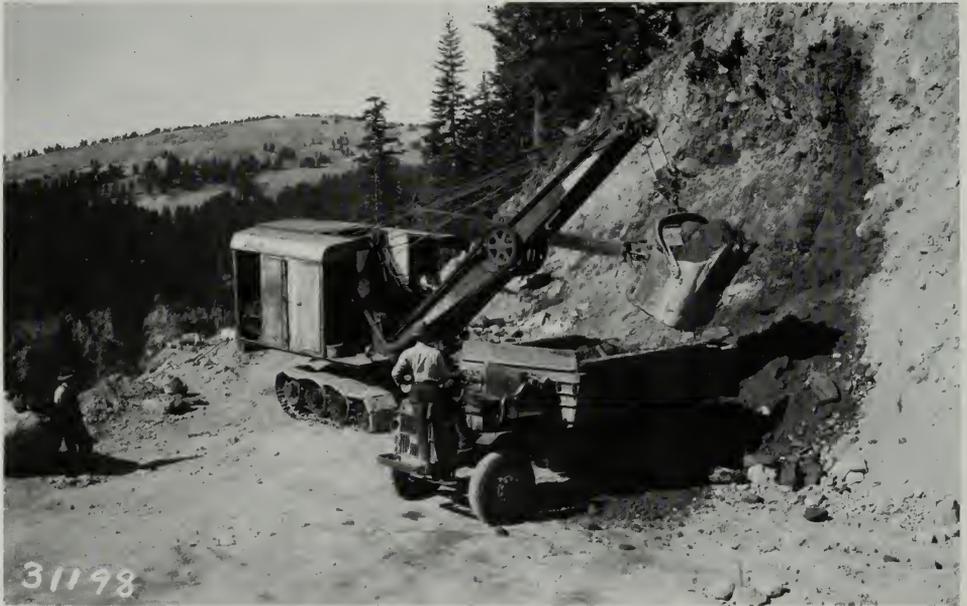
Excavating the cut at Anderson Point, 1937. Struble, BPR-FHWA.

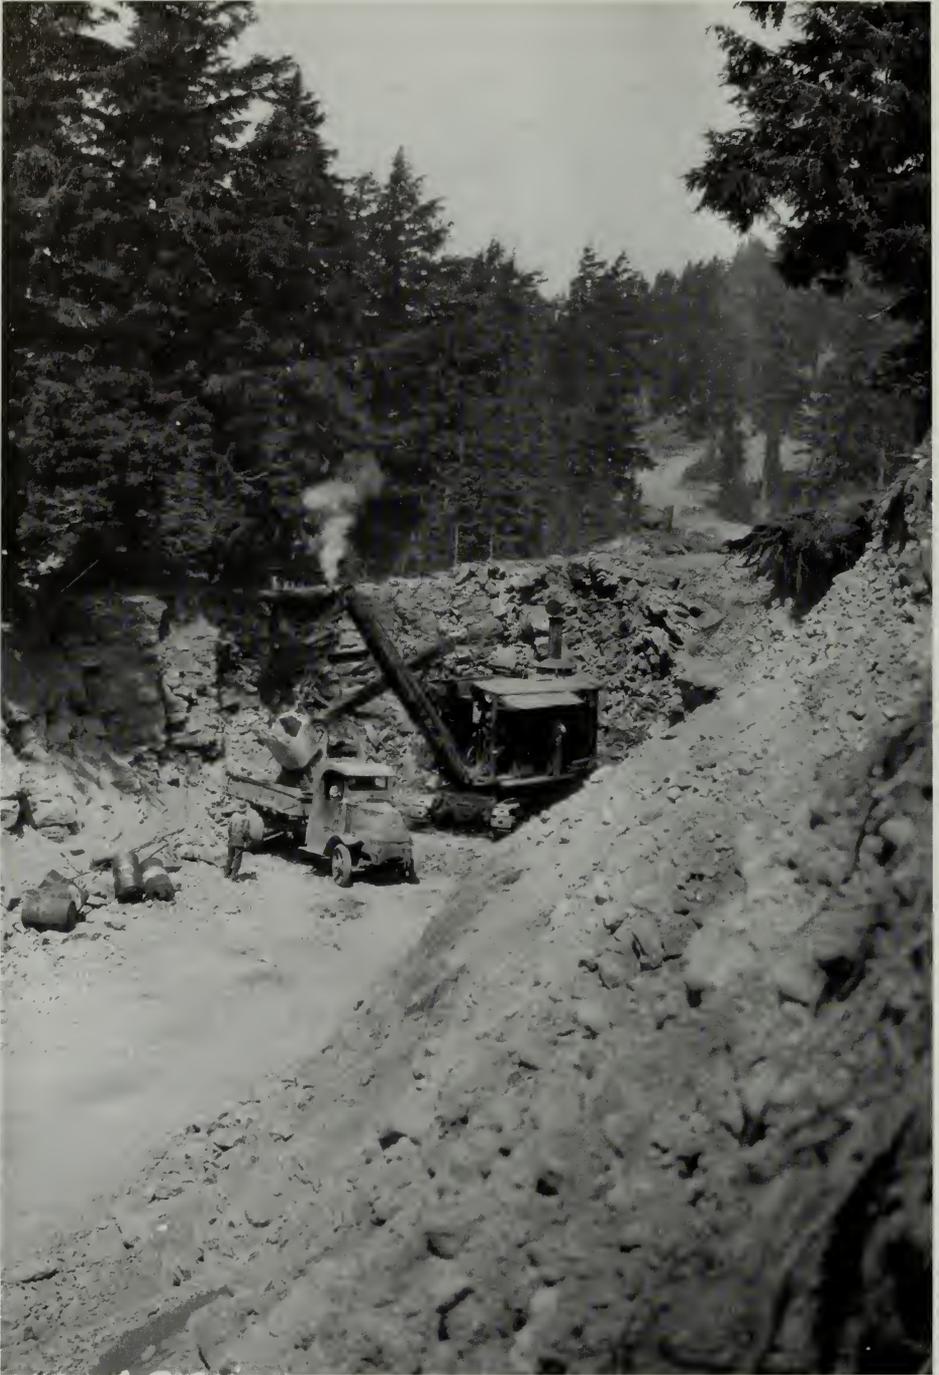
Steam shovel excavating at road station 130, segment 7-A, in 1932. *Sargent, BPR-FHWA.*

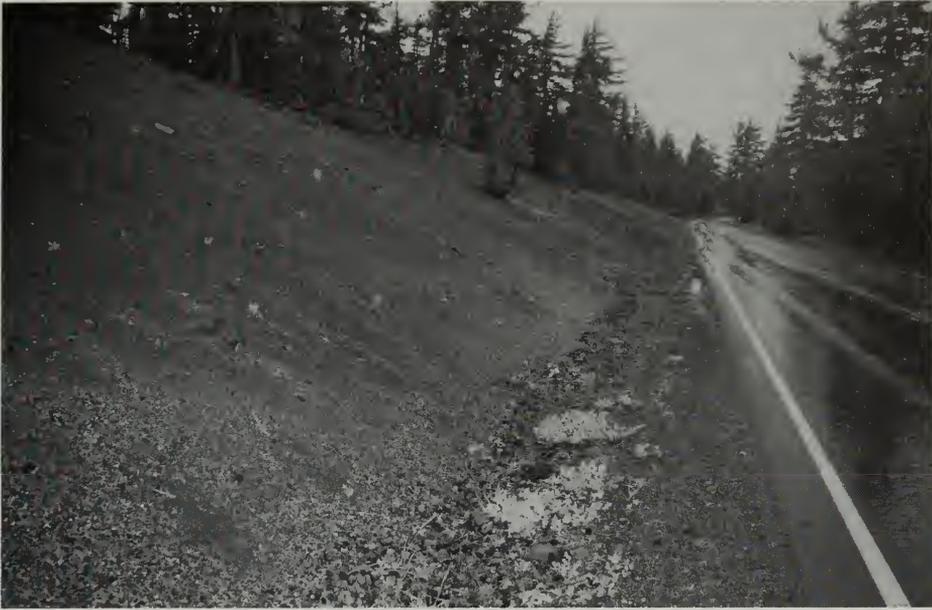
Typical section of Rim Drive showing a daylighted cut, road segment 7-B. *Steve Mark.*

The typical section for Rim Drive is a twenty-four foot bituminous-surfaced roadbed with an eight inches gravel sub-grade with two-foot shoulders on cuts but six foot shoulders on fills. The maximum gradient is eight percent, except on a small section near Mount Scott where a ten percent grade was used. Curves were designed with spiral transitions and super elevations based on a 35 miles per hour speed limit. At the heart of the road structure is its earth base, over which the wider roadway is imposed. Once grading was completed, crews placed a sub-grade of crushed one-inch minus rock. This was rolled, compacted, and covered with a surface of two inches of slow-curing bituminous material. Although black bituminous material known as asphalt has been used as a “wearing course” for centuries, (there are naturally occurring deposits of asphalt, or rock asphalt), the bituminous material used on Rim Drive is a by-product of refining crude oil. What motorists see as the road is its bituminous surface, one that consists of aggregate and asphaltic coatings, overtopped by a final “chip seal coat,” a layer of uncoated aggregate that gave it its coarse pebbled texture. The surface is durable and is resistant to the actions of most acids, alkalis, and salts. It is a very strong paving material able to sustain heavy traffic loads while remaining flexible enough to withstand environmental conditions and stresses.

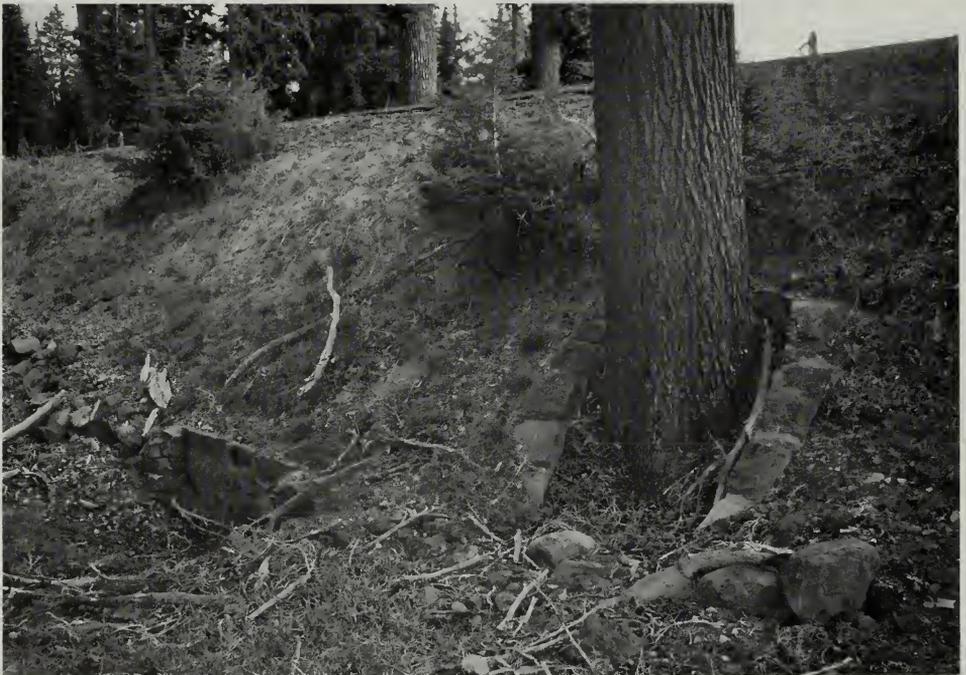
Tree protection device and culvert headwall visible on fill as part of road segment 7-A near the Discovery Point parking area. *Steve Mark.*

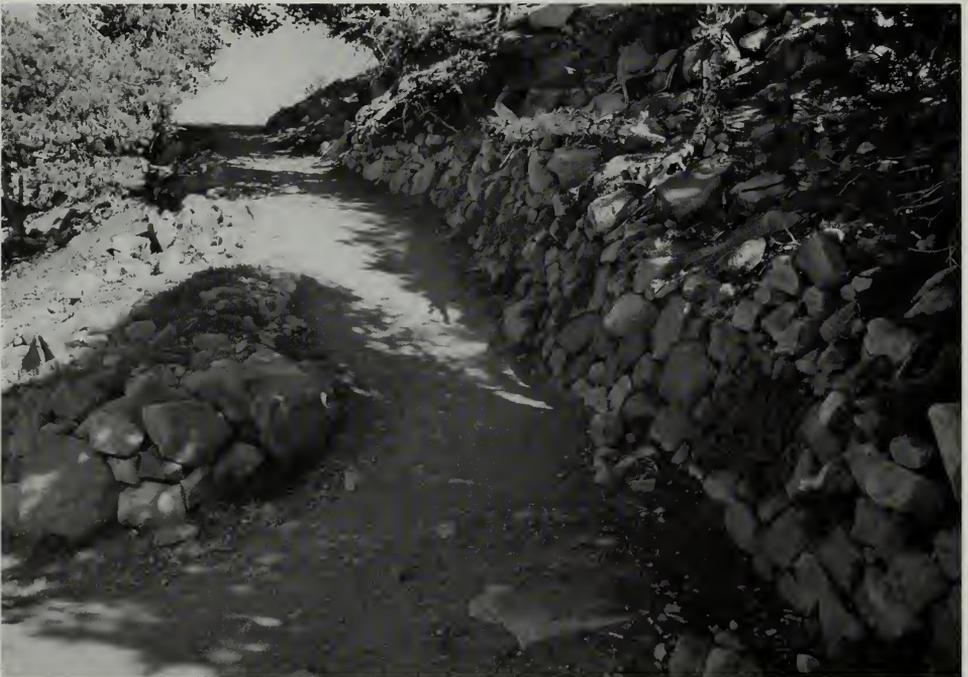
Dry laid retaining wall on the Watchman Trail. *Steve Mark.*

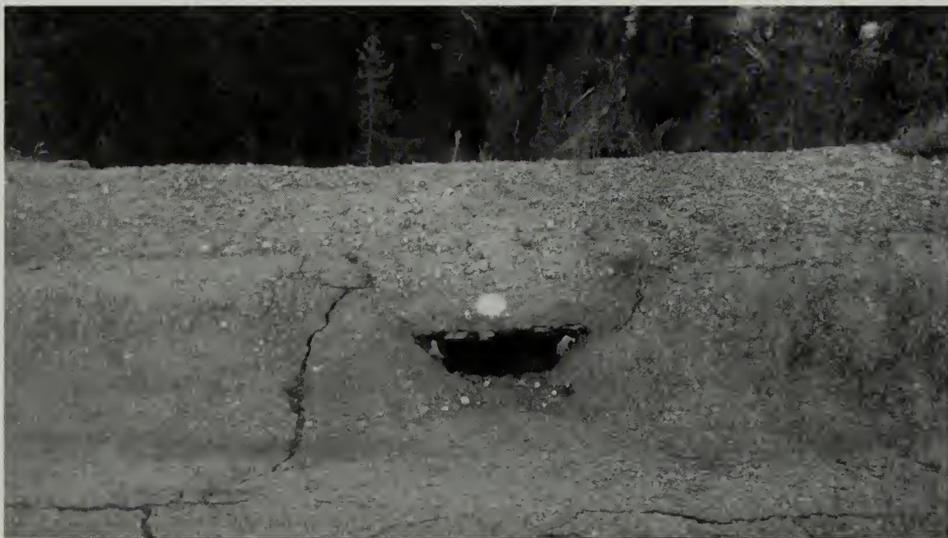
Opening for a drop inlet. *Jerry Watson*

The other type of drainage utilizes paved ditches on both sides of the roadway that lead to a drop inlet. They are effective because they resist abrasion by traffic and reduce water penetration. Open bituminous surfaced road drains or “gutters,” generally found along road margins in segments 7-B and 7-C, are easily inspected for blockages and can be constructed relatively quickly and inexpensively, but are also effective at draining road sub-grades--provided they flow to adequate outfalls. Water flows to these roadside ditches or gutters, which are connected to drop inlets. The inlets then carry the water in a culvert down the slope to a discharge area below the roadbed. The quantities of water to be drained depend on rainfall intensity, duration, and frequency, along with the size and character of areas drained. Their design is normally predicated on short and intense summer storms, thus winter snowpack runoff can sometimes overload this type of drainage system.

Concrete catch basins and steel sloped culverts are examples of drop inlets found on the margins of Rim Drive in segments 7-D and 7-E. A drop inlet is normally used to drop low to medium volumes of water over a sharp incline of 30 percent or more. Drop inlets on Rim Drive usually consist of two components, a vertical pipe and a horizontal pipe. The drop pipe can be square or round in cross-section and is constructed of concrete or corrugated steel. Drop inlets on road margins of Rim Drive allow rapid removal of surface water, with the entry point normally concentrating the flow to a small area. This point can plug with debris, or local scouring can occur, due to the high velocity of the water. Protection of the bed and edges of what is a permanent watercourse was accomplished by means of rock armor, gabions, and headwalls at the point of entry in order to prevent erosion by water discharging from pipes during peak runoff.

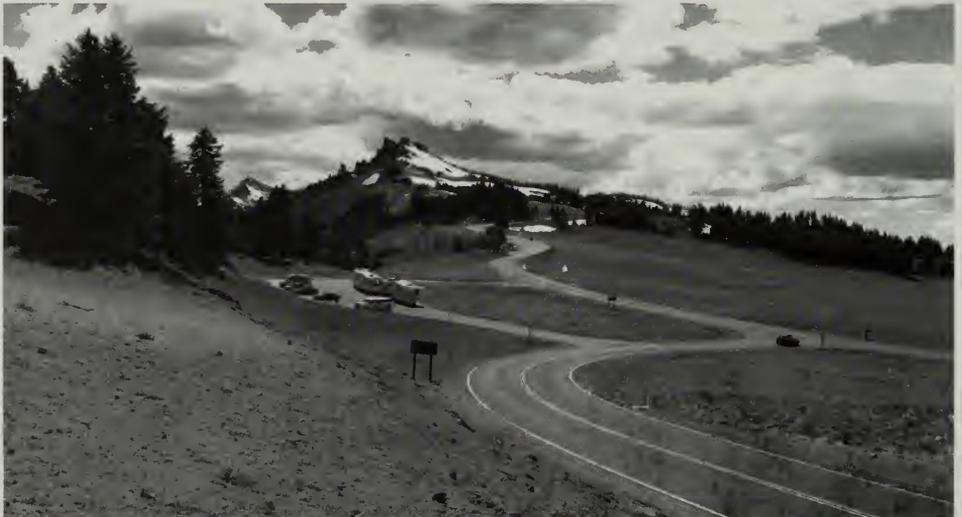
North Junction parking area and Rim Drive. *Jet Lowe, HAER.*

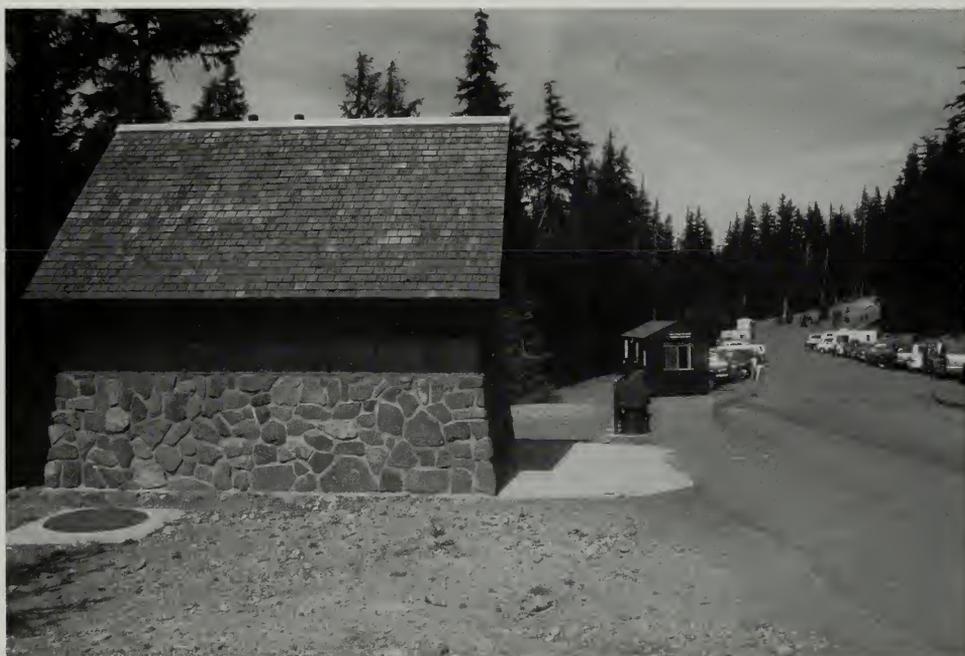
Fuel transfer building and Cleetwood Cove parking area. *Jerry Watson.*

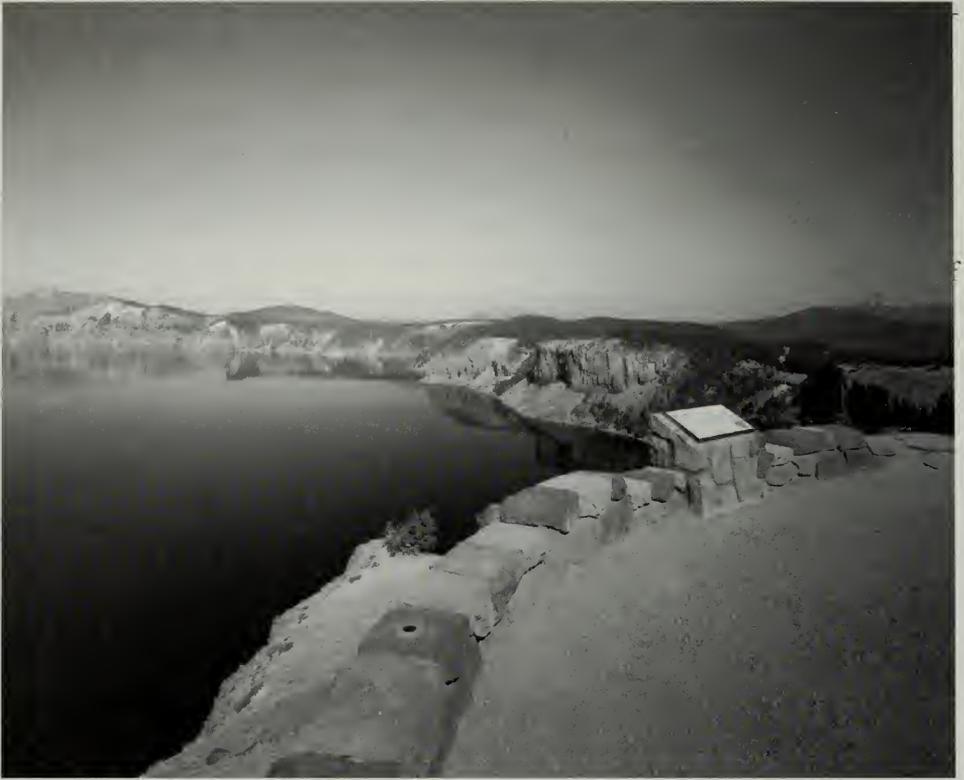
Section of parapet wall at Skell Head with the wayside exhibit mounted on a stone masonry base. *Jet Lowe, HAER.*

plan from 1984 prompted park staff to replace most of the metalphoto plaques with fiberglass panels in 1987-88. All of the panels were mounted on stone bases built to match the character and integrity of the original masonry guardrails and parapet walls. A few of the bases are free-standing, but some of the panels are mounted vertically by means of long steel posts.

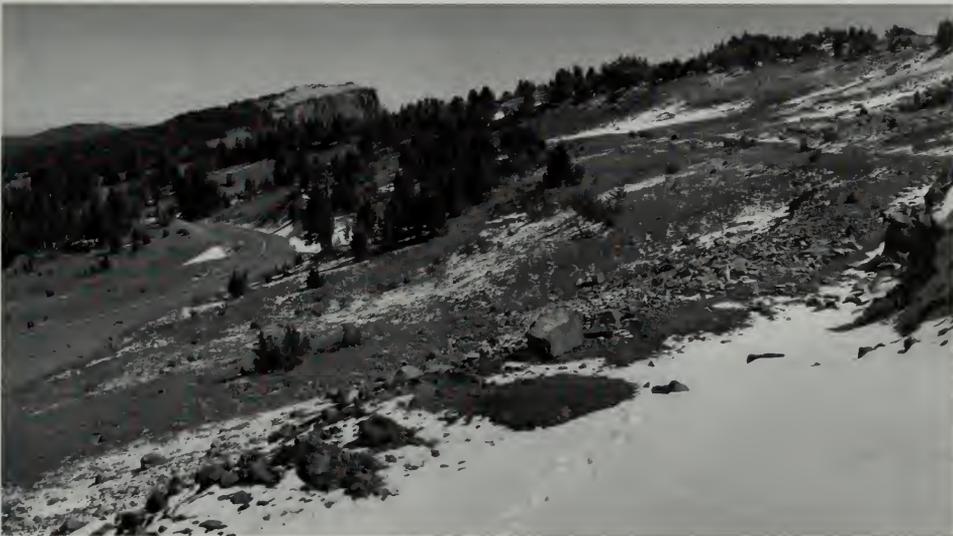
Old Rim Road in the foreground with Rim Drive at left. *Jet Lowe, HAER.*

Most of the planting done as part of “old road obliteration” consisted of small trees chosen to match the composition of surrounding forests. They were to provide screening from the view of motorists and pedestrians who might otherwise easily discern the old Rim Road’s alignment from Rim Drive. Most of this work occurred in four of the five road segments (7-B, 7-C, 7-D, and 7-E) and involved mountain hemlock, Shasta red fir, and whitebark pine, depending upon what was already thriving at the site that required screening. Most of the planted specimens are extant, and seven decades later are part of an indecipherable native forest holding segments of the old Rim Road. Much of the west Rim Drive (segment 7-A) was not planted, so the old road has remained visible, especially where the alignment occurred above the newer circuit. These visible sections were converted to a hiking trail in 1994, following something of a precedent set by the NPS in 1932 when it incorporated a short (0.3 mile) section of the old road into the Watchman Trail.

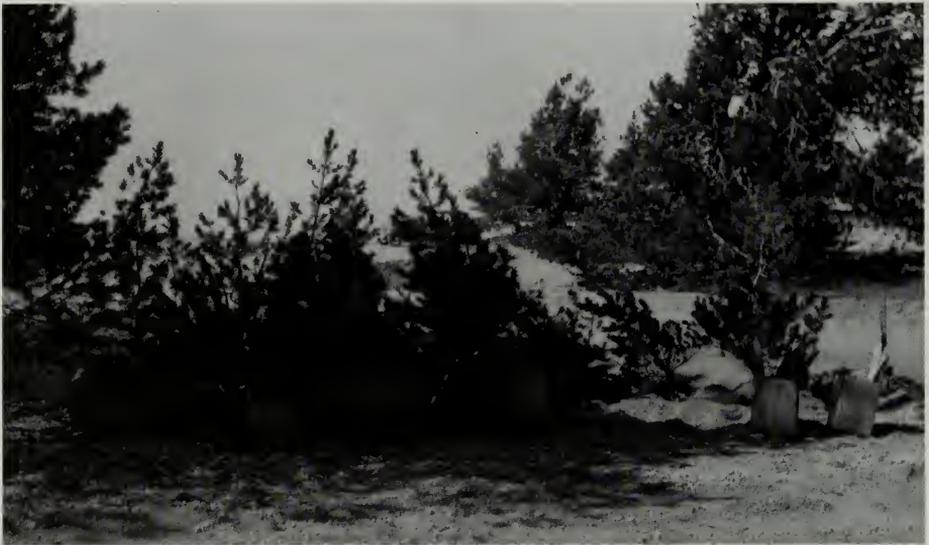
Whitebark pine ready for special planting at Cloudcap, 1935. *Lange, NARA, RG 79, SB*

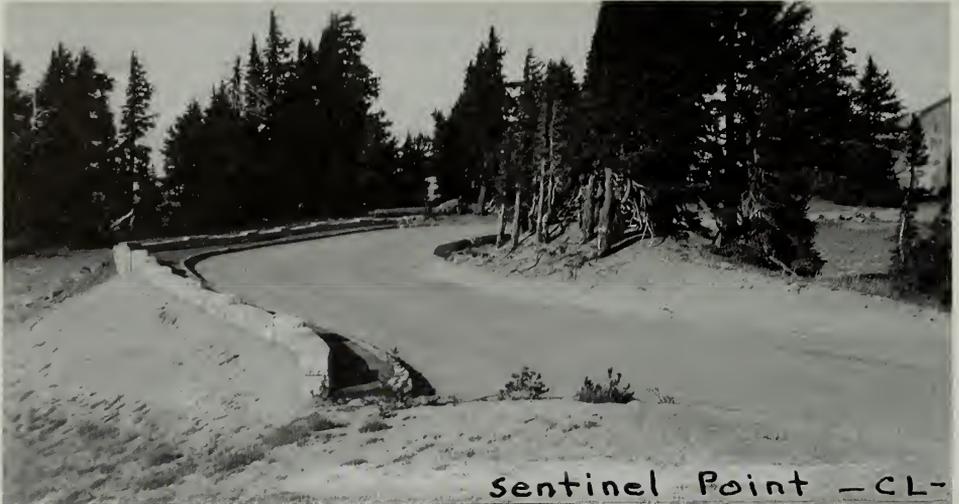
This parking overlook (later called “Victor View”) as it appeared when complete in 1938. Note the small amount of fill at left. *Lange, CLNPMAC.*
